January 12, 2017

**Subject: Arborist Assessment Report
Higgs Beach Park at Atlantic Boulevard
Key West, Monroe County, Florida
E Sciences Project Number 7-0313-001**

November 28th, 2016 Tree Disposition Table (updated per E Sciences' field assessment on January 5th, 2017)

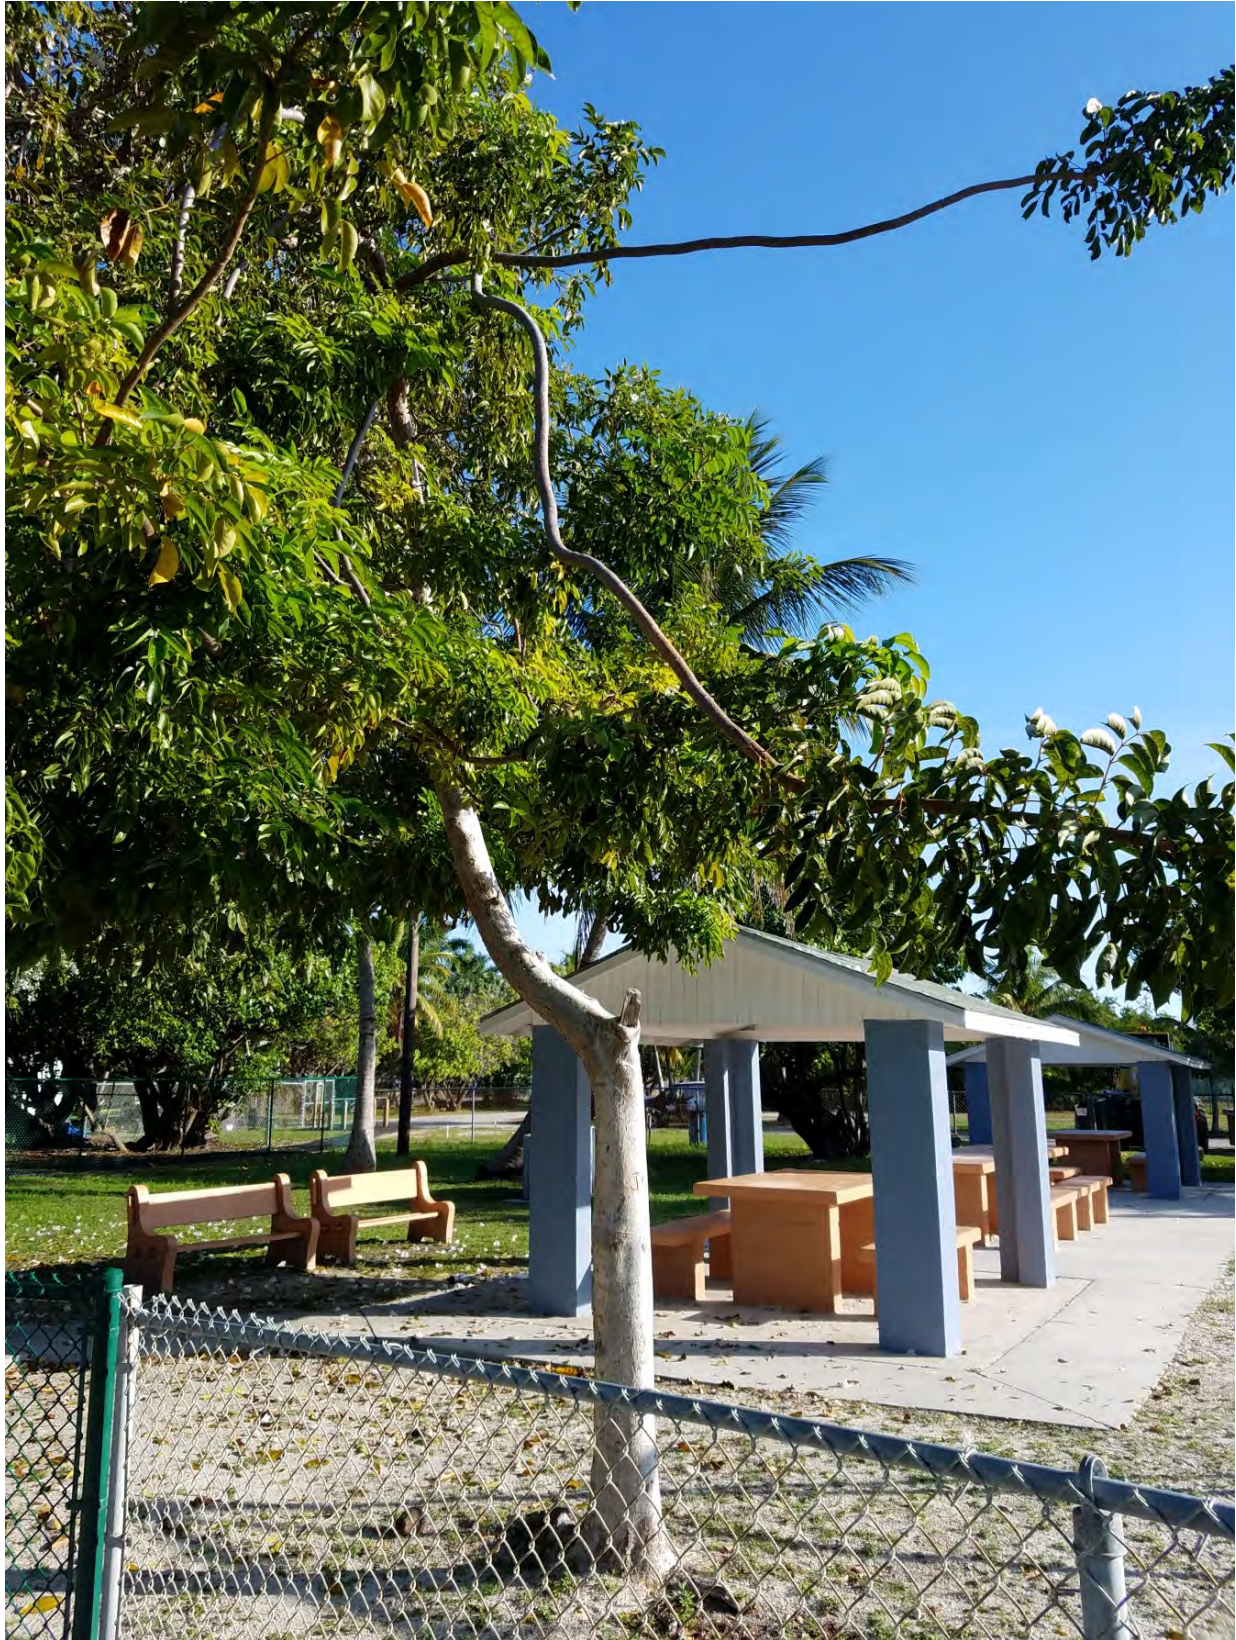
Photo 9 – Tree No. 209.

E Sciences determined that trees proposed for relocation were suitable candidates, with the exception of three trees (numbers 187, 209, and 214). These three trees were determined to be in poor condition due to a variety of defects (i.e. significant canopy reduction, significant defoliation, etc.). Based on the poor condition of these trees, relocation is not recommended due to the reduced likelihood of transplant survival. The "disposition" values of these trees, along with the corresponding mitigation values, were adjusted accordingly in the tree data table (see **Attachment 1**).

LD-05	207	Cocos nucifera	Coconut Palm		30 GW		Good								GOOD	Remain						
LD-05	208	Cocos nucifera	Coconut Palm		25 GW		Good								GOOD	Remain						
LD-05	209	Bursera simaruba	Gumbo Limbo	9	13	14	Poor	Reduced Canopy (Major)	Lopsided					9	FAIR CONDITION - In the way of construction	Remove	1					
LD-05	209A	Thespesia populnea	Portia		30-35		N/A								LARGE CLUMP / INVASIVE - No mitigation required	Remove						1
LD-05	210	Bursera simaruba	Gumbo Limbo				Fair	Discolored Foliage			Fertilization					Remain						
LD-05	211	Thespesia populnea	Portia		30-35		N/A								LARGE CLUMP / INVASIVE - No mitigation required	Remove						1
LD-05	212	Bursera simaruba	Gumbo Limbo	4	7	3	Poor	Reduced Canopy (Major)							BAD STRUCTURE	Remove	1					
LD-05	213	Bursera simaruba	Gumbo Limbo	10	12	8	Good/Fair	Stubs			Crown Cleaning				FAIR CONDITION -In the way of construction	Relocate				1		
LD-05	214	Bursera simaruba	Gumbo Limbo	5	10	9	Poor	Defoliated (Moderate)	Reduced Canopy (Moderate)					11	FAIR CONDITION -In the way of construction	Remove	1

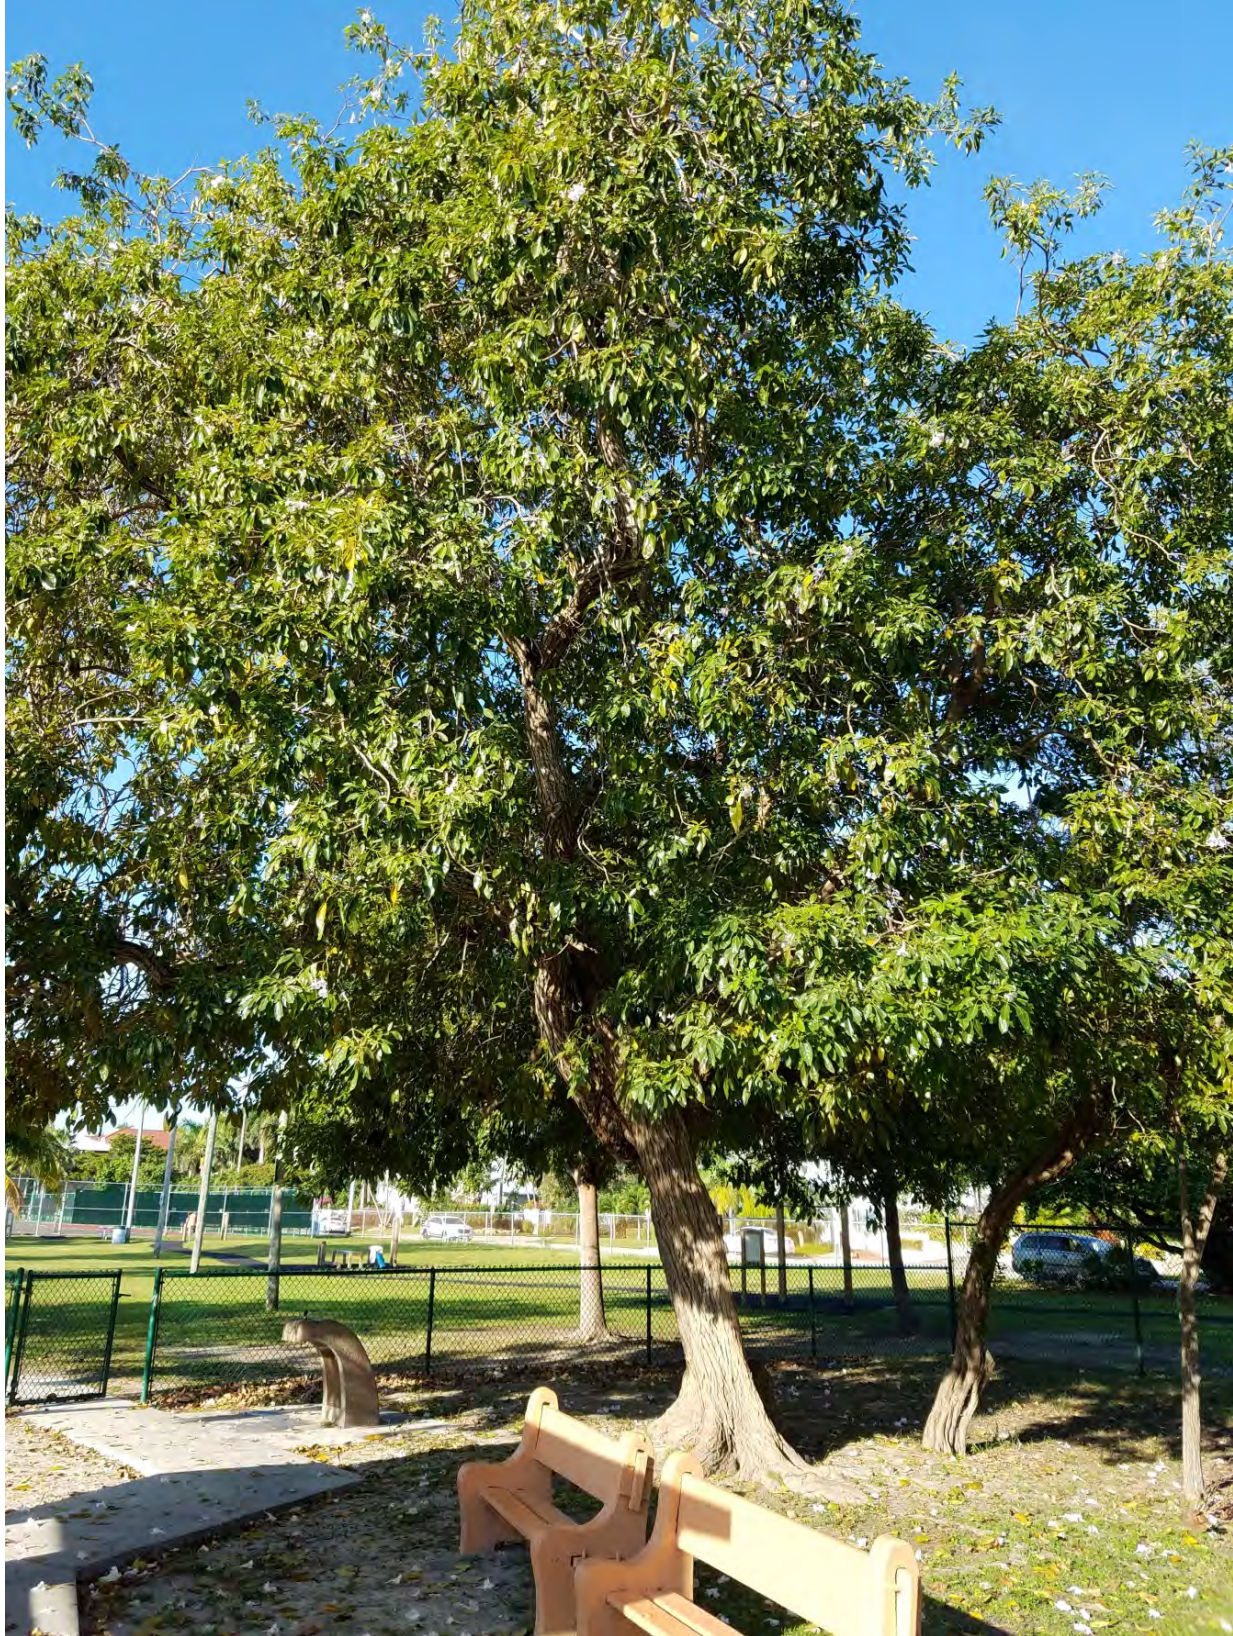
Photo 10 – Tree No. 200B.

Three Category 1 trees (numbers 200B, 473, and 507) were found to be in fair or better condition with issues including slightly lopsided canopies, sprouting/stubs, and recumbent growth form. No significant structural damage or decay was observed with these trees that would indicate a higher likelihood of failure. Consequently, these trees should be considered for preservation vs. removal, with remediation efforts (e.g. structural pruning, crown cleaning) performed where recommended.

LD-05	200B	Tabebuia sp.	Tabebuia	38	45		Fair	Lopsided Canopy	Sprouting		Structure Pruning	Crown Cleaning		10	FAIR-To be evaluated by a Certified Arb.	Remain						
LD-05	200C	Thespesia populnea	Portia				N/A								LARGE CLUMP / INVASIVE - No mitigation required	Remove						1
LD-05	200D	Thespesia populnea	Portia				N/A								LARGE CLUMP / INVASIVE - No mitigation required	Remove						1
LD-05	200E	Thespesia populnea	Portia				N/A								LARGE CLUMP / INVASIVE - No mitigation required	Remove						1
LD-05	200F	Callistemon citrinus	Bottlebrush	12			Fair	Co Dominant Leaders, Included Bark	Trunk Damage (Moderate)		Structure Pruning					Remain						
LD-05	200G	Conocarpus erectus sericeus	Silver Buttonwood	10			Fair	Poor Structure							BAD STRUCTURE	Remove	1					
LD-05	200H	Cardia sebestena	Orange Geiger	7			Fair	Poor Structure							BAD STRUCTURE	Remove	1					
LD-05	201	Cocos nucifera	Coconut Palm		25 GW		Good								GOOD	Remain

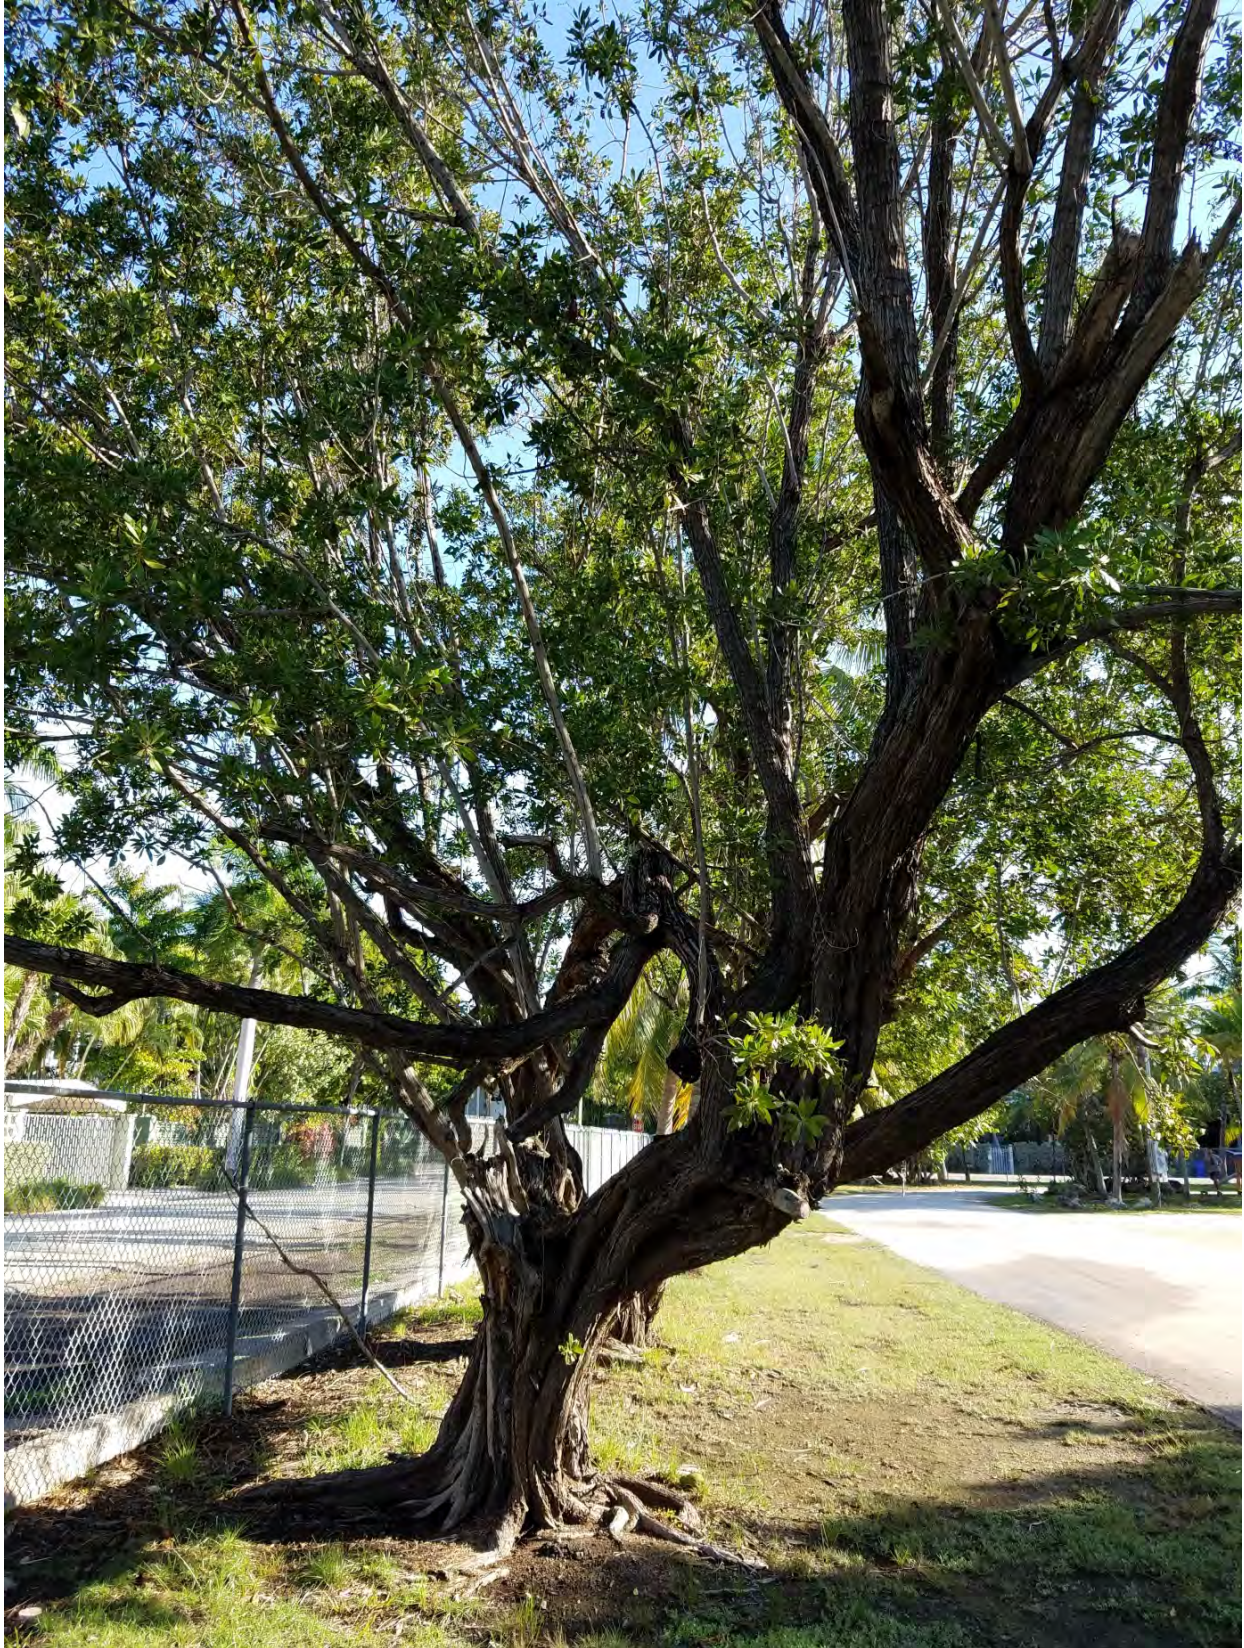
Photo 12 – Tree No. 229.

However, one tree proposed to "remain" (number 229) was found to be in poor condition (i.e. major limb damage). The disposition for this tree was changed to "remove" on the tree data table due to the reduced likelihood of transplant survival.

LD-05	229	Conocarpus erectus	Green Buttonwood	30	35	35	Poor	Trunk Damage (Major)	Limb Damage (Major)					12	STRUCTURAL ISSUES	Remove	1					
LD-05	230	Conocarpus erectus	Green Buttonwood	54	30	50	Good/Fair	Stubs			Crown Cleaning				ACCEPTABLE	Remain						
LD-05	231	Cocos nucifera	Coconut Palm		40		Good/Fair	Discolored Foliage			Fertilization				GOOD	Remain

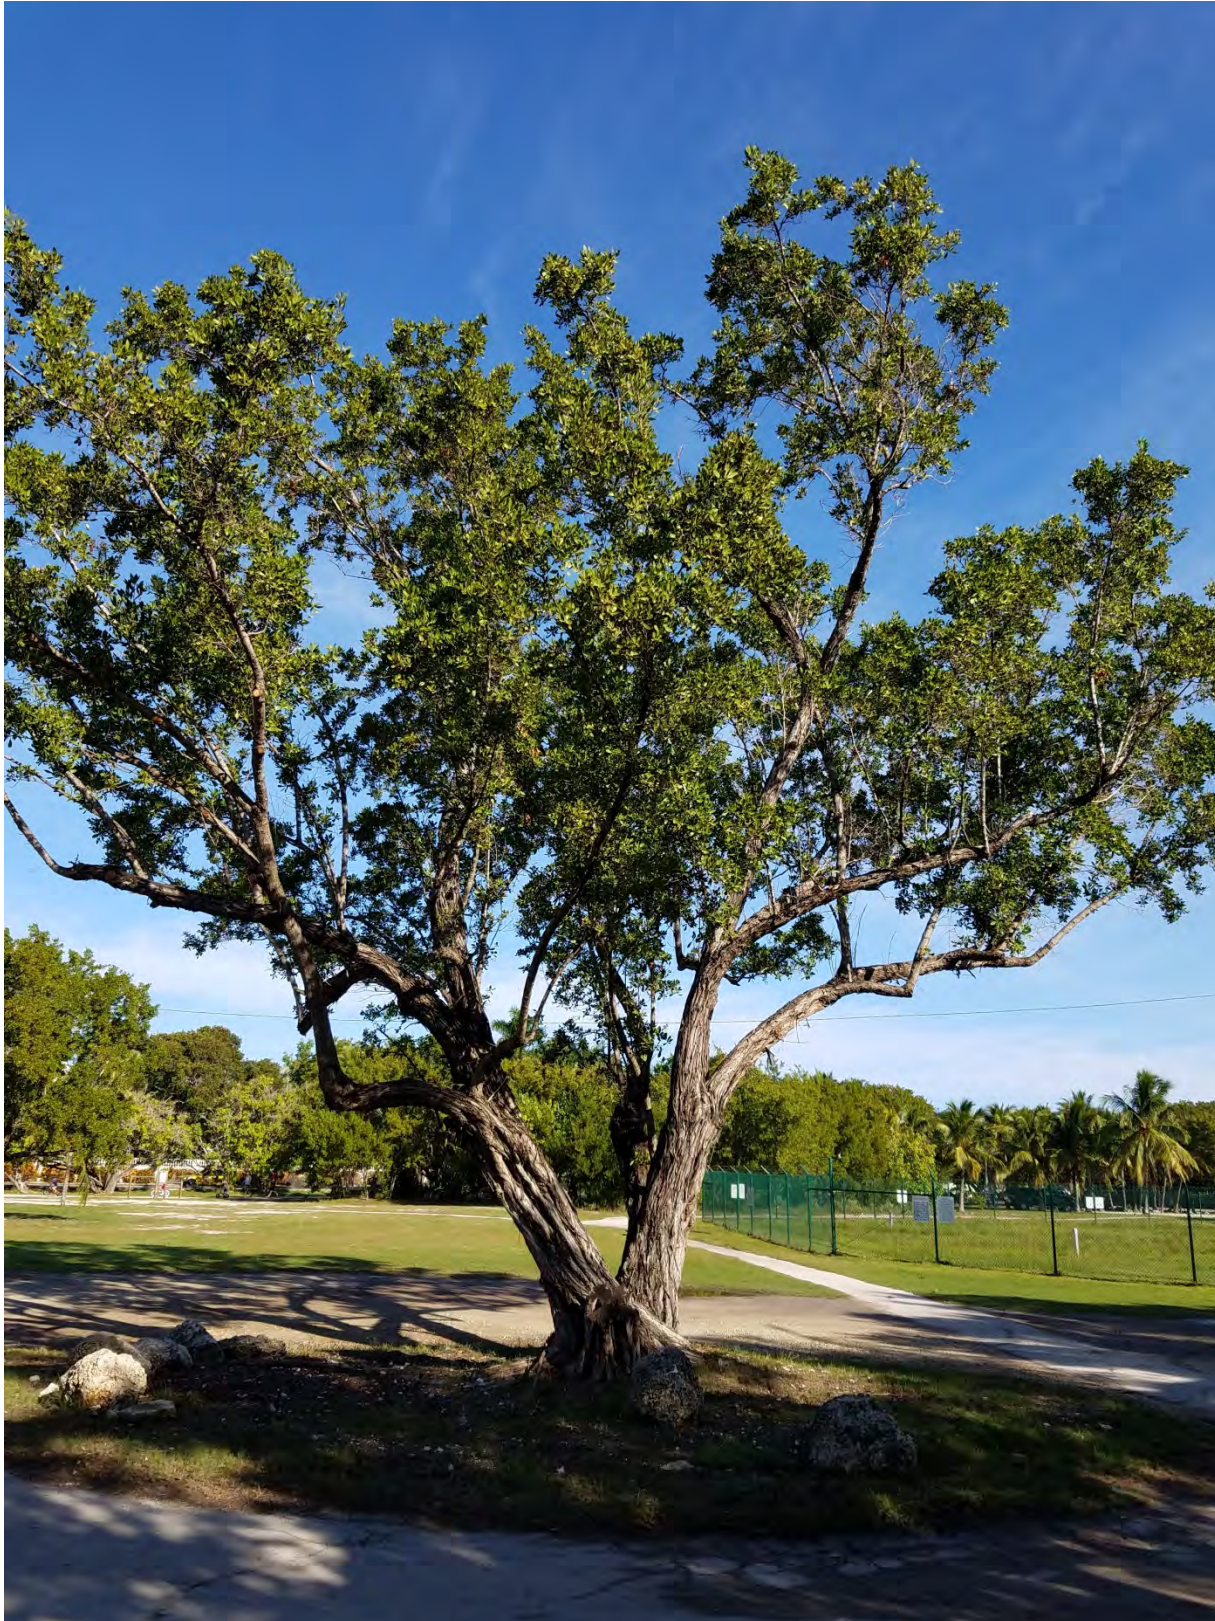
Photo 14 – Tree No. 271.

Five Category 2 trees (numbers 187, 271, 400, 403, and 420B), including green buttonwood (*Conocarpus erectus*), mahogany (*Swietenia mahagoni*), and tropical almond (*Terminalia catappa*) were determined to be in good condition and displayed relatively large, healthy canopies providing excellent shade, habitat and aesthetic values. Although tropical almond is listed as a Florida Exotic Pest Plant Council (FLEPPC) Category II tree (i.e. considered “somewhat” invasive), this particular tree is not anticipated to spread and outcompete native vegetation in a manicured park setting (i.e. active mowing between trees). Based on the conditions and values of these trees, E Sciences recommends that design alterations be considered (if practicable) to avoid impacts to these trees and preserve them in place, performing remediation pruning where recommended.

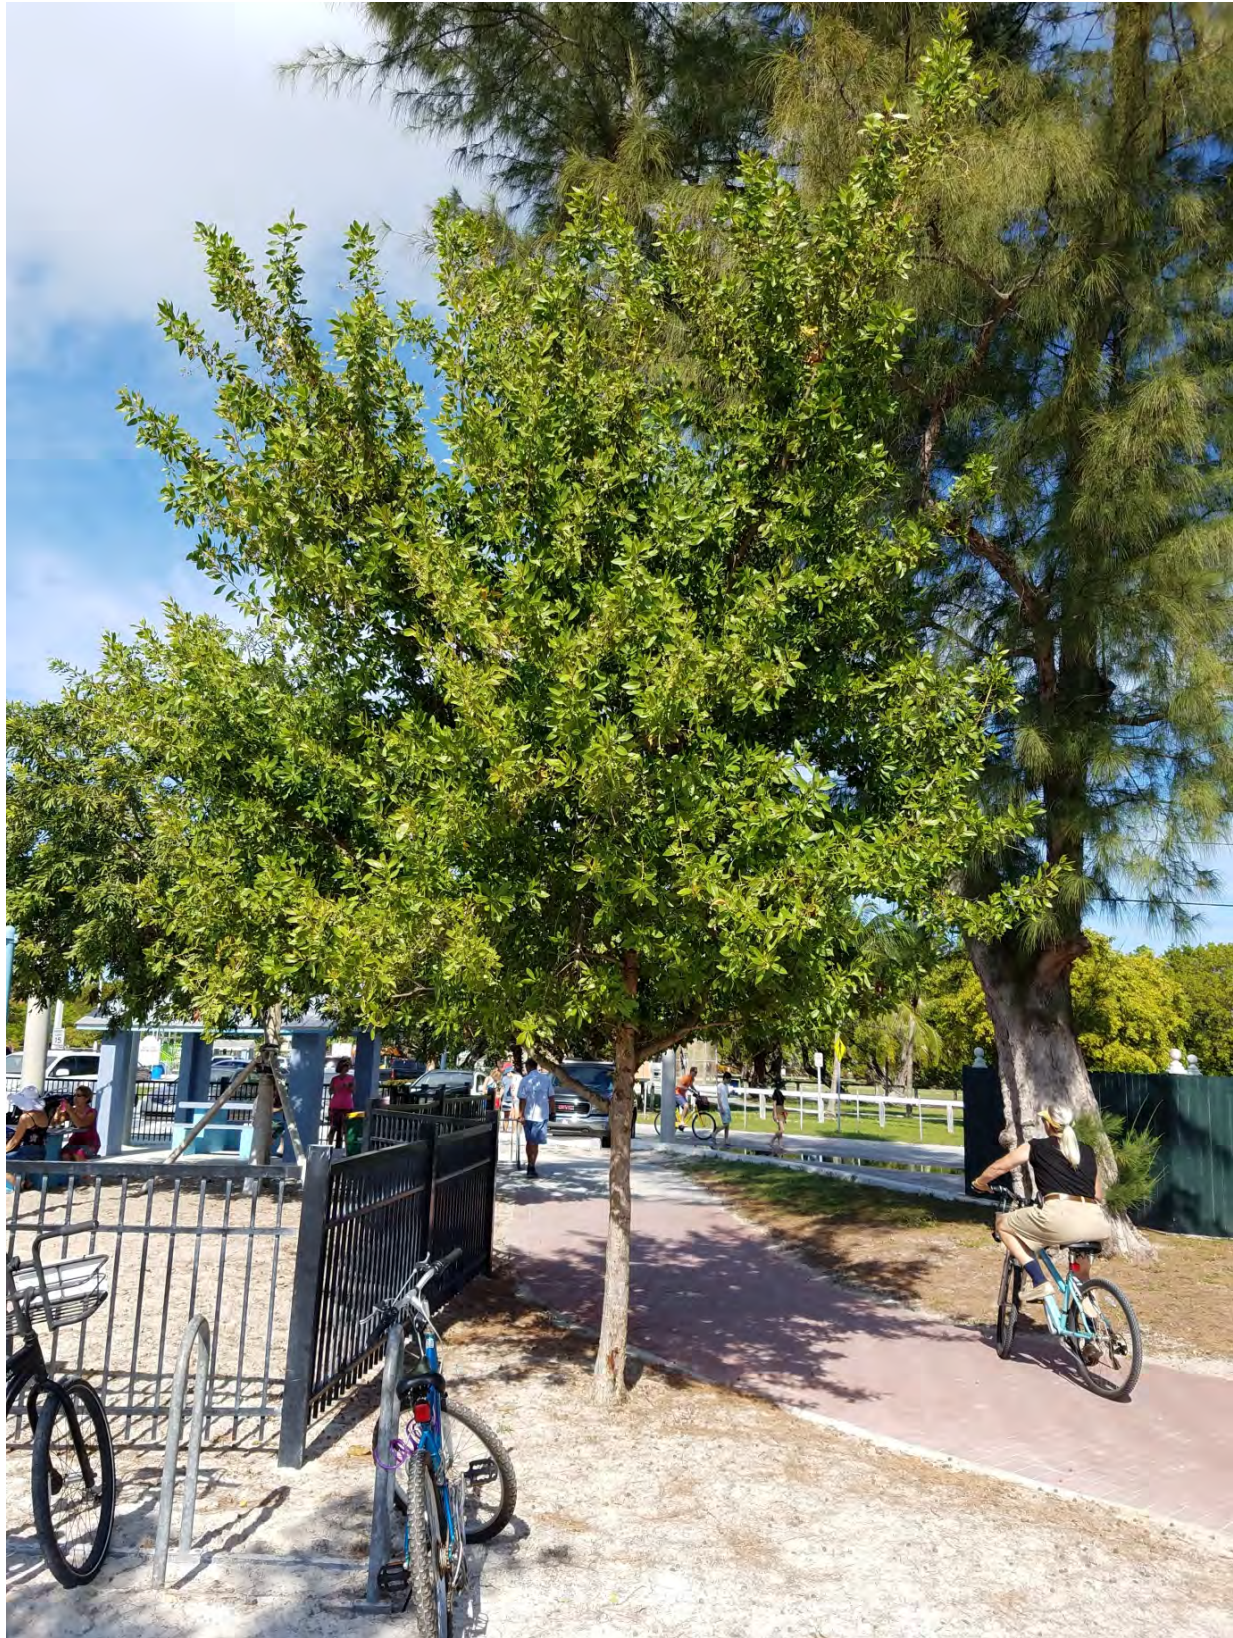
Photo 20 – Tree No. 378B.

- Addition of species names where they were missing
- Correction of species names where they were incorrect
- Correction of proposed disposition on table where it did not match symbol on map
- Addition of one tree (number 378B) to the tree table that was not on tree disposition plan or table (see **Attachment 3 – Tree Disposition Plan Mark Up** for tree location).
