# STAFF REPORT

RE: 916 Elizabeth Street (permit application # T2019-0412)

FROM: Karen DeMaria, City of Key West Urban Forestry Manager

**RE: Update to Certified Arborist Tree Risk and Viability Assessment, Chelsea House Hotel**

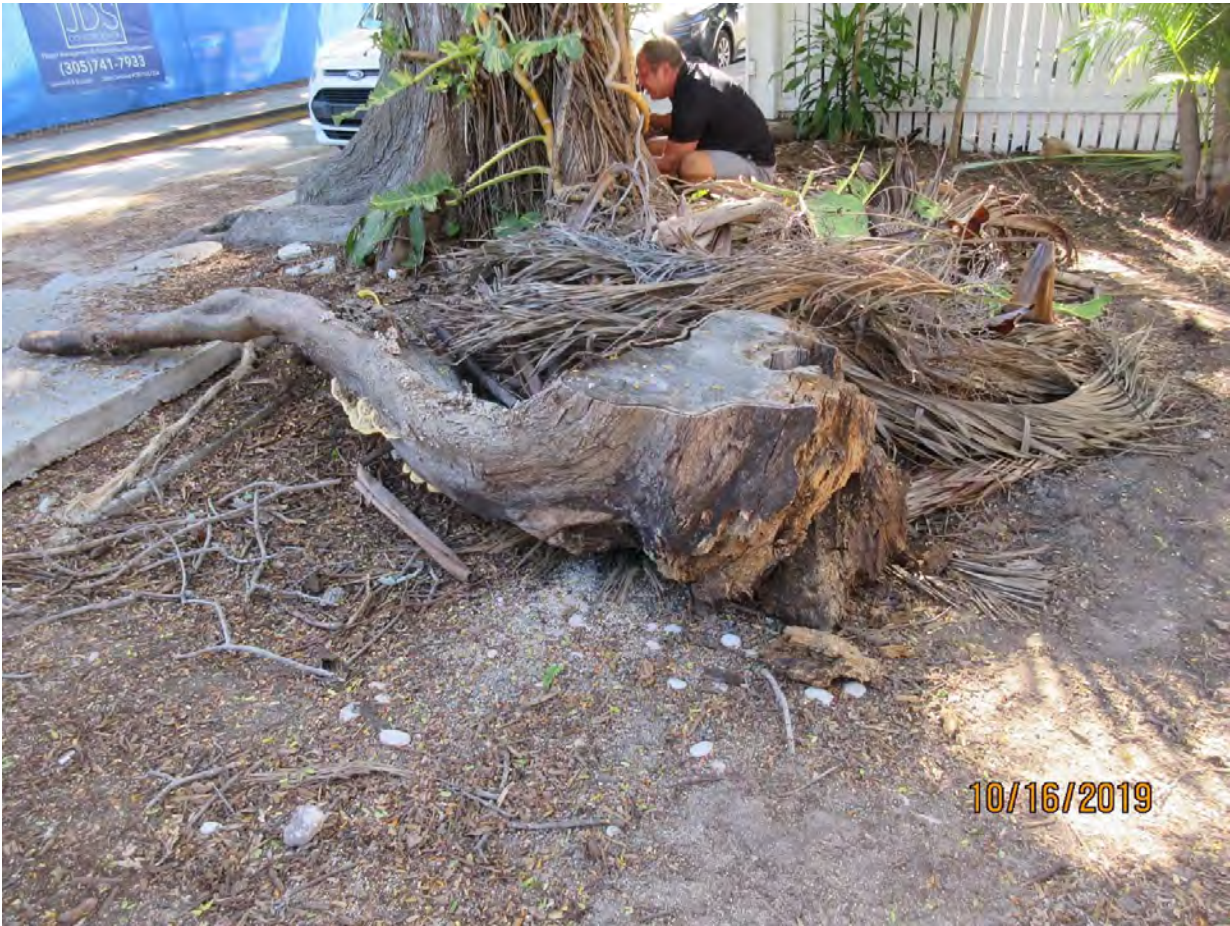
Photo showing old stump area that easily removed during clean up of area.

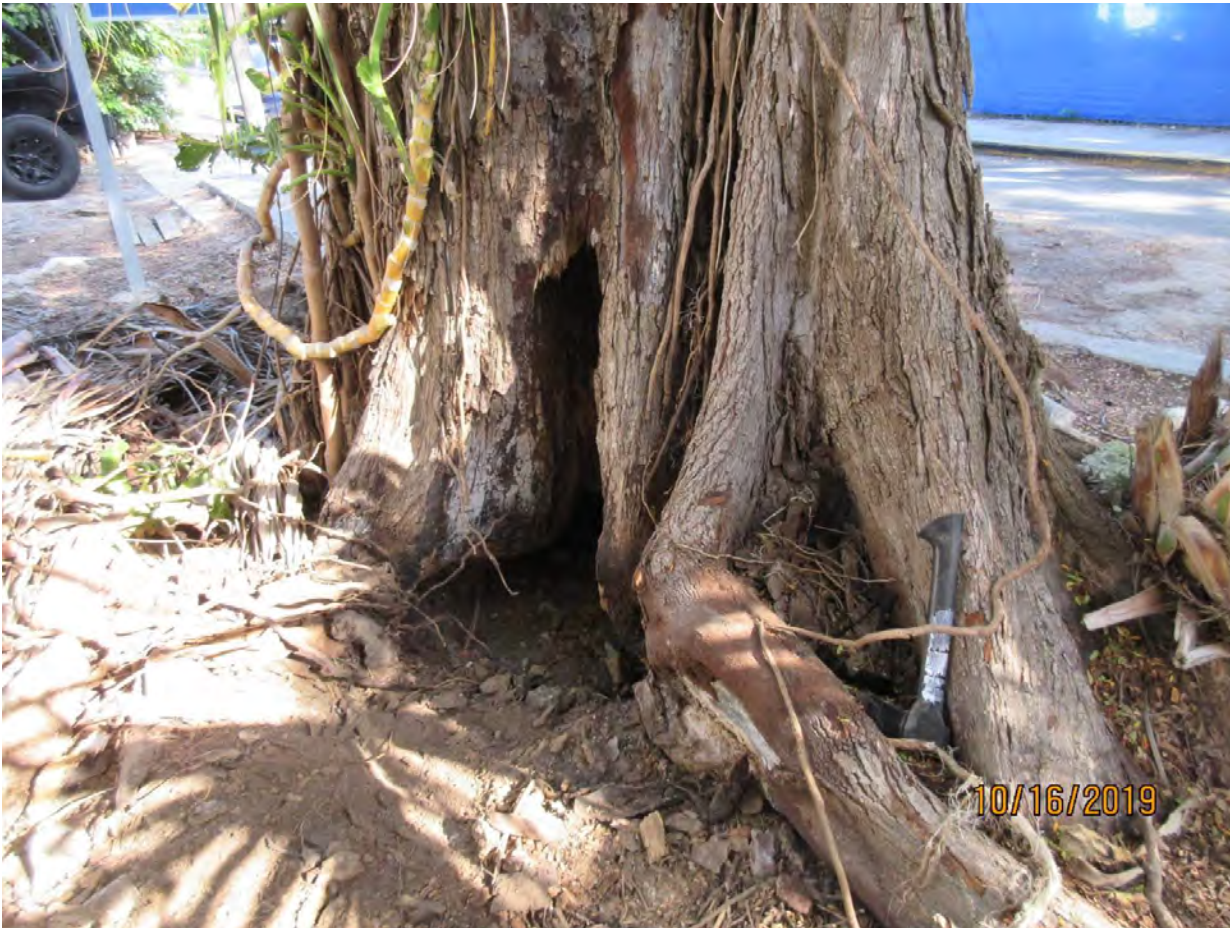
Photo of the base of the tree, cleaned up, showing decay/hole area.

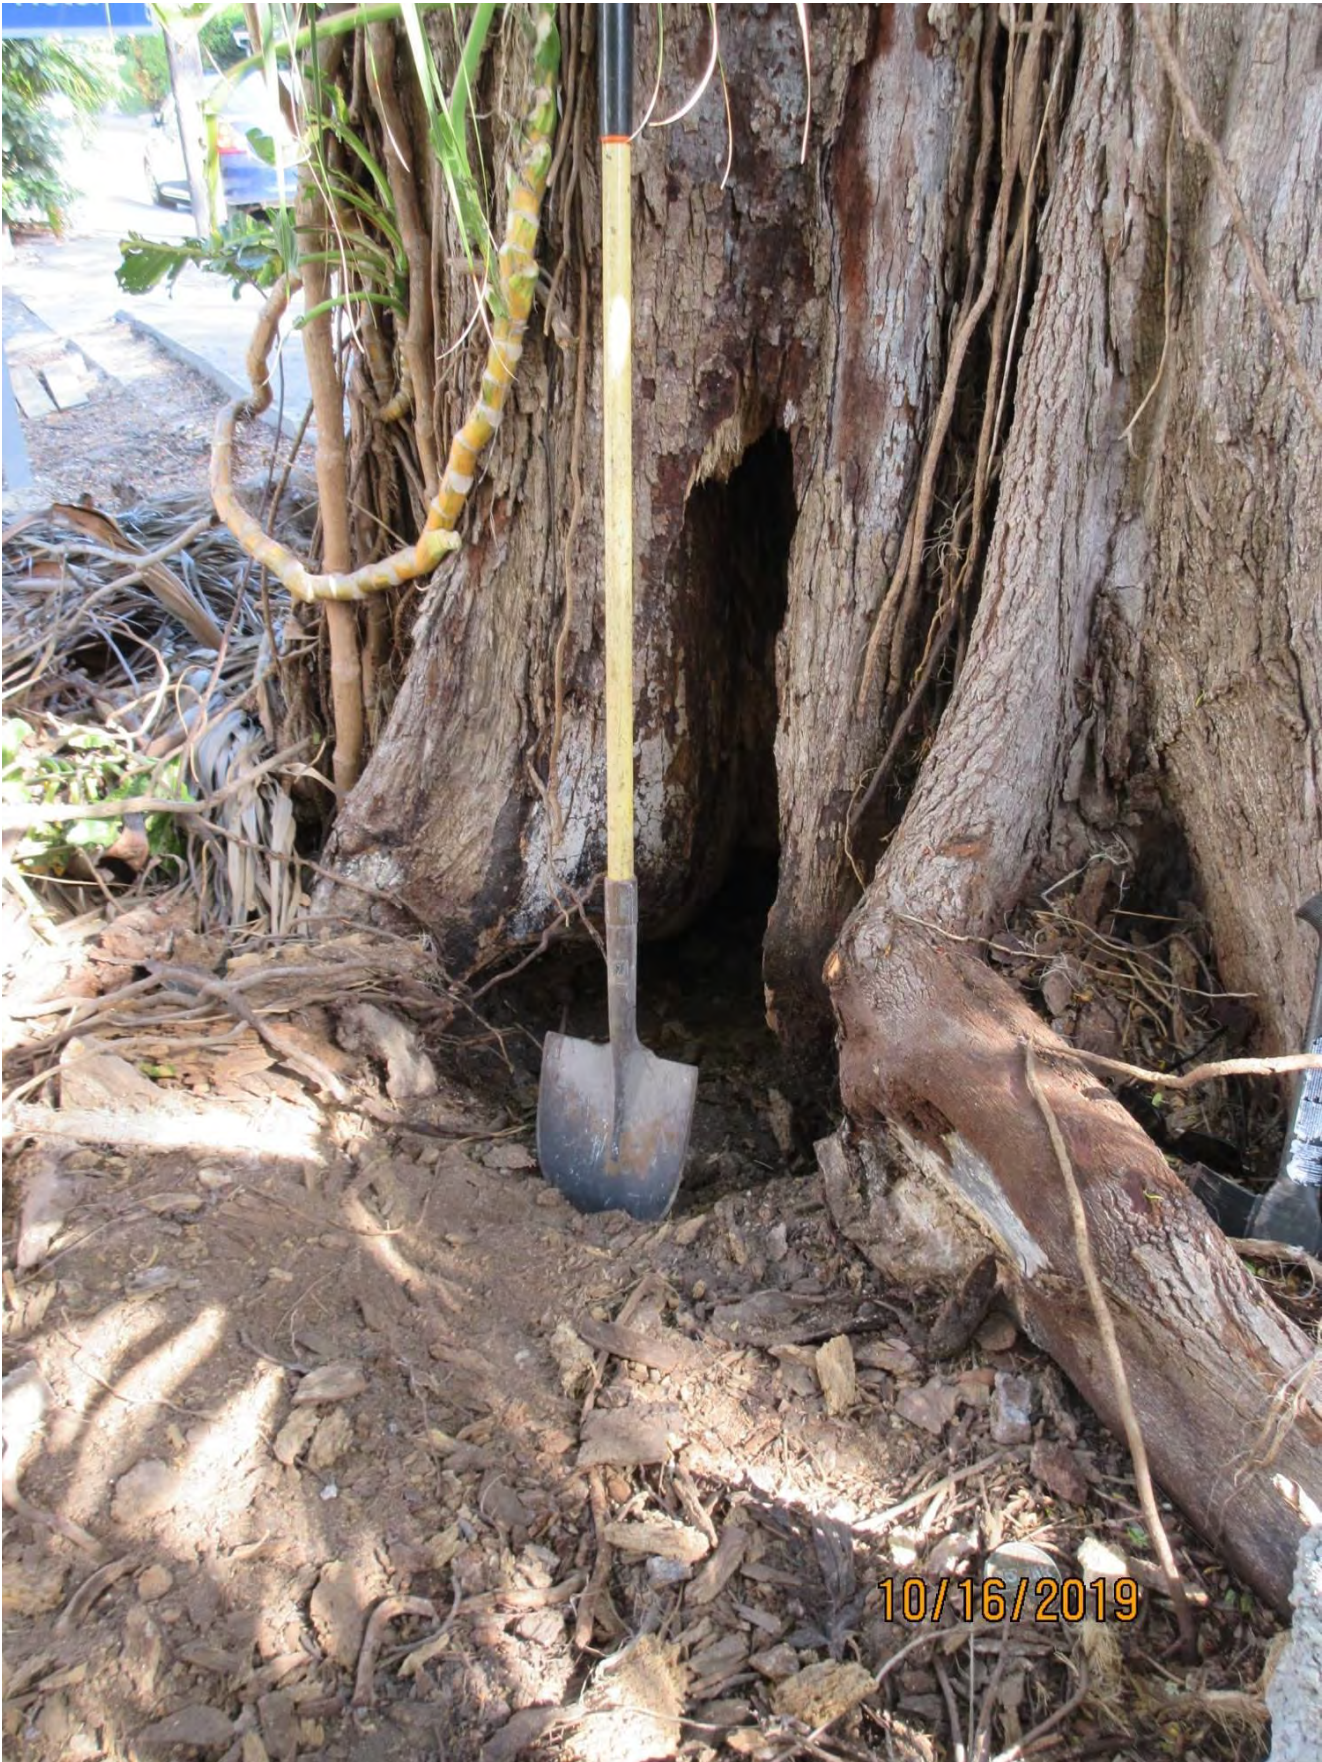
Photo showing base of tree hole area with a shovel to show size of area.

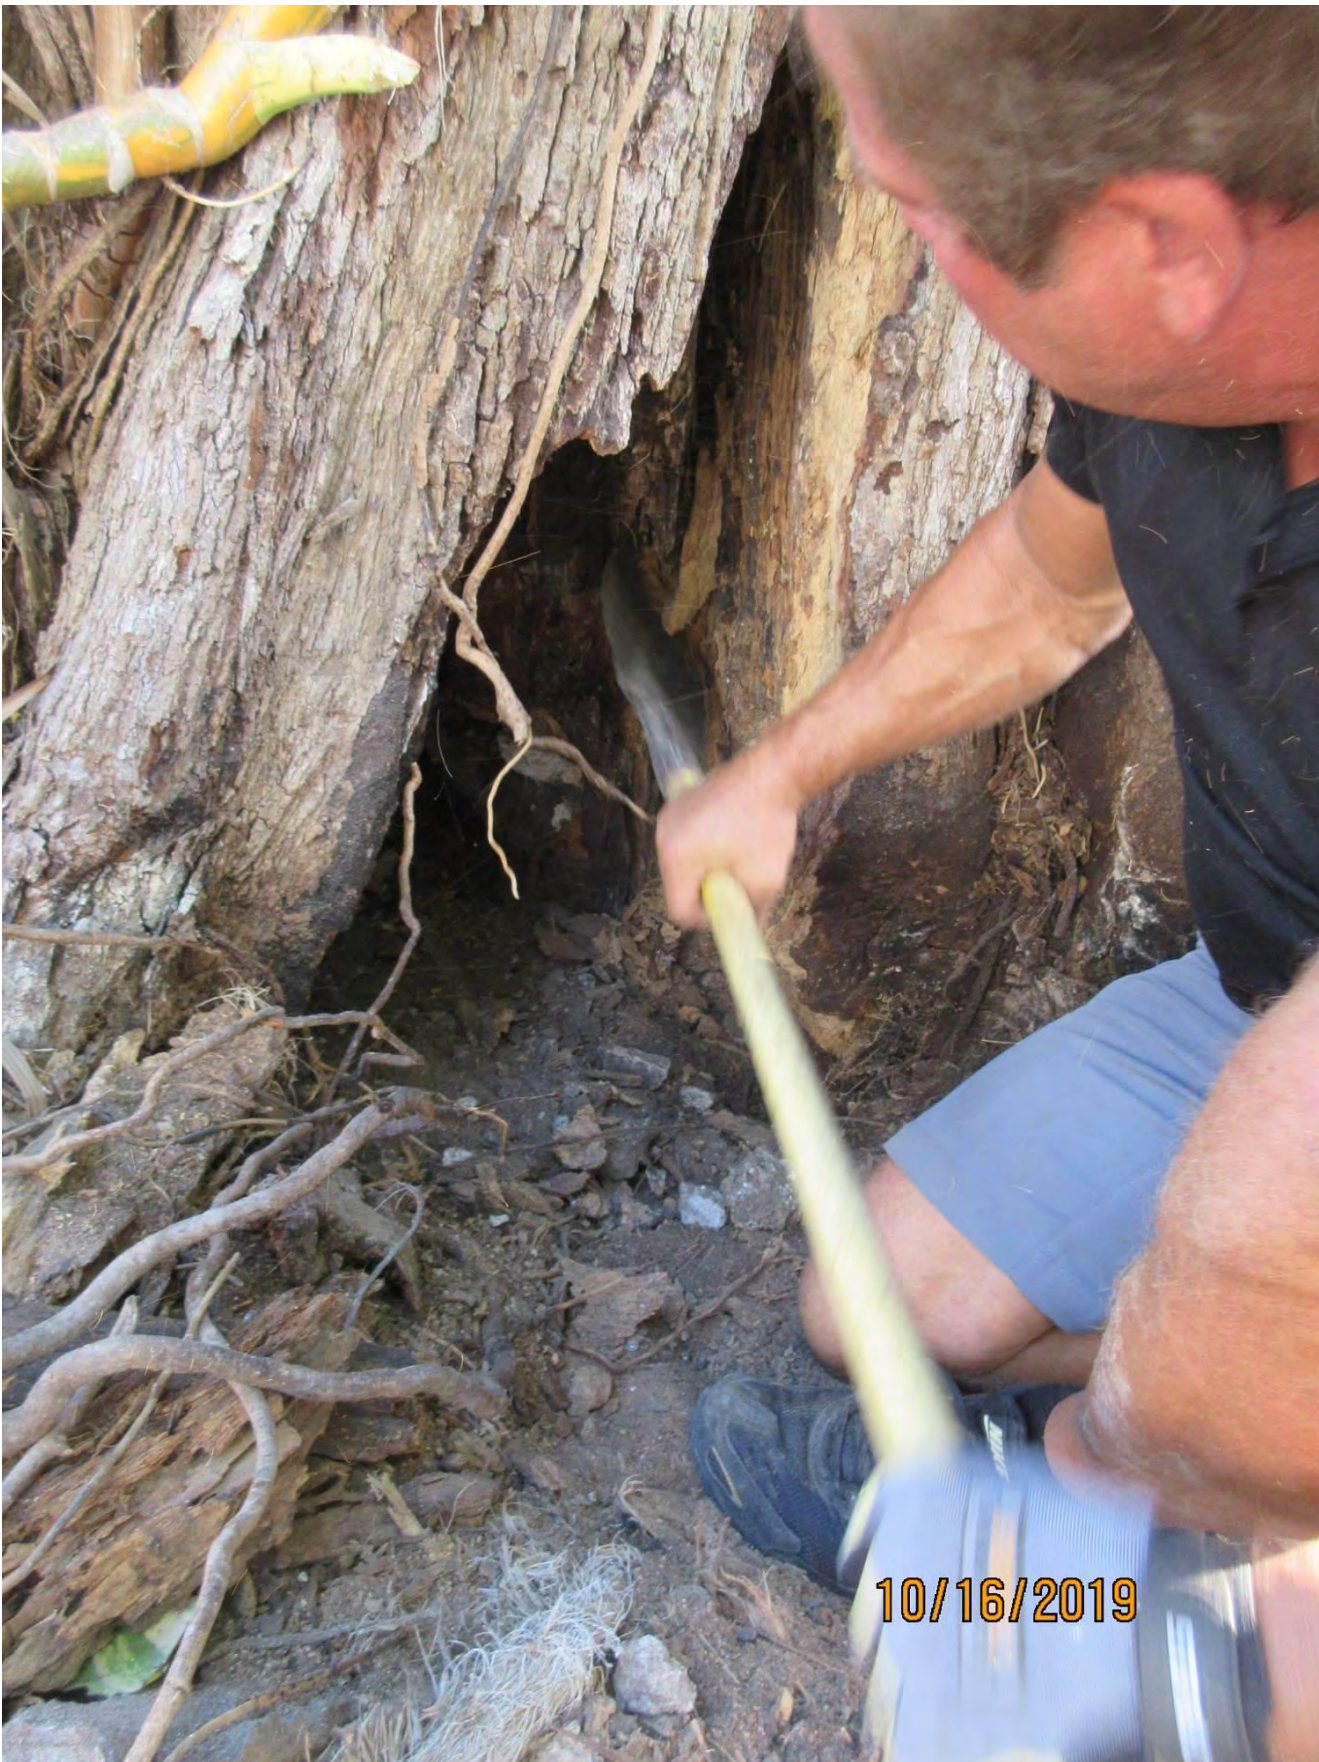
Photo showing the interior decay. Shovel would tap the wood and it would fall off easily.

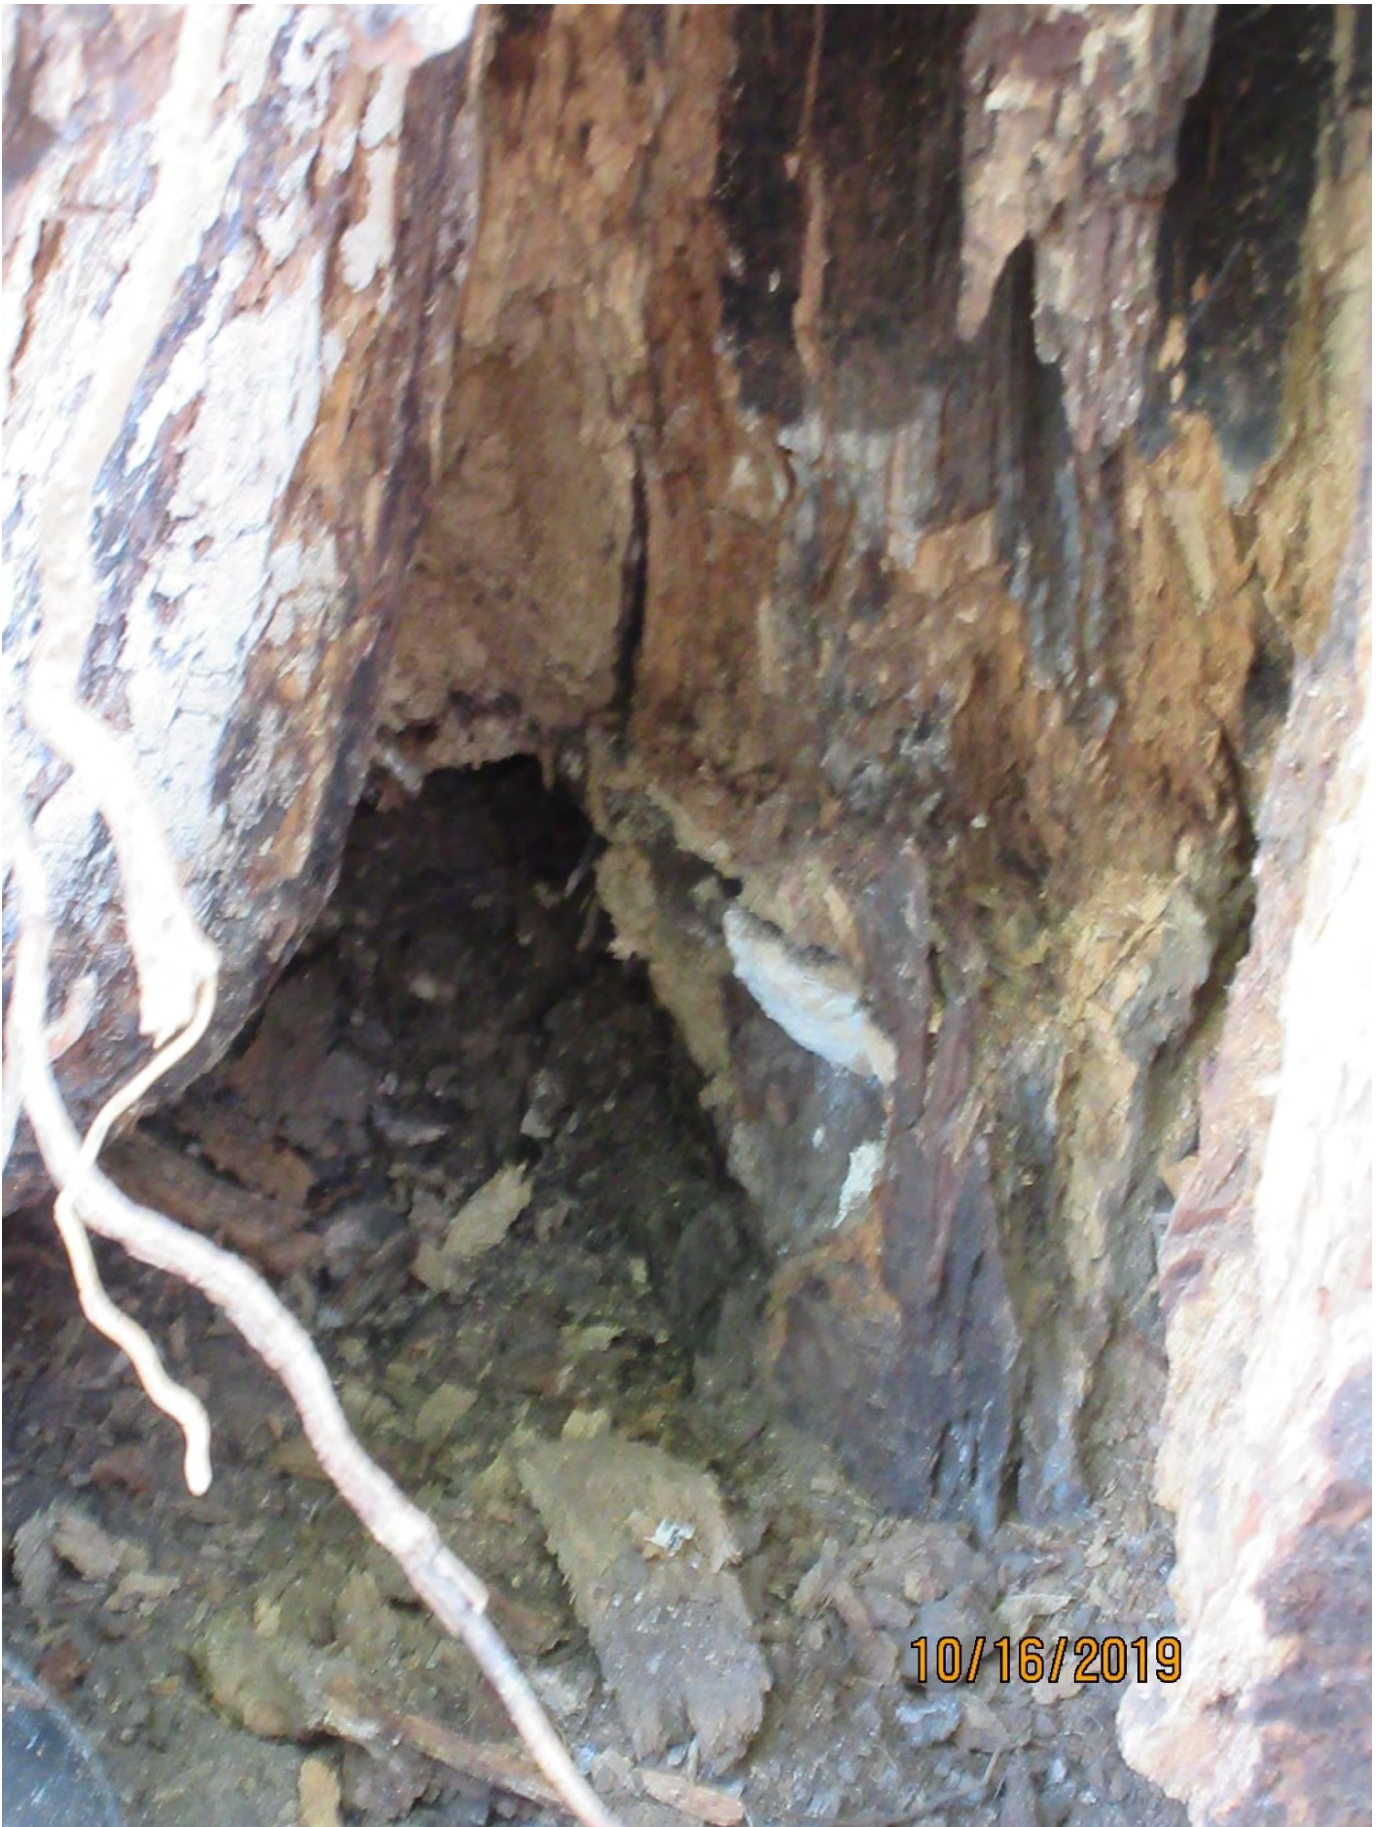
Close up photo of hole/decay area, view 1.

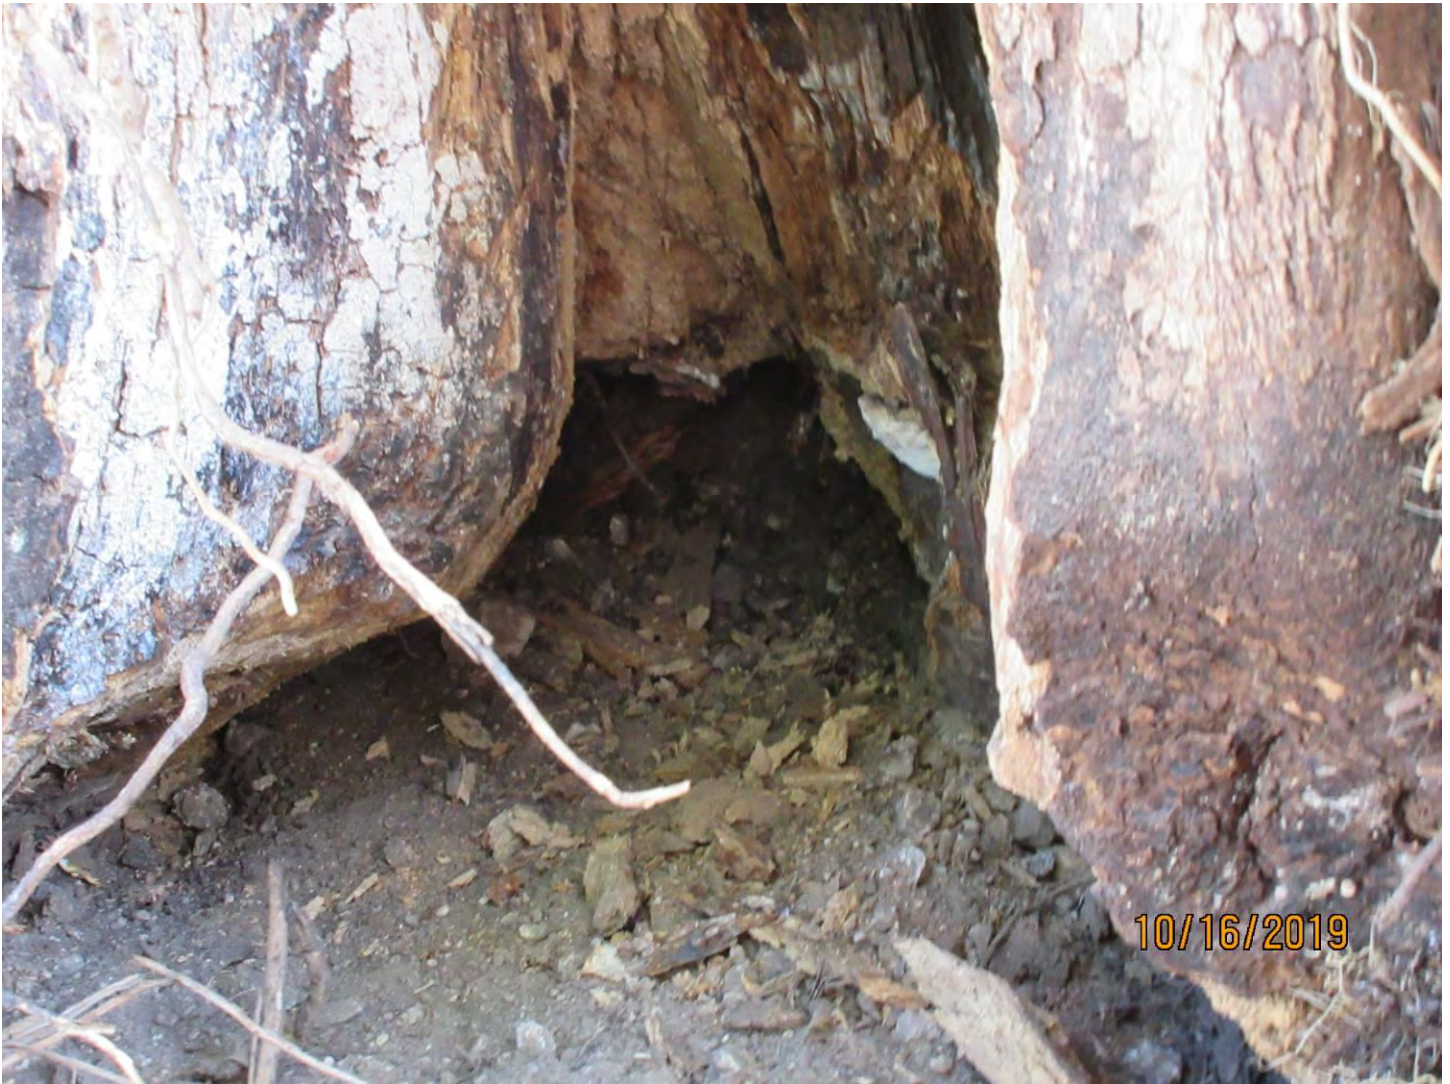
Close up photo of hole/decay area, view 2.

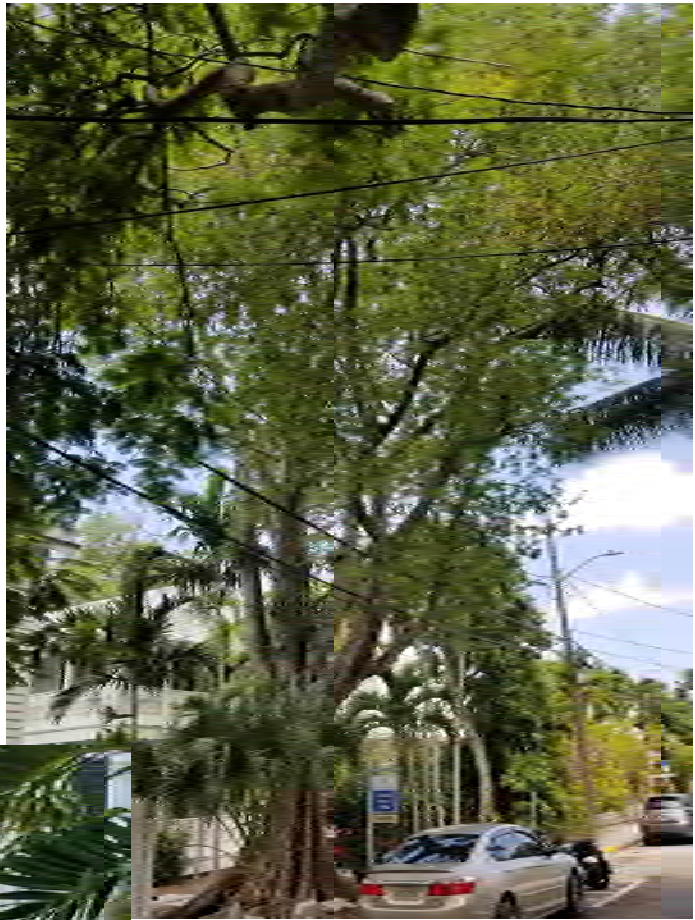
Photo 1. Overall view of tree from south

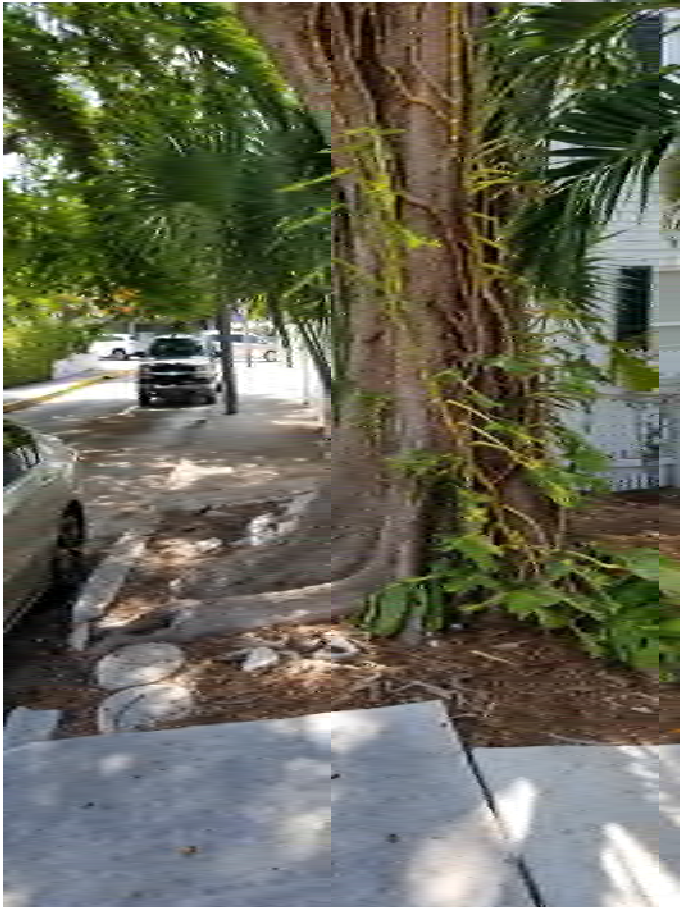
- There is currently no continuation of paving from one side of the tree to the other, and the roots have also dislodged a portion of the roadside curb, and the adjacent segment of sidewalk.

Photo 2. View of tree from north. Sidewalk is missing, adjacent pavers and curb broken.

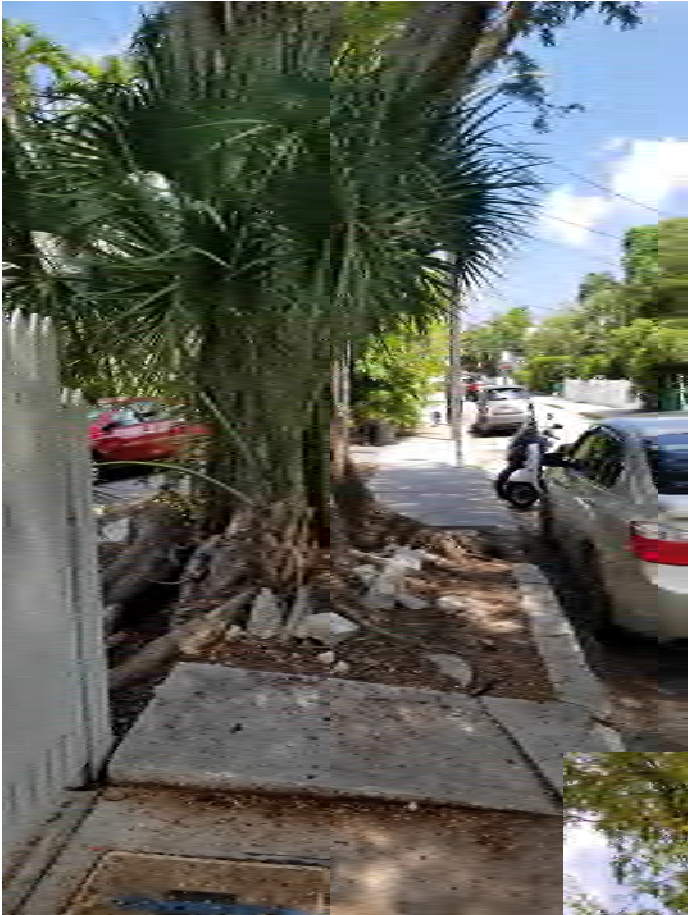
Photo 3. View of base of tree from the south.

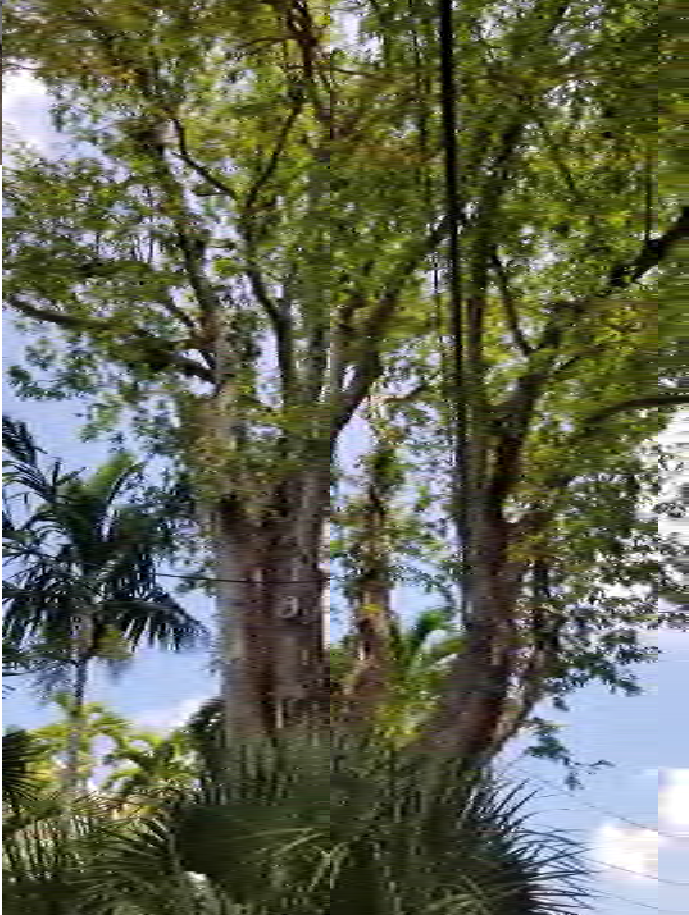
- Overhead utility lines pass through the middle of the canopy, and branches are in contact with and pressing against the lines.
- The base of the trunk has a cavity approximately three feet in diameter. The cavity is cone shaped, with the top extending upwards up to approximately four feet. The inside edges of the cavity all exhibit significant signs of decay, with 2-3 inches of completely friable/loose wood fragments prior to sound wood. The decay is a white rot, which causes greater structural damage than brown rot. The decay is likely caused by an aggressive fungal pathogen. Based on the fungal conchs on the (formerly) adjacent stump, the fungus is likely to be a variety of *Ganoderma*, which is a very destructive pathogen that is difficult to control.

Photo 4. View of canopy and utility lines

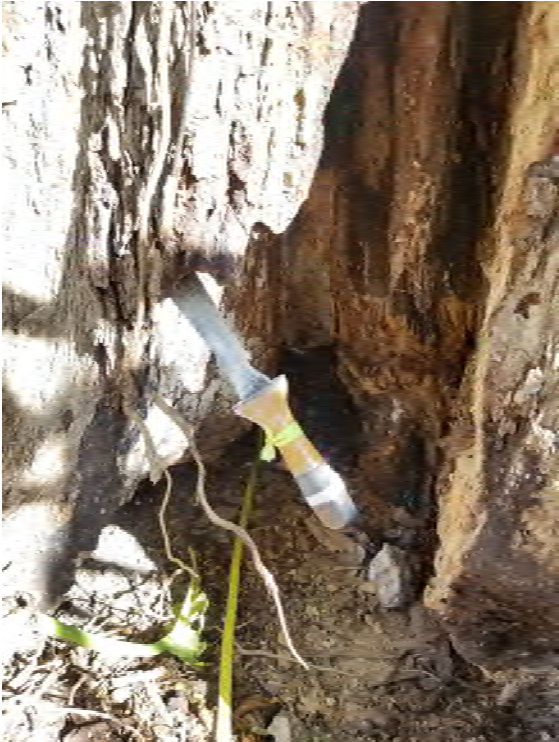
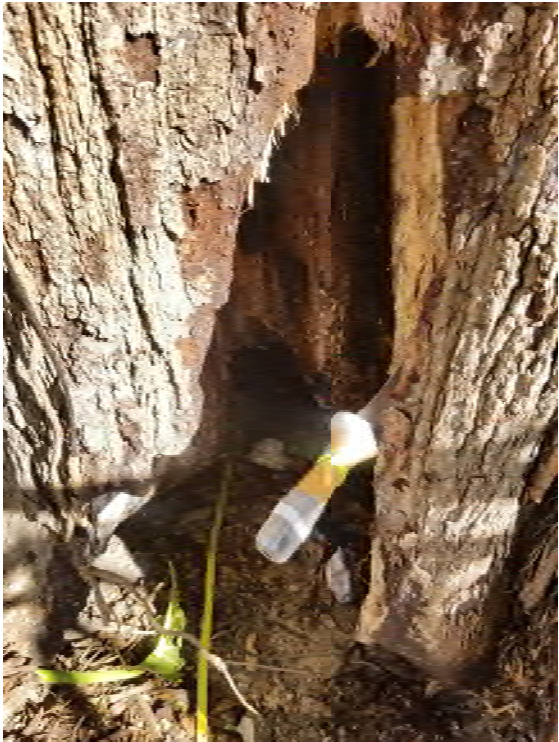
Photos 5 & 6. View of cavity on southwest side of tree. Soil knife inserted into white rot to a depth of approximately three inches on both sides.

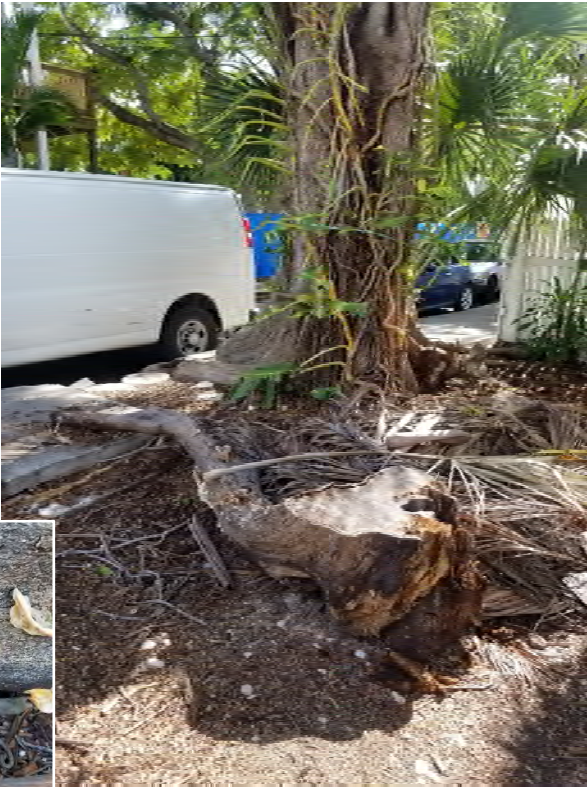
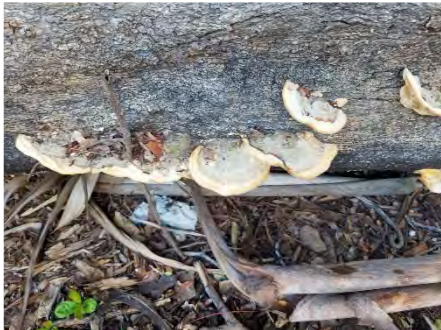
Photos 7 & 8. View of stump removed from southwest side of tree. White rot visible on right side of stump, fungal conchs visible on main root (larger view on inset).

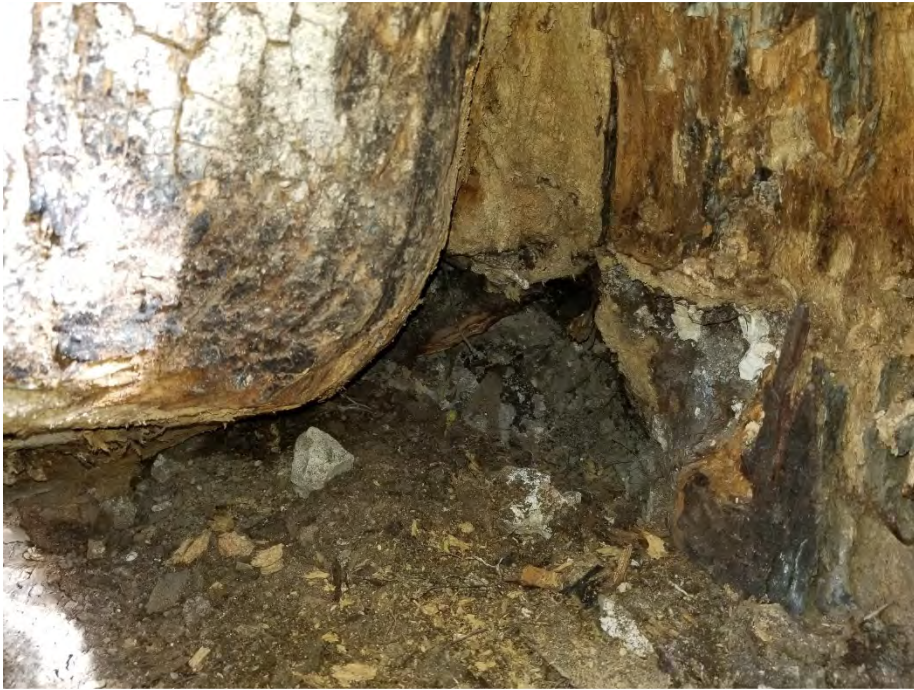
- The removal of the dead stump from the tree that was abutting the tamarind allowed for viewing beneath the base of the tamarind tree. Owing to the space occupied by the formerly abutting tree, the tamarind tree has no roots (or any wood mass) directly under the tree, and no roots/root

flair on the southwest side. Noting that the roots on the opposite (northeast) side are truncated by the curb (and may be further impacted through curb/sidewalk reconstruction), the tree has a significantly increased risk of failure in either direction.

Photo 9. View within center cavity of tree, no roots or woody mass beneath the tree (root flair curving out is visible).
