# STAFF REPORT

RE: 916 Elizabeth Street (permit application # T2019-0412)

FROM: Karen DeMaria, City of Key West Urban Forestry Manager

**RE: Update to Certified Arborist Tree Risk and Viability Assessment, Chelsea House Hotel**

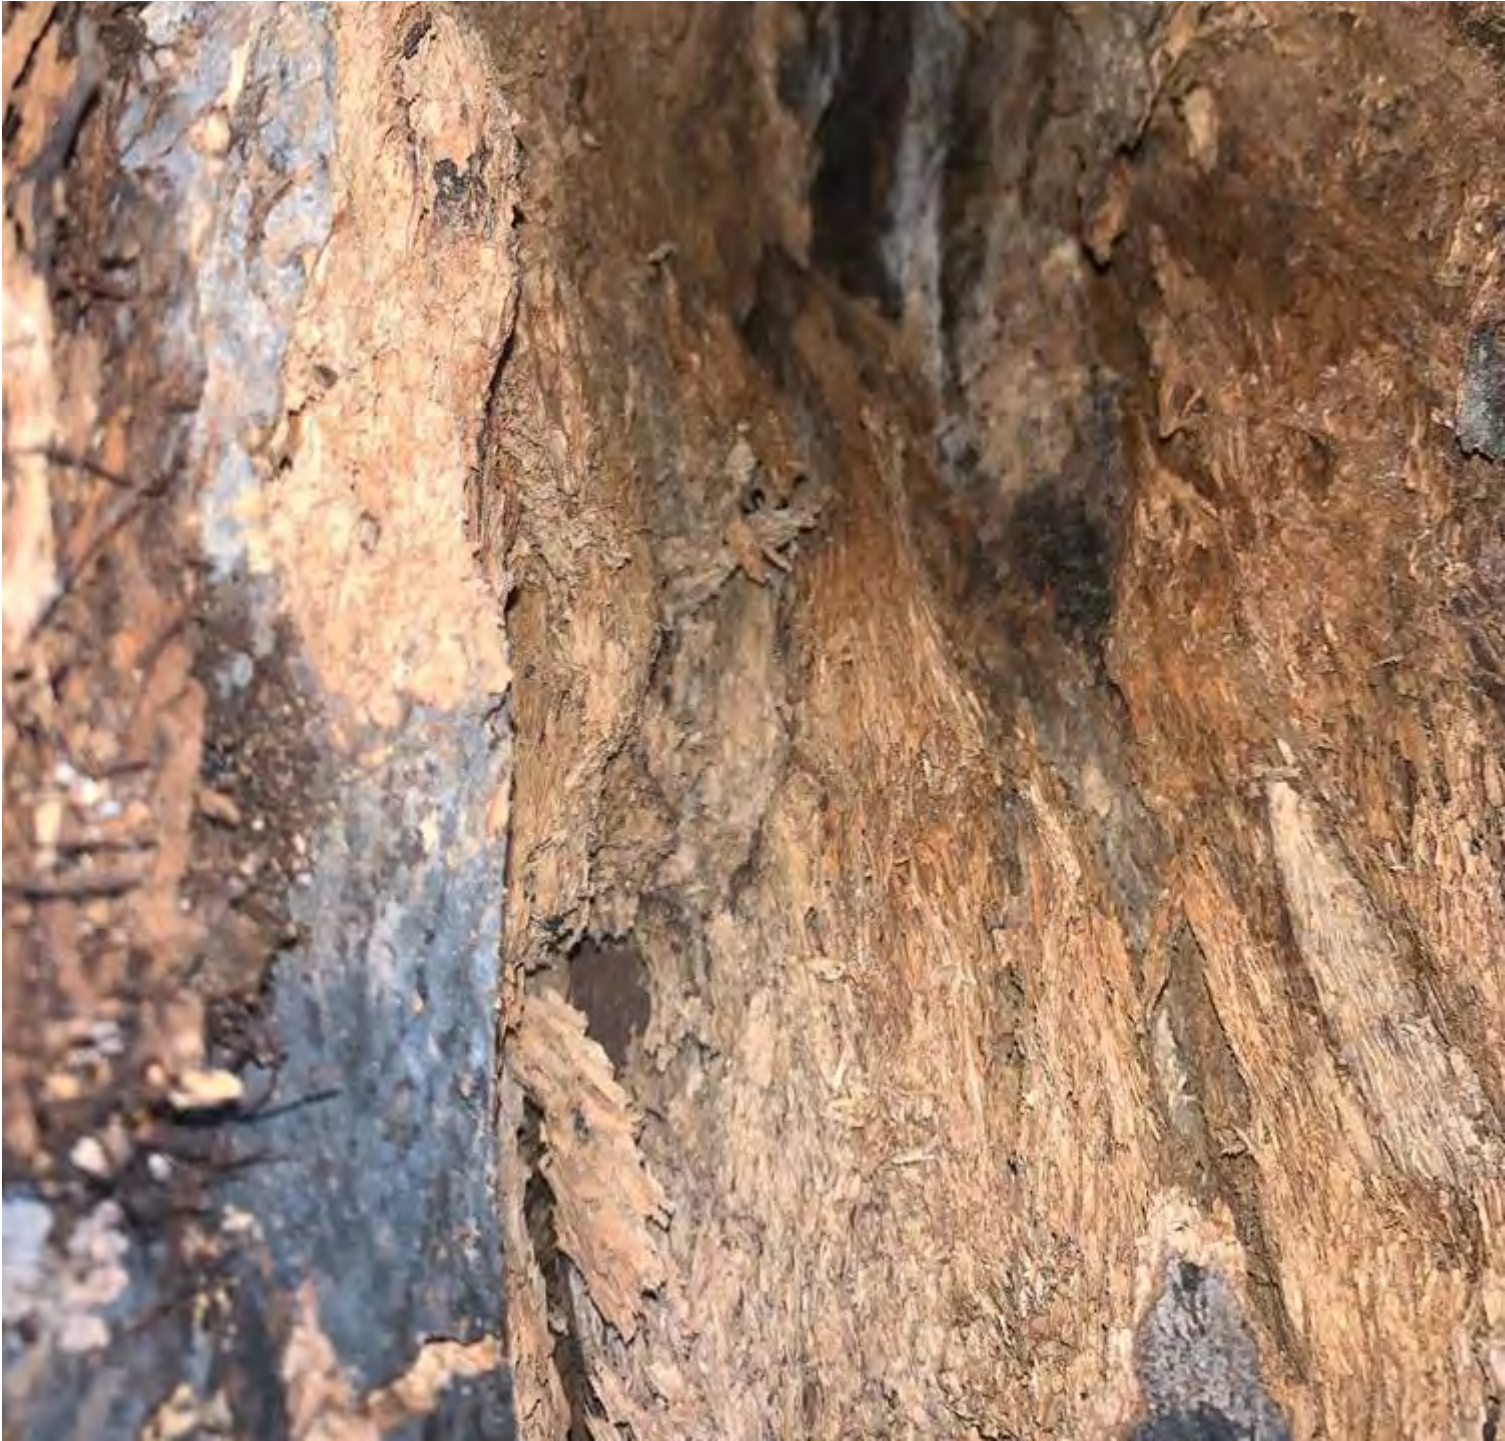
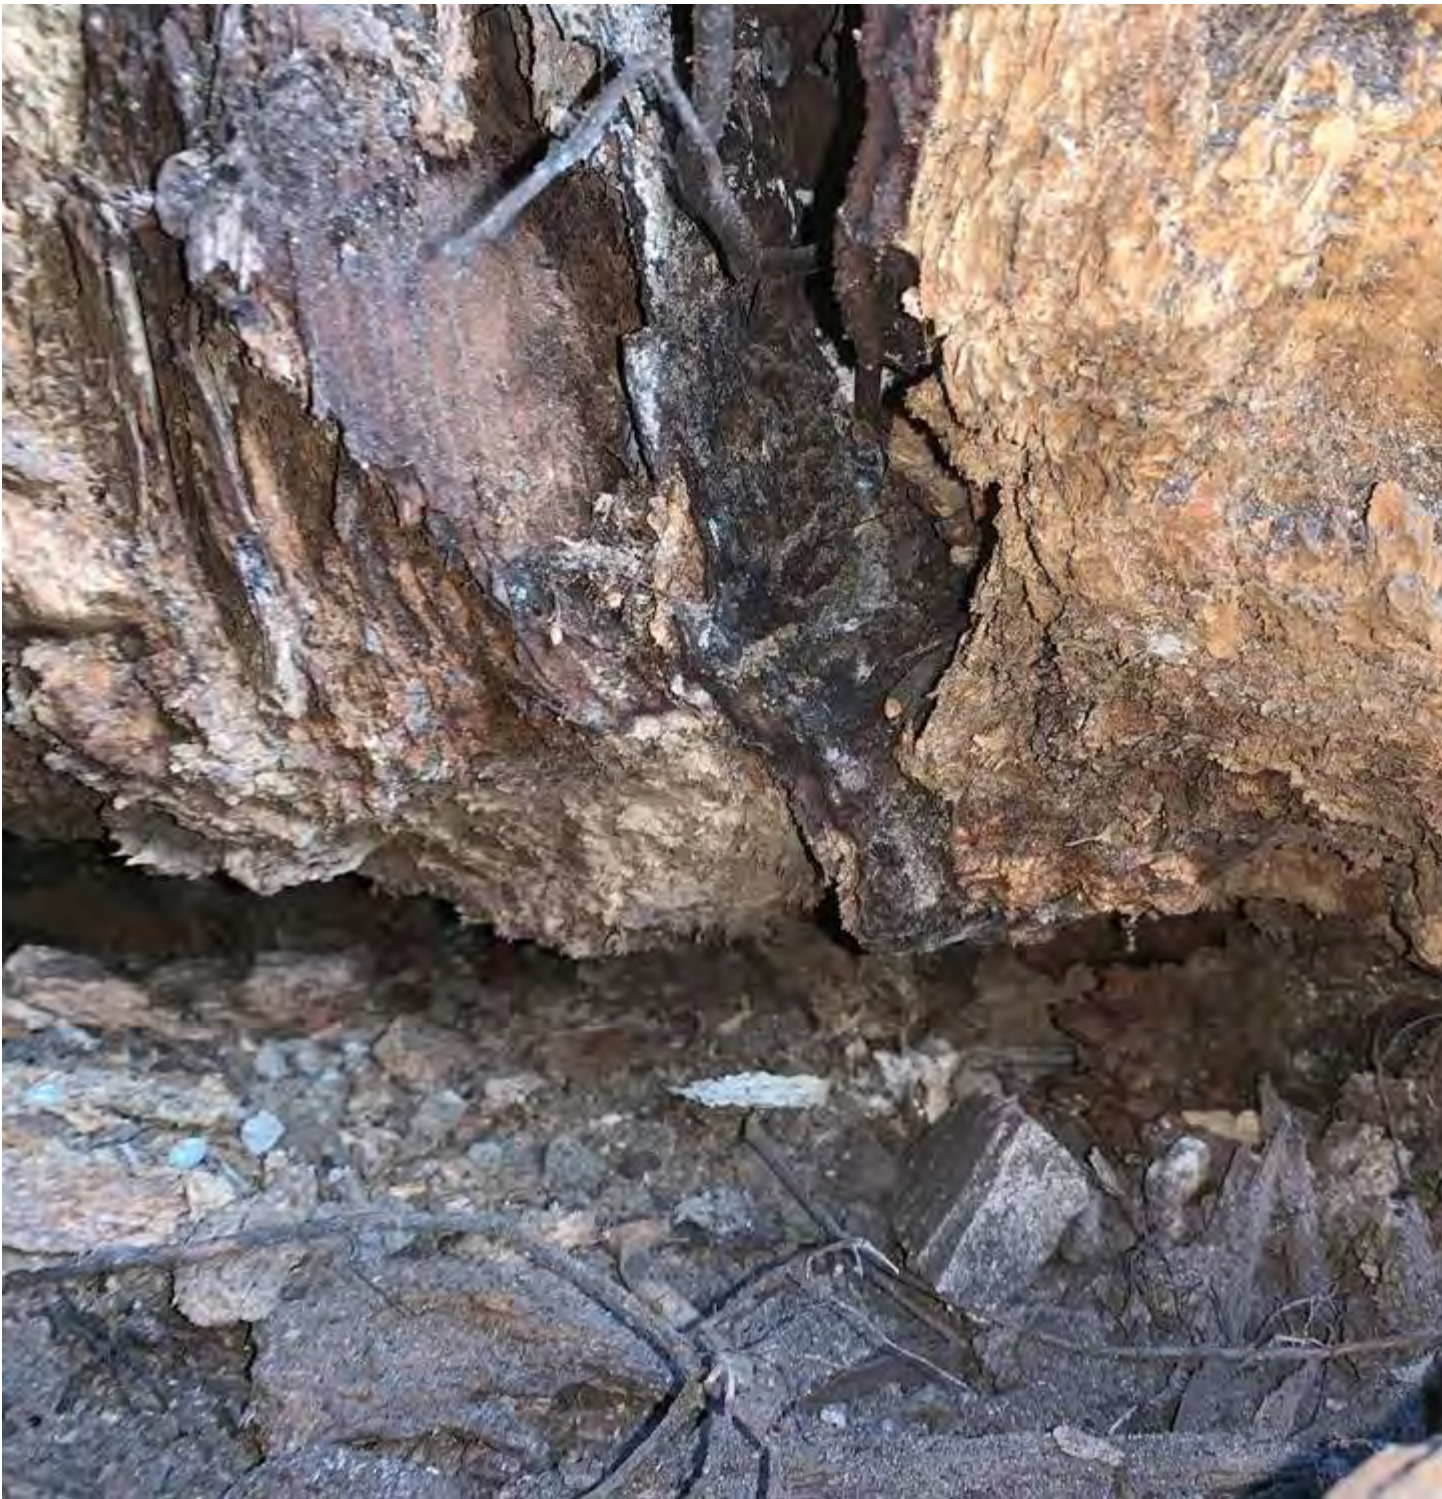
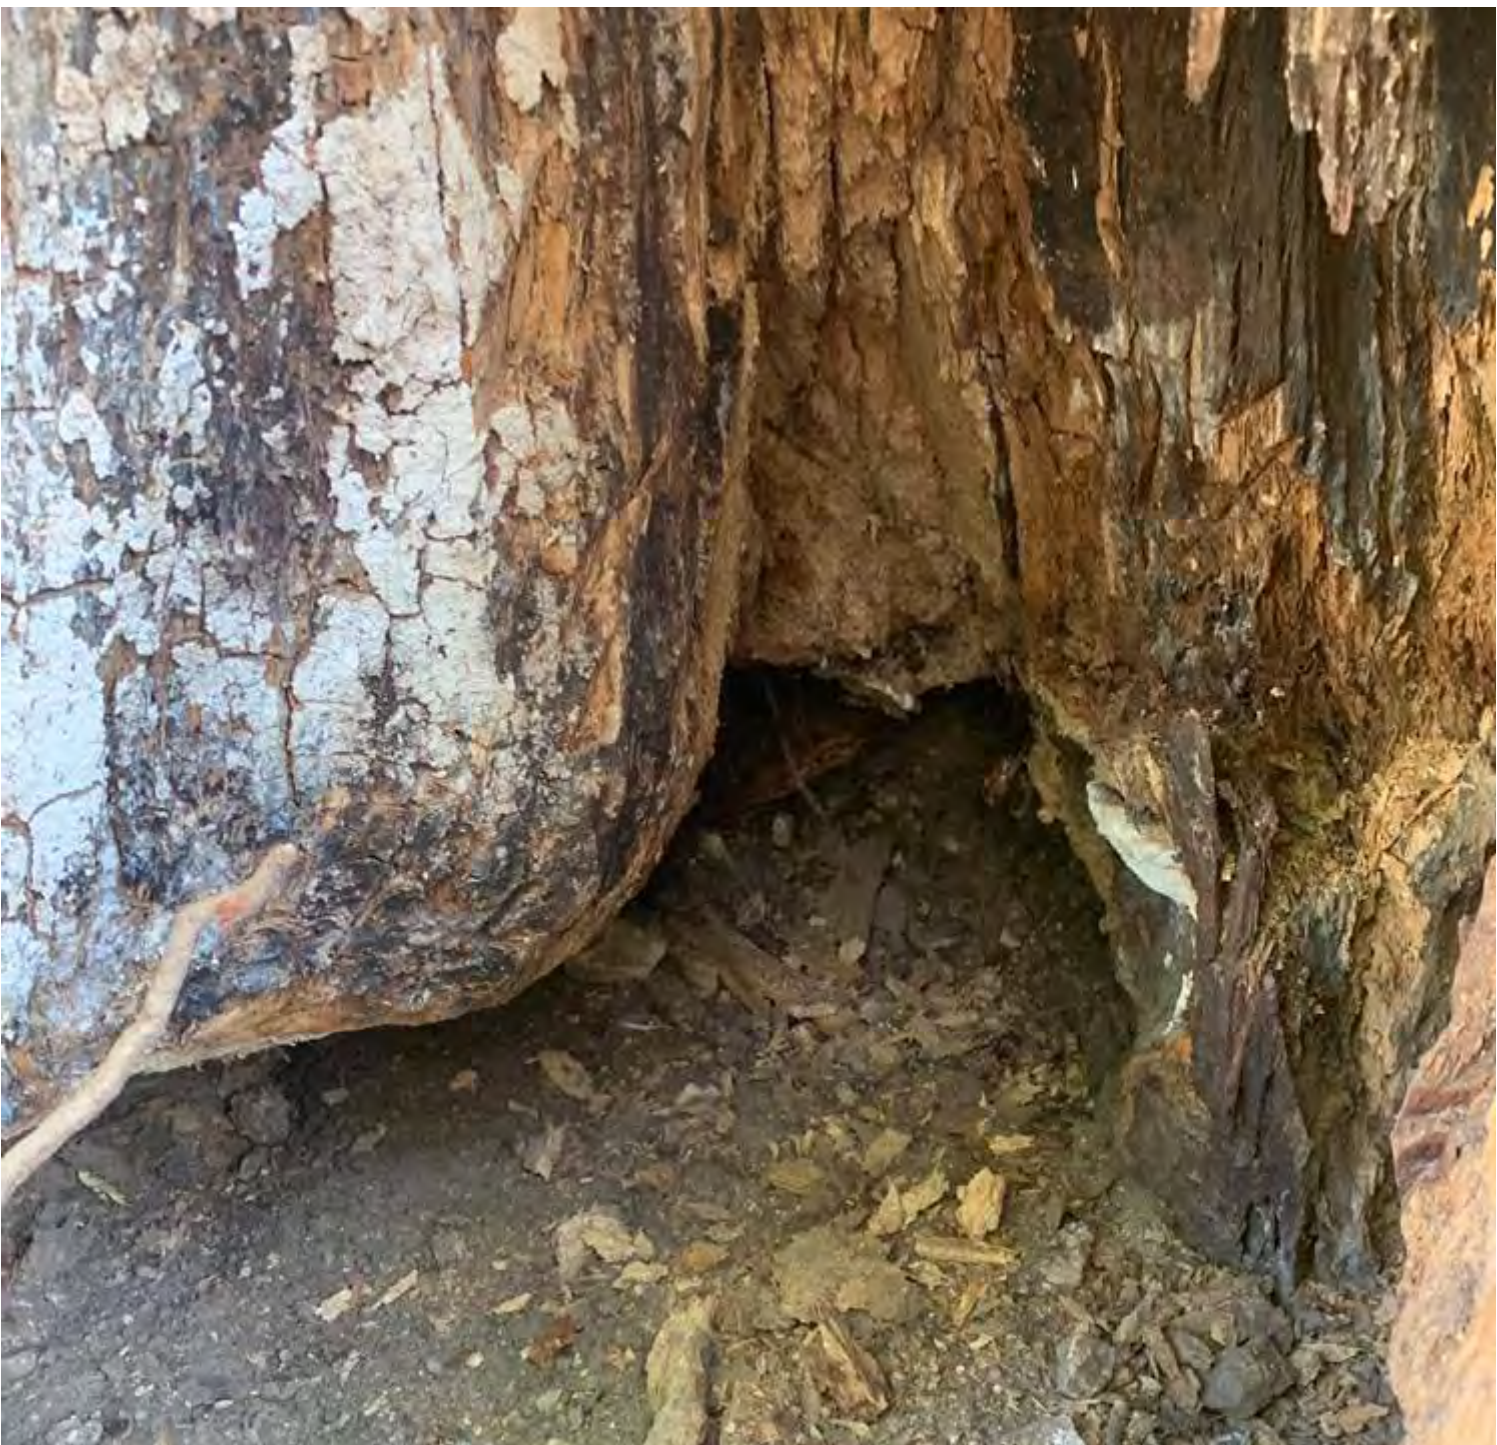
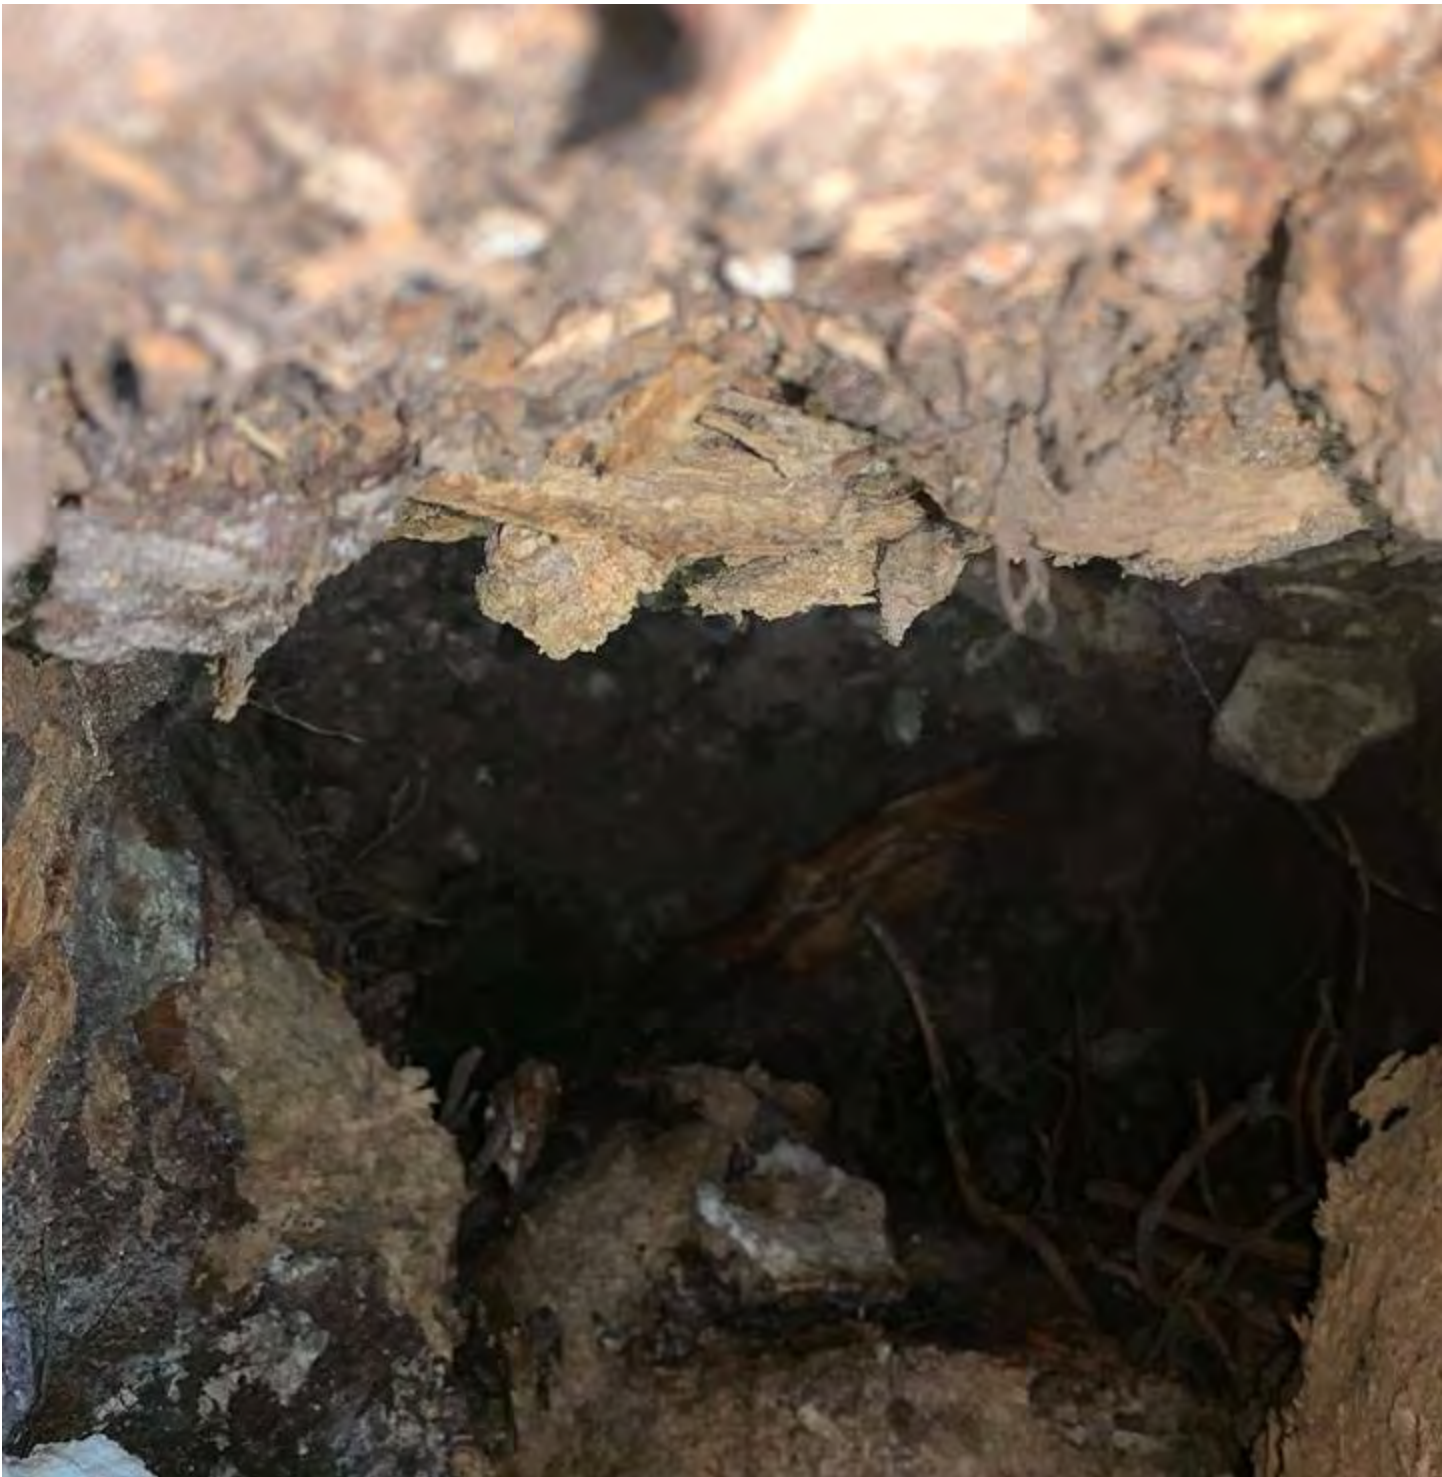
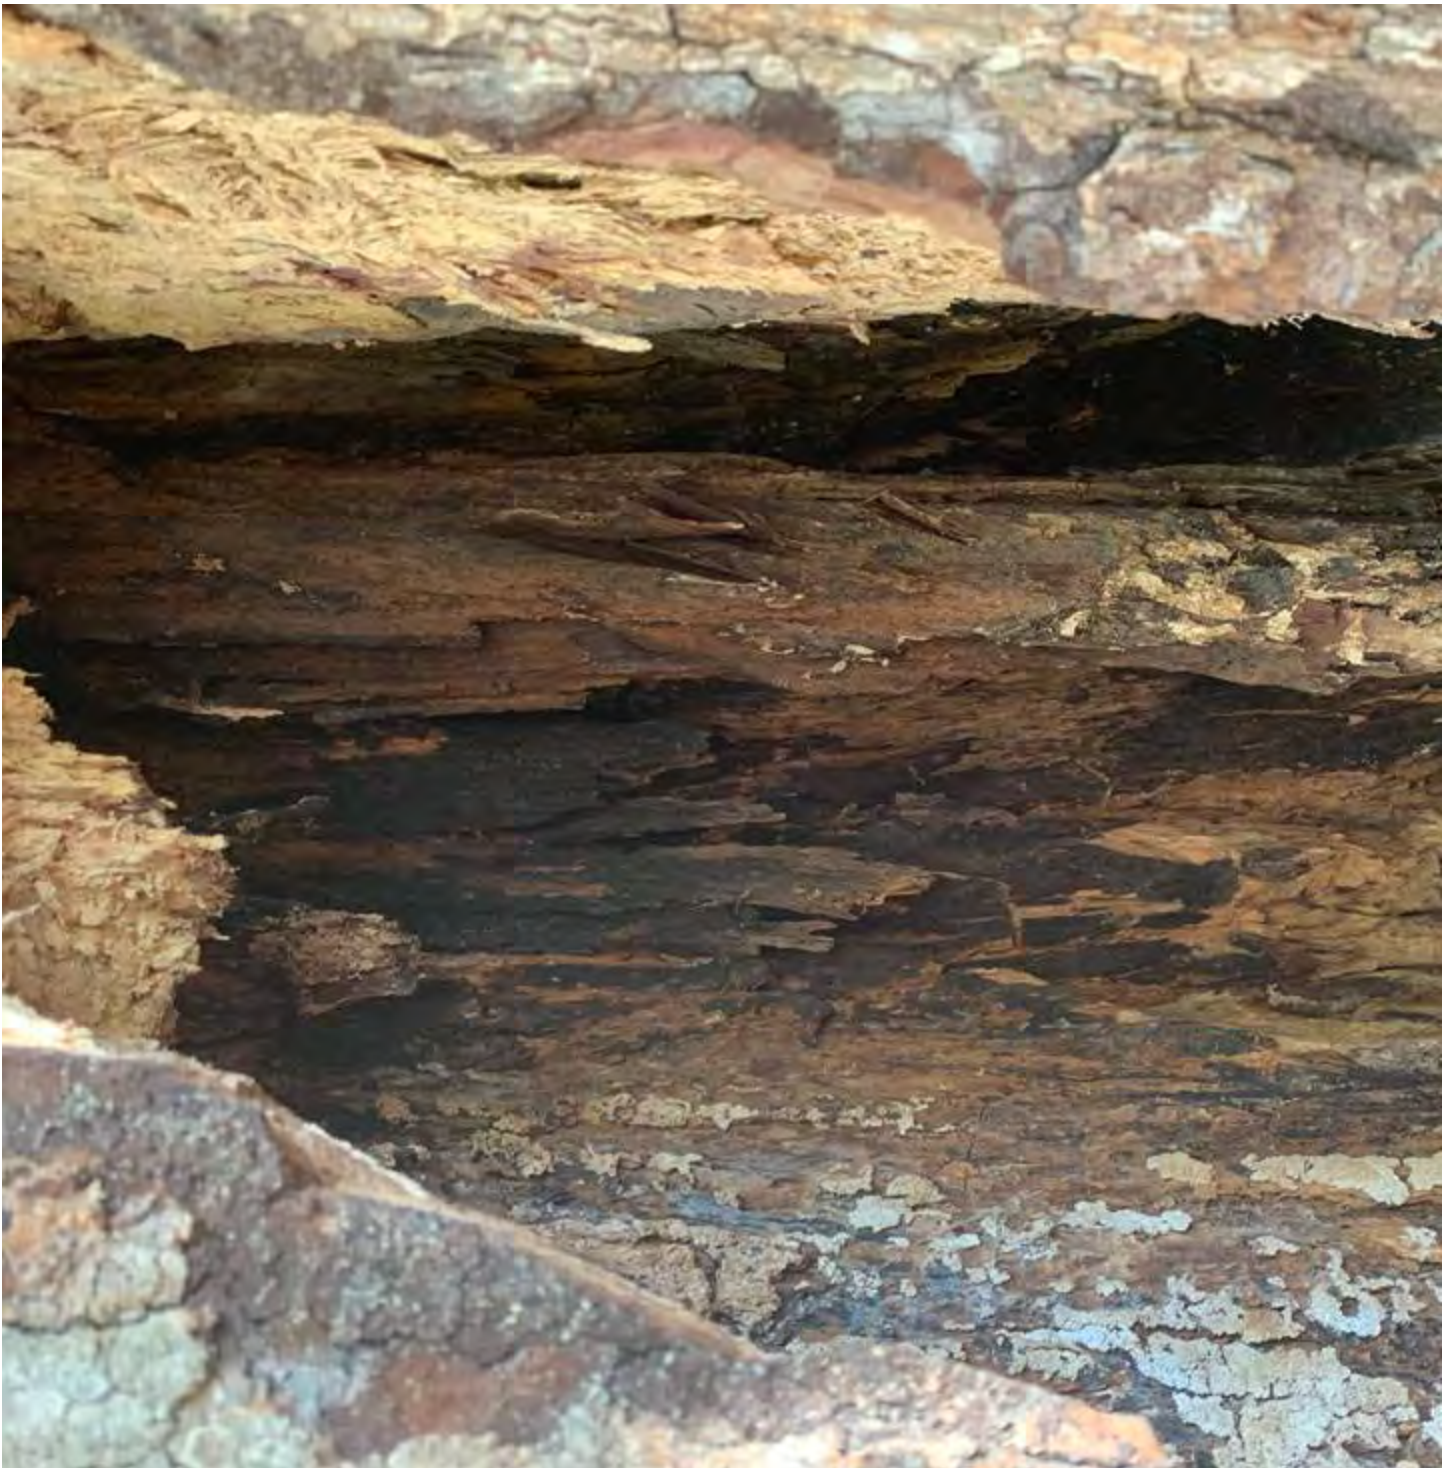
Karen, I was brought in by JDS Construction to examine the Indian Tamirind Tree. After extensive examination of the cavity on the western base of the tree. I have found that there is a cavity opening with advanced decay throughout the heartwood approximately 52" from the soil level extending upwards. I noted extensive decay and fungi development in the remaining support roots. With the amount of rot and decay it is at high risk of structural failure supporting this large canopy. (Please see attached photos)

It's my professional opinion and with over 30 years in the field of arboriculture that our options for public safety and to prevent property damage are limited to complete Tree removal and replacement.
