**Subject: Truman Seawall Repair Recommendations (PO No. 079755)**

# TRUMAN SEAWALL

CITY OF KEY WEST  
SEAWALL REPAIR & REPLACEMENT OPTIONS

**SUBSURFACE SOIL EXPLORATION AND  
PRELIMINARY GEOTECHNICAL ENGINEERING EVALUATION  
PROPOSED SEAWALL REPLACEMENT  
TRUMAN WATERFRONT  
KEY WEST, MONROE COUNTY, FLORIDA**

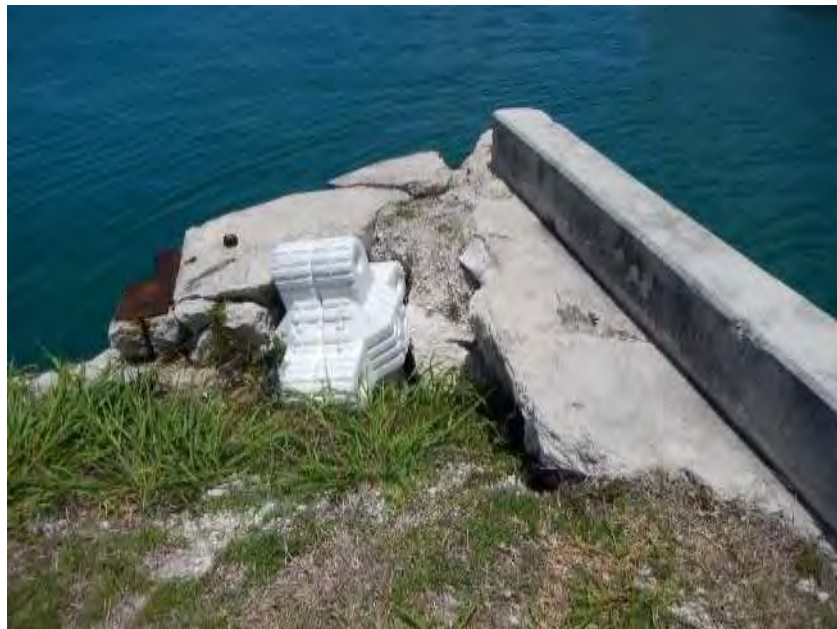
The Northeast end of the NOAA seawall. The concrete seawall cap does not extend all the way to the edge (damage is apparent). Quikrete bags appear to have been placed along the line where the cap should run. Looking Northeast.

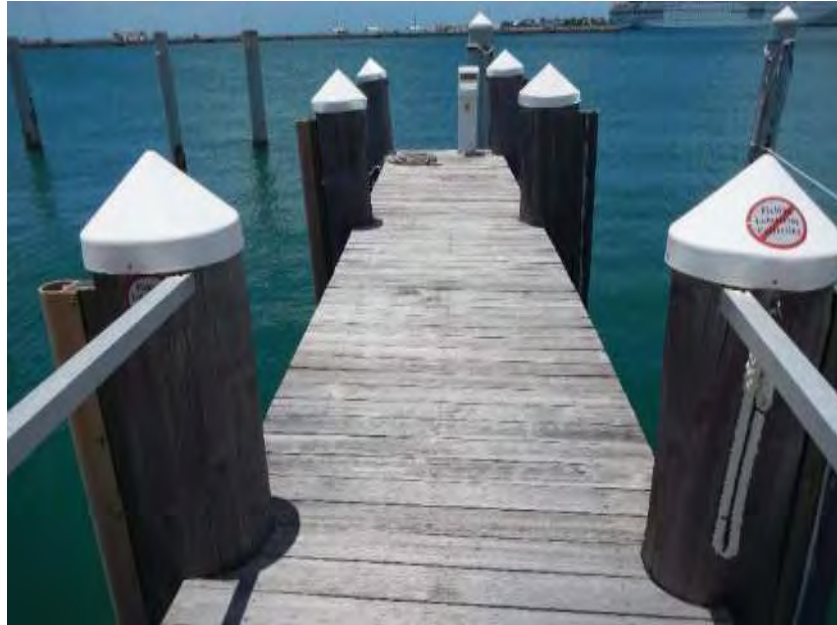
**Photo: 9**

View of the seawall from Dock 2 – right. Quikrete bags are visible along the bottom edge of the seawall.

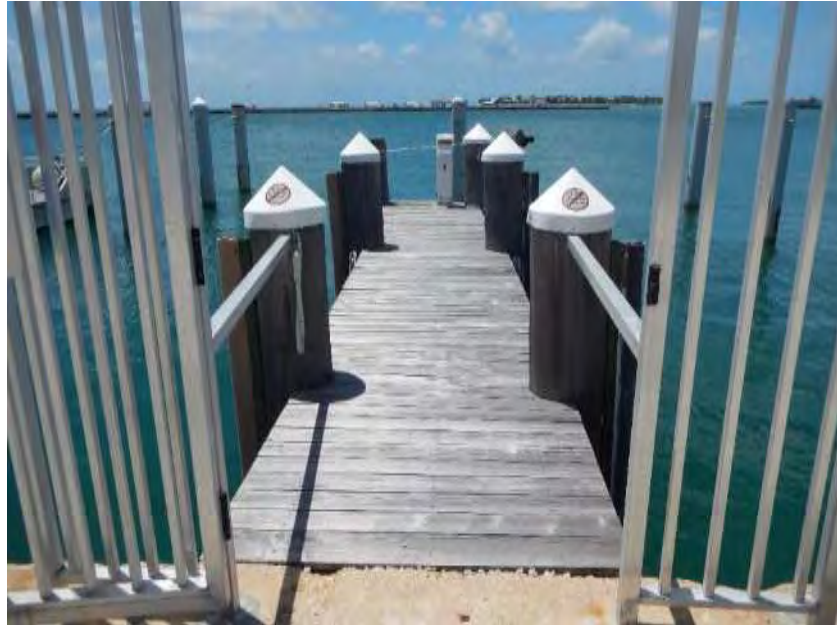
**Photo: 11**

**Description:**  
View of the seawall from Dock 3 – left. The quikrete bags appear to stop between Docks 2 and 3, and a concrete wall takes its place, running from the edge of the seawall to the top of grade.

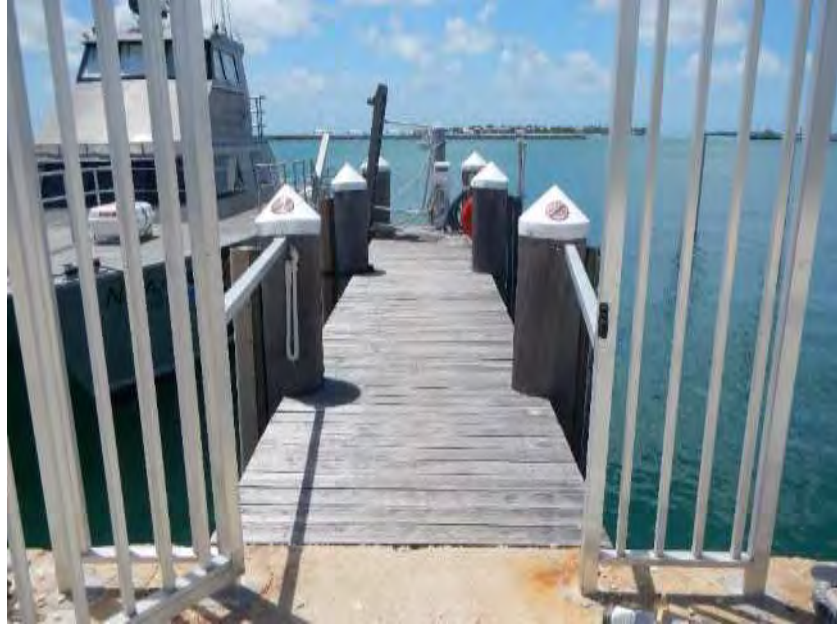
**Photo: 13**

**Description:**  
View of the seawall from Dock 4 – left. The concrete wall along the bottom appear to continue through the end of the seawall.

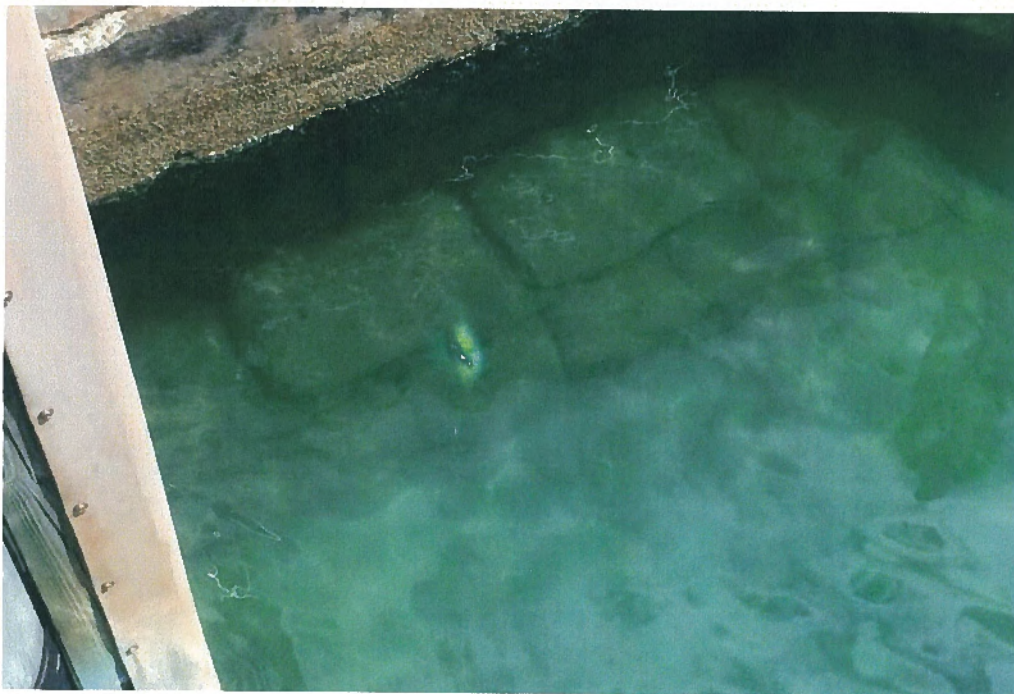
**4) Sand-Cement Bags by Toe of Seawall**

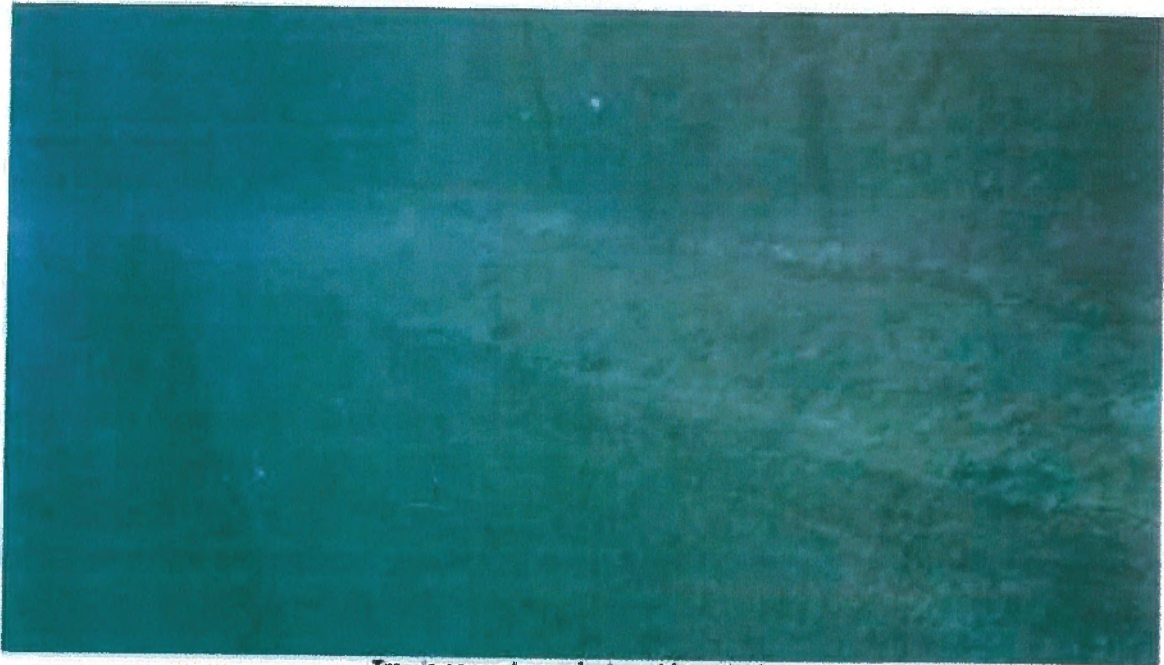
*Tremie concrete repair viewed from the top.*

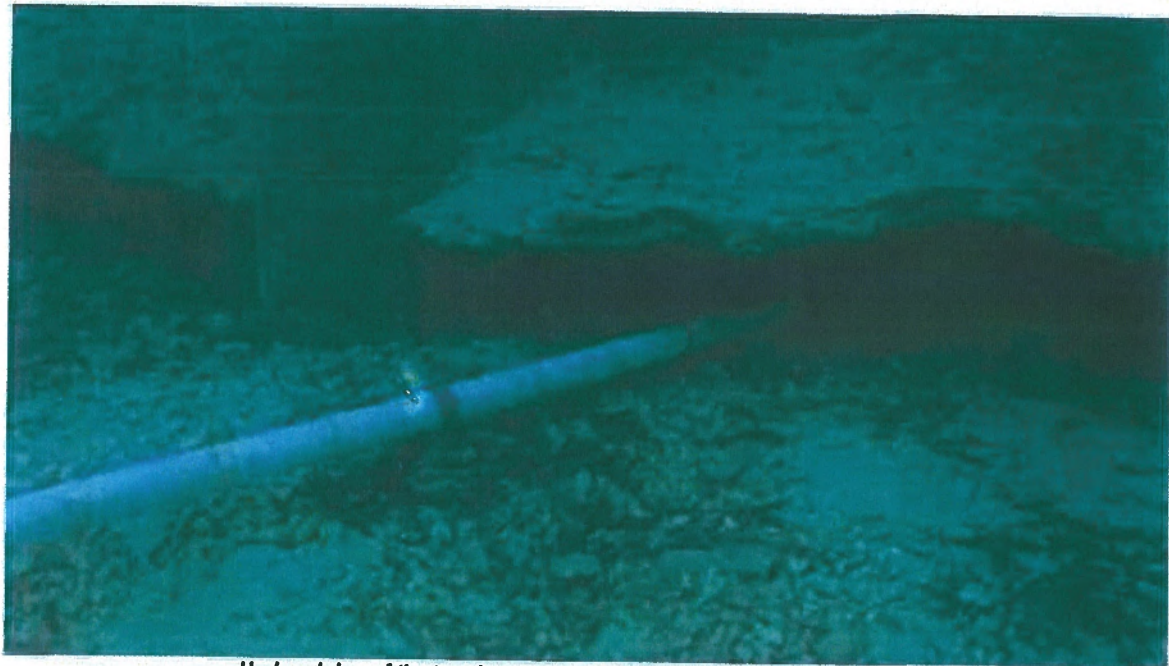
*Undermining of the tremie concrete repairs at the base of the bulkhead.*

From an engineering perspective, the main issue with the bulkhead at present is stability. The concrete sheet piles do not have adequate toe embedment to provide the fixity of the bulkhead at the base necessary for an earth retaining structure. Compounding this issue is the continued erosion of the limestone material at the toe. Therefore, my advice is not to proceed with trenching behind the bulkhead and filling with concrete as an alternative engineered solution.

If NOAA desires to pursue a near term solution that will plug the holes at the base of the bulkhead and reinforce to some degree the soft limestone bottom, I would recommend a tremie pour similar to what was done before. It is understood that this is not an engineered solution but rather a preventative maintenance measure against sinkholes. This approach was discussed openly amongst the group and the final concept is detailed in sketches SK-1, SK-2, and SK-3 attached. The tremie pour will be wide enough to encompass the Quikrete sacks on the eastern half of the site and high enough to cap the existing tremie pour on the west half.

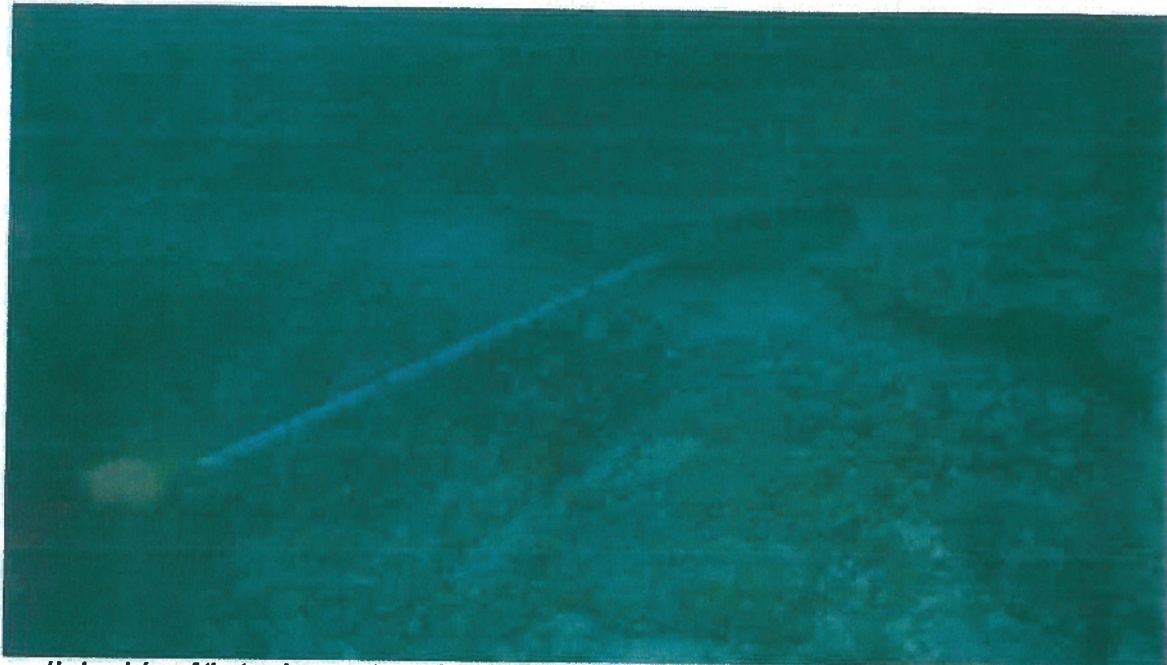
*Undermining of the tremie concrete repairs at the base of the bulkhead. Note the steep slope of the dredge line.*

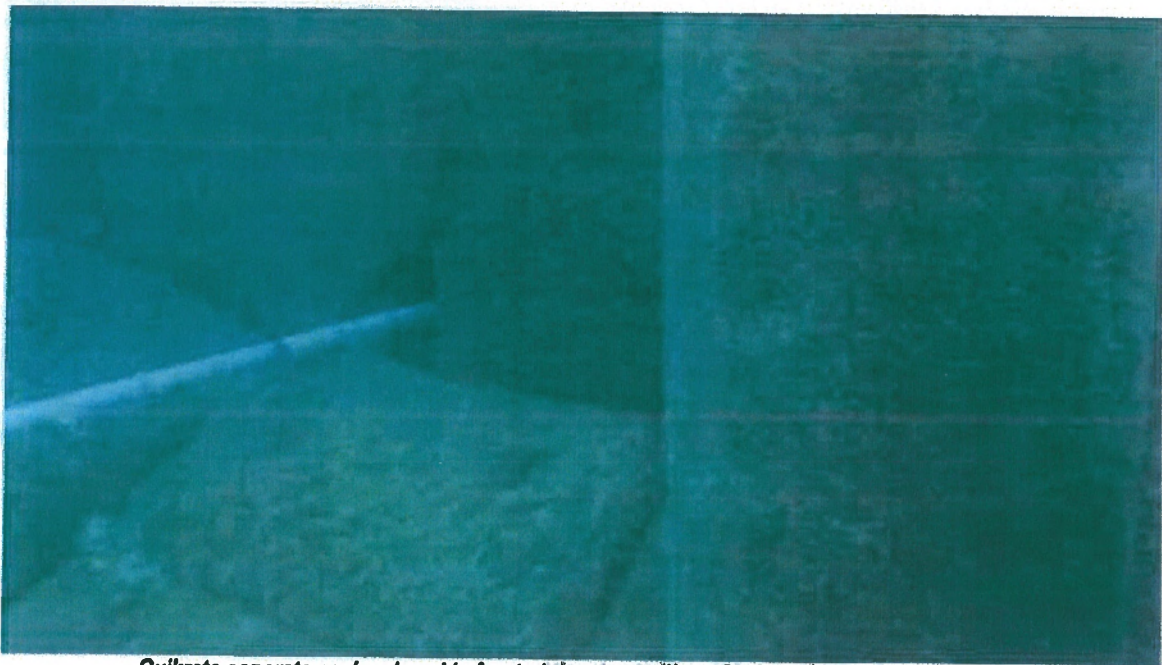
***Quikrete concrete sacks placed in front of the sheet piling. Cavity evident above the sacks.***
