STAFF REPORT

DATE: May 2, 2022

RE: 522 Elizabeth Street (permit application # T2022-0124)

FROM: Karen DeMaria, City of Key West Urban Forestry Manager

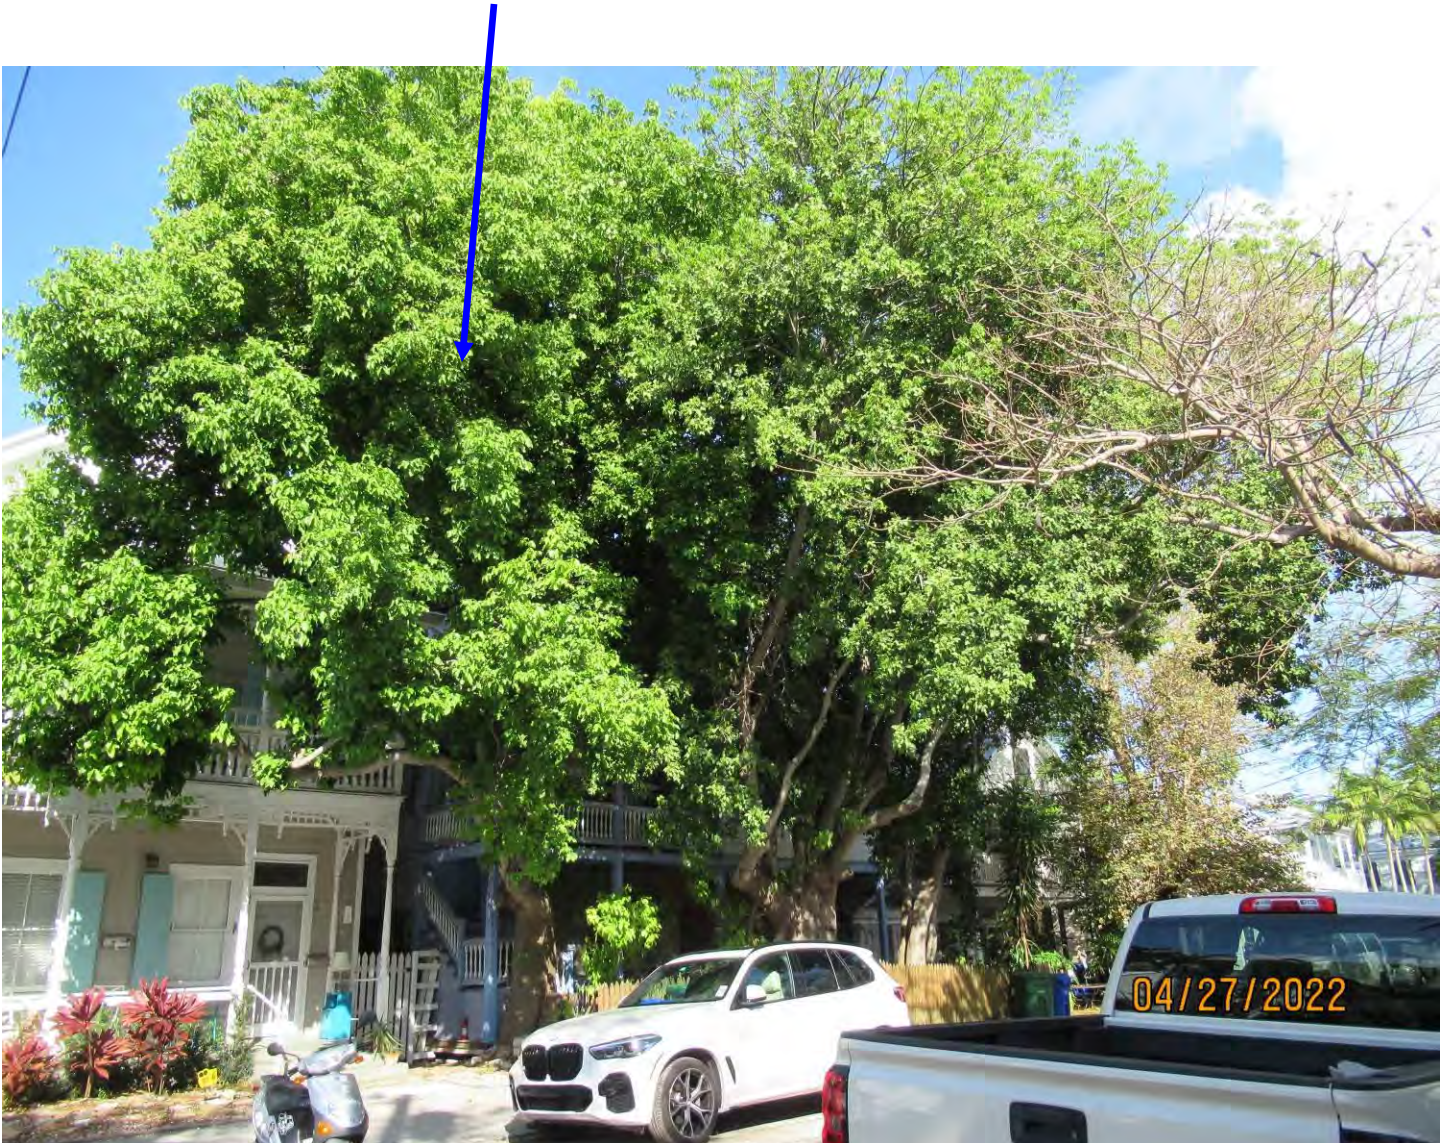
Photo showing whole tree and its location.

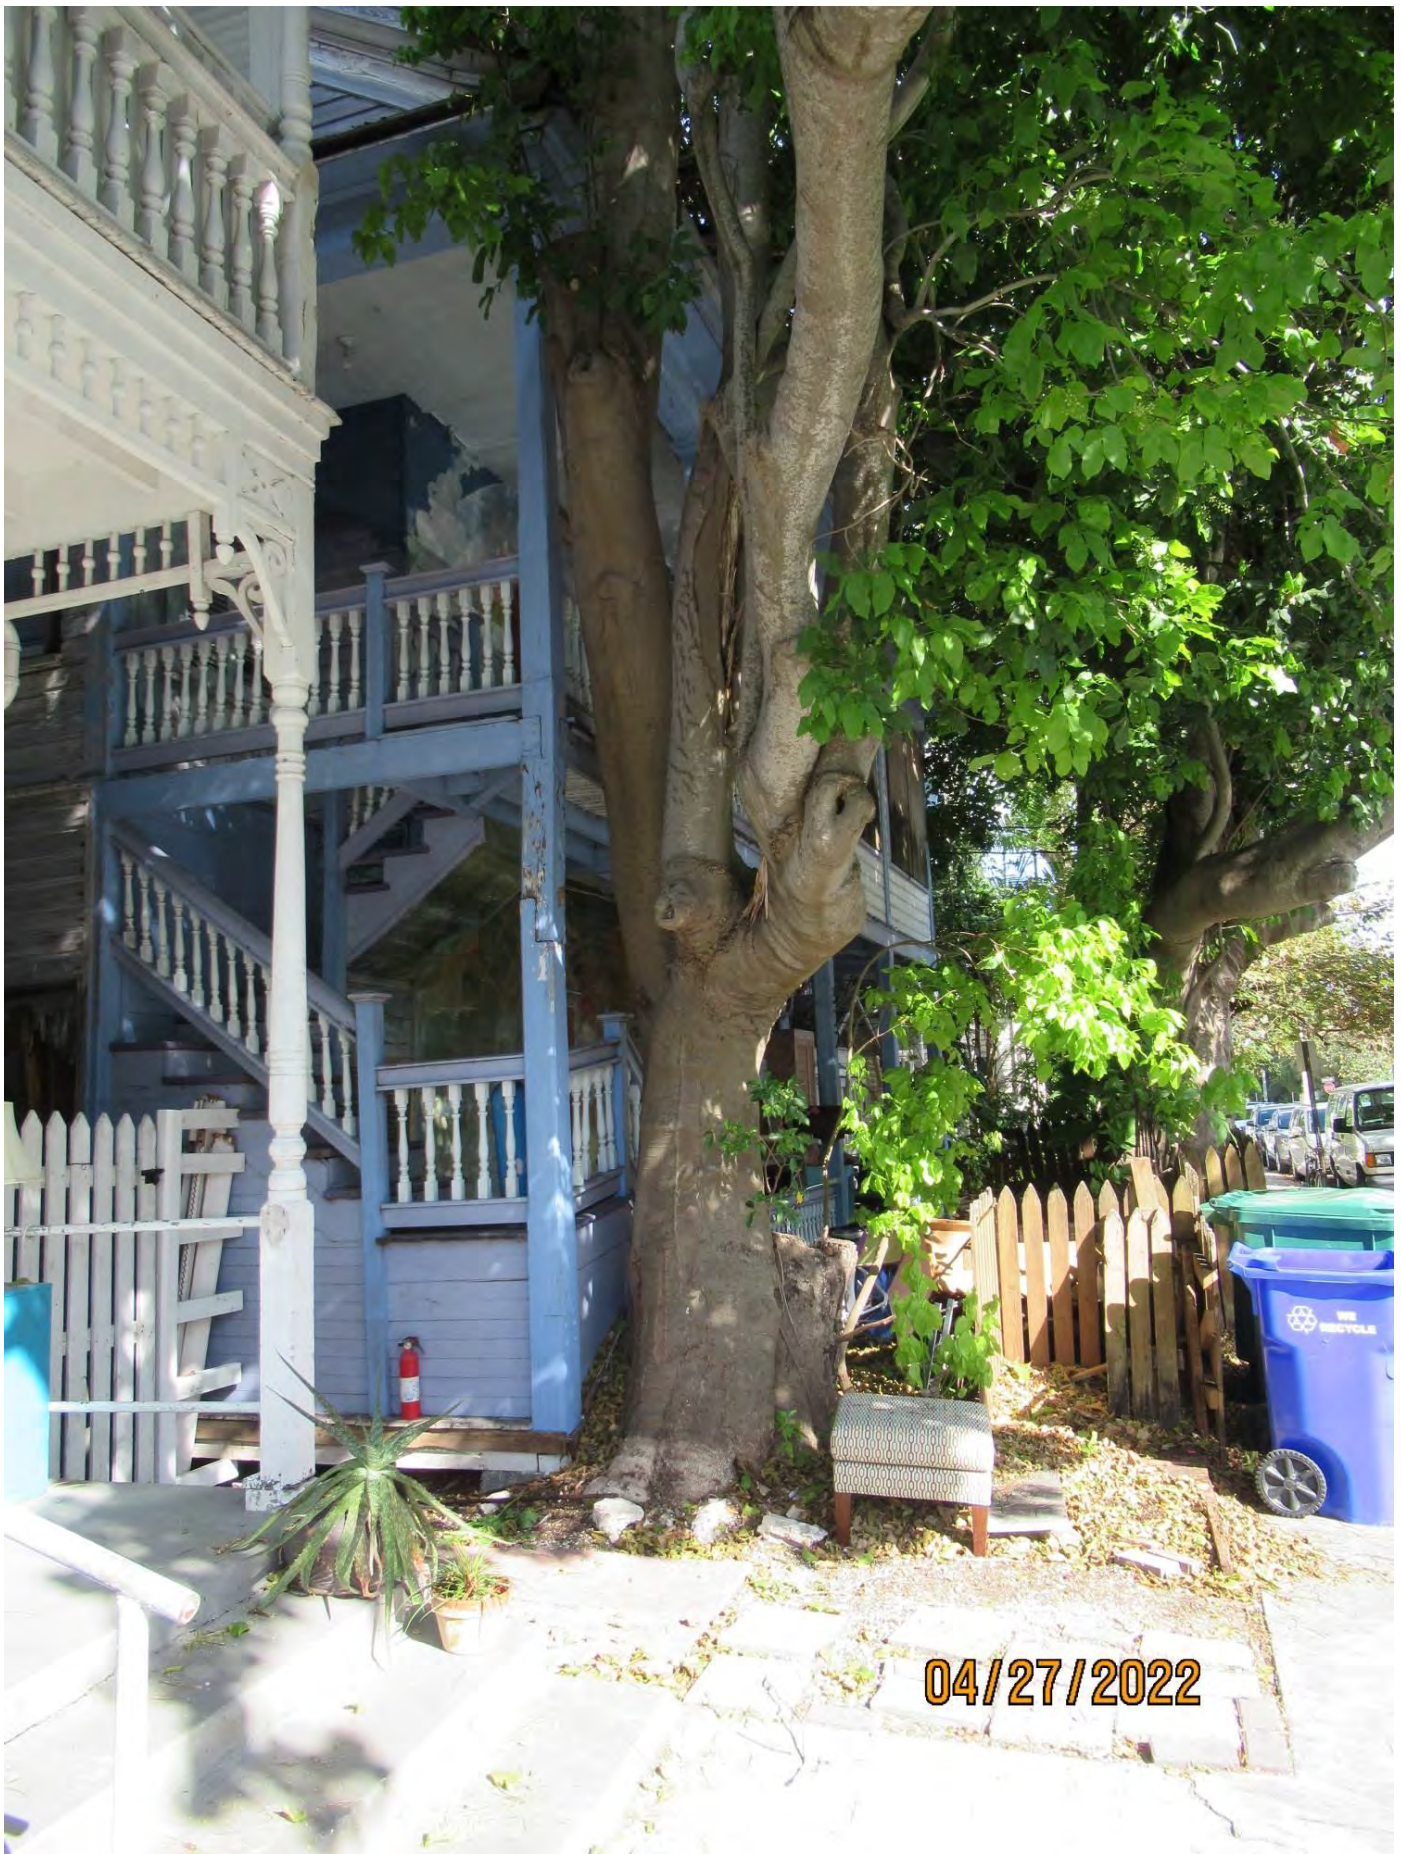
Photo showing base and trunk of tree, view 1.

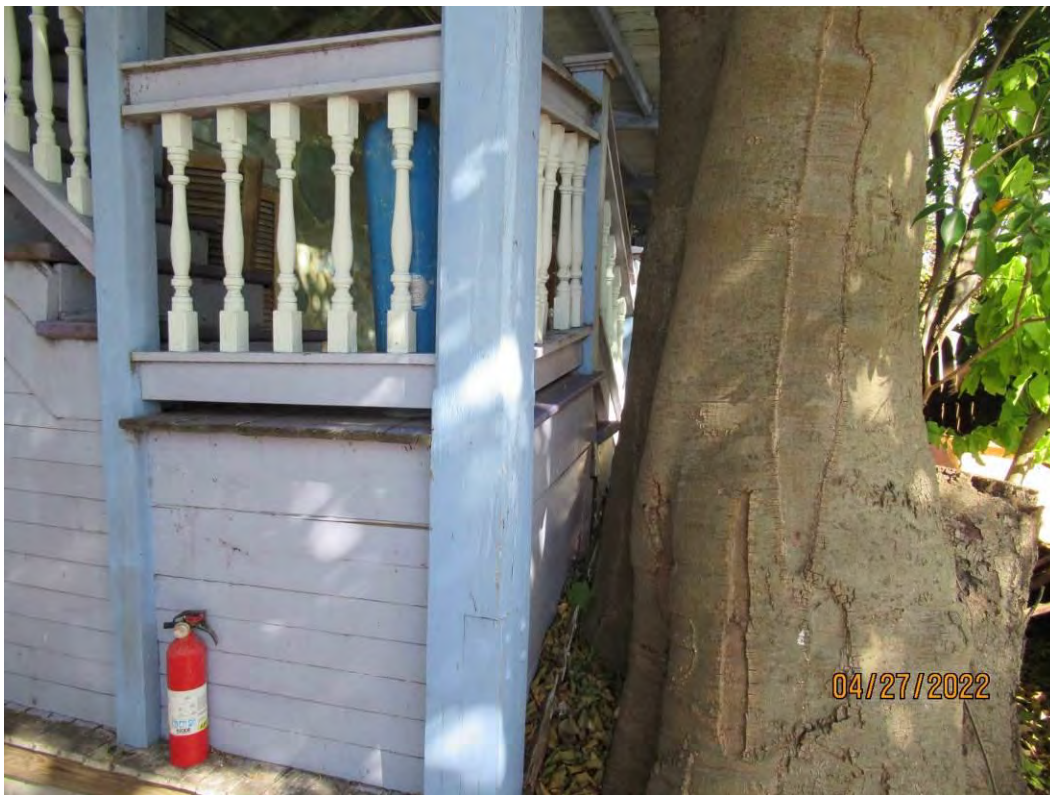
Photo showing location of base of tree and tree trunk in relation to structure, view 1.

Location: 40% (tree impacting structure at base and at roof eve, canopy impacts from adjacent large Spanish Lime tree.)

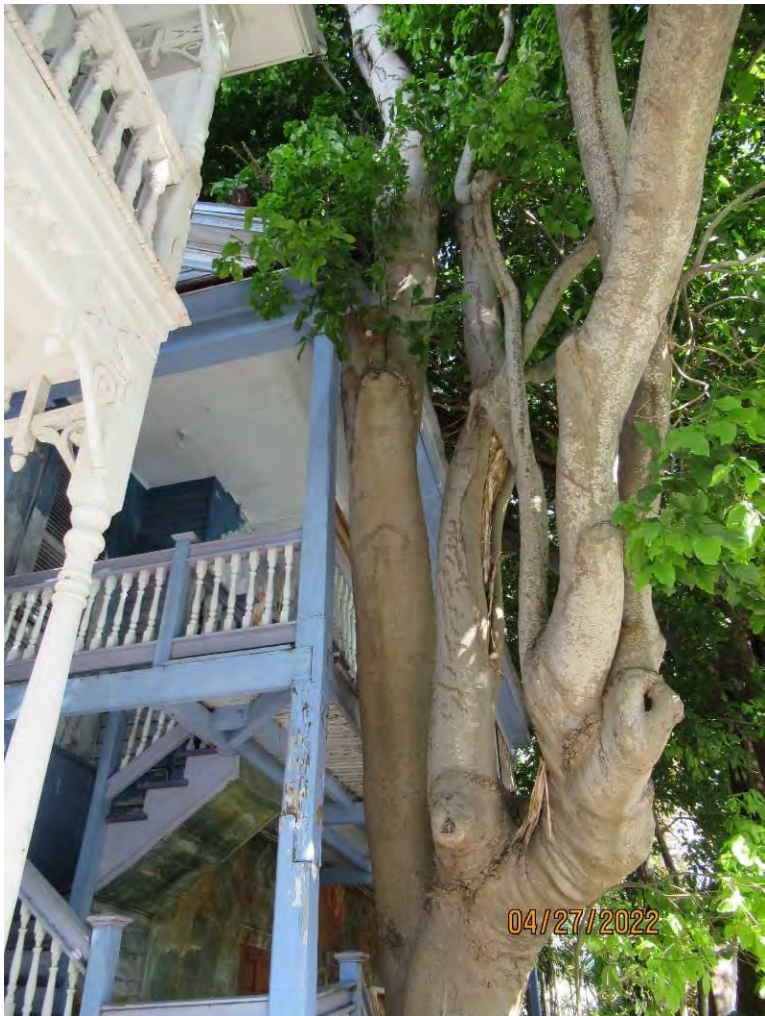
Photo showing location of tree canopy relation to structure, view 1.

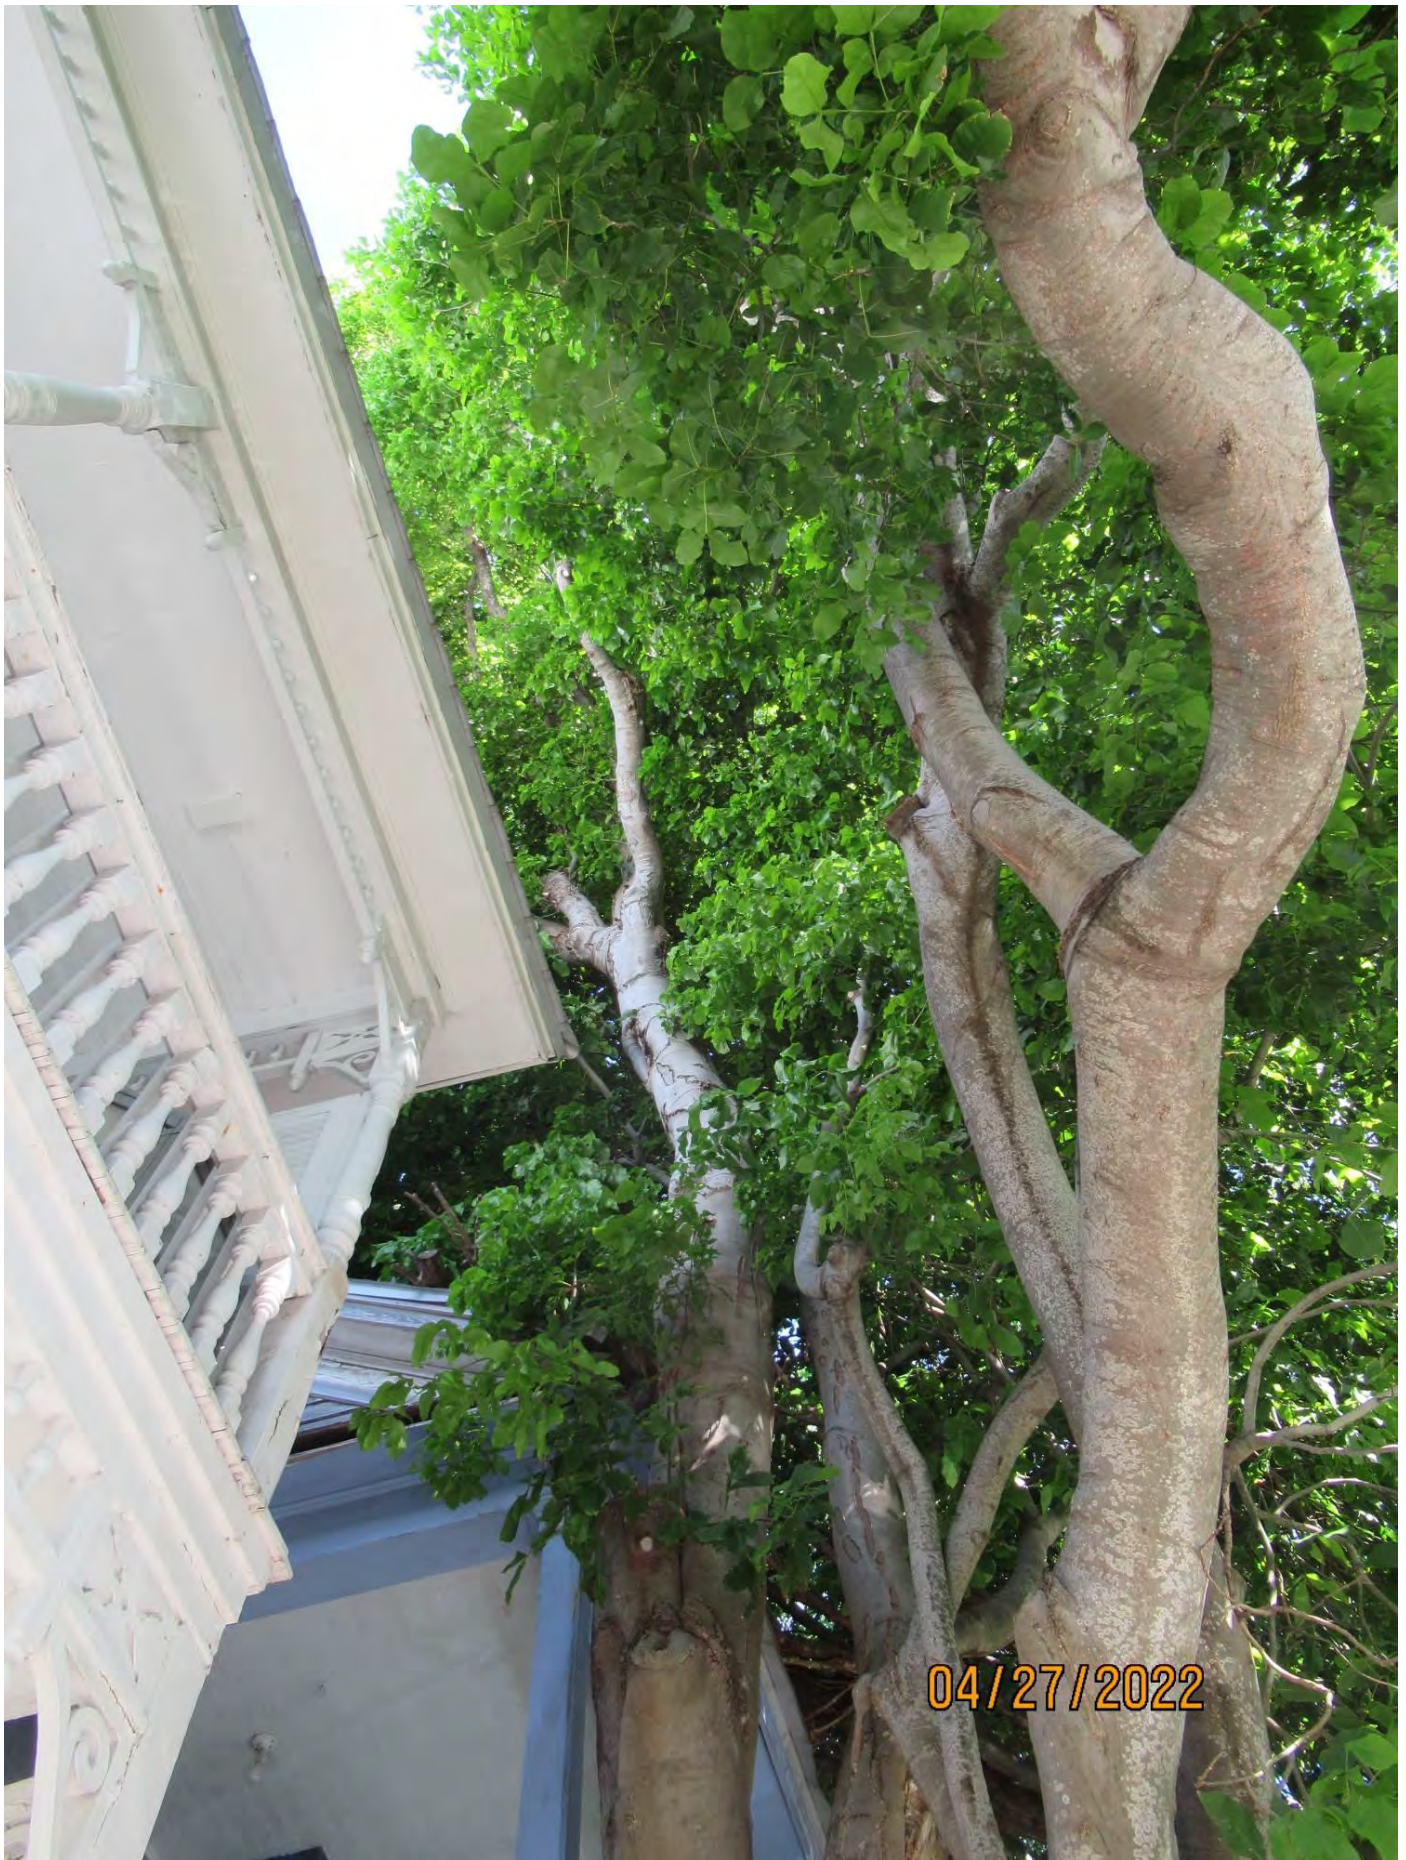
Photo showing location of tree canopy in relation to structure, view 2.

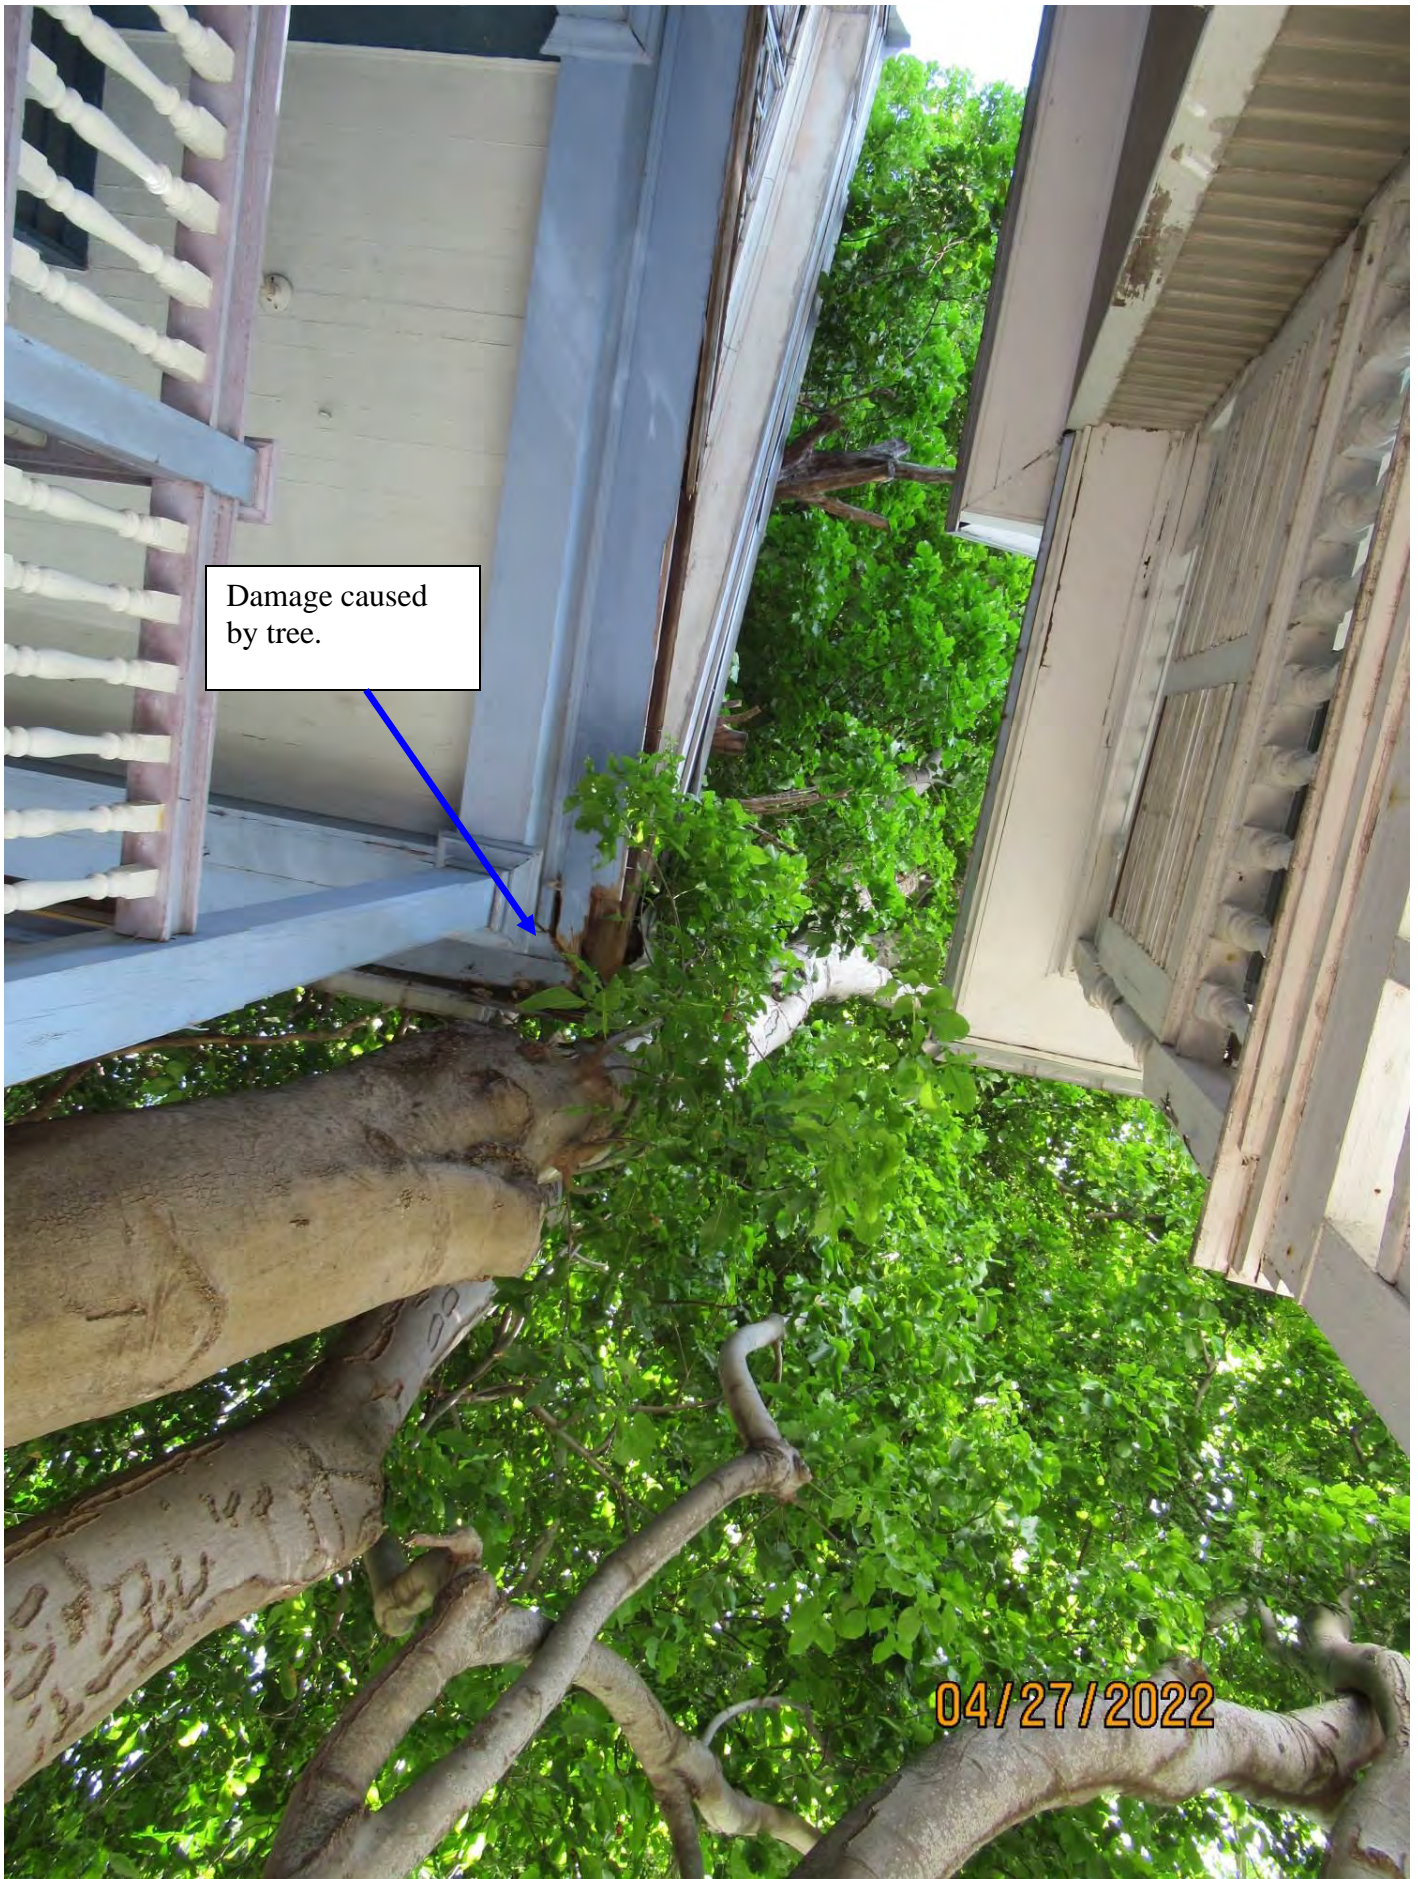
Damage caused
by tree.

Photo showing location of tree canopy in relation to structures, view 3.

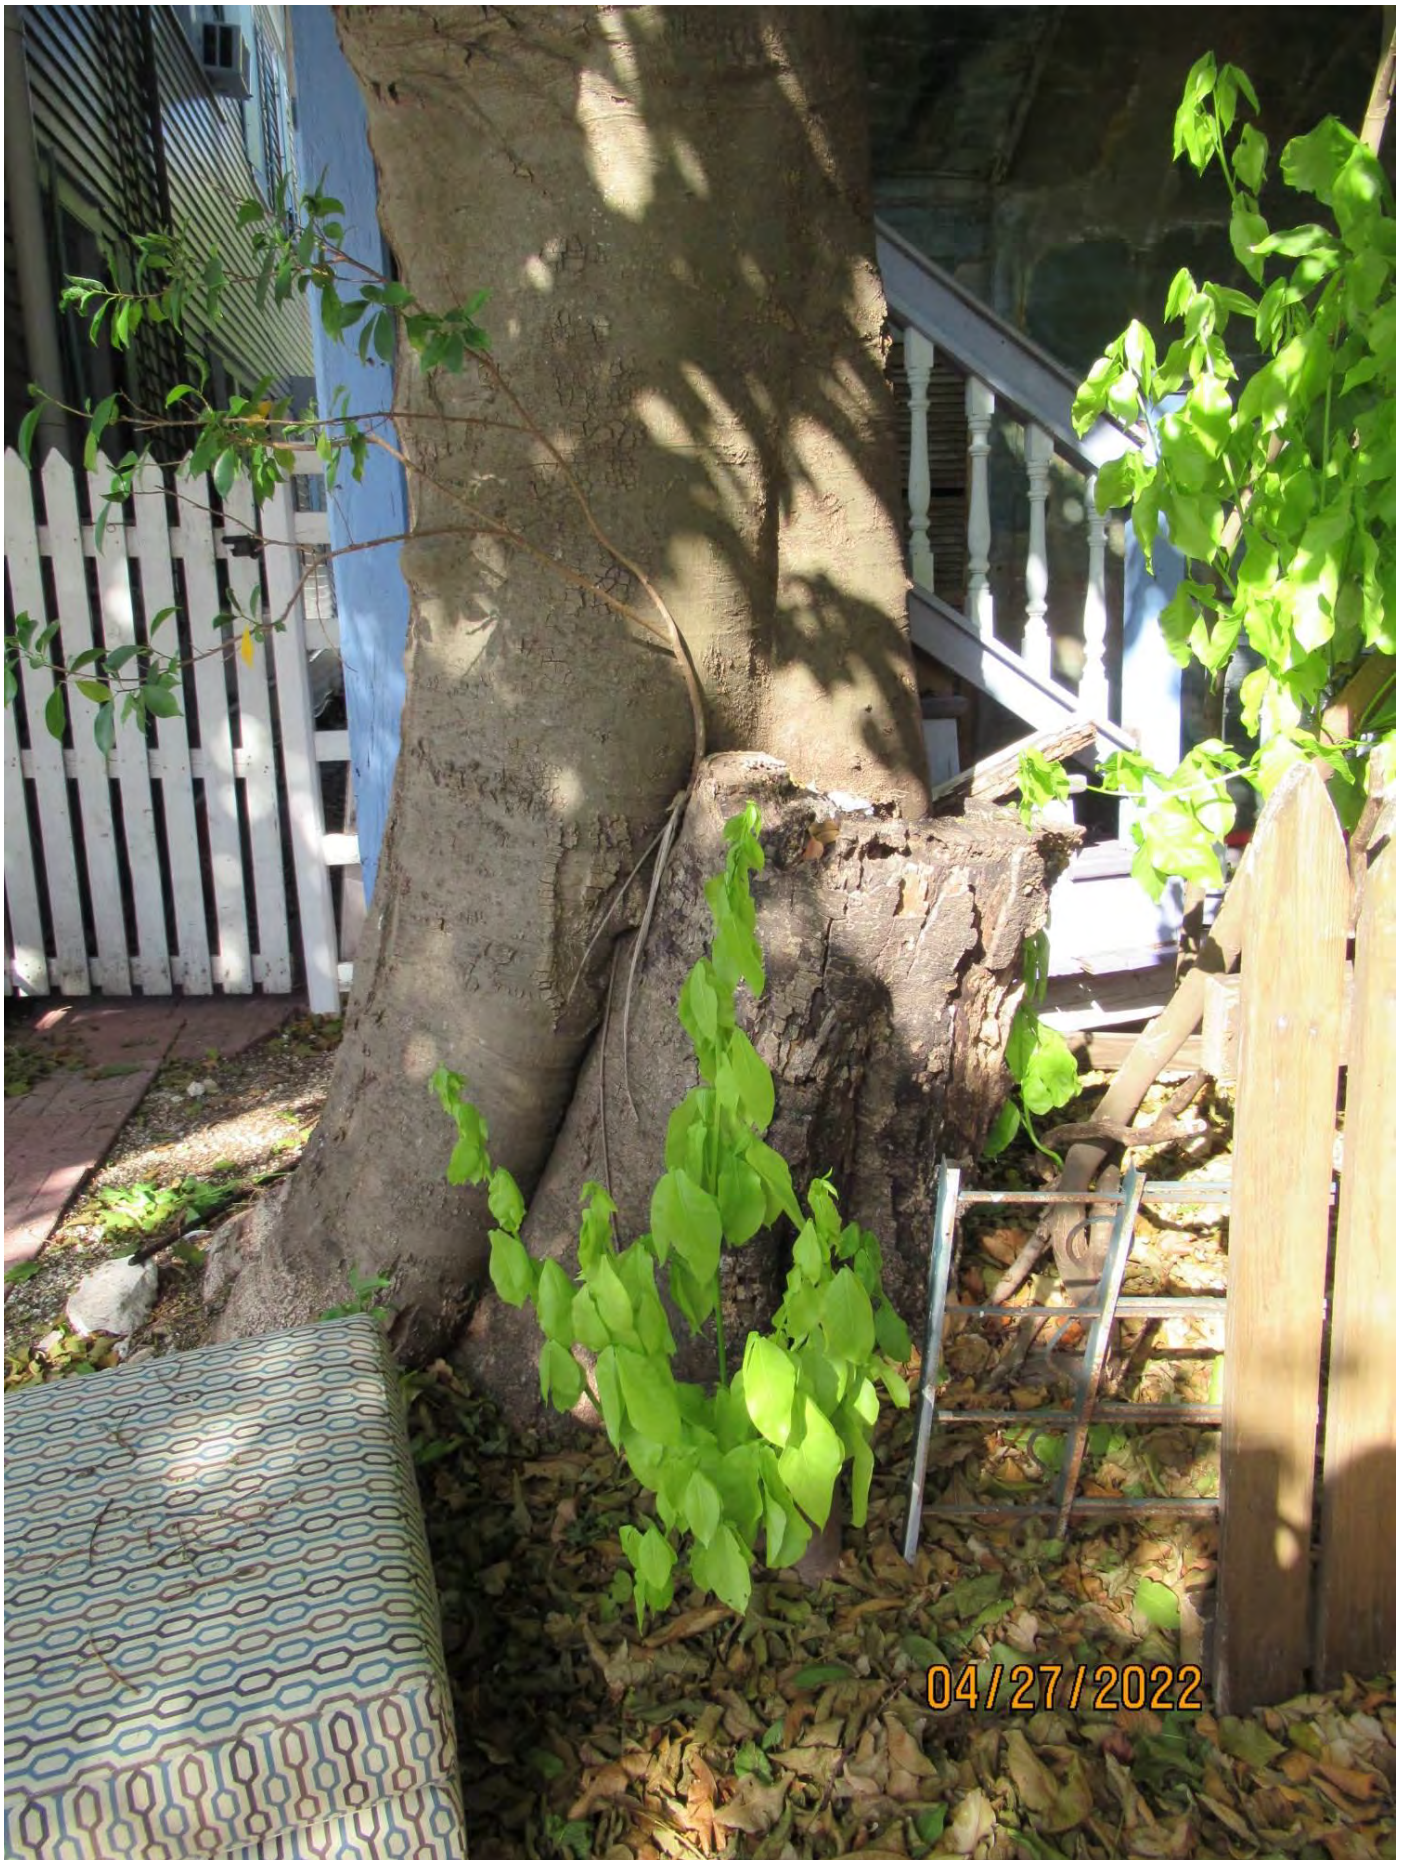
Photo of base of tree area showing old, decay trunk stump, view 1.

Condition: 50% (overall condition is fair to poor, decay in canopy due to old branch tears, large trunk stump decay at base area.)

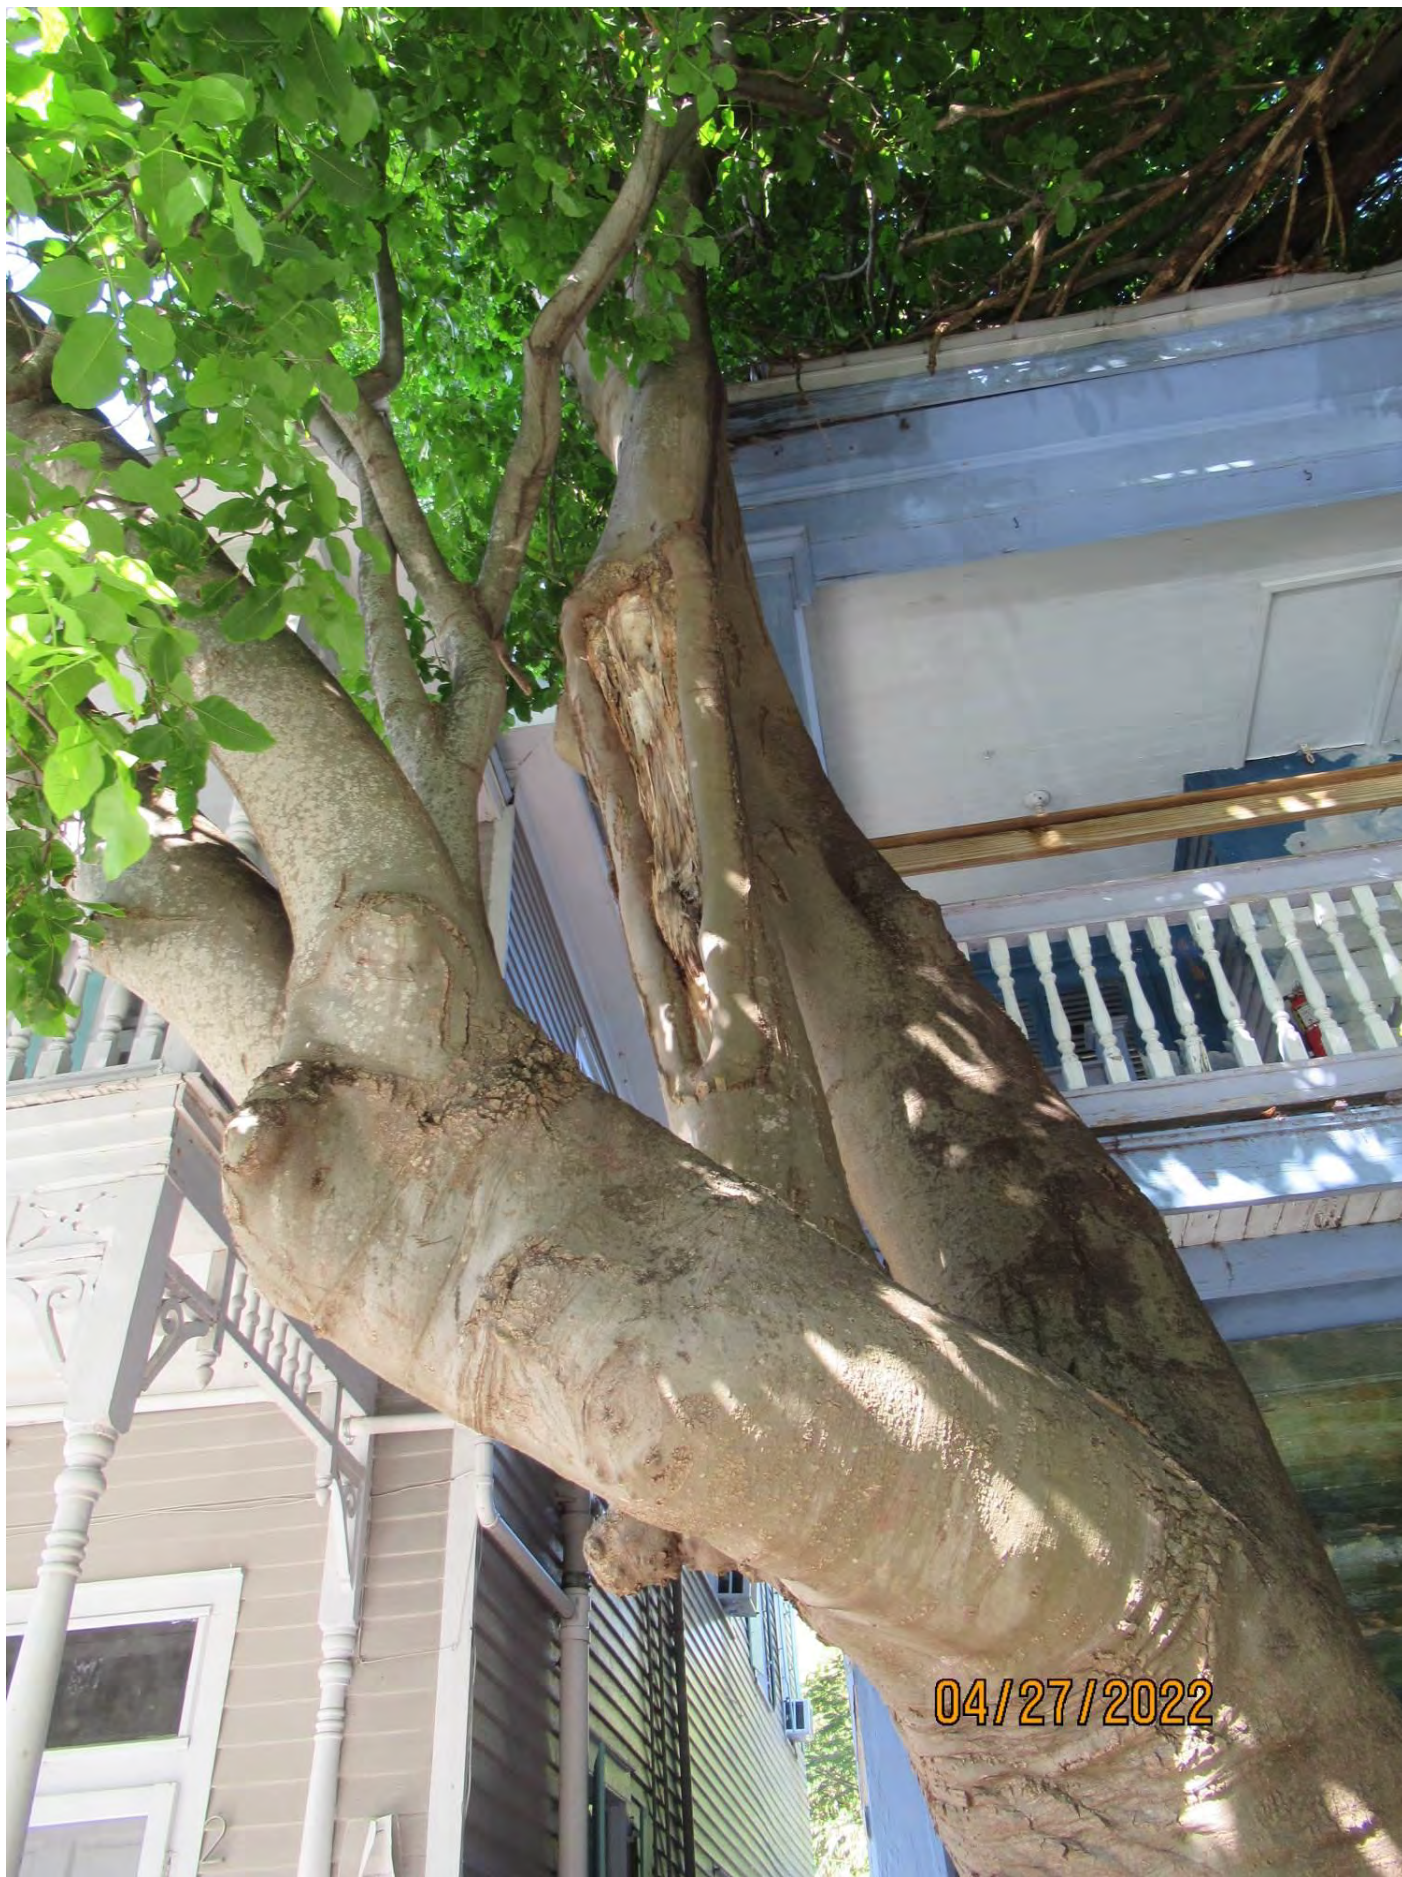
Photo of tree trunks.

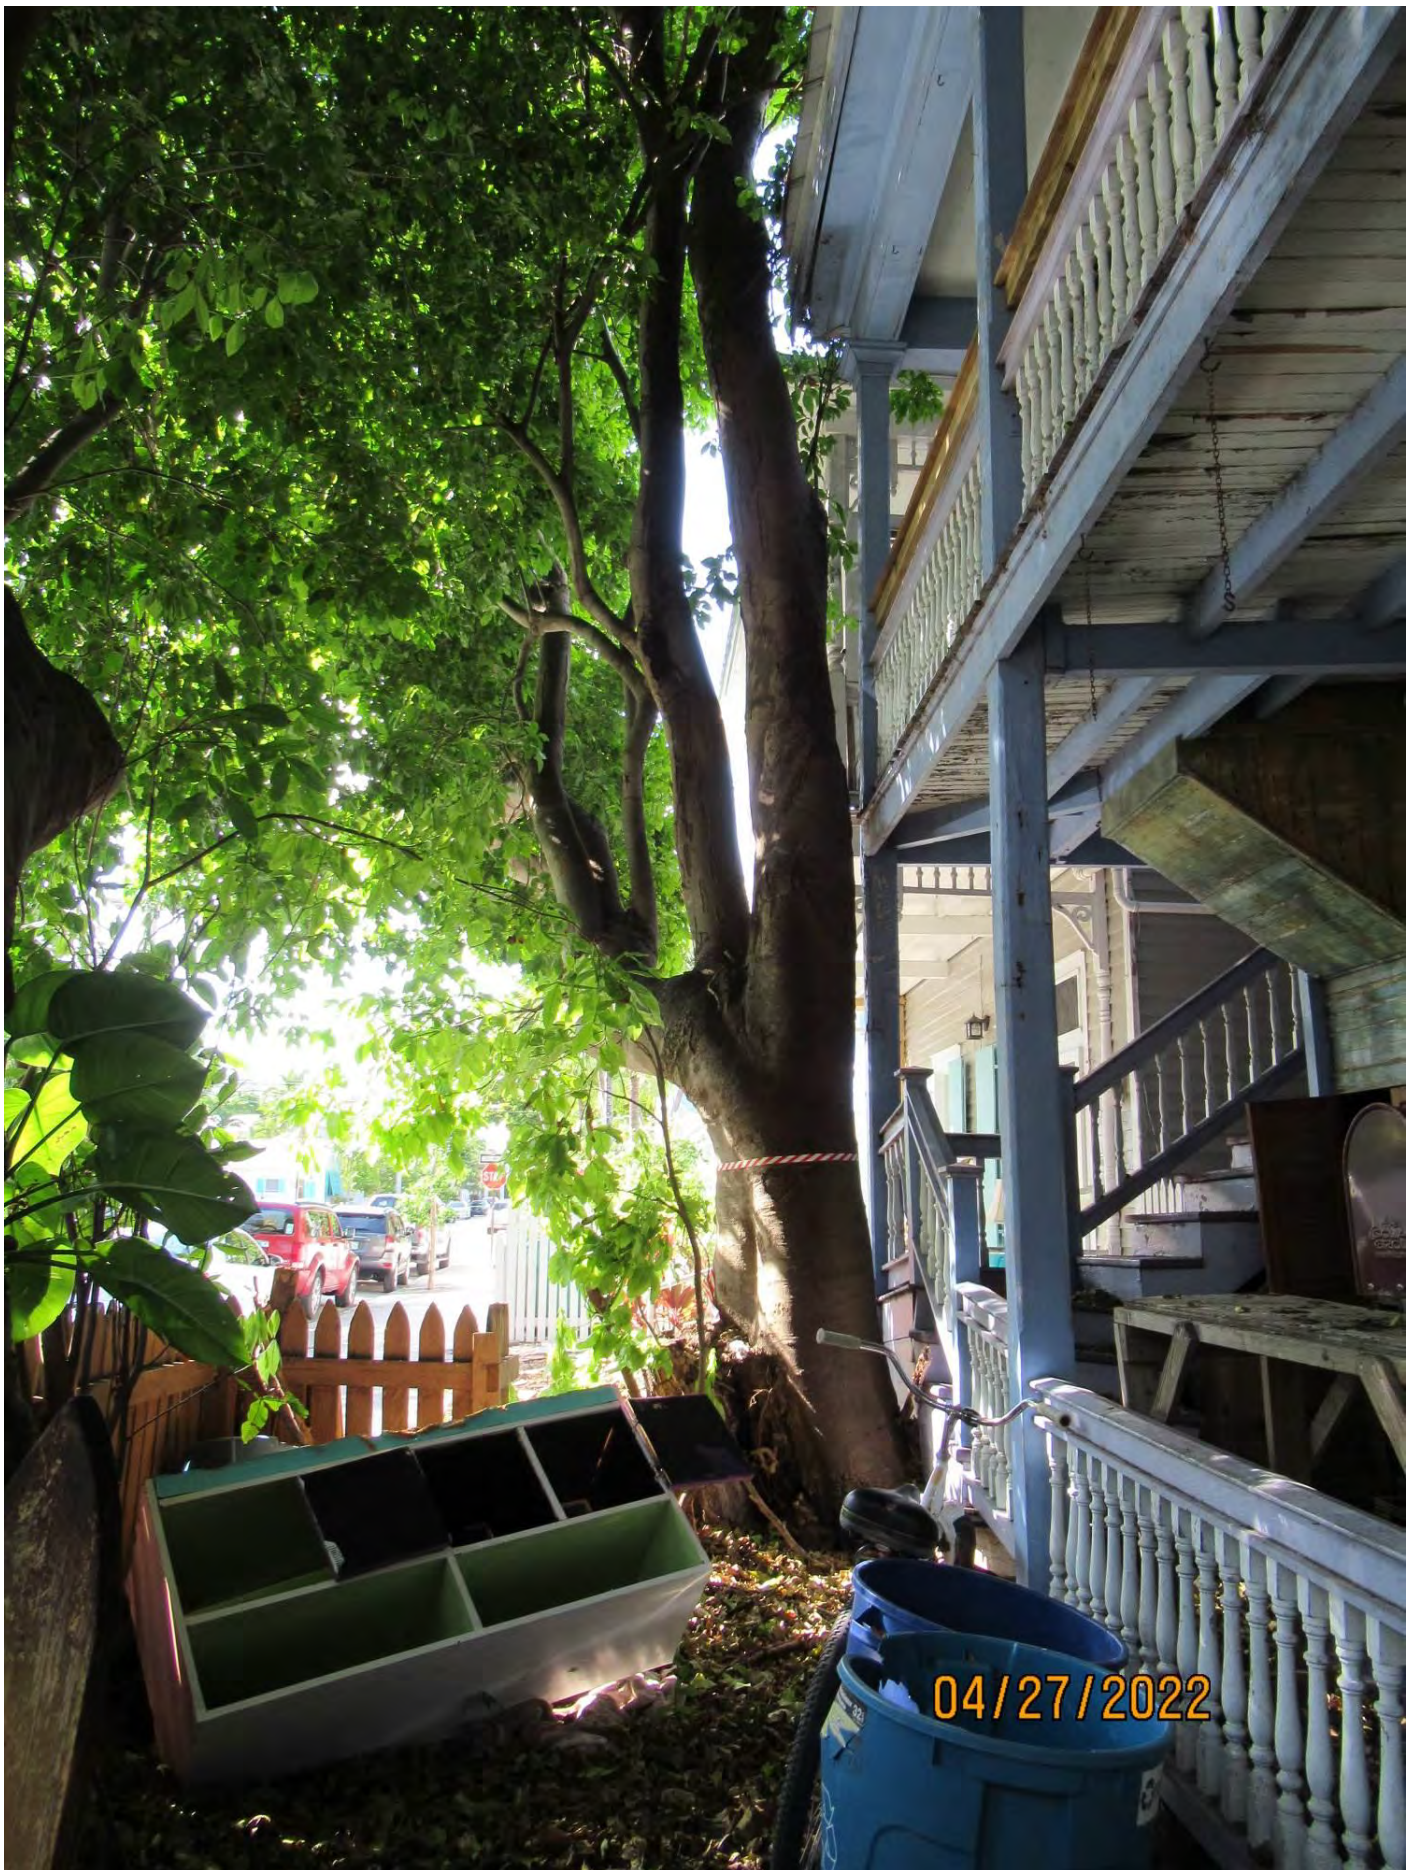
Photo showing base and trunk of tree, view 2.

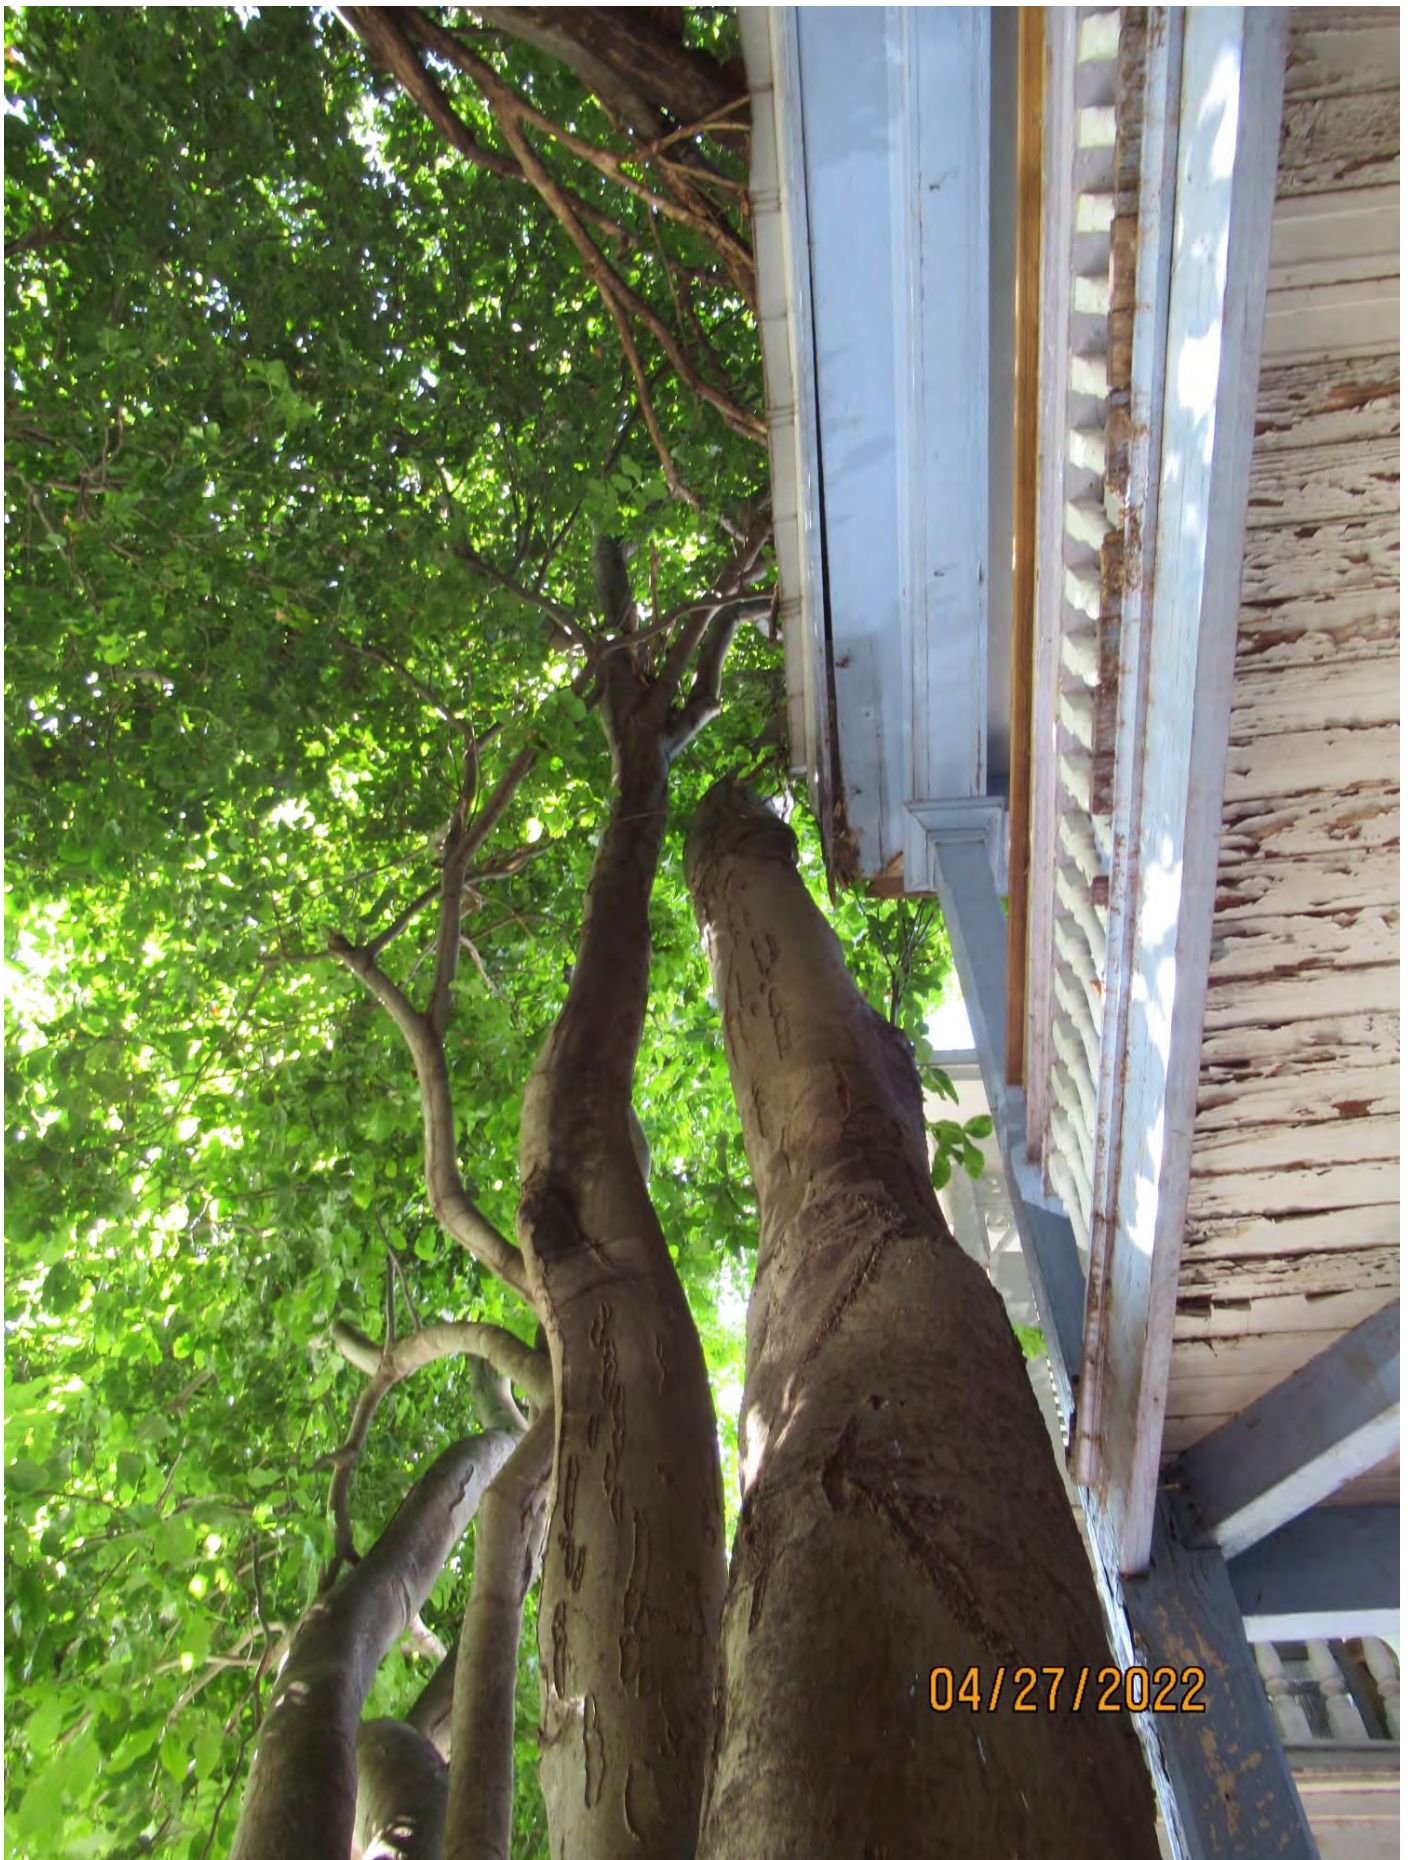
Photo showing location of tree canopy in relation to structure, view 4.

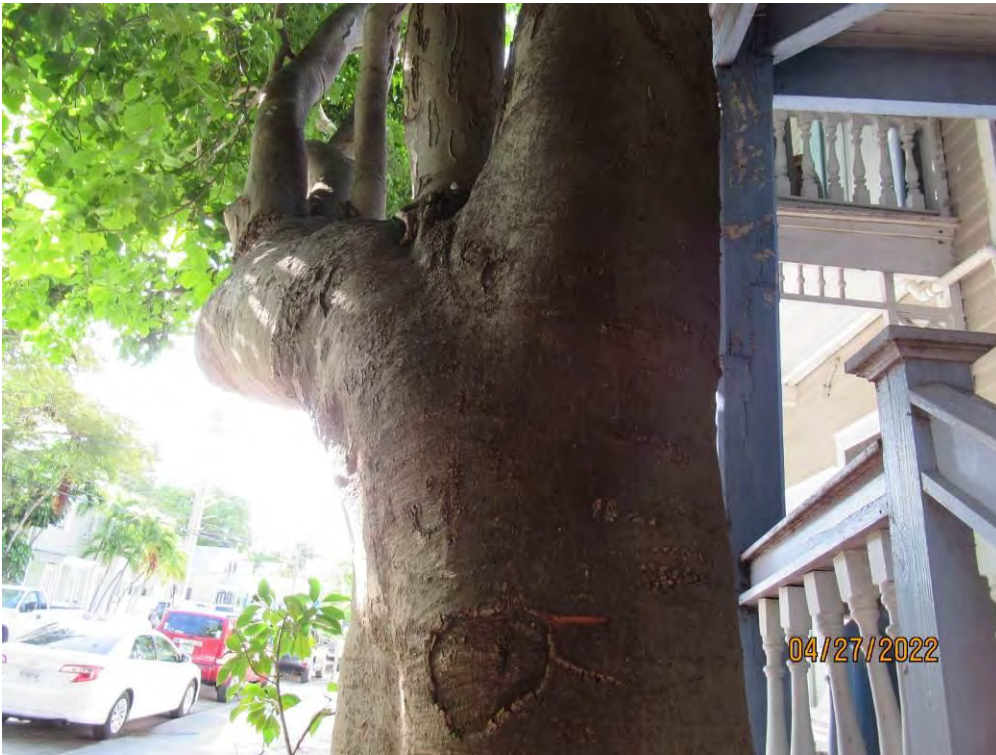
Photo showing main trunk and crotch area.
