STAFF REPORT

DATE: May 2, 2022

RE: 522 Elizabeth Street (permit application # T2022-0124)

FROM: Karen DeMaria, City of Key West Urban Forestry Manager

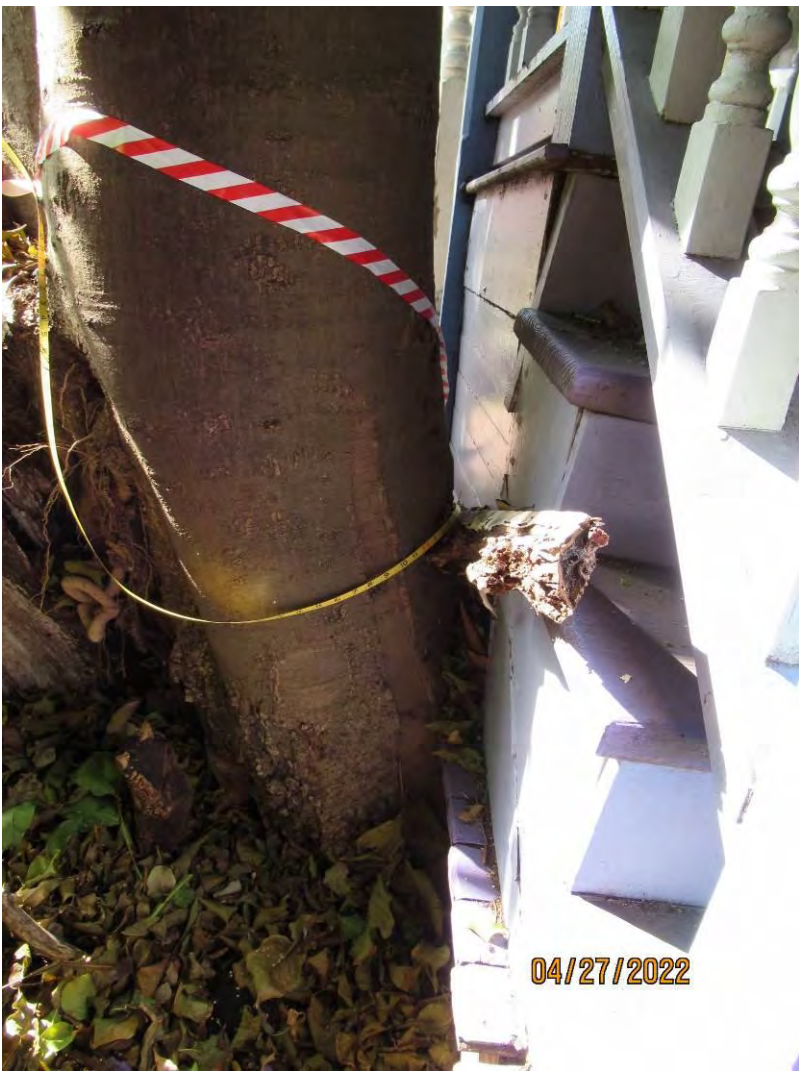
Photo showing location of base of tree and tree trunk in relation to structure, view 2.

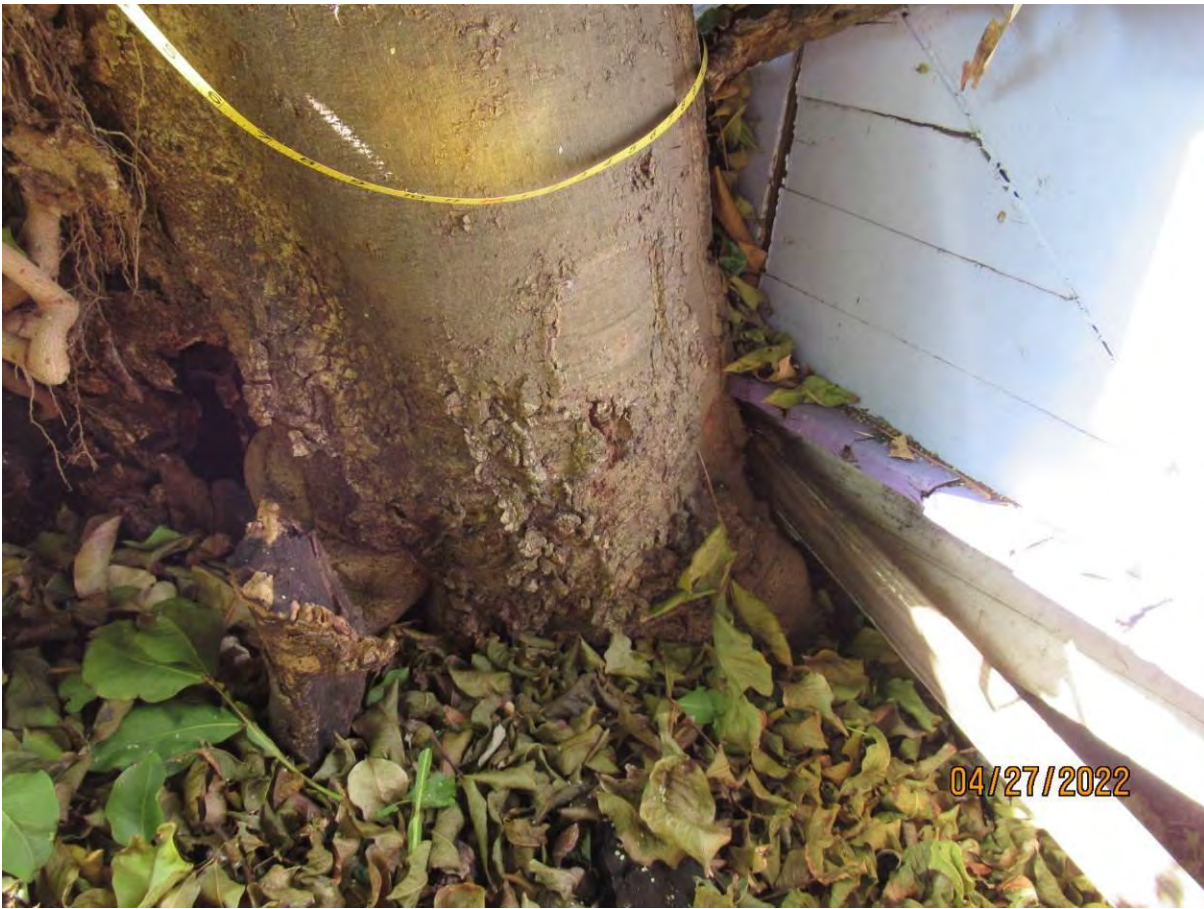
Close up photo
of base of tree
and structure
impacts.

Location: 40% (tree impacting structure at base and at roof eve, canopy impacts from adjacent large Spanish Lime tree.)

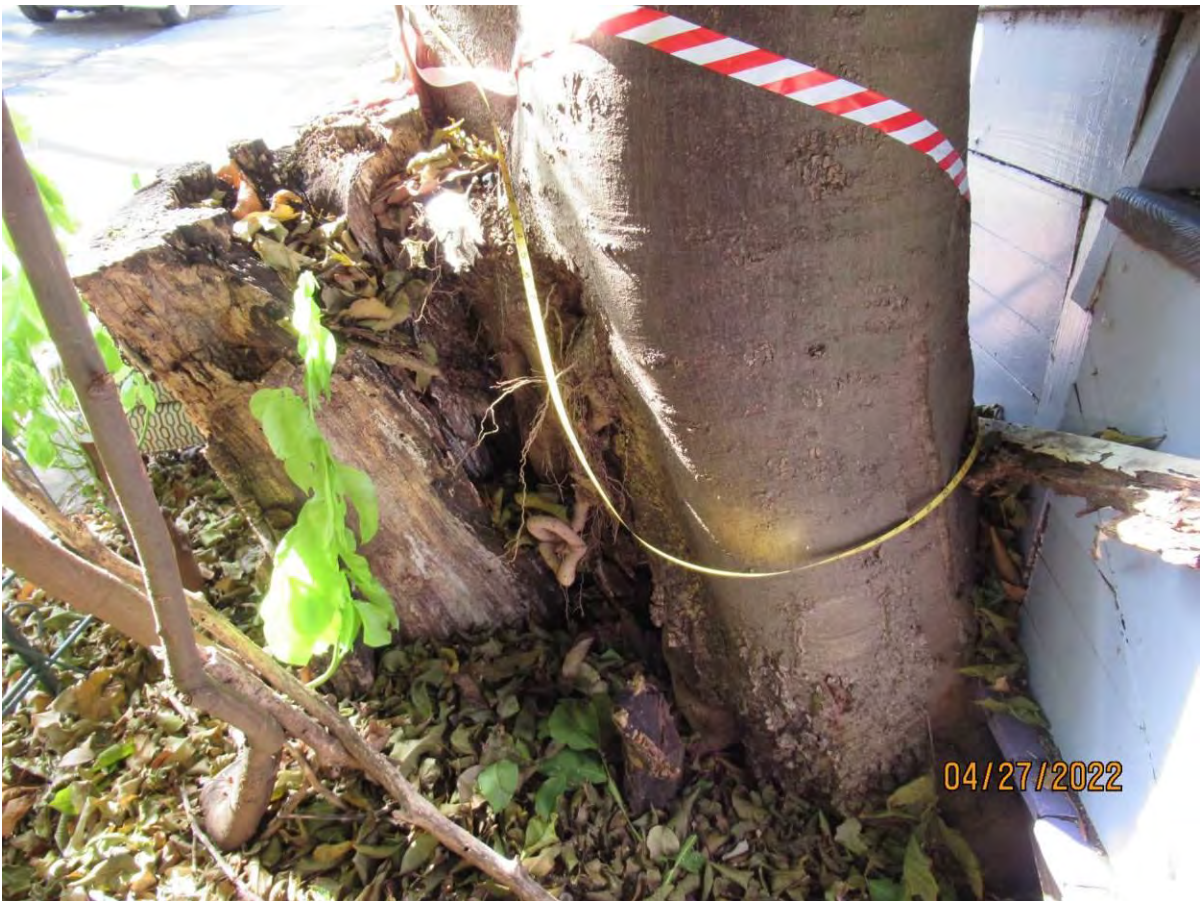
Photo of base
of tree and
old trunk
stump, view
2.

Condition: 50% (overall condition is fair to poor, decay in canopy due to old branch tears, large trunk stump decay at base area.)

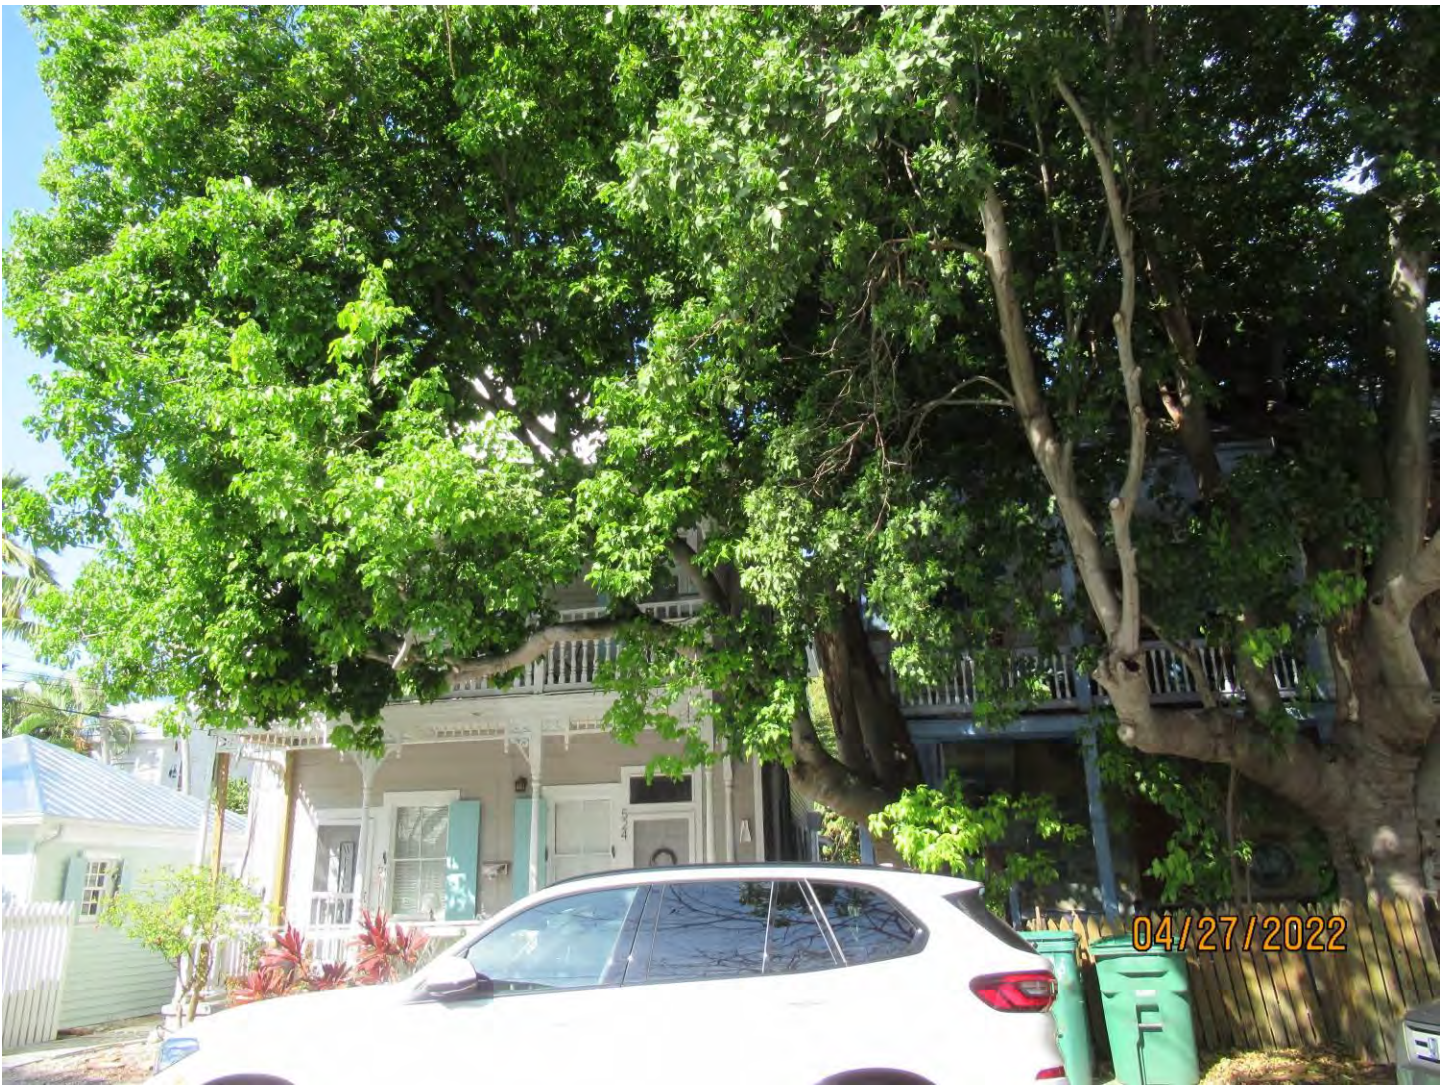
Photo of tree canopy.

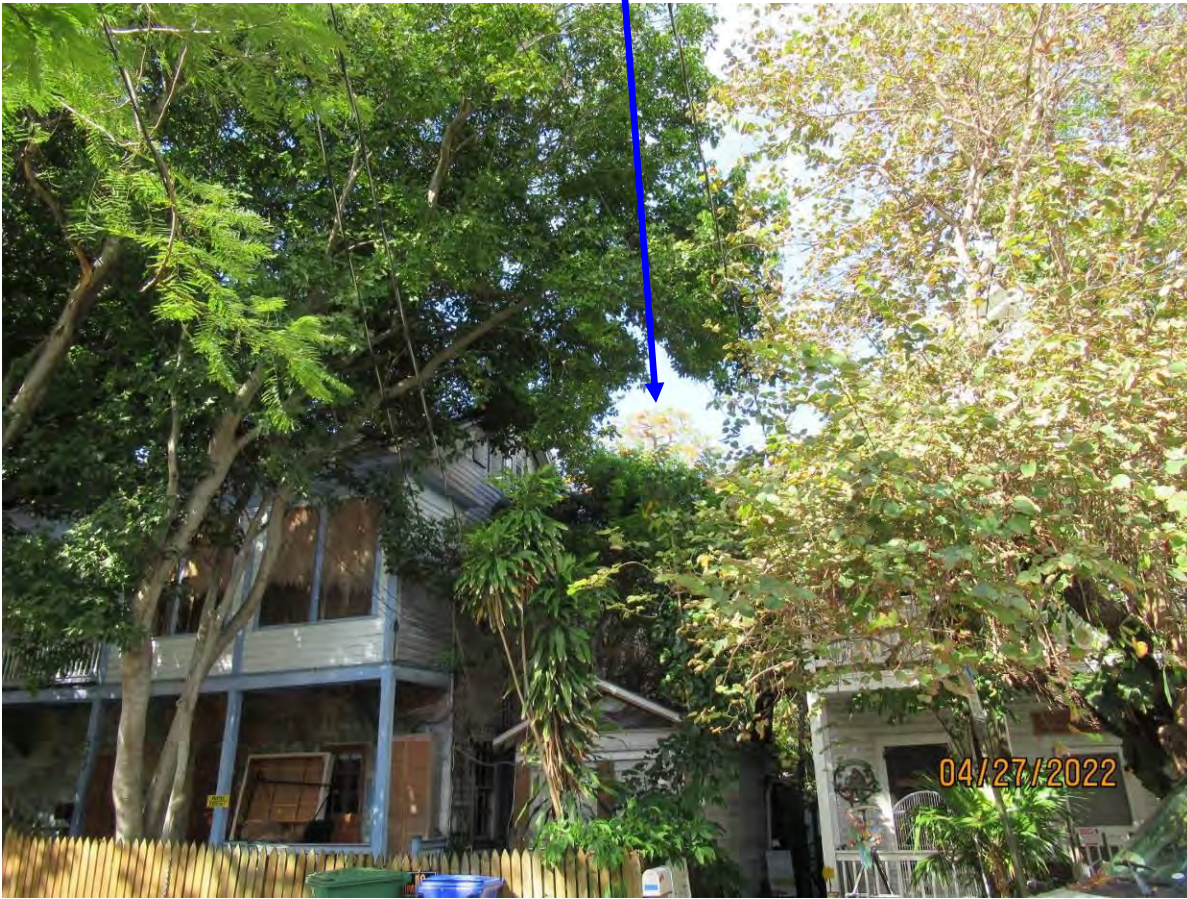
Photo showing location of tree in backyard.

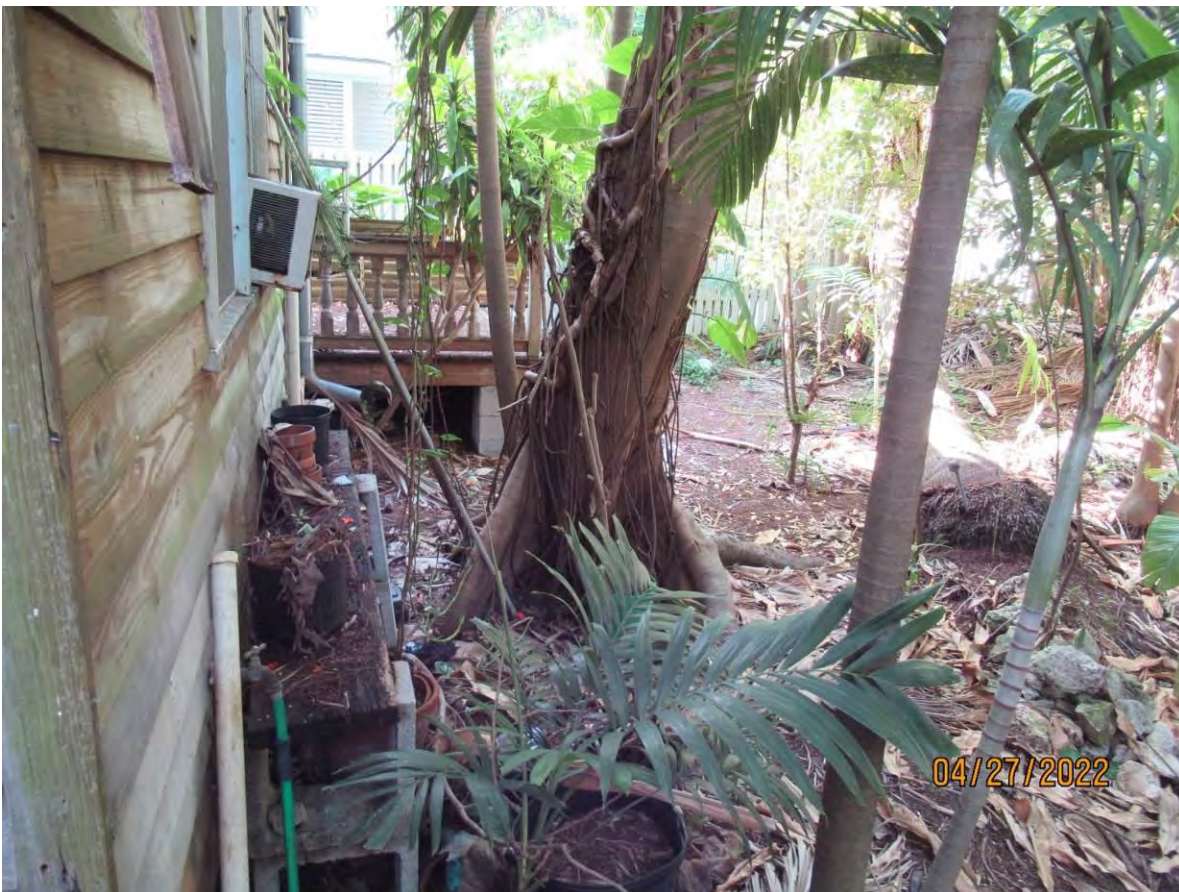
Photo showing location of trunk and base of tree in relation to structure, view 1.

Location: 70% (in back yard, base of tree approximately 5 ft from structure on piers)

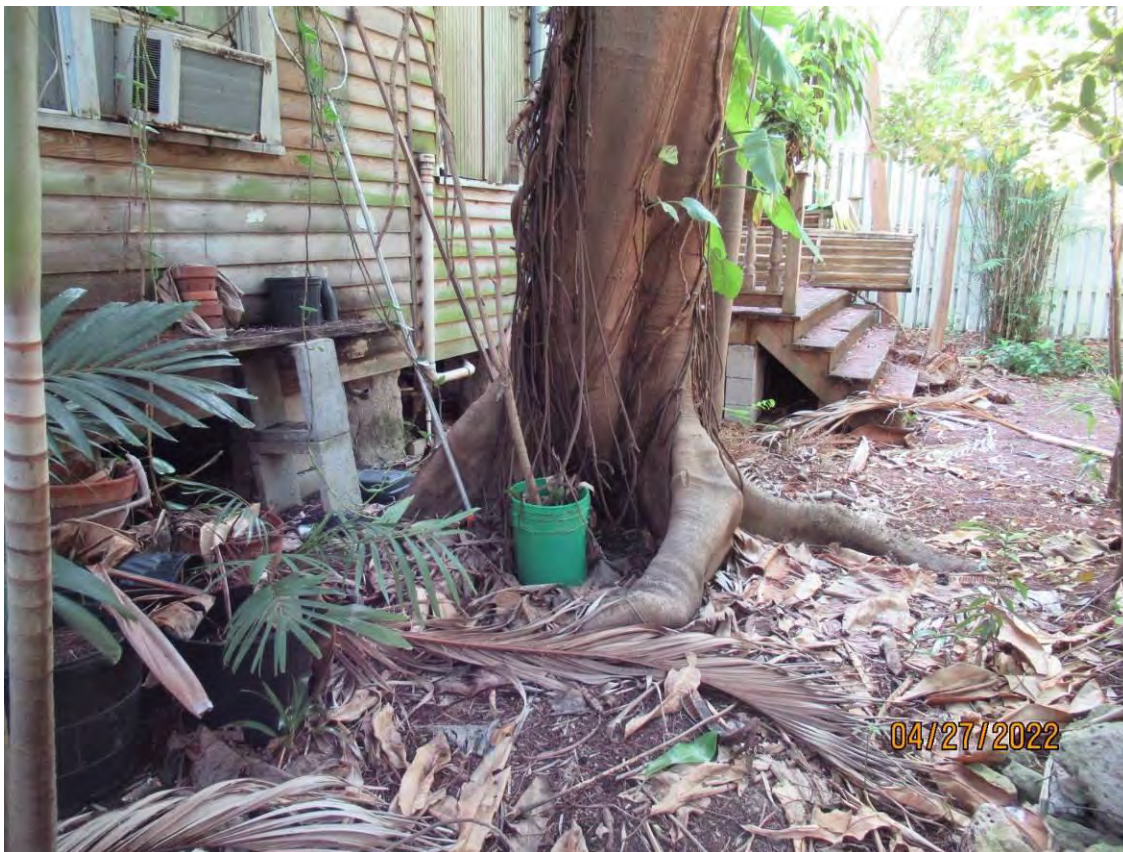
Photo of base of tree, view 1.

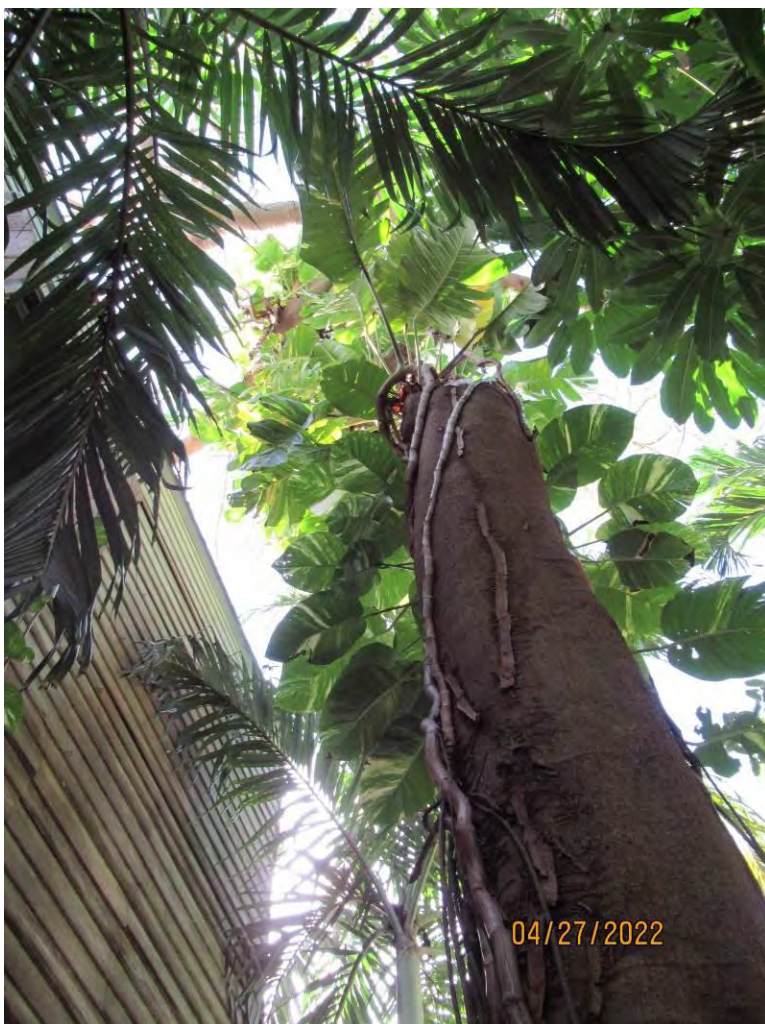
Photo of tree trunk, view 1.

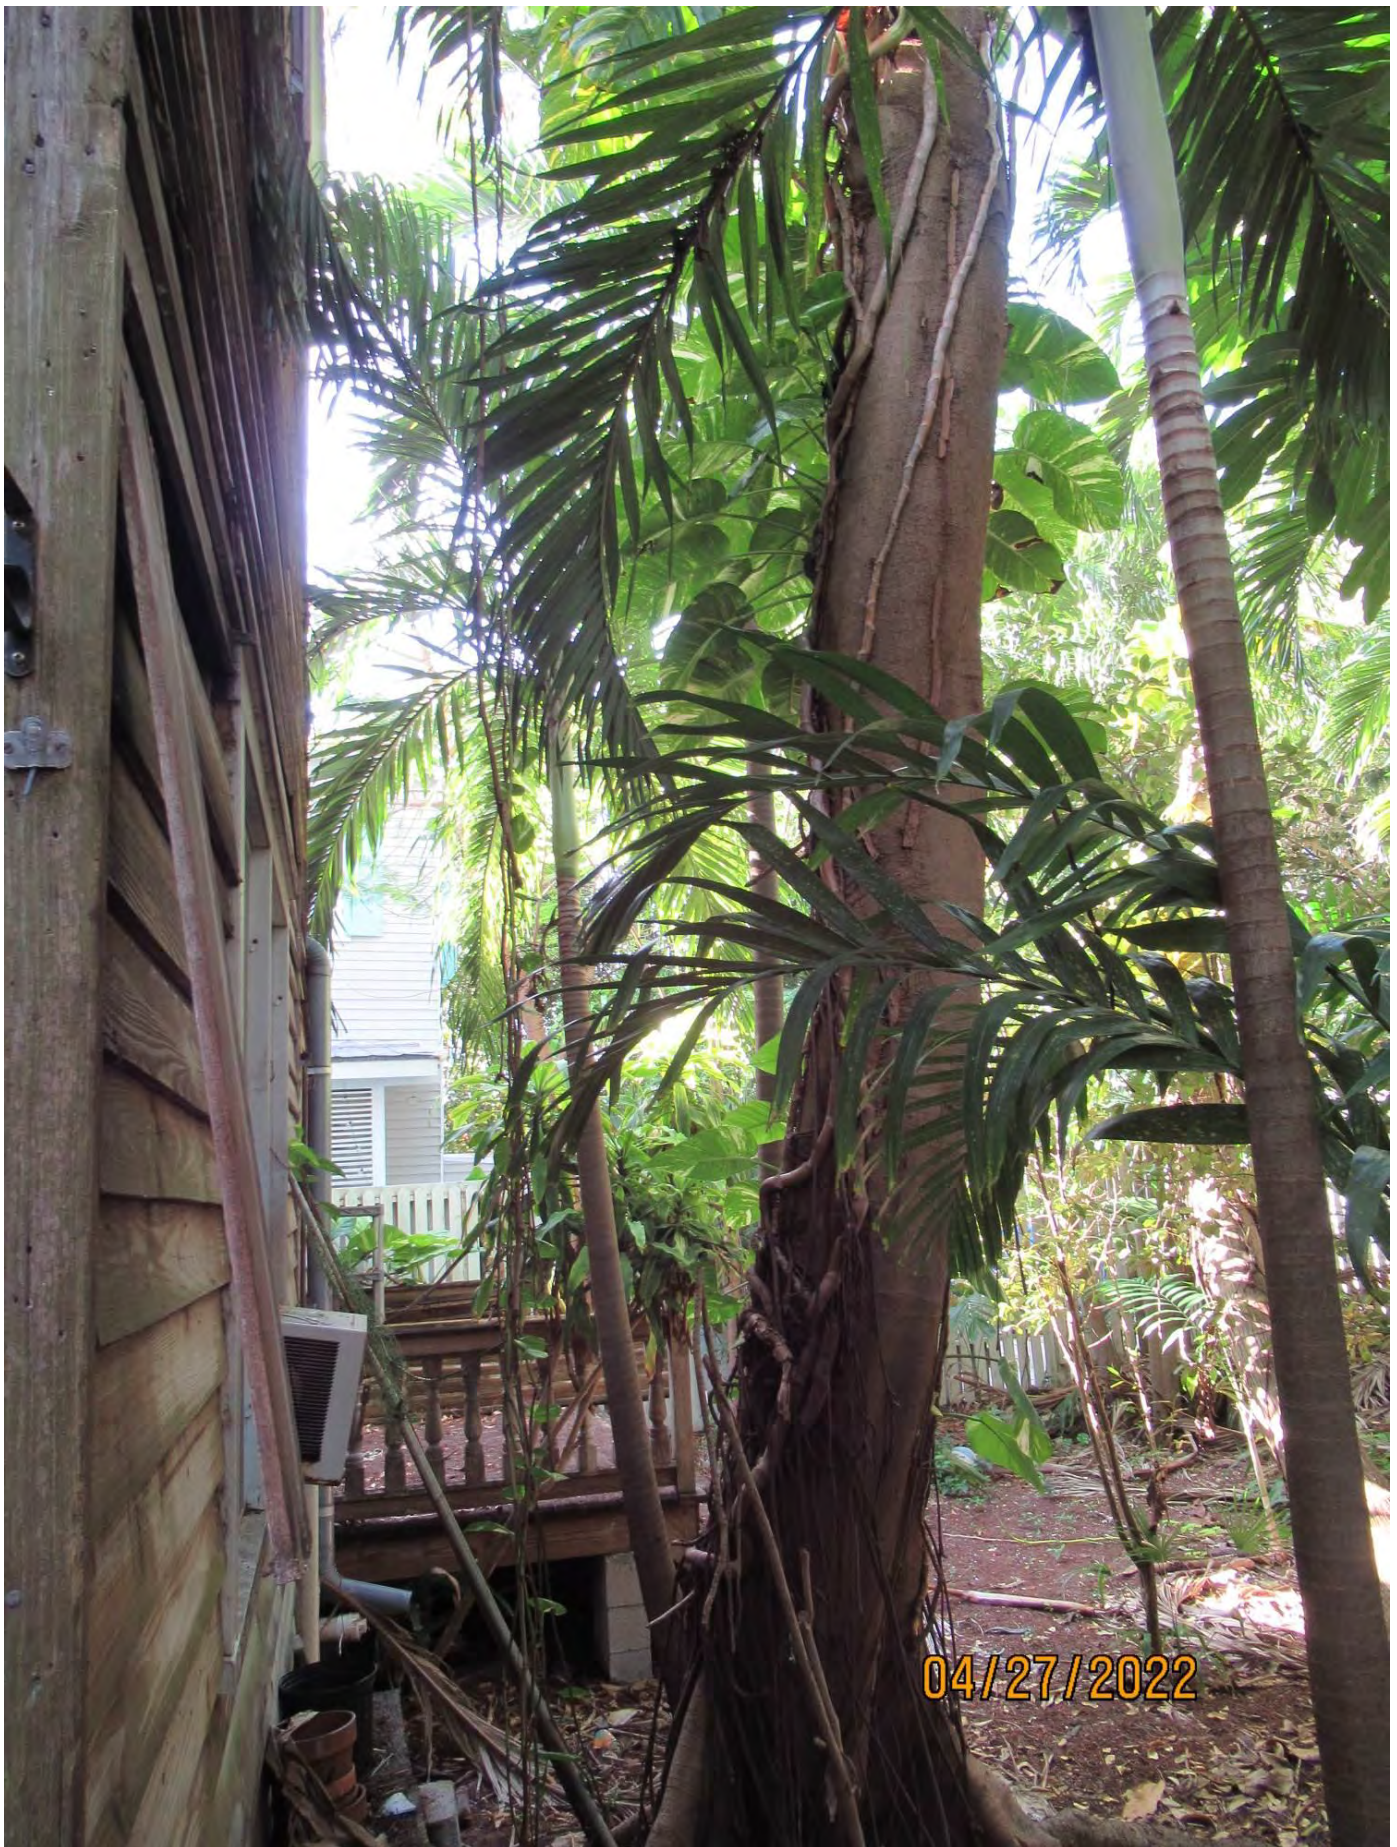
Photo of tree trunk, view 2.

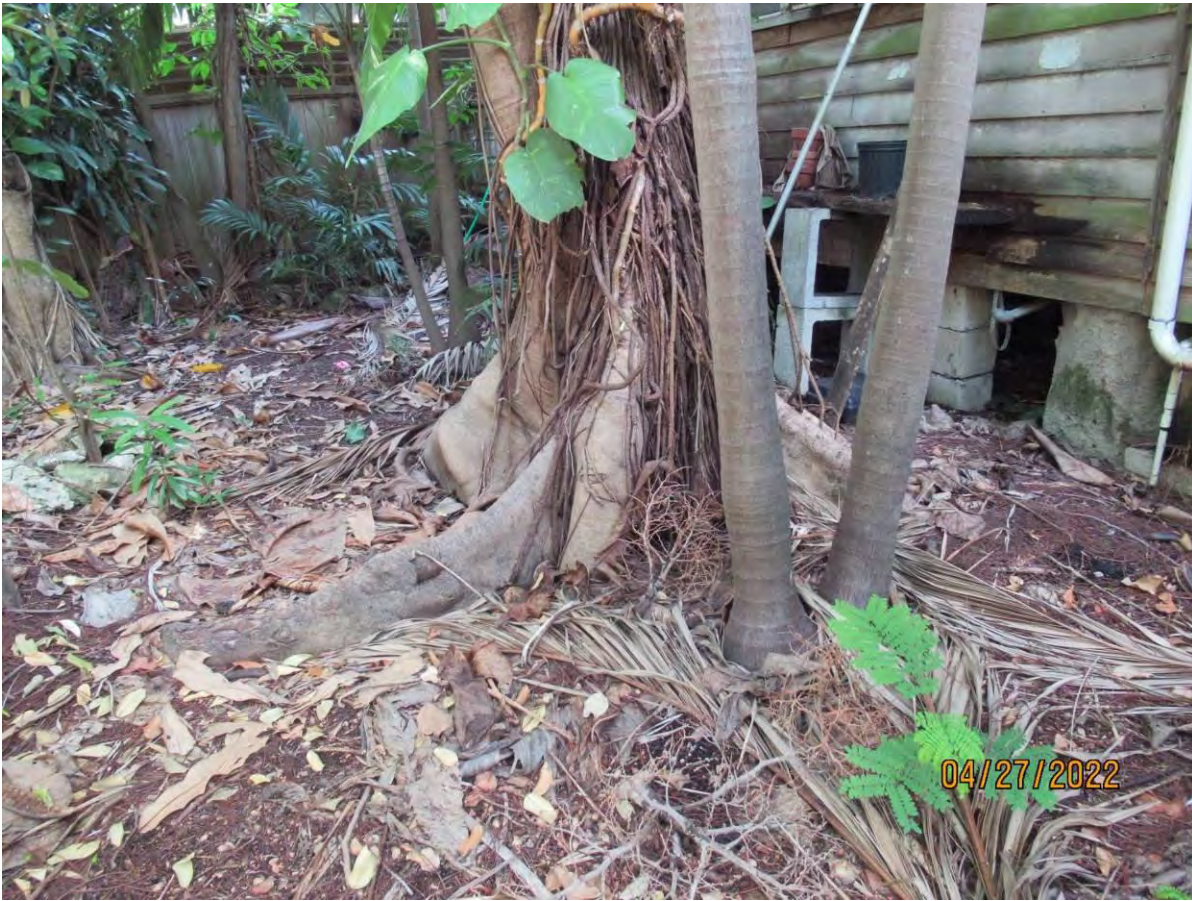
Photo of
base of tree,
view 2.

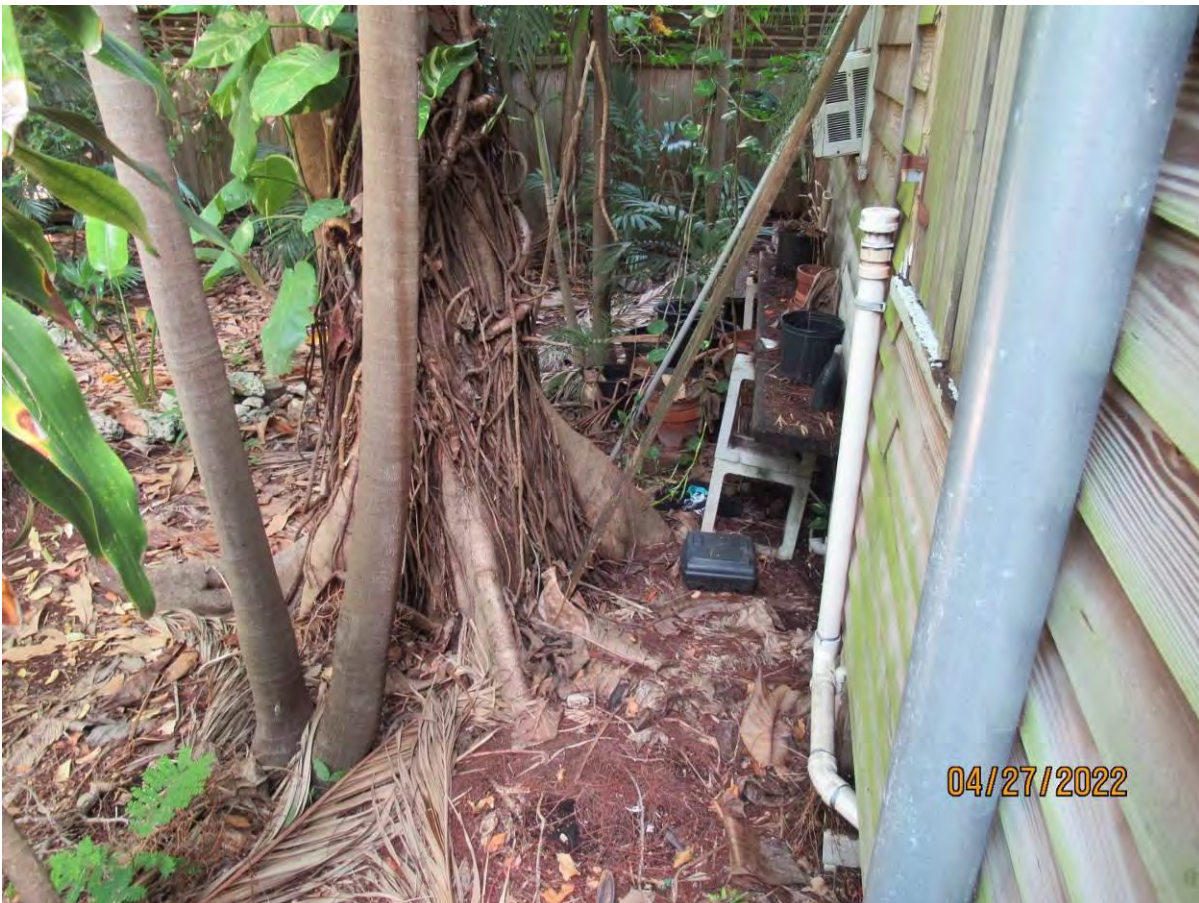
Photo of
base of tree
showing
location in
relation to
structure.

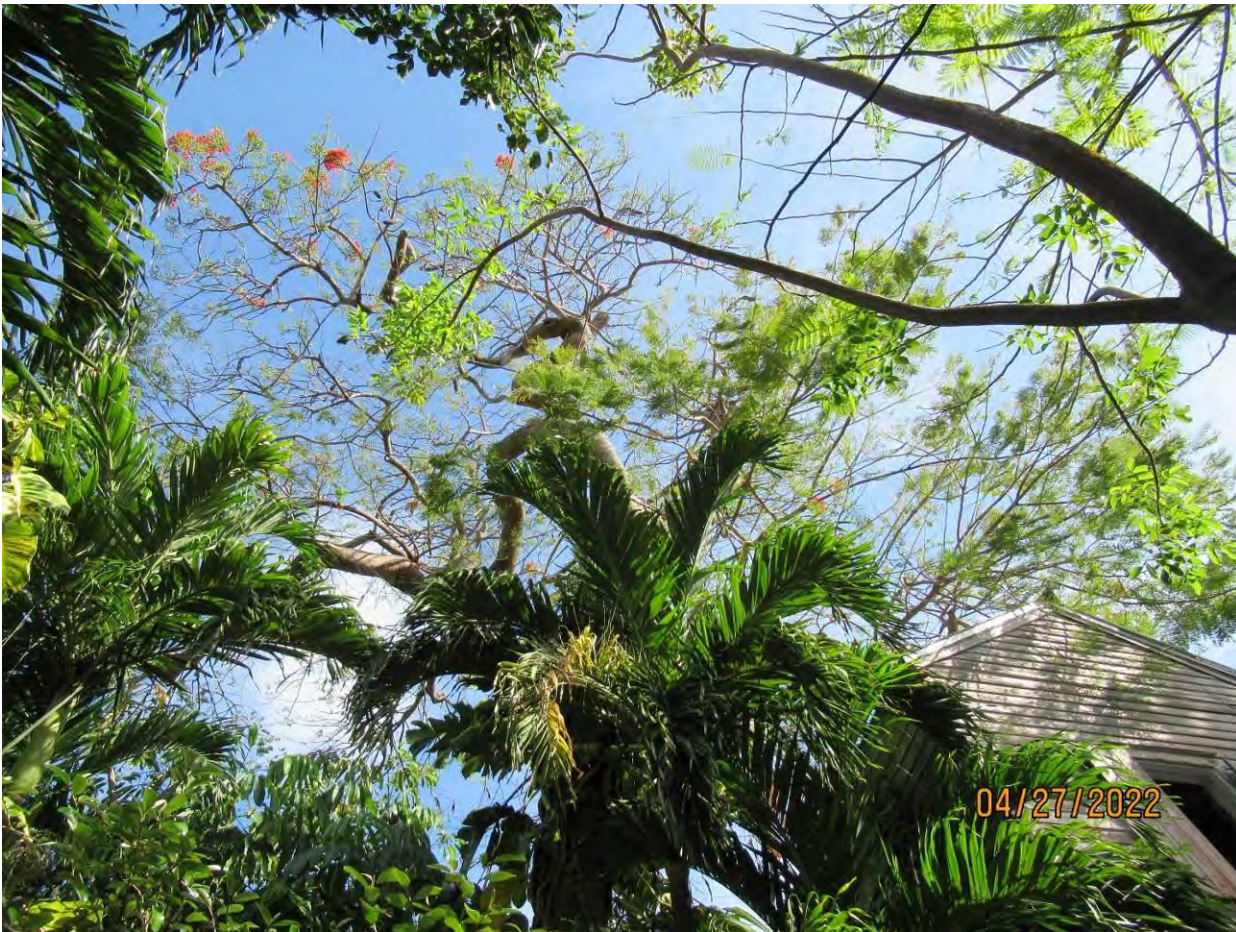
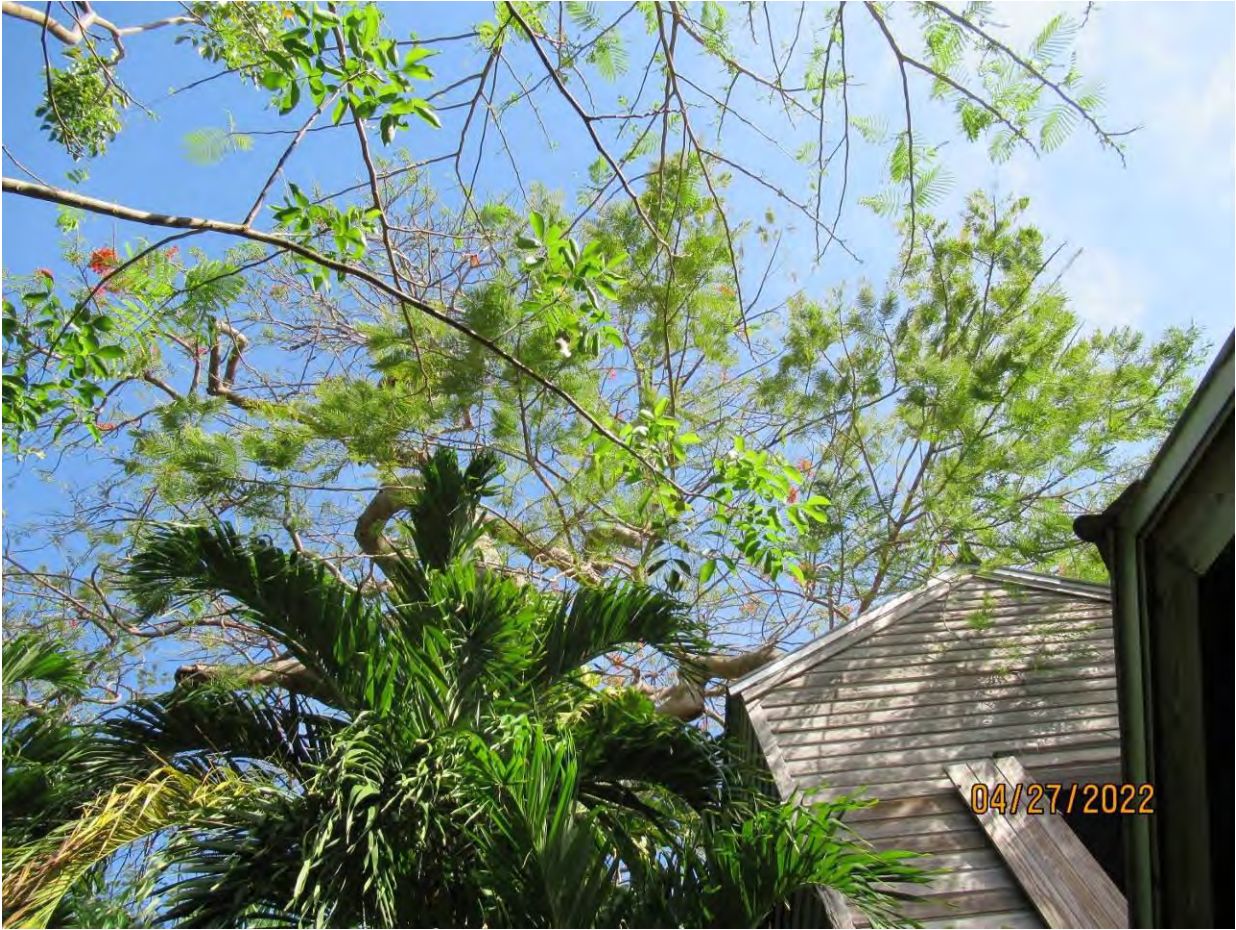
Two
photos of
tree
canopy.

Condition: 70% (overall condition is fair to good, extended trunk with high branches over structure)

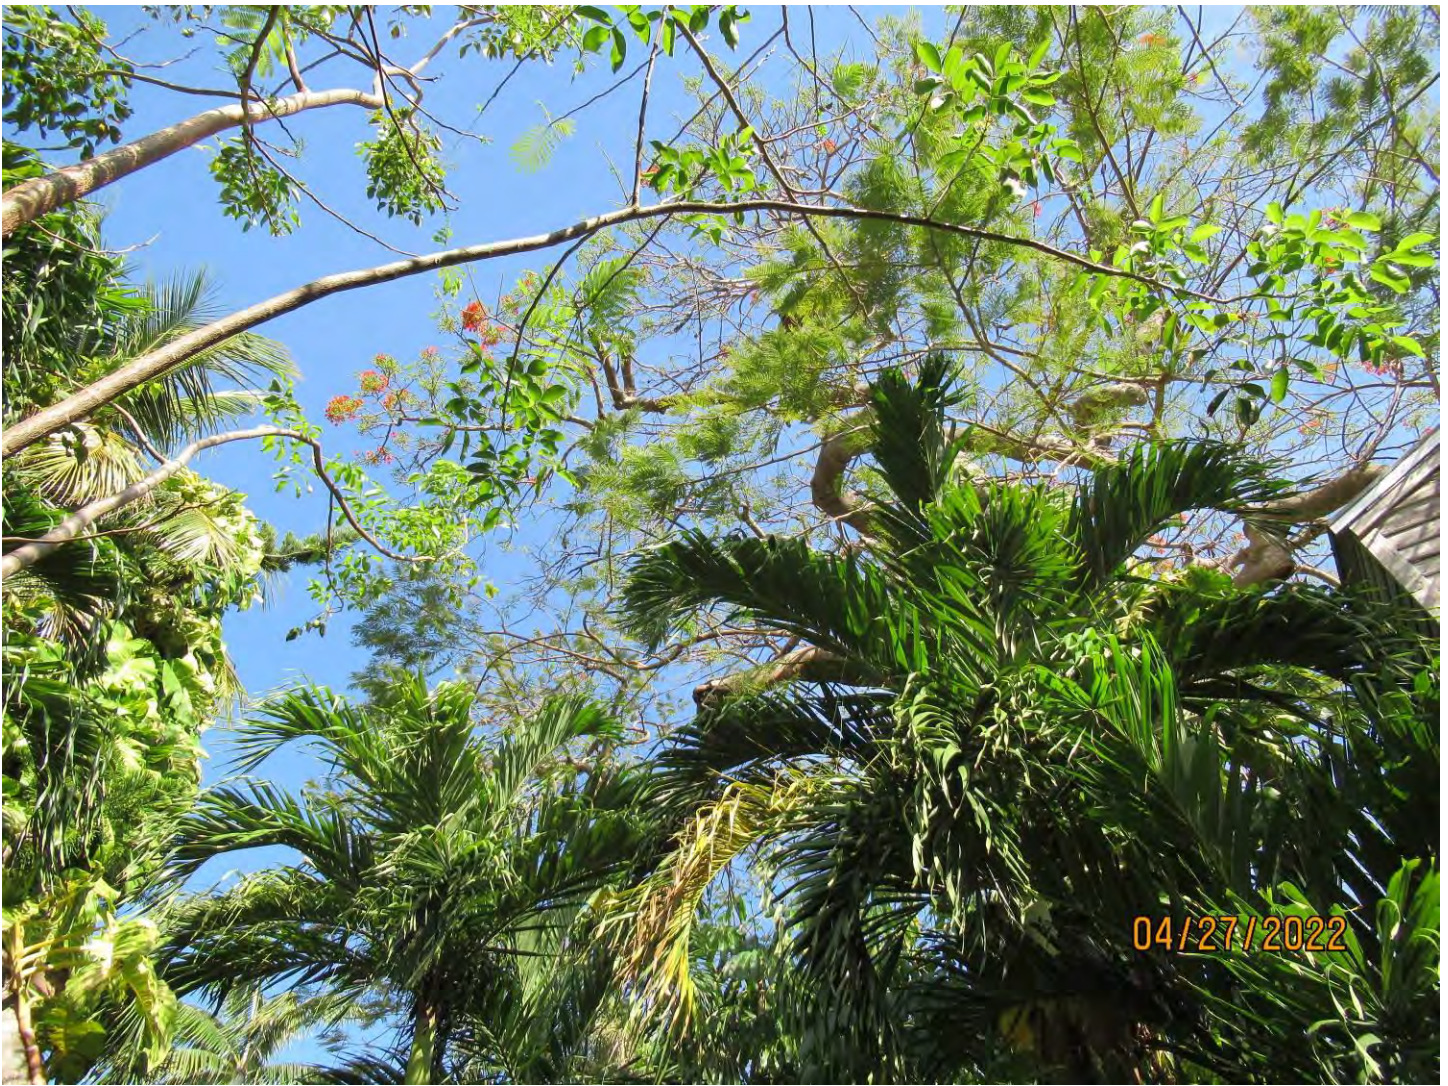
Photo of tree canopy.
