November 20, 2013

**Subject: Arborist Assessment of Trees
Former Glynn Archer Elementary School Site
1302 White Street, Key West, FL 33040
E Sciences Proposal Number 1-1702-01**

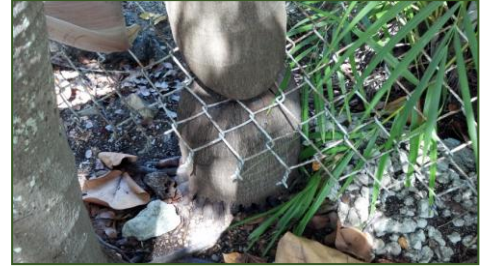
Tree 15, 16, 16a-d: Alexander Palm

Observations: Two of these palms are listed on the tree survey; however, there are six total within this courtyard. E Sciences did not observe any obvious signs of health or structural deficiency with the exception of one double-stemmed palm that is growing through the fence (see photo right). Only palms that are eight feet tall are protected per Sec. 110-321(a)(2).

Rating: Good, poor

Recommendation: E Sciences recommends removal of palms in good condition only if needed due to conflict with new landscape elements.

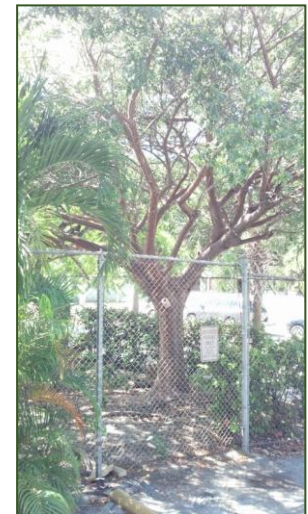
Tree 18 Royal Poinciana

Observations: This tree has major structural flaws, including crossing leaders and bark and major decay throughout the center of the trunk (see photos to the right and left).

Recommendation: E Sciences recommends removal of this tree in accordance with Sec. 110-327(a) of the City's municipal code. If the City desires to keep this tree due to the canopy it provides, E Sciences recommends structural pruning for correctable defects and frequent monitoring. E Sciences also recommends consultation with an arborist experienced with bracing and propping.

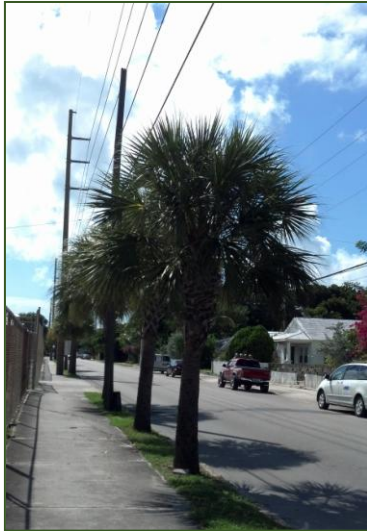
Trees 20 through 26: Cabbage Palm

Observations: These seven cabbage palms appear to be in good health and condition. However, they are all growing close to the utility line along United Street.

Recommendation: E Sciences recommends preserving palms that do not conflict with the proposed design: 25 and 26. E Sciences recommends monitoring the remaining palms for utility conflict and removing parasitic trees such as strangler fig (*Ficus aurea*).

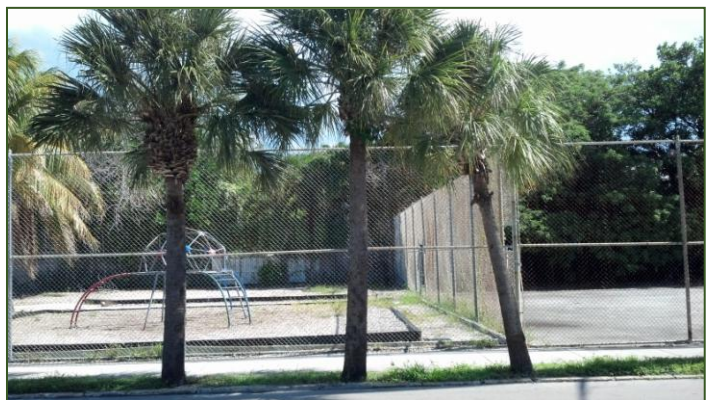
Trees 40 through 44 (including 42a): Cabbage Palm

Observations: There are six cabbage palms along the north side of the property (south side of United Street) west of the coconut palms. Like the other palms along United Street, these palms are close to the utility lines running along the south side of United Street. The line is currently one or two feet above the palms, with the center of the palms being located two to three feet from the line. These palms are all in good condition. One of the palms has a slight lean (see photo above).

Recommendation: E Sciences recommends preserving Trees 40 through 42, which do not conflict with the proposed landscape design. The rest should be removed and replaced.

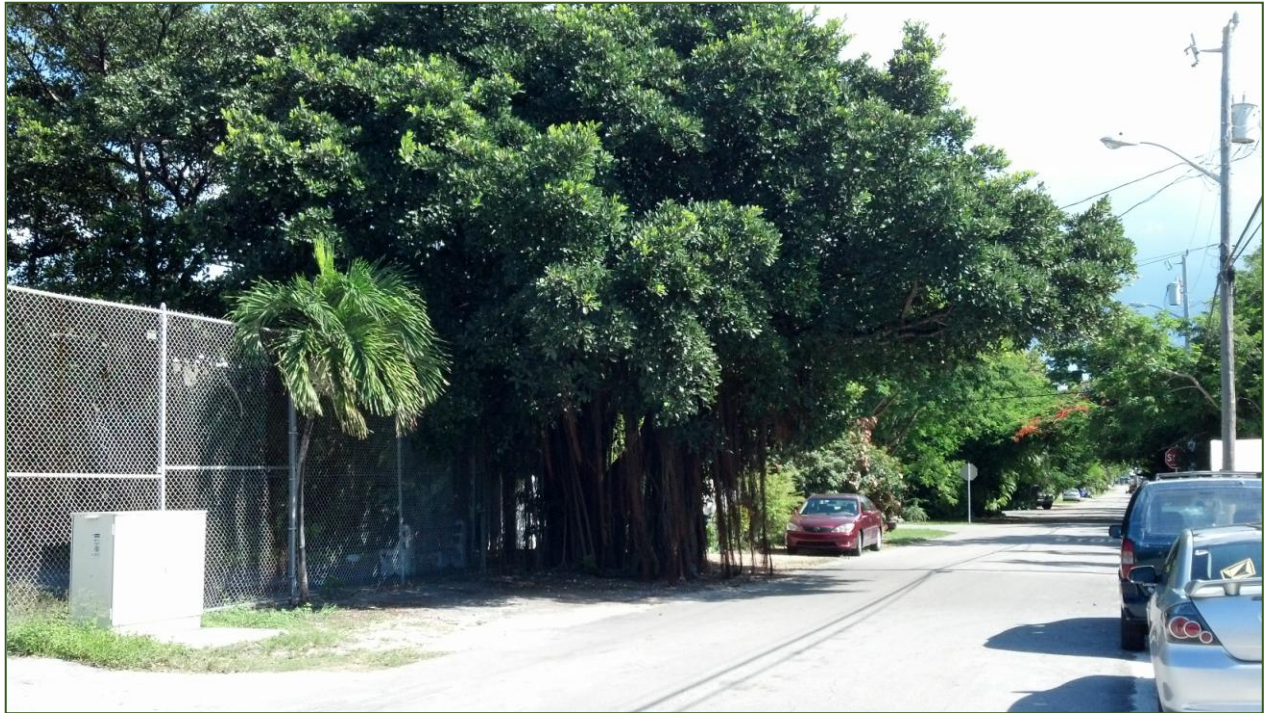
Tree 45: Strangler Fig

Observations: This tree provides shade for Grinnell Street and visual interest from a number of angles (see photo below). The tree's structure is typical for this species. The tree is growing into the fence on the west side of the property. This is likely to result in damage to the fence.

Rating: Fair

Recommendation: E Sciences recommends monitoring the health and conditions of this tree every few years. The tree should be maintained for clearance along Grinnell Street.

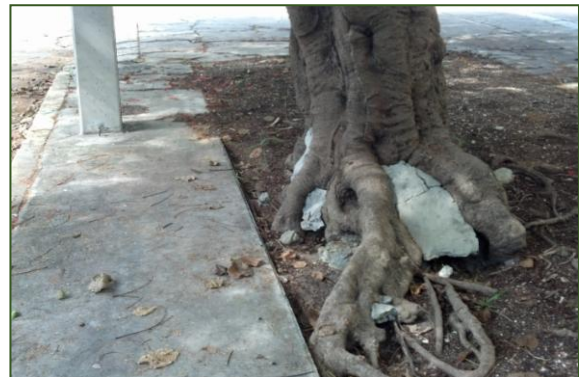
Tree 46: Royal Poinciana

Observations: This tree conflicts with a utility pole, overhead utilities, and the Seminary Street curb and sidewalk (see photo right). Overall, the tree appears healthy and its structure is typical of a mature specimen of this species. E Sciences observed numerous crossing limbs and some dead leaders within the crown. Branch connections in some locations are compromised due to decay observed associated with previous pruning cuts. Some larger limbs appear to be sprouts from prior damage; these large sprouts are likely to be more

weakly attached than other limbs and are located over a target (sidewalk). Cement has been inserted into gaps in the base of the tree. Root structure was observed to be poor.

Recommendation: E Sciences recommends removal of this tree per Sec. 110-327(a) of the City's municipal code.

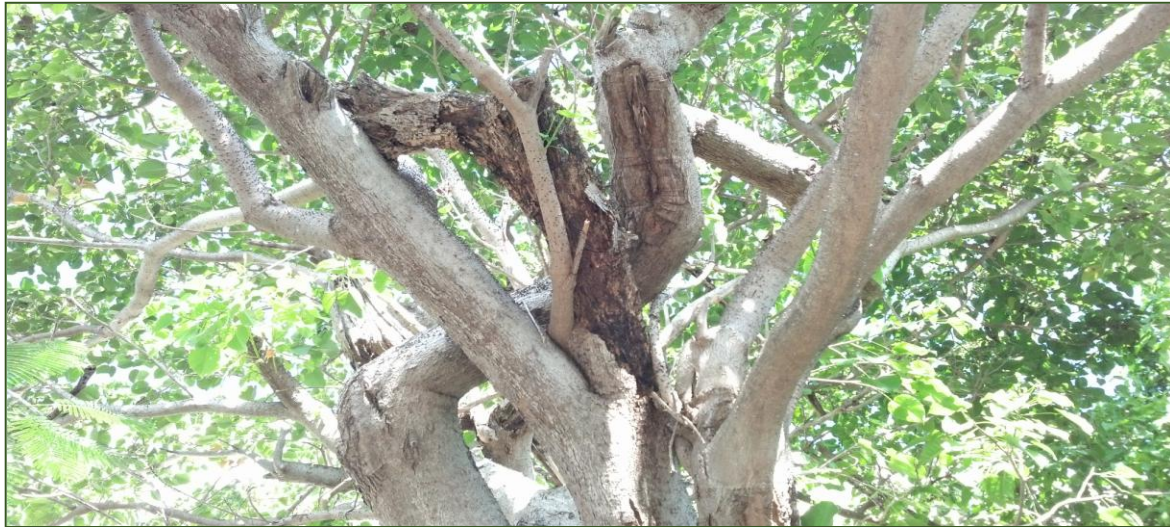
Tree 47: Sandbox Tree (*Hura crepitans*)

Observations: This tree conflicts with the utility lines along Seminary Street and has structural flaws and signs of diminished health and condition. The tree is being impacted at the base by concrete. E Sciences observed numerous hanging and fallen limbs, with a number of dead or decaying limbs likely to fall in the near future. The tree has a substantial lean and decay within old wounds (see photo below).

Rating: Poor

Recommendation: E Sciences recommends removal of this tree per Sec. 110-327(a) of the City's municipal code and replacement. If the City desires preservation, E Sciences recommends structural pruning and crown cleaning. E Sciences also recommends monitoring the condition of this tree annually or biannually.

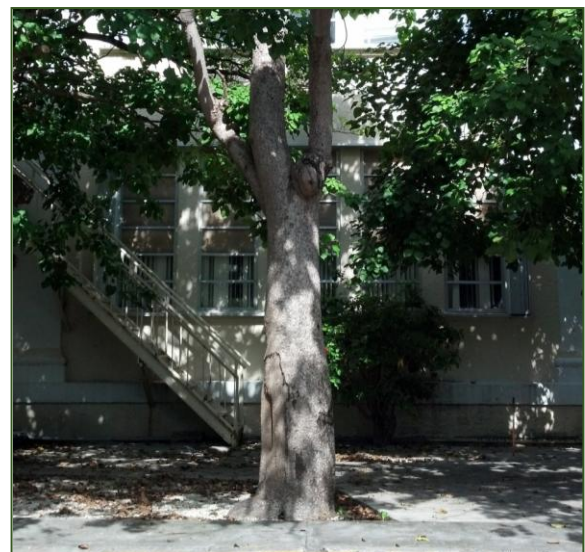
Tree 49: Sandbox Tree

Observations: This tree conflicts with the utility lines along Seminary Street and has structural flaws and signs of diminished health and condition. The tree has co-dominant leaders, with included bark and excessive growth at the attachment. E Sciences observed stress cracks along some of the larger limbs and die-back towards the tips of some of the leaders hanging over the street. There is an old wound on the trunk, which is cracked to the base of the tree (see photo right).

Rating: Poor

Recommendation: E Sciences recommends removal

of this tree per Sec. 110-327(a) of the City's municipal code and replacement. If the City desires preservation, E Sciences recommends structural pruning and crown cleaning. E Sciences also recommends monitoring the condition of this tree annually or biannually.

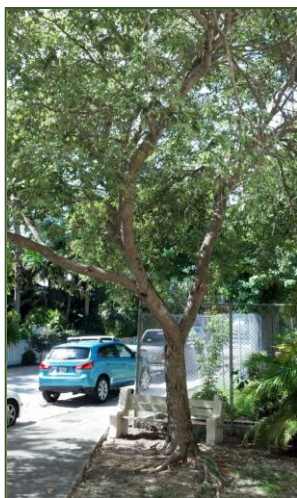
Tree 52: Jamaican Dogwood (*Piscidia piscipula*)

Observations: This tree has co-dominant leaders (photo left). There are crossing limbs, dead limbs and decay is present in old wounds. E Sciences observed included bark at one of the branch connections.

Rating: Poor

Recommendation: E Sciences recommends removal of this tree per Sec. 110-327(a) of the City's municipal code and replacement.

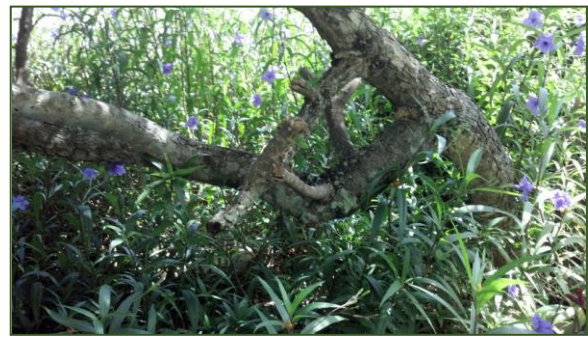
Tree 58: Tree of Life

Observations: This tree is planted in poor soil and leans heavily. E Sciences observed some decay and sprouts at the site of previous pruning cuts, which include stub cuts. Because the tree is small, defects are unlikely to pose a risk (see photo right).

Rating: Fair

Recommendation: E Sciences recommends preservation.

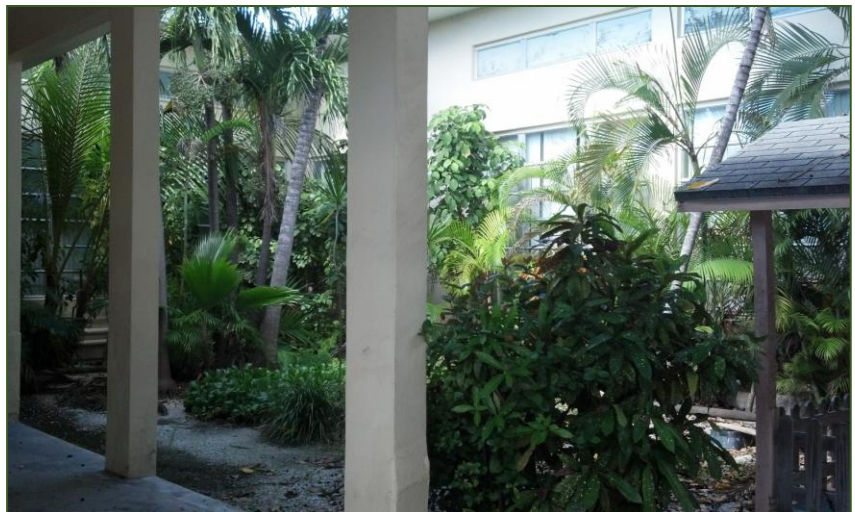
Courtyard Trees

There are trees located within a courtyard surrounded on four sides by buildings (see photo right). These trees include fourteen Alexander palms, one coconut palm, and one umbrella tree. Because the courtyard is surrounded by buildings on all four sides (with one small opening), these trees should be exempt from permitting per Sec. 110-322(b).
