November 20, 2013

Mr. Bert L. Bender, Architect
Bender & Associates Architects, P.A.
410 Angela Street
Key West, FL 33040

**Subject: Arborist Assessment of Trees
Former Glynn Archer Elementary School Site
1302 White Street, Key West, FL 33040
E Sciences Proposal Number 1-1702-01**

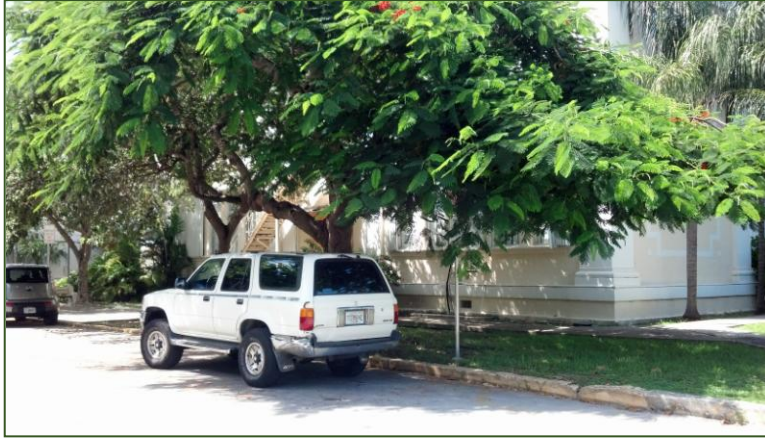
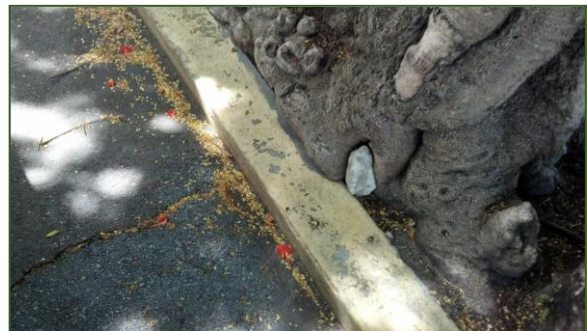
Tree 1: Royal Poinciana (*Delonix regia*)

Observations: This tree is located in a highly trafficked location at the corner of White Street and Seminary Street. The tree crown structure is typical of the species, as are the surface roots present throughout the root zone. E Sciences observed some decay within old pruning cuts at some of the branch connections. These cuts range from four to eight inches long. Roots show signs of mechanical damage, likely

due to mowing. The tree abuts the Seminary Street curb and is impacting the integrity of the curb and street. The curb is likely to be limiting the growth of roots on the south side of the tree. Grass does not grow well under royal poinciana trees and thus erosion has occurred at the base of the tree. This erosion and the lack of root structure to the south create a situation where the tree's stability is compromised. There is concrete in the base of the tree, which likely was used in an attempt to stabilize the area under the tree. The tree is cracking the road and growing over the curb (see photo right).

Rating: Fair

Recommendation: While this species is visually appealing and iconic to Key West, this particular specimen is located too close to the sidewalk and street. This placement has resulted in potential destabilization of the tree due to lack of root structure to the south and the likelihood of continued damage to the street and curb. E Sciences recommends removing and replacing this tree in association with Sec. 110-327(a) of the City's municipal code.

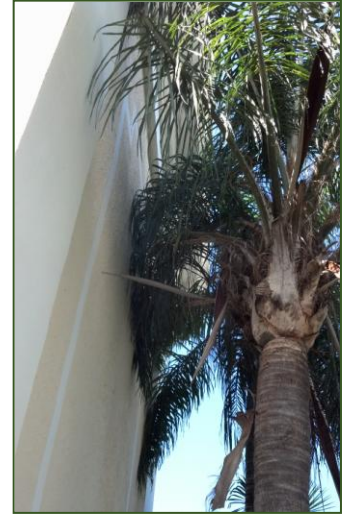
Trees 2 and 3: Queen Palm (*Syagrus romanzoffiana*)

Observations: These two palm trees are located adjacent to the east side of the building. E Sciences observed slight pencil-necking (narrowing of the trunk) towards the base of the palms. Due to the proximity of the building, the crown of the palms are limited (see photo right). The palms also appear to lack overall vigor, potentially due to poor, alkaline soils typical of the area, lack of nutrients, or premature removal of older fronds.

Rating: Fair

Recommendation: While this palm is not included in Section 110-254 of the City of Key West or Section 114-102 of the Monroe County Code, it is listed on the Florida Exotic Pest Plant Council (FLEPPC) List of Invasive Plant Species. These specimens are too close to the building to reach their full canopy potential. E Sciences recommends removing these palms and replacing with new, suitable trees.

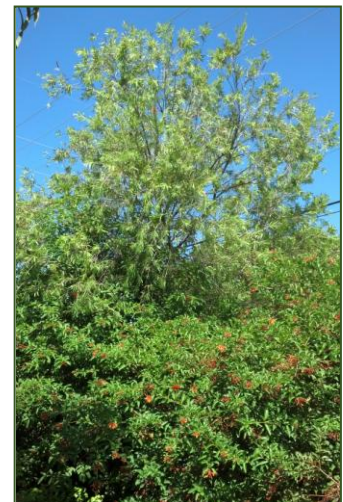
Tree 5: Weeping Bottlebrush Tree (*Callistemon viminalis*)

Observations: This tree is almost completely engulfed by shrubs and thus is not growing to its canopy potential (see photo right). Very little of the canopy is exposed. The root structure of this tree is poor. The tree leans heavily and is being supported by one rope, which is girdling the tree (see photo left).

Rating: Poor

Recommendation: This tree is listed on the FLEPPC List of Invasive Plant Species and is in poor condition. E Sciences recommends removal and replacement.

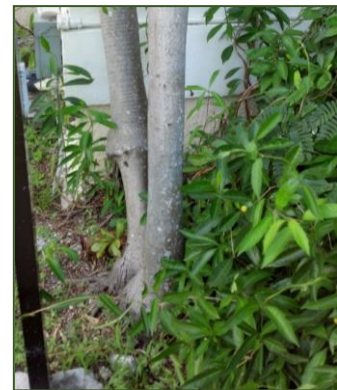
Tree 7: Alexander Palm

Observations: This double palm has slight pencil-necking at the base (see photo right), but is otherwise healthy.

Recommendation: If this tree does not fit within the context of the new landscape design, E Sciences recommends removal and replacement.

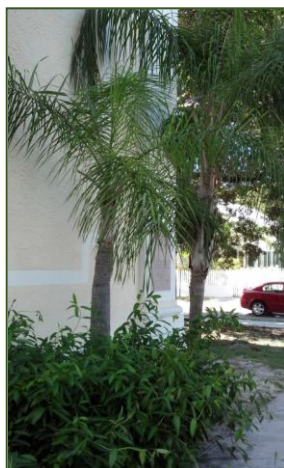
Tree 9, 9a: Queen Palm

Observations: Next to Tree 9 is another queen palm, which will be identified as Tree 9a. Both of these palms are stunted and chlorotic. They are too close to the building and have had too many fronds removed (see photo left).

Rating: Poor

Recommendation: This palm is listed on the FLEPPC List of Invasive Plant Species. These two palms are too close to the building and in poor condition. E Sciences recommends removal and replacement.

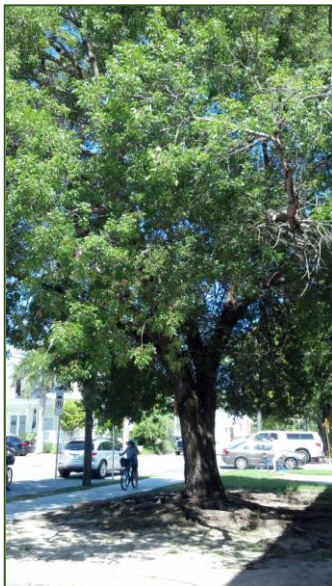
Tree 11: West Indian Mahogany (*Swietenia mahagoni*)

Observations: This mature tree has two, upright co-dominant leaders low in the tree, and E Sciences observed included bark between the two leaders (see photo right), which reduces the tree's wind tolerance and increases the likelihood of failure. Within the canopy, E Sciences observed a number of dead leaders; some were attached and some were hanging. There are a number of stub cuts within the canopy. The tree has plenty of root space and good root structure. There has been some mechanical root damage.

Rating: Fair

Recommendation: This mature tree appears to be in good health, but has some structural flaws. See photo left. E Sciences recommends pruning the tree to remove dead wood and hangers from the canopy, correct stub cuts, and to take some weight off of the tree to remove some pressure from the connection between the tree's co-dominant leaders. The root zone should be protected with mulch or another cover to prevent erosion and discourage use of mechanical equipment within the root zone. E Sciences also recommends monitoring the tree annually for structure.

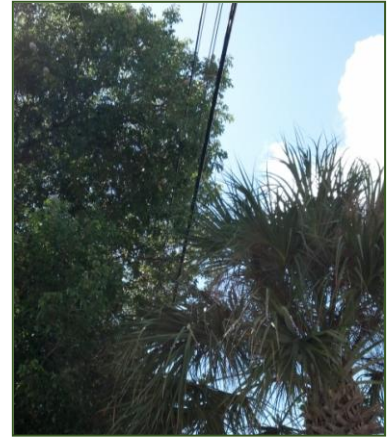
Trees 12 and 13: Cabbage Palm (*Sabal palmetto*)

Observations: Only one tree is located at the corner of White Street and United Street as opposed to the two shown on the tree survey. The remaining tree is a cabbage palm in good condition. Palm fronds are close to the overhead utility line that runs along the south side of United Street but should not interfere with the lines (see photo right).

Rating: Good

Recommendation: E Sciences recommends preservation.

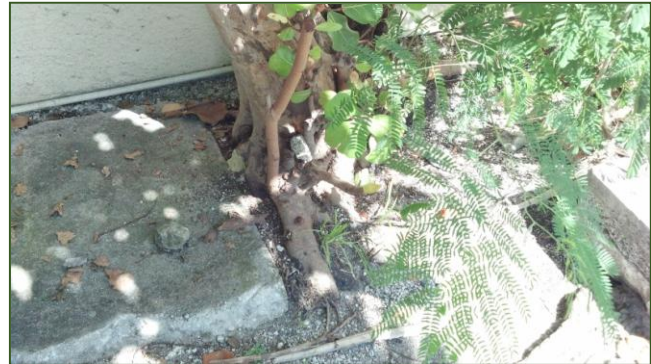
Tree 14: Seagrape (*Coccoloba uvifera*)

Observations: This tree is placed very close to the building and a concrete pad, both of which will limit the tree's growth (see photo right). E Sciences observed that the tree is leaning away from the school. Only one third of the canopy remains; it appears that major leaders were removed or damaged. There are old wounds and stub cuts present.

Rating: Poor

Recommendation: E Sciences recommends removal in accordance with Sec. 110-327(a) of the City's municipal code. The tree is in poor condition and close to the building.

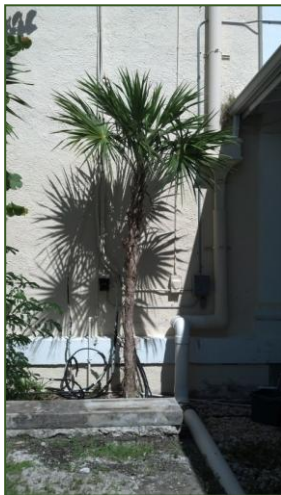
Tree 14a: Florida Thatch Palm (*Thrinax radiata*)

Observations: This tree is very close to the building but appears healthy and structurally sound (see photo left).

Rating: Good

Recommendation: E Sciences recommends preservation or relocation.

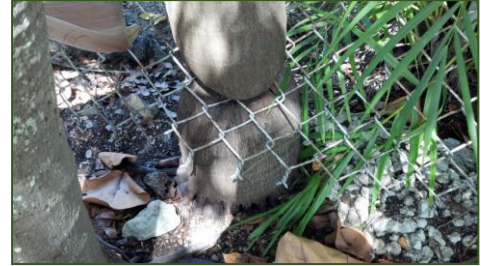
Tree 15, 16, 16a-d: Alexander Palm

Observations: Two of these palms are listed on the tree survey; however, there are six total within this courtyard. E Sciences did not observe any obvious signs of health or structural deficiency with the exception of one double-stemmed palm that is growing through the fence (see photo right). Only palms that are eight feet tall are protected per Sec. 110-321(a)(2).

Rating: Good, poor

Recommendation: E Sciences recommends removal of palms in good condition only if needed due to conflict with new landscape elements.

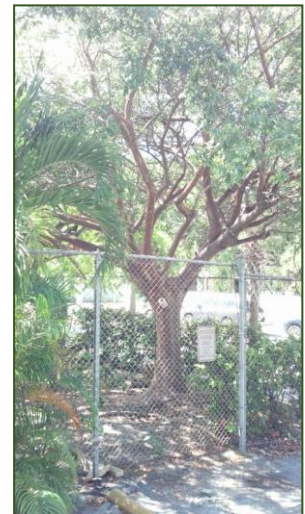
Tree 17: Gumbo Limbo (*Bursera simaruba*)

Observations: This tree appears to be in good health and has good structure for a tree of this species (see photo right). E Sciences observed some dead branches, attached and hanging, and some crossing limbs. There is also a small structure attached to the tree with a rope that will soon be girdling the tree.

Rating: Good

Recommendation: While this tree is in relatively good condition, E Sciences recommends removing and replacing this tree due to conflict with new landscape elements

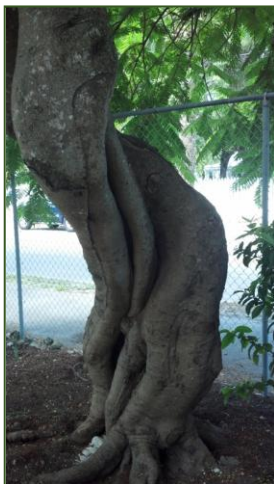
Tree 18 Royal Poinciana

Observations: This tree has major structural flaws, including crossing leaders and bark and major decay throughout the center of the trunk (see photos to the right and left).

Recommendation: E Sciences recommends removal of this tree in accordance with Sec. 110-327(a) of the City's municipal code. If the City desires to keep this tree due to the canopy it provides, E Sciences recommends structural pruning for correctable defects and frequent monitoring.

E Sciences also recommends consultation with an arborist experienced with bracing and propping.

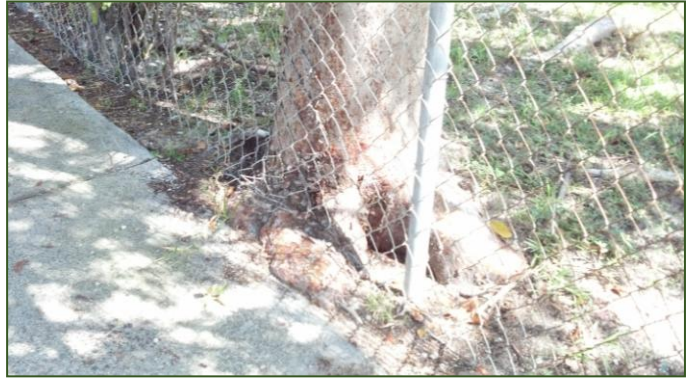
Tree 19: Gumbo Limbo

Observations: This tree is growing too close to the fence and sidewalk and is damaging both. There is an approximate three-inch lift in sidewalk that would be difficult to correct without significant damage to the tree. The tree is growing into the fence. The canopy is small relative to the size of the tree. E Sciences observed crossing limbs within the crown.

Rating: Poor

Recommendation: E Sciences recommends removal of this tree.

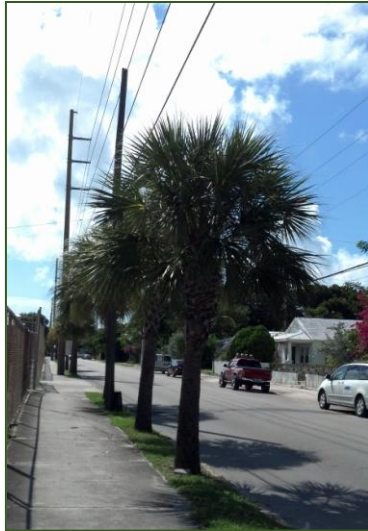
Trees 20 through 26: Cabbage Palm

Observations: These seven cabbage palms appear to be in good health and condition. However, they are all growing close to the utility line along United Street.

Recommendation: E Sciences recommends preserving palms that do not conflict with the proposed design: 25 and 26. E Sciences recommends monitoring the remaining palms for utility conflict and removing parasitic trees such as strangler fig (*Ficus aurea*).

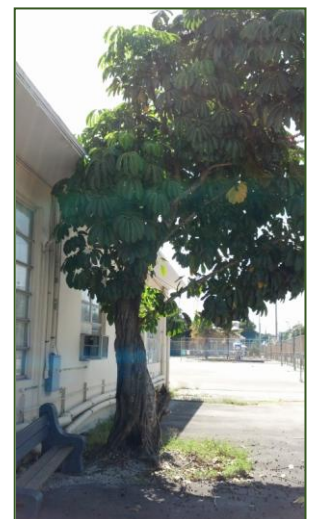
Tree 27: Queensland Umbrella (*Schefflera actinophylla*)

Observations: This tree is in poor condition and is conflicting with the building (see photo right). There have been major cuts or breaks in this tree, resulting in large wounds and reduced canopy.

Rating: Poor

Recommendation: E Sciences recommends removing this tree, which is not a protected species per Sec. 110-254 of the City's code and is listed on the FLEPPC list of invasive species.

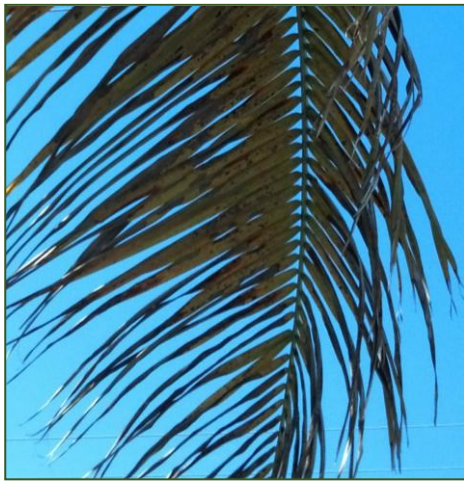
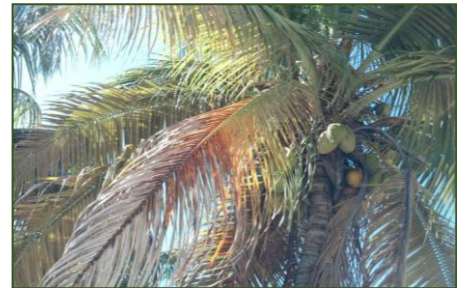
Trees 37 through 39: Coconut Palm (*Cocos nucifera*)

Observations: E Sciences observed fronds that were yellowing, with browning tips and brown spots (see photos left and below). E Sciences also observed cracks in the trunks of these palms.

Rating: Fair

E Sciences recommends removal of these palms and replacement.

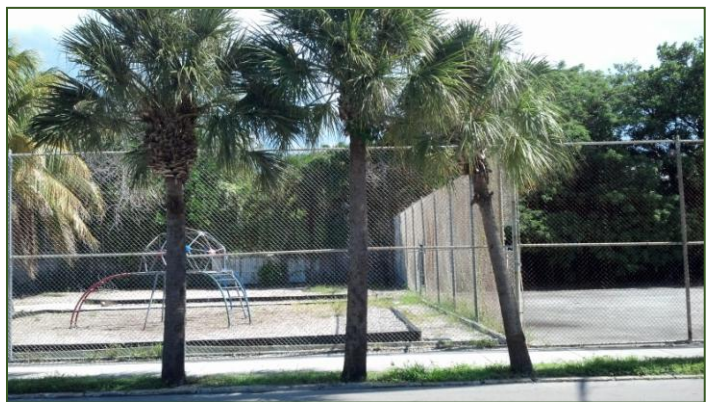
Trees 40 through 44 (including 42a): Cabbage Palm

Observations: There are six cabbage palms along the north side of the property (south side of United Street) west of the coconut palms. Like the other palms along United Street, these palms are close to the utility lines running along the south side of United Street. The line is currently one or two feet above the palms, with the center of the palms being located two to three feet from the line. These palms are all in good condition. One of the palms has a slight lean (see photo above).

Recommendation: E Sciences recommends preserving Trees 40 through 42, which do not conflict with the proposed landscape design. The rest should be removed and replaced.

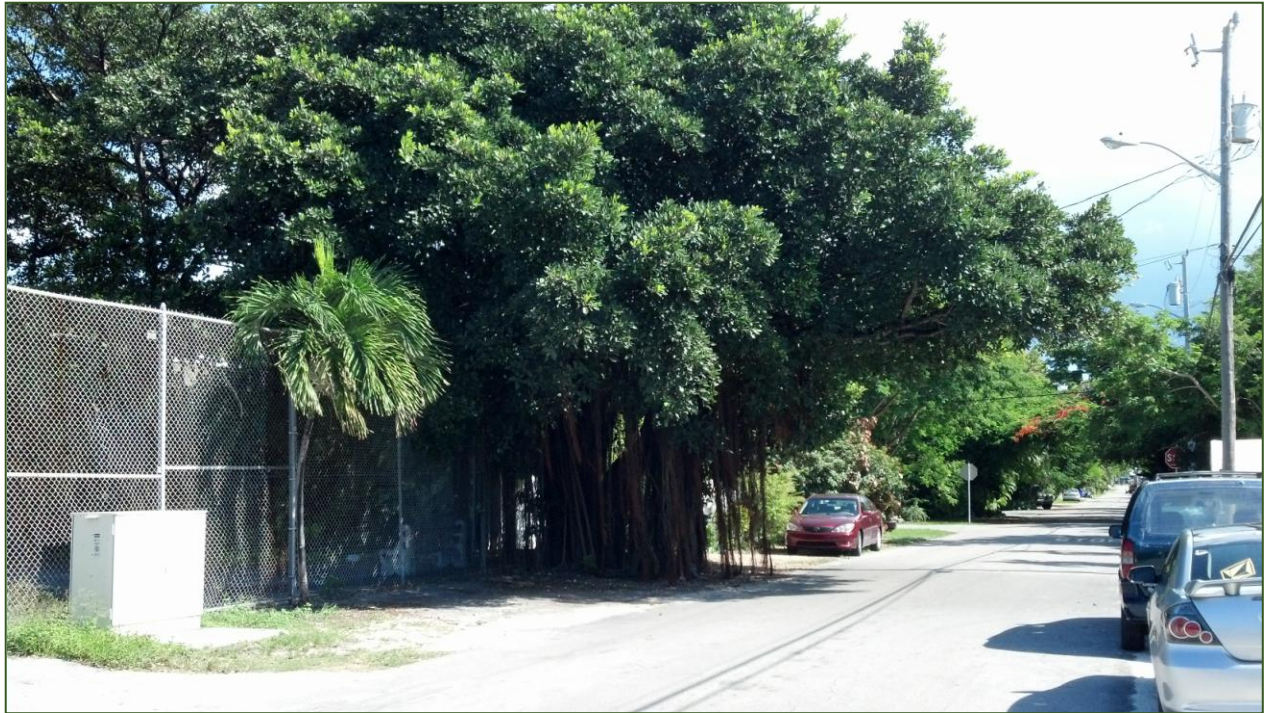
Tree 45: Strangler Fig

Observations: This tree provides shade for Grinnell Street and visual interest from a number of angles (see photo below). The tree's structure is typical for this species. The tree is growing into the fence on the west side of the property. This is likely to result in damage to the fence.

Rating: Fair

Recommendation: E Sciences recommends monitoring the health and conditions of this tree every few years. The tree should be maintained for clearance along Grinnell Street.

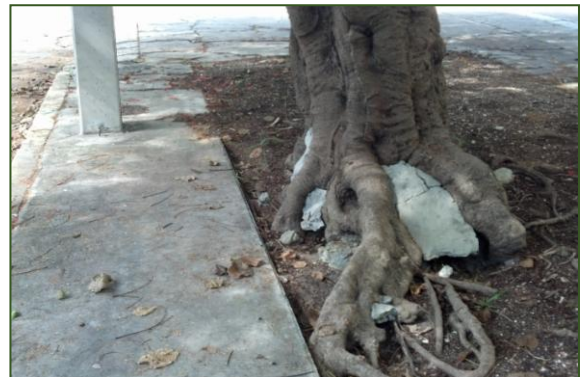
Tree 46: Royal Poinciana

Observations: This tree conflicts with a utility pole, overhead utilities, and the Seminary Street curb and sidewalk (see photo right). Overall, the tree appears healthy and its structure is typical of a mature specimen of this species. E Sciences observed numerous crossing limbs and some dead leaders within the crown. Branch connections in some locations are compromised due to decay observed associated with previous pruning cuts. Some larger limbs appear to be sprouts from prior damage; these large sprouts are likely to be more

weakly attached than other limbs and are located over a target (sidewalk). Cement has been inserted into gaps in the base of the tree. Root structure was observed to be poor.

Rating: Fair

Recommendation: E Sciences recommends removal of this tree per Sec. 110-327(a) of the City's municipal code.

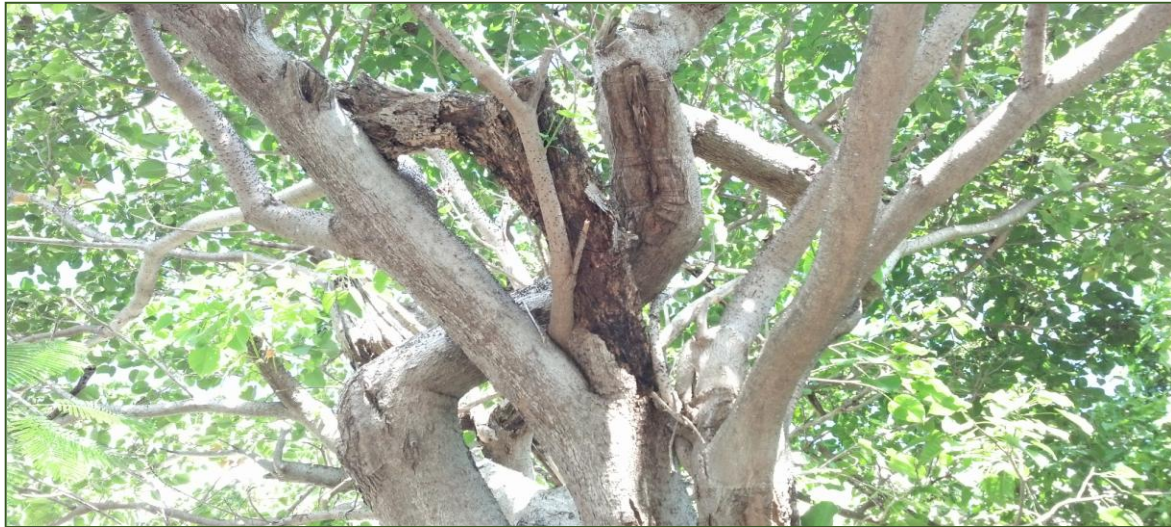
Tree 47: Sandbox Tree (*Hura crepitans*)

Observations: This tree conflicts with the utility lines along Seminary Street and has structural flaws and signs of diminished health and condition. The tree is being impacted at the base by concrete. E Sciences observed numerous hanging and fallen limbs, with a number of dead or decaying limbs likely to fall in the near future. The tree has a substantial lean and decay within old wounds (see photo below).

Rating: Poor

Recommendation: E Sciences recommends removal of this tree per Sec. 110-327(a) of the City's municipal code and replacement. If the City desires preservation, E Sciences recommends structural pruning and crown cleaning. E Sciences also recommends monitoring the condition of this tree annually or biannually.

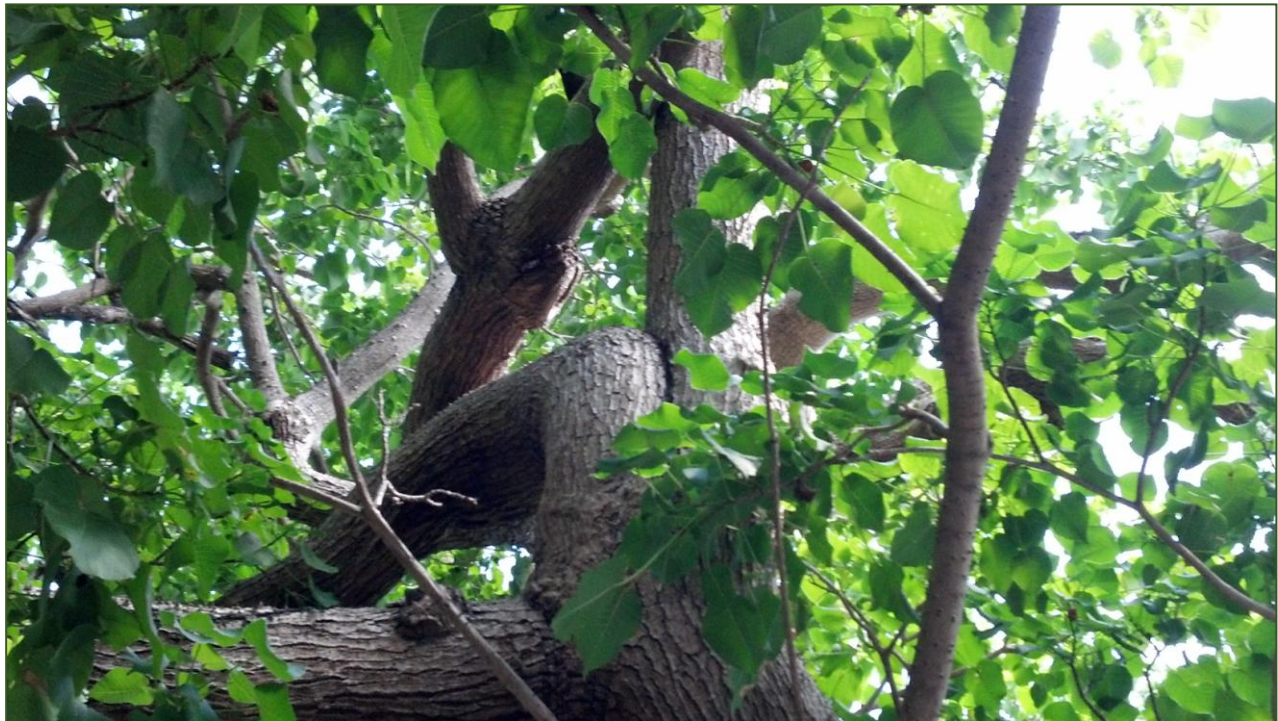
Tree 48: Sandbox Tree

Observations: This tree conflicts with the utility lines along Seminary Street and has structural flaws and signs of diminished health and condition. E Sciences observed numerous hanging and fallen limbs, with a number of dead or decaying limbs likely to fall in the near future. There are also stub cuts and crossing

leaders with included bark in the crown (see photo below). A fungus was observed growing on one of the larger limbs; this is often a sign of decay within the wood.

Rating: Poor

Recommendation: E Sciences recommends removal of this tree per Sec. 110-327(a) of the City's code and replacement. If the City desires preservation, E Sciences recommends structural pruning and crown cleaning. E Sciences also recommends monitoring the condition of this tree annually or biannually.

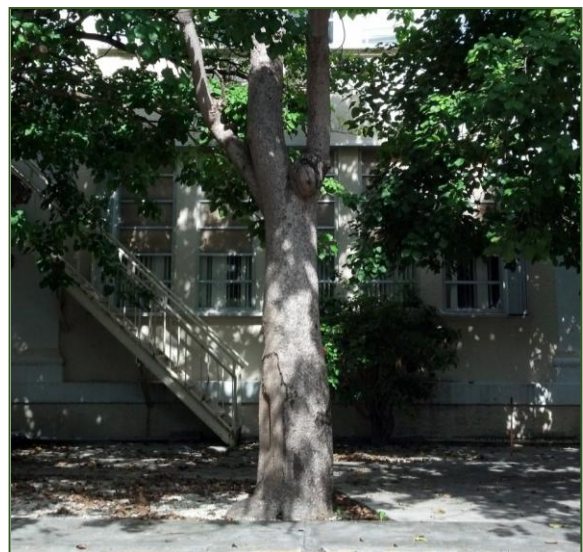
Tree 49: Sandbox Tree

Observations: This tree conflicts with the utility lines along Seminary Street and has structural flaws and signs of diminished health and condition. The tree has co-dominant leaders, with included bark and excessive growth at the attachment. E Sciences observed stress cracks along some of the larger limbs and die-back towards the tips of some of the leaders hanging over the street. There is an old wound on the trunk, which is cracked to the base of the tree (see photo right).

Rating: Poor

Recommendation: E Sciences recommends removal

of this tree per Sec. 110-327(a) of the City's municipal code and replacement. If the City desires preservation, E Sciences recommends structural pruning and crown cleaning. E Sciences also recommends monitoring the condition of this tree annually or biannually.

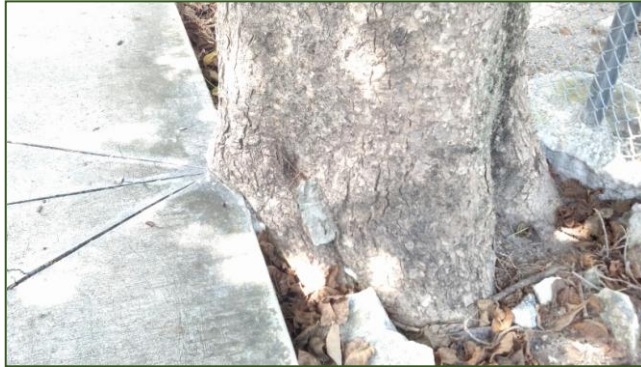
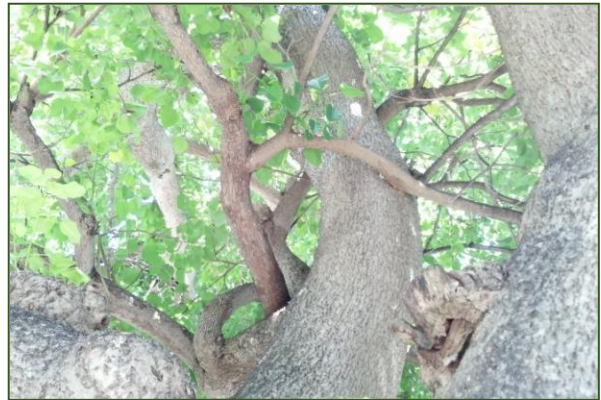
Tree 50: Sandbox Tree

Observations: This tree is abutting the sidewalk along Seminary Street and is growing over the cement and interfering with the fence behind it (see photo left) which is damaging the sidewalk and the tree. Overall, the crown structure of this tree is poor, with included bark at attachments, crossing and/or pressing leaders (see photo below) and decay visible at the locations of old

pruning cuts or breaks. Fungus was observed, which is an indication of decay.

Rating: Poor

Recommendation: E Sciences recommends removal of this tree per Sec. 110-327(a) of the City's municipal code and replacement. If the City desires preservation, E Sciences recommends structural pruning and crown cleaning. E Sciences also recommends monitoring the condition of this tree annually or biannually.

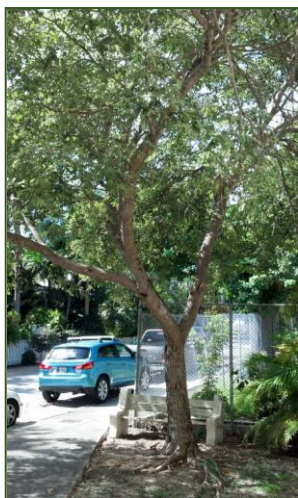
Tree 52: Jamaican Dogwood (*Piscidia piscipula*)

Observations: This tree has co-dominant leaders (photo left). There are crossing limbs, dead limbs and decay is present in old wounds. E Sciences observed included bark at one of the branch connections.

Rating: Poor

Recommendation: E Sciences recommends removal of this tree per Sec. 110-327(a) of the City's municipal code and replacement.

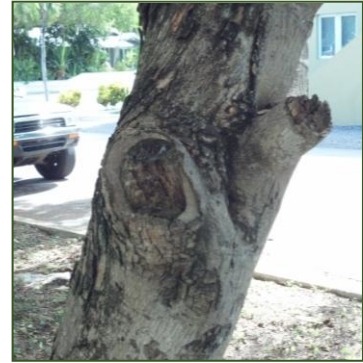
Tree 53: Jamaican Dogwood

Observations: This tree is leaning and has poor root structure. There are crossing leaders, dead limbs and decay is present in old wounds (see photo right).

Rating: Poor

Recommendation: E Sciences recommends removal of this tree per Sec. 110-327(a) of the City's municipal code and replacement.

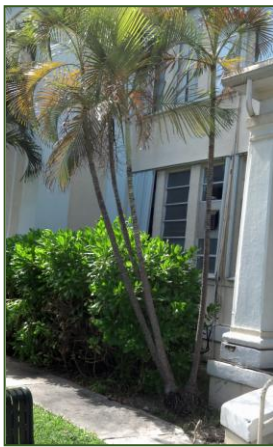
Tree 54: Alexander Palm

Observations: This four-stemmed palm was observed to be chlorotic (see photo left).

Recommendation: If this palm does not fit within the context of the new landscape design, E Sciences recommends removal and replacement.

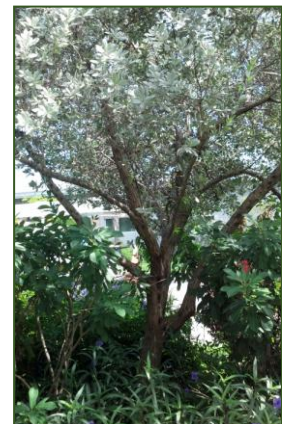
Tree 56: Silver Buttonwood (*Conocarpus erectus* var. *sericeus*)

Observations: This tree is planted in poor soil, but appears to be in good health. The form is typical of this species (see photo right).

Recommendation: If this tree does not fit within the context of the new landscape design, E Sciences recommends removal and replacement.

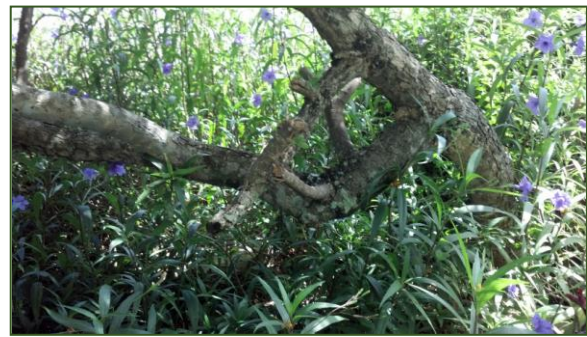
Tree 58: Tree of Life

Observations: This tree is planted in poor soil and leans heavily. E Sciences observed some decay and sprouts at the site of previous pruning cuts, which include stub cuts. Because the tree is small, defects are unlikely to pose a risk (see photo right).

Recommendation: E Sciences recommends preservation.

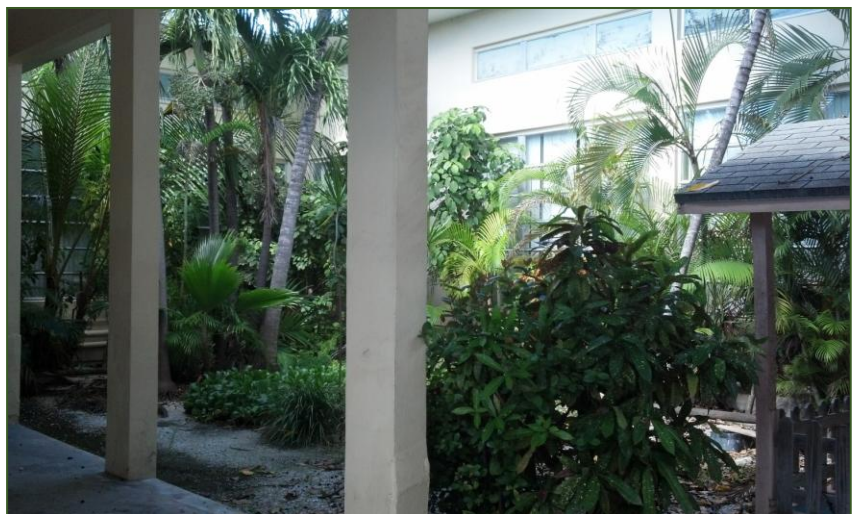
Courtyard Trees

There are trees located within a courtyard surrounded on four sides by buildings (see photo right). These trees include fourteen Alexander palms, one coconut palm, and one umbrella tree. Because the courtyard is surrounded by buildings on all four sides (with one small opening), these trees should be exempt from permitting per Sec. 110-322(b).
