REPORT OF MARINE SURVEY

VALUATION APPRAISAL INSPECTION of the vessel

**" KEY WEST FIRE BOAT"
2003 Boston Whaler Guardian**

**PREPARED EXCLUSIVELY FOR:
Key West Fire Department
City of Key West**

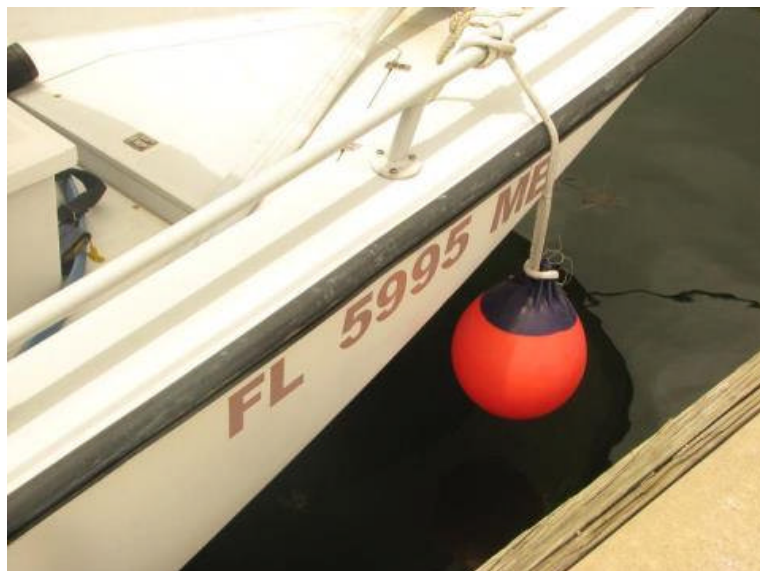
Exterior was inspected from the waterline up. There are nicks and scratches which can be expected of a workboat of this age. The bottom is quite fouled with marine growth and needs to be hauled out for maintenance and new anti-fouling paint.

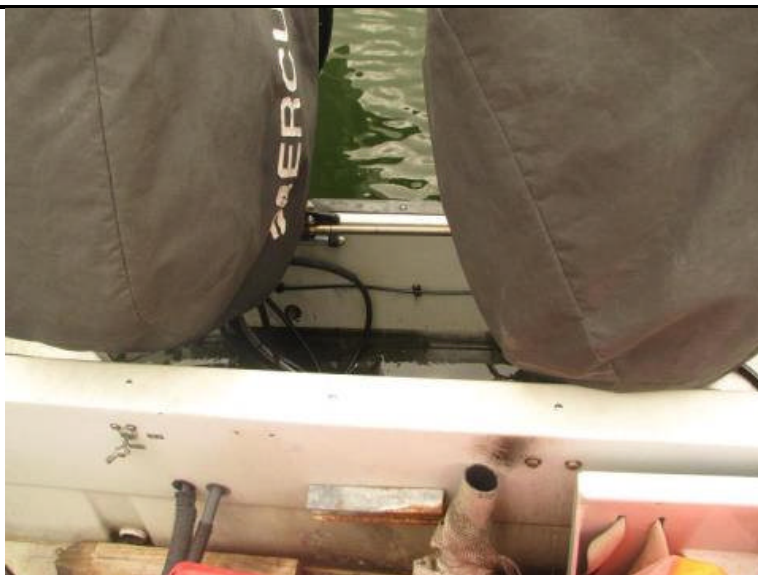
Condition summary: Hydraulic leak noticeable at starboard engine. It appears to have been spliced but oil was not cleaned up.

Identify leak in starboard steering hose.

Fix leak and clean up oil to avoid contamination of seawater.

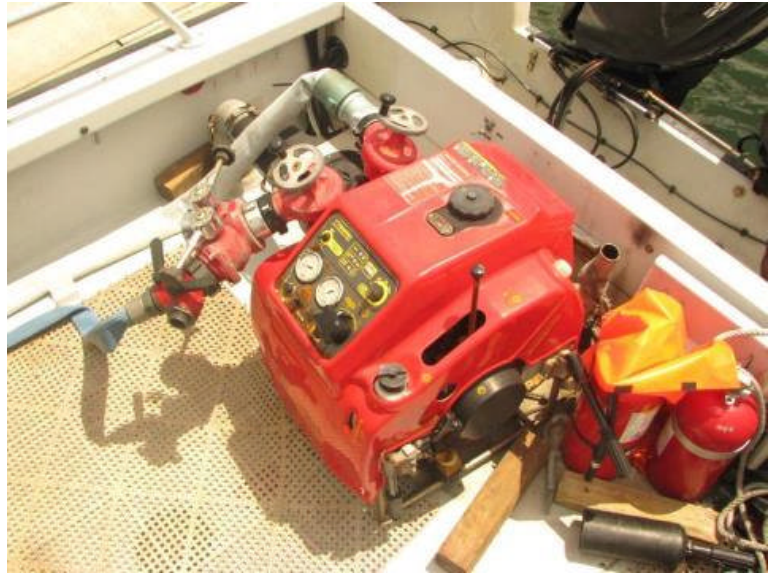
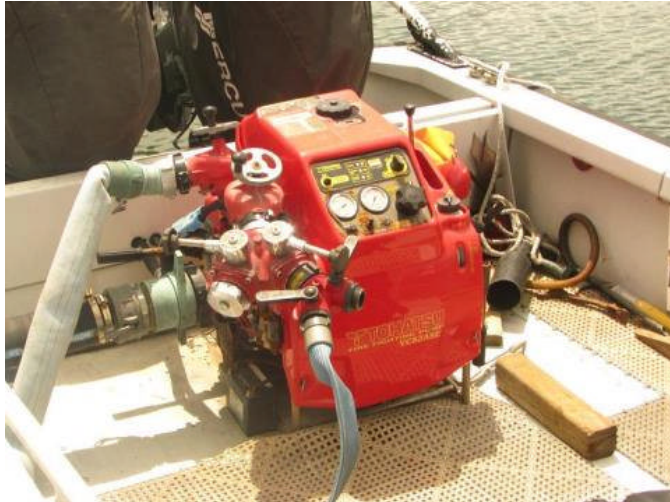
Tohatsu
VC82ASE
gasoline built in
firefighting pump
with forward
monitor. Also
large portable
extinguishers
were seen aboard
along with misc
fire fighting
equipment.

Fire pump is a valuable part of the intended purpose of this vessel.

Maintain and
cover pump to avoid premature devaluation.

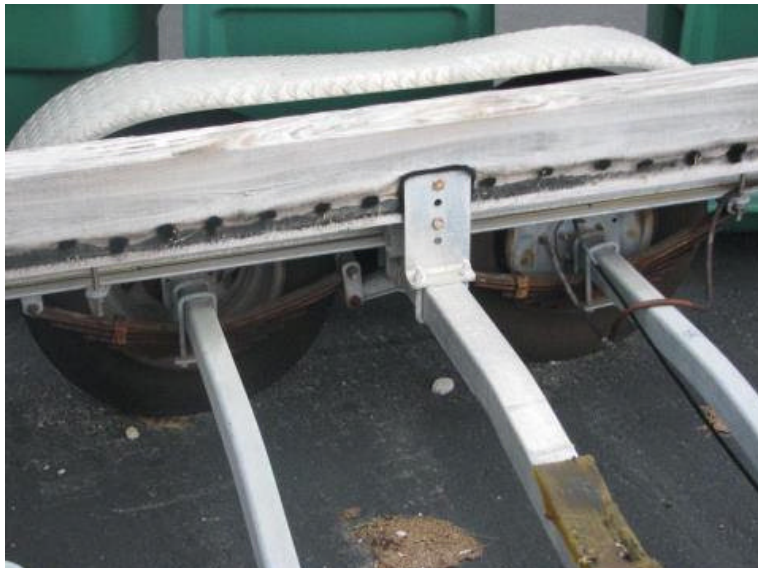
Aluminum frame
in good
condition.
Suspension
springs rusted.
Unknown if surge
brake is in
operating
condition. Tires
are in good
condition.

Recommend
springs be
inspected before
next use.
