# STAFF REPORT

**RE: 616 Eaton Street (permit application #7059 )**

FROM: Karen DeMaria, Urban Forestry Manager,  
City of Key West

An application was received for the removal of **(1) Spanish Lime tree and (1) Sandbox tree**. A site inspection was done on July 21, 2014 and documented the following:

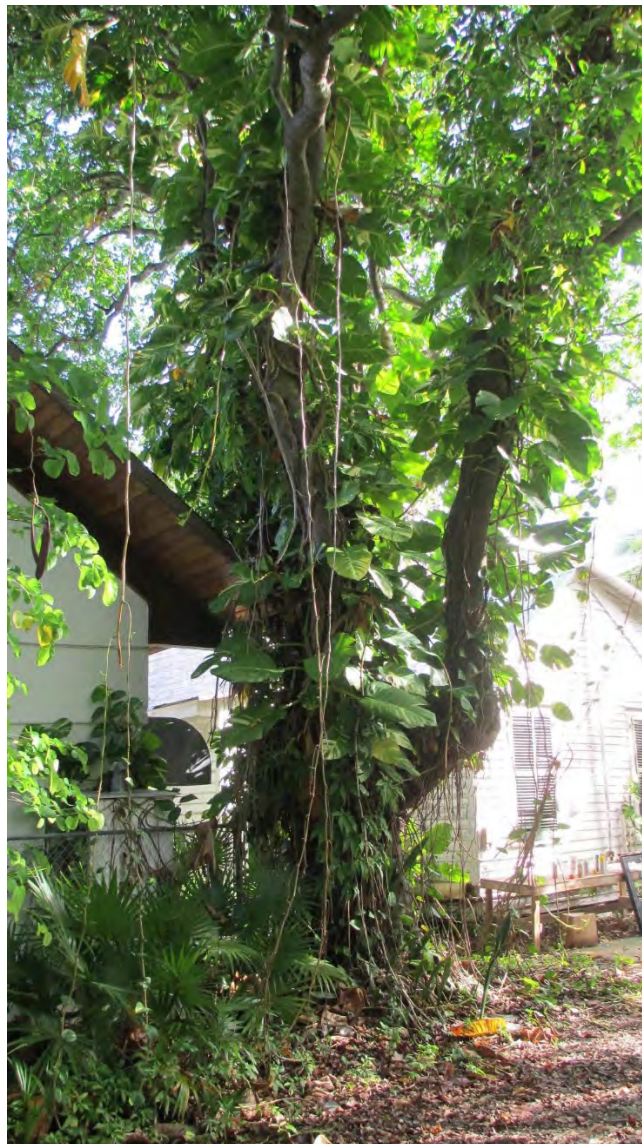
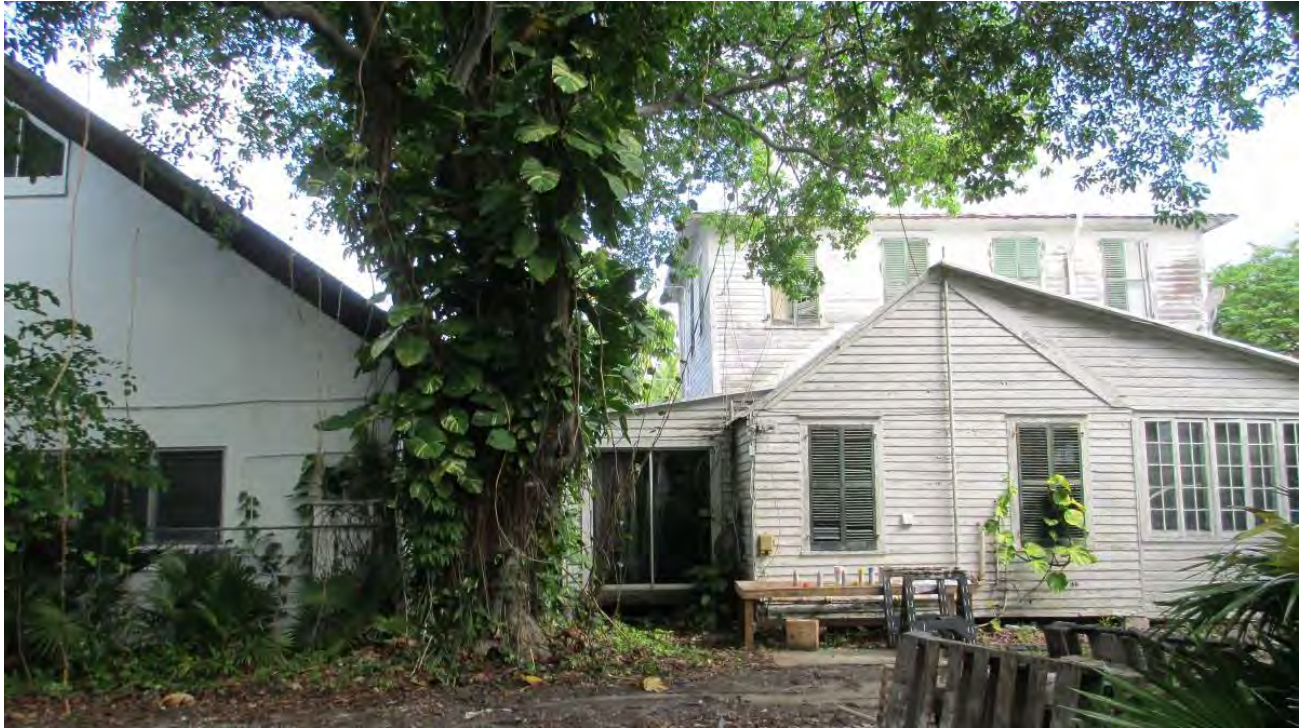
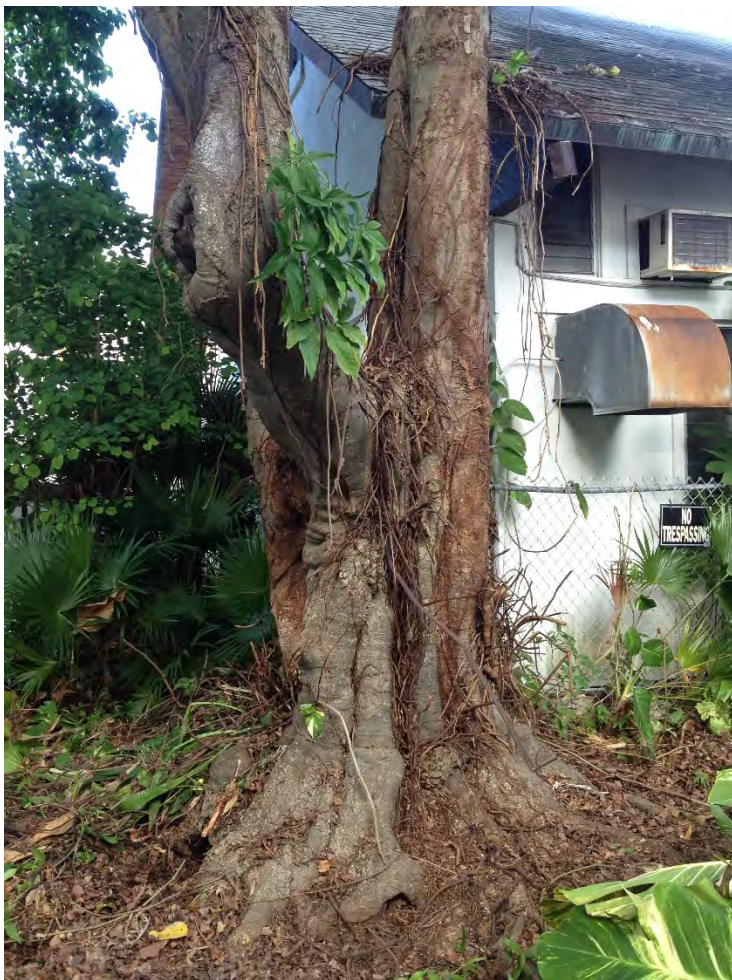
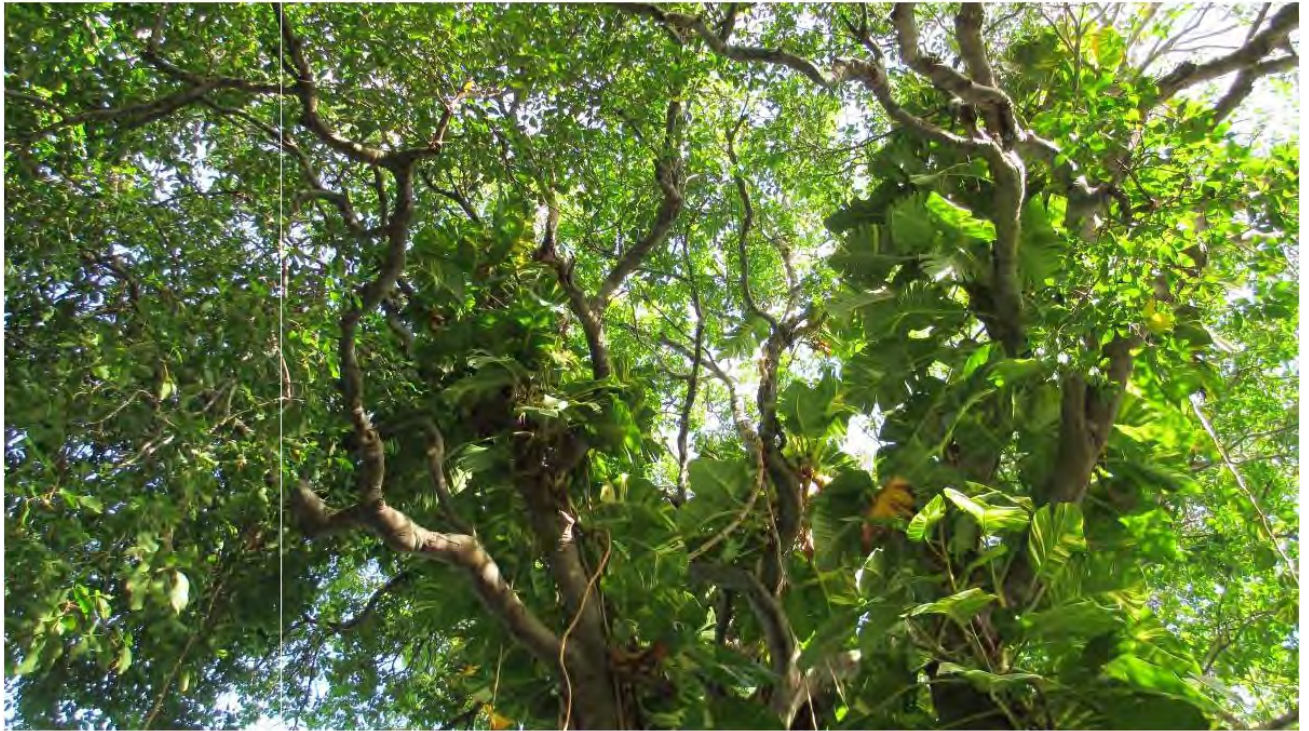
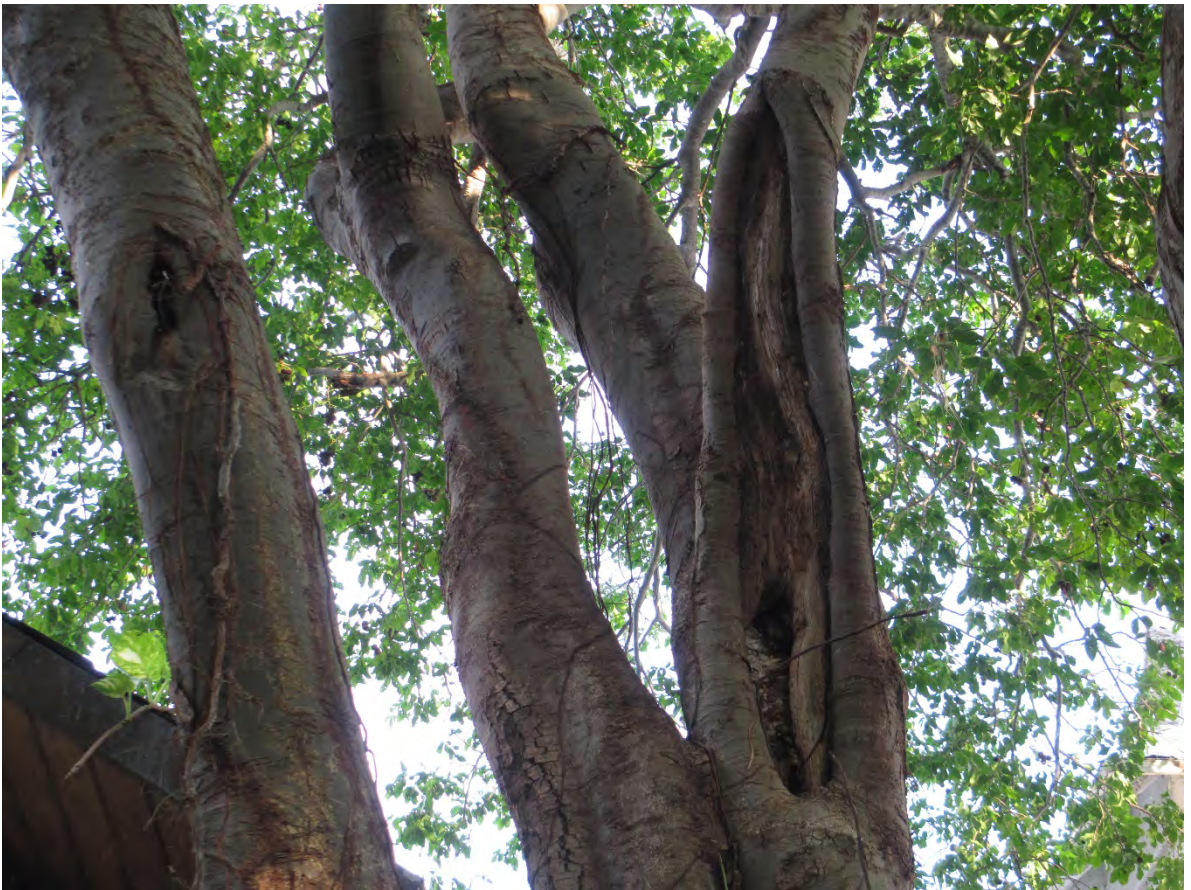
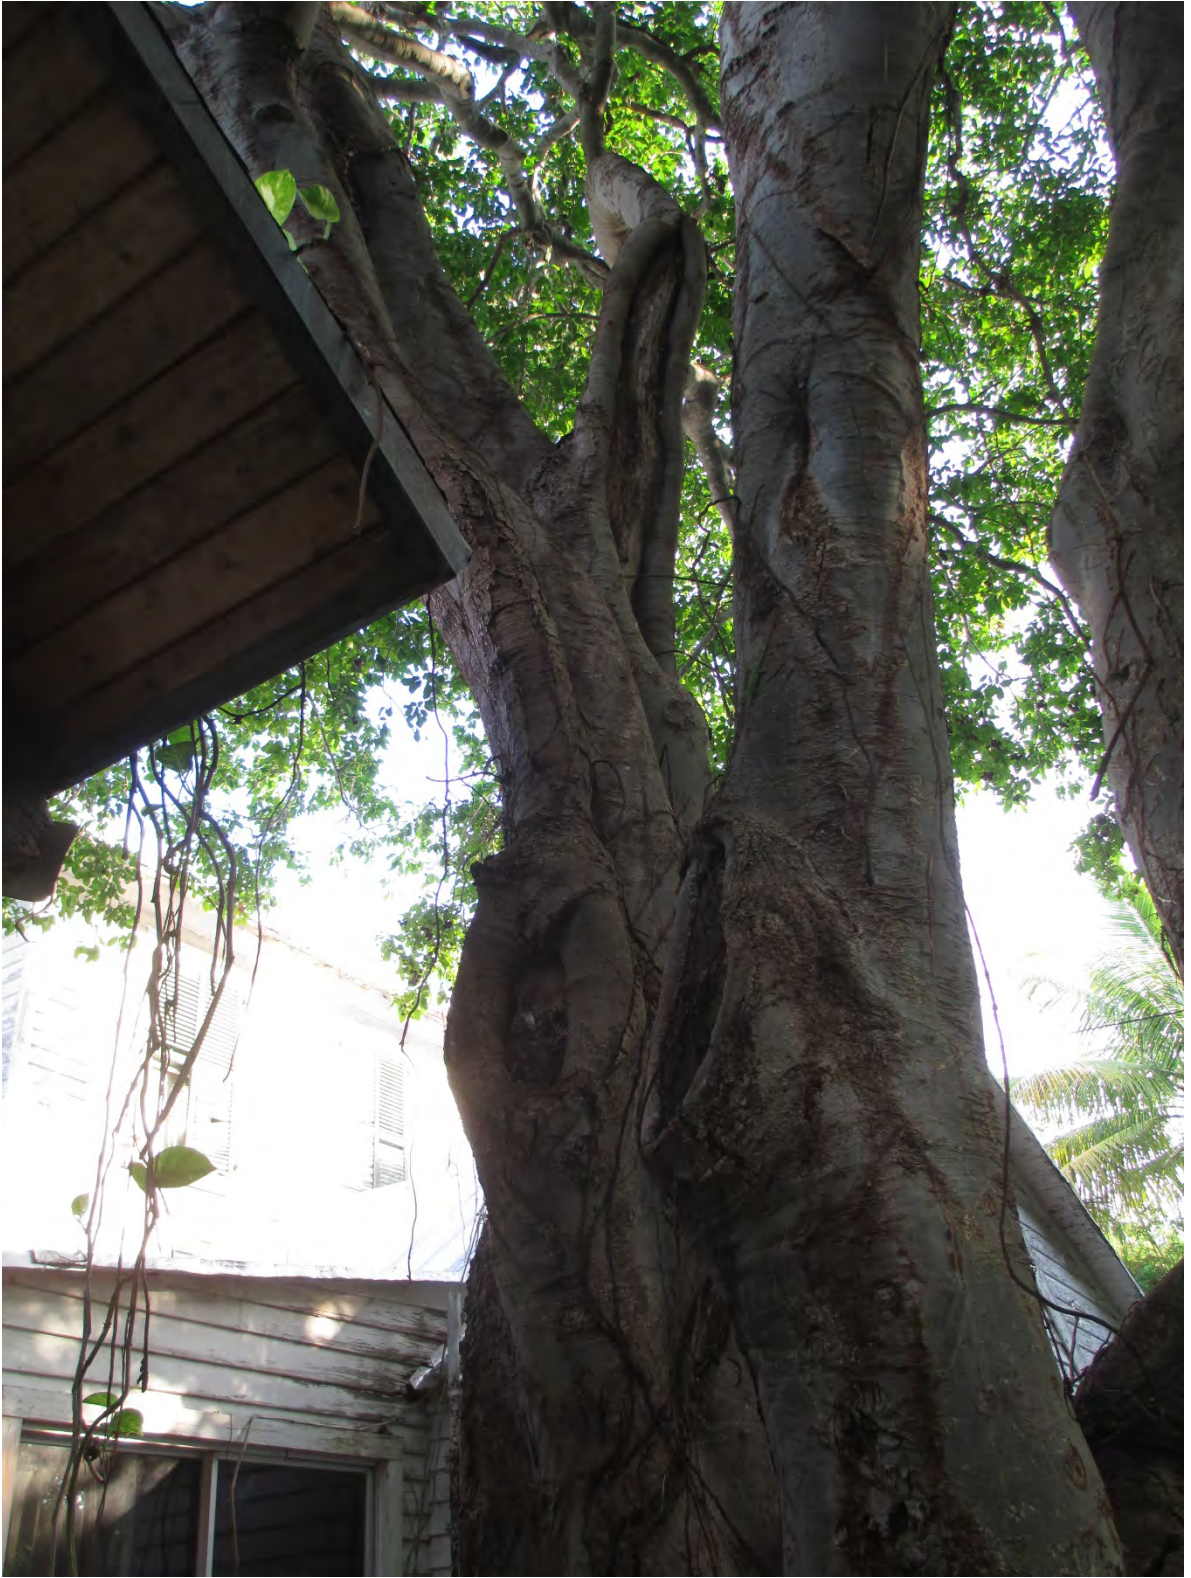
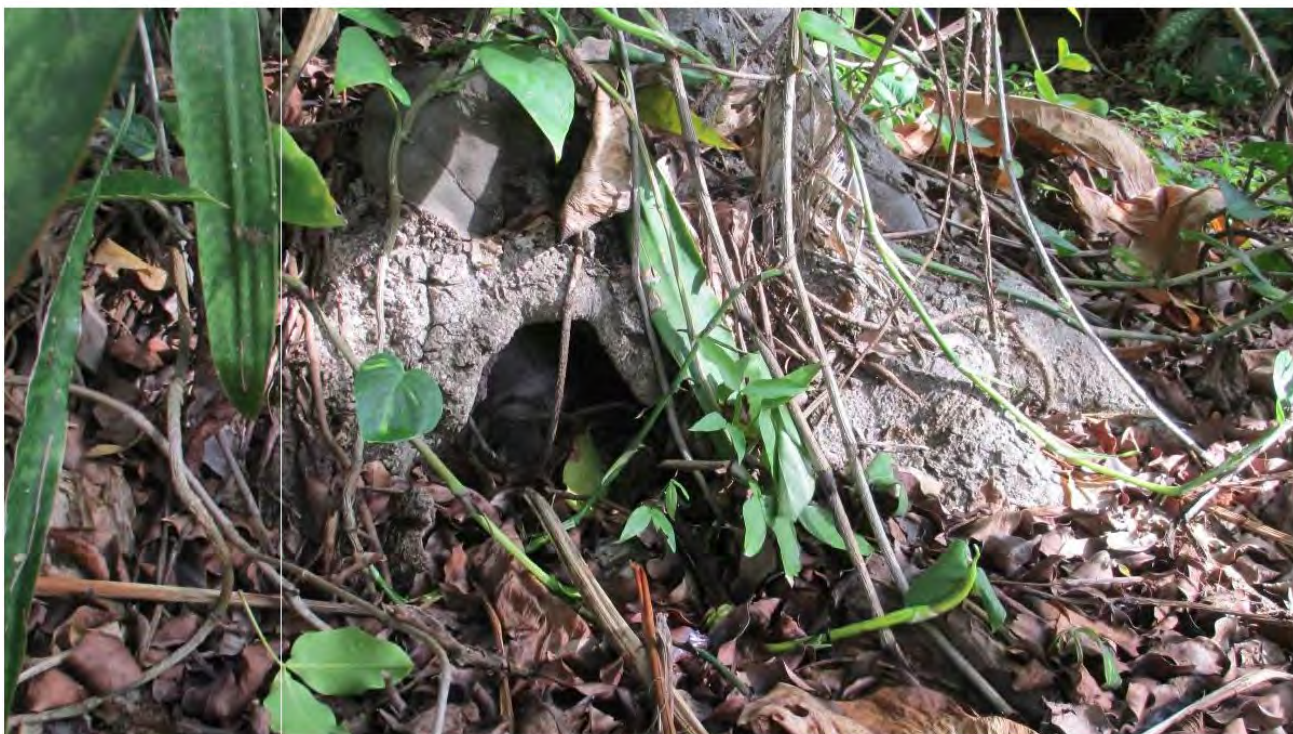
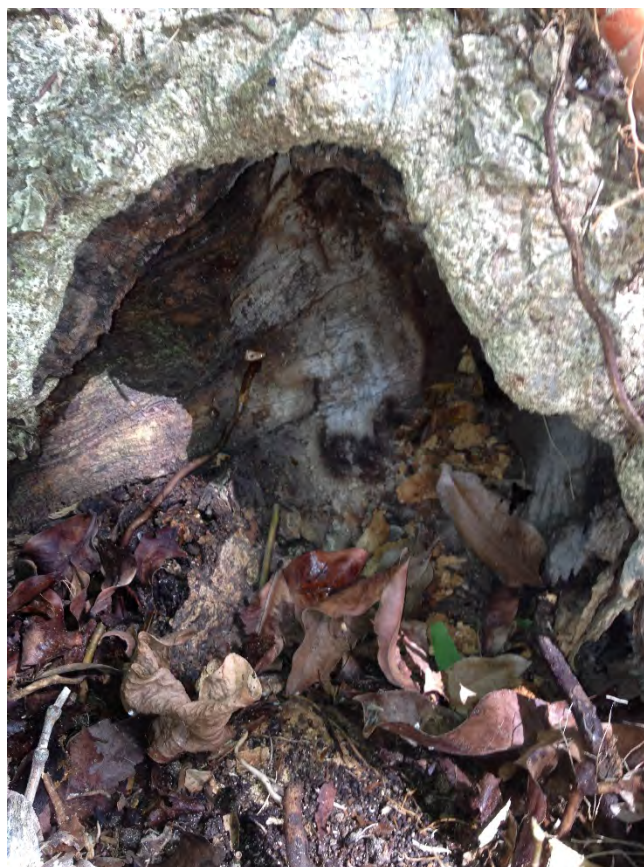
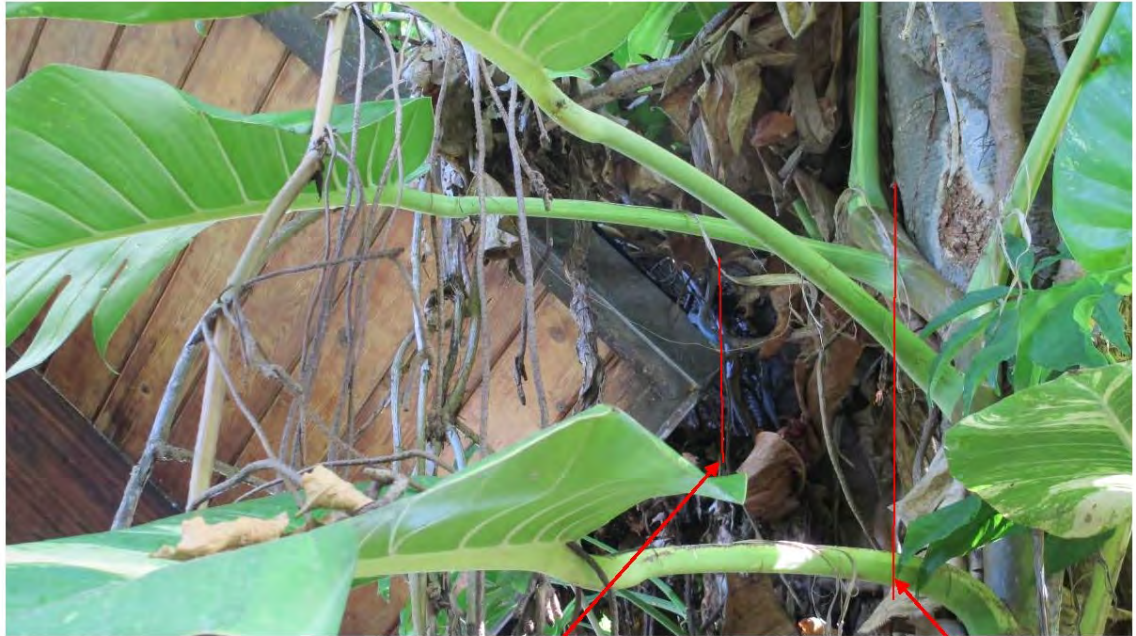
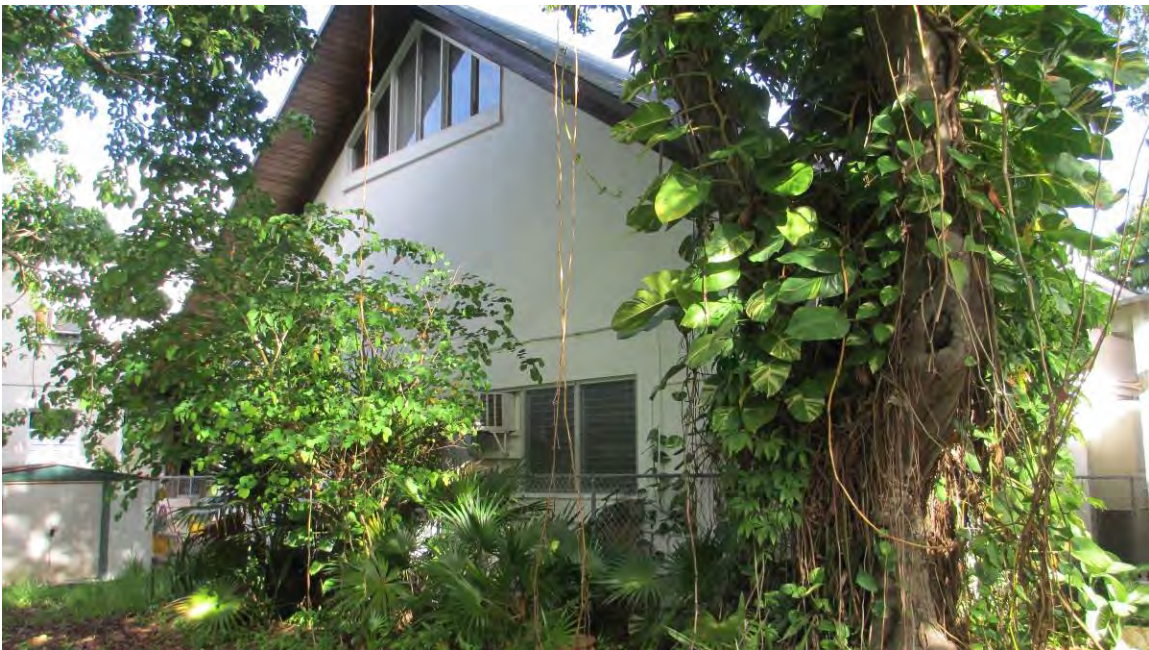
1. Tree Species: #2 Spanish Lime  
(Melicoccus bijugatus)

Cavity hole at  
base of tree-  
extends straight  
back at least 1  
foot.

Location: 60% (backyard tree, growing very close to two historic structures)

Condition: 50% (fair to poor, tree was covered in vines, hole/cavity at base of tree)

#2 Spanish Lime Fair - Poor Approx 35" diameter. Under root flare and trunk decayed. Recommend removal.

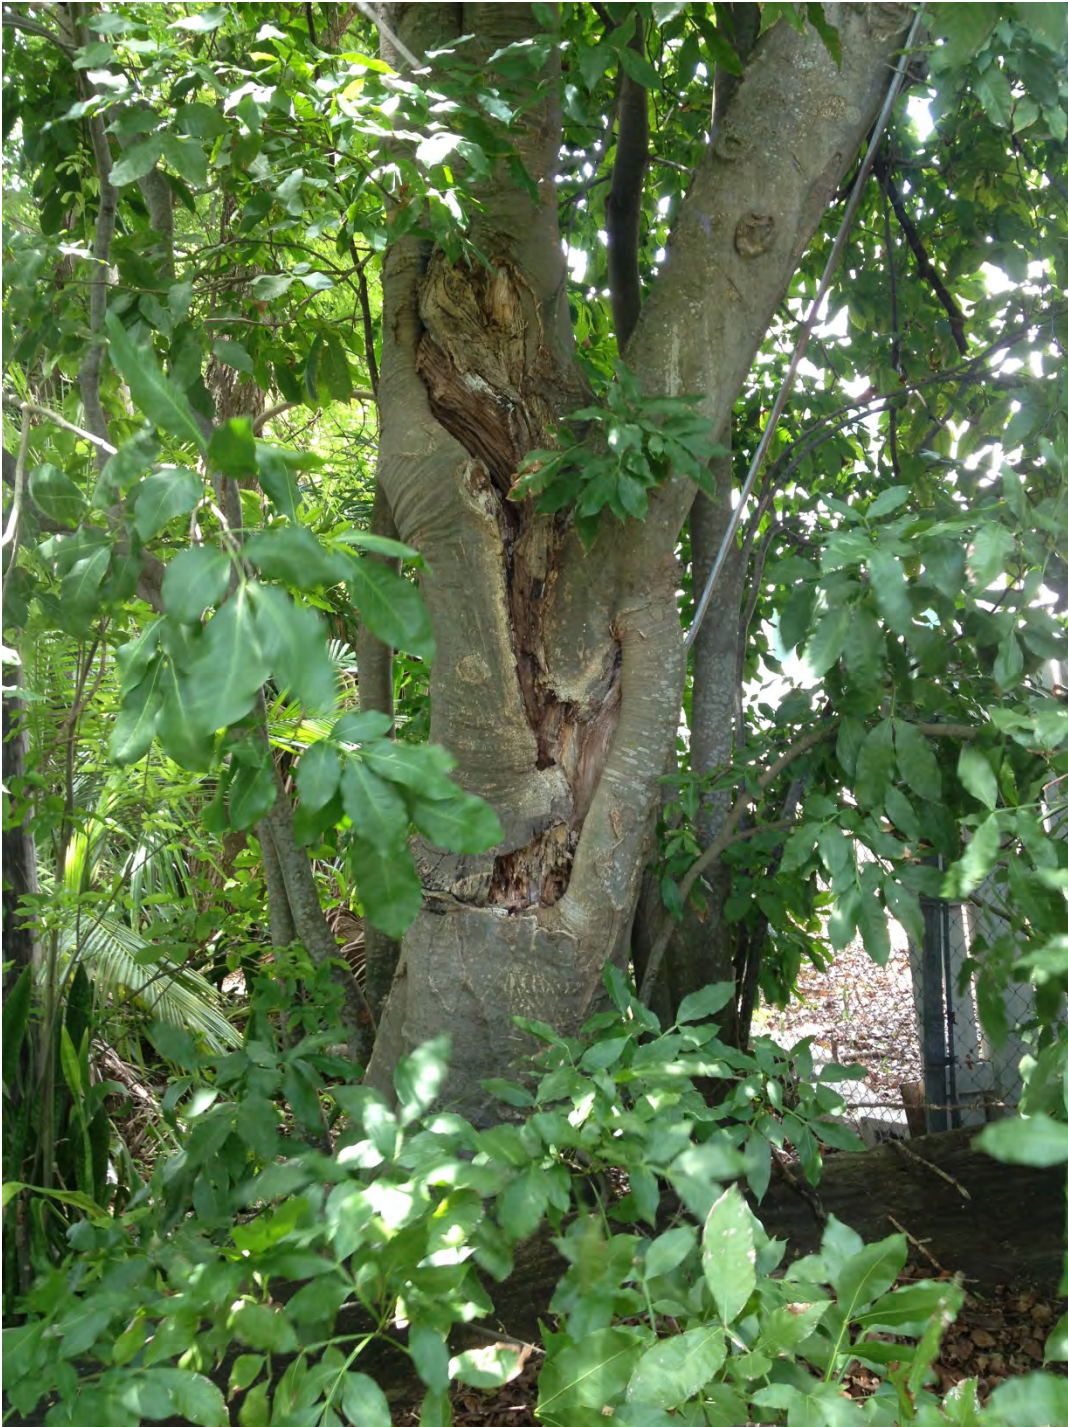
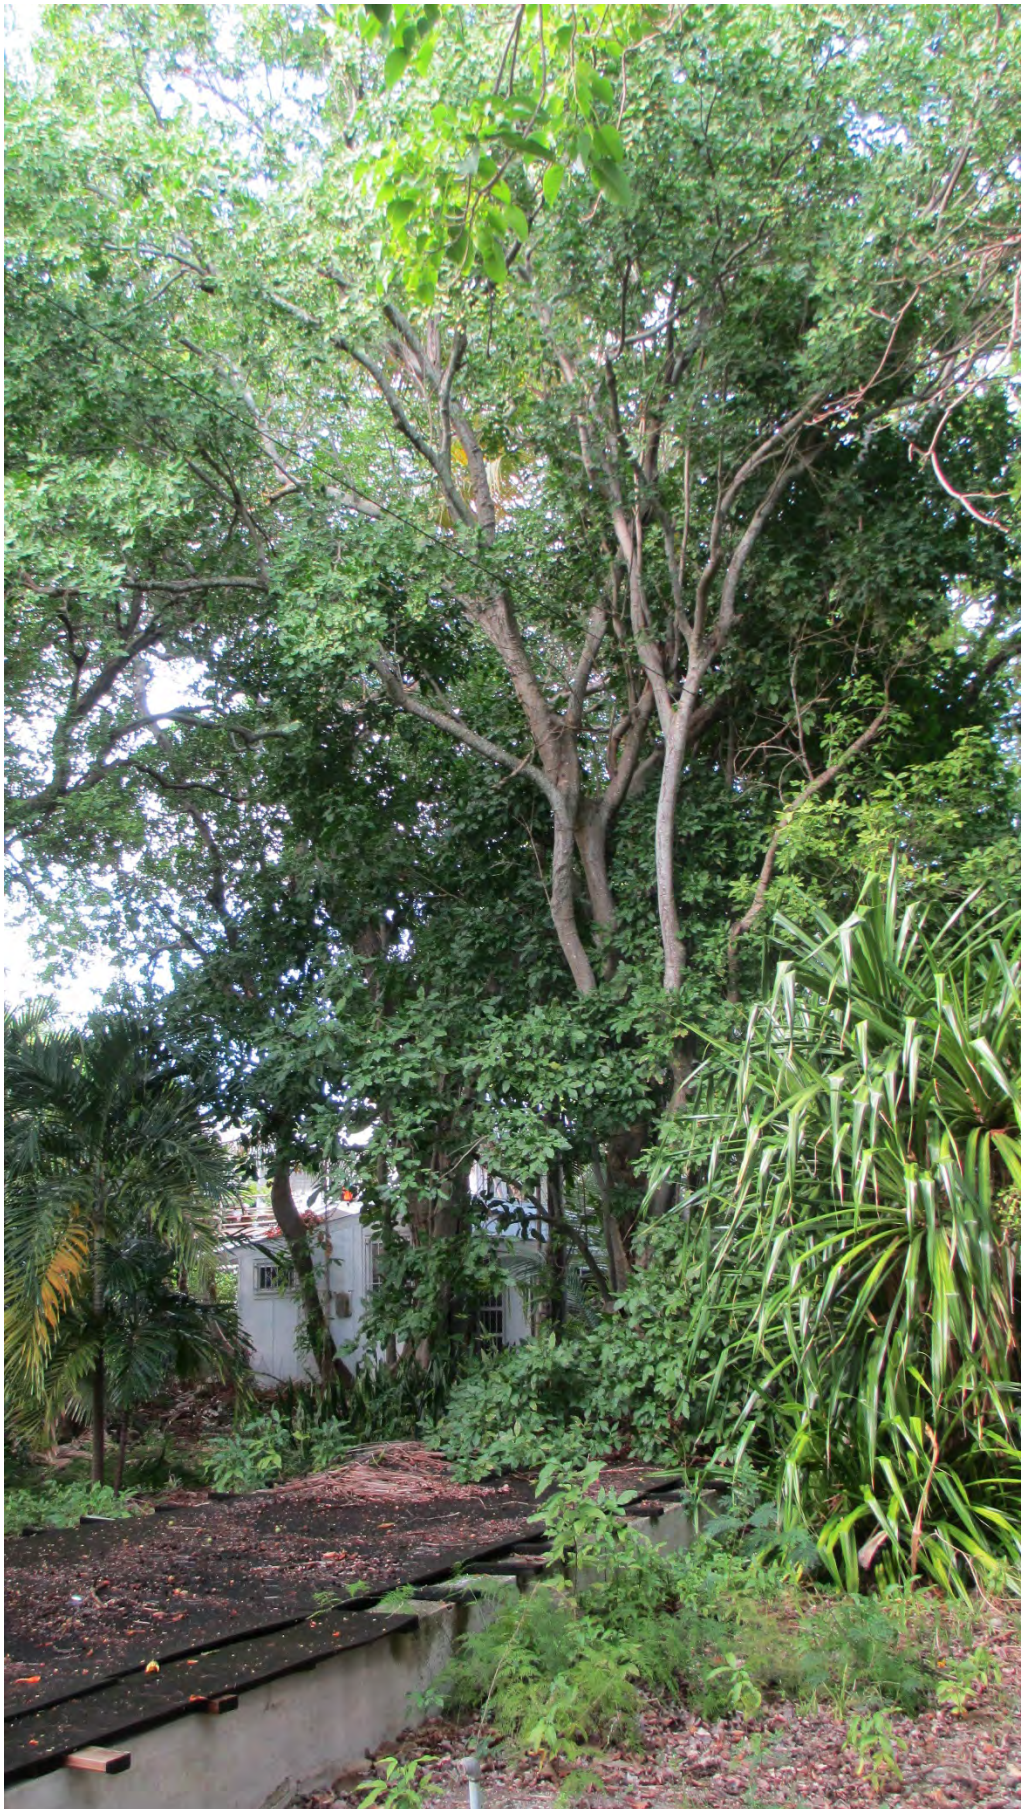
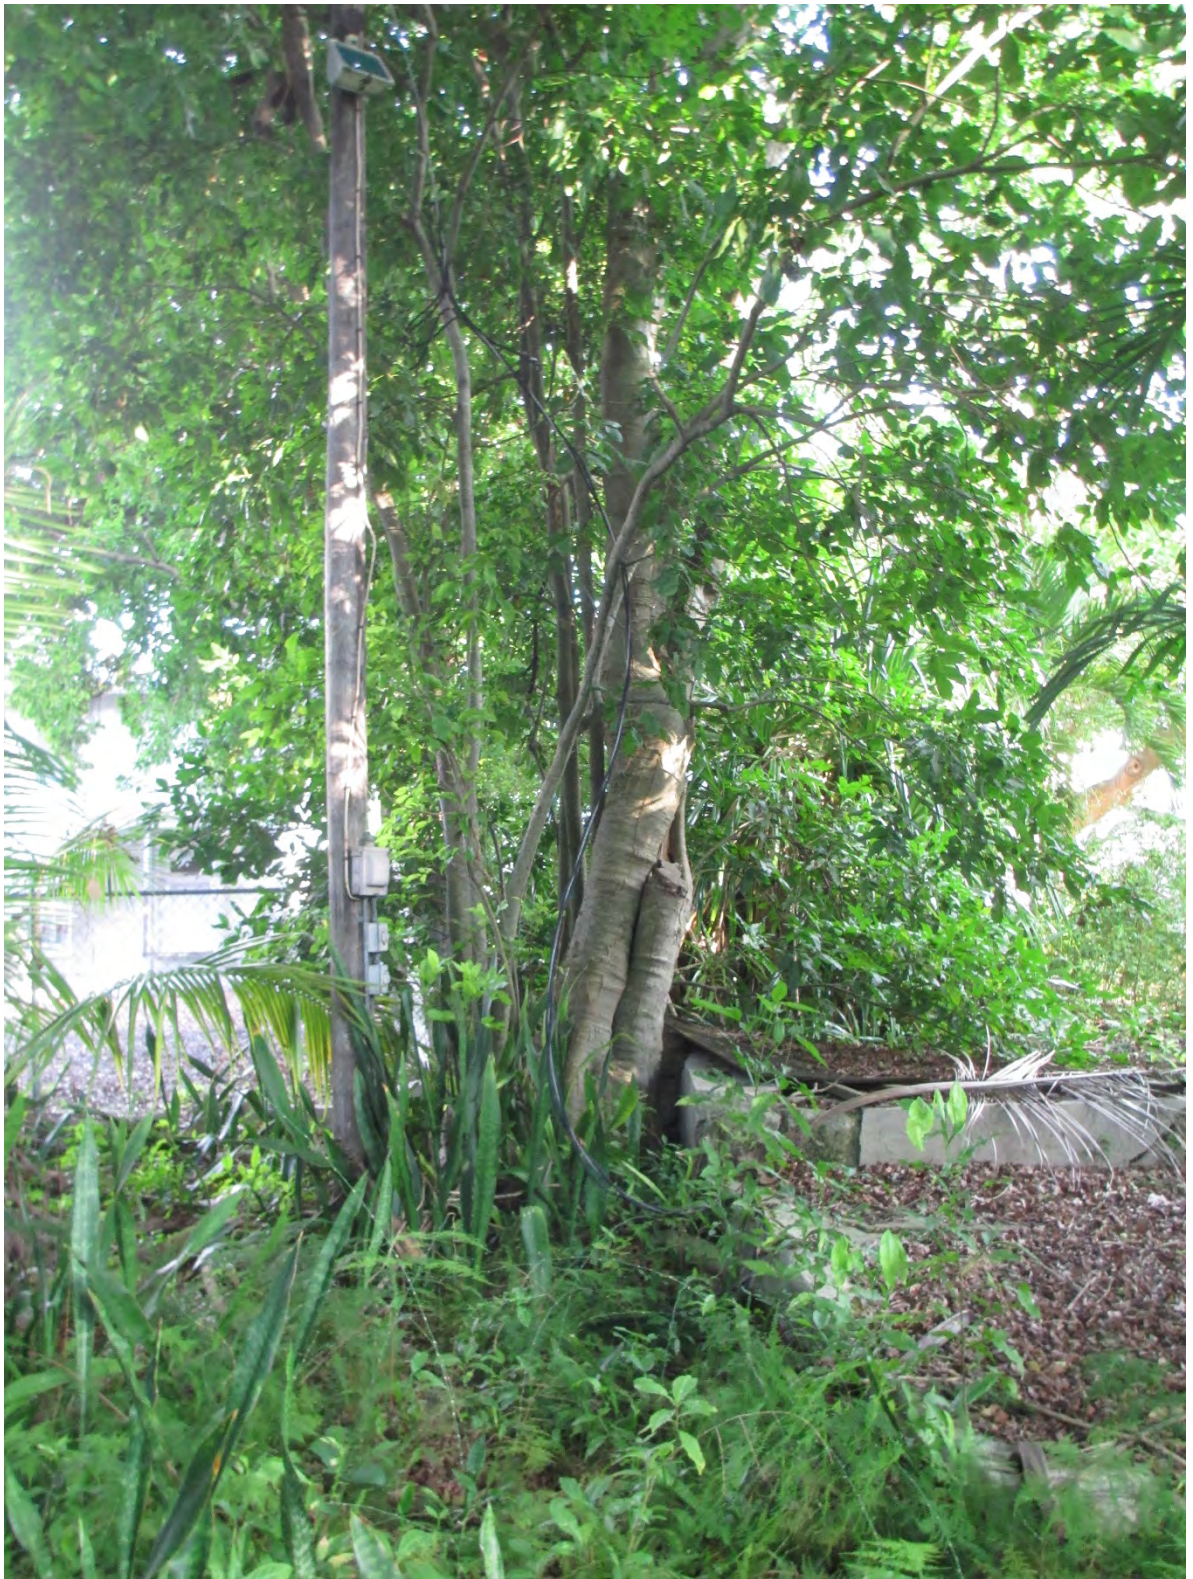
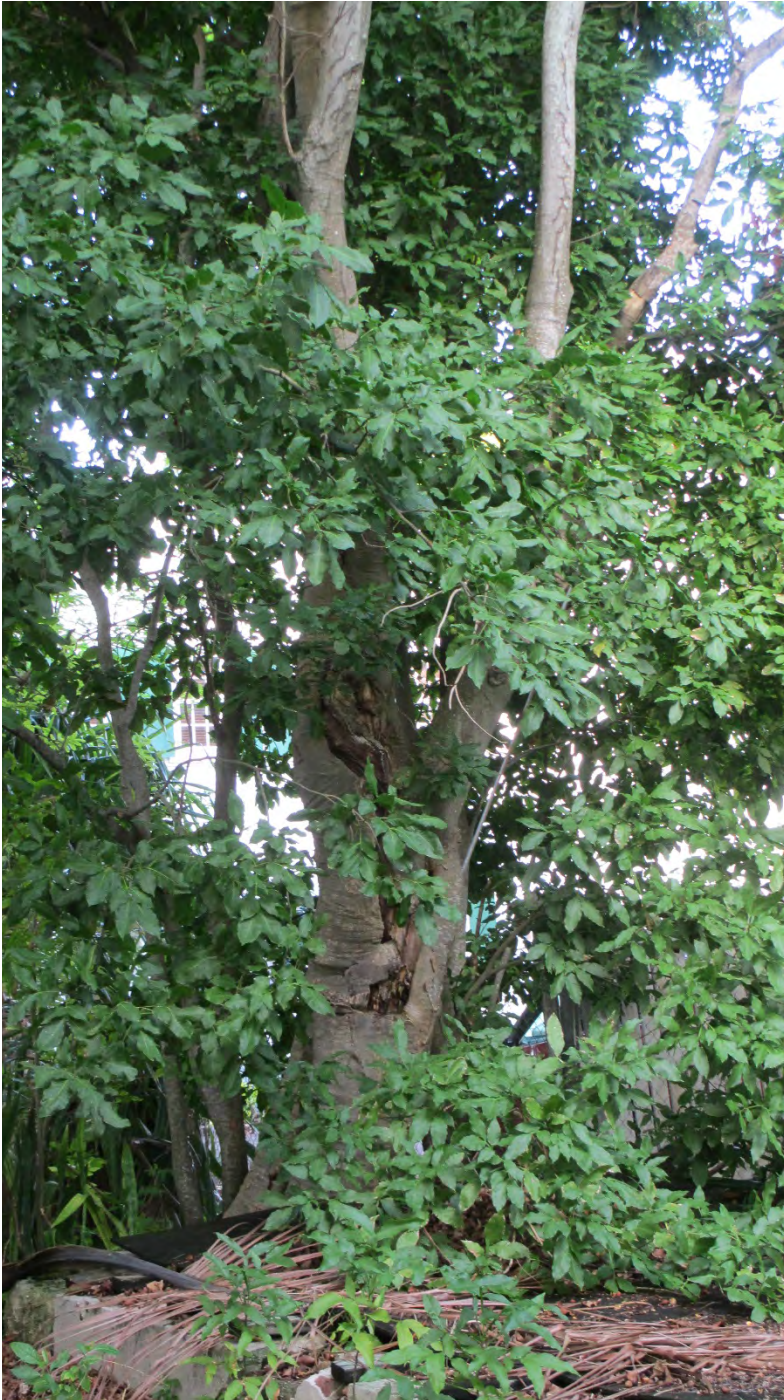
2. Tree Species: #20 Spanish Lime (*Melicoccus bijugatus*)

Location: 40% (back yard tree, roots into concrete inground structure/cistern)

Condition: 30% (poor, codominant trunks-one ripped out, decay)

#20 Spanish Lime tree is approx 20 3/4" located at the southwest rear yard adjacent to church parking lot and immediately adjacent and west of underground concrete structure. Large codominant stem ripped away from trunk during past hurricane seasons causing decay throughout trunk. Tree is in poor condition. Recommend removal.

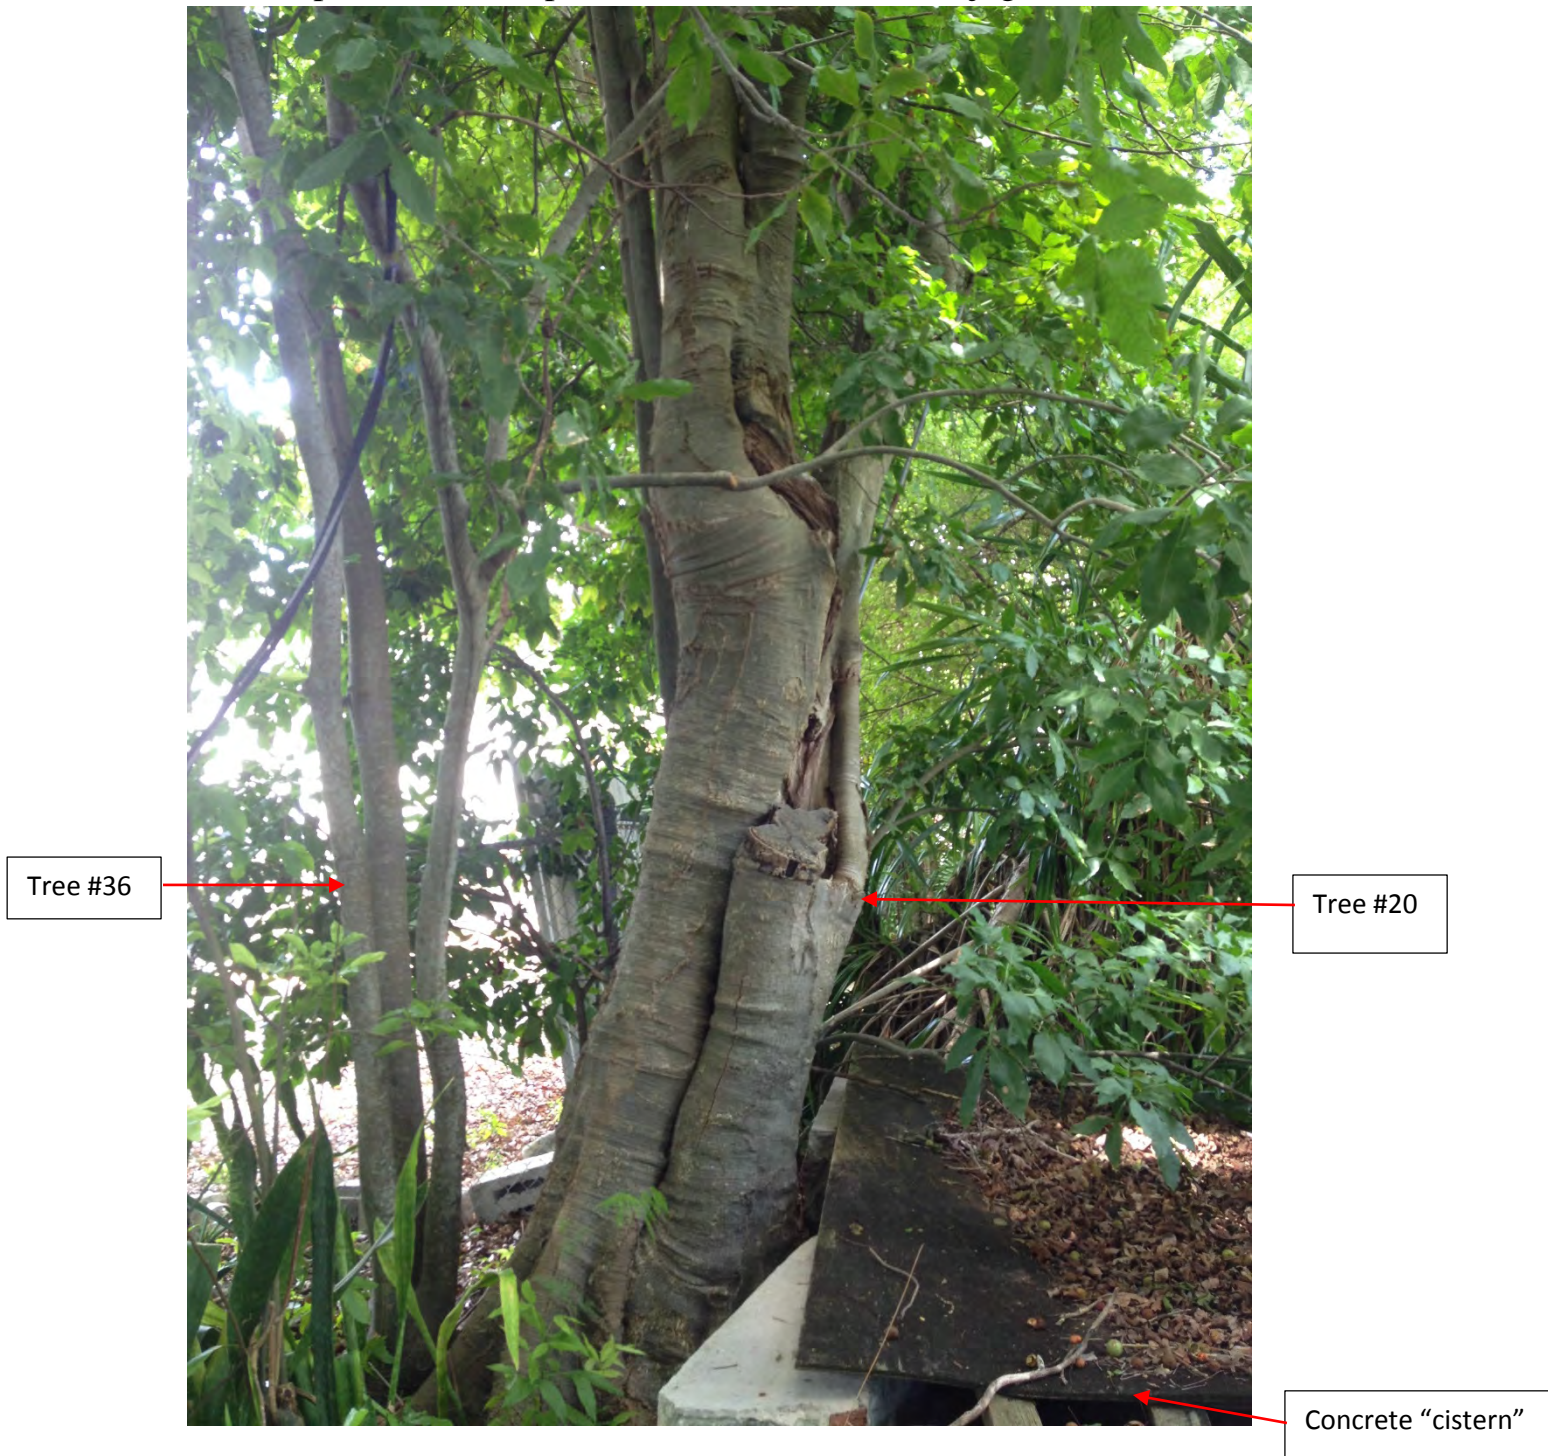
3 Tree Species: #36 Spanish Lime (*Melicoccus bijugatus*)

Location: 60% (back yard tree, in root zone of tree #20, close to property line)

Condition: 40% (poor-regrowth from old cut trunk)

#36 Spanish Lime, approx diameter totaling 6", located in rear yard west northwest adjacent to church parking lot and adjacent to larger Spanish Lime at underground concrete structure. Three Spanish Lime stems are regrowth from prior removed small tree. Poor condition. Recommend removal.

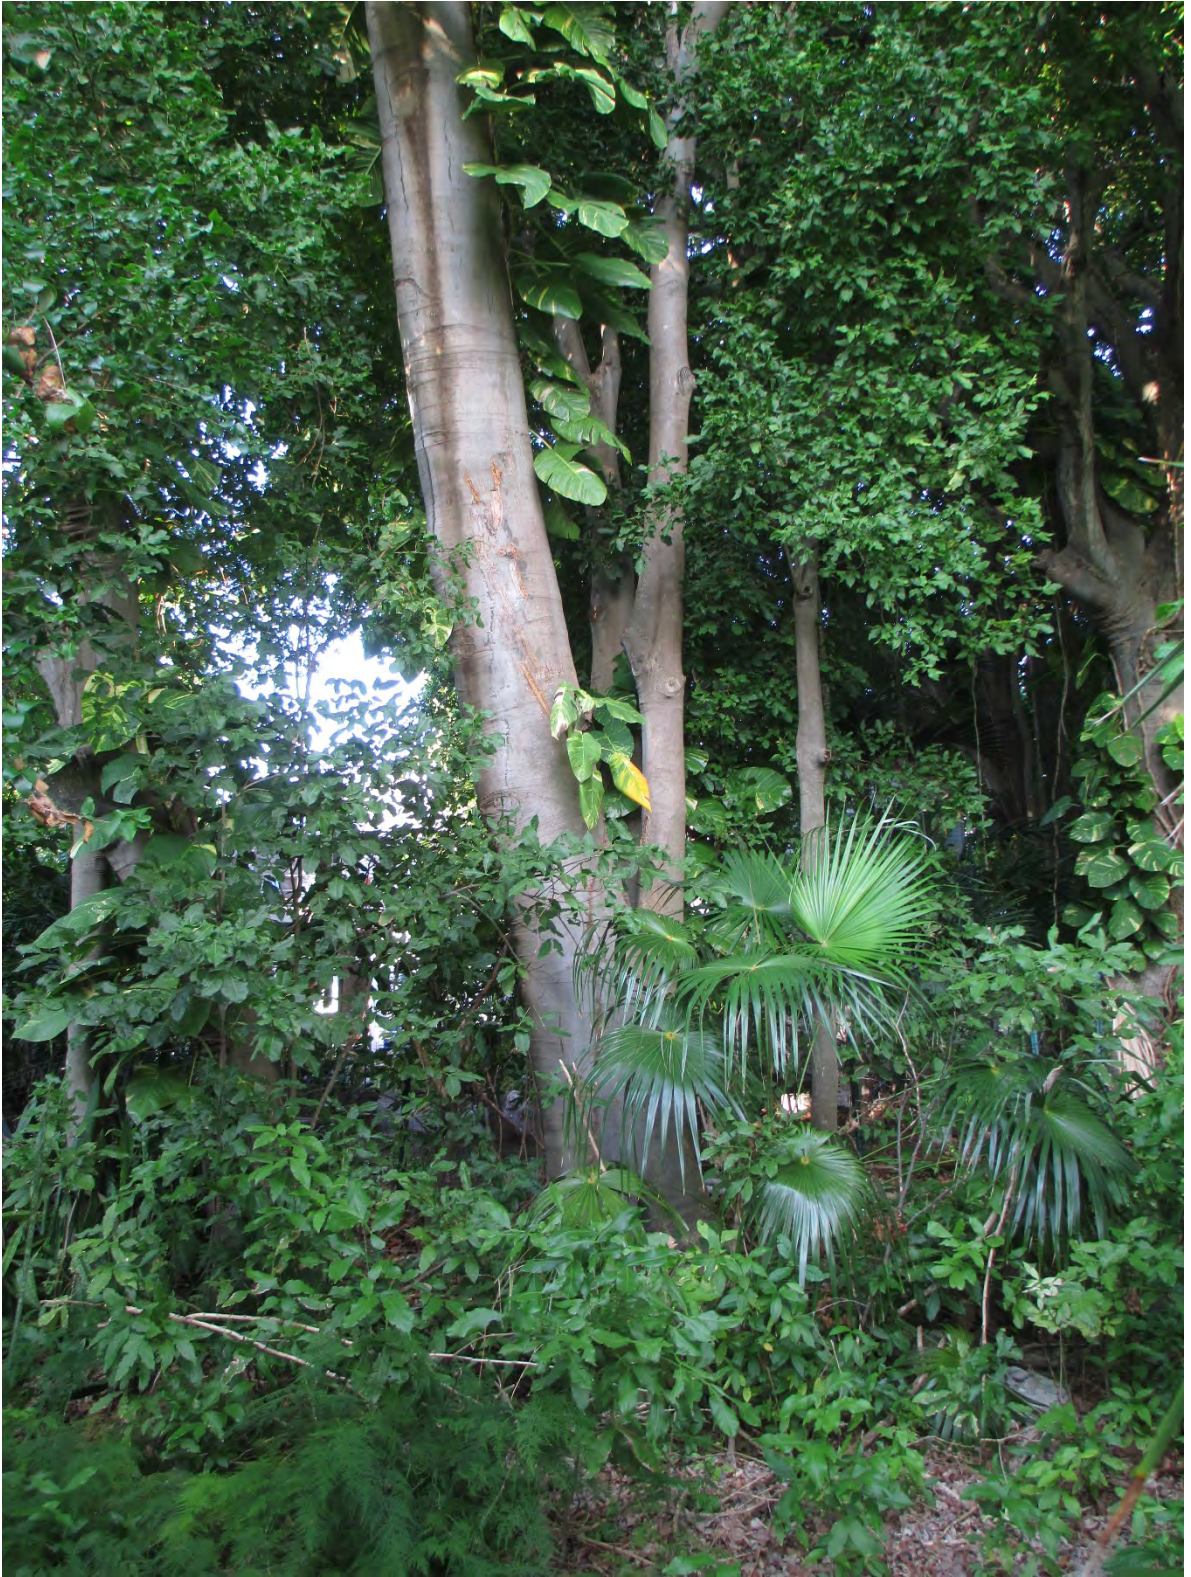
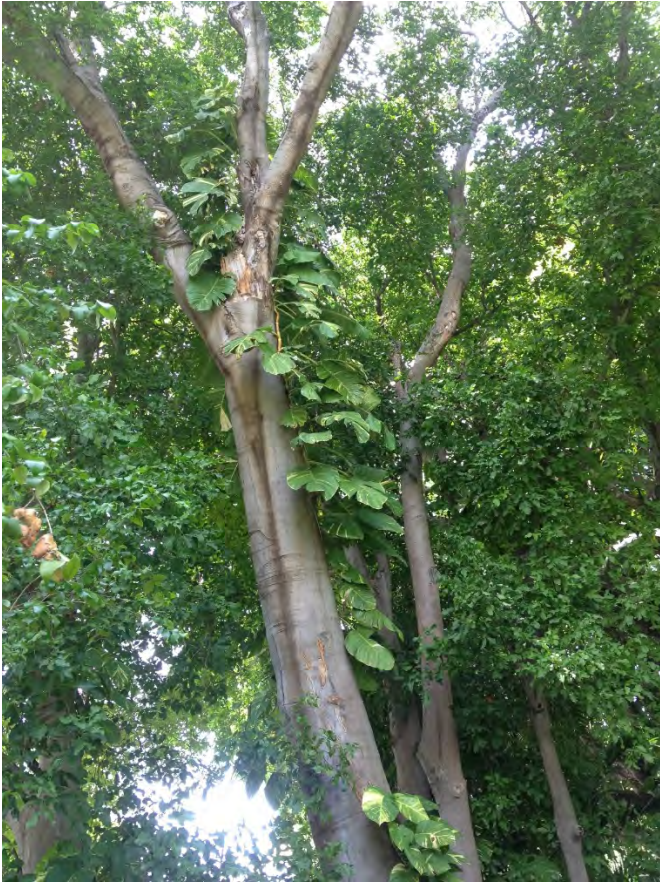
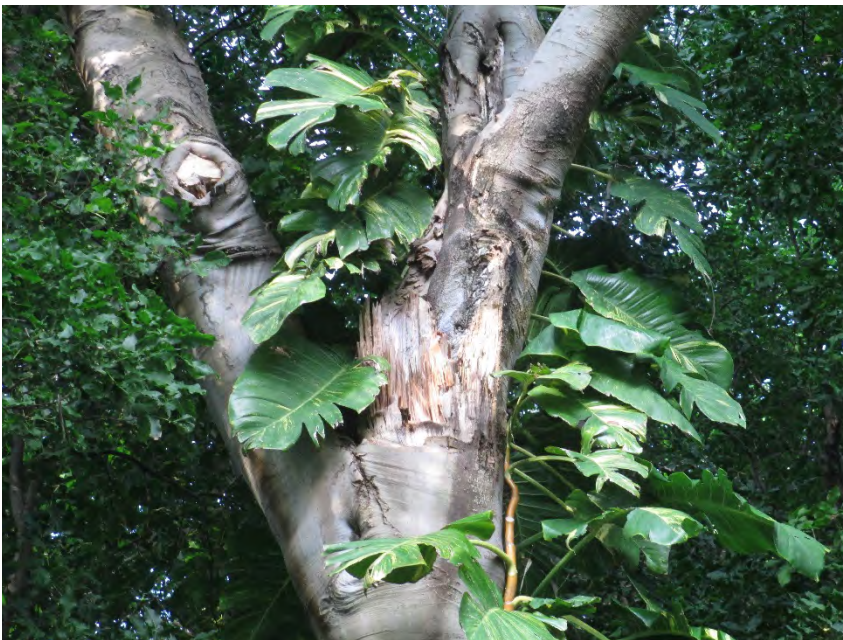
4. Tree Species: #33 Spanish Lime (*Melicoccus bijugatus*)

Location: 60% (back yard tree, close to property line and church accessory structures)

Condition: 50% (fair to poor, codominant trunks with large rip and decay)

#33 Spanish Lime, approx diameter 28 1/2", located at rear yard extreme southwest immediately adjacent to property line. Poor condition. Spanish Lime has rip away of codominant branch with large area of decay to include remaining branch. Recommend removal.
