# STAFF REPORT

**RE: 616 Eaton Street (permit application #7059 )**

FROM: Karen DeMaria, Urban Forestry Manager,  
City of Key West

An application was received for the removal of **(1) Spanish Lime tree and (1) Sandbox tree**. A site inspection was done on July 21, 2014 and documented the following:

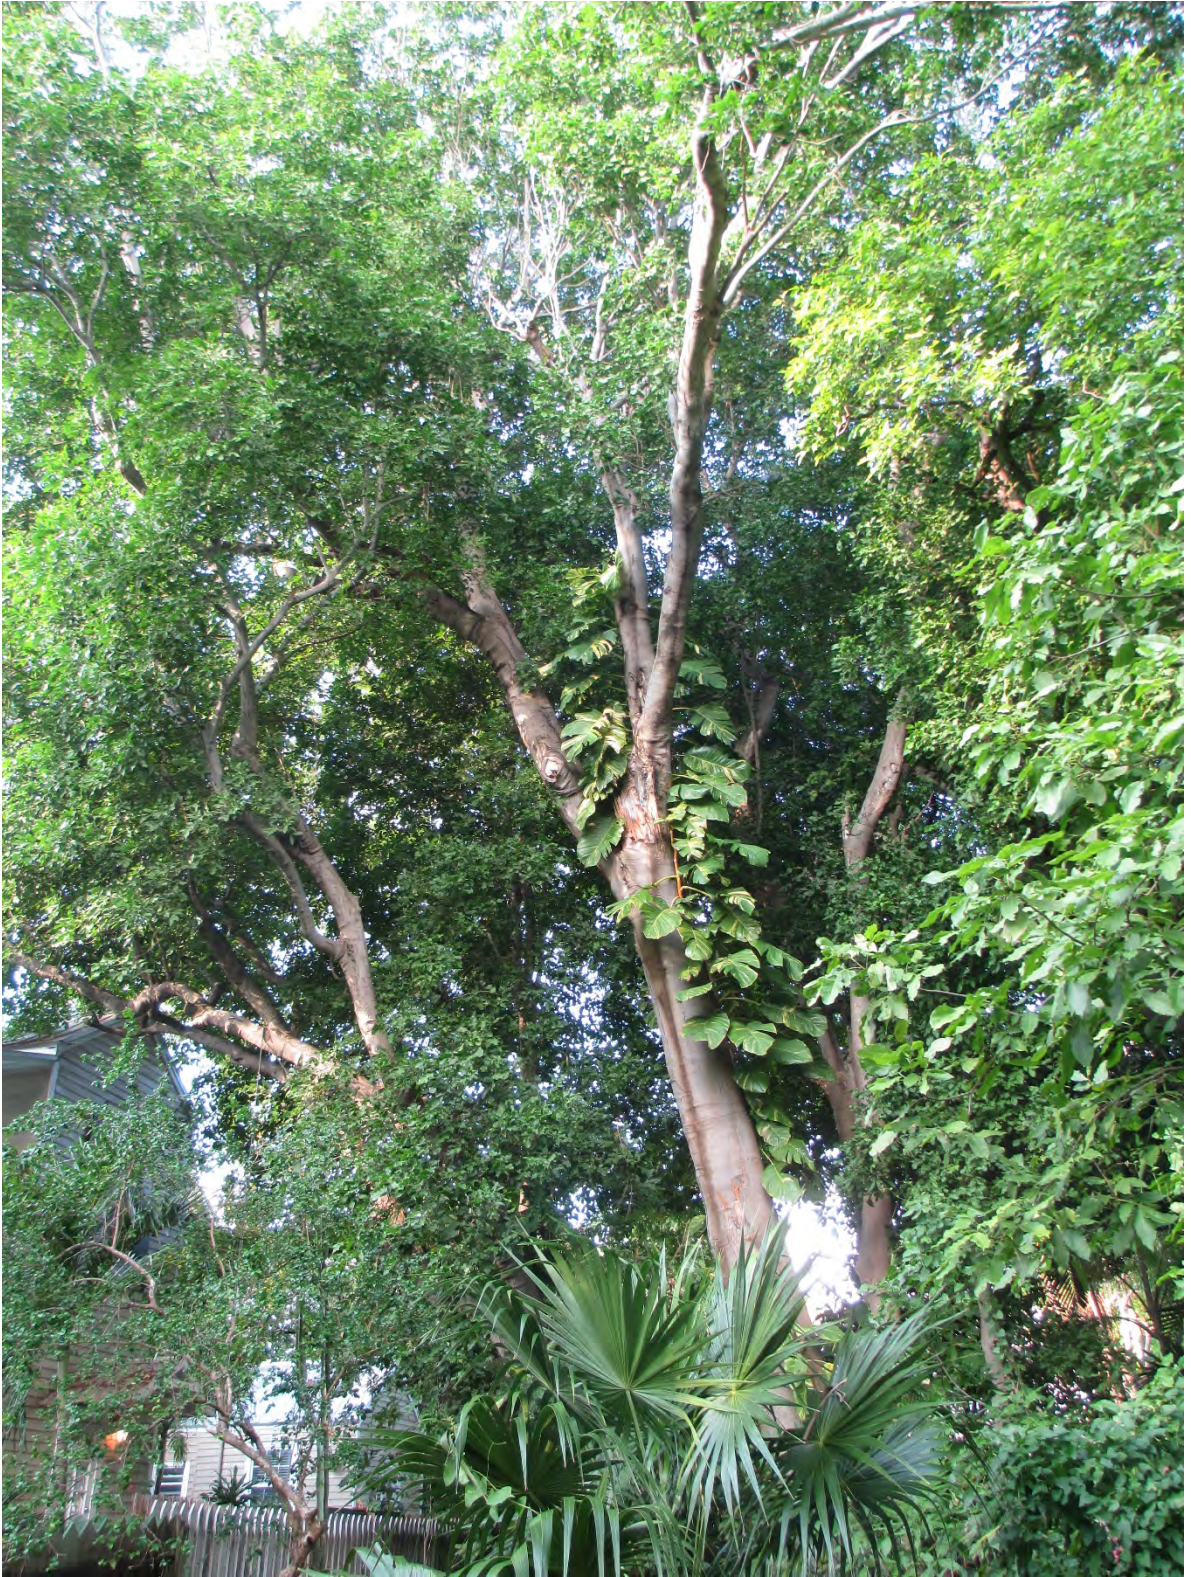
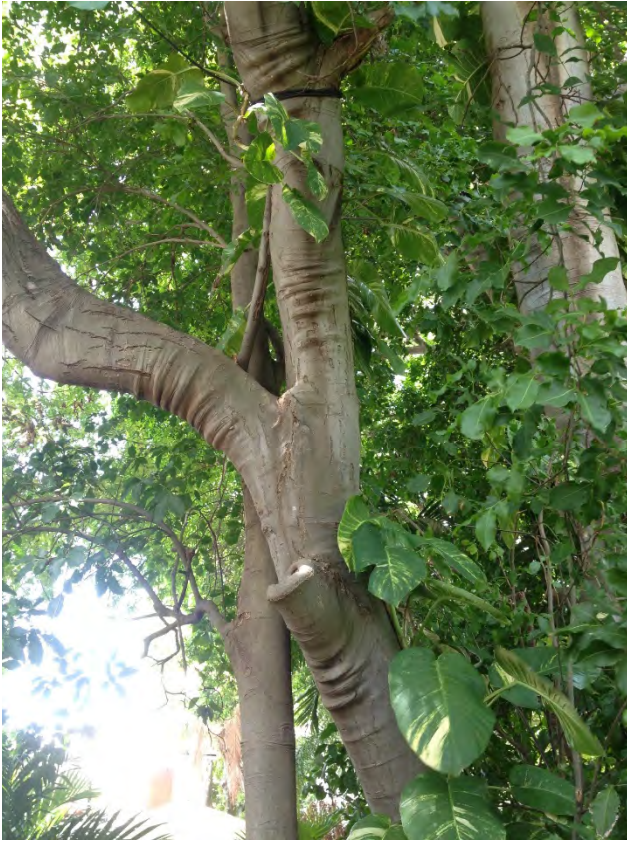
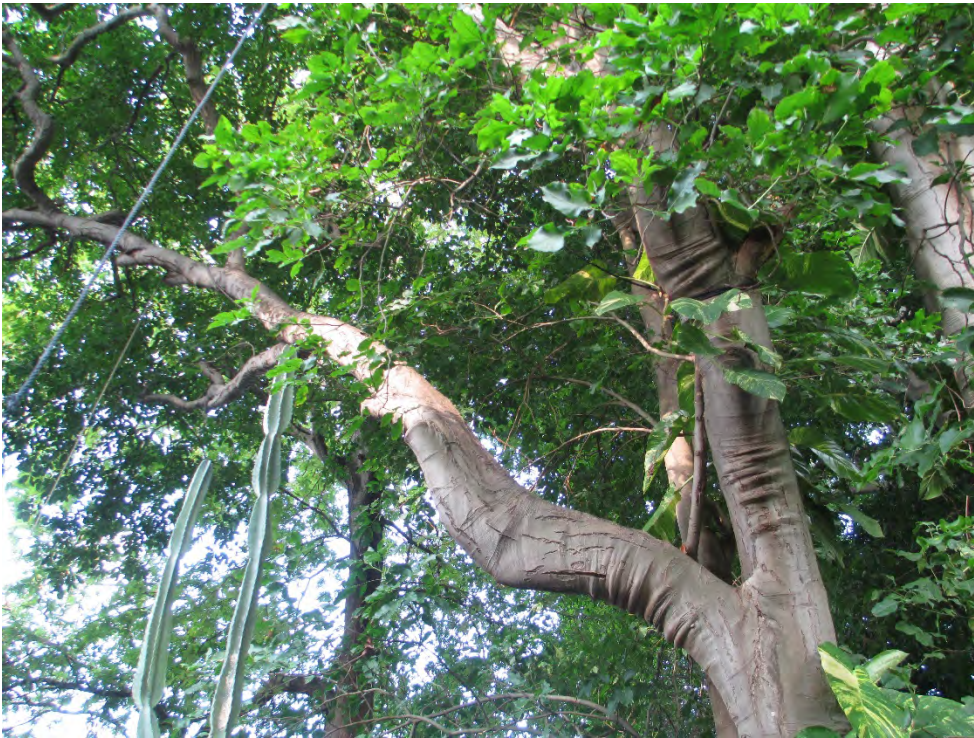
5. Tree Species: #34 Spanish Lime (*Melicoccus bijugatus*)

Condition: 50% (fair to poor, included bark, large crack)

#34 Spanish Lime, approx diameter 15 1/4", located in extreme rear yard south southwest immediately adjacent to property line. Spanish Lime tree is in poor condition. Vertical crack developing at first branch union with included bark. Southern branch is larger in diameter than trunk hence increased tension on branch union. Southern branch extends over adjacent commercial property. Recommend removal.

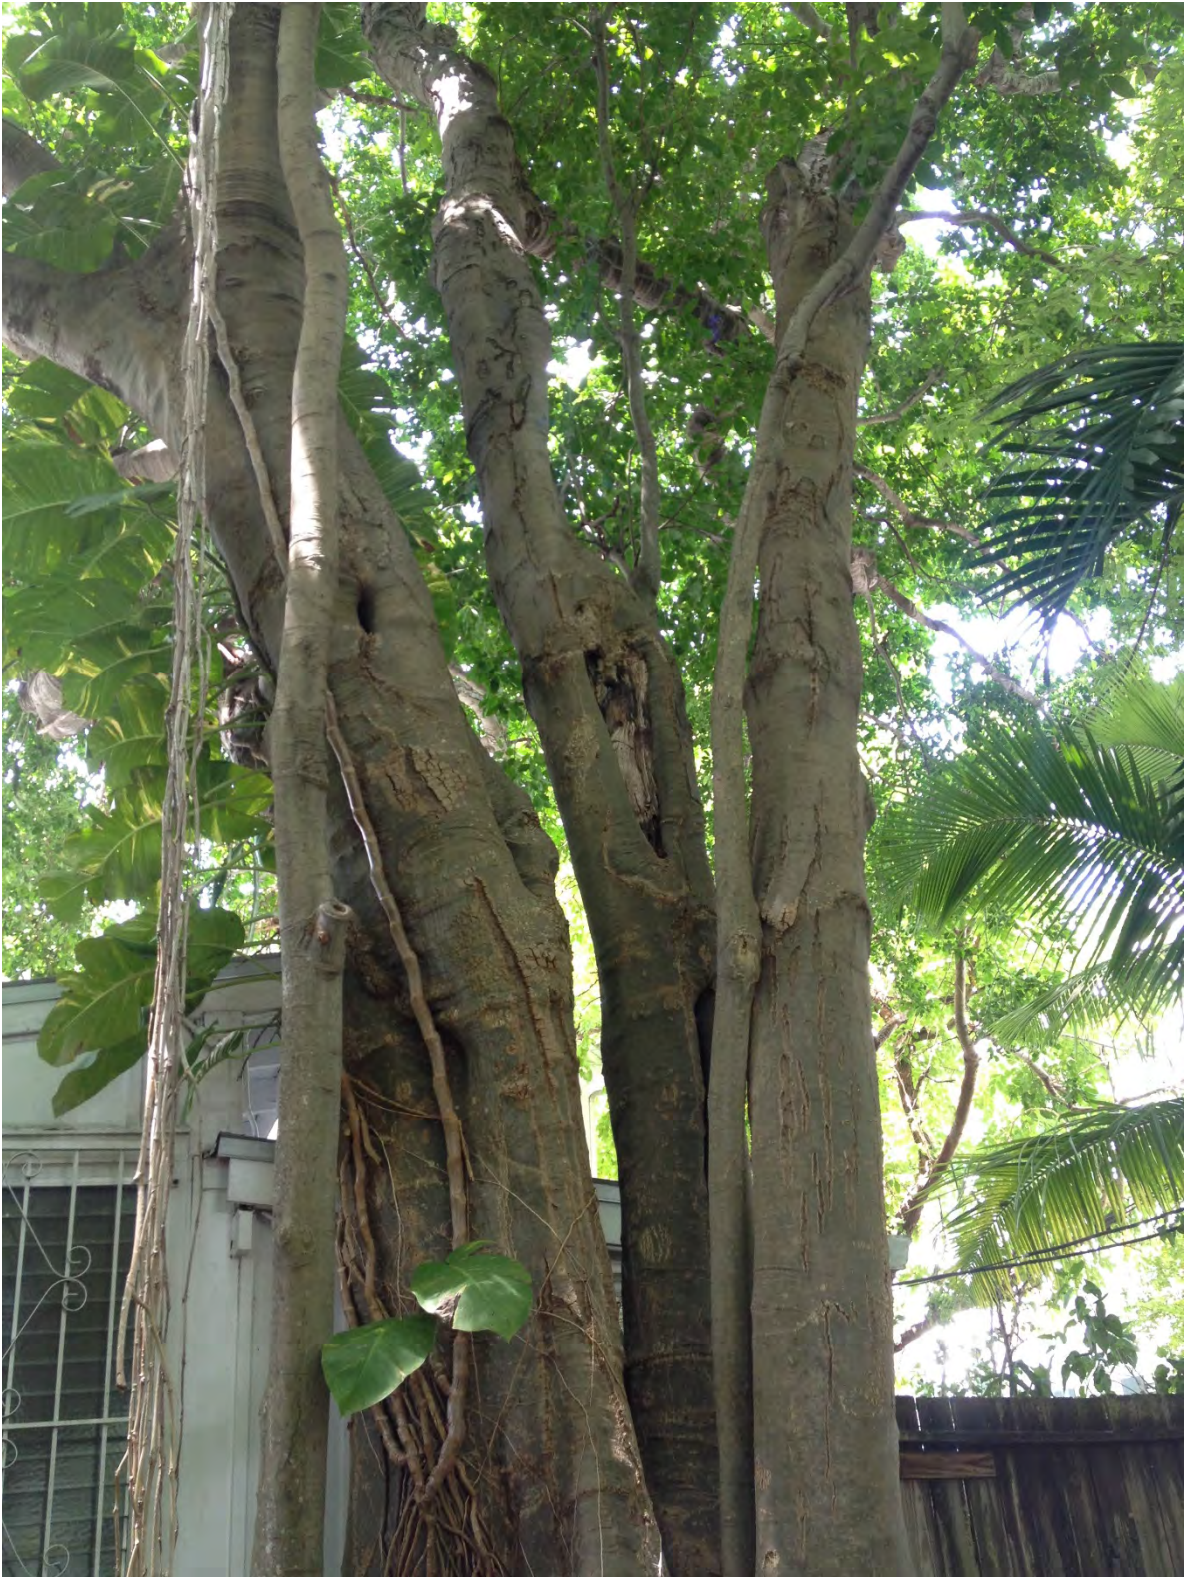
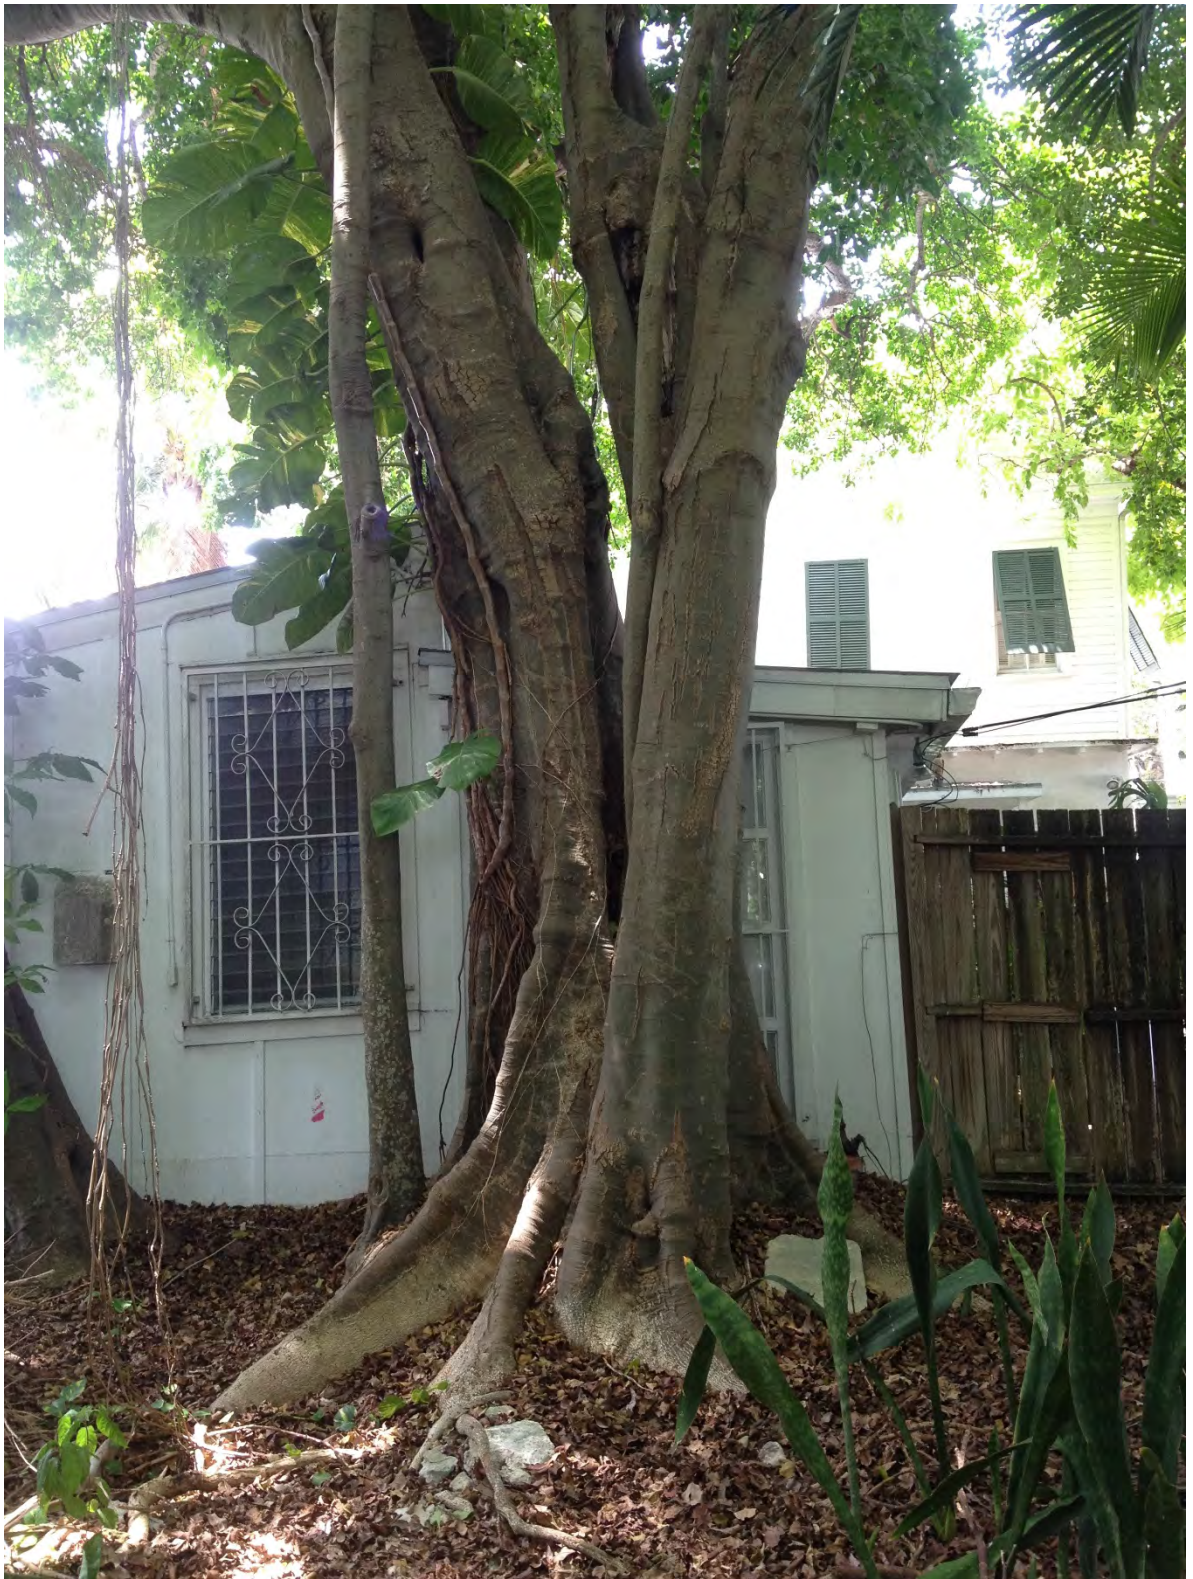
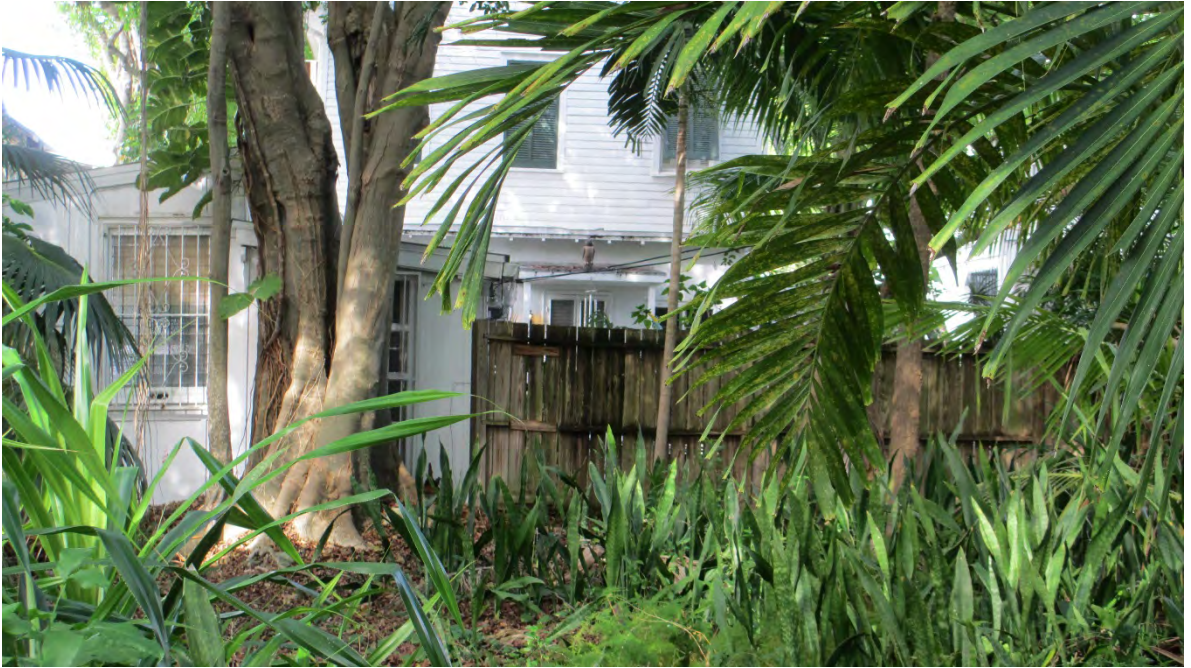
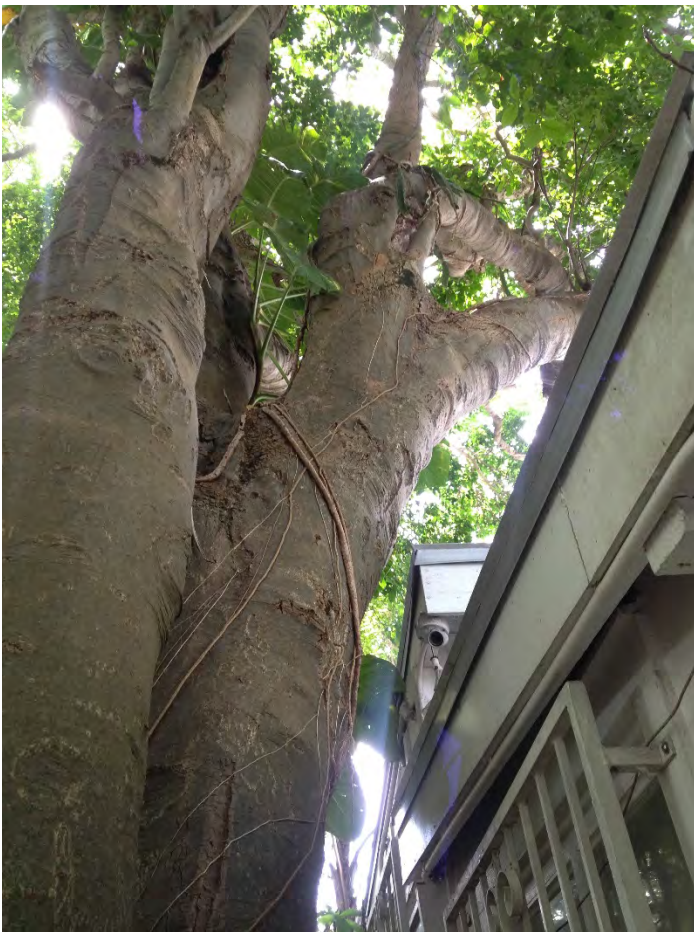
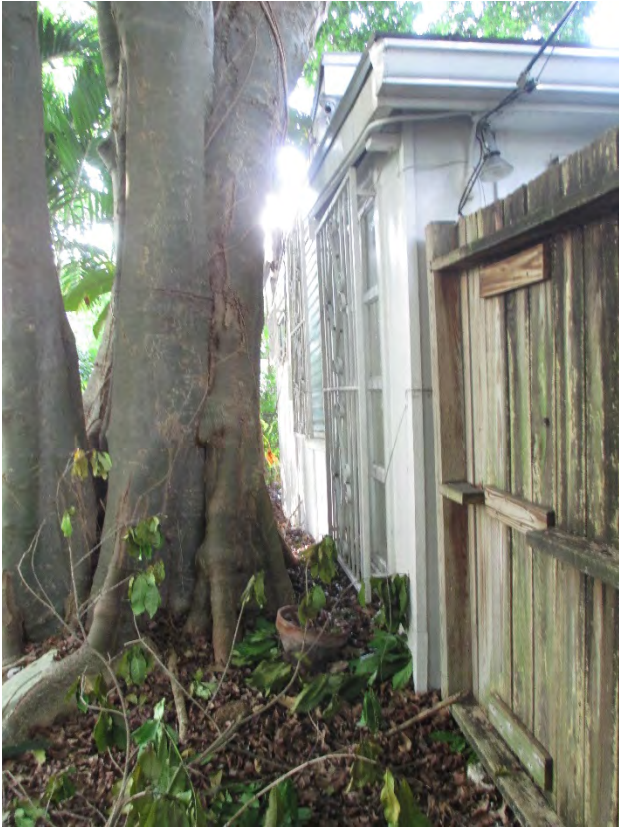
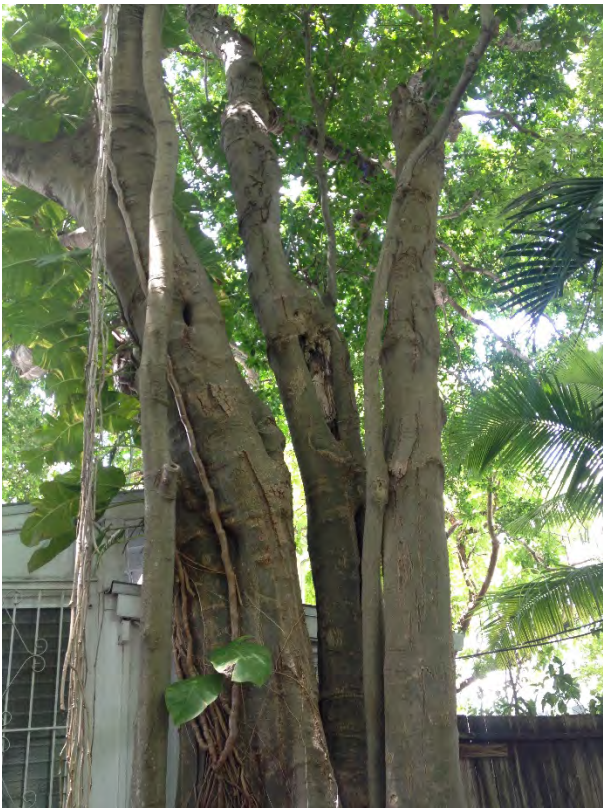
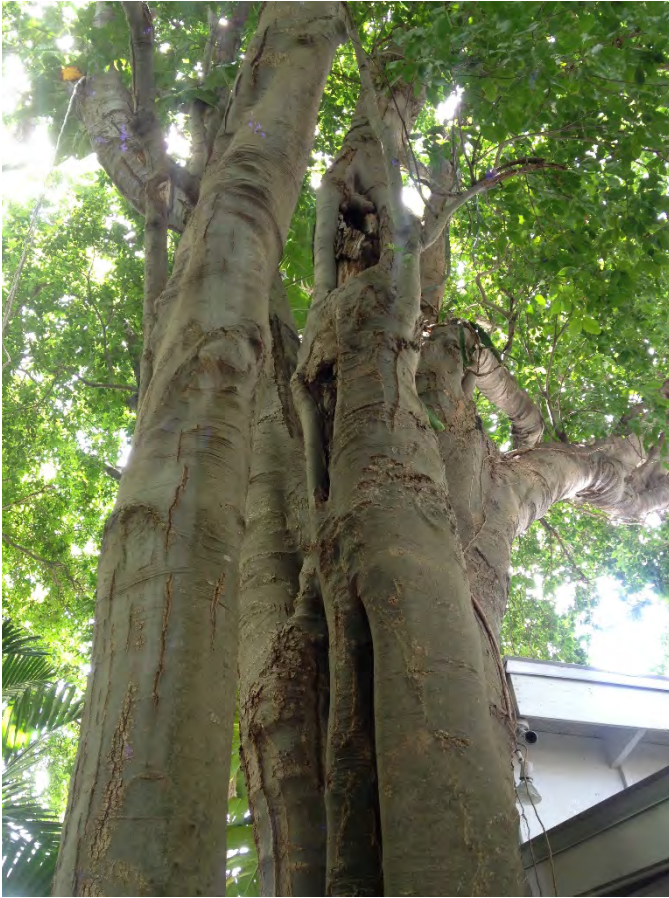
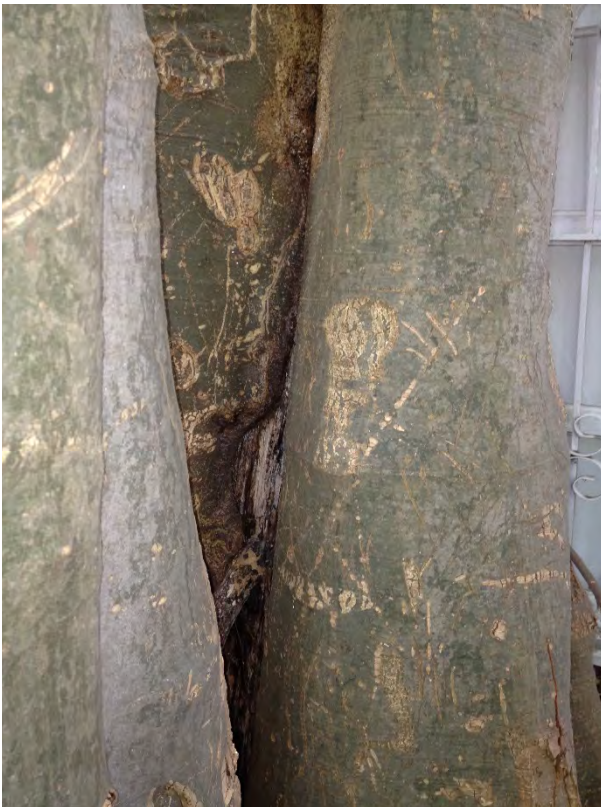
6. Tree Species: #41, #42, #43 Spanish Lime (*Melicoccus bijugatus*)

Location: 40% (impacting structure next door)

Condition: 40% (several trunk in one root ball that have grown together, decay, poor structure)

#41, 42 and 43 (3 trunks, 1 rootball) Spanish Lime trees are at west rear yard immediately adjacent to neighboring building. Appears trees are lifting building. They are growing in a cluster in such close proximity to one another that their trunks are competing for space. All have varying degrees of decay from moderate to severe. They are individually and collectively in poor health. Recommend removal.

Spanish Lime tree #41 is the northwestern and smallest tree with a diameter of approx 15 1/2". Tree decayed from base of trunk into codominant rip away to top of trunk in canopy. Appears to be seedling from larger Spanish Lime tree in same cluster. Poor condition.

Spanish Lime tree #42 is the northeast trunk in cluster with approx diameter of 17 1/2". Trunk is resting on tree #41 and #43. Trunk flare and roots are void on west side of tree. Codominant rip way at top of trunk. Appears to be seedling from larger Spanish Lime tree in same cluster.

Spanish Lime tree #43 is the southern and largest trunk in cluster with approx diameter of 32 ". Tree is leaning south with trunk flare and root area reduced due to seedling growth of trees #41 and 42. Codominant branch to west over neighboring building is included approx 2' rendering a poor branch union.

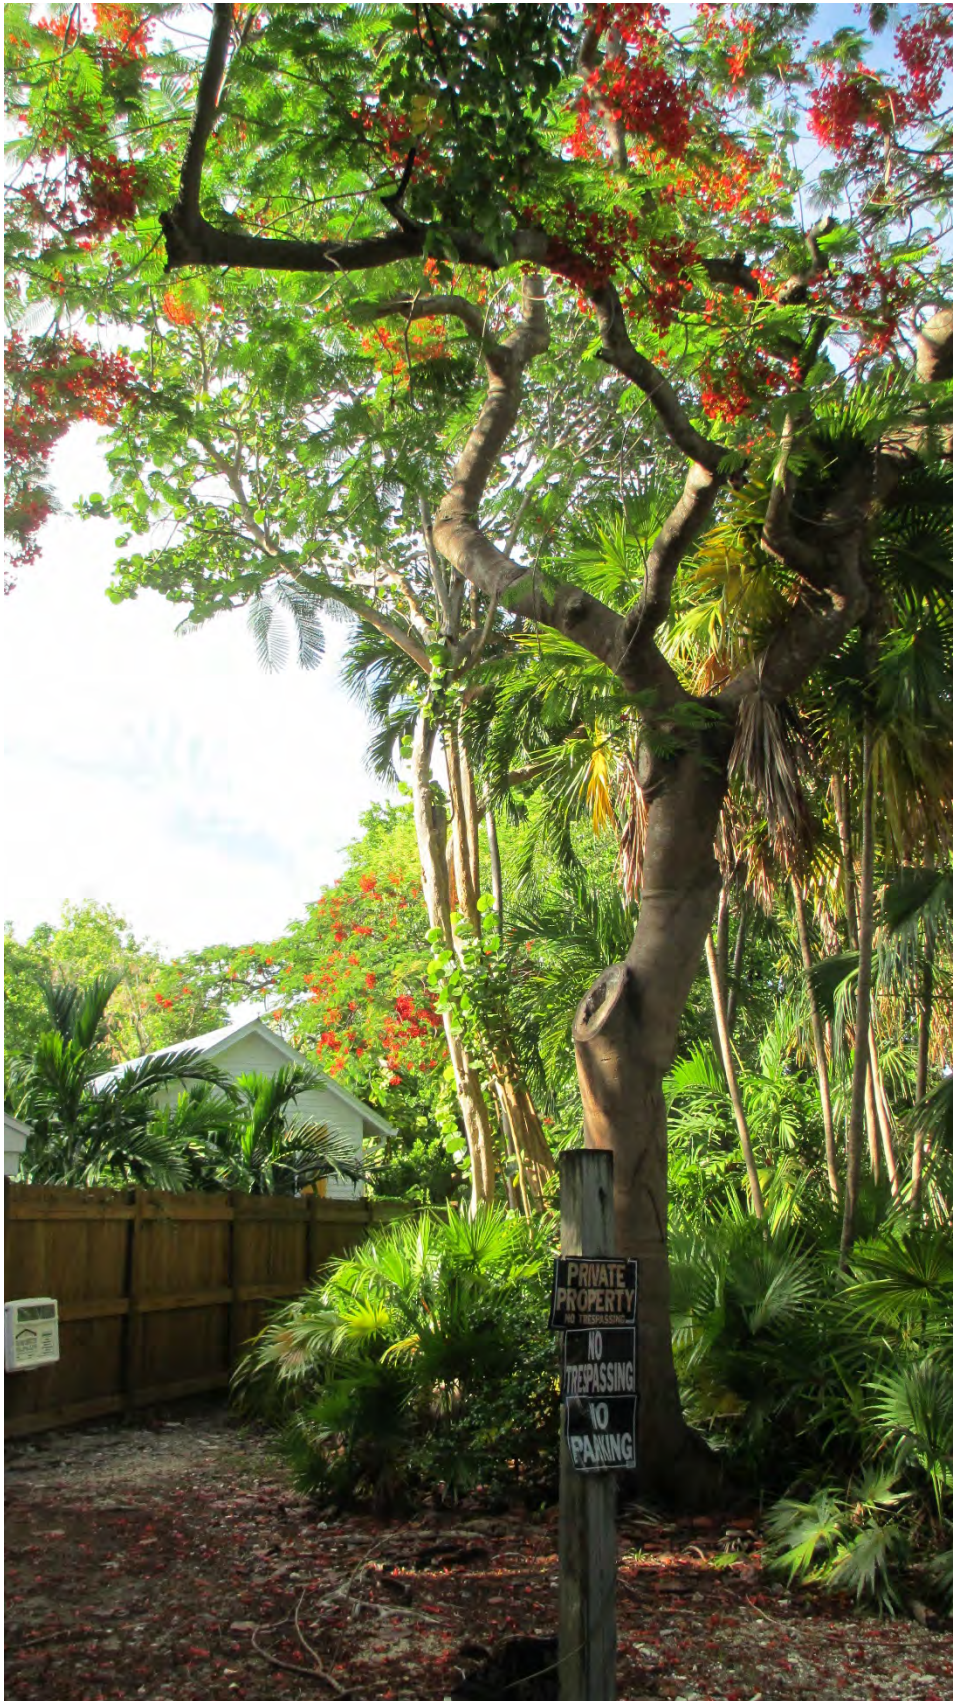
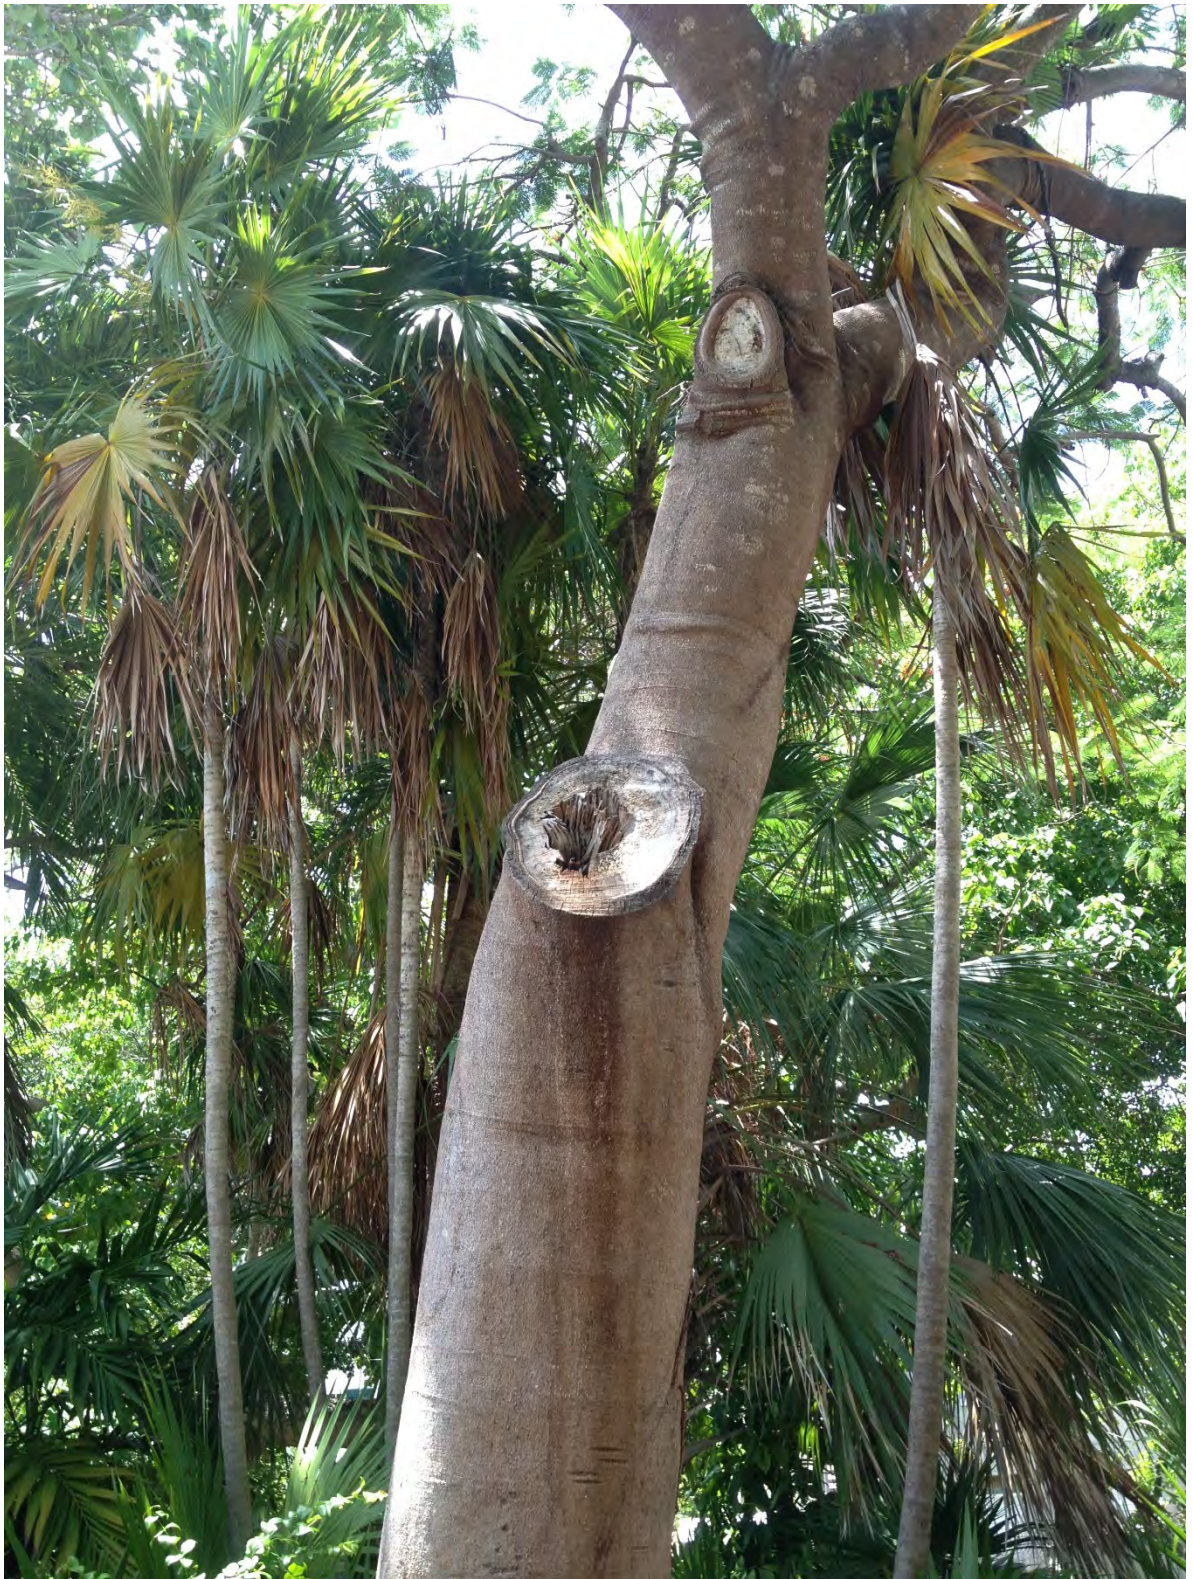
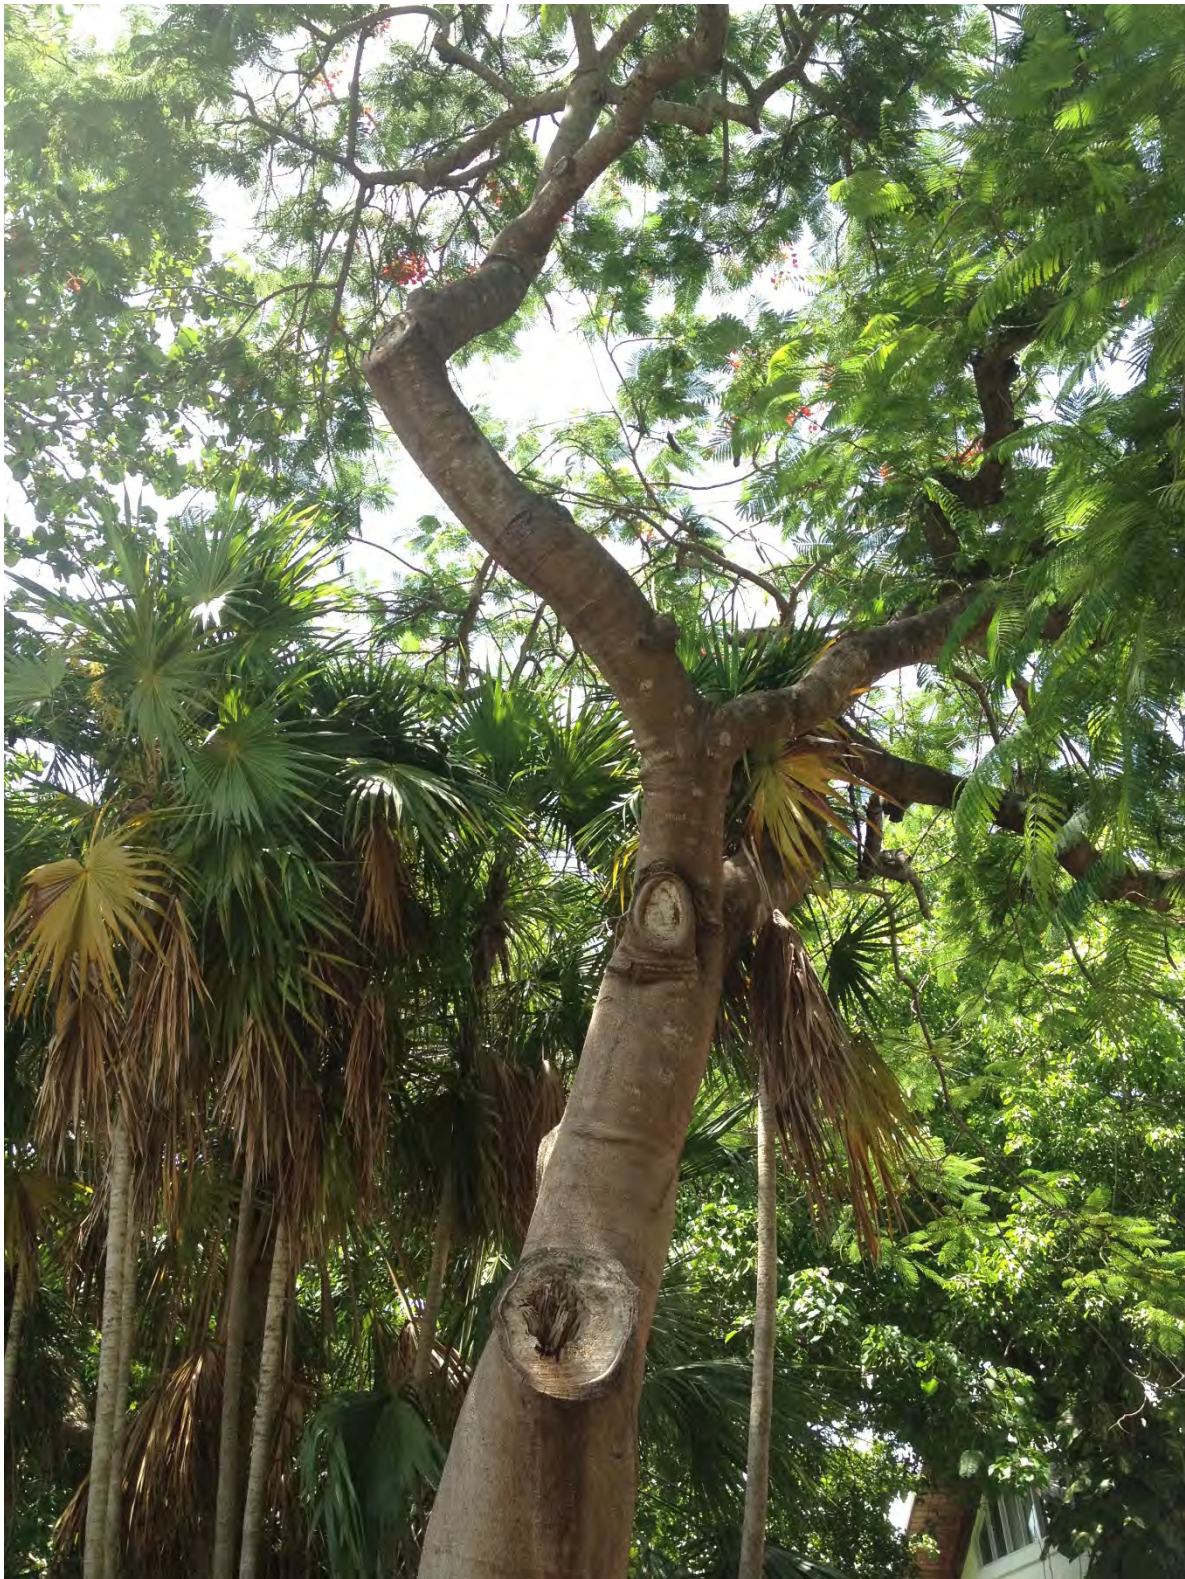
7. Tree Species: #3 Royal Poinciana (Delonix regia)

Condition: 50% (fair, old, poor cuts with decay)

#3 Poinciana, diameter approx 19 1/4", located in rear yard northeast side of property at easement to neighbor gate. Poinciana has had prior poor pruning practices on major branches; flush cuts past branch collars. All cuts currently demonstrating decay. Poinciana trees have poor compartmentalization. This type of pruning will cause decay throughout branches and into trunk. Recommend removal.
