# STAFF REPORT

**RE: 616 Eaton Street (permit application #7059 )**

FROM: Karen DeMaria, Urban Forestry Manager,  
City of Key West

An application was received for the removal of **(1) Spanish Lime tree and (1) Sandbox tree**. A site inspection was done on July 21, 2014 and documented the following:

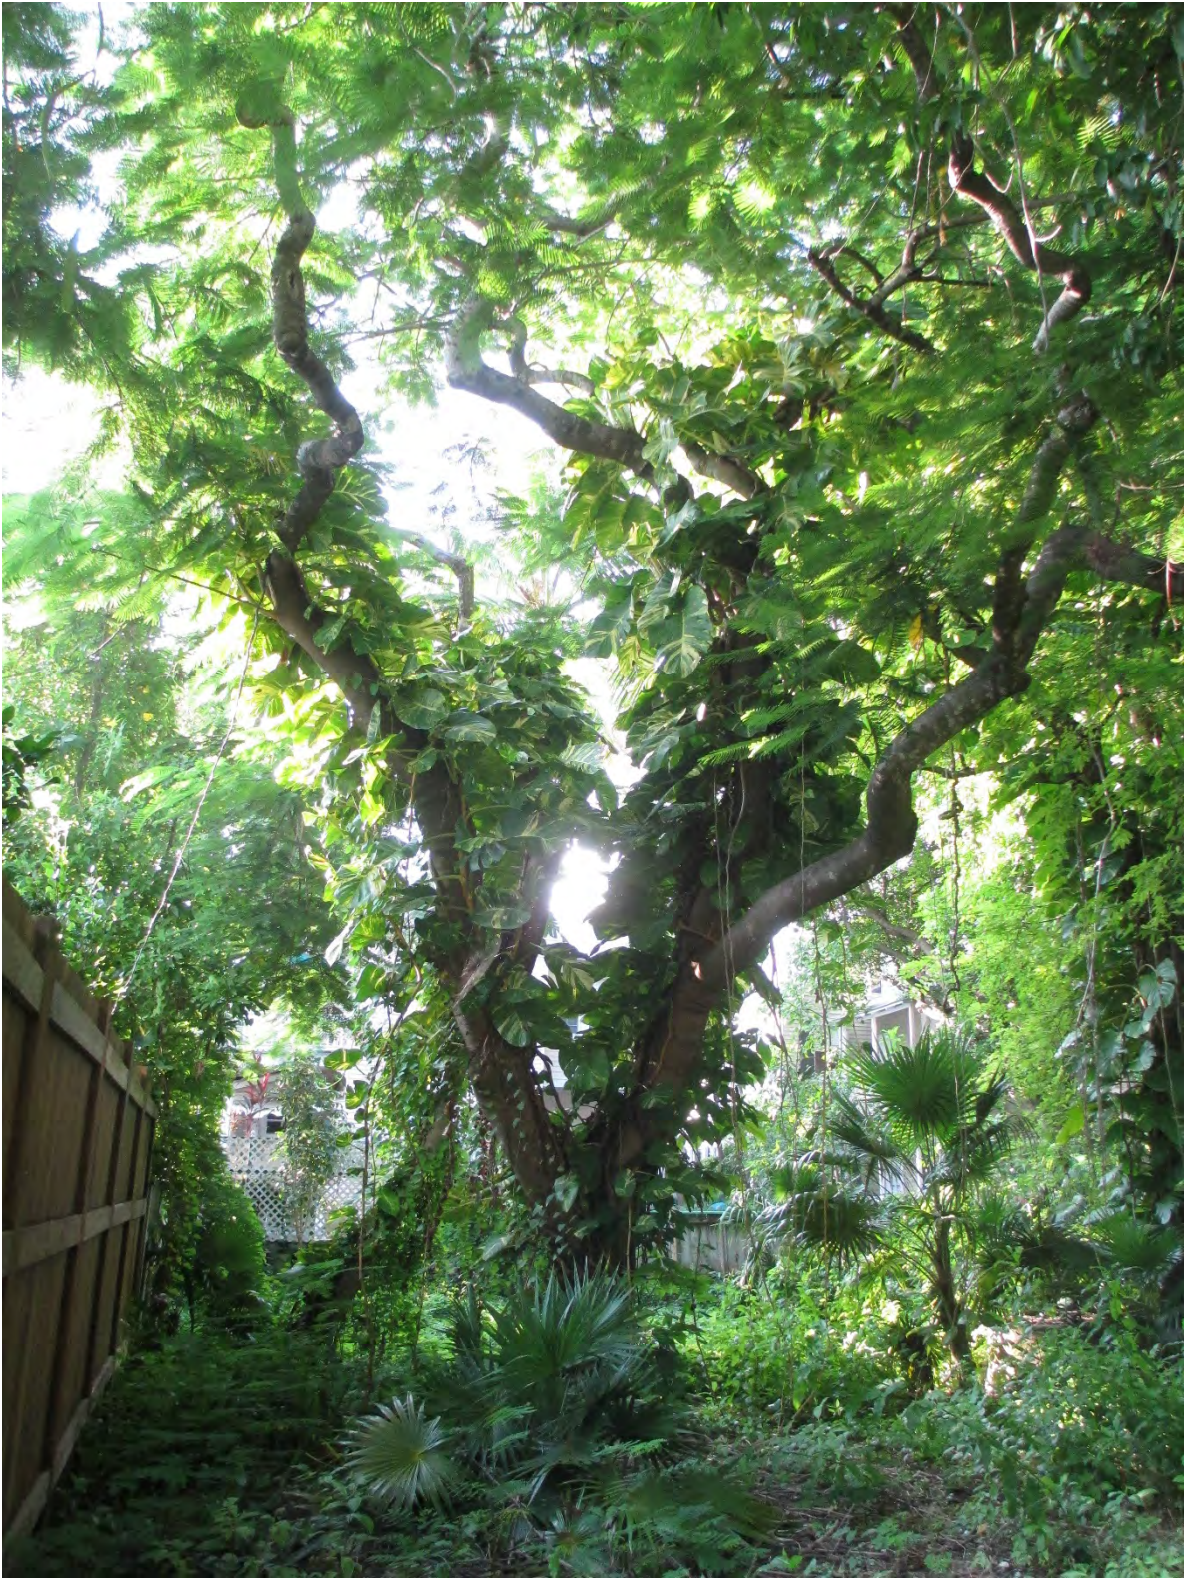
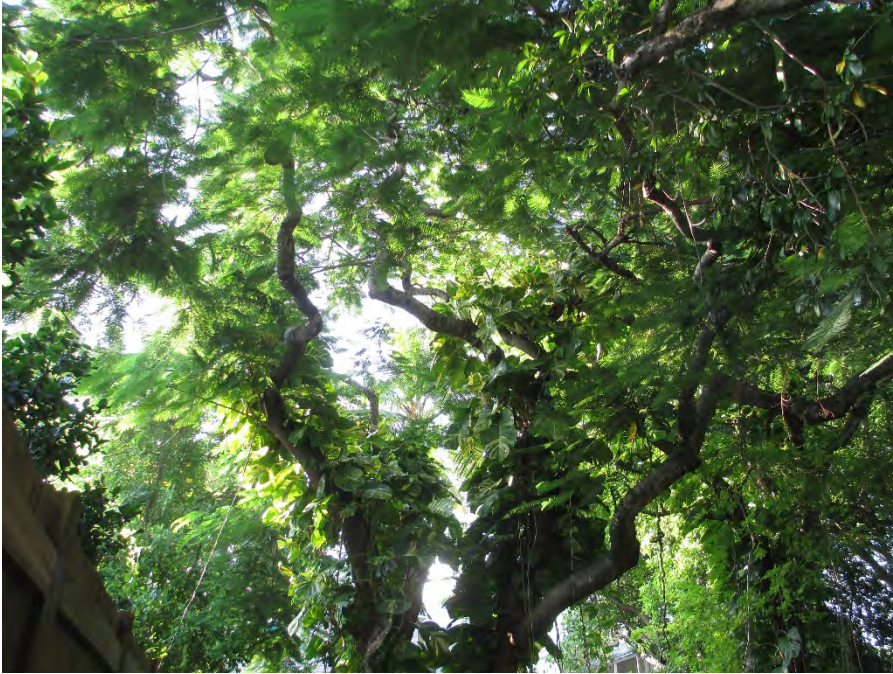
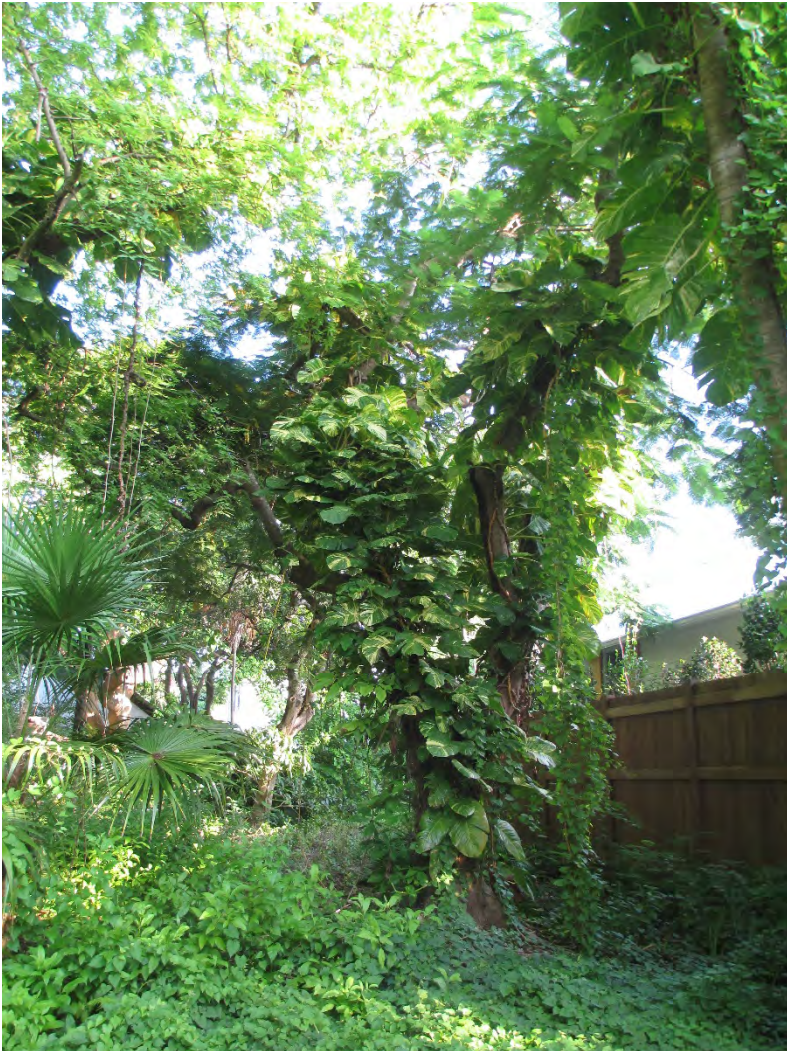
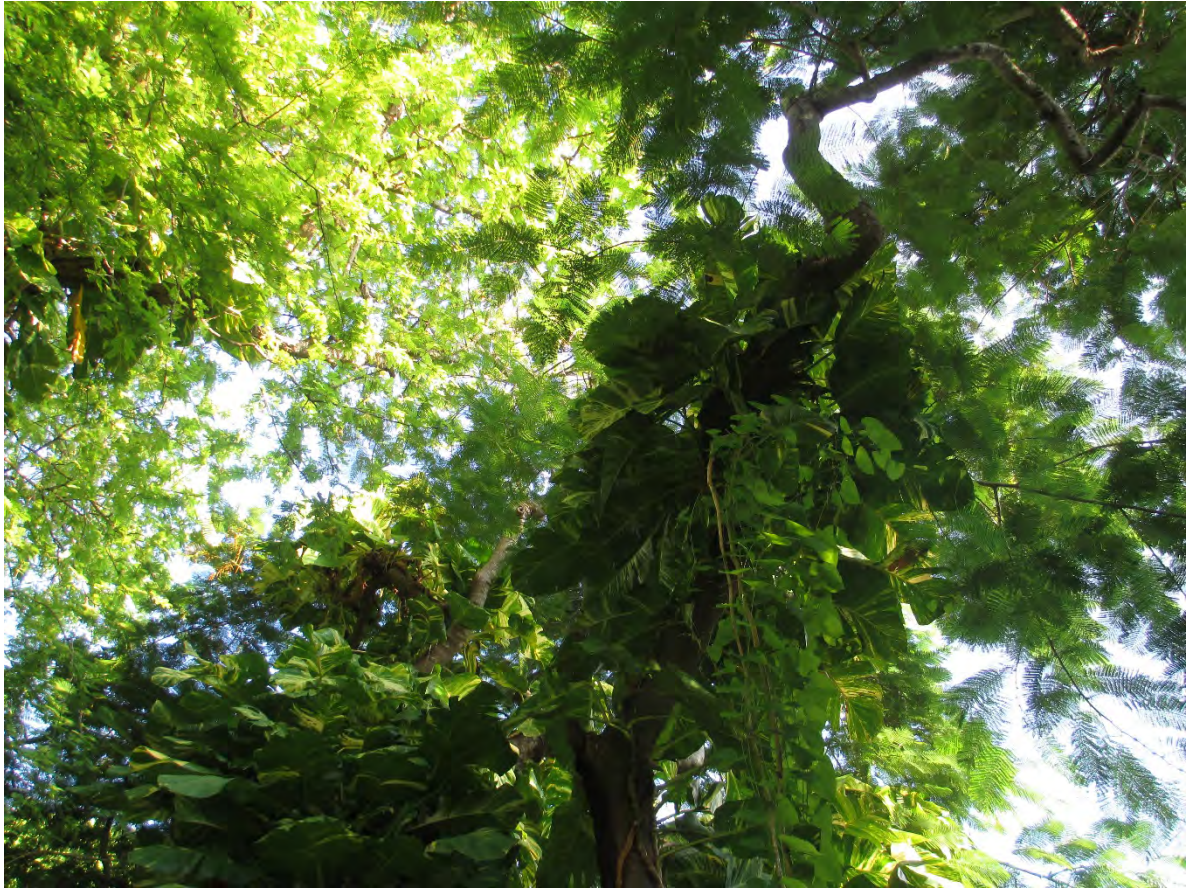
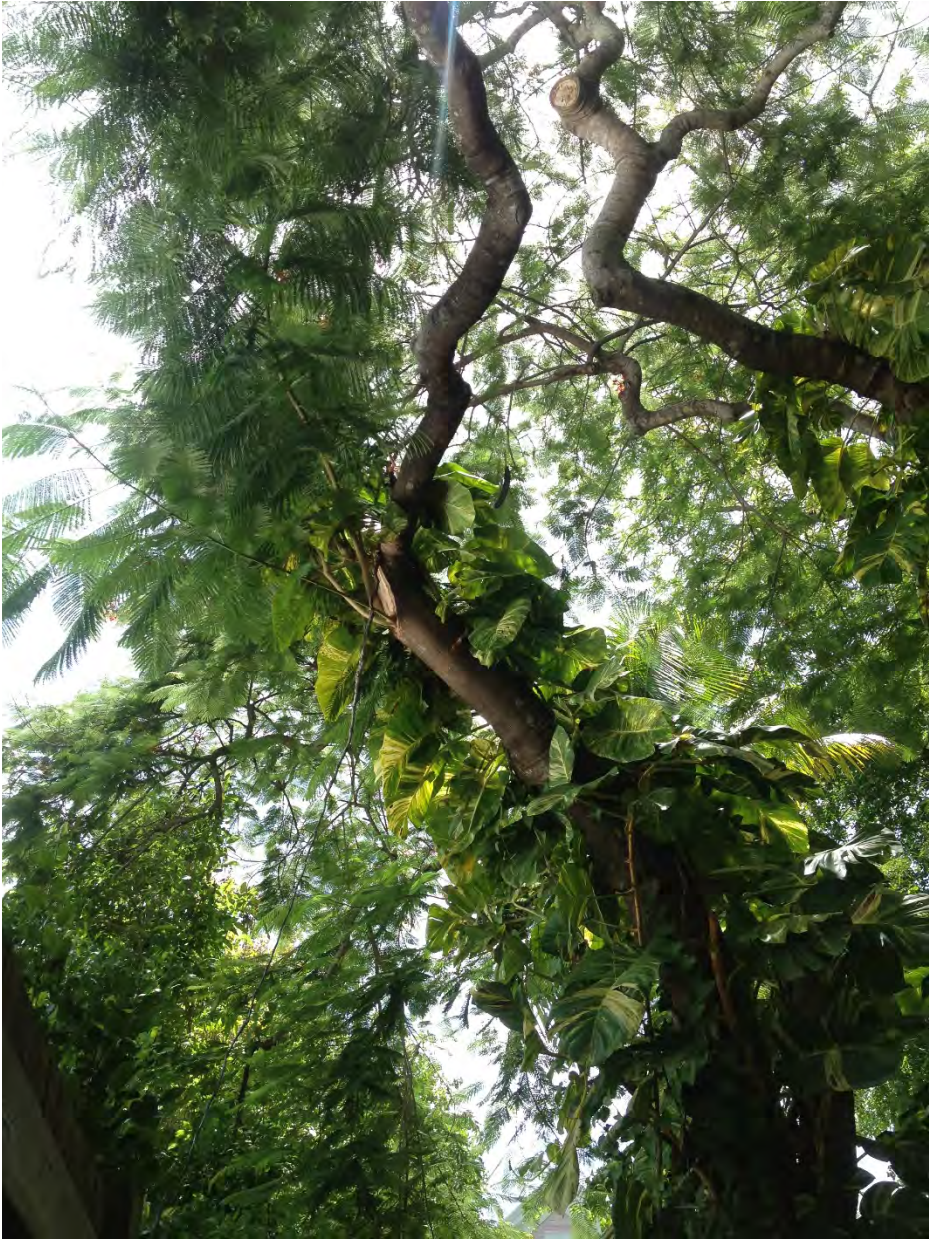
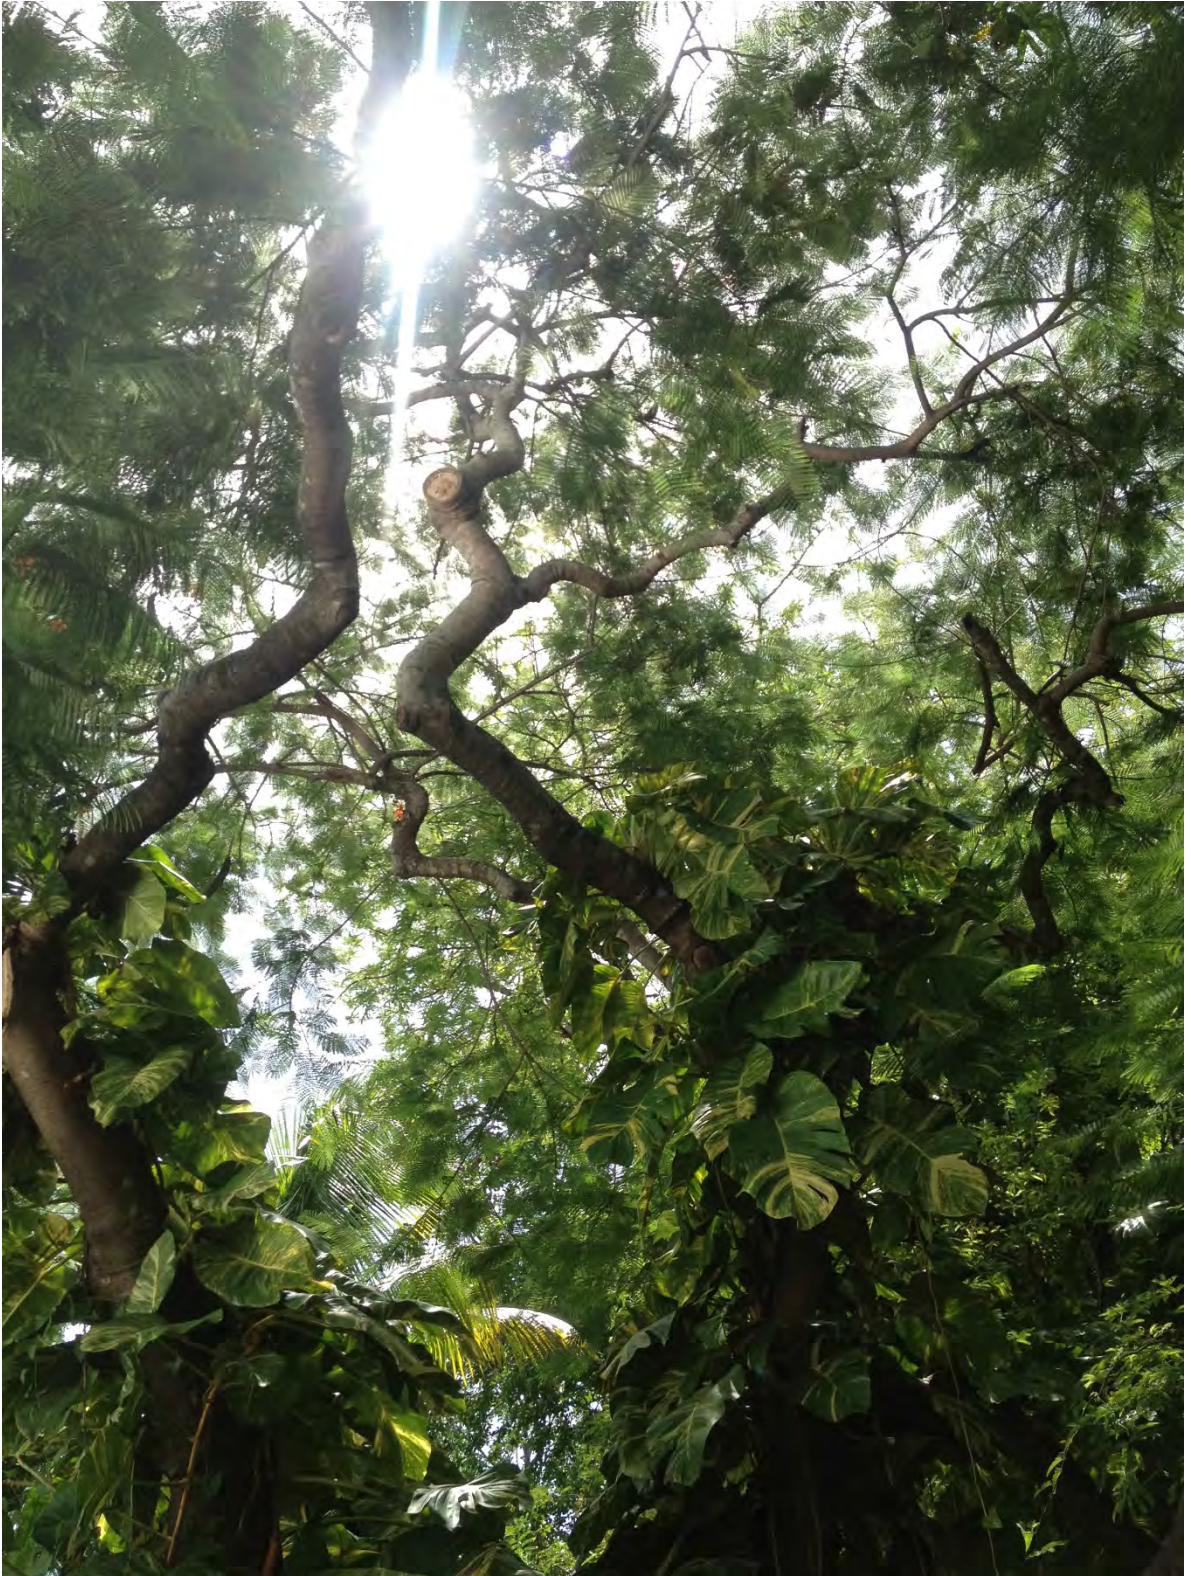
8. Tree Species: # 22 Royal Poinciana (Delonix regia)

Condition: 60% (fair)

#22 Poinciana tree, approx 21 1/4" diameter, located in rear yard center east adjacent wooden fence. Tree condition is poor. Two main and only major branches have developed decay in branches due to prior pruning practices of flush cutting and overlifting. Recommend removal.

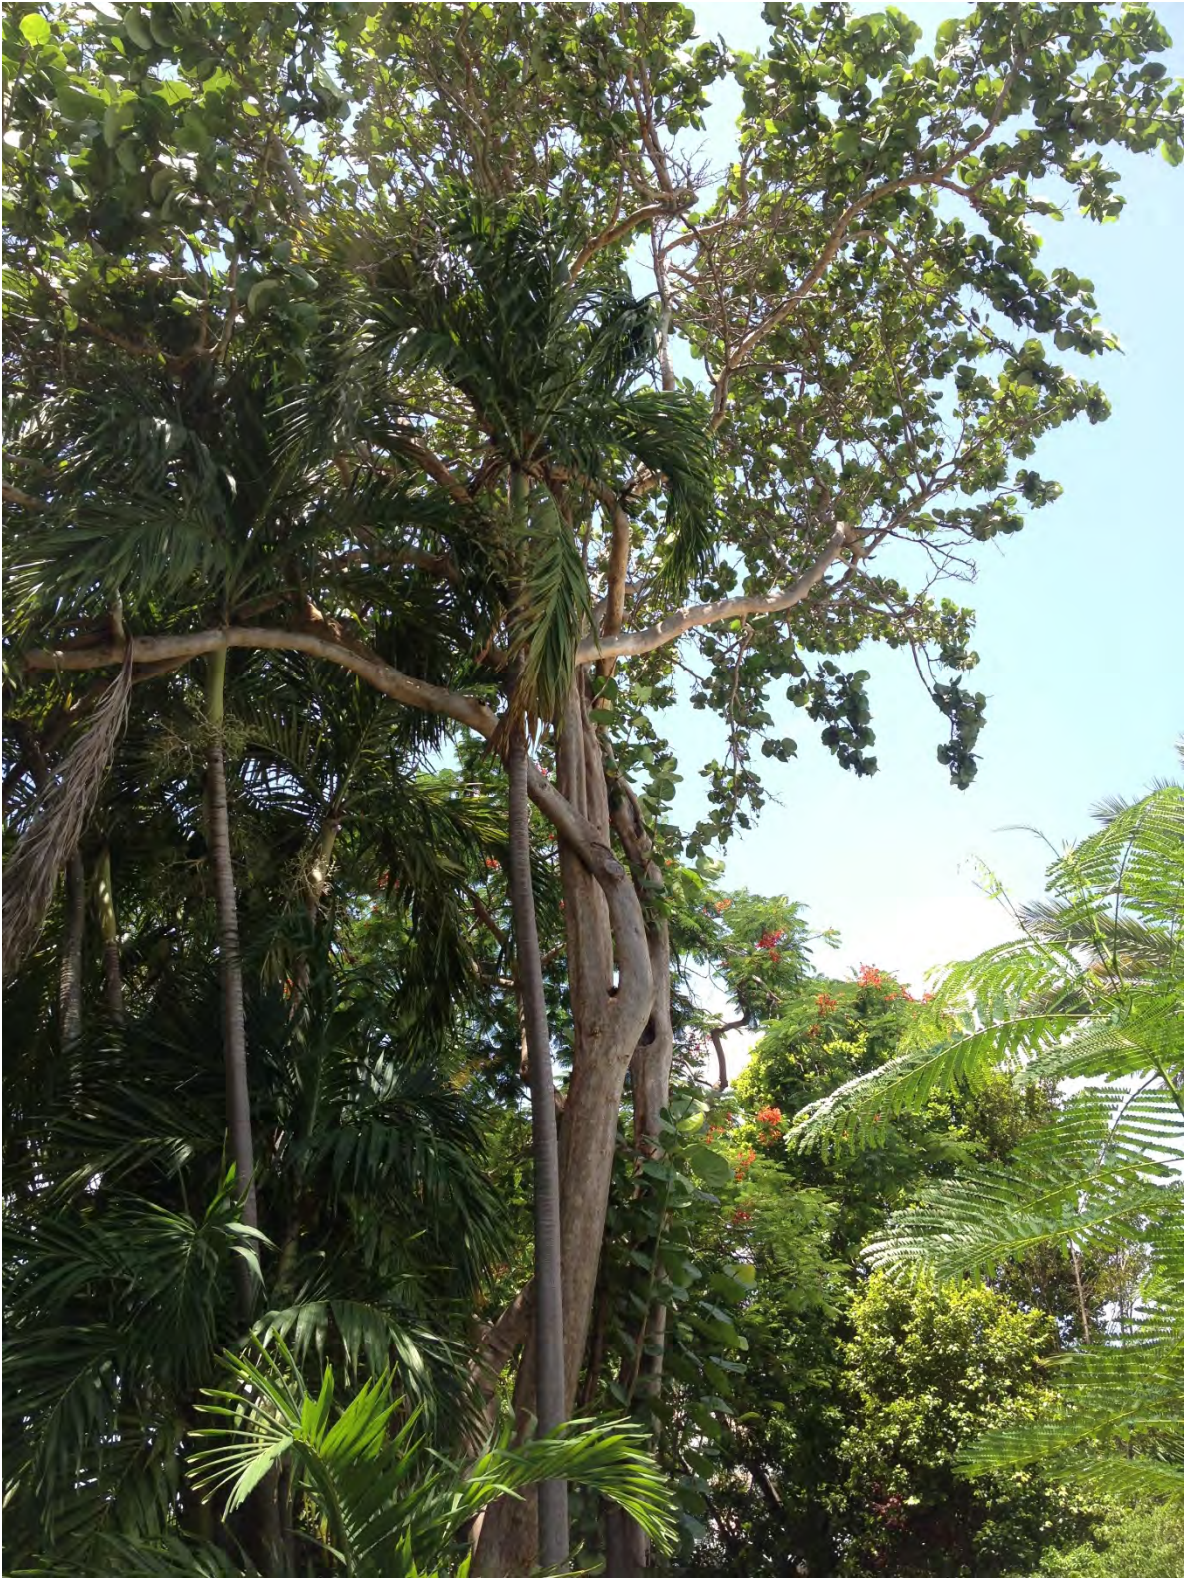
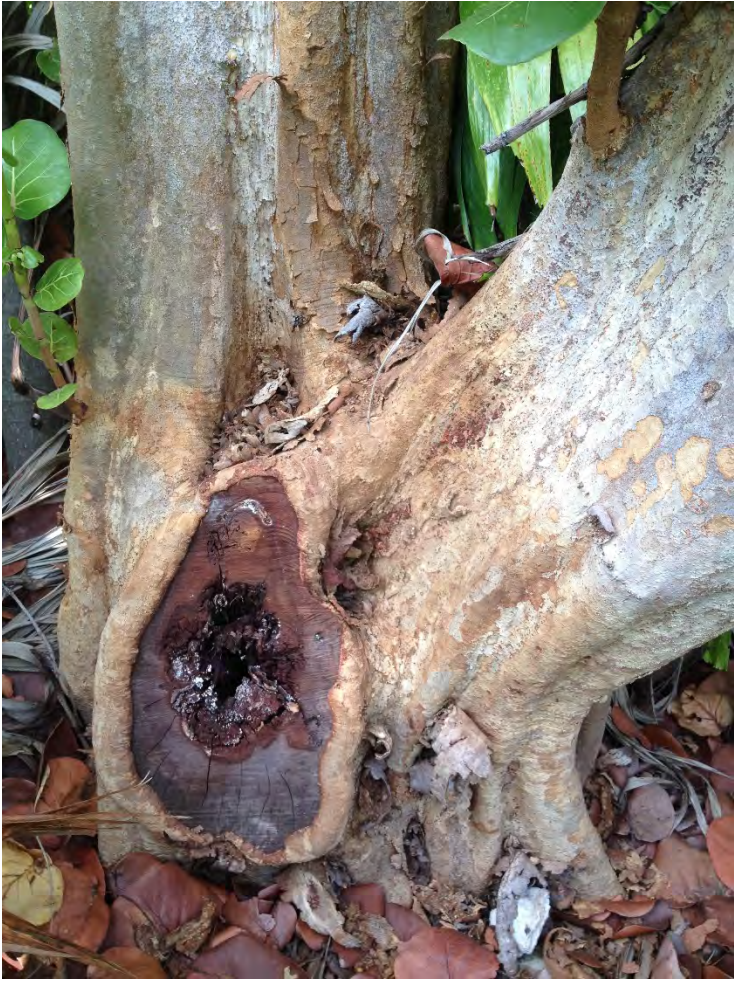
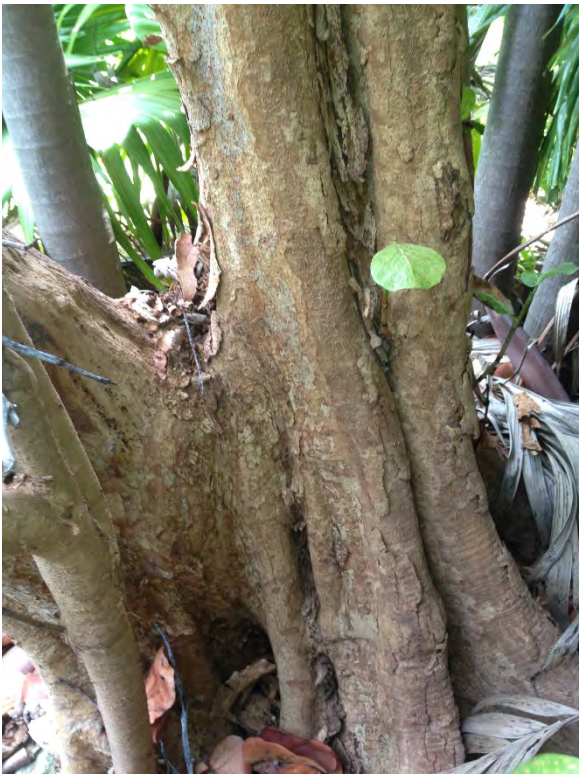
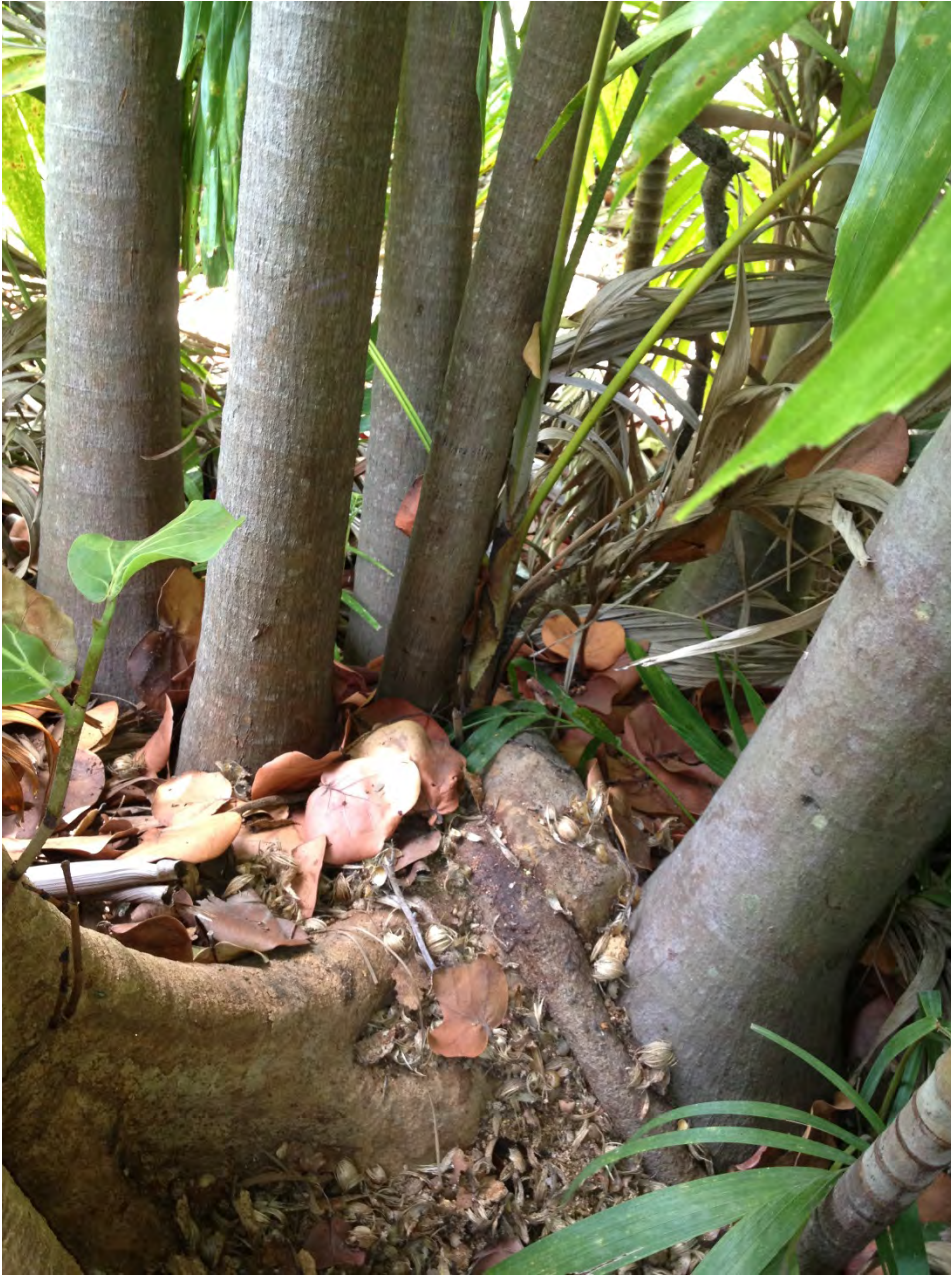
9. Tree Species: #4 Sea Grape (*Cocoloba uvifera*)

Condition: 40% (codominant trunks with lion tails structure, decay, prone to falling)

#4 Seagrape tree, codominant stems 11 1/2" and 13" approx diameter is located in rear yard at northeast side of property adjacent to neighbor. Tree is overlifted or Lions tailed with decay at bottom of trunk from past pruning. Generally Seagrape trees have high propensity of wind throw or blow over; this tree being overlifted the odds are very high for failure. Recommend removal.
