# STAFF REPORT

**RE: 616 Eaton Street (permit application #7059 )**

FROM: Karen DeMaria, Urban Forestry Manager,  
City of Key West

An application was received for the removal of **(1) Spanish Lime tree and (1) Sandbox tree**. A site inspection was done on July 21, 2014 and documented the following:

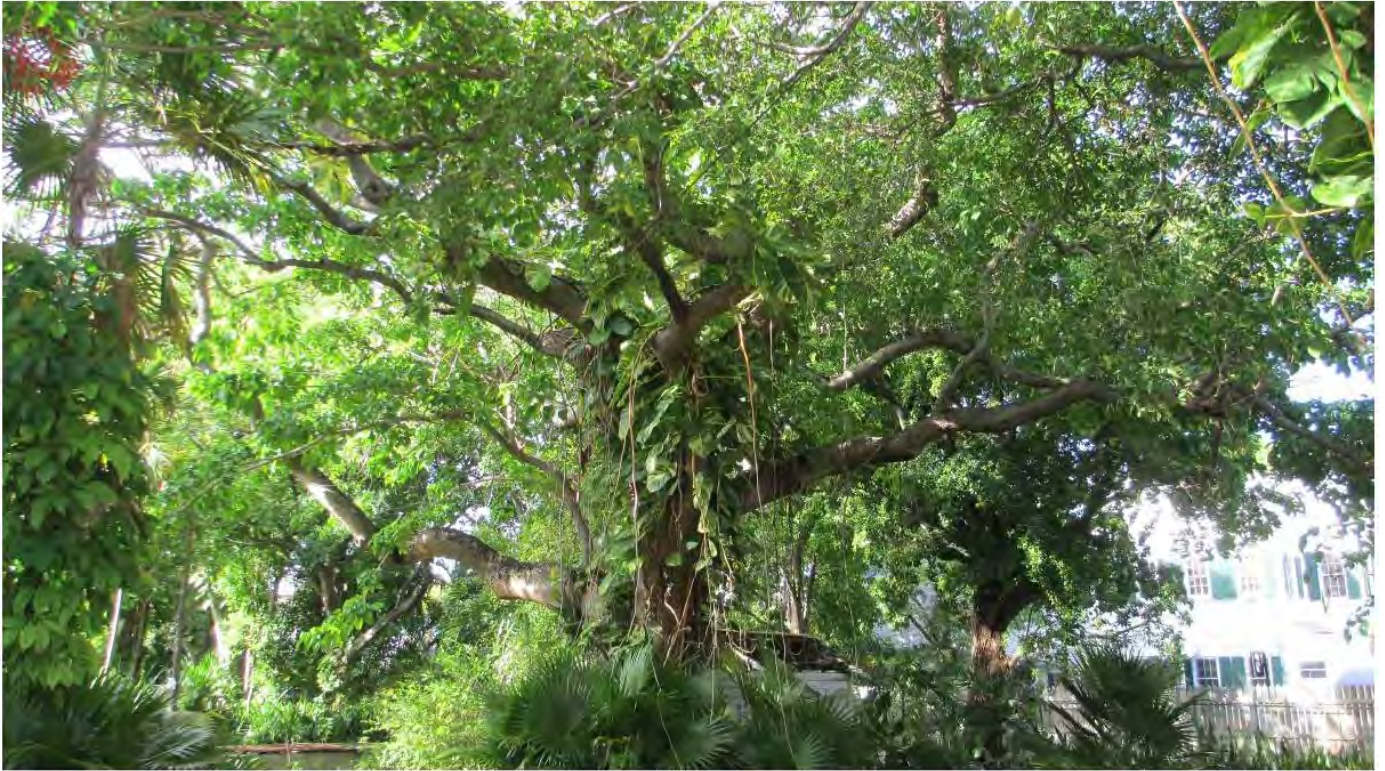
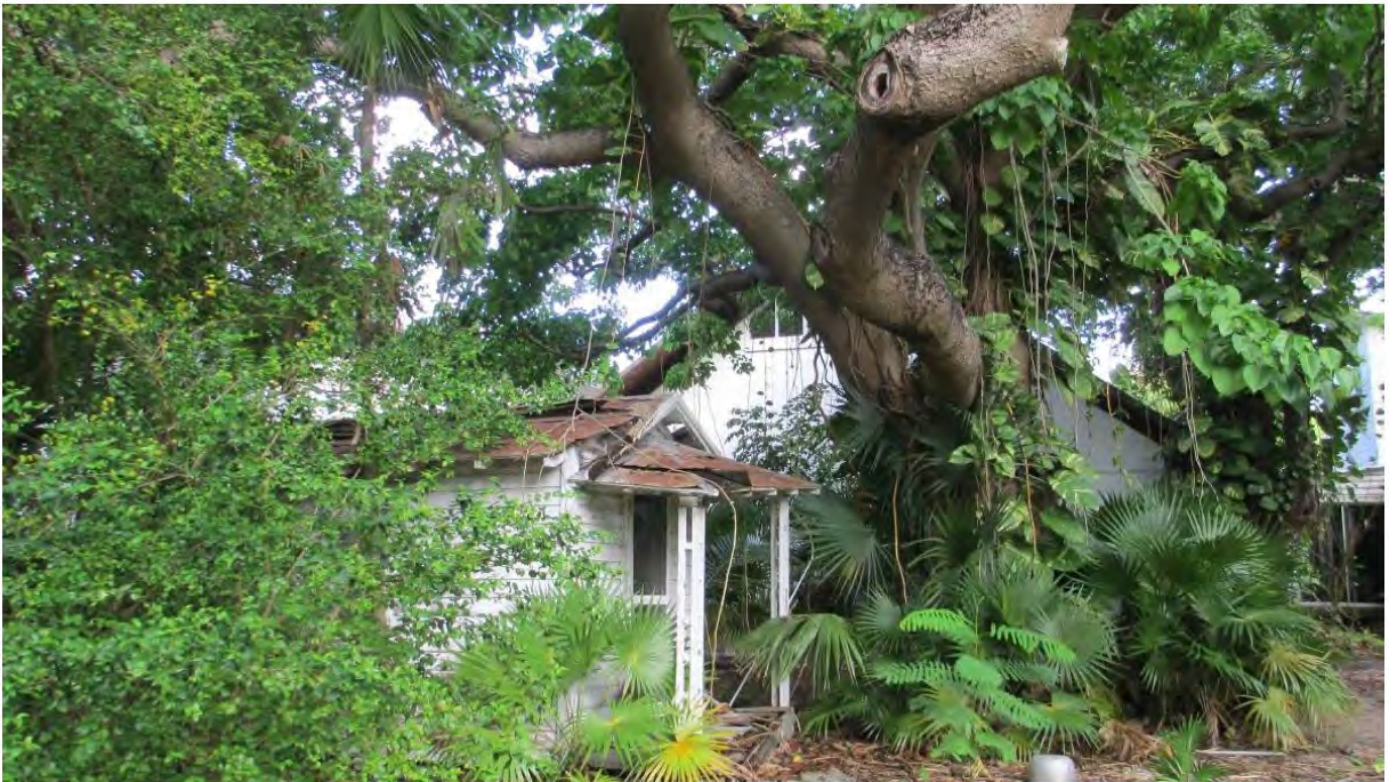
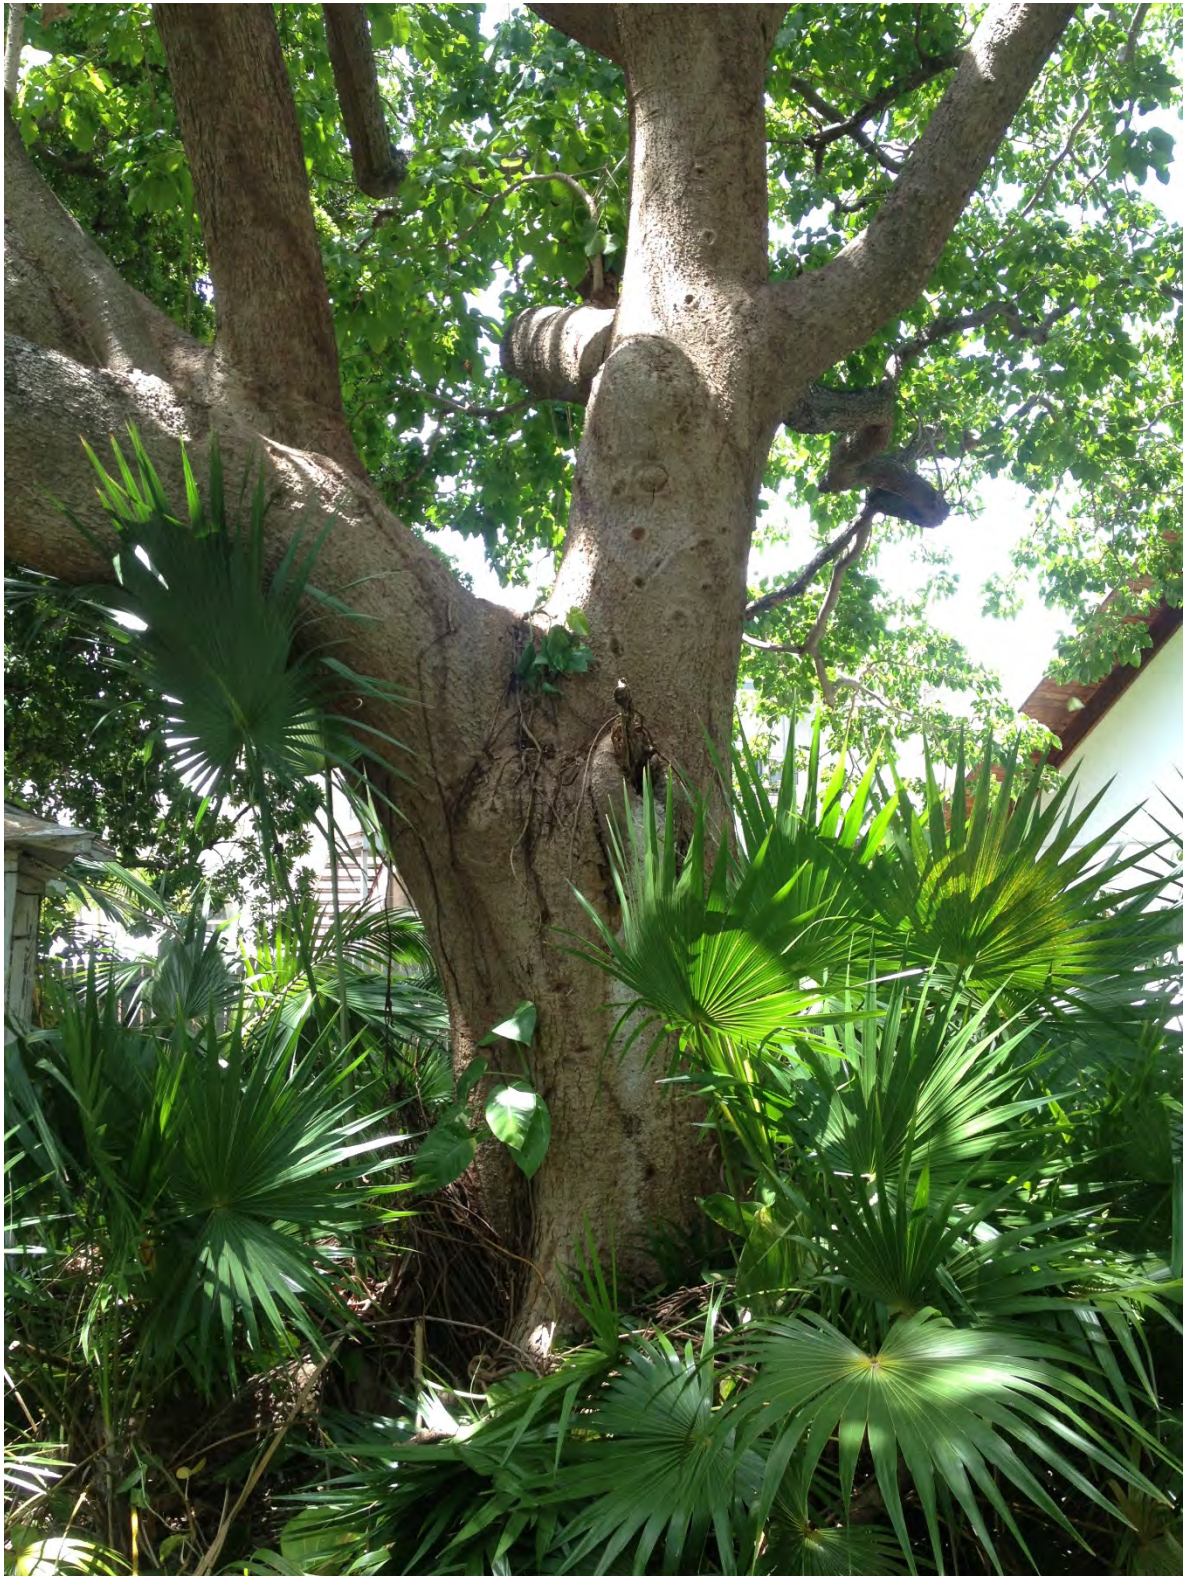
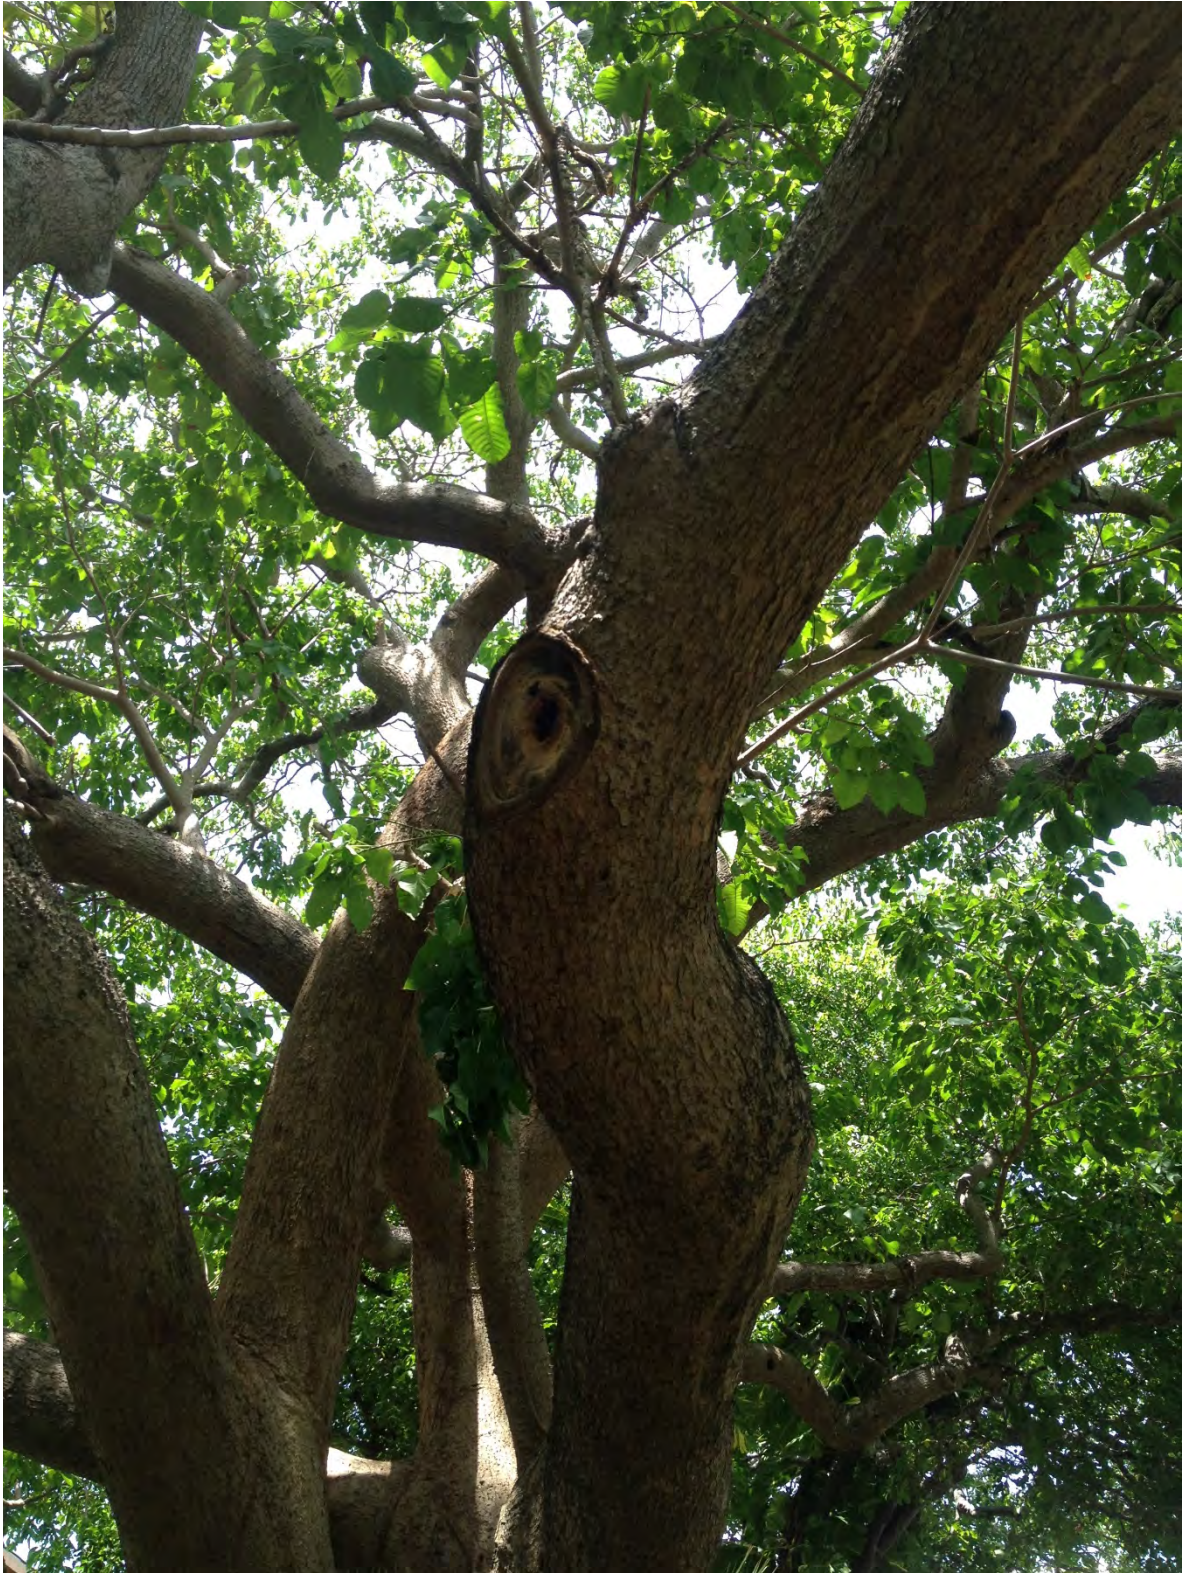
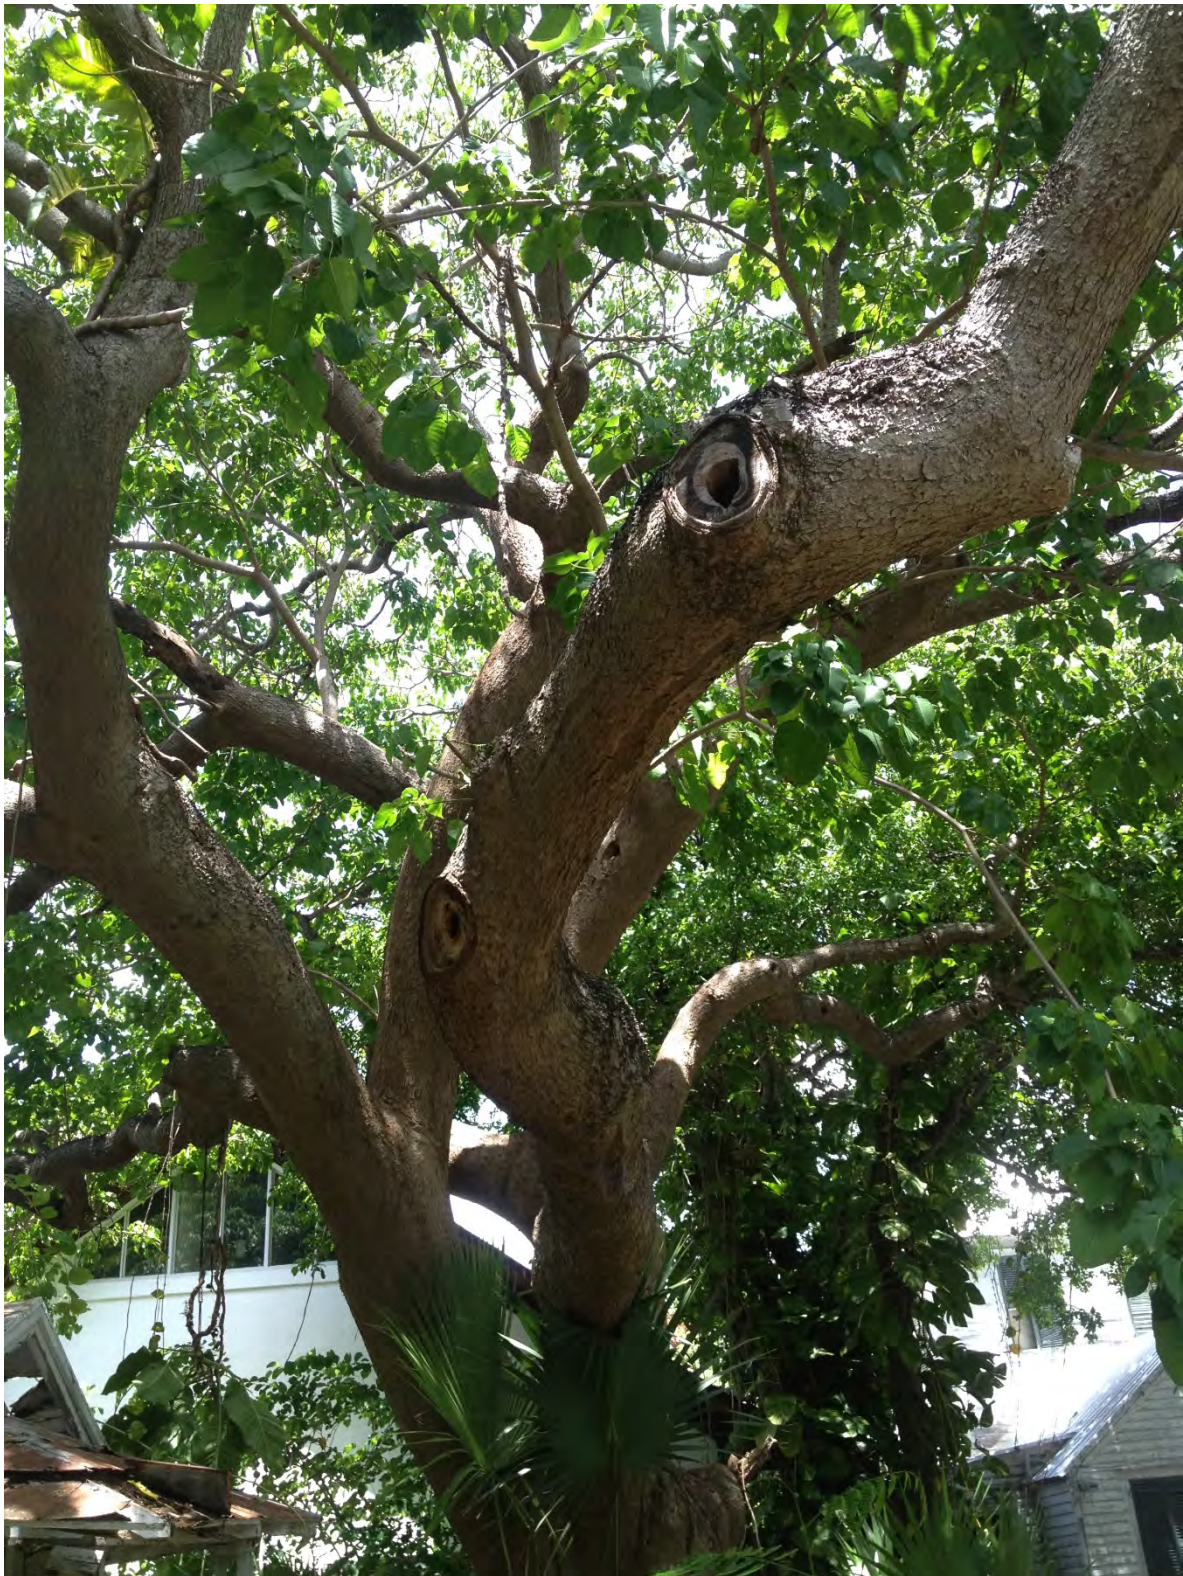
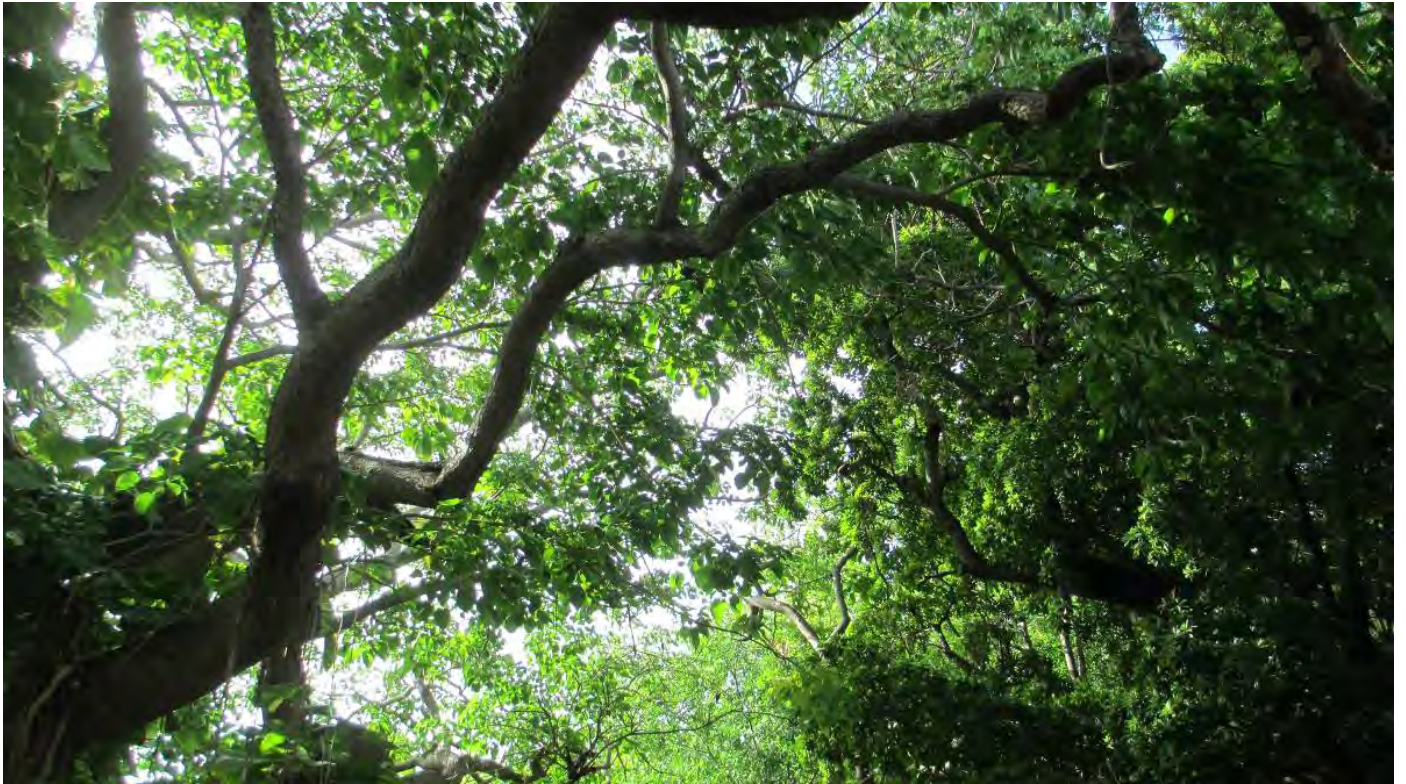
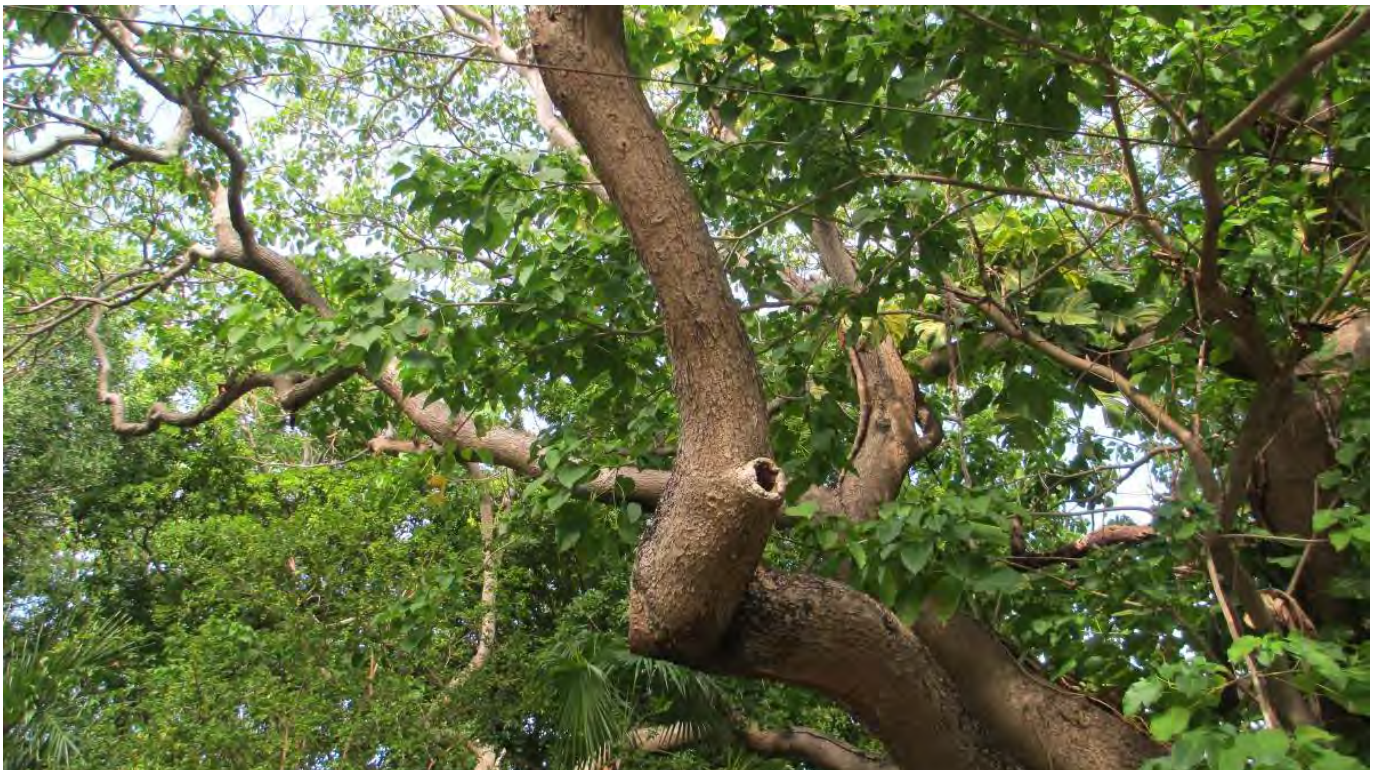
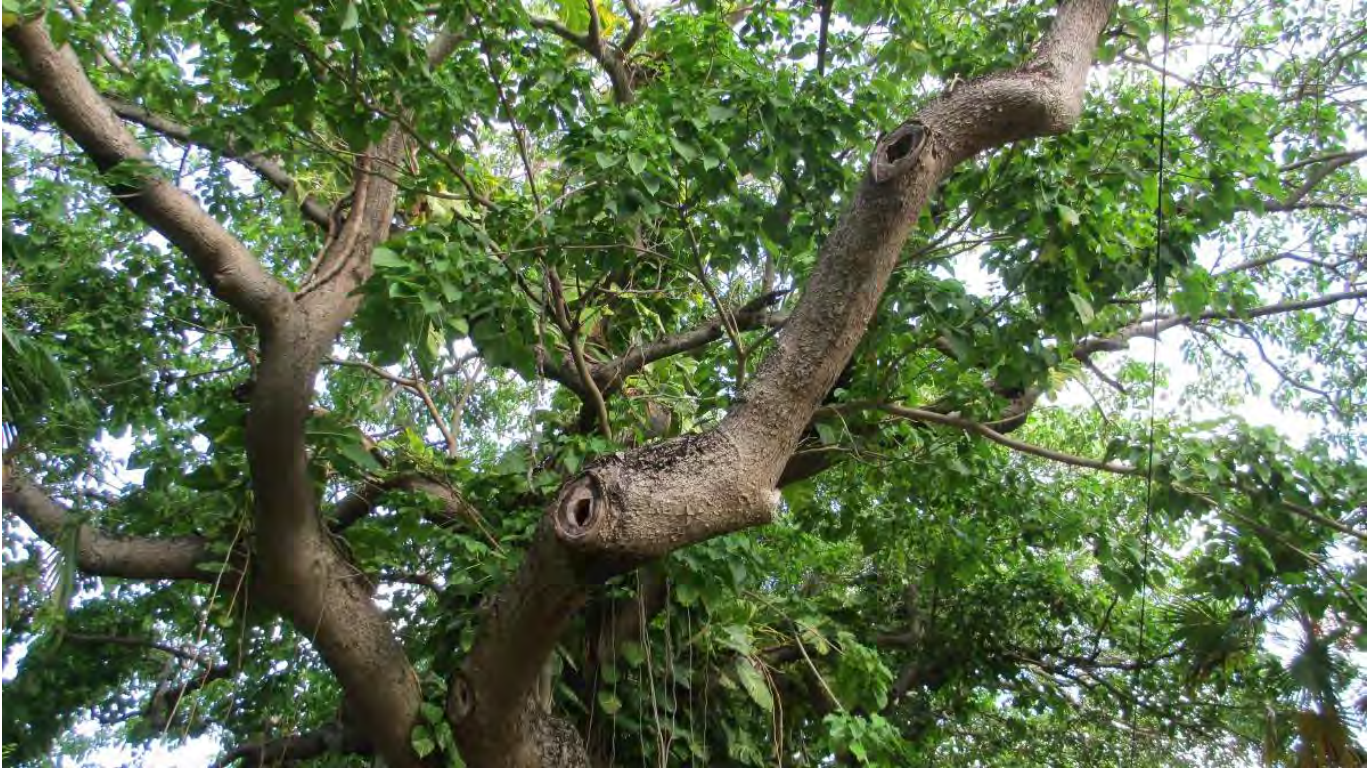
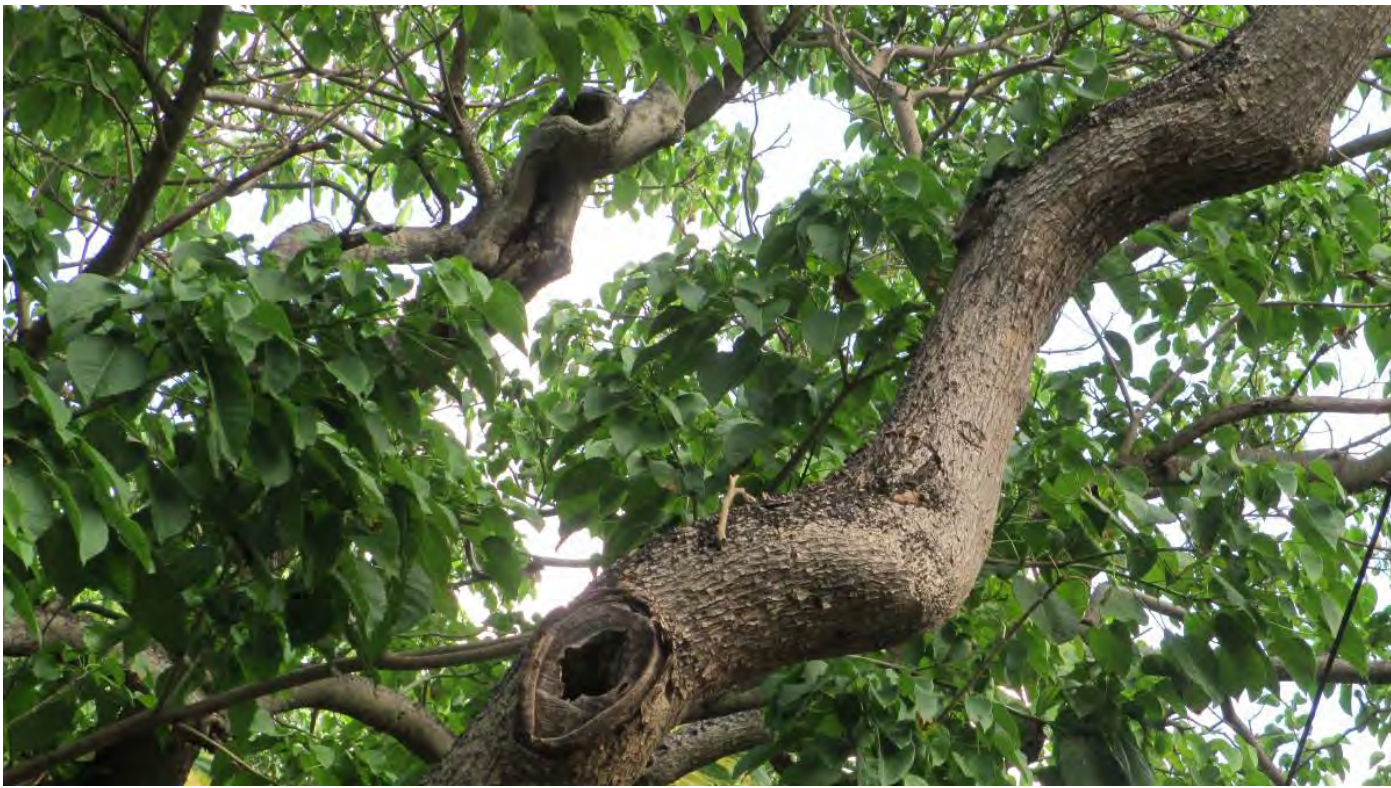
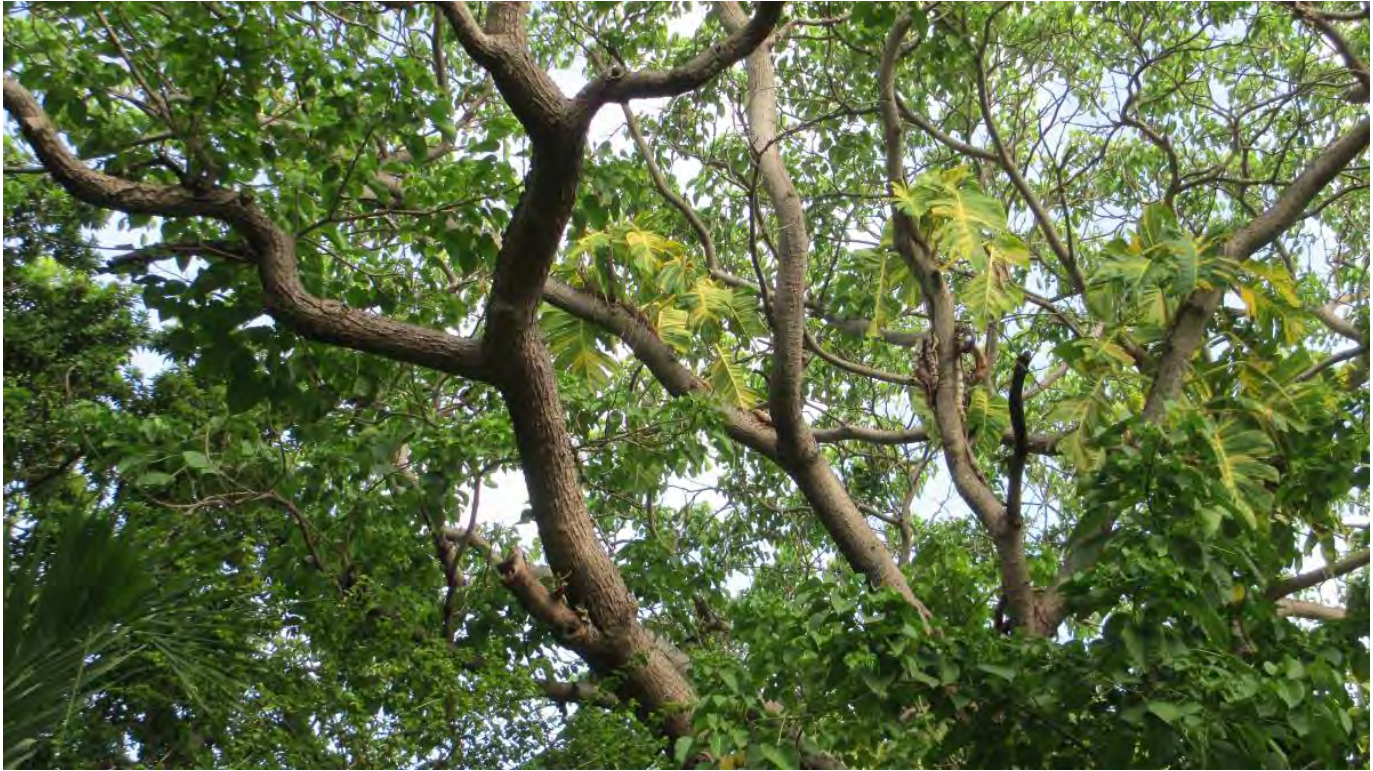
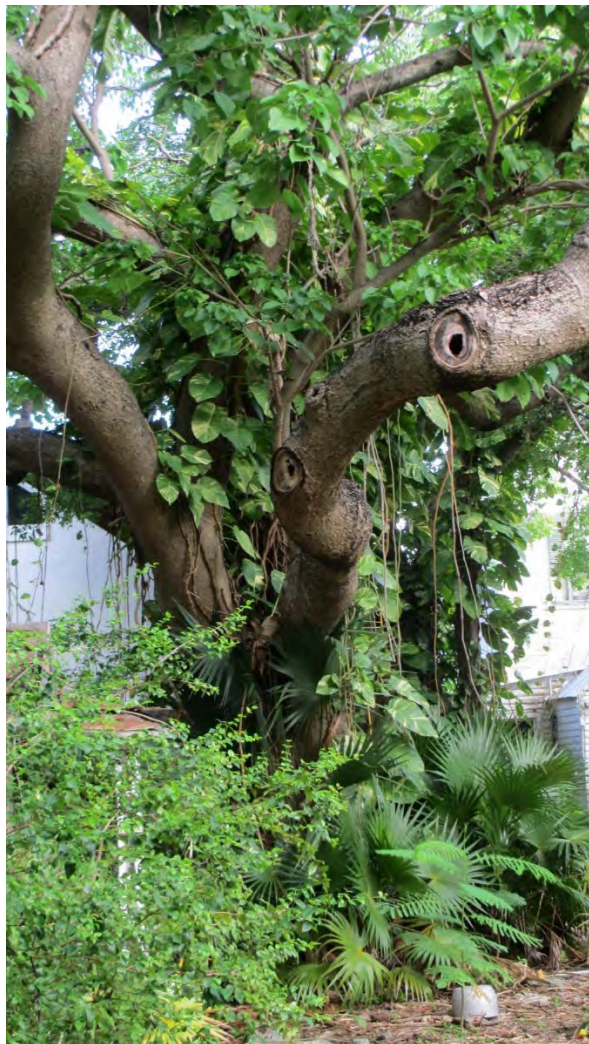
10. Tree Species: Sandbox (*Hura crepitans*)

Condition: 50% (fair but in decline, vines were growing along trunk and in canopy, some decay, especially in old cuts, observed on large branches)

#10 Sandbox tree, located in rear yard, north center. Tree appears to be very mature in age with estimated age over one hundred years. Sandbox trees may have a life span of one hundred fifty years. Tree canopy is thin, flushing lower branches and shedding large upper canopy branches. All lateral and upper branches have sun scald causing bark splitting and decay on entire length of branch. This may be the result of the thin canopy and shedding branches. I suspect that the hurricane seasons of 1998 (Georges-very dry hurricane including drought conditions of same year) 2004 and 2005 rendered the tree little energy to restore injury. It is my professional opinion that this tree is in decline and should be removed.
