Building Inspection Report and Schedule of Repairs

Inspection Report

Property Address:
231 Margaret St.
Key West Fl. 33040

Historic Half Shell Restaurant

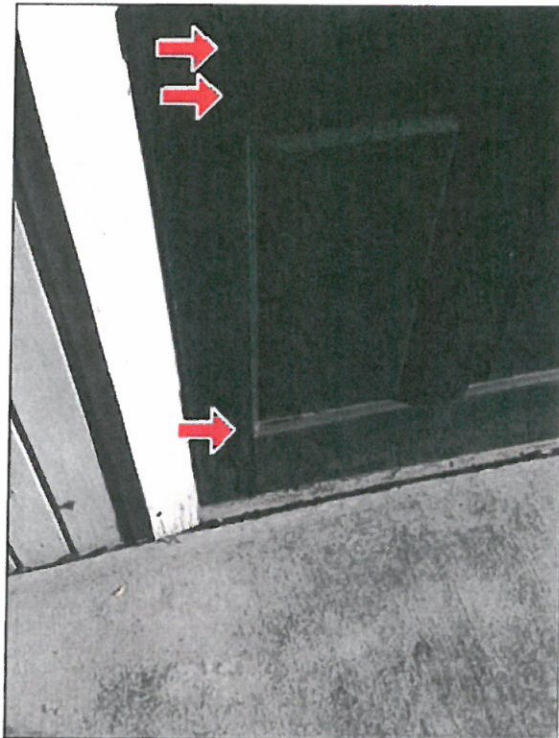
2.1 Picture 2 Weather Damaged Door

The other doors throughout the building were found to be operable though somewhat aged.

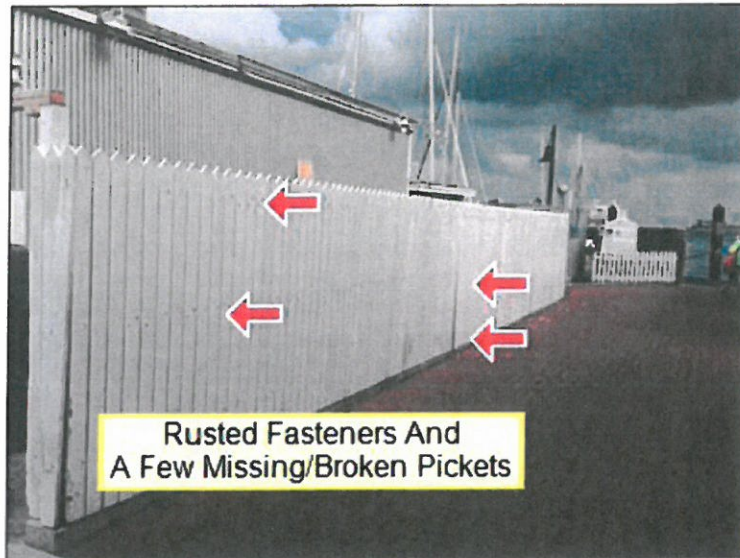
2.3 Picture 2 Fence

The fence along the northeast side of the property was found in fairly good condition although the fasteners are rusted and a few pickets are loose or missing.

**Rusted Fasteners And
A Few Missing/Broken Pickets**

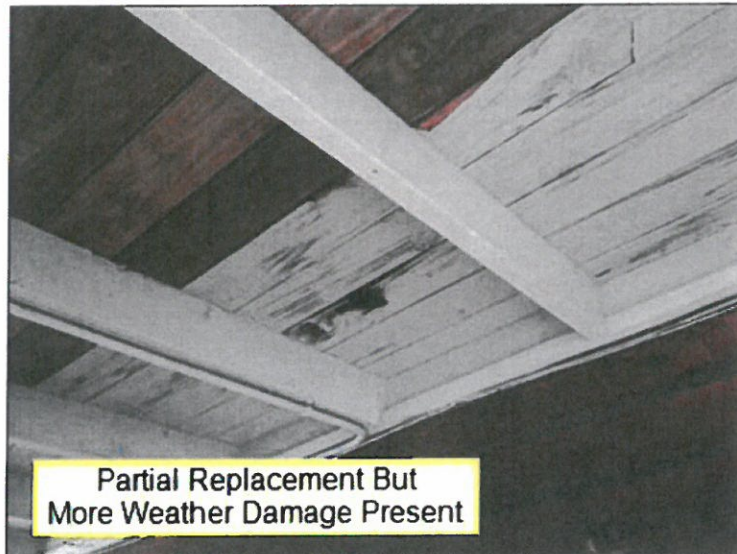
2.3 Picture 3 Front Porch Ceiling

2.3 Although the front porch cover seems to have been repaired recently a lot of rot still remains.

**Partial Replacement But
More Weather Damage Present**

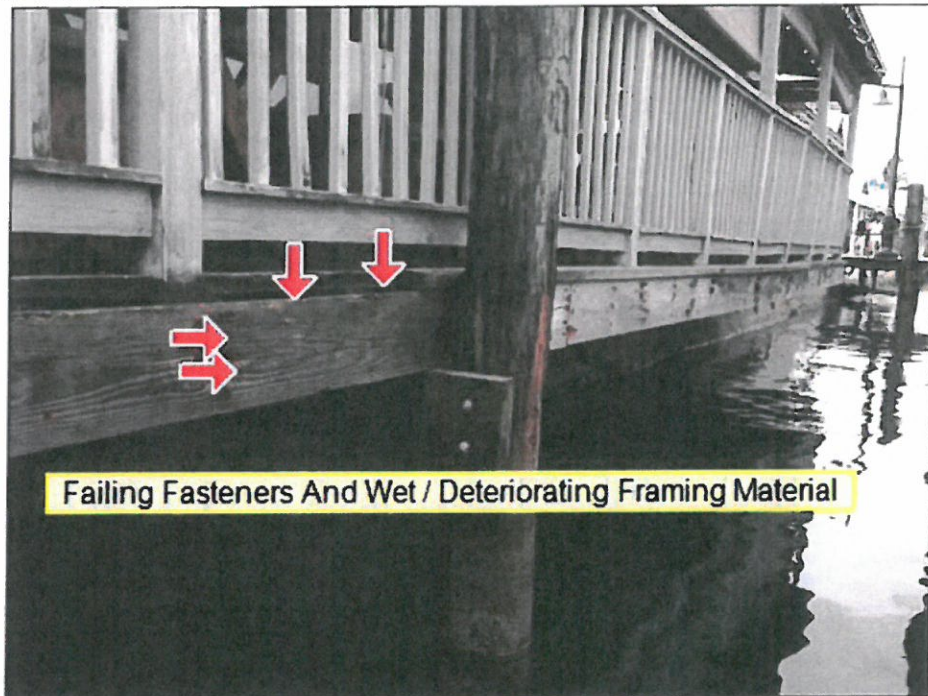
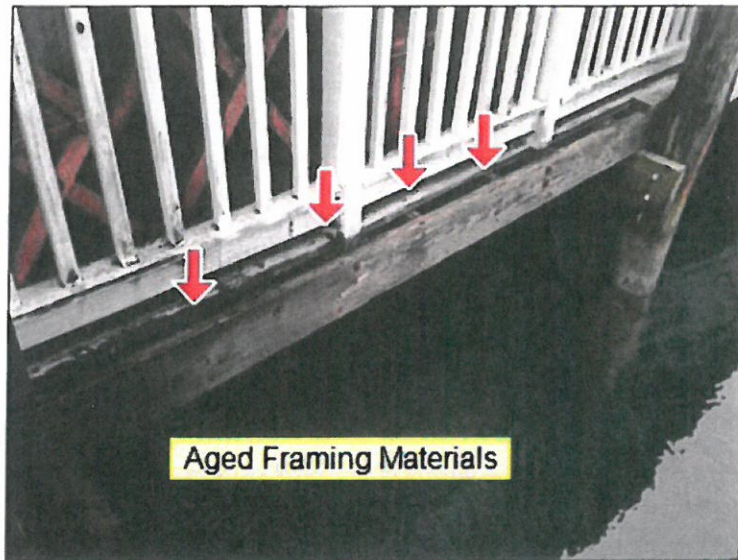
3.2 The cantilever structure of the restaurant appears to be structurally sound at this time. A number of fasteners are rusted and the framing material does show signs of water damage and it is my recommendation a structural engineer be contacted for further evaluation and recommendation.

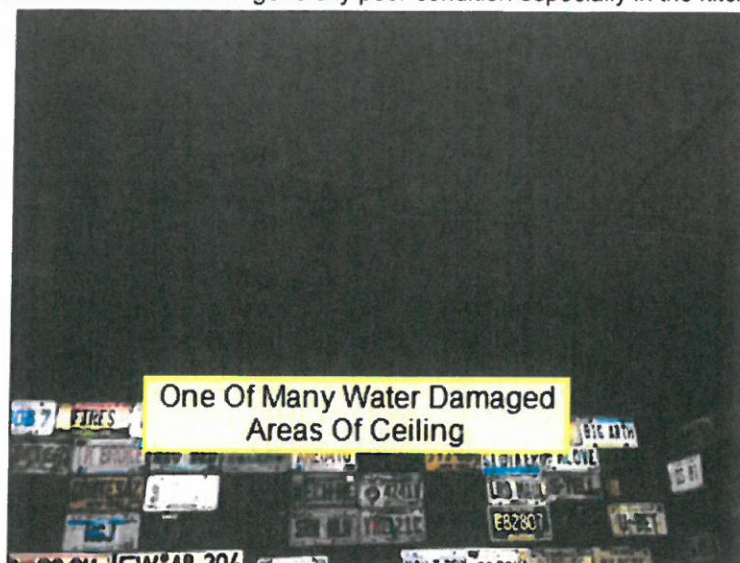
5.0 Picture 1 Ceiling

5.0 The ceilings throughout the restaurant are in generally poor condition especially in the kitchen area..

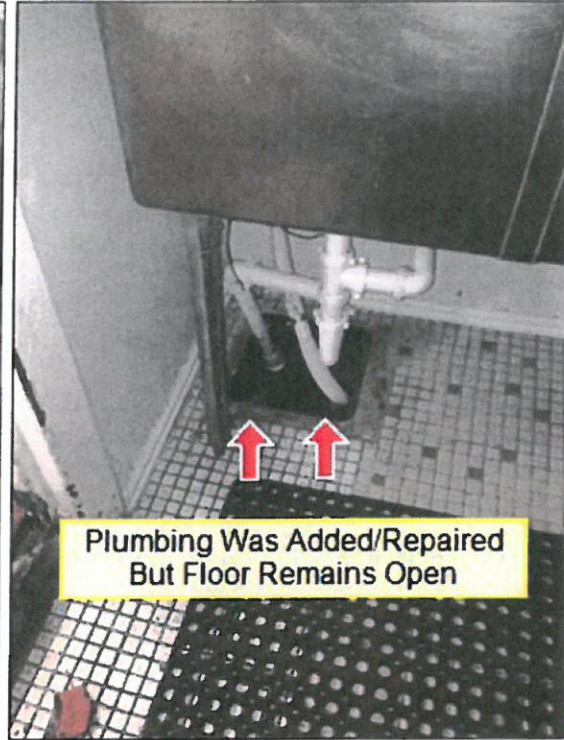
6.2 The kitchen floor in this aged building has obviously undergone quite a few changes over the years.

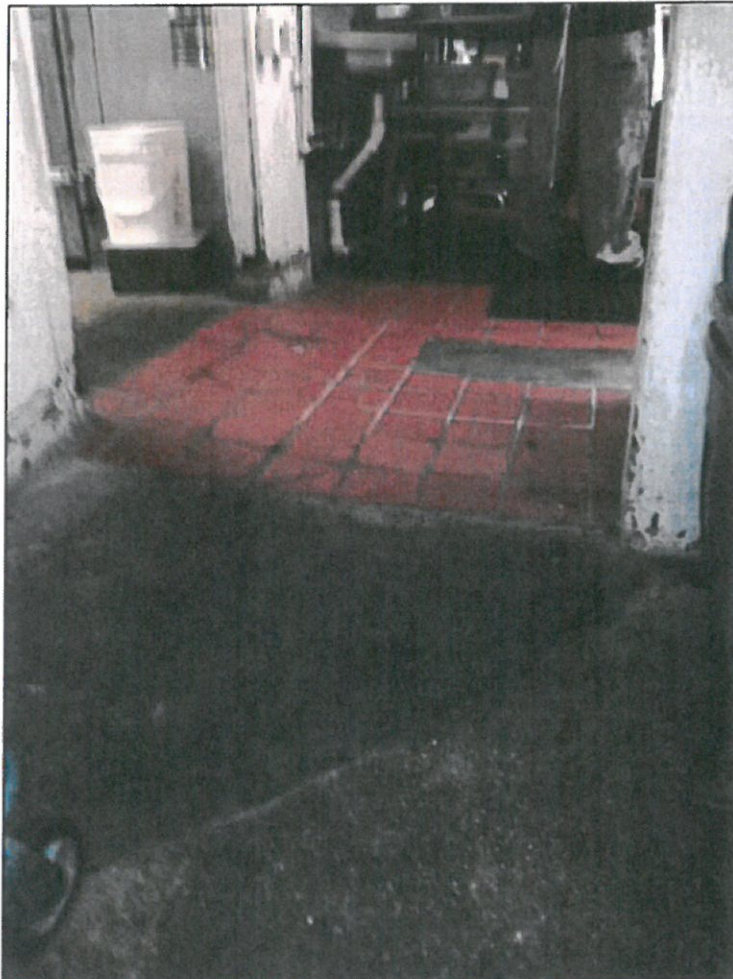
6.2 Picture 5 Typical Flooring Situation

Flooring in this area Does Have Problems
But Some Repairs Have
Been Made

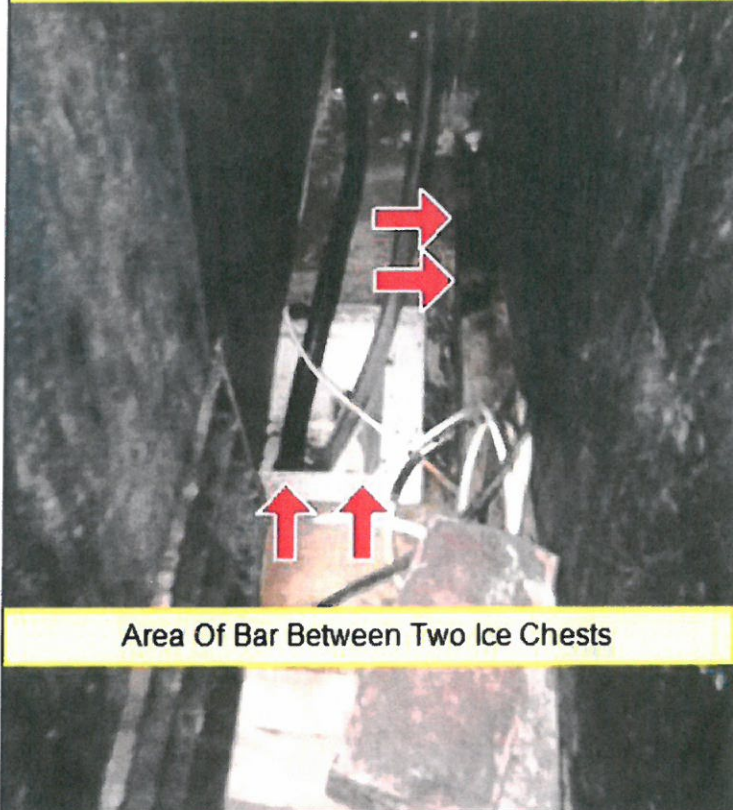
6.2 Picture 6 Drain

Area Of Bar Between Two Ice Chests

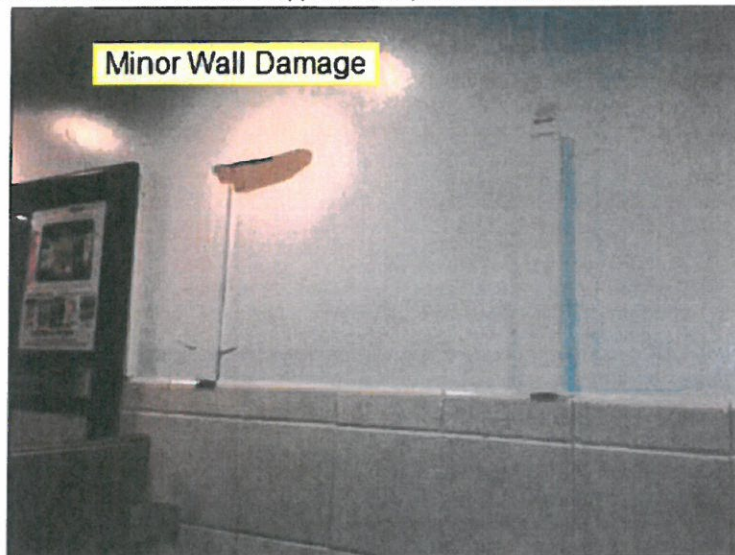
7.1 Picture 1 Mens Bathroom

7.1 Minor damage to the men's bathroom wall as it appears the picture was removed.

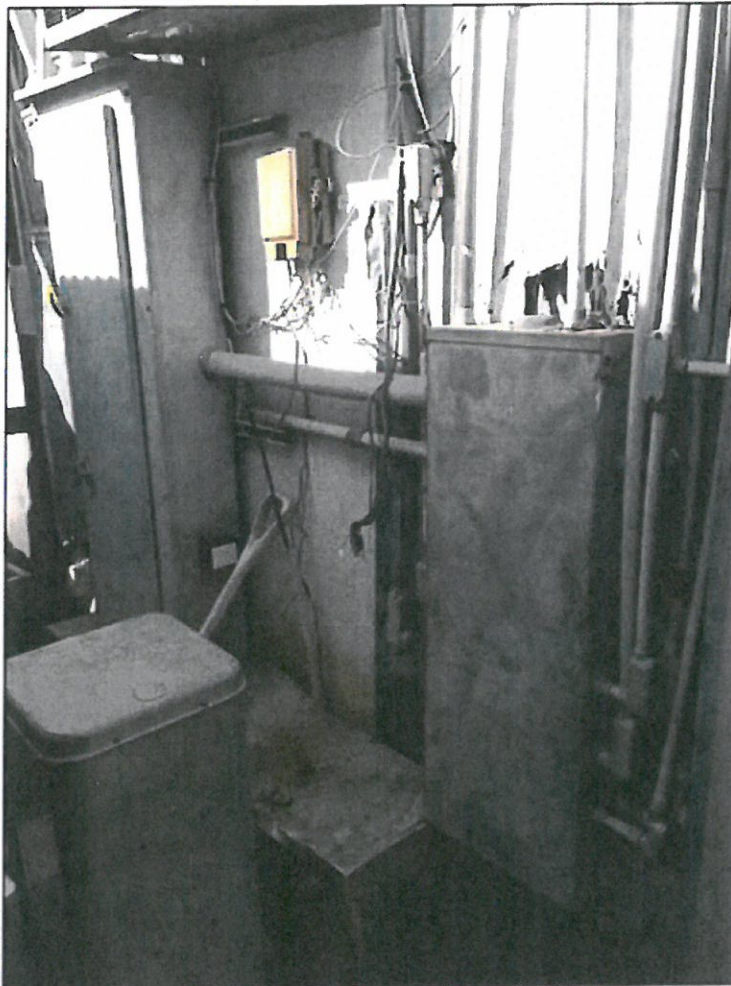
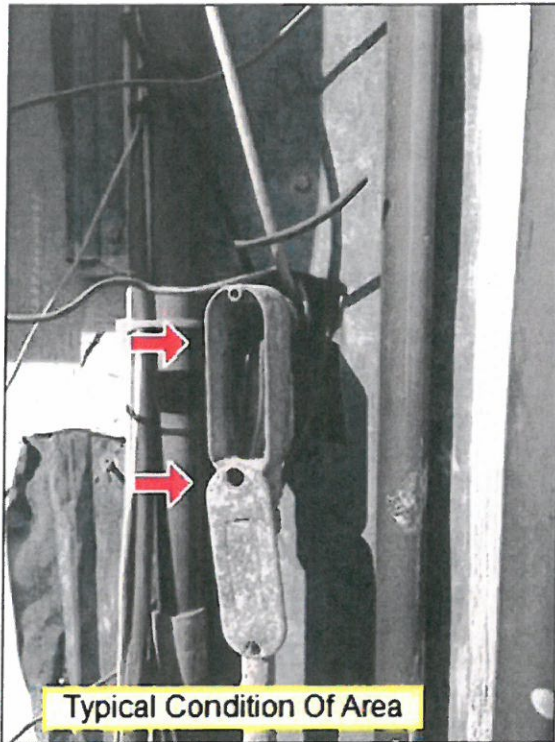
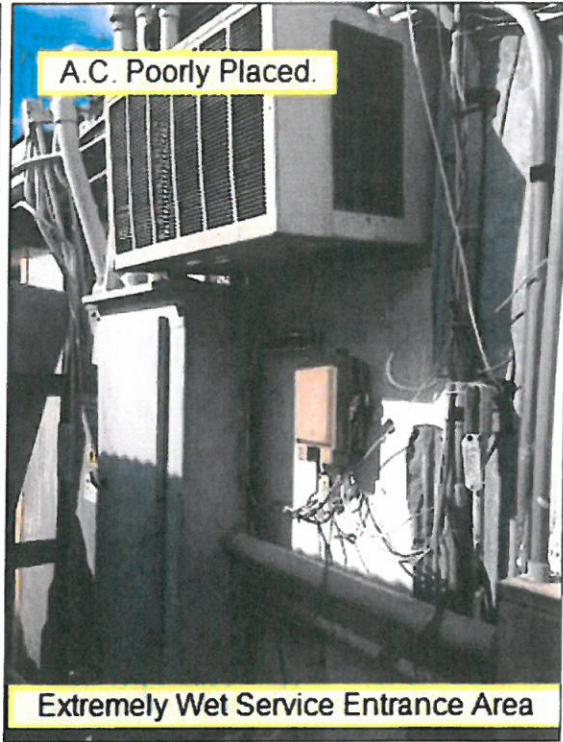
8.1 The service entrance as a whole was in poor condition. Loose panels, loose panel covers, overloaded circuits and an extreme amount of moisture in that area makes a poor overall situation.

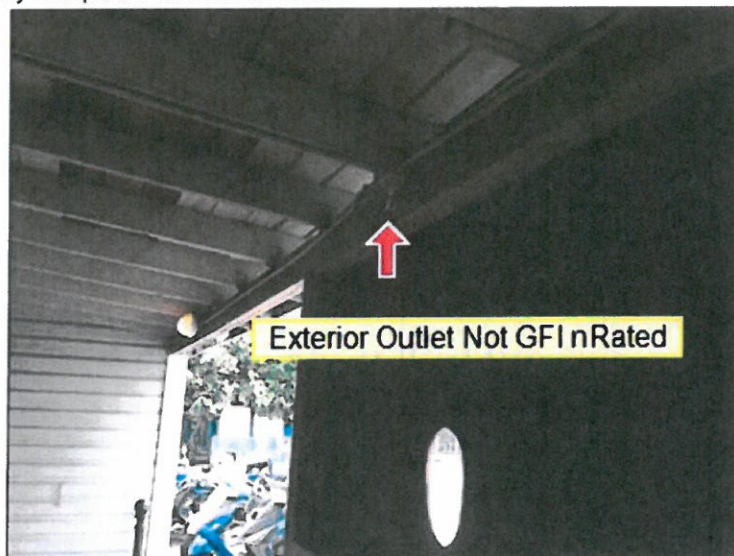
8.4 Picture 1 Front Entry

8.4 The overhead front entry receptacle was not GFI rated.

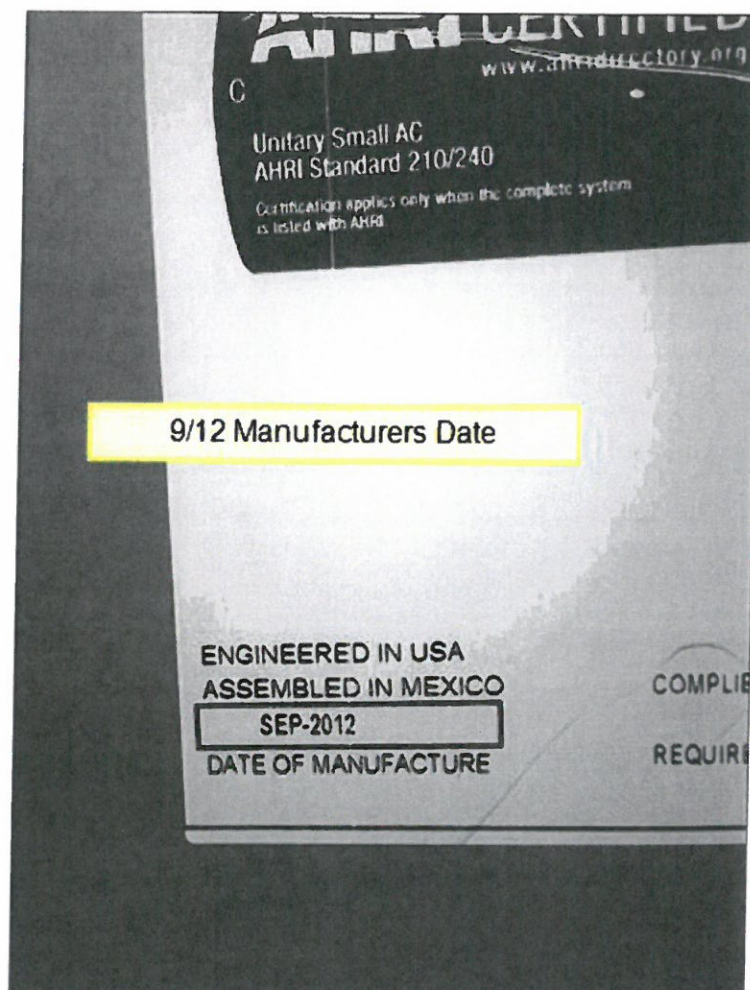
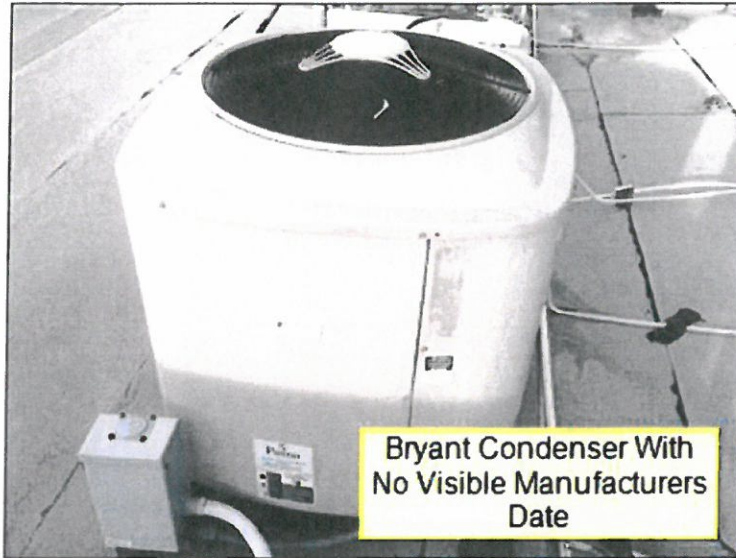
9.0 A lot of the cooling equipment on the property is obsolete. A lot of cooling equipment is in good working order with manufacturer's information present , and a lot of cooling equipment on the property is functional yet no records of manufacturers information could be found.

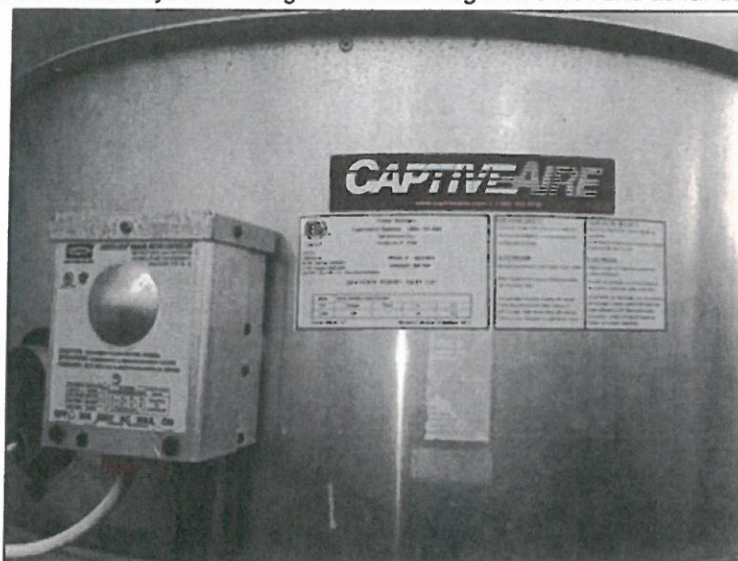
9.4 Picture 1 Distribution Systyem

9.4 The staff maintains the distribution system throughout the building works well and as far as I can tell I agree.
