STAFF REPORT

DATE: February 26, 2016

RE: **1664 Dunlap Drive-Poinciana Gardens**
(permit application # T16-7794)

FROM: Karen DeMaria, City of Key West Urban Forestry Manager

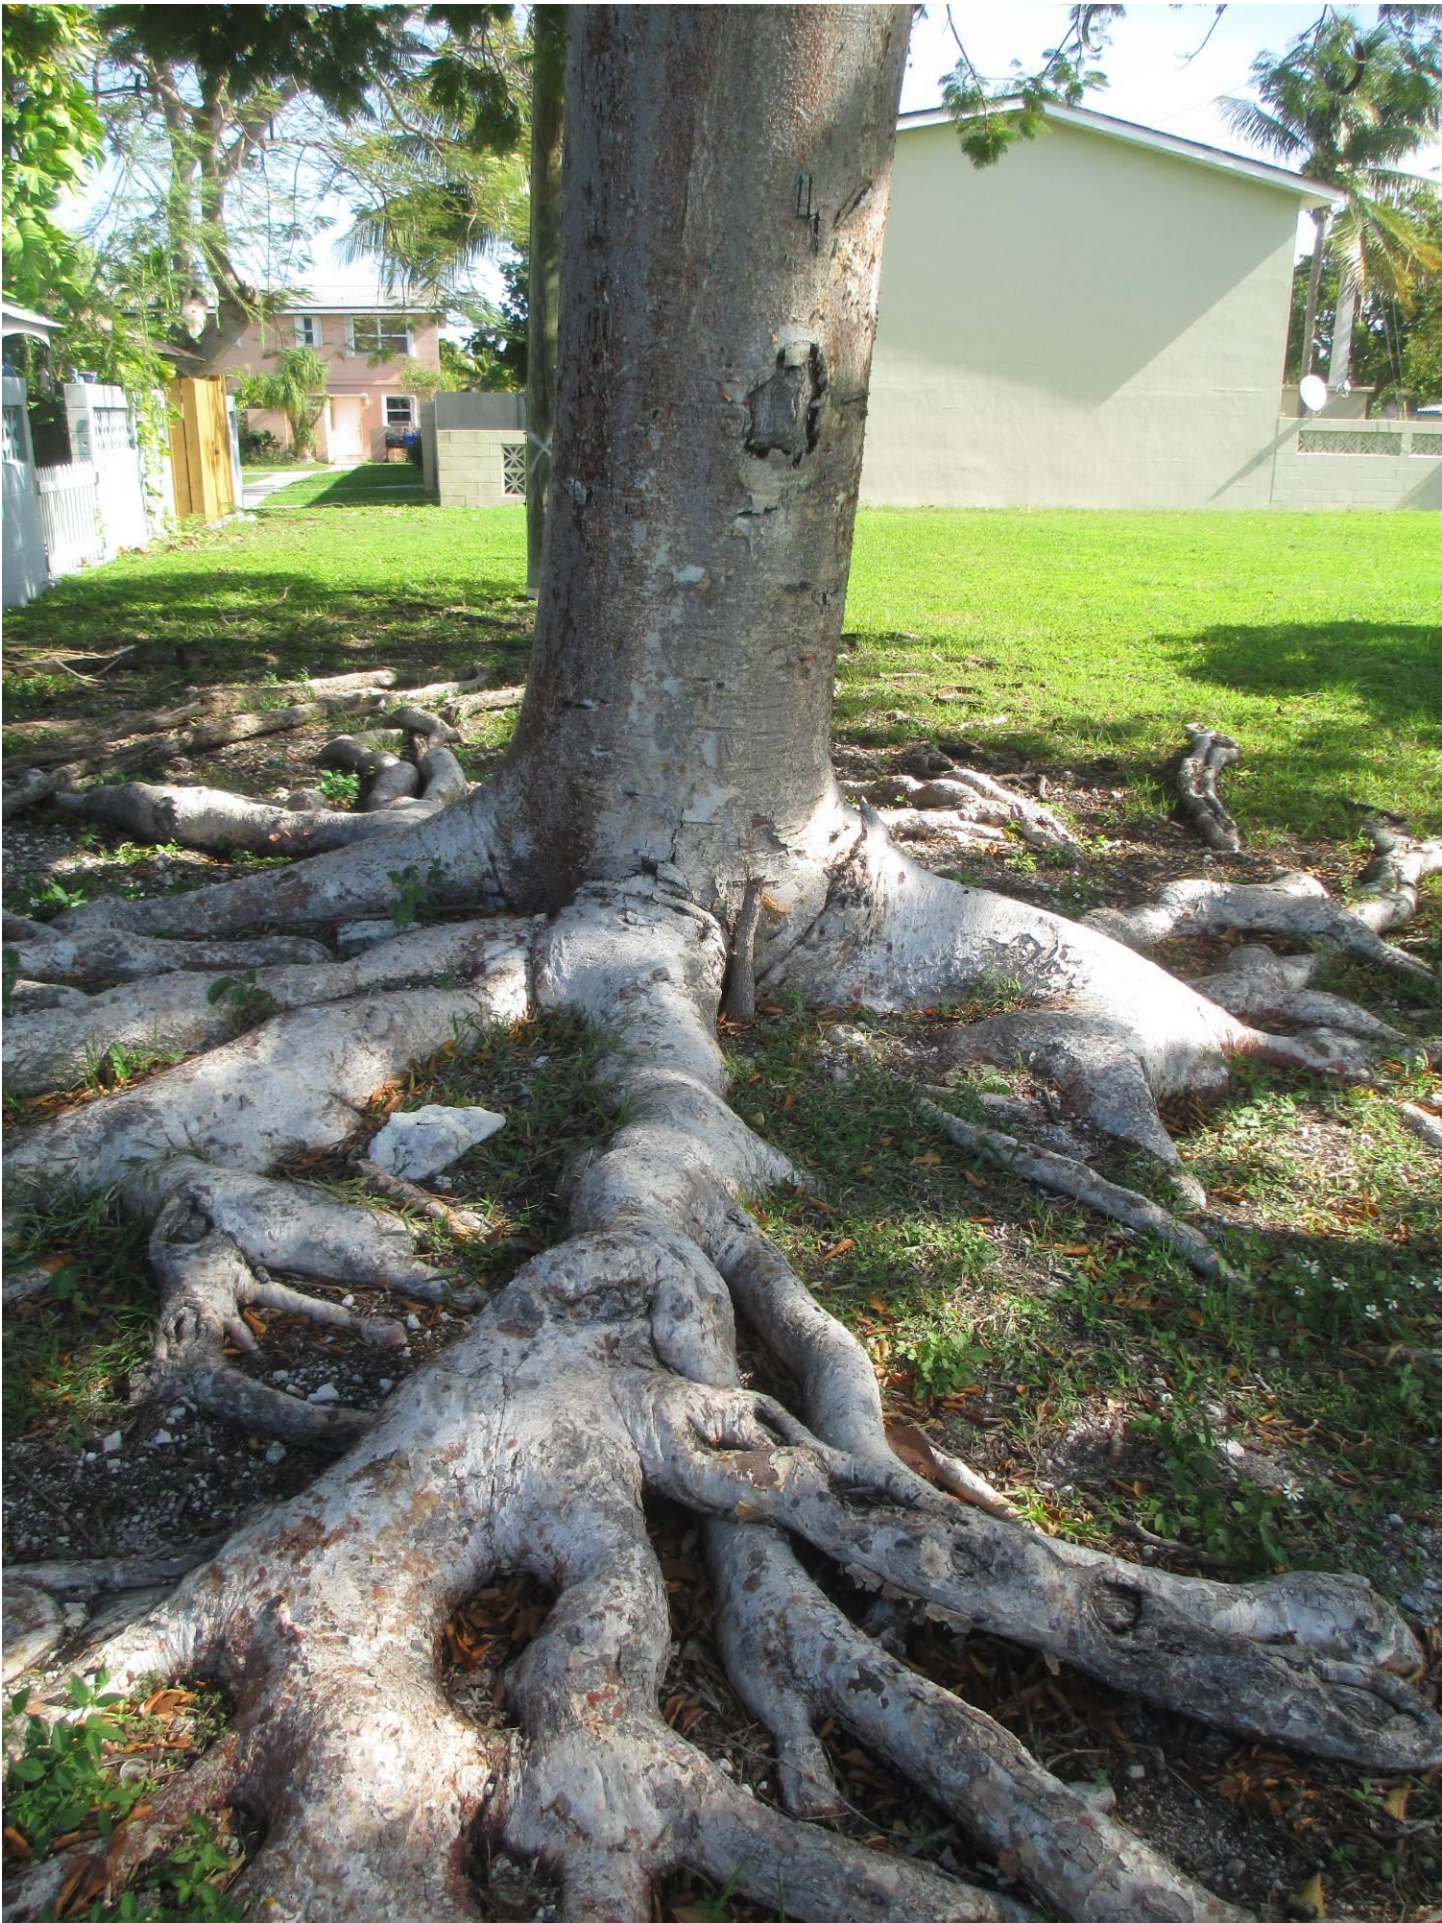
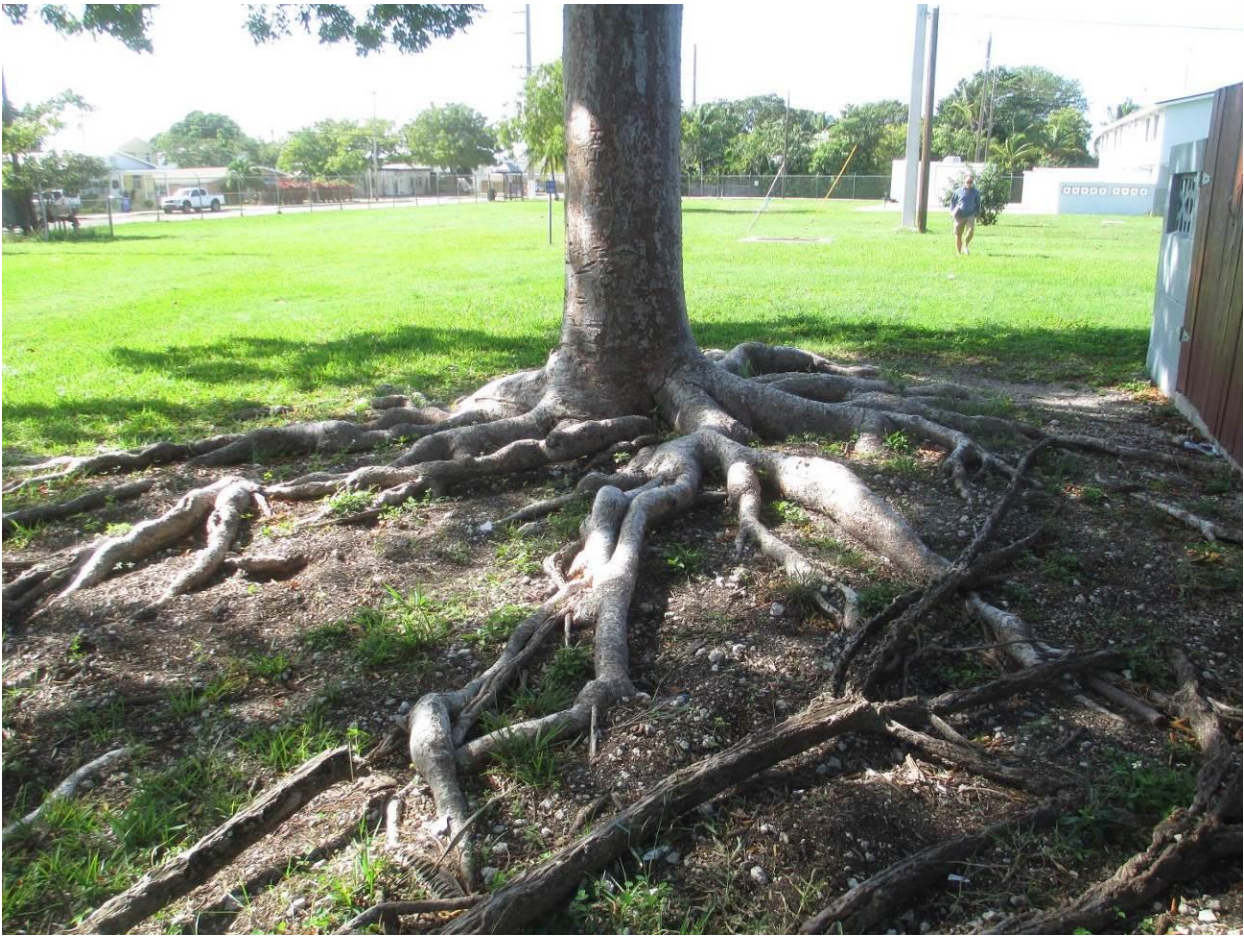
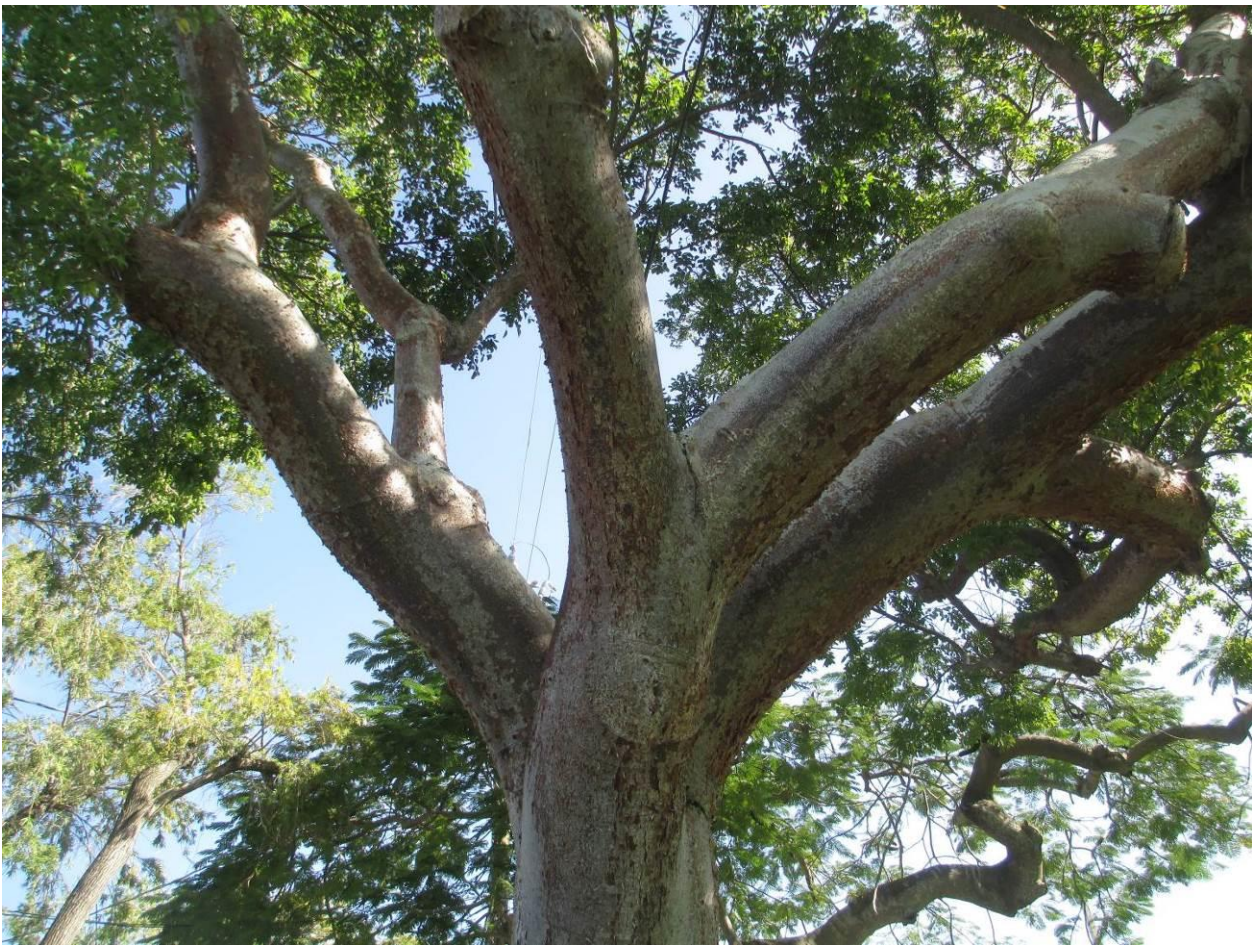
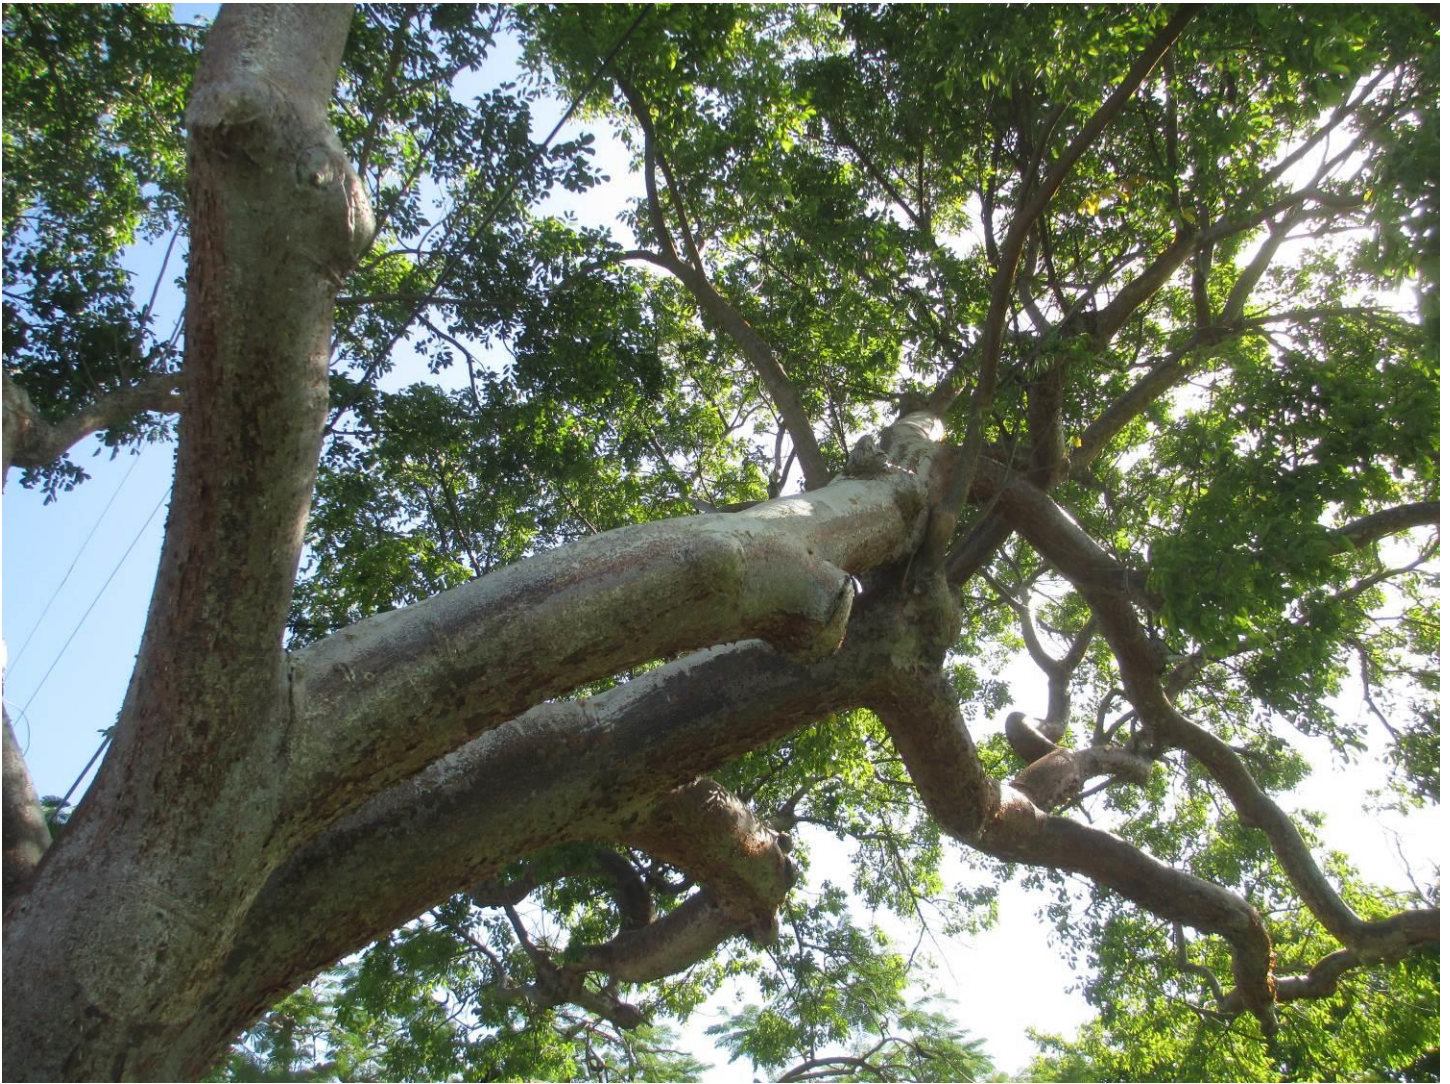
Tree #1: Gumbo Limbo (*Bursera simaruba*)

Diameter: 32"

Condition: 60% (fair, a large tree, lots of exposed surface roots, some crossed branches in canopy)

Total Average Value = 80%

Value x Diameter = 25 replacement caliper inches

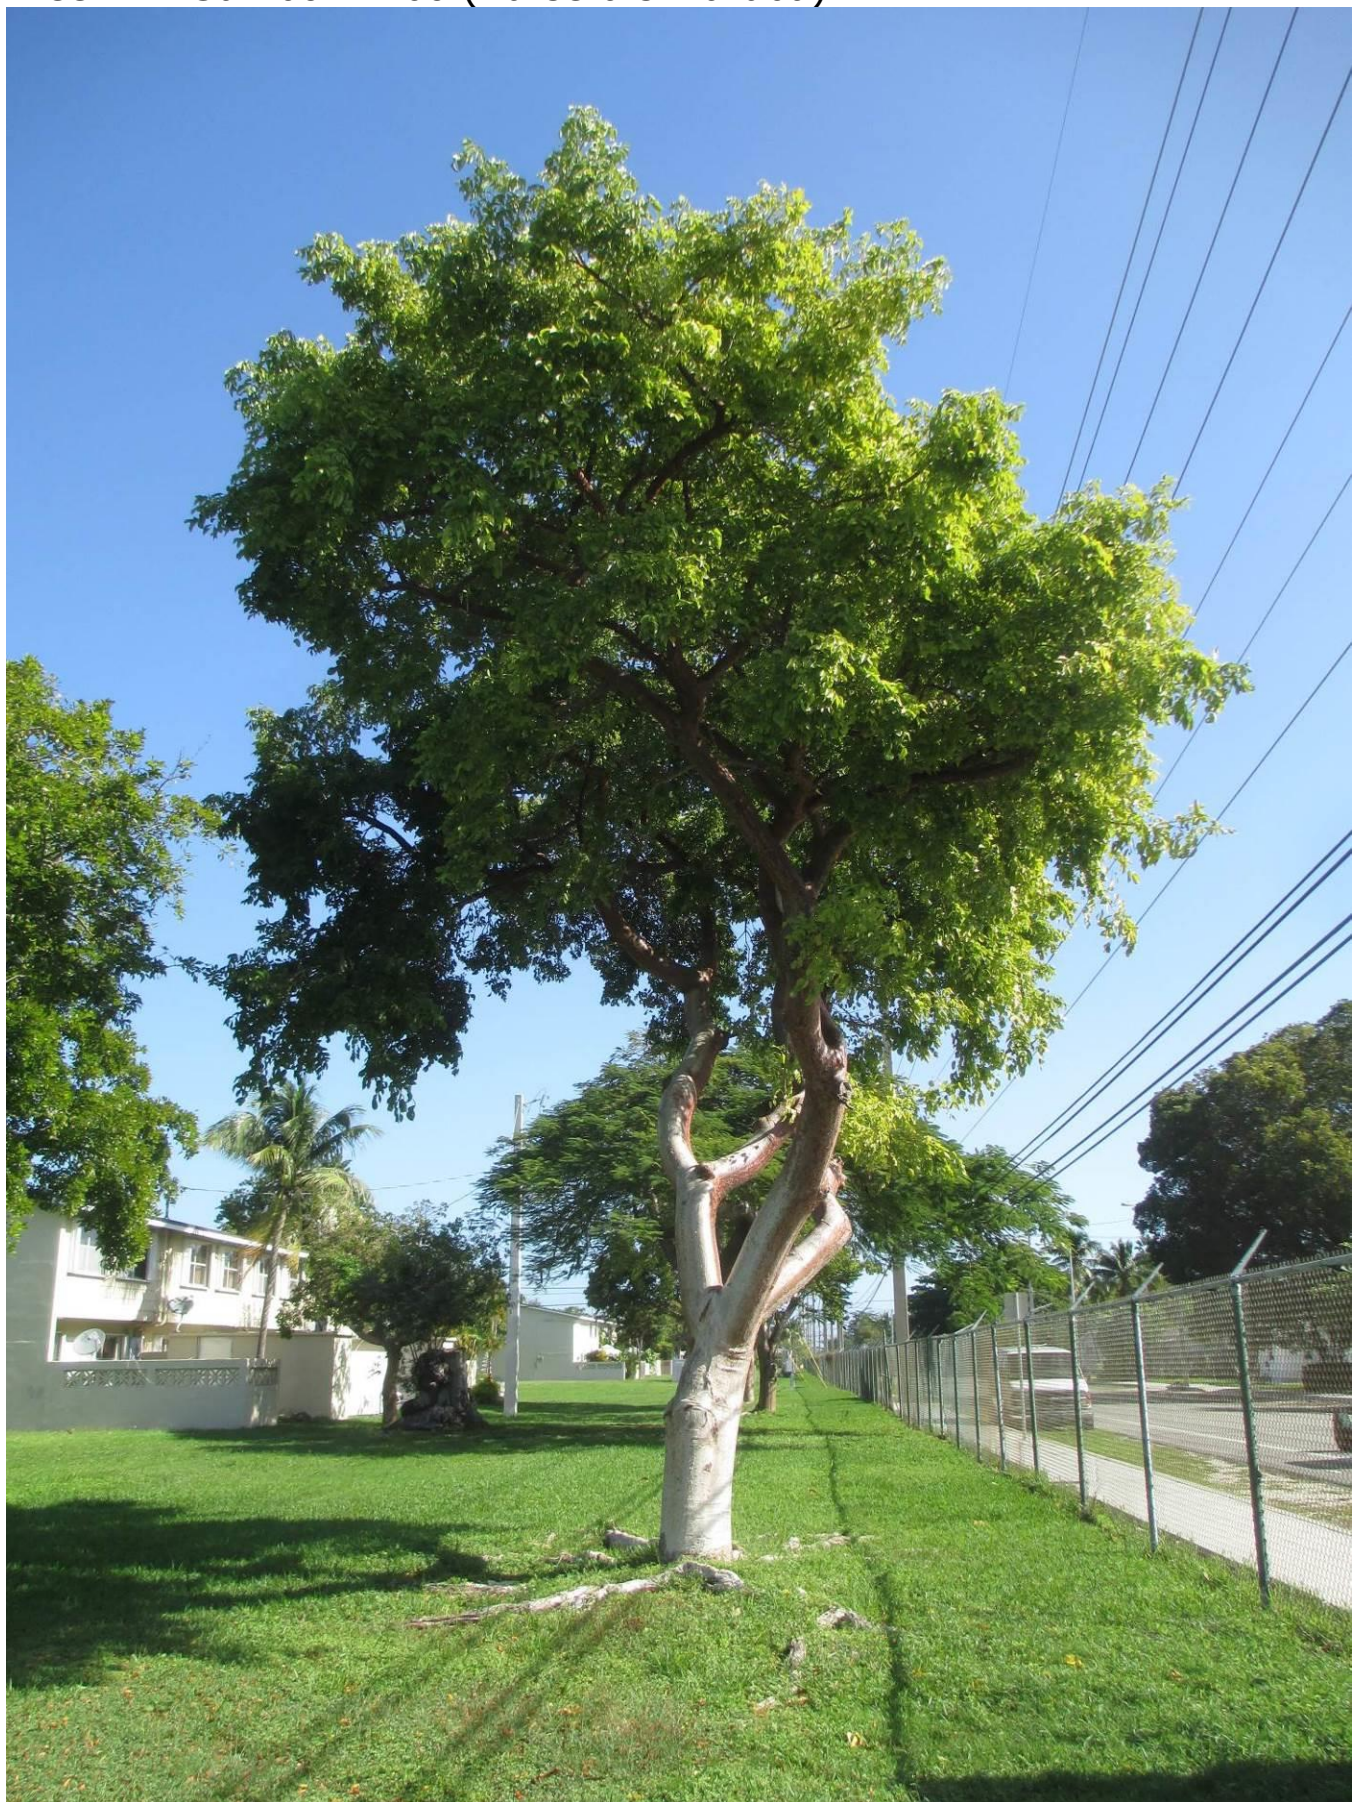
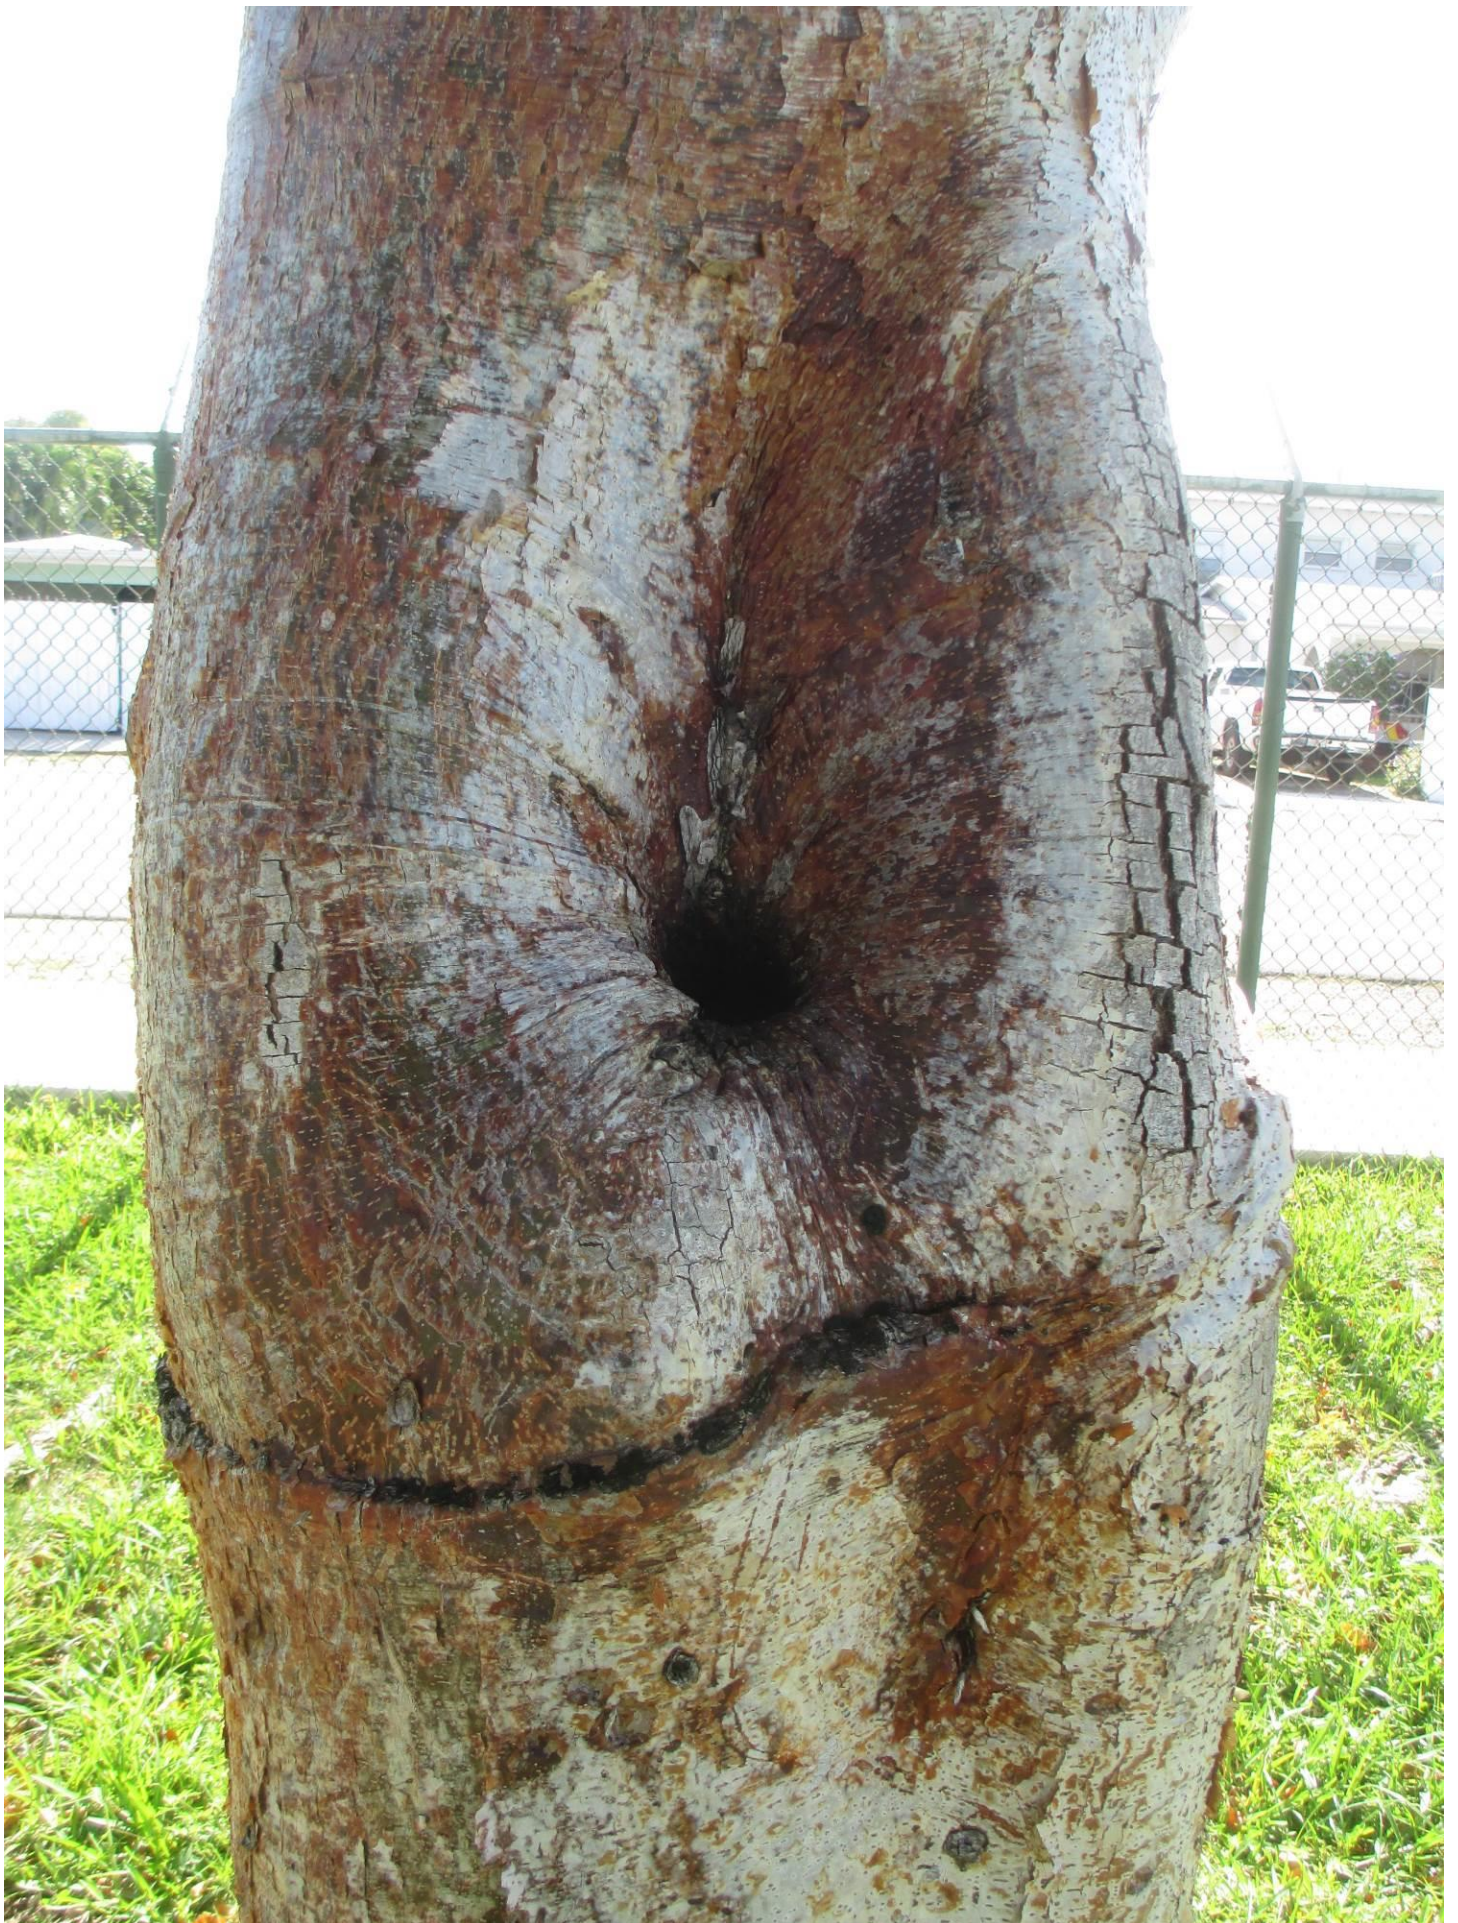
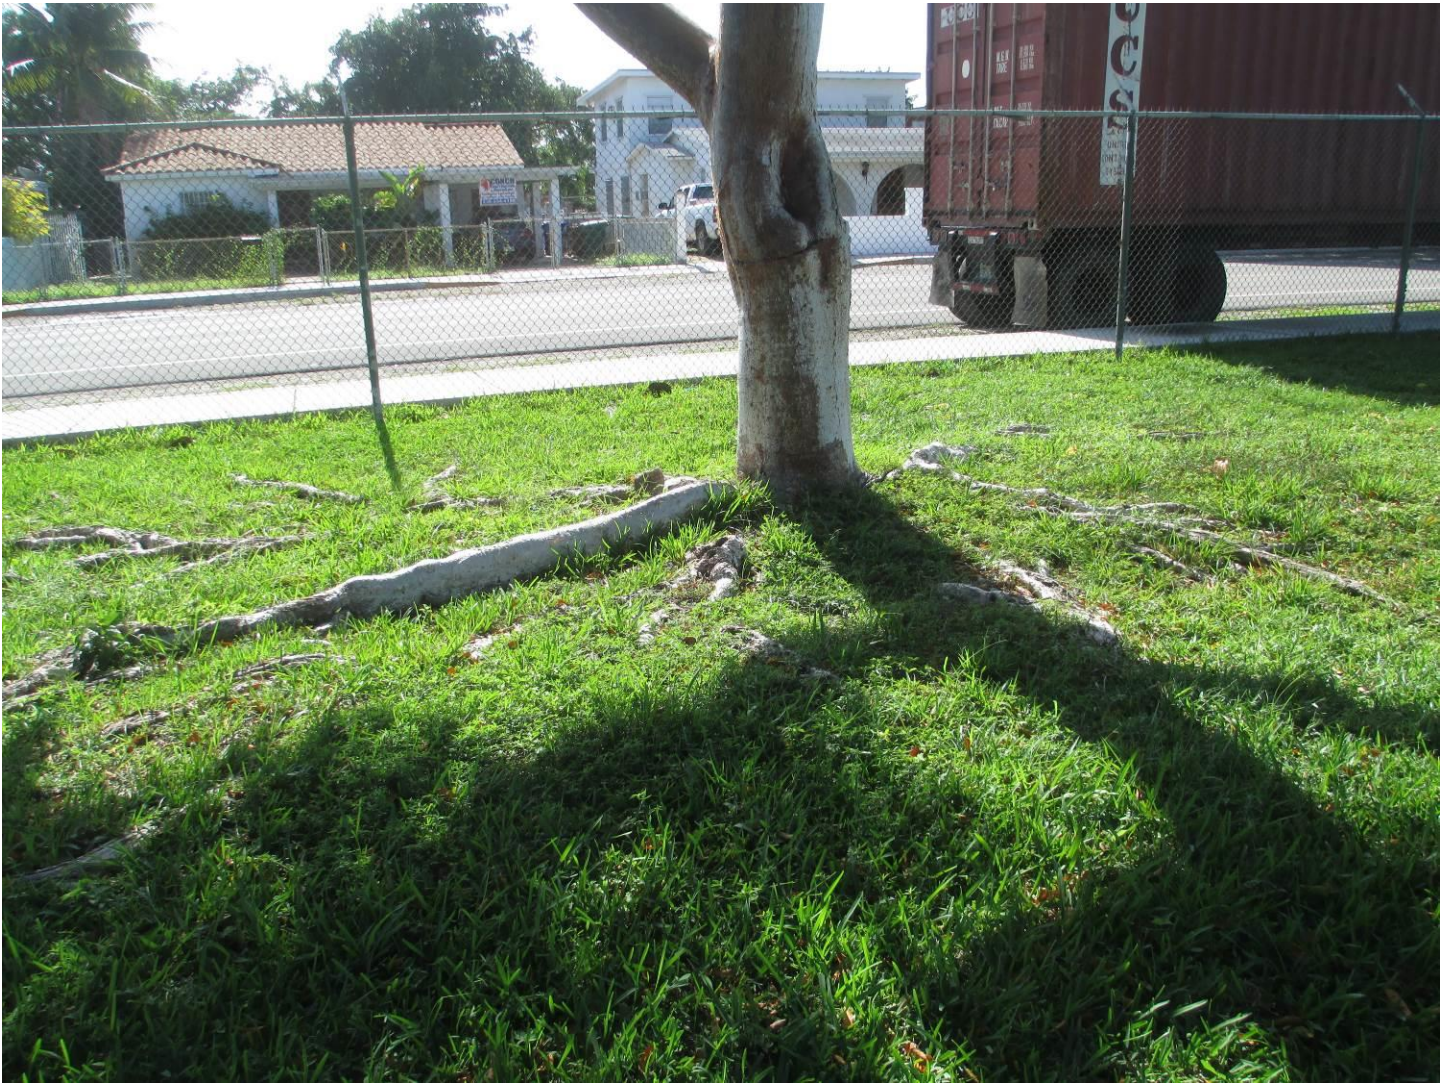
Tree #4: Gumbo Limbo (*Bursera simaruba*)

Diameter: 16"

Condition: 40% (poor, hole and decay in main trunk below canopy)

Total Average Value = 73%

Value x Diameter = 11 replacement caliper inches

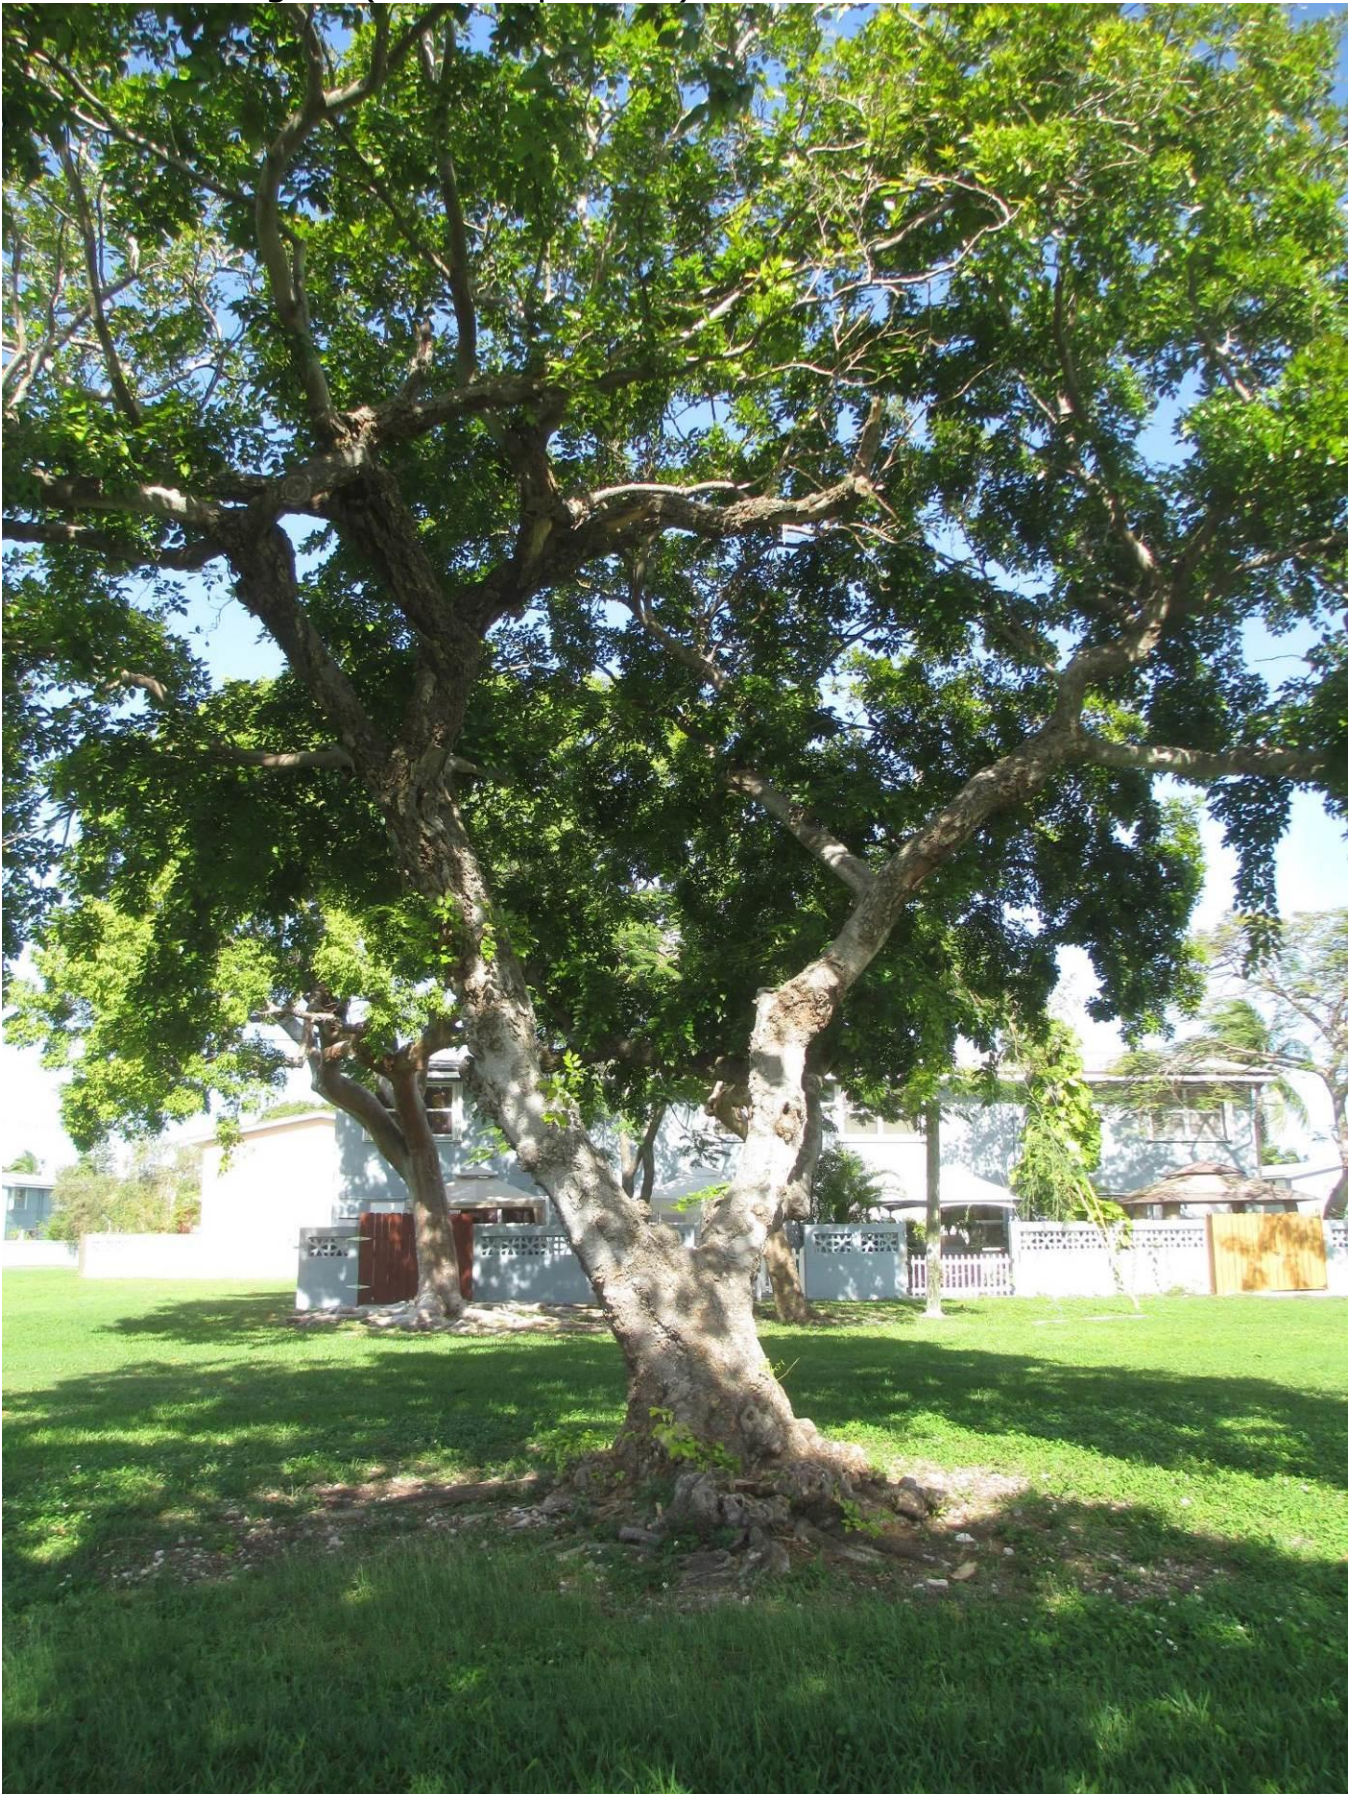
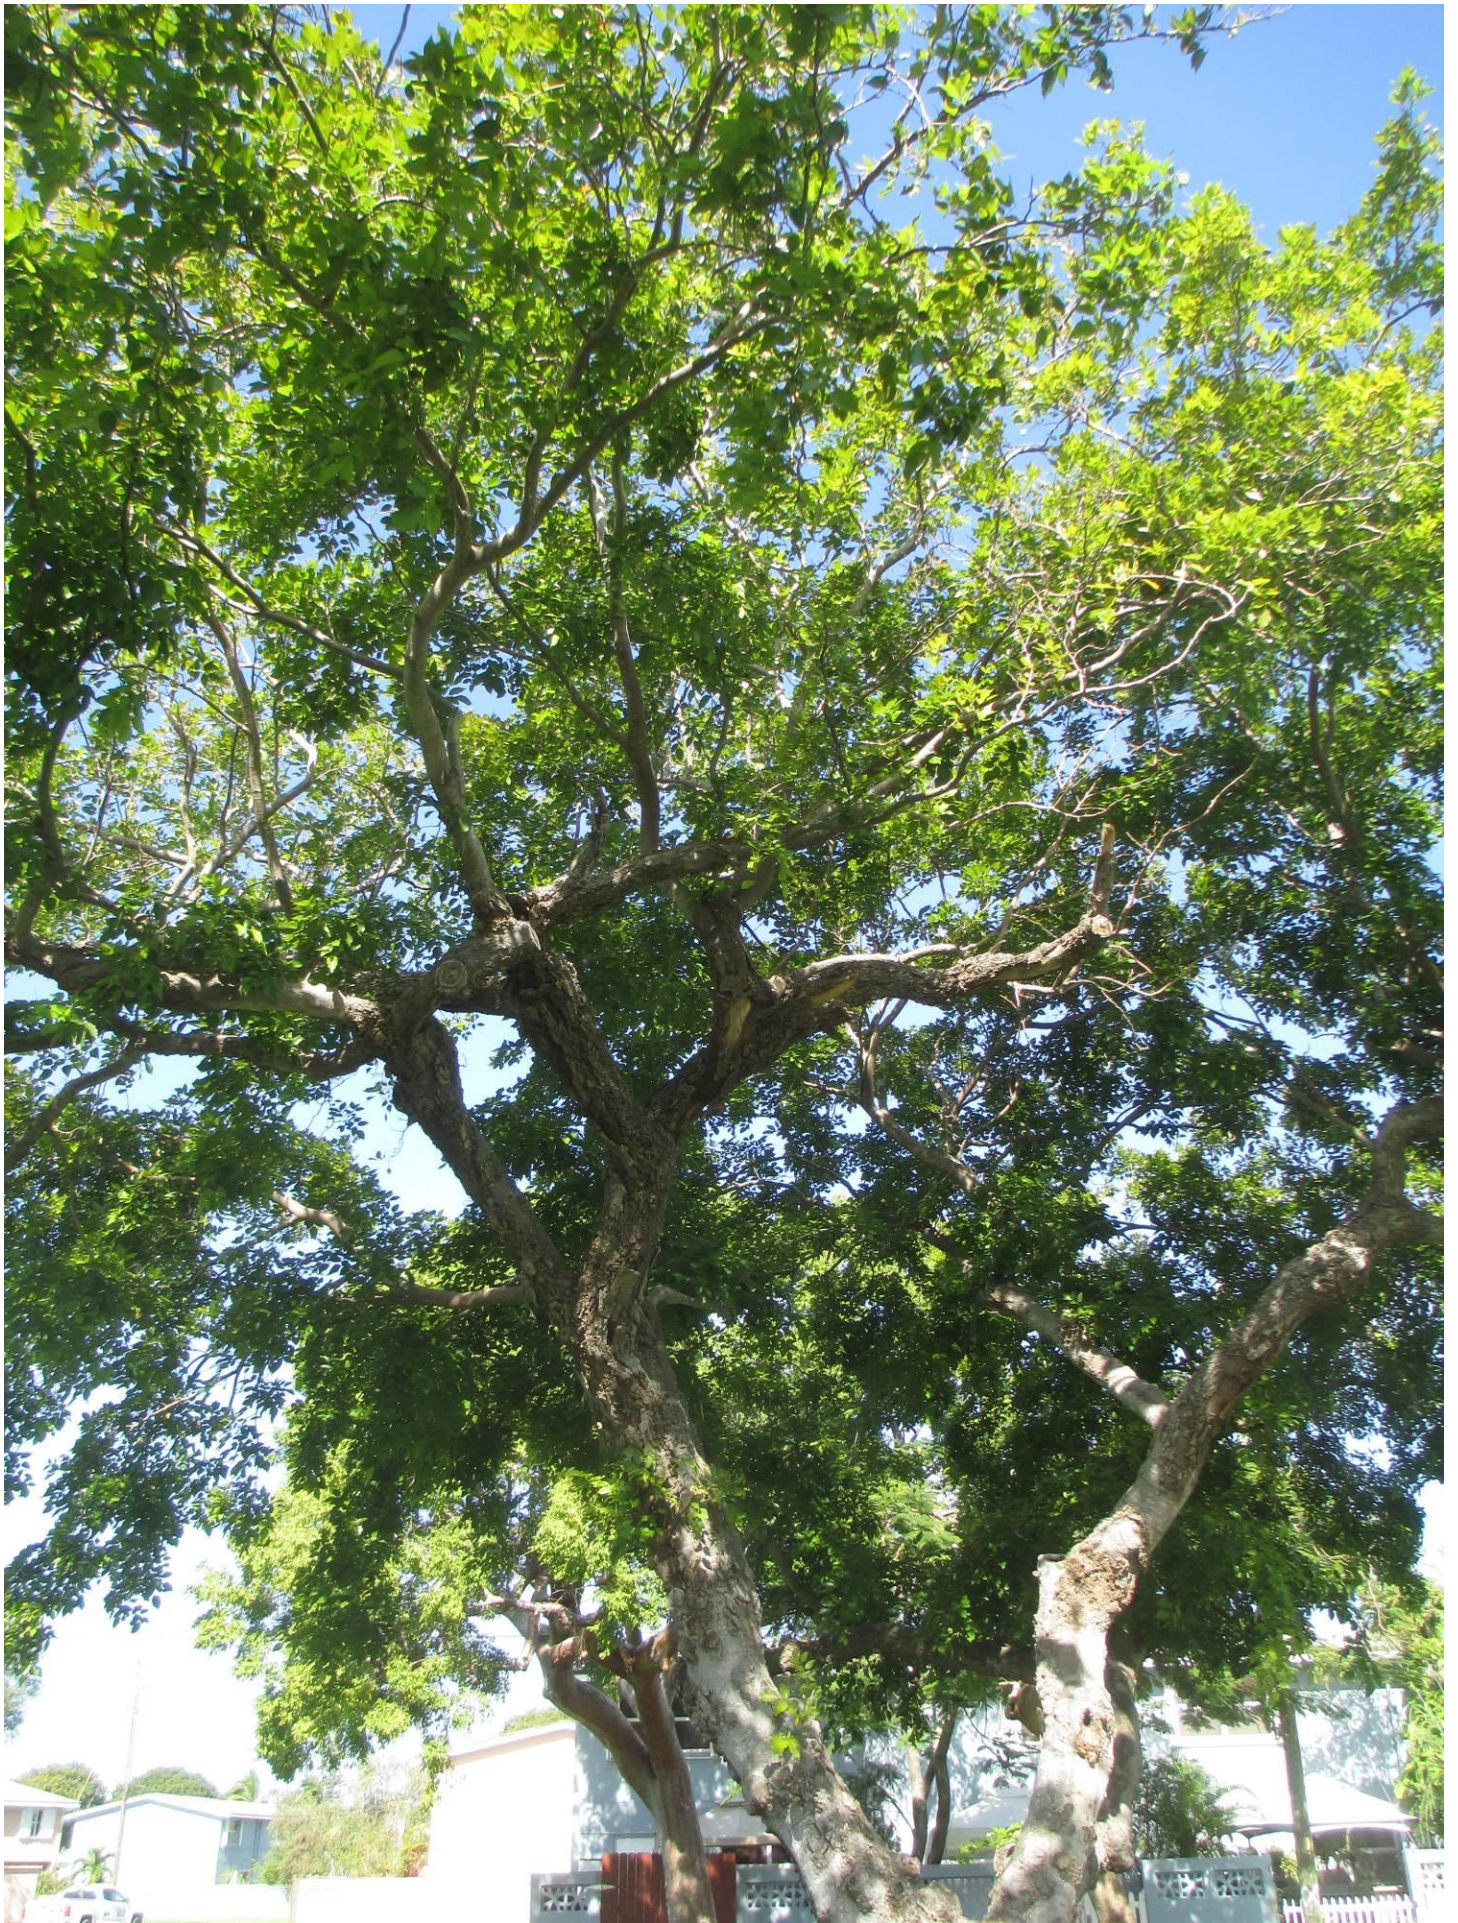
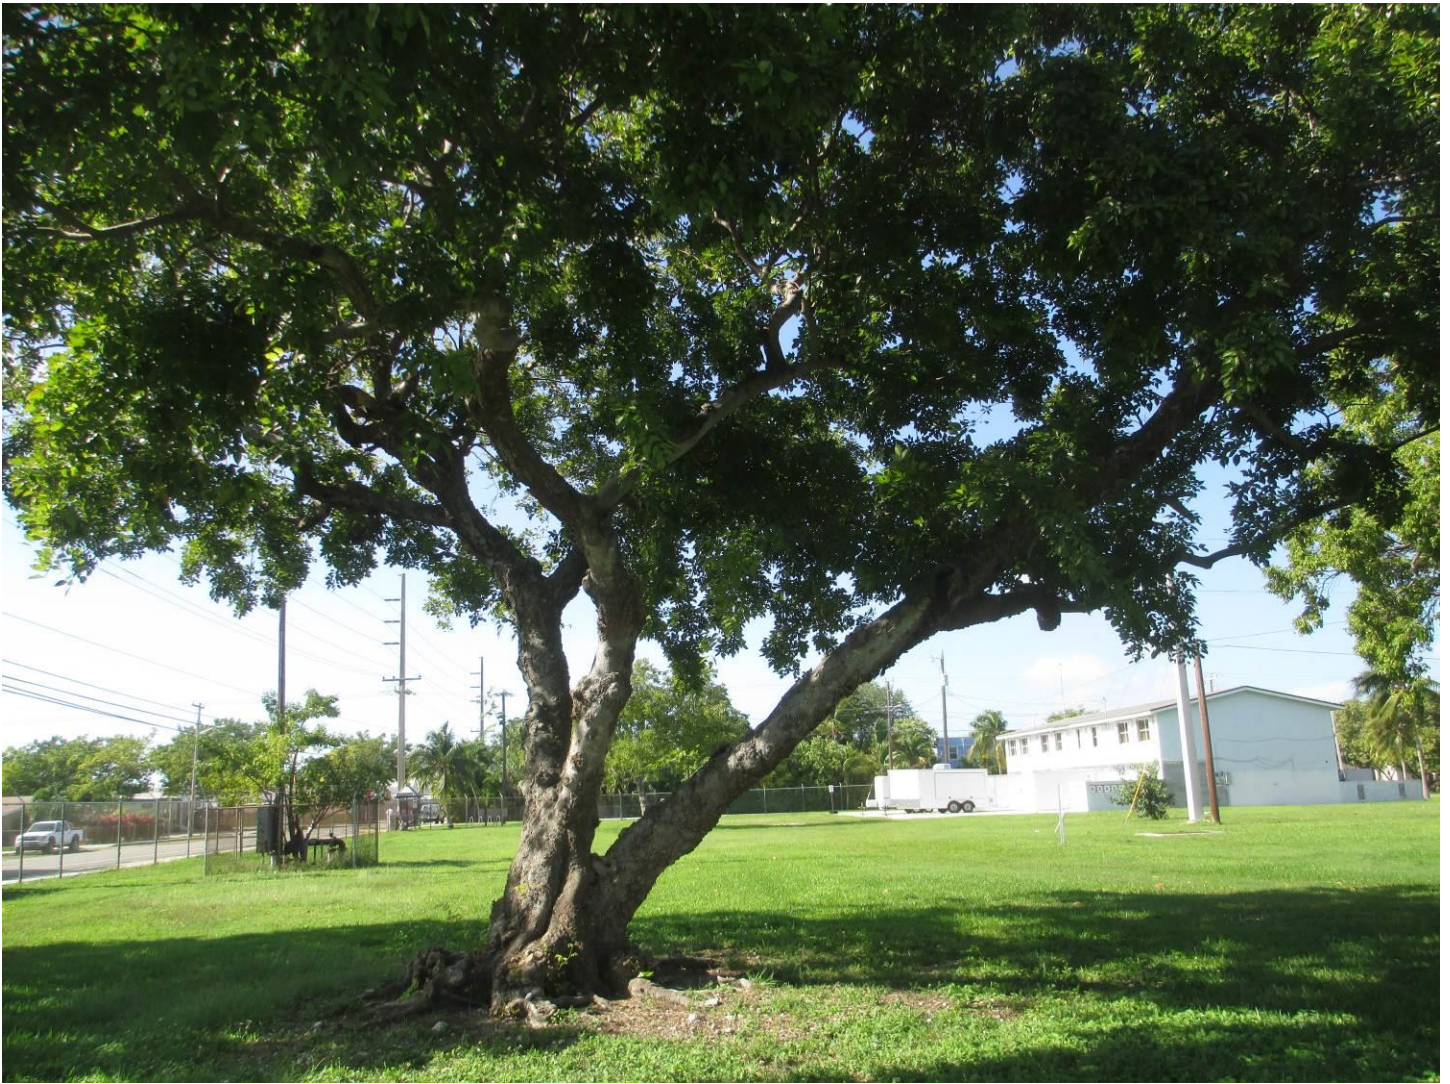
Tree #6: Pongam (*Millettia pinnata*)

Diameter: 52"

Condition: 50% (fair to poor, lots of decay in canopy)

Total Average Value = 60%

Value x Diameter = 31 replacement caliper inches
