STAFF REPORT

DATE: February 26, 2016

RE: **1664 Dunlap Drive-Poinciana Gardens**
(permit application # T16-7794)

FROM: Karen DeMaria, City of Key West Urban Forestry Manager

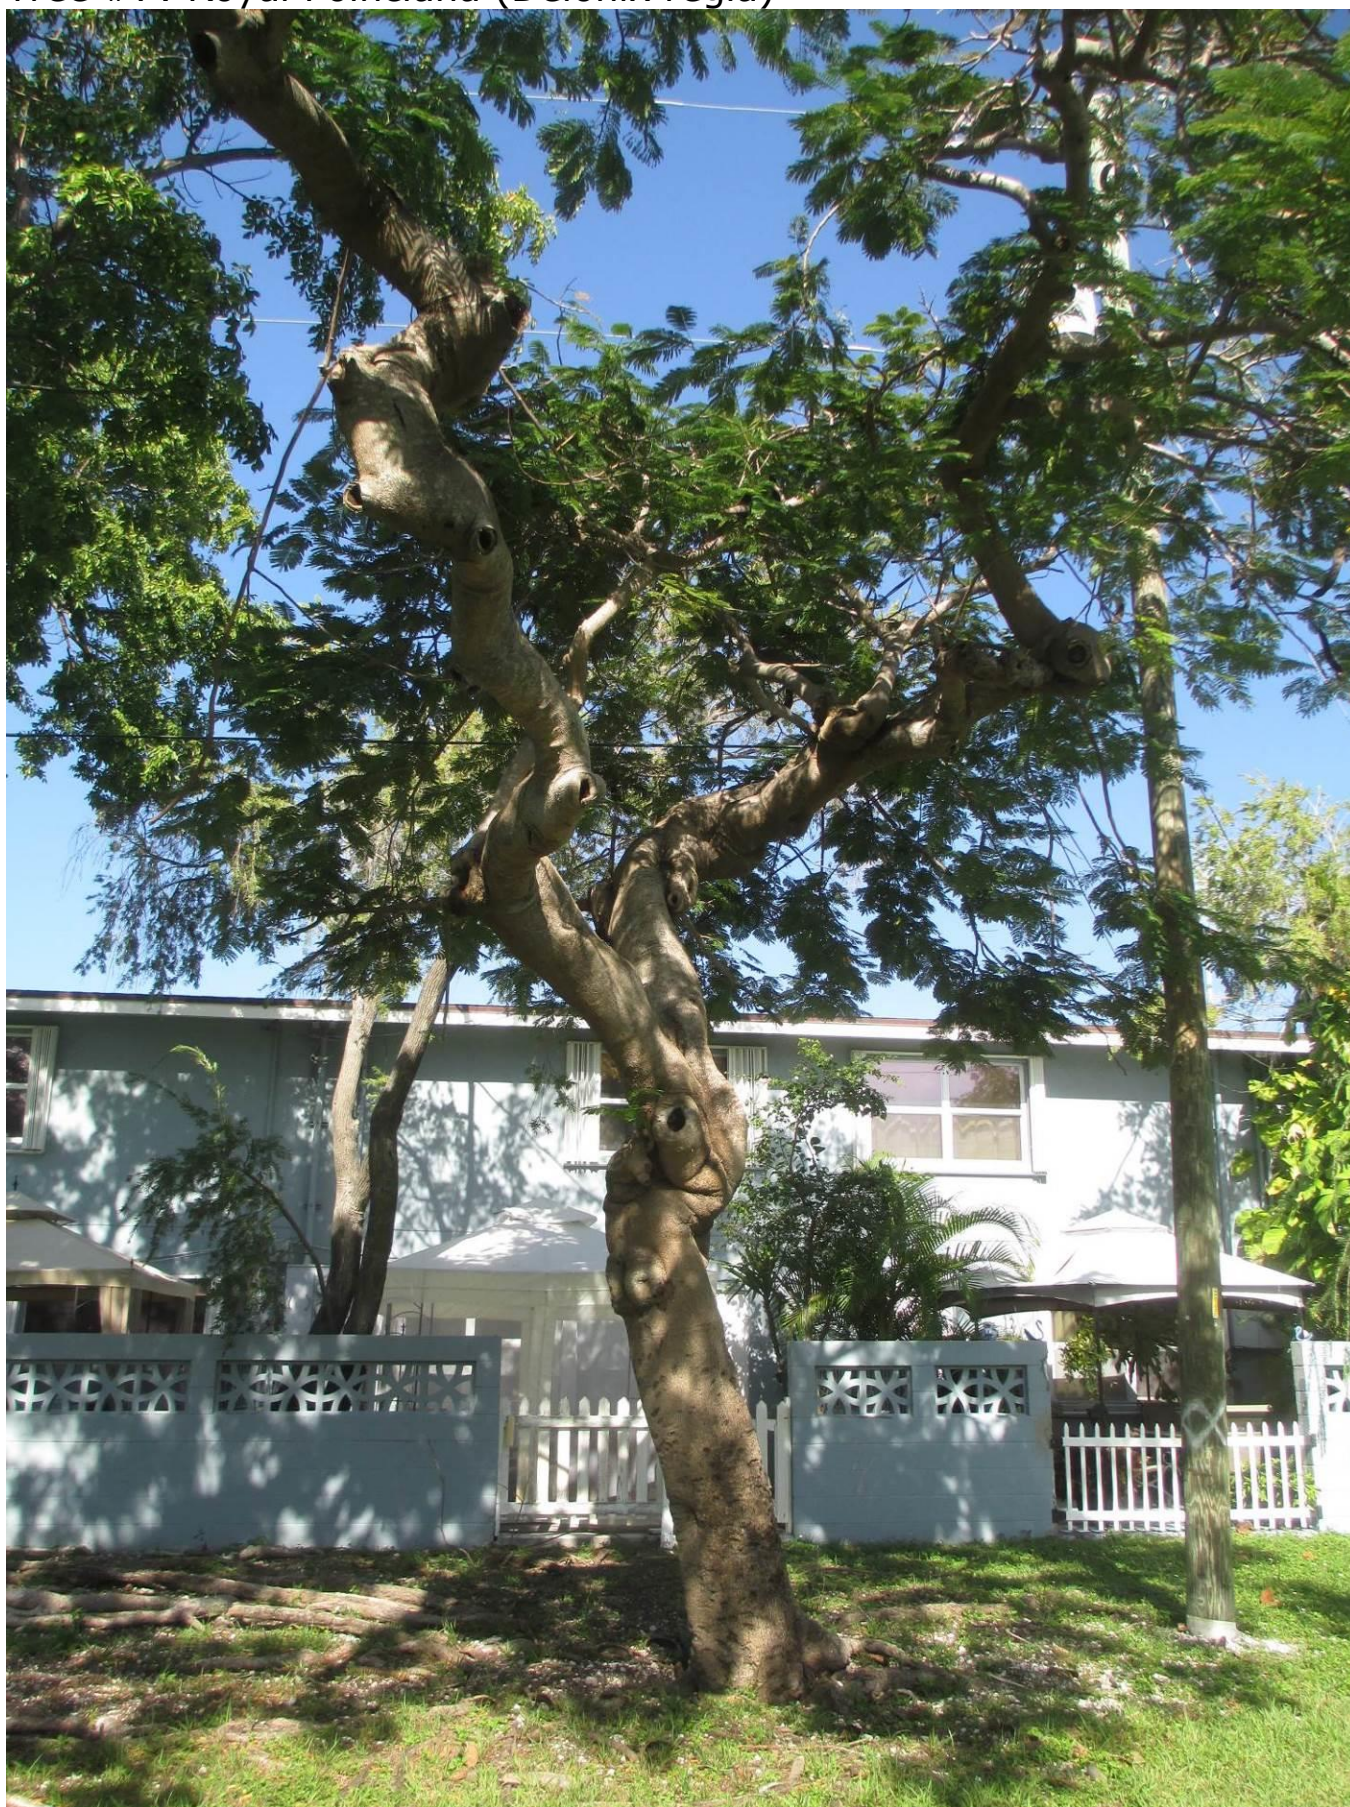
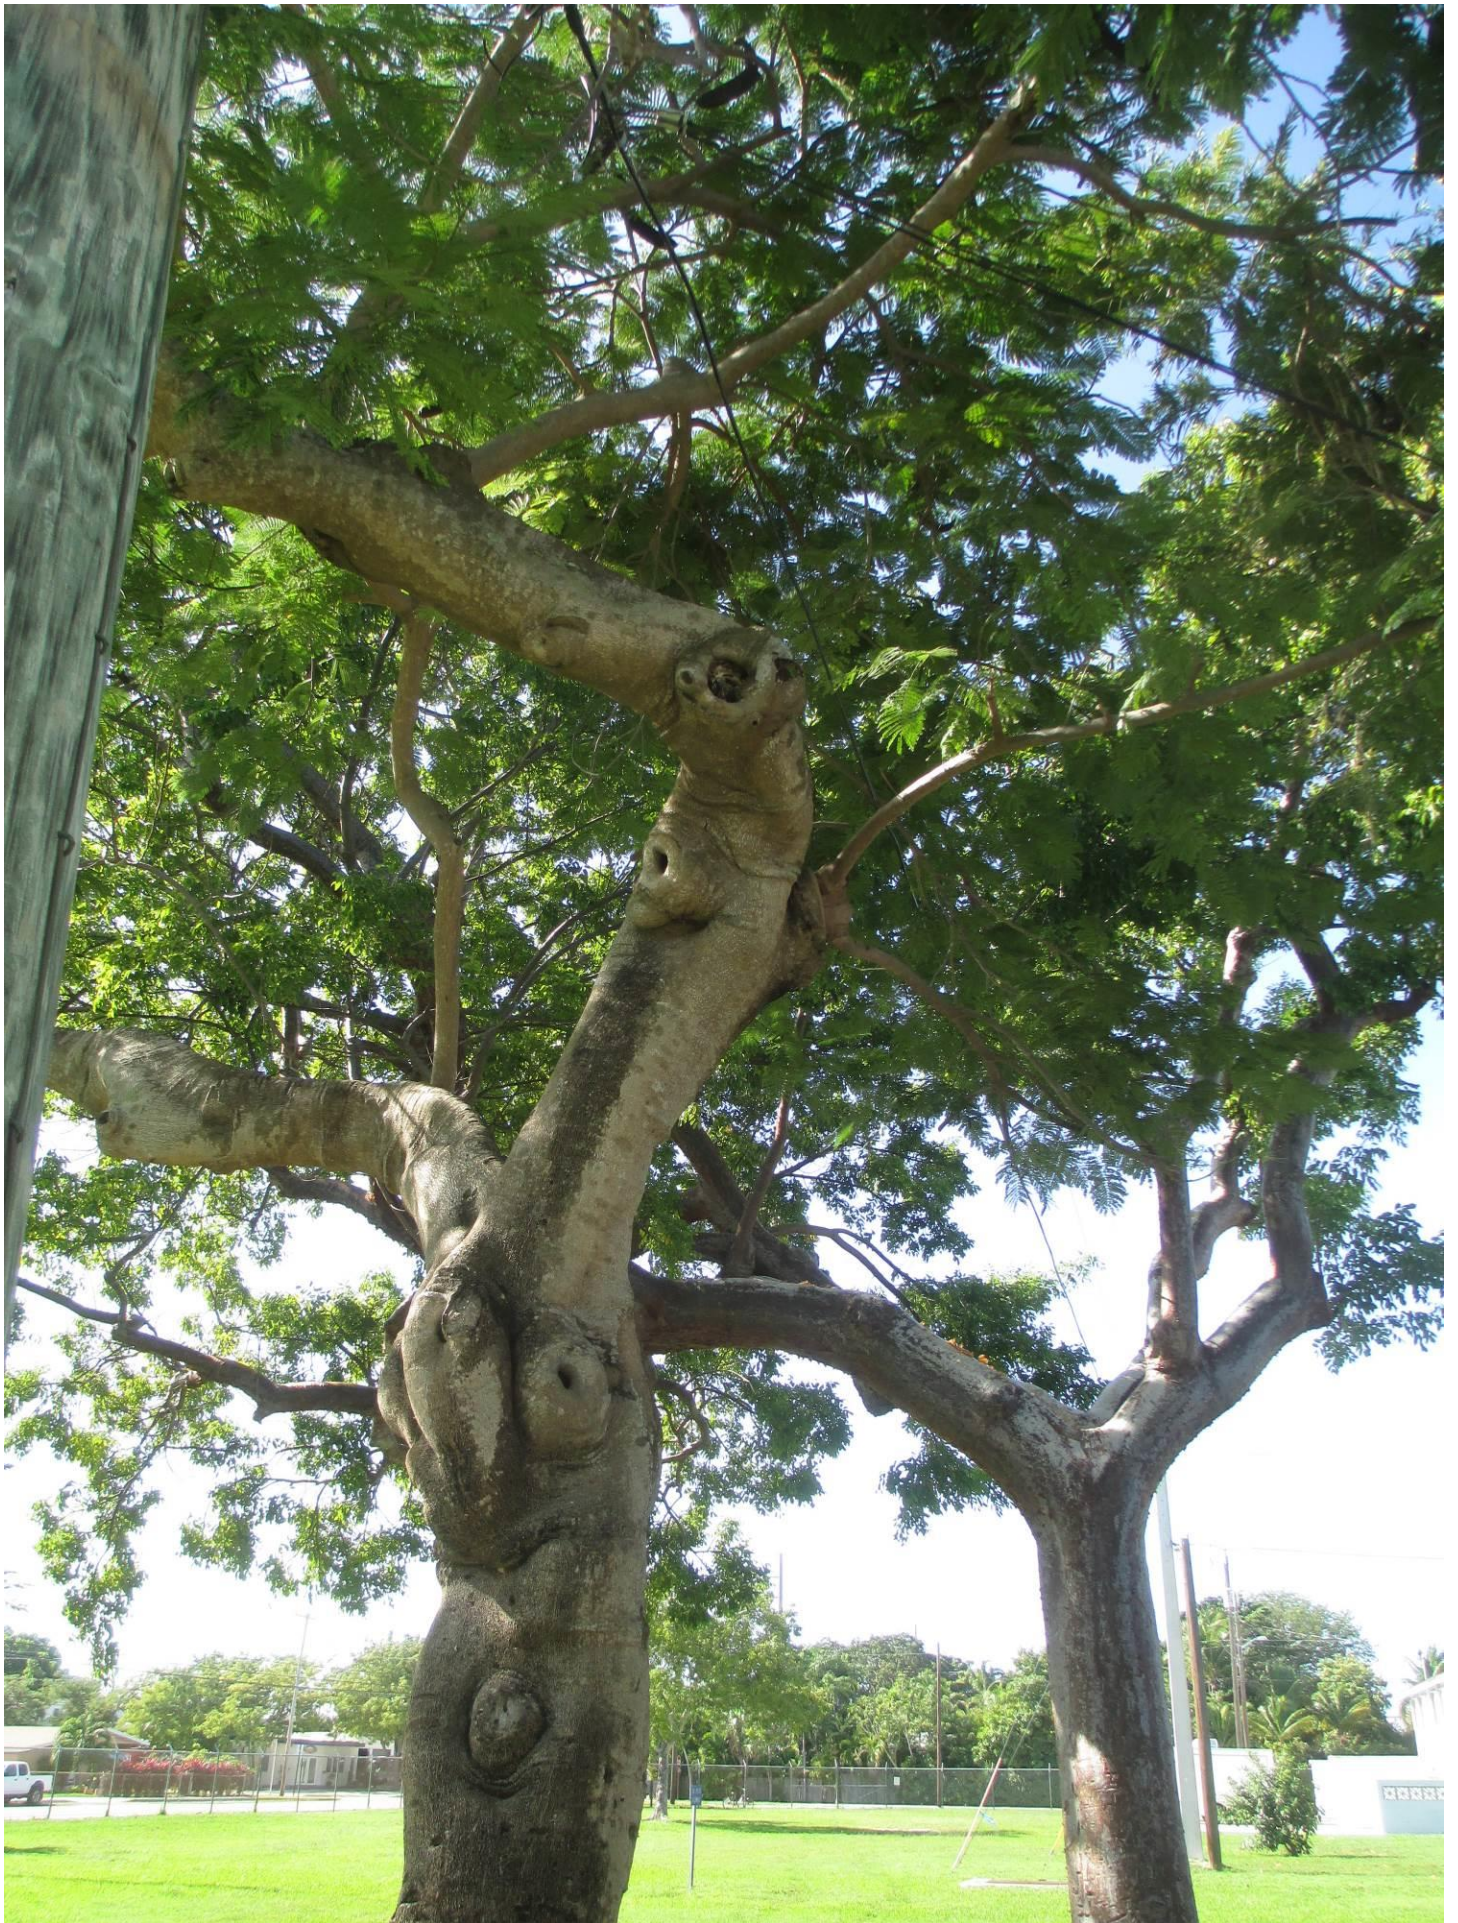
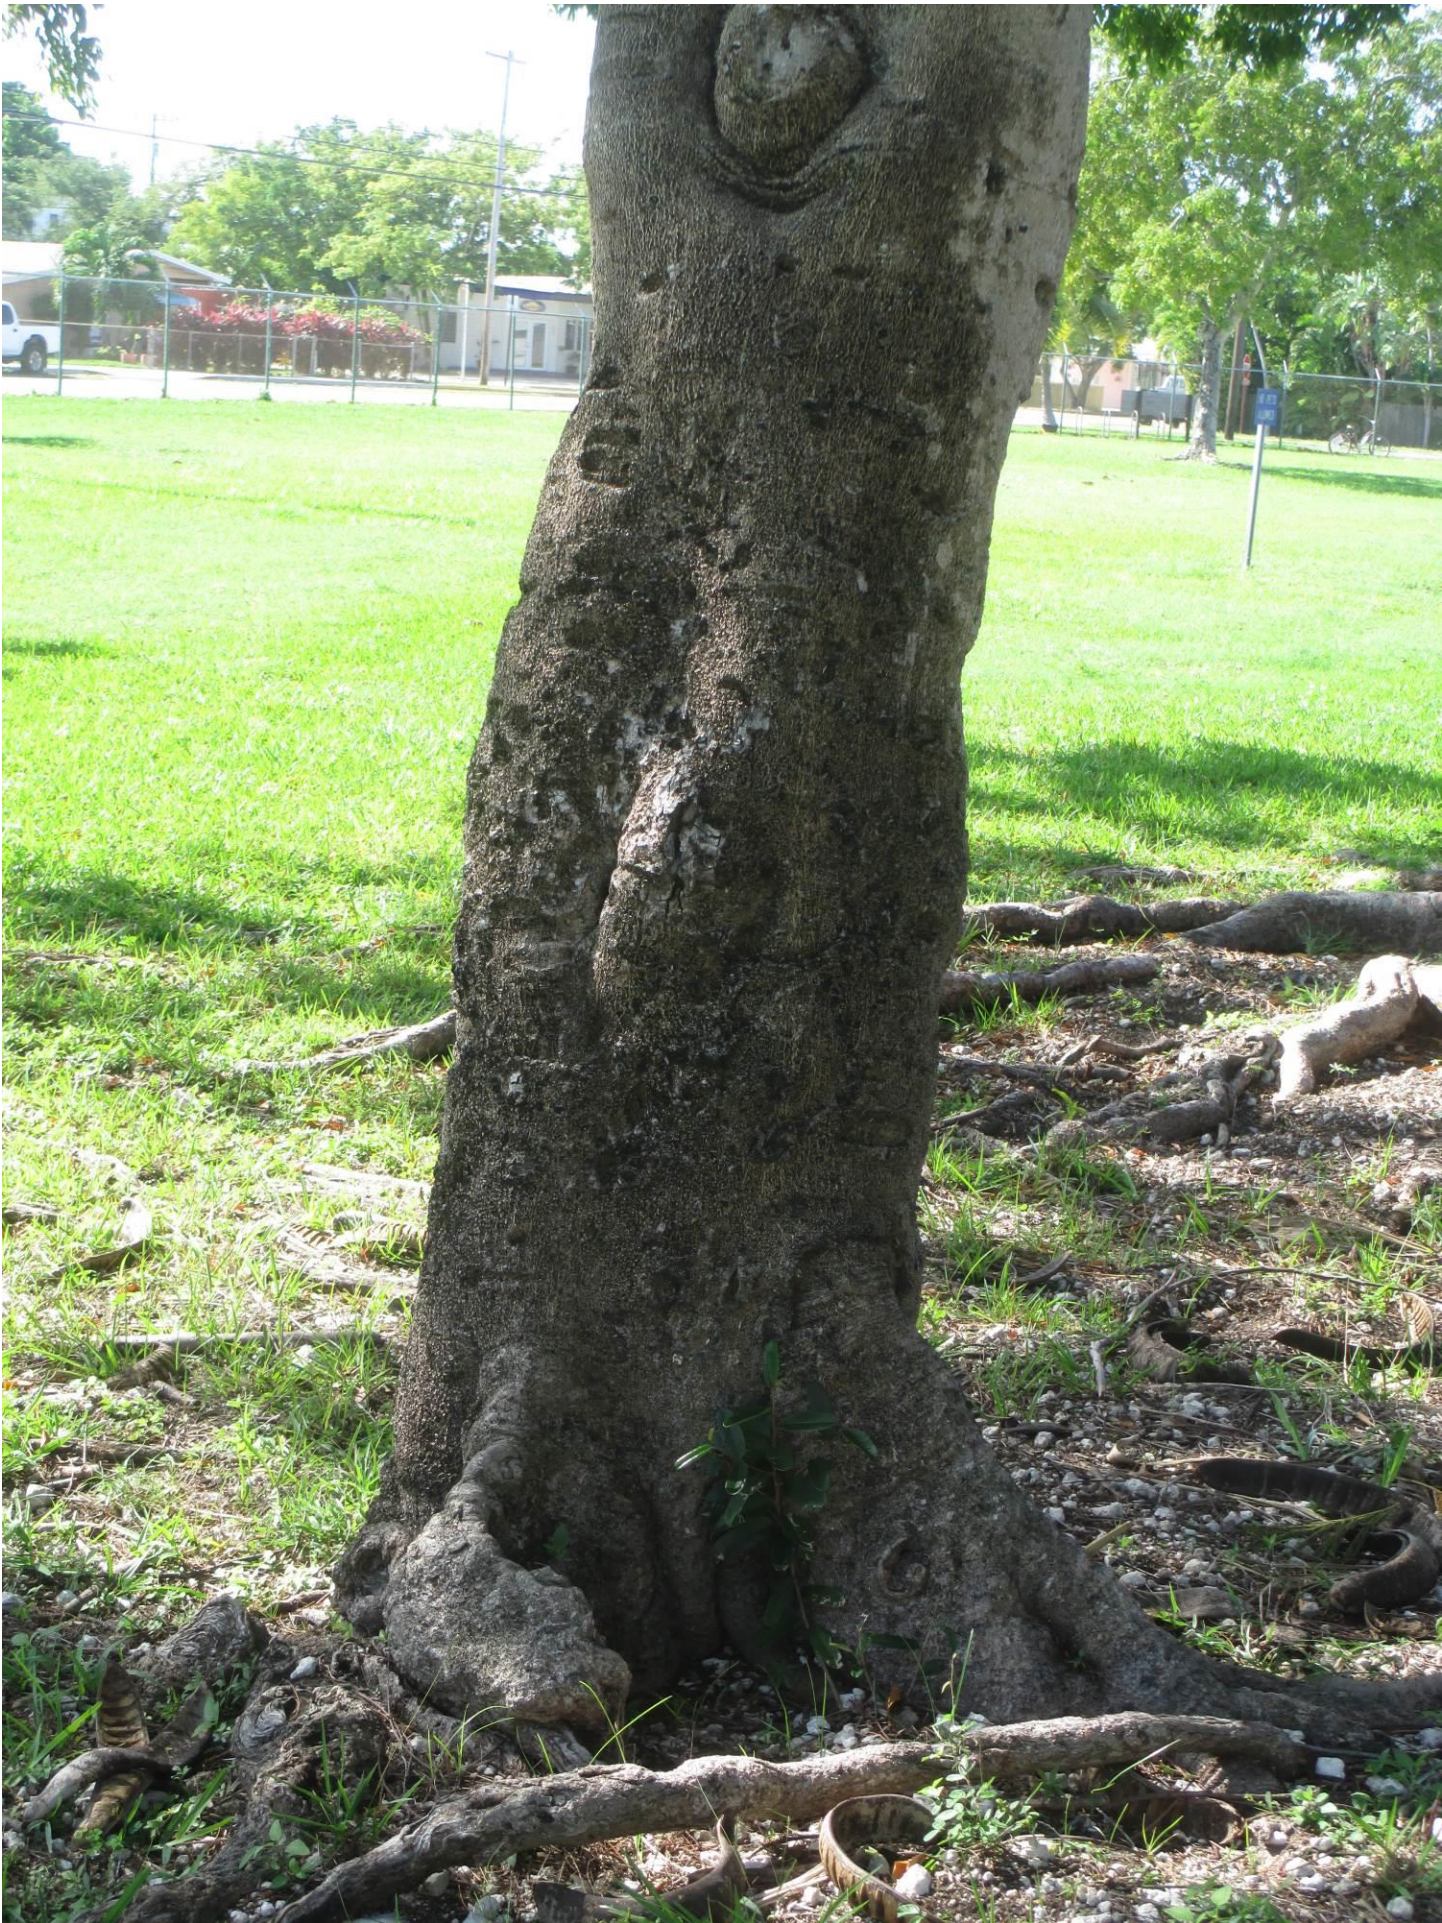
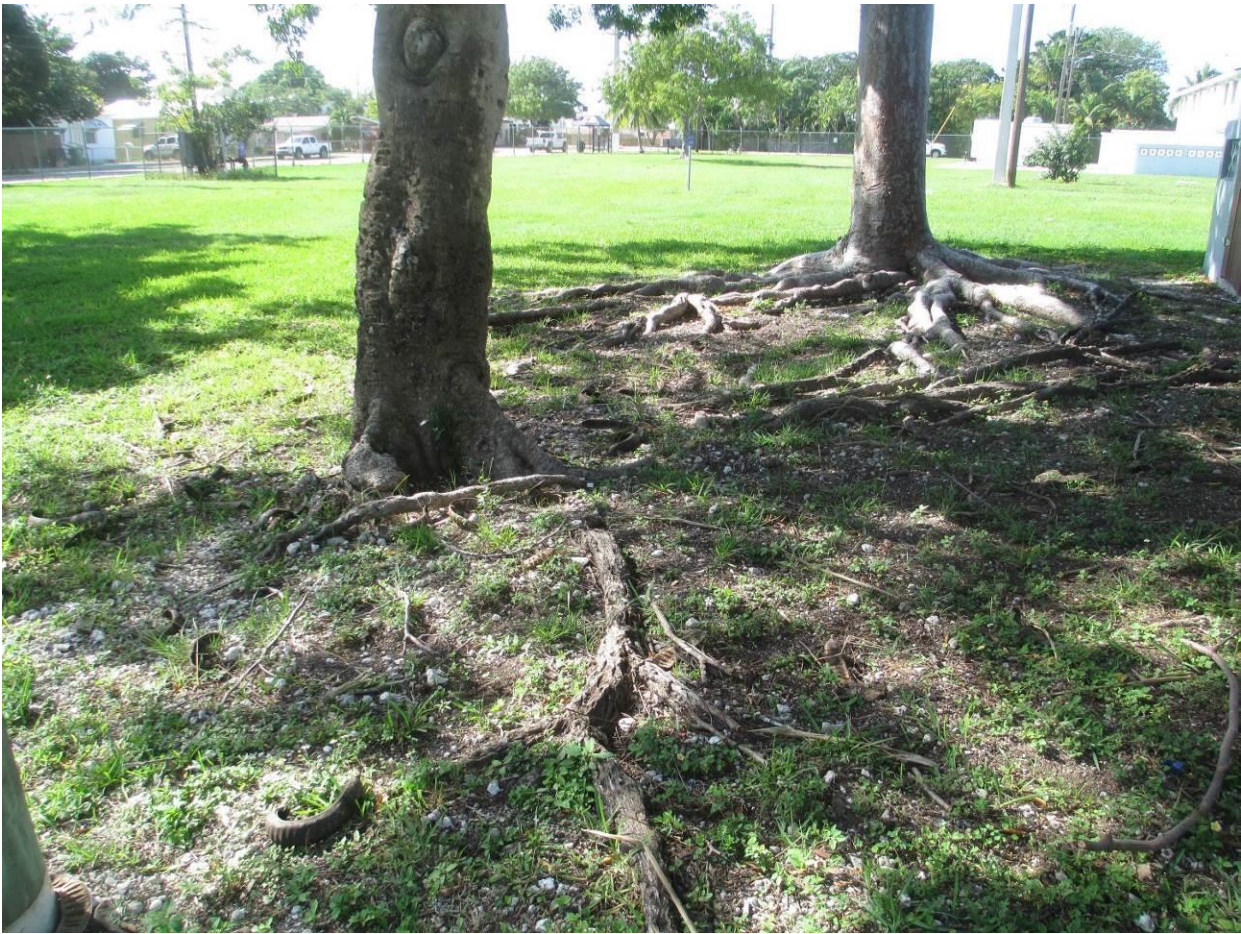
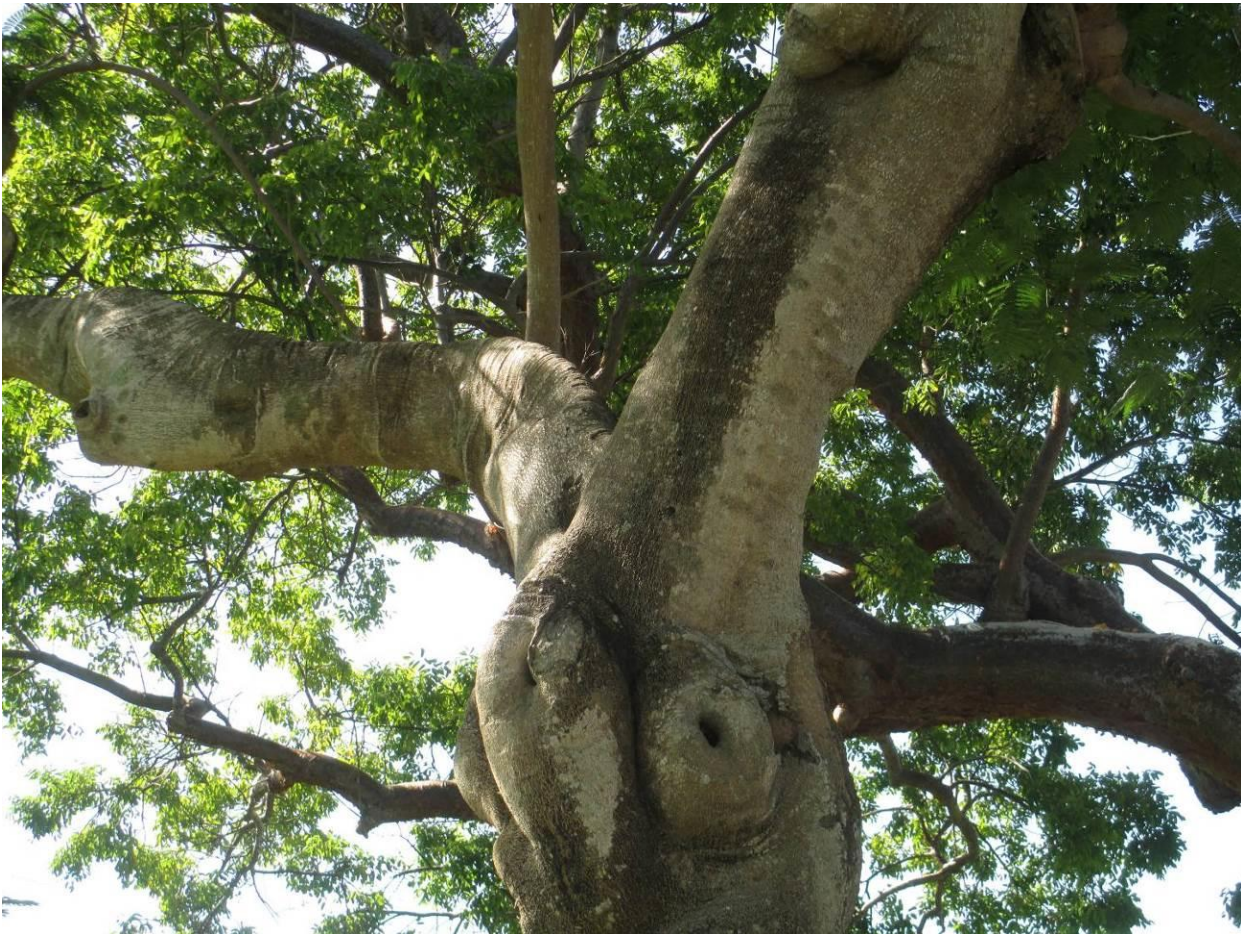
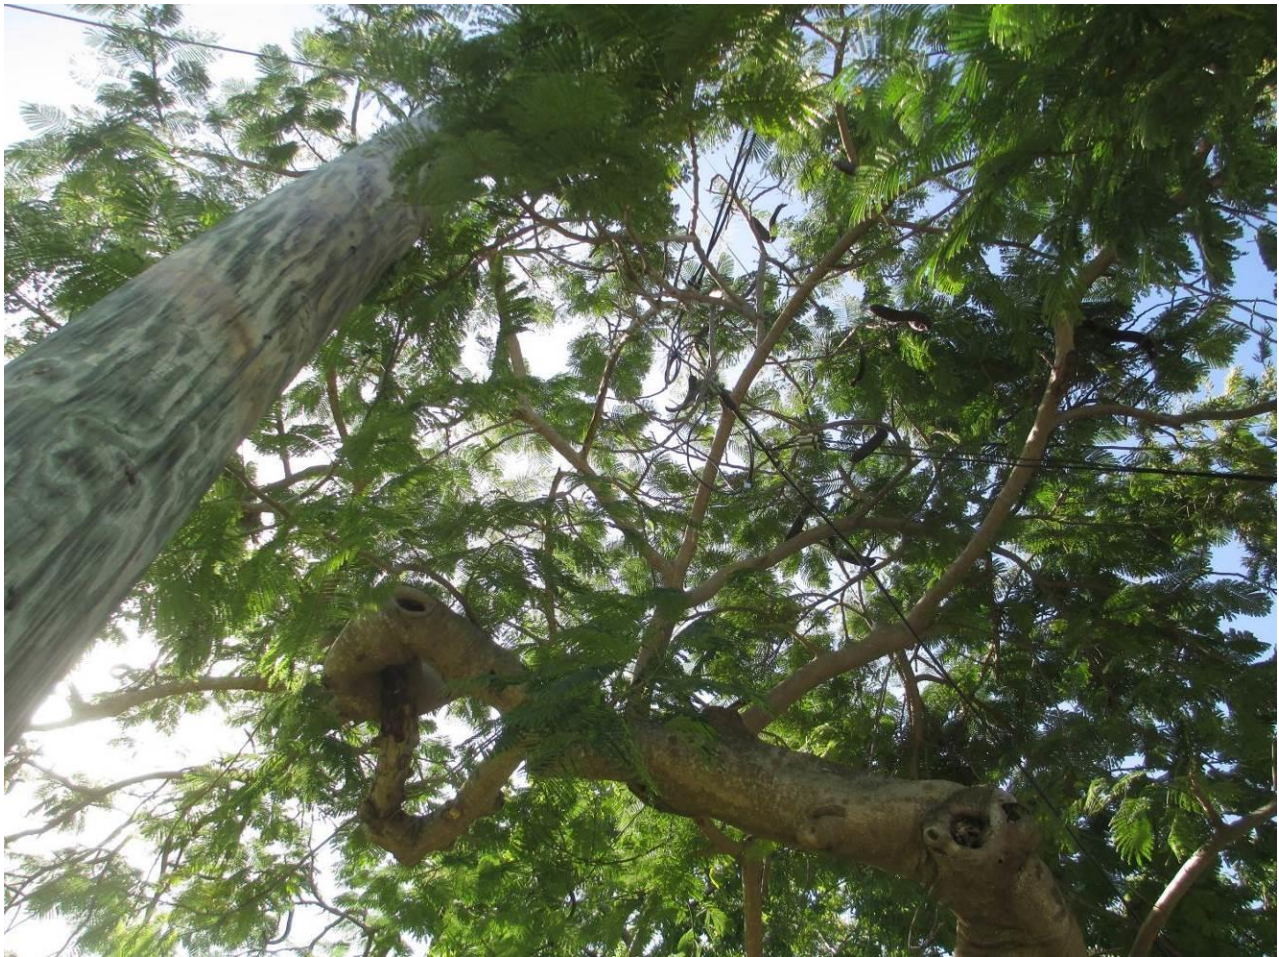
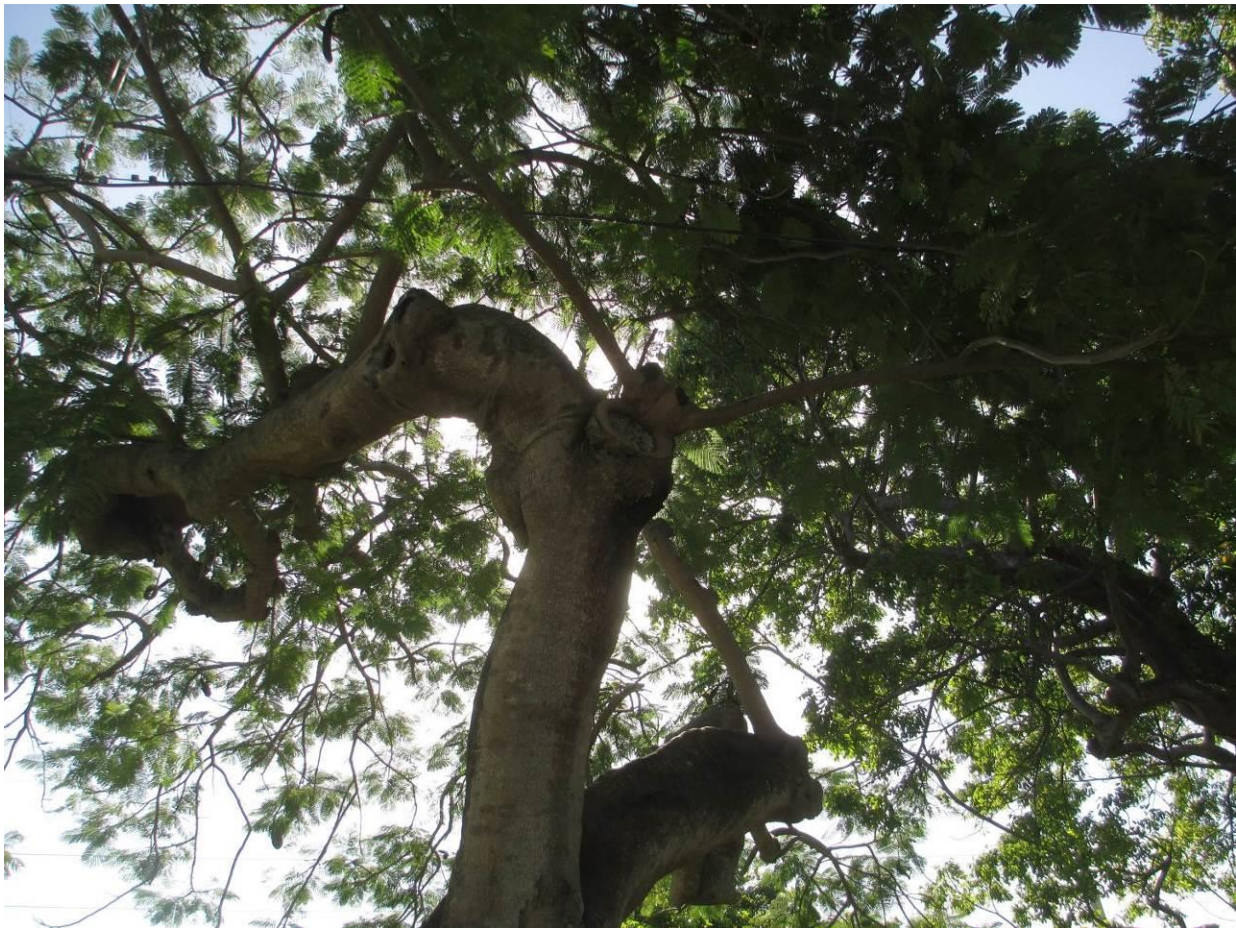
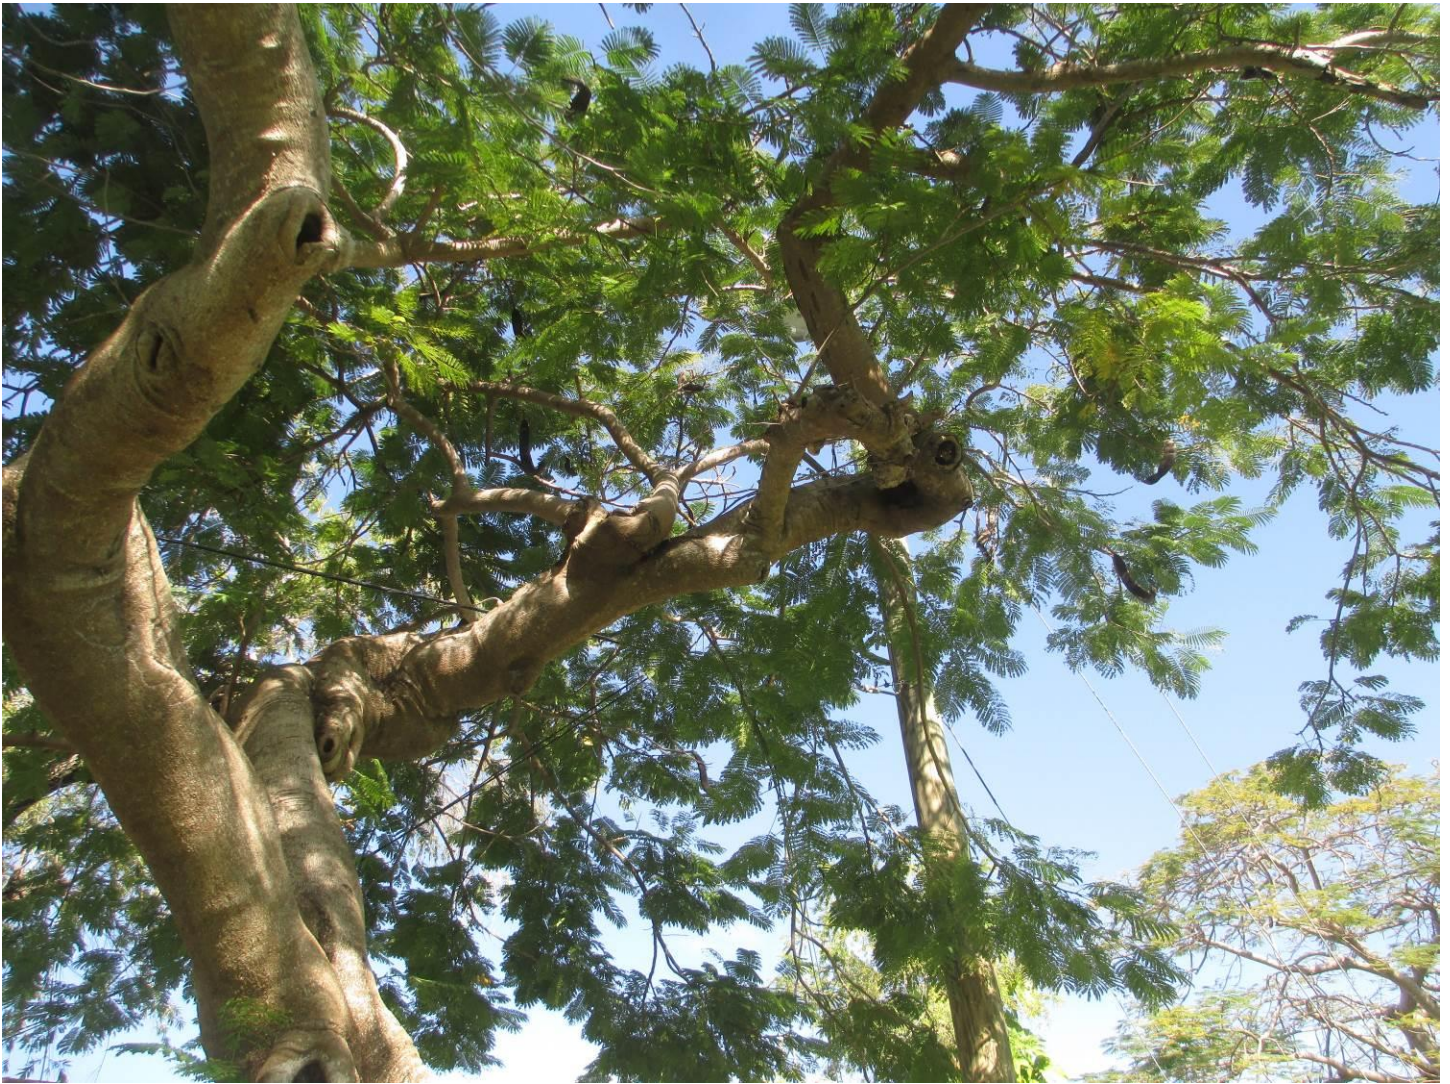
Tree #7: Royal Poinciana (*Delonix regia*)

Diameter: 22"

Location: 60% (close to an existing utility pole)

Condition: 50% (fair to poor, lots of decay in canopy and main trunk)

Total Average Value = 70%

Value x Diameter = 15 replacement caliper inches
