STAFF REPORT

DATE: February 26, 2016

RE: **1664 Dunlap Drive-Poinciana Gardens**
(permit application # T16-7794)

FROM: Karen DeMaria, City of Key West Urban Forestry Manager

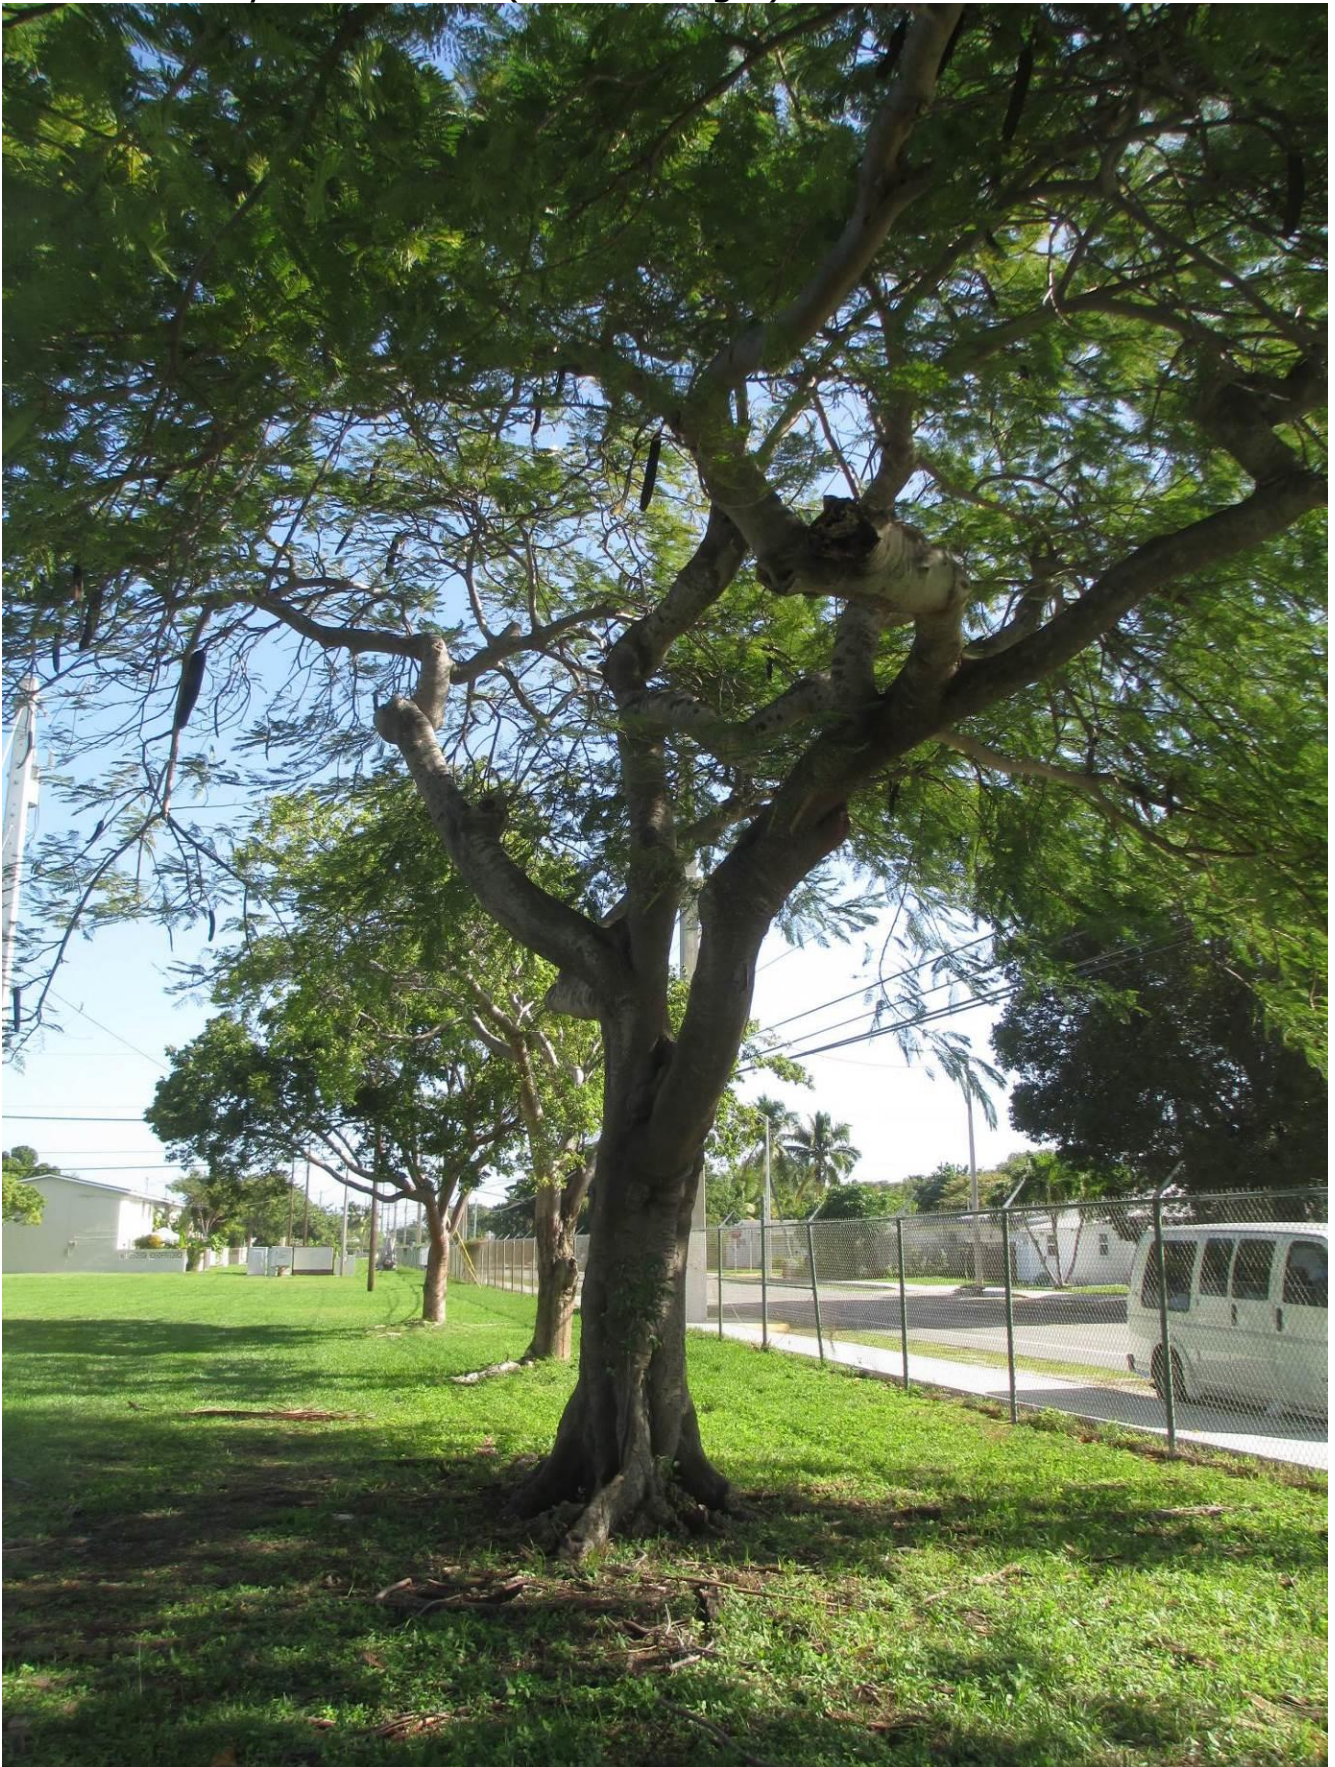
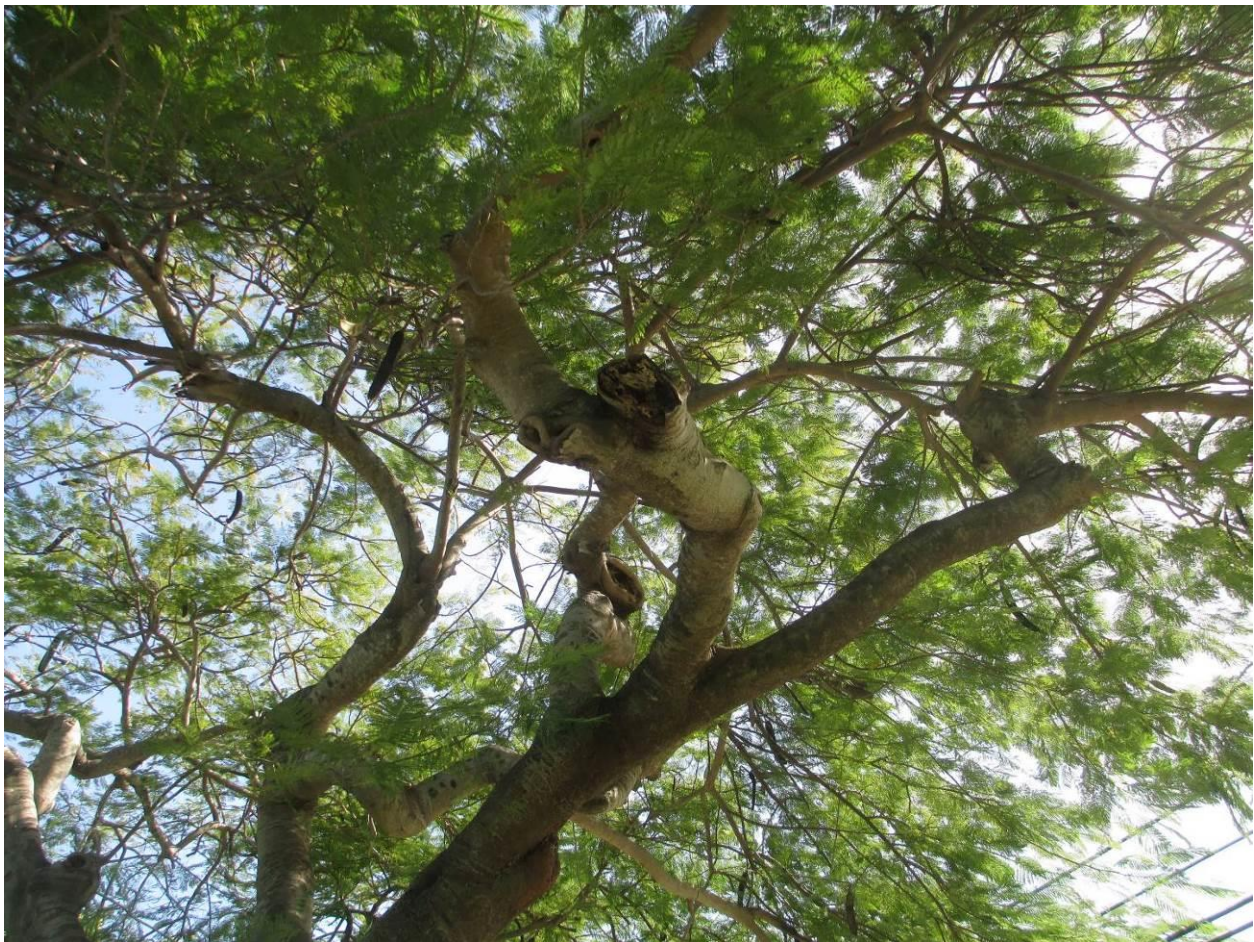
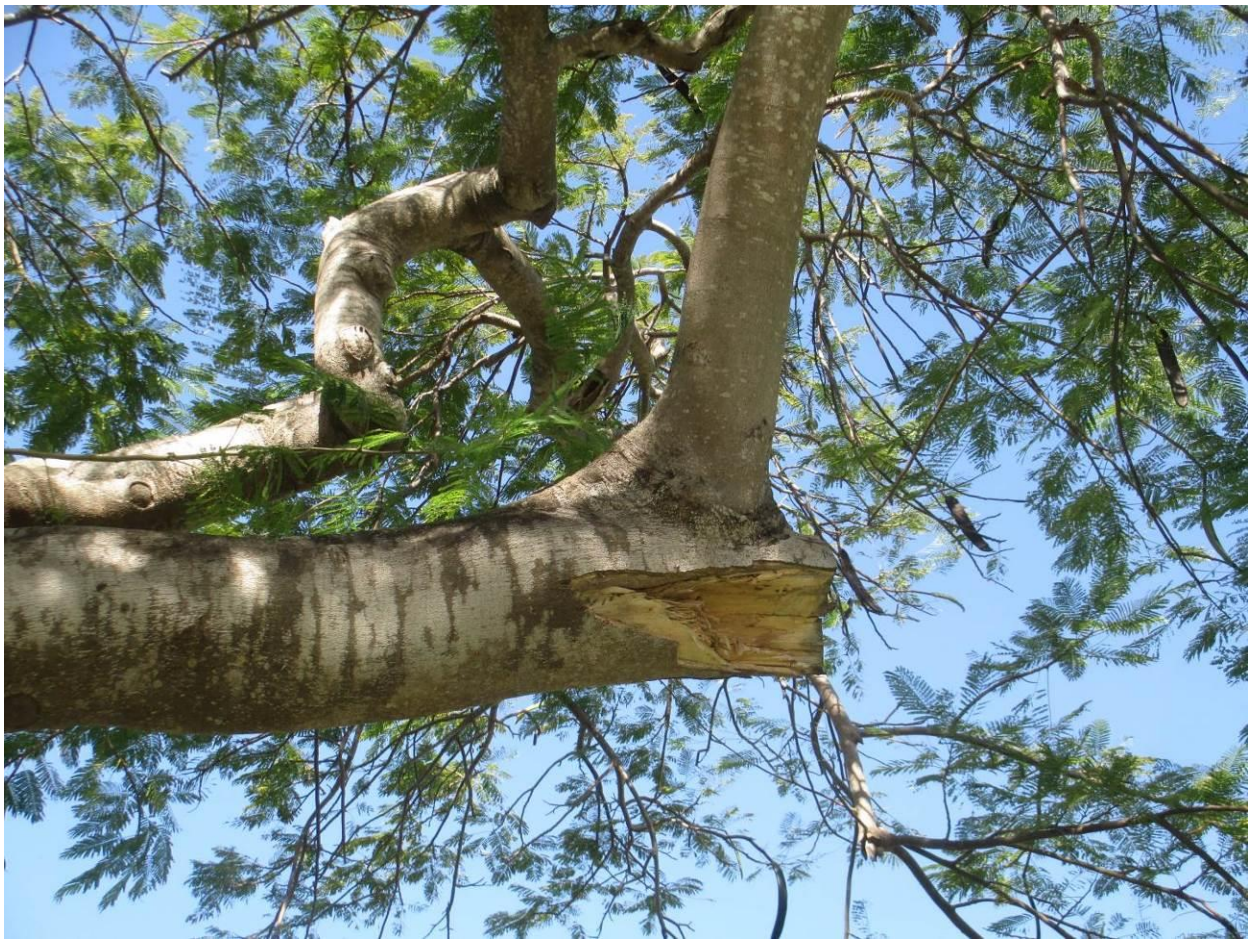
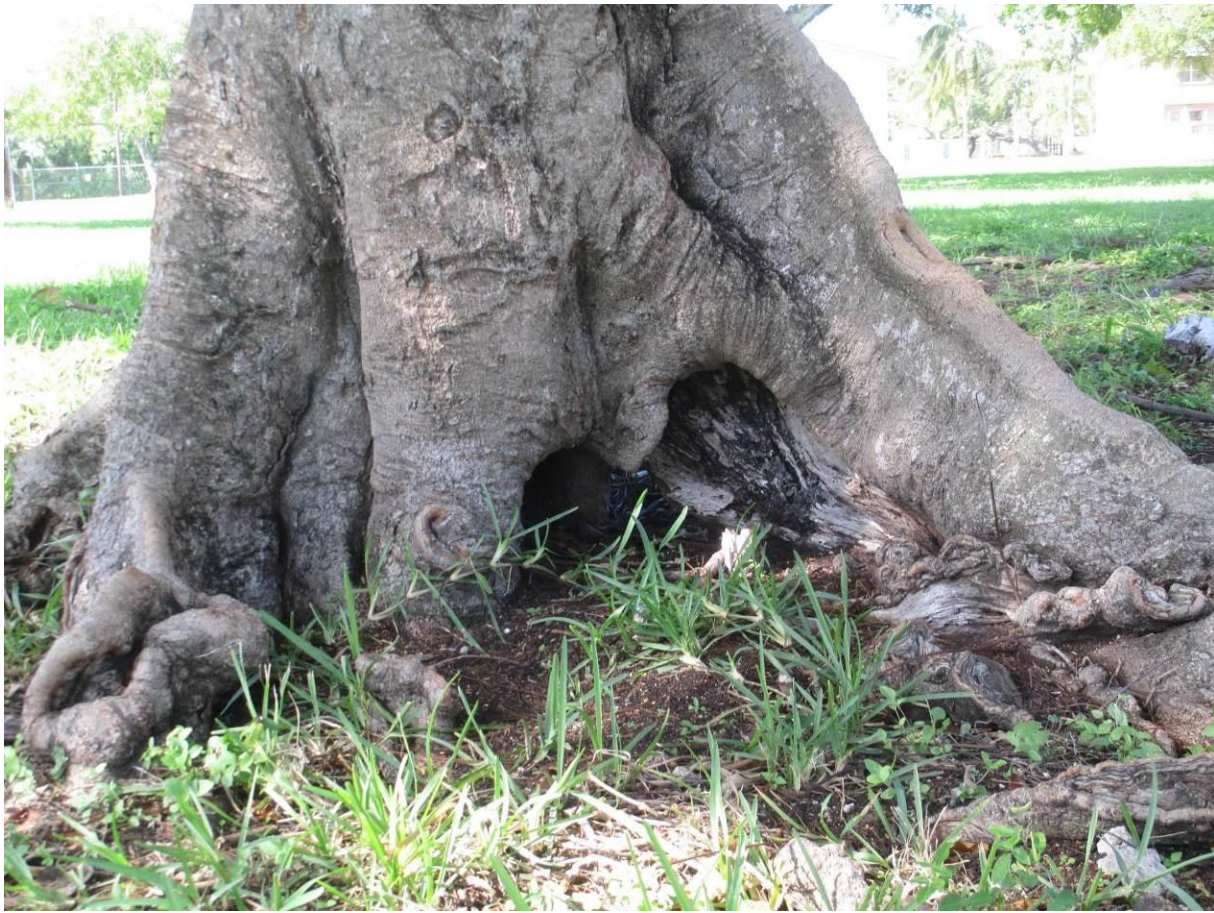
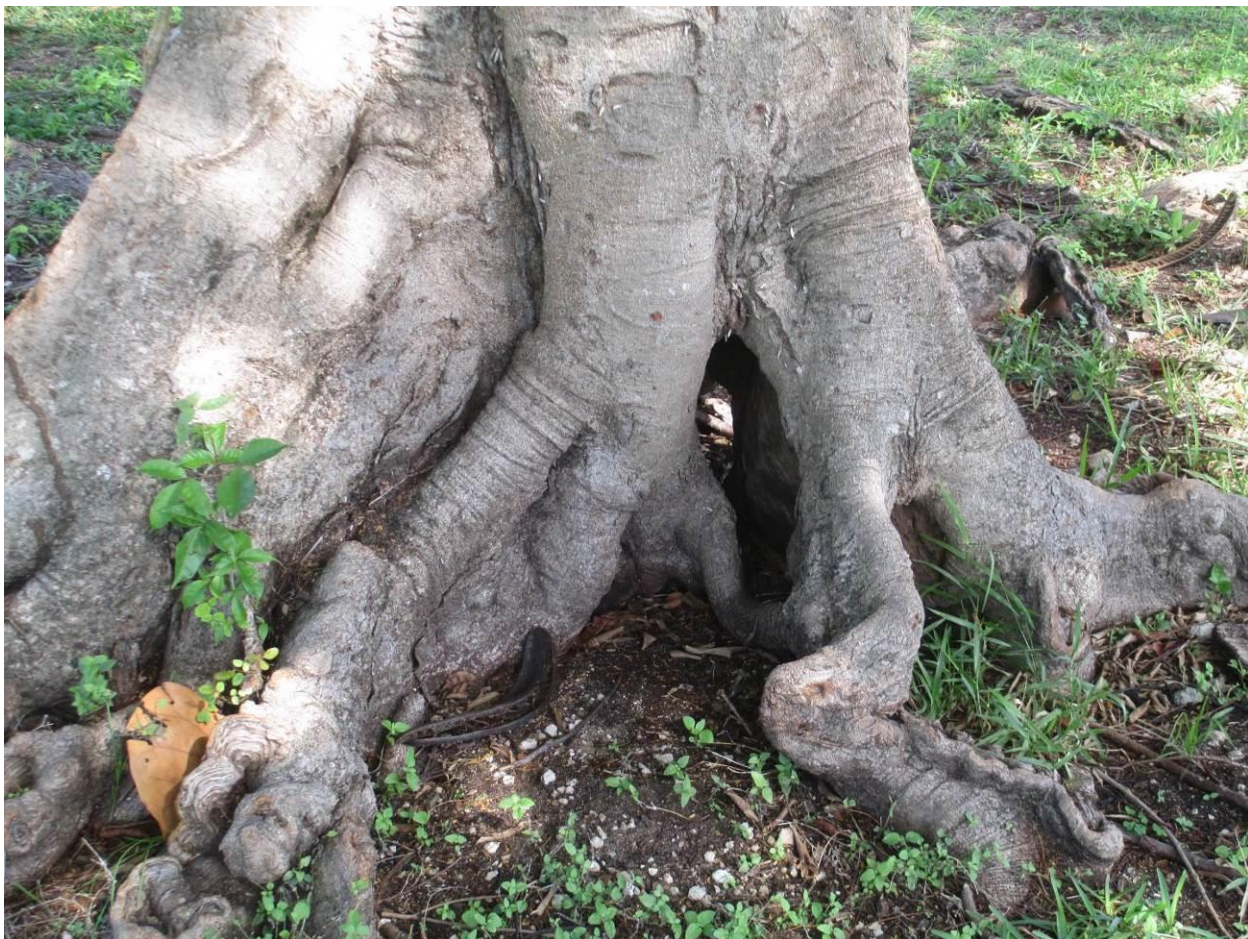
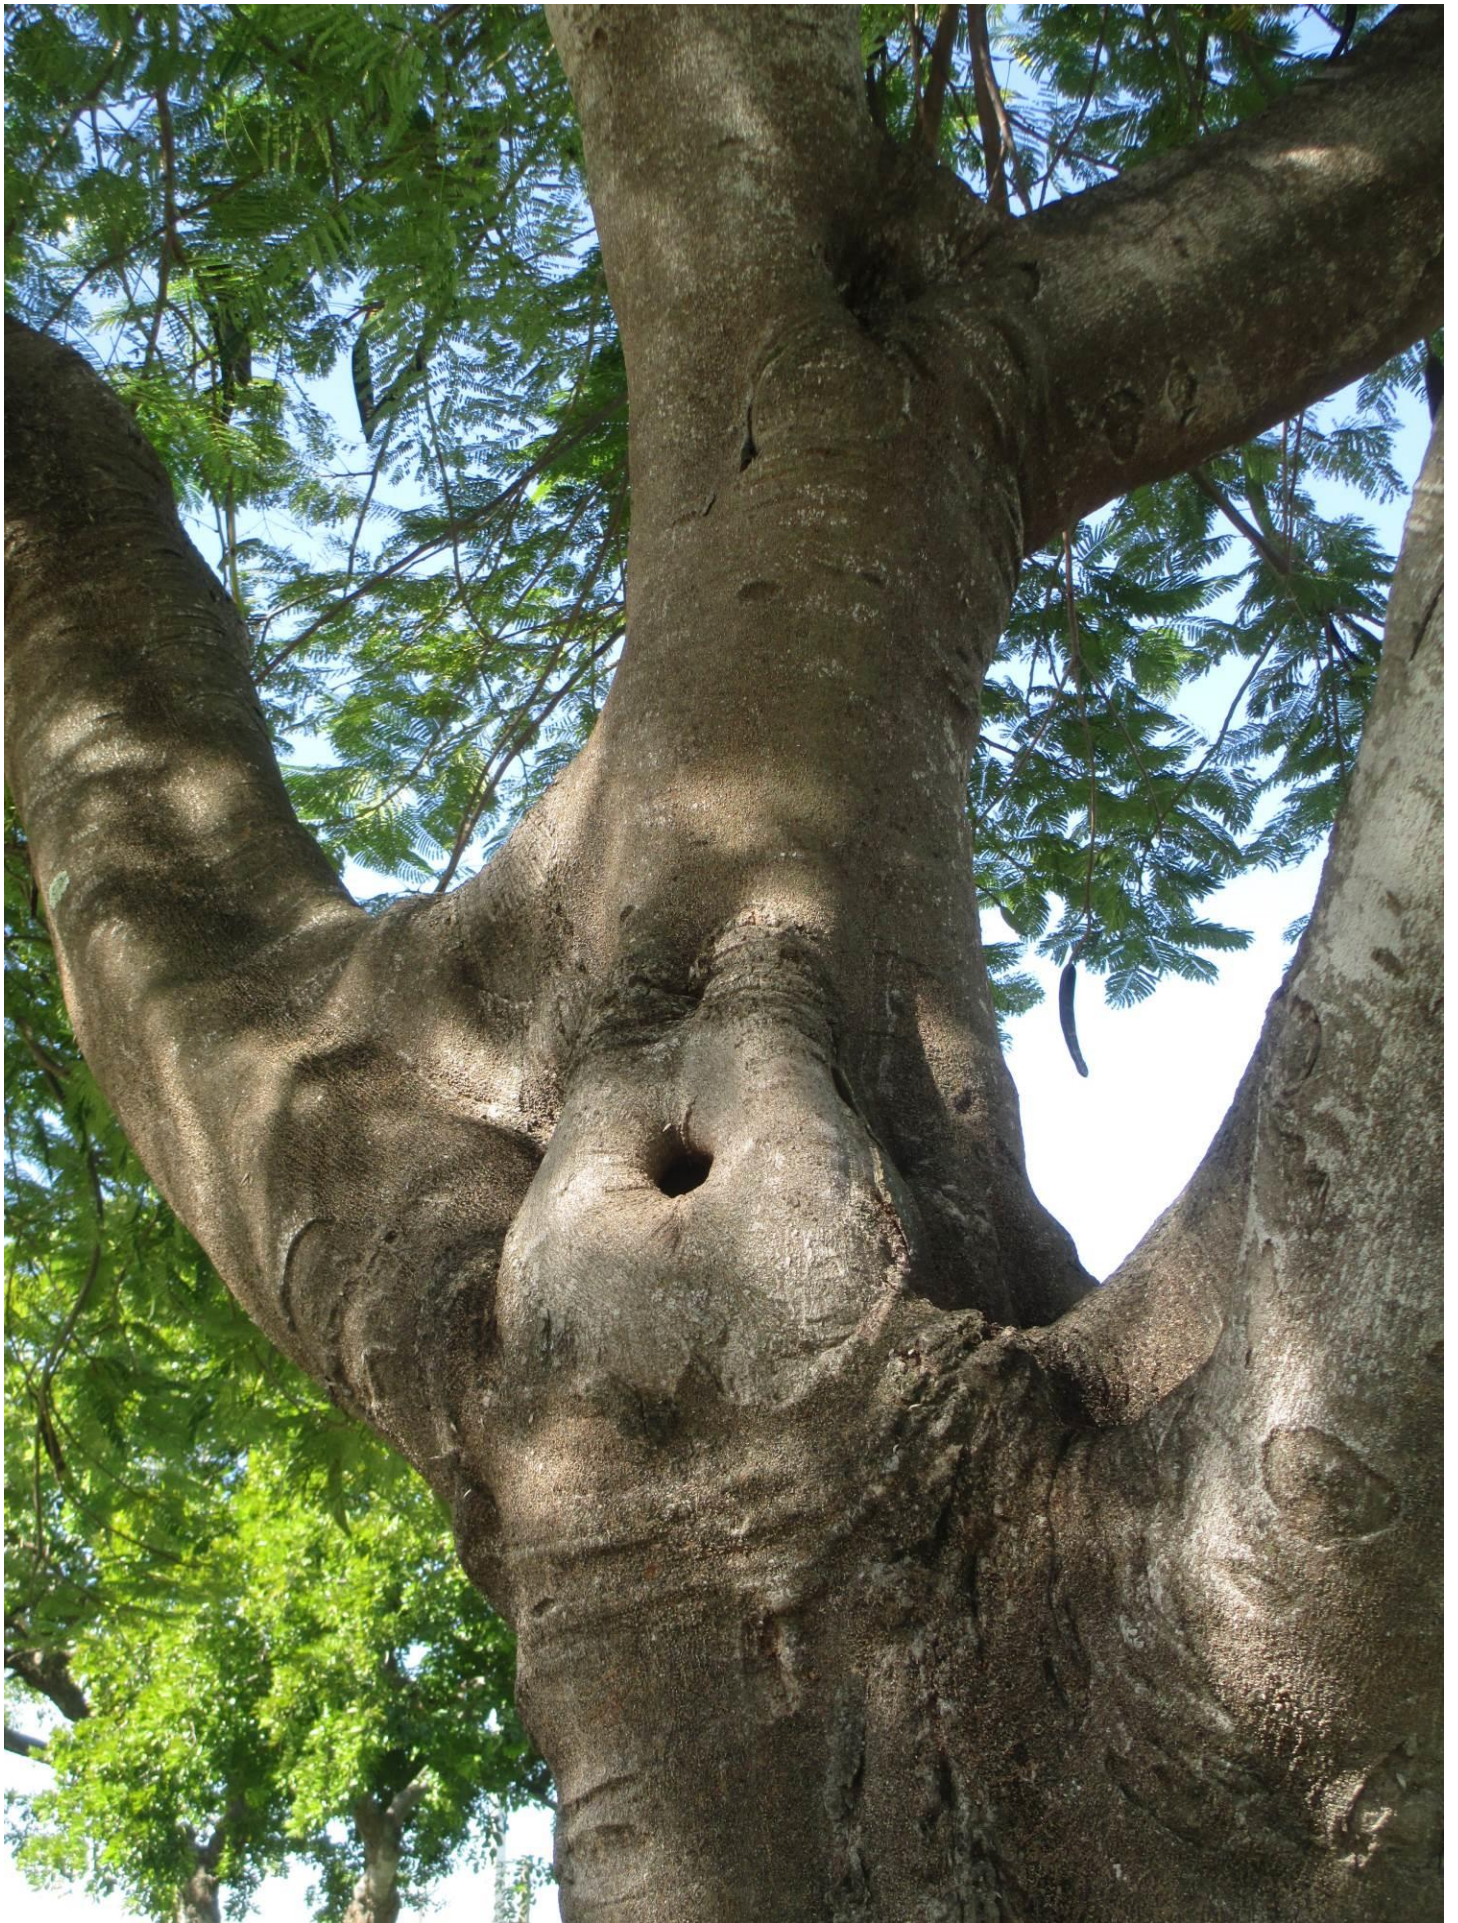
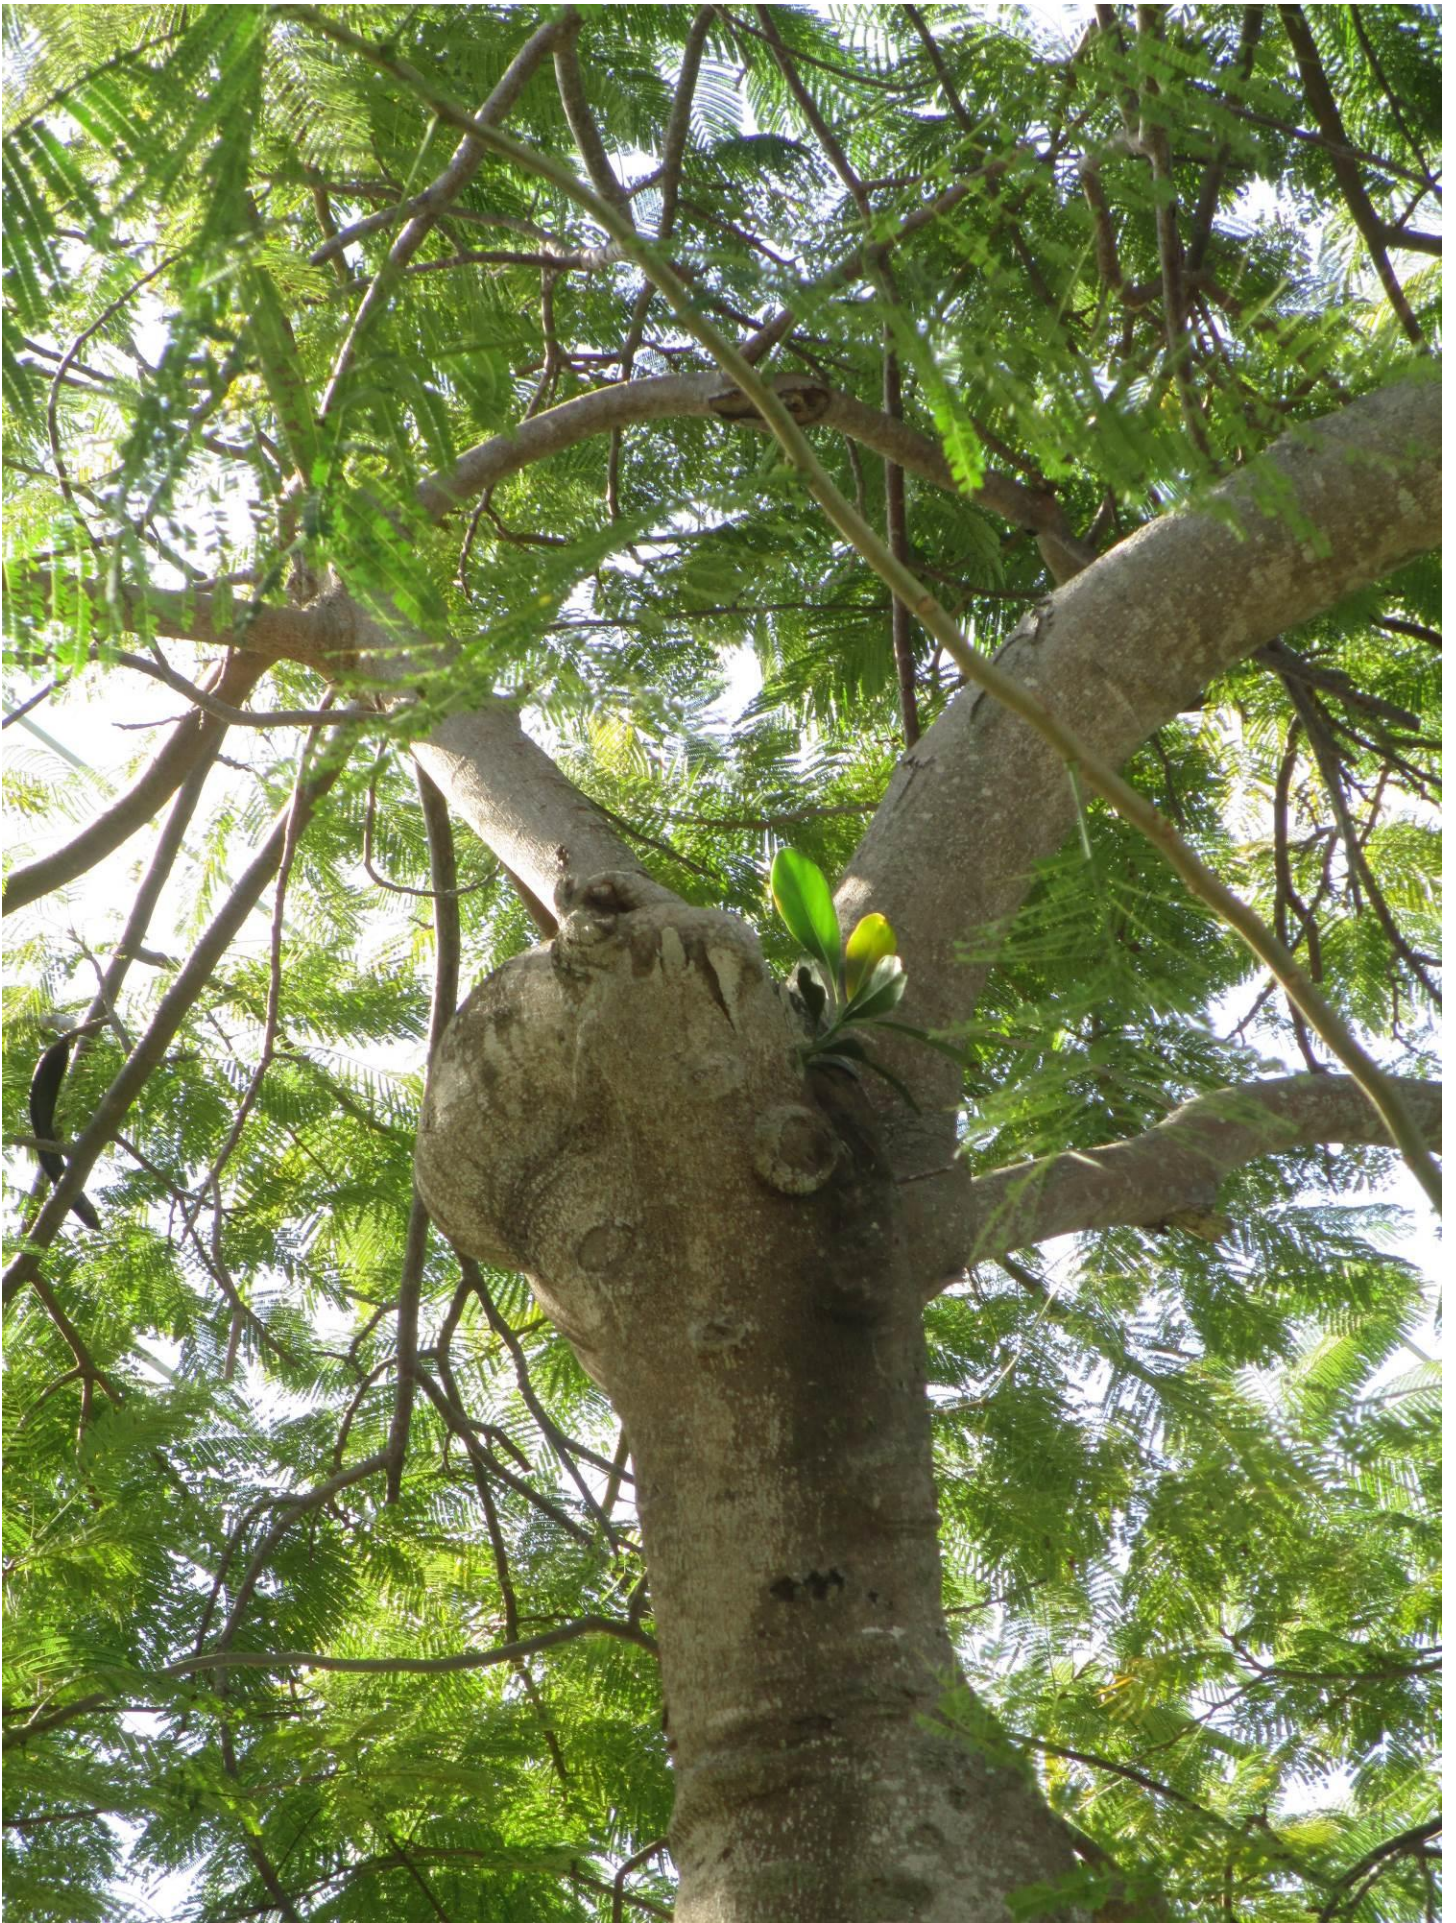
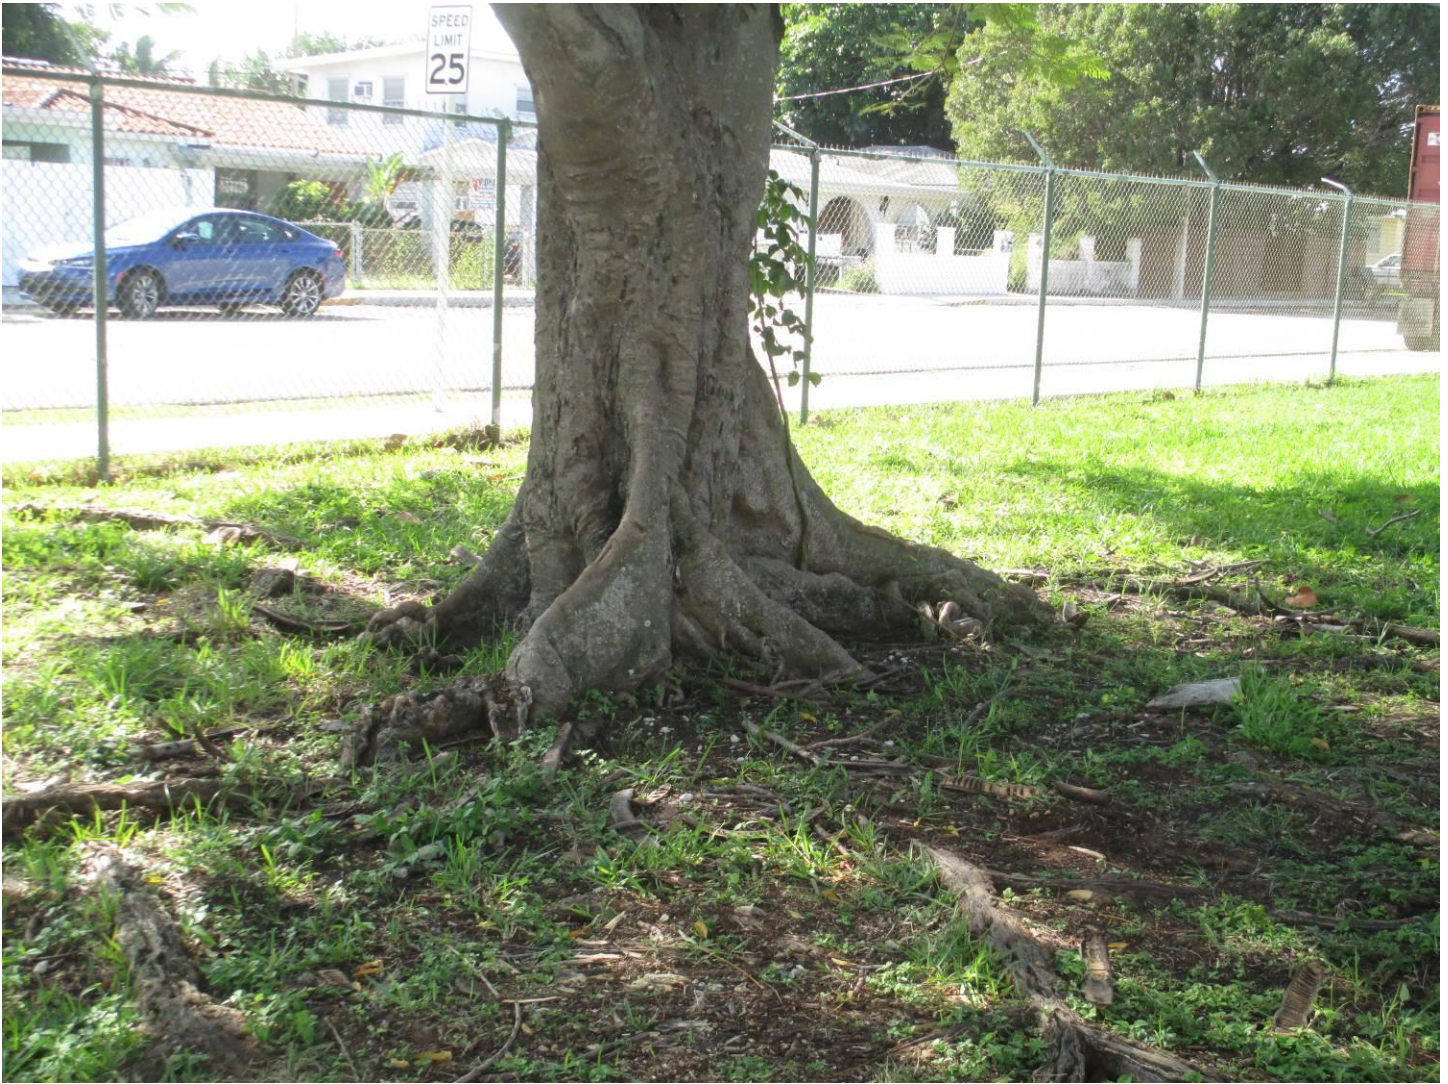
Tree #8: Royal Poinciana (*Delonix regia*)

Diameter: 26"

Condition: 30% (poor, hole in the base, lots of decay in canopy and in main trunk system)

Total Average Value = 70%

Value x Diameter = 18 replacement caliper inches
