STAFF REPORT

DATE: February 26, 2016

RE: **1664 Dunlap Drive-Poinciana Gardens**
(permit application # T16-7794)

FROM: Karen DeMaria, City of Key West Urban Forestry Manager

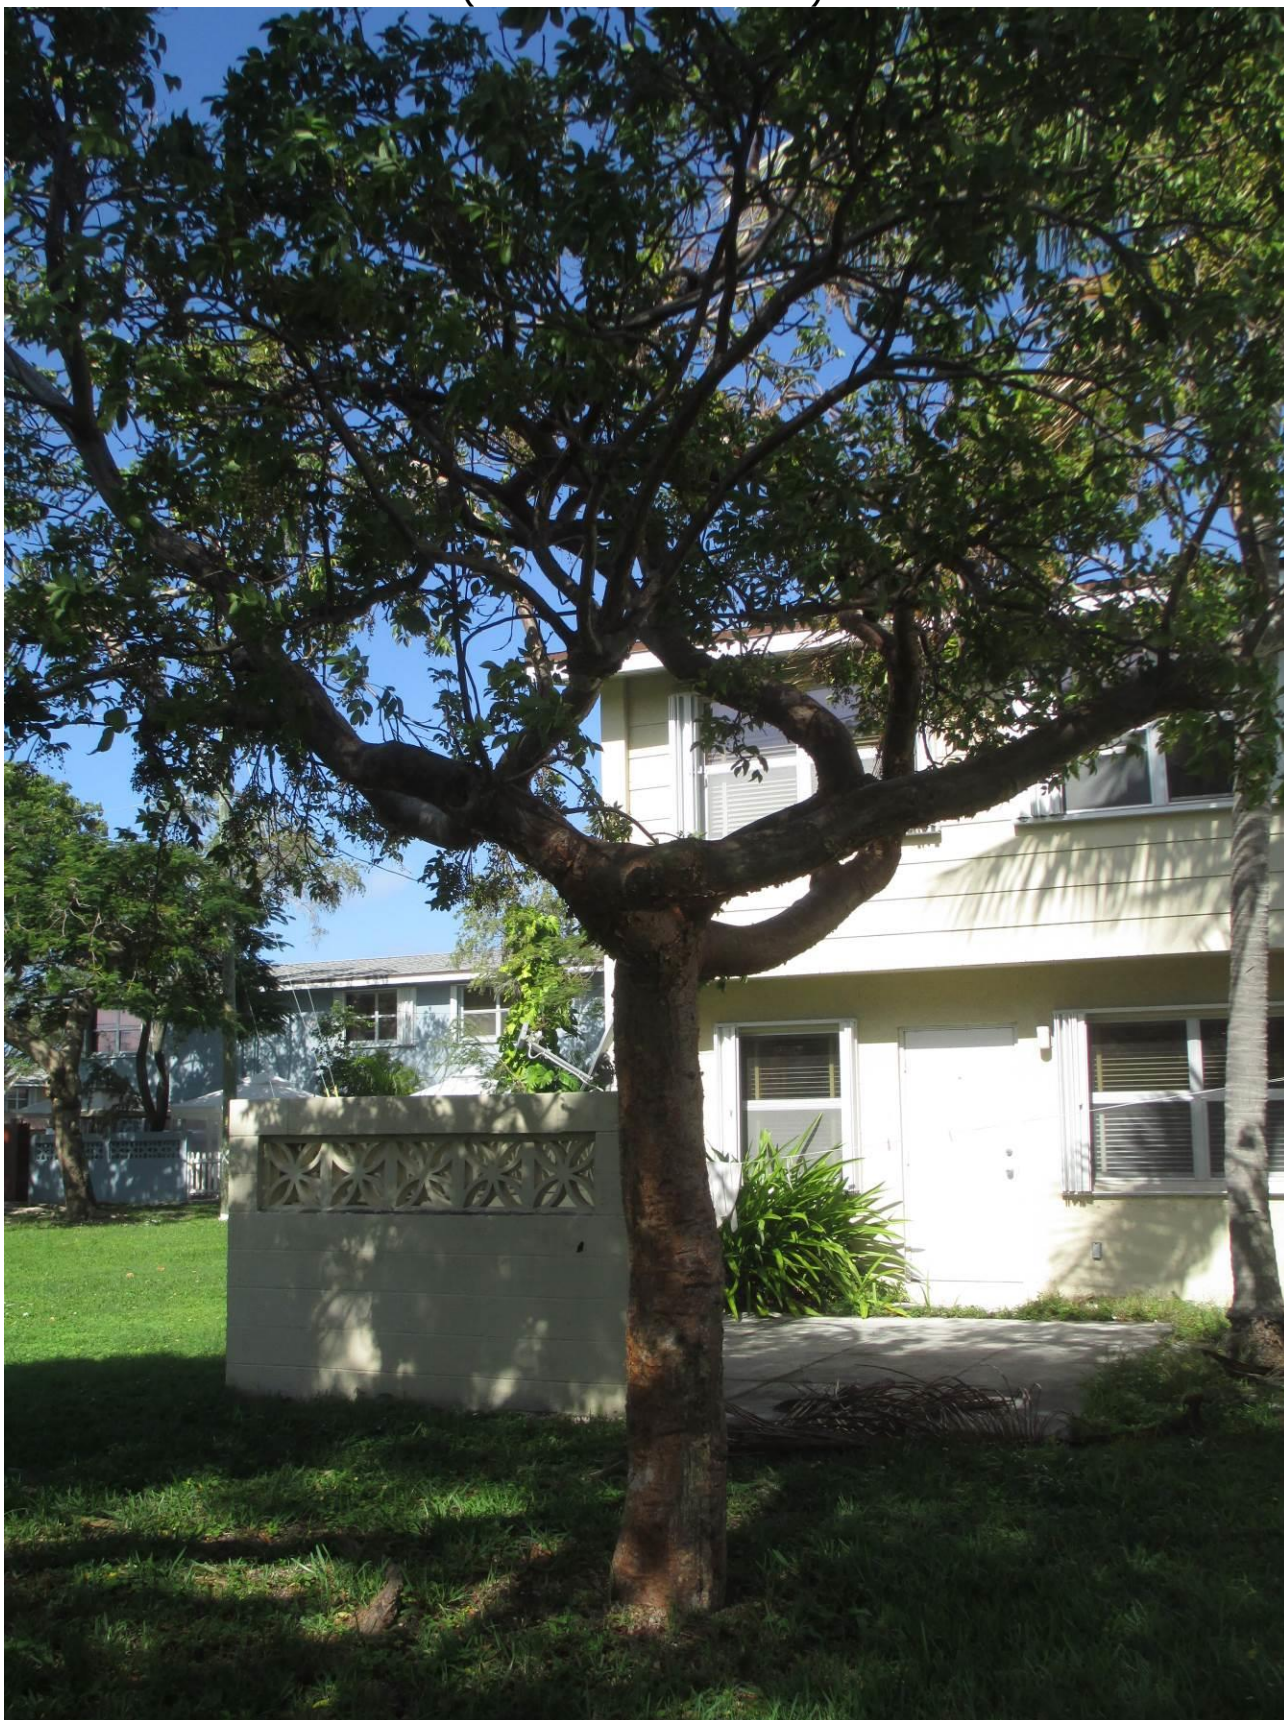
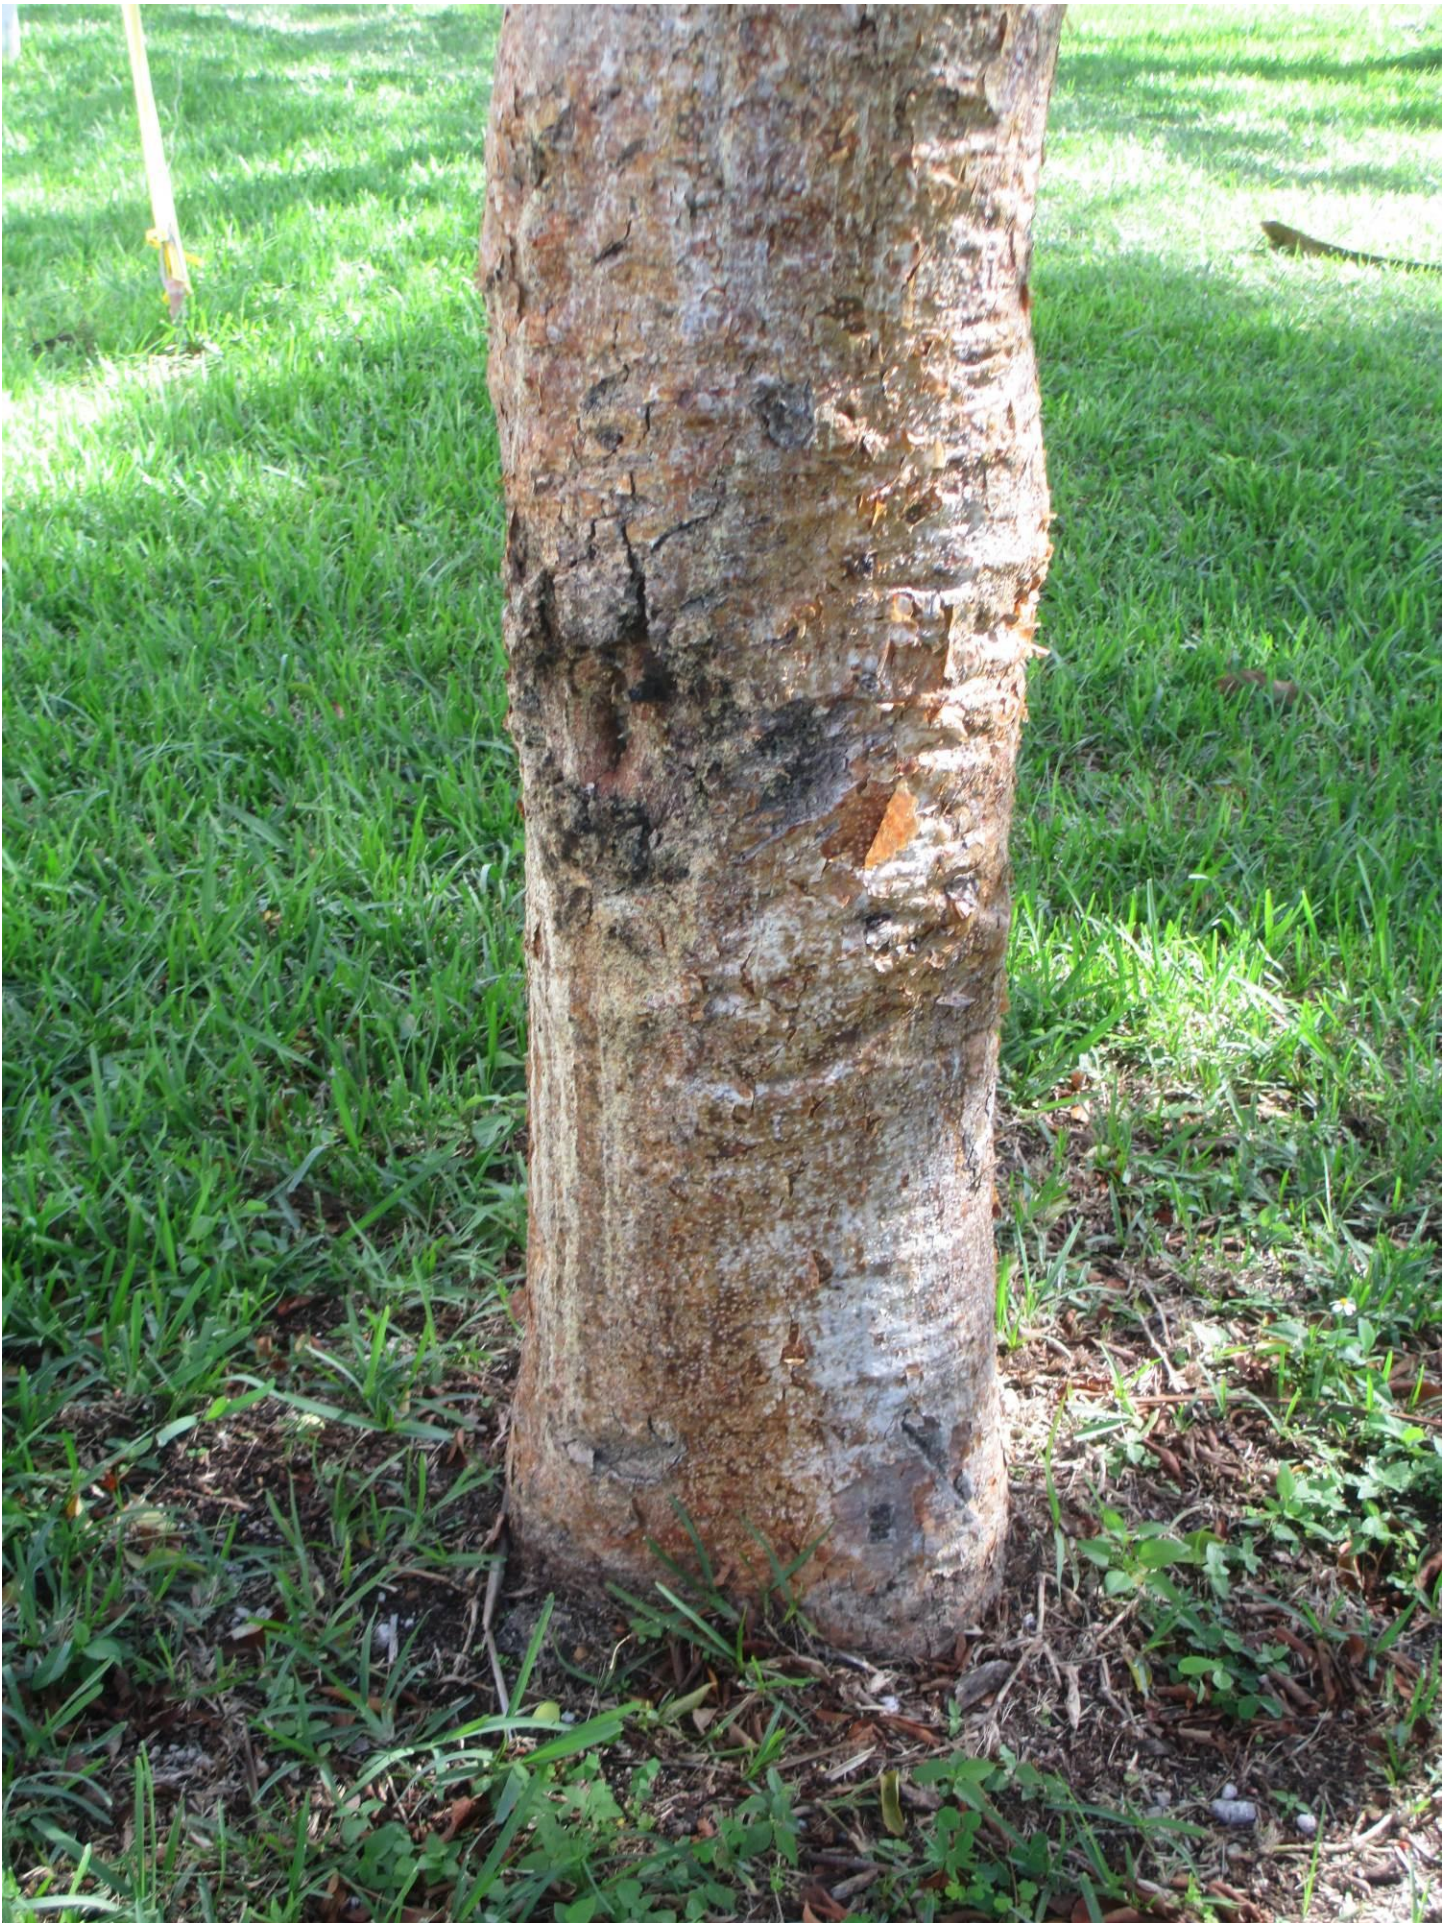
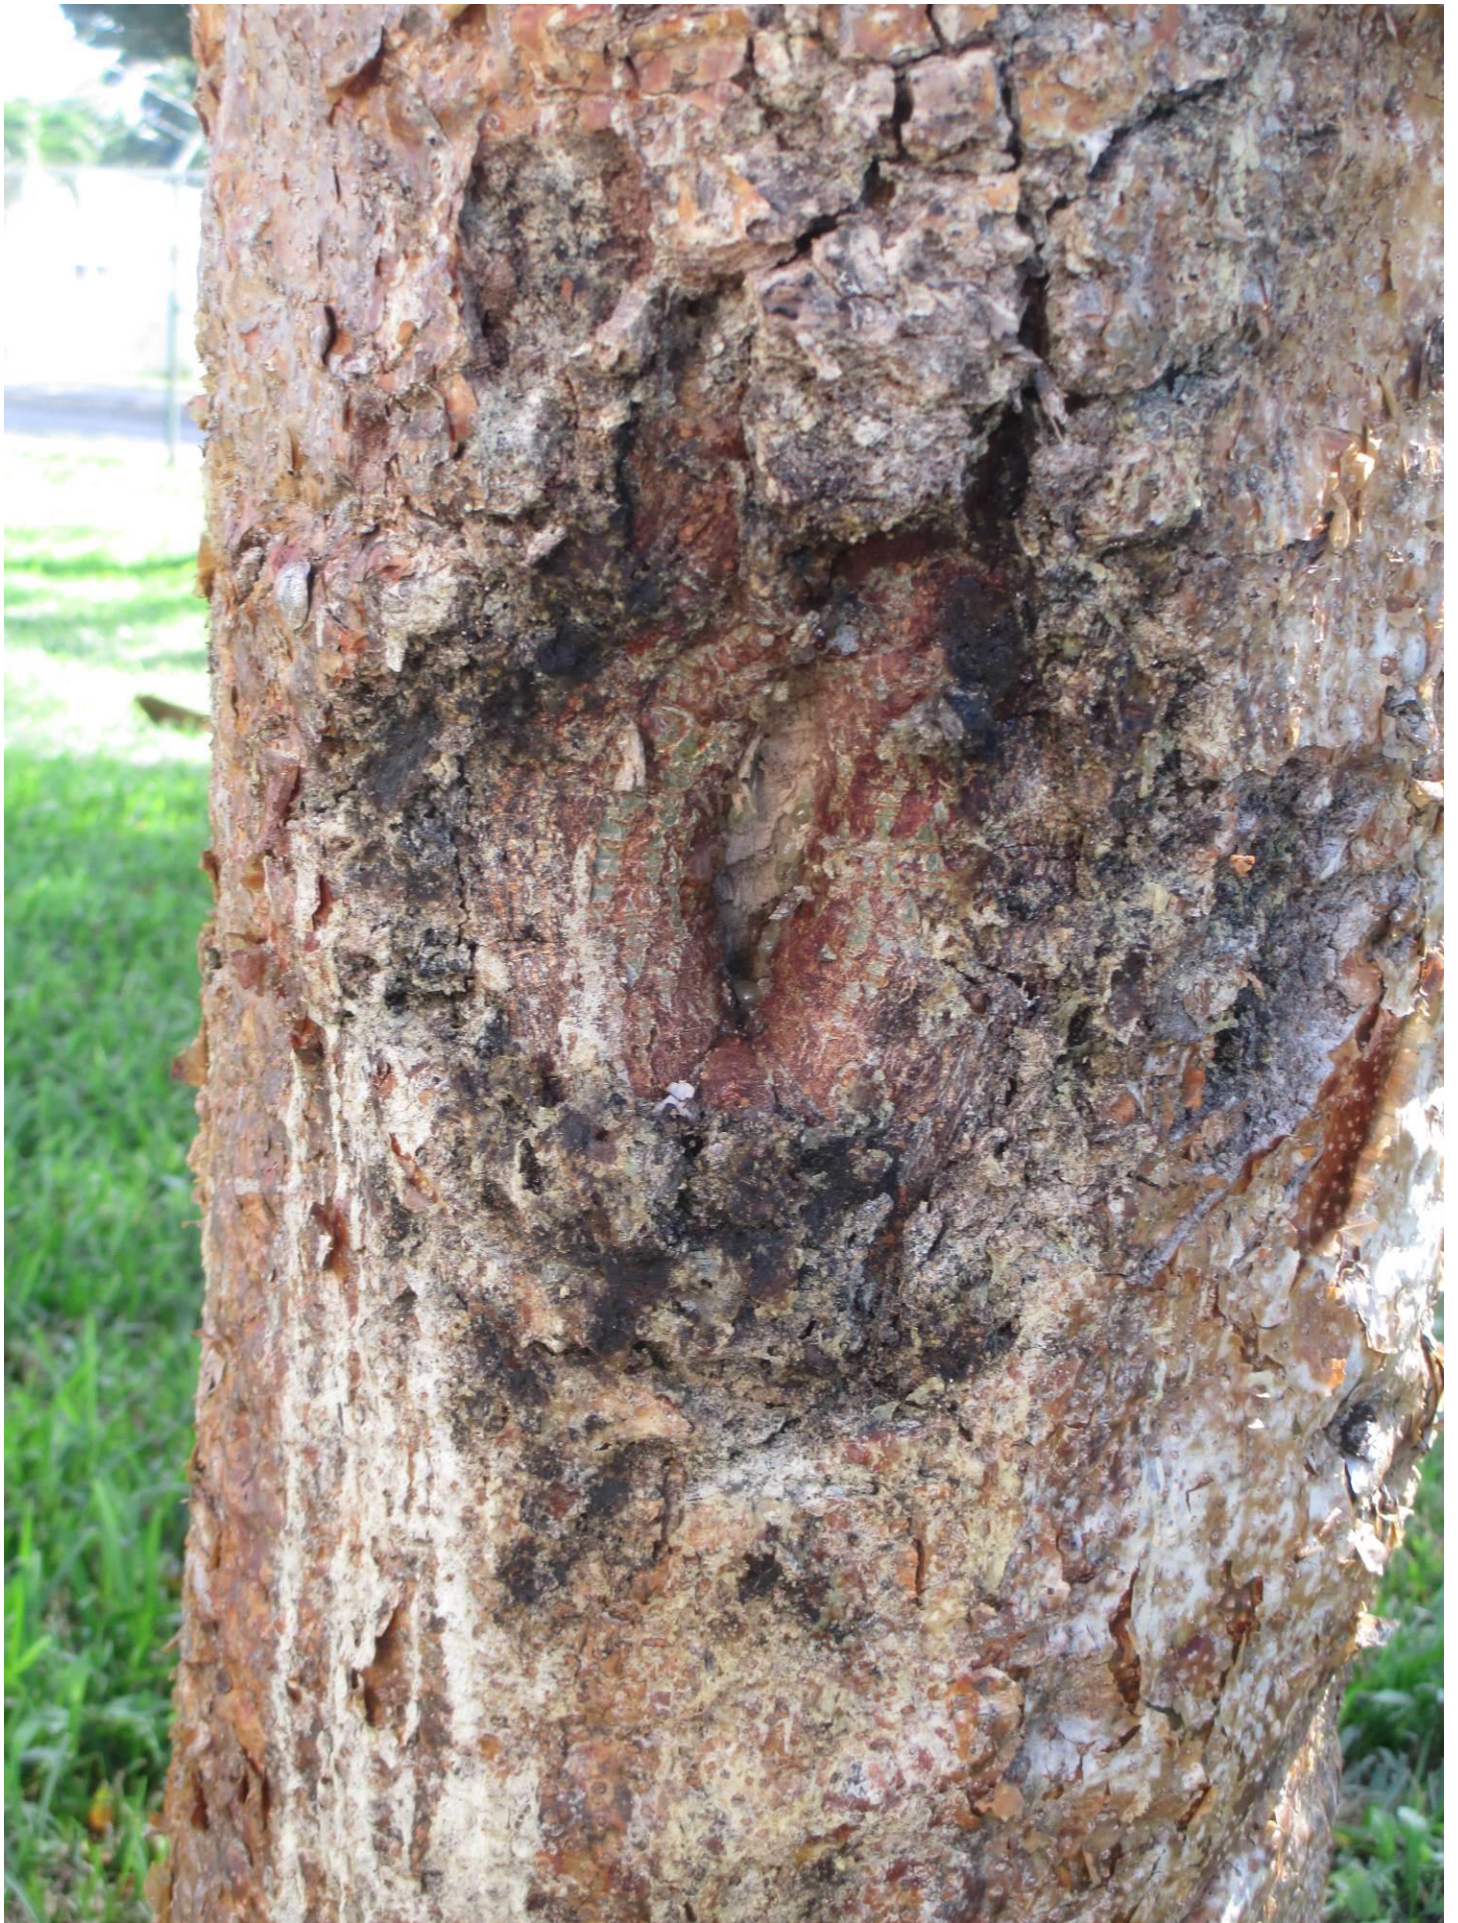
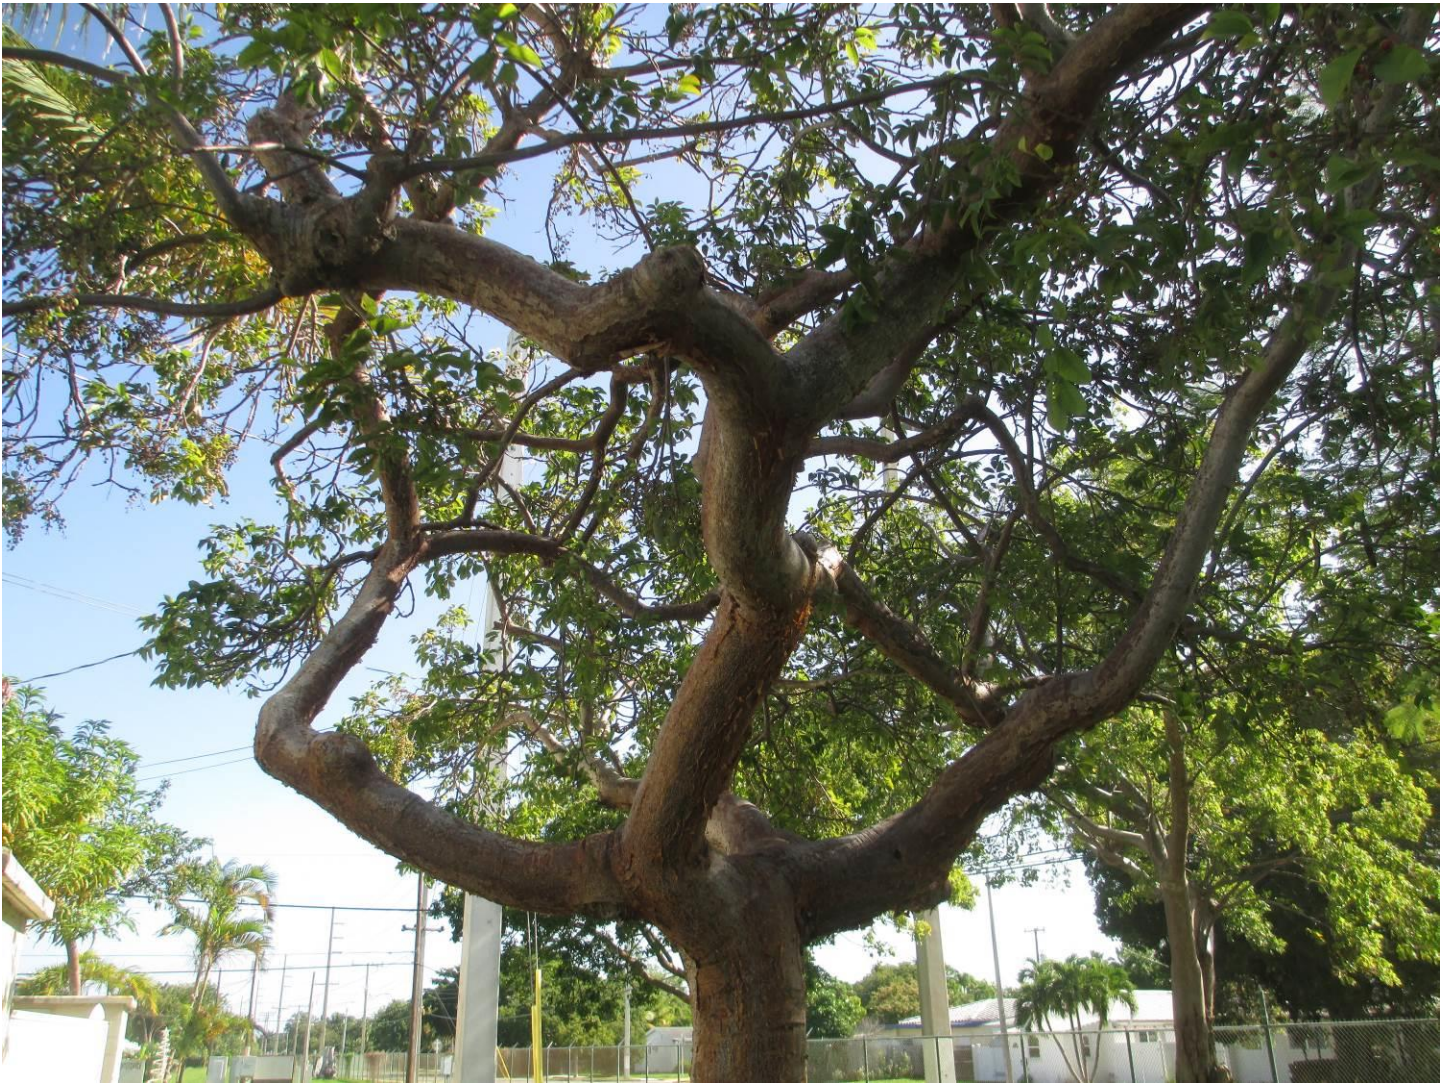
Tree #9: Gumbo Limbo (*Bursera simaruba*)

Diameter: 12"

Location: 70% (exposed surface roots close to back porch area)

Condition: 20% (very poor-evidence of disease or insects in main trunk)

Total Average Value = 63%

Value x Diameter = 7 replacement caliper inches

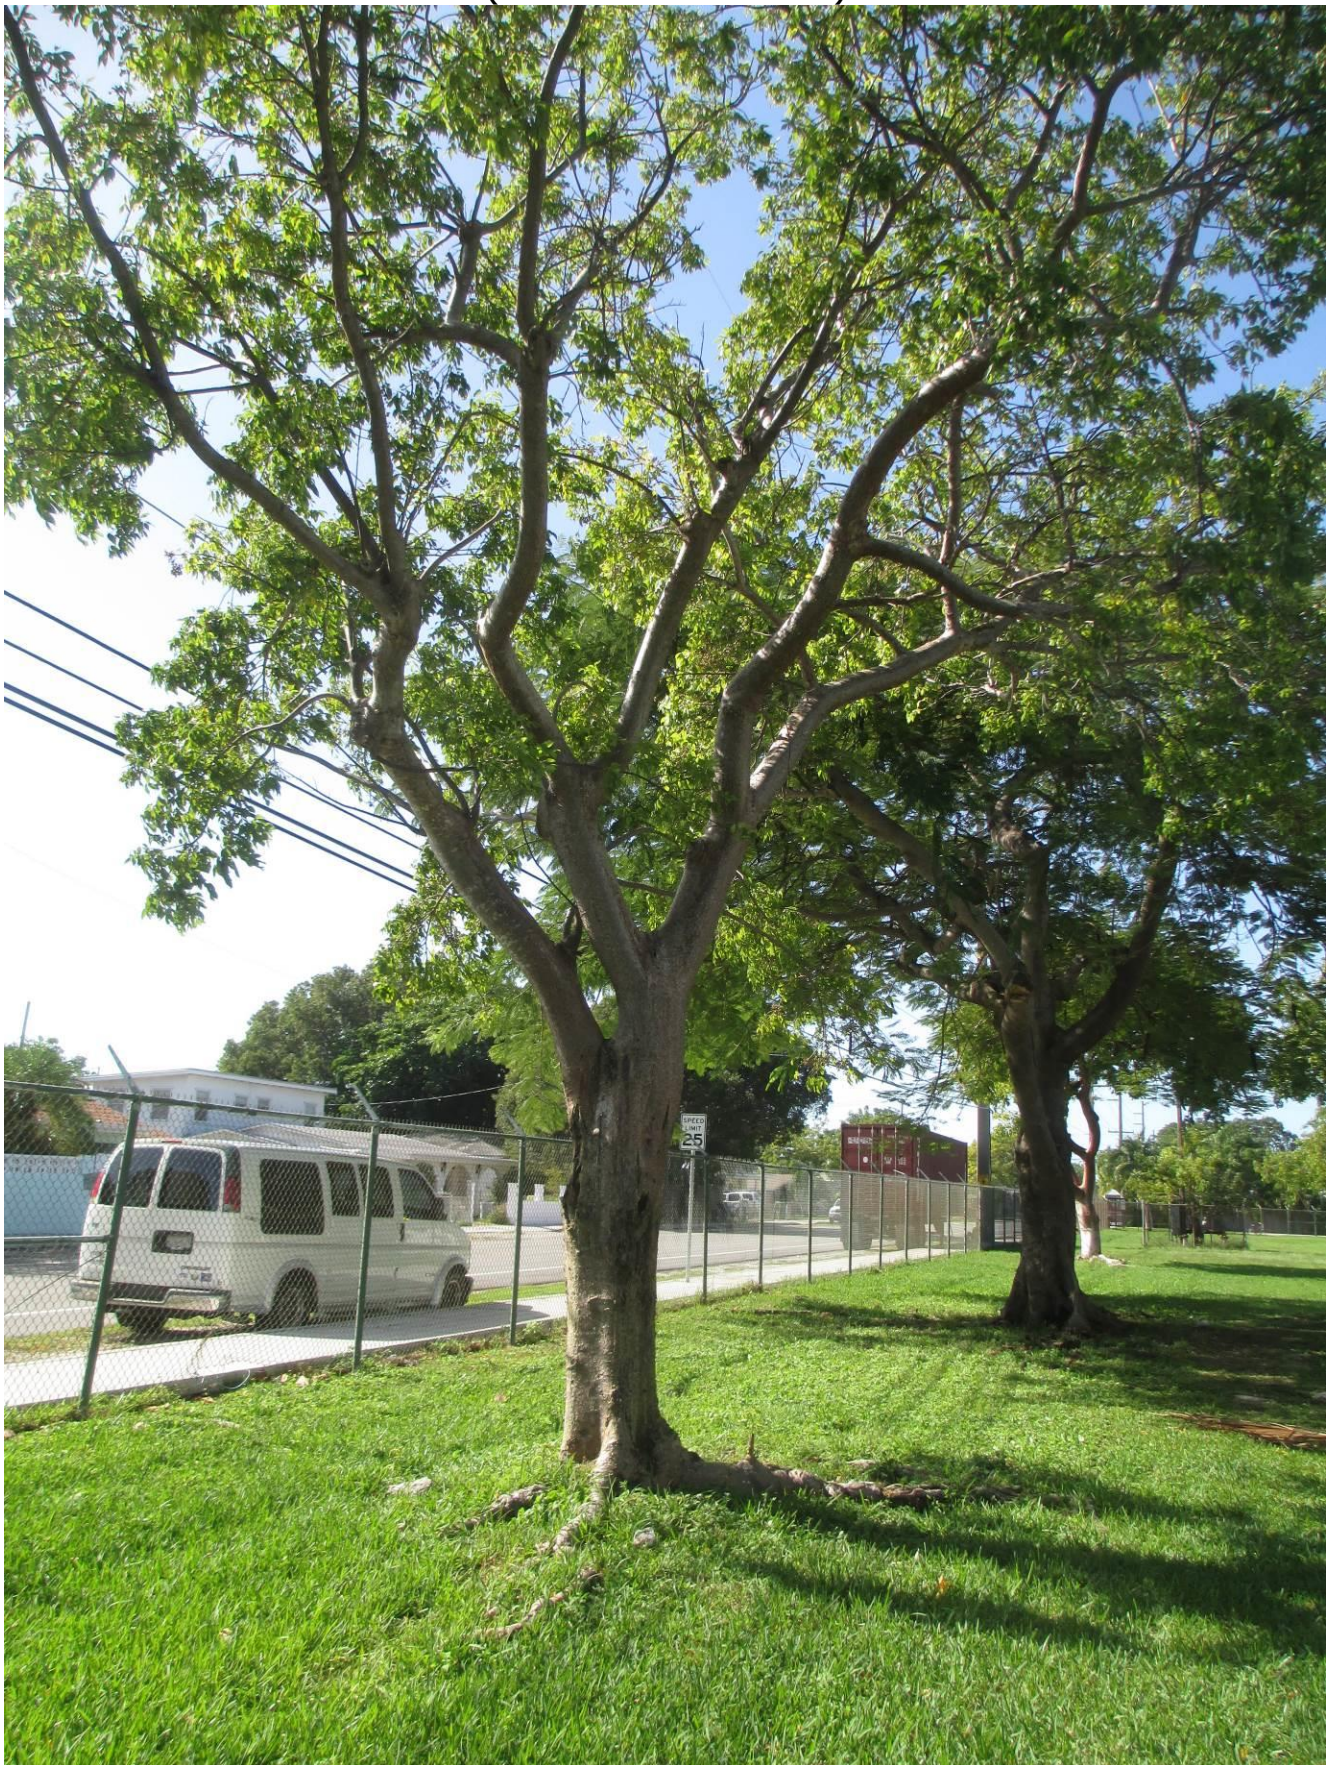
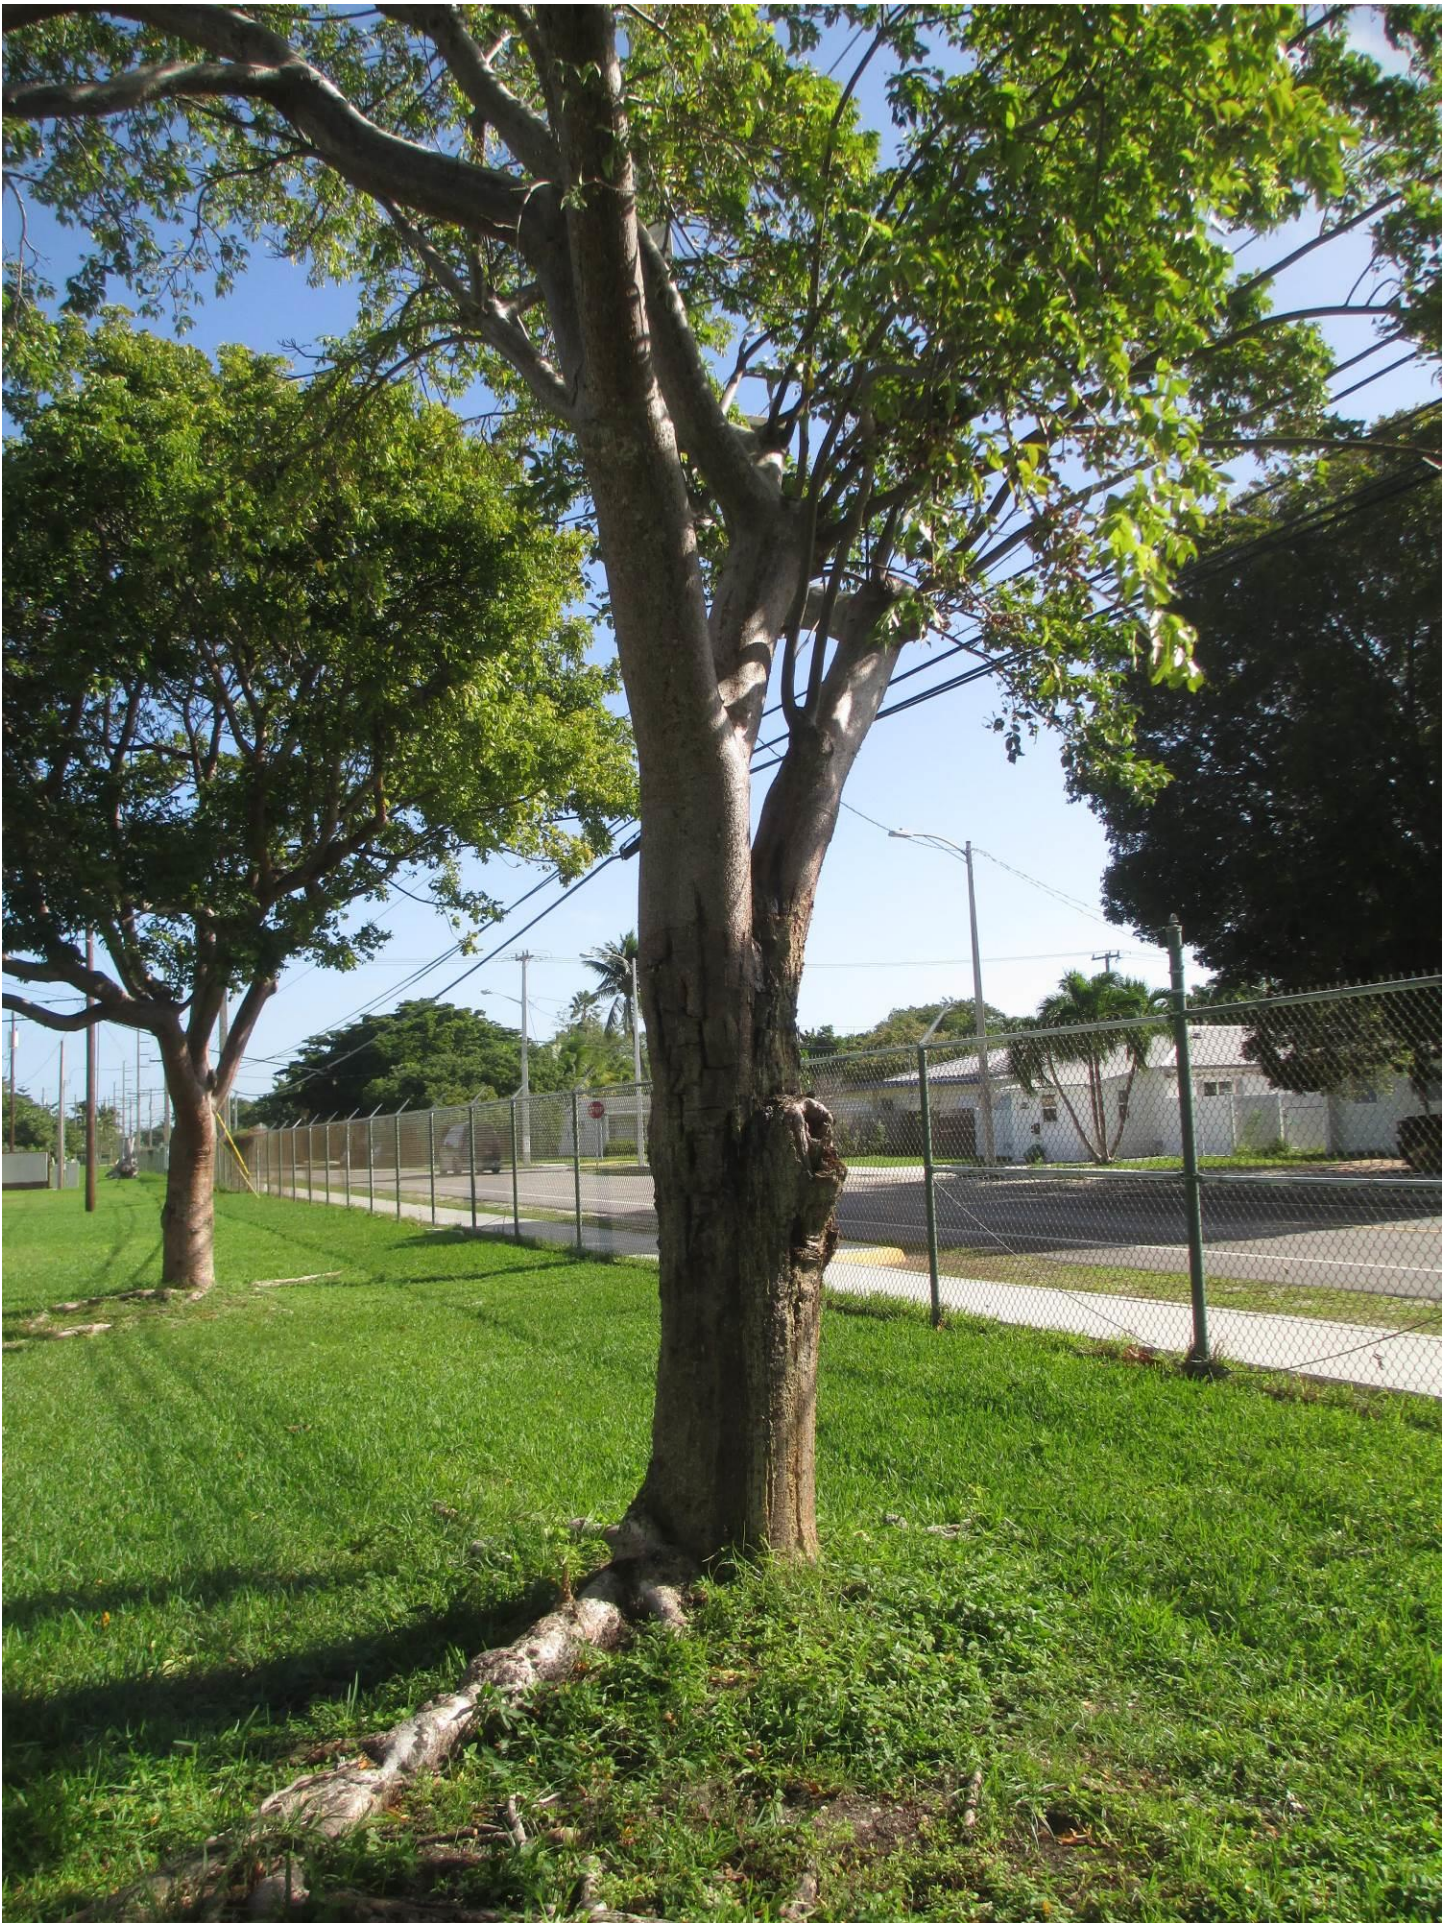
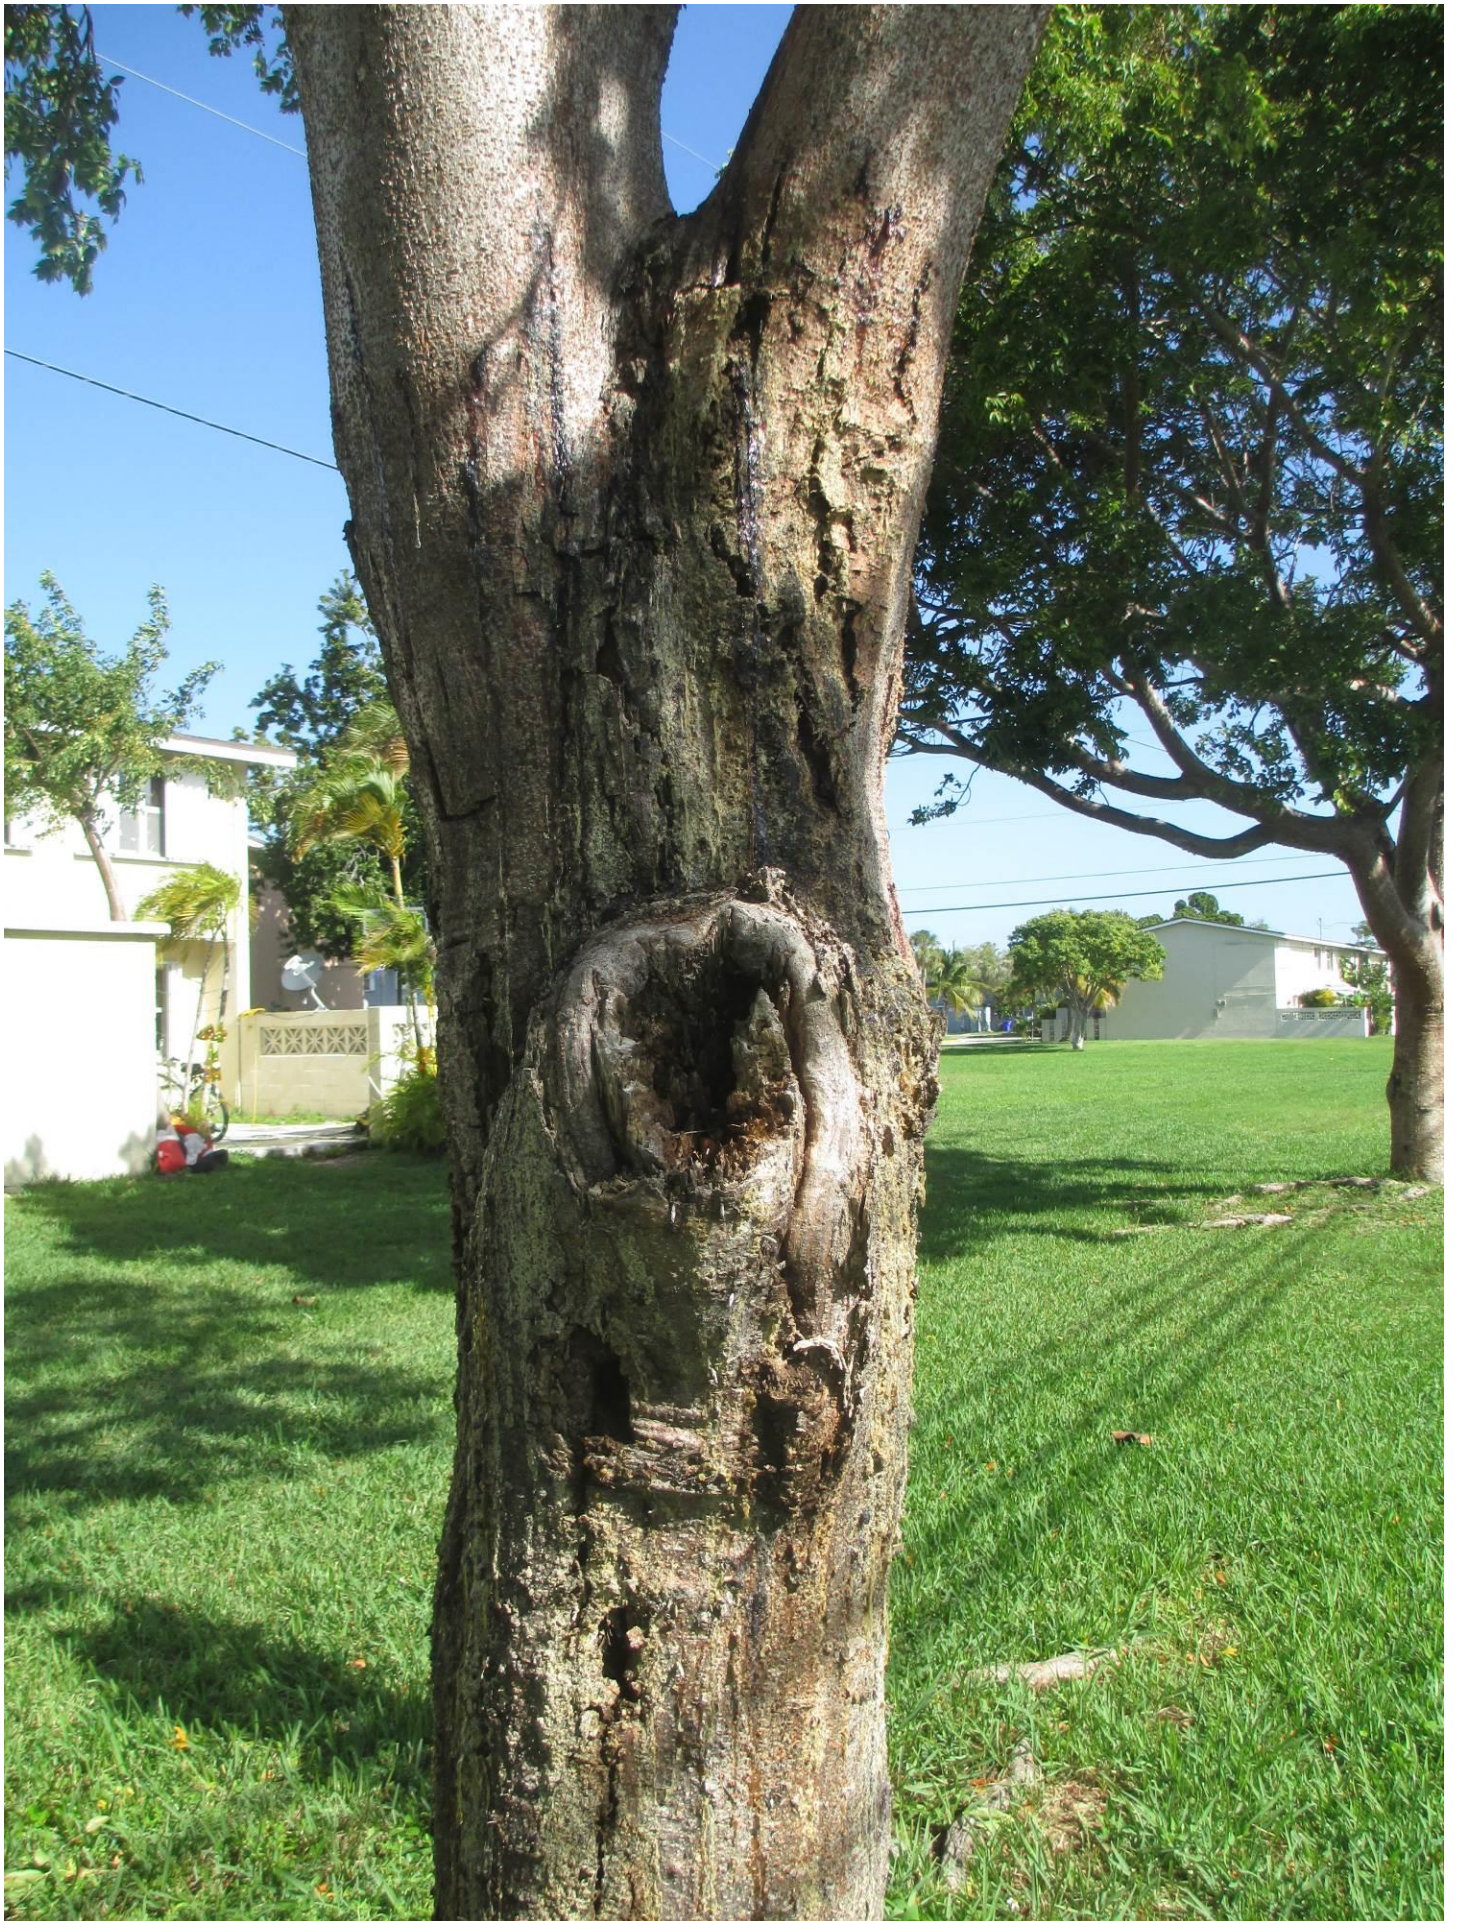
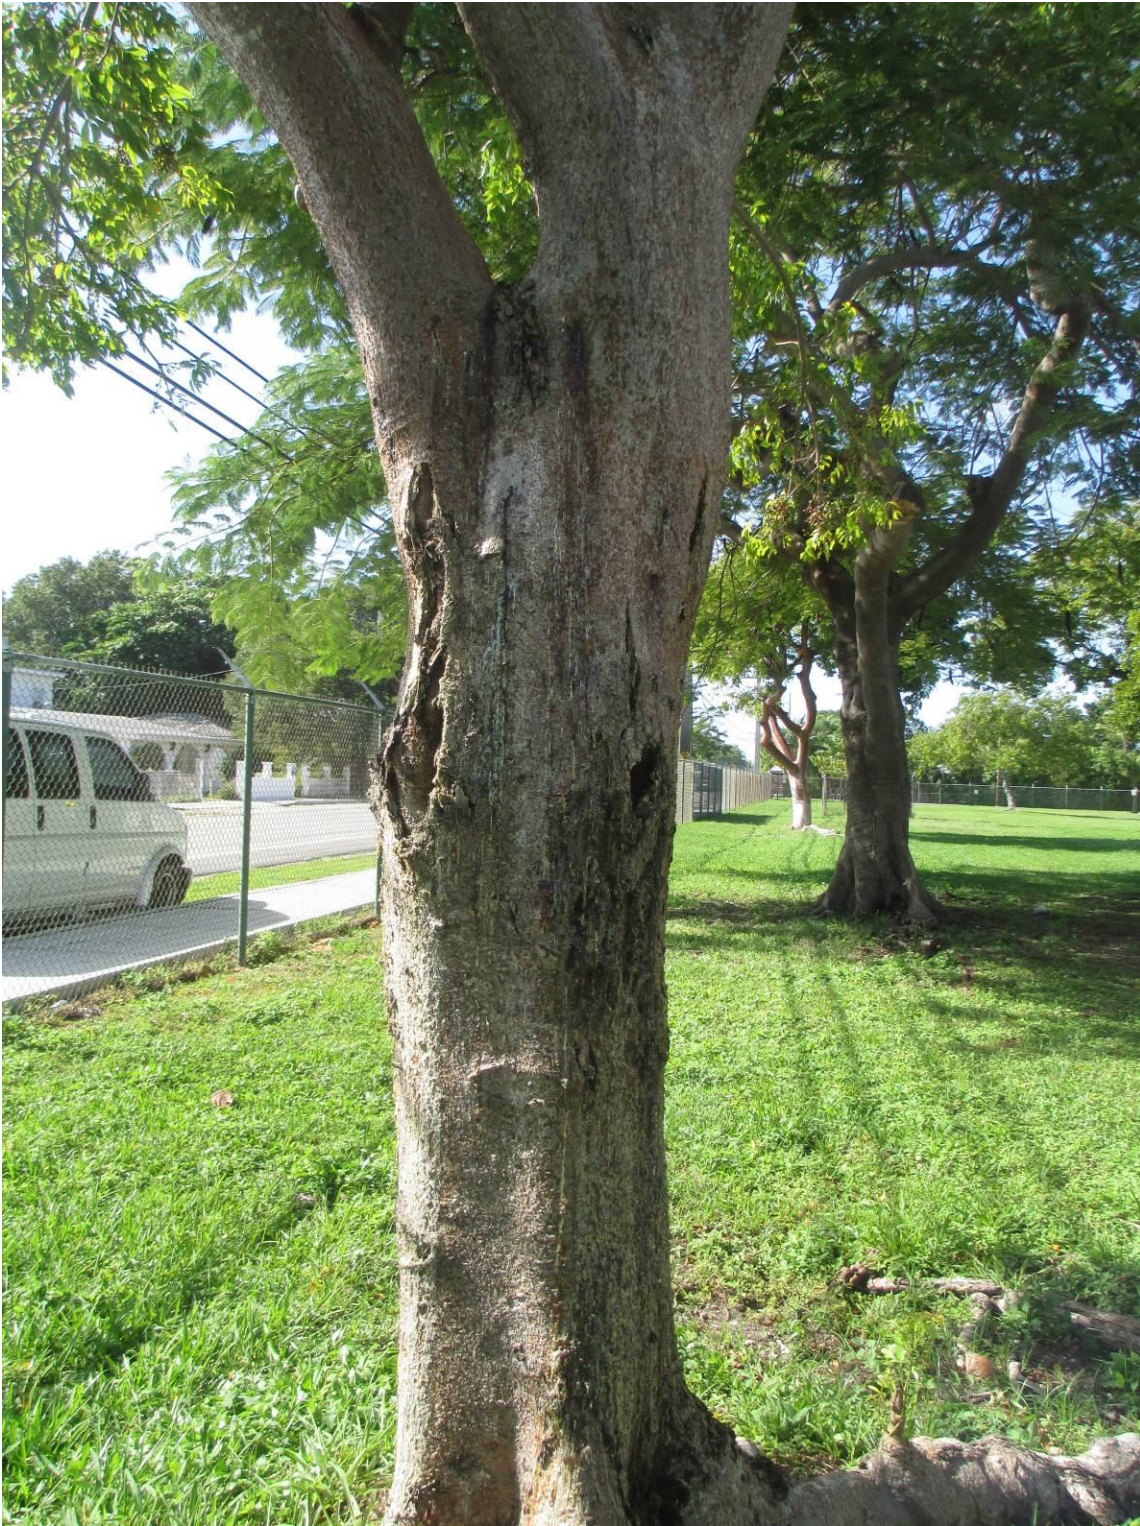
Tree #11: Gumbo Limbo (*Bursera simaruba*)

Diameter: 21"

Condition: 20% (diseased)

Total Average Value = 66%

Value x Diameter = 13 replacement caliper inches
