STAFF REPORT

DATE: February 26, 2016

RE: **1664 Dunlap Drive-Poinciana Gardens**
(permit application # T16-7794)

FROM: Karen DeMaria, City of Key West Urban Forestry Manager

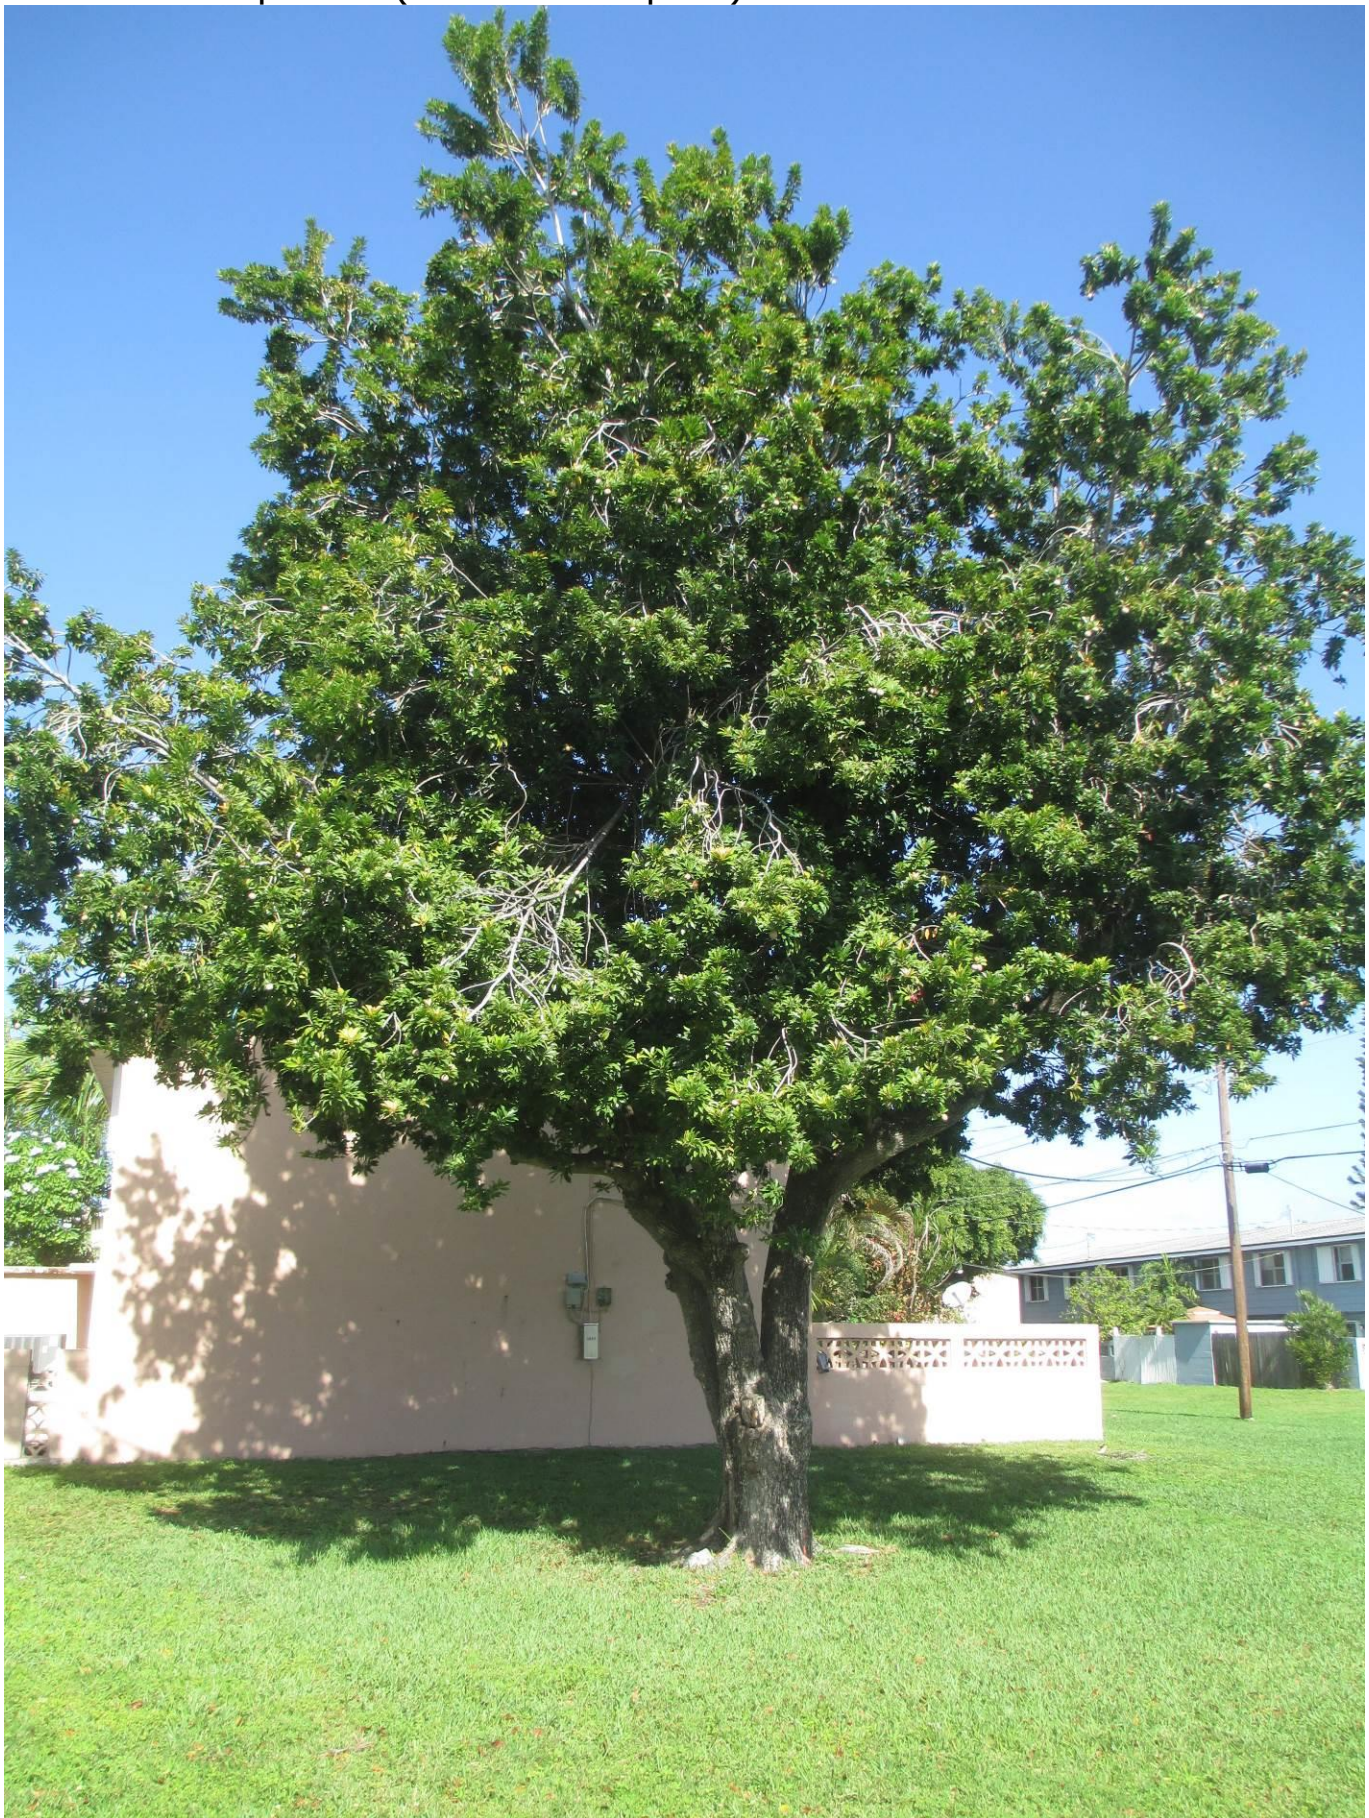
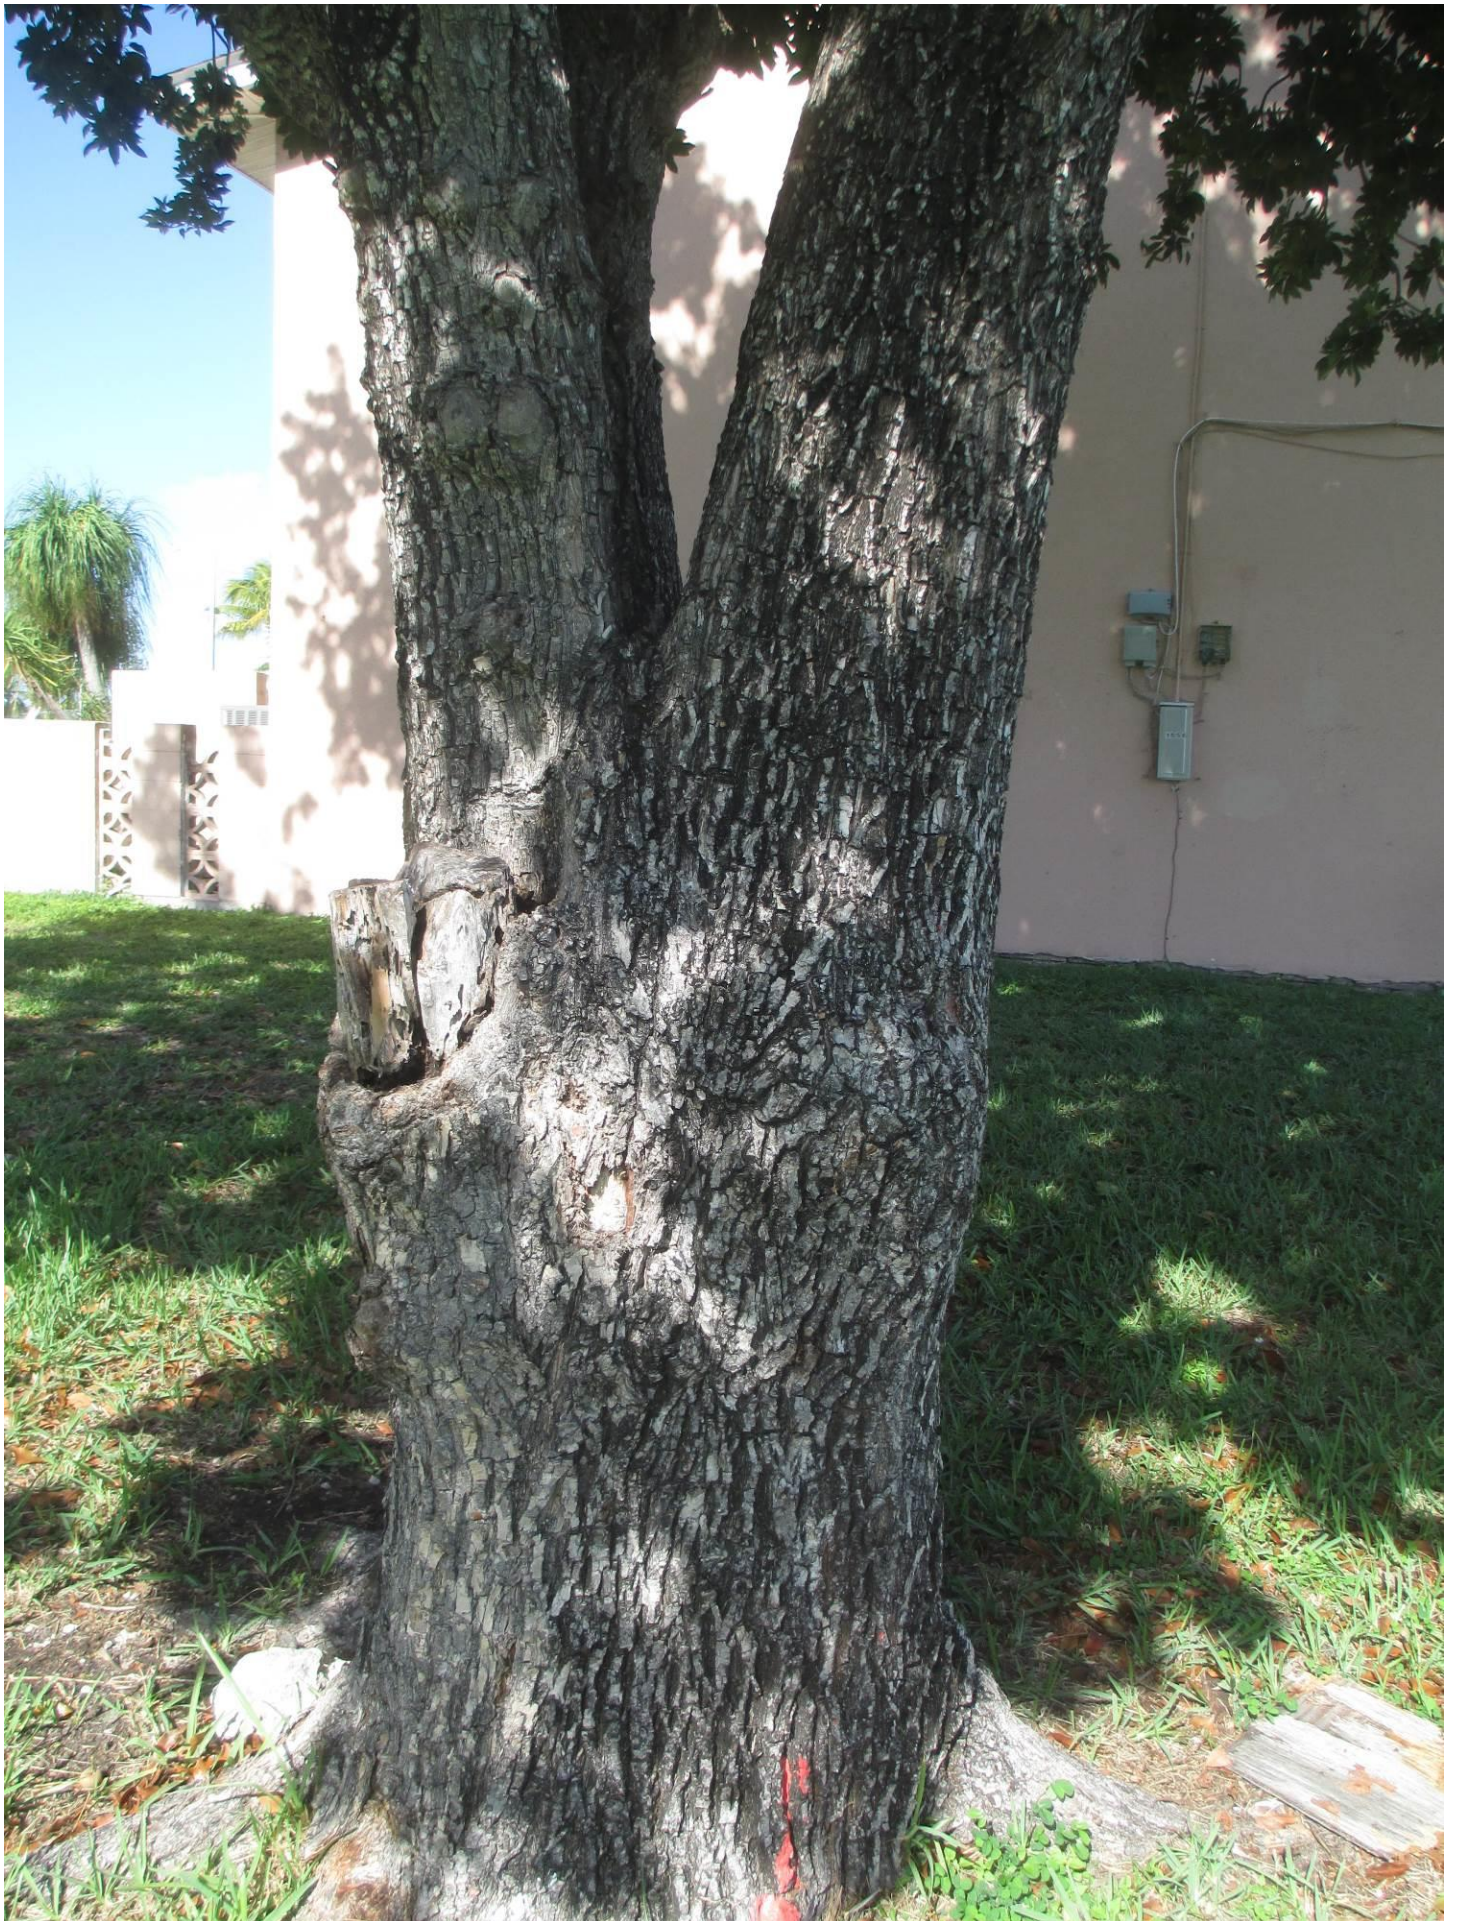
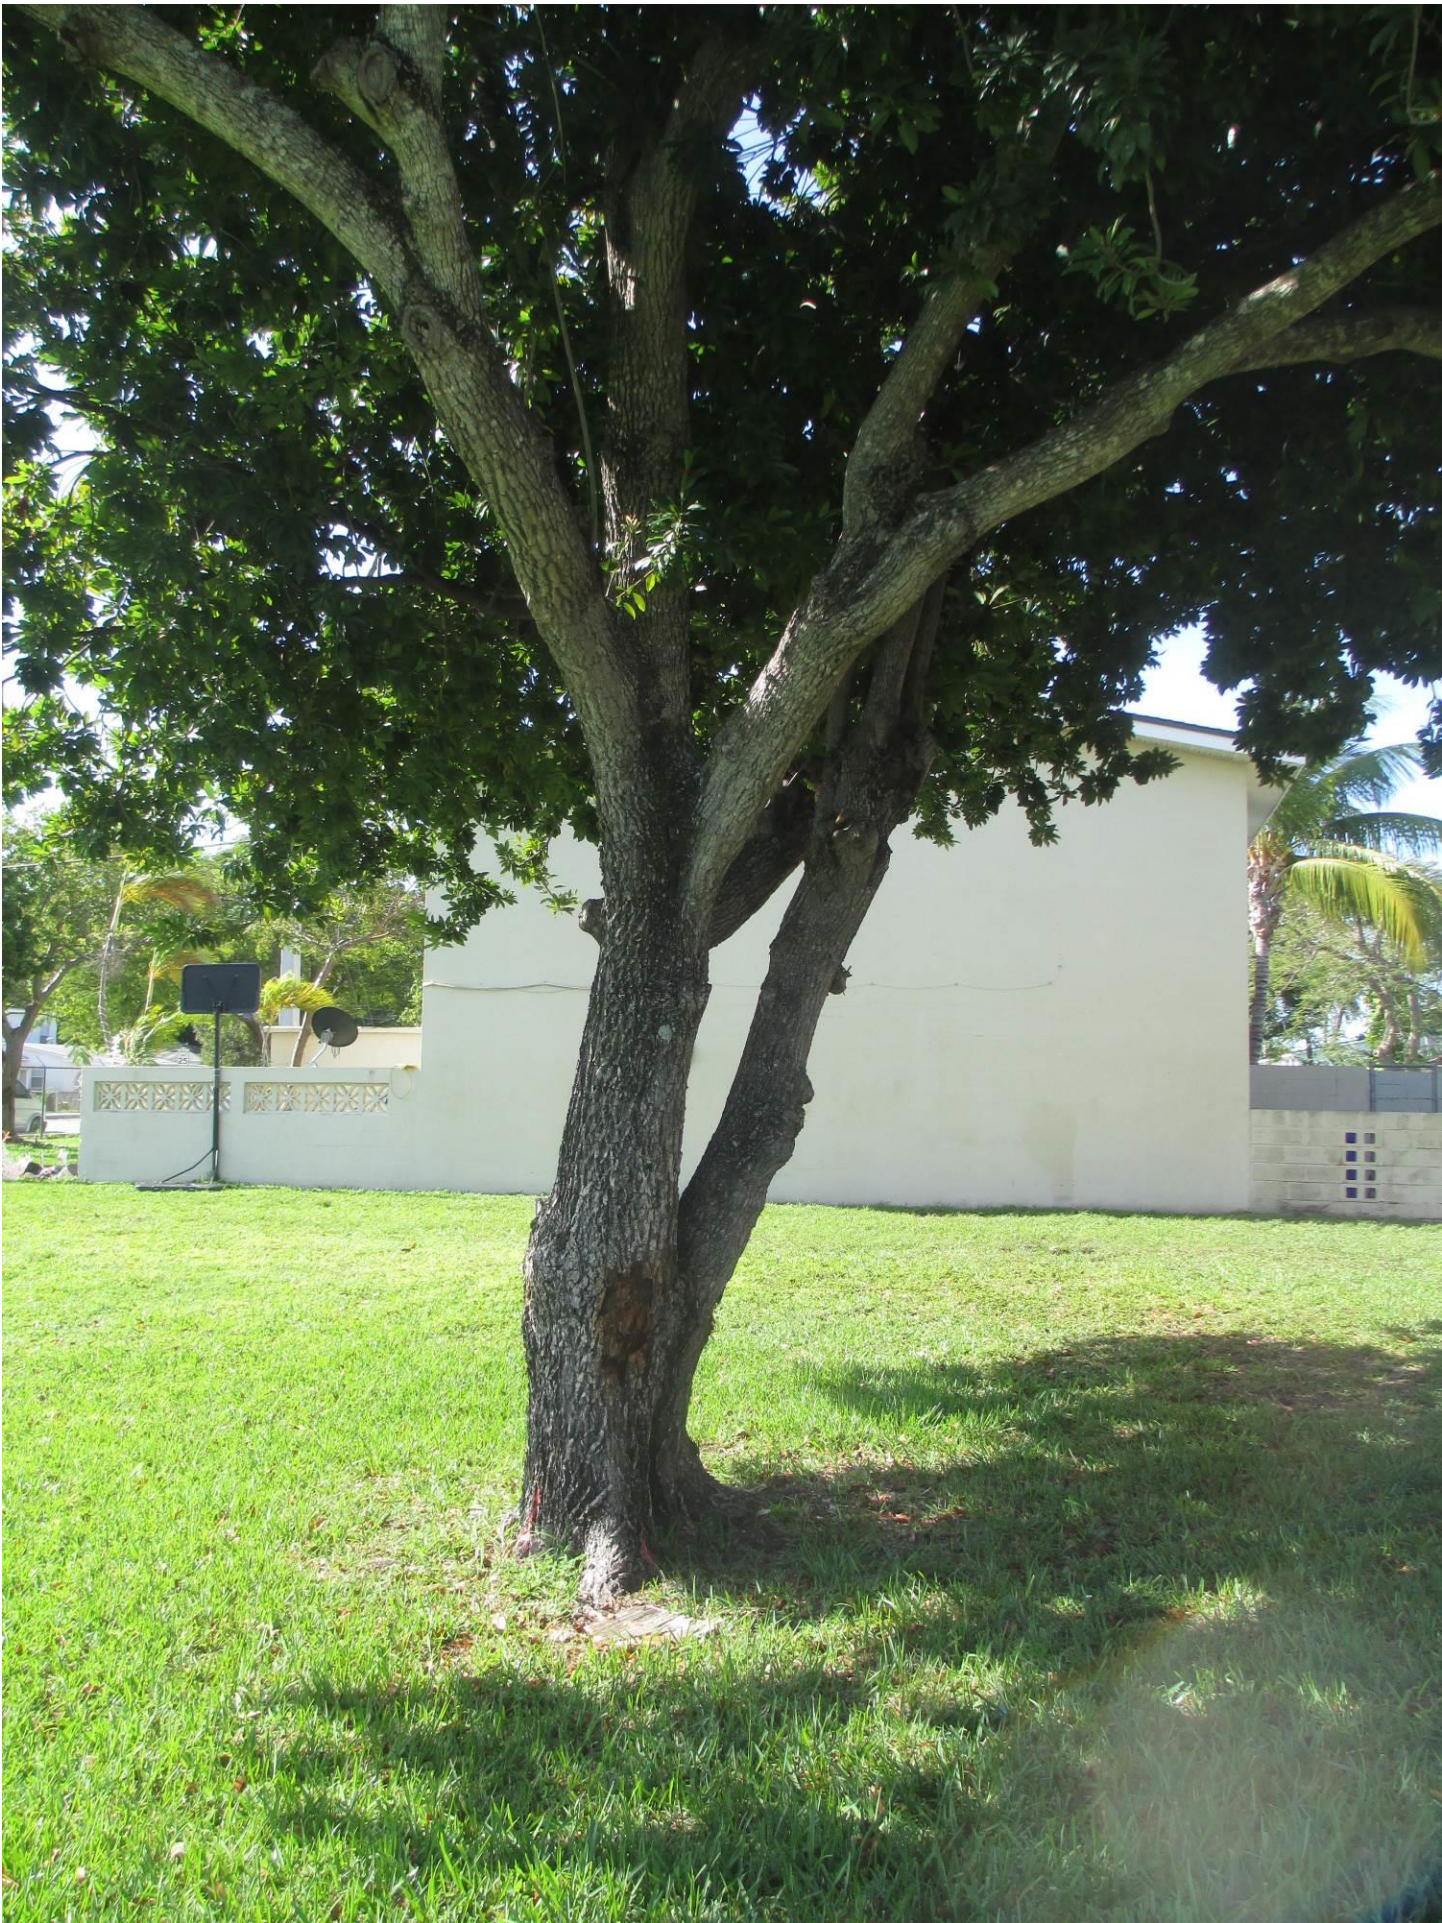
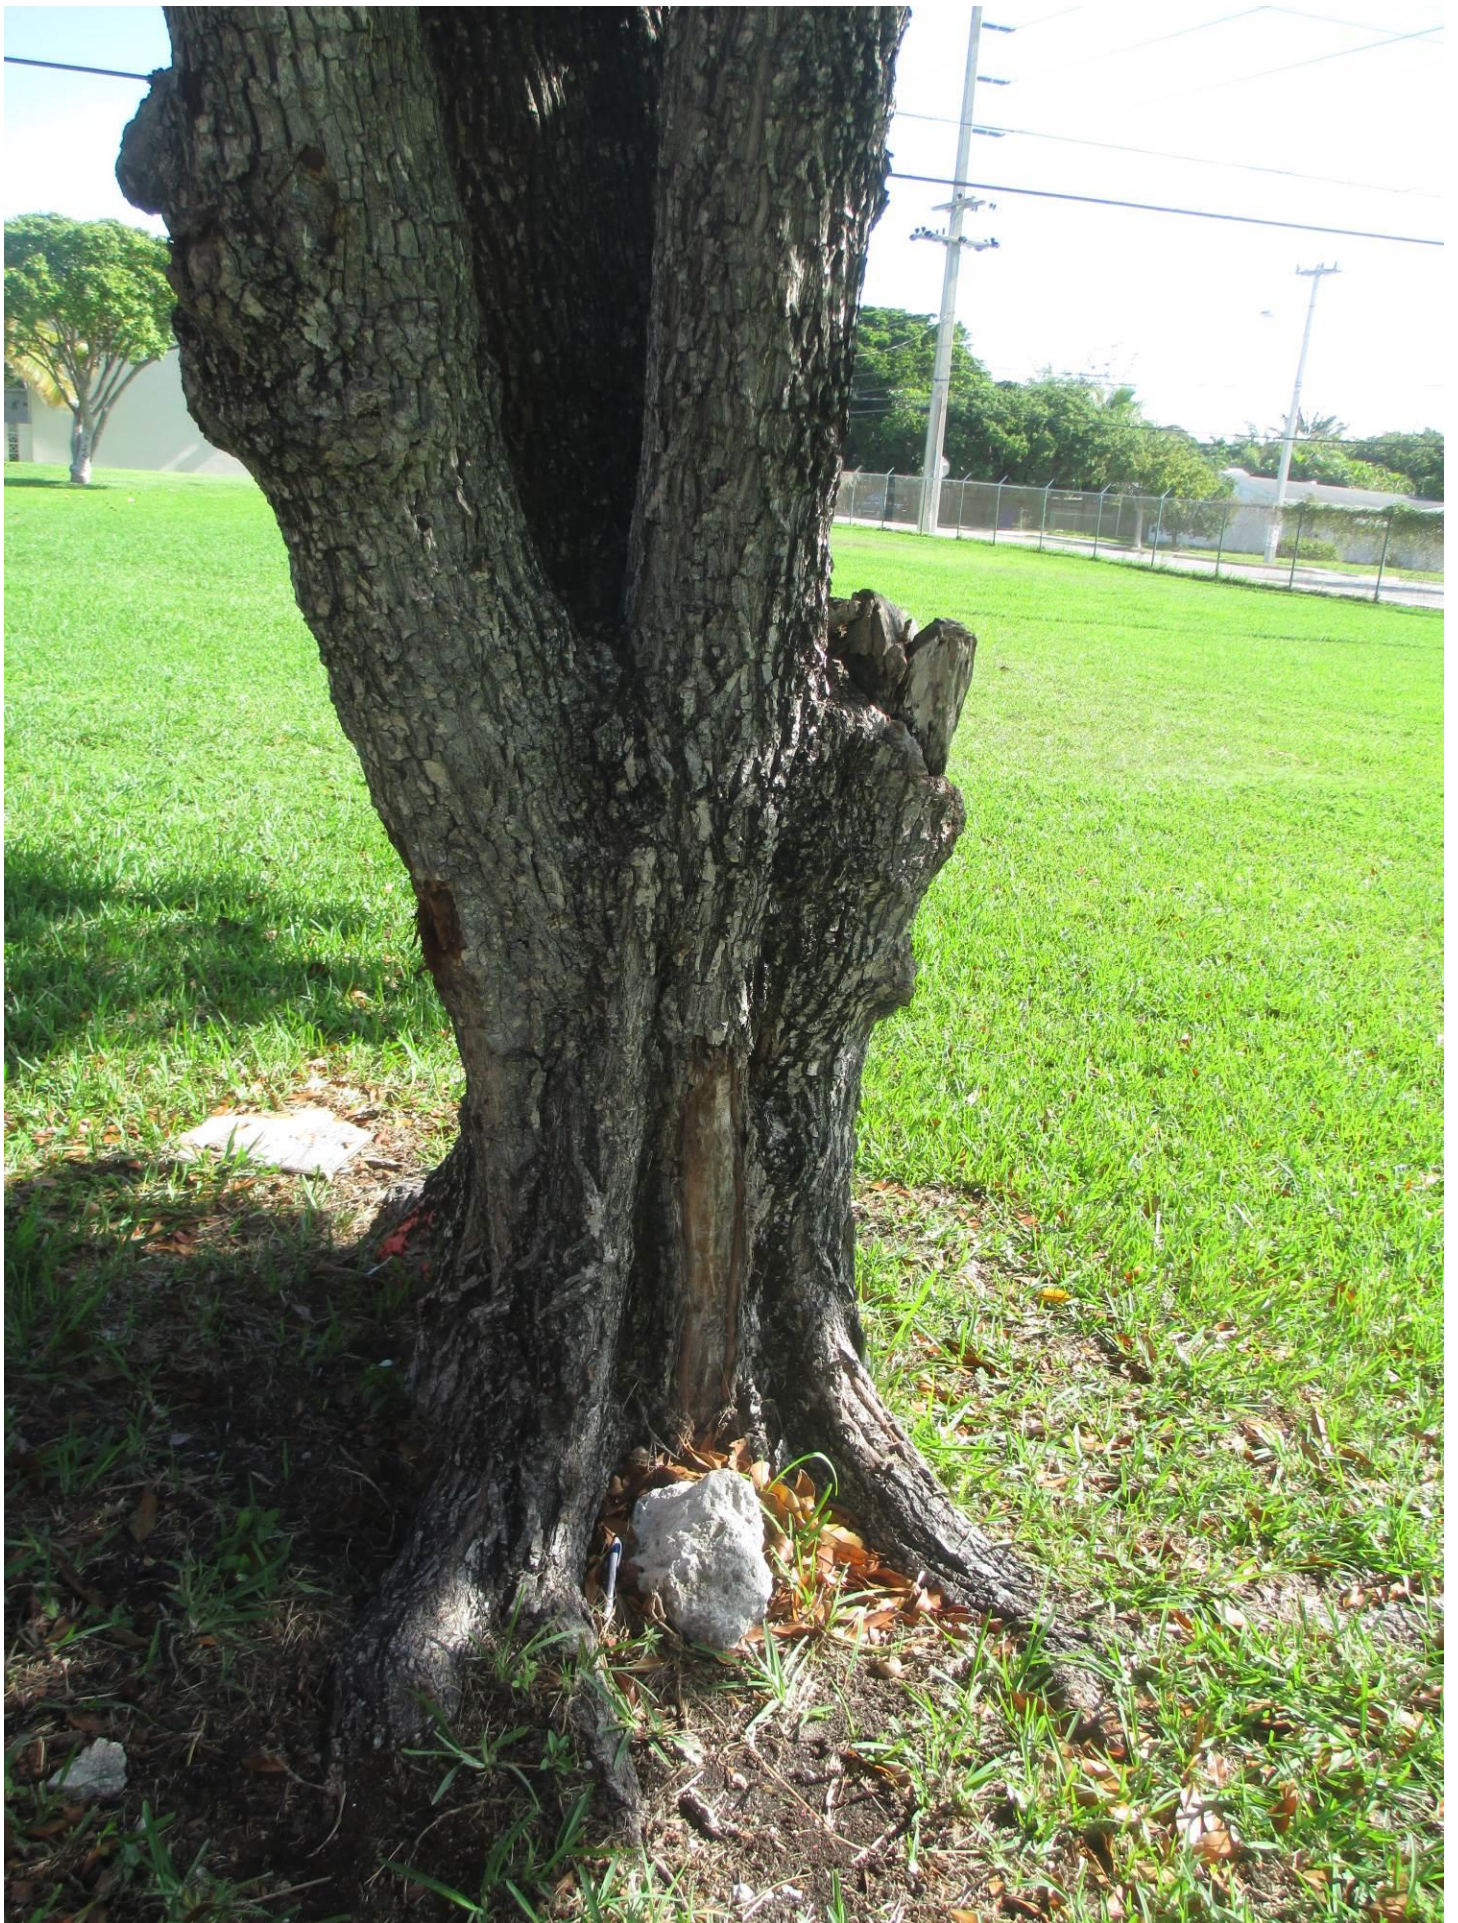
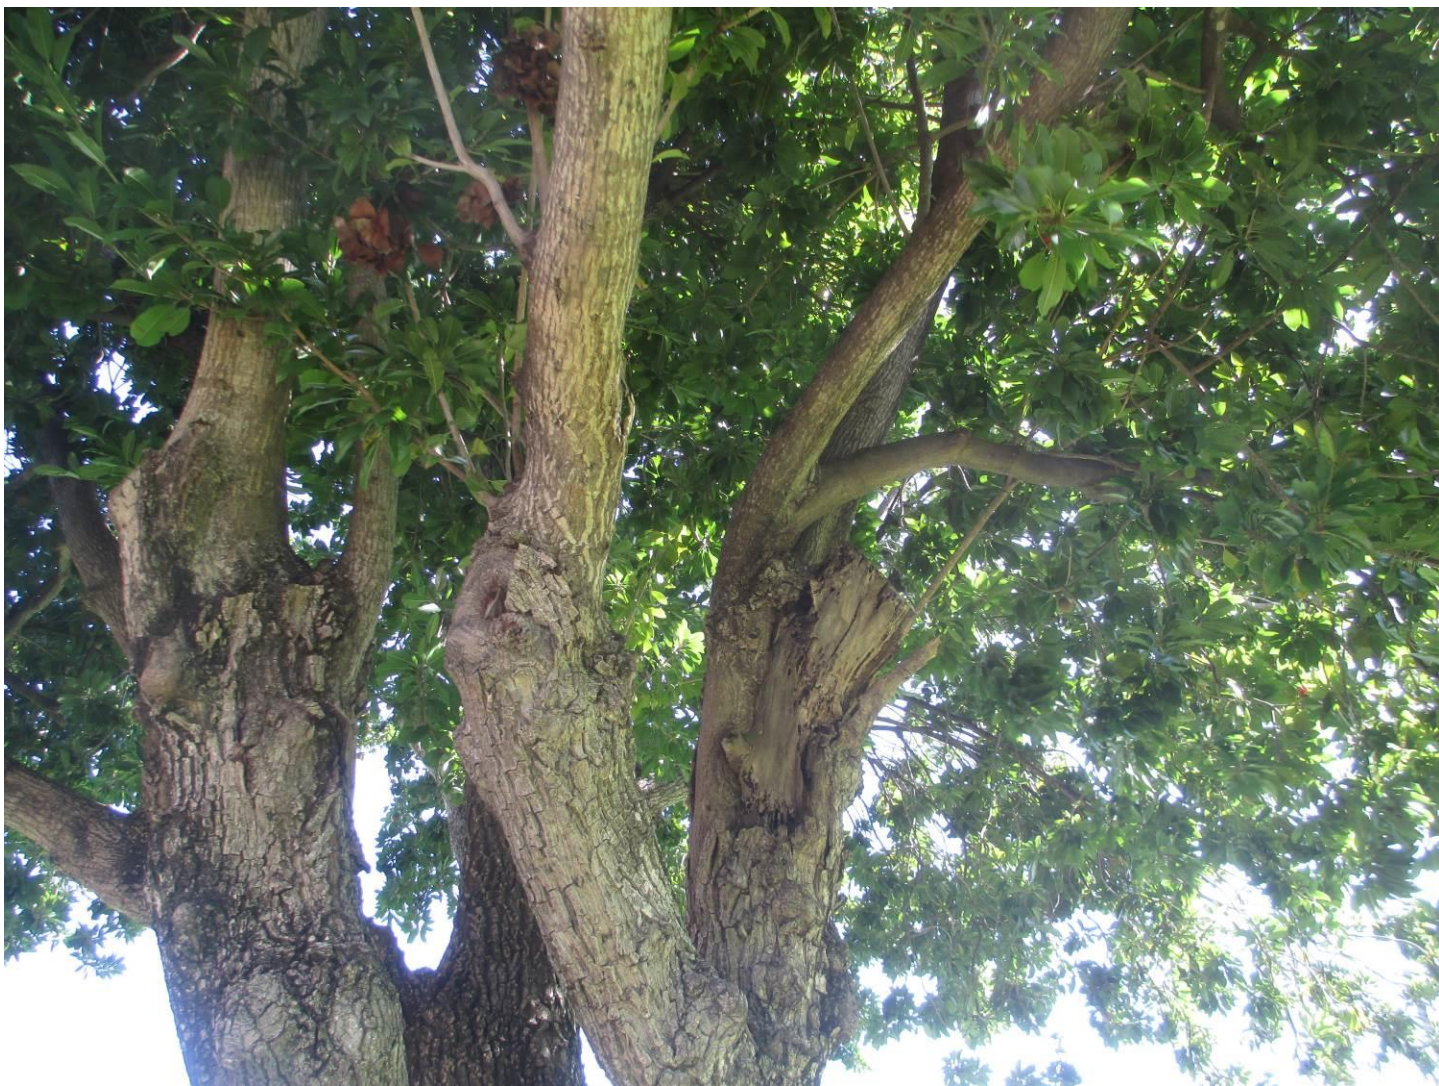
Tree #12: Sapodilla (*Manilkara zapota*)

Diameter: 36"

Condition: 30% (poor, lots of decay)

Total Average Value = 70%

Value x Diameter = 25 replacement caliper inches

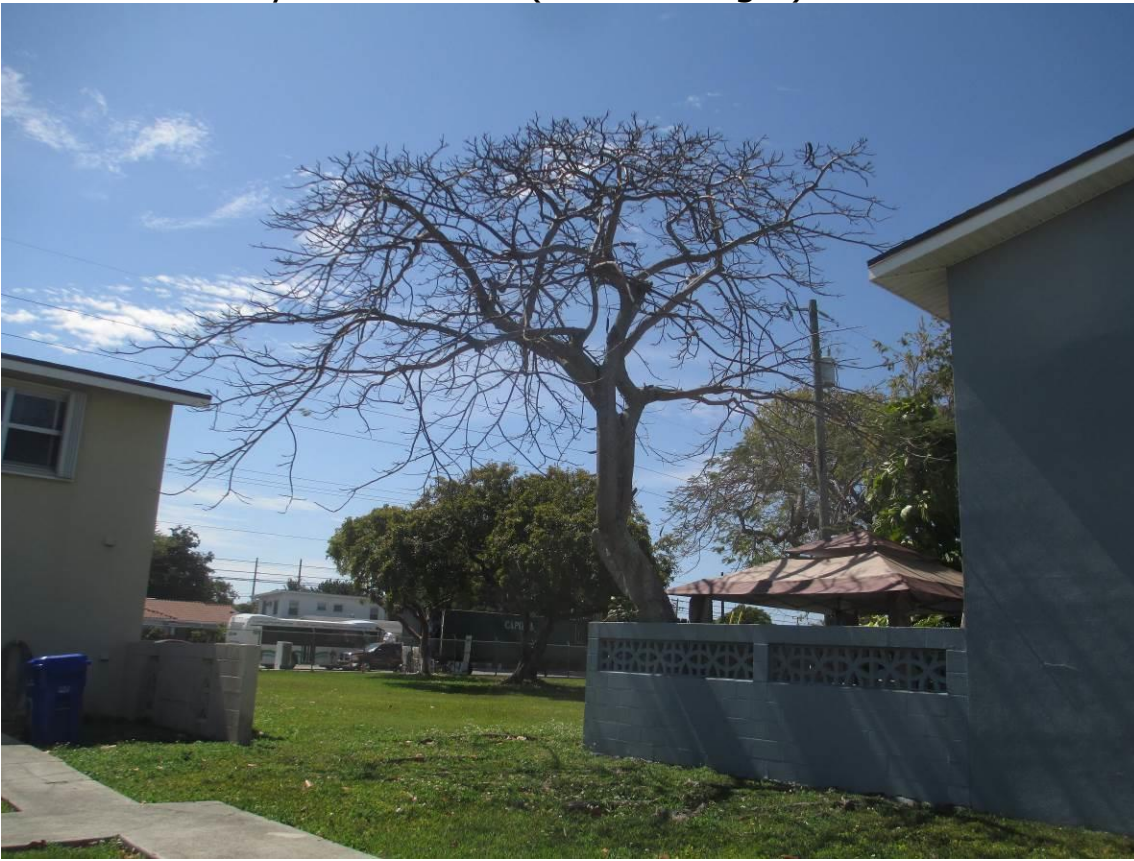
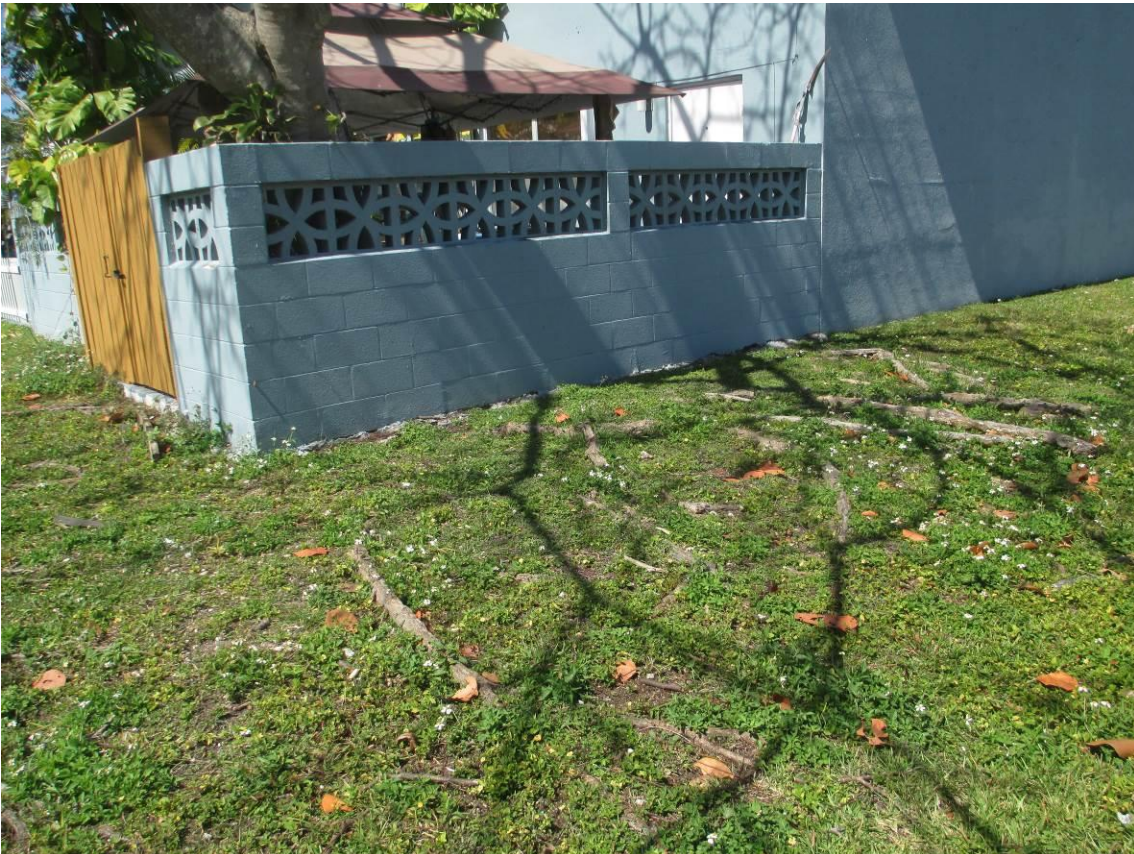
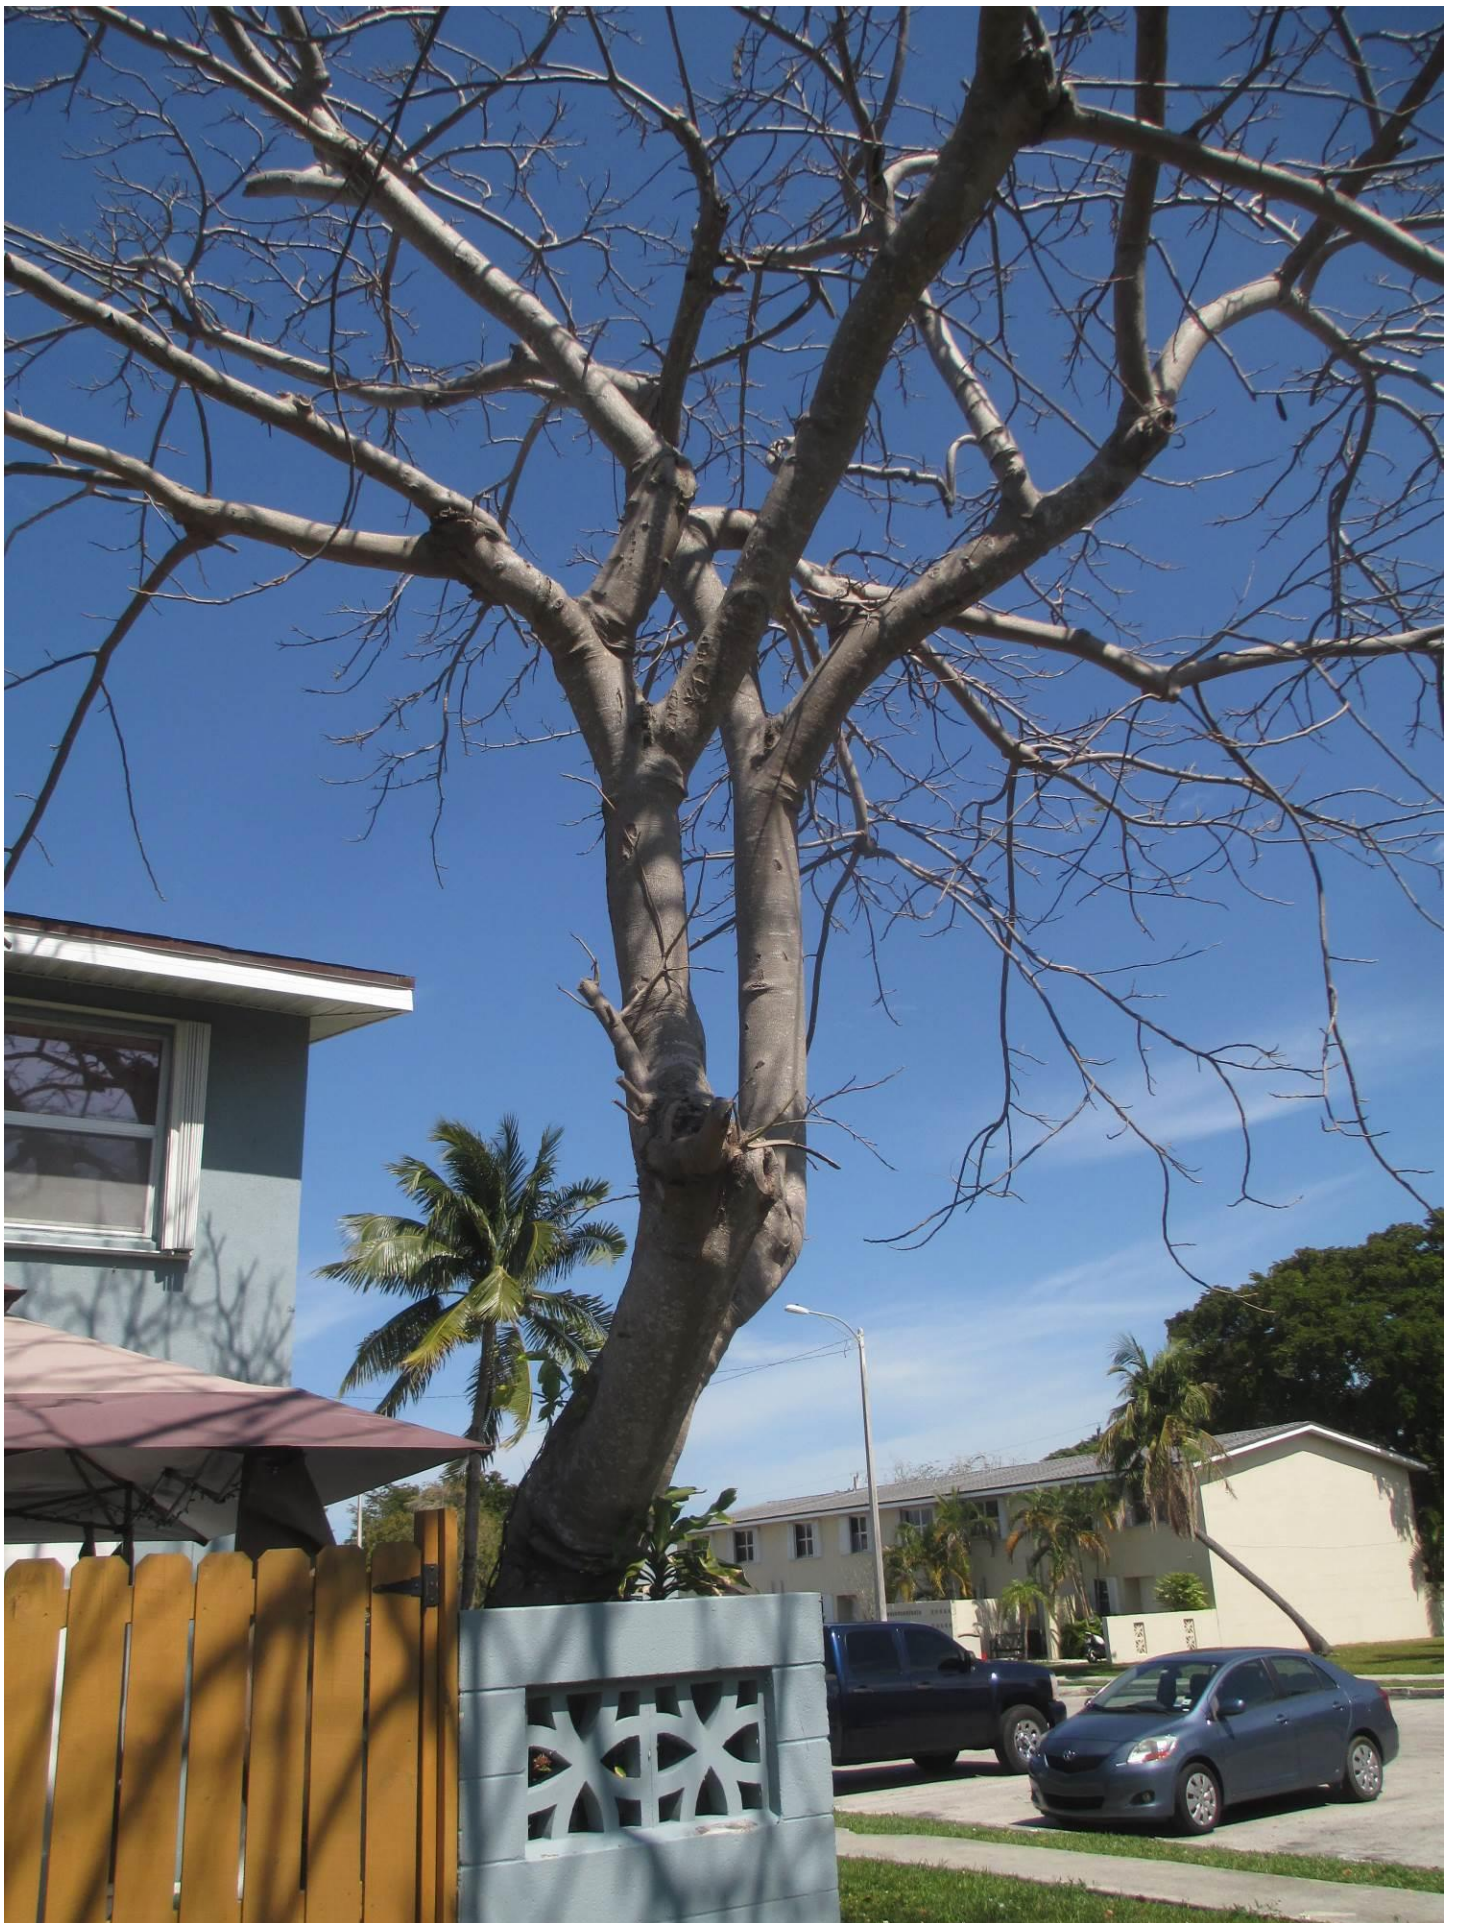
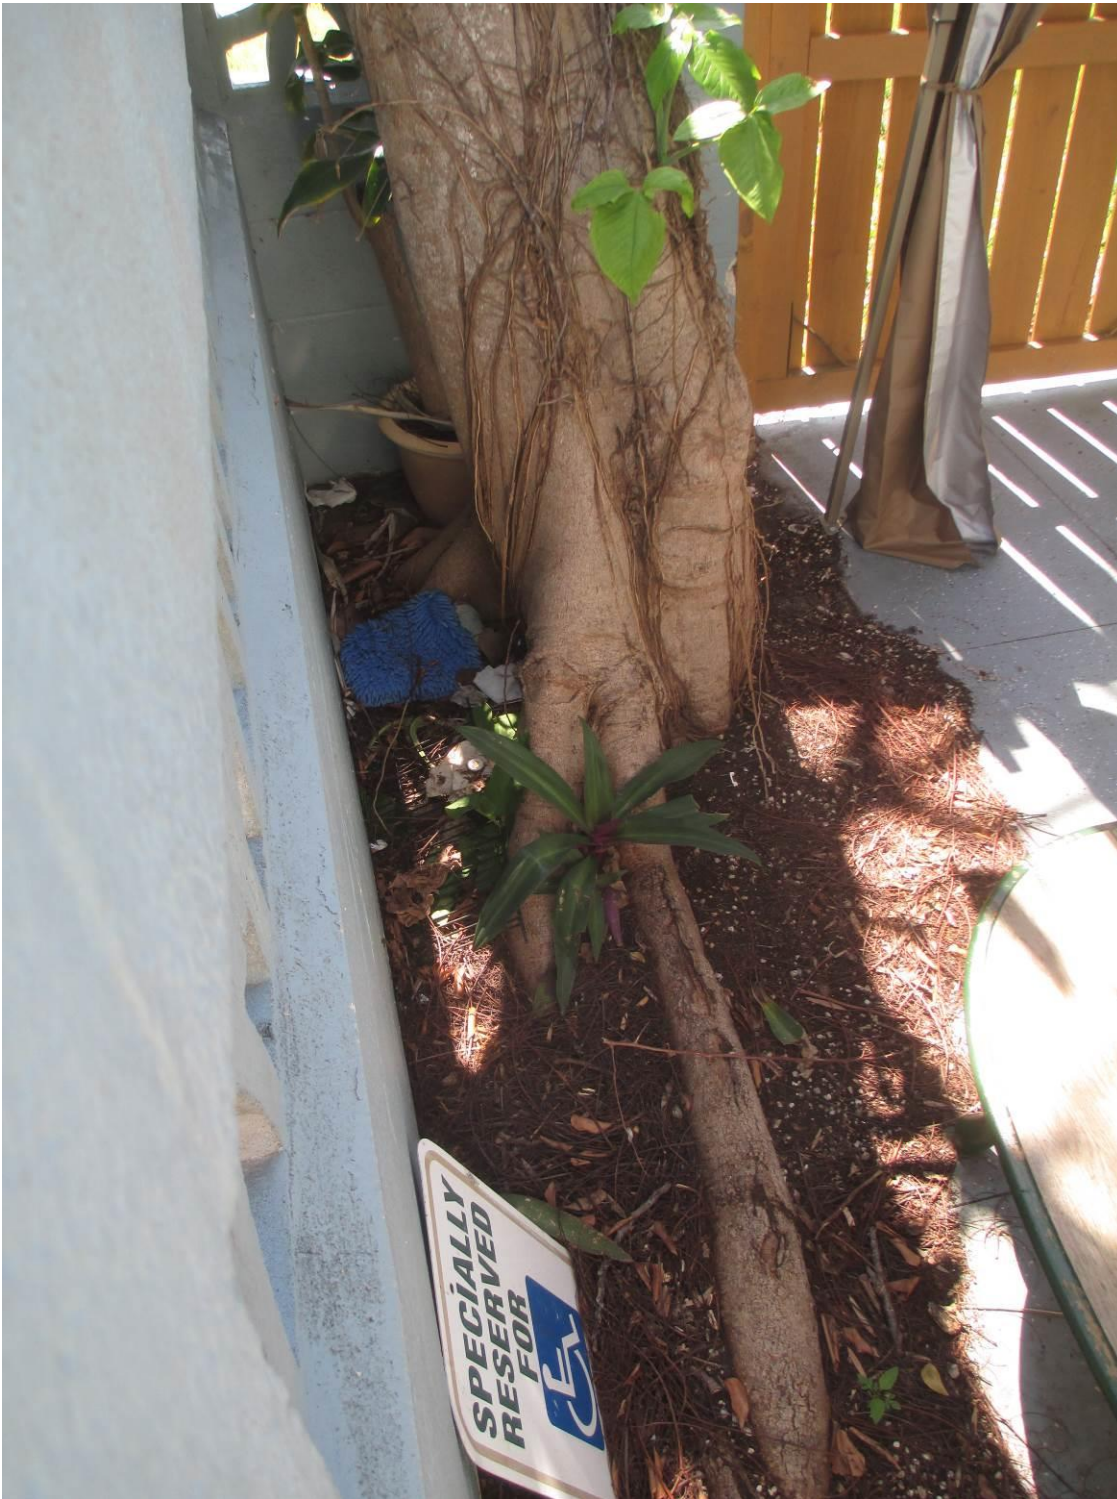
Tree #14: Royal Poinciana (*Delonix regia*)

Diameter: 14"

Location: 60% (roots impacting public open area)

Condition: 40% (some decay, lot of exposed surface roots)

Total Average Value = 66%

Value x Diameter = 9 replacement caliper inches

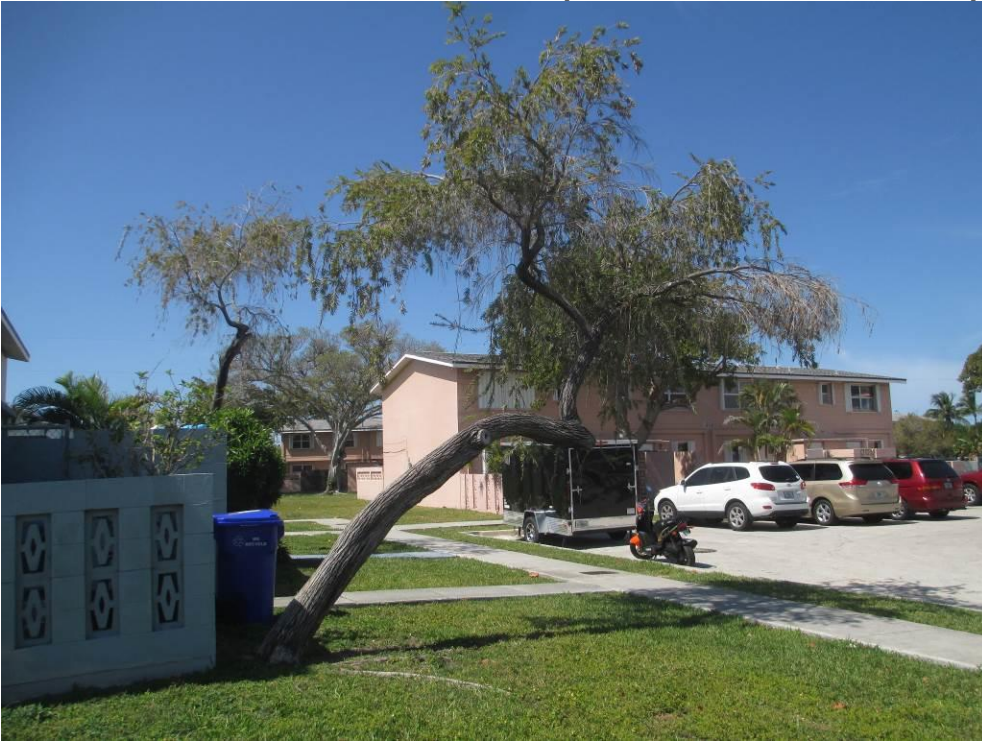
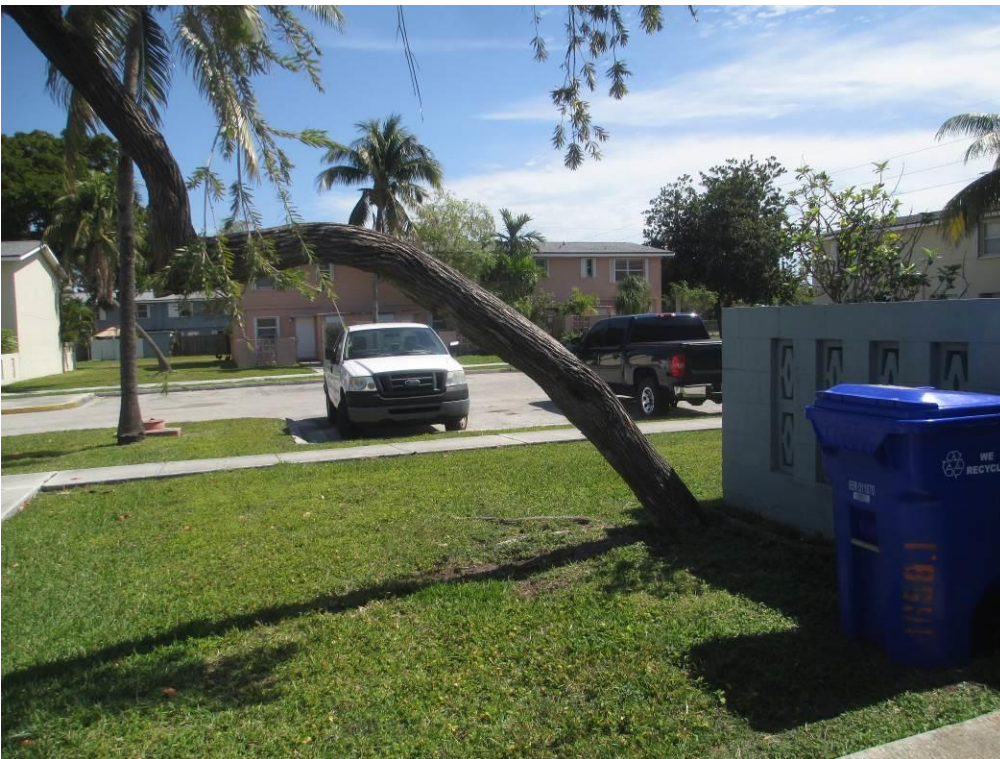
Tree #15: Bottlebrush (*Callistemon viminalis*)

Diameter: 10"

Condition: 40% (poor, strong lean)

Total Average Value = 53%

Value x Diameter = 5 replacement caliper inches
