STAFF REPORT

DATE: February 26, 2016

RE: **1664 Dunlap Drive-Poinciana Gardens**
(permit application # T16-7794)

FROM: Karen DeMaria, City of Key West Urban Forestry Manager

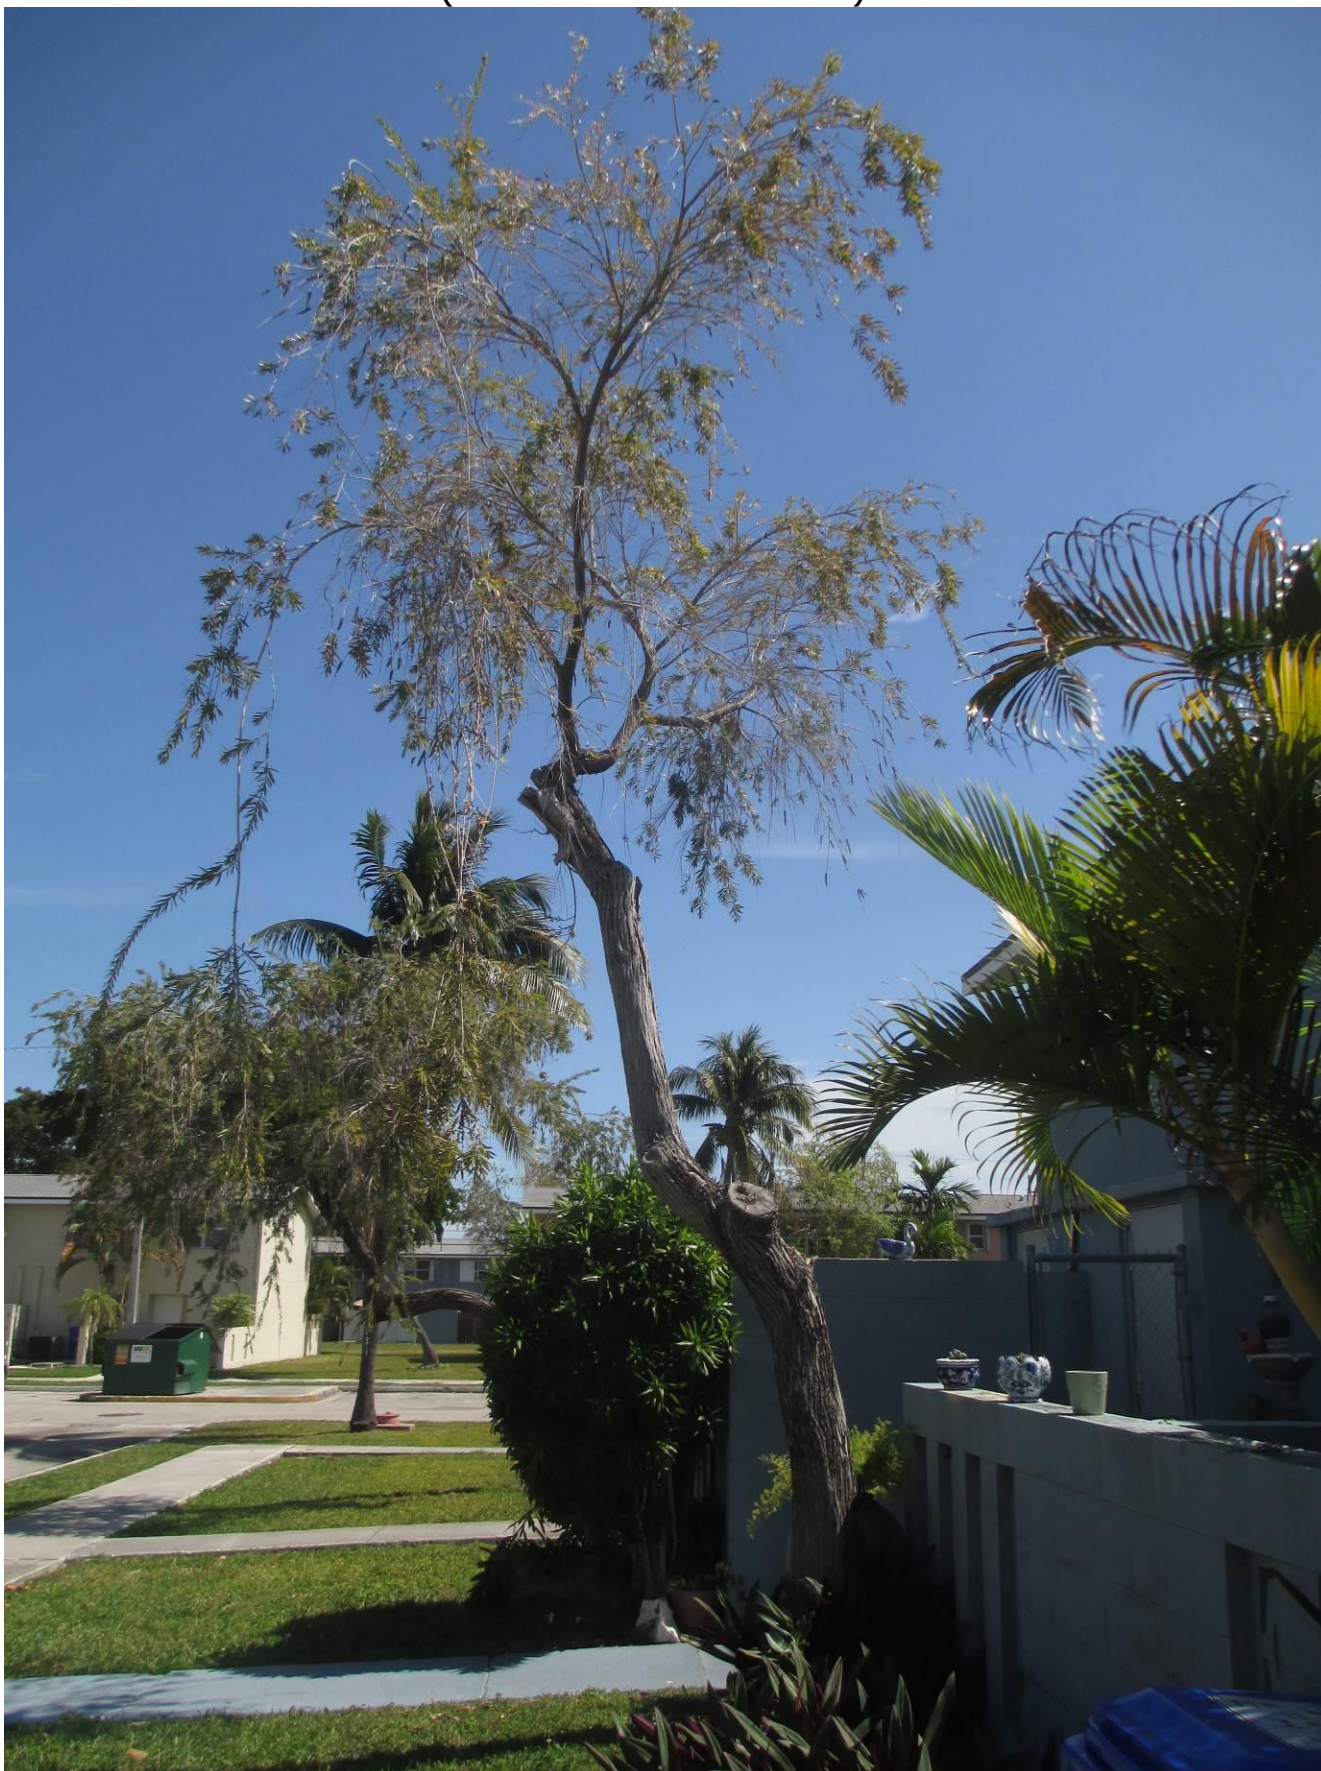
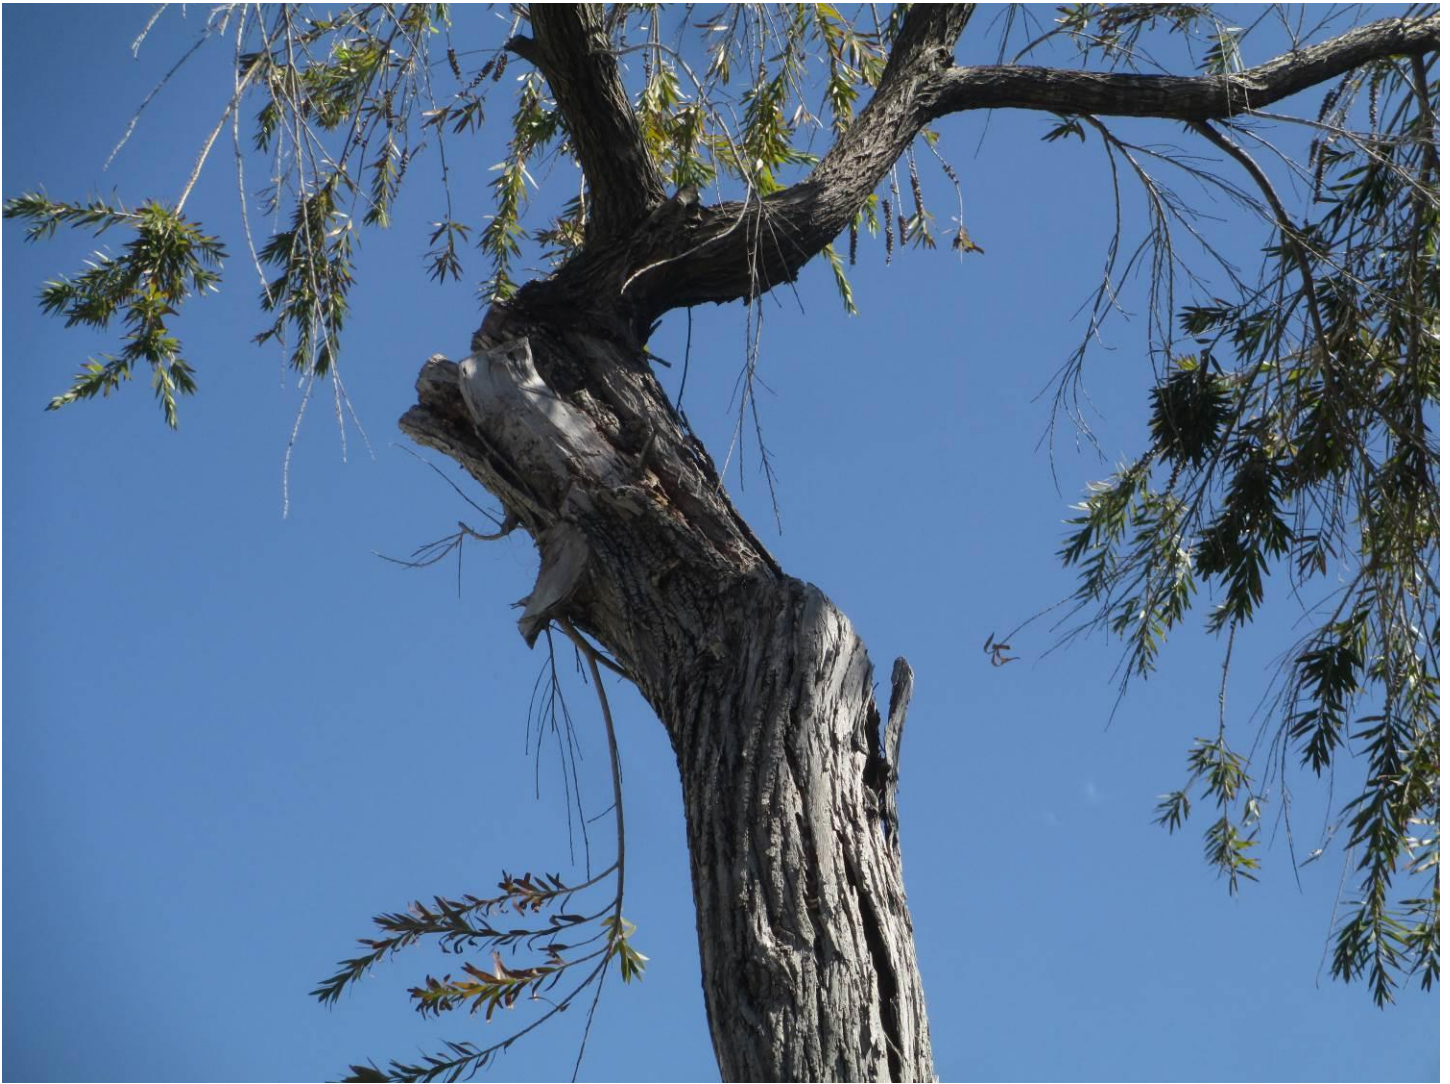
Tree #16: Bottlebrush (*Callistemon viminalis*)

Diameter: 11"

Condition: 30% (poor, major decay at old cut in canopy)

Total Average Value = 50%

Value x Diameter = 5 replacement caliper inches

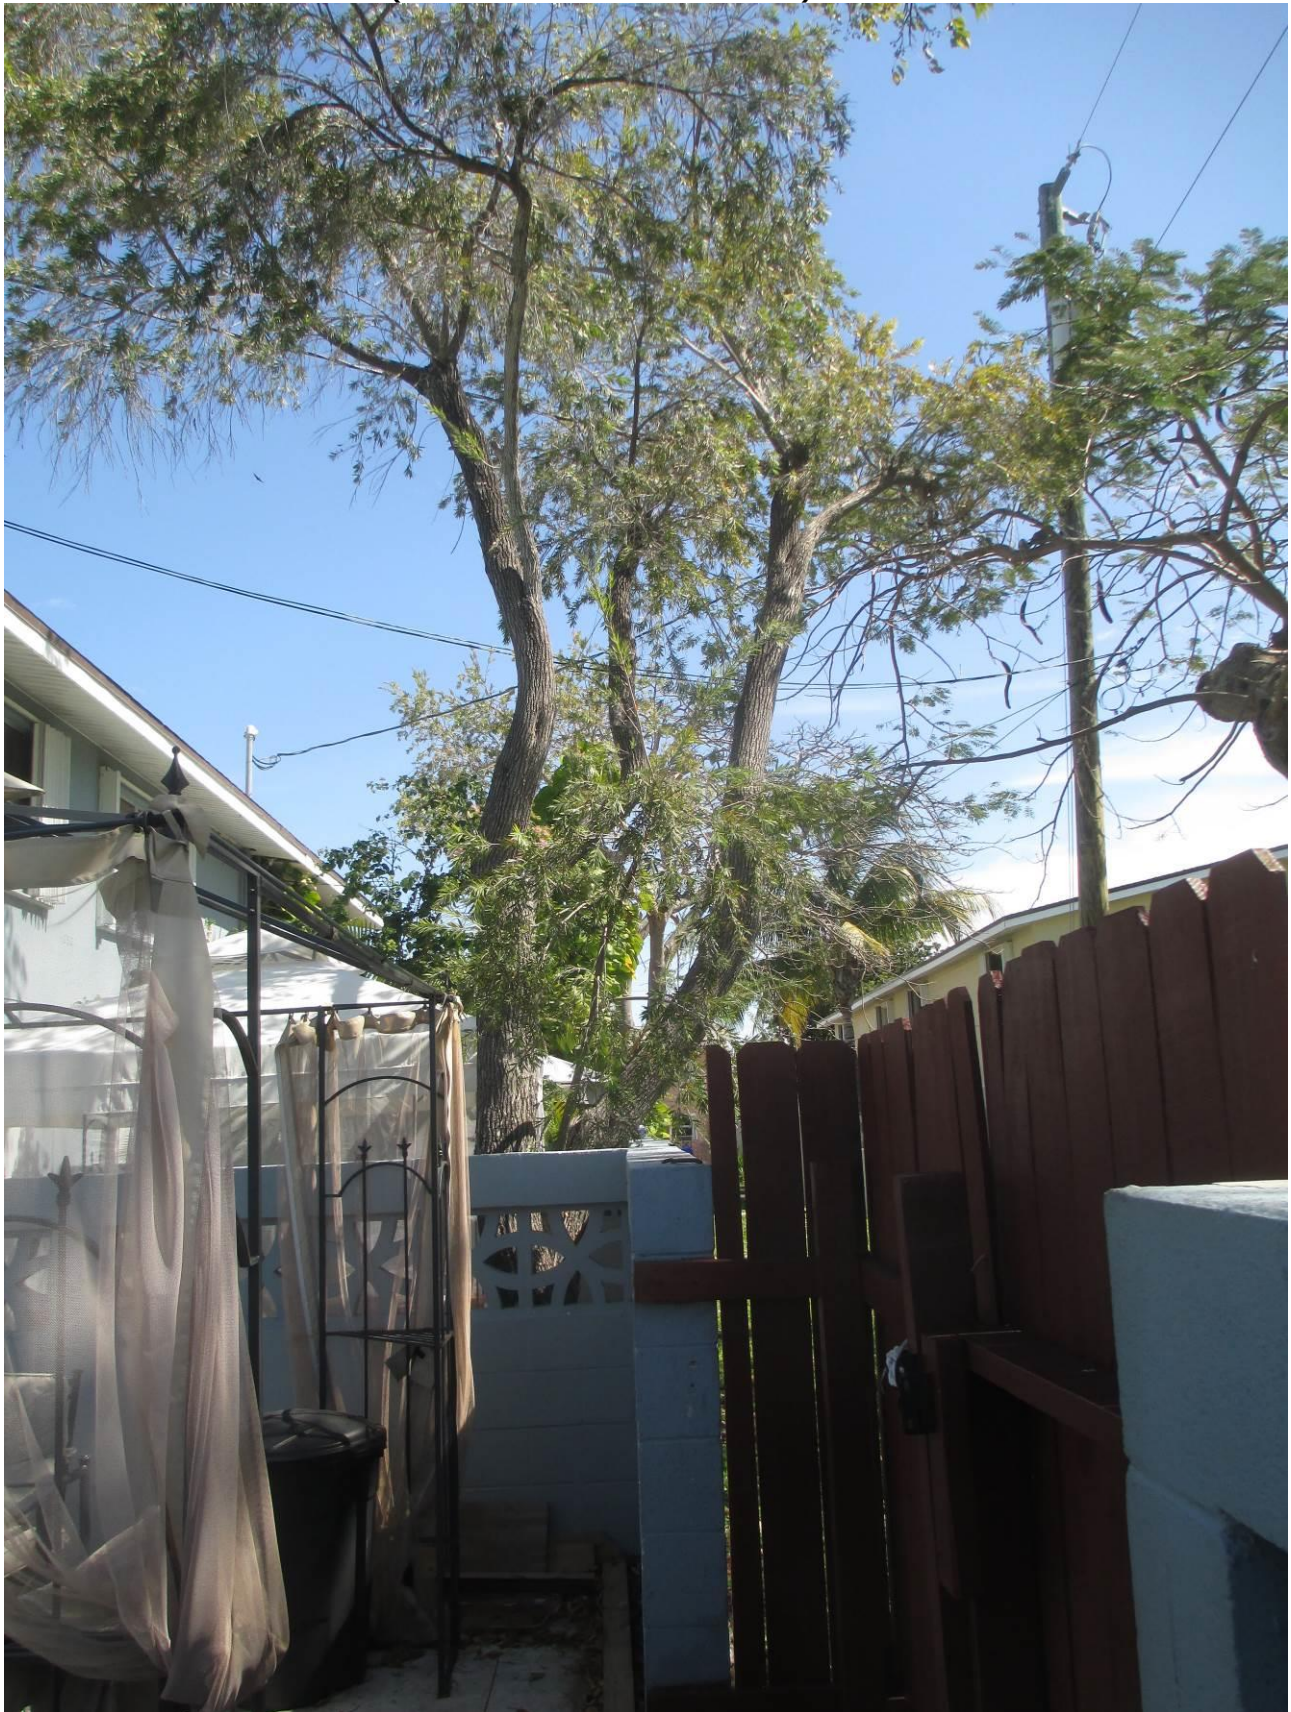
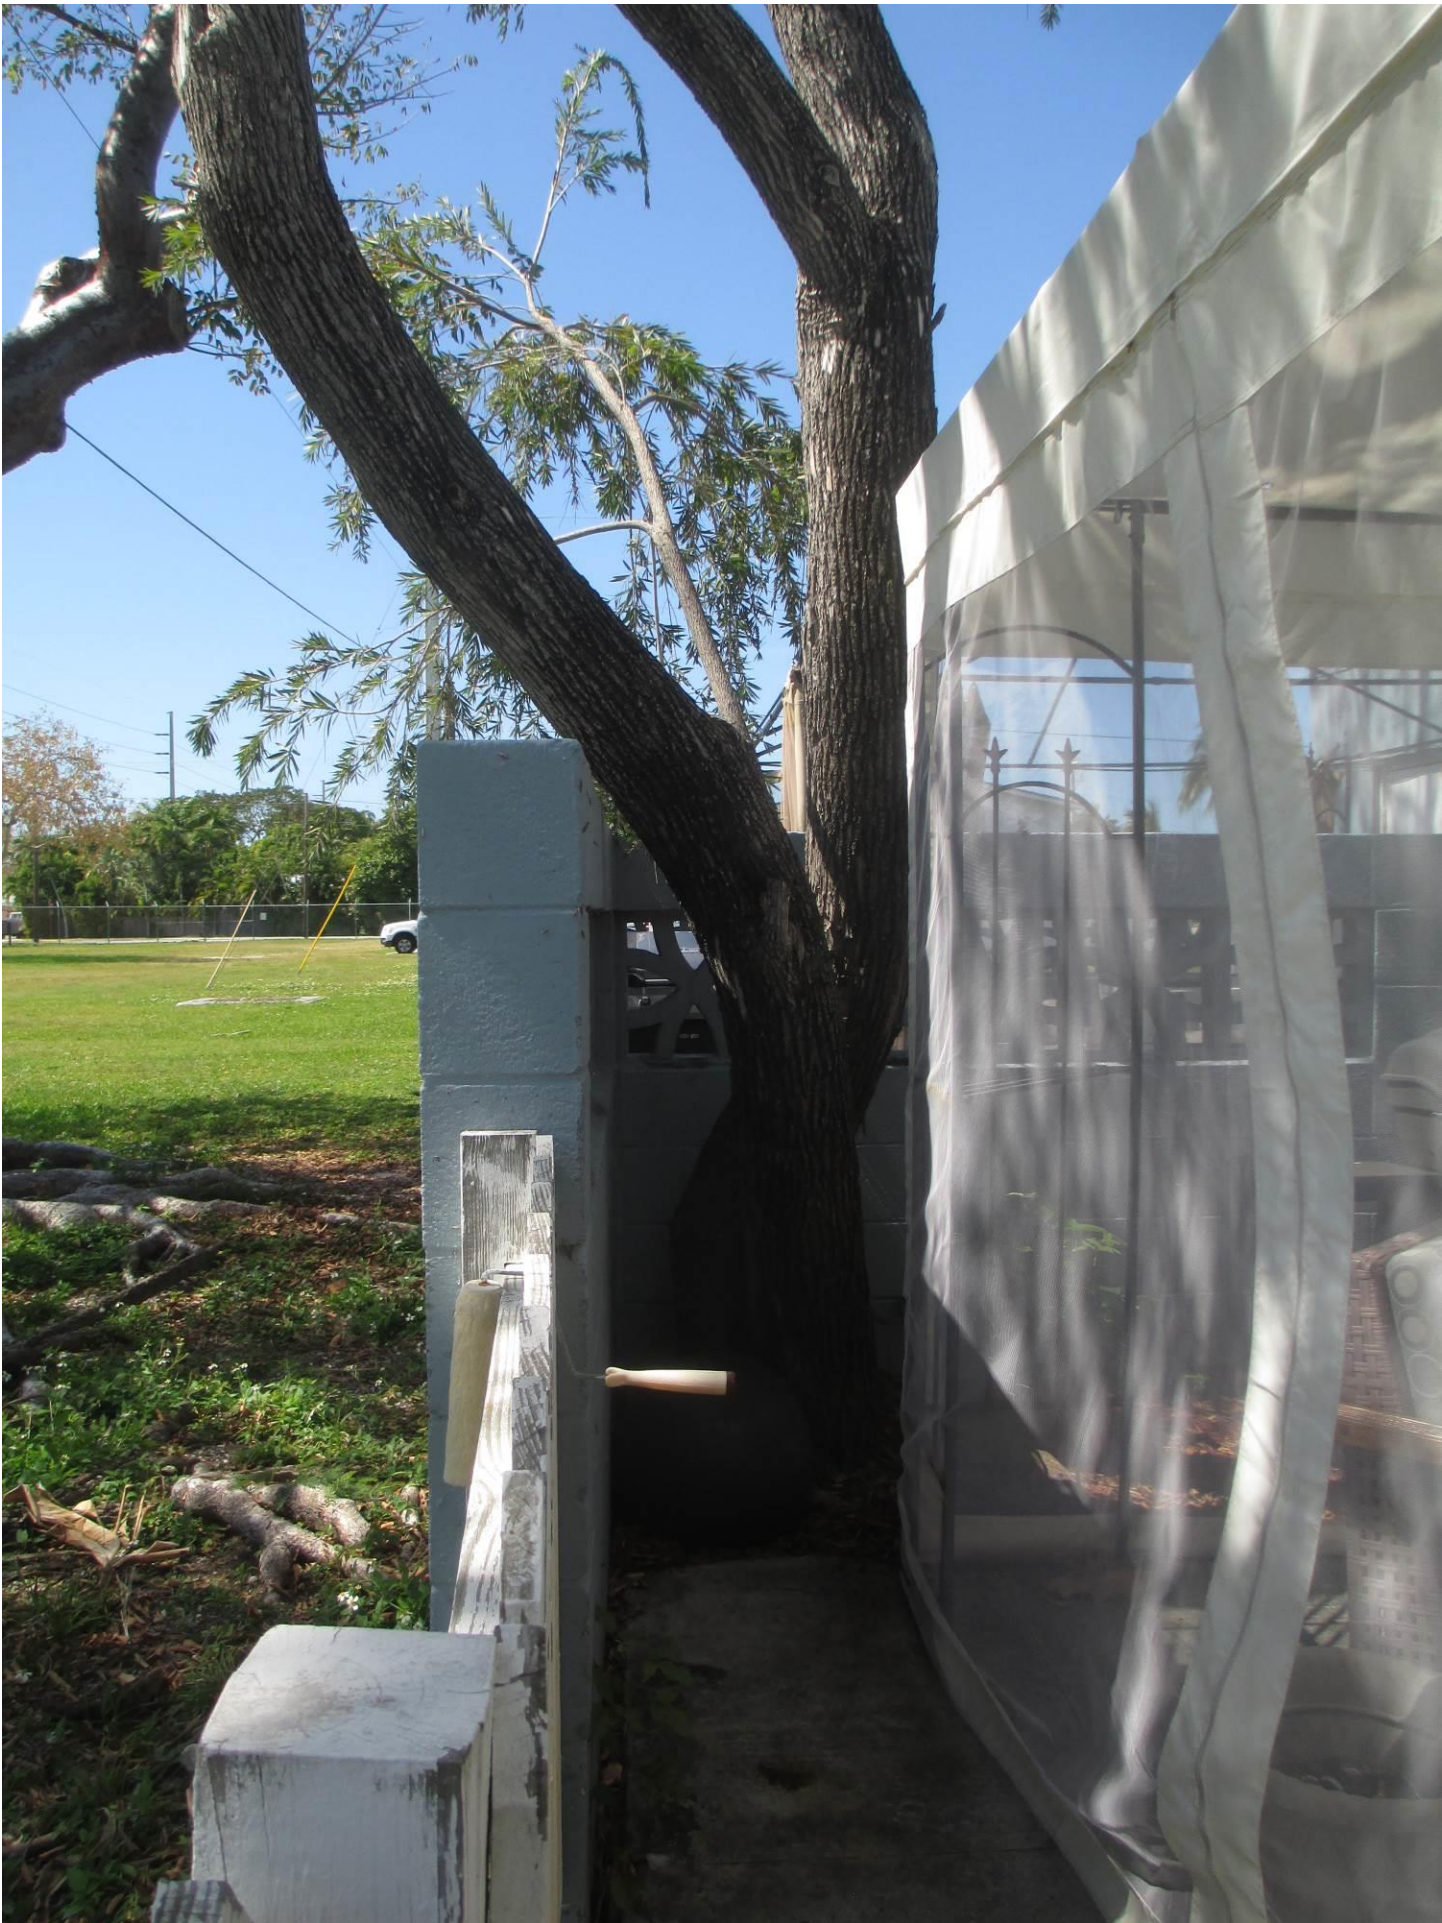
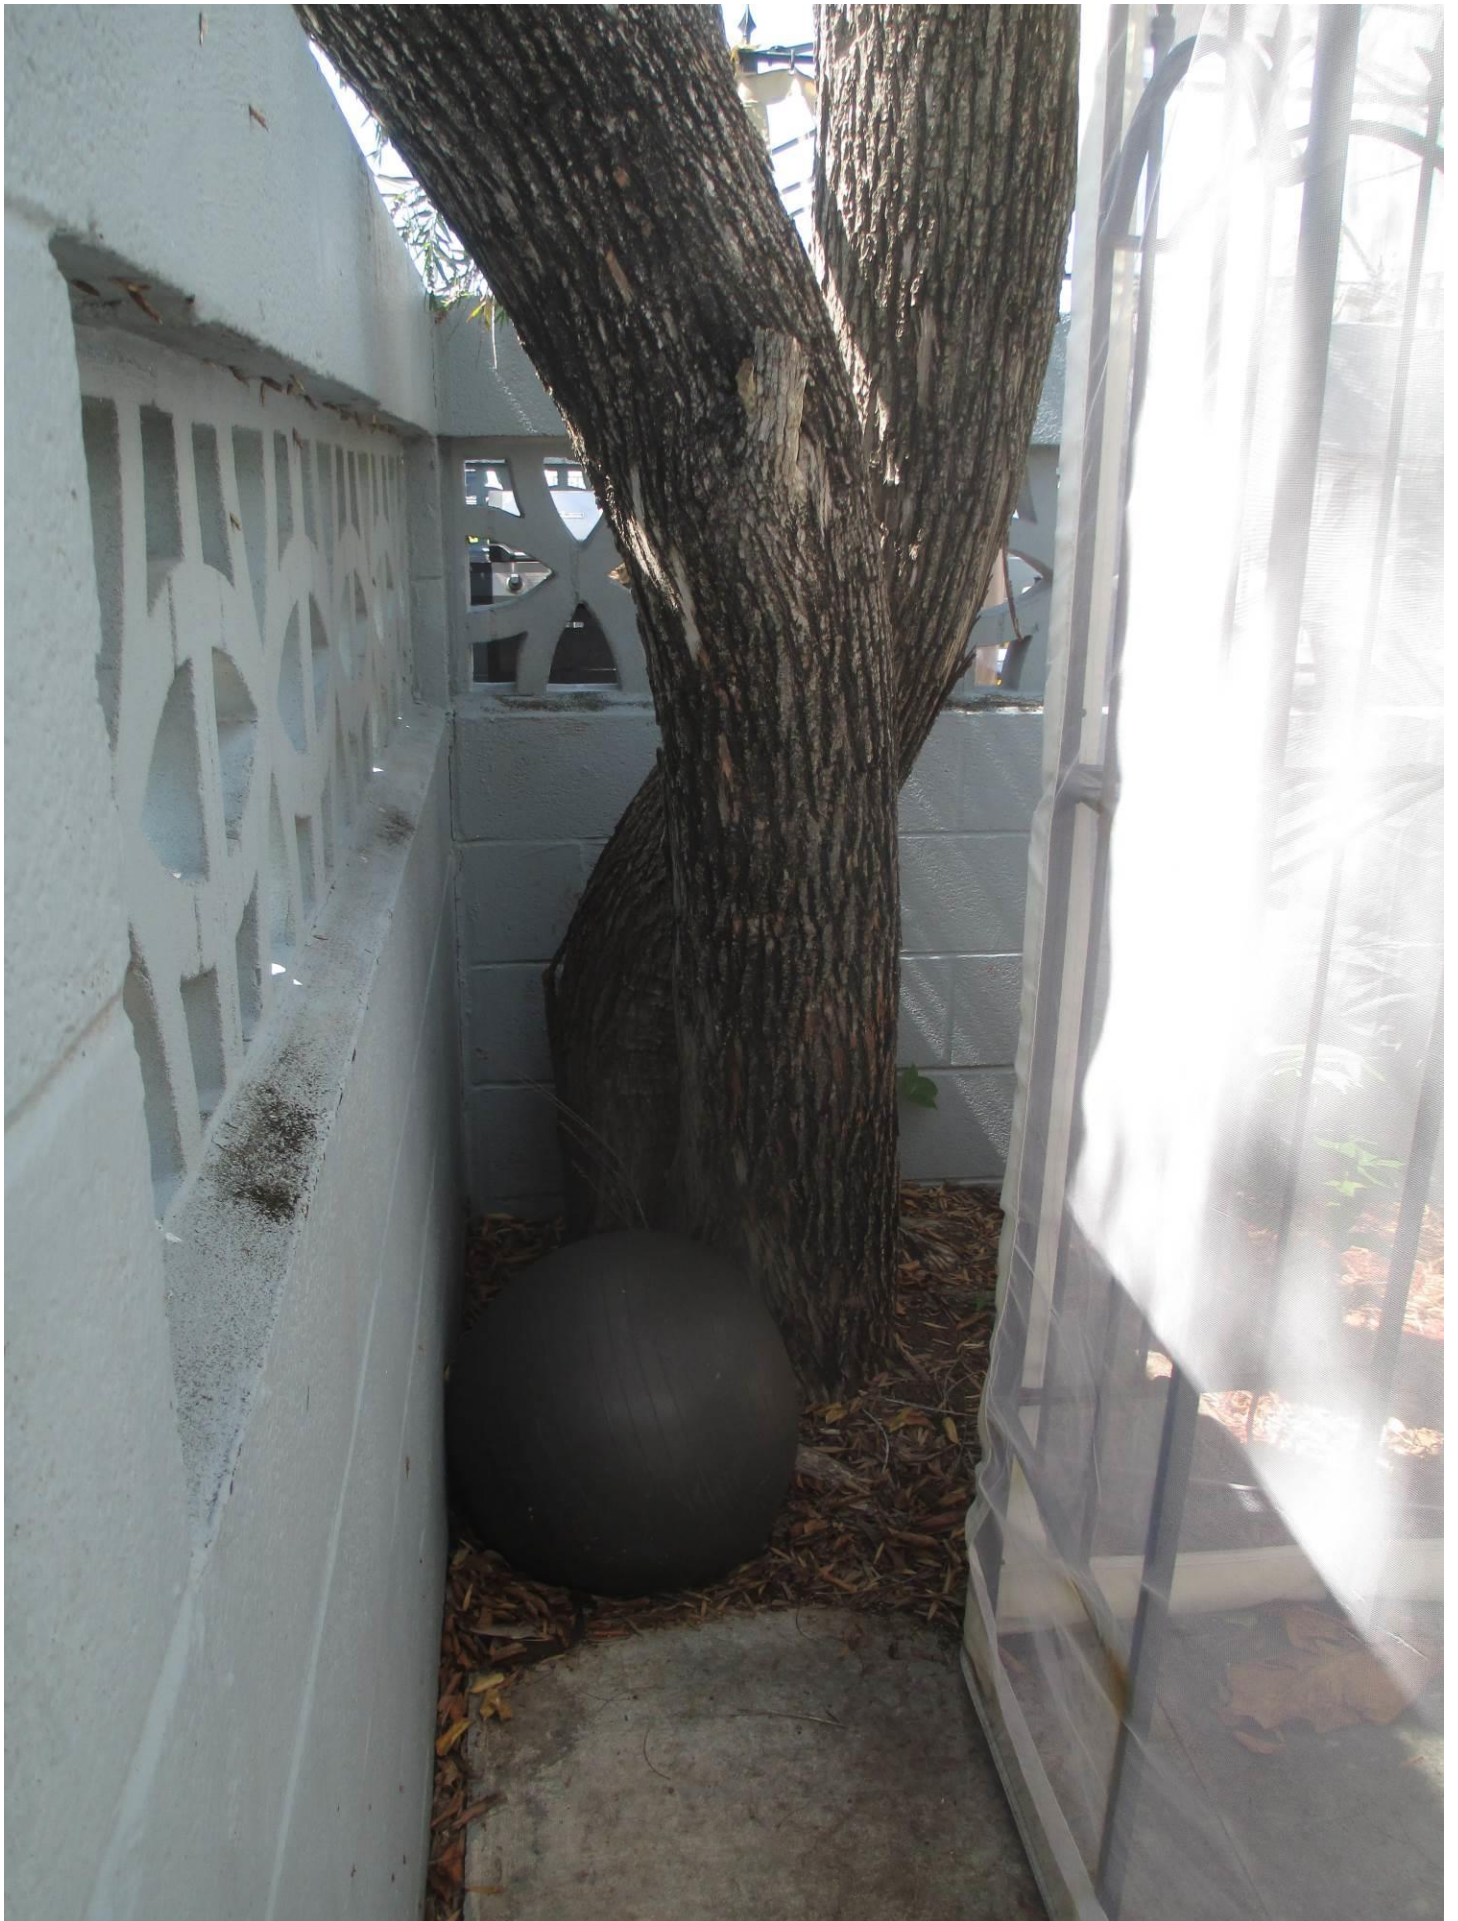
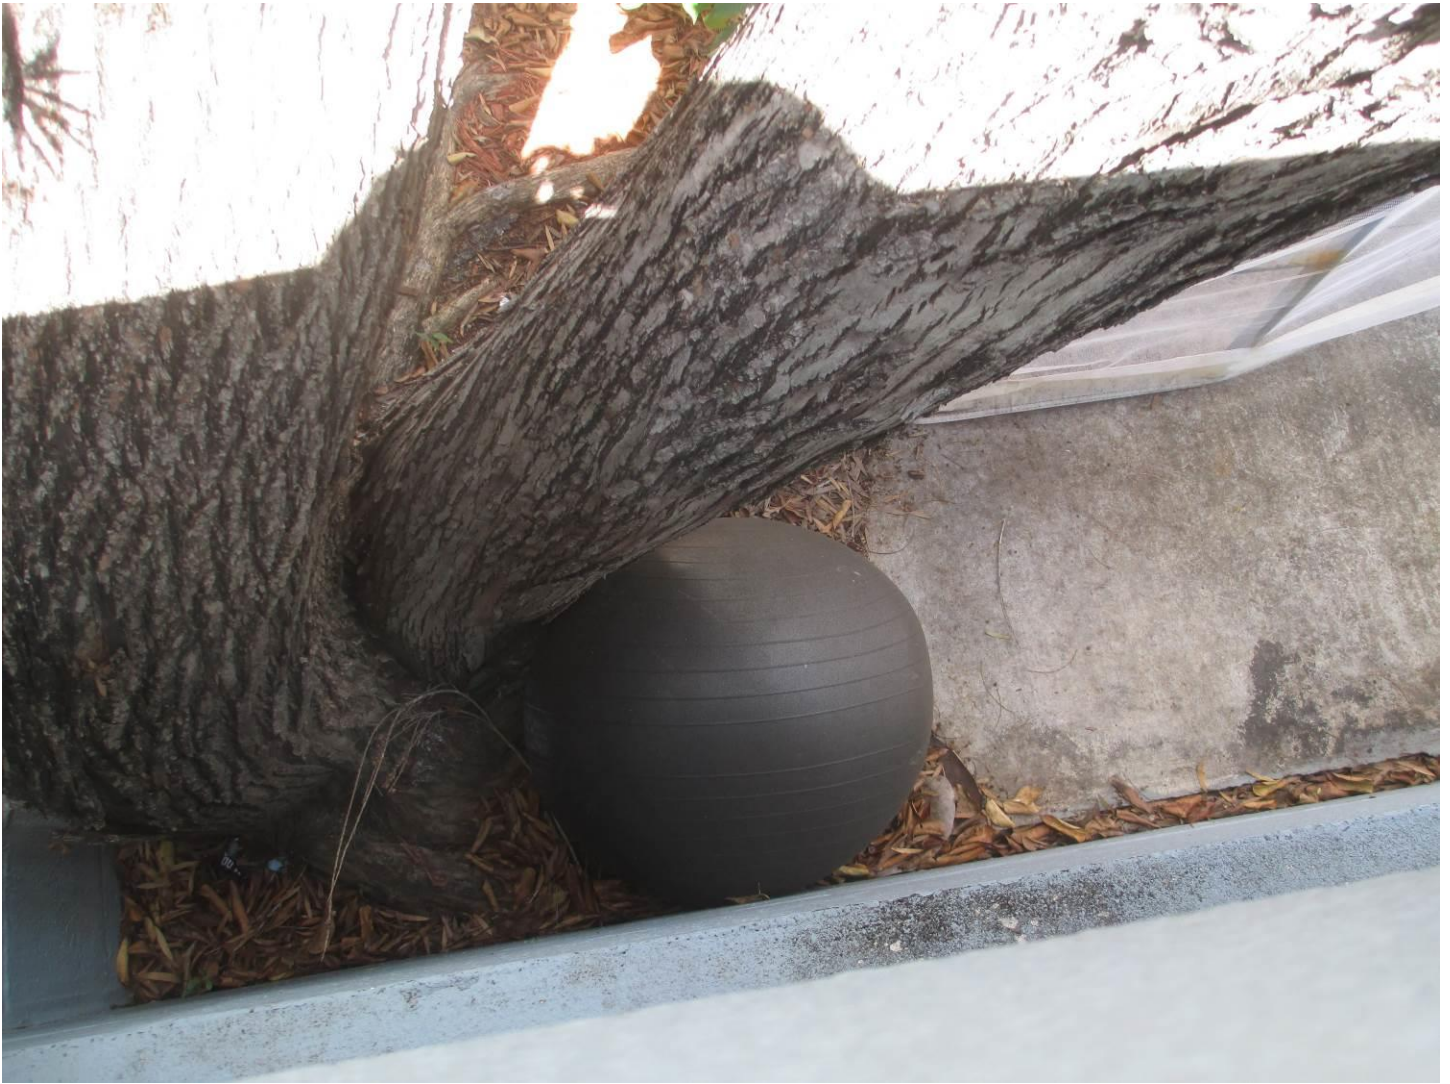
Tree #17: Bottlebrush (*Callistemon viminalis*)

Diameter: 22"

Location: 60% (one trunk on wall)

Condition: 50% (fair to poor, codominant trunks)

Total Average Value = 53%

Value x Diameter = 11 replacement caliper inches

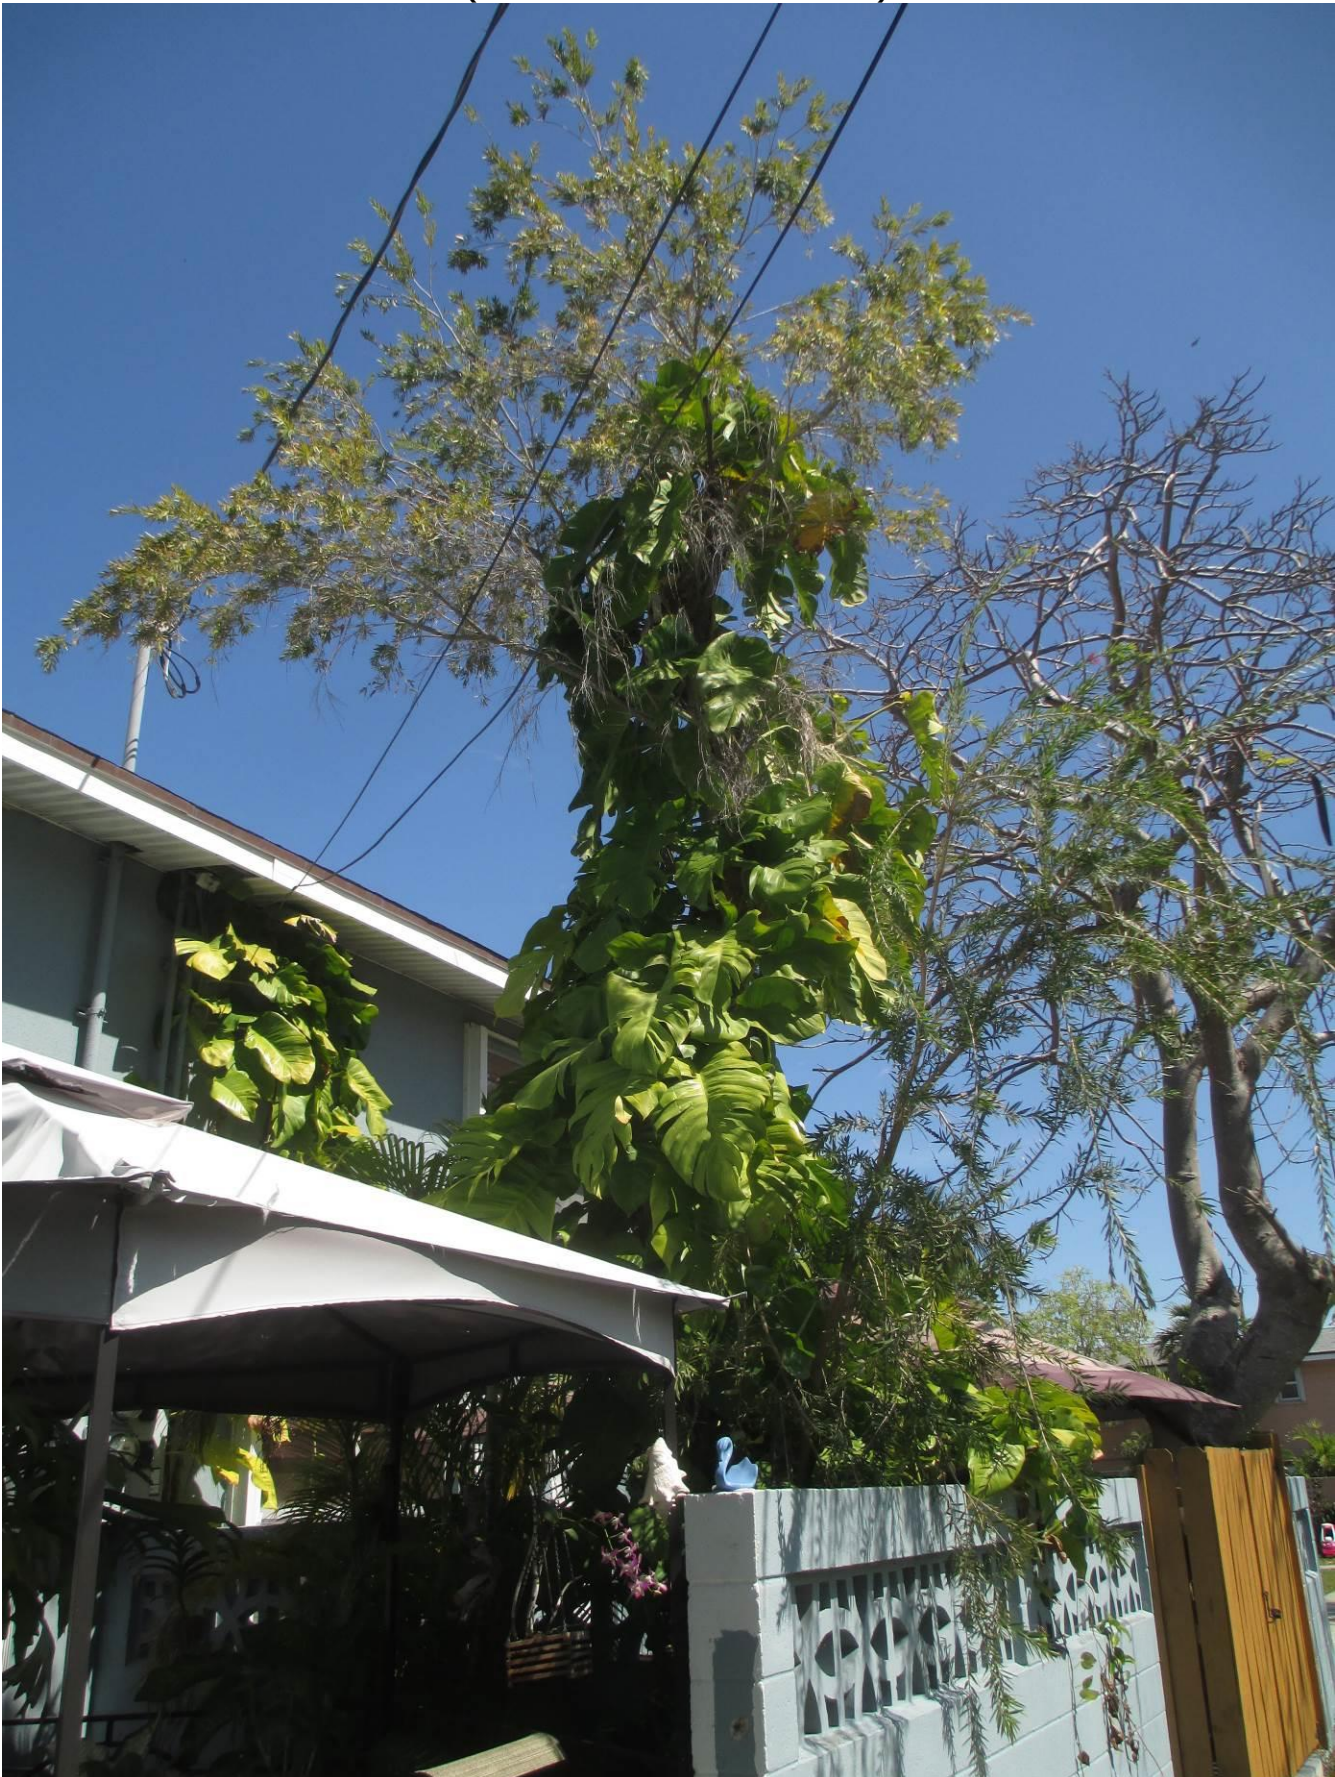
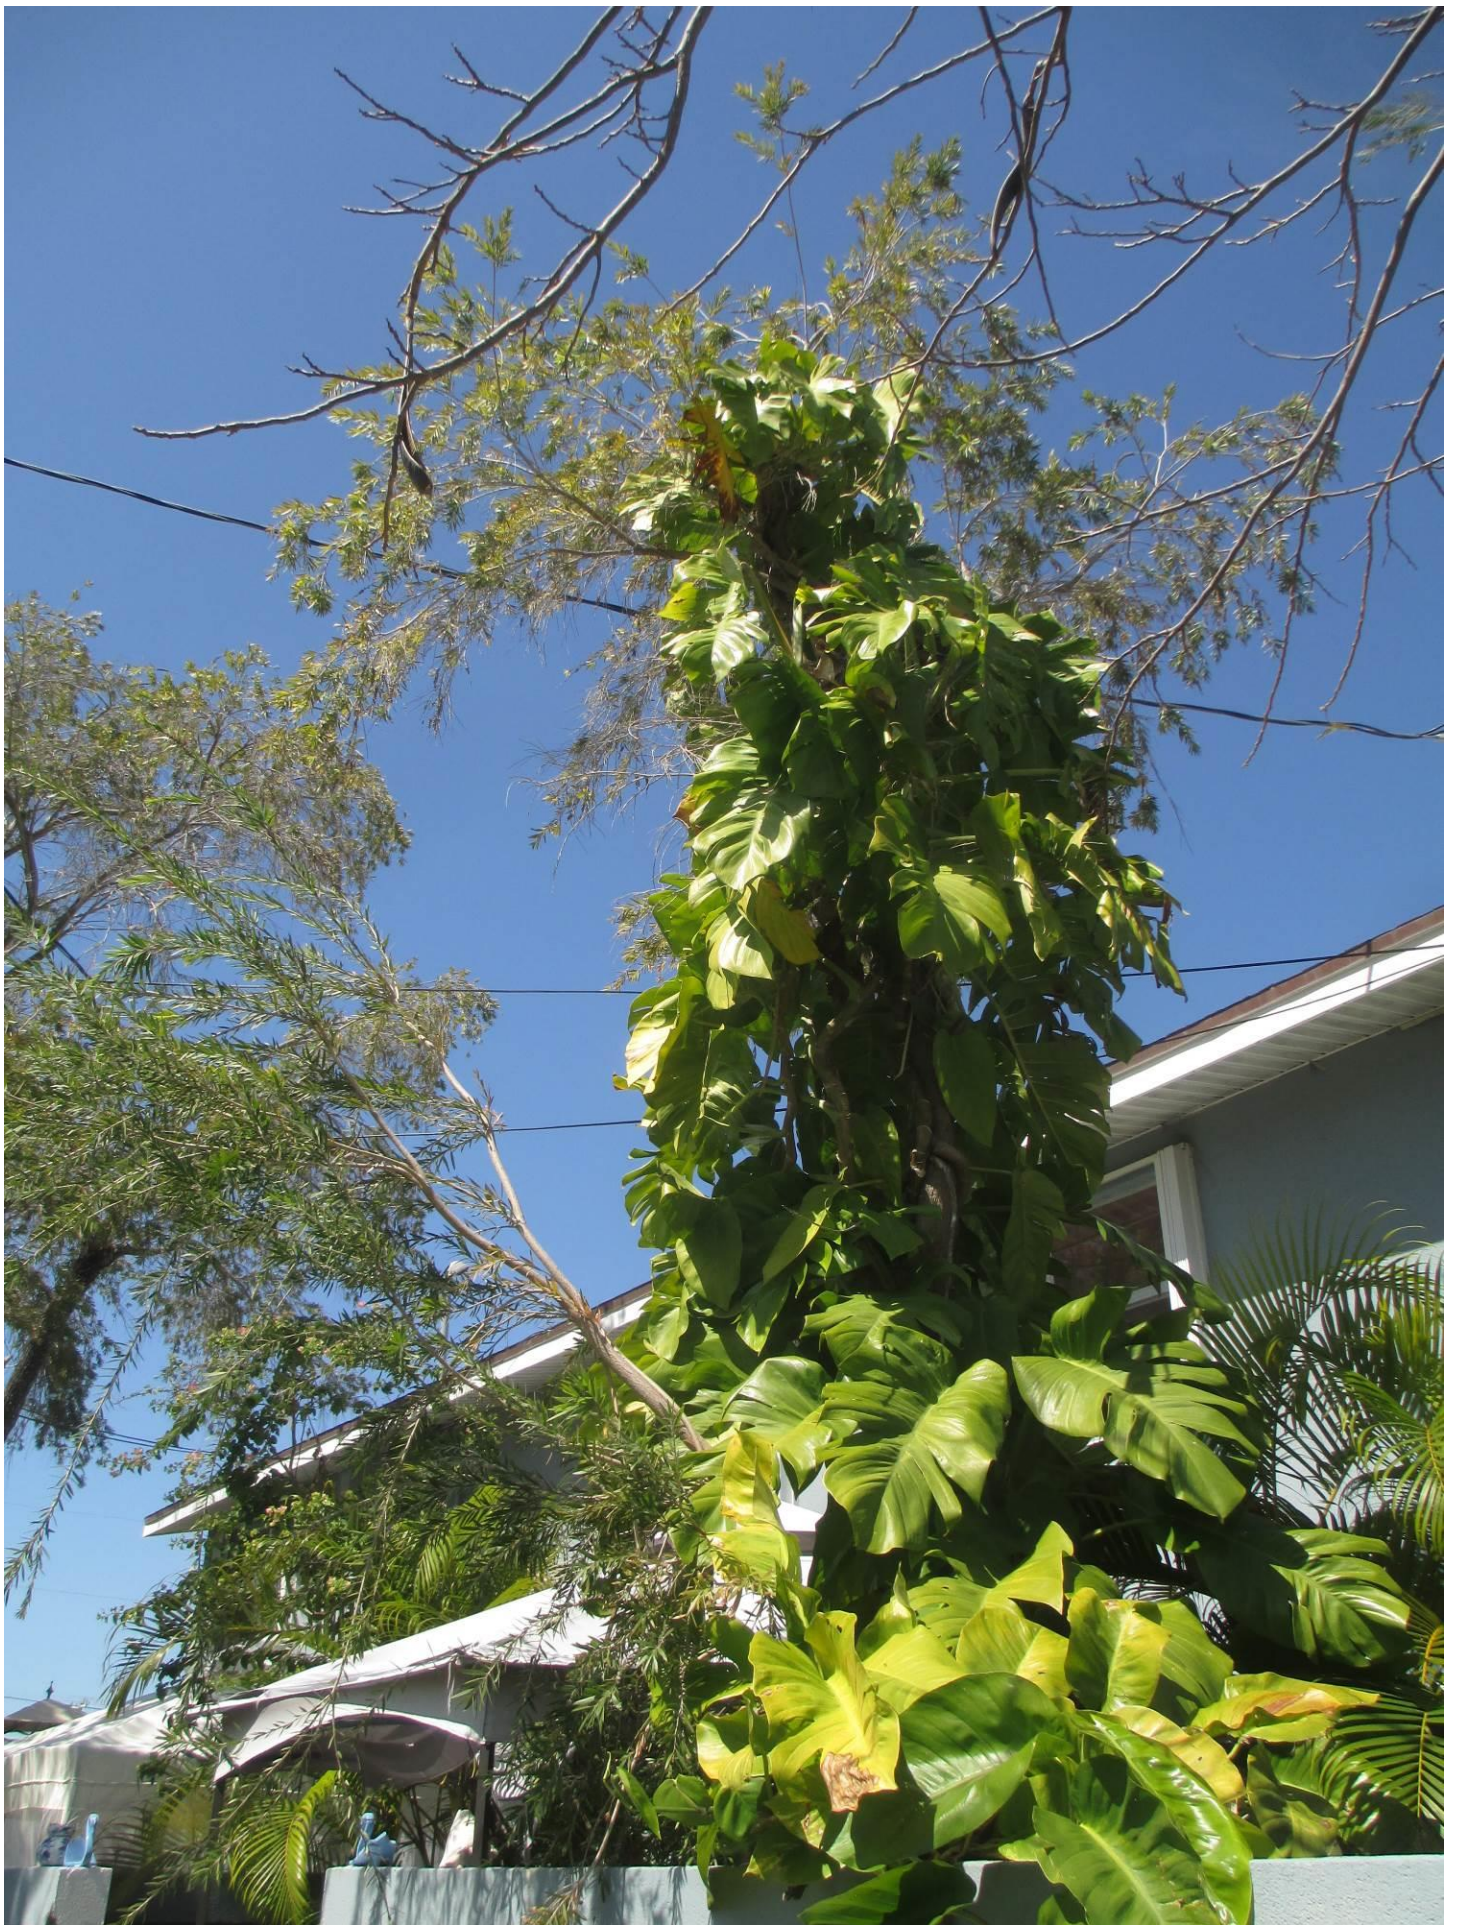
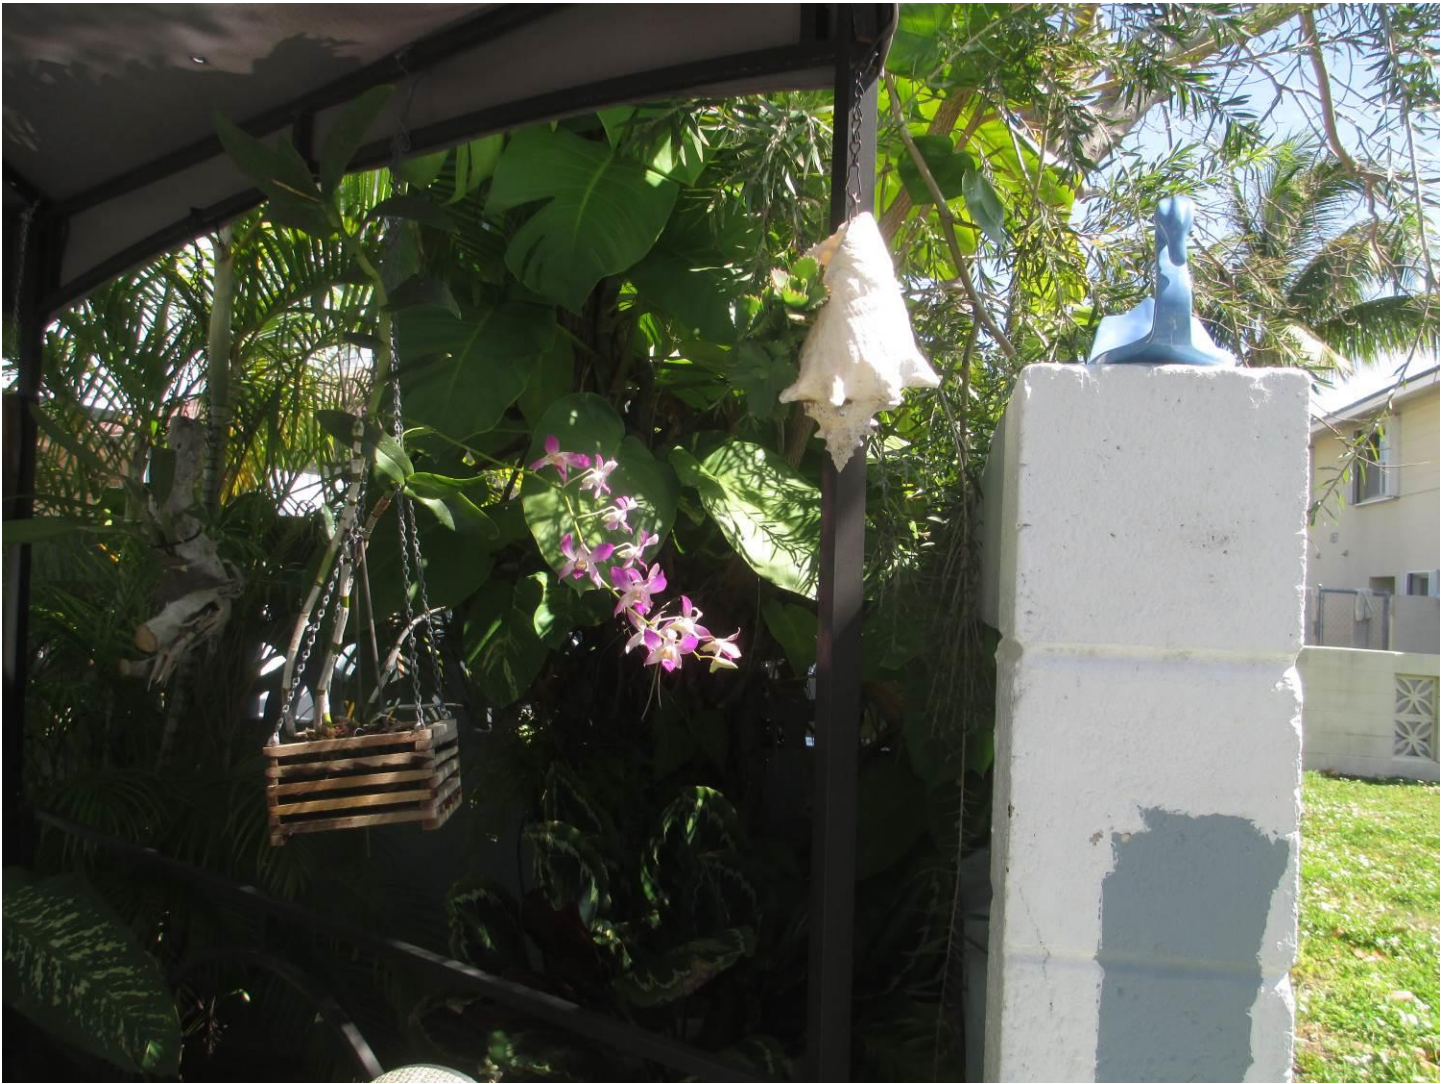
Tree #18: Bottlebrush (*Callistemon viminalis*)

Diameter: 9"

Condition: 30% (poor)

Total Average Value = 50%

Value x Diameter = 4 replacement caliper inches
