STAFF REPORT

DATE: February 26, 2016

RE: **1664 Dunlap Drive-Poinciana Gardens**
(permit application # T16-7794)

FROM: Karen DeMaria, City of Key West Urban Forestry Manager

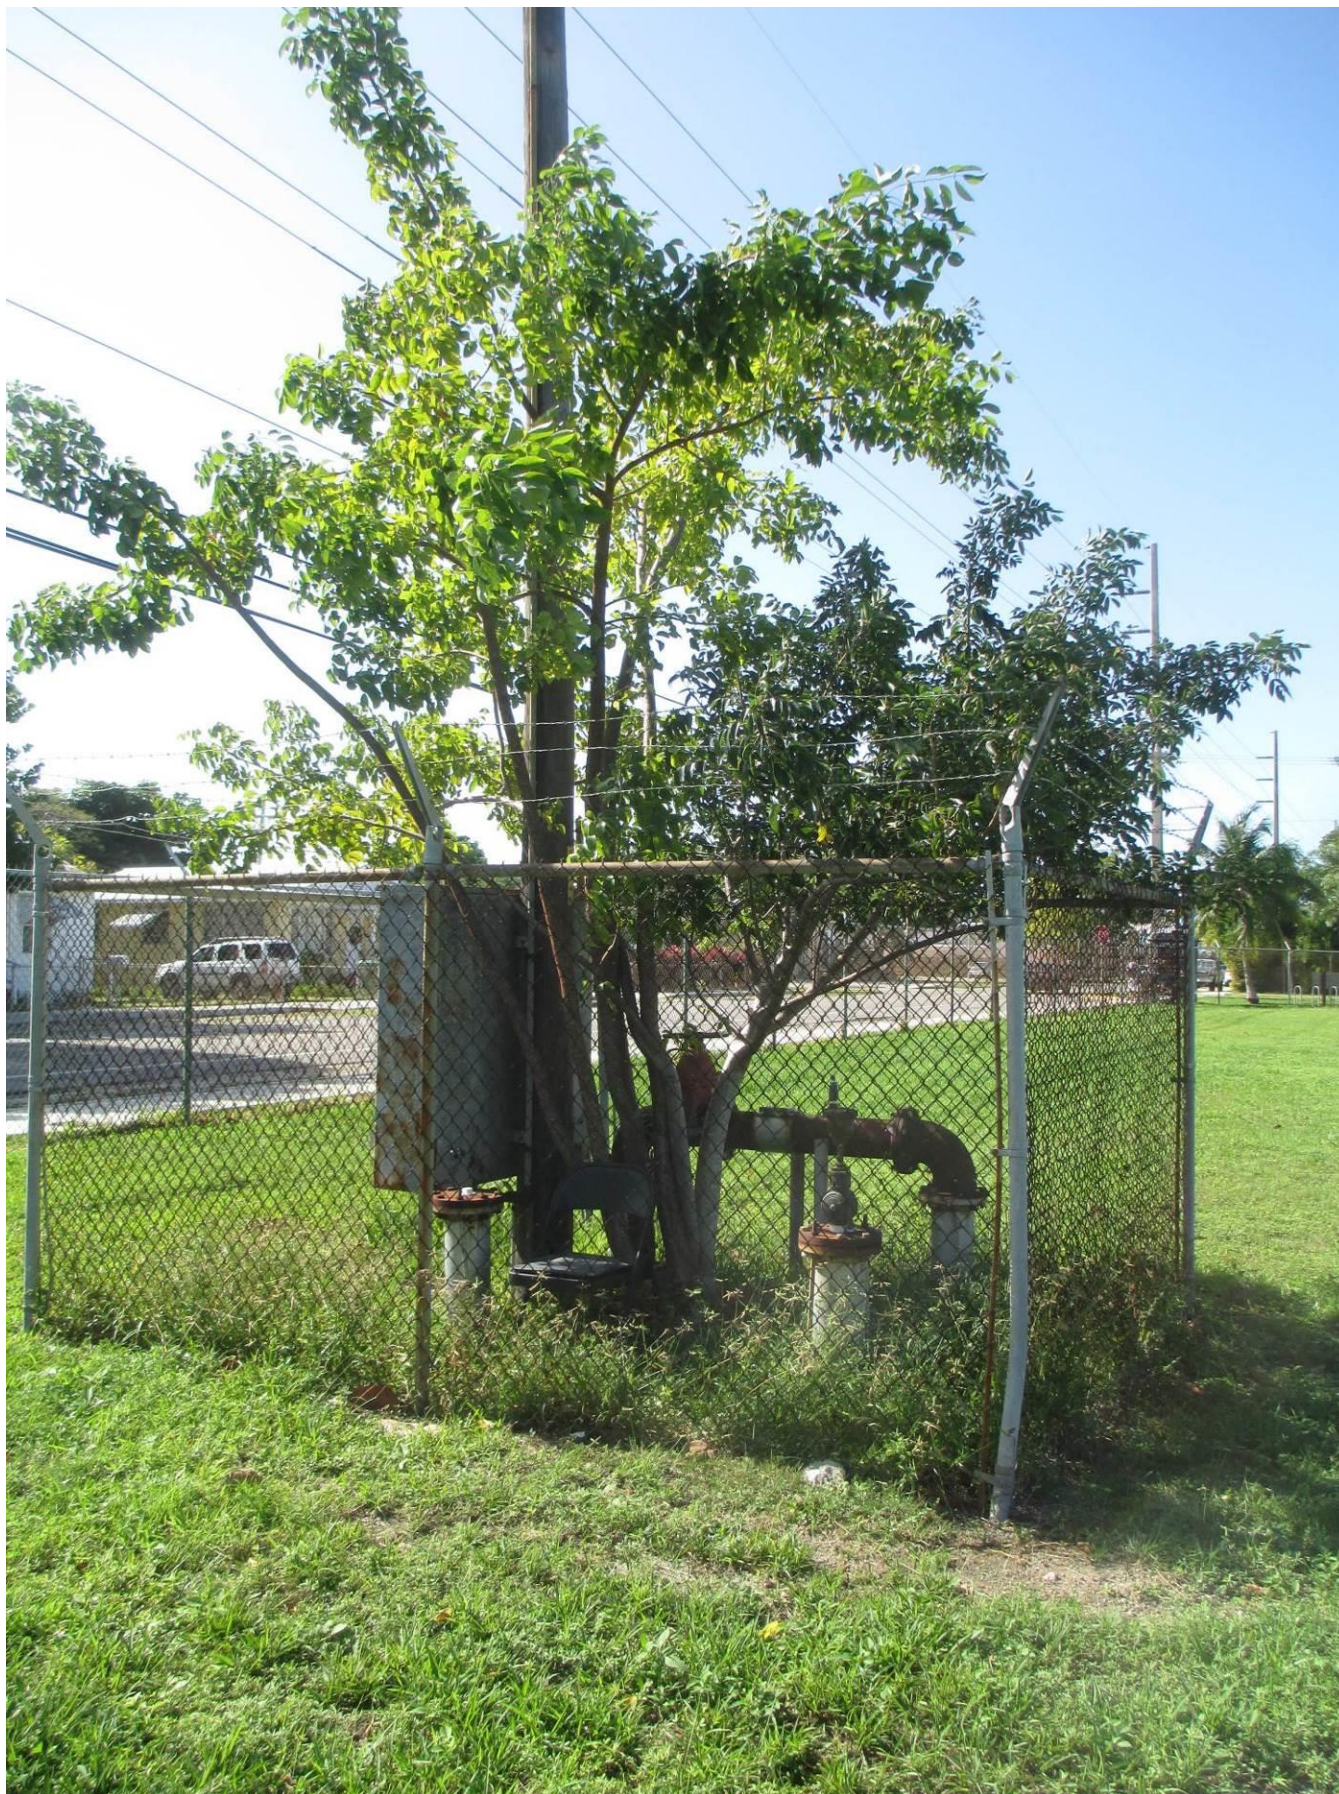
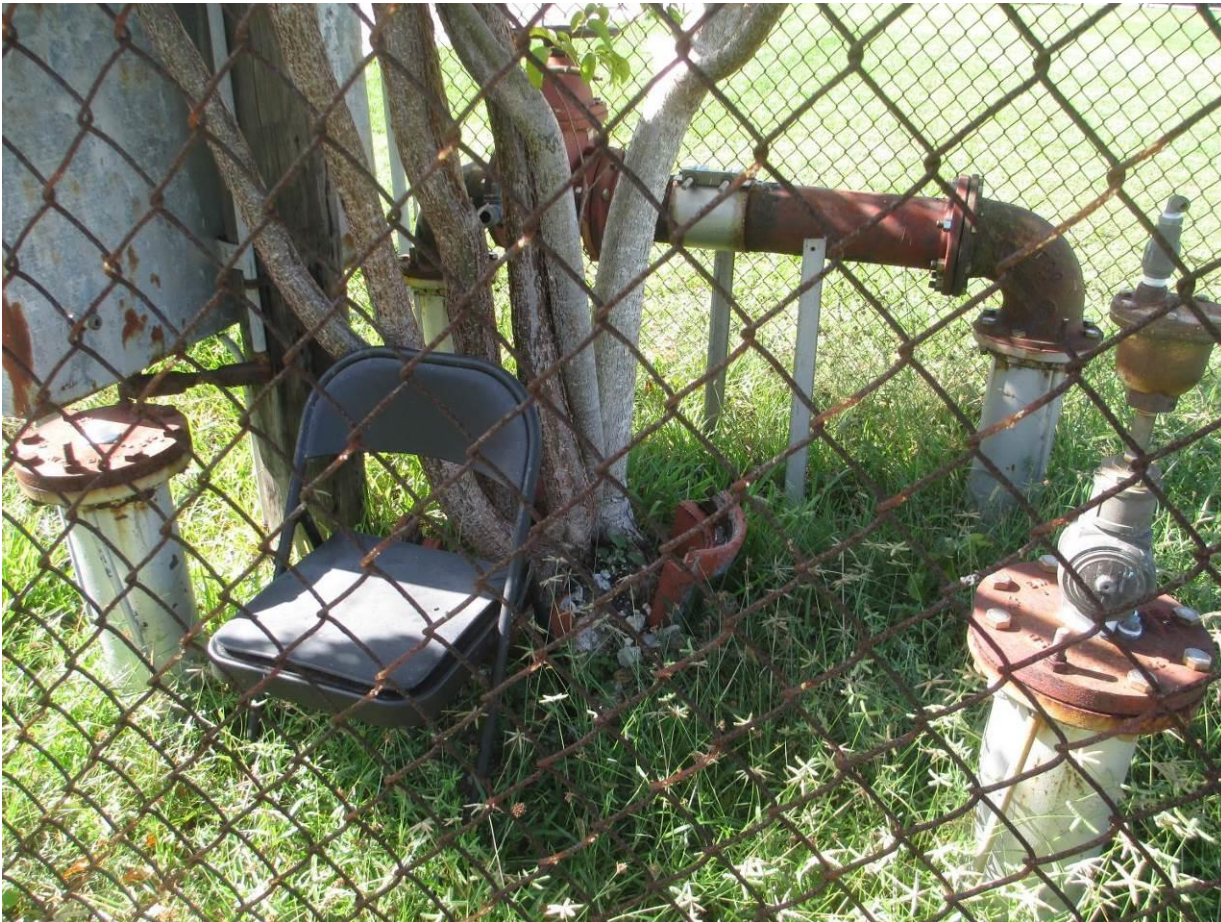
Tree #19: Gumbo Limbo (*Bursera simaruba*)

Diameter: 8"

Location: 20% (growing in fire/water line area)

Condition: 30% (poor, sprawling, multi trunked)

Total Average Value = 50%

Value x Diameter = 4 replacement caliper inches

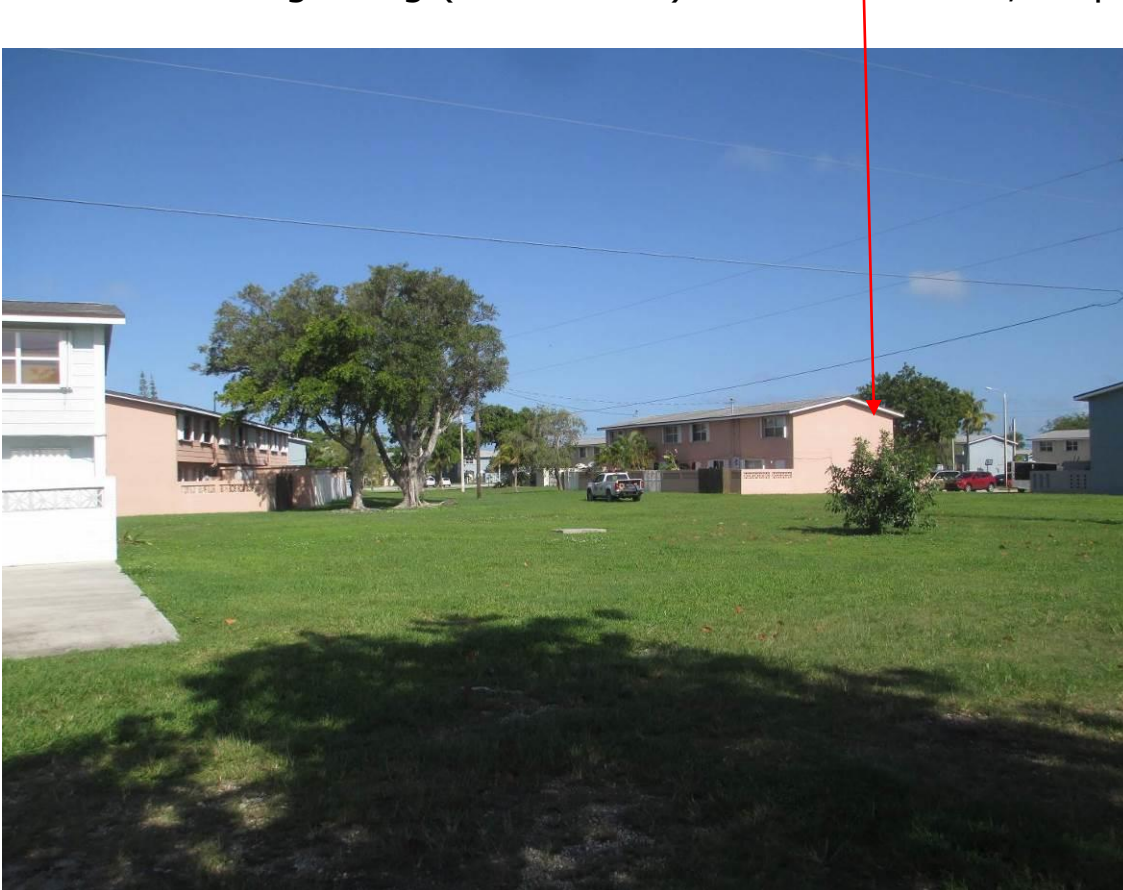
Tree #5: Strangler Fig (*Ficus aurea*)-shrub not a tree, no permit required

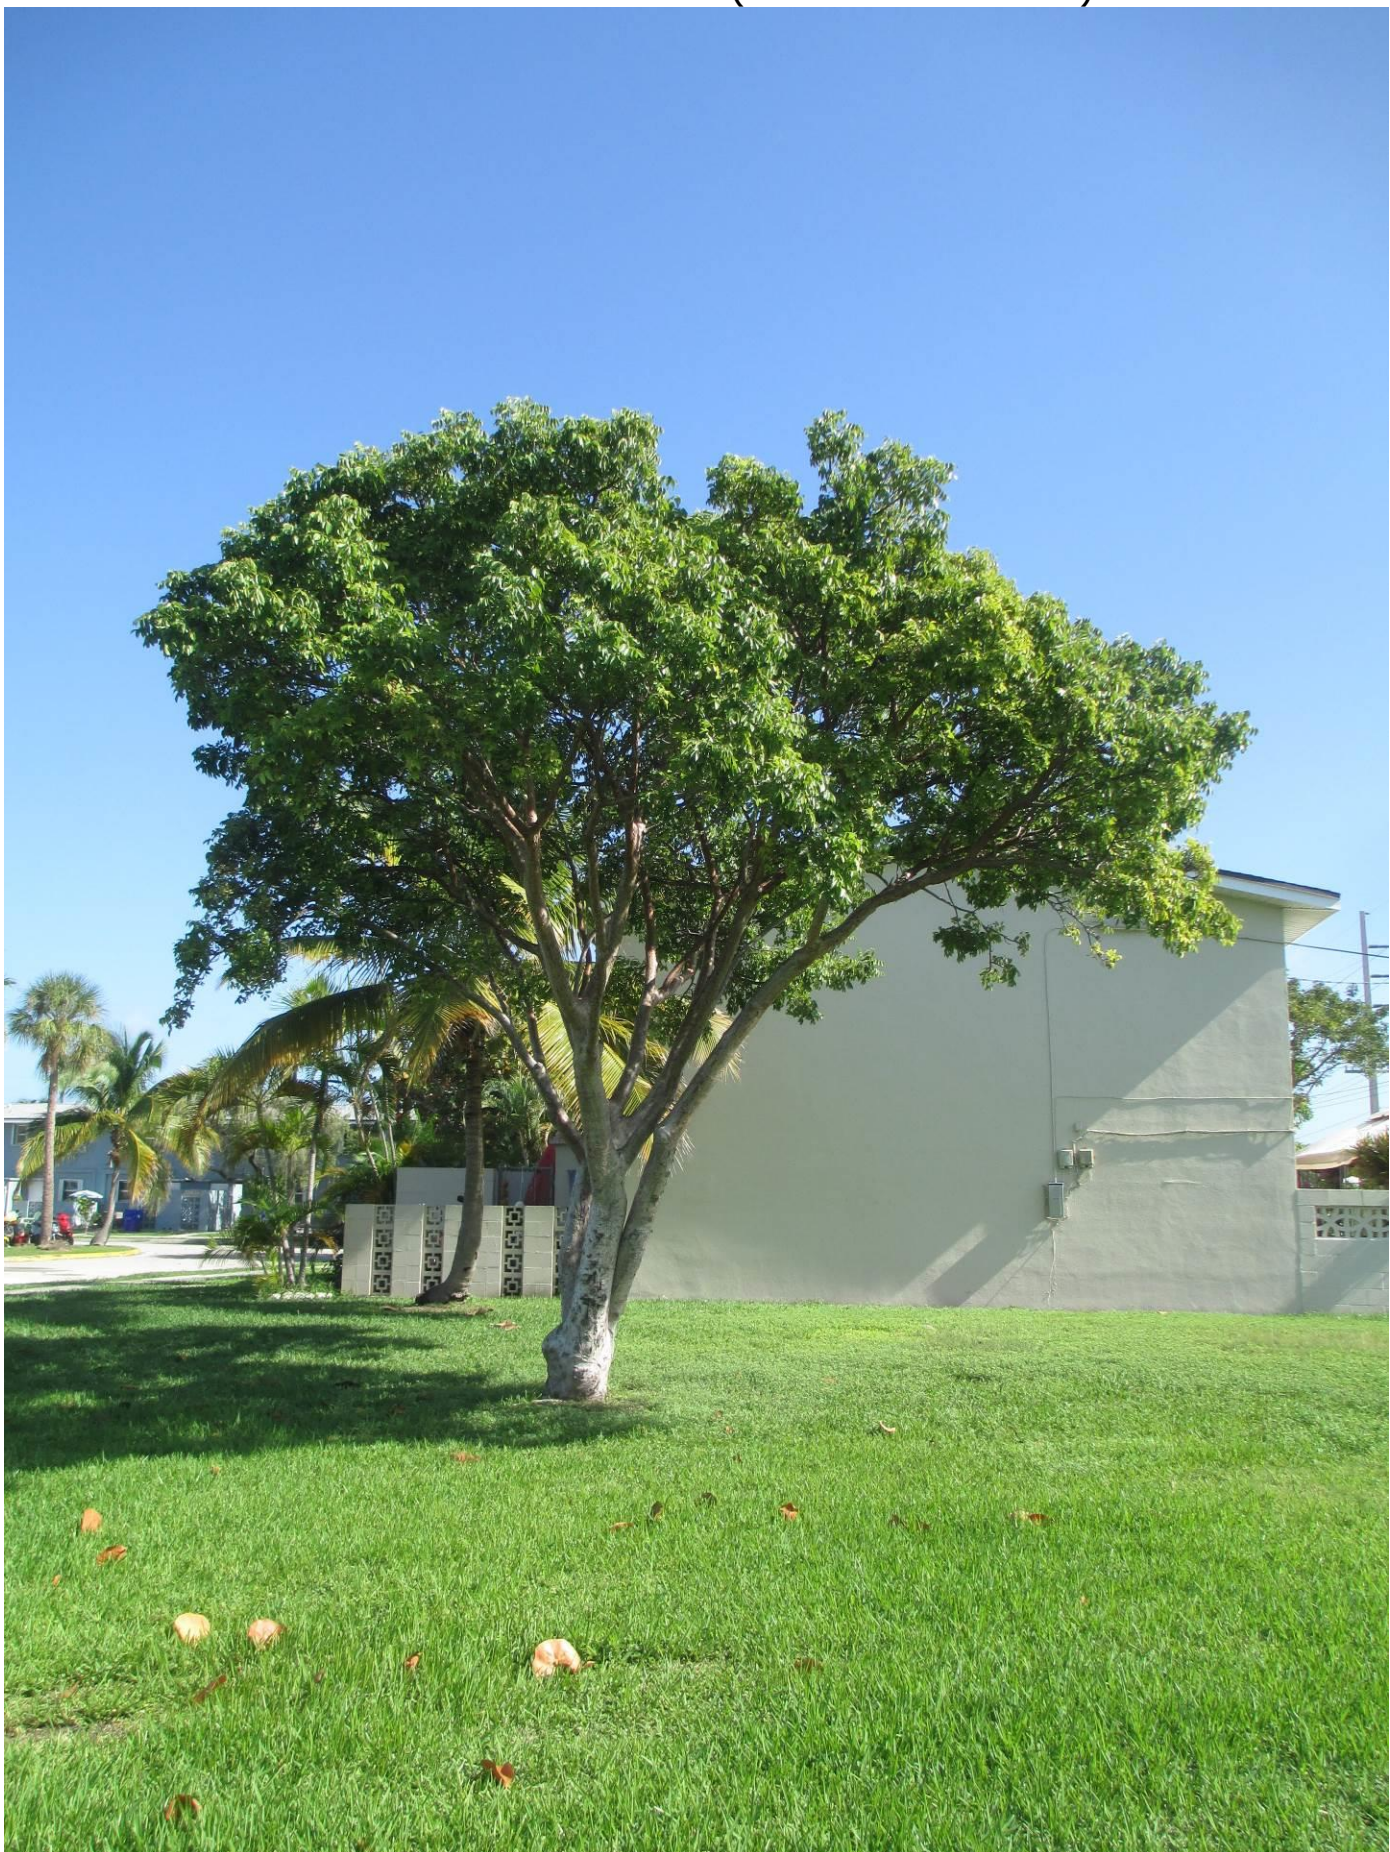
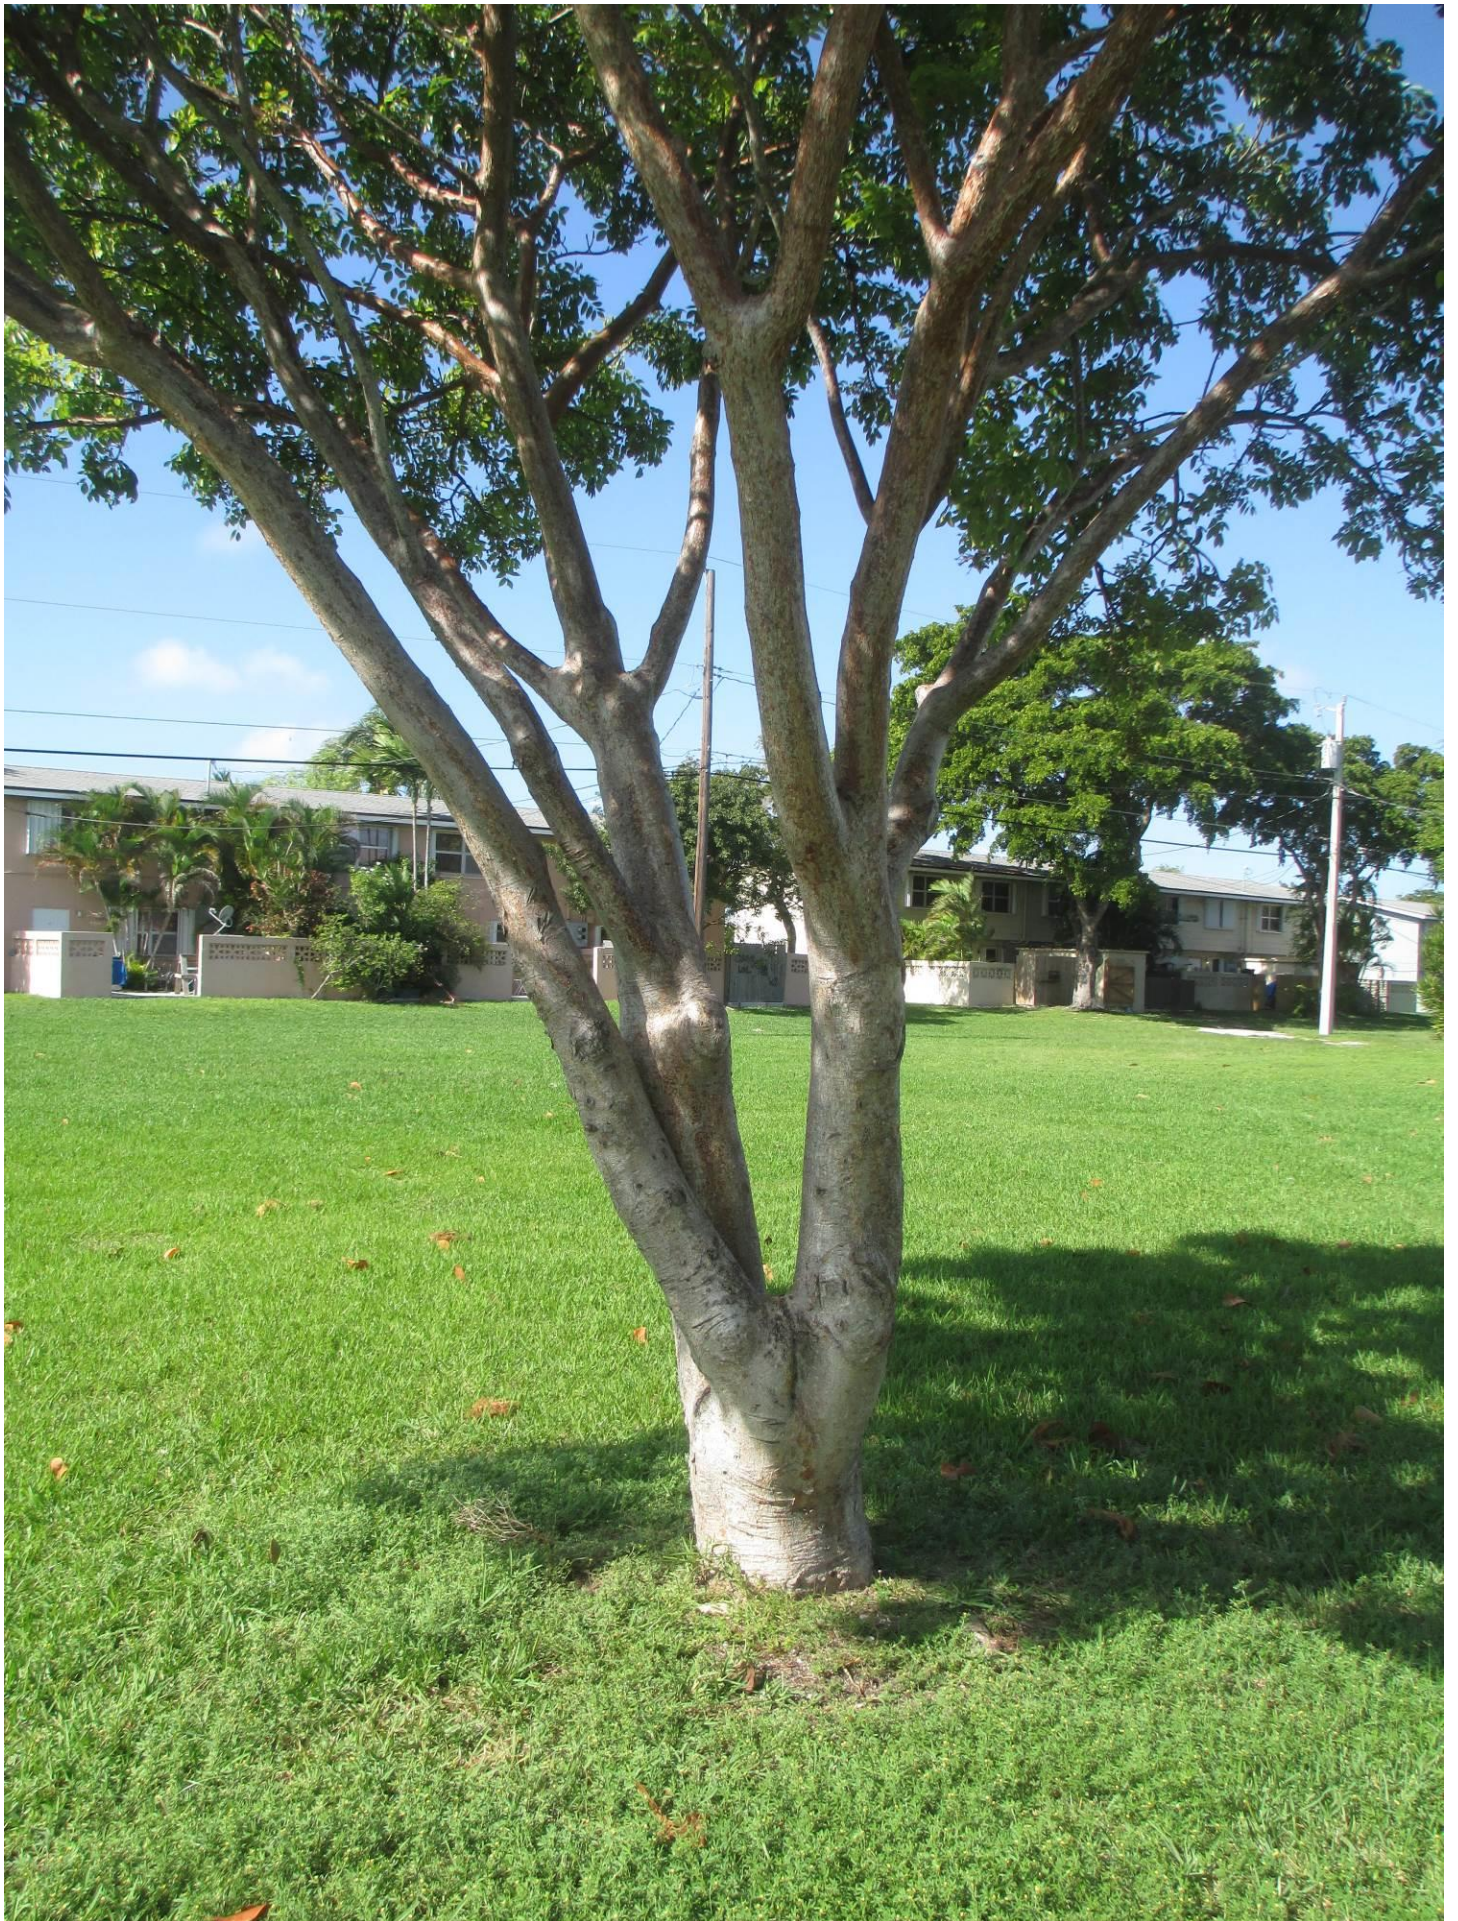
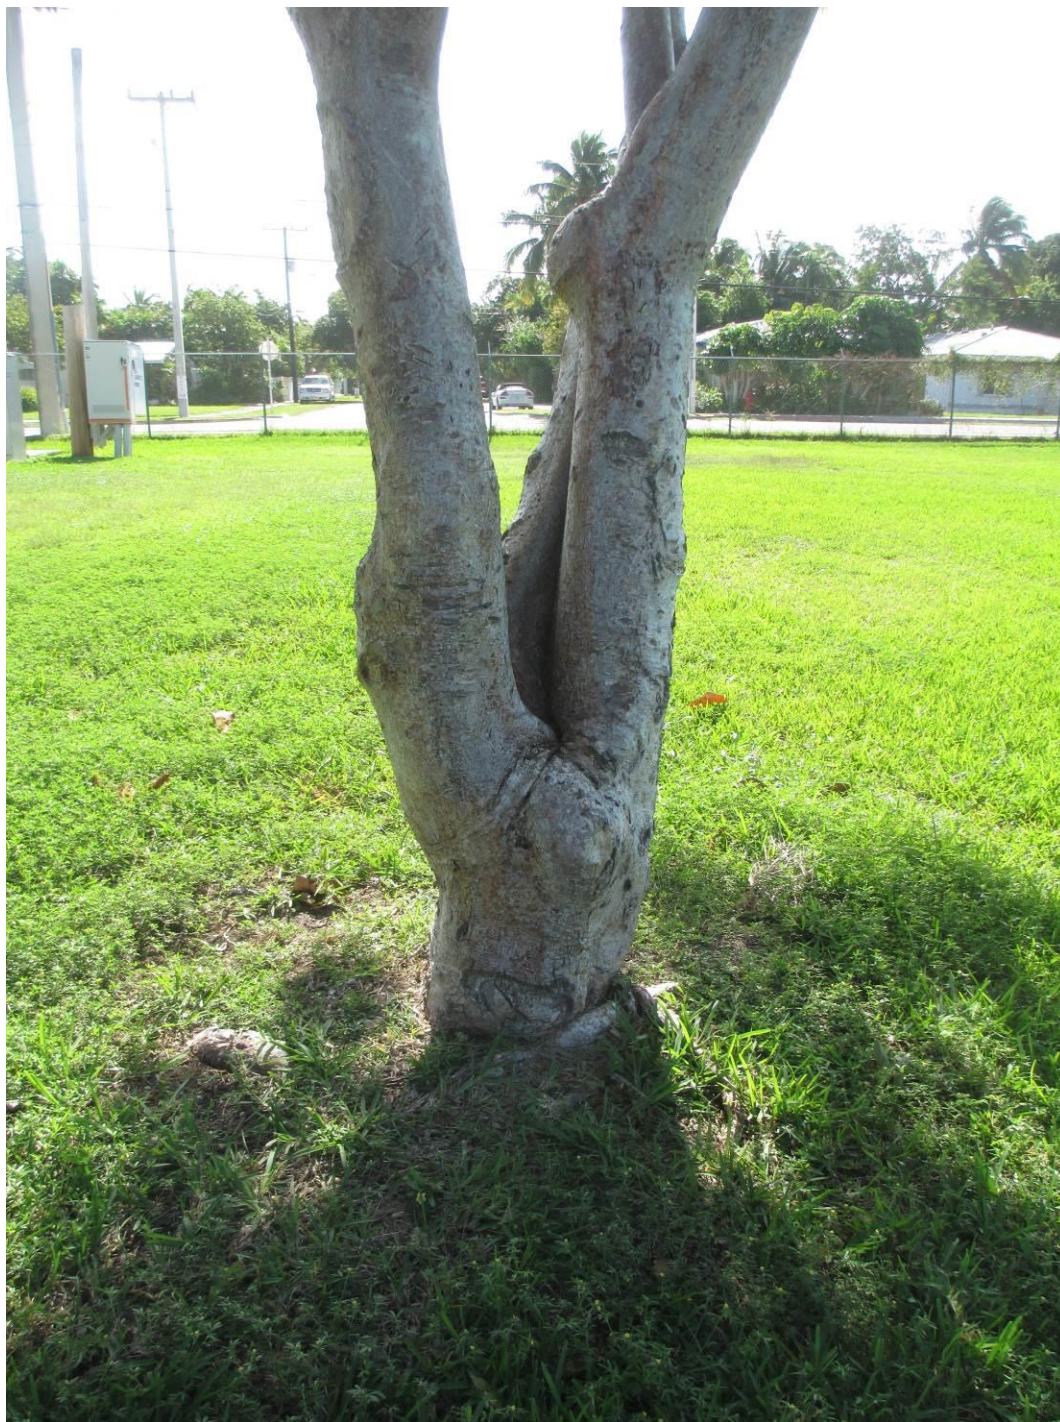
TO REMAIN: Tree #13: Gumbo Limbo (*Bursera simaruba*)

Diameter: 13"
