BUILDING INSPECTION REPORT

Report Number
315

Margaret Street Turtle
Kraals Site
Key West, FL
33040

Inspection Date: **07/27/2015**

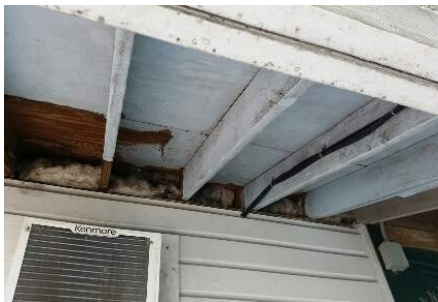
3.

Location: Exterior Right **System:** Roof **Condition:** Fascia is missing

Explanation: Fascia is observed to be missing. Fascias are normally applied at roof edges to prevent water and pest infiltration.

Impact Consequences: The fascia areas at roof edges are vulnerable to water and pest infiltration if not adequately covered and sealed. Adding and or restoring fascia in this area is recommended.

Recommended Action: Install

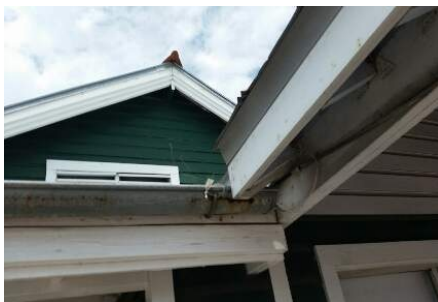
4.

Location: Restaurant Entrance **System:** Roof **Condition:** Gutter is deteriorated

Explanation: A gutter is observed to be in a deteriorated condition. Repairs are required to restore the gutter to its functional condition.

Impact Consequences: Gutters are a key component in the controlled drainage of run-off water away from the building exterior elements. Gutters that do not perform as intended may result in saturation of soils near the foundation which in turn can result in basement moisture or leakage issues. Repair should include restoring the gutters their intended condition and assuring that water freely flows and drains from the gutter.

Recommended Action: Repair or replace

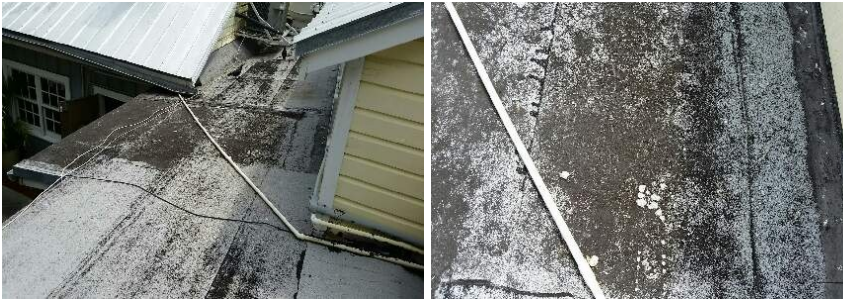
13.

Location: Roof **System:** Roof **Condition:** Soft Spots On Roof Surface

Explanation: Sheathing support of the roof covering is observed to be soft when walked upon.

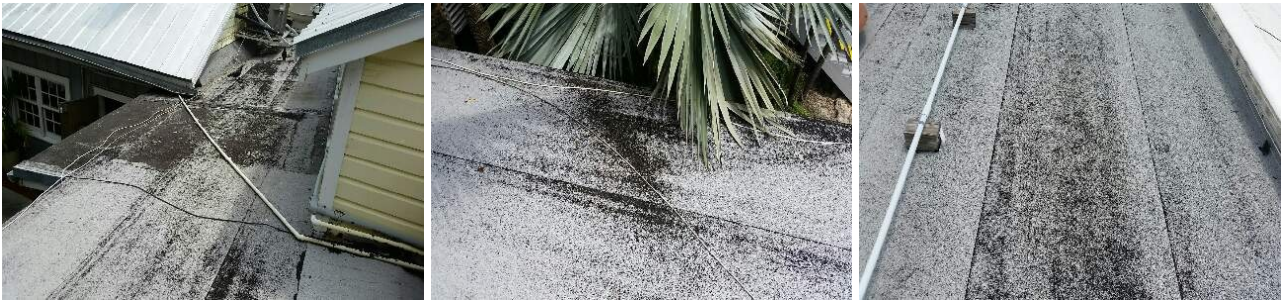
14.

Location: Roof **System:** Roof **Condition:** Asphalt roll roofing displays granule loss

Explanation: Areas of granule loss are noted in the roof shingle surface.

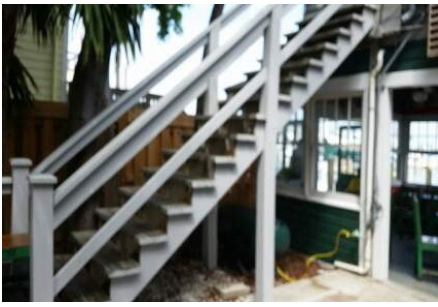
9.

Location: Upper Dining Deck **System:** Exterior **Condition:** Exterior stair railing is shaky

Explanation: Exterior stair railings should be installed and maintained so as to be sufficiently secured to prevent failure or detachment under normal use. Shaky railings are an indication that the railings are deteriorating and in need of corrective repairs or replacement.

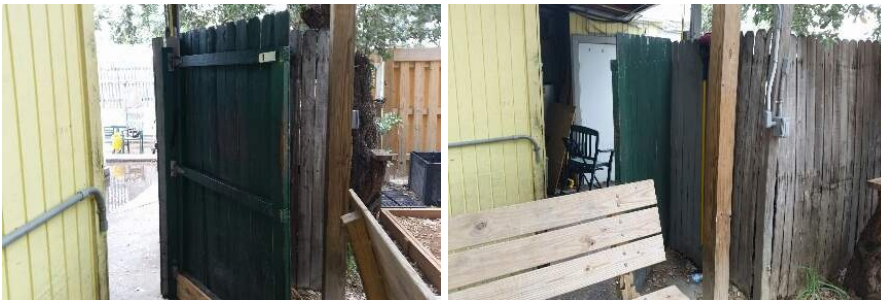
10.

Location: Exterior Rear **System:** Exterior **Condition:** Damaged Gate

Explanation: The gate in the noted location is observed to be damaged.

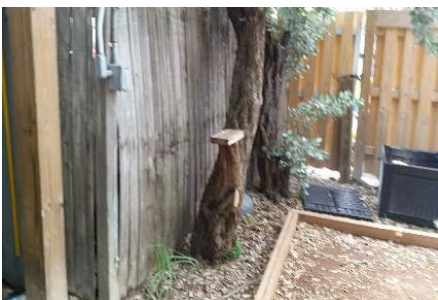
11.

Location: Exterior Rear **System:** Exterior **Condition:** Exterior fence is deteriorated

Explanation: The fence displays conditions of deterioration and is in need of repair.

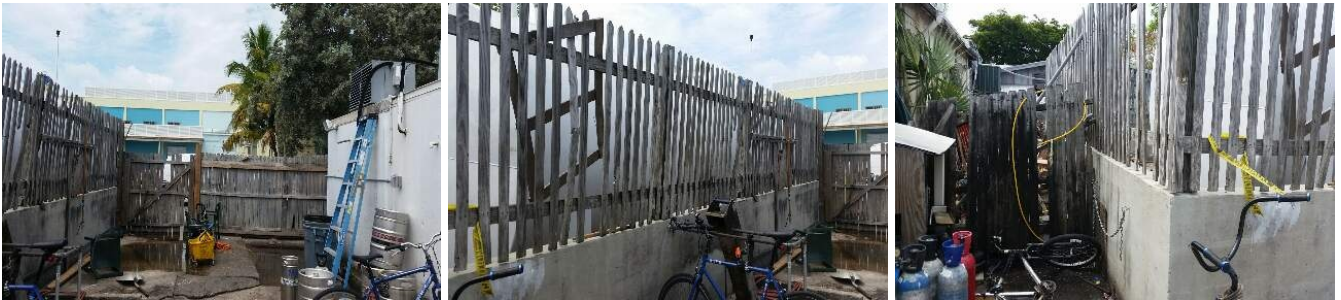
15.

Location: Exterior Rear **System:** Exterior **Condition:** Exterior fence is deteriorated

Explanation: The fence displays conditions of deterioration and is in need of repair.

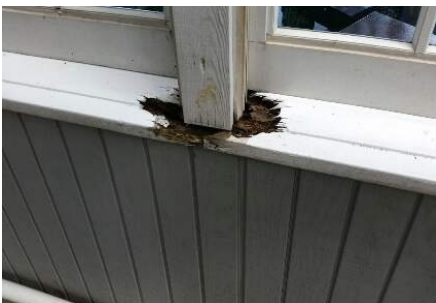
16.

Location: Lower Dining Deck **System:** Exterior **Condition:** Exterior window frame and or sill is rotted

Explanation: Deterioration of the window frame and or sill is noted with rot observed.

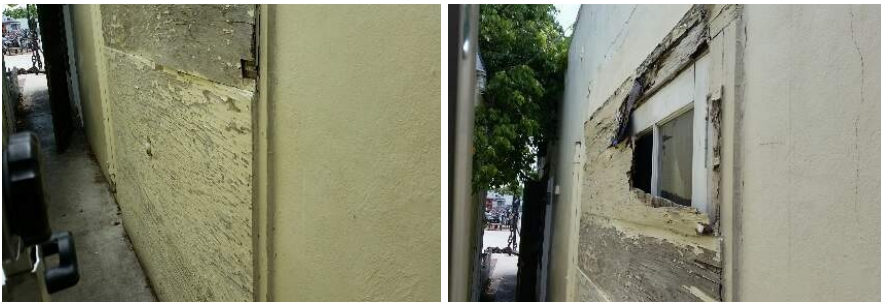
25.

Location: Exterior Ice Machine area **System:** Exterior **Condition:** Rot observed on wood elements

Explanation: Wood elements that display rot should be replaced

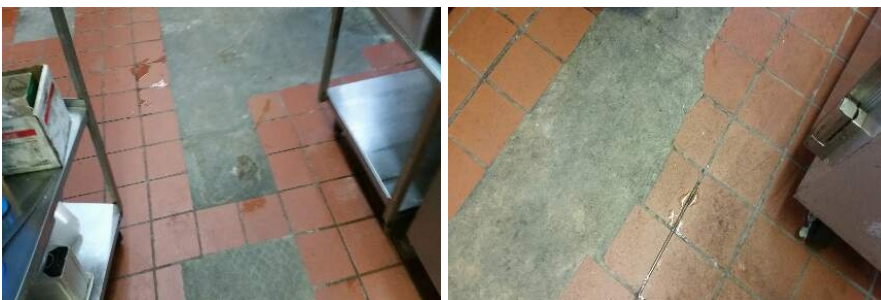
1.

Location: Kitchen **System:** Interior **Condition:** Missing Floor Covering

Explanation: Floor covering is observed to be missing in the noted location.

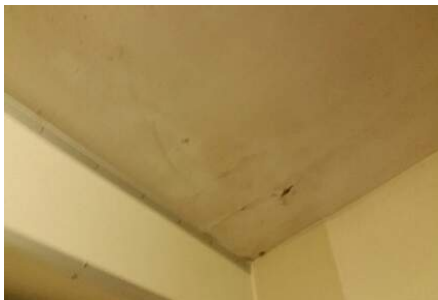
6.

Location: Walk In Cooler Hallway **System:** Interior **Condition:** DRY Ceiling Stain Roof Leak

Explanation: A stain on a ceiling surface is observed to test low for moisture content using moisture meters or thermal imaging camera. The source of the moisture intrusion is suspected to be from a past roof leak which may or may not have been repaired.

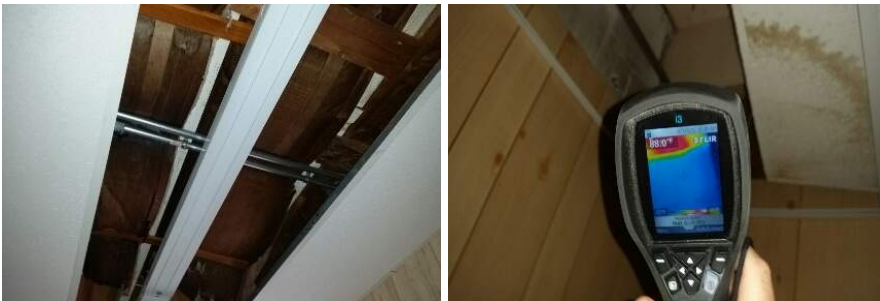
8.

Location: Accounting Office **System:** Interior **Condition:** WET Ceiling Stain Roof Leak

Explanation: A stain on a ceiling surface is observed to test high for moisture content using moisture meters or thermal imaging camera. The source of the moisture intrusion is suspected to be from an active roof leak.

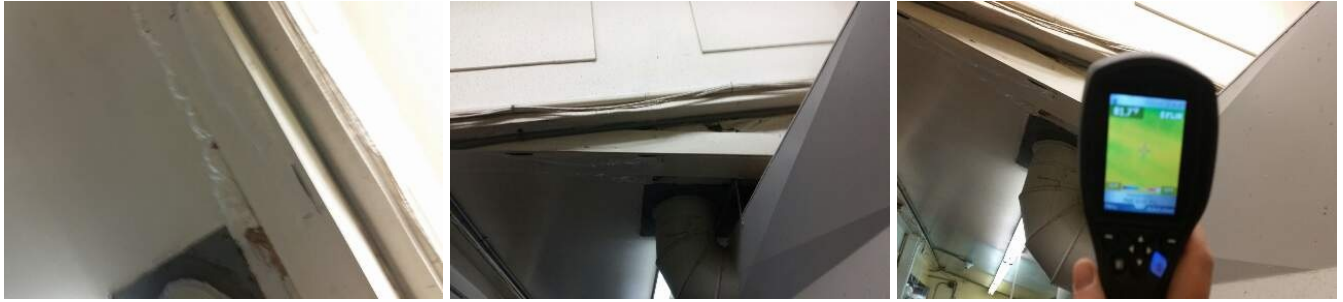
19.

Location: Kitchen **System:** Interior **Condition:** WET Ceiling Stain Roof Leak

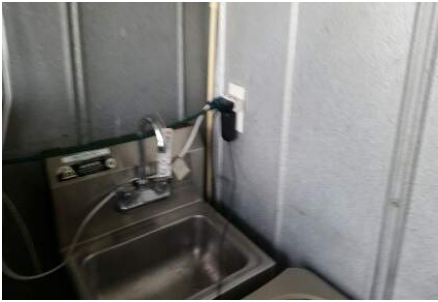
29.

Location: Lower Dining Deck **System:** Electrical **Condition:** Ground fault protection for an outlet is recommended

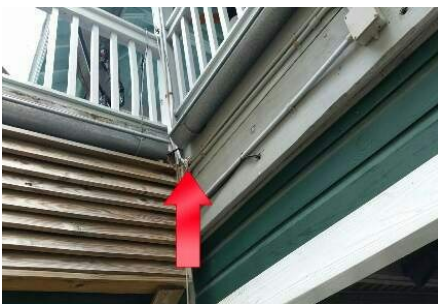
30.

Location: Lower Dining Deck **System:** Electrical **Condition:** Unsafe installation of a junction box

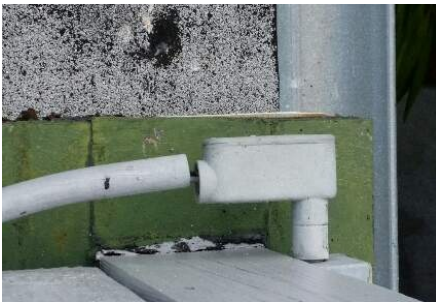
37.

Location: Upper Dining Deck **System:** Electrical **Condition:** Conduit Not Properly Connected

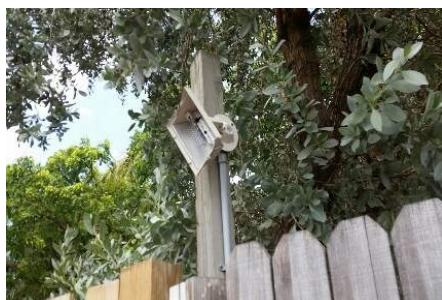
45.

Location: Exterior Rear **System:** Electrical **Condition:** Electrical Fixture has a missing or damaged globe or glass
