# Structural Condition Assessment Truman Water Front Park, Building 103 Key West, Florida

AES Project No. 314-192  
December 4, 2014

Re: Structural Condition Assessment  
Truman Water Front Park, Building 103  
Key West, Florida

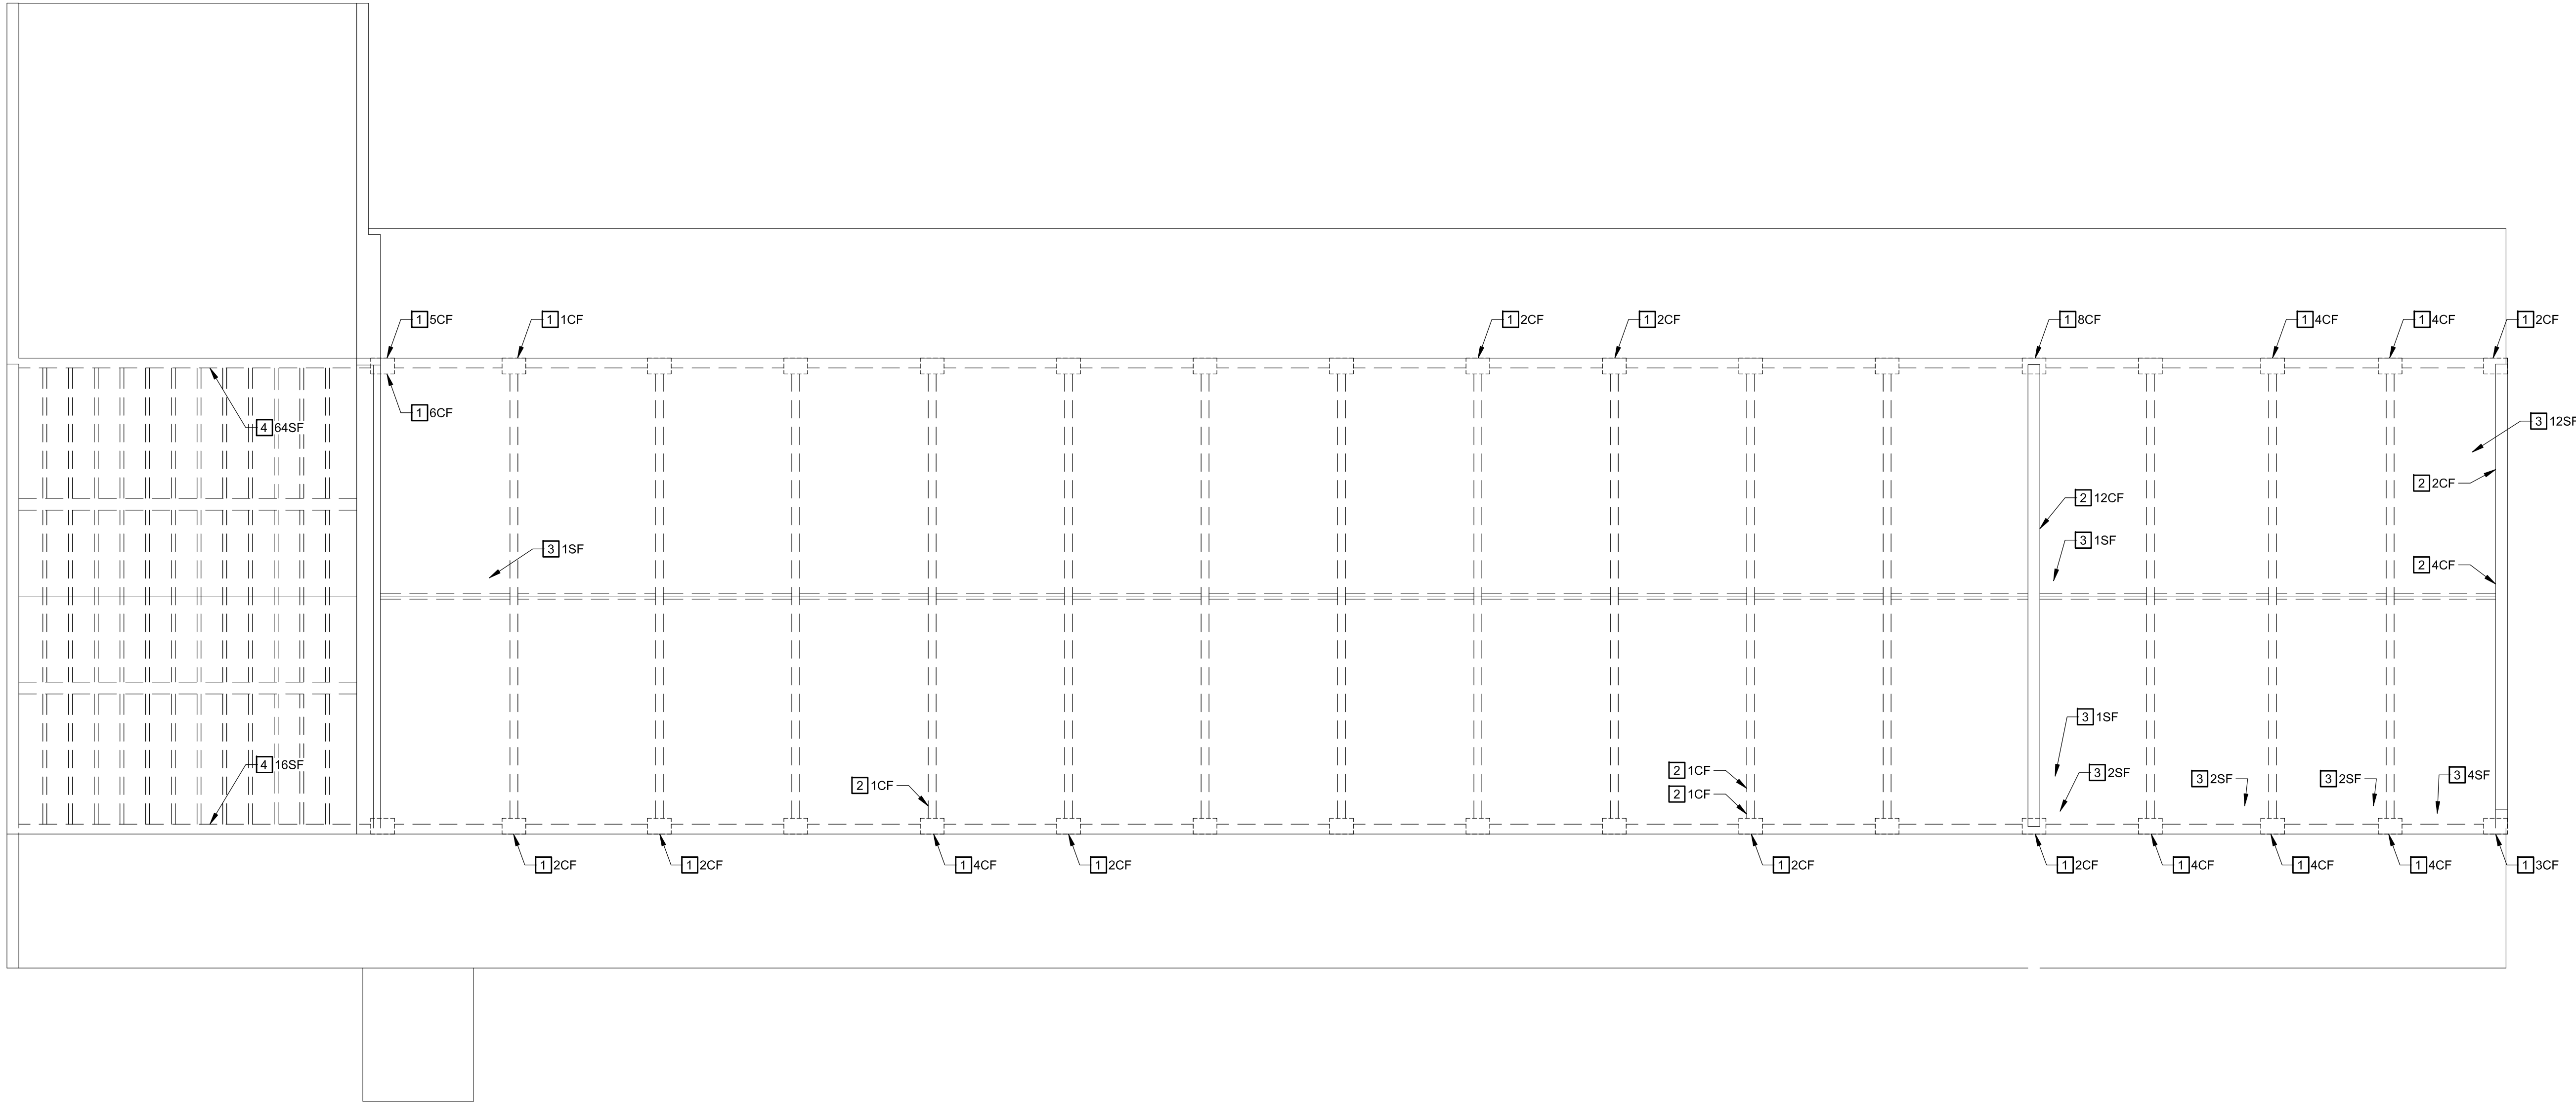
**HIGH ROOF PLAN**  
SCALE: 1/8" = 1'-0"

- 1] SPALLED COLUMN WITH EXPOSED CORRODING REINFORCING.
- 2] SPALLED BEAM WITH EXPOSED CORRODING REINFORCING.
- 3] SPALLED SLAB WITH EXPOSED CORRODING REINFORCING.
- 4] WALL SPALL WITH EXPOSED CORRODING REINFORCING.
- 5] CARBONATION TEST LOCATION.

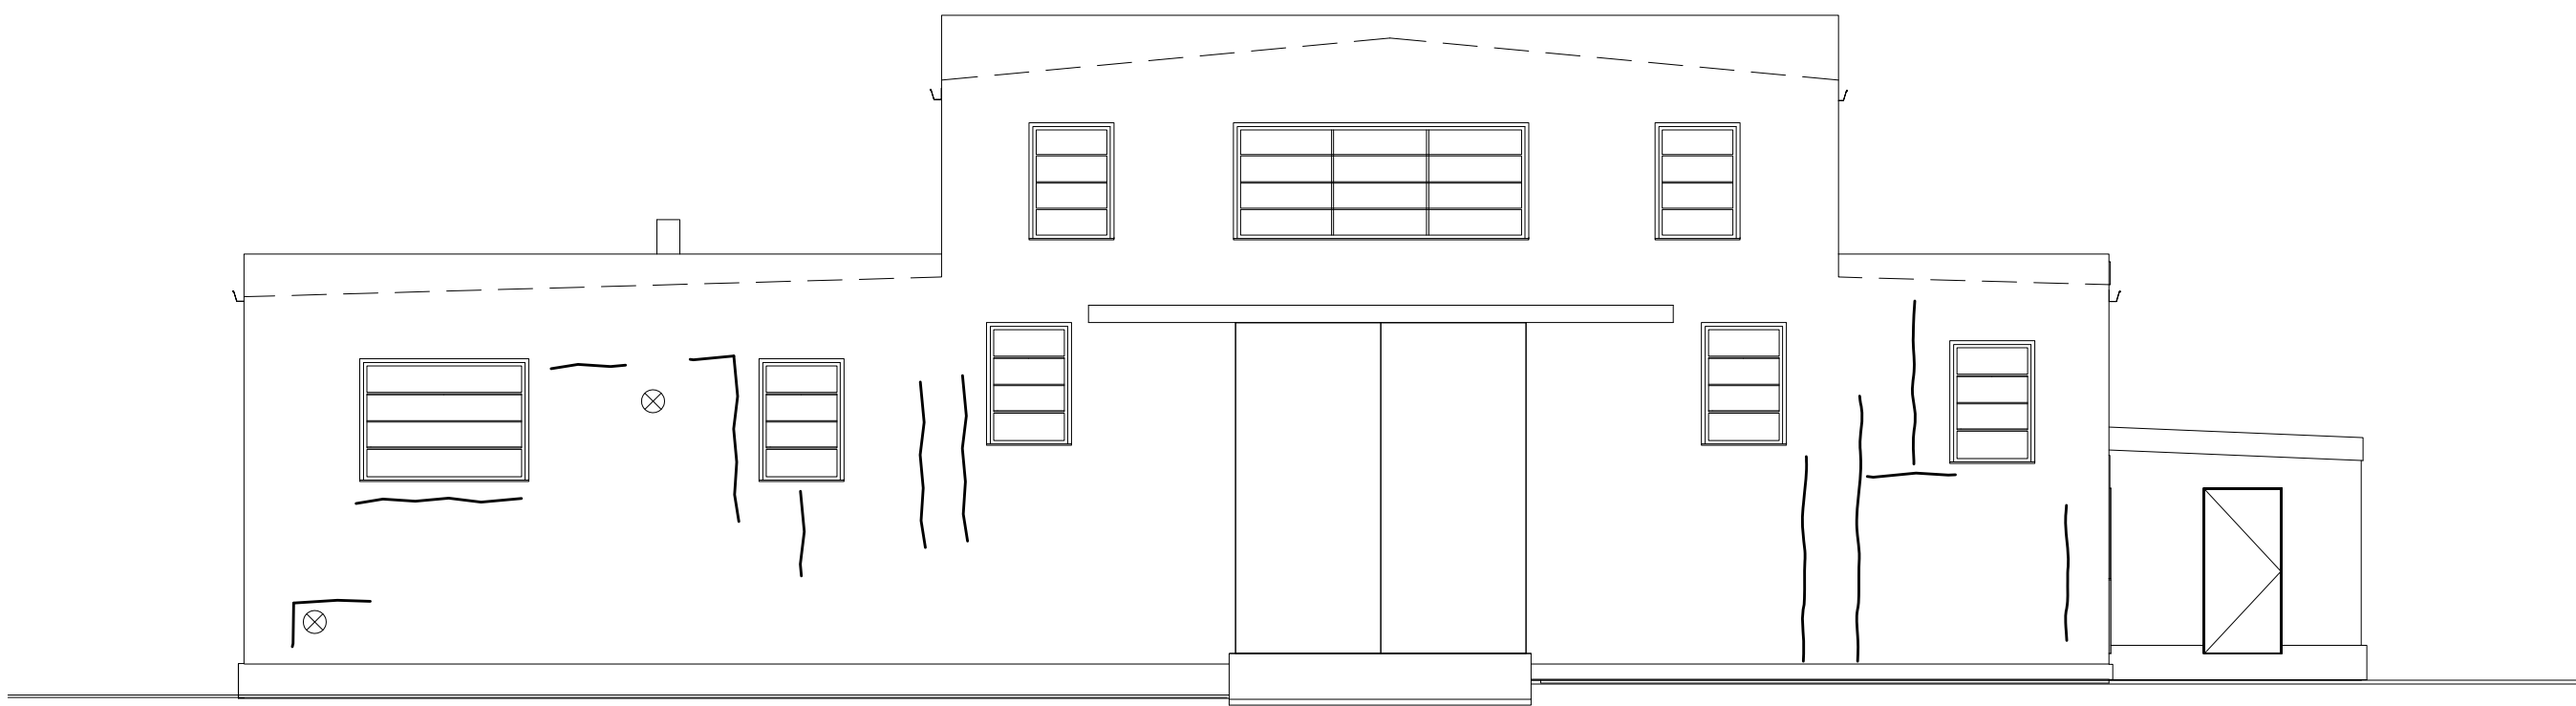
**WEST ELEVATION**  
SCALE: 1/8" = 1'-0"  
STUCCO CRACKS

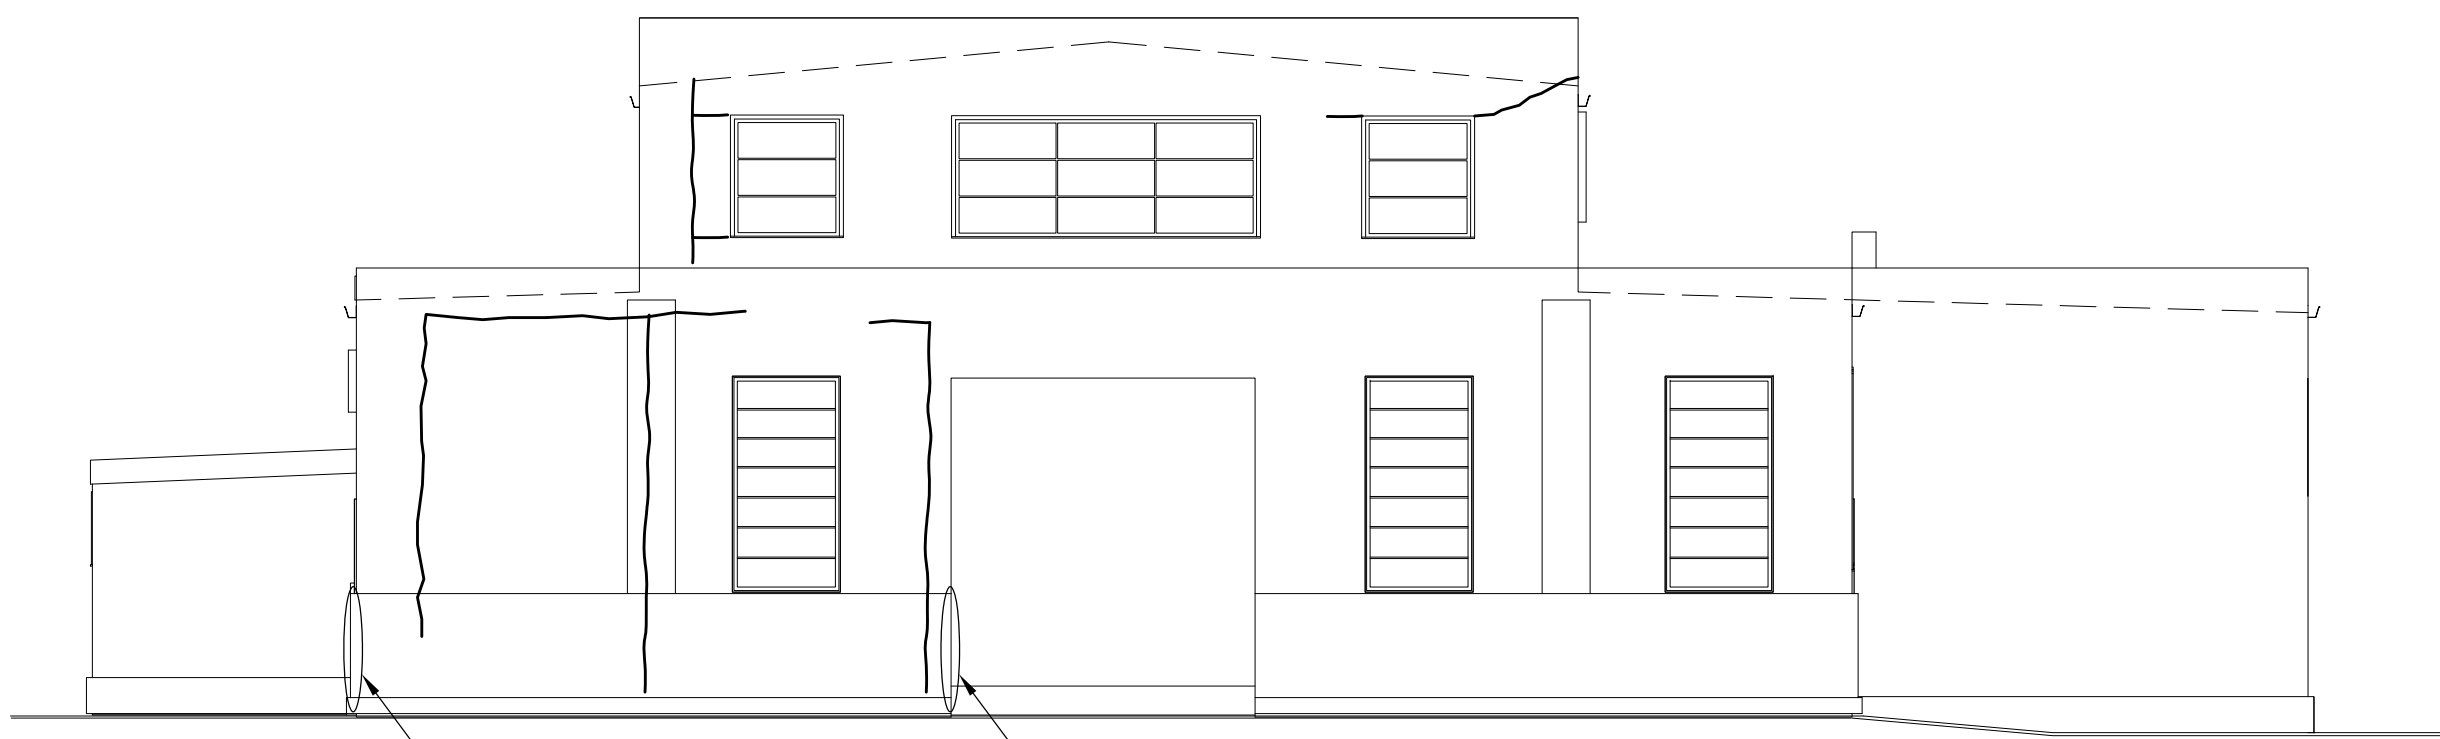
**EAST ELEVATION**  
SCALE: 1/8" = 1'-0"  
STUCCO CRACKS

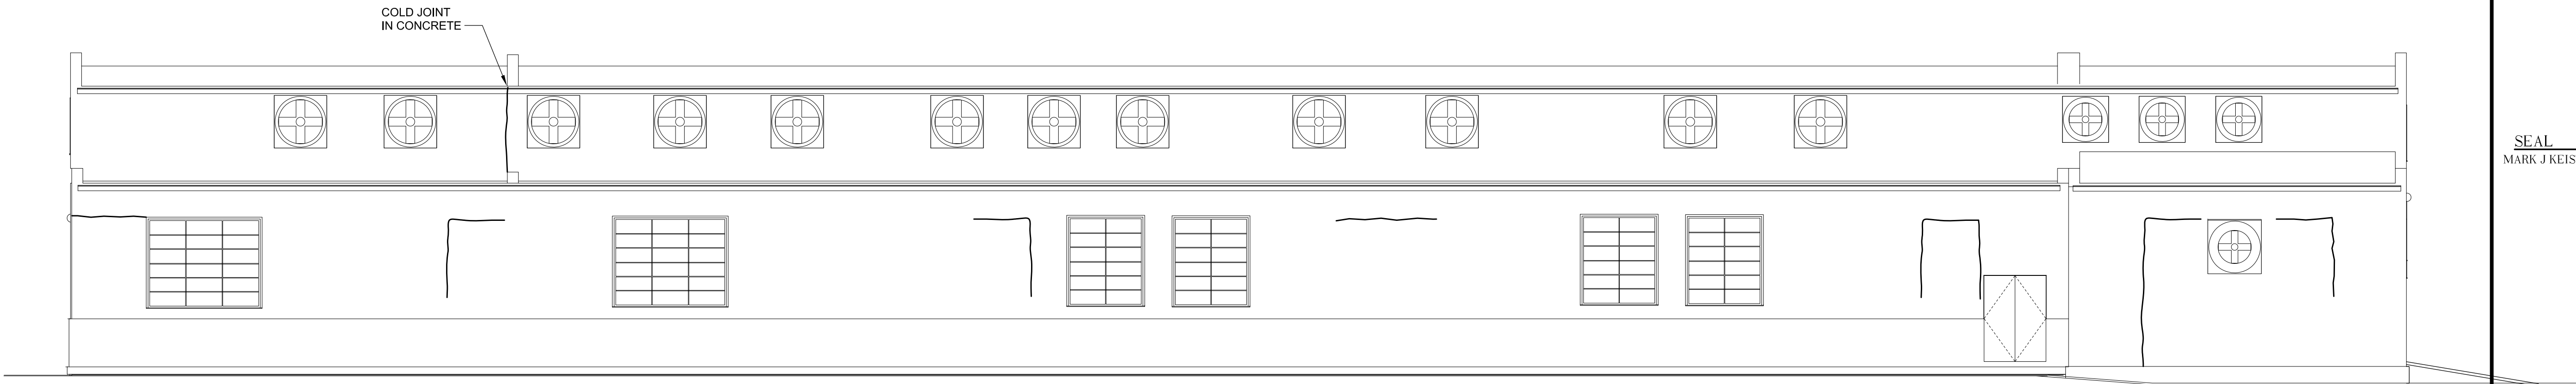
**NORTH ELEVATION**  
SCALE: 1/8" = 1'-0"  
STUCCO CRACKS
