# STRUCTURAL ASSESSMENT REPORT

For  
Key West Bight Seawall  
Key West, FL

Certificate of Authorization No. 29691  
UNITED Project No.: 0301-20

May 9, 2014

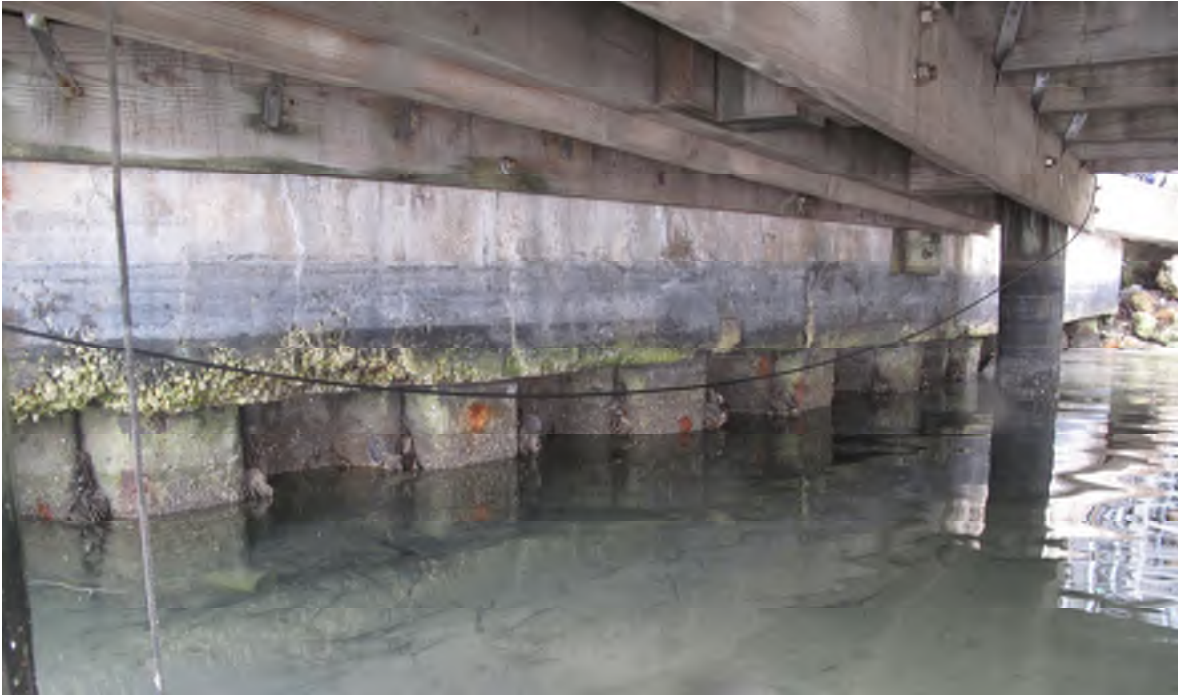
- 3.1.1. Vertical crack and concrete scaling/weathering with exposed aggregate in the concrete cap located about 54' from the reference point (RP) 1. (Photo 1.1)

**Photo 1.1 – Concrete Scaling/Weathering**

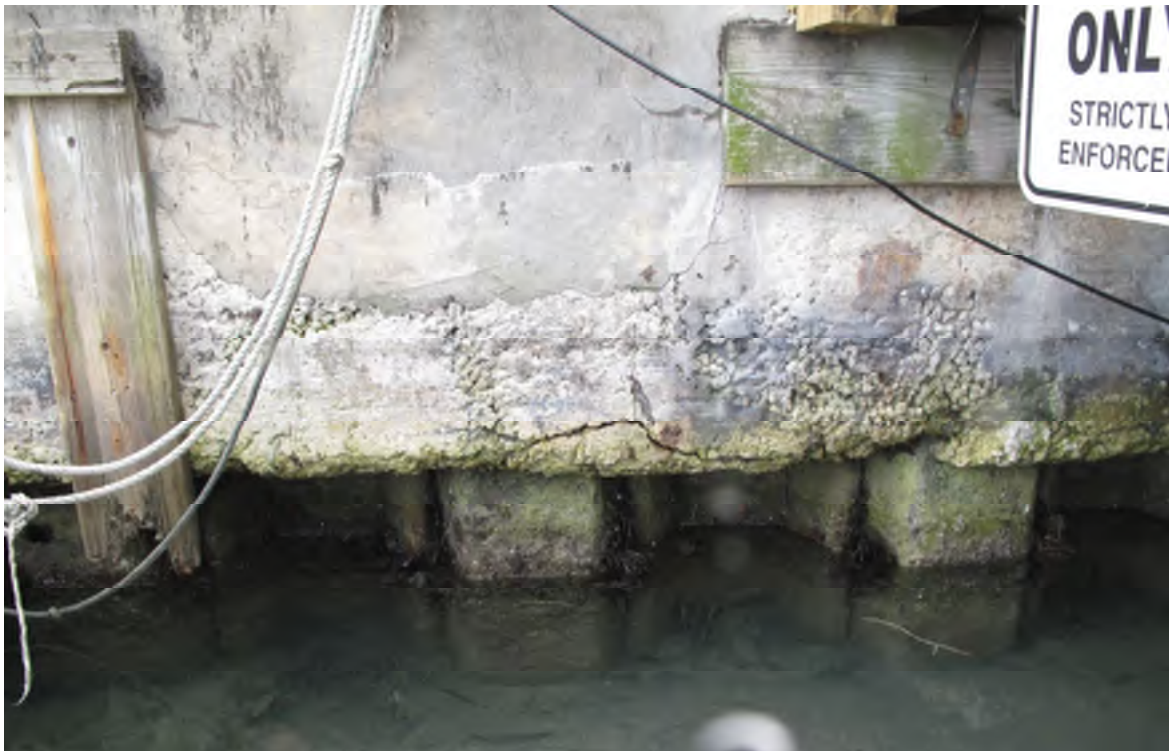
- 3.1.2. Crack/Delamination in the concrete cap and small hole in sheet pile located about 40' from RP1. The hole is about 2"x2" square in size. (Photo 1.2)

**Photo 1.2 – Crack/Delamination in Pile Cap**

At locations where there is a hole in the sheet pile, fill hole by pumping grout until all voids are filled.

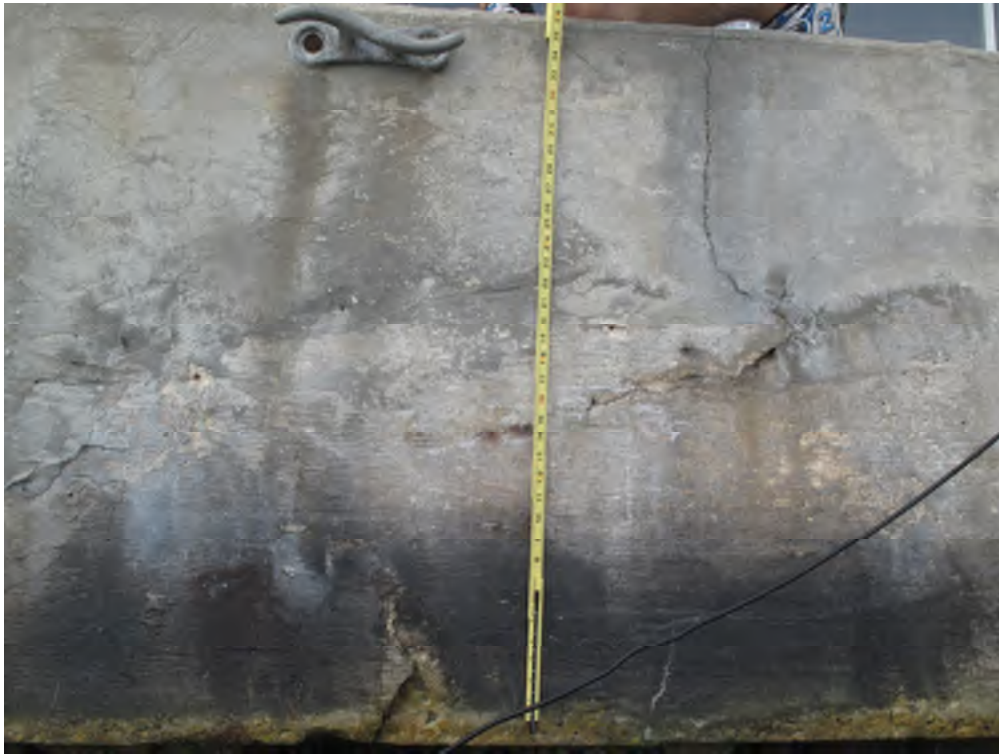
- 3.1.3. Crack in the concrete cap located about 28' from RP1. Crack width varied between 0.035"-0.06". (Photo 1.3)
- 3.1.4. Large hole in sheet pile about 12"x12" square and crack/delamination in the concrete cap about 20' from RP1. (Photo 1.4 & 1.5)

**Photo 1.3 – Crack in Pile Cap**

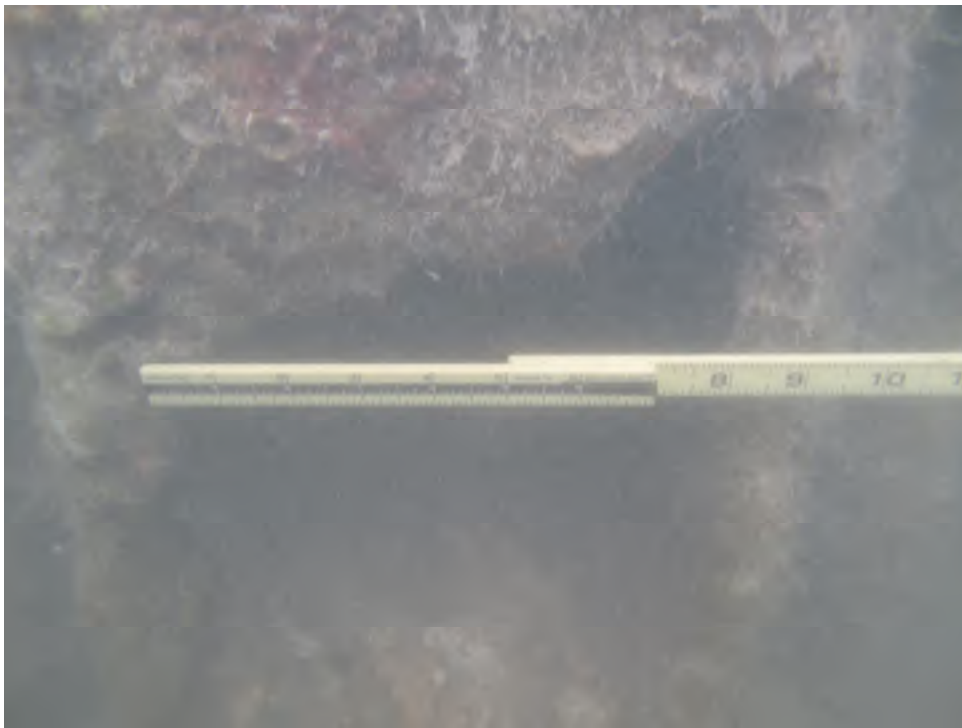
**Photo 1.4 – Hole in Steel Sheet Pile**

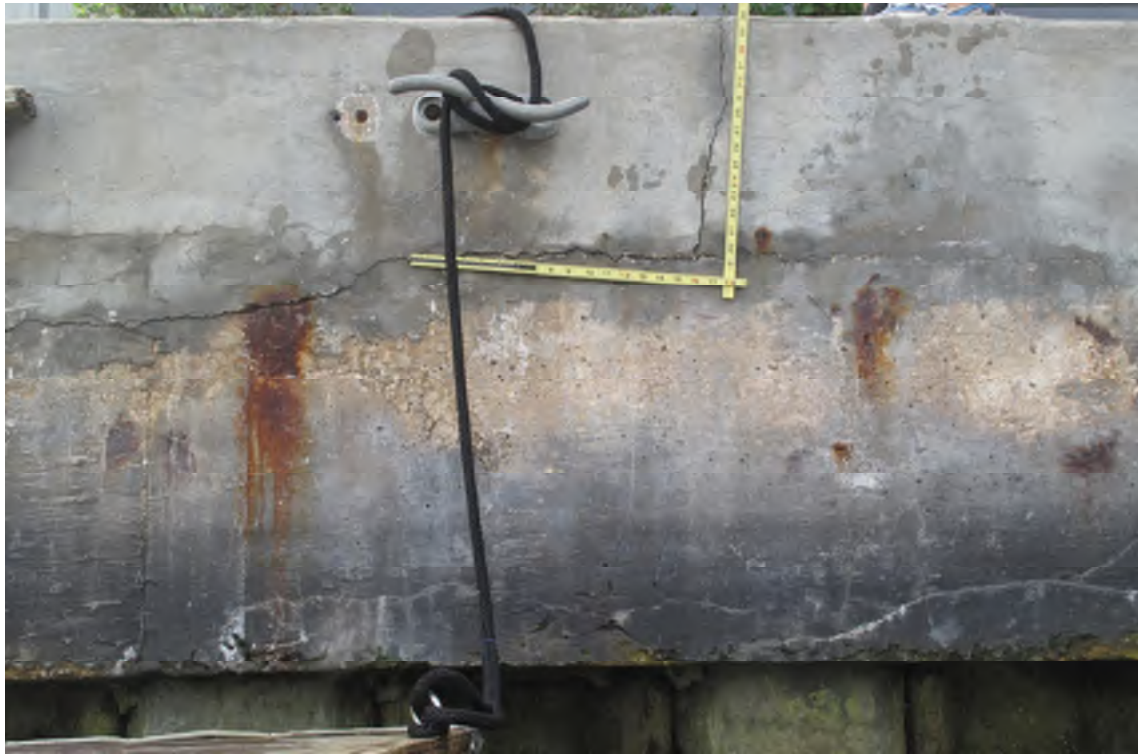
**Photo 1.5 – Crack/Delamination in Pile Cap**

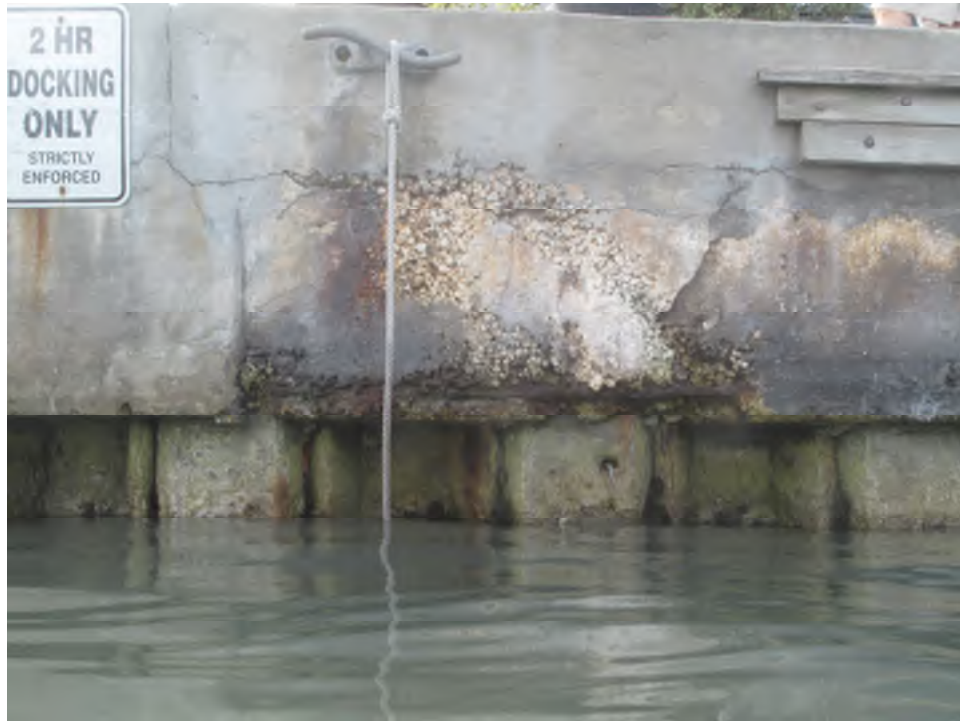
- 3.1.5. Spall with corroded rebar and concrete scaling/weathering with exposed aggregate in the concrete cap located about 11' from RP1. (Photo 1.6)
- 3.1.6. Spall with corroded rebar in the concrete cap located at RP1. (Photo 1.7)

**Photo 1.6 – Spall with Corroded Reinforcement**

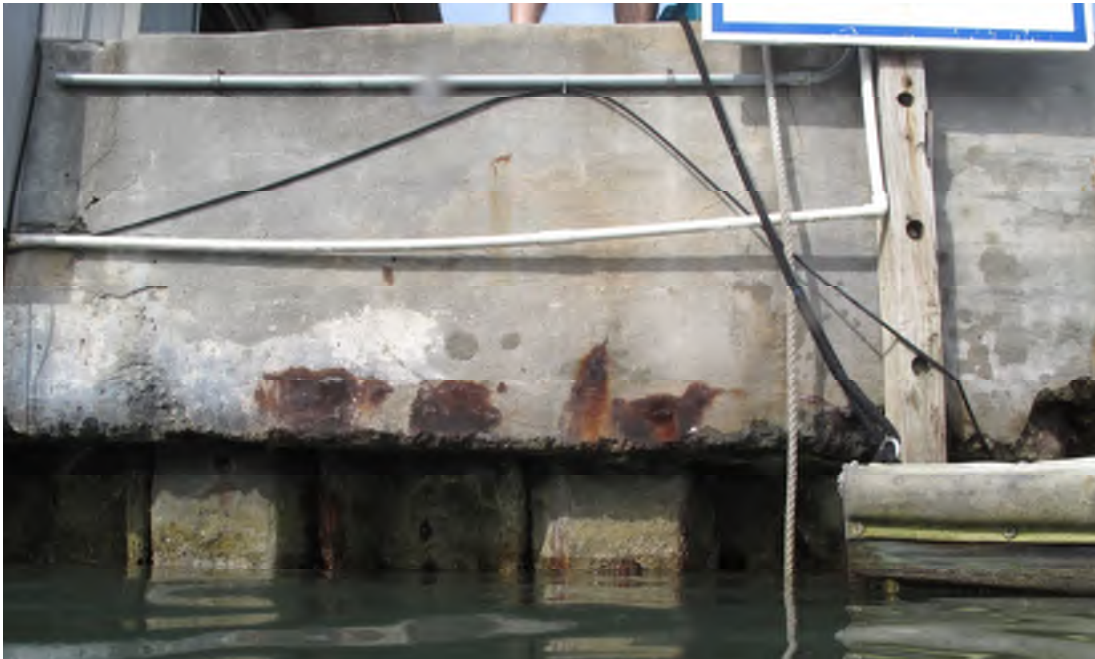
- 3.1.7. Corrosion stains in the concrete cap and within the splash zone of the steel sheet pile located about 4' from RP1. (Photo 1.8)
- 3.1.8. Crack/Delamination in the concrete cap and corrosion stains within the splash zone of the steel sheet pile located about 10' from RP1. (Photo 1.9)

**Photo 1.8 – Cracks with Corrosion Stains**

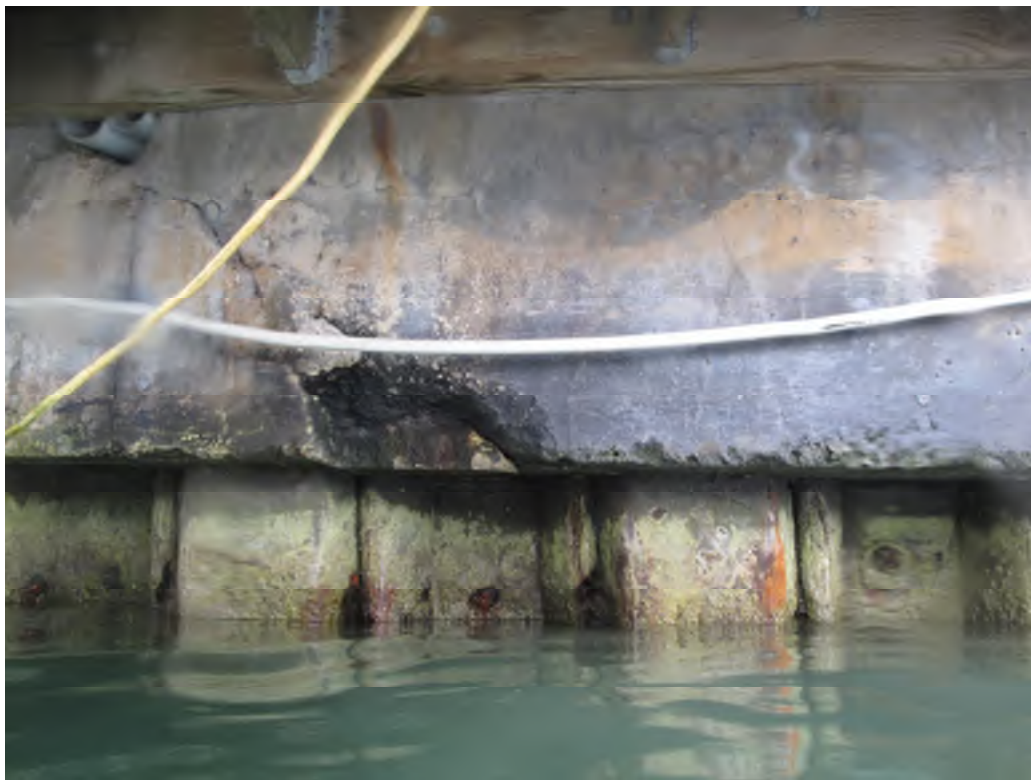
- 3.1.9. Spall and cracks in the concrete cap located about 16' from RP1. Crack width varied between 0.016"-0.03". (Photo 1.10)
- 3.1.10. Delamination in steel sheet pile about 5"x5" square located about 19' from RP1.

**Photo 1.10 – Concrete Spall**

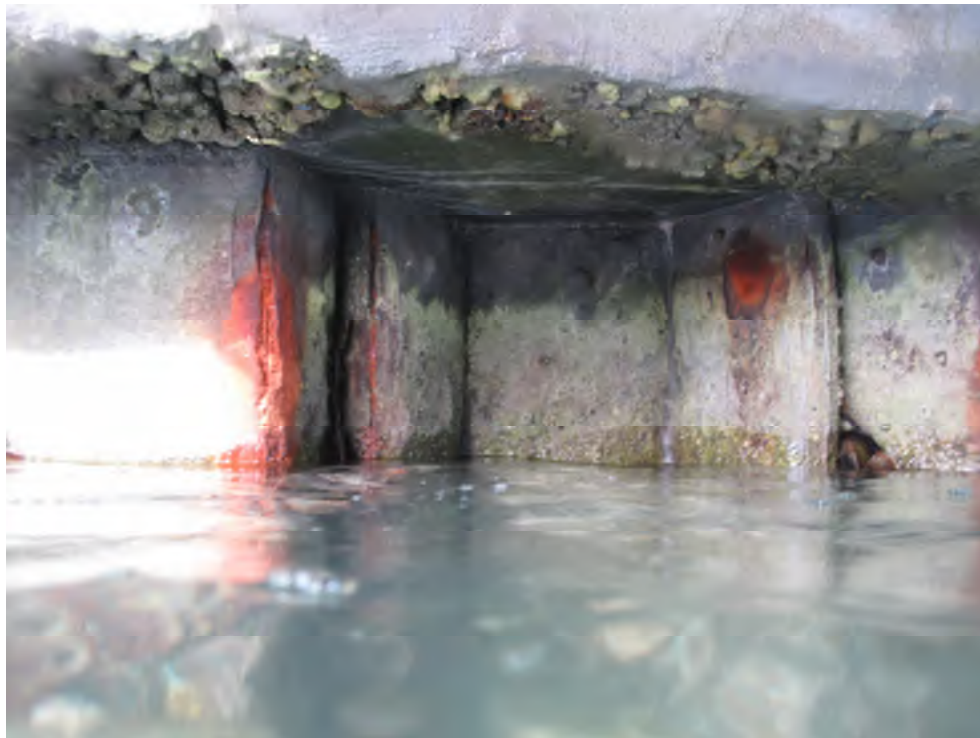
- 3.1.11. Hairline cracks with corrosion stains in the steel sheet pile at the concrete cap interface and concrete scaling/weathering with exposed aggregate at underside of cap located about 27' from RP1. Crack widths in the sheet pile were greater than 0.06". Crack widths in the cap varied between 0.007"-0.10". (Photo 1.11)

Photo 1.11 – Cracks in Sheet Pile and Concrete Scaling/Weathering in Cap

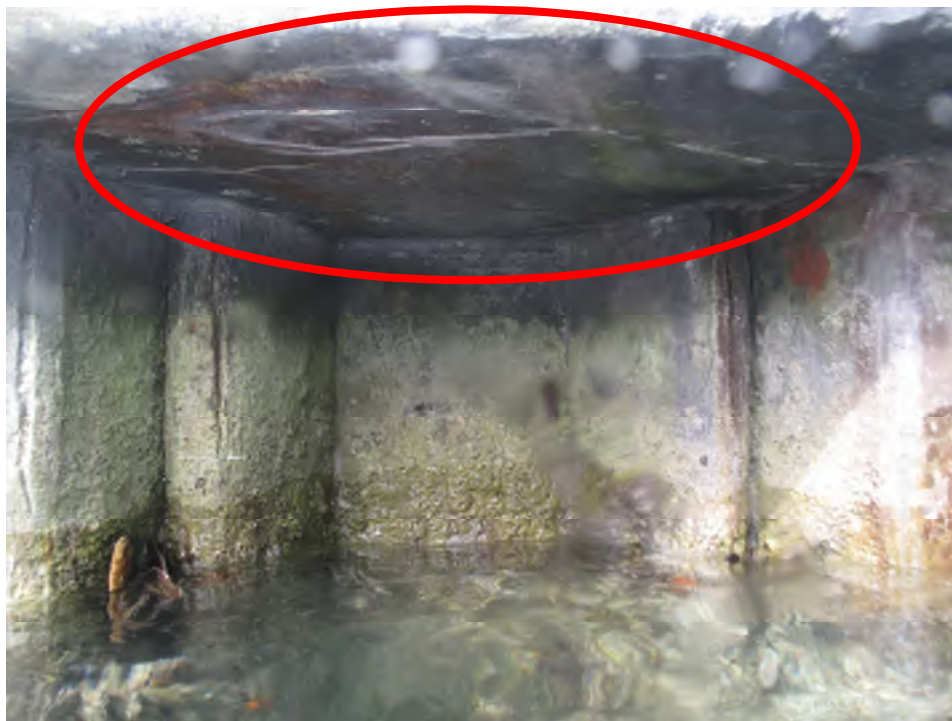
- 3.1.12. Hairline cracks in the sheet pile at the concrete cap interface and cracks with efflorescence at the underside of the concrete cap located about 32' from RP1. Crack widths in the sheet pile were greater than 0.06". Crack widths in the cap varied between 0.007"-0.10". (Photo 1.12)

Photo 1.12 – Crack in Pile Cap with Efflorescence

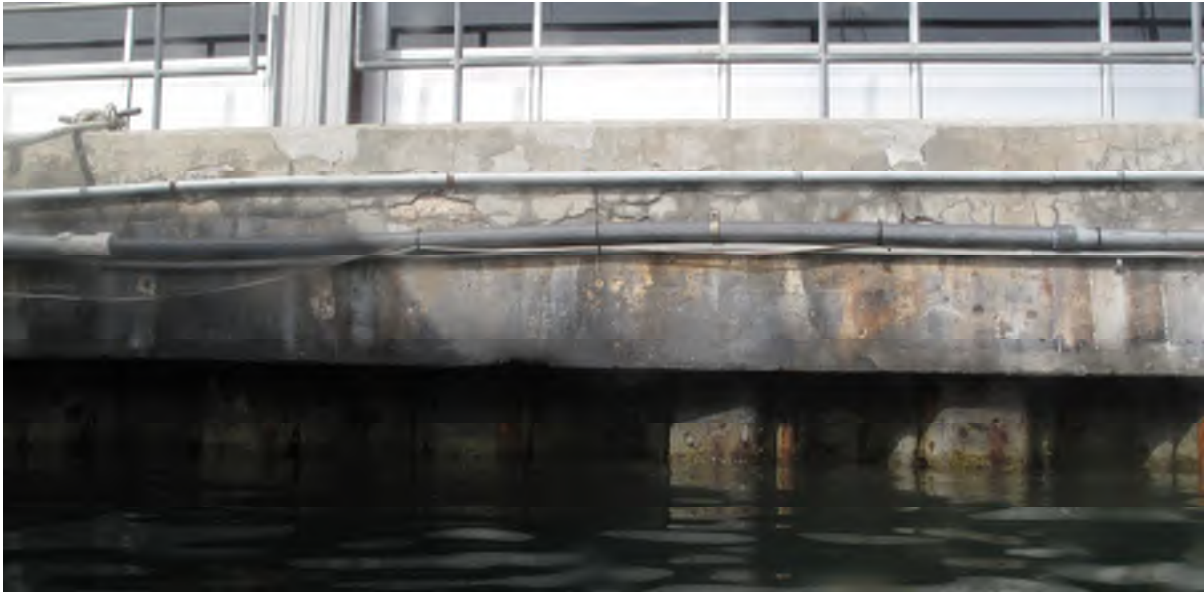
- 3.1.13. Hairline cracks in the sheet pile at the concrete cap interface and cracks/delamination about 1' from top of concrete cap located from 30'-50' from RP1. (Photo 1.13)

**Photo 1.13 – Cracks/Delamination in Concrete Cap**

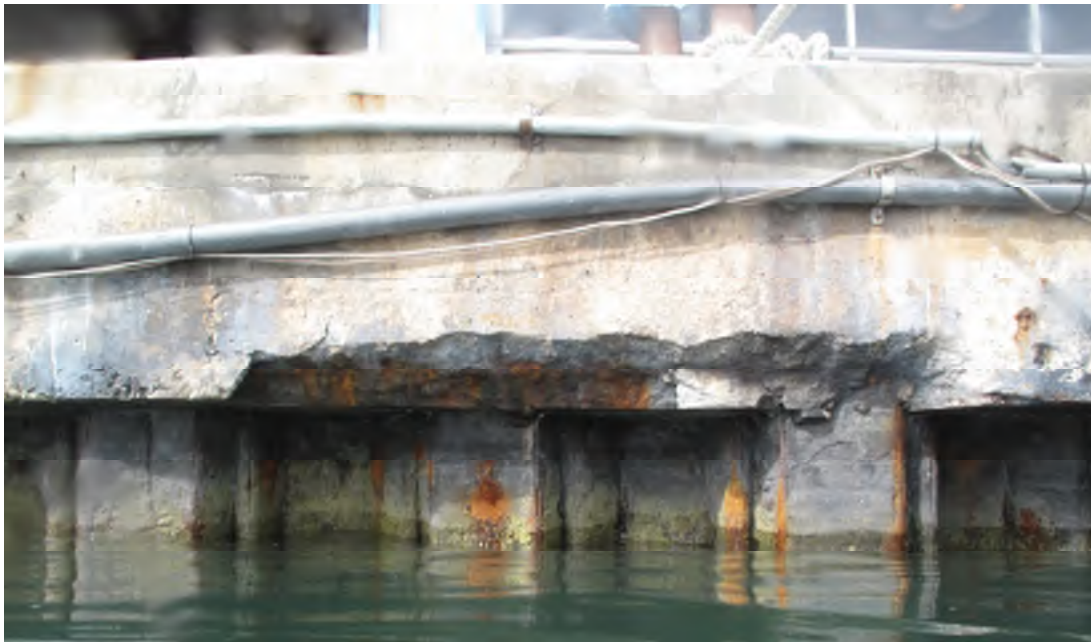
- 3.1.14. Spall with corroded rebar in the concrete cap and hairline cracks in the sheet pile at the concrete cap interface located about 67'-73' from RP1. (Photo 1.14)

**Photo 1.14 – Spall with Corroded Reinforcement**

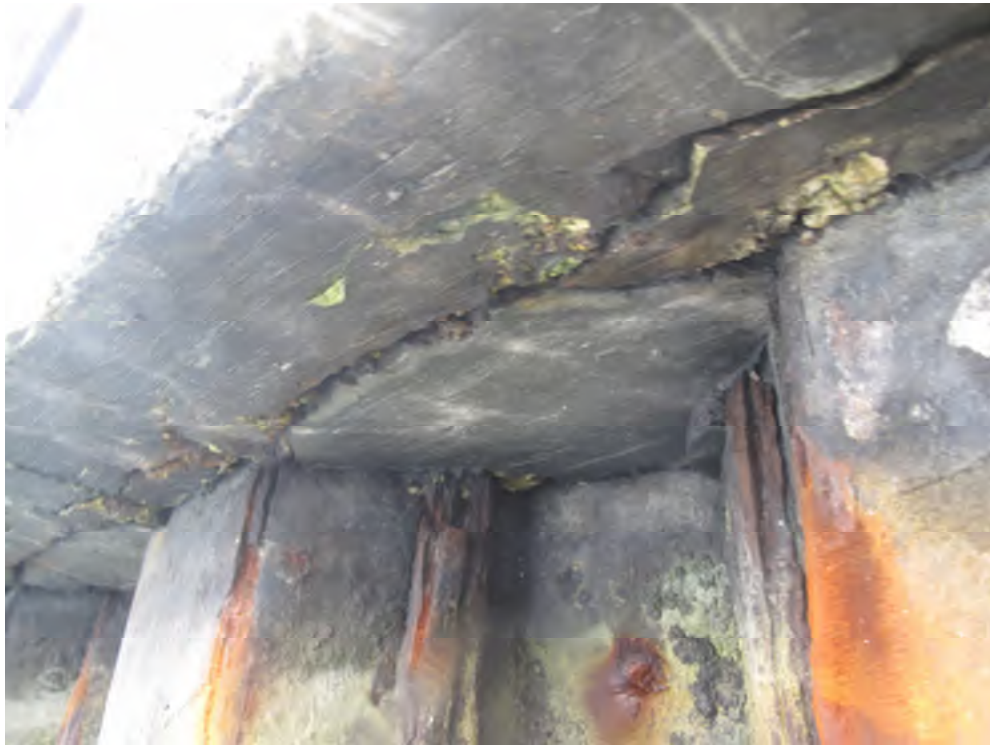
- 3.1.16. Hairline cracks with corrosion stains in the sheet pile at the concrete cap interface and crack/delamination at the underside of the concrete cap located 3'-26' from RP2. (Photo 1.15)

**Photo 1.15 – Cracks in Sheet Pile & Crack/Delamination in Concrete Cap**

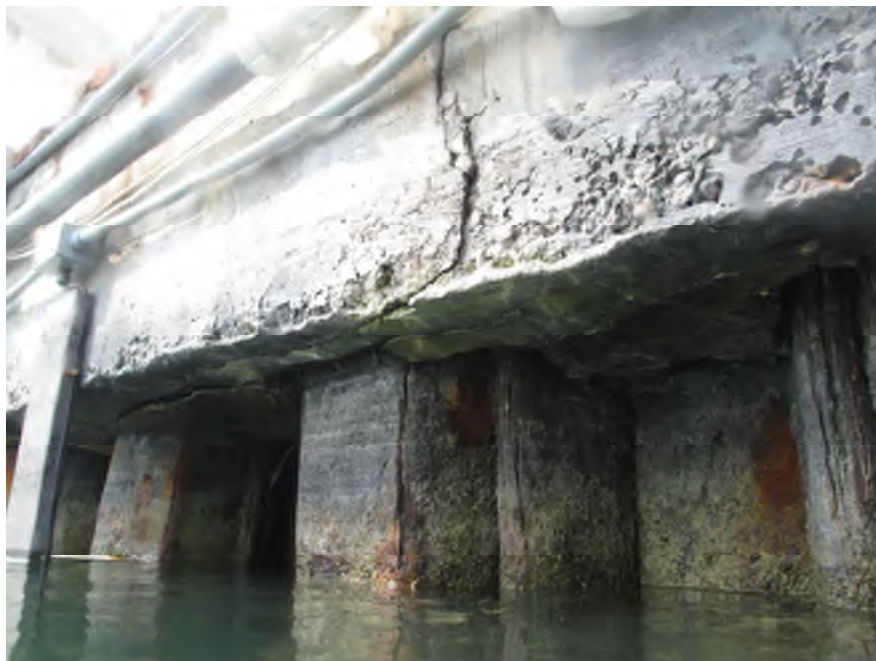
**Photo 1.16**

- 3.1.18. Hairline cracks with corrosion stains in the sheet pile at the concrete cap interface. Concrete scaling/weathering with exposed aggregate and crack/delamination in the concrete cap located 34'-40' from RP2. (Photo 1.16)

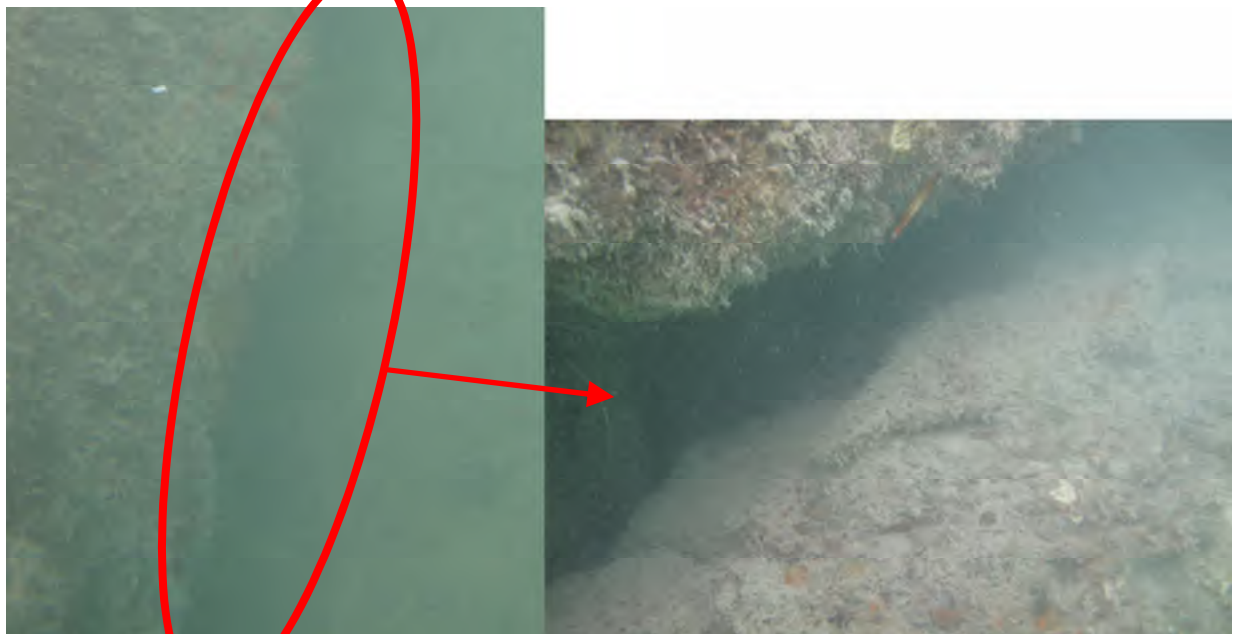
- 3.2.1. Large hole/split between the main concrete wall and a second, wider, concrete wall underwater about mid-depth. The split runs approximately from 0'-34' from RP3. (Photo 2.1)

**Photo 2.1 – Void/Split between Two Walls**  
(Picture on the left is a top view)

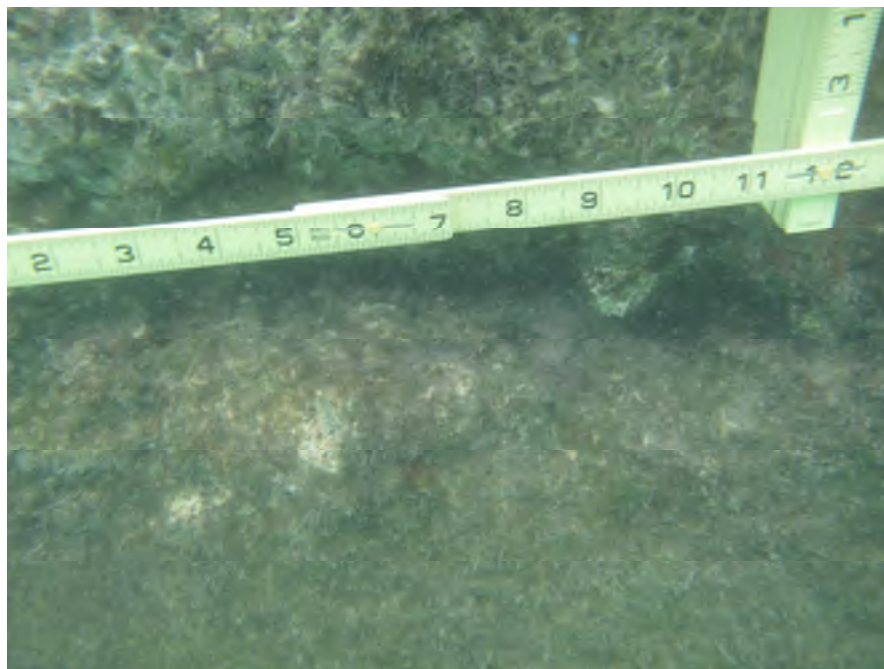
- 3.2.2. Vertical crack from above water surface to underwater hole at seafloor located 33' from RP3. Crack width varied between 0.04"-0.06".
- 3.2.3. Hole at mid-depth of wall about 6"x12" located 43' from RP3. (Photo 2.2)

**Photo 2.2 – Spall/Void in Concrete Seawall**

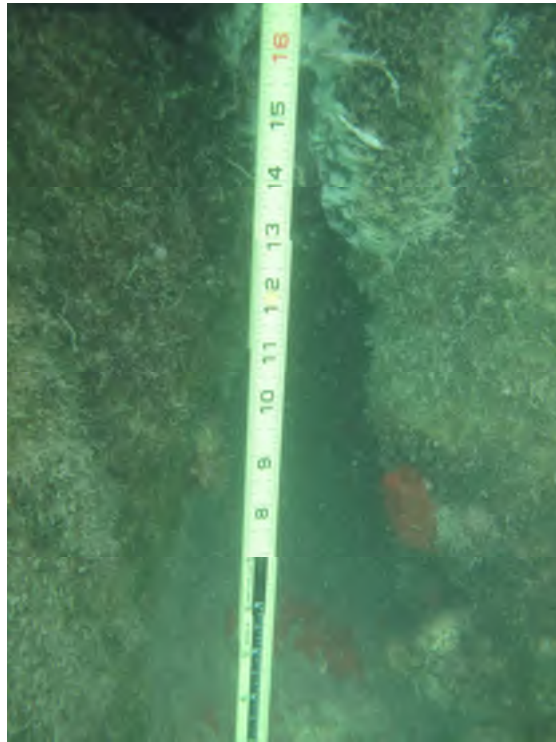
- 3.2.4. Vertical crack from top of wall to large hole at seafloor located 50' from RP3. (Photo 2.3)
- 3.2.5. Crack/Delamination from top of wall to underwater located 71' from RP3. (Photo 3.1)

**Photo 2.3 – Void in Concrete Seawall**

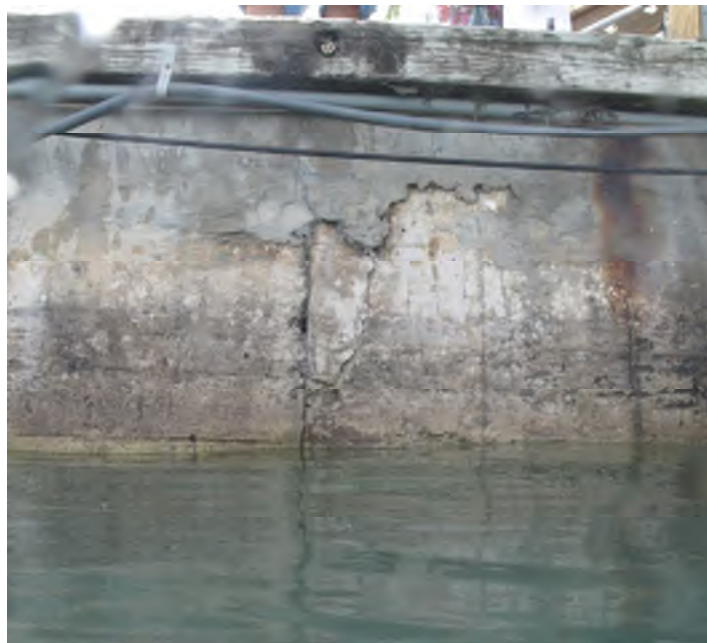
**Photo 3.1 – Crack/Delamination in Concrete Seawall**

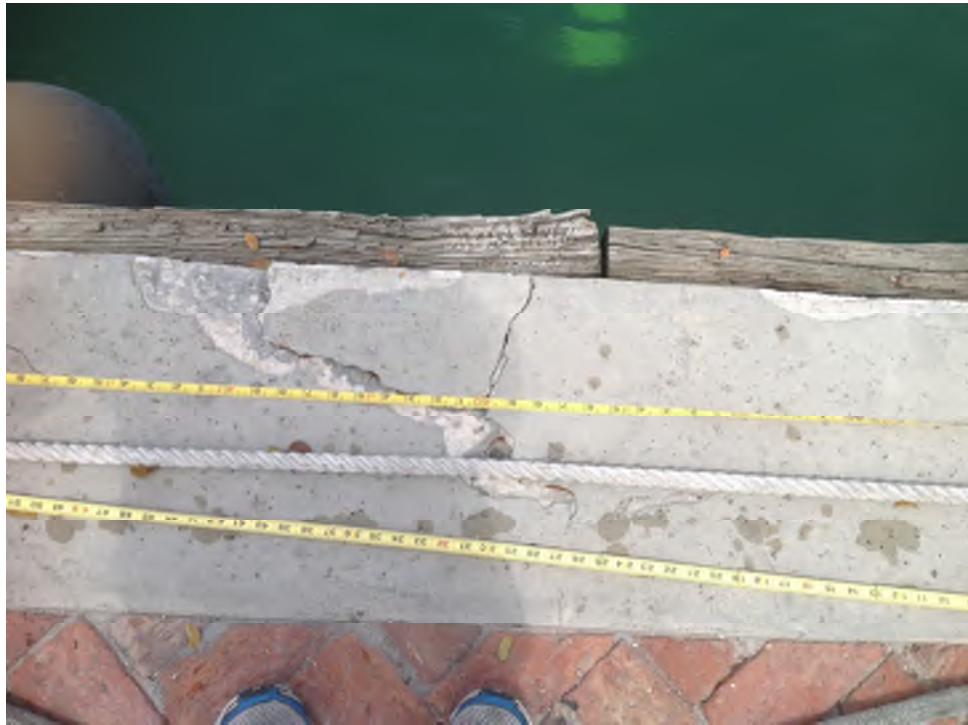
- 3.2.7. Vertical crack from top of wall to underwater hole located at 144' from RP3.
- 3.2.8. Spall/Delamination on top of concrete wall located at 154' from RP3. (Photo 4.1)

Photo 4.1 – Spall/Delamination top of Concrete Seawall

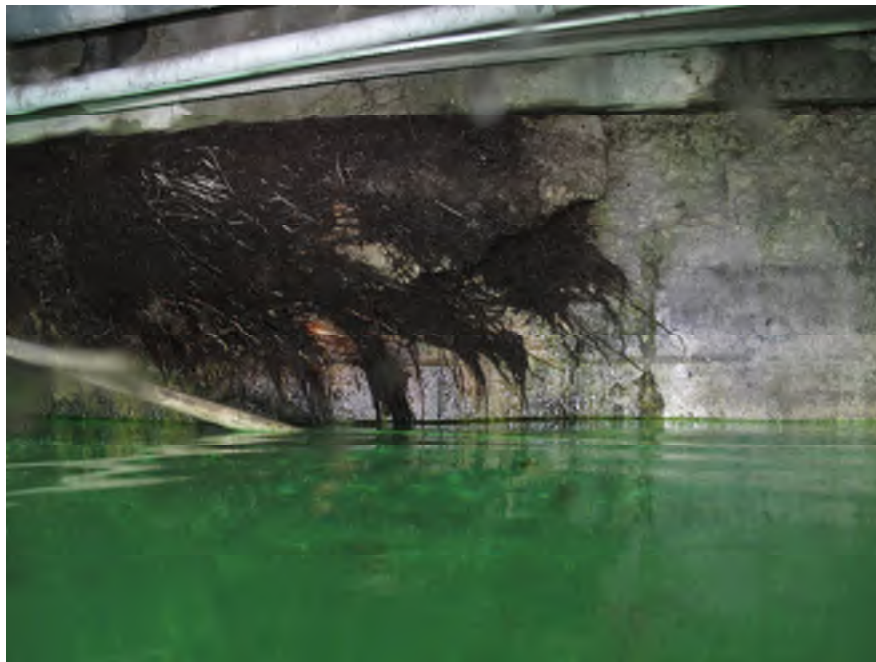
- 3.2.9. Vertical crack from top of wall to bottom of wall underwater located at 21' from RP4.
- 3.2.10. Crack/Delamination with heavy vegetation and concrete scaling/weathering located at 38' from RP4. (Photo 4.2)

Photo 4.2 – Crack/Delamination in Concrete Seawall

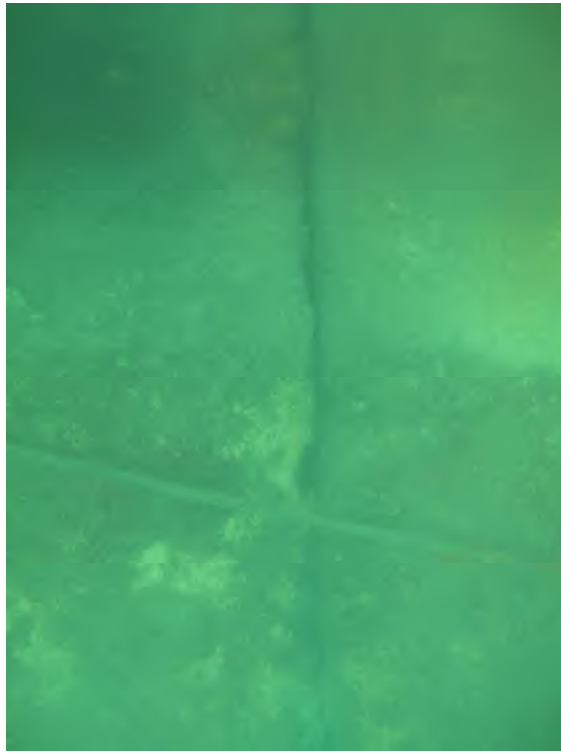
- 3.2.11. Spall at top of wall with vertical crack extending to the bottom of wall underwater located at 58' from RP4.
- 3.2.12. Joint in concrete wall with voids located 94' from RP4. (Photo 5.1)

**Photo 5.1 – Seawall Joint with Voids**

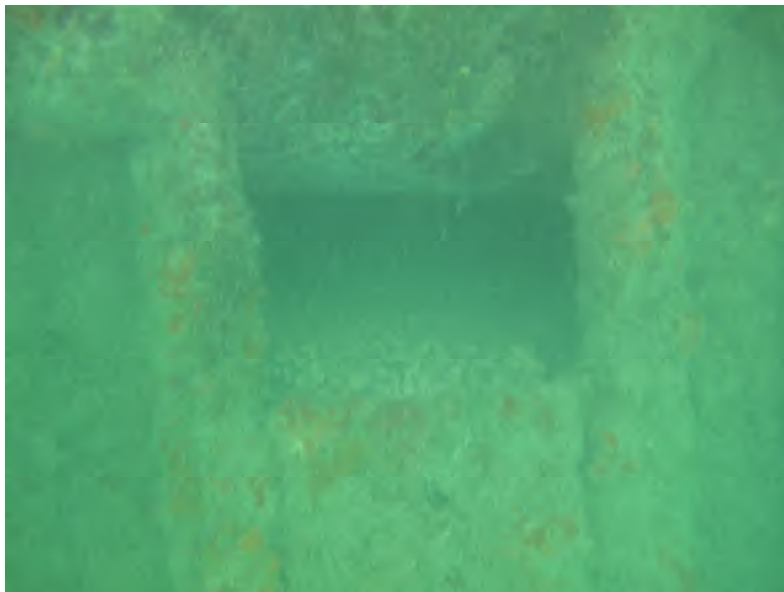
- 3.2.13. Approximate 16"x16" hole in the concrete wall located 108' from RP4. (Photo 5.2)
- 3.2.14. Joint in concrete wall with voids located 121' from RP4.

**Photo 5.2 – Hole in Concrete Seawall**

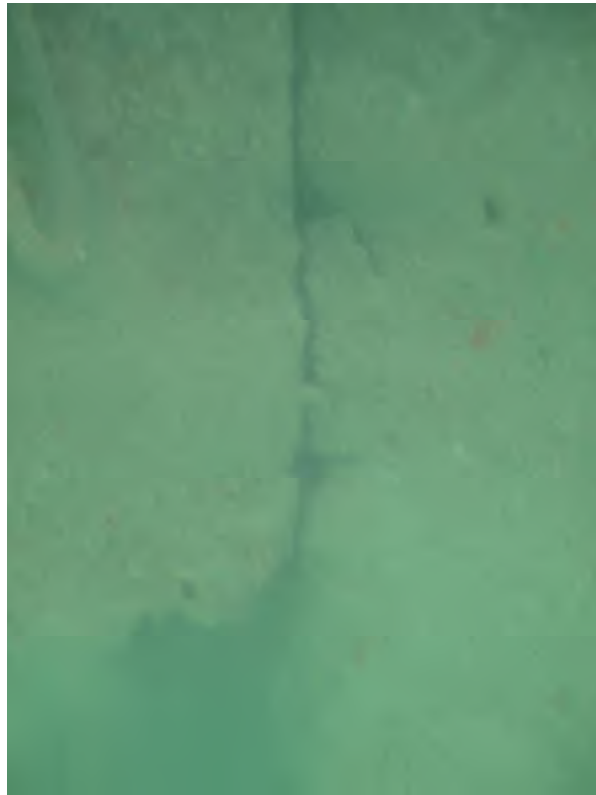
- 3.2.15. Joint in concrete wall with voids and hole at seafloor located 13' from RP5. (Photo 5.3)
- 3.2.16. Vertical crack in underwater portion of wall located at 23' from RP5.

**Photo 5.3 – Seawall Joint with Voids**

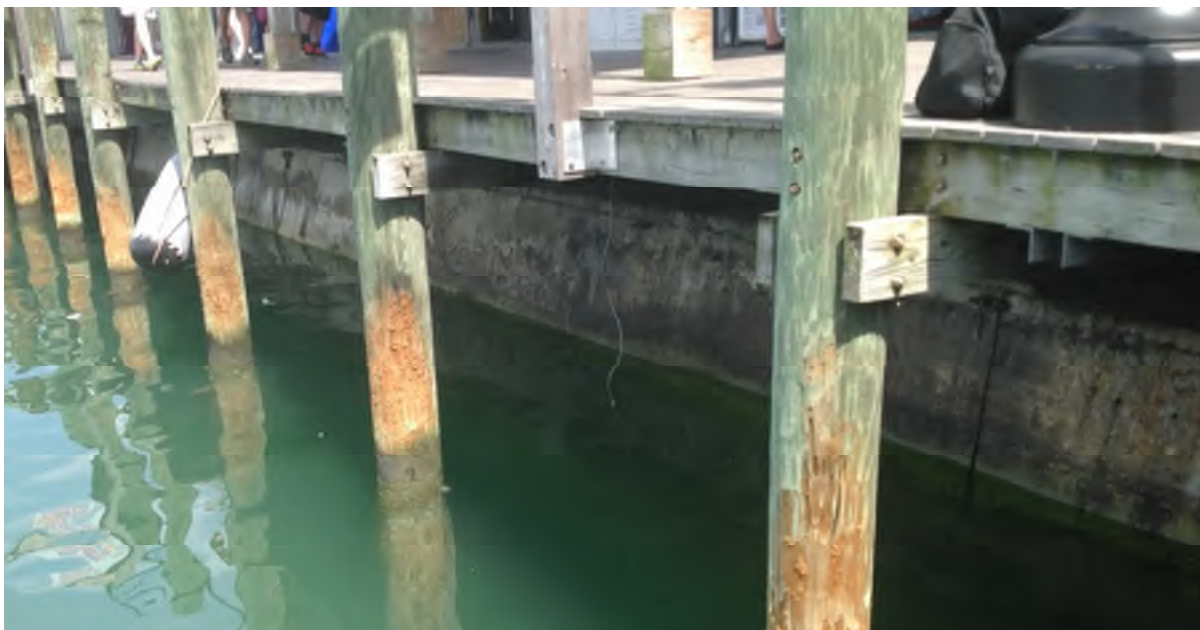
- 3.2.18. Cracks and concrete scaling/weathering with exposed aggregate of wall above waterline located from 10'-90' from RP7. (5.4)
- 3.2.19. Cracks/Delamination with corrosion stains and concrete scaling/weathering with exposed aggregate of wall above waterline located from 0'-110' from RP8. (6.1)

**Photo 5.4 – Cracks and Concrete Scaling/Weathering in Seawall**

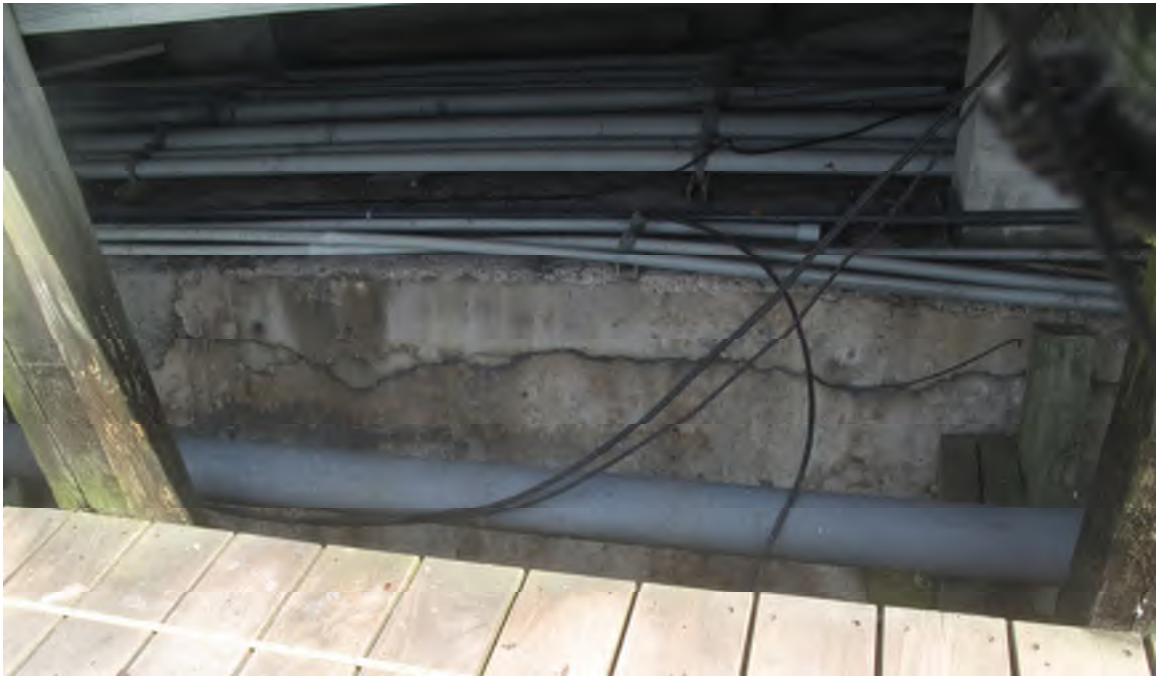
**Photo 6.1 – Cracks/Delamination in Concrete Seawall**

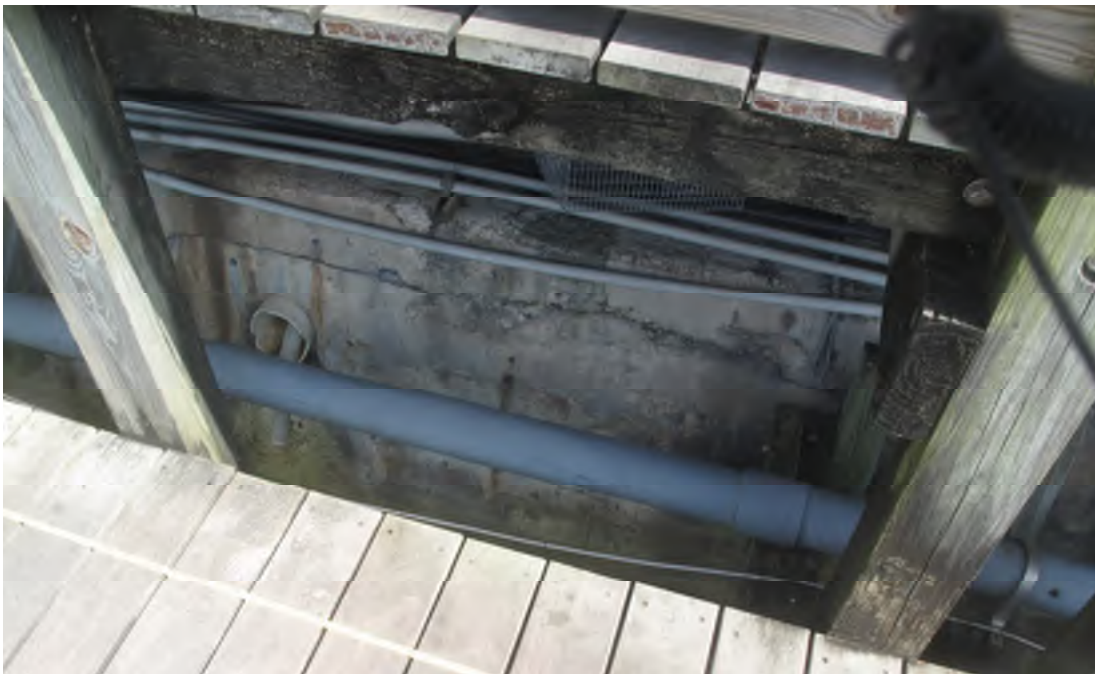
**Photo 6.2**

- 3.2.20. Cracks/spalls with voids along the wall bottom and portions of the wall have scoured at the seafloor. This occurs approximately from 90'-105' from RP8. (Photo 6.2)

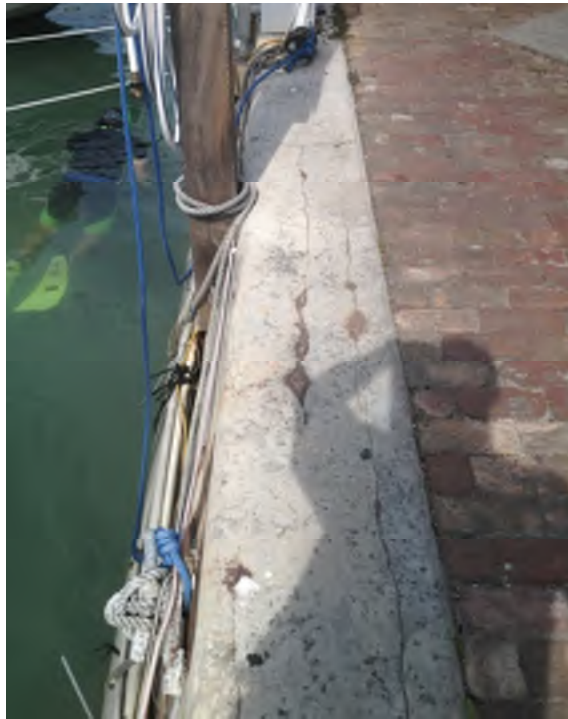
- 3.2.21. Cracks/Delamination with corrosion stains on top of concrete wall and face above waterline located 10'-52' from RP8. (Photo 7.1)
- 3.2.22. Cracks/spalls with voids along the wall bottom and portions of the wall have scoured at the seafloor located 52' from RP8.

**Photo 7.1 – Cracks/Delamination with Corrosion Stains top of Seawall**

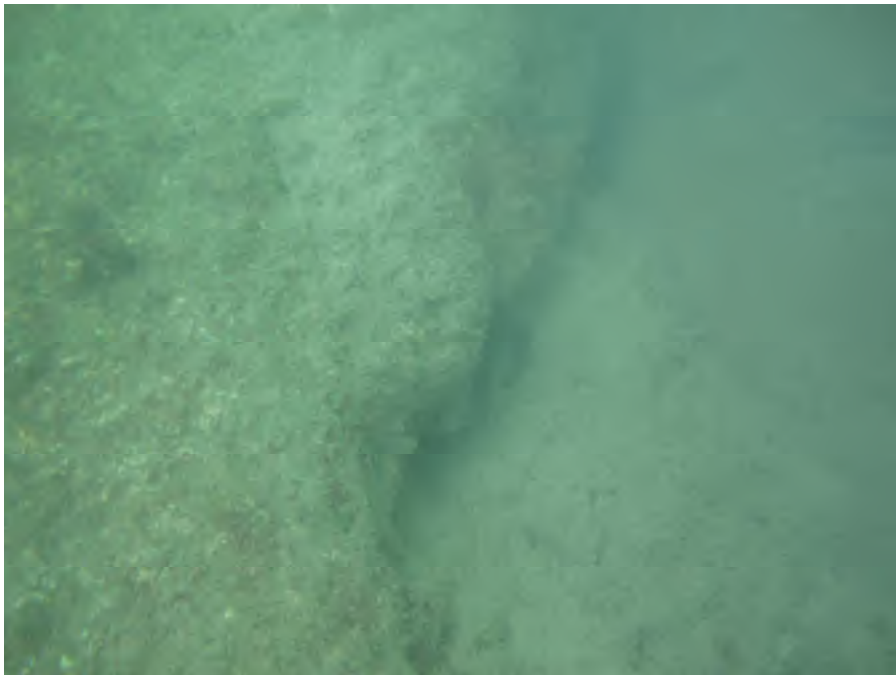
- 3.2.23. Vertical crack and scour/hole at seafloor located 27' from RP9. (Photo 7.2)
- 3.2.24. Large vertical crack from top of wall to seafloor located 46' from RP9. (Photo 7.3)

**Photo 7.2 – Scour at Seafloor**

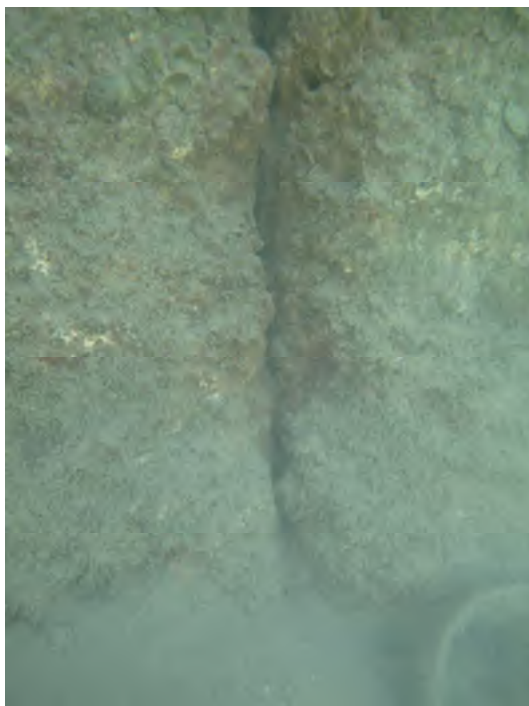
**Photo 7.3 – Vertical Crack in Seawall**

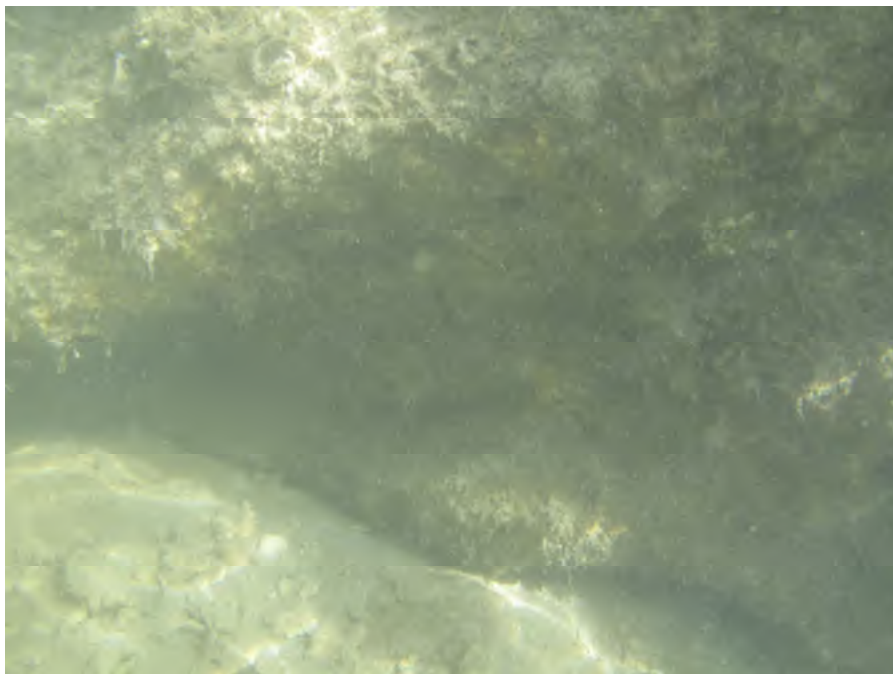
- 3.2.25. Vertical crack from top of wall to hole on seafloor located 69' from RP9.
- 3.2.26. Portions of the wall have spalled/weathered away from 127'-153' from RP9 (Photo 8.1).

**Photo 8.1 – Spall and Scour at Seafloor**

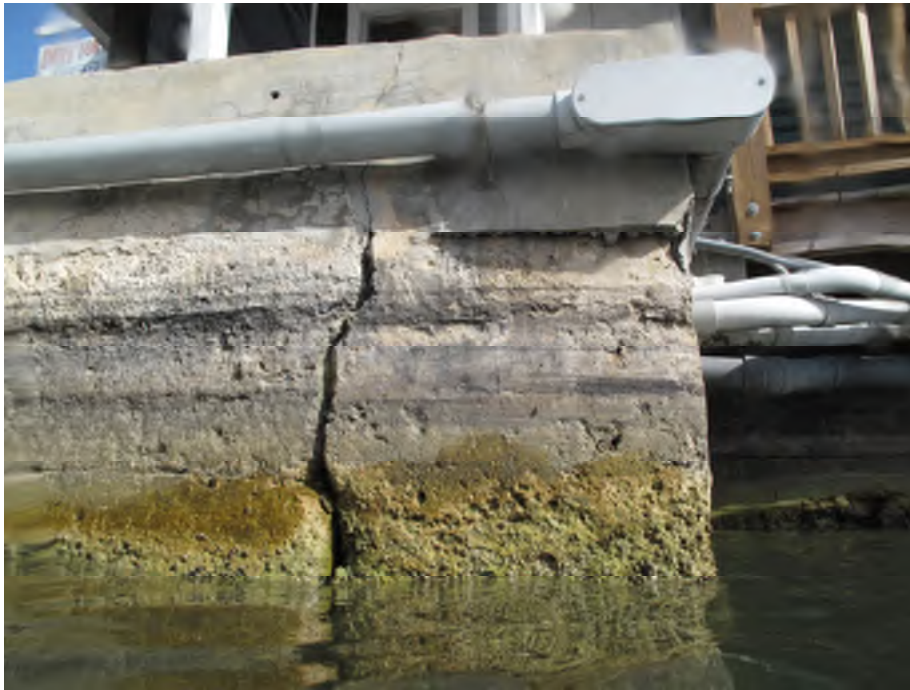
- 3.2.27. Large vertical crack from top of wall to seafloor located at 157' from RP9. (Photo 8.2)
- 3.2.28. Wall has a split/void that is approximately 6" deep and runs approximately 0'-20' from RP10. (Photo 8.3 & 8.4)

**Photo 8.2 – Vertical Crack/Delamination in Seawall**
