# STRUCTURAL ASSESSMENT REPORT

For  
Key West Bight Seawall  
Key West, FL

Certificate of Authorization No. 29691  
UNITED Project No.: 0301-20

May 9, 2014

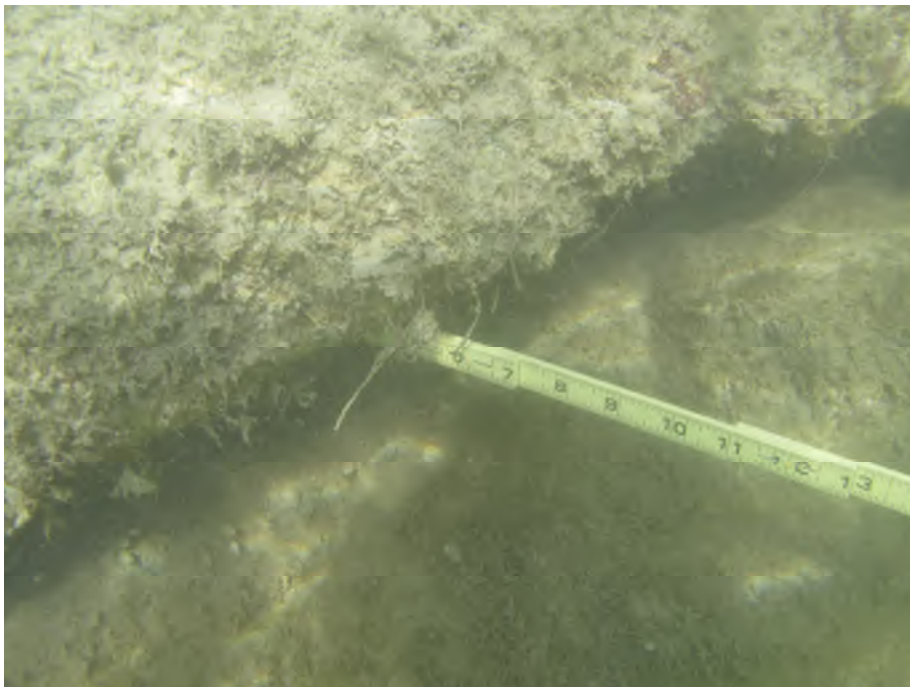
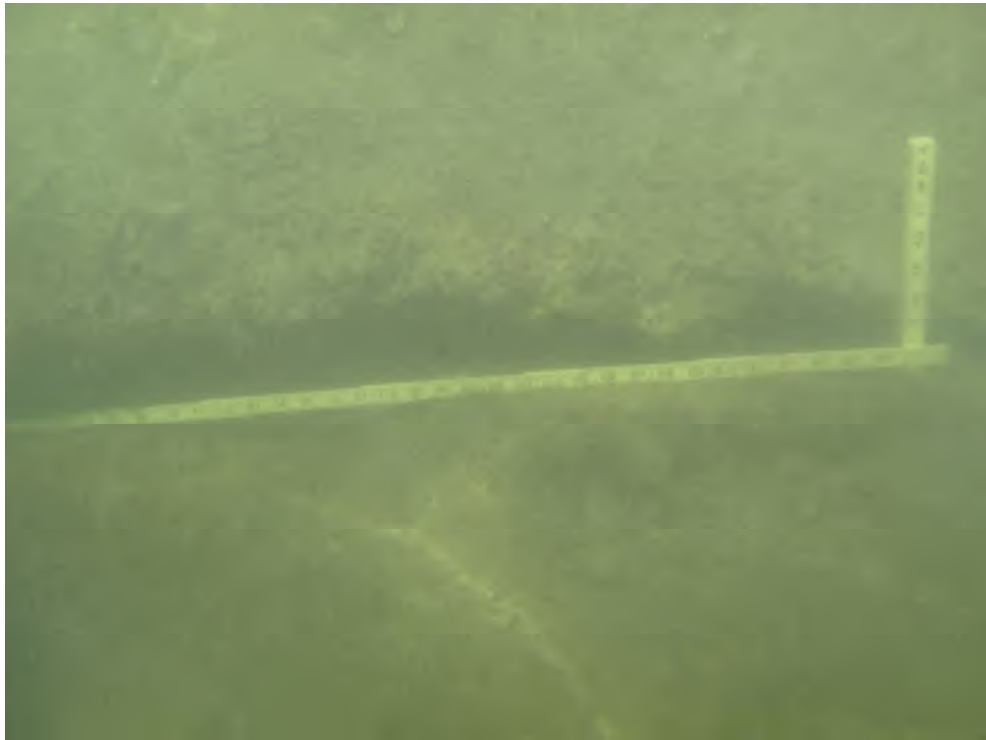
- 3.2.27. Large vertical crack from top of wall to seafloor located at 157' from RP9. (Photo 8.2)
- 3.2.28. Wall has a split/void that is approximately 6" deep and runs approximately 0'-20' from RP10. (Photo 8.3 & 8.4)

**Photo 8.3 – Split/Void in Seawall**

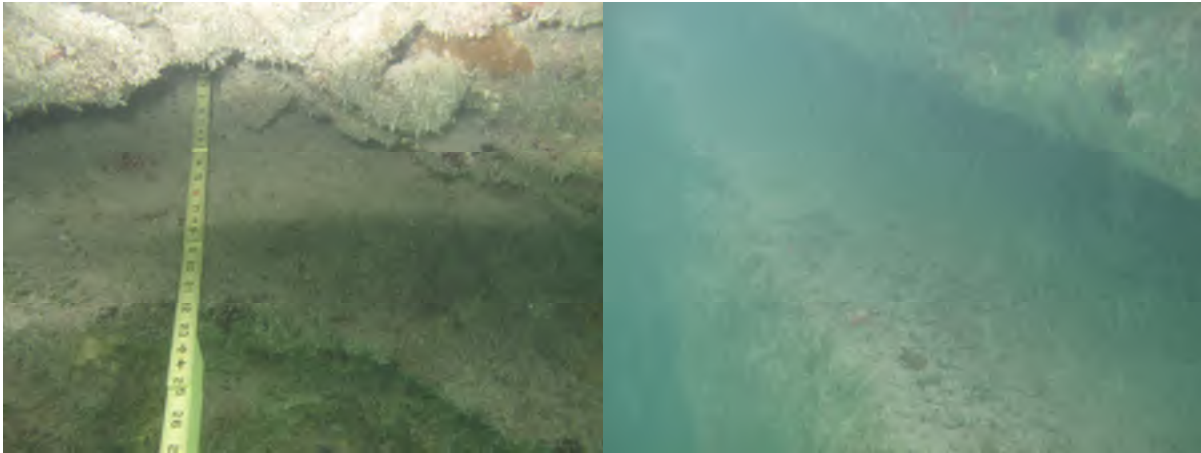
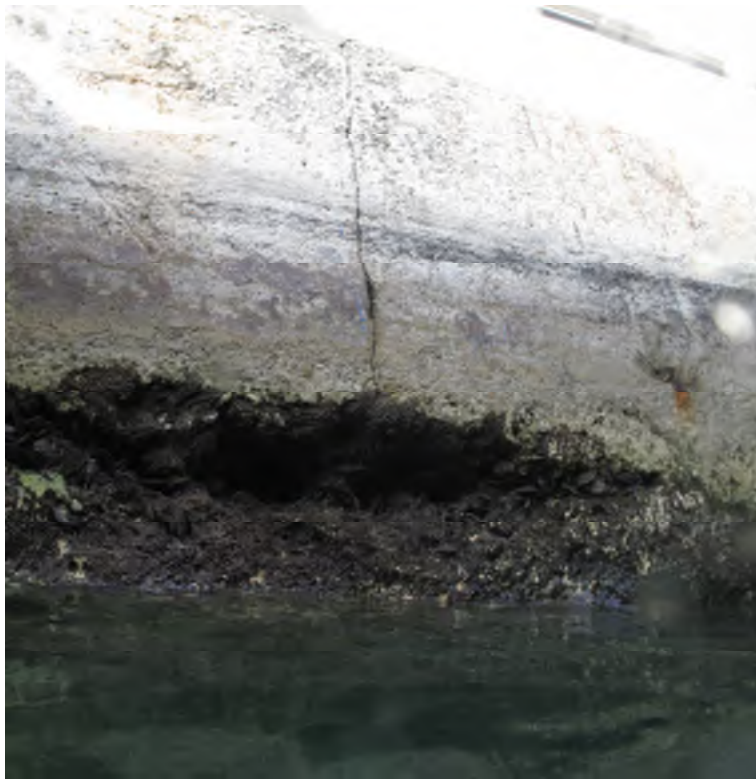
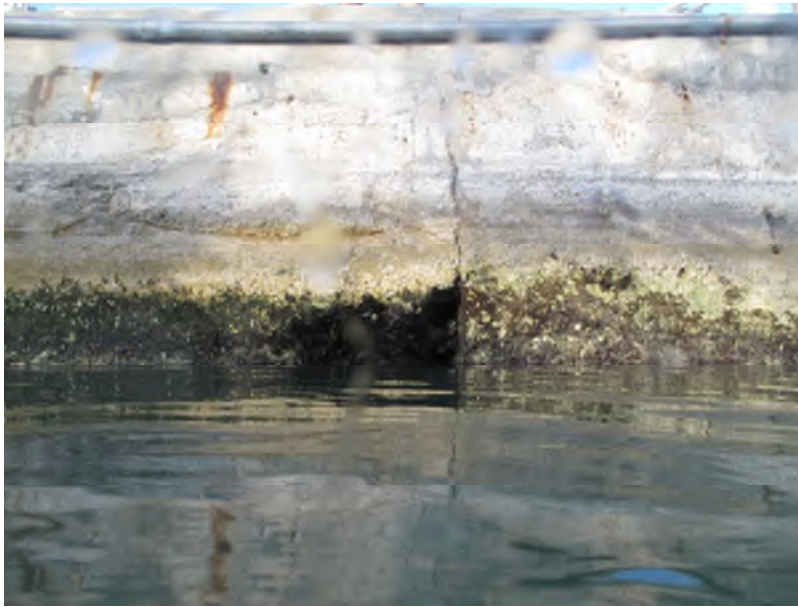
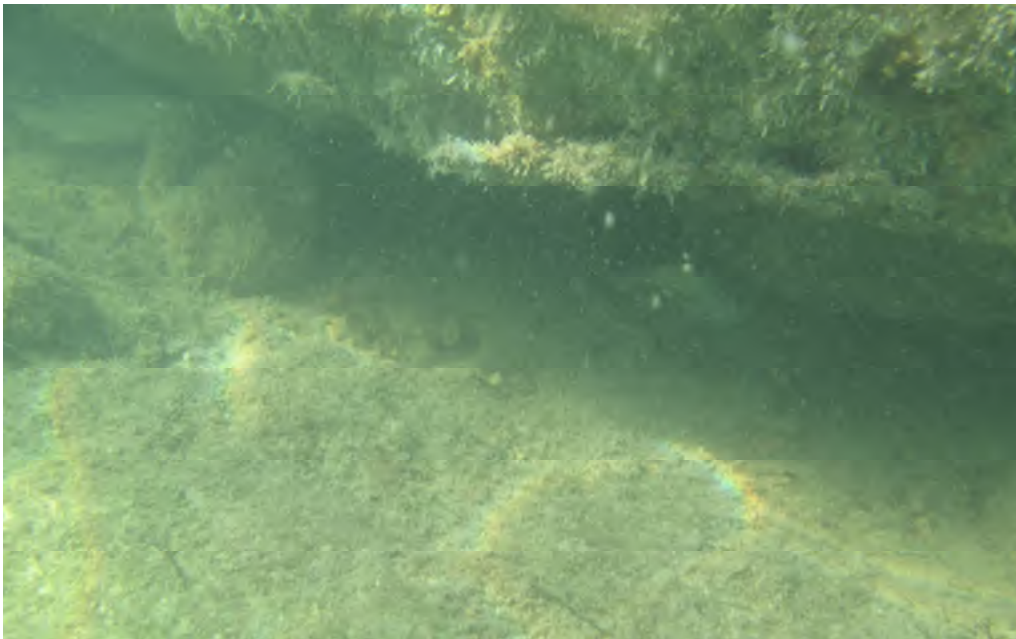
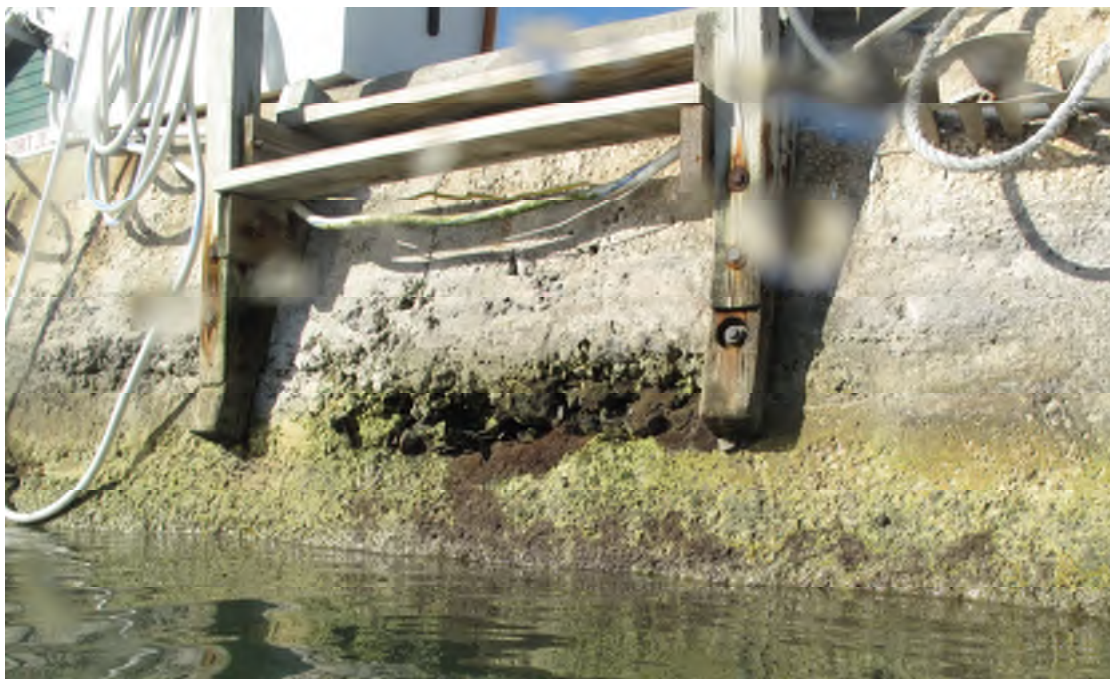
- 3.3.1. Wall has significant holes/voids, scour, spalls, concrete scaling/weathering with exposed aggregate and cracks/delaminations from Thompson Fish House to RP11 (approximately 190'). (Photos 9.1-9.5)

**Photo 9.1 – Large Hole in Seawall**

**Photo 9.2 – Spall and Concrete Scaling/Weathering**

**Photo 9.4 – Scour at Seafloor**

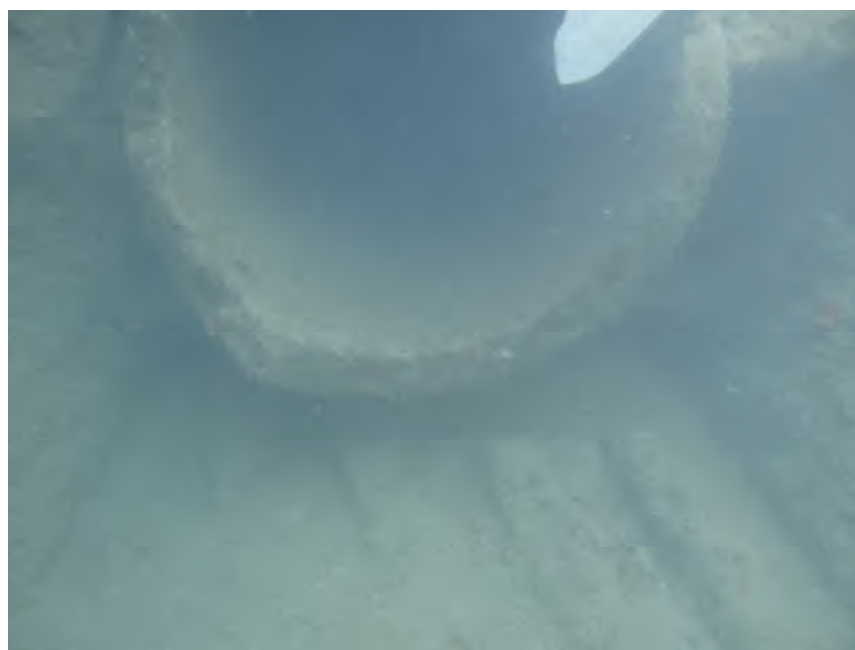
- 3.3.5. Vertical crack running down to scour located 17' from RP11.
- 3.3.6. Voids around pipe outlets located at 41' and 44' from RP11. (Photo 10.1)
- 3.3.7. Spall and delamination at the top of wall 3' from RP12. (Photo 10.2)

**Photo 10.1 – Voids around Pipe Outlet**

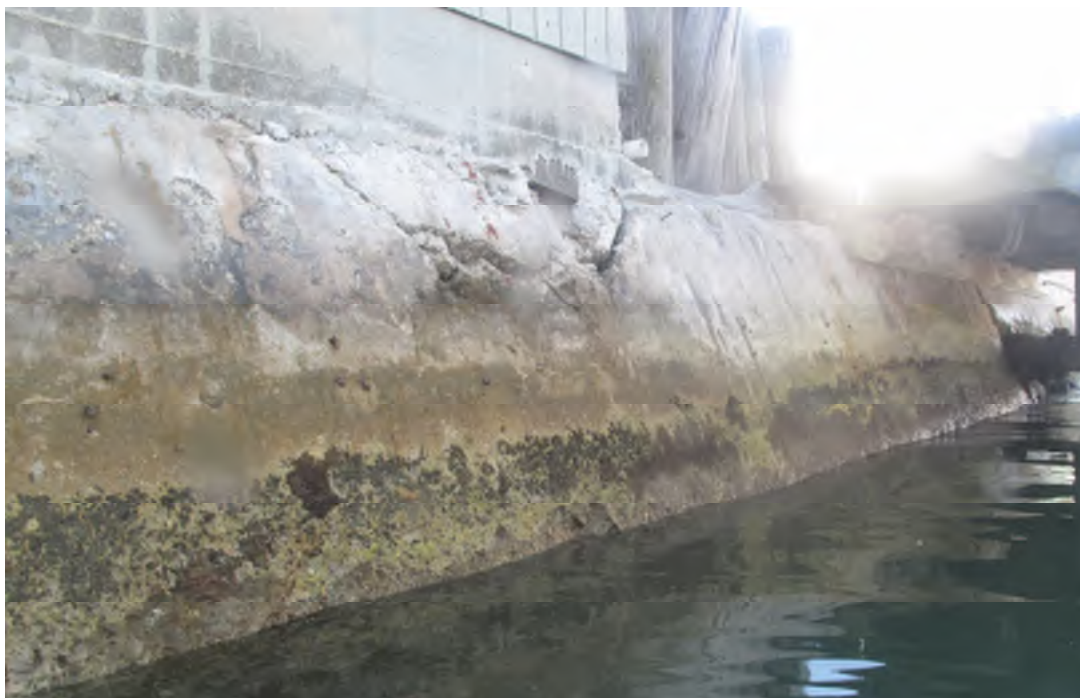
**Photo 10.2 – Spall and Delamination top of Seawall**

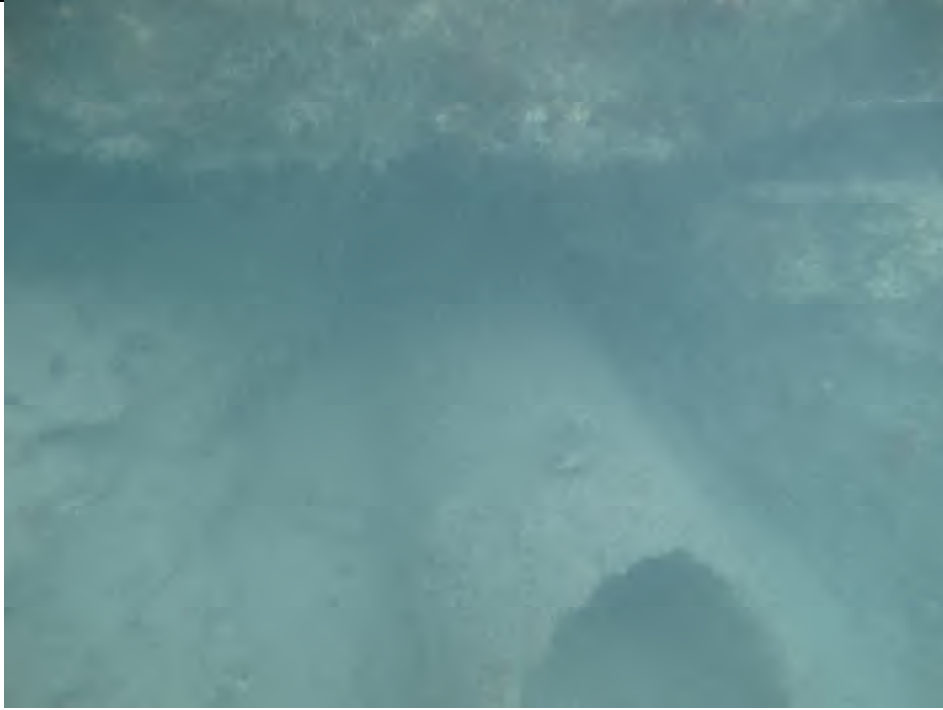
- 3.3.8. Large 1' tall by 28" deep scour at seafloor located 7'-14' from RP12. (Photo 10.3)
- 3.3.9. Large hole/void around pipe outlet located 30' from RP12. Scour at seafloor located 29'-34' from RP12. (Photo 10.4)

**Photo 10.4 – Void around Pipe Outlet**

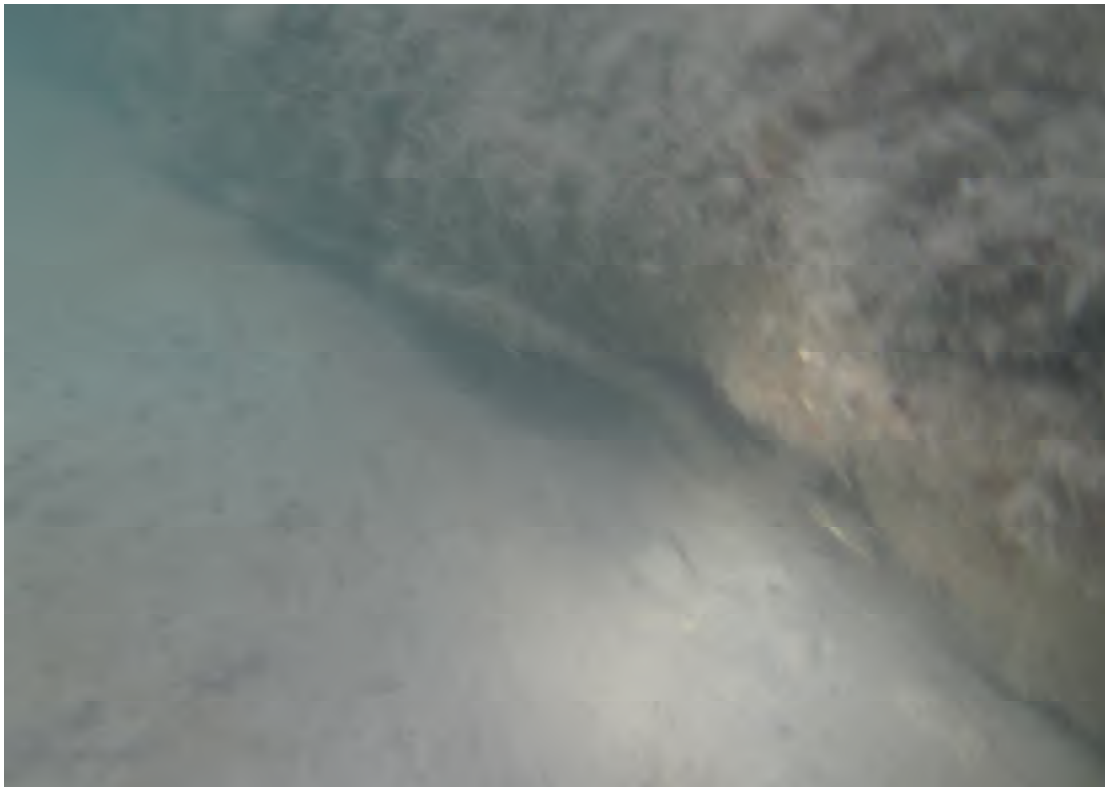
- 3.3.12. Scour at seafloor located 52'-121' from RP12. (Photo 11.1)
- 3.3.13. Large horizontal crack at wall mid-height located 71'-80' from RP12.
- 3.3.14. Horizontal crack above waterline located 78'-110' from RP12. (Photo 11.2)

**Photo 11.1 – Scour at Seafloor**

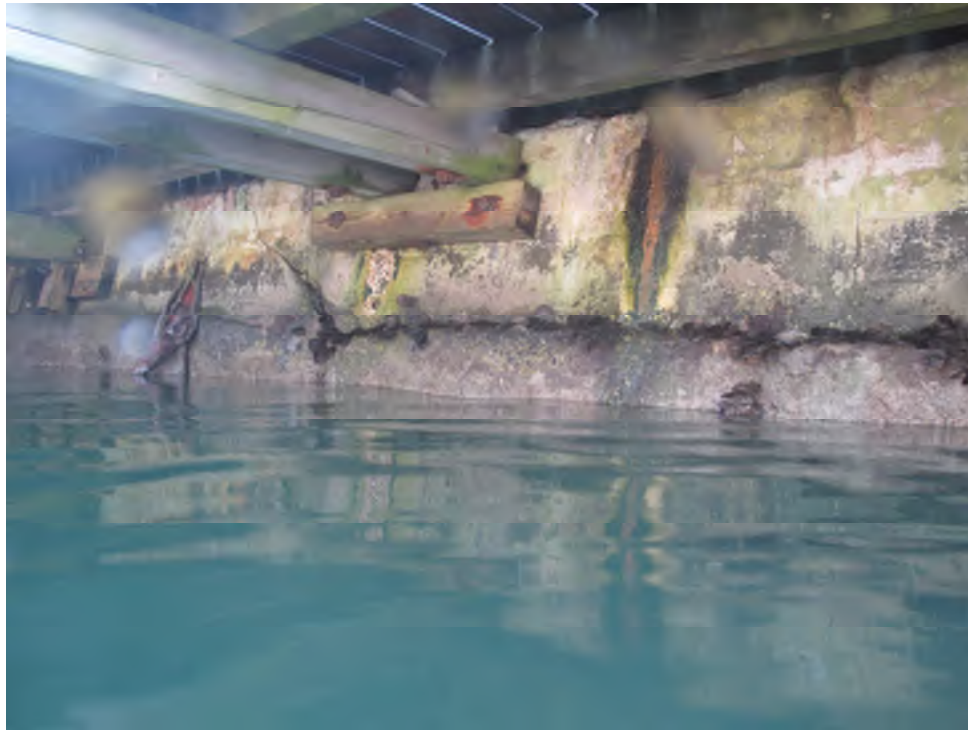
**Photo 11.2 – Crack/Delamination in Seawall**

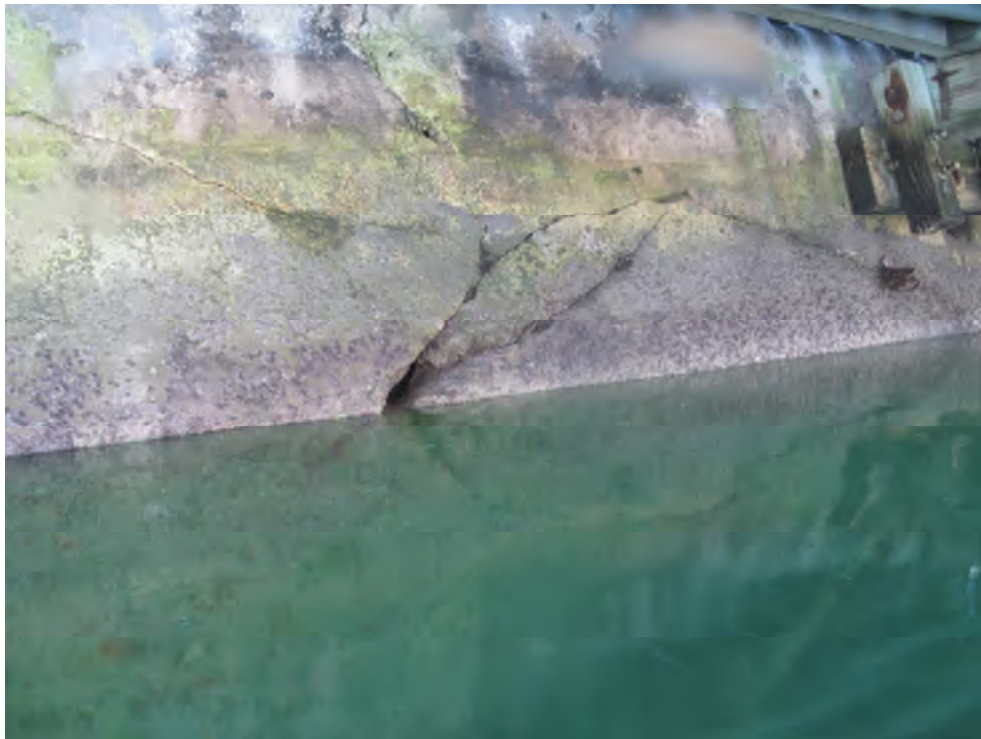
**Photo 11.3**

- 3.3.17. Vertical and horizontal cracking with voids located at 134' from RP12 (Photo 11.3).

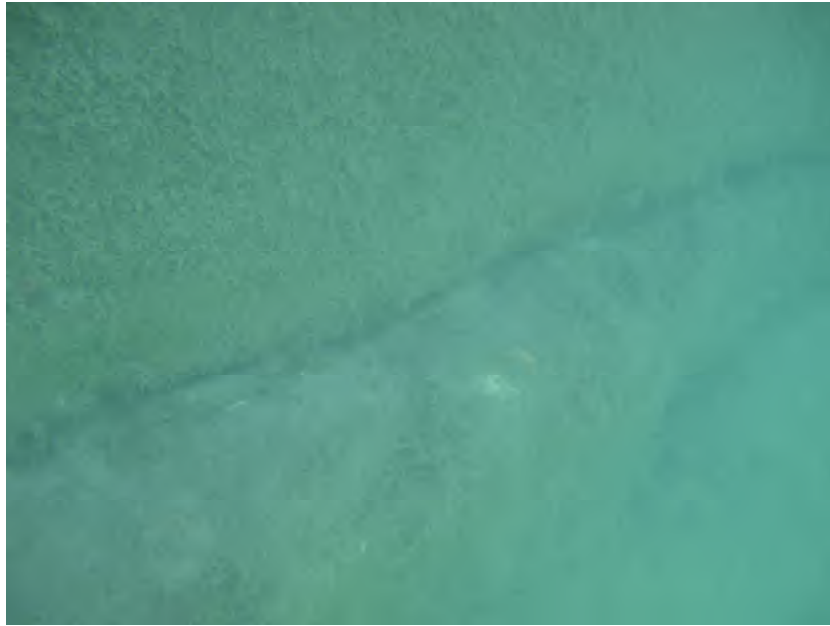
**Photo 12.1**

- 3.3.20. Control joint with voids located at 29' from RP13.
- 3.3.21. Large hole at seafloor located 36'-41' from RP13.
- 3.3.22. Wall has split/void located 179'-184' from RP13. (Photo 12.1)

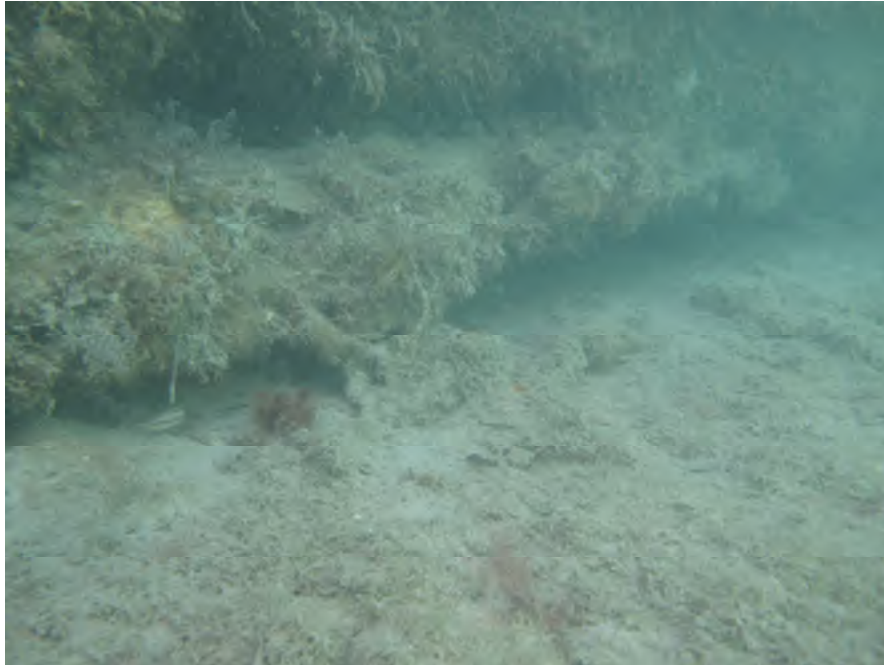
**Photo 13.1**

- 3.3.23. Wall has spall/scour at seafloor located 188'-224' and 245'-260' from RP13. (Photo 13.1)
- 3.3.24. Cracks/Delamination at the concrete wall transition located at 260' from RP13. (Photo 13.2)

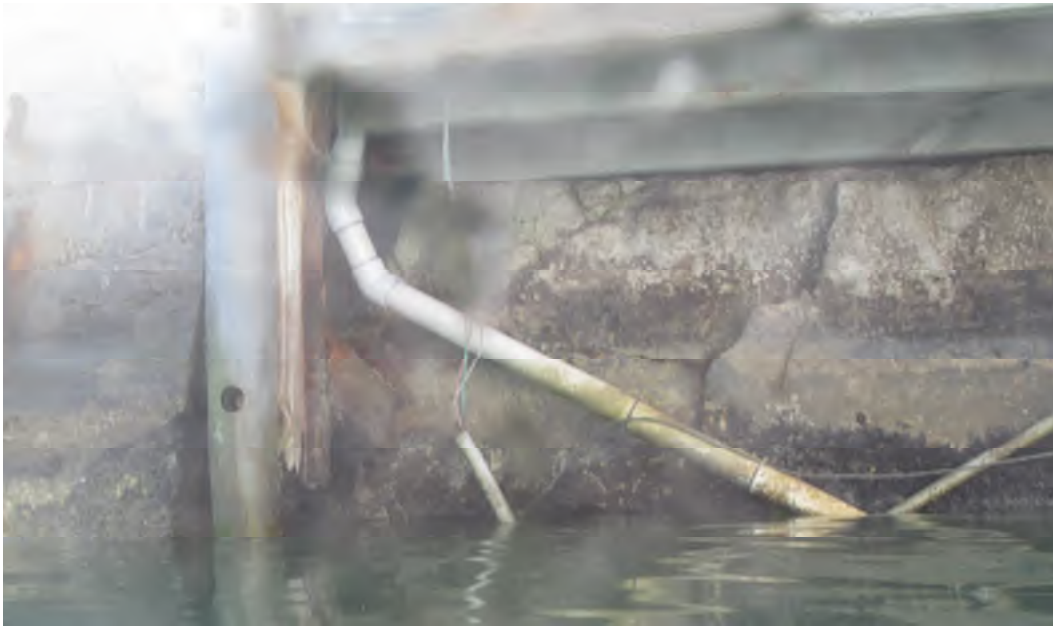
**Photo 13.2 – Crack/Delamination at Seawall Transition**

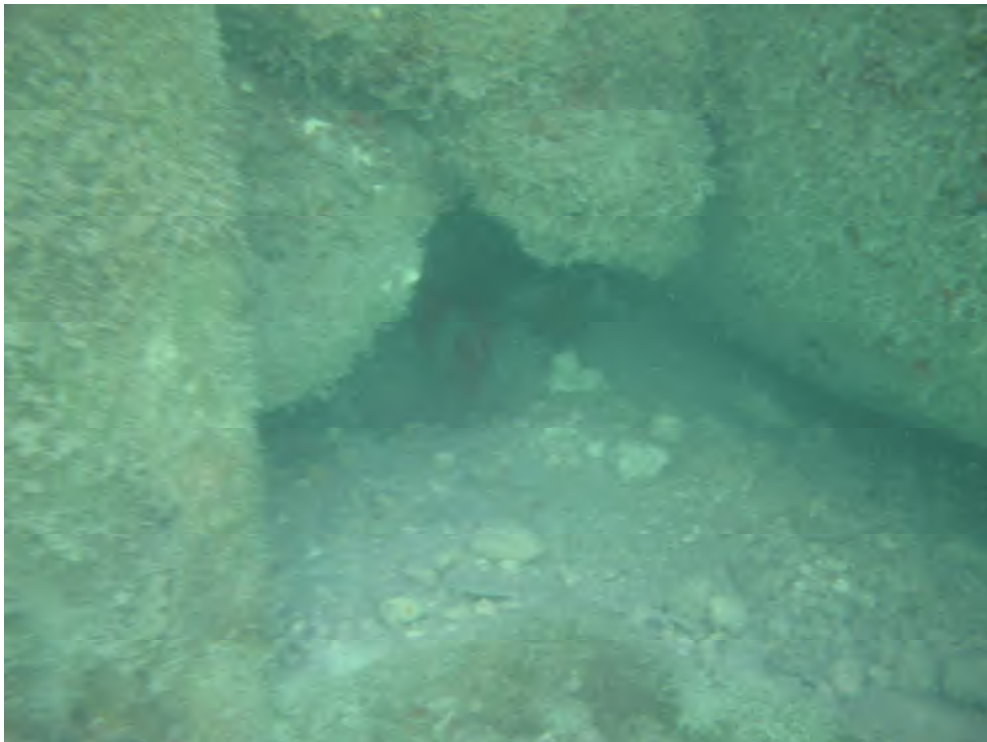
- 3.3.25. Voids around drainage outlet located at 9' and 36' from RP14. (Photo 13.3)
- 3.3.26. Hole with backfill washout located at 73' from RP14. (Photo 14.1)

**Photo 13.3 – Voids around Pipe Outlet**

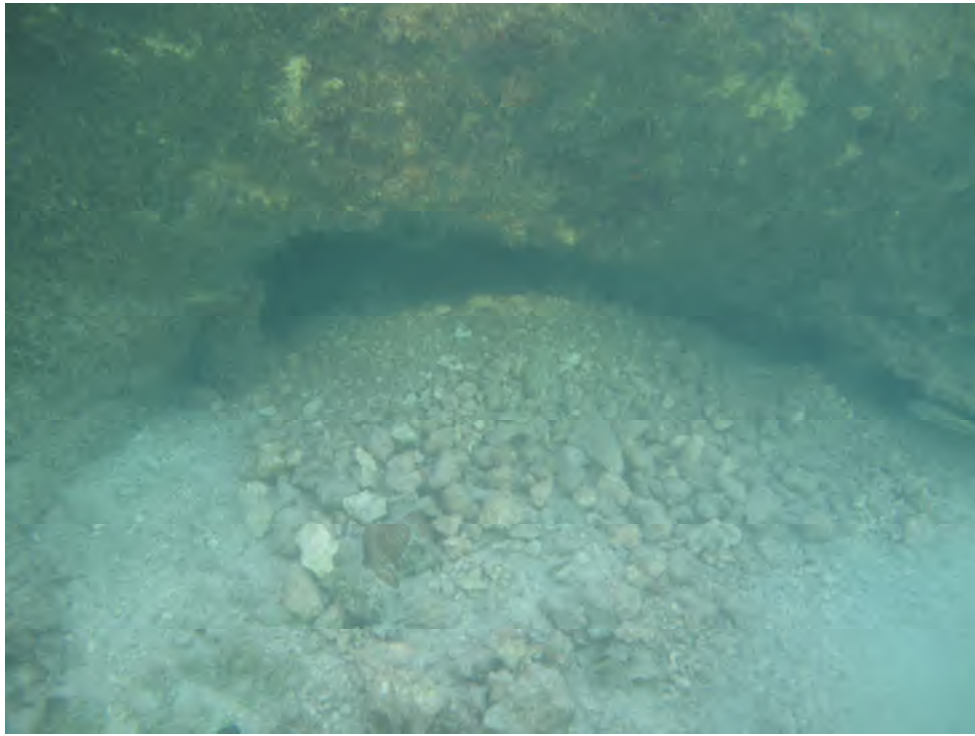
**Photo 14.1 – Void with Backfill Washout**

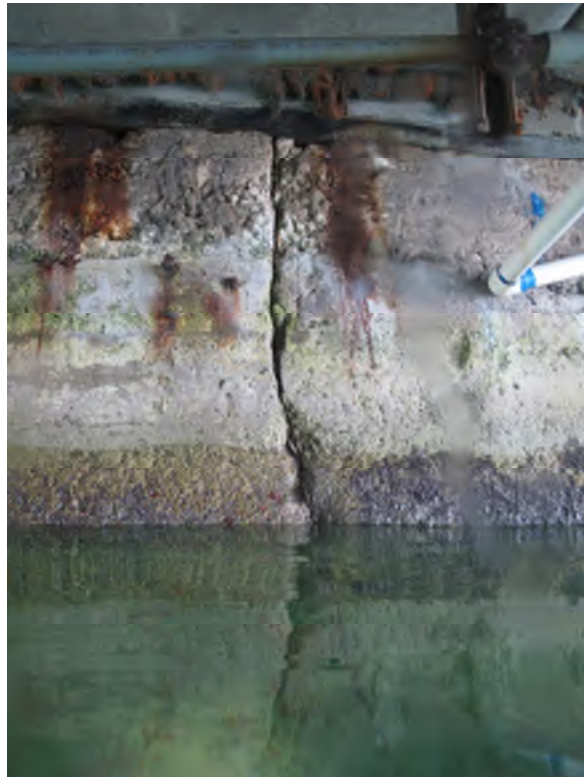
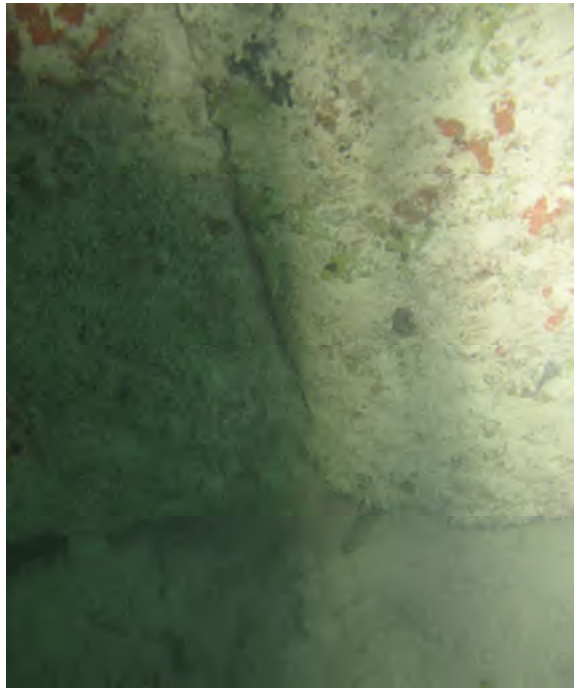
- 3.3.29. Vertical crack from top of wall to hole/scour at the seafloor located 111' from RP14. (Photo 14.2 & 14.3)
- 3.3.30. Scour at seafloor that runs from 105'-127' from RP14.

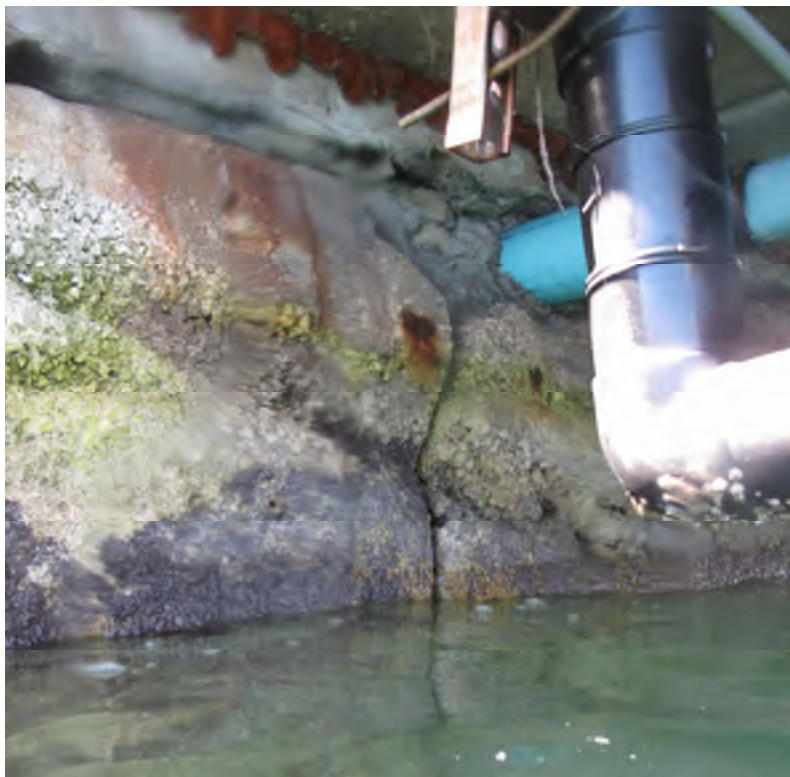
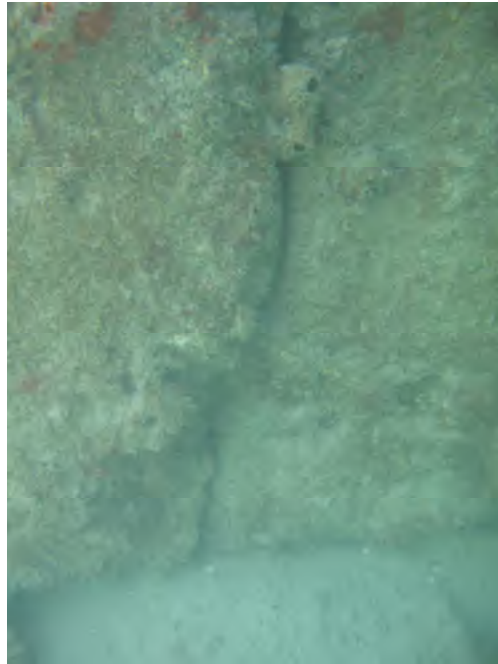
- 3.3.31. Vertical crack from top of wall to seafloor and concrete scaling/weathering with exposed aggregate located 125' from RP14. (Photo 14.4 & 14.5)

**Photo 14.5 – Vertical Crack in Seawall**

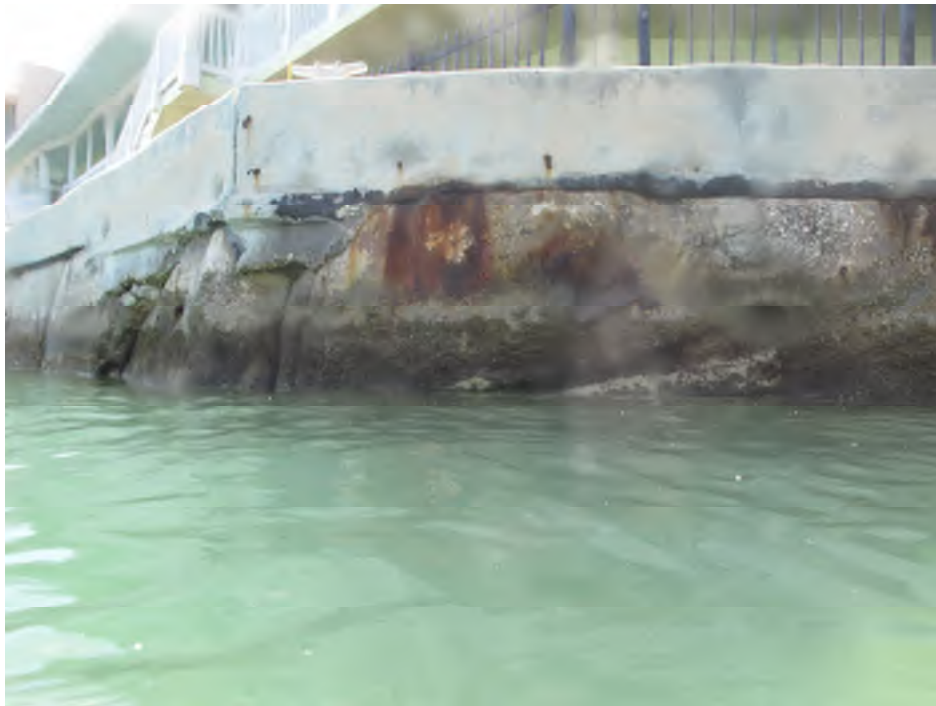
- 3.3.33. Cracks/Delamination, spalls and concrete scaling/weathering with exposed aggregate and corrosion stains located at 150' from RP14. (Photo 14.6)

**Photo 14.6 – Cracks/Delamination, Spalls, & Concrete Scaling/Weathering with Corrosion Stains**

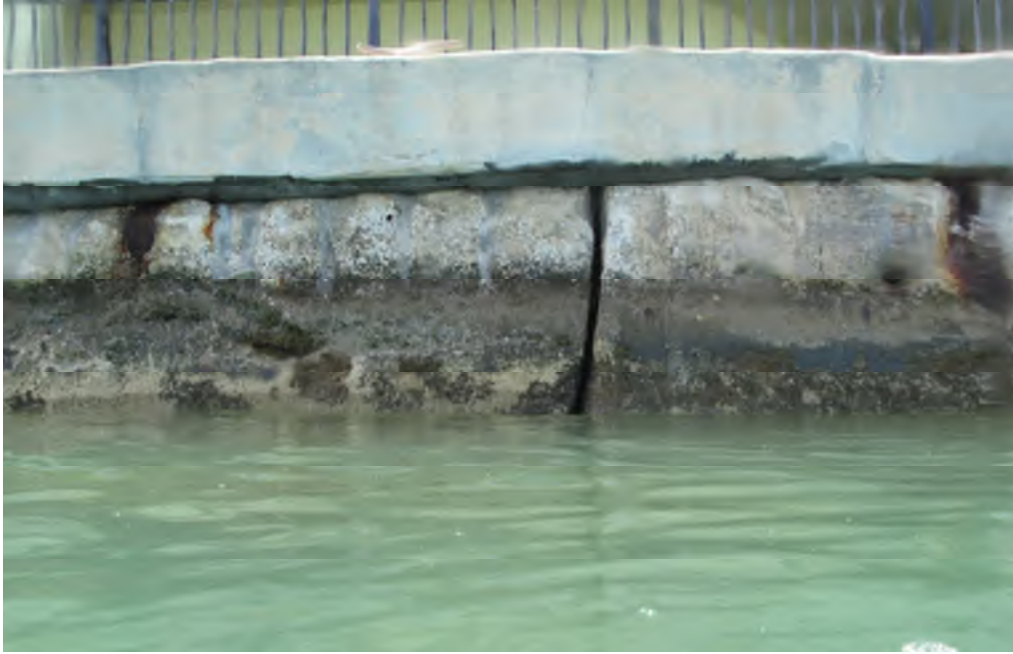
- 3.3.34. Vertical crack from top of wall to seafloor located 9' from RP15.
- 3.3.35. Wide vertical crack from top of wall to seafloor located 18' from RP15. (Photo 15.1)

**Photo 15.1 – Large Vertical Crack in Seawall**
