January 12, 2017

**Subject: Arborist Assessment Report
Higgs Beach Park at Atlantic Boulevard
Key West, Monroe County, Florida
E Sciences Project Number 7-0313-001**

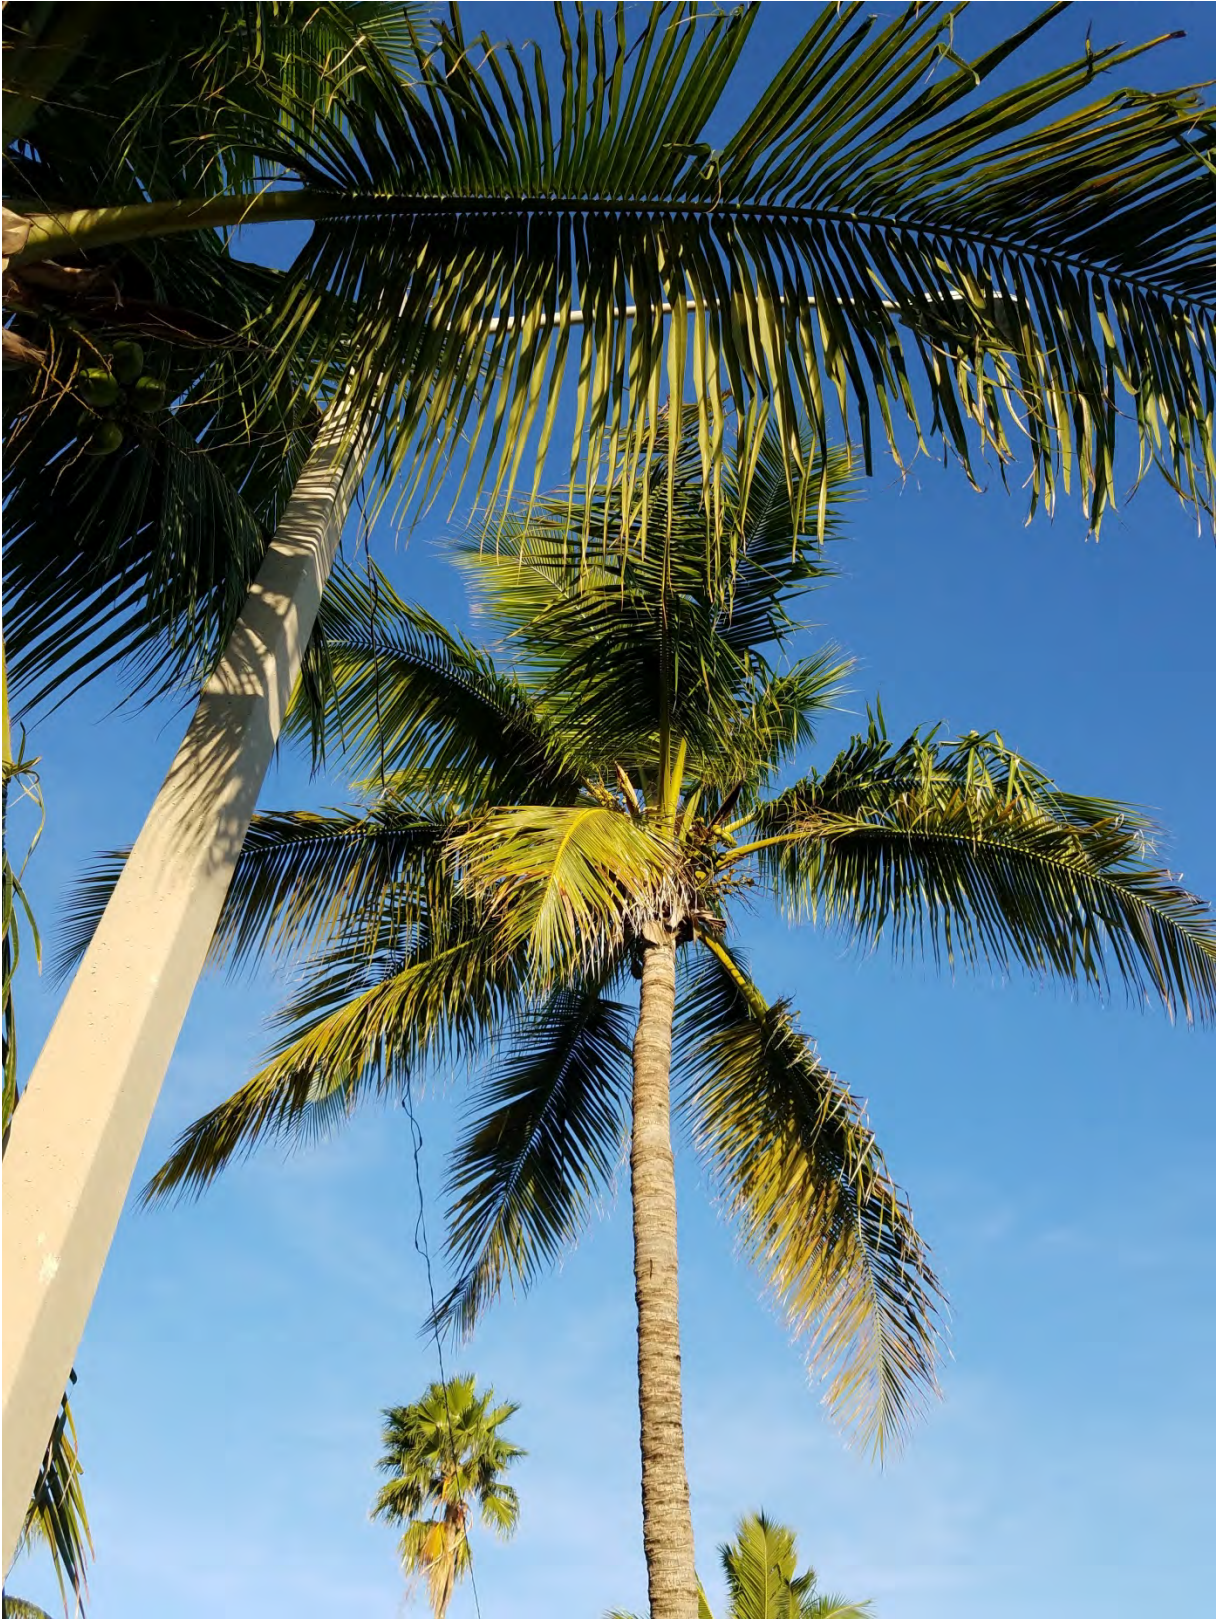
Photo 1 – Tree No. 116.

LD-03	114	Cocos nucifera	Coconut Palm				Good										Remain									
LD-03	115	Cocos nucifera	Coconut Palm				Good										Remain									
LD-03	116	Cocos nucifera	Coconut Palm				Good	Utility Line Conflict			Clearance Pruning				1		Remain									
LD-03	117	Cocos nucifera	Coconut Palm				Good										Remain									
LD-03	118	Cocos nucifera	Coconut Palm				Good										Remain									
LD-03	119	Cocos nucifera	Coconut Palm				Good										Remain									
LD-03	120	Cocos nucifera	Coconut Palm		20 GW		Good										Relocate						1			
LD-03	121	Cocos nucifera	Coconut Palm				Good										Remain									
LD-03	122	Cocos nucifera	Coconut Palm				Good										Remain									
LD-03	123	Cocos nucifera	Coconut Palm				Good										Remain									
LD-03	124	Cocos nucifera	Coconut Palm				Good										Remain									
LD-03	125	Cocos nucifera	Coconut Palm				Good										Remain									
LD-03	126	Cocos nucifera	Coconut Palm				Good										Remain

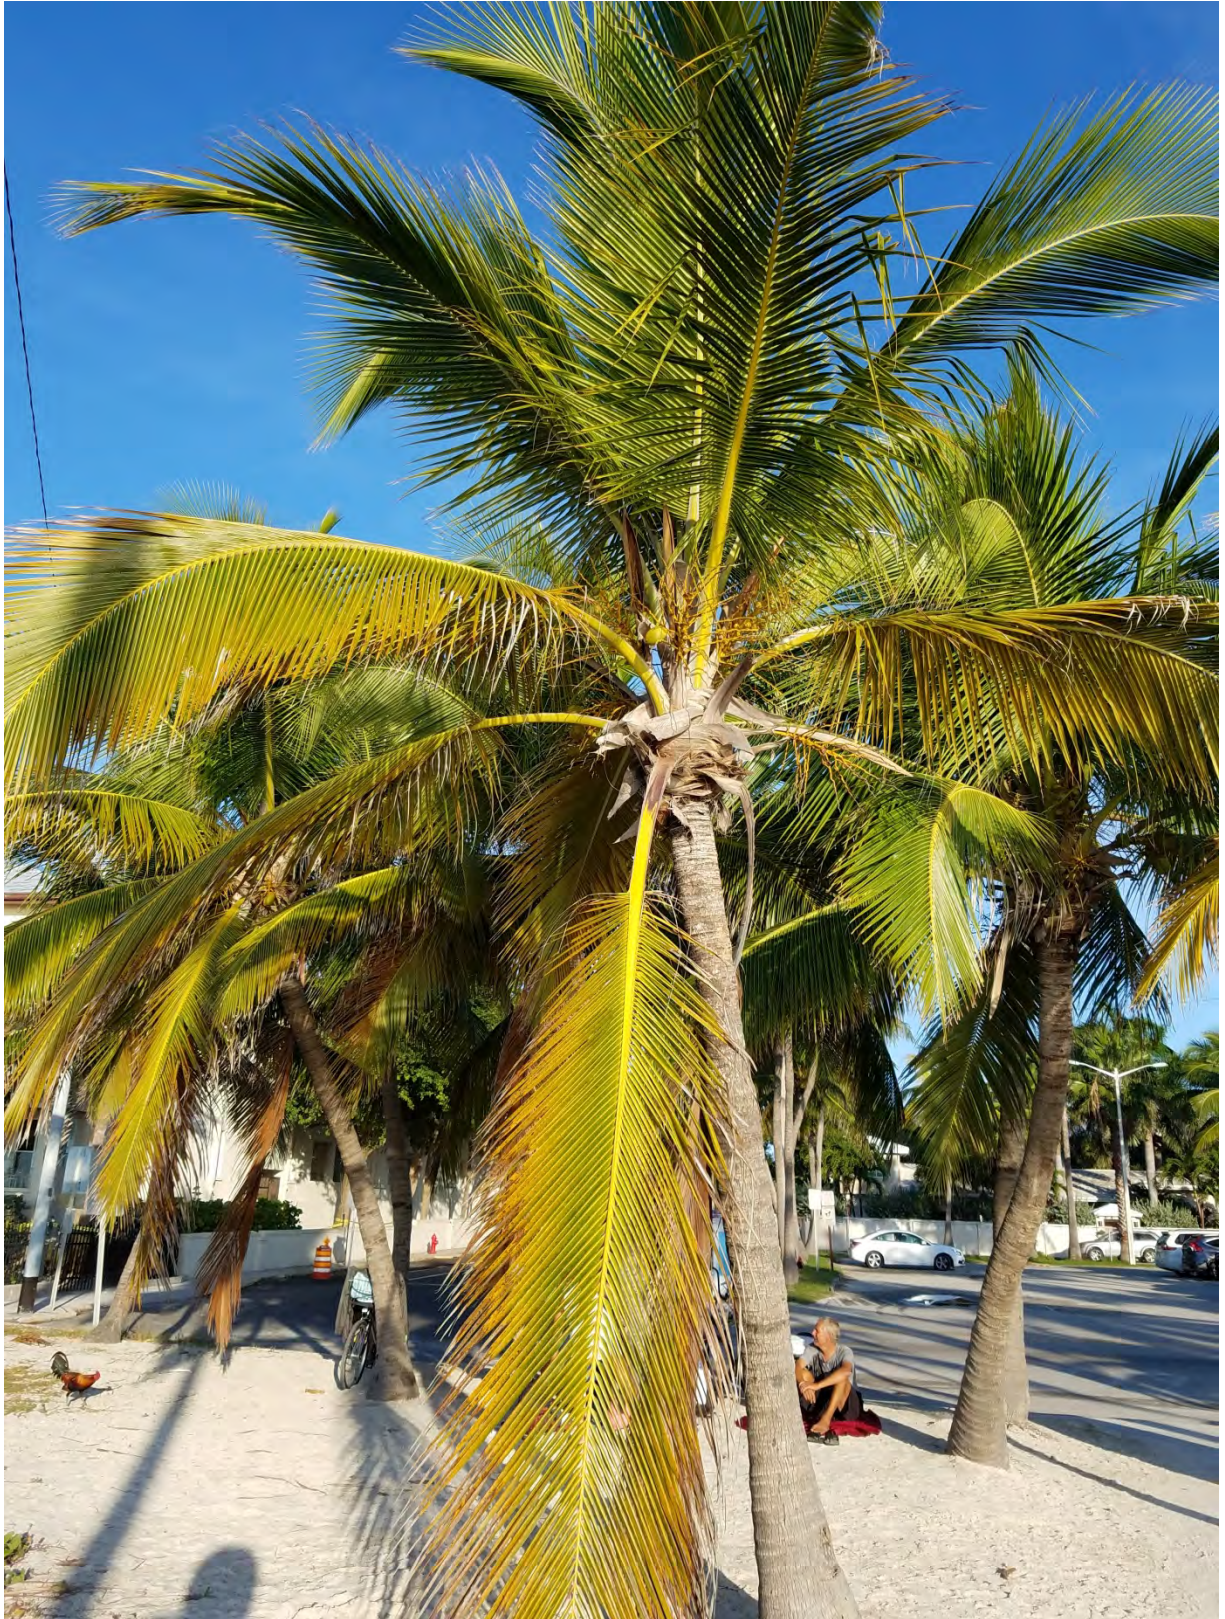
Photo 3 – Tree No. 129.

LD-03	127	Cocos nucifera	Coconut Palm				Good										Remain									
LD-03	128	Cocos nucifera	Coconut Palm				Good										Remain									
LD-03	129	Cocos nucifera	Coconut Palm				Fair	Nutrient Deficiency			Fertilization				3		Remain									
LD-03	130	Cocos nucifera	Coconut Palm				Fair	Nutrient Deficiency			Fertilization				4		Remain									
LD-03	131	Cocos nucifera	Coconut Palm				Good										Remain									
LD-03	132	Cocos nucifera	Coconut Palm				Good										Remain									
LD-03	133	Cocos nucifera	Coconut Palm				Good										Remain									
LD-03	134	Cocos nucifera	Coconut Palm				Good										Remain									
LD-03	135	Cocos nucifera	Coconut Palm				Good										Remain									
LD-03	136	Cocos nucifera	Coconut Palm				Good										Remain									
LD-03	137	Cocos nucifera	Coconut Palm				Good										Remain									
LD-03	138	Cocos nucifera	Coconut Palm				Good										Remain

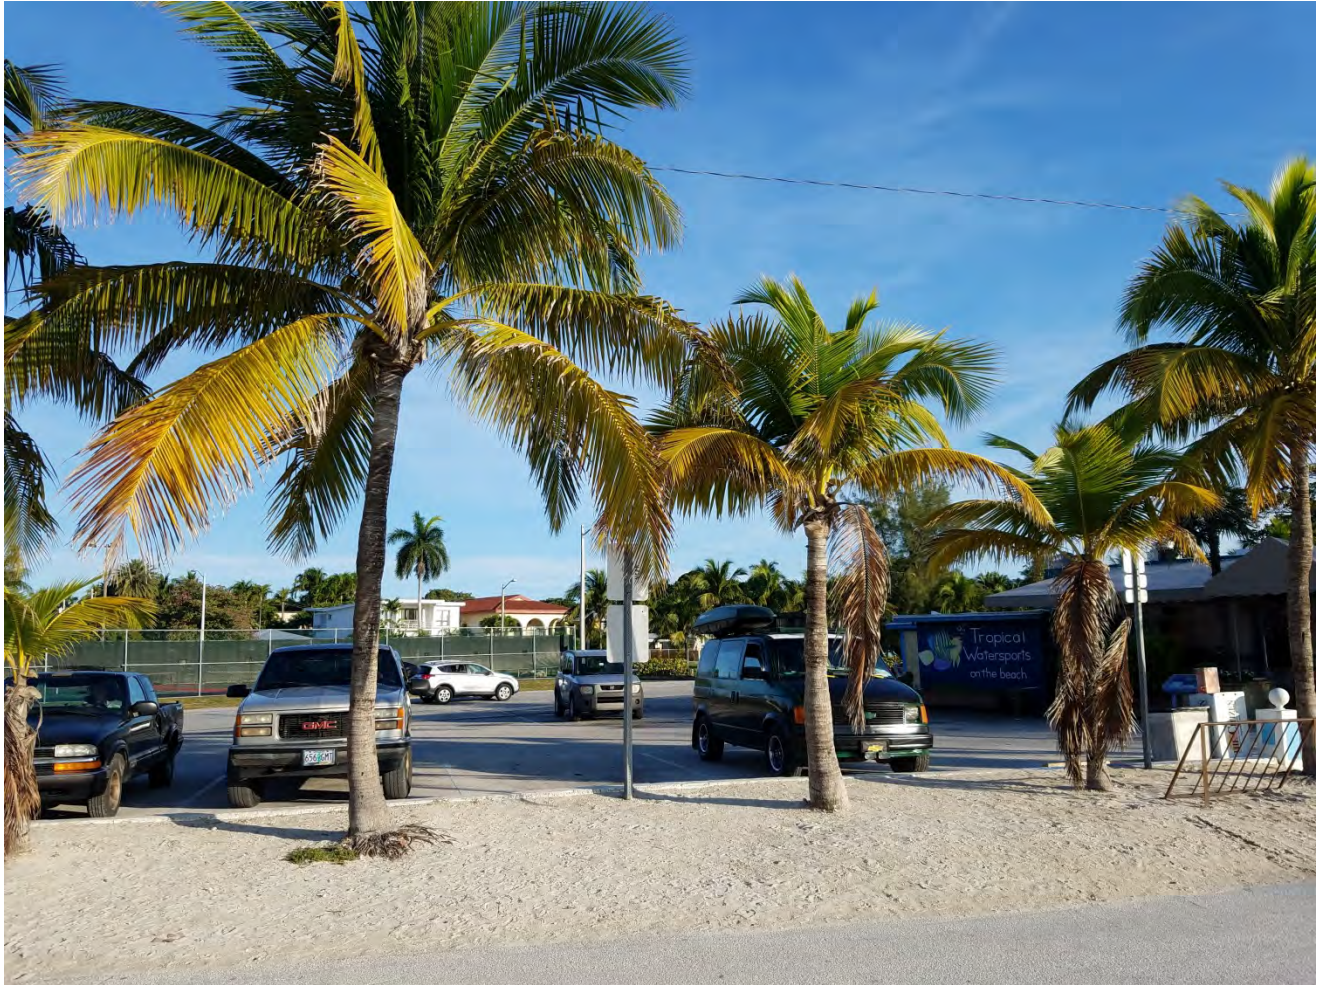
Photo 6 – Trees No. 150 to 156 (overview).

LD-03	148	Cocos nucifera	Coconut Palm		6 GW		Good/Fair									FAIR CONDITION -In the way of construction	Relocate						1			
LD-03	149	Cocos nucifera	Coconut Palm				Good										Remain									
LD-03	150	Cocos nucifera	Coconut Palm				Fair	Nutrient Deficiency			Fertilization						Remain									
LD-03	151	Cocos nucifera	Coconut Palm				Fair	Nutrient Deficiency			Fertilization						Remain									
LD-03	152	Cocos nucifera	Coconut Palm				Fair	Nutrient Deficiency			Fertilization						Remain									
LD-03	153	Cocos nucifera	Coconut Palm				Fair	Nutrient Deficiency			Fertilization						Remain									
LD-03	154	Cocos nucifera	Coconut Palm				Fair	Nutrient Deficiency			Fertilization						Remain									
LD-03	155	Cocos nucifera	Coconut Palm				Fair	Nutrient Deficiency	Utility Line Conflict		Fertilization	Clearance Pruning					Remain									
LD-03	156	Cocos nucifera	Coconut Palm				Fair	Nutrient Deficiency			Fertilization						Remain

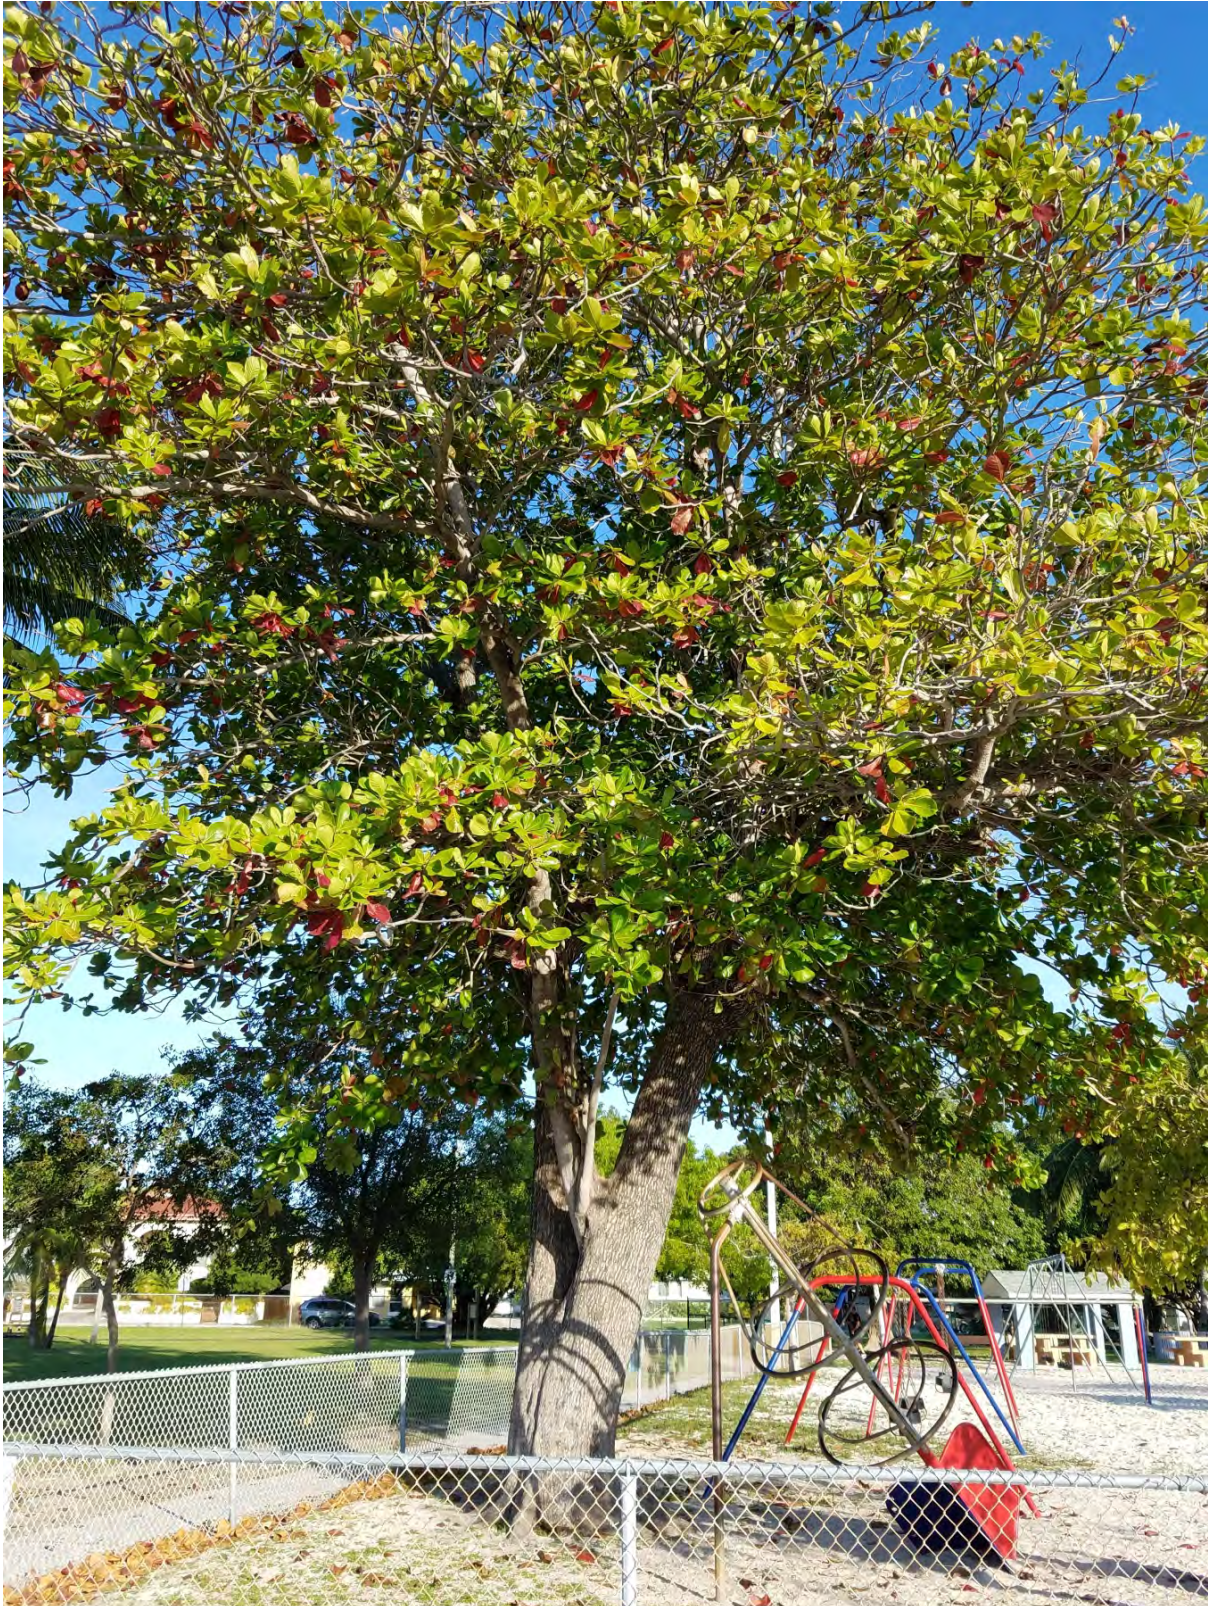
Photo 8 – Tree No. 187.

E Sciences determined that trees proposed for relocation were suitable candidates, with the exception of three trees (numbers 187, 209, and 214). These three trees were determined to be in poor condition due to a variety of defects (i.e. significant canopy reduction, significant defoliation, etc.). Based on the poor condition of these trees, relocation is not recommended due to the reduced likelihood of transplant survival. The "disposition" values of these trees, along with the corresponding mitigation values, were adjusted accordingly in the tree data table (see **Attachment 1**).

Five Category 2 trees (numbers 187, 271, 400, 403, and 420B), including green buttonwood (*Conocarpus erectus*), mahogany (*Swietenia mahagoni*), and tropical almond (*Terminalia catappa*) were determined to be in good condition and displayed relatively large, healthy canopies providing excellent shade, habitat and aesthetic values. Although tropical almond is listed as a Florida Exotic Pest Plant Council (FLEPPC) Category II tree (i.e. considered “somewhat” invasive), this particular tree is not anticipated to spread and outcompete native vegetation in a manicured park setting (i.e. active mowing between trees). Based on the conditions and values of these trees, E Sciences recommends that design alterations be considered (if practicable) to avoid impacts to these trees and preserve them in place, performing remediation pruning where recommended.

LD-03	187	Terminalia catappa	Tropical Almond	48	60	60	Good	Co Dominant Leaders, Included Bark	Sprouts		Crown Cleaning		Consider Keeping (REMAIN)	8	FAIR CONDITION -In the way of construction	Remain								
LD-03	188	Bursera simaruba	Gumbo Limbo				Fair	Defoliated (Minor)			Fertilization				FAIR CONDITION -In the way of construction		Relocate					1		
LD-03	188A	Cocos nucifera	Coconut Palm				Good									Remain								
LD-04	189	Cocos nucifera	Coconut Palm				Good									Remain								
LD-04	190	Cocos nucifera	Coconut Palm				Good									Remain								
LD-04	191	Coccoloba uvifera	Sea Grape				Good/Fair	Lopsided Canopy	Utility Line Conflict		Structure Pruning	Crown Cleaning				Remain								
LD-04	191A	Coccoloba uvifera	Sea Grape				Good/Fair	Lopsided Canopy	Utility Line Conflict		Structure Pruning	Crown Cleaning				Remain								
LD-04	191B	Coccoloba uvifera	Sea Grape				Good/Fair	Lopsided Canopy	Utility Line Conflict		Structure Pruning	Crown Cleaning				Remain

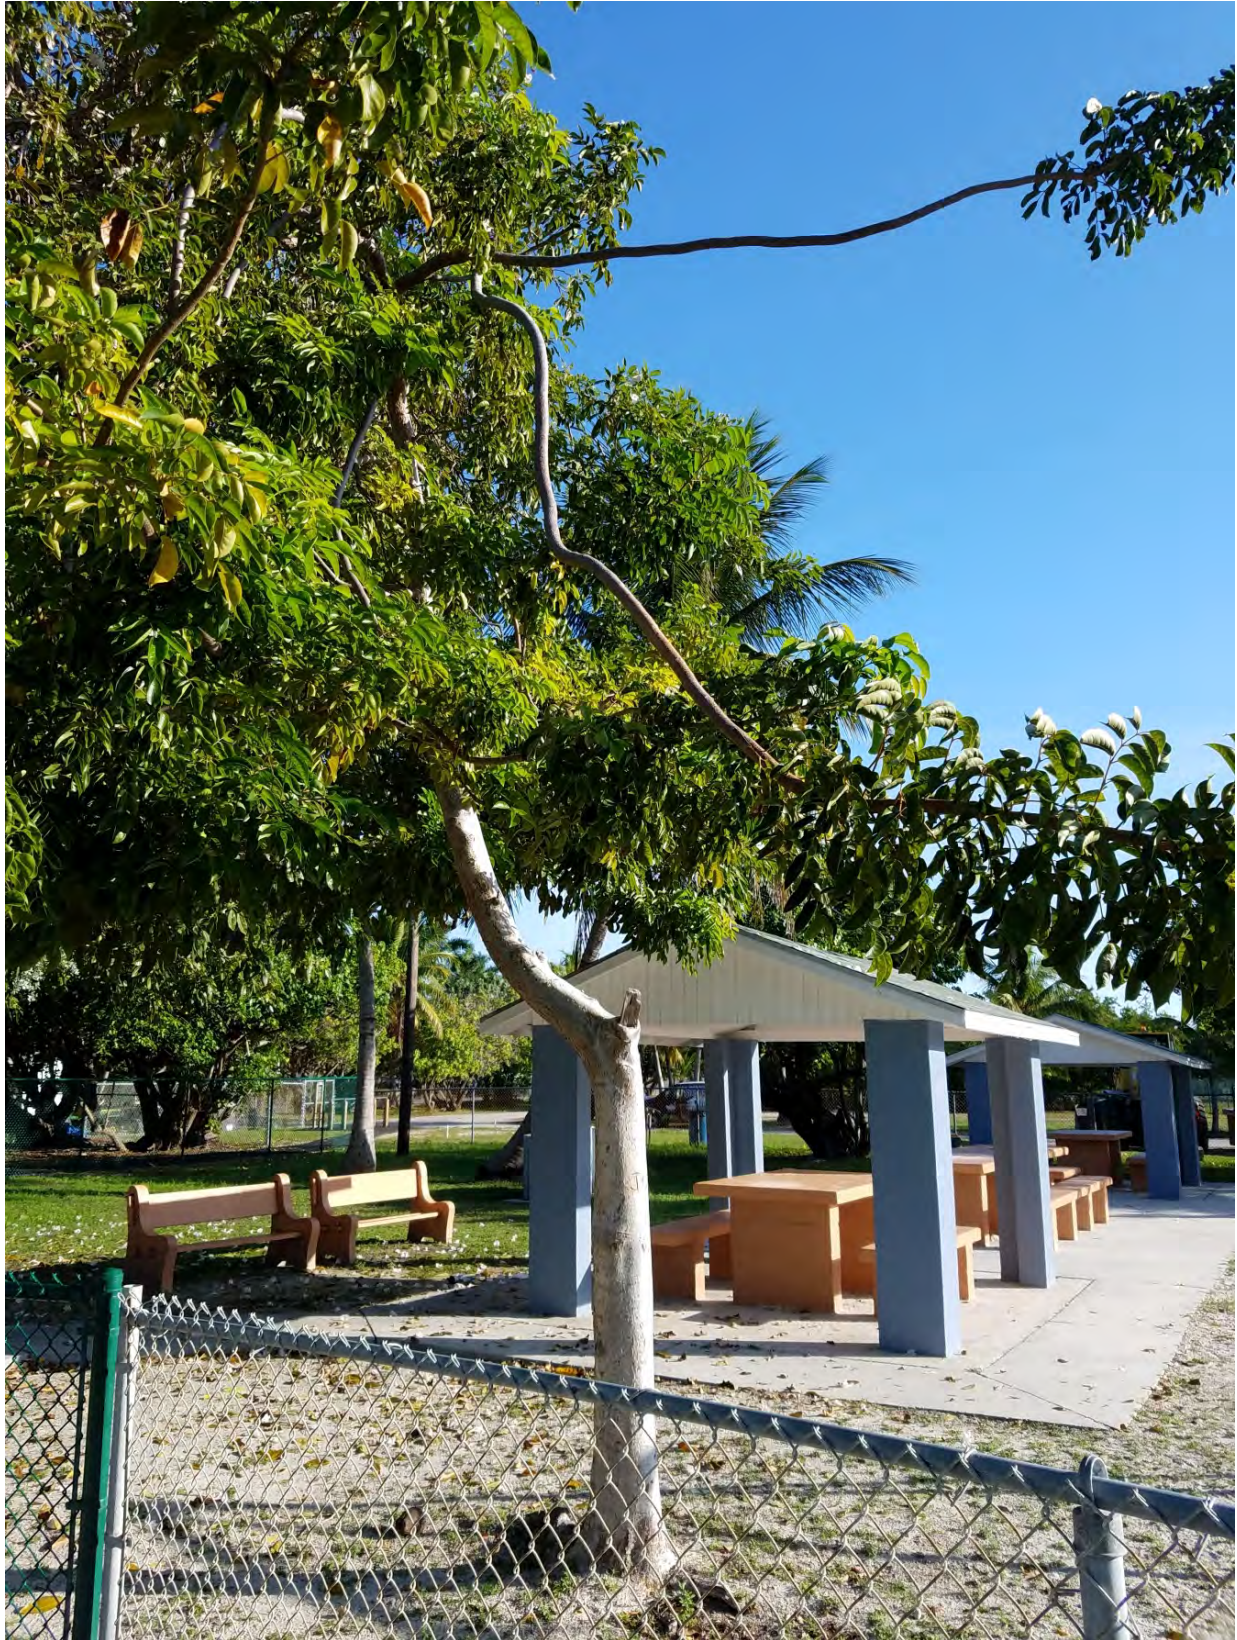
Photo 9 – Tree No. 209.

LD-05	207	Cocos nucifera	Coconut Palm		30 GW		Good								GOOD	Remain								
LD-05	208	Cocos nucifera	Coconut Palm		25 GW		Good								GOOD	Remain								
LD-05	209	Bursera simaruba	Gumbo Limbo	9	13	14	Poor	Reduced Canopy (Major)	Lopsided				Consider Removal Due to Condition	9	FAIR CONDITION - In the way of construction			Remove	1					
LD-05	209A	Thespesia populnea	Portia		30-35		N/A								LARGE CLUMP / INVASIVE - No mitigation required			Remove						1
LD-05	210	Bursera simaruba	Gumbo Limbo				Fair	Discolored Foliage			Fertilization					Remain								
LD-05	211	Thespesia populnea	Portia		30-35		N/A								LARGE CLUMP / INVASIVE - No mitigation required			Remove						1
LD-05	212	Bursera simaruba	Gumbo Limbo	4	7	3	Poor	Reduced Canopy (Major)							BAD STRUCTURE			Remove	1					
LD-05	213	Bursera simaruba	Gumbo Limbo	10	12	8	Good/Fair	Stubs			Crown Cleaning				FAIR CONDITION -In the way of construction		Relocate					1

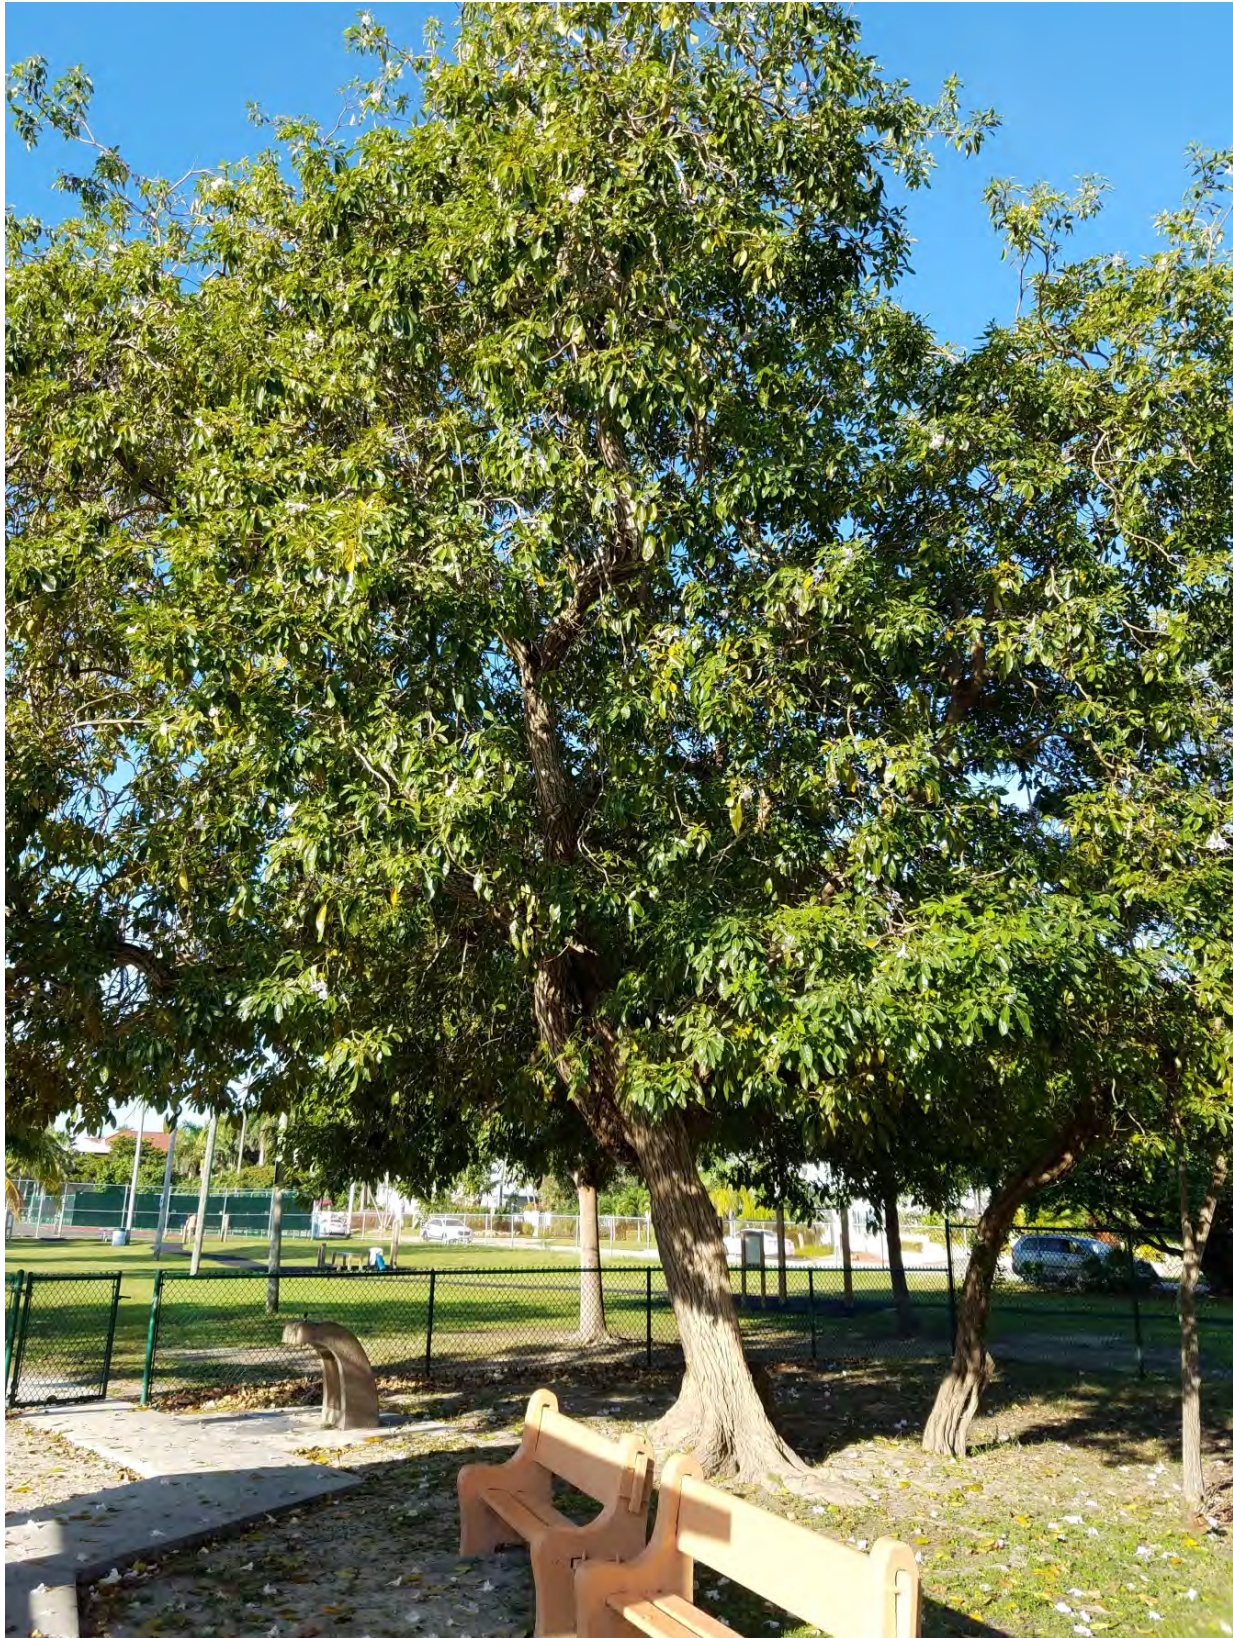
Photo 10 – Tree No. 200B.

Three Category 1 trees (numbers 200B, 473, and 507) were found to be in fair or better condition with issues including slightly lopsided canopies, sprouting/stubs, and recumbent growth form. No significant structural damage or decay was observed with these trees that would indicate a higher likelihood of failure. Consequently, these trees should be considered for preservation vs. removal, with remediation efforts (e.g. structural pruning, crown cleaning) performed where recommended.

LD-05	200B	Tabebuia sp.	Tabebuia	38	45		Fair	Lopsided Canopy	Sprouting		Structure Pruning	Crown Cleaning	Consider Keeping (REMAIN)	10	FAIR-To be evaluated by a Certified Arb.	Remain								
LD-05	200C	Thespesia populnea	Portia				N/A								LARGE CLUMP / INVASIVE - No mitigation required			Remove						1
LD-05	200D	Thespesia populnea	Portia				N/A								LARGE CLUMP / INVASIVE - No mitigation required			Remove						1
LD-05	200E	Thespesia populnea	Portia				N/A								LARGE CLUMP / INVASIVE - No mitigation required			Remove						1
LD-05	200F	Callistemon citrinus	Bottlebrush	12			Fair	Co Dominant Leaders, Included Bark	Trunk Damage (Moderate)		Structure Pruning					Remain								
LD-05	200G	Conocarpus erectus sericeus	Silver Buttonwood	10			Fair	Poor Structure							BAD STRUCTURE		Remove	1						
LD-05	200H	Cardia sebestena	Orange Geiger	7			Fair	Poor Structure							BAD STRUCTURE		Remove	1						
LD-05	201	Cocos nucifera	Coconut Palm		25 GW		Good								GOOD	Remain

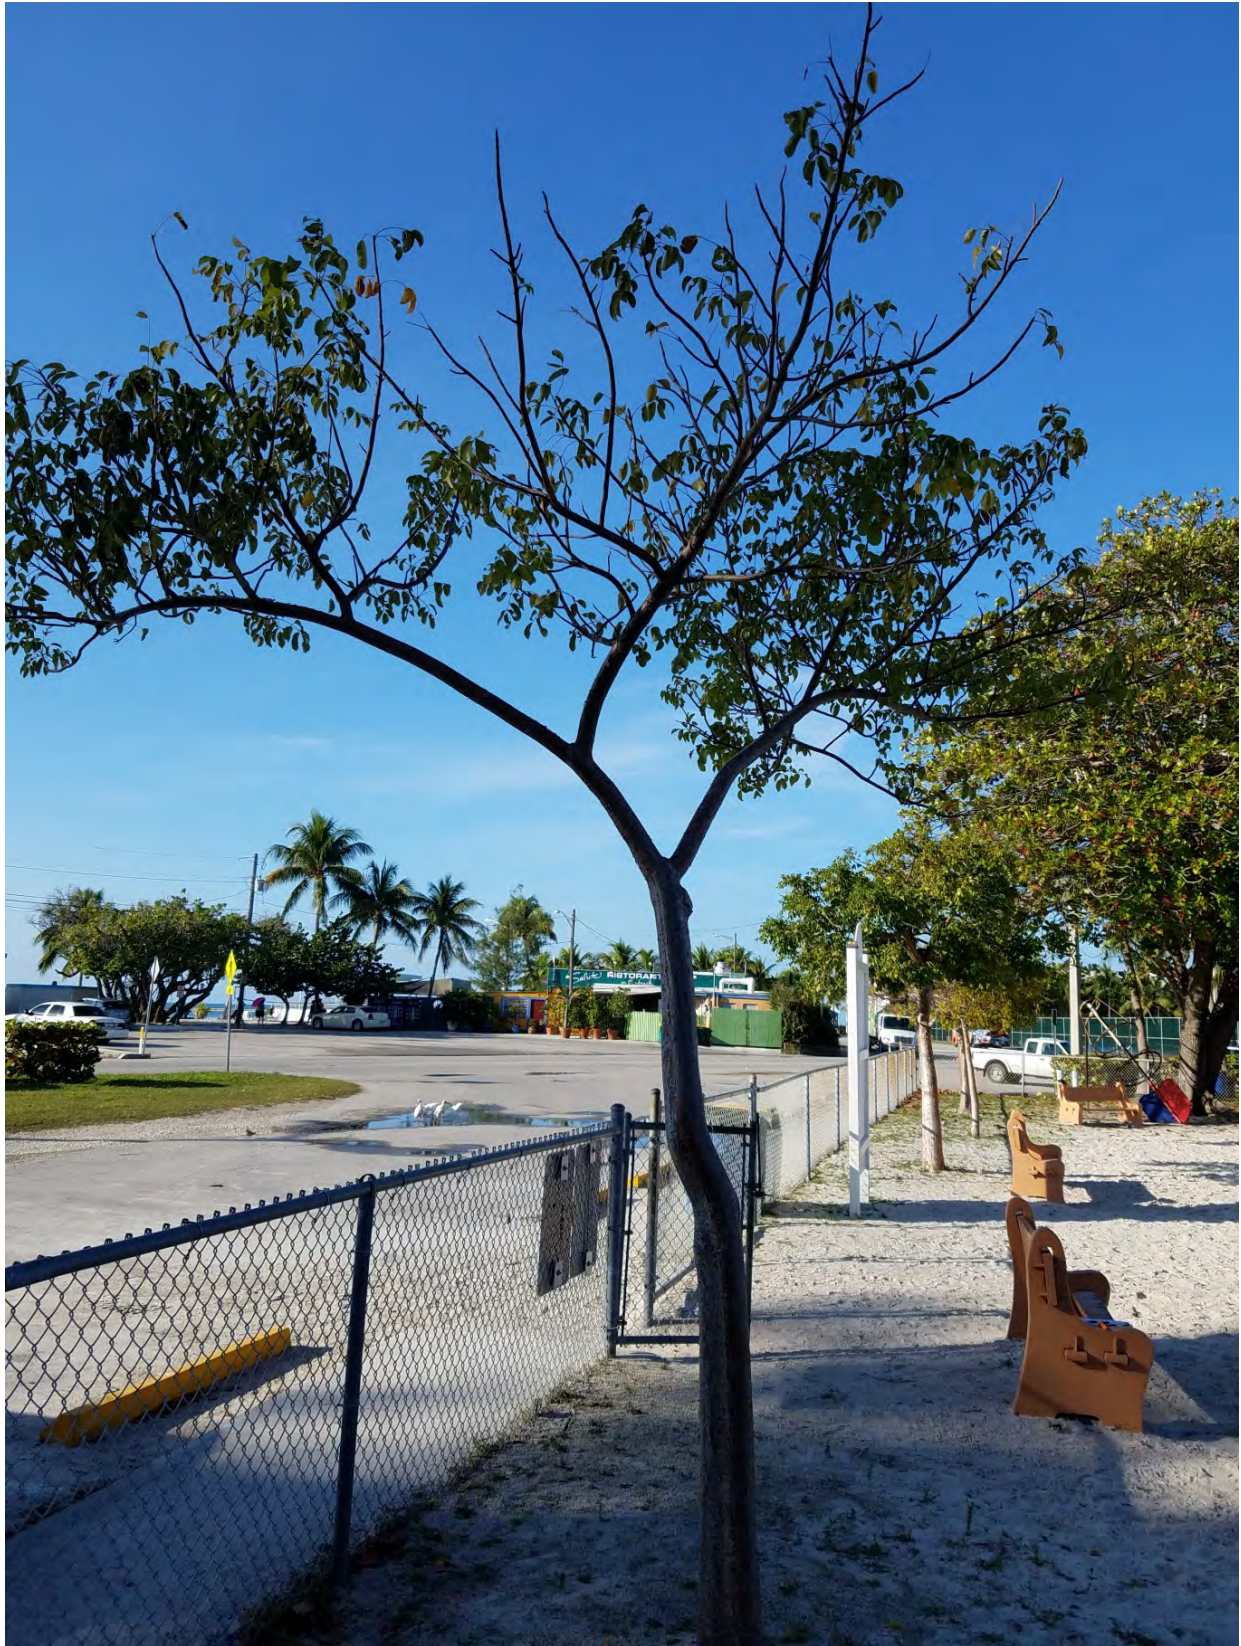
Photo 11 – Tree No. 214.

LD-05	214	Bursera simaruba	Gumbo Limbo	5	10	9	Poor	Defoliated (Moderate)	Reduced Canopy (Moderate)				Consider Removal Due to Condition	11	FAIR CONDITION -In the way of construction			Remove	1

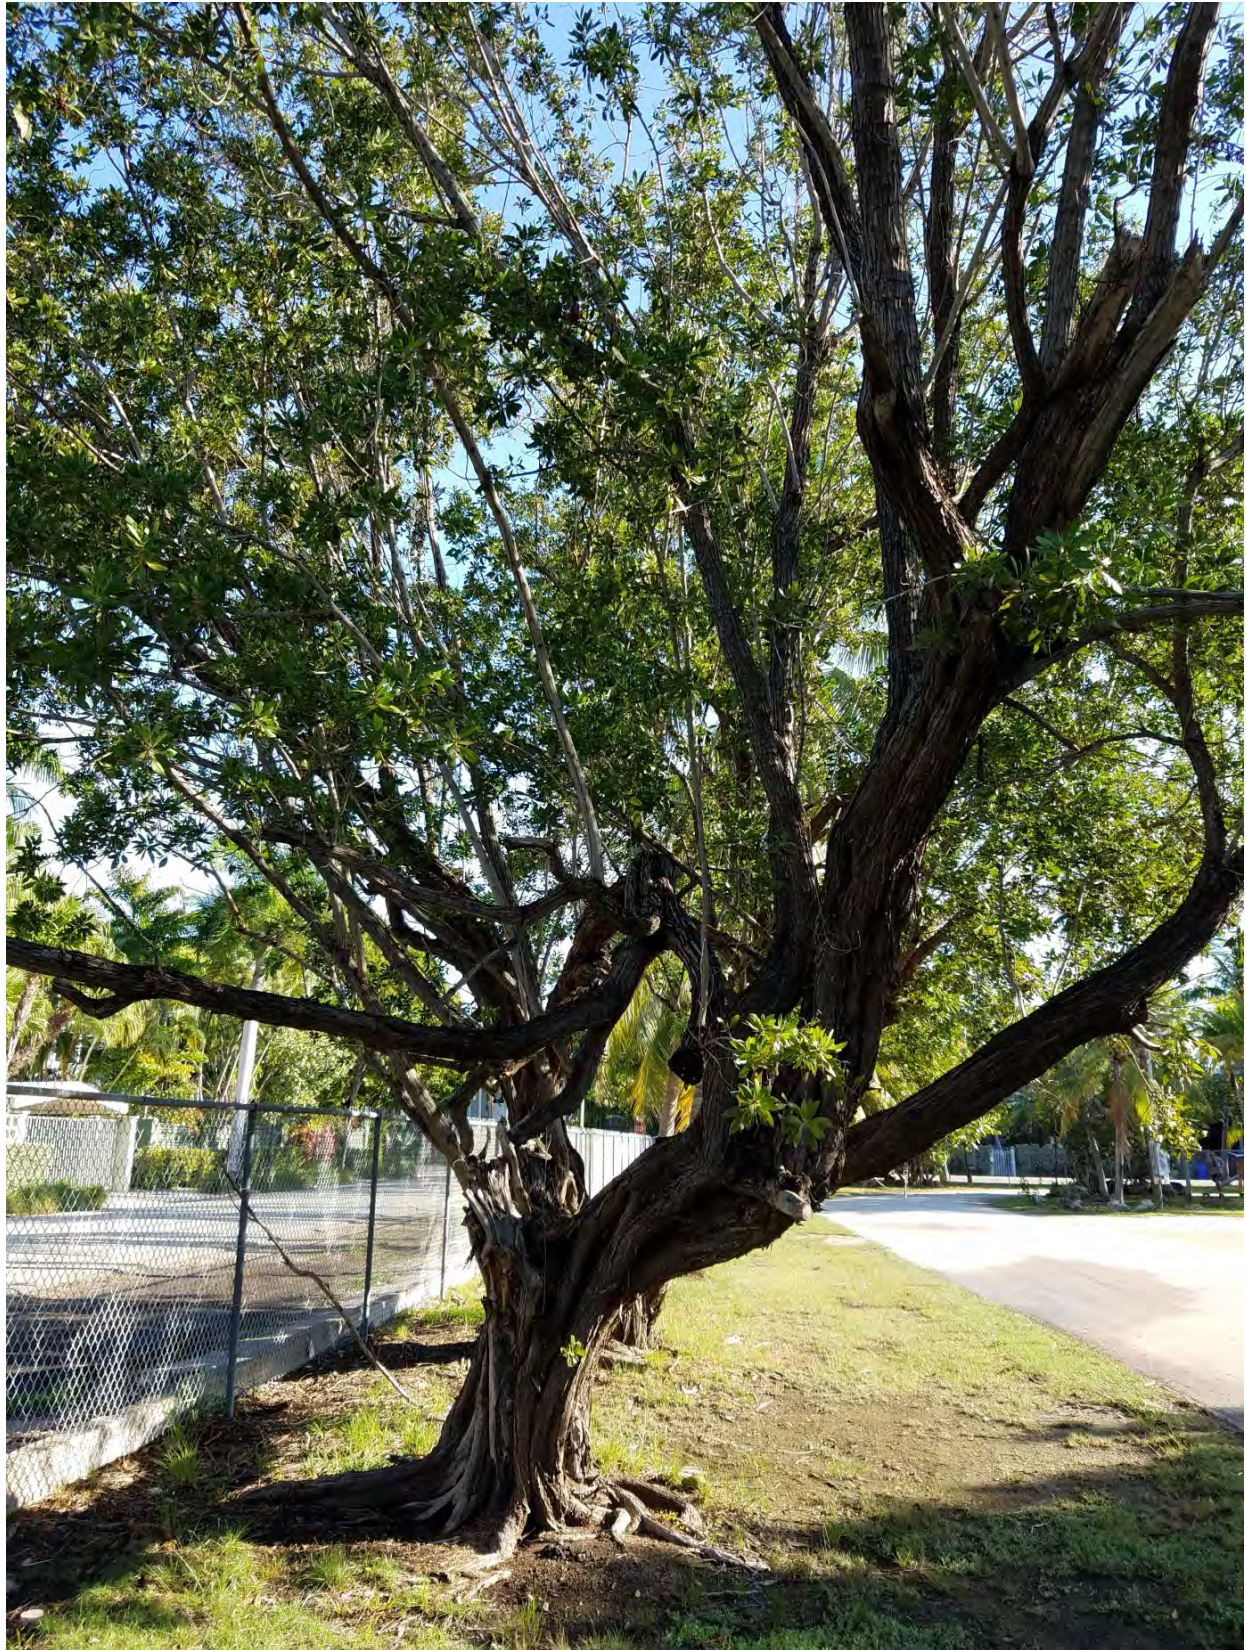
Photo 12 – Tree No. 229.

However, one tree proposed to "remain" (number 229) was found to be in poor condition (i.e. major limb damage). The disposition for this tree was changed to "remove" on the tree data table due to the reduced likelihood of transplant survival.

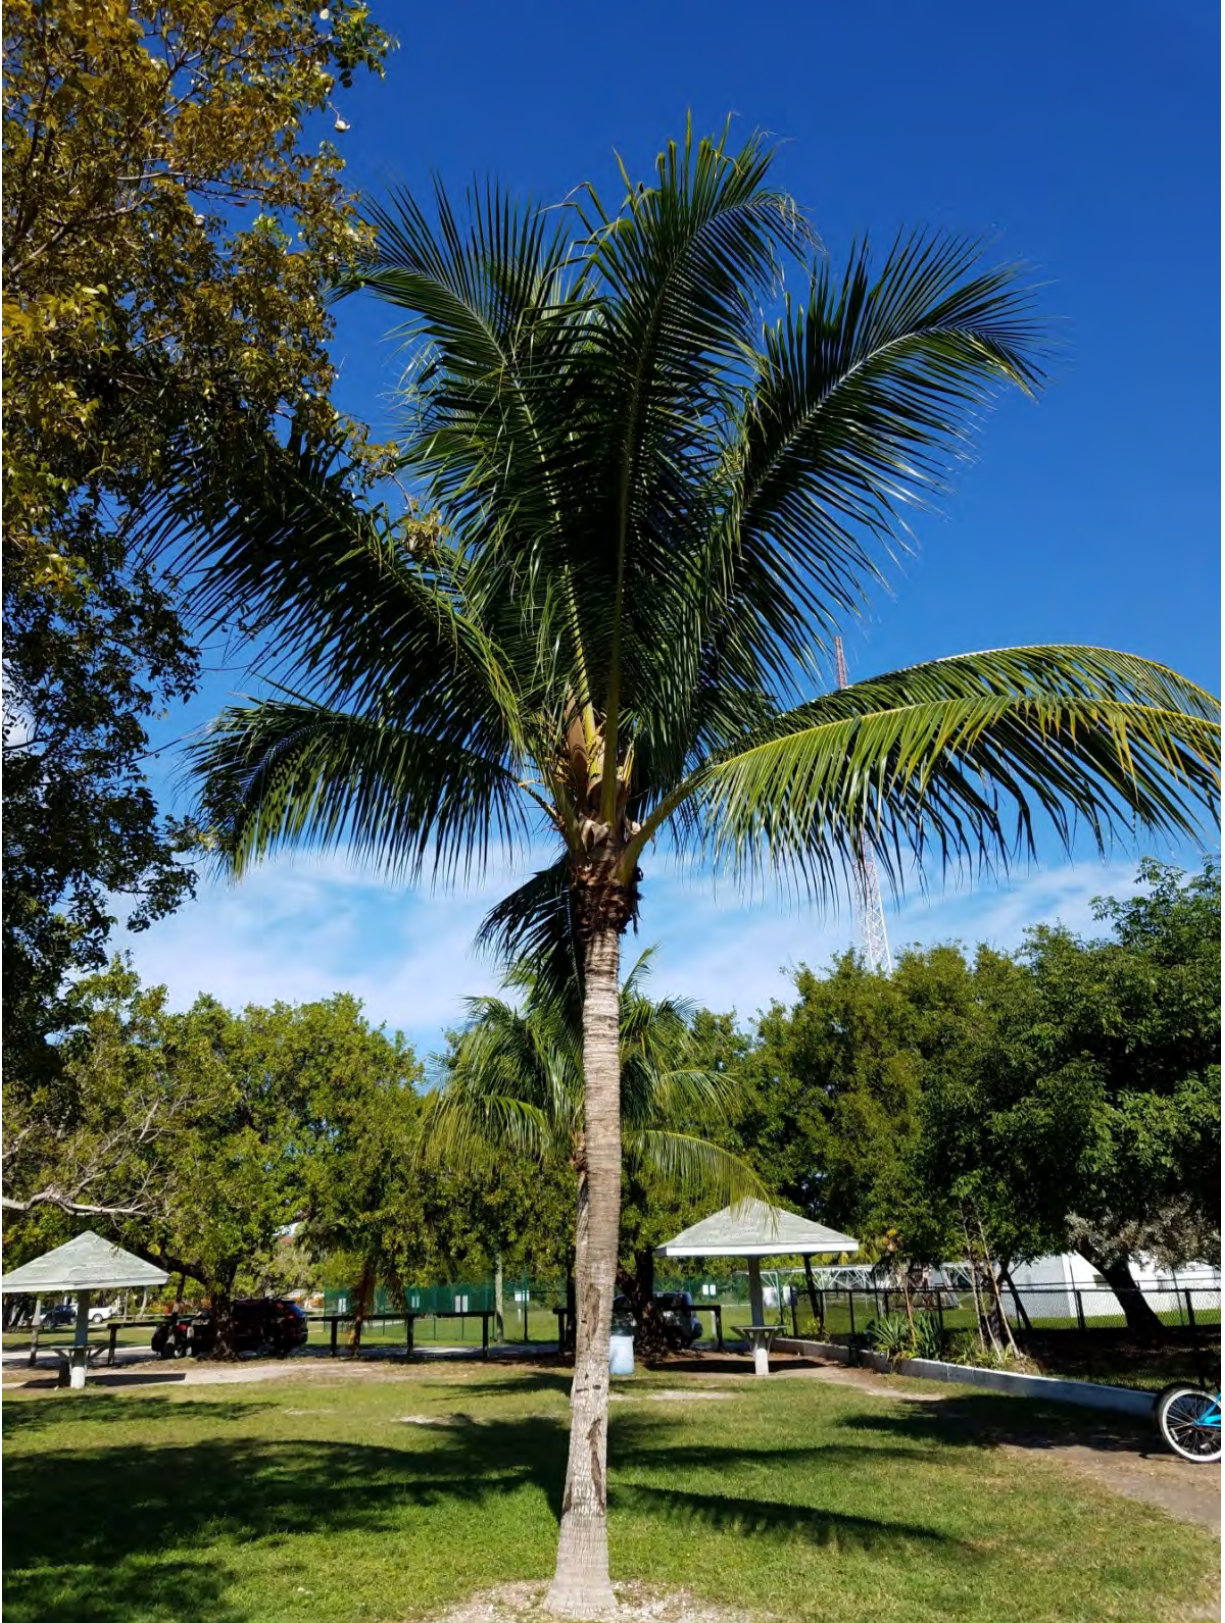
Photo 15 – Tree No. 412

LD-06	411	Cocos nucifera	Coconut Palm		16 - 18		Good						Switched to "Relocate" per map		GOOD	Relocate							1	
LD-06	412	Cocos nucifera	Coconut Palm		16 - 18 GW		Good							15	FAIR CONDITION -In the way of construction	Relocate							1	
LD-06	413	Swietenia mahagoni	Mahogany	16	35	50	Good	Stubs	Dead Wood		Crown Cleaning					Remain								
LD-06	414	Not used					N/A																	
LD-06	415	Not used					N/A																	
LD-06	416	Not used					N/A																	
LD-06	417	Not used					N/A																	
LD-06	418	Not used					N/A																	
LD-06	419	Not used					N/A																	
LD-06	420	Washingtonia robusta	Washington Palm	14	20 GW	6	Fair	Discolored Foliage							In the way of construction			Remove			1			
LD-06	420A	Bursera simaruba	Gumbo Limbo	14	20	24	Fair	Growing Under Wall							In the way of construction - Wall/Root issues			Remove	1					
LD-06	420B	Swietenia mahagoni	Mahogany	18	38	33	Good/Fair	Lopsided Canopy			Structure Pruning		Good Candidate to "Remain"		REMAINS IF LAYOUT IS REVISED-TWO PARKING SPACES	Remain

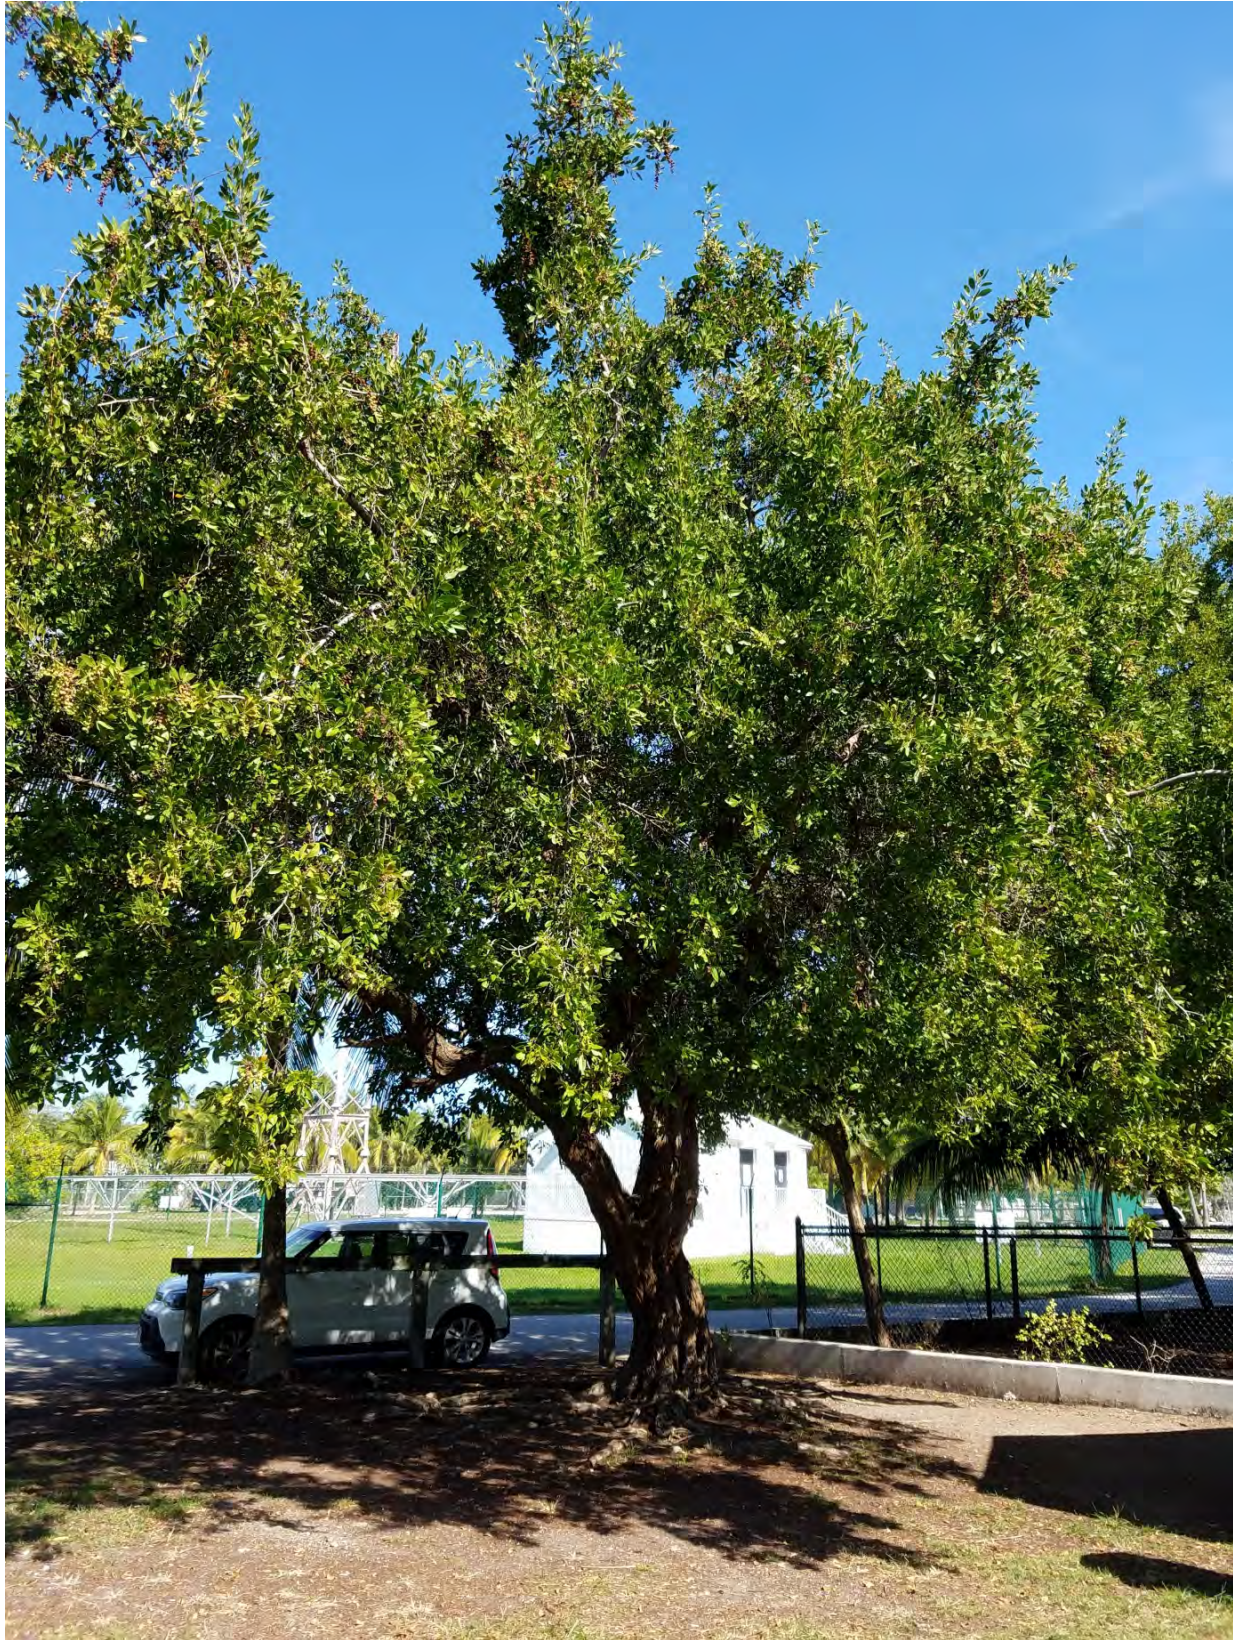
Photo 18 – Tree No. 403.

LD-06	402	Cocos nucifera	Coconut Palm		18 GW		Fair	Discolored Foliage			Fertilization				FAIR CONDITION -In the way of construction		Relocate						1	
LD-06	403	Conocarpus erectus	Green Buttonwood	36	37	50	Good						Keep if Possible (Good Condition)	18	LARGE TREE - In the way of construction	Remain								
LD-06	404	Thespesia populnea	Portia		35		N/A								LARGE CLUMP / INVASIVE - No mitigation required			Remove						1
LD-06	405	Cocos nucifera	Coconut Palm		16 - 18		Good								GOOD	Remain								
LD-06	406	Cocos nucifera	Coconut Palm		16 - 18		Good								GOOD	Remain								
LD-06	407	Bursera simaruba	Gumbo Limbo		25		Good/Fair	Trunk Damage (Minor)	Cavities							Remain								
LD-06	408	Cocos nucifera	Coconut Palm		16 - 18		Good								GOOD	Remain								
LD-06	409	Swietenia mahagoni	Mahogany	13	24	28	Good/Fair	Lopsided Canopy							LARGE TREE - In the way of construction		Remove	1						
LD-06	410	Cocos nucifera	Coconut Palm		12 GW		Good							16	FAIR CONDITION -In the way of construction		Relocate						1
