January 12, 2017

**Subject: Arborist Assessment Report
Higgs Beach Park at Atlantic Boulevard
Key West, Monroe County, Florida
E Sciences Project Number 7-0313-001**

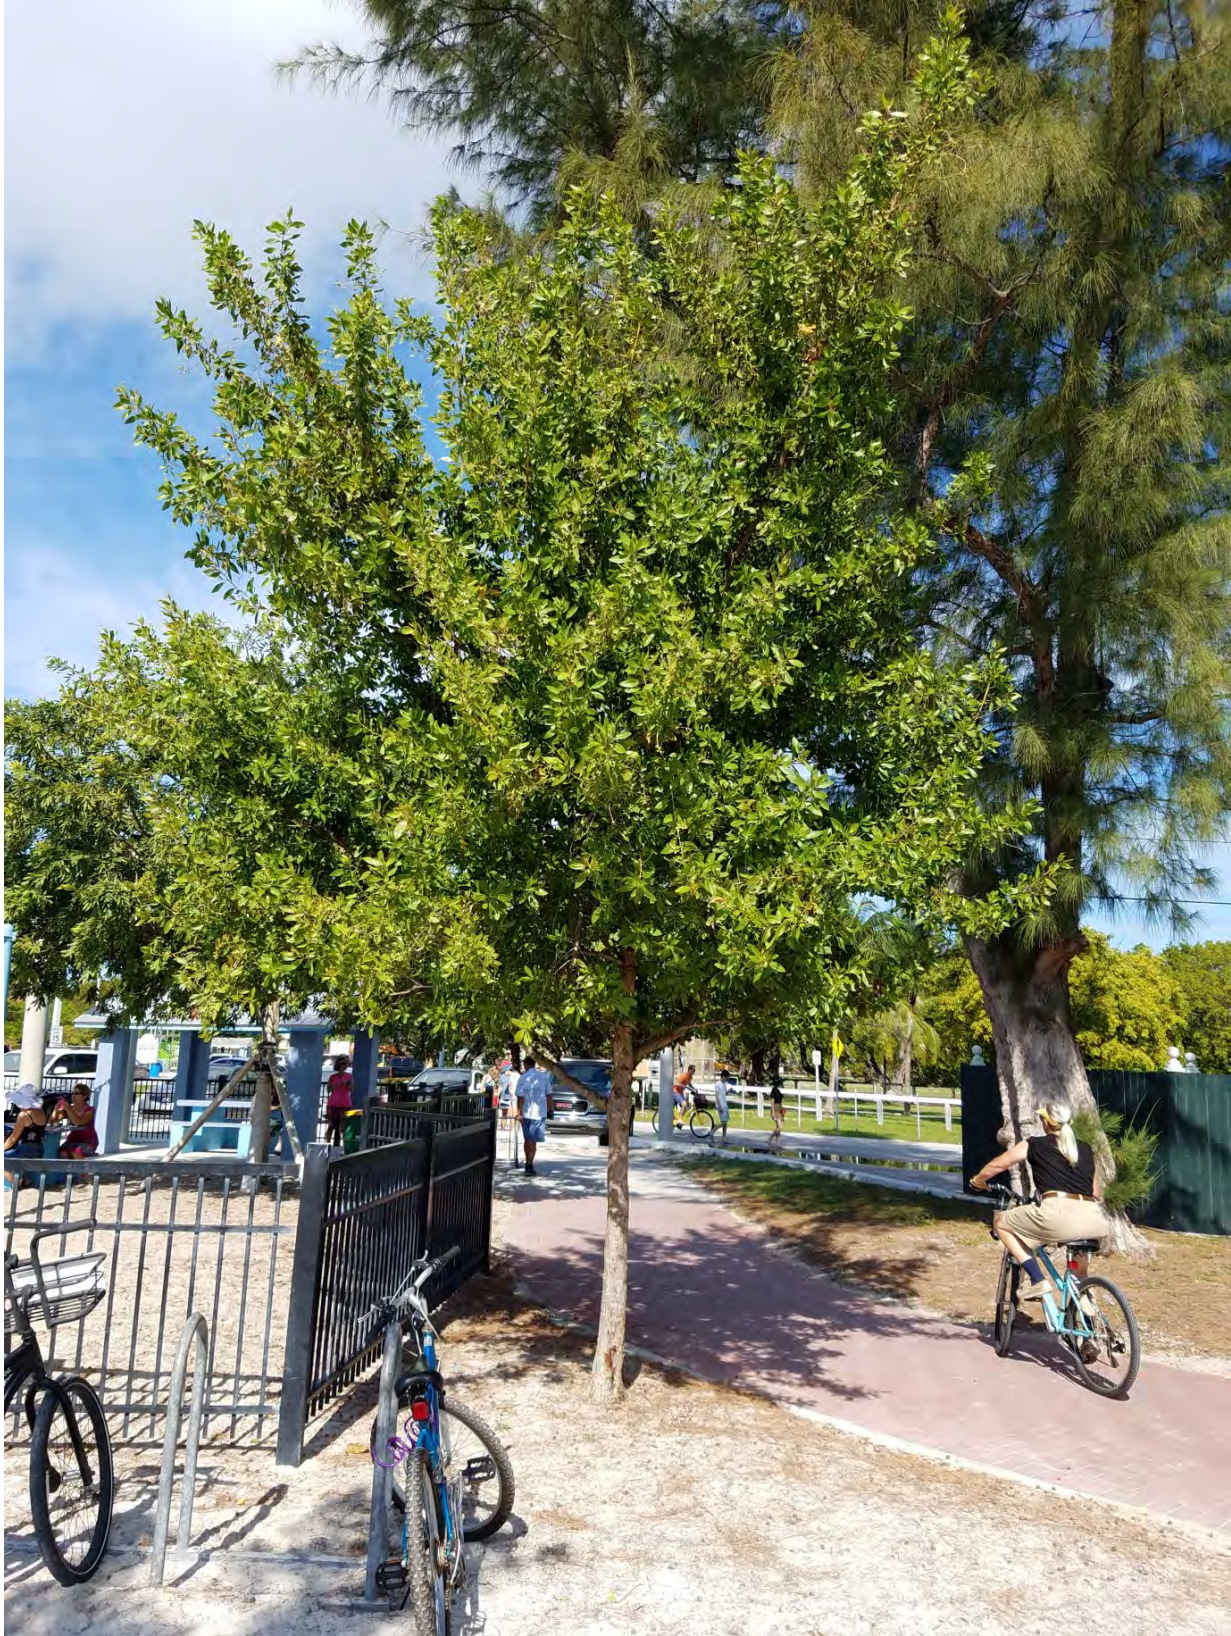
Photo 20 – Tree No. 378B.

- Addition of species names where they were missing
- Correction of species names where they were incorrect
- Correction of proposed disposition on table where it did not match symbol on map
- Addition of one tree (number 378B) to the tree table that was not on tree disposition plan or table (see **Attachment 3 – Tree Disposition Plan Mark Up** for tree location).

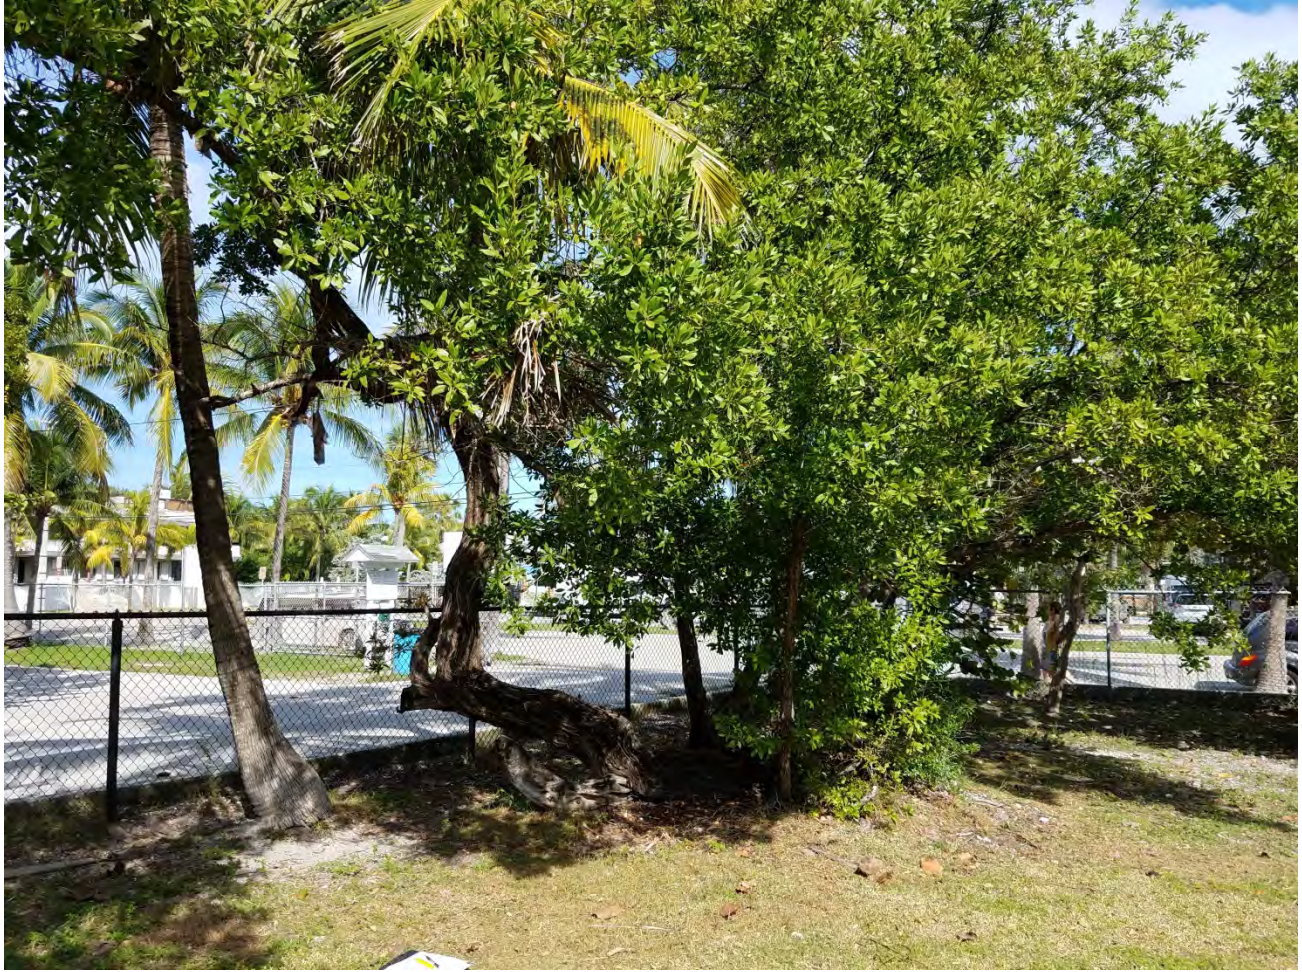
Photo 21 – Tree No. 507.

Three Category 1 trees (numbers 200B, 473, and 507) were found to be in fair or better condition with issues including slightly lopsided canopies, sprouting/stubs, and recumbent growth form. No significant structural damage or decay was observed with these trees that would indicate a higher likelihood of failure. Consequently, these trees should be considered for preservation vs. removal, with remediation efforts (e.g. structural pruning, crown cleaning) performed where recommended.

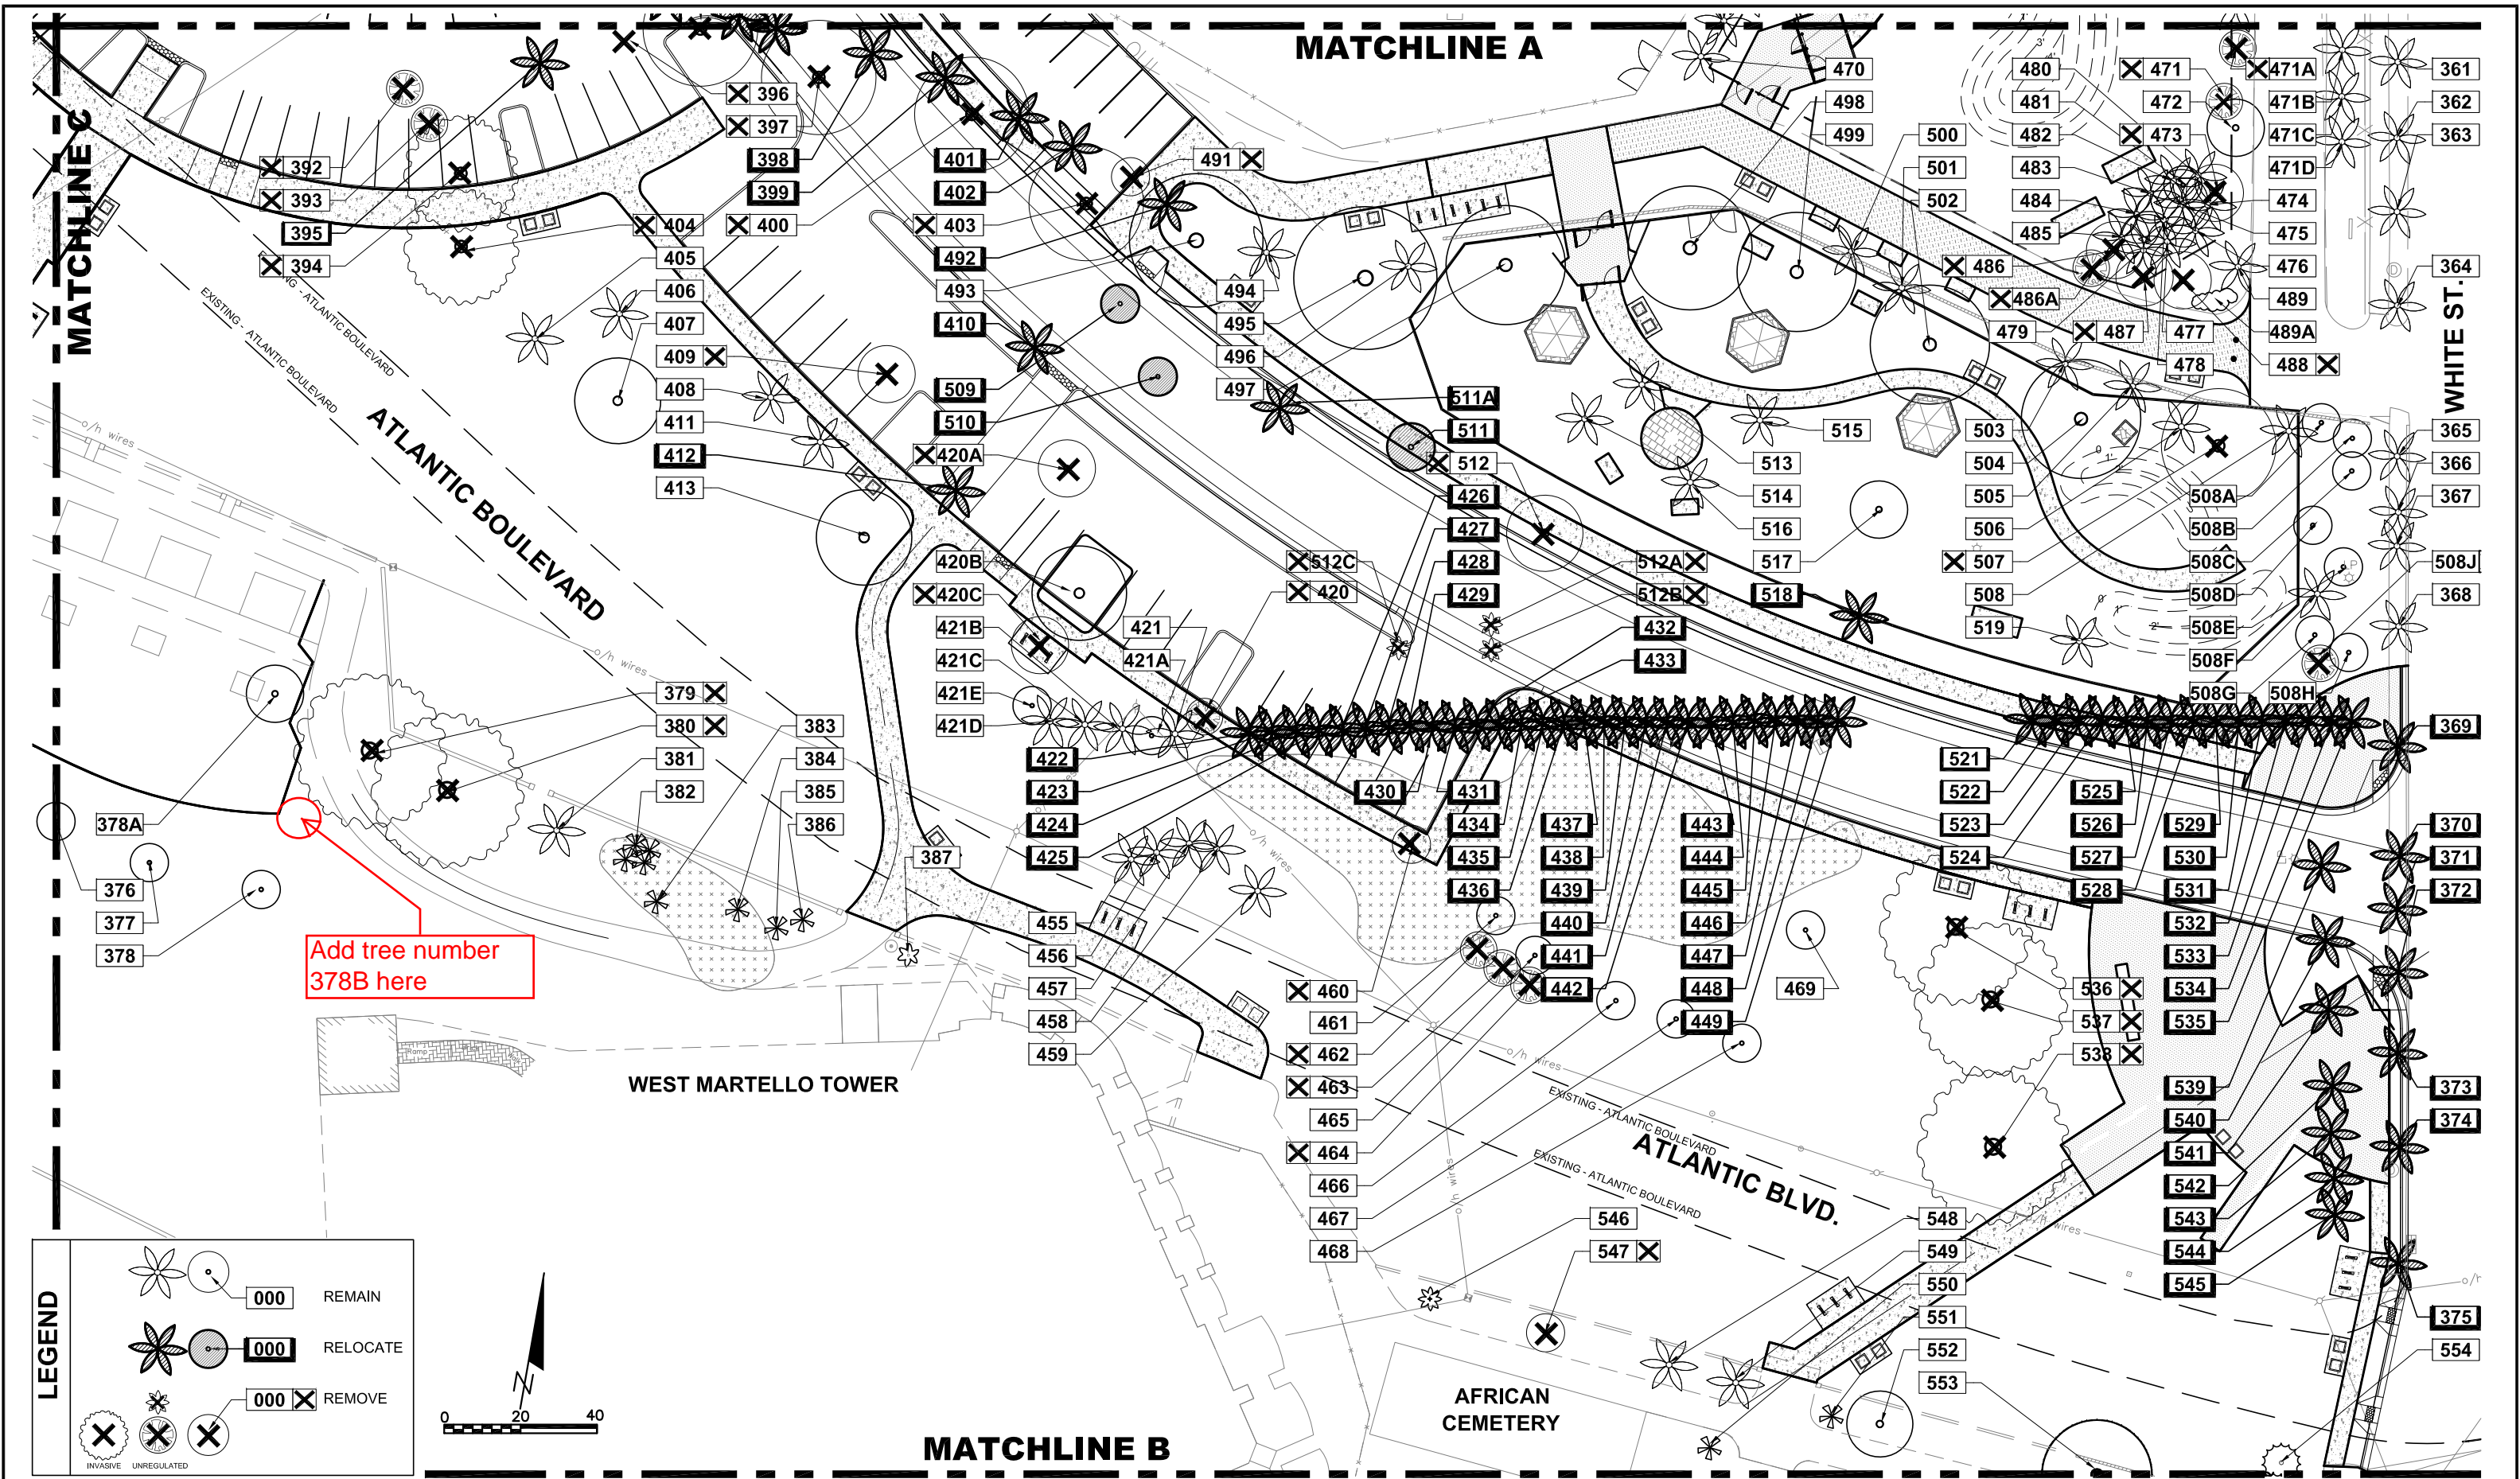
LD-06

Add tree number
378B here
