STAFF REPORT

DATE: June 1, 2017

RE: **Seaside Ct North and South (permit application # T17-8509)**

FROM: Karen DeMaria, City of Key West Urban Forestry Manager

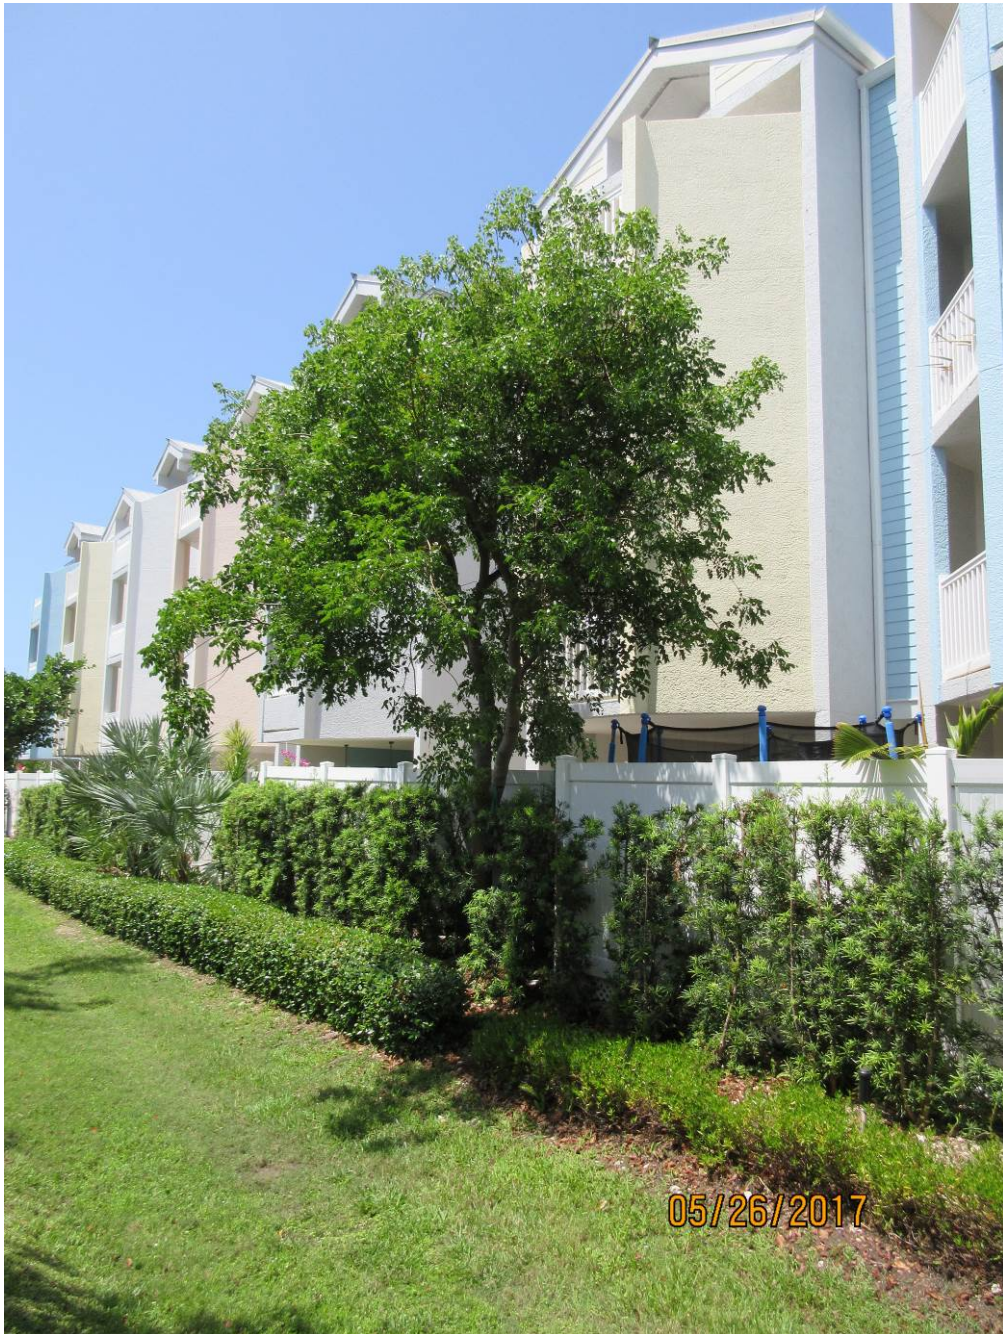
Tree#1

Diameter: 7.5"

Location: 30% (wrong tree wrong place, roots impacting infrastructure on building side, canopy impacting views)

Species: 100% (on protected tree list)

Condition: 50% (fair, included bark, no space for roots to grow due to slope of retention pond, canopy constantly trimmed)

Total Average Value = 60%

Value x Diameter = 4.5 replacement caliper inches

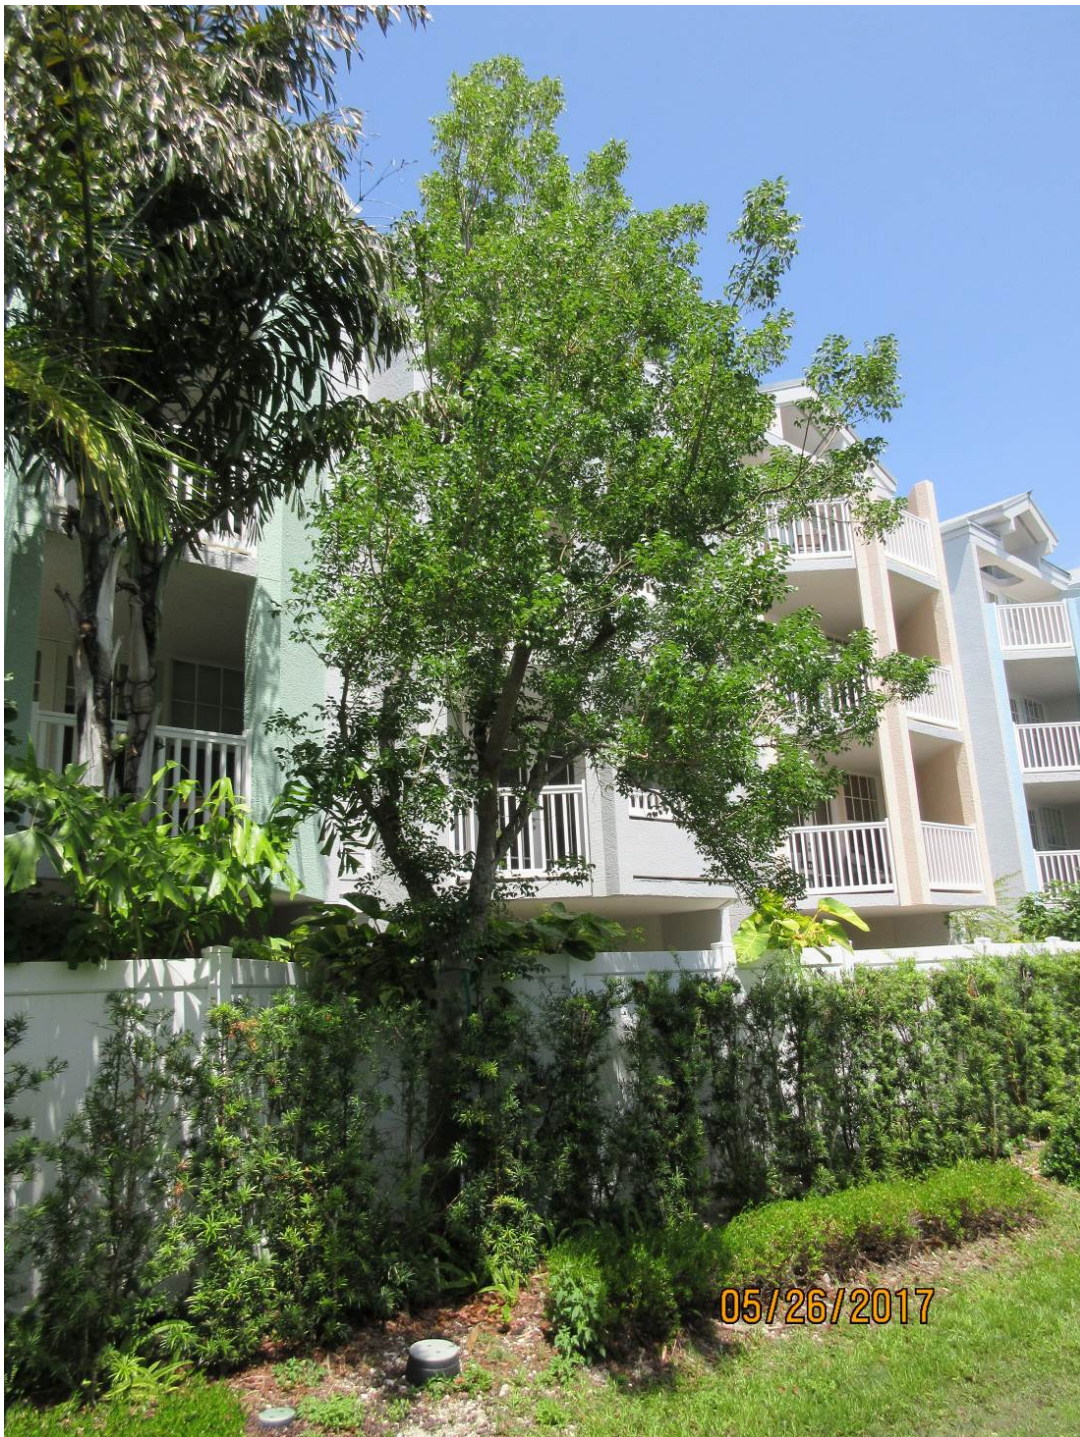
Tree #2

Diameter: 7"

Location: 30% (wrong tree wrong place, roots impacting infrastructure on building side, canopy impacting views)

Species: 100% (on protected tree list)

Condition: 30% (poor, one sided canopy, included bark, no space for roots to grow due to slope of retention pond, canopy constantly trimmed)

Total Average Value = 53%

Value x Diameter = 3.7 replacement caliper inches

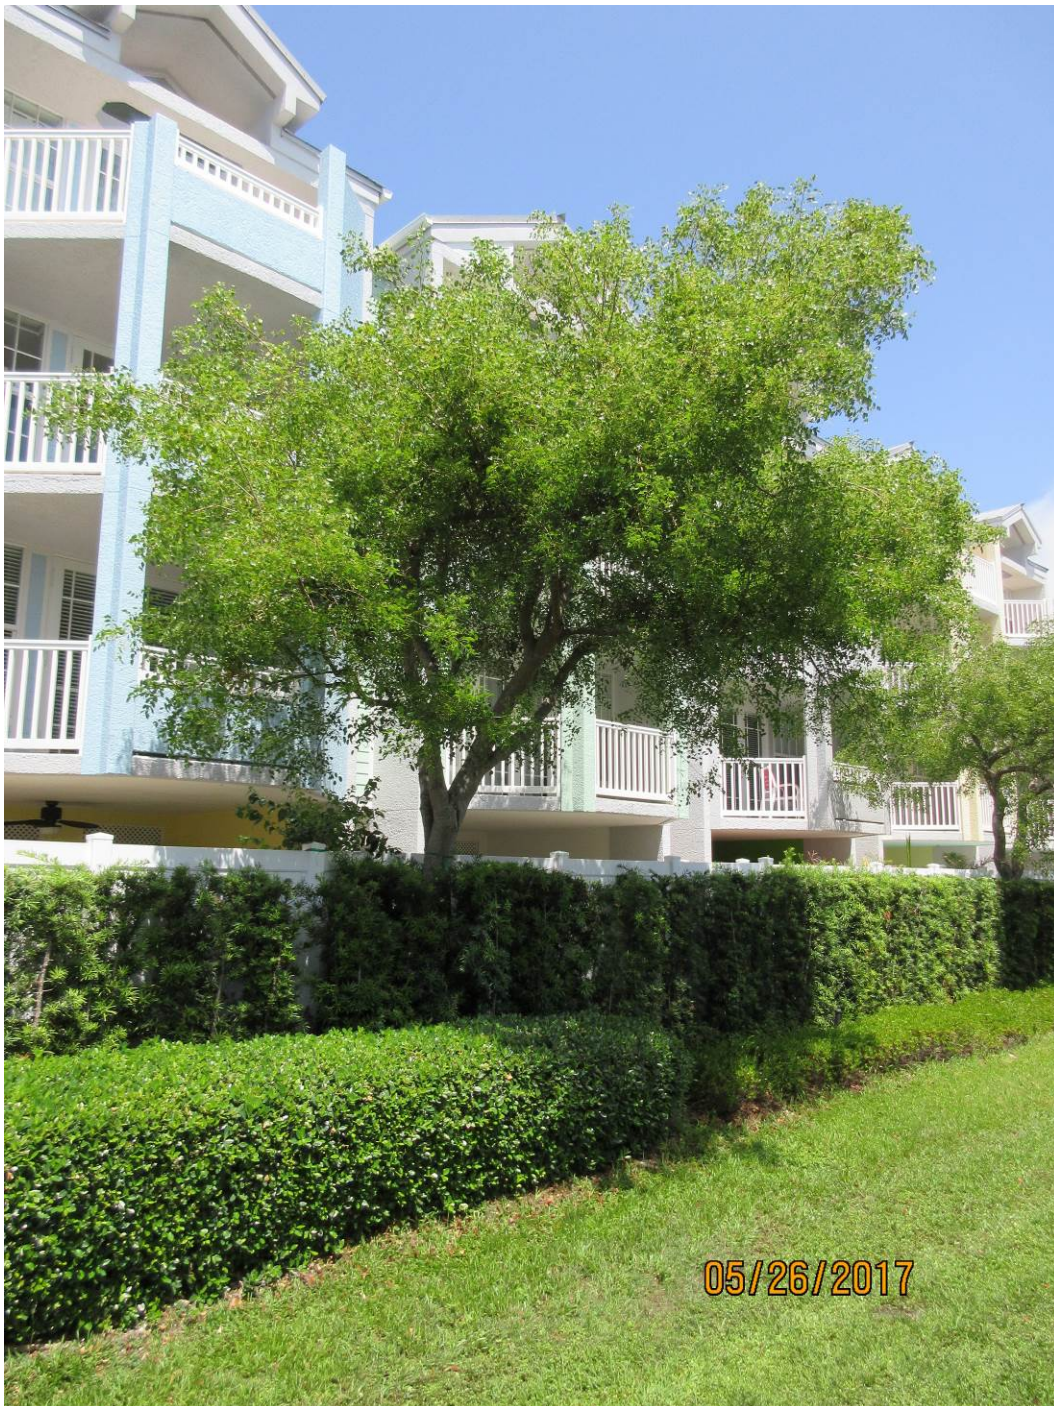
Tree #3

Diameter: 8.75"

Location: 30% (wrong tree wrong place, roots impacting infrastructure on building side, canopy impacting views)

Species: 100% (on protected tree list)

Condition: 50% (fair, included bark, no space for roots to grow due to slope of retention pond, canopy constantly trimmed)

Total Average Value = 60%

Value x Diameter = 5.25 replacement caliper inches

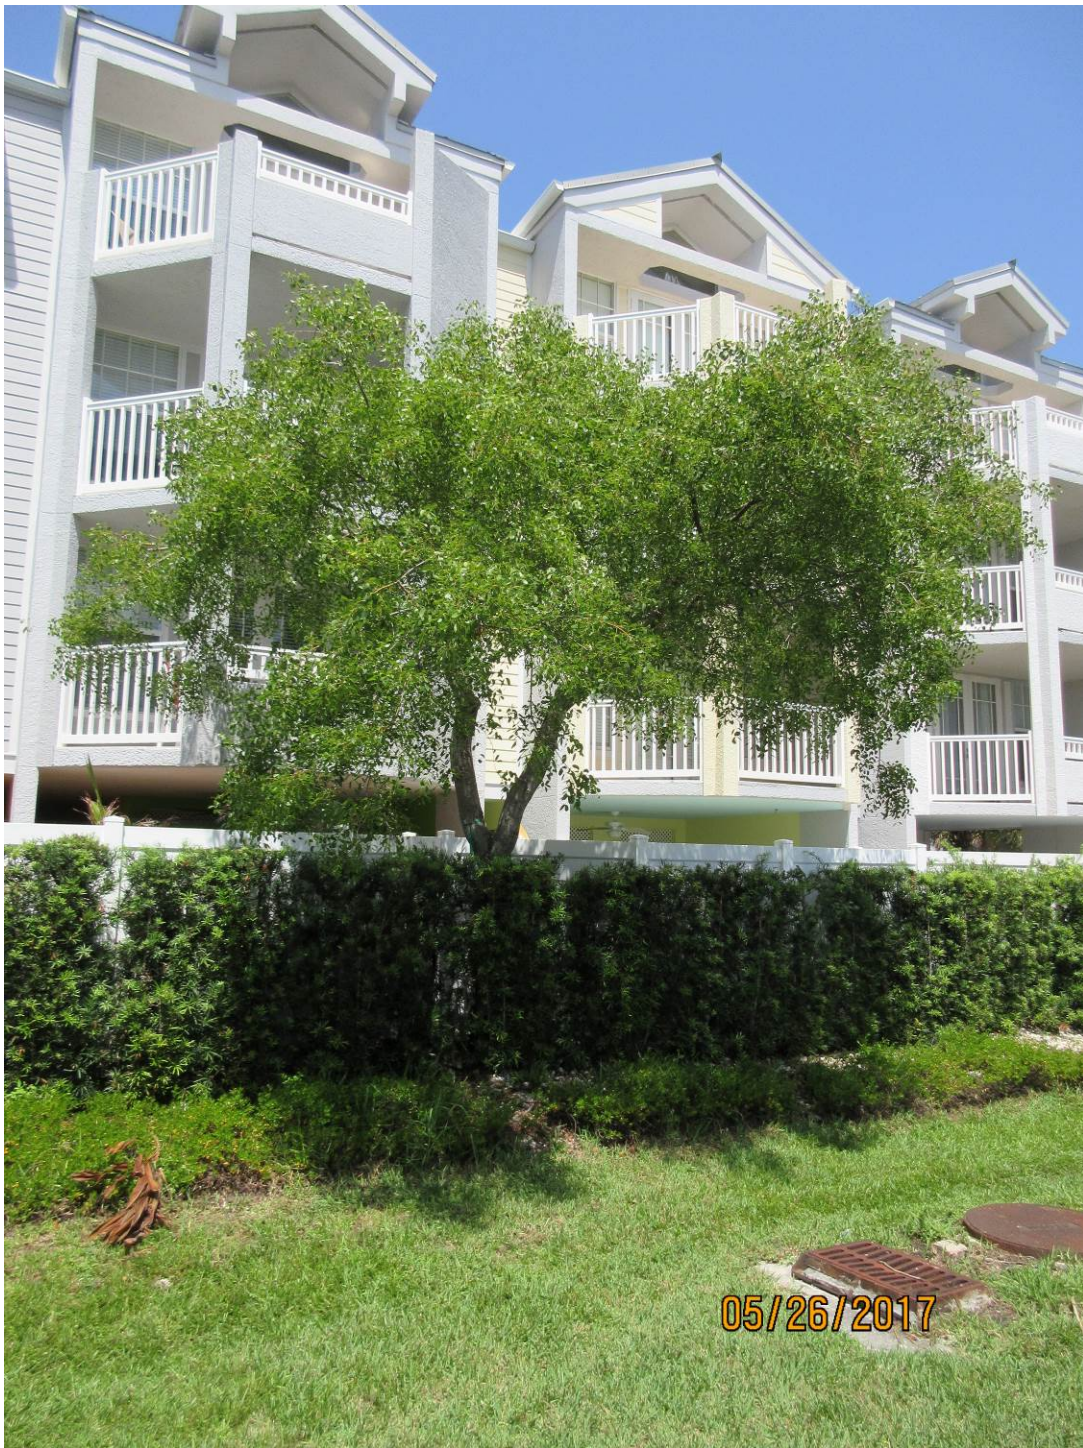
Tree #4

Diameter: 7.25"

Location: 30% (wrong tree wrong place, roots impacting infrastructure on building side, canopy impacting views)

Species: 100% (on protected tree list)

Condition: 50% (fair, included bark, no space for roots to grow due to slope of retention pond, canopy constantly trimmed)

Total Average Value = 60%

Value x Diameter = 4.35 replacement caliper inches

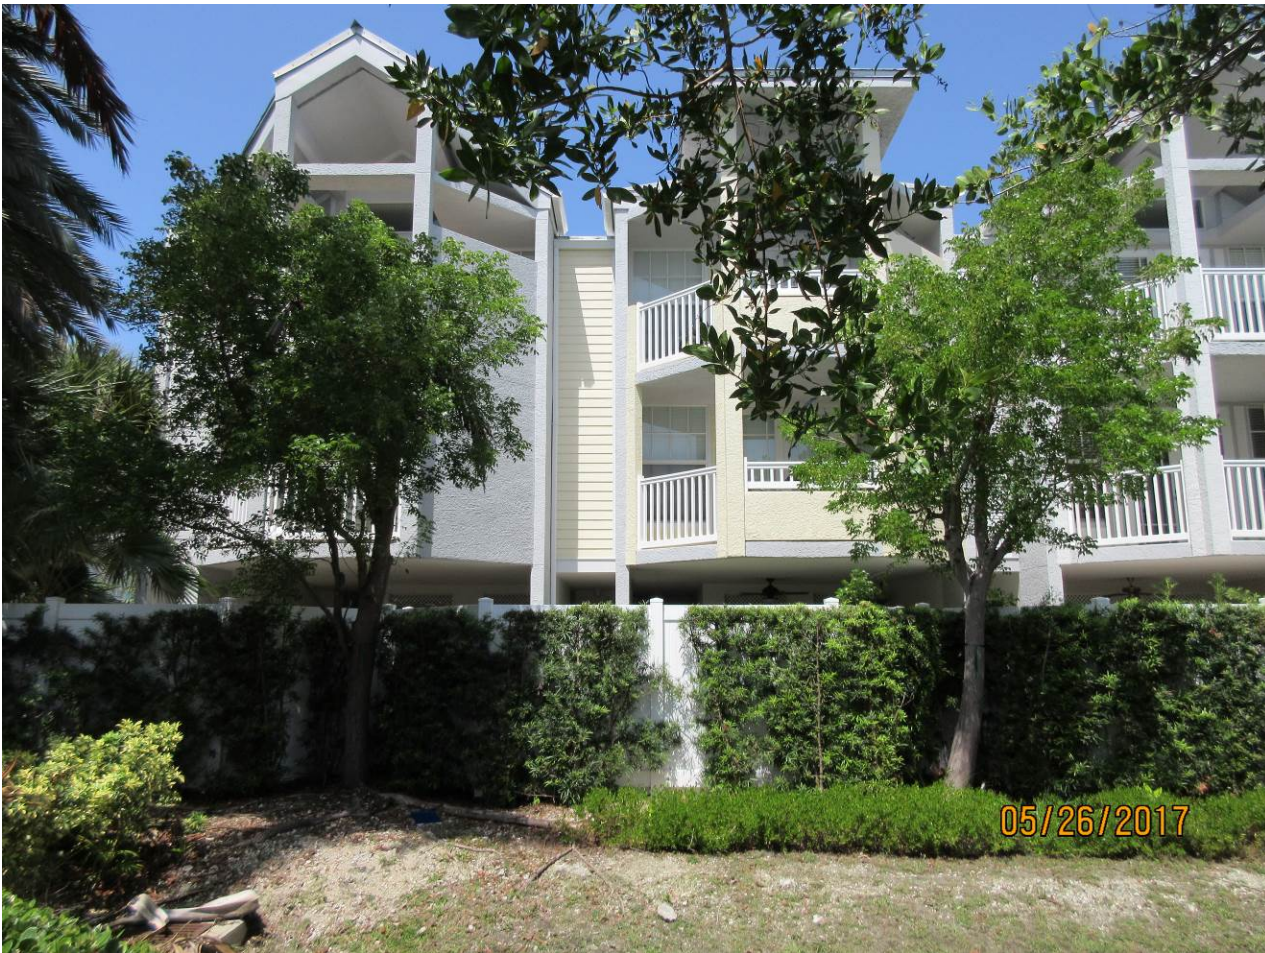
Tree #5

Tree #6

Tree #5: Diameter: 8.5"

Location: 30% (wrong tree wrong place, roots impacting infrastructure on building side, canopy impacting views)

Species: 100% (on protected tree list)

Condition: 40% (poor, included bark, no space for roots to grow due to slope of retention pond, canopy constantly trimmed)

Total Average Value = 56%

Value x Diameter = 4.7 replacement caliper inches

Tree #6: Diameter: 6.75"

Value x Diameter = 3.7 replacement caliper inches

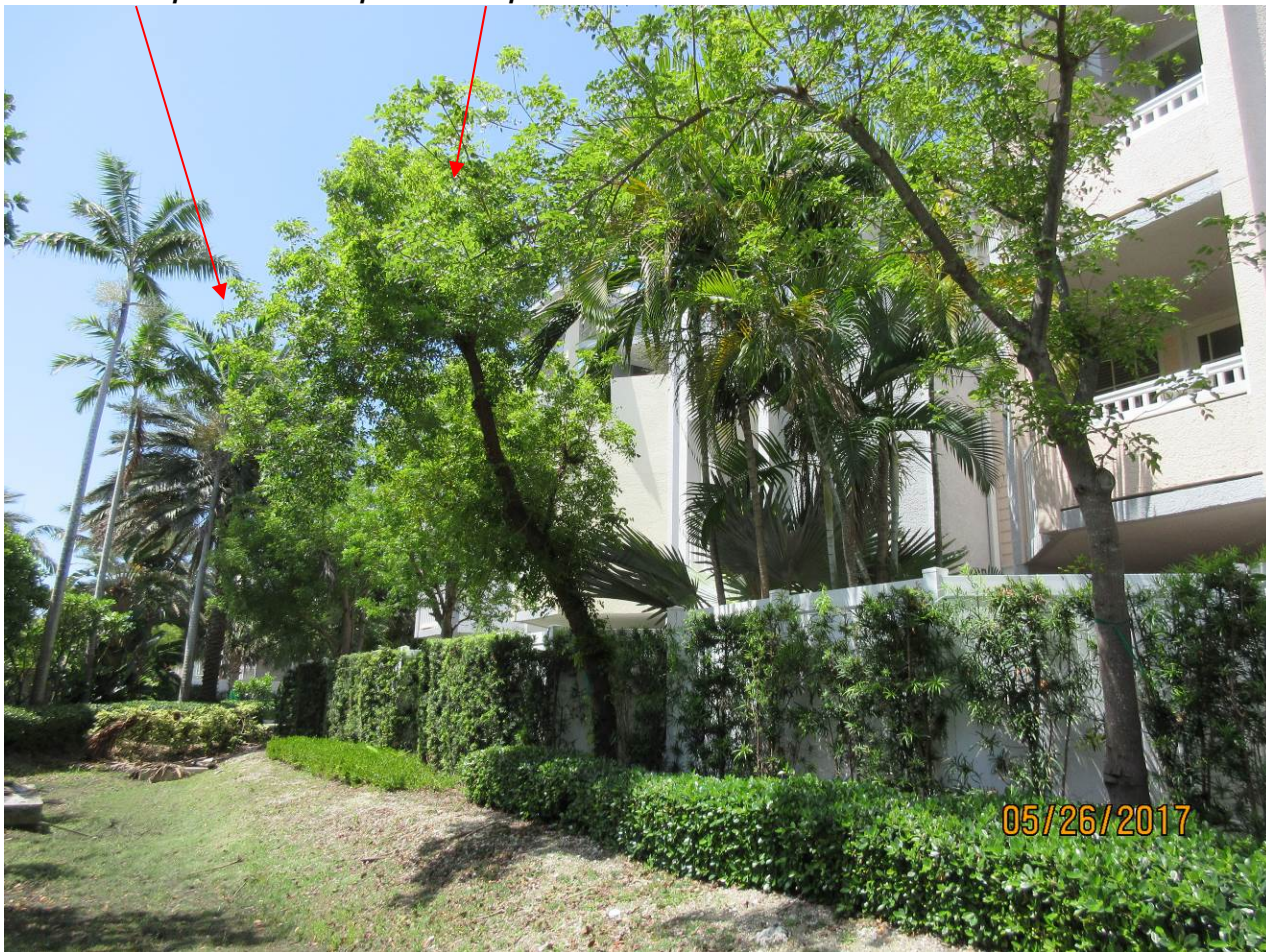
Tree #5, #6, #7, and #8

Tree #7: Diameter: 7.5"

Location: 30% (wrong tree wrong place, roots impacting infrastructure on building side, canopy impacting views)

Species: 100% (on protected tree list)

Condition: 30% (poor, included bark, strong growth lean, no space for roots to grow due to slope of retention pond, canopy constantly trimmed)

Total Average Value = 53%

Value x Diameter = 3.9 replacement caliper inches

Tree #8: Diameter: 6.25"

Condition: 30% (poor, included bark, poor structure, no space for roots to grow due to slope of retention pond, canopy constantly trimmed)

Value x Diameter = 3.3 replacement caliper inches

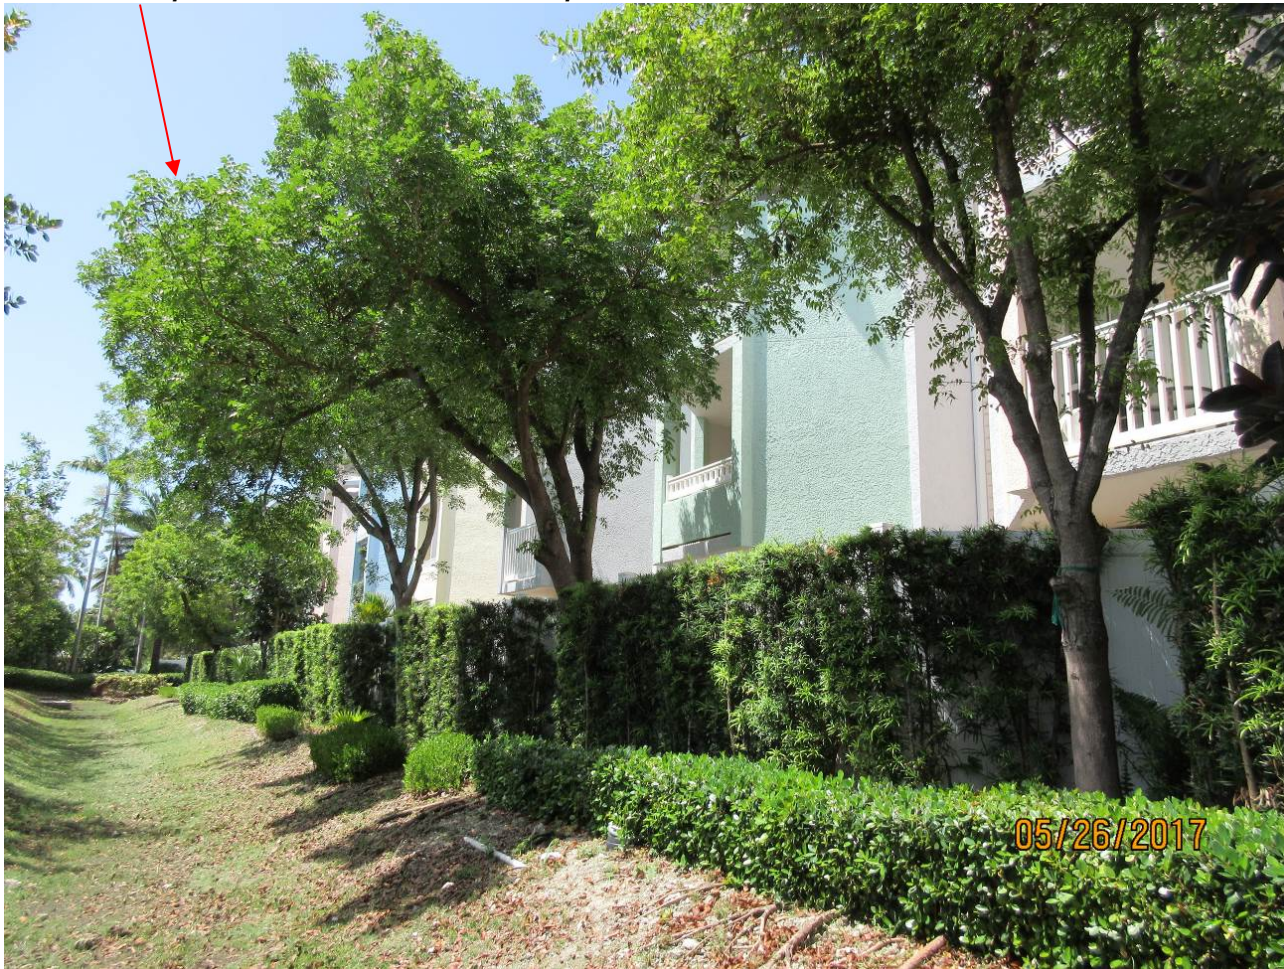
Tree #9,

#10,

and #11

Tree #9: Diameter: 9.25"

Location: 30% (wrong tree wrong place, roots impacting infrastructure on building side, canopy impacting views)

Species: 100% (on protected tree list)

Condition: 40% (poor, included bark, no space for roots to grow due to slope of retention pond, canopy constantly trimmed)

Total Average Value = 56%

Value x Diameter = 5.1 replacement caliper inches

Tree #10: Diameter: 11"

Value x Diameter = 6.1 replacement caliper inches

Tree #11: Diameter: 7"

Condition: 40% (fair, included bark, no space for roots to grow due to slope of retention pond, canopy constantly trimmed)

Value x Diameter = 3.9 replacement caliper inches

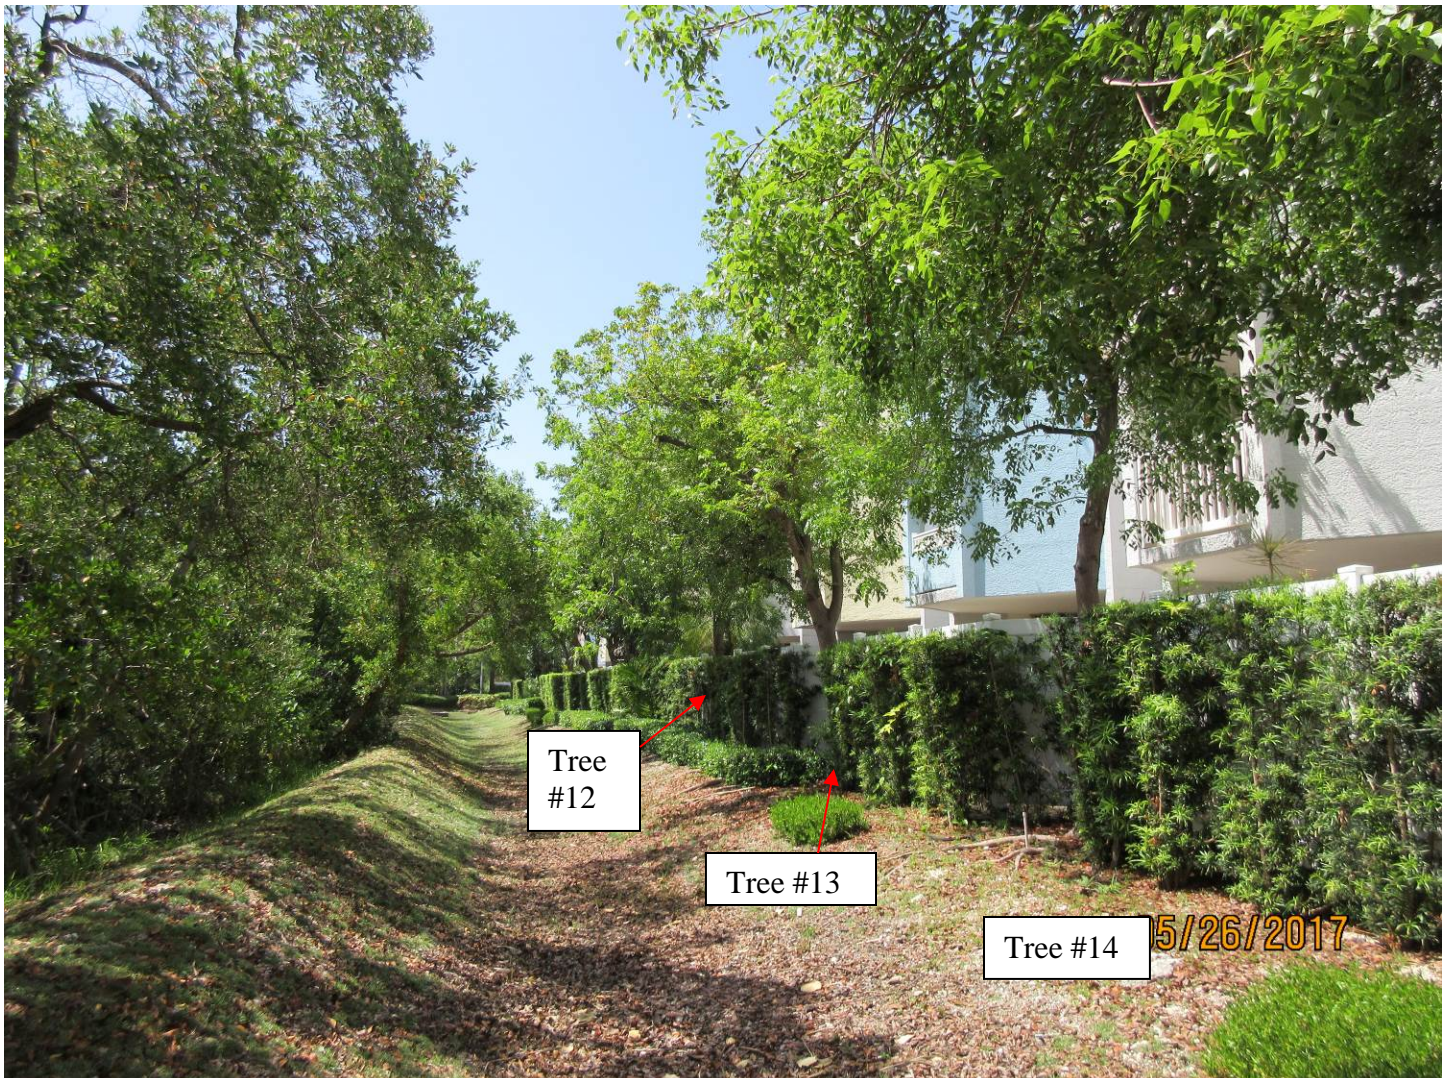
Tree #12: Diameter: 7.25"

Location: 30% (wrong tree wrong place, roots impacting infrastructure on building side, canopy impacting views)

Species: 100% (on protected tree list)

Condition: 30% (poor, included bark, no space for roots to grow due to slope of retention pond, canopy constantly trimmed)

Total Average Value = 53%

Value x Diameter = 3.8 replacement caliper inches

Tree #13: Diameter: 9.5"

Condition: 40% (poor, included bark, poor structure, no space for roots to grow due to slope of retention pond, canopy constantly trimmed)

Total Average Value = 56%

Value x Diameter = 5.3 replacement caliper inches

Tree #14: Diameter: 7.25"

Condition: 50% (fair, no space for roots to grow due to slope of retention pond, canopy constantly trimmed)

Total Average Value = 60%

Value x Diameter = 4.3 replacement caliper inches

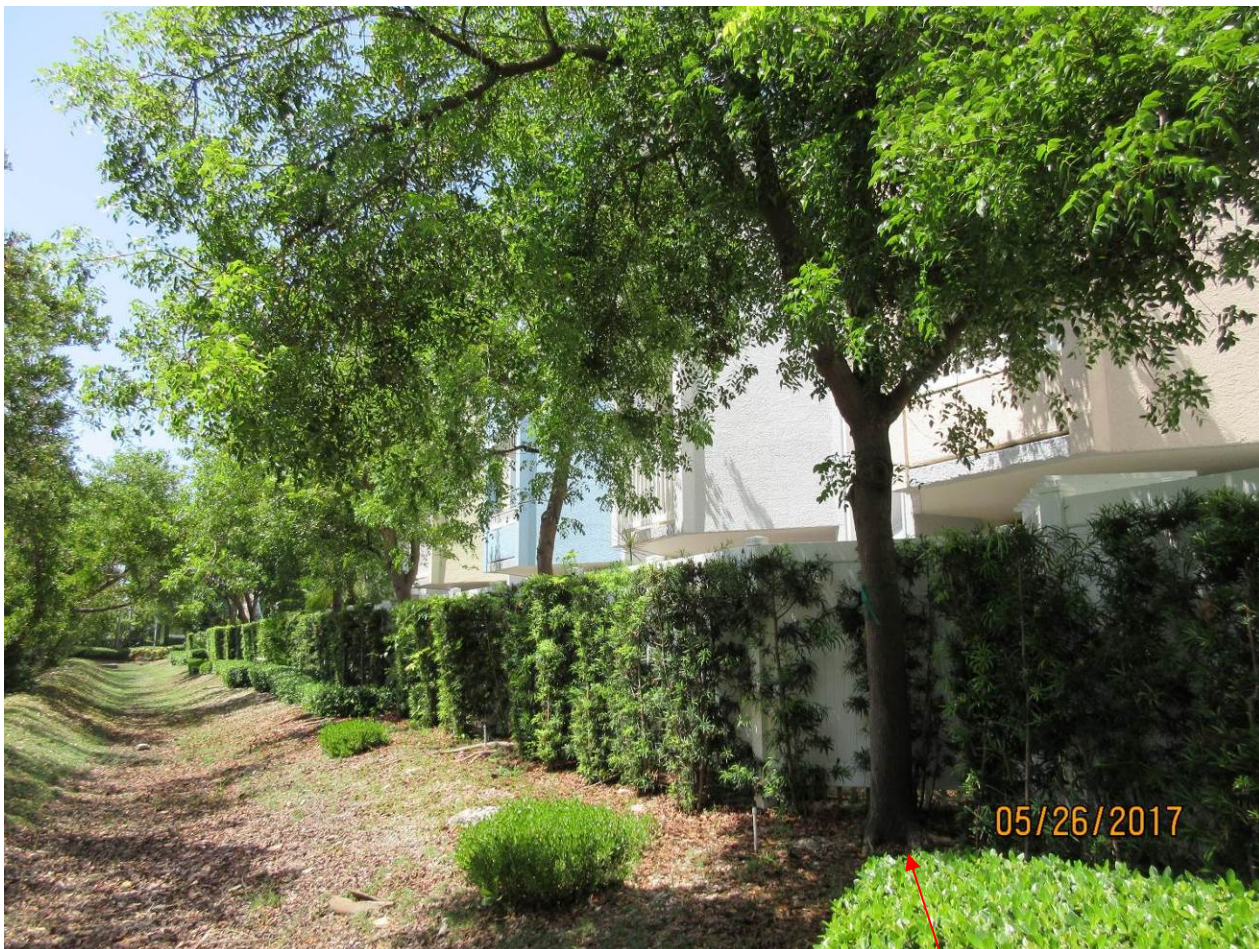
Tree #15

Tree #15: Diameter: 8.5"

Location: 30% (wrong tree wrong place, roots impacting infrastructure on building side, canopy impacting views)

Species: 100% (on protected tree list)

Condition: 40% (poor, included bark, no space for roots to grow due to slope of retention pond, canopy constantly trimmed)

Total Average Value = 56%

Value x Diameter = 4.7 replacement caliper inches

Recommendation: Recommend approval of the removal of fifteen (15) Mahogany trees at Seaside Court North and South, to be replaced with 66.6 caliper inches of dicot or fruit trees from approved list, FL#1, to be planted on site.
