UPDATED STAFF REPORT

RE: **1121 Margaret Street (permit application # T17-8610)**

FROM: Karen DeMaria, City of Key West Urban Forestry Manager

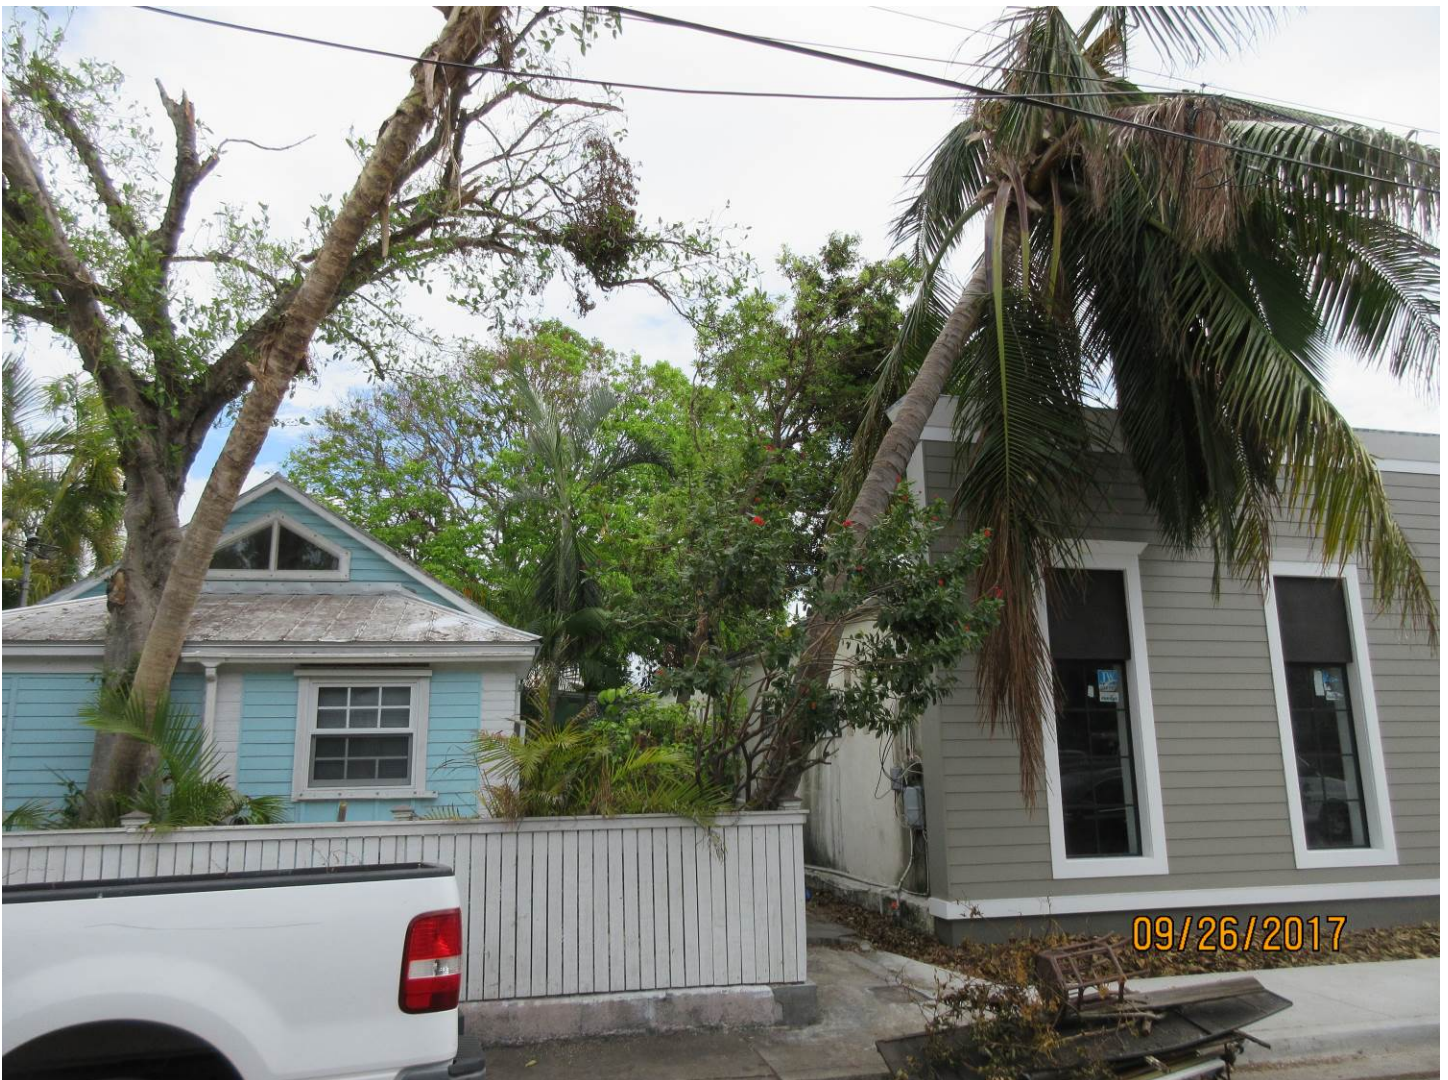
The trees appear to be in mostly the same condition as prior to the hurricane. The Mahogany tree does have a more pronounced lean over the house and trunk curve due to hurricane winds.

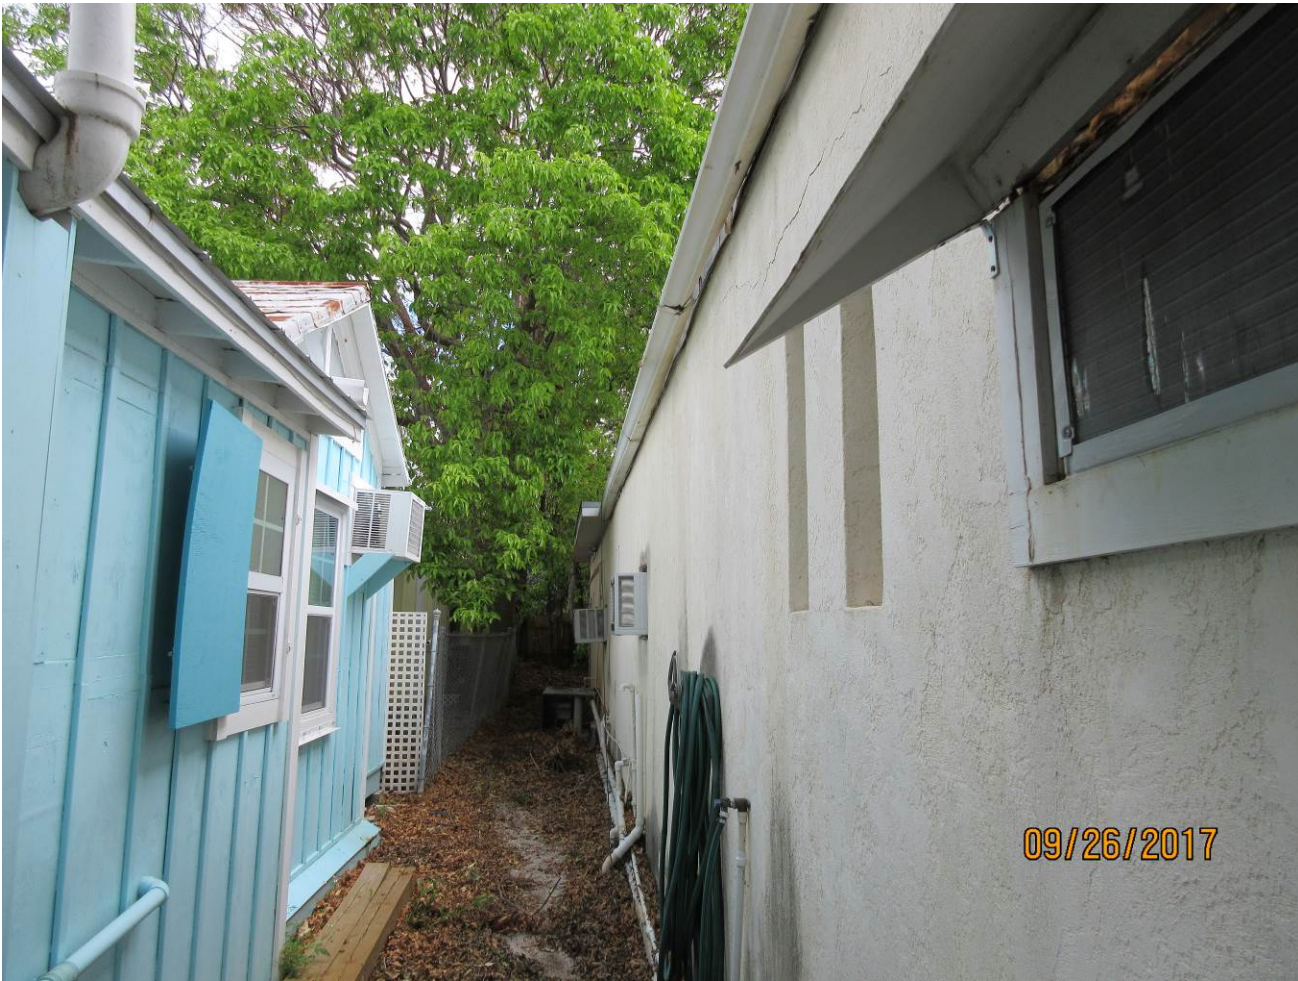
Spanish Lime Tree #1: Diameter: 3.5"

Condition: 50% (poor structure)

Spanish Lime Tree #2: Diameter: 6.3"

Condition: 30% (very poor, codominant trunks, fence imbedded in one trunk)

Recommendation: Recommend approval of the removal of two (2) young Spanish Lime trees and (1) Mahogany tree at 1121 Margaret Street to be replaced with a total of 11.6 caliper inches of dicot or fruit trees from approved list, FL#1, to be planted on site.

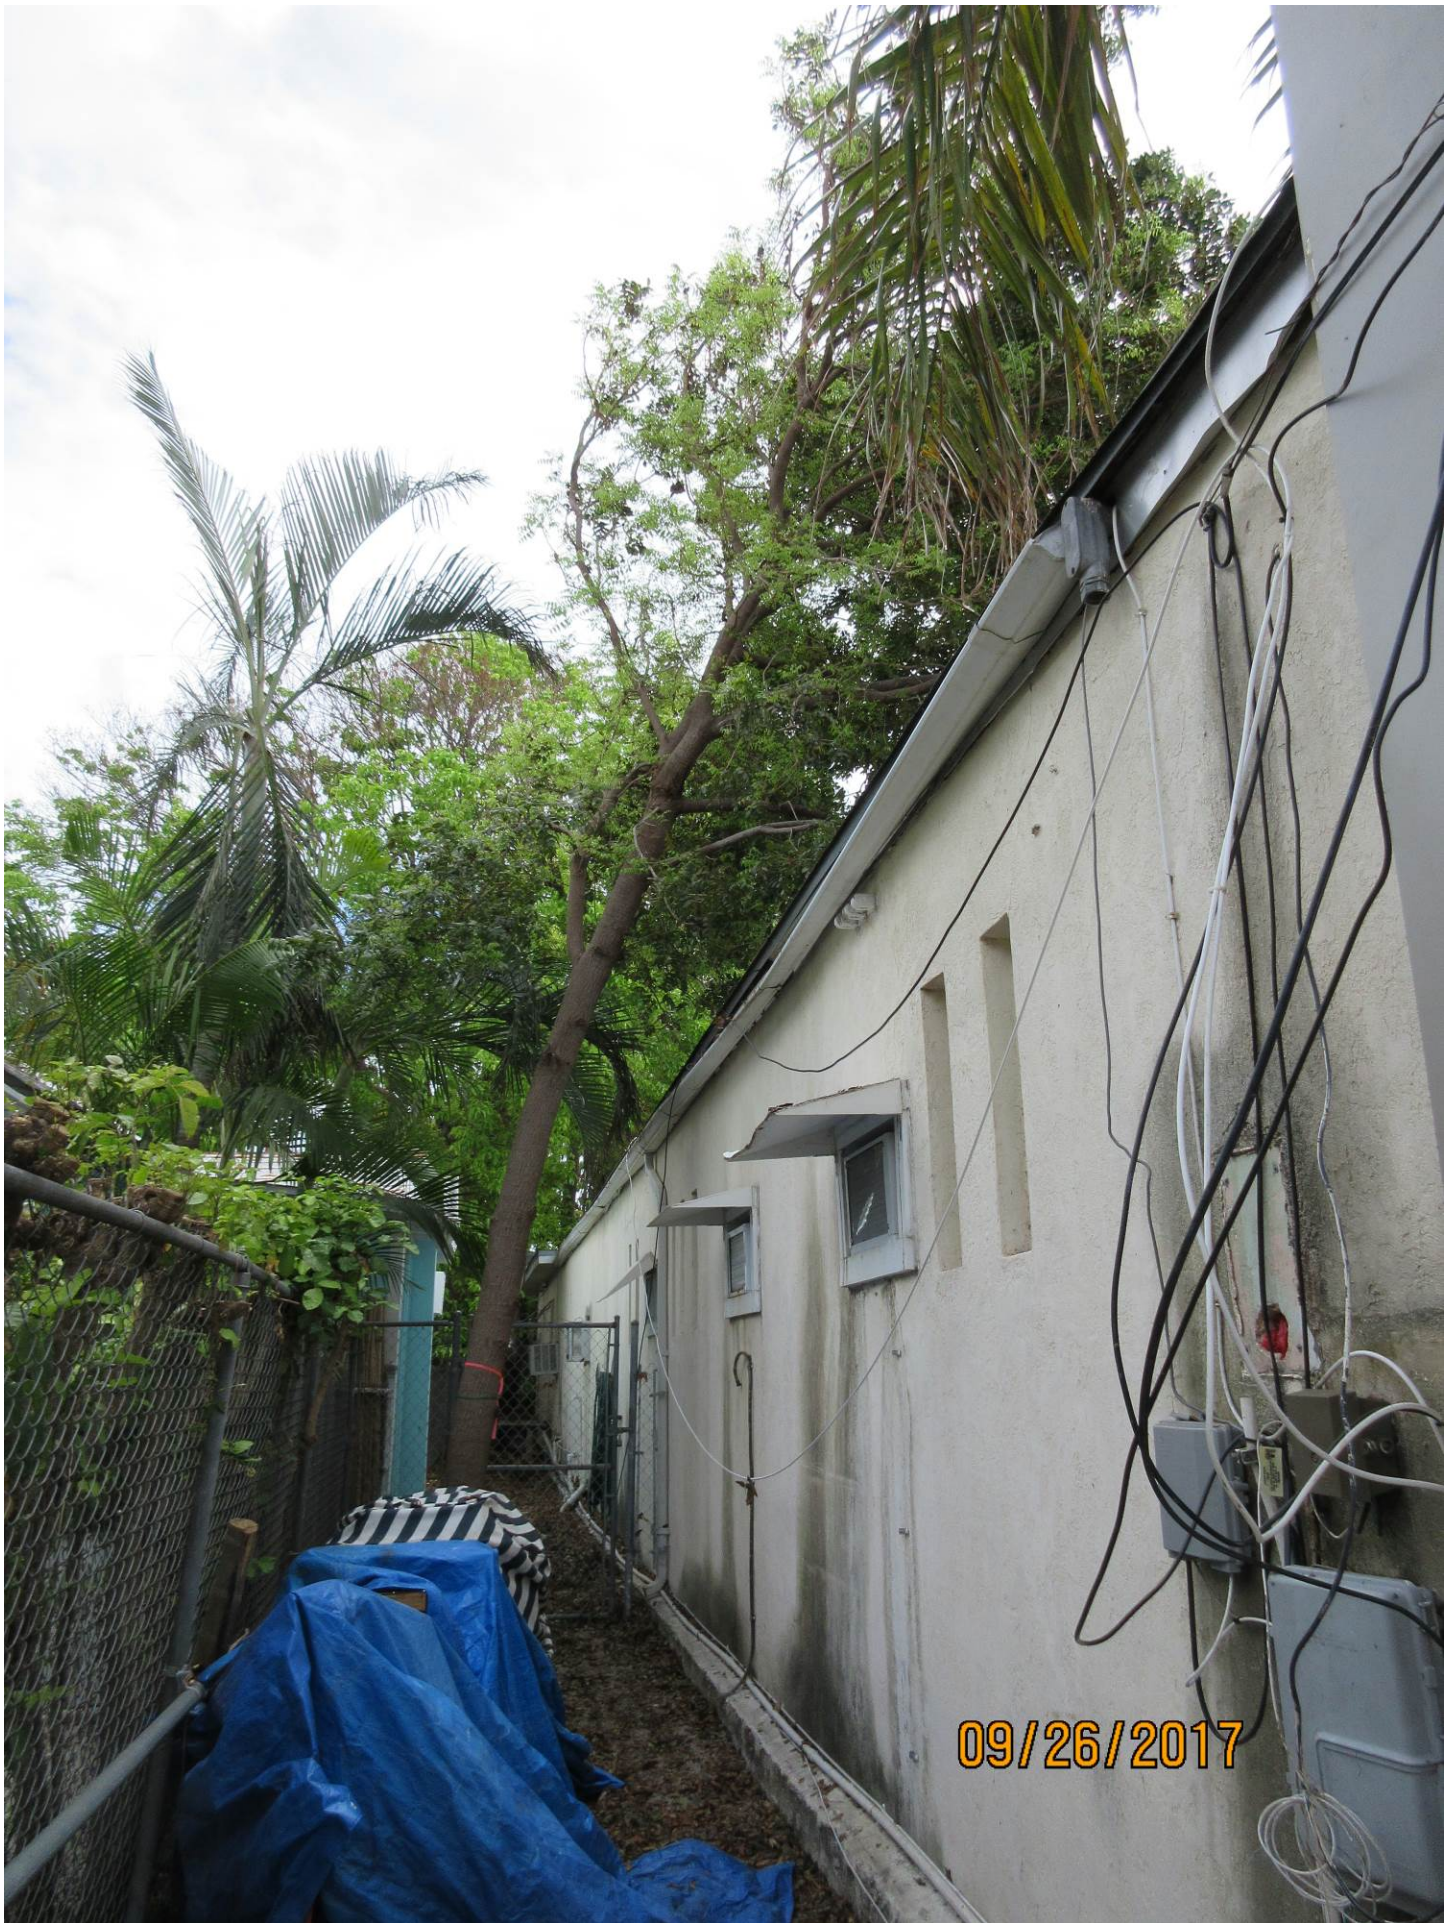
Mahogany Tree Diameter: 8.5"

Location: 60% (growing in between two structures-small growing space, wrong tree species, wrong place)

Condition: 50% (fair to poor- stronger and more pronounced lean over the house)
