# Structural Condition Assessment Key West Diesel Plant Key West, Florida

AES Project No. 316-048  
August 3, 2016

Re: Structural Condition Assessment  
Key West Diesel Plant  
Key West, Florida

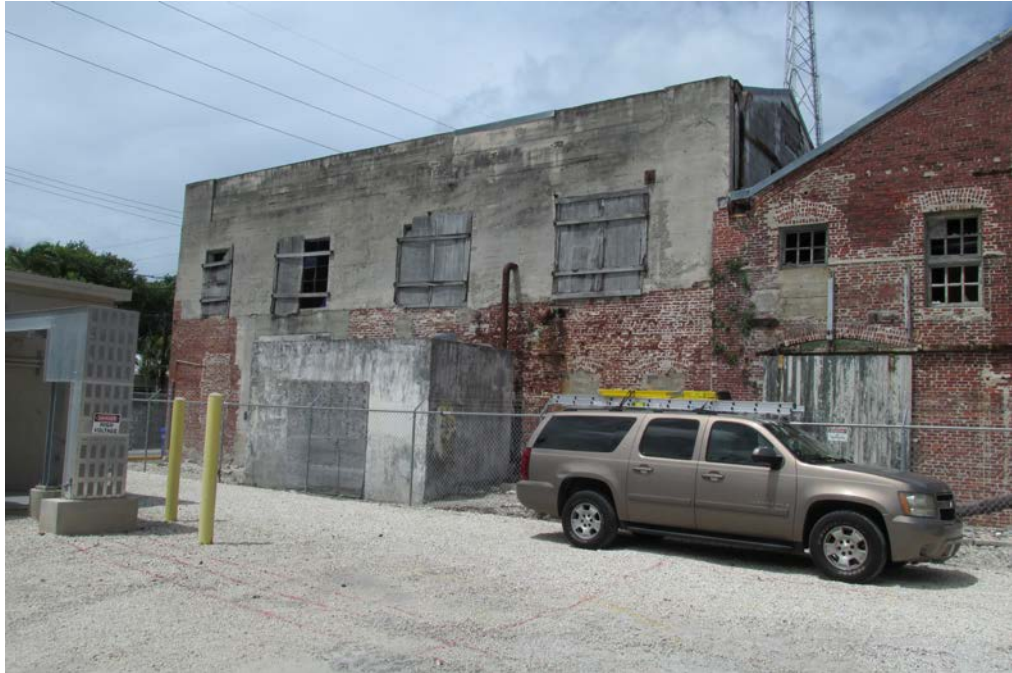
PHOTOGRAPH 5 (BUILDING IV AND V)

The abandoned Diesel Plant consists of four (4) connected one-story, buildings with the three (3) eastern buildings housing four (4) electric dynamos and the southwestern building having a lower roof that probably housed a shop and support spaces. The northernmost eastern building (Building I) houses one (1) dynamo and consists of a high new pre-engineered wood truss framed roof with plywood sheathing and metal roofing supported by perimeter multi-wythe brick walls and interior steel beams and columns (see Photographs 1 and 2). The easternmost center building (Building II) houses two (2) dynamos and consists of metal roofing on plywood sheathing, on wood joists and beams supported by heavy timber trusses and steel beams and columns that support crane beams (see Photographs 3 and 4). The heavy timber roof trusses are supported by perimeter multi-wythe brick walls. The southernmost eastern building (Building IV) houses one (1) dynamo and consists of metal roofing on wood sheathing on wood joists and beams supported by heavy timber trusses, and perimeter low multi-wythe brick walls and upper concrete walls (see Photographs 5 and 6).

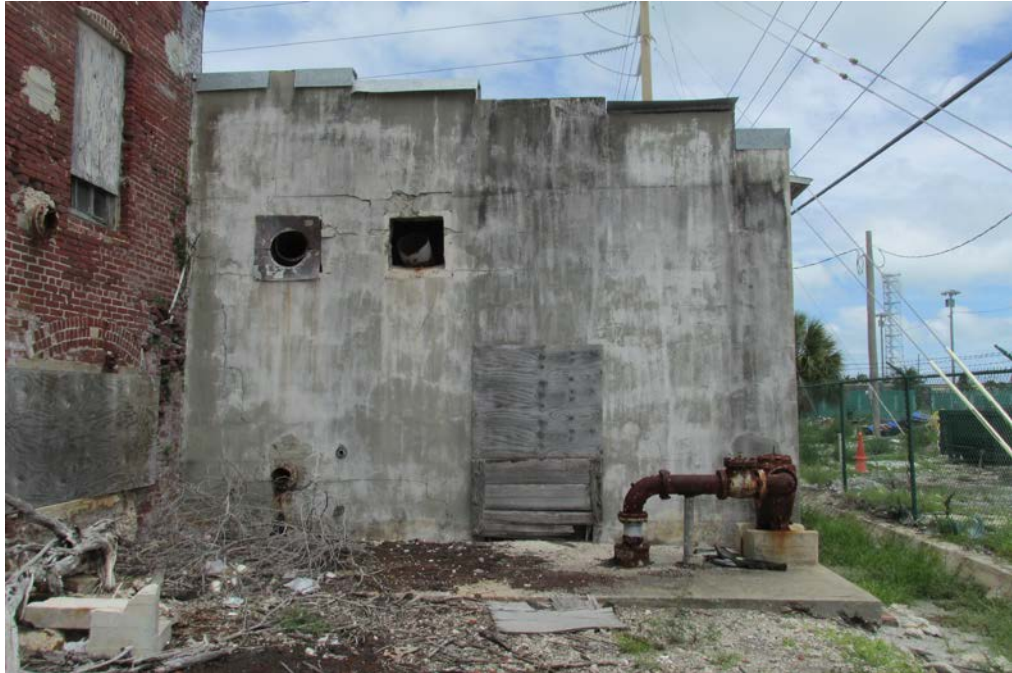
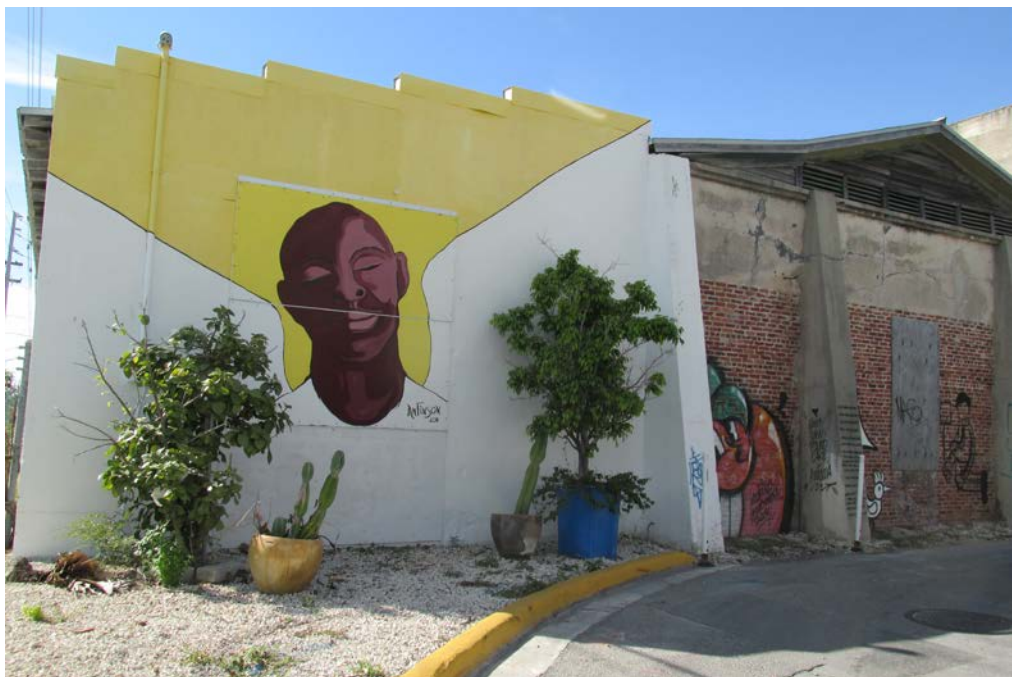
Below the roof structure is a gantry crane supported by a steel crane beam and steel columns independent of the perimeter brick walls. To the east of this building is an exterior concrete exhaust structure (Building V), which consists of a concrete roof slab with concrete parapets supported by concrete walls (see Photographs 7 and 8). The southwestern building (Building III) consists of metal roofing on wood sheathing on wood joists, and beams supported by interior steel beams and columns and perimeter multi-wythe brick walls, CMU walls and concrete walls (see Photographs 9 and 10).

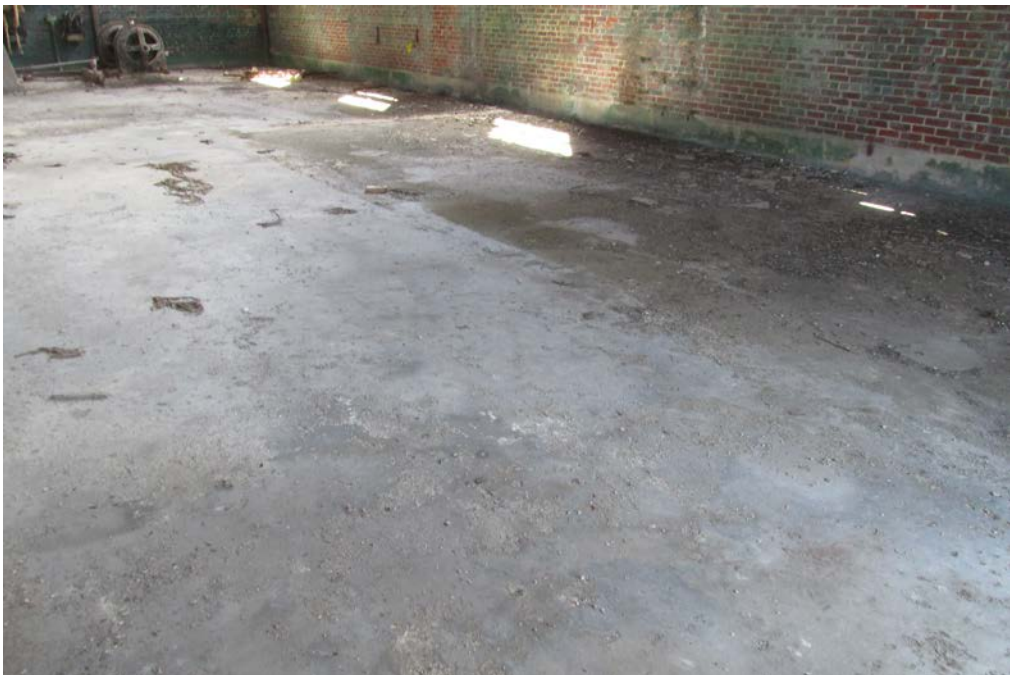
PHOTOGRAPH 14 (BUILDING I)

- I. The northernmost, eastern building (Building I) has been recently re-roofed and the original wood structure supported by the steel beams and trusses have been replaced with plywood sheathing and wood trusses. The new roofing and roof structure is in excellent condition except that the roofing screws are not stainless steel and are corroding (see Photograph 12). The original steel beams, trusses and columns are in good condition with surficial corrosion except for one (1) column, which has a badly corroded base with more than 20% material loss (see Photograph 13). The slab on grade is cracked and uneven and there is a large crack at the interior door to the adjacent building, and several of the western window sills are spalled with corroded reinforcing and the remainder are cracked (see Photographs 14, 15 and 16).

Building I is in good condition with the exterior masonry requiring repair and several window lintels requiring replacement. The steel structure is in good condition with surficial corrosion except for one (1) column that needs reinforcement due to excessive corrosion at its base. All of the steel needs to be cleaned of corrosion and coated with a corrosion inhibiting coating. The slab on grade is cracked and uneven and is due for replacement. The exterior masonry requires repointing and all of the corroded embedments and steel lintels need to be cleaned of corrosion and coated with a corrosion inhibiting coating. The deteriorated face brick needs to be removed and replaced and the vegetation in the wall cracks needs to be removed and the cracks repointed. At the western return metal panel wall, the badly corroded angle purlin needs replacement as well as the wall metal panels. The concrete spall in this wall also requires repair.

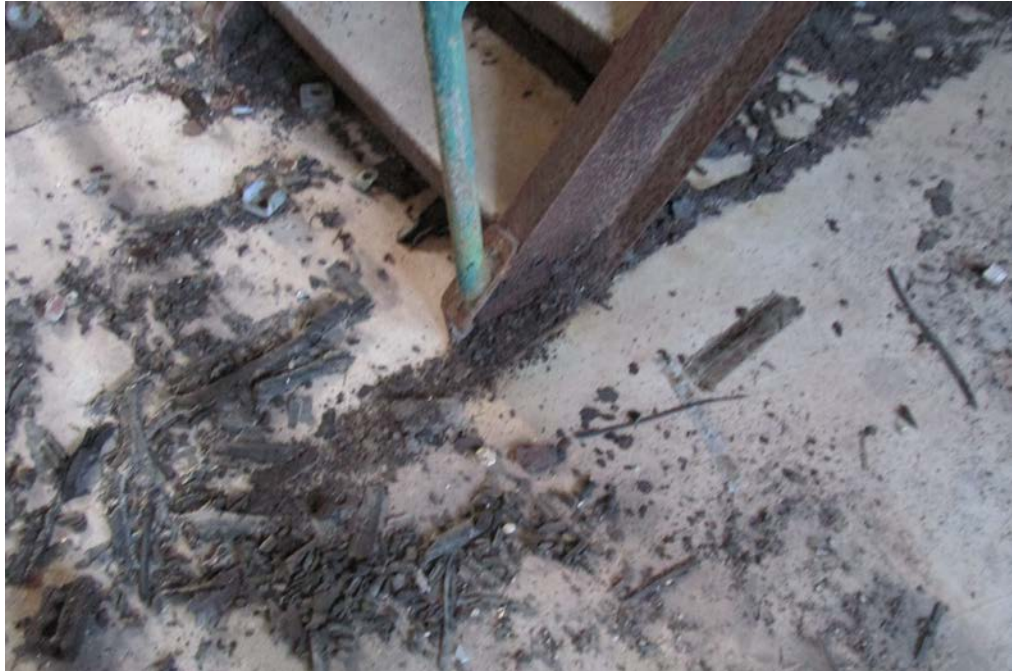
PHOTOGRAPH 31 (BUILDING II)

The stair to the concrete platform has badly corroded stair stringer bases with more than 20% material loss and the concrete platform has extensive large concrete spalls with exposed corroding reinforcing (see Photographs 31, 32 and 33). The exterior masonry walls are in good condition, but there are numerous cracks, corroded embedments, deteriorated mortar, deteriorated face brick, infilled arch brick with no lintel, large areas of missing brick, corroding lintels and brick cracks with vegetation (see Photographs 34, 35, 36, 37, 38 and 39).

The remainder of the buildings are in worse condition than Building I with Building IV being in the worst condition with a portion of missing roof. These buildings are stable but require new roofs with extensive roof sheathing replacement and some wood structure reinforcement and replacement. At the areas of missing and badly deteriorated roofing, these roofs could sustain significant damage in a severe wind event losing the remainder of their roofing and sheathing. In general, the steel structure is in good condition with surficial corrosion but several columns will need reinforcement due to excessive corrosion at their bases. All of the steel needs to be cleaned of corrosion and coated with a corrosion inhibiting coating. At Building IV, the wall opening with numerous loose and missing bricks and falling bricks needs to be shored or repaired immediately to prevent further deterioration of the wall. The exterior masonry walls are in good condition except for the northwest corner of Building II where there is a large area of missing brick that needs to be rebuilt. The remaining walls need to be repointed, deteriorated face brick removed and replaced and the vegetation in the wall cracks removed and the cracks repointed. Like Building I, all of the corroded embedments and steel lintels need to be cleaned of corrosion and coated with a corrosion inhibiting coating. In many of the arched brick openings, brick has been infilled with no lintel installed. This infill brick is being held in place by the mortar alone and in areas is cracking. This infill brick needs to be removed or steel lintels installed to support it. At Building II, the concrete platform is in poor condition with large spalls and the concrete carbonated to the reinforcing with the concrete containing high levels of chlorides. If it is the owner's desire to rehabilitate this platform when the concrete is repaired, it should be treated with a penetrating corrosion inhibitor or an active cathodic protection system installed. Due to the thickness of the platform walls, both will be expensive, therefore strong consideration should be taken for demolishing this platform. The exterior concrete walls and pits, except for Building V, are in poor condition requiring extensive repair. Like the Building II concrete platform, the concrete contains high levels of chlorides and once repaired, the walls should be treated with a penetrating corrosion inhibitor or an active cathodic protection system installed, and the exterior concrete coated with a penetrating sealer. The exterior pits and chutes are abandoned and should be cleaned of debris, the top of the deteriorated walls demolished to 8" below grade and filled with clean fill or stone. All of the interior trench and pit edge angles are in poor condition and badly corroded. All of the dynamo pits are full of water and breeding mosquitos. When the deteriorated dynamos are removed, the pits need to be pumped empty of water. The pits and trenches need to be dewatered, cleared of debris with the edge angles removed, and the pits and trenches filled with clean fill or stone with a concrete slab on grade placed, drilled and adhesived into the pit and trench walls level with the surrounding concrete slabs on grade. If any of the dynamos are kept for display, their pits should be pumped empty of water and filled and capped as described above.

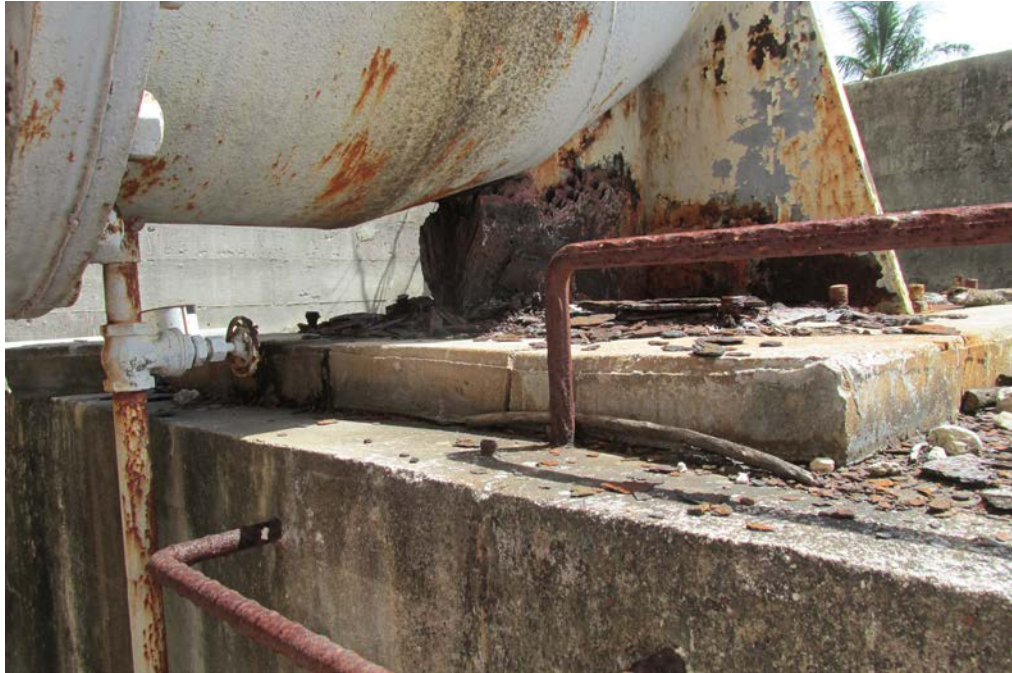
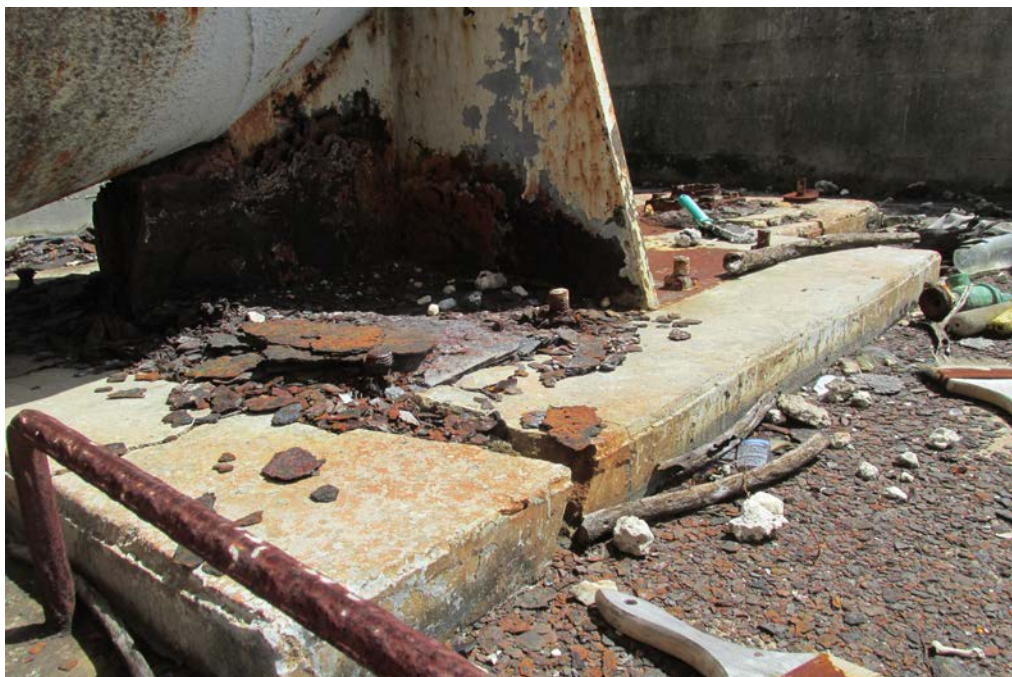
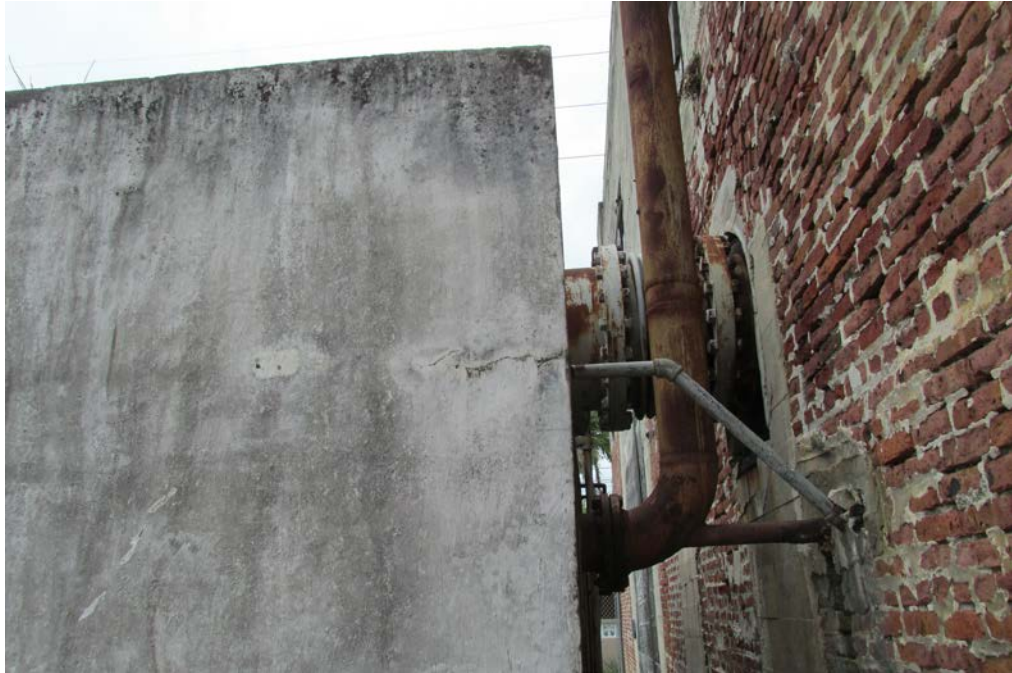
- V. The concrete exhaust building (Building V) is in good condition with corroded steel ladders; a badly corroded pipe support, a cracked housekeeping pad and a hairline crack in the roof parapet (see Photographs 50, 51, 52 and 53). The exterior pit and chute walls are in poor condition with cracked and spalling concrete with corroding reinforcing (see Photograph 54). All of the interior pits are full of water and breeding mosquitos. The interior trench and pit edge angles are in poor condition and badly corroded (see Photograph 55). All of the dynamos are in poor condition and badly corroded (see Photograph 56).

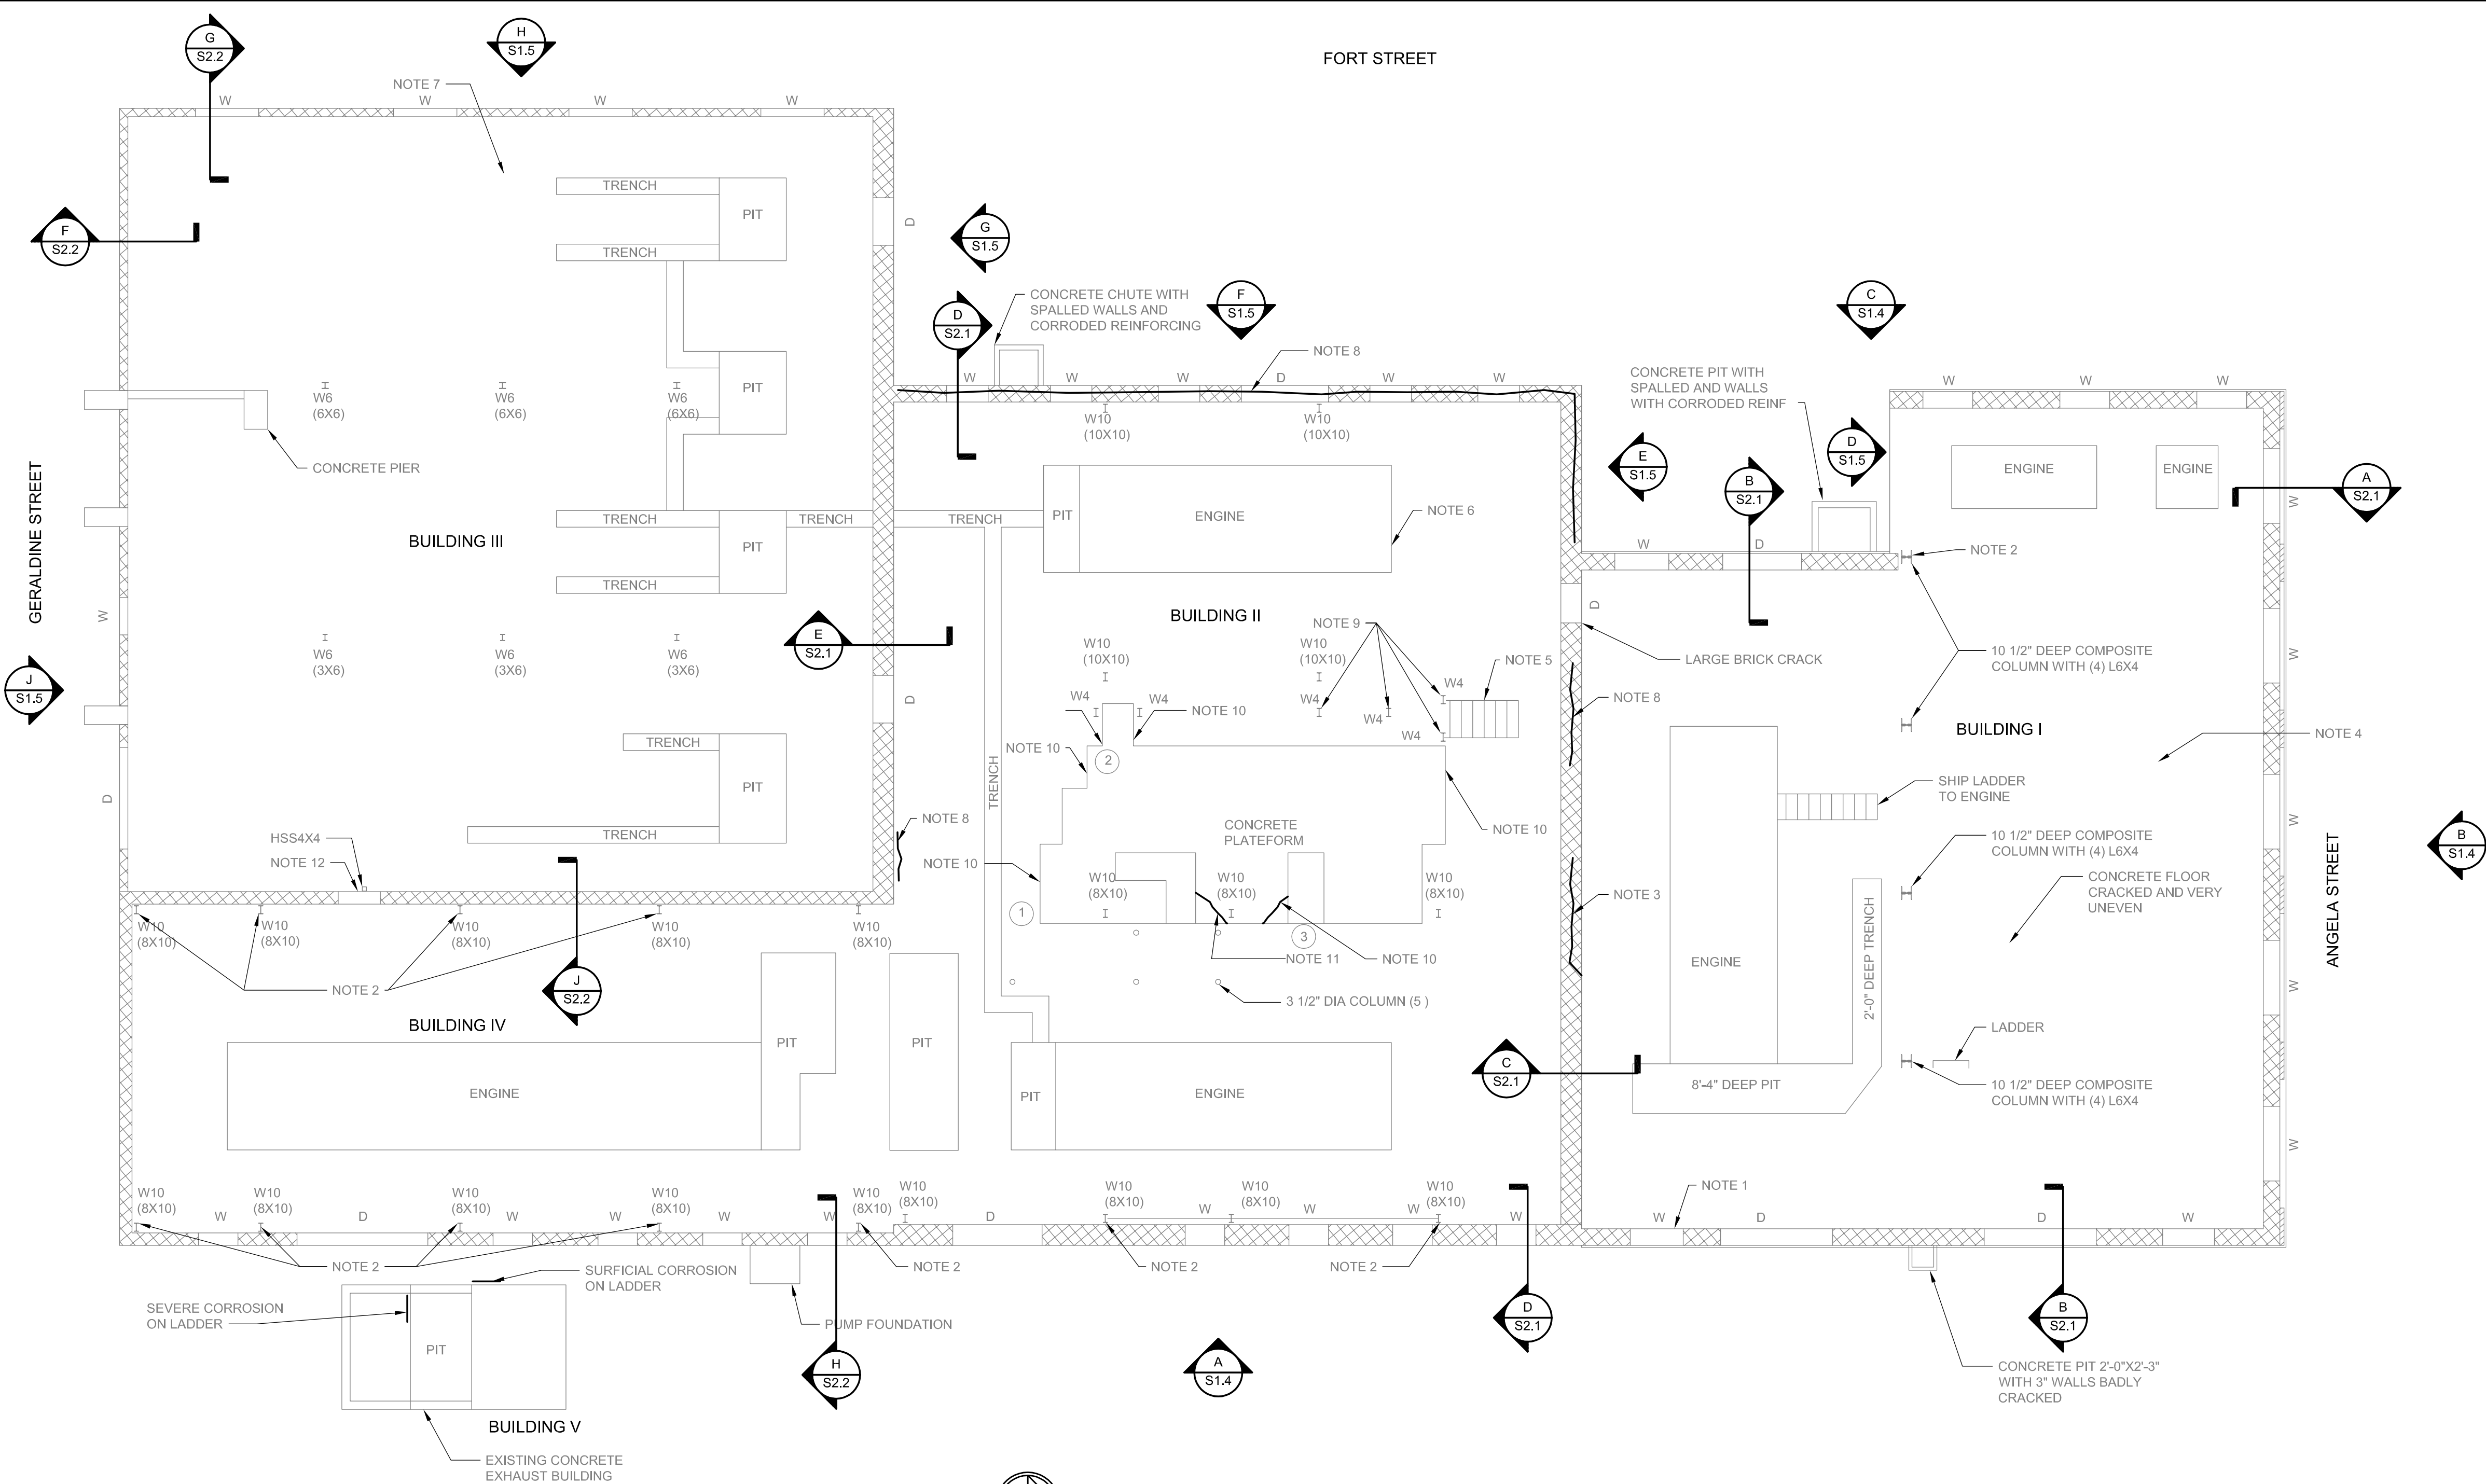
EXISTING FLOOR PLAN

1. DETERIORATED FACE OF BRICK
2. BADLY CORRODED COLUMN BASE AND OR COLUMN
3. CRACKS IN BRICK AT WALL PENETRATIONS AND ELEVATED OPENINGS
4. CONCRETE FLOOR CRACKED AND UNEVEN
5. BADLY CORRODED STAIR STRINGERS AT BASE OF STAIR
6. TRENCH AND PIT EDGE ANGLE BADLY CORRODED
7. CONCRETE FLOOR CRACKED AND UNEVEN - TRENCH AND PIT EDGE ANGLES ARE BADLY CORRODED
8. DETERIORATED MORTAR JOINTS
9. BADLY CORRODED POST BASE
10. LARGE SPALL WITH EXPOSED CORRODING REINFORCING
11. SEVERE CRACK AT CONCRETE BASE
12. BADLY DETERIORATED BRICK AT WALL OPENING
13. SURFICIAL CORROSION ON ALL STRUCTURAL STEEL.

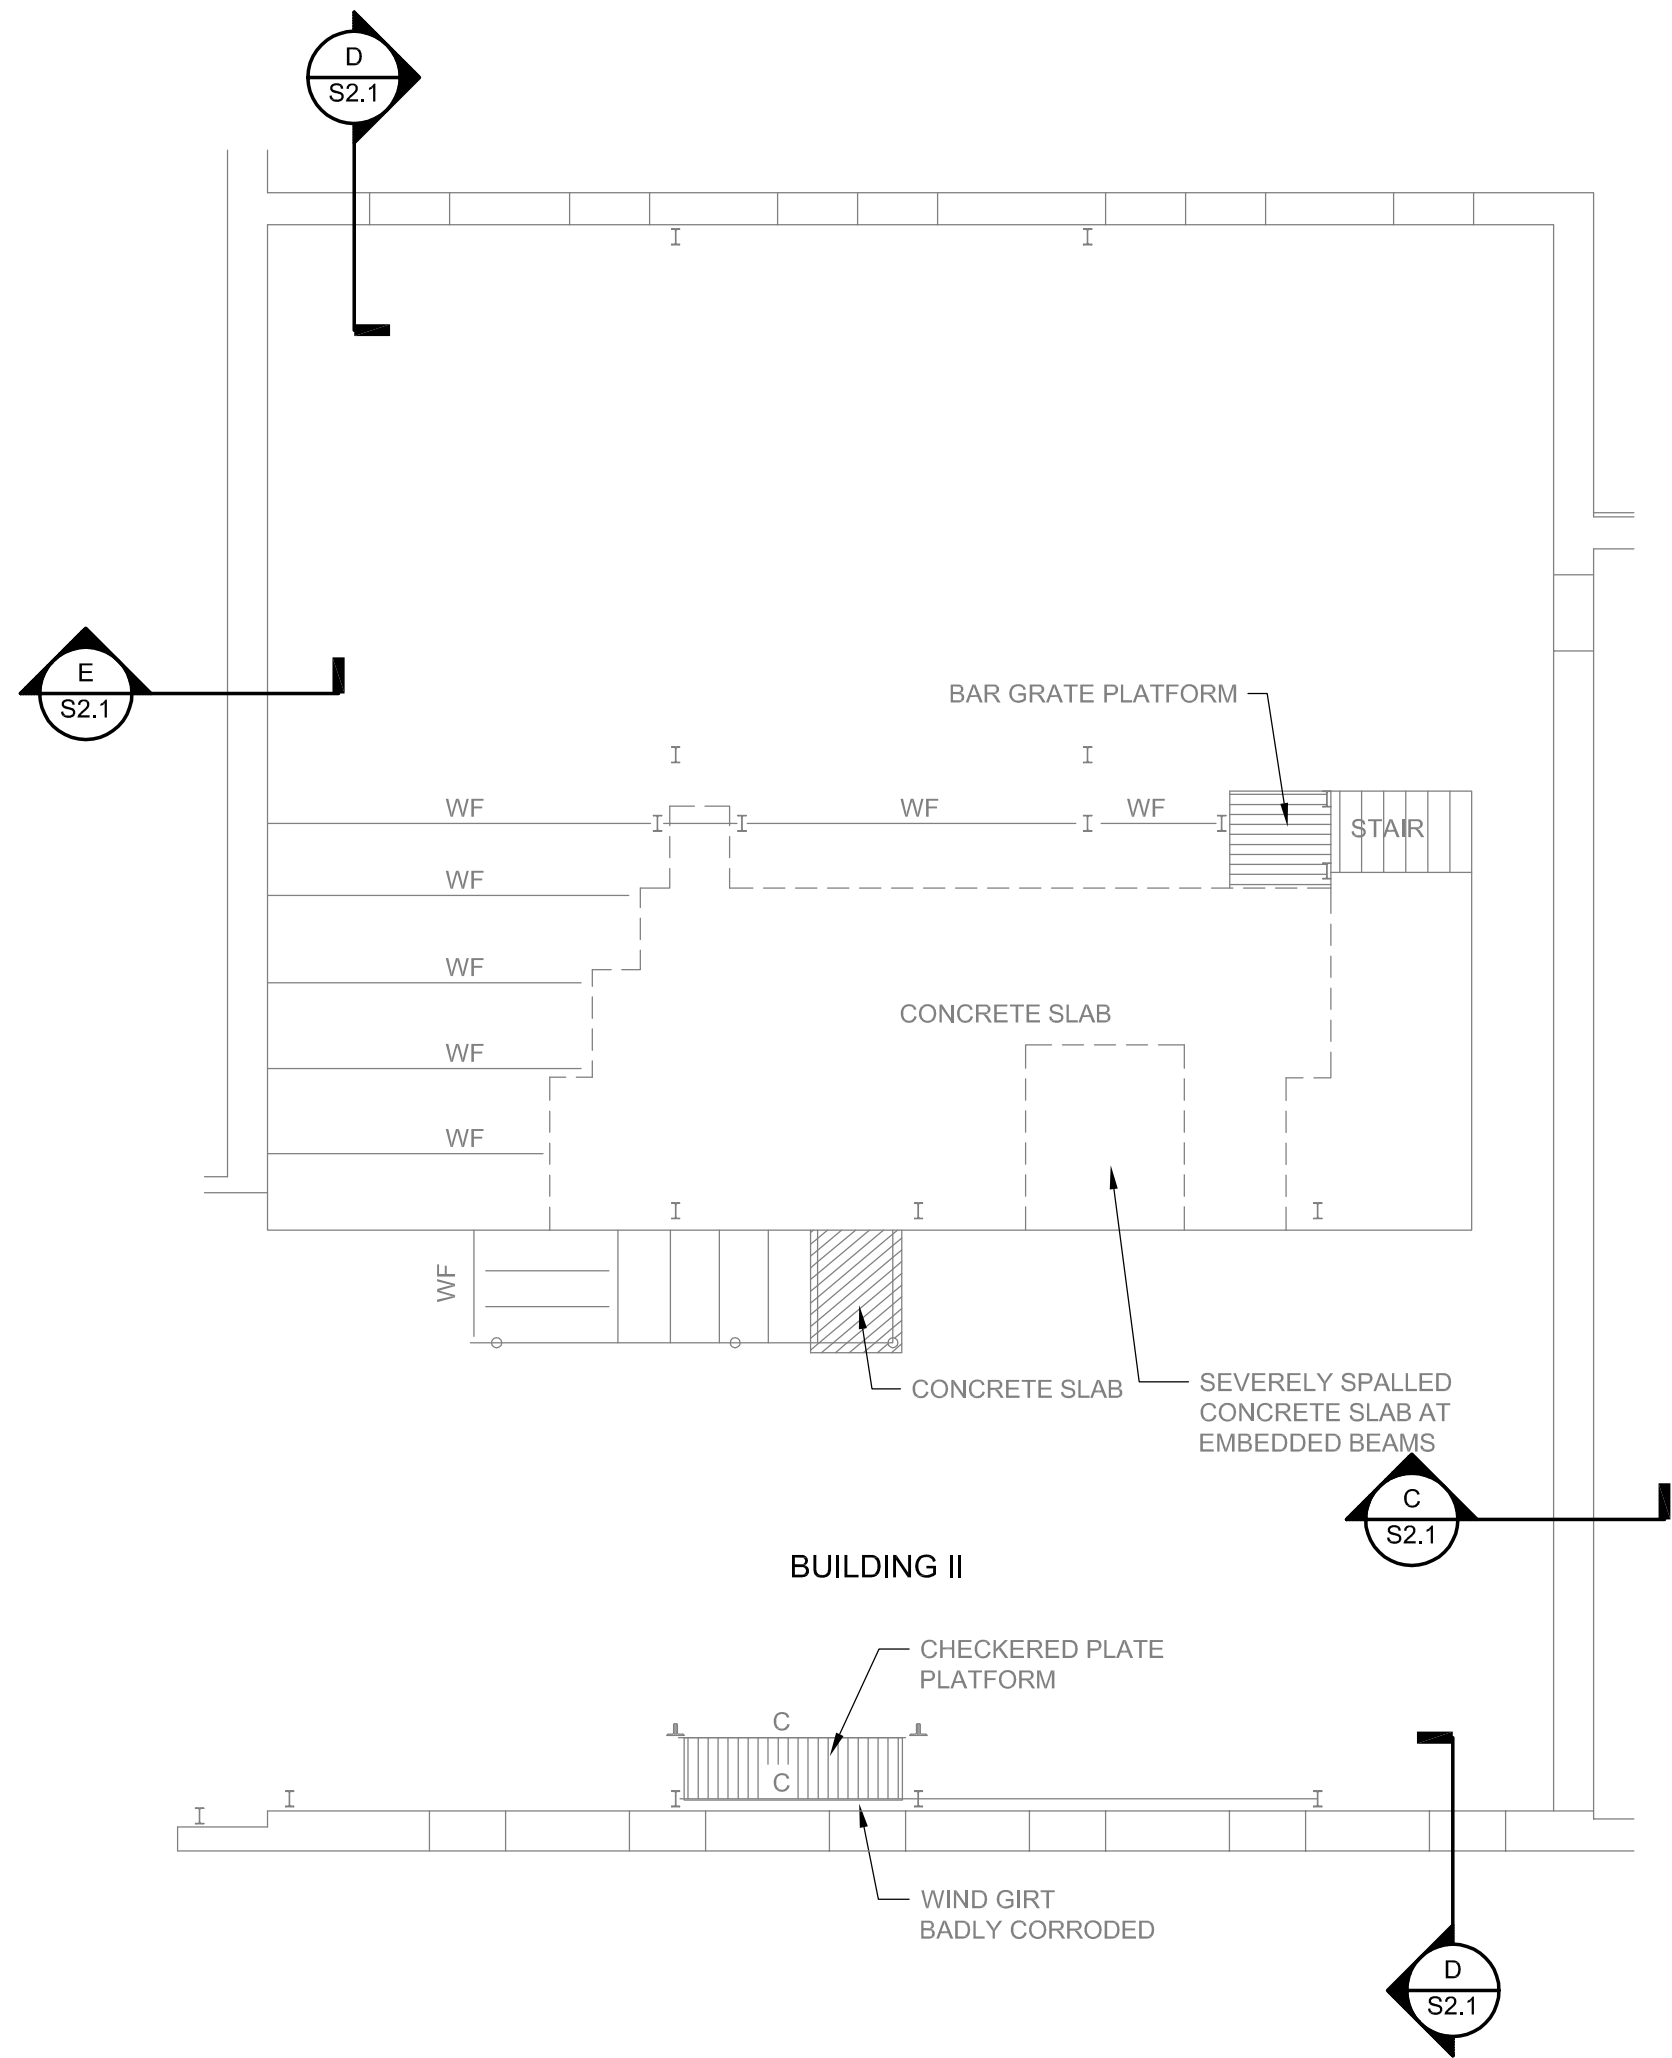
**EXISTING MEZZANINE FLOOR PLAN BUILDING II**

1. SURFICIAL CORROSION ON ALL STRUCTURAL STEEL.
