# BUILDING INSPECTION REPORT

Report Number  
908

631 Greene Street  
Restaurant  
Key West, FL  
33040

Client Name **Key West Historic Seaport**

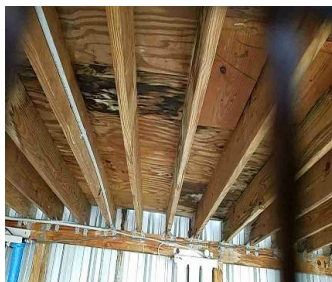
1.

**Location:** Exterior Left **System:** Roof **Condition:** Rot observed on sheathing

**Explanation:** Our examination of the roof structure has revealed indications that moisture issues at the roof structure has resulted in rotting of the roof sheathing.

**Impact Consequences:** The design of the roof structure assumes all framing and support members are intact and bearing their contribution of loads and forces. A deteriorated area of roof sheathing can seriously compromise the integrity of the roof structure. A possible outcome of this condition is that the roof may not be capable of bearing heavy loads or forces without broader damage to the roof structure. Immediate investigation by a roof framing specialist is recommended.

**Recommended Action:** Repair

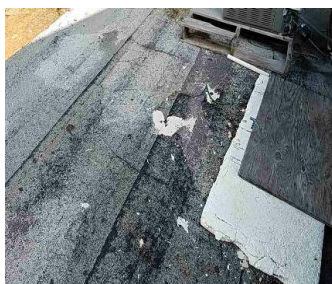
2.

**Location:** Exterior Left **System:** Roof **Condition:** Asphalt roll roofing is old

**Explanation:** The shingle roof surface is displaying indicators that the protective roof covering is at or near the end of its service life.

**Impact Consequences:** As a result of a review of the roof covering the overall condition is such that the roof is deemed to be at or beyond its limits of its serviceable life. Extensive indicators of age are noted. Consideration should be given to replacing the roof covering; the ultimate failure of the roof covering in preventing water infiltration

is unpredictable. Failing to replace the roof covering may result in damage to the structure and contents of the building.

**Recommended Action:** Monitor closely; consider replacing

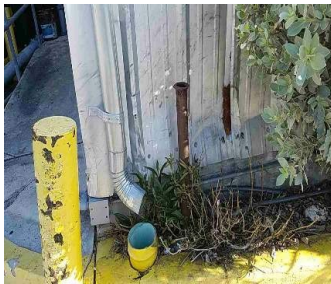
1.

**Location:** Exterior Front **System:** Exterior **Condition:** Damaged Metal Siding Components

**Explanation:** Damaged metal siding components are observed to be damaged.

**Impact Consequences:** Damaged components of the metal siding present opportunities for both water and pest intrusion into the building. Repair or replace damaged components.

**Recommended Action:** Repair or Replace

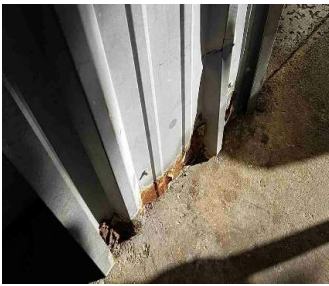
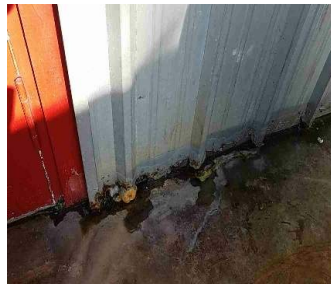
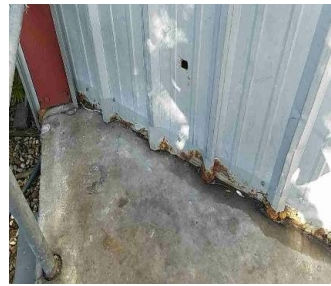
2.

**Location:** Throughout **System:** Exterior **Condition:** Rusted Metal Siding Components

**Explanation:** Metal siding components are observed to be rusted.

**Impact Consequences:** Rusted metal siding components may promote both water and pest intrusion into the subject property. Repair or replace rusted areas in order to restore the sidings intended function.

**Recommended Action:** Repair or Replace

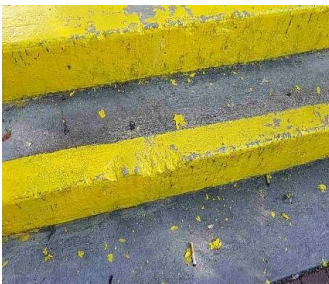
3.

**Location:** Exterior Front **System:** Exterior **Condition:** Deteriorated Concrete Components of Exterior Stairs

**Explanation:** Exterior stairs display deterioration of concrete structural components

**Impact Consequences:** Repair the areas of deteriorated components on the exterior stairs in order to restore structural integrity and prevent trip hazards.

**Recommended Action:** Repair

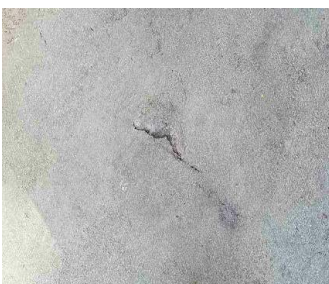
4.

**Location:** Exterior Front **System:** Exterior **Condition:** Trip hazard(s) on walkway

**Explanation:** Uneven surface conditions in the walkway present the risk of tripping for persons traversing the walkway.

**Impact Consequences:** Trip hazards are a safety concern requiring immediate attention.

**Recommended Action:** Repair

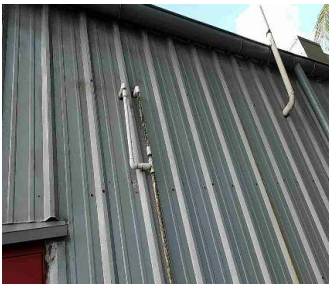
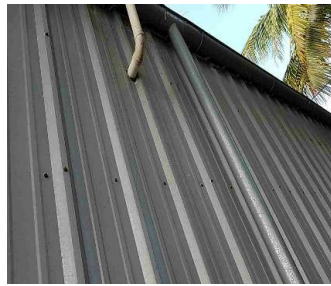
5.

**Location:** Exterior Right **System:** Exterior **Condition:** Unsealed AC Condensate Drain Through Exterior Wall

**Explanation:** The penetration of the air conditioning condensate drain is not sealed.

**Impact Consequences:** Seal the drain line penetration in order to prevent pest and water infiltration.

**Recommended Action:** Repair

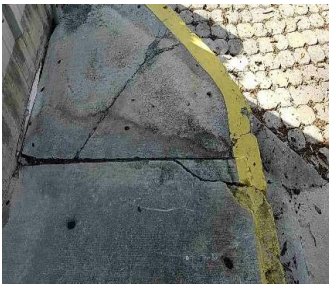
6.

**Location:** Exterior Left **System:** Exterior **Condition:** Trip hazard(s) on walkway

**Explanation:** Uneven surface conditions in the walkway present the risk of tripping for persons traversing the walkway.

**Impact Consequences:** Trip hazards are a safety concern requiring immediate attention.

**Recommended Action:** Repair

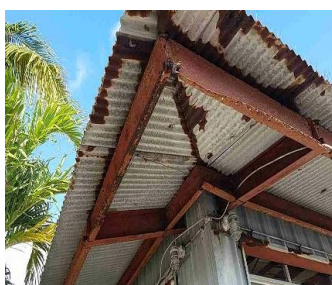
**1.**

**Location:** Exterior Right **System:** Structure **Condition:** Deteriorated or Damaged Beams

**Explanation:** Structural support beams are observed to be damaged or deteriorated.

**Recommended Action:** Repair

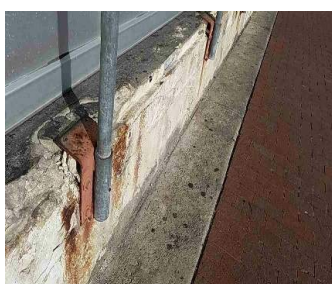
**2.**

**Location:** Exterior Right **System:** Structure **Condition:** Foundation wall is cracked; minor

**Explanation:** Cracks in the foundation wall are observed during examination of the exterior of the building. At the time of inspection the crack(s) are regarded to be minor. Ascertaining the cause of a crack cannot be readily determined during a building inspection but are typically due to shrinkage of the concrete during curing settlement of soils below the footings pressure of soils against the foundation wall or from a physical shock seismic or hydrological event. At the time of inspection adverse effects are not observed.

**Recommended Action:** Monitor

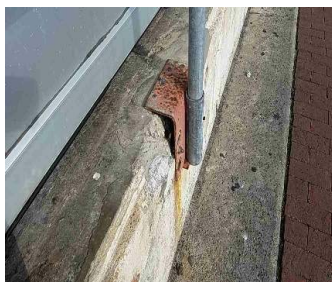
3.

**Location:** Exterior Right **System:** Structure **Condition:** Foundation wall is damaged

**Explanation:** An area of damage is noted in the foundation wall.

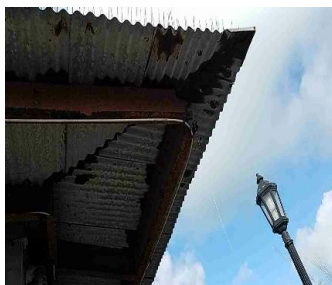
4.

**Location:** Exterior Right **System:** Structure **Condition:** Deteriorated or Damaged Beams

**Explanation:** Structural support beams are observed to be damaged or deteriorated.

**Recommended Action:** Repair

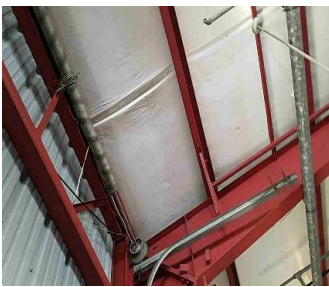
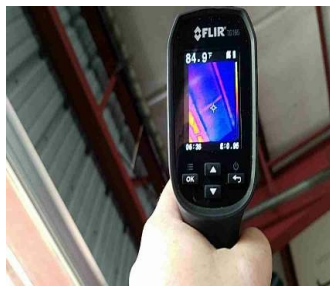
1.

**Location:** Lounge **System:** Interior **Condition:** DRY Ceiling Stain Roof Leak

**Explanation:** A stain on a ceiling surface is observed to test low for moisture content using moisture meters or thermal imaging camera. The source of the moisture intrusion is suspected to be from a past roof leak which may or may not have been repaired.

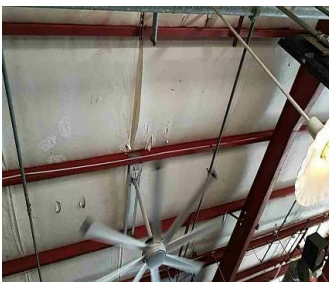
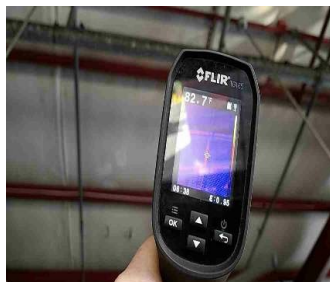
2.

**Location:** Lounge **System:** Interior **Condition:** WET Ceiling Stain Roof Leak

**Explanation:** A stain on a ceiling surface is observed to test high for moisture content

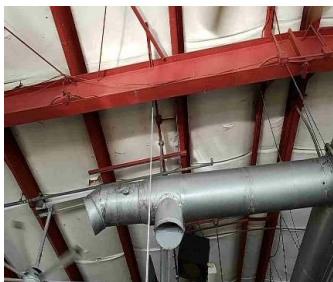
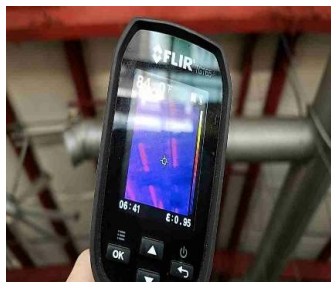
3.

**Location:** Lounge **System:** Interior **Condition:** DRY Ceiling Stain Roof Leak

**Explanation:** A stain on a ceiling surface is observed to test low for moisture content using moisture meters or thermal imaging camera. The source of the moisture intrusion is suspected to be from a past roof leak which may or may not have been repaired.

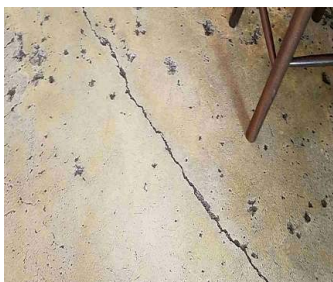
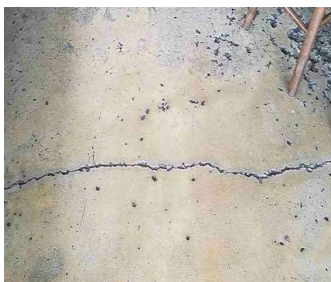
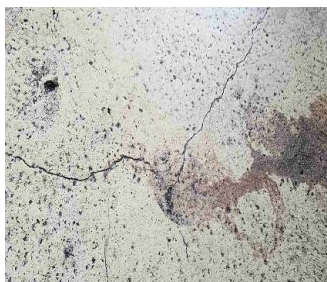
4.

**Location:** Throughout **System:** Interior **Condition:** Typical Settlement of Concrete Floor

**Explanation:** The exposed concrete floor displays typical settlement cracks.

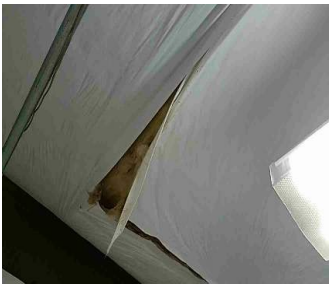
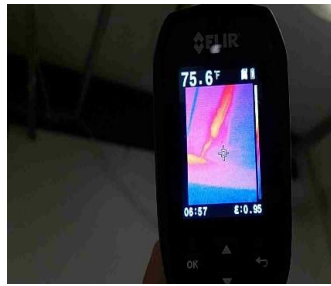
5.

**Location:** Storage **System:** Interior **Condition:** WET Ceiling Stain Roof Leak

**Explanation:** A stain on a ceiling surface is observed to test high for moisture content using moisture meters or thermal imaging camera. The source of the moisture intrusion is suspected to be from an active roof leak.

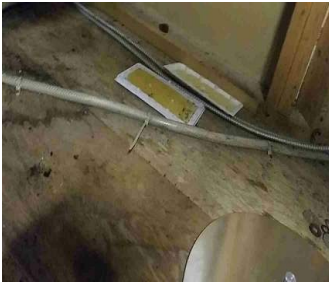
6.

**Location:** Storage **System:** Interior **Condition:** Evidence of pest entry.

**Explanation:** There is indication of pest entry into the interior of the building.

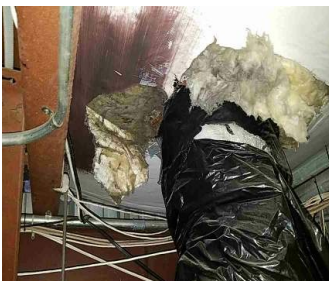
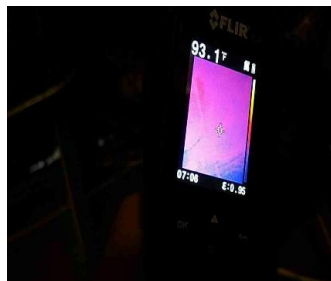
7.

**Location:** Storage **System:** Interior **Condition:** WET Ceiling Stain Roof Leak

**Explanation:** A stain on a ceiling surface is observed to test high for moisture content using moisture meters or thermal imaging camera. The source of the moisture intrusion is suspected to be from an active roof leak.

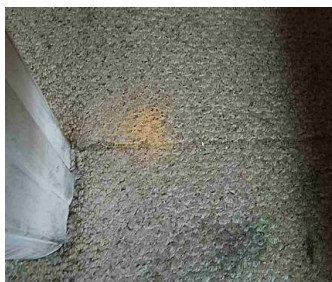
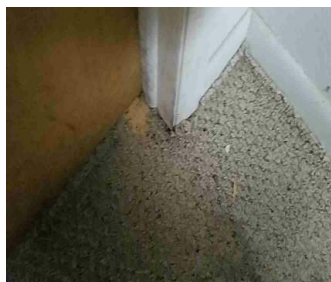
8.

**Location:** Office **System:** Interior **Condition:** Pest Damage Suspected

**Explanation:** Damage to interior components is suspected to be from pest entry

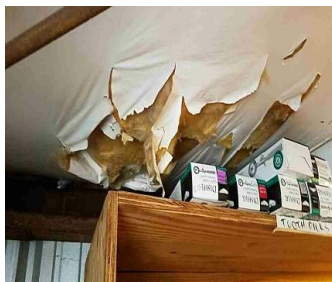
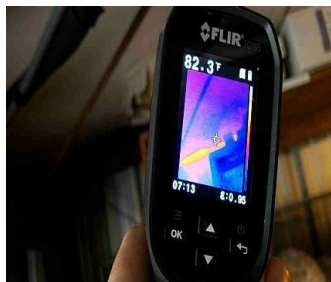
9.

**Location:** Storage **System:** Interior **Condition:** WET Ceiling Stain Roof Leak

**Explanation:** A stain on a ceiling surface is observed to test high for moisture content using moisture meters or thermal imaging camera. The source of the moisture intrusion is suspected to be from an active roof leak.

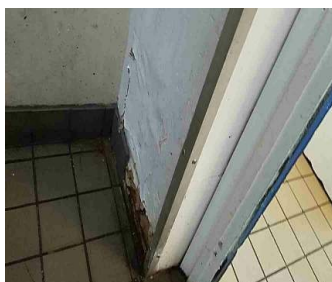
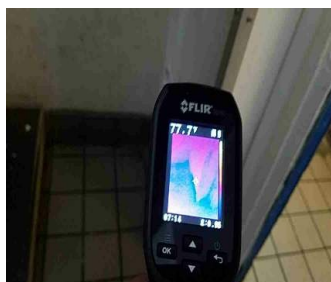
10.

**Location:** Kitchen **System:** Interior **Condition:** WET Wall Stain Plumbing Component Leak

**Explanation:** A stain on a wall surface is observed to test high for moisture content using moisture meters or thermal imaging camera. The source of the moisture intrusion is suspected to be from an active plumbing distribution or drain pipe leak.

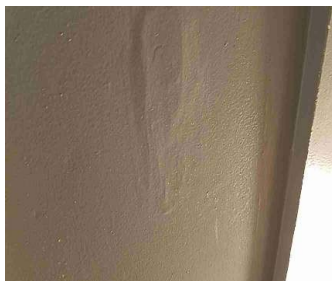
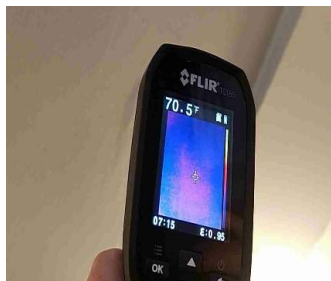
11.

**Location:** Kitchen **System:** Interior **Condition:** WET Ceiling AC Component Leak

**Explanation:** A stain on a ceiling surface is observed to test high for moisture content using moisture meters or thermal imaging camera. The source of the moisture intrusion is suspected to be from an active air conditioning component leak.

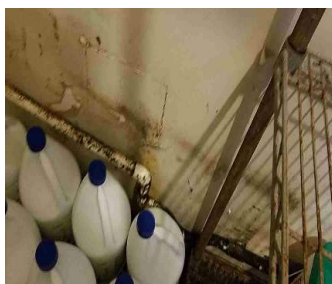
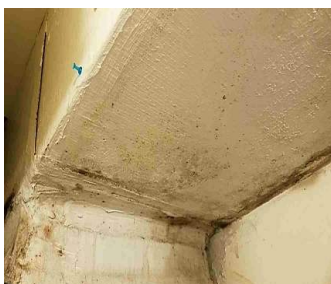
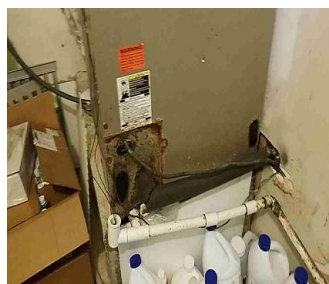
12.

**Location:** Kitchen **System:** Interior **Condition:** Mold Suspected On Interior Surfaces

**Explanation:** Mold or Fungus is observed to be growing on interior surfaces.

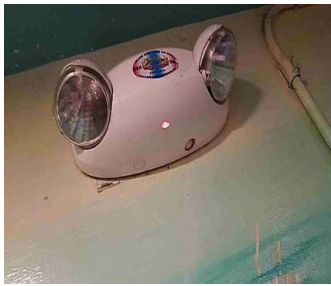
13.

**Location:** Mens Restroom **System:** Interior **Condition:** Failed Flood Light Test  
**Explanation:** The flood light failed to illuminate upon restricting the power source or using the test button.  
**Impact Consequences:** Flood lights should be installed with a battery backup in case of power loss. Replace the battery or fixture in order to restore its intended function.  
**Recommended Action:** Repair or Replace  
[Click here to find out more about this item](#)

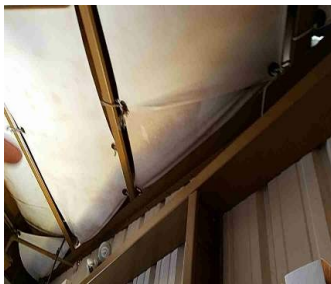
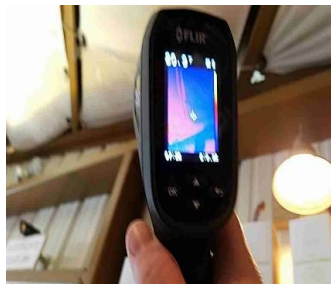
14.

**Location:** Gift Shop **System:** Interior **Condition:** WET Ceiling Stain Roof Leak  
**Explanation:** A stain on a ceiling surface is observed to test high for moisture content using moisture meters or thermal imaging camera. The source of the moisture intrusion is suspected to be from an active roof leak.  
**Impact Consequences:** The roof area above the ceiling should be investigated further by a licensed roofing contractor in order to determine the extent of the leak as well as the proper remedy. A health hazard may be present should the moisture accumulation provide an ideal environment for mold to grow. A separate line item deficiency will be noted within this report should the Inspector observe surface mold growth in the noted location.  
**Recommended Action:** Repair  
[Click here to find out more about this item](#)

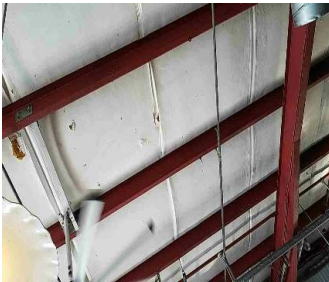
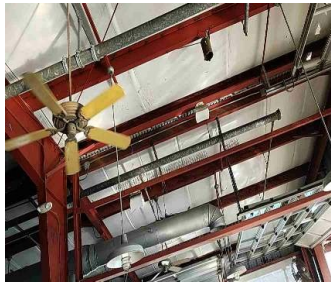
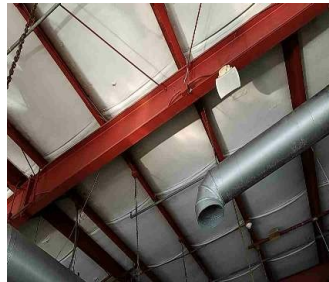
1.

**Location:** Throughout **System:** Insulation Ventilation **Condition:** Damaged Interior Roof Decking Insulation

**Explanation:** The insulation attached to the interior roof deck is damaged.

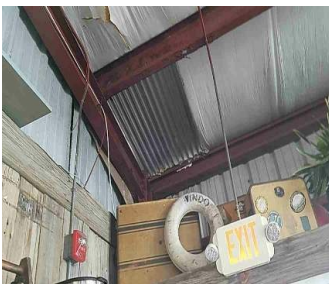
2.

**Location:** Main Dining Room **System:** Insulation Ventilation **Condition:** Loose Interior Roof Deck Insulating Materials

**Explanation:** Interior roof deck insulation is not adequately secured.

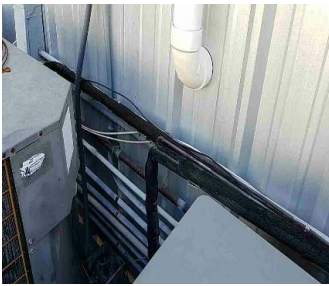
**1.**

**Location:** Exterior Left **System:** Heating And Cooling **Condition:** Refrigerant Line Insulation Missing or Damaged

**Explanation:** The insulated covering for the refrigerant line is missing or damaged.

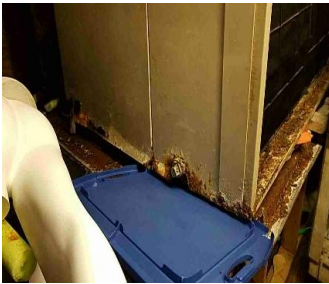
2.

**Location:** Storage **System:** Heating And Cooling **Condition:** Evaporator unit is damaged

**Explanation:** Physical damage is noted to the evaporator section of the air conditioner. Damage is often due to mishandling during cleaning and maintenance and can include damage to the coils fins or casing.

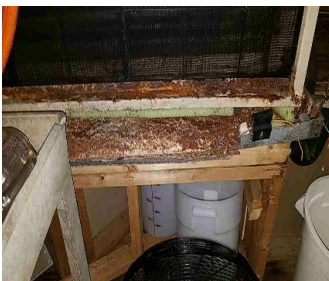
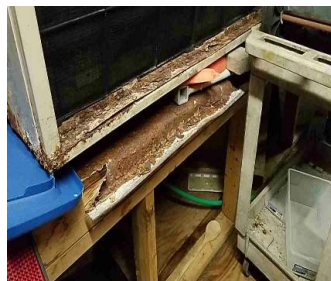
3.

**Location:** Storage **System:** Heating And Cooling **Condition:** Deteriorated Drip Pan

**Explanation:** Drip pan for condensation system is deteriorated.

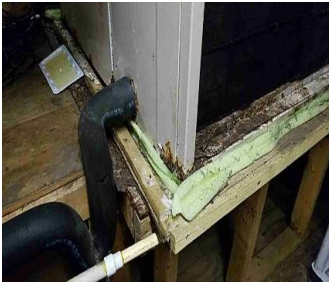
4.

**Location:** Storage **System:** Heating And Cooling **Condition:** Evaporator unit is damaged

**Explanation:** Physical damage is noted to the evaporator section of the air conditioner. Damage is often due to mishandling during cleaning and maintenance and can include damage to the coils fins or casing.

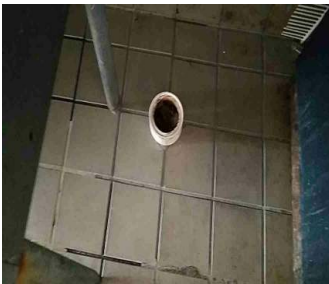
1.

**Location:** Lounge **System:** Plumbing **Condition:** Drainage system has unsealed openings

**Explanation:** An opening in the drainage system is observed to not be sealed or is improperly sealed.

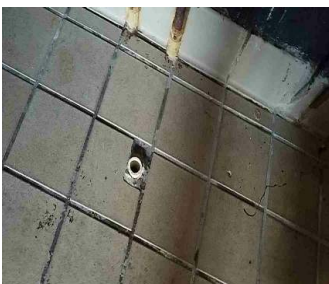
2.

**Location:** Lounge **System:** Plumbing **Condition:** Drainage system has unsealed openings

**Explanation:** An opening in the drainage system is observed to not be sealed or is improperly sealed.

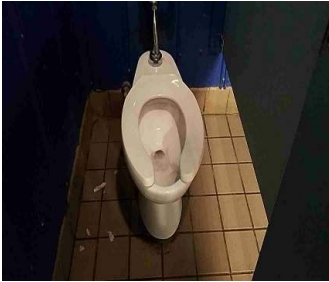
3.

**Location:** Womens Restroom **System:** Plumbing **Condition:** Toilet is loose

**Explanation:** The toilet is observed to be not securely affixed to the floor.

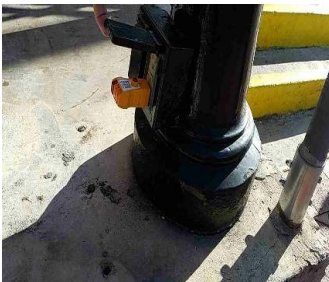
1.

**Location:** Exterior Front **System:** Electrical **Condition:** Electrical outlet does not work

**Explanation:** An electrical outlet is observed to be inoperative.

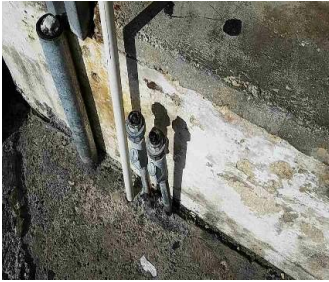
2.

**Location:** Exterior Right **System:** Electrical **Condition:** Unterminated active wiring observed

**Explanation:** Wires are observed to be not terminated in a protective box and this wiring is active.

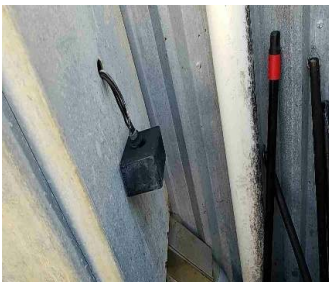
3.

**Location:** Exterior Left **System:** Electrical **Condition:** Surge Suppression Requires Replacement

**Explanation:** The surge suppression device installed in the panel indicates it requires to be replaced.

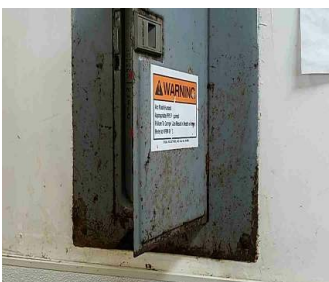
4.

**Location:** Kitchen **System:** Electrical **Condition:** Evidence of water at electrical distribution or sub panel.

**Explanation:** An electrical panel or sub panel displays the presence of current or past water infiltration into the panel or to its exterior

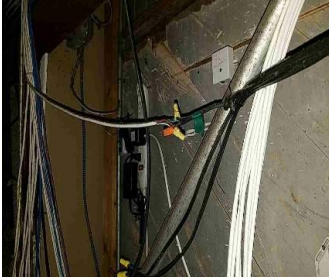
5.

**Location:** Storage **System:** Electrical **Condition:** Wire connections are not performed in boxes

**Explanation:** Splices are observed wire runs. Splices are not permitted to be applied in locations outside of protective boxes.

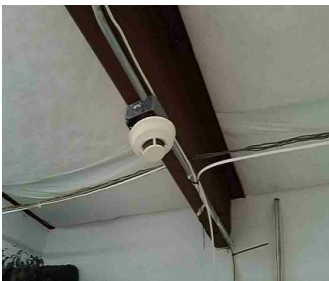
6.

**Location:** Office **System:** Electrical **Condition:** Detector [smoke fire or CO] is loose

**Explanation:** A smoke fire or carbon monoxide detector is observed to be not adequately secured at its present location.

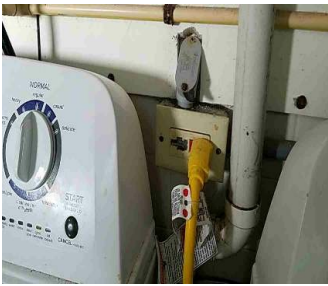
7.

**Location:** Kitchen **System:** Electrical **Condition:** Electrical outlet is damaged  
**Explanation:** An electrical outlet is observed to be damaged. The usual cause is due to impact or other forms of mechanical action to fracture the insulating body of the outlet.

**Impact Consequences:** An outlet that has been damaged may result in the internal contacts not being secured as required and the risk of short circuiting and arcing is now possible. Damaged outlets should be considered a safety hazard and should be immediately replaced.

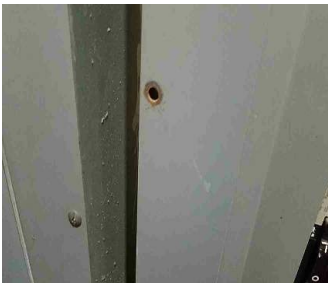
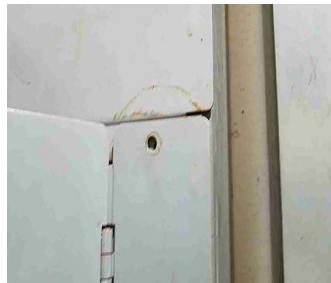
## 8.

**Location:** Kitchen **System:** Electrical **Condition:** Panel cover screws are missing on the electrical panel

**Explanation:** All screws for electrical panel covers should be installed to assure that the cover is properly located and securely attached. Screws used to secure the cover must be of the type supplied by the manufacturer which have tips that are blunted to prevent the piercing of wires when turning the screws into place.
