RESOLUTION NO. 18-088

## **ORDER TO REPAIR, ALTER, OR IMPROVE BUILDINGS**

# Structural Condition Assessment Key West Diesel Plant Key West, Florida

Re: Structural Condition Assessment  
Key West Diesel Plant  
Key West, Florida

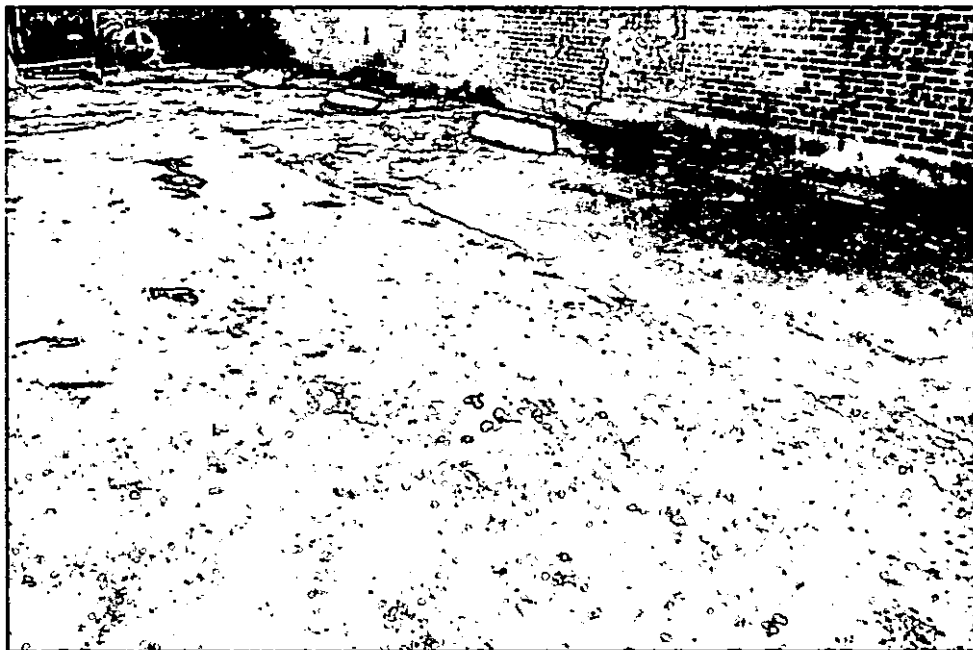
PHOTOGRAPH 14 (BUILDING I)

1. The northernmost, eastern building (Building I) has been recently re-roofed and the original wood structure supported by the steel beams and trusses have been replaced with plywood sheathing and wood trusses. The new roofing and roof structure is in excellent condition except that the roofing screws are not stainless steel and are corroding (see Photograph 12). The original steel beams, trusses and columns are in good condition with surficial corrosion except for one (1) column, which has a badly corroded base with more than 20% material loss (see Photograph 13). The slab on grade is cracked and uneven and there is a large crack at the interior door to the adjacent building, and several of the western window sills are spalled with corroded reinforcing and the remainder are cracked (see Photographs 14, 15 and 16).

Building I is in good condition with the exterior masonry requiring repair and several window lintels requiring replacement. The steel structure is in good condition with surficial corrosion except for one (1) column that needs reinforcement due to excessive corrosion at its base. All of the steel needs to be cleaned of corrosion and coated with a corrosion inhibiting coating. The slab on grade is cracked and uneven and is due for replacement. The exterior masonry requires repointing and all of the corroded embedments and steel lintels need to be cleaned of corrosion and coated with a corrosion inhibiting coating. The deteriorated face brick needs to be removed and replaced and the vegetation in the wall cracks needs to be removed and the cracks repointed. At the western return metal panel wall, the badly corroded angle purlin needs replacement as well as the wall metal panels. The concrete spall in this wall also requires repair.

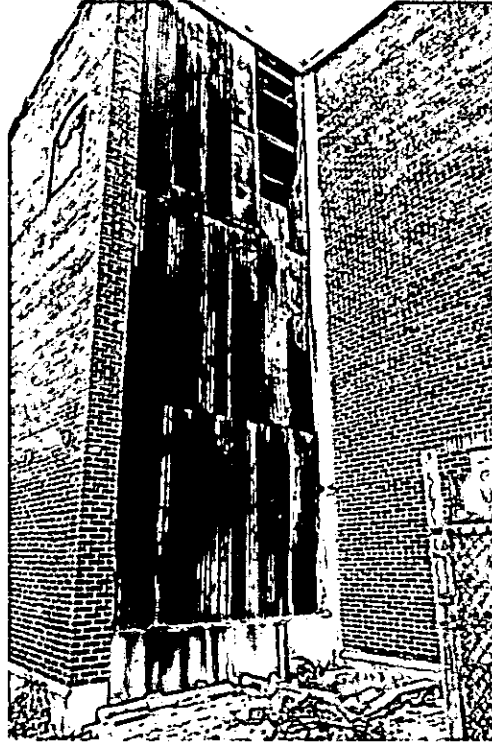
PHOTOGRAPH 27 (BUILDING I)

The exterior masonry walls are in good condition but there are numerous cracks, corroded embedments, deteriorated mortar, corroded lintels, deteriorated face brick, brick cracks with vegetation and random cracks in the concrete water table (see Photographs 17, 18, 19, 20, 21, 22 and 23). At the western return metal panel wall, there is a badly corroded angle purlin and a large column spall with corroded reinforcing and an area of missing metal wall panel (see Photographs 24, 25 and 26). The remaining metal panels are corroded and in poor condition (see Photograph 27).

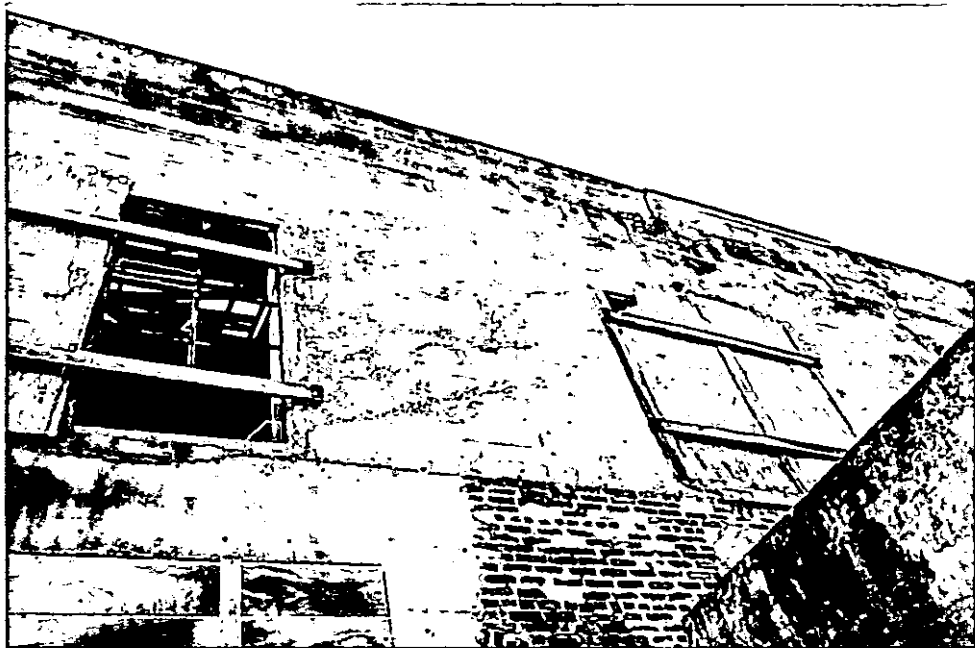
PHOTOGRAPH 44 (BUILDING IV)

- IV. The southernmost eastern building (Building IV) is in worse condition than Building II with a large area of missing metal roofing and wood sheathing, a deteriorated bottom roof truss chord and a wall opening with numerous loose and missing bricks with bricks falling (see Photographs 40, 41 and 42). The wood roof joists are in poor condition but the wood trusses appear in good condition. The steel structure is in good condition with surficial corrosion but many of the steel column bases are severely corroded with more than 20% material loss (see Photograph 43). The exterior masonry walls are in good condition but there are numerous cracks, corroded embedments, deteriorated mortar and loose and missing face brick. The upper concrete walls have large areas of honey combed concrete and an area of spalled concrete with corroded reinforcing (see Photographs 44 and 45).

The remainder of the buildings are in worse condition than Building I with Building IV being in the worst condition with a portion of missing roof. These buildings are stable but require new roofs with extensive roof sheathing replacement and some wood structure reinforcement and replacement. At the areas of missing and badly deteriorated roofing, these roofs could sustain significant damage in a severe wind event losing the remainder of their roofing and sheathing. In general, the steel structure is in good condition with surficial corrosion but several columns will need reinforcement due to excessive corrosion at their bases. All of the steel needs to be cleaned of corrosion and coated with a corrosion inhibiting coating. At Building IV, the wall opening with numerous loose and missing bricks and falling bricks needs to be shored or repaired immediately to prevent further deterioration of the wall. The exterior masonry walls are in good condition except for the northwest corner of Building II where there is a large area of missing brick that needs to be rebuilt. The remaining walls need to be repointed, deteriorated face brick removed and replaced and the vegetation in the wall cracks removed and the cracks repointed. Like Building I, all of the corroded embedments and steel lintels need to be cleaned of corrosion and coated with a corrosion inhibiting coating. In many of the arched brick openings, brick has been infilled with no lintel installed. This infill brick is being held in place by the mortar alone and in areas is cracking. This infill brick needs to be removed or steel lintels installed to support it. At Building II, the concrete platform is in poor condition with large spalls and the concrete carbonated to the reinforcing with the concrete containing high levels of chlorides. If it is the owner's desire to rehabilitate this platform when the concrete is repaired, it should be treated with a penetrating corrosion inhibitor or an active cathodic protection system installed. Due to the thickness of the platform walls, both will be expensive, therefore strong consideration should be taken for demolishing this platform. The exterior concrete walls and pits, except for Building V, are in poor condition requiring extensive repair. Like the Building II concrete platform, the concrete contains high levels of chlorides and once repaired, the walls should be treated with a penetrating corrosion inhibitor or an active cathodic protection system installed, and the exterior concrete coated with a penetrating sealer. The exterior pits and chutes are abandoned and should be cleaned of debris, the top of the deteriorated walls demolished to 8" below grade and filled with clean fill or stone. All of the interior trench and pit edge angles are in poor condition and badly corroded. All of the dynamo pits are full of water and breeding mosquitos. When the deteriorated dynamos are removed, the pits need to be pumped empty of water. The pits and trenches need to be dewatered, cleared of debris with the edge angles removed, and the pits and trenches filled with clean fill or stone with a concrete slab on grade placed, drilled and adhesived into the pit and trench walls level with the surrounding concrete slabs on grade. If any of the dynamos are kept for display, their pits should be pumped empty of water and filled and capped as described above.

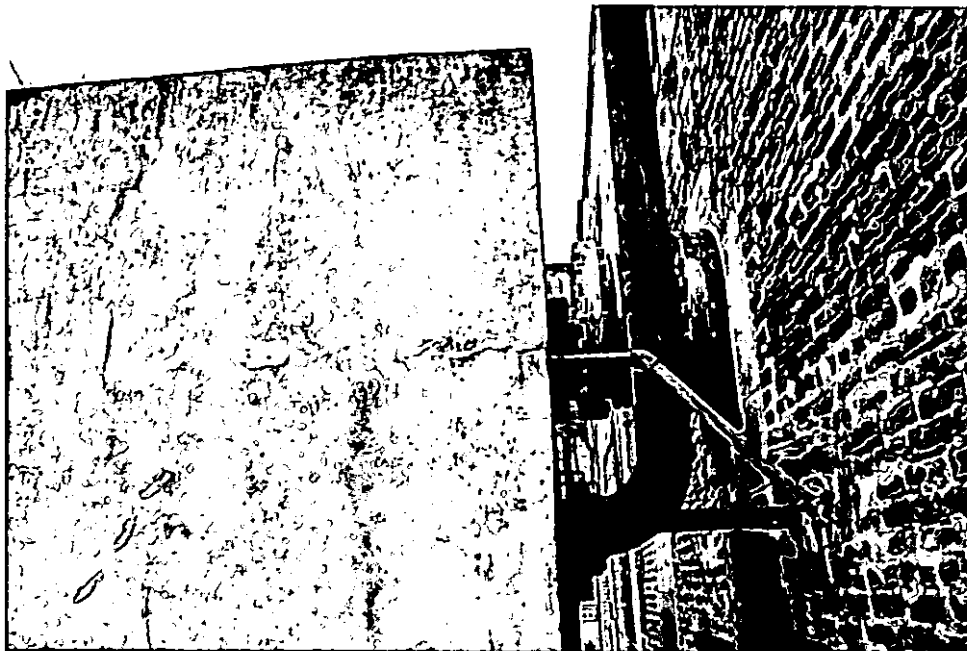
- V. The concrete exhaust building (Building V) is in good condition with corroded steel ladders; a badly corroded pipe support, a cracked housekeeping pad and a hairline crack in the roof parapet (see Photographs 50, 51, 52 and 53). The exterior pit and chute walls are in poor condition with cracked and spalling concrete with corroding reinforcing (see Photograph 54). All of the interior pits are full of water and breeding mosquitos. The interior trench and pit edge angles are in poor condition and badly corroded (see Photograph 55). All of the dynamos are in poor condition and badly corroded (see Photograph 56).

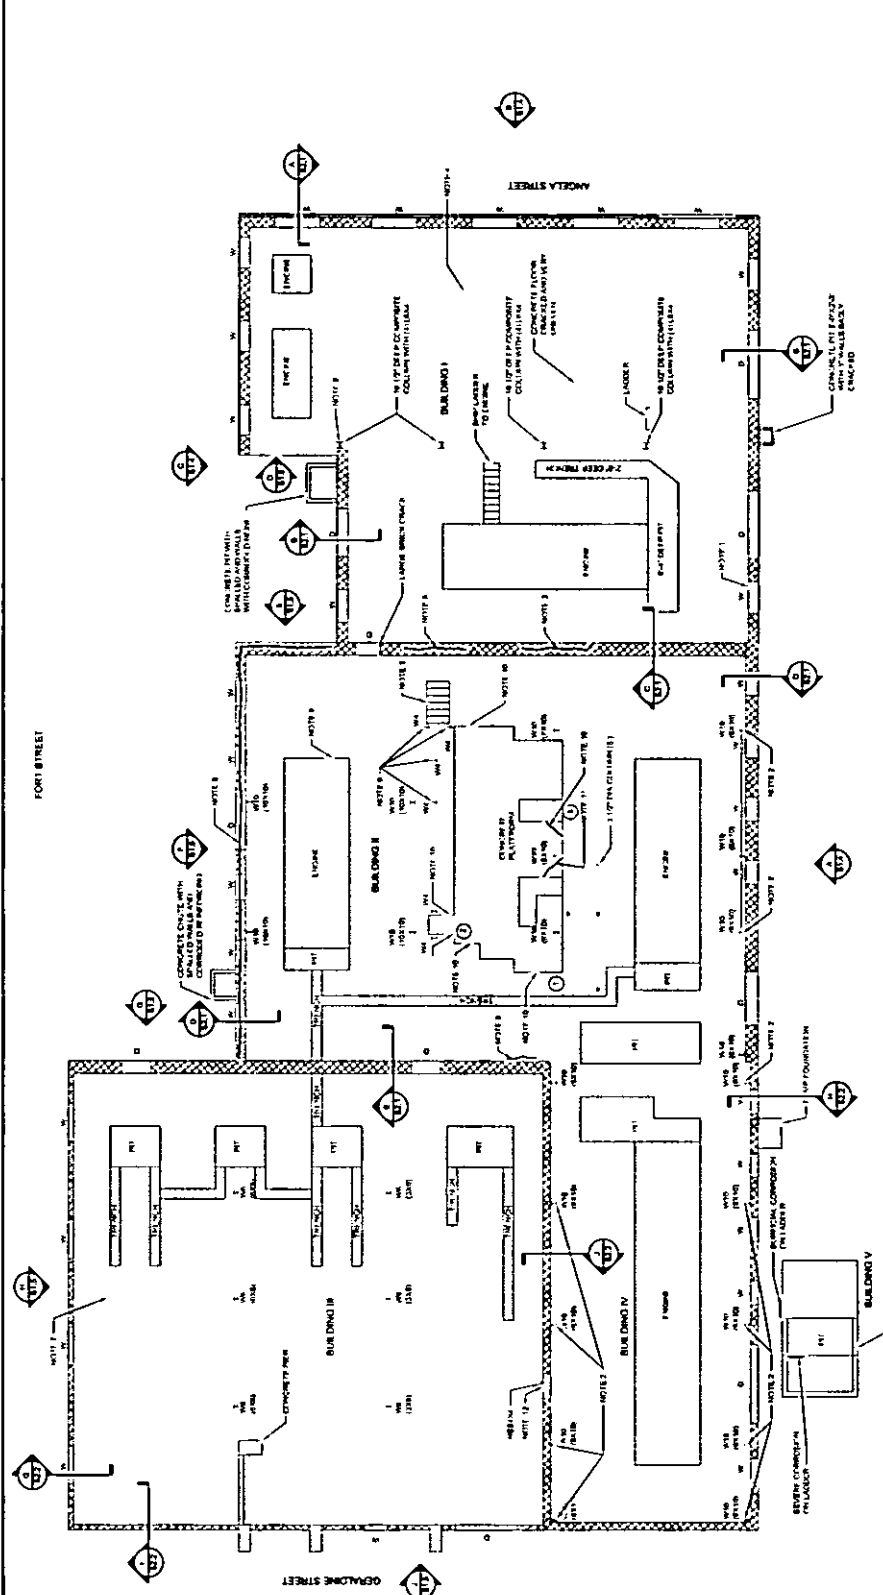
## EXISTING FLOOR PLAN

- REMARKS:
1. DETERMINED FACE OF BRICK.
  2. EXISTING CONCRETE COLUMN BAY AND ON COLUMN.
  3. CRACKS IN BRICK AT WALL FOR TREATING AND CLEANING OPERATIONS.

4. CONCRETE FLOOR CRACKED AND UNLEVEL.
  5. EXISTING CONCRETE FLOOR CRACKED AND UNLEVEL.
  6. EXISTING CONCRETE FLOOR CRACKED AND UNLEVEL.
  7. CONCRETE FLOOR CRACKED AND UNLEVEL - TRENCH AND PIT EDGE.
