**Subject: Key West Bight Marina Pile Assessment
From Dock H1 through Dock A**

CITY OF KEY WEST
PORT & MARINE SERVICES

KEY WEST BIGHT MARINA
DOCK AND PIER PILE ASSESSMENT REPORT

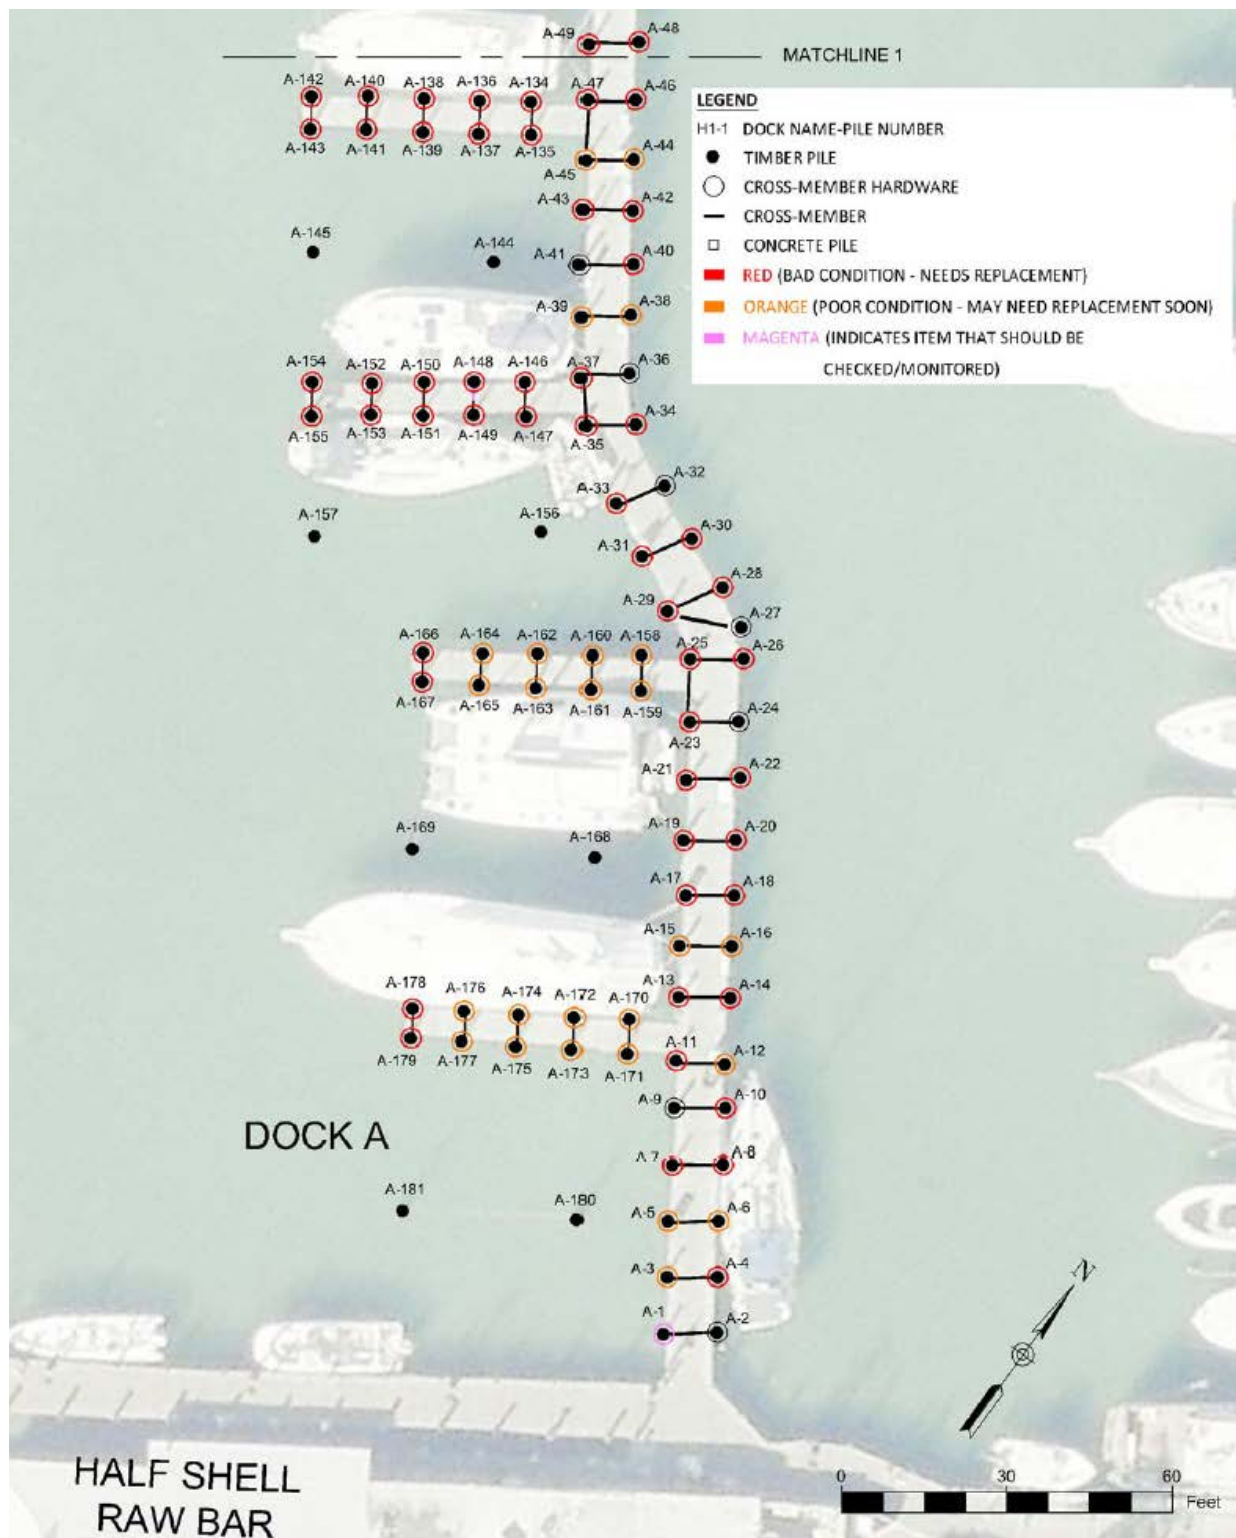
Figure 2: Dock A Plan View with Deficiencies

Dock A consisted of timber support piles, both horizontal and diagonal cross-members, and mooring piles. The condition of all the piles was found to be satisfactory (no major deficiencies noted for any of the piles). As shown in Figure 2 and Figure 3, however, there were various cross-member hardware that were galvanized steel and showed signs of minor to heavy corrosion. The galvanized corroded hardware was mainly contained to the horizontal cross-member connections, along with a few observed on the diagonal cross-members. Figure 4 shows the view of a typical component with galvanized corroded hardware. At least 149 connection points had the corroded galvanized hardware, making the number of bolts/all-threads that would need to be replaced approximately 298. Refer to Table 1 below for the summary of Harbor Walk deficiencies and to Appendix A for the condition descriptions of all components inspected.

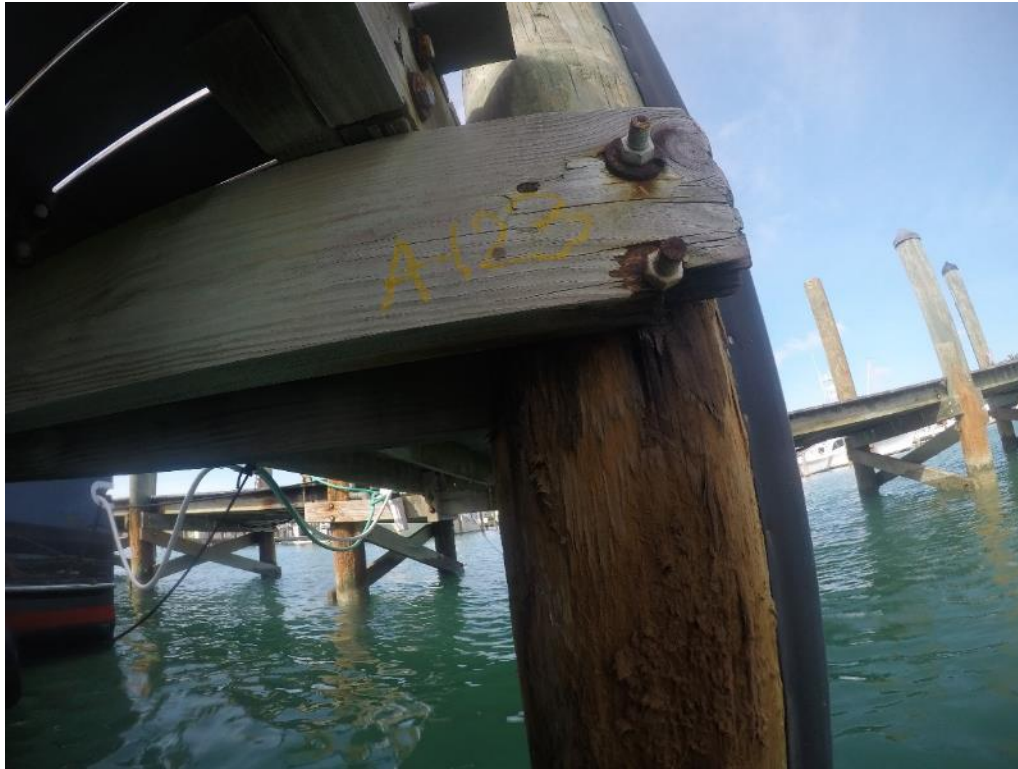
Figure 4: Pile A-123 with Corroding Galvanized Bolt Connections

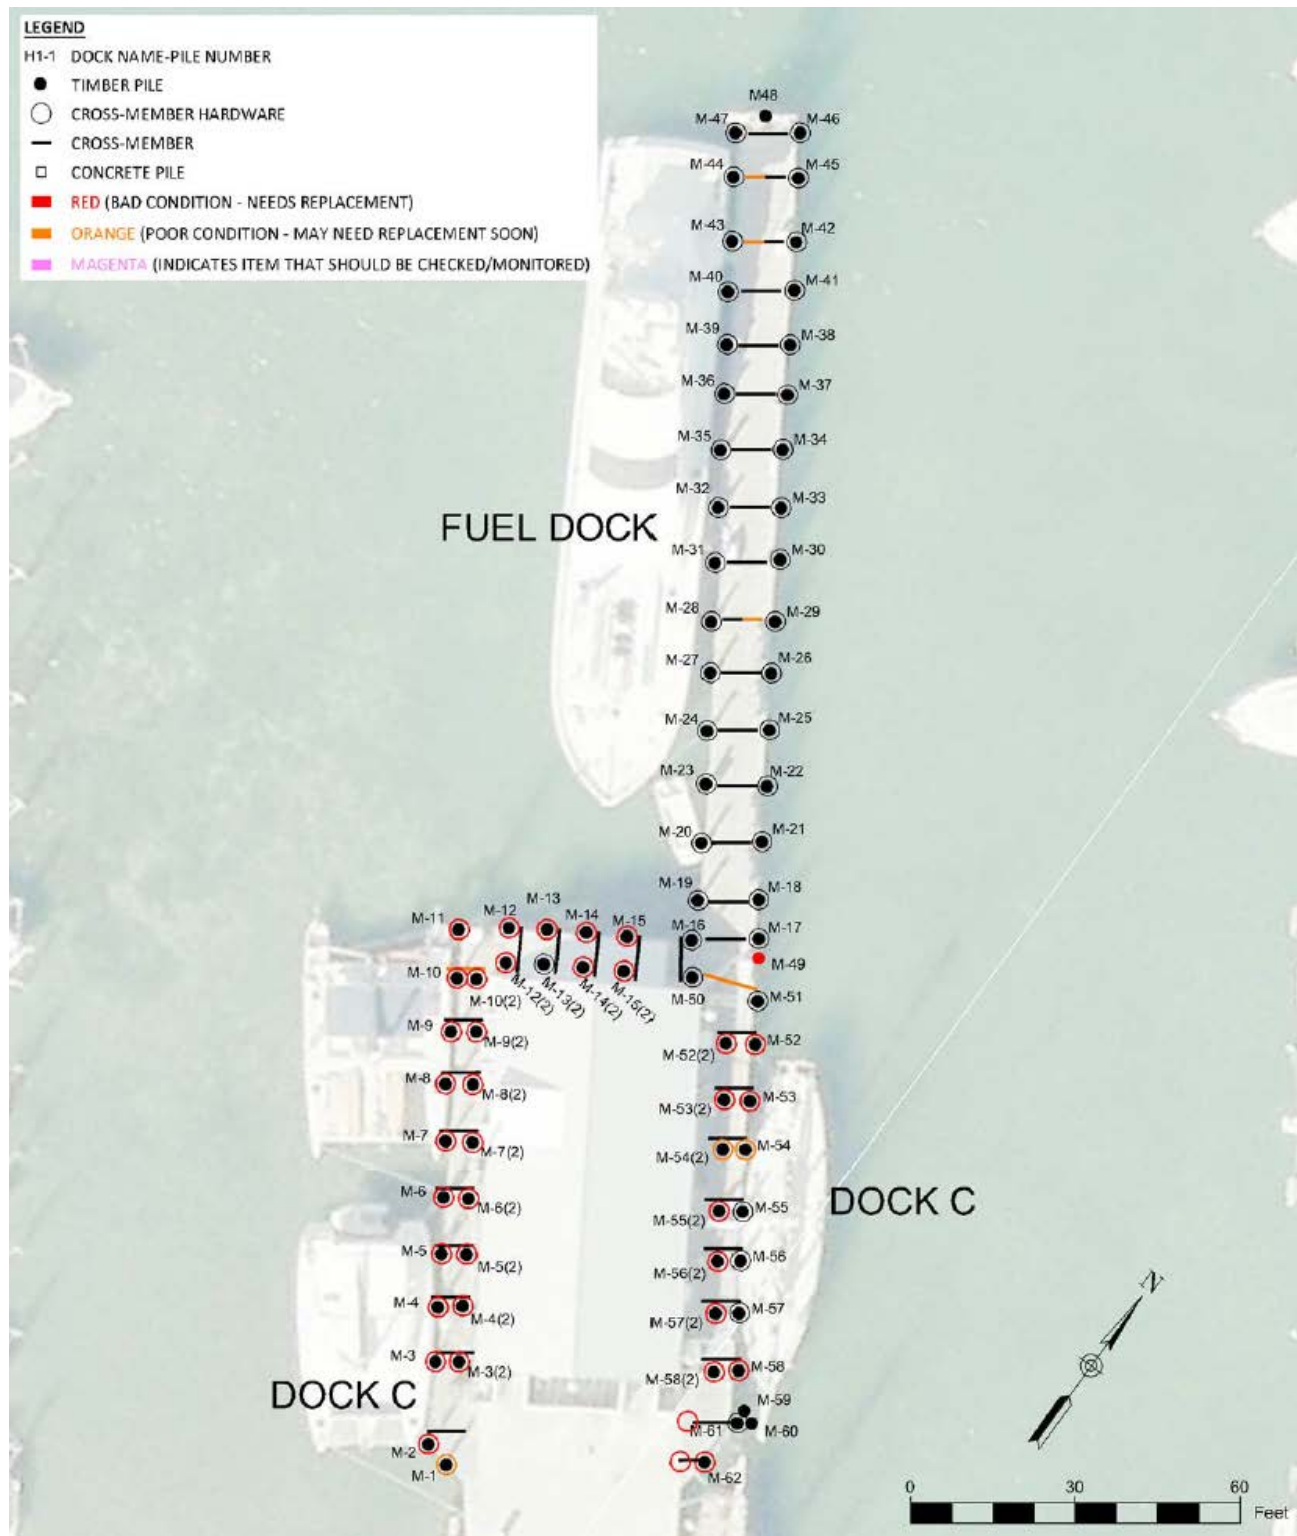
Figure 5: Dock C and Fuel Dock with Deficiencies

The piles for Dock C and the Fuel Dock were labeled as “M” during the inspection, as a dock name had not yet been determined. As can be seen from Figure 5, the main source of deficiencies on Dock C consist of the galvanized corroded hardware on the pile cross-members. Pile M-49 was in bad condition, just north of the Dock Master’s office. Along the Fuel Dock, there were various piles with abandoned man-made holes from cleats that have since been relocated, and there did not appear to be any major damage to the piles. There were some horizontal cross-members on the Fuel Dock that did show signs of damage (splitting/cracking, possible boat impact damage), an example of which is shown in Figure 6. At least 40 connection points had the corroded galvanized hardware, making the number of bolts/all-threads that would need to be replaced approximately 80. Refer to Table 3 below for the summary of Harbor Walk deficiencies and to Appendix A for the condition descriptions of all components inspected.

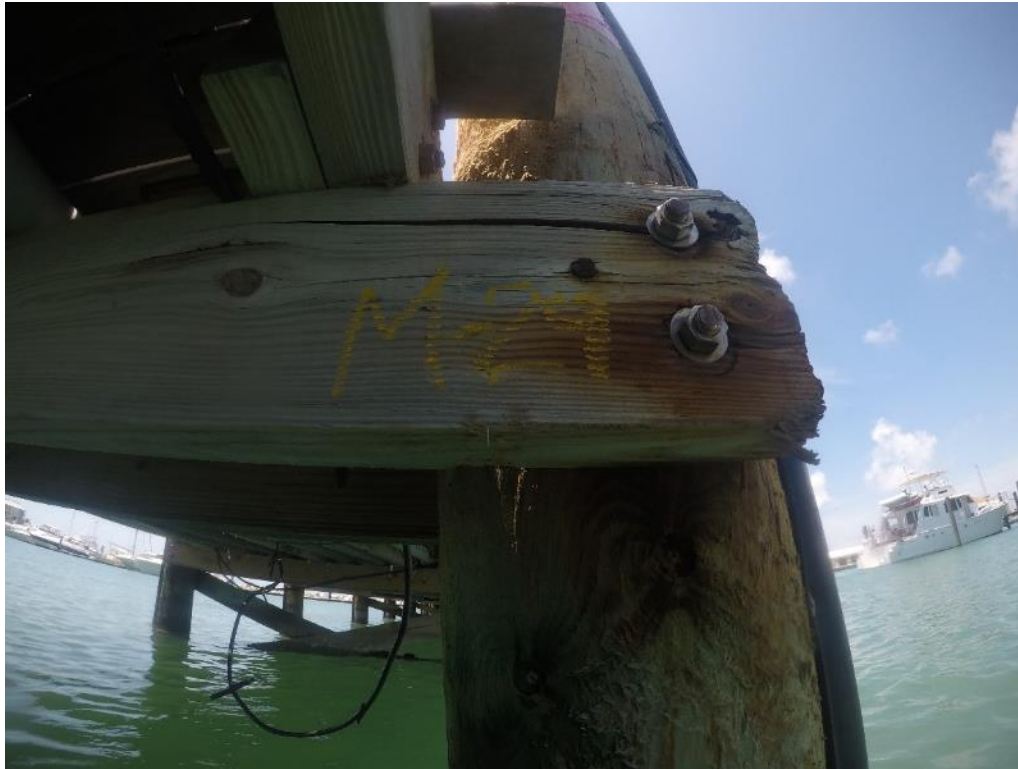
Figure 6: Pile M-29 Showing Cracked Horizontal Cross-Member

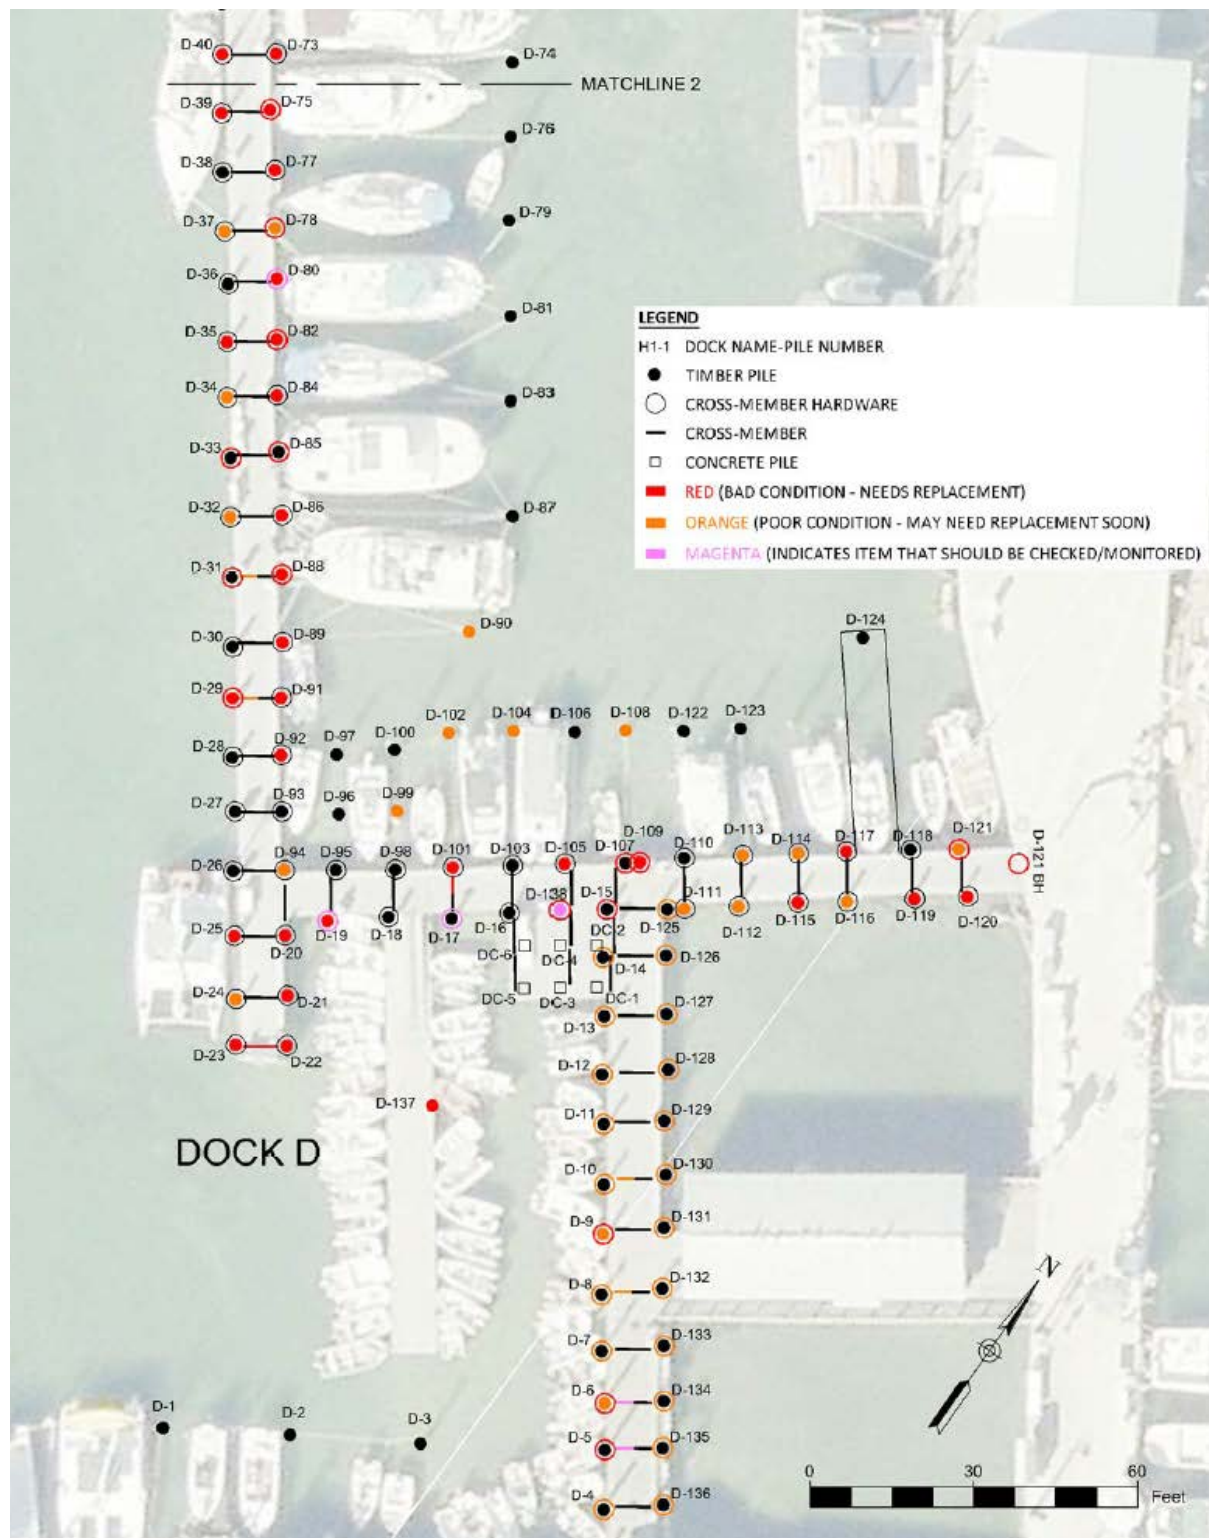
Figure 7: Dock D with Deficiencies

Dock D presented the most issues out of all of the docks, as can be seen in Figure 7 and Figure 8, as well as in the Table in Appendix A. Major rot/wear of approximately 30-80% section loss in the tidal zone was observed on at least 40 of the piles that support the dock, and an additional 24 piles were showing signs of rot/wear significant enough to be of concern (approximately 10-30% section loss in the tidal zone). Figure 9 and Figure 10 show examples of the type of degradation observed on the piles. At least 40 connection points had the corroded galvanized hardware, making the number of bolts/all-threads that would need to be replaced approximately 80. Refer to Table 5 below for the summary of Harbor Walk deficiencies and to Appendix A for the condition descriptions of all components inspected.

Based on the visual inspection, we recommend that all piles that were noted as being in “bad” condition be replaced, especially with regard to the various piles that make up the structural support for Dock D. Changing of connection hardware from galvanized to stainless steel should also be considered for most of the docks that still have these components. This work should be scheduled as soon as practical.

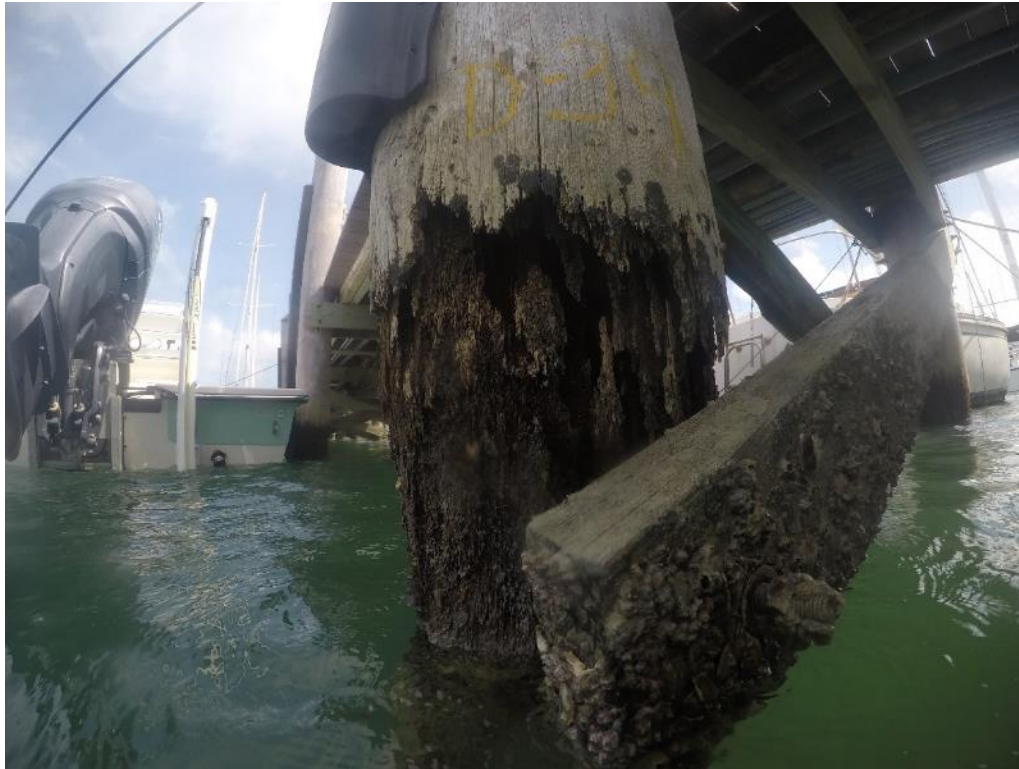
Figure 9: Pile D-39 Showing Rot at Waterline

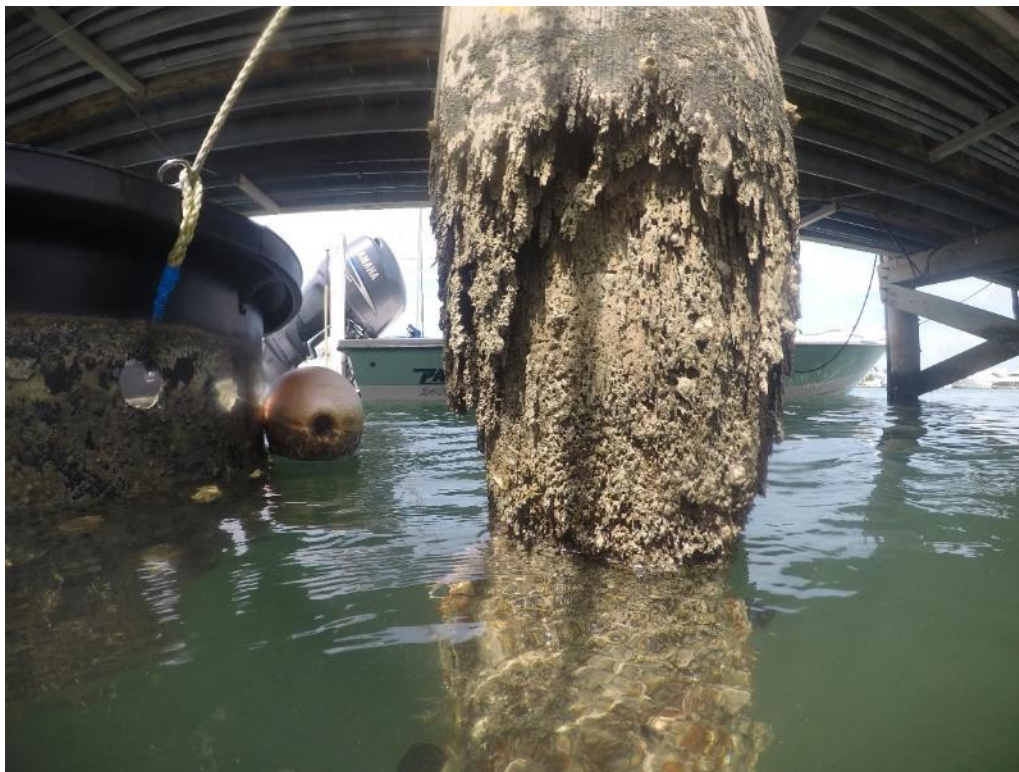
Figure 10: Pile D-73 Showing Heavy Rot at Waterline

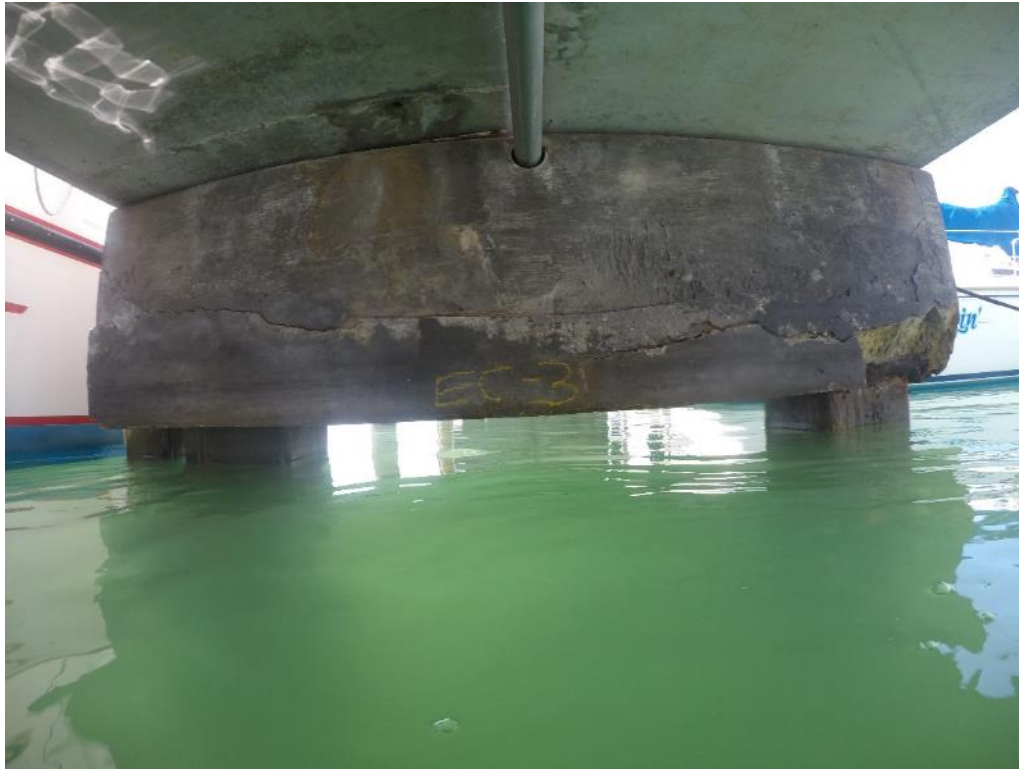
The condition of Dock E is different from the other docks as the timber piles on this dock are mainly fender piles. The configuration of the supports for Dock E is shown in Figure 11, where the supports for the dock are concrete piles all the way until the end, at which point there are two timber piles supporting the dock. The major deficiencies for Dock E consisted mainly of worn fender/mooring piles, of which there were 10 that might be of concern (minor to moderate shaving of the pile with up to 3" diameter loss from wear). At the end of the dock, there were also two timber piles with galvanized hardware connections with surface corrosion on the horizontal cross-member. As for the concrete supports, the first 6 supports are actually for a concrete pier topped with wood decking, after which the dock transitions into a wood pier with concrete piles. Most of the concrete caps on the concrete pier showed signs of horizontal cracking (1/16" to 1/8" thick) or damage (spalling/chipping, with no exposed metal), as shown in Figure 12, which should be monitored for future signs of wear/deterioration. Along the wood pier with concrete piles, all of the horizontal cross-members were attached to the piles by corroding galvanized bolts/all-threads. At least 40 connection points (4 per every concrete pile pair) had the corroded galvanized hardware, making the number of bolts/all-threads that would need to be replaced approximately 80. Refer to Table 7 below for the summary of Harbor Walk deficiencies and to Appendix A for the condition descriptions of all components inspected.

Figure 12: Pile Pair and Cap EC-3 Showing Crack and Spall on Face

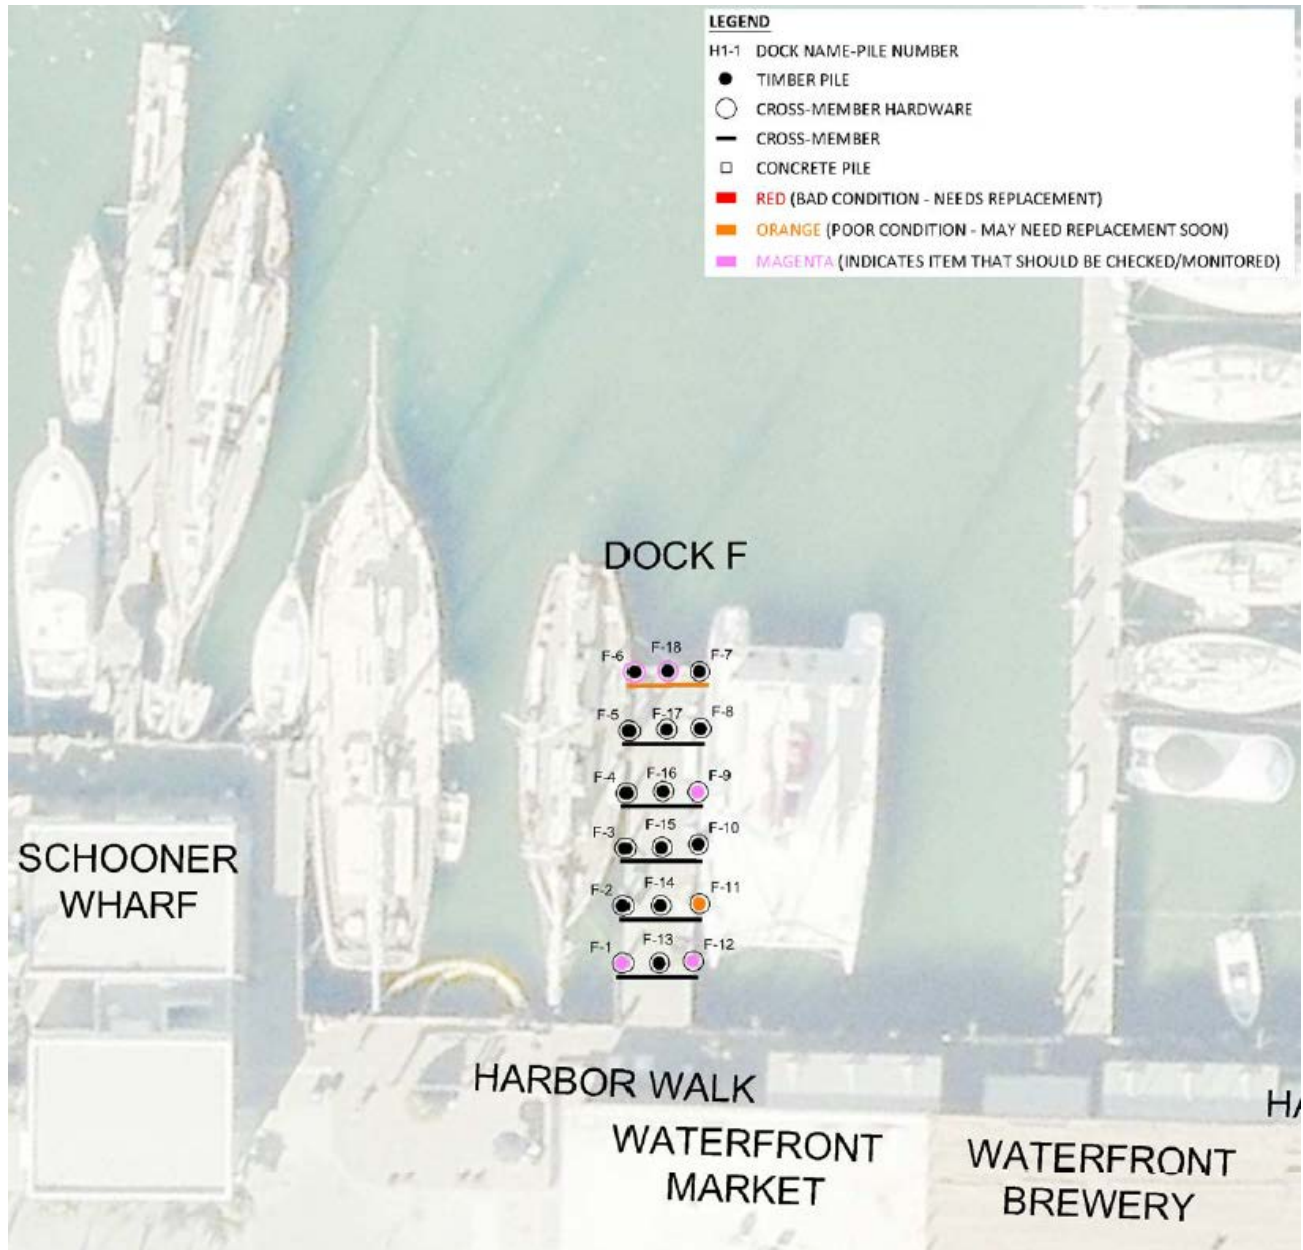
Figure 13: Dock F with Deficiencies

Dock F is a small wide dock, as shown in Figure 13. The only deficiencies noted on this dock were horizontal/diagonal cracking on the horizontal timber member at the end of the dock, as shown in Figure 15, and bent stainless steel hardware connections on pile F-18. Items of note also include that the piles showed signs of splitting/wear along the top. Refer to Table 9 below for the summary of Harbor Walk deficiencies and to Appendix A for the condition descriptions of all components inspected.

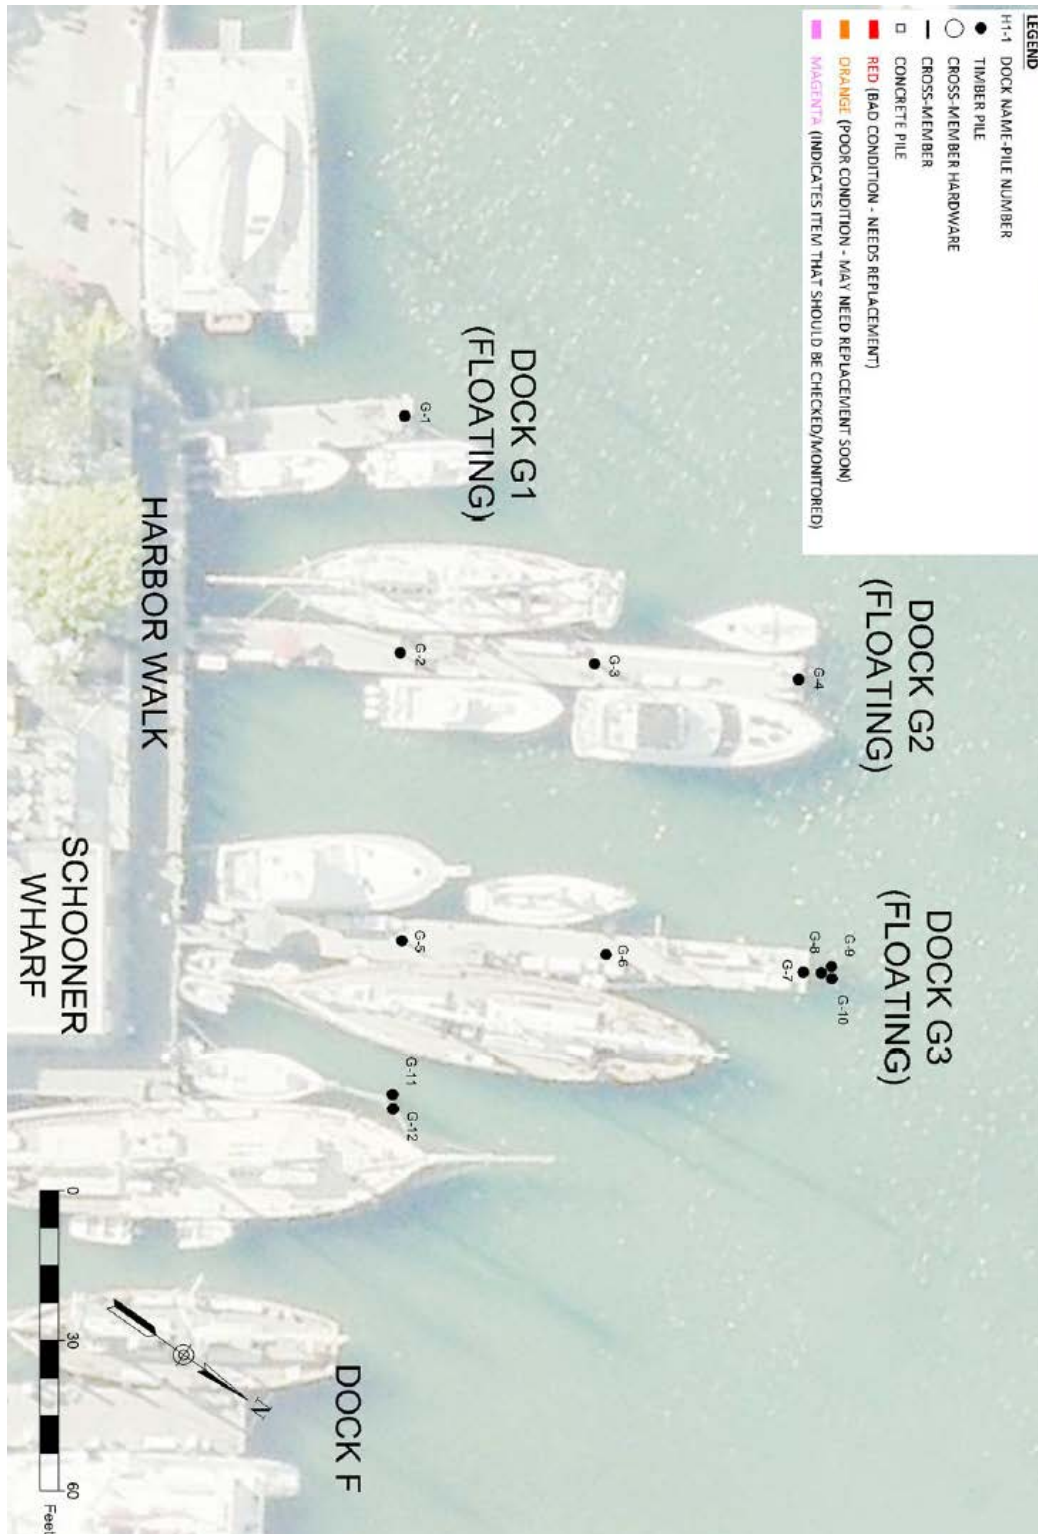
Figure 14: Dock G with Deficiencies

Dock G consists of 3 floating docks, G1, G2, and G3, each of a larger size than the previous, as shown in Figure 14. The support components for these docks are timber guide piles, a dolphin at the end of Dock G3, and 2 mooring piles, all of which appeared to be in good condition. No deficiencies noted. Refer to Appendix A for the condition of all components inspected.

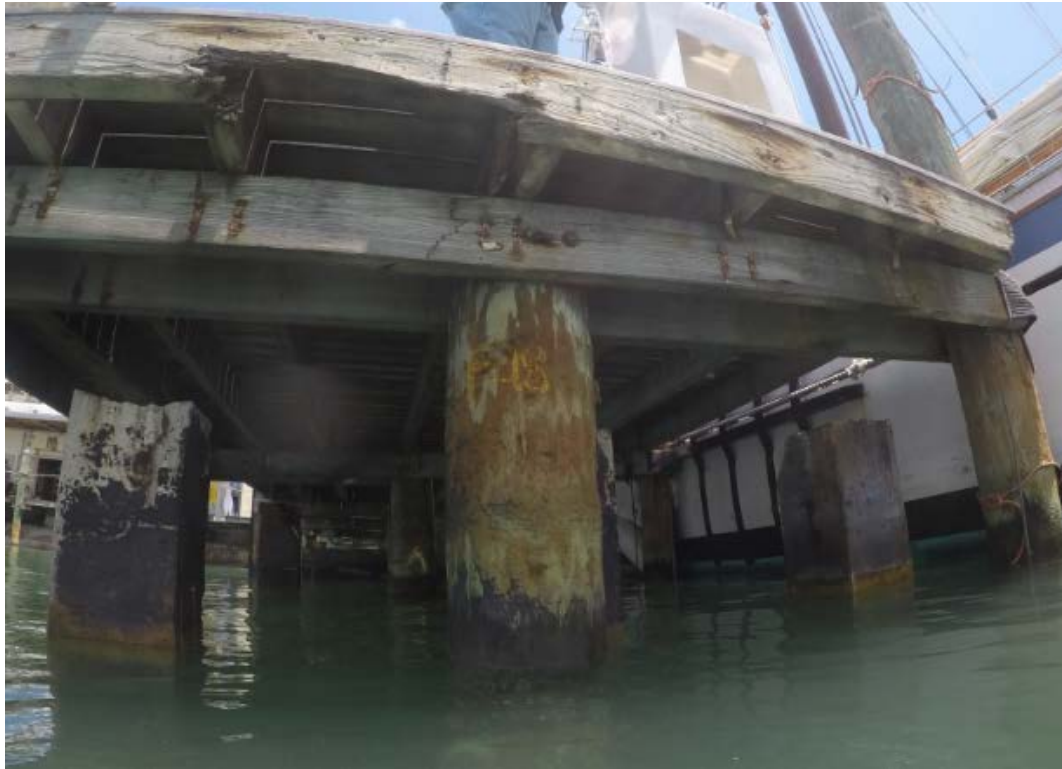
Figure 15: Pile F-18 Showing Cracking Horizontal Member and Bent Hardware

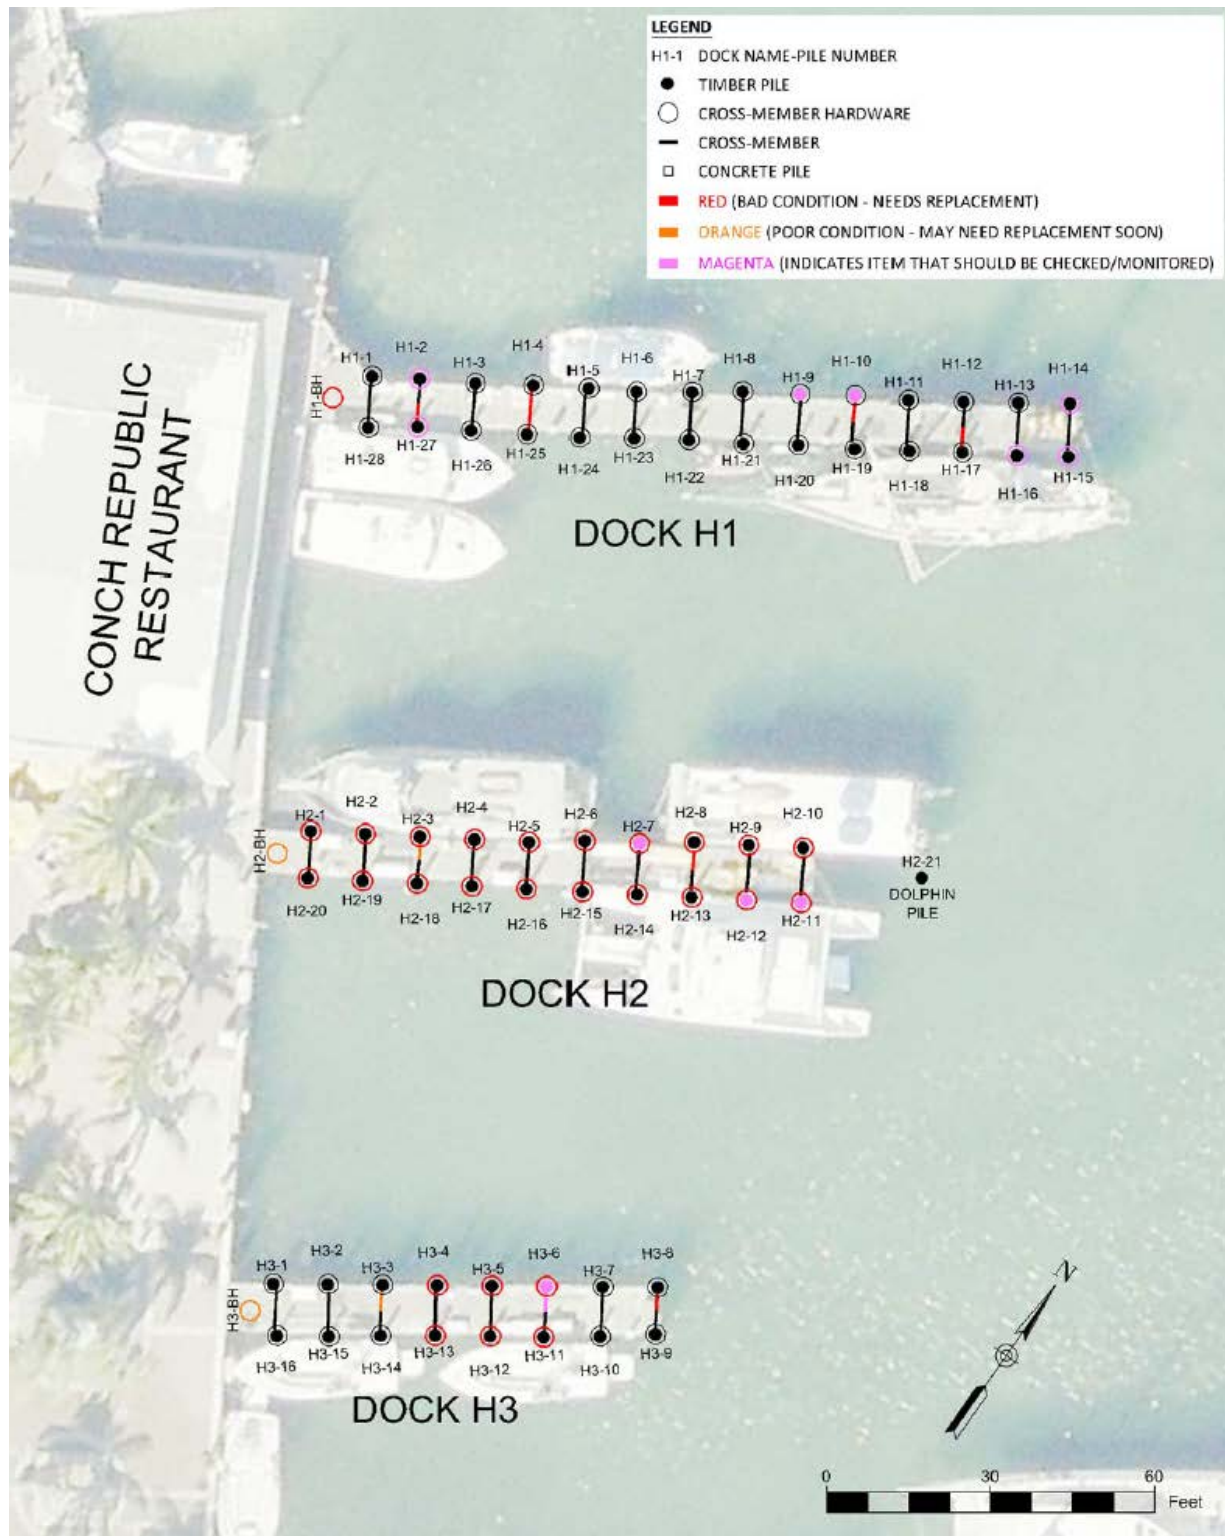
Figure 16: Dock H with Deficiencies

Dock H consists of 3 fixed pier wood docks, H1, H2, and H3, as shown in Figure 16. The timber support piles on all three of these docks appeared to be in good condition, however, Dock H1 had some rotting cross-member boards (noted at piles H1-4, H1-10, H1-17, H1-25, and H1-27). The connection hardware on Dock H1 was in good condition and appeared to be stainless steel. On Dock H2, all of the connection hardware for the horizontal members was galvanized, and has moderate to severe corrosion with metal loss. On Dock H3, approximately 60% of connections are stainless steel and 40% are galvanized bolts/all-threads, and some horizontal cross-members showed signs of damage (decay, splitting, cracking). The galvanized hardware has moderate to severe corrosion and metal loss. Stainless steel hardware is in good condition. Overall, 6 diagonal cross-members were showing signs of rotting at the ends, and at least 26 connection points had the corroded galvanized hardware, as well as at the bulkheads (each with approximately 6 bolts), making the number of bolts/all-threads that would need to be replaced approximately 70. Refer to Table 11 below for the summary of Harbor Walk deficiencies and to Appendix A for the condition descriptions of all components inspected.

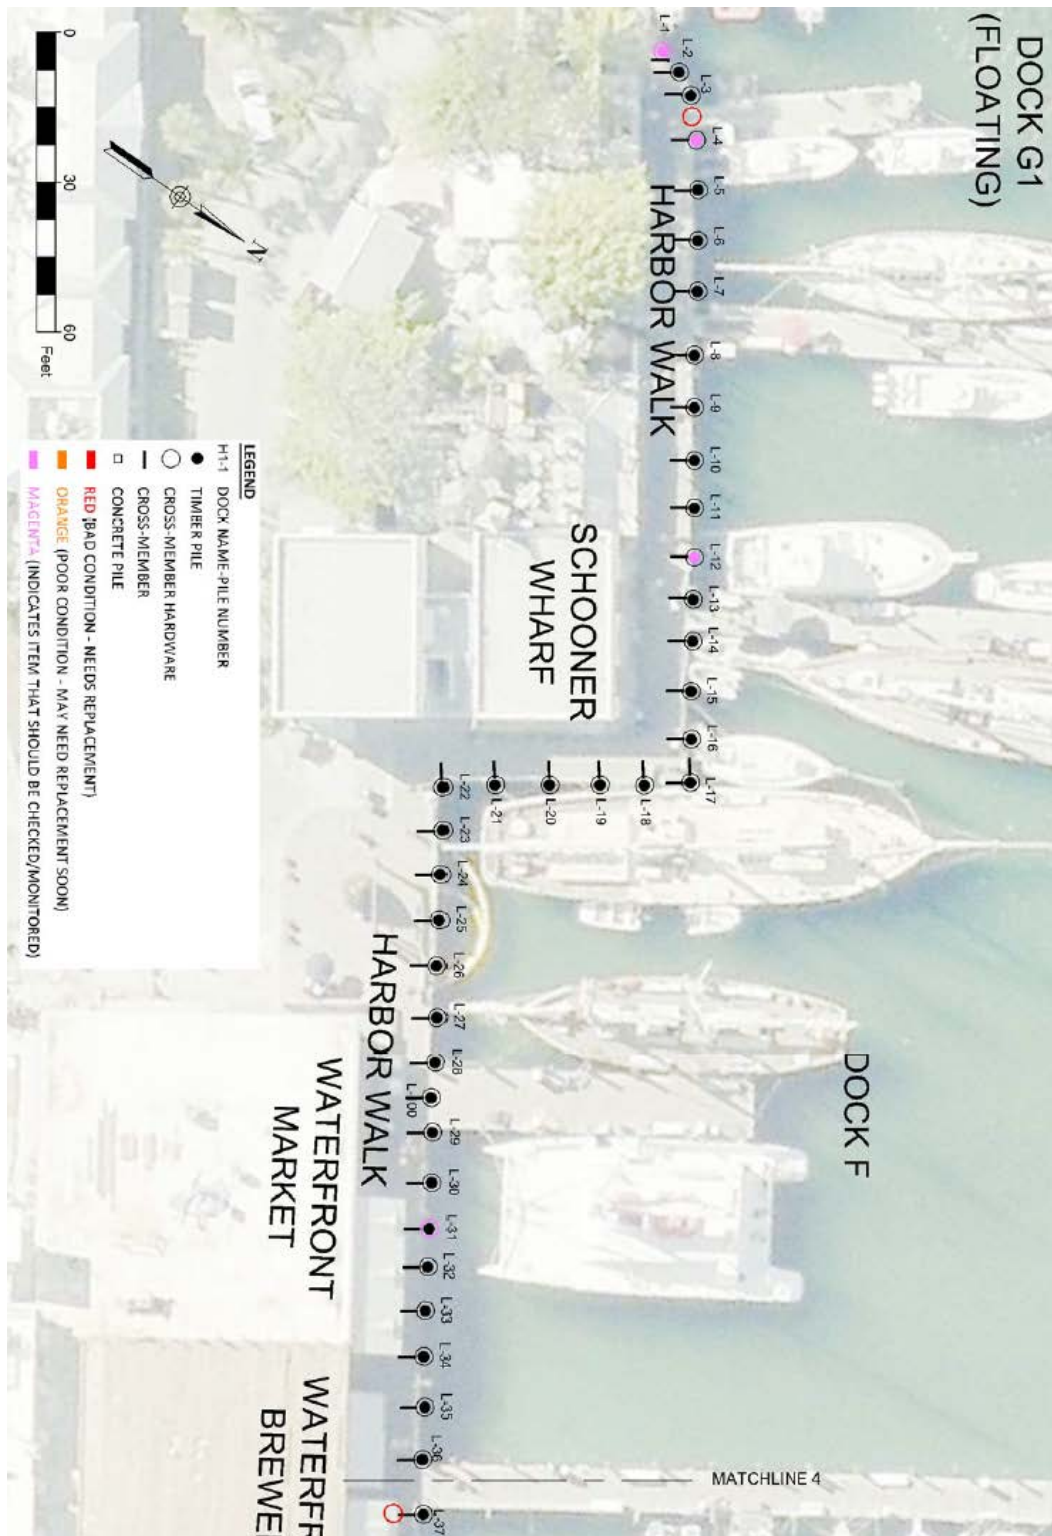
Figure 17: Harbor Walk Pier with Deficiencies

The Harbor Walk Pier was defined as the frontage pier lining the seawall from the Schooner Wharf Bar to the Half Shell Raw Bar. The extent of the piles inspected for this section is shown in Figure 17 through Figure 19. The condition of piles along the pier were noted to be in fairly good condition, with the exception of piles L-50 (decay and over 80% section loss at the tidal zone) and L-53 (shaved with 1-1/2" of section loss). Overall most of the cross-members and hardware connections were also in good condition, however along part of the seawall (in front of the Waterfront Market, piles L-37 to L-44) there were connections that still utilized galvanized hardware that was corroding. A similar situation occurs with the 2 piles (L-98 and L-99) connecting to the Half Shell Raw Bar overhang, both of which had galvanized and corroding hardware, and also on pile L-55 (at the start of Dock D). Piles L-31, L-42, L-51, and L-59 had missing or loose hardware. Additionally, the knee braces that support the Turtle Kraals walkway were inspected, and the diagonal supports on members TK-6 and TK-7 were observed to be disconnected from the Refer to Table 13 below for the summary of Harbor Walk deficiencies and to Appendix A for the condition descriptions of all components inspected.
