STAFF REPORT

RE: **813 Waddell Avenue (permit application # T2019-0125)**

FROM: Karen DeMaria, City of Key West Urban Forestry Manager

An application was received requesting the removal of **(2) Gumbo Limbo and (2) Mango trees**. A site inspection was done and documented the following:

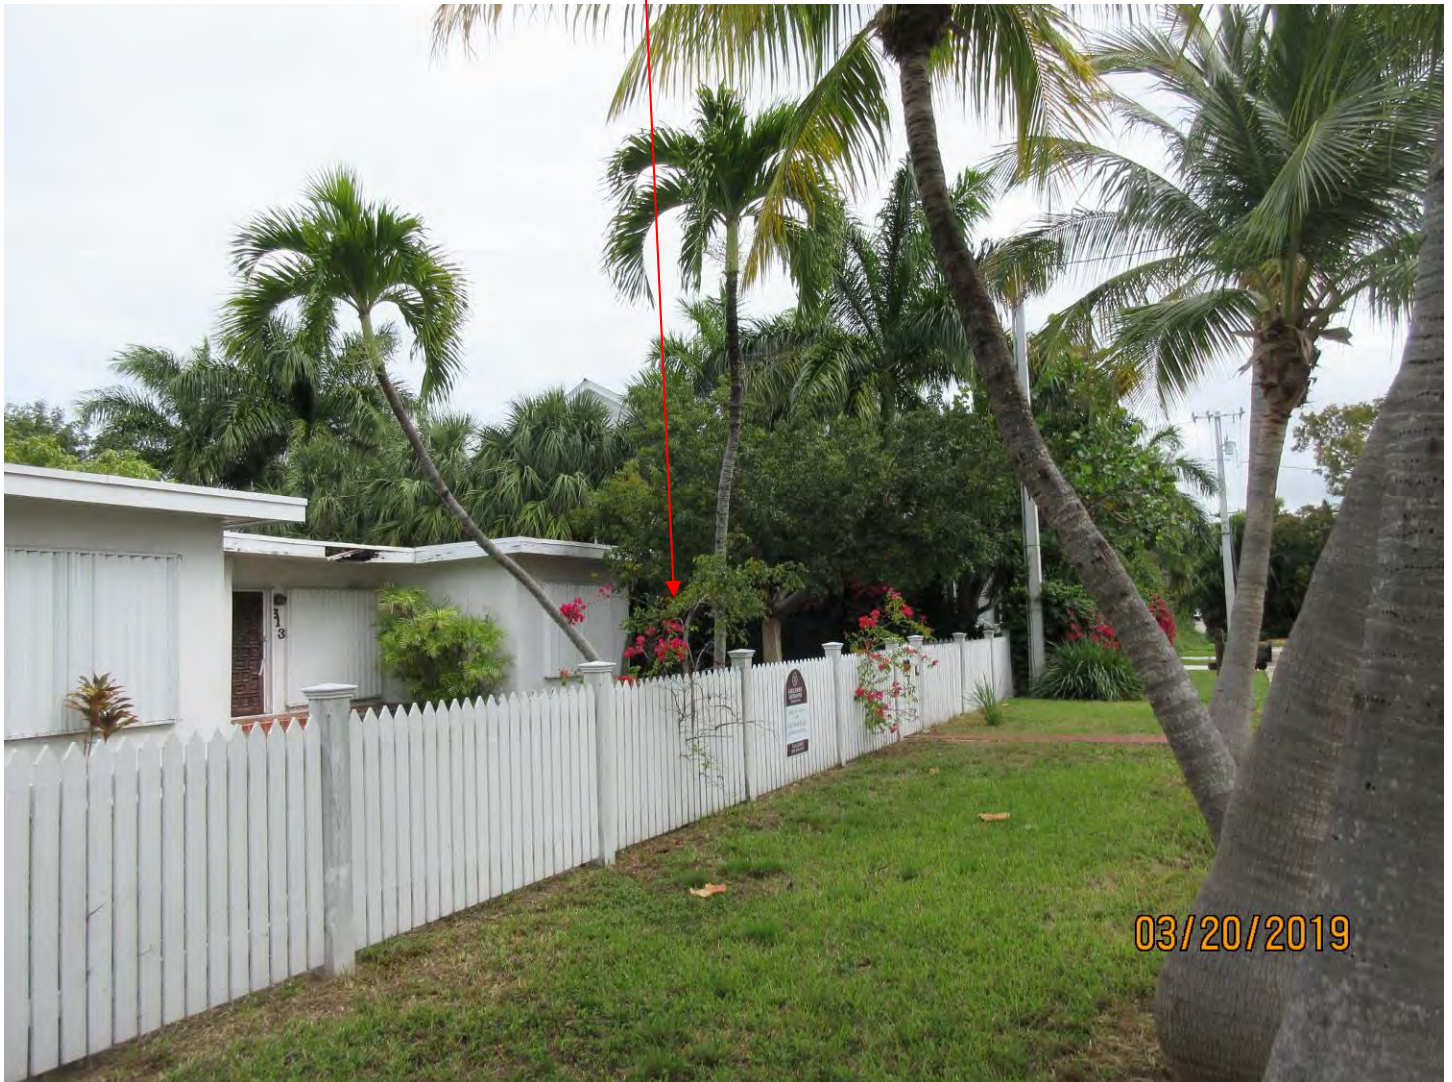
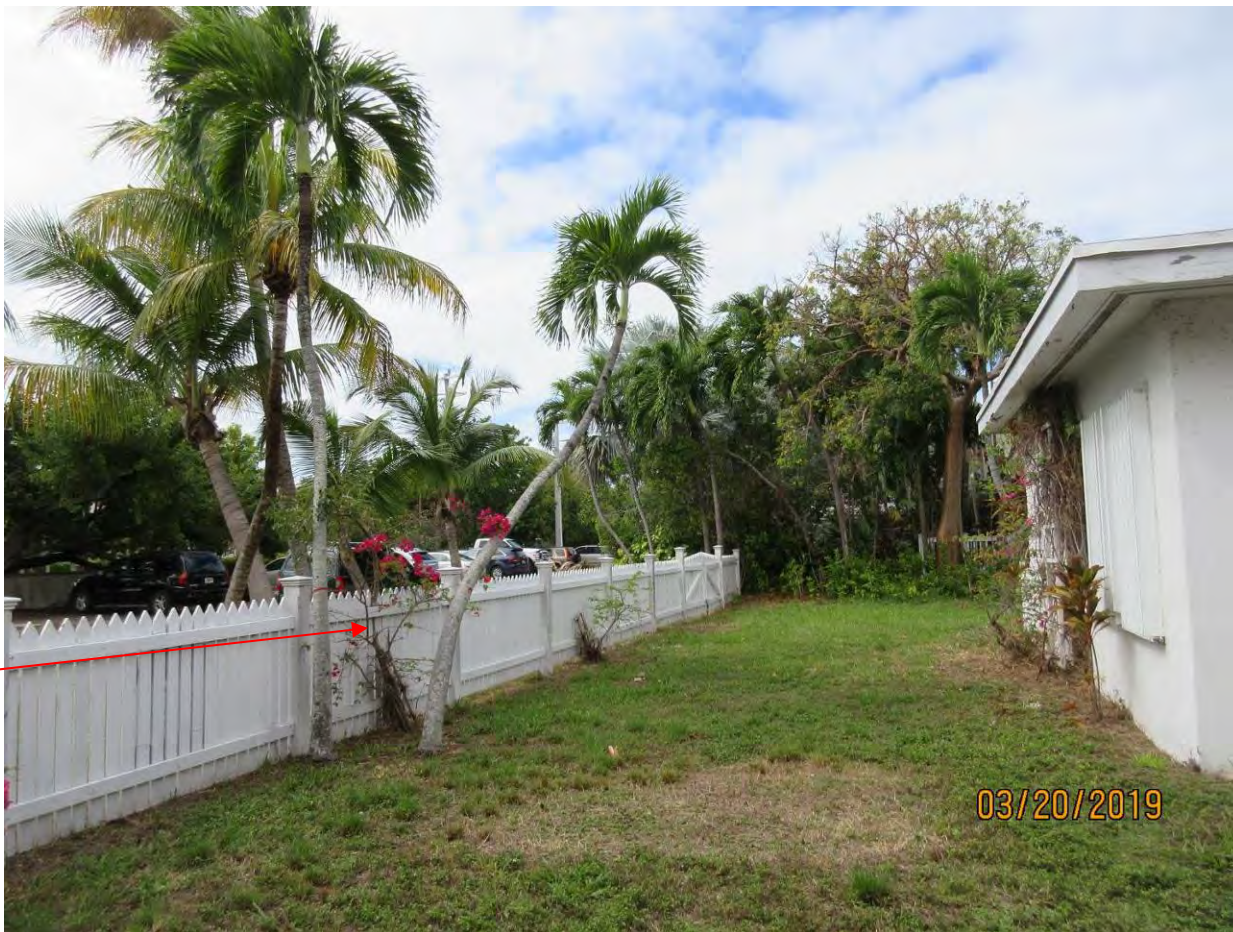
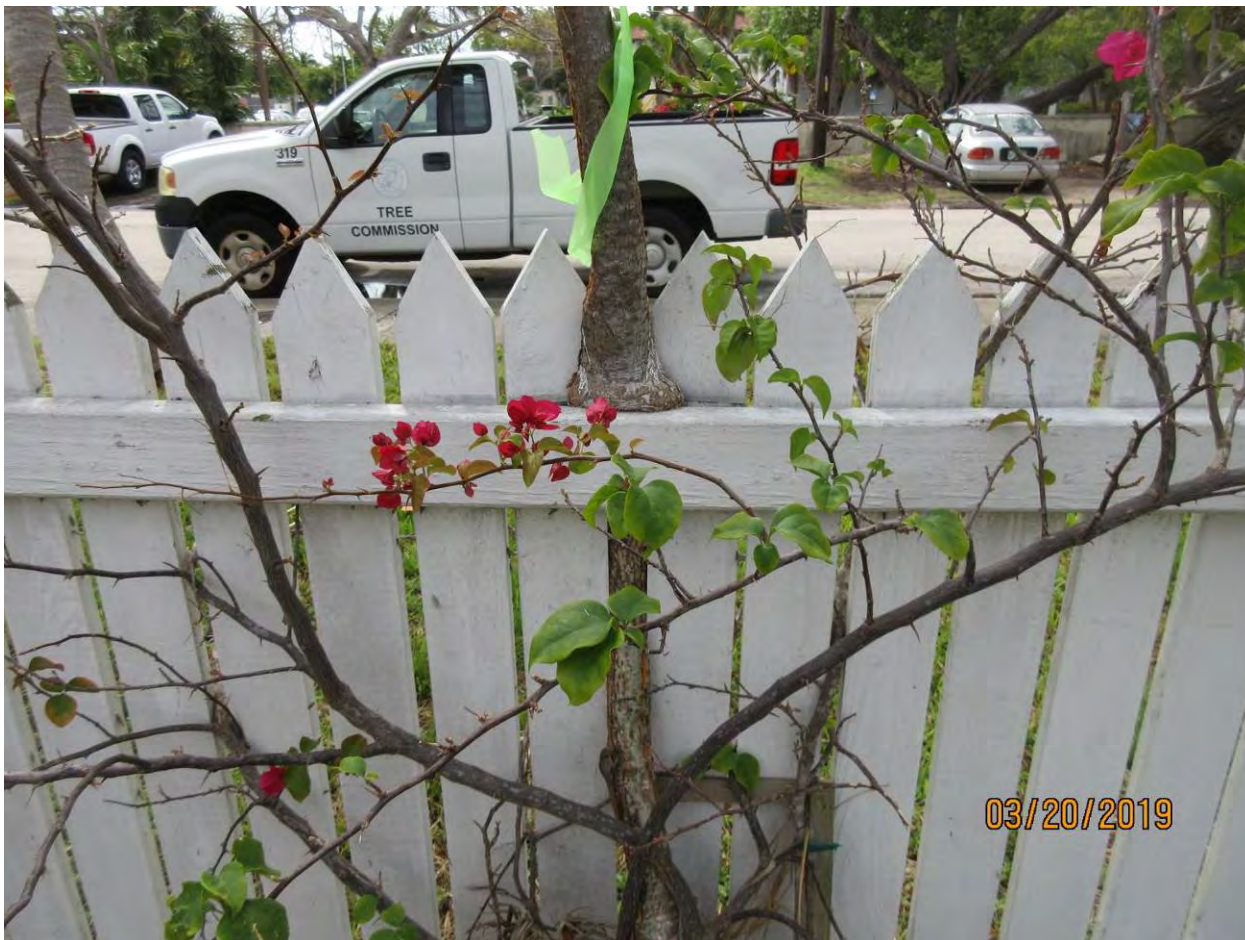
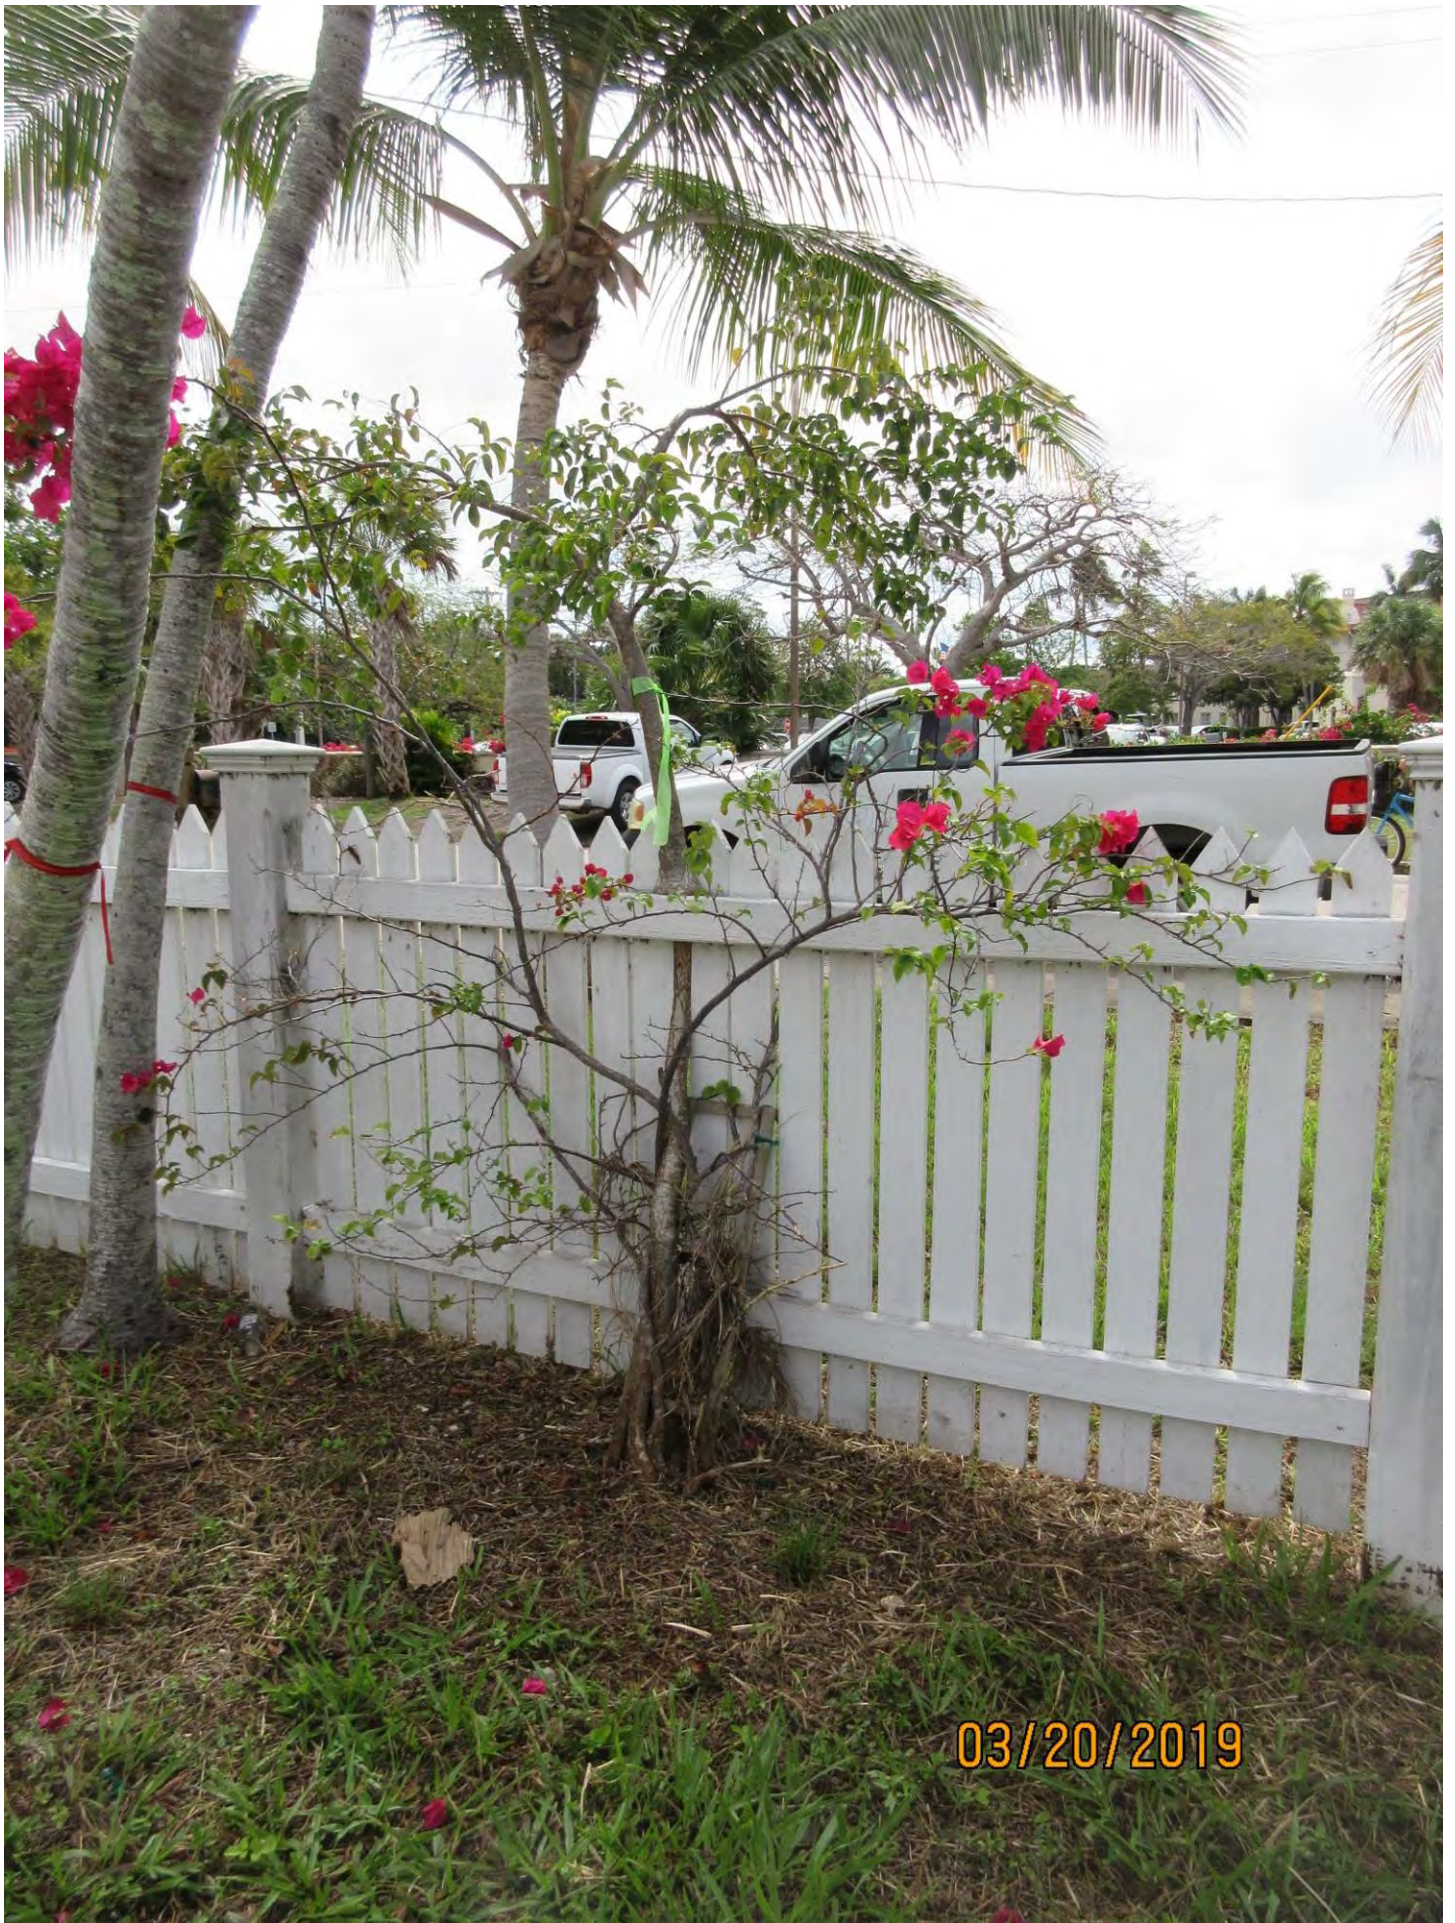
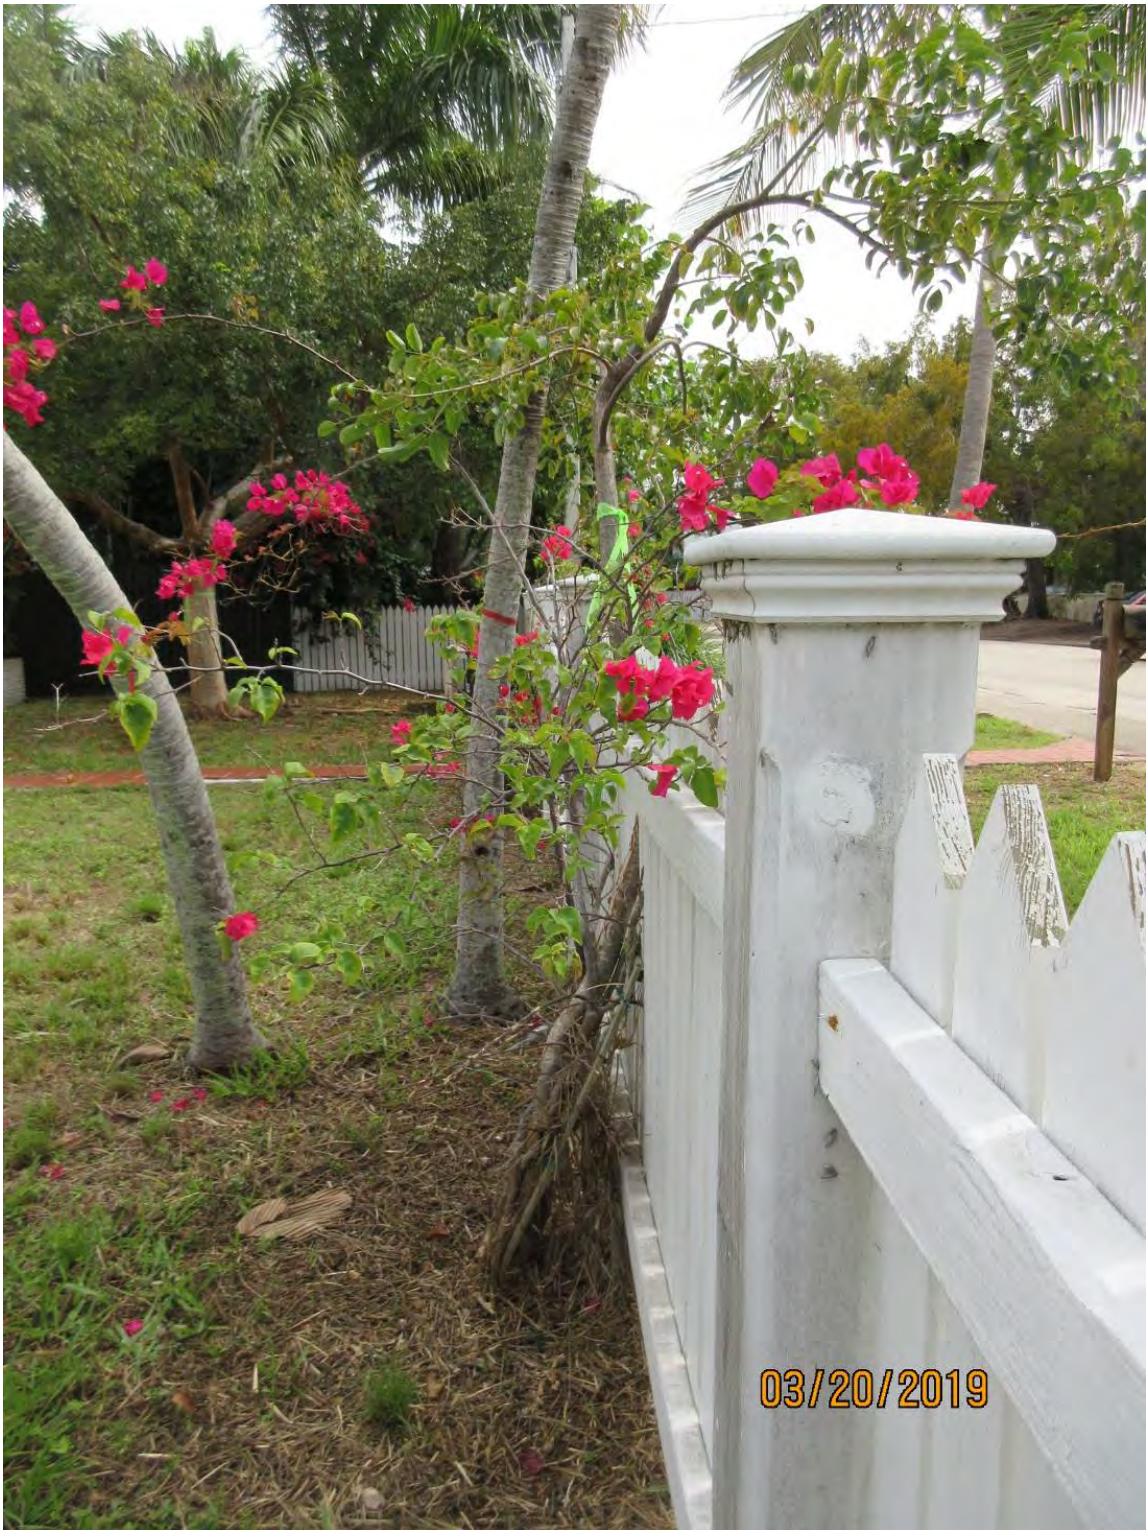
Tree #73:

Diameter: 1.9"

Location: 20% (growing in fence)

Condition: 40% (poor, main trunk damaged by growth into fence)

Total Average Value = 53%

Value x Diameter = 1 replacement caliper inches

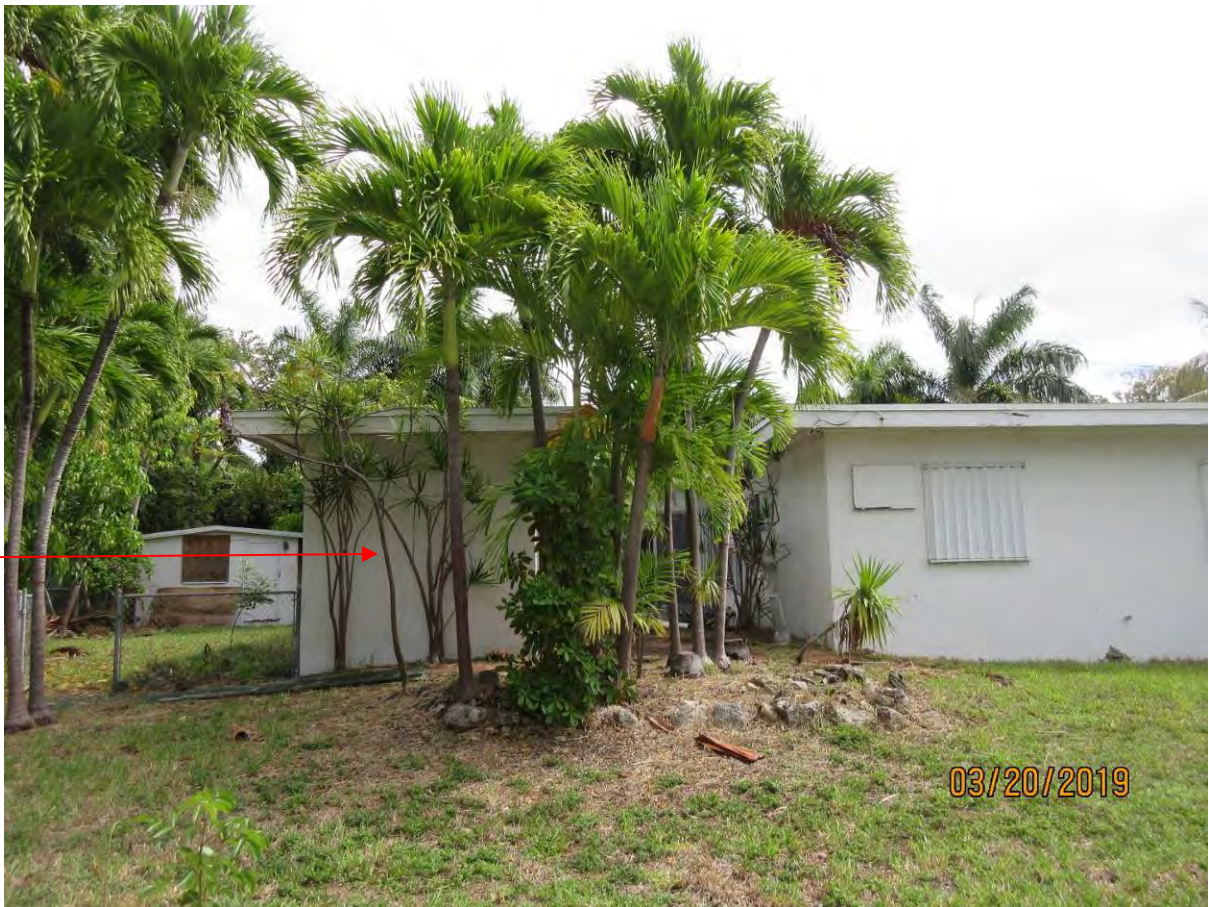
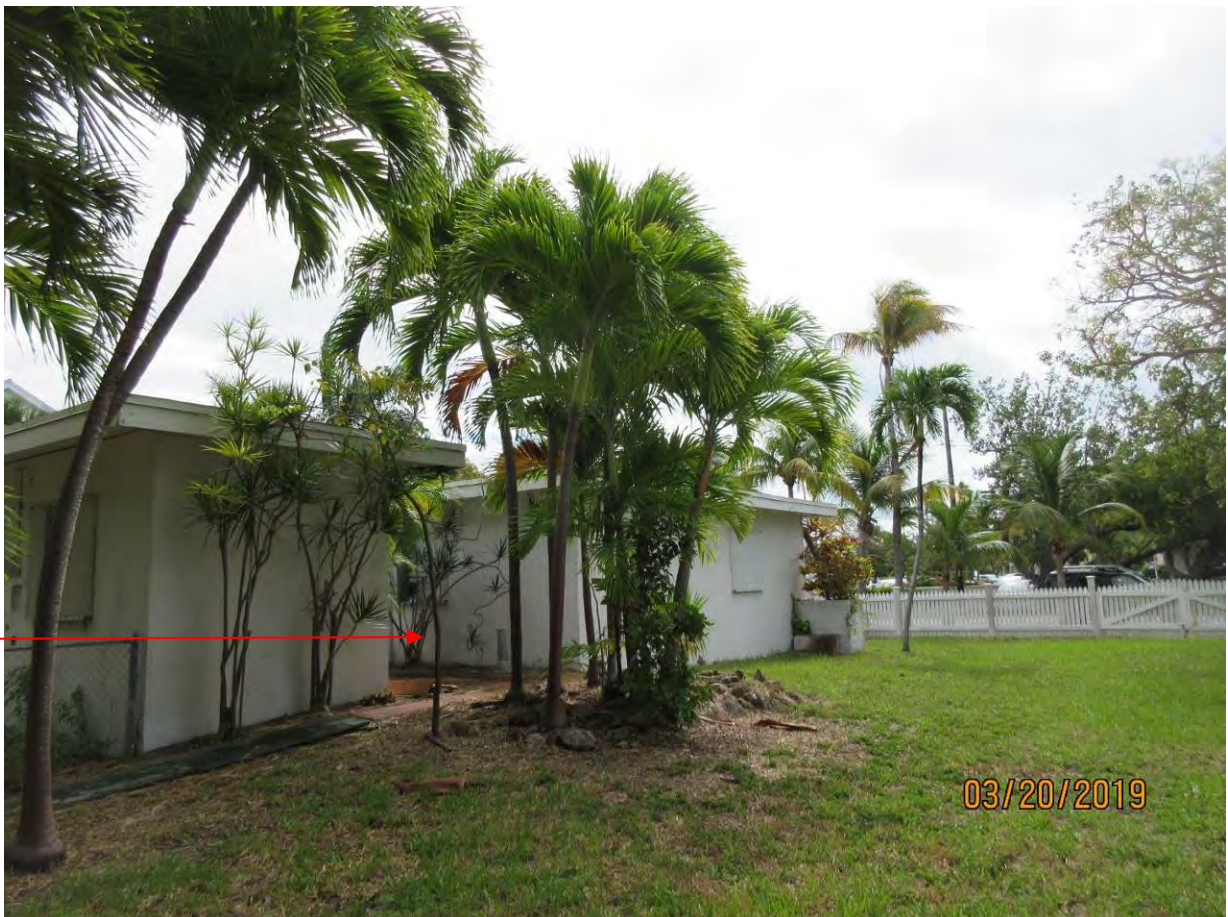
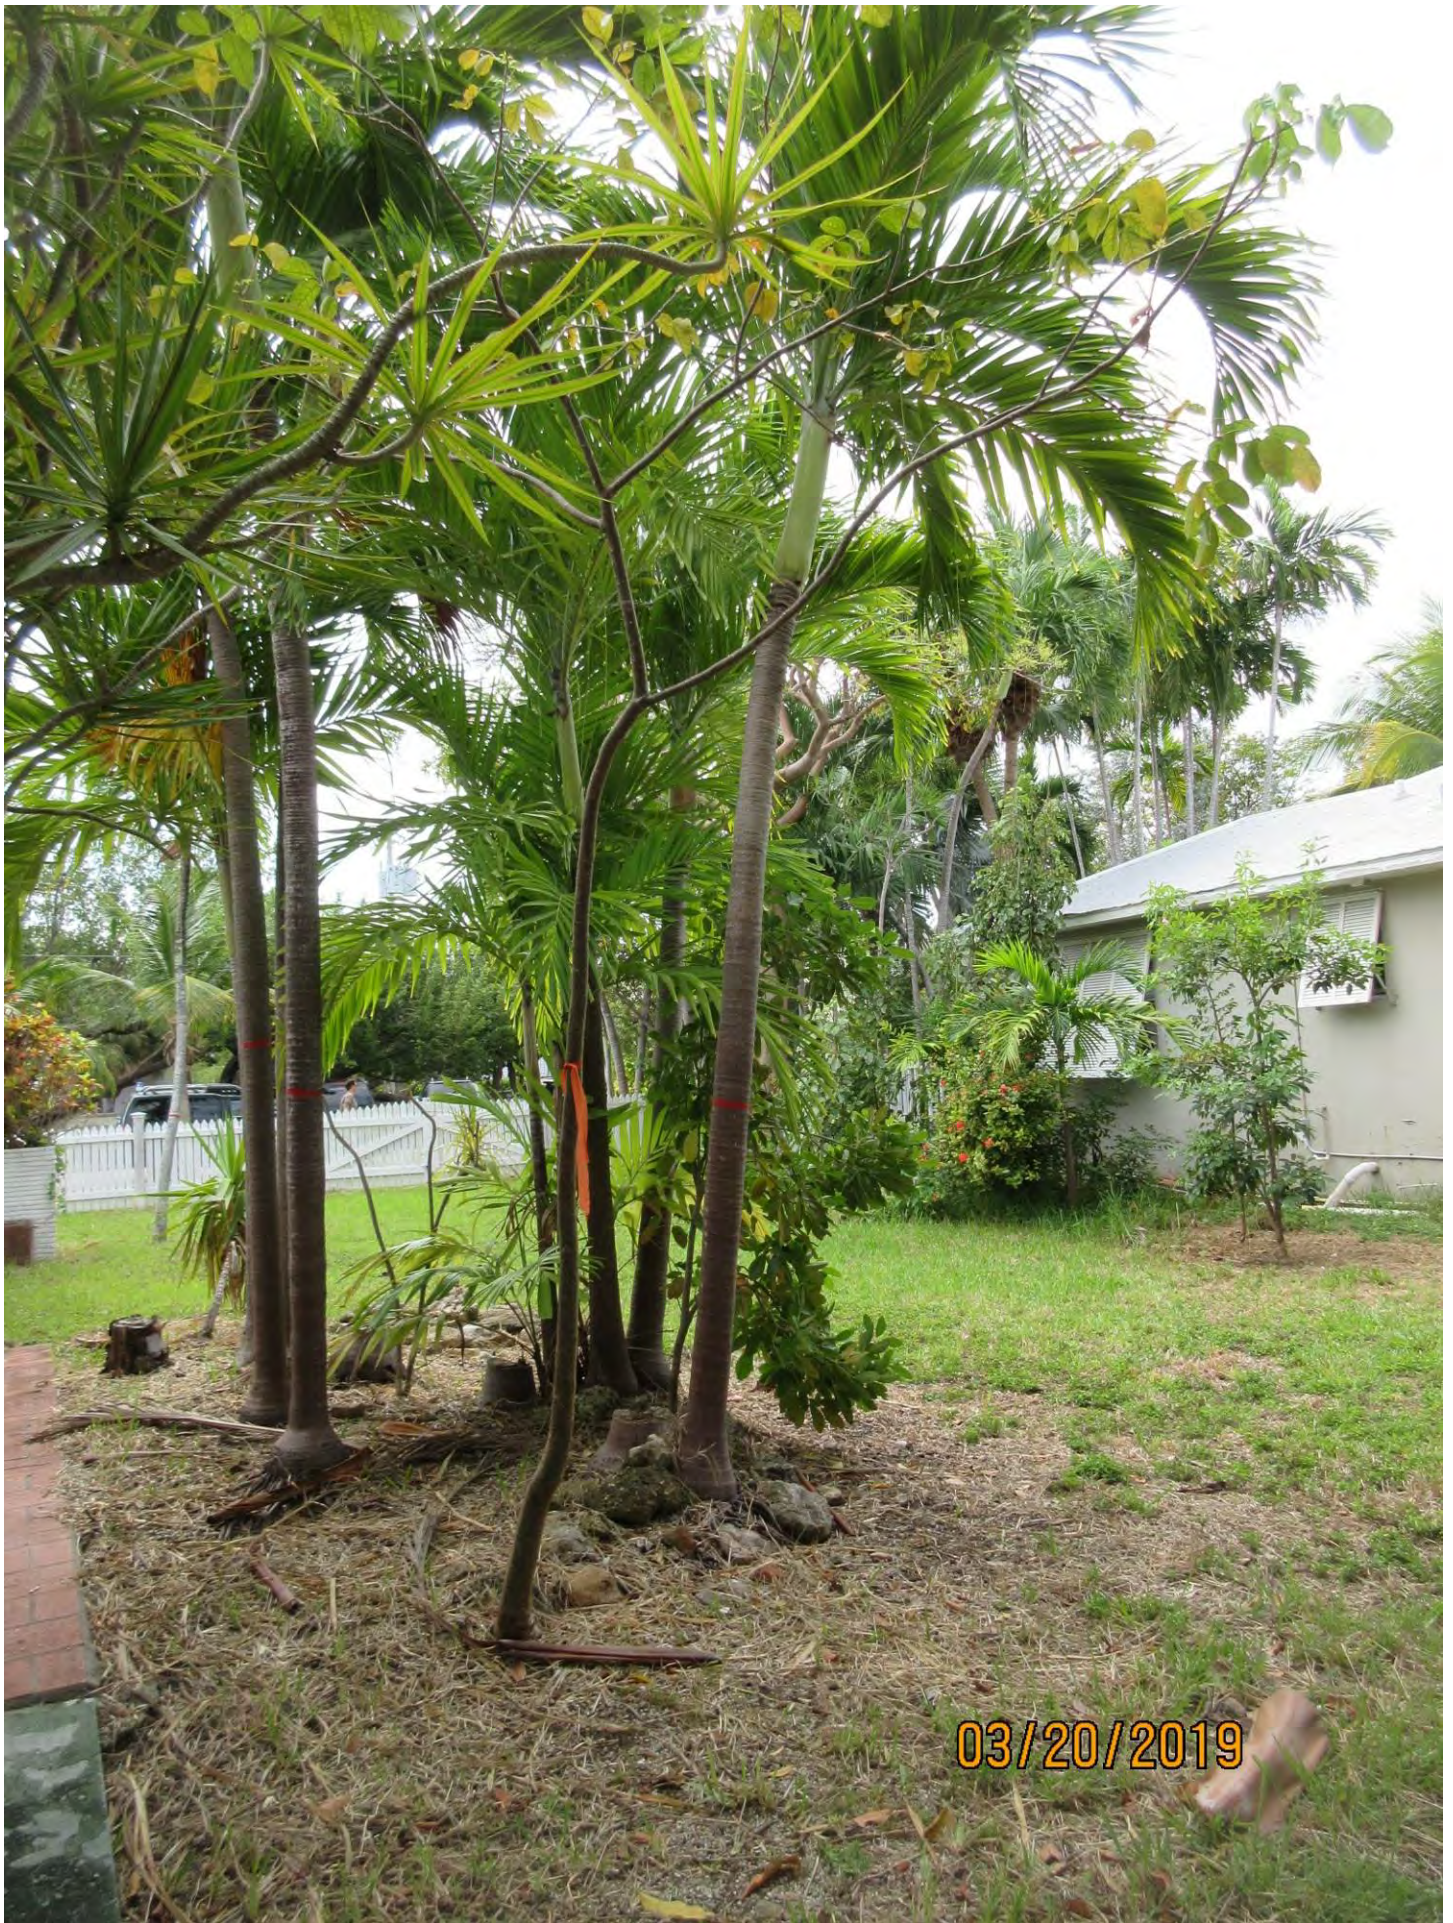
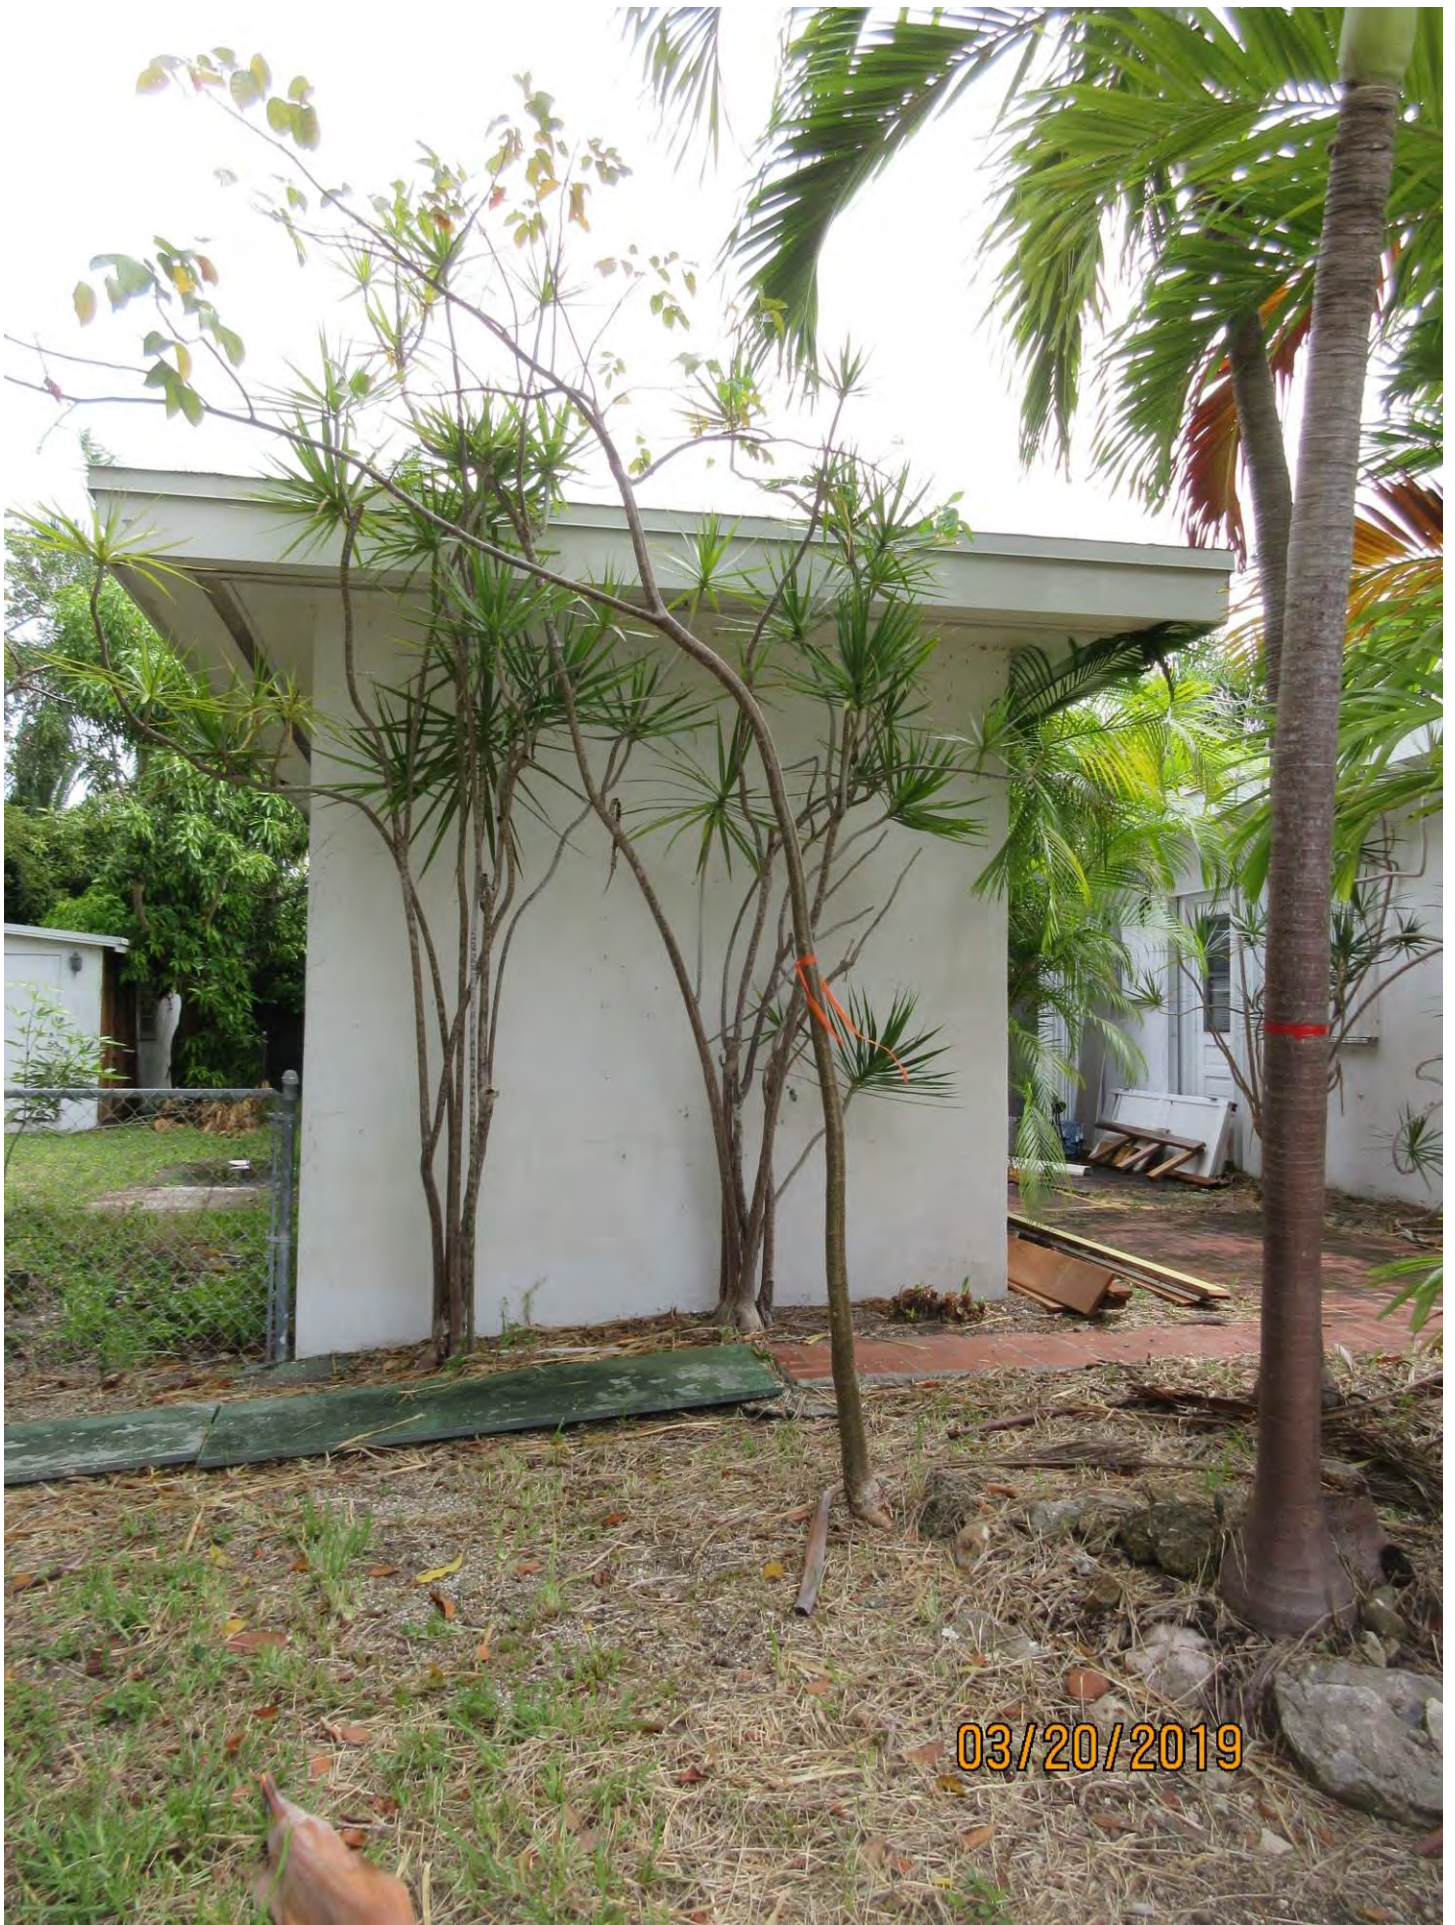
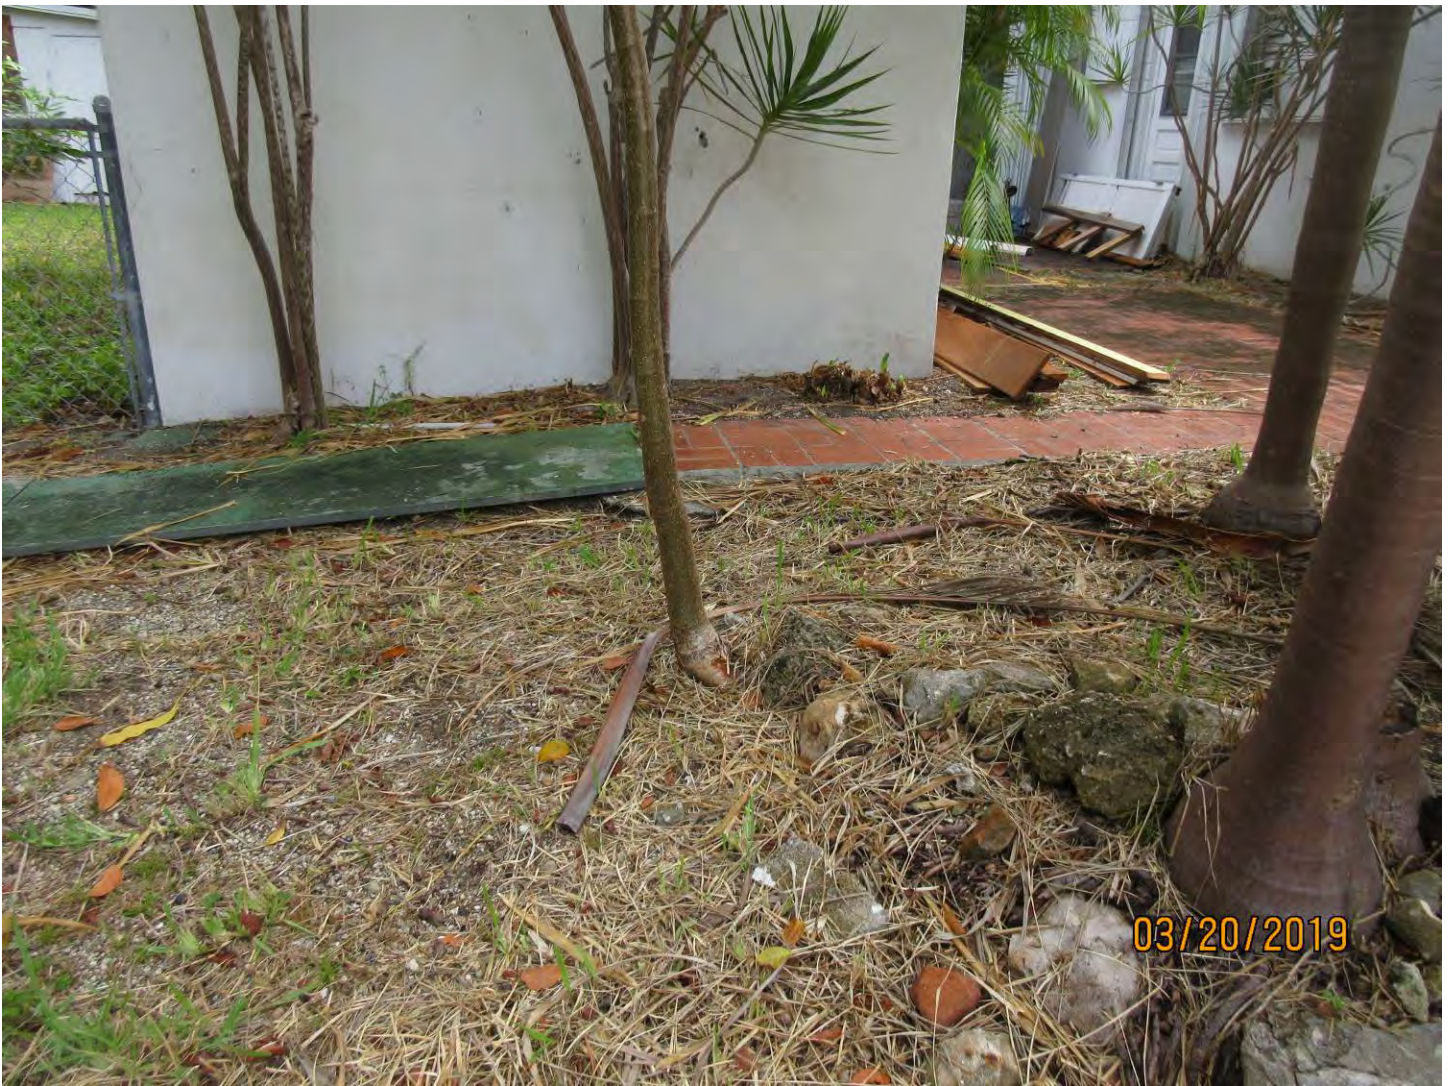
Tree #22:

Diameter: 1.9"

Location: 80%

Condition: 60% (fair, young tree)

Total Average Value = 80%

Value x Diameter = 1.5 replacement caliper inches
