STAFF REPORT

RE: **813 Waddell Avenue (permit application # T2019-0125)**

FROM: Karen DeMaria, City of Key West Urban Forestry Manager

An application was received requesting the removal of **(2) Gumbo Limbo and (2) Mango trees**. A site inspection was done and documented the following:

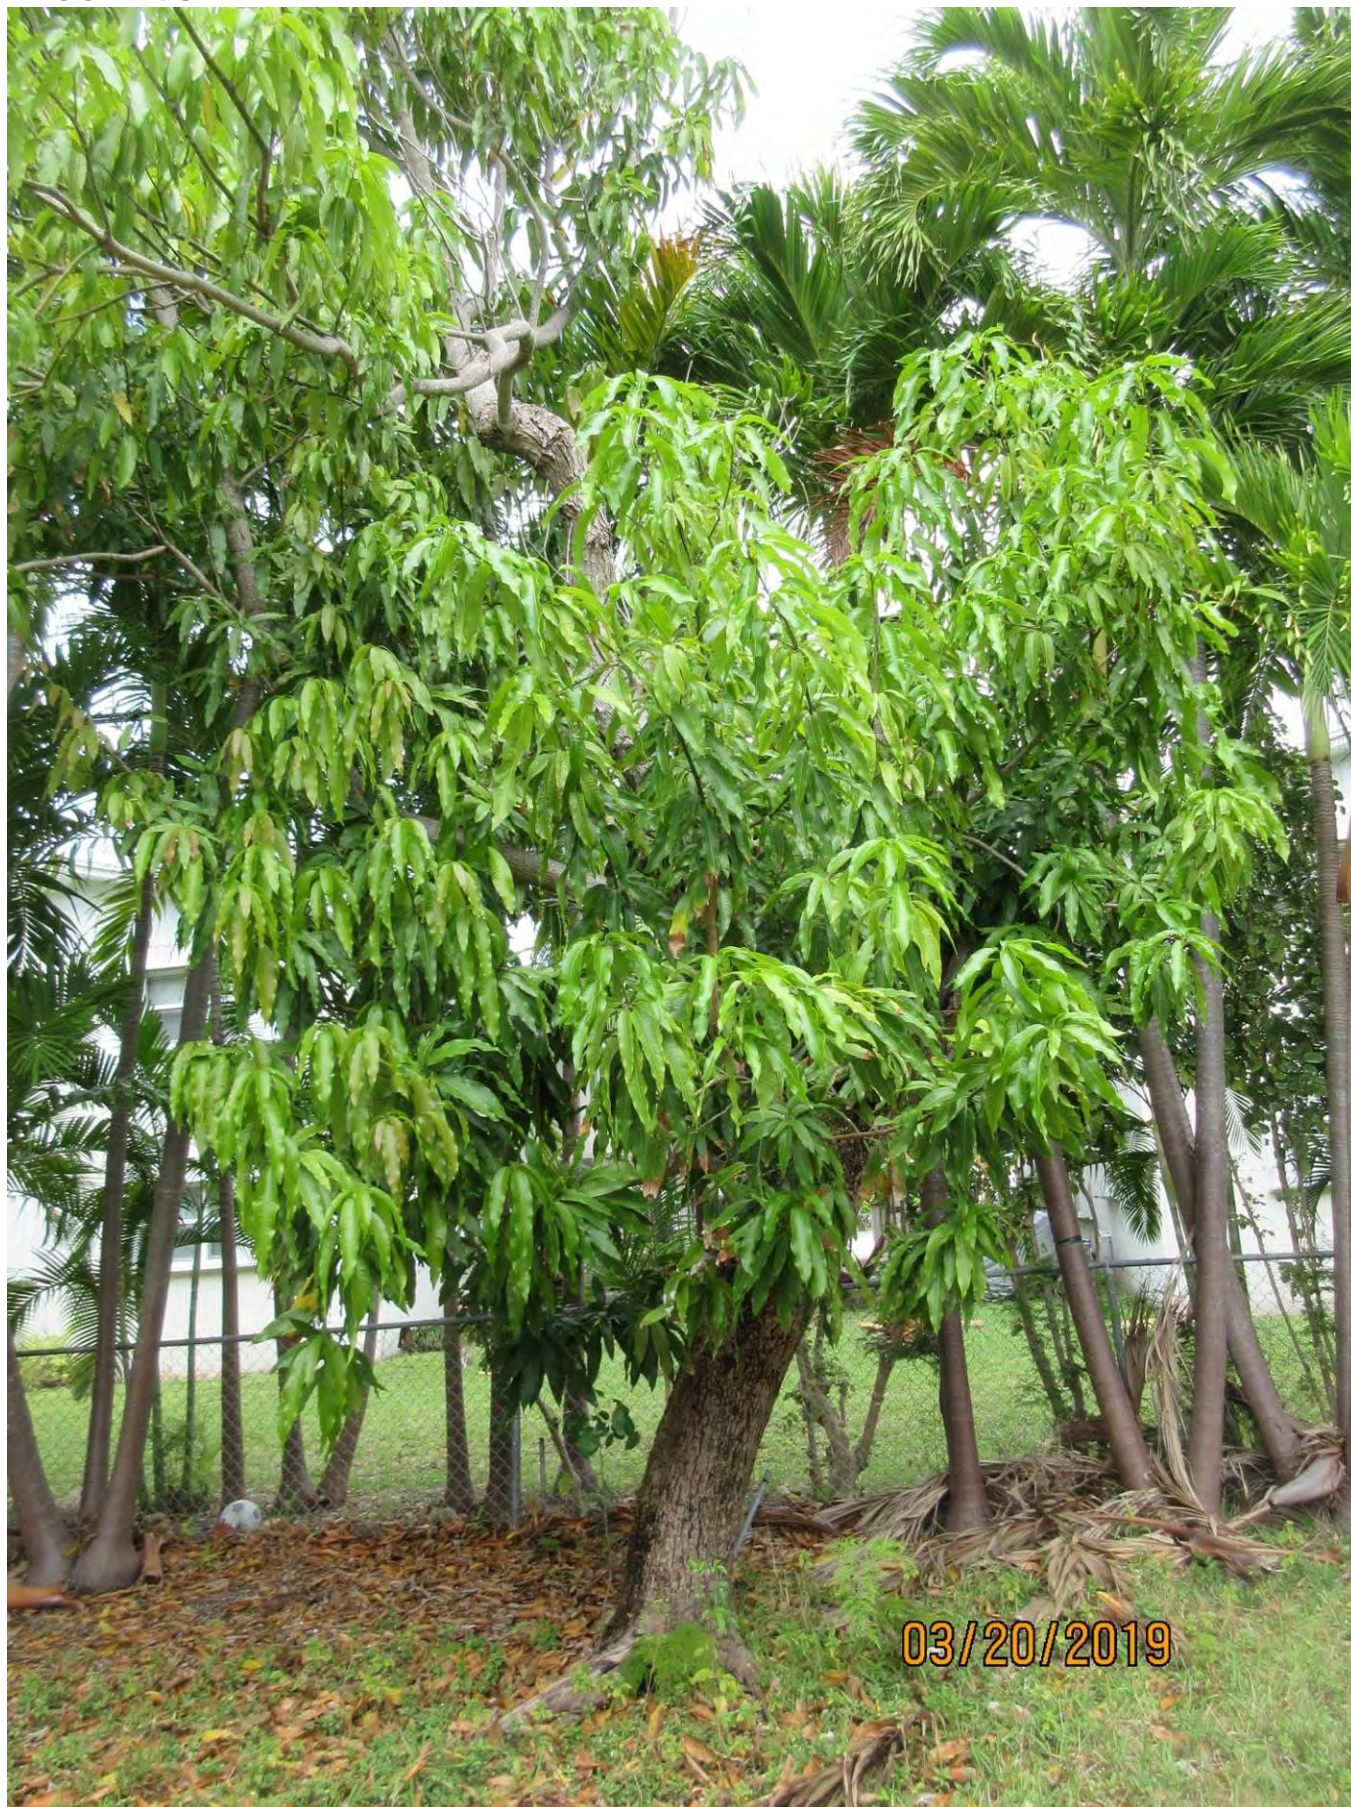
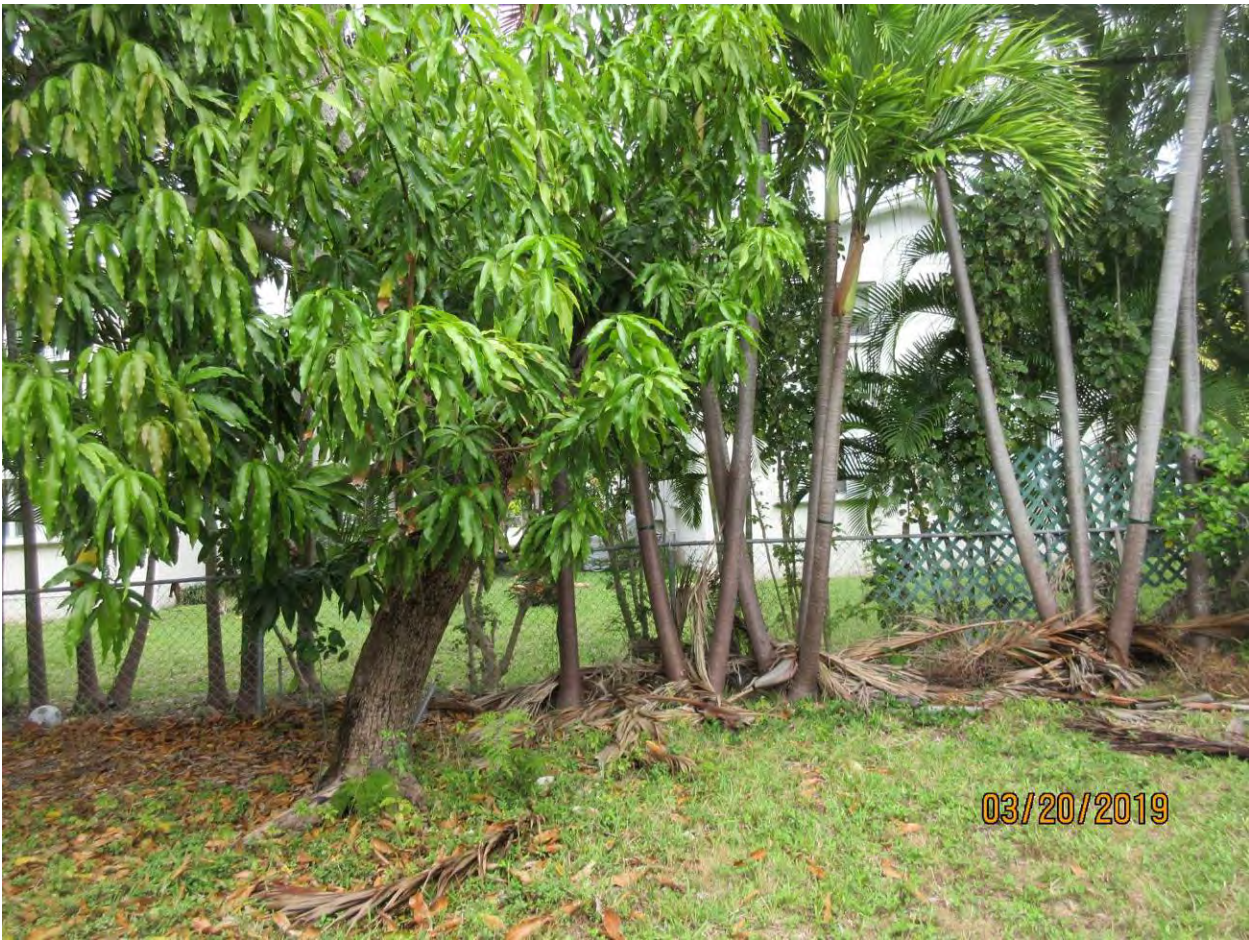
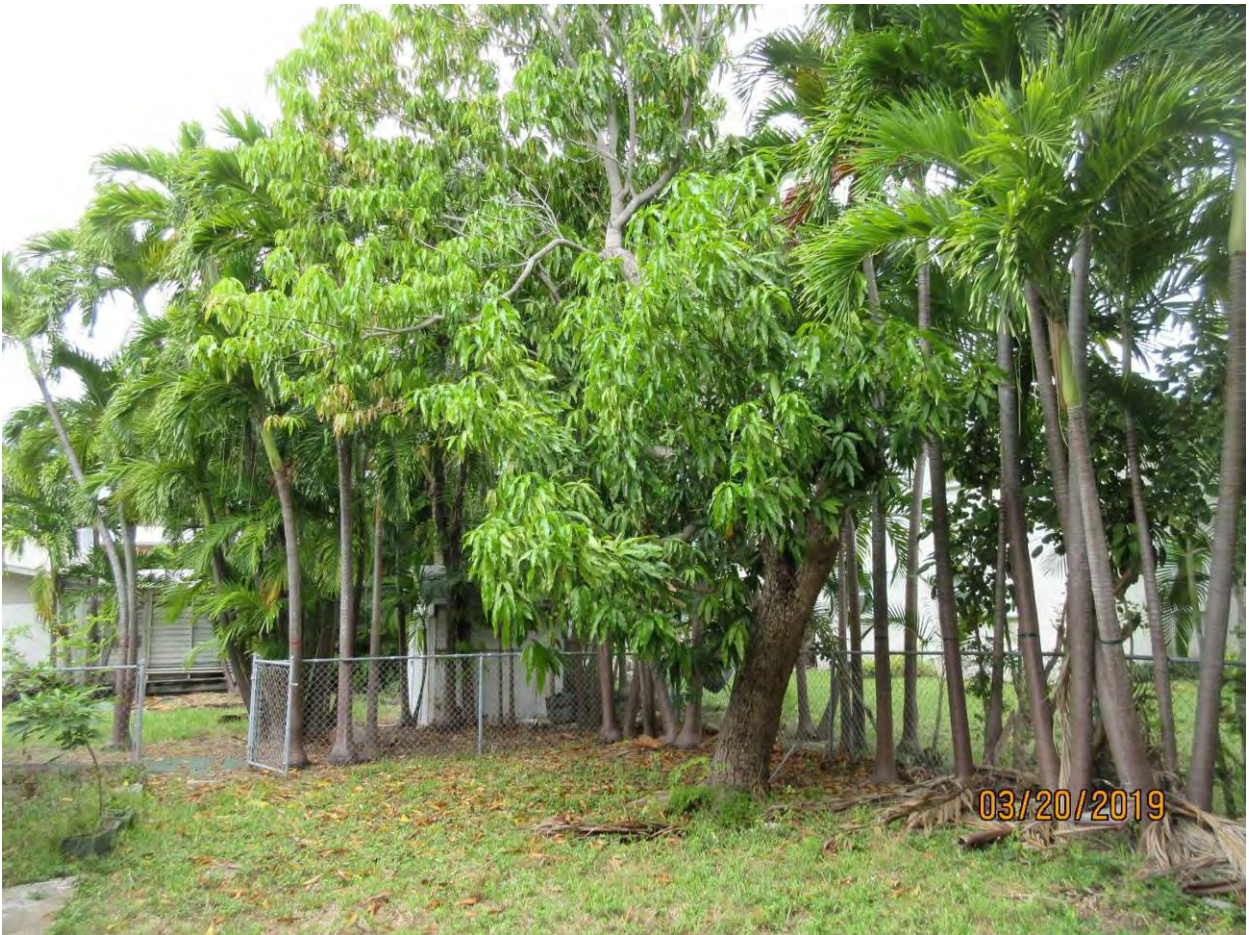
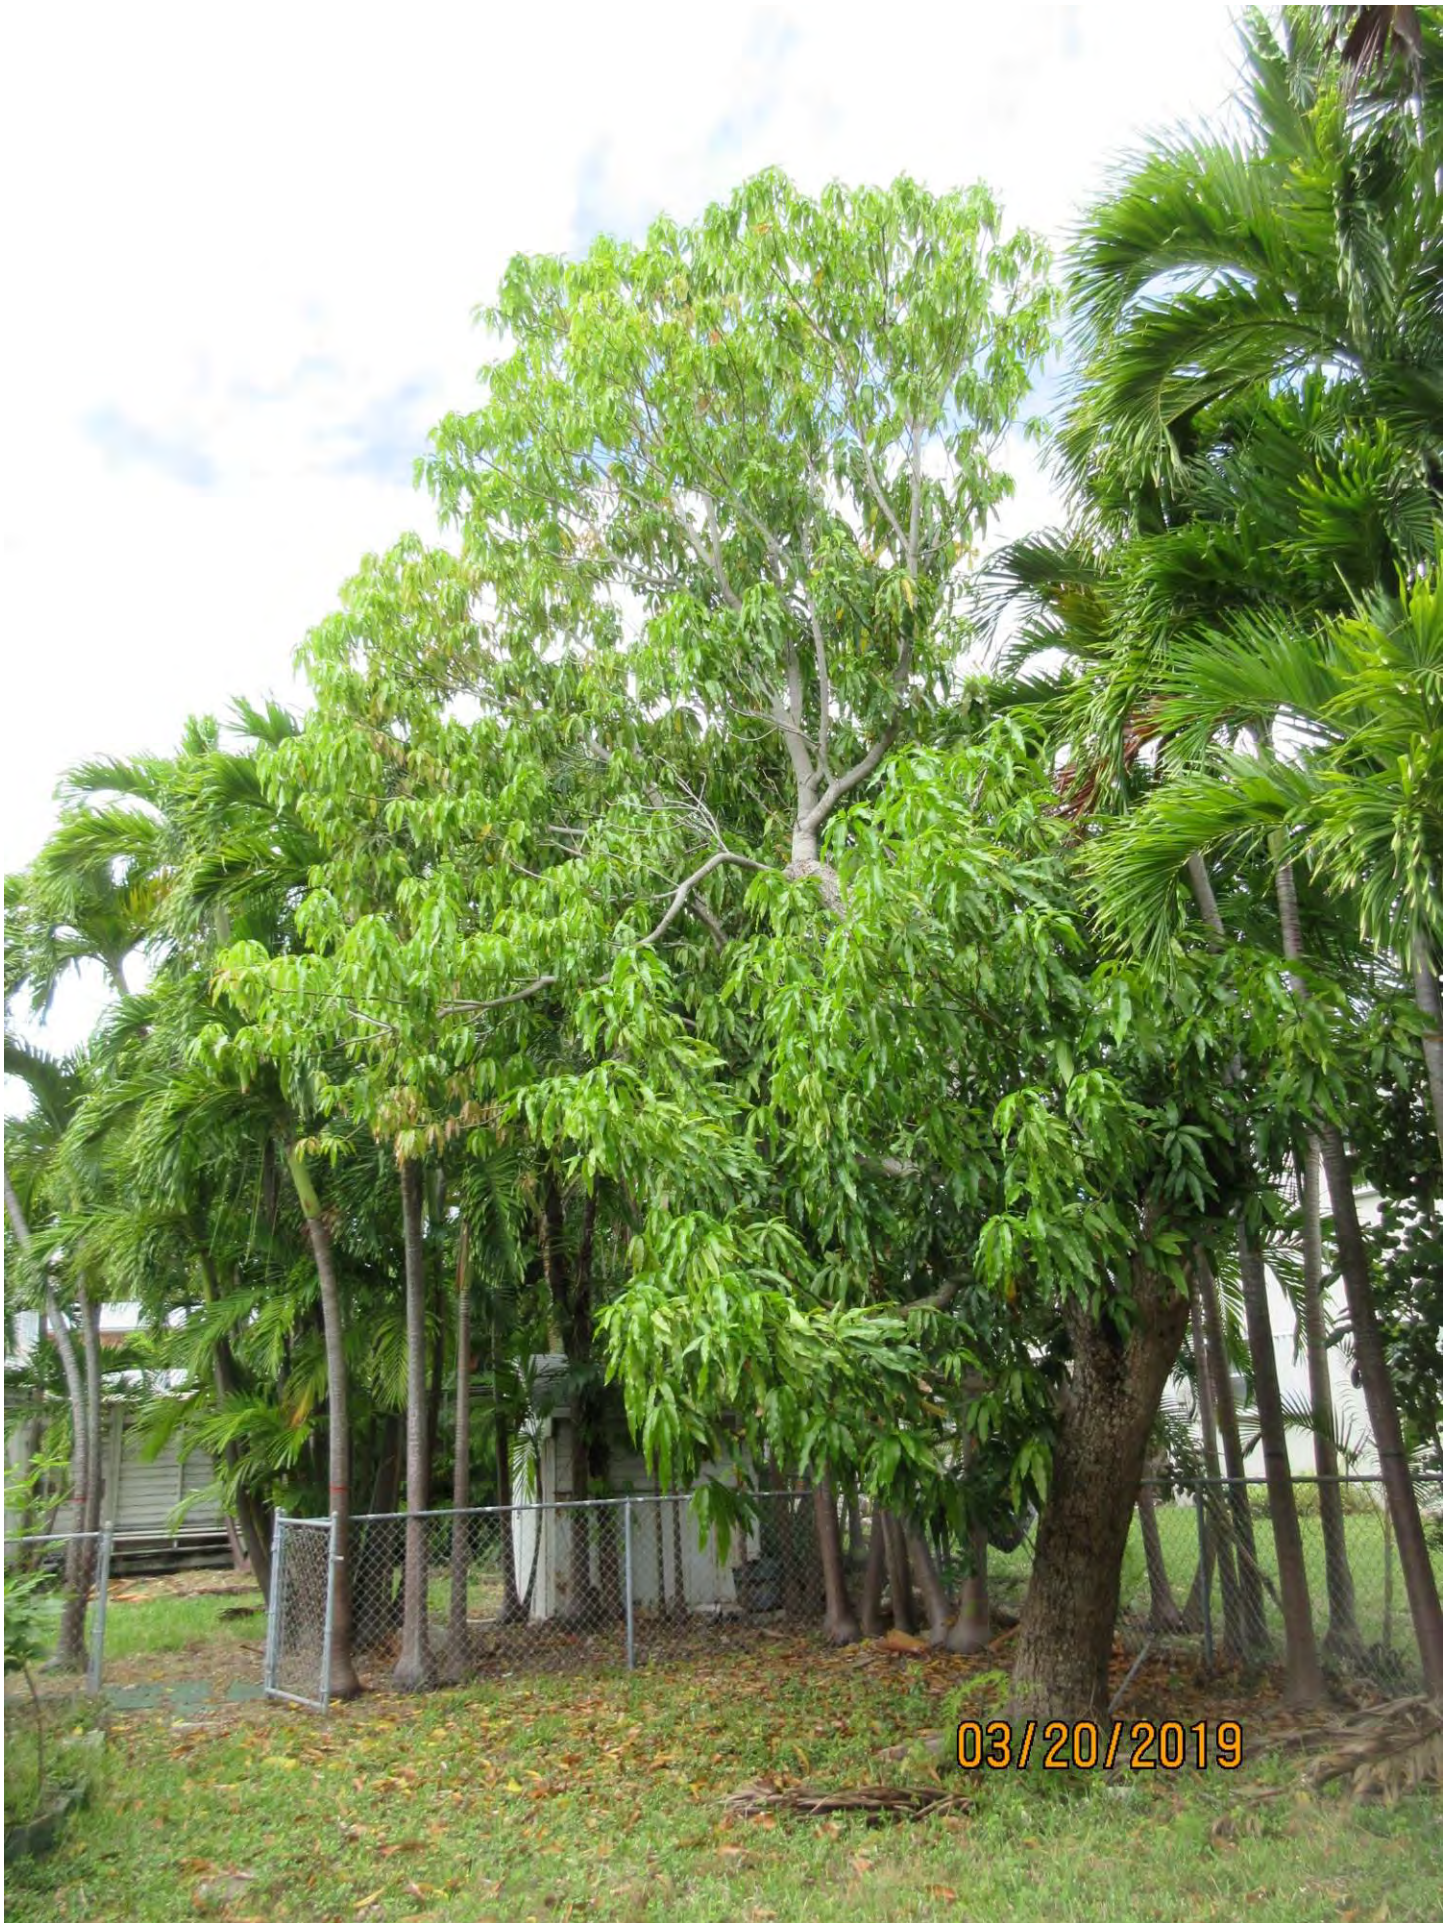
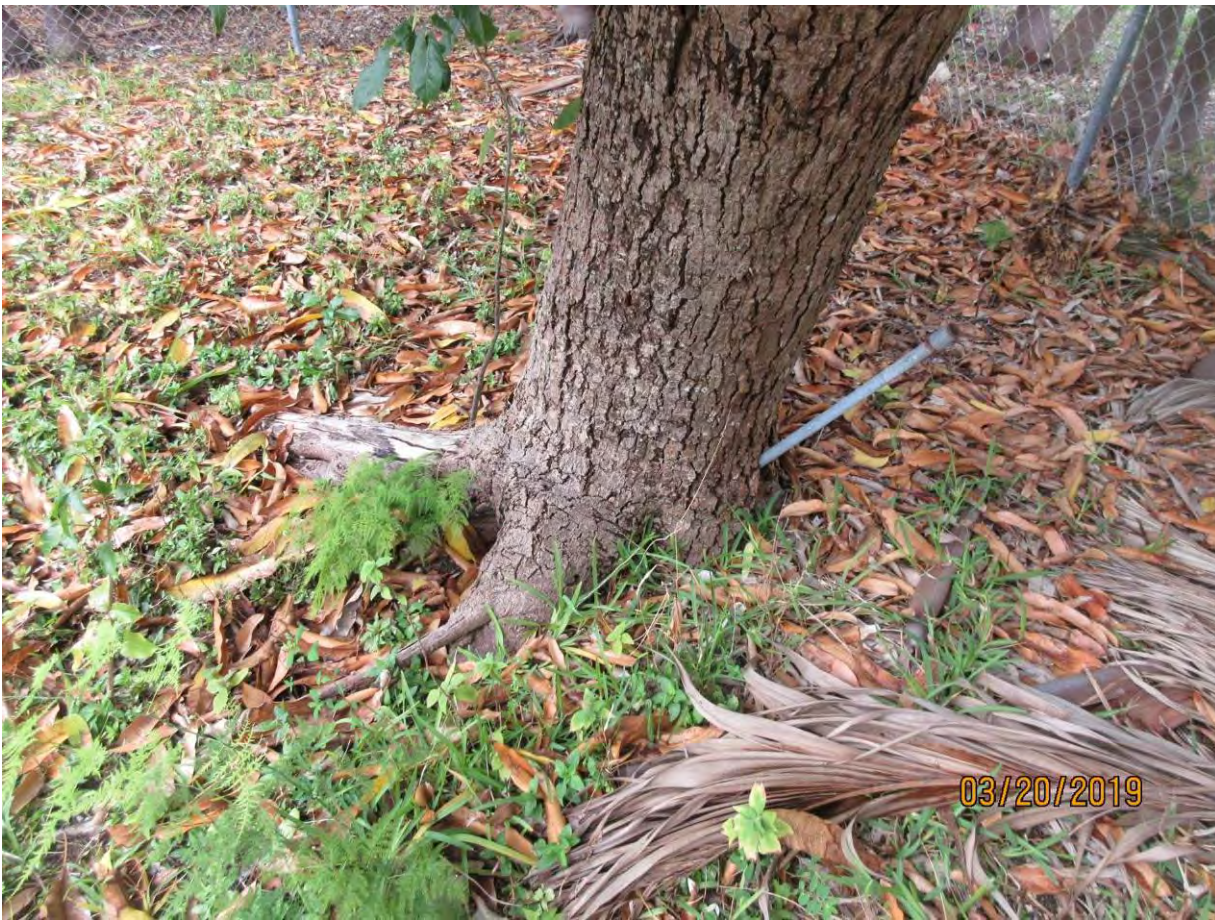
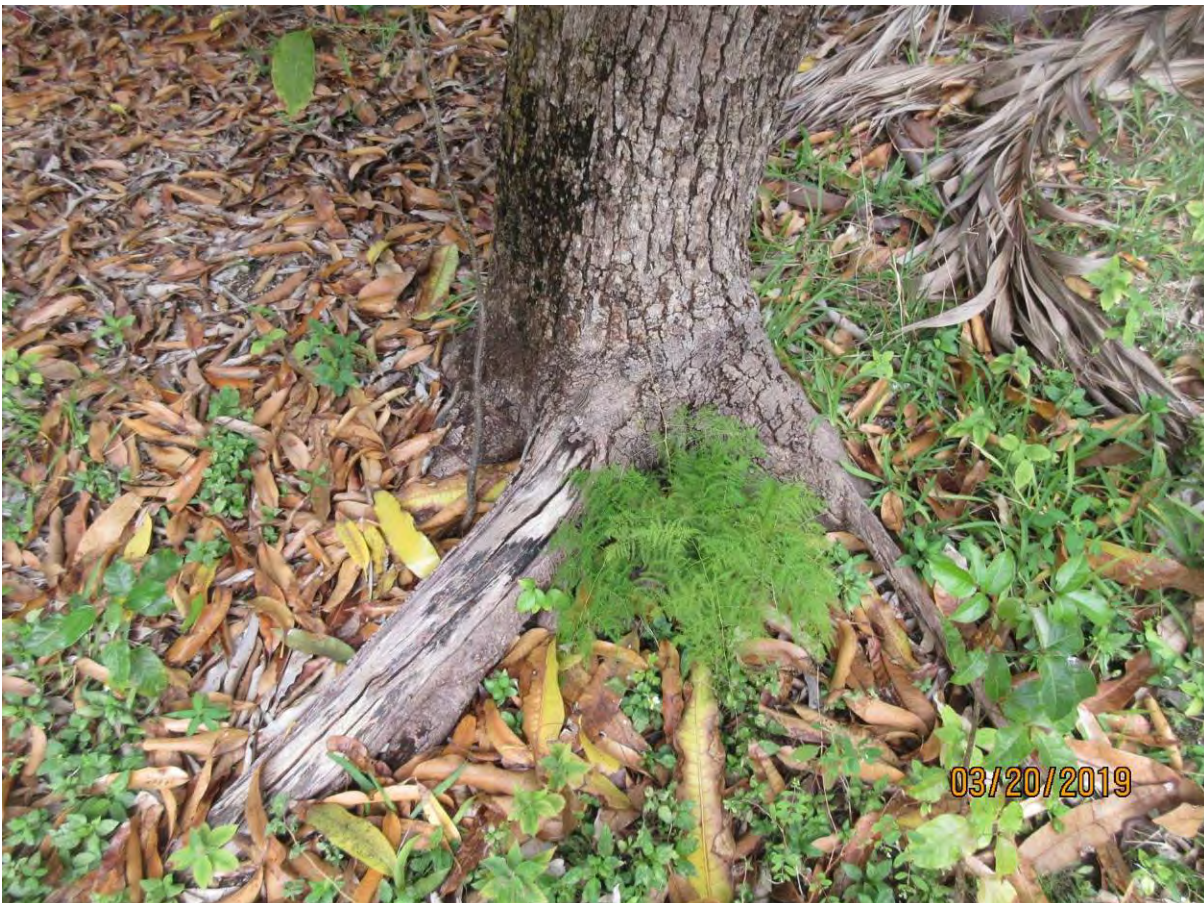
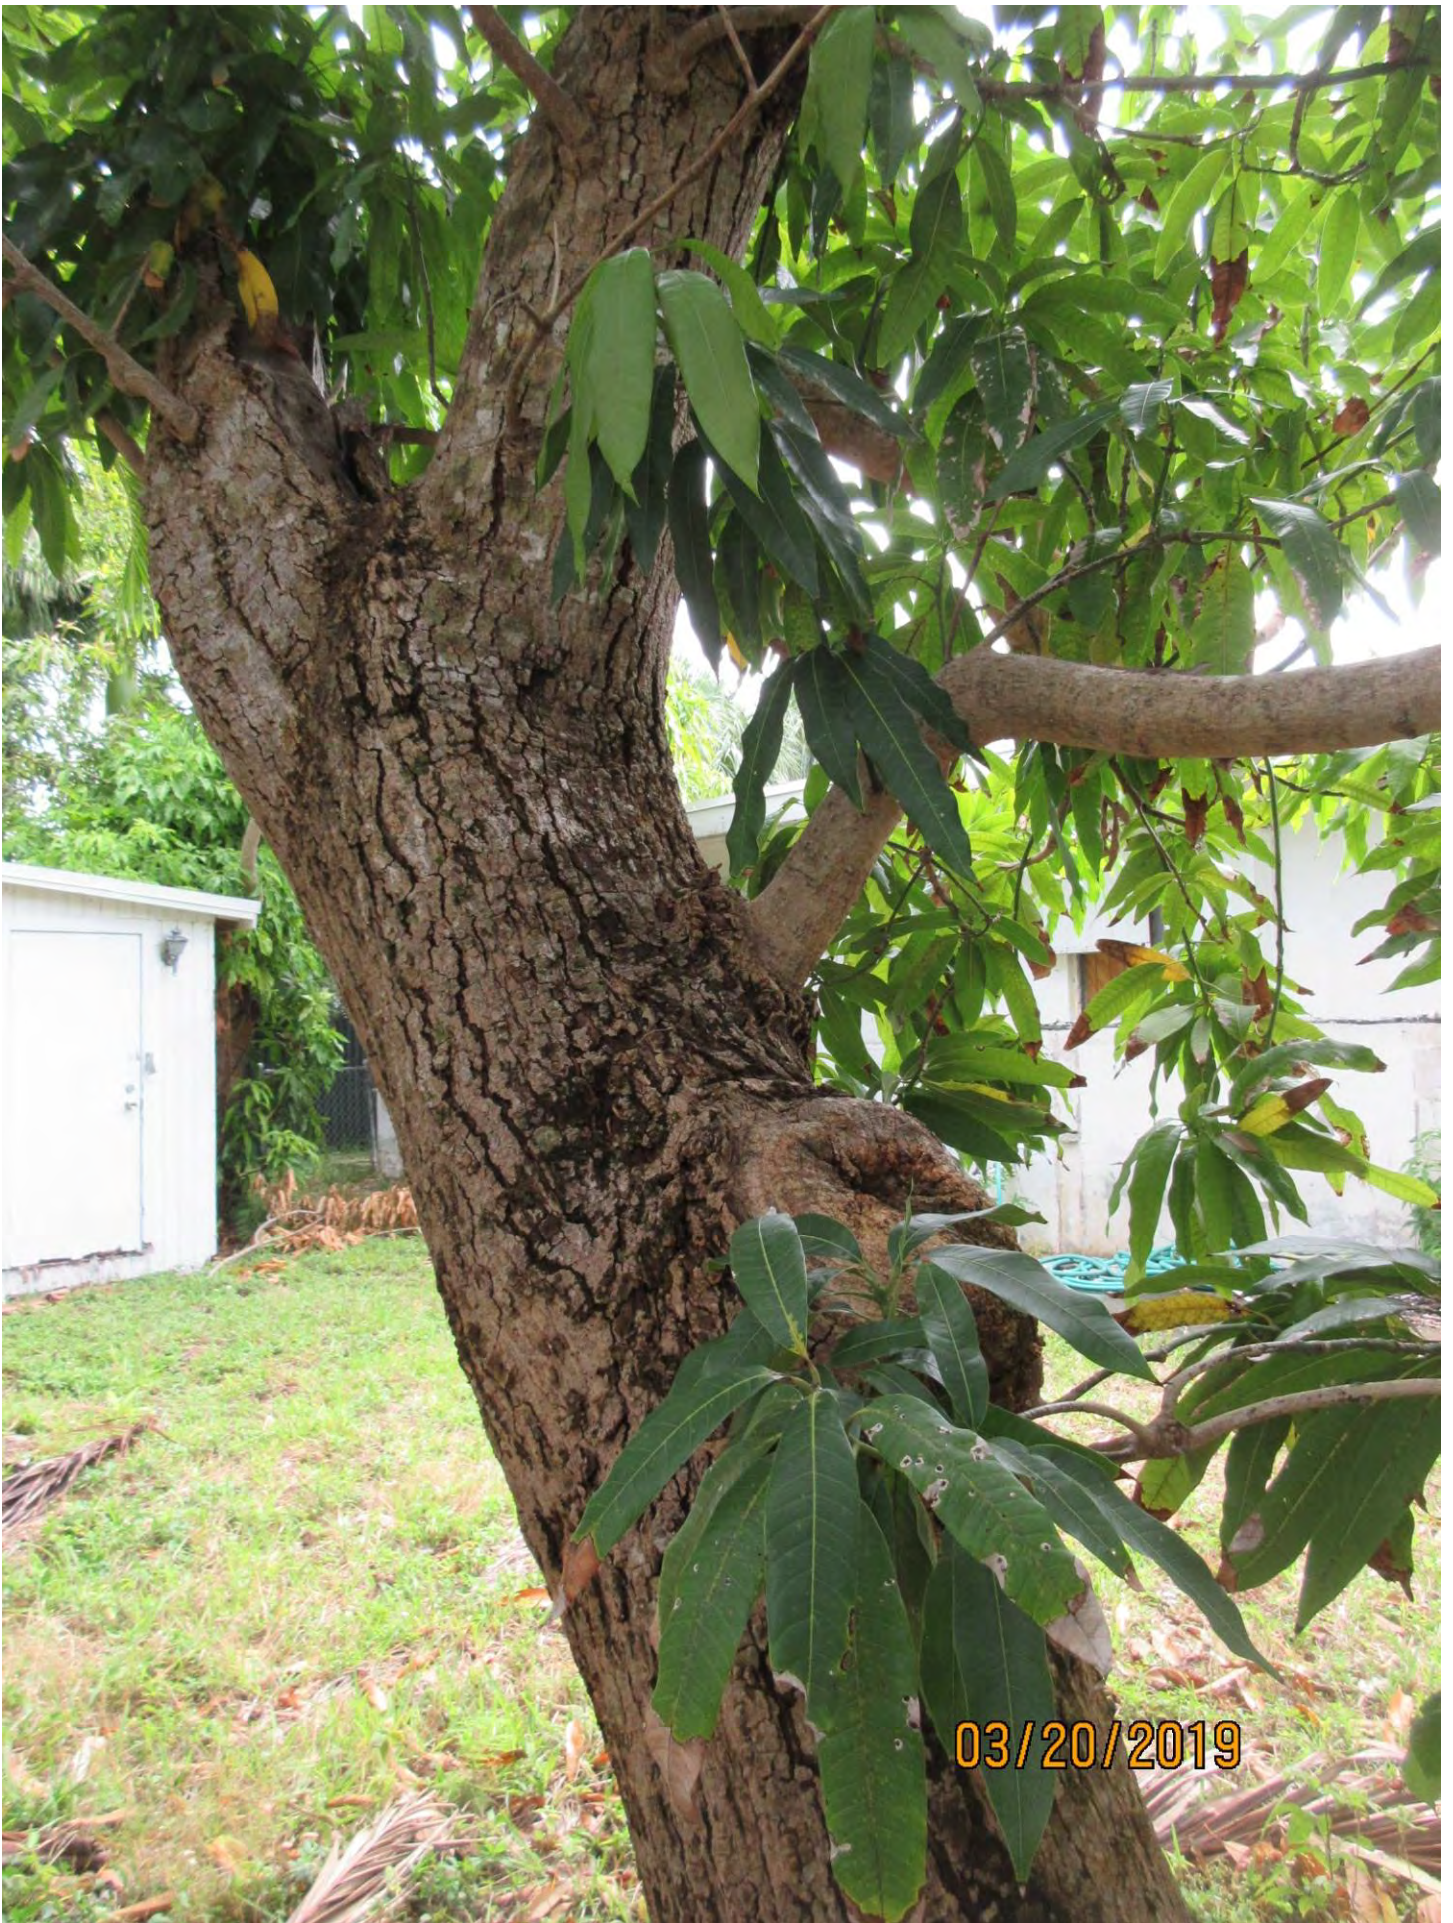
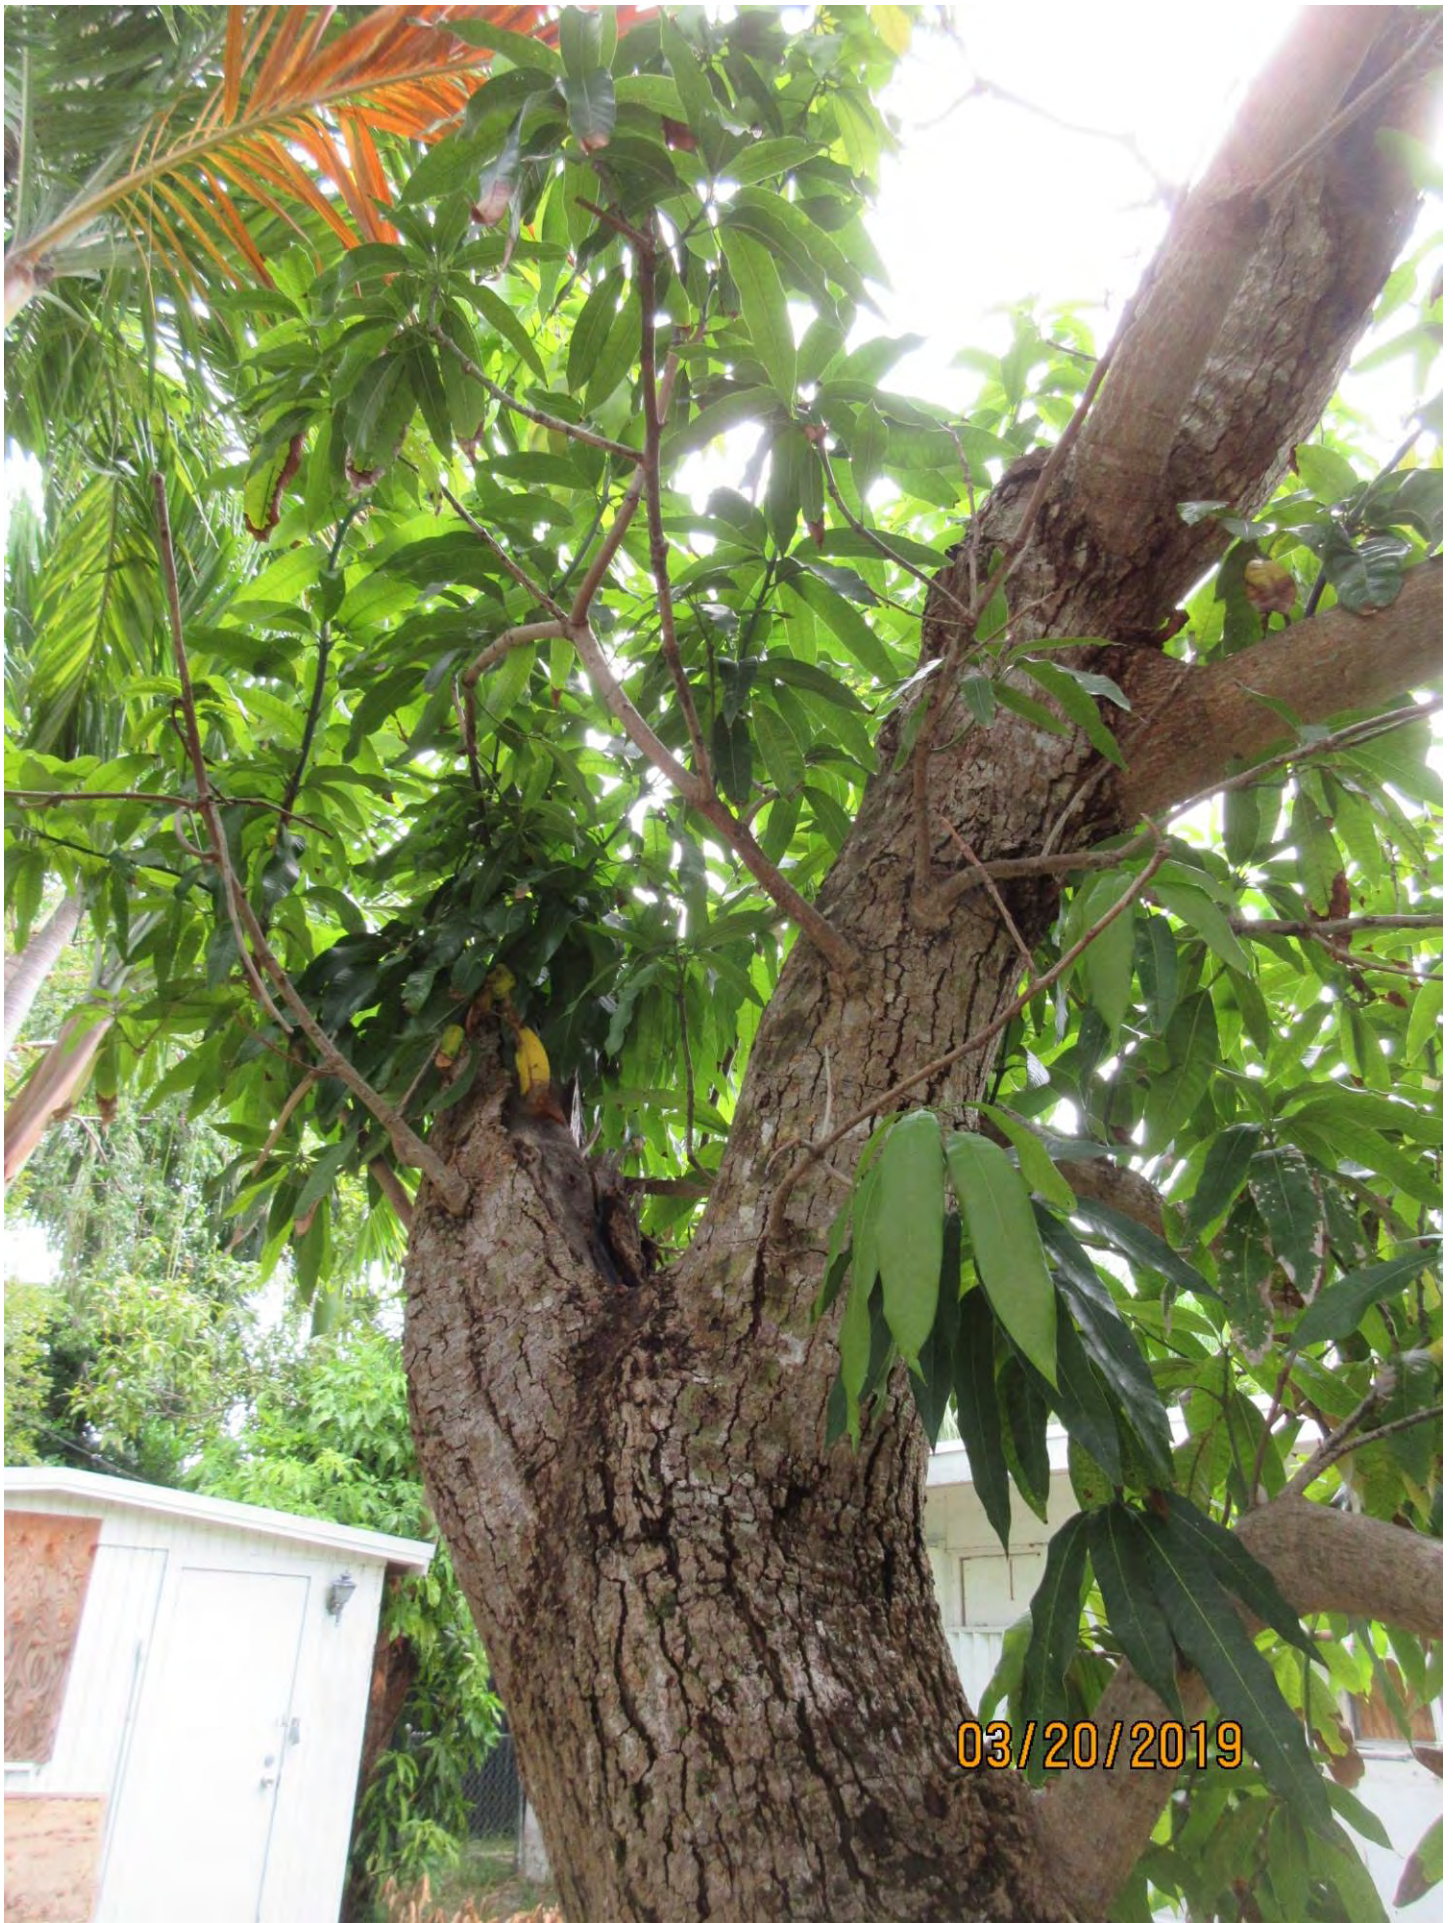
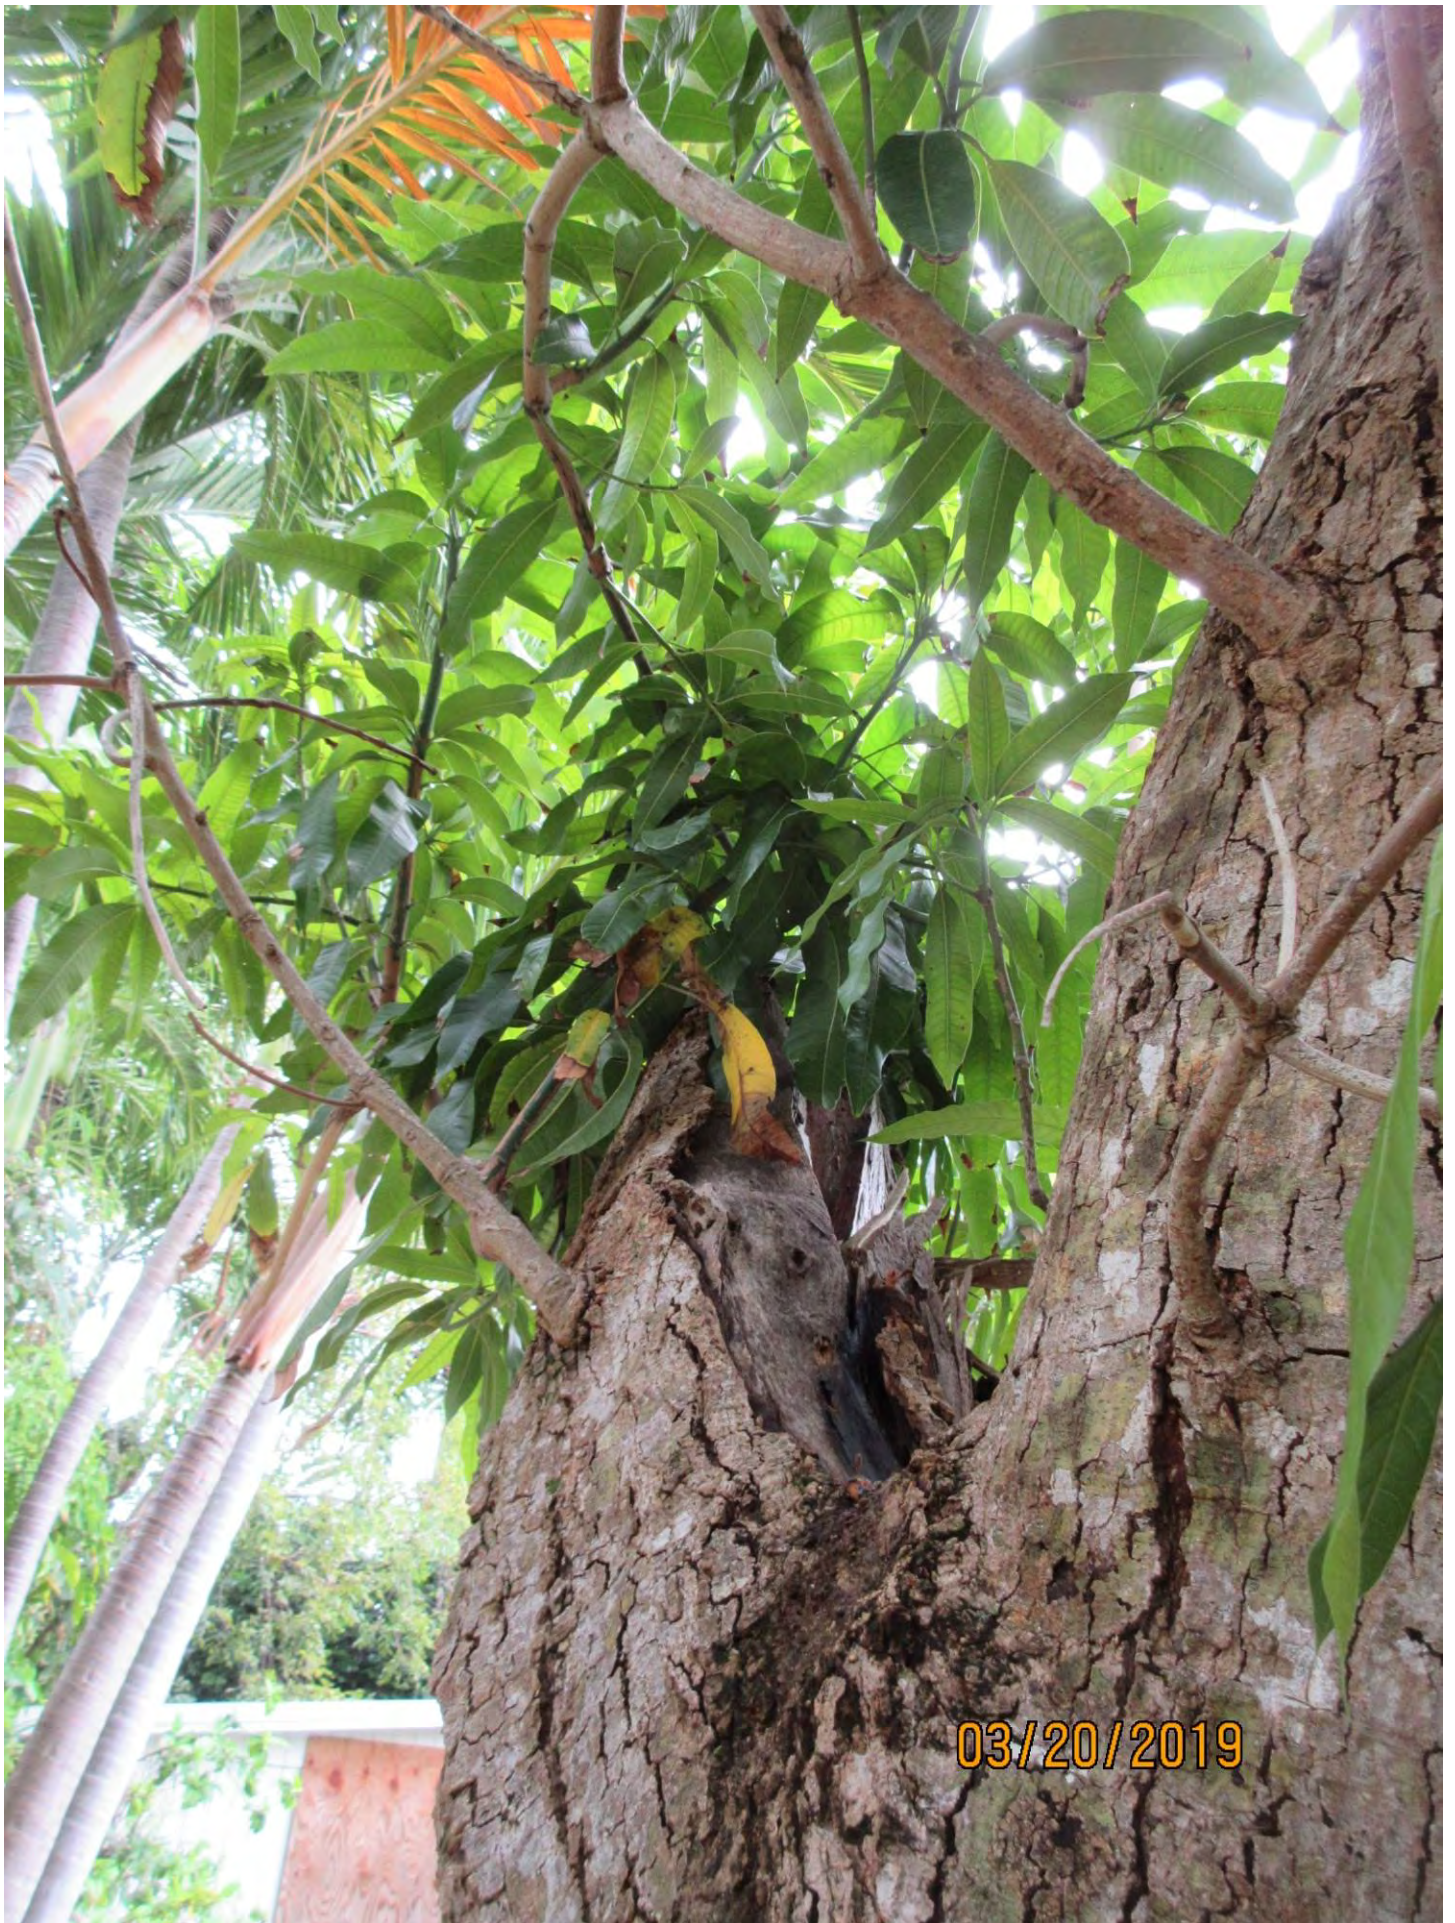
Tree #46:

Diameter: 18.1"

Location: 80% (back yard tree)

Condition: 50% (fair to poor, main trunk and old growth with lots of decay and damage, new growth on old growth is healthy, structure poor)

Total Average Value = 76%

Value x Diameter = 13.7 replacement caliper inches
