STAFF REPORT

RE: **813 Waddell Avenue (permit application # T2019-0125)**

FROM: Karen DeMaria, City of Key West Urban Forestry Manager

An application was received requesting the removal of **(2) Gumbo Limbo and (2) Mango trees**. A site inspection was done and documented the following:

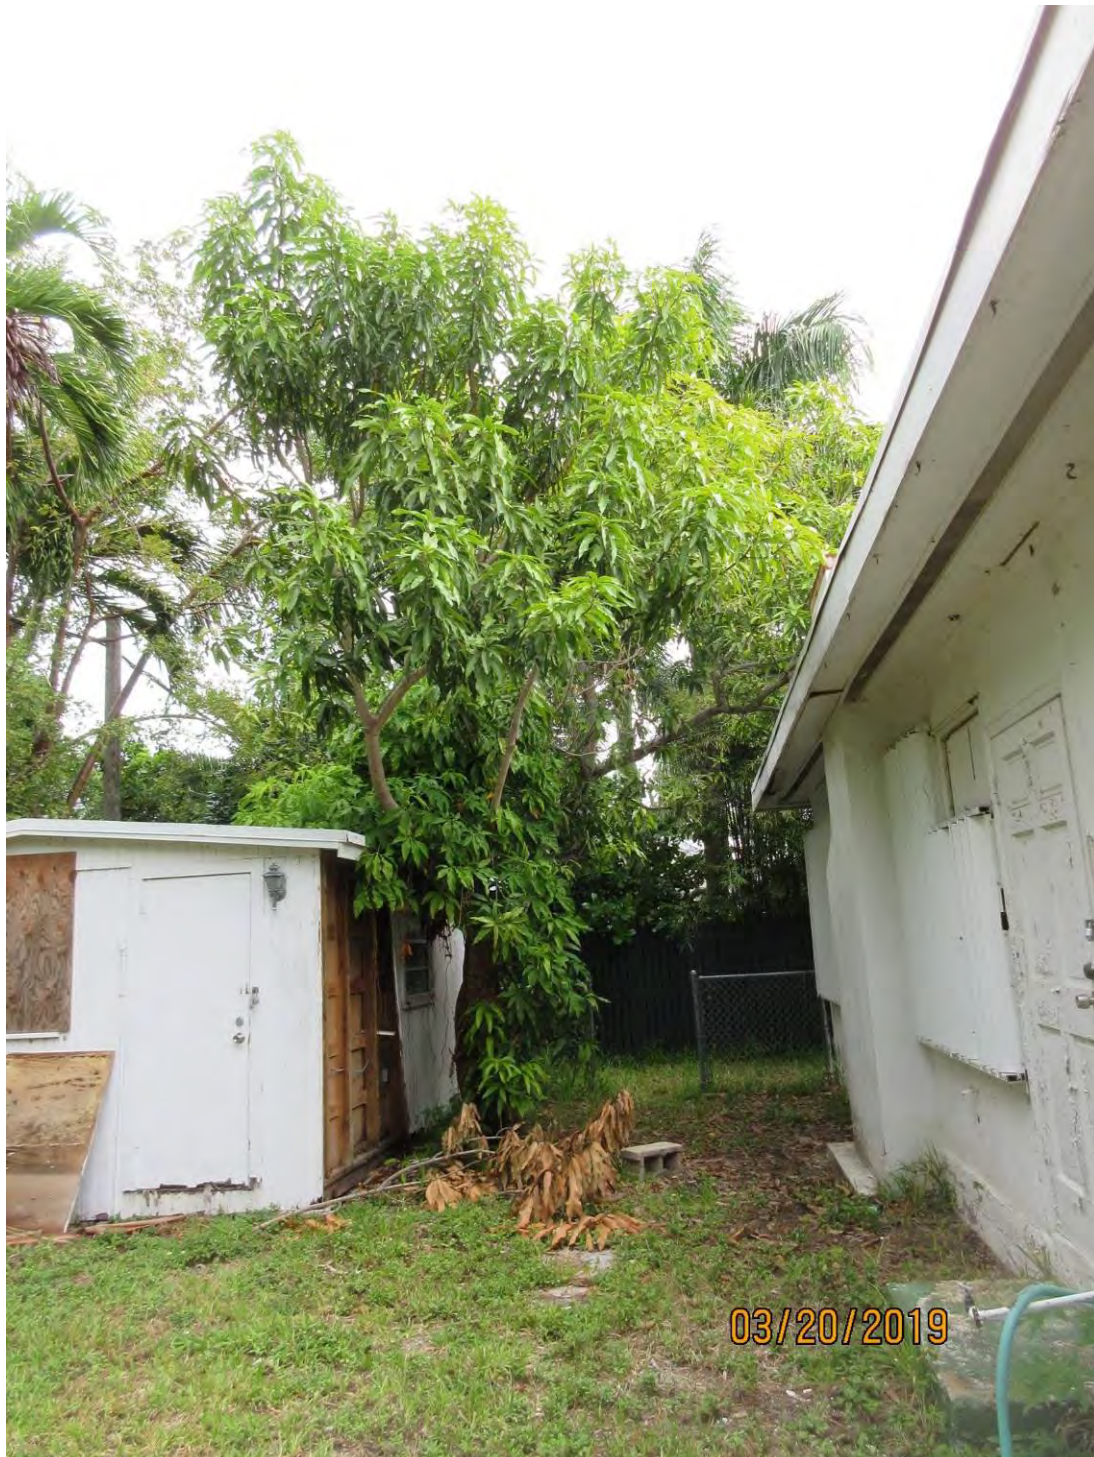
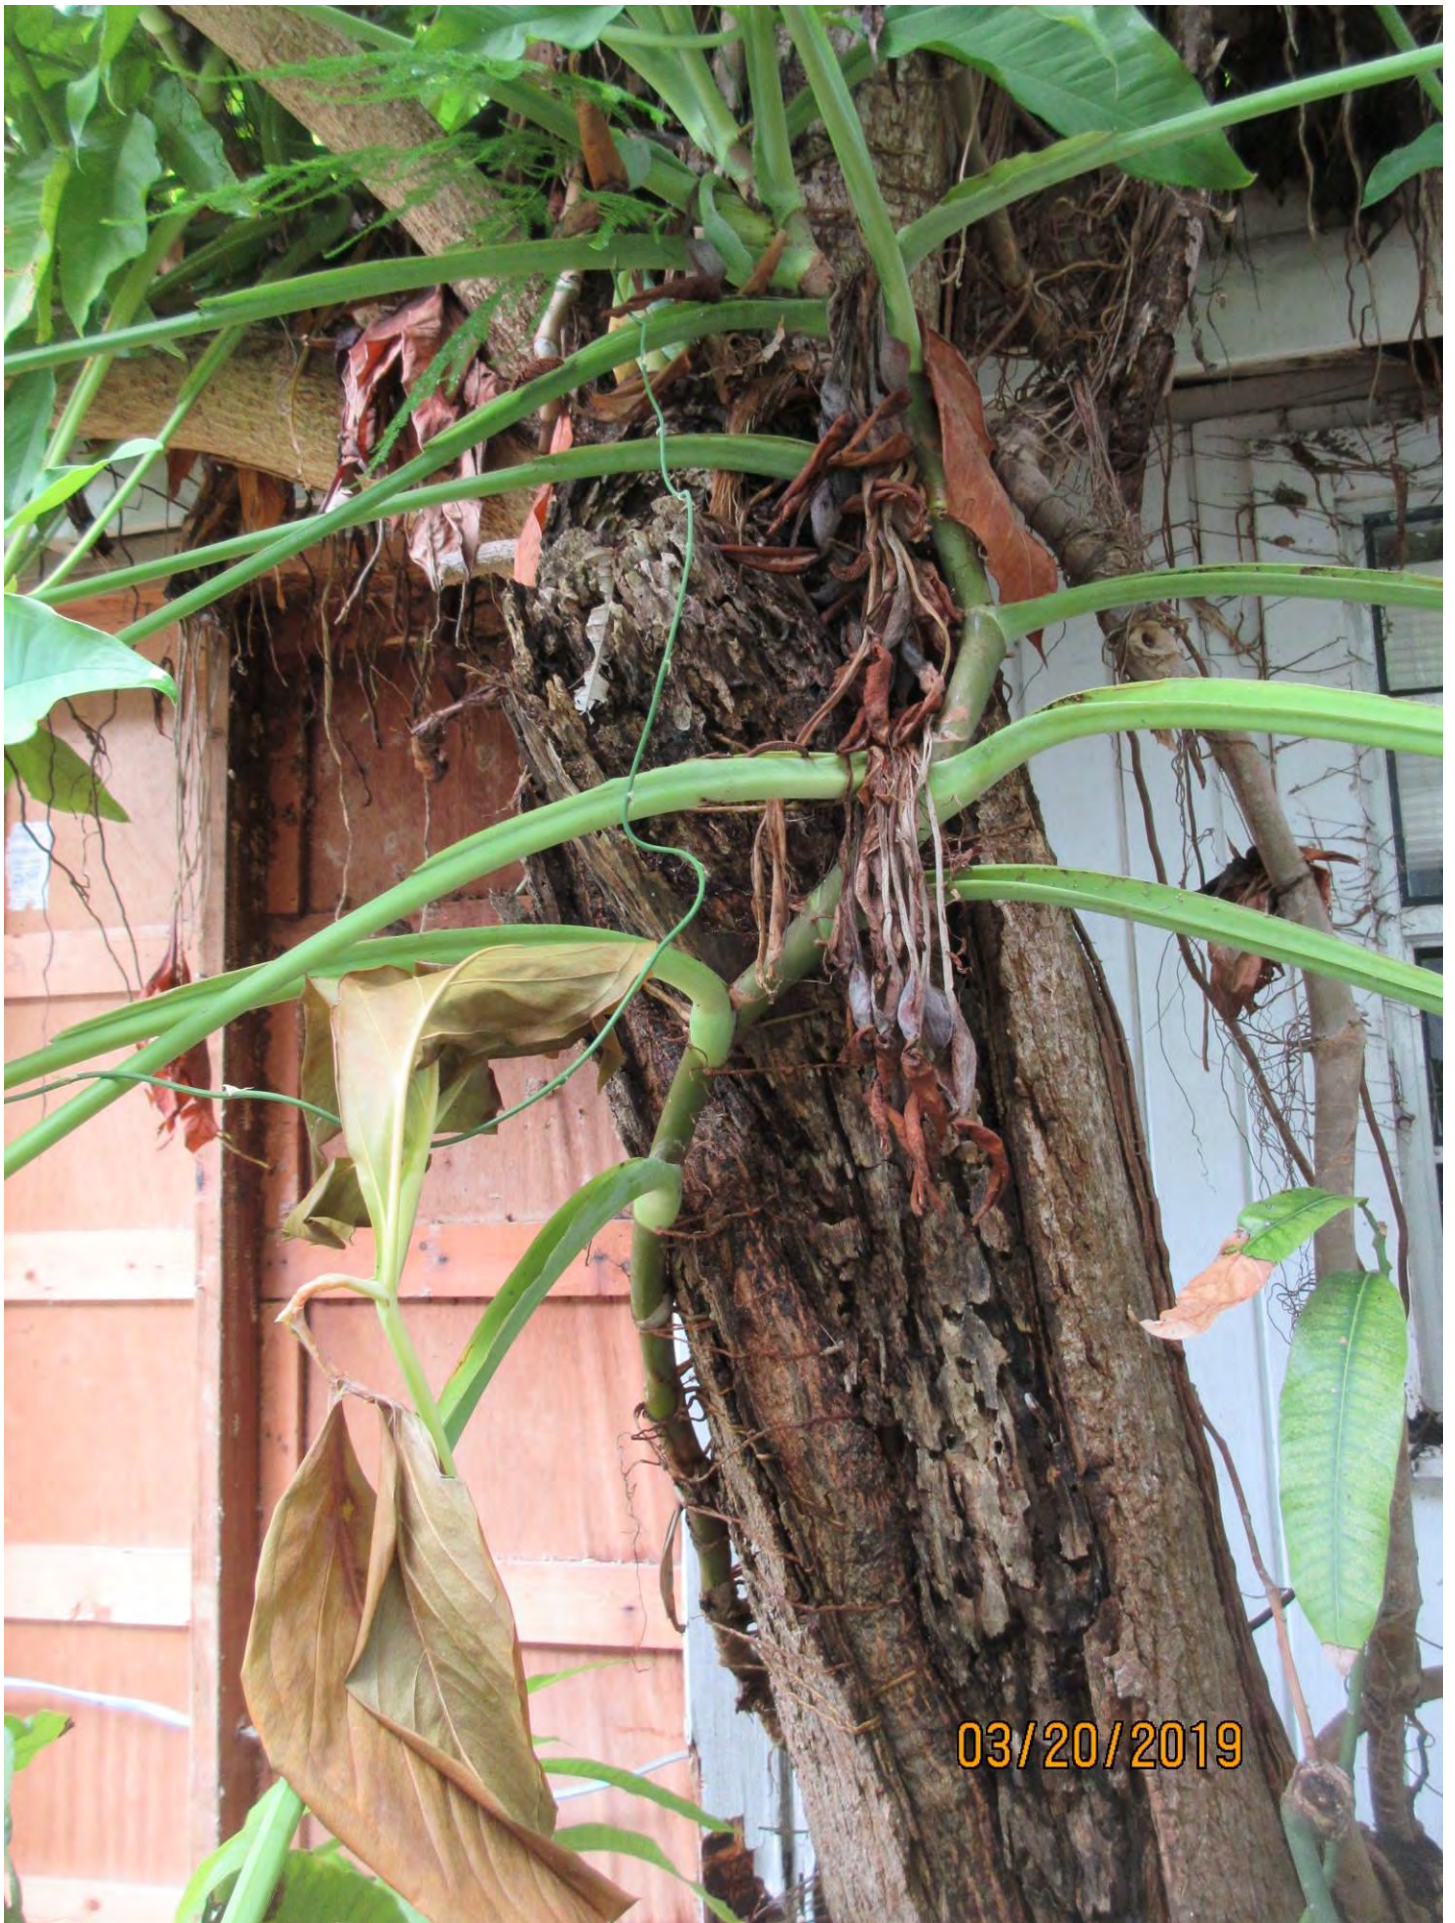
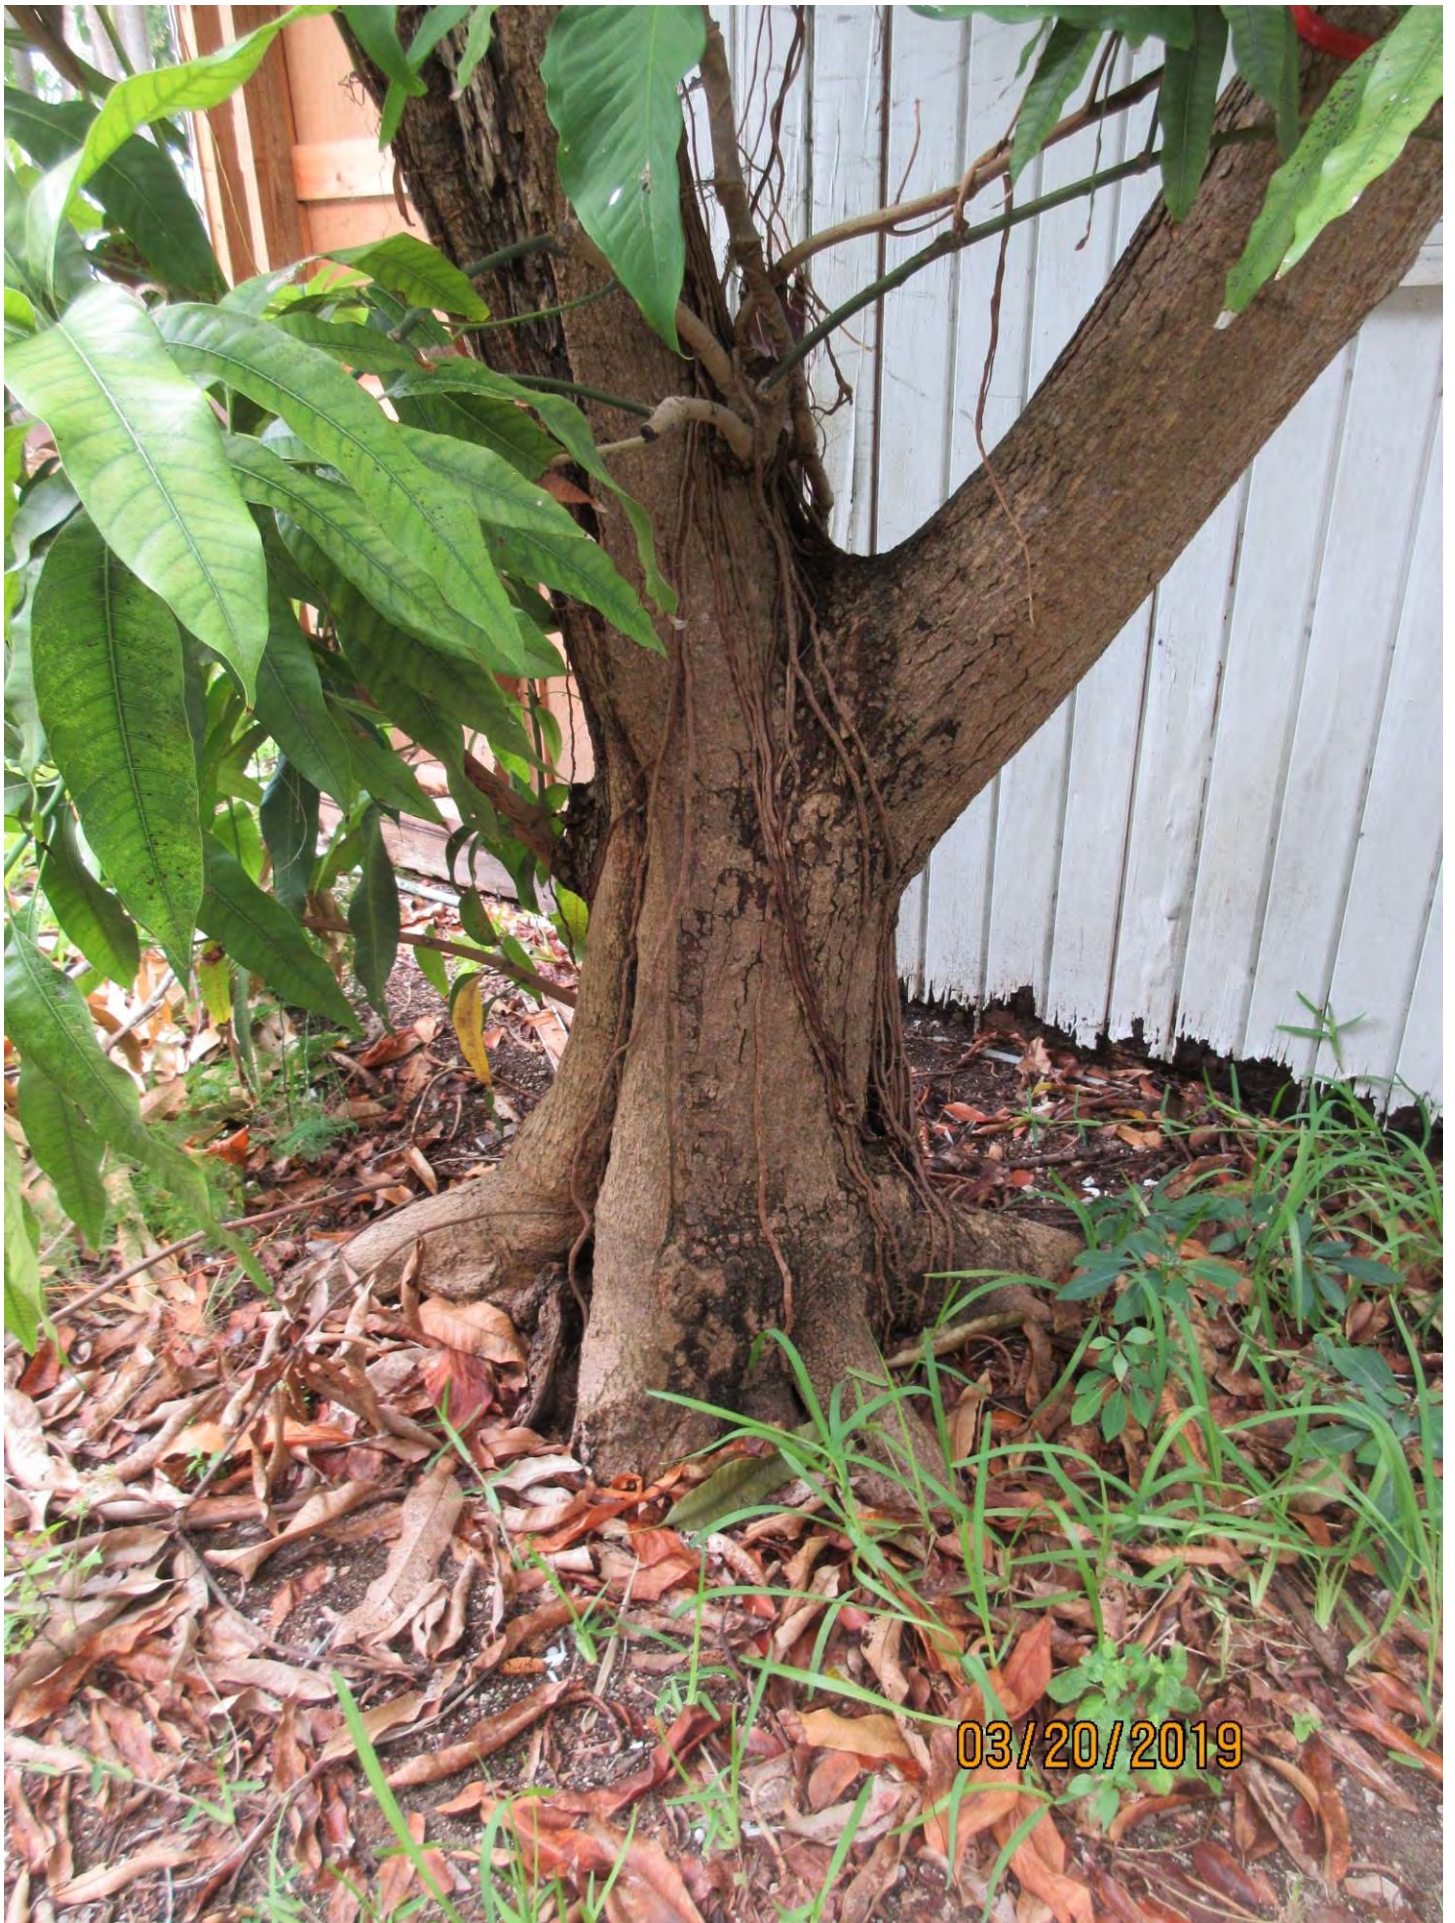
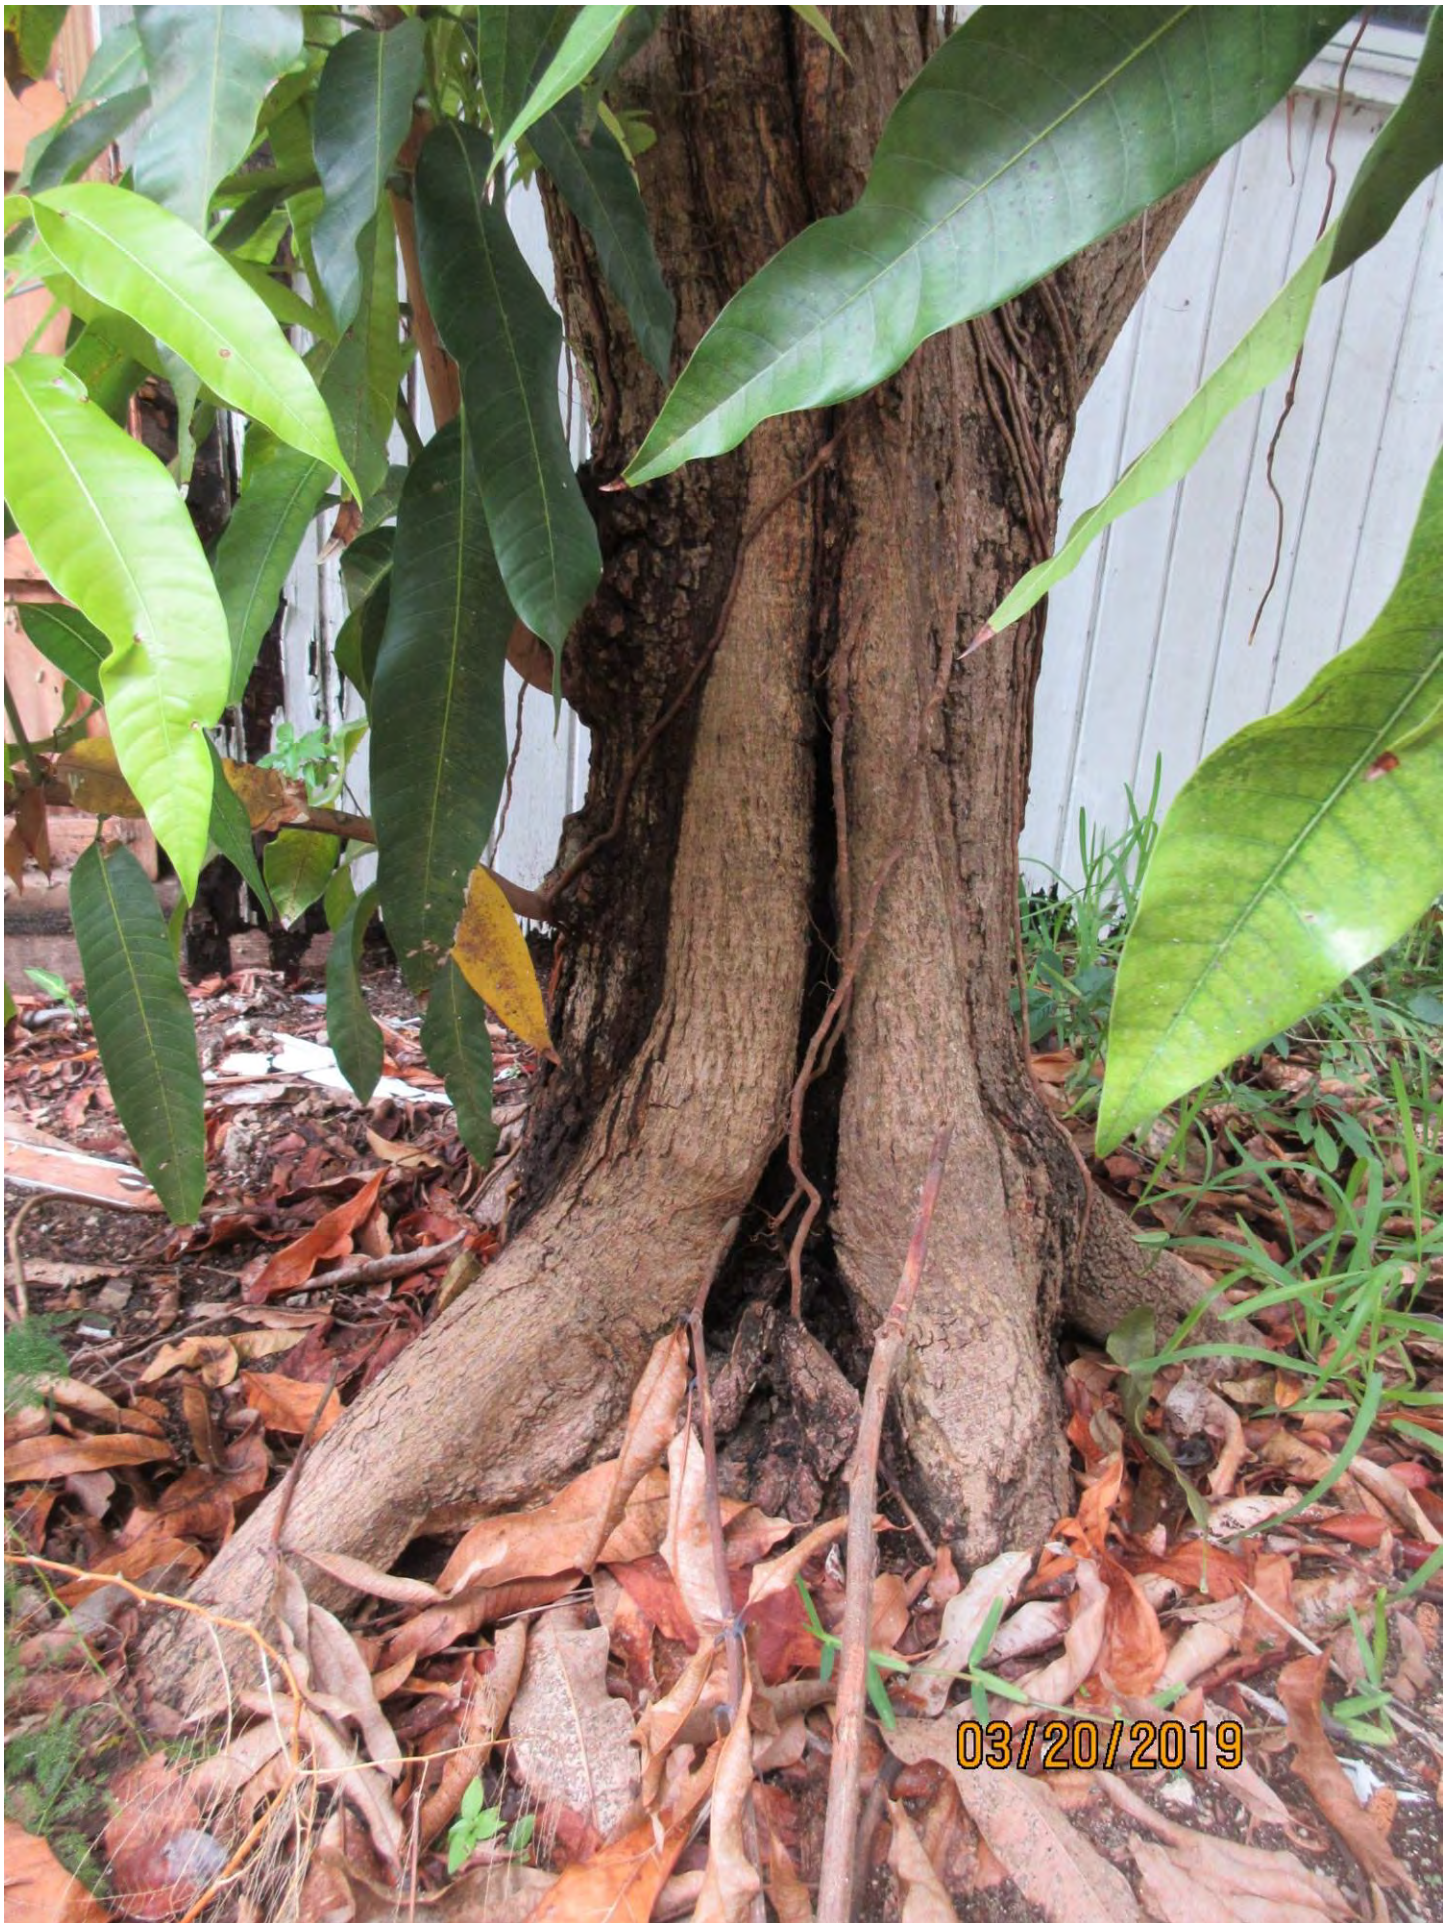
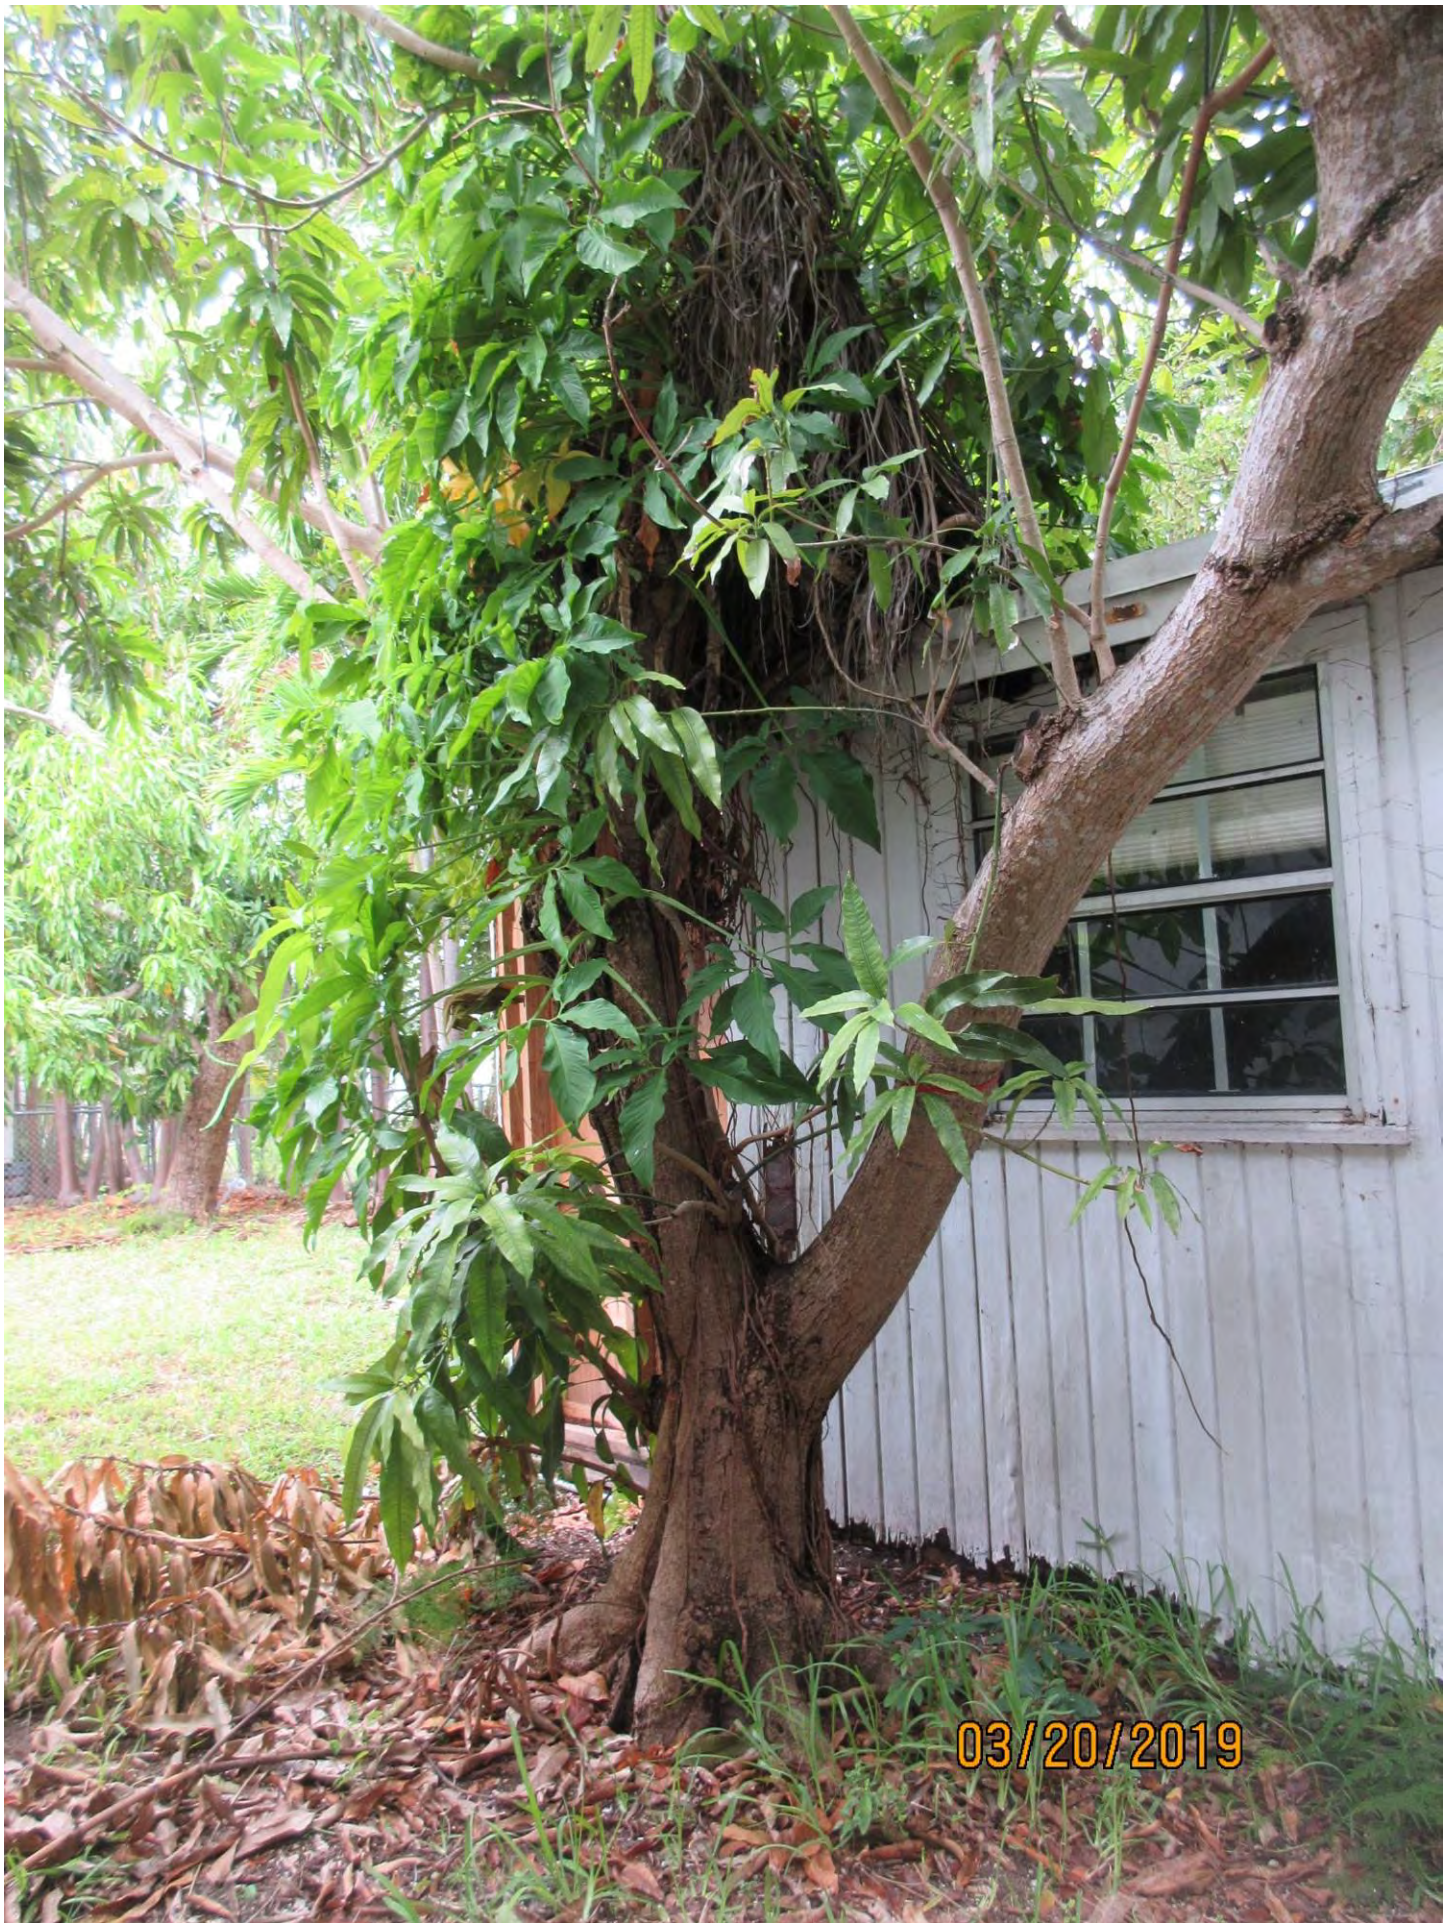
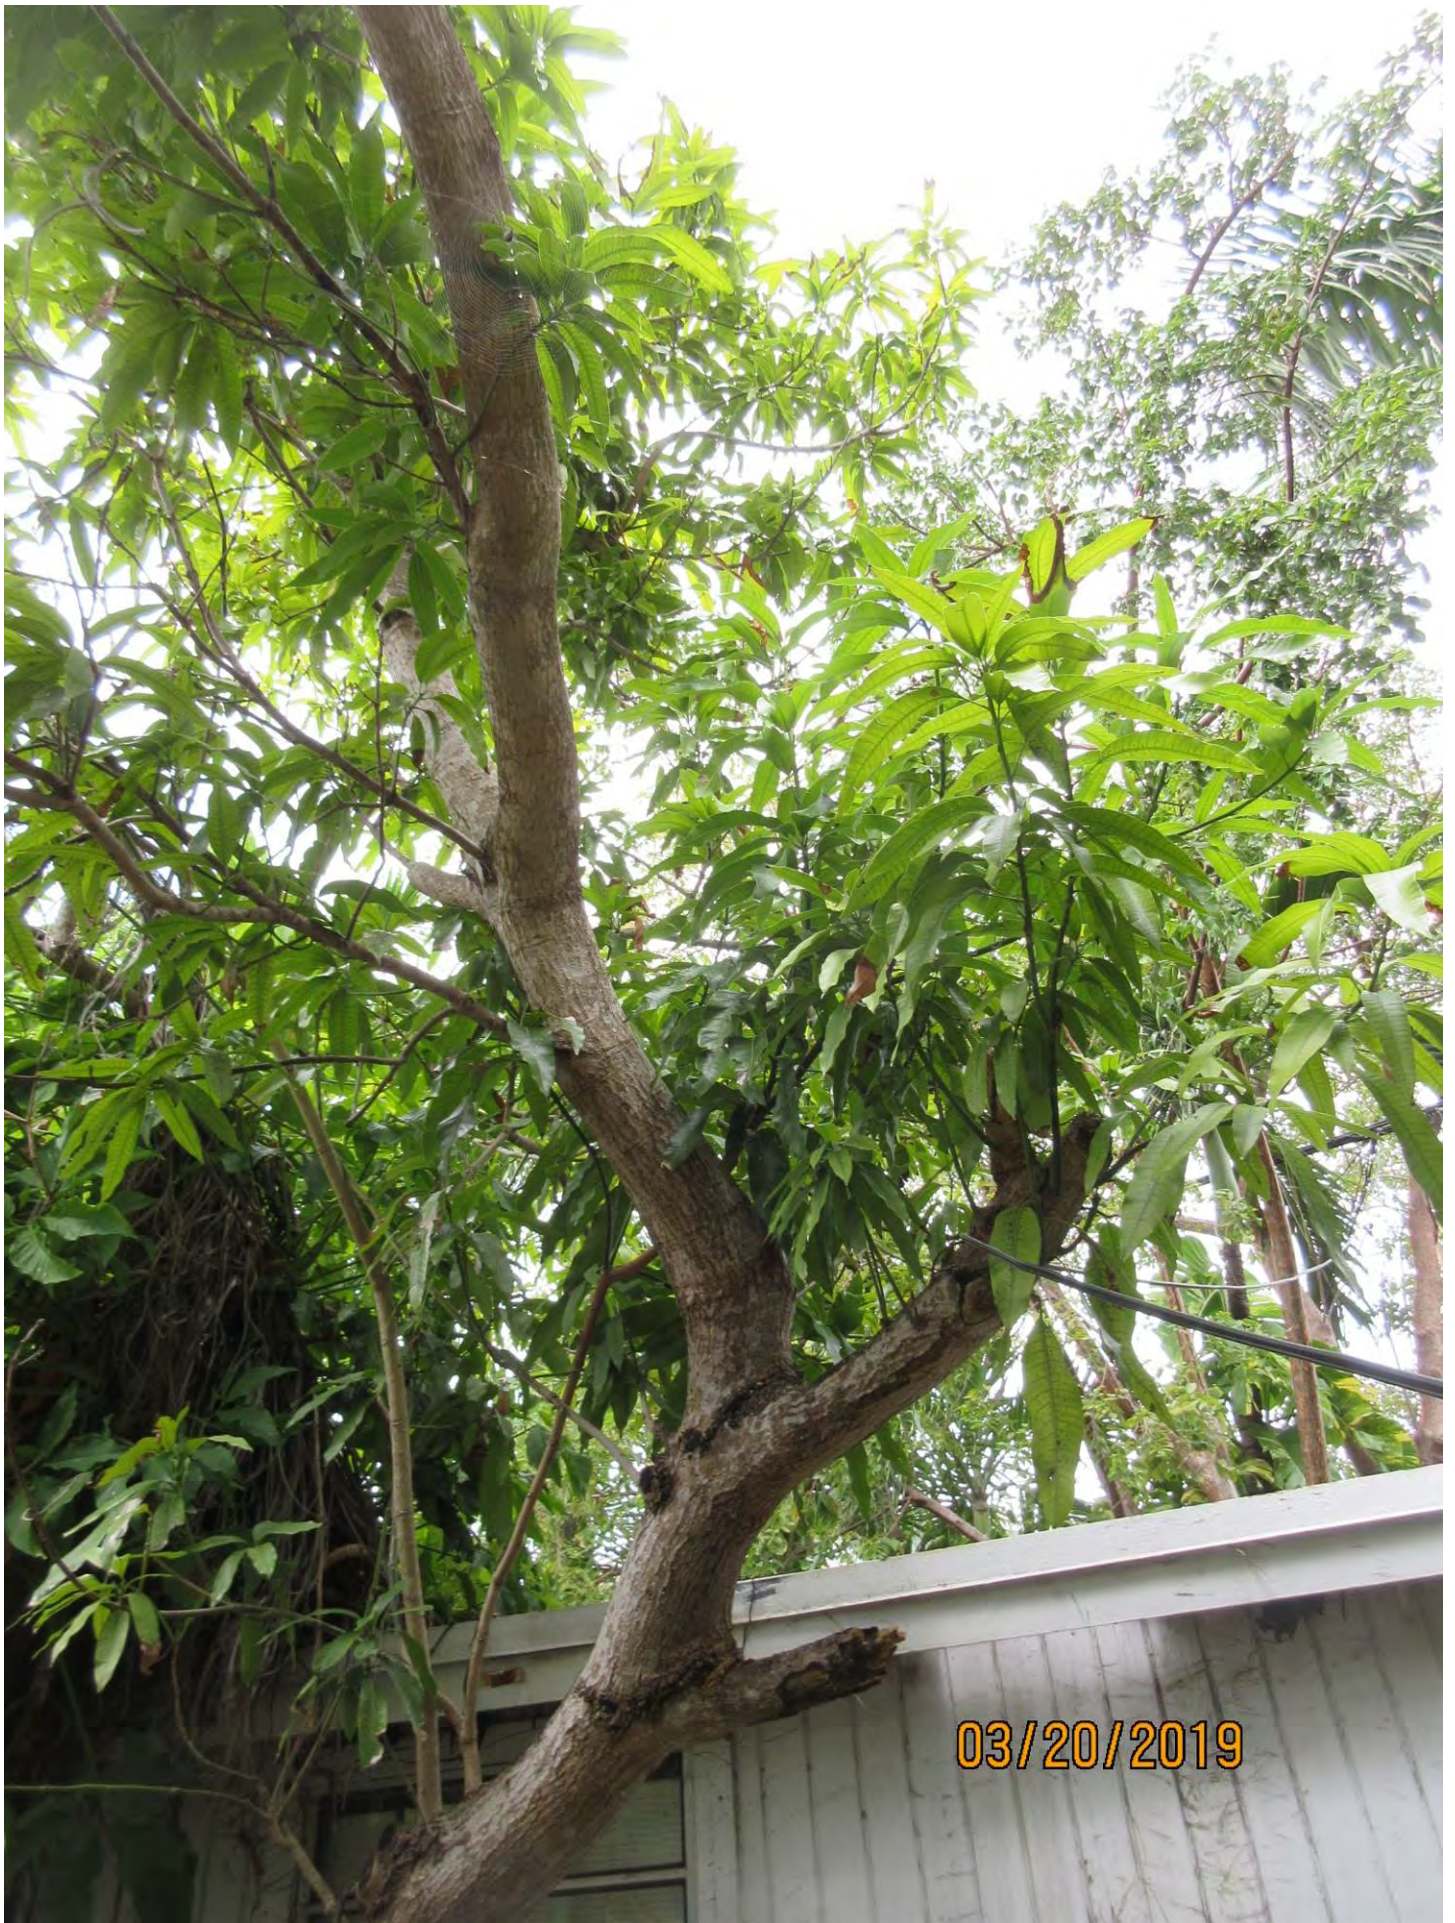
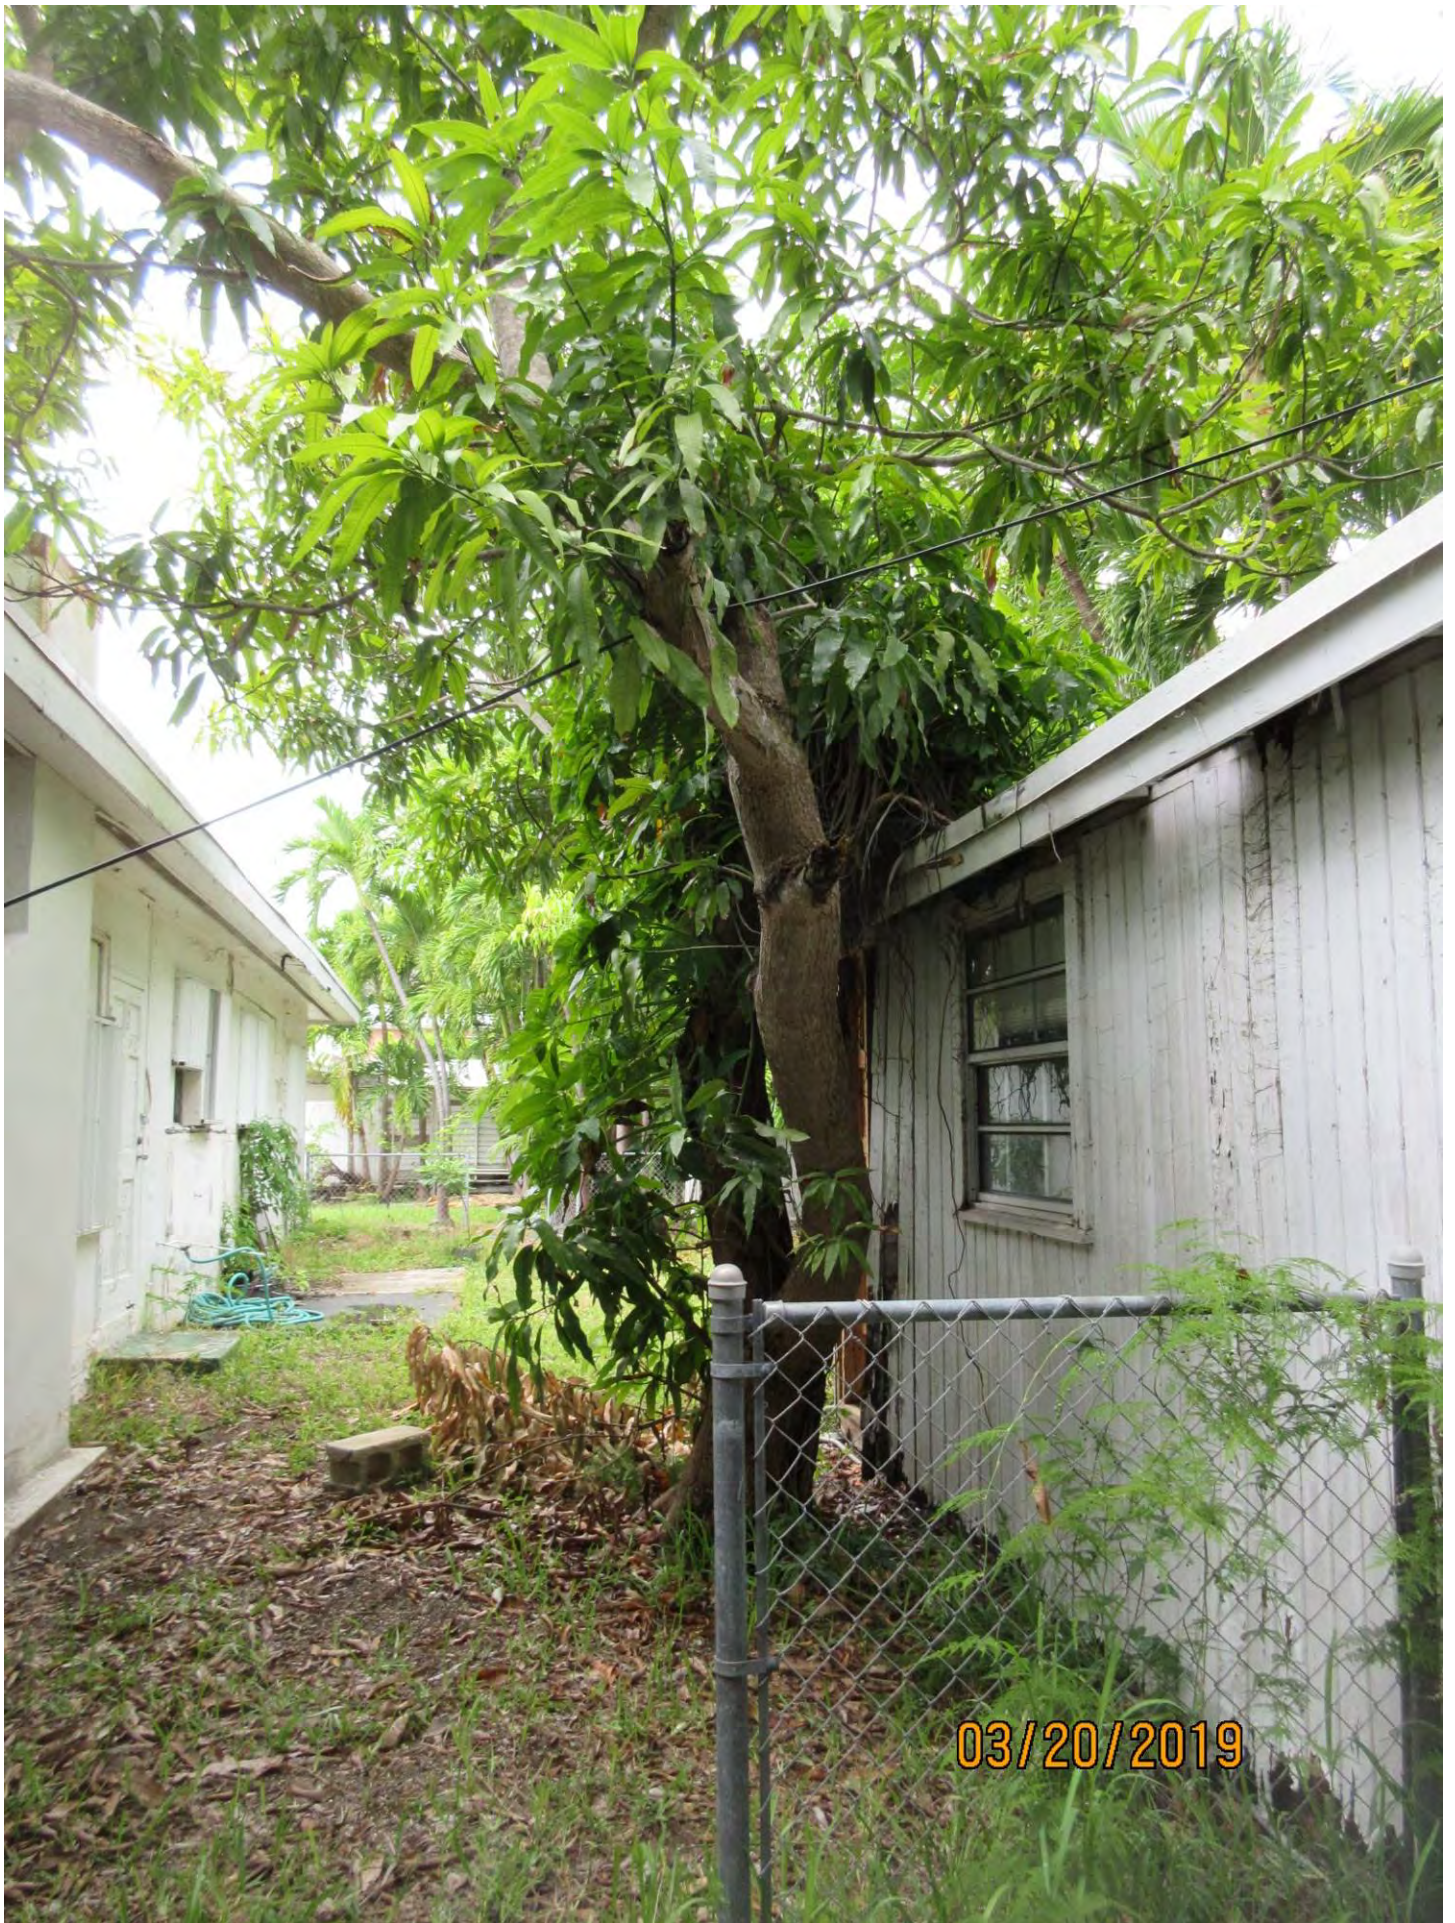
Tree #69:

Diameter: 20"

Location: 60% (close to structure, old cable/phone line in canopy)

Condition: 40% (poor, most of trunk is decayed, philodendron type vine growing along trunk and in canopy)

Total Average Value = 66%

Value x Diameter = 13.2 replacement caliper inches
