Re: Compliance Assistance Offer  
Stock Island Landfill-Closed  
WACS 97636  
Monroe County

**Florida Department of  
Environmental Protection  
Inspection Checklist**

**Facility Name:** STOCK ISLAND LF (SOUTHERNMOST WTE & KEY WEST LF)

Complaint Investigation Inspection for Landfill - Closed - Not in Long Term Care

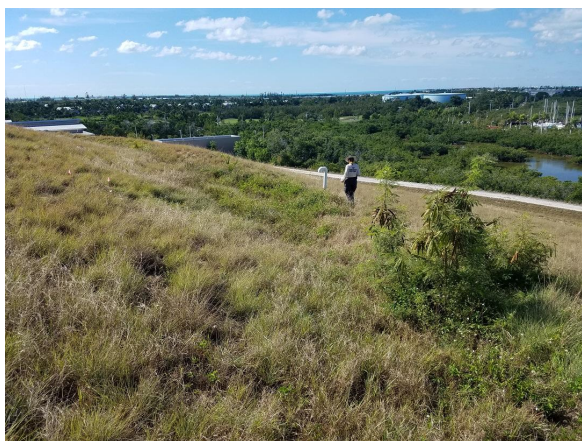
Explanation: Along the uppermost bench on the west side and the northwest corner of the landfill, there was some low points that could retain stormwater and accelerate erosion.

The cover in the low area on the west step is greener than the surrounding cover, which could indicate that stormwater is accumulating in that area.

Low point on west step

Corrective Action: Restore bench to original grade and stabilize with vegetation.

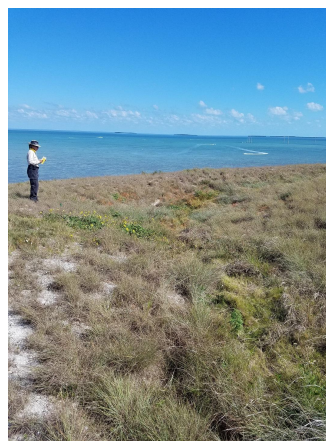
Low area on northwest corner step

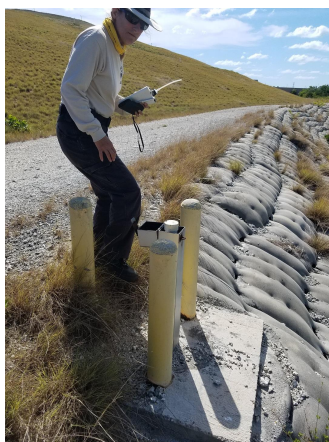
Explanation: No locks were observed on the monitoring wells. Department staff were able to open the well cover.

Unsecured monitoring well.

Monitoring well (MW) #2 was examined. Neither the well housing, nor the well cap were locked to prevent tampering.

Corrective Action: Appropriately lock and secure monitoring wells.

The LTC Report does not mention monitoring well security. However, if the wells are to remain in place they should be secured from tampering as required in 62-701.510(2)(d)5. F.A.C.

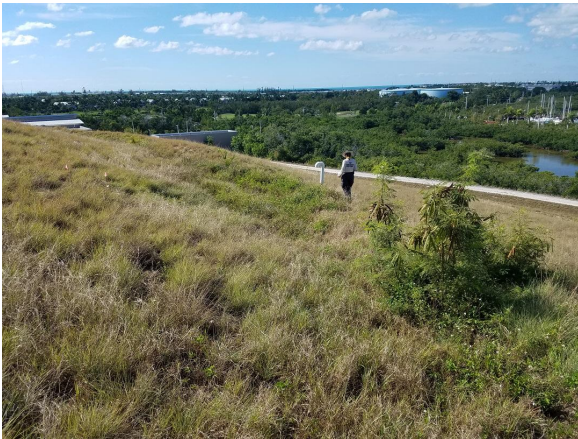
Explanation: The landfill cover does not show signs of recent mowing. Mr. Castro stated he does not remember when the last mowing event occurred. He further stated that the city's mower is not in operation at this time.

Overgrown plant on cover

Corrective Action: The city is supposed to mow the landfill cover six times a year. Mr. Castro stated that he is looking at getting a contractor to maintain the cover.
