Evaluation Report for Turtle Kraals

Evaluation Report for the Turtle Kraals Tower Bar Structure at 231 Margaret Street

Key West, Florida

November 20, 2015

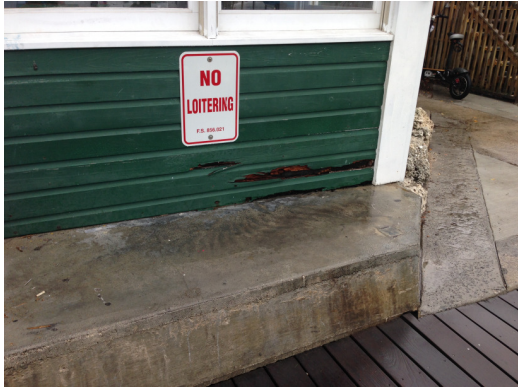
- i) Roof Canopy at the rear covered walkway: Both beam end supports were observed to possess inadequate, possessing insufficient gravity and wind uplift support capacity, thus requiring new support columns (See Pics.7&8).
- ii) Exterior Cladding: an area of the exterior wood cladding at the building's north west corner was observed to have rot due to water intrusion (See Pic.1).

(Pic. 1) Exterior cladding
(Deterioration from moisture)

Exterior Cladding: The areas deteriorated wood cladding/siding requires replacement (See Pic 1).

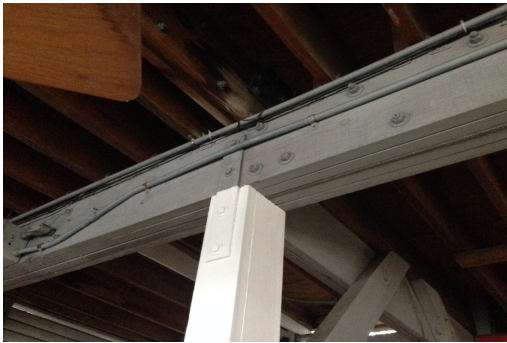
The wood support beams were observed to be in good condition, displaying no visible signs of distress or deterioration. The beams were observed to possess adequate support for both gravity and wind uplift loads (See Pics.2&3).

(Pic.2) Typical Interior Roof
Framing and Support

B. Wood Beams: No action at this time.

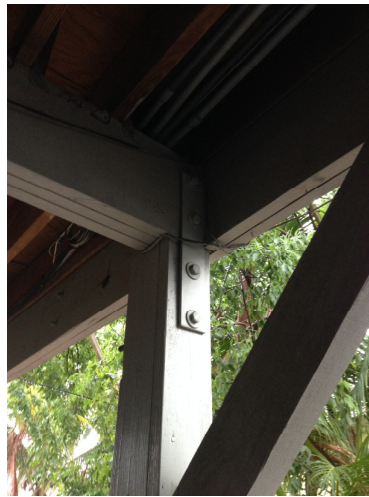
(Pic.3) Typical Perimeter Roof
Support

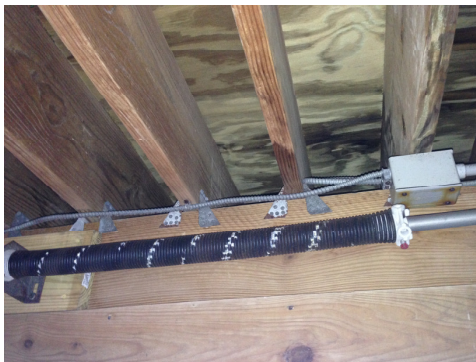
Large areas of the 2"x12" flat roof/roof deck floor joists and plywood deck appeared weathered, displaying discoloration due to moisture intrusion from a deteriorated roofing (See Pic. 4). At the time of inspection, a large area of the roof framing was still wet from a recent rainfall (See Pic. 5). No sagging or excessive deflections were observed.. The roof framing was observed to possess adequate support for both gravity and wind uplift loads.

(Pic.4) Typical Roof Framing
(2x12 spaced at 12" o.c.)

In its current condition, the roof/floor wood framing does not pose a structural concern. However, the roofing should be repaired/replaced as soon as possible to eliminate the moisture intrusion into the roof/floor framing which will result eventually in the deterioration and weakening of the floor structure. In our opinion, the Durable plywood deck waterproofing system by Duradek will be the best suitable deck waterproofing system for this application.

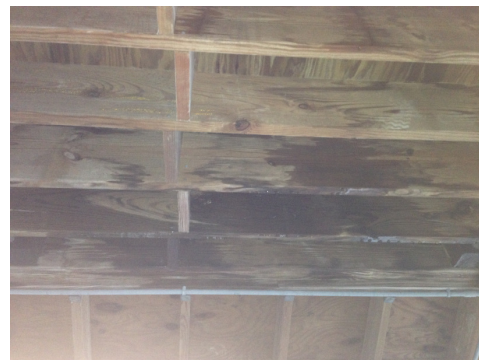
(Pic.5) Typical Roof Framing
Weathered & Wet from Moisture
Intrusion

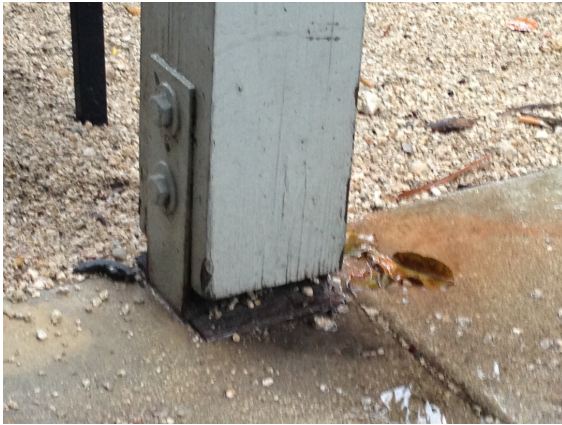
The majority of the wood columns were observed to be generally in good condition. Several column posts displayed an inadequate bearing configuration, where a gap exists between the bottom of the column and the concrete support, relying solely on the connecting metal bracket and bolts to sustain full gravity loads (See Pic.6). Several column base support brackets were observed to possess some level of corrosion, from mild to severe, due to exposure to moisture.

(Pic.6) Wood column post at covered walkway (Gap at base)

At the locations where the wood columns possess gaps at their base, wood shim plates should be placed within the gap space in order to create full bearing. Where the base plates/metal connectors have corroded, the plates should be replaced.

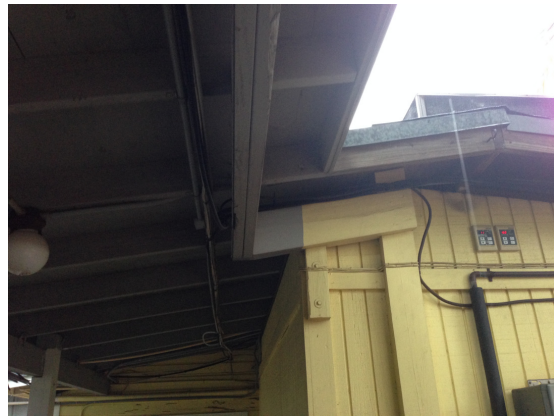
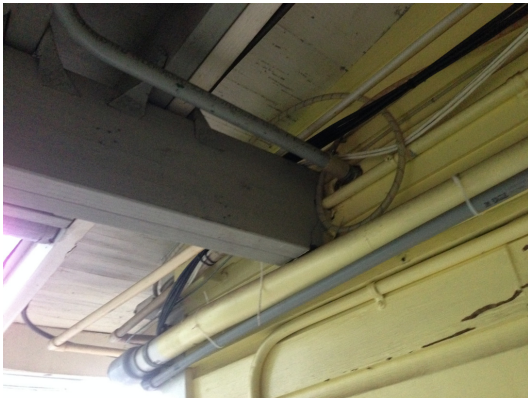
(Pic.7) Inadequate beam support at walkway canopy structure

(Pic.8) Inadequate beam support at walkway canopy structure

Rear walkway roof canopy: Beam end support columns are required to properly support the wood beams (See Pics. 7&8). The new wood columns should possess the same configuration as the existing remaining canopy support columns.

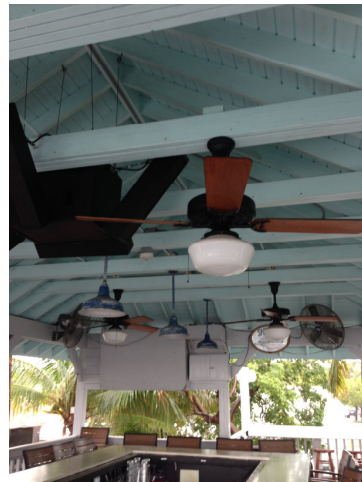
The upstairs bar building structure consists of wood column posts supporting perimeter wood beams, supporting a wood framed hip roof structure (See Pic.9). The free standing gazebo structure: column posts, beams, roof framing, and roof sheathing appear to be in good condition. The roof rafters do not appear to possess adequate lateral and uplift load connections to the wood beams, at least not visible (See Pic. 12). Also no rafters to ridge connections were visible. One wood beam to column post connections was observed to be insufficient since the connection was placed at the beam end, possessing no edge distance (See Pic.10). The wood lateral bracing was observed to be in good condition, however at one corner bracing, the bottom connecting bolts is missing (See Pic.11).

(Pic.9) Upstairs bar roof structure (no visible roof rafter uplift connections)

The roof framing requires further investigation to assure that their connectors are not hidden, exploratory investigation will be required. In the event that no connectors are found, new connectors are to be installed. The new connections are to be designed to resist a combination of uplift and lateral loads due to wind. This may require the use of metal clip angles and metal straps at each wood rafters. The inadequate wood beam to post connection shown in pic.10 requires to be redesigned to achieve a connection possessing adequate edge distance; This may

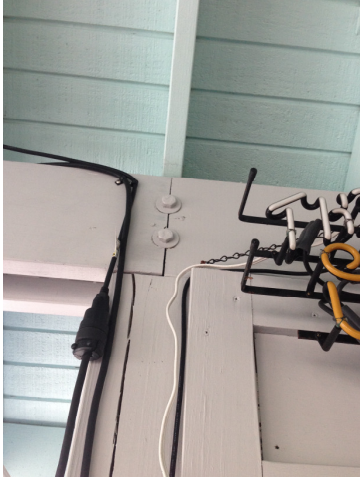
(Pic. 10) Upstairs bar wood beam (Inadequate connection)

require the replacement of the entire wood beam at that location. The missing bracing bolt shown in pic.11 requires to be installed.

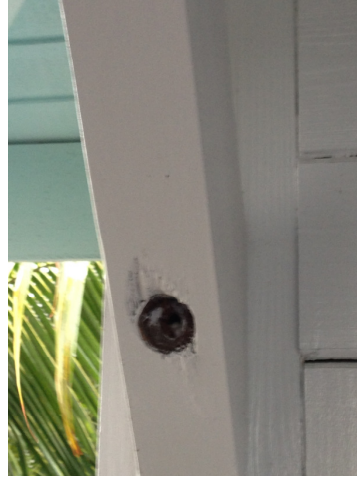
(Pic. 11) Upstairs bar wood bracing (Missing bolt connector)

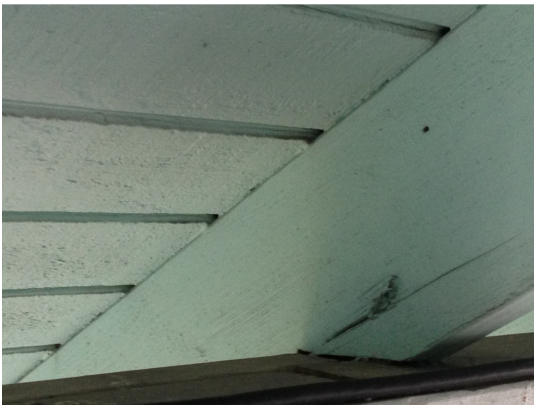
(Pic.12) Upstairs bar roof rafters (No visible roof uplift connections)
