BUILDING INSPECTION REPORT

Report Number
315

Margaret Street Turtle
Kraals Site
Key West, FL
33040

Inspection Date: **07/27/2015**

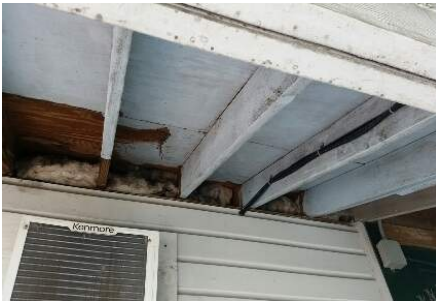
3.

Location: Exterior Right **System:** Roof **Condition:** Fascia is missing

Explanation: Fascia is observed to be missing. Fascias are normally applied at roof edges to prevent water and pest infiltration.

Impact Consequences: The fascia areas at roof edges are vulnerable to water and pest infiltration if not adequately covered and sealed. Adding and or restoring fascia in this area is recommended.

Recommended Action: Install

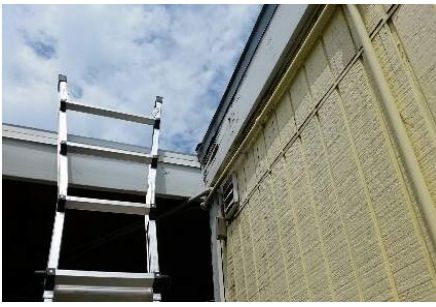
5.

Location: Exterior Ice Machine area **System:** Roof **Condition:** Fascia wood is rotted

Explanation: The condition of the fascia is such that wood rot and deterioration has occurred.

Impact Consequences: Rotted wood at fascias is an indication that the ability of the fascia to protect against water infiltration and pest entry has been compromised. All rotted and deteriorated wood at fascias should be removed and replaced. Failure to correct this condition may result in costly repairs to adjacent areas damaged as a result of loss of protection.

Recommended Action: Replace

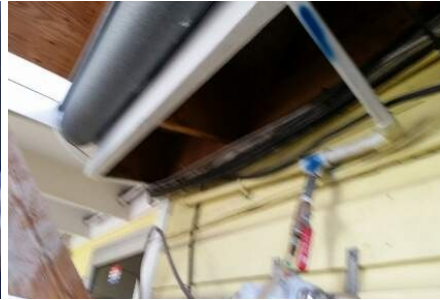
6.

Location: Exterior Ice Machine area **System:** Roof **Condition:** Soffit is missing

Explanation: Soffit protection is observed to be missing.

Impact Consequences: The soffit areas at roof edges are vulnerable to water infiltration and pest intrusion if not adequately sealed. Adding and or restoring soffit in this area is recommended.

Recommended Action: Install

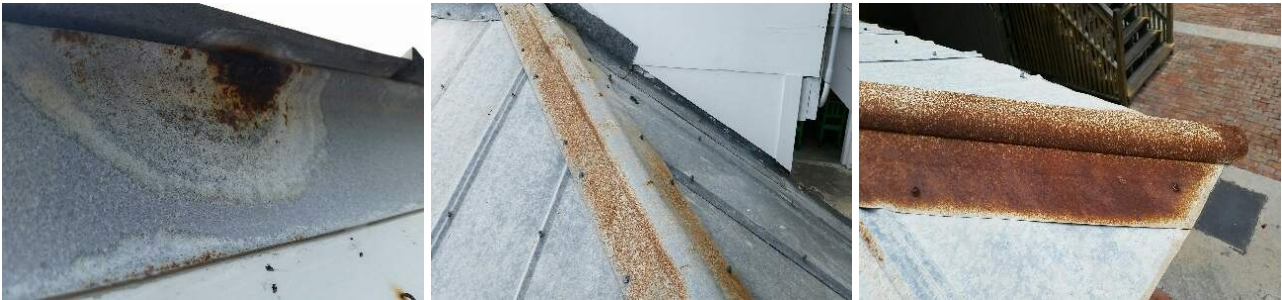
8.

Location: Roof **System:** Roof **Condition:** Metal roofing is rusted

Explanation: The metal roof covering is observed to have areas of rust.

Impact Consequences: Areas of rust are an indication that the metal roofing is near or past its useful life expectancy and replacement should be considered as the most effective form of action. Rust often leads to perforation and leaks; surface repairs typically provide only short-term protection.

Recommended Action: Monitor closely; consider replacing

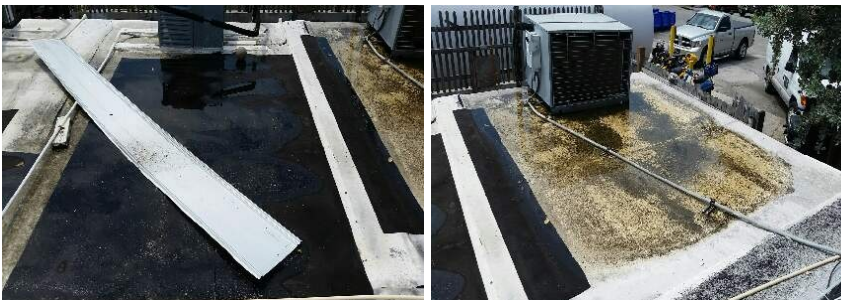
9.

Location: Roof **System:** Roof **Condition:** Water ponding on roof surface is observed

Explanation: Active water ponding is observed on the roof surface. Poor roof surface drainage increases the risk of leakage and can reduce the life expectancy of the roof.

Impact Consequences: Flat and low-slope roofs should be sufficiently sloped such that all water will drain from its surface. Water that ponds on the surface will add to the weight loading at the affected area which will over time enlarge this area and compound the problem. Leaks are most likely to occur at seams that are immersed in water. Correction to the roof surface profile is required. A roofing specialist should be consulted to assess for current condition and for requirements and costs for remedial action.

Recommended Action: Replace consult specialist

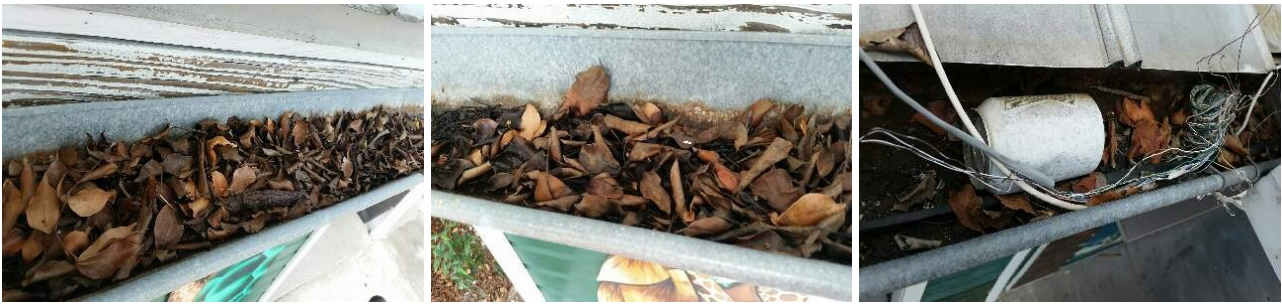
10.

Location: Roof **System:** Roof **Condition:** Gutter is clogged

Explanation: Debris has built up in the gutters such that the free flow of water has been restricted.

Impact Consequences: Gutters are a key component in the controlled drainage of run-off water away from the building exterior elements. Water backing up in the gutter may add sufficient weight to the gutter to cause its detachment from the structure. Gutters that do not perform as intended may result in saturation of soils near the foundation which in turn can result in basement moisture or leakage issues. Repair should include removing debris and assuring that water freely flows and drains from the gutter.

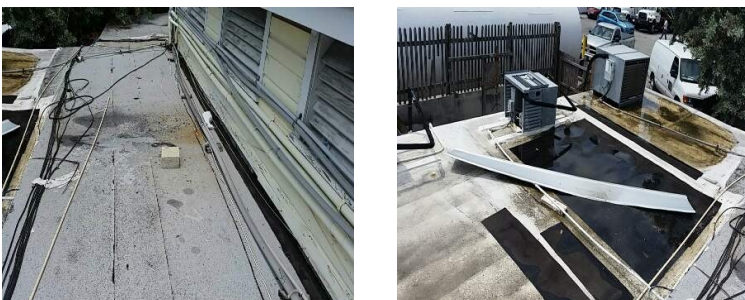
12.

Location: Roof **System:** Roof **Condition:** Debris On Roof

Explanation: Debris is observed on the roof surface.

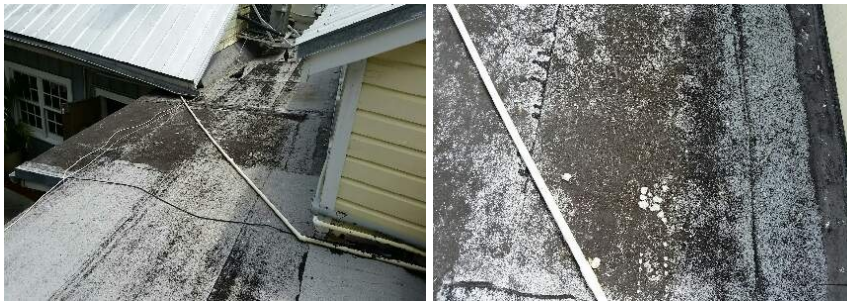
13.

Location: Roof **System:** Roof **Condition:** Soft Spots On Roof Surface

Explanation: Sheathing support of the roof covering is observed to be soft when walked upon.

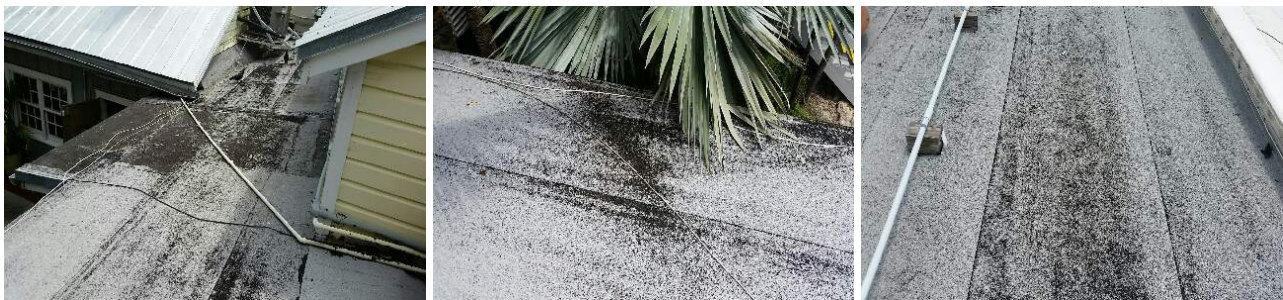
14.

Location: Roof **System:** Roof **Condition:** Asphalt roll roofing displays granule loss

Explanation: Areas of granule loss are noted in the roof shingle surface.

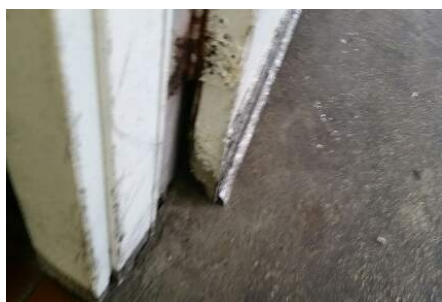
1.

Location: Kitchen **System:** Exterior **Condition:** Exterior door is deteriorated

Explanation: The overall condition of an exterior door is observed to be deteriorated such that its operability and performance characteristics are impaired. Exterior door operation and performance considerations include: ability to restrict forced entry; ability to open and close with relative ease; ability to securely close and latch; ability to restrict entry of air water and pests.

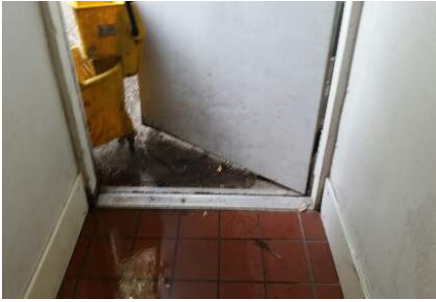
2.

Location: Walk In Cooler Hallway **System:** Exterior **Condition:** Exterior door is deteriorated

Explanation: The overall condition of an exterior door is observed to be deteriorated such that its operability and performance characteristics are impaired. Exterior door operation and performance considerations include: ability to restrict forced entry; ability to open and close with relative ease; ability to securely close and latch; ability to restrict entry of air water and pests.

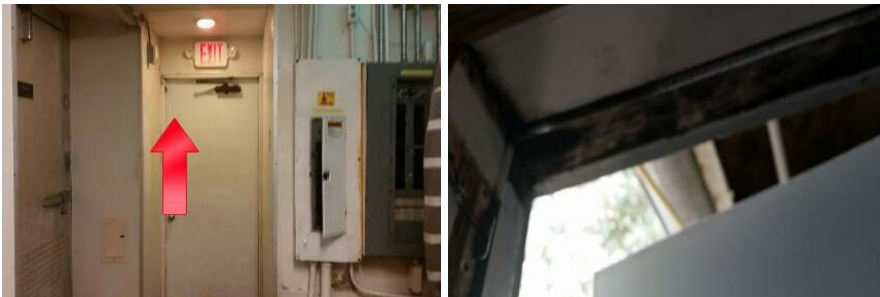
3.

Location: Walk In Cooler Hallway **System:** Exterior **Condition:** Exterior door frame and or sill is rotted

Explanation: Deterioration of the door frame is noted with rot observed.

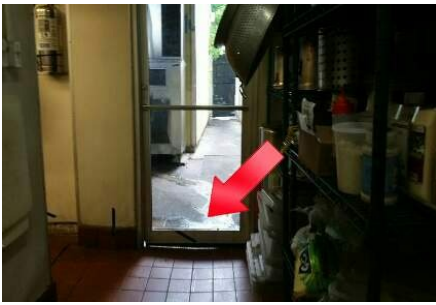
4.

Location: Walk In Cooler Hallway **System:** Exterior **Condition:** Gaps In Seal of Exterior Door

Explanation: Exterior door displays gaps when fully closed.

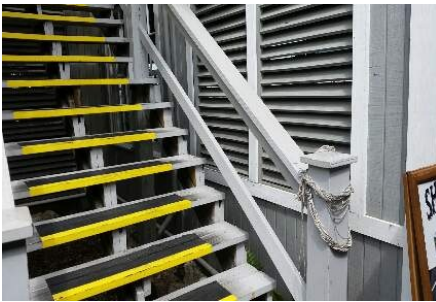
5.

Location: Tower Bar Stairway **System:** Exterior **Condition:** Exterior deck railing is shaky

Explanation: Exterior deck railings should be installed and maintained so as to be sufficiently secured to prevent failure or detachment under normal use. Shaky deck railings are an indication that the railings are deteriorating and in need of corrective repairs or replacement.

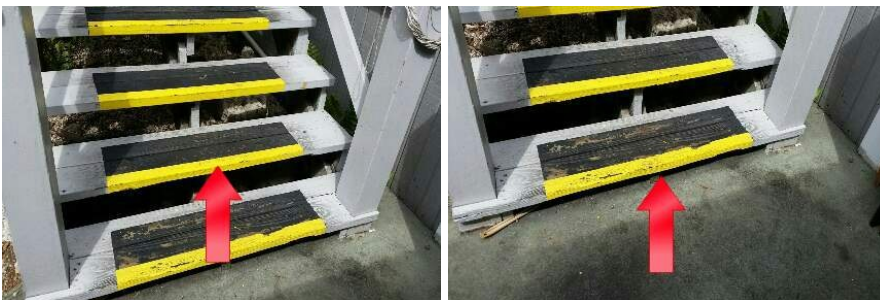
6.

Location: Tower Bar Stairway **System:** Exterior **Condition:** Exterior wood steps have bouncy tread(s)

Explanation: One or more of the step treads is noted to move or bounce when walked upon. This condition is indicative of insufficient support under the treads.

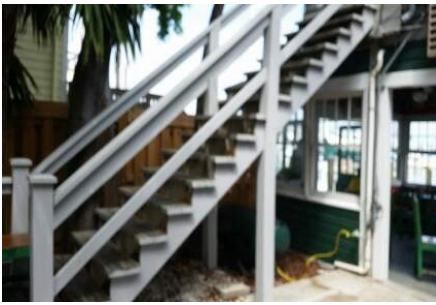
9.

Location: Upper Dining Deck **System:** Exterior **Condition:** Exterior stair railing is shaky

Explanation: Exterior stair railings should be installed and maintained so as to be sufficiently secured to prevent failure or detachment under normal use. Shaky railings are an indication that the railings are deteriorating and in need of corrective repairs or replacement.

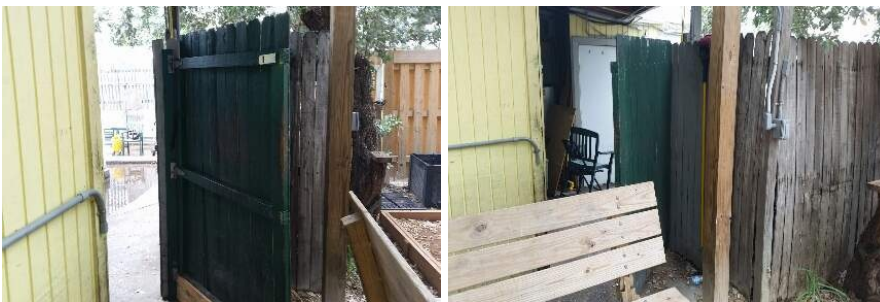
10.

Location: Exterior Rear **System:** Exterior **Condition:** Damaged Gate

Explanation: The gate in the noted location is observed to be damaged.

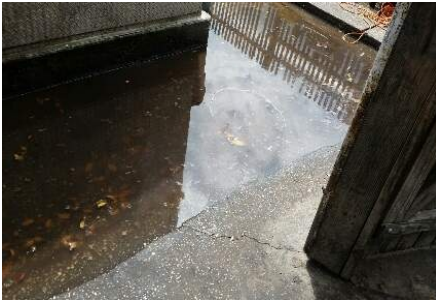
12.

Location: Exterior Rear **System:** Exterior **Condition:** Water pools on walkway

Explanation: The surface condition is such that there are dips in the walkway surface that may result in water pooling on the walkway.

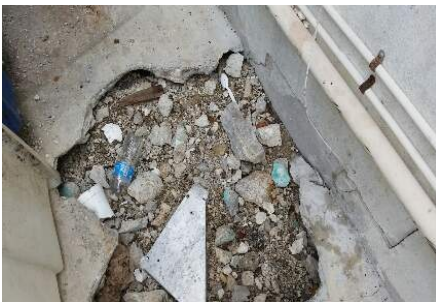
13.

Location: Exterior Rear **System:** Exterior **Condition:** Washed Out Area Of Grading

Explanation: A section of grading is not level to a point at which it may pose a safety hazard.

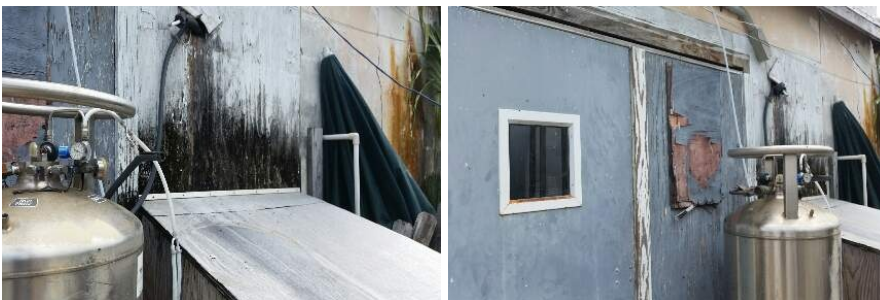
14.

Location: Exterior Rear **System:** Exterior **Condition:** Rot observed on wood elements

Explanation: Wood elements that display rot should be replaced

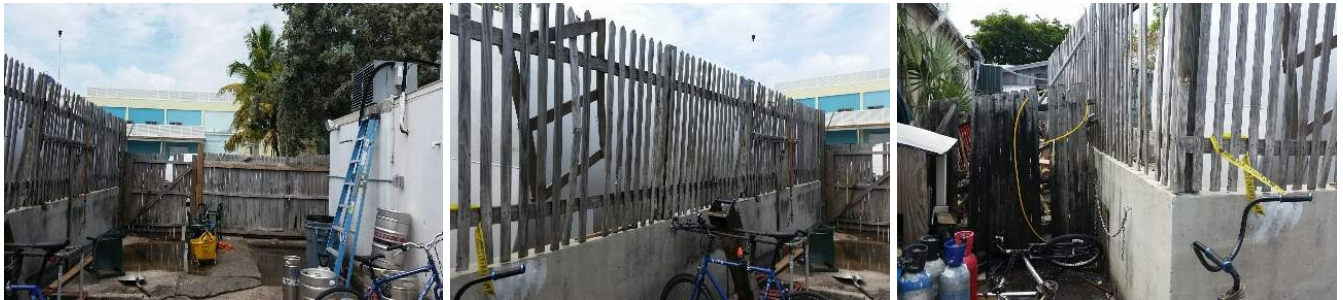
15.

Location: Exterior Rear **System:** Exterior **Condition:** Exterior fence is deteriorated

Explanation: The fence displays conditions of deterioration and is in need of repair.

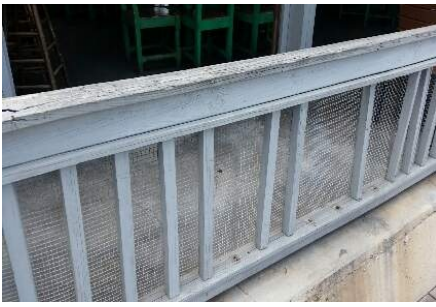
20.

Location: Lower Dining Deck **System:** Exterior **Condition:** Exterior deck railing is shaky

Explanation: Exterior deck railings should be installed and maintained so as to be sufficiently secured to prevent failure or detachment under normal use. Shaky deck railings are an indication that the railings are deteriorating and in need of corrective repairs or replacement.

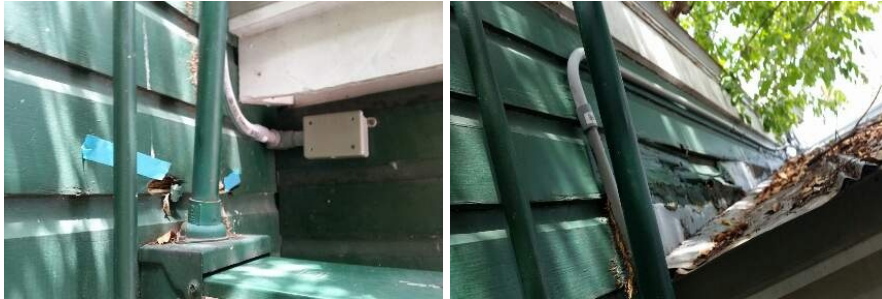
23.

Location: Restaurant Entrance **System:** Exterior **Condition:** Rot observed on wood elements

Explanation: Wood elements that display rot should be replaced

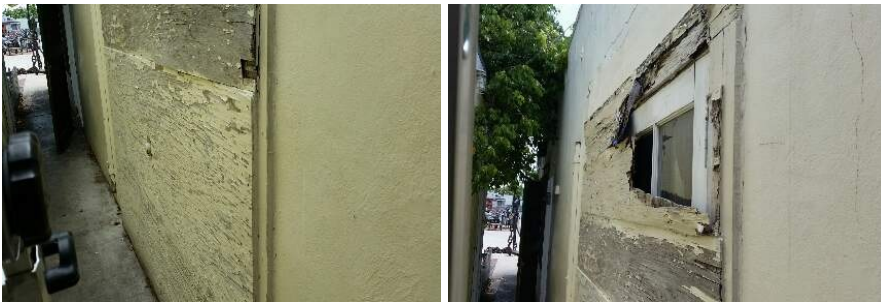
25.

Location: Exterior Ice Machine area **System:** Exterior **Condition:** Rot observed on wood elements

Explanation: Wood elements that display rot should be replaced

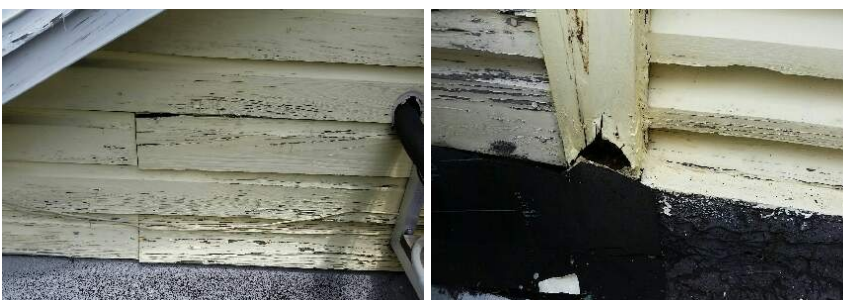
27.

Location: Roof **System:** Exterior **Condition:** Wood siding is rotted

Explanation: Rot is noted in portions of the exterior wood siding. Wood damaged by rot should be removed and replaced.

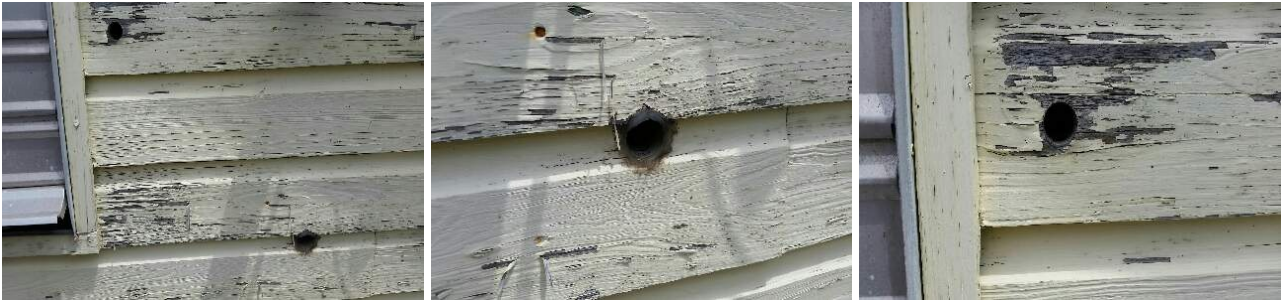
28.

Location: Roof **System:** Exterior **Condition:** Unsealed Opening From Removed Component

Explanation: A wall penetration from a previously located component is not properly sealed.

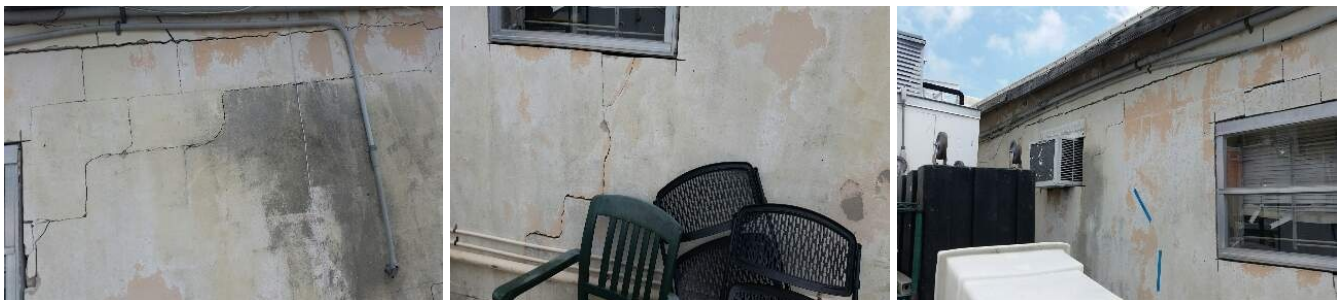
1.

Location: Exterior Rear **System:** Structure **Condition:** Exterior masonry wall displays settlement

Explanation: The degree and nature of cracks through brick and or mortar is such that settlement of the supporting foundation is indicated.

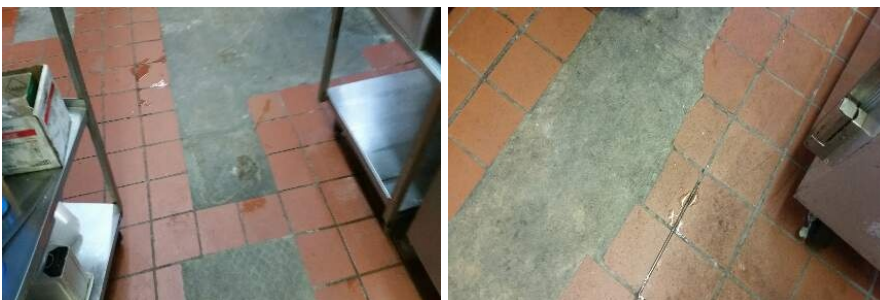
1.

Location: Kitchen **System:** Interior **Condition:** Missing Floor Covering

Explanation: Floor covering is observed to be missing in the noted location.

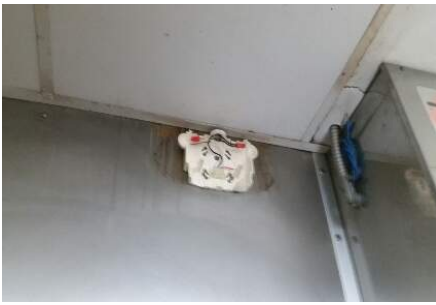
2.

Location: Kitchen **System:** Interior **Condition:** Flood Light Installation Recommended

Explanation: An emergency flood light is recommended to be placed in the location noted.

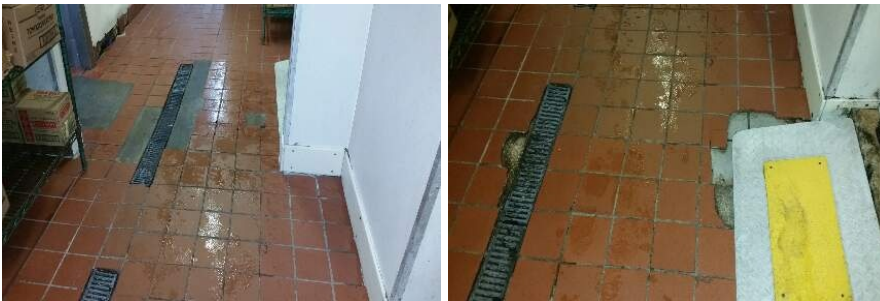
3.

Location: Walk In Cooler Hallway **System:** Interior **Condition:** Floor cover is damaged

Explanation: Damage is noted in the floor cover due to wear impact abrasion scratches stains etc. that affect the cosmetic appearance of the floor cover.

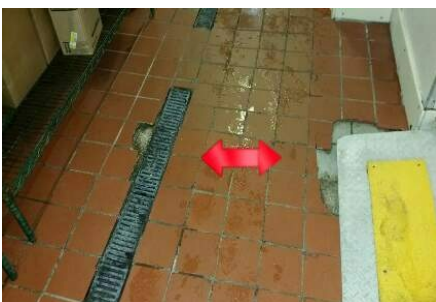
4.

Location: Walk In Cooler Hallway **System:** Interior **Condition:** Trip hazard in floor surface

Explanation: The floor surface has an abrupt change in height where different floor finishes abut. This condition has a variation that is sufficiently great as to present a potential trip hazard.

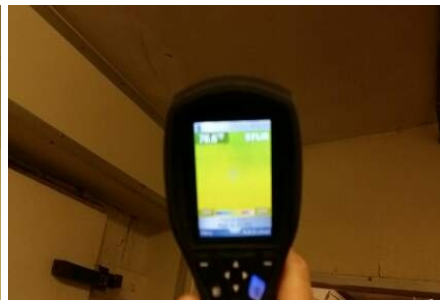
6.

Location: Walk In Cooler Hallway **System:** Interior **Condition:** DRY Ceiling Stain Roof Leak

Explanation: A stain on a ceiling surface is observed to test low for moisture content using moisture meters or thermal imaging camera. The source of the moisture intrusion is suspected to be from a past roof leak which may or may not have been repaired.

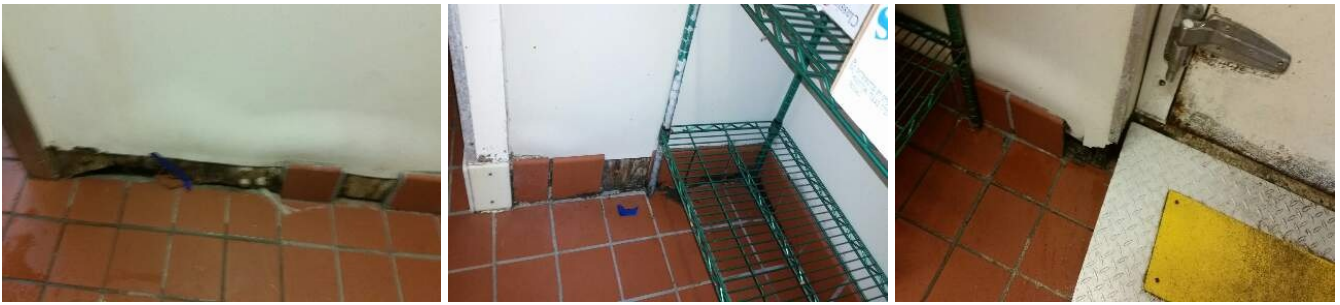
7.

Location: Walk In Cooler Hallway **System:** Interior **Condition:** Rot Observed In Wood Elements of Interior Wall

Explanation: Interior walls containing wood elements display evidence of water intrusion and wood rot.

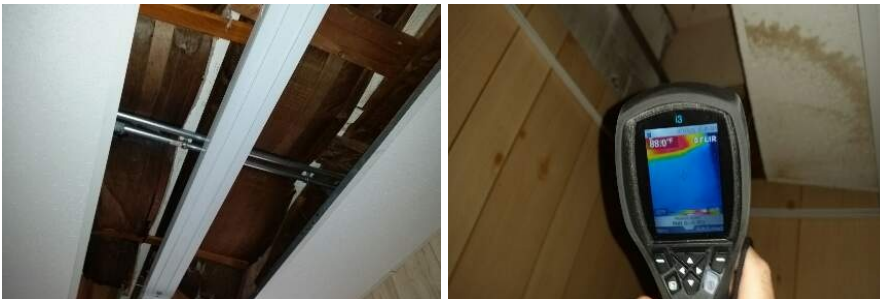
8.

Location: Accounting Office **System:** Interior **Condition:** WET Ceiling Stain Roof Leak

Explanation: A stain on a ceiling surface is observed to test high for moisture content using moisture meters or thermal imaging camera. The source of the moisture intrusion is suspected to be from an active roof leak.

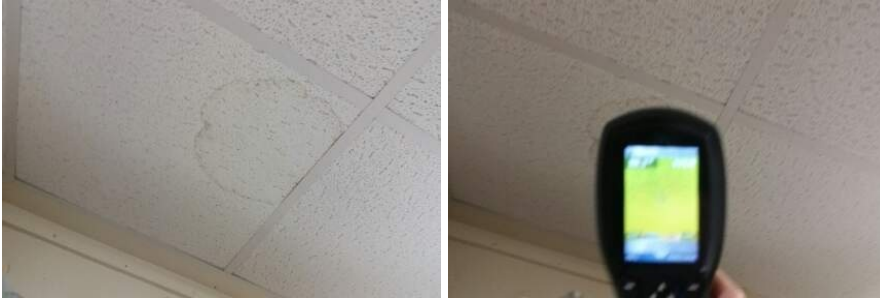
10.

Location: Office Storage Area **System:** Interior **Condition:** DRY Ceiling Stain Roof Leak

Explanation: A stain on a ceiling surface is observed to test low for moisture content using moisture meters or thermal imaging camera. The source of the moisture intrusion is suspected to be from a past roof leak which may or may not have been repaired.

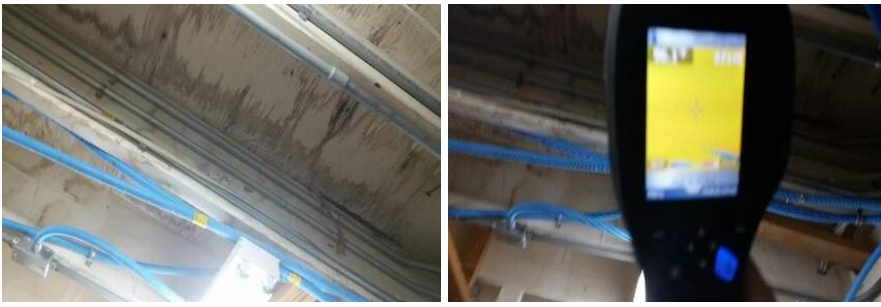
12.

Location: Office Storage Area **System:** Interior **Condition:** DRY Ceiling Stain Roof Leak

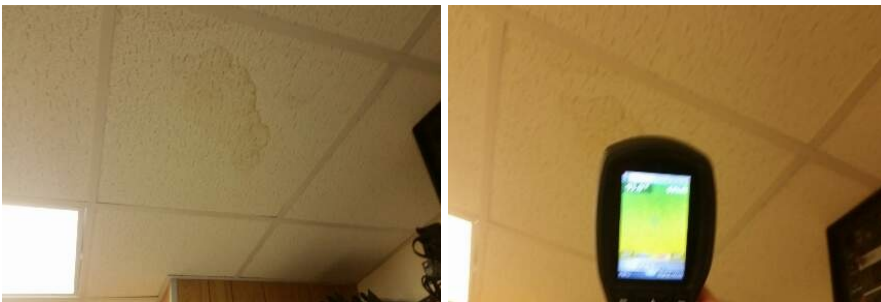
13.

Location: Office Storage Area **System:** Interior **Condition:** DRY Ceiling Stain Roof Leak

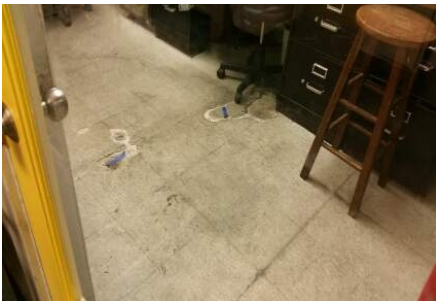
14.

Location: Office **System:** Interior **Condition:** Floor cover is damaged

Explanation: Damage is noted in the floor cover due to wear impact abrasion scratches stains etc. that affect the cosmetic appearance of the floor cover.

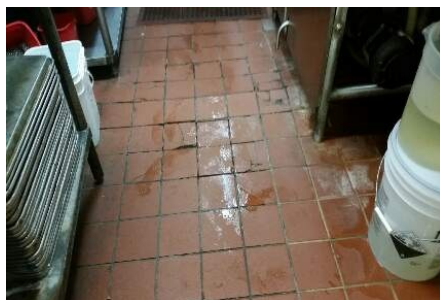
18.

Location: Kitchen **System:** Interior **Condition:** Floor is uneven

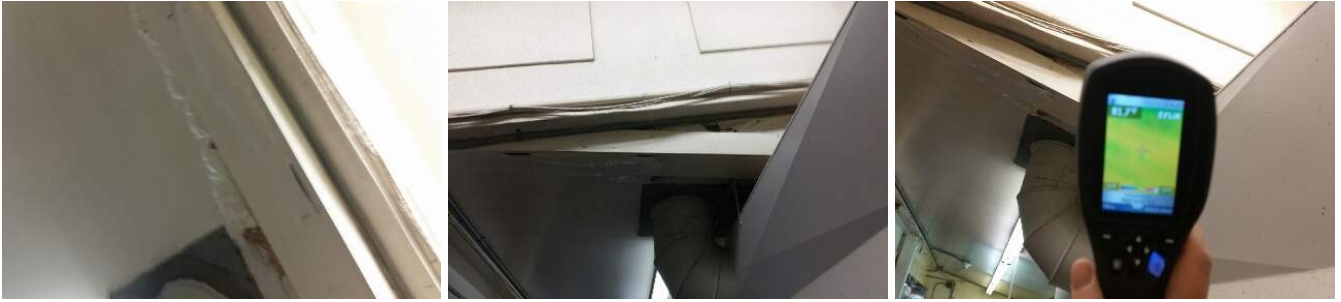
19.

Location: Kitchen **System:** Interior **Condition:** WET Ceiling Stain Roof Leak

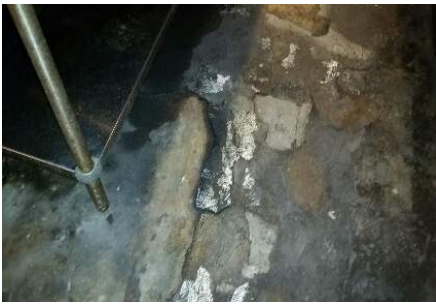
21.

Location: Interior Bar **System:** Interior **Condition:** Trip hazard in floor surface

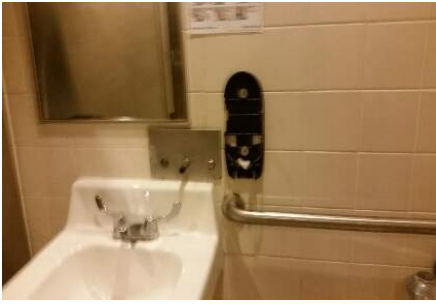
24.

Location: Mens Room **System:** Interior **Condition:** Missing Sanitizer or Soap dispenser

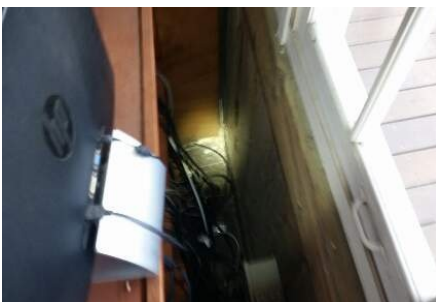
26.

Location: Restaurant Main Dining **System:** Interior **Condition:** Evidence of pest entry.

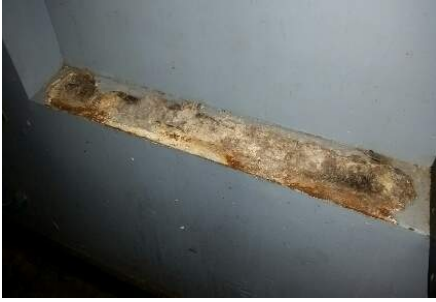
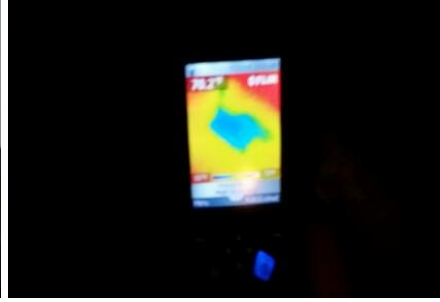
27.

Location: Interior Bar **System:** Interior **Condition:** WET Wall Stain Plumbing Component Leak

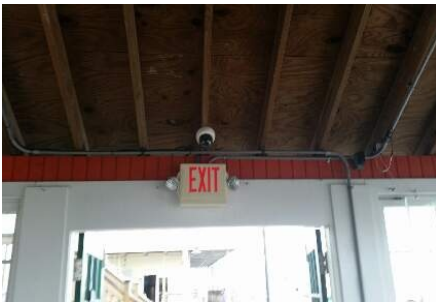
29.

Location: Lower Dining Deck **System:** Interior **Condition:** Failed Flood Light Test

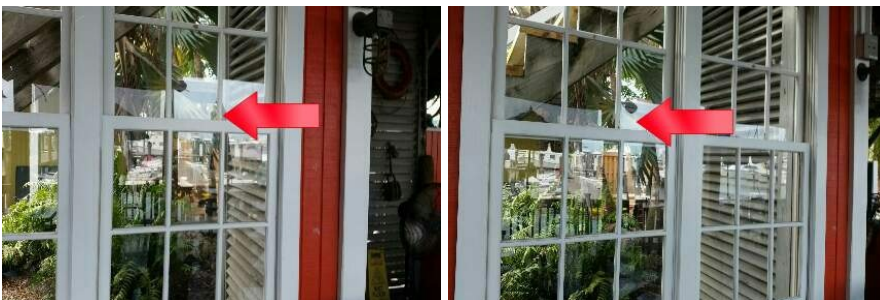
31.

Location: Lower Dining Deck **System:** Interior **Condition:** Window Pane Trim Missing or Damaged

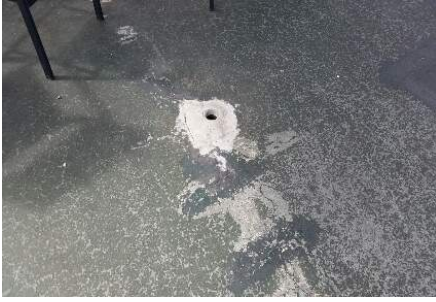
32.

Location: Upper Dining Deck **System:** Interior **Condition:** Trip hazard in floor surface

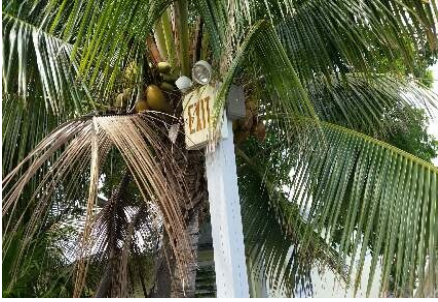
35.

Location: Upper Dining Deck **System:** Interior **Condition:** Inoperable Exit Sign

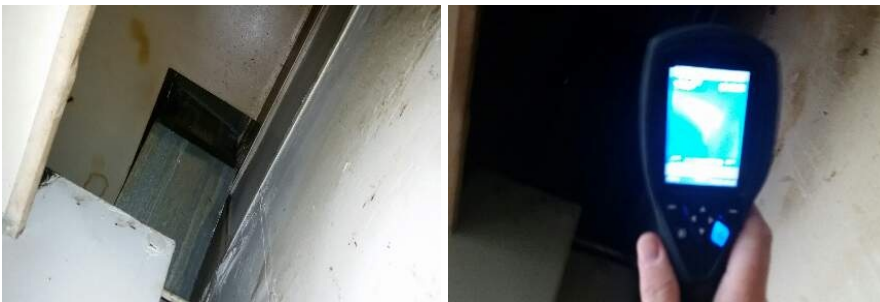
1.

Location: Kitchen **System:** Insulation Ventilation **Condition:** Vent Ducting Not Sealed To Exterior

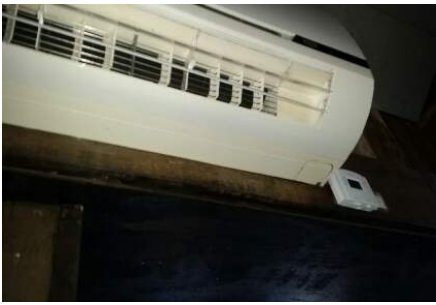
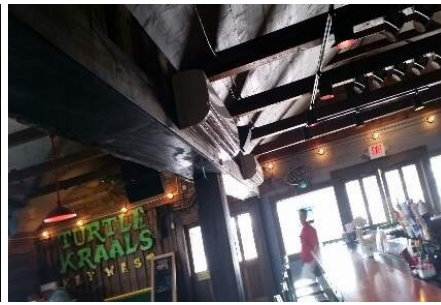
1.

Location: Interior Bar **System:** Heating And Cooling **Condition:** Excess Condensation Dripping From Interior AC Components

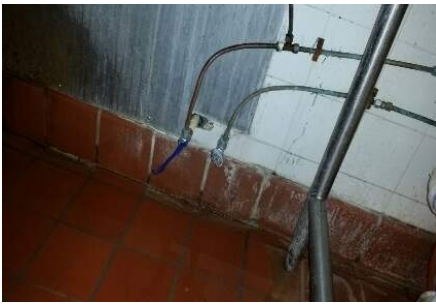
5.

Location: Kitchen **System:** Plumbing **Condition:** Missing Shut Off Valve

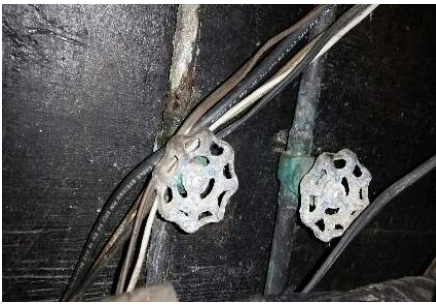
8.

Location: Exterior Bar **System:** Plumbing **Condition:** Obsolete Shut Off Valve

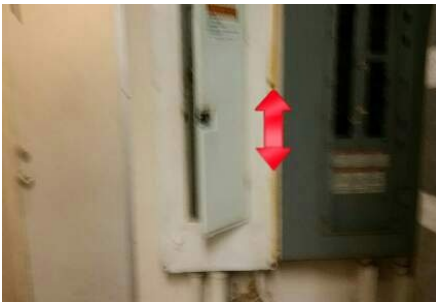
4.

Location: Walk In Cooler Hallway **System:** Electrical **Condition:** Panel cover screws are missing on the electrical panel

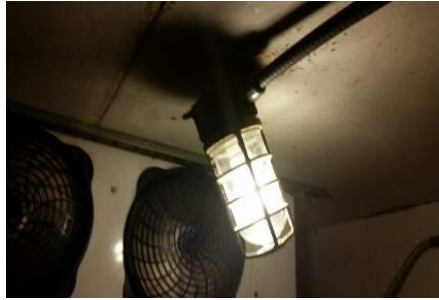
7.

Location: Walk In Cooler Hallway **System:** Electrical **Condition:** Electrical fixture is loose

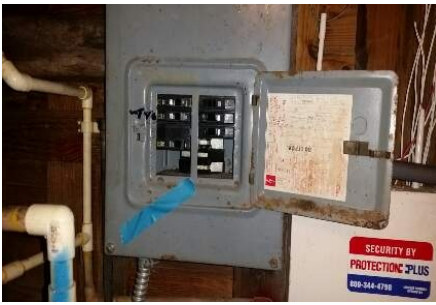
12.

Location: Storage Room **System:** Electrical **Condition:** The panel cover has uncovered openings

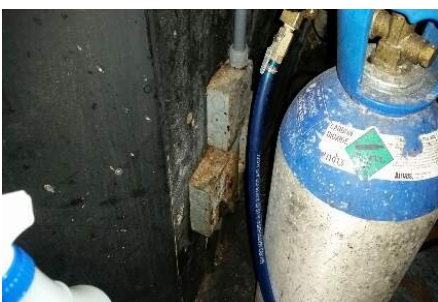
20.

Location: Interior Bar **System:** Electrical **Condition:** Deteriorated Junction Box

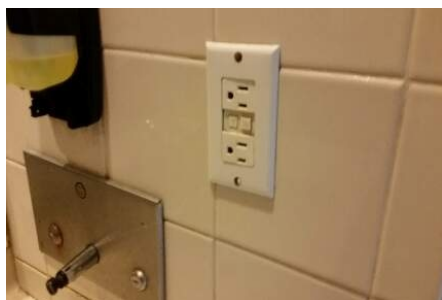
21.

Location: Womens Room **System:** Electrical **Condition:** Electrical outlet does not work

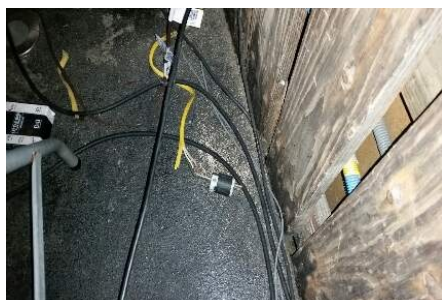
22.

Location: Restaurant Main Dining **System:** Electrical **Condition:** Unsafe Wiring Installation

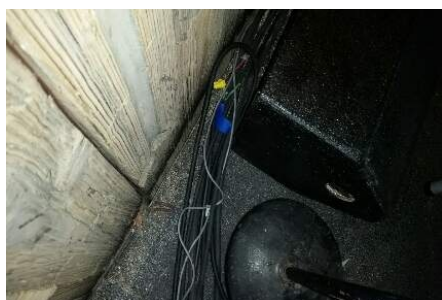
23.

Location: Restaurant Main Dining **System:** Electrical **Condition:** Wire connections are not performed in boxes

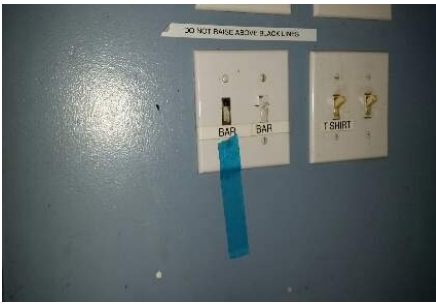
26.

Location: Interior Bar **System:** Electrical **Condition:** Electrical switch is damaged

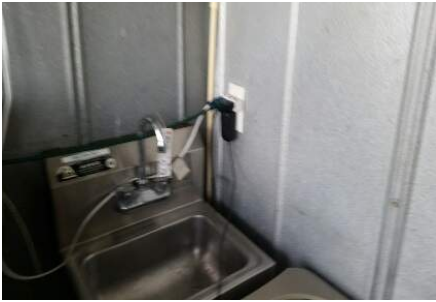
29.

Location: Lower Dining Deck **System:** Electrical **Condition:** Ground fault protection for an outlet is recommended

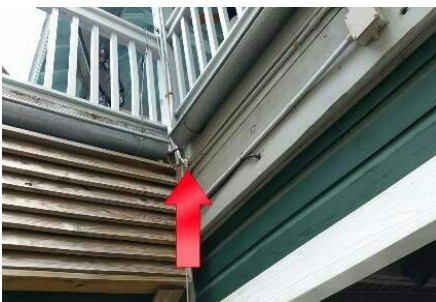
30.

Location: Lower Dining Deck **System:** Electrical **Condition:** Unsafe installation of a junction box

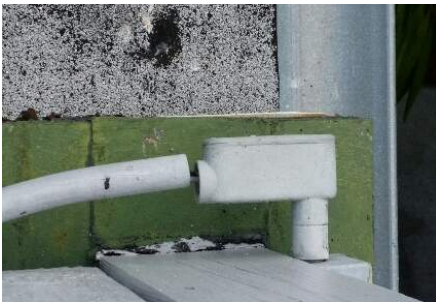
37.

Location: Upper Dining Deck **System:** Electrical **Condition:** Conduit Not Properly Connected

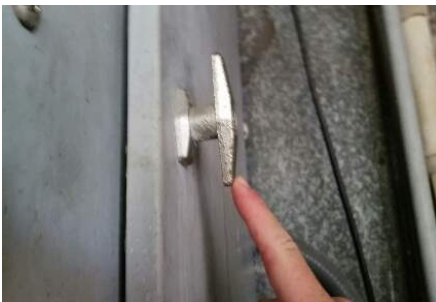
41.

Location: Exterior Rear **System:** Electrical **Condition:** Damaged Panel Cover

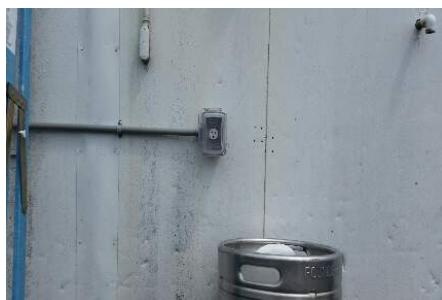
43.

Location: Exterior Rear **System:** Electrical **Condition:** Ground fault protection for an outlet is recommended

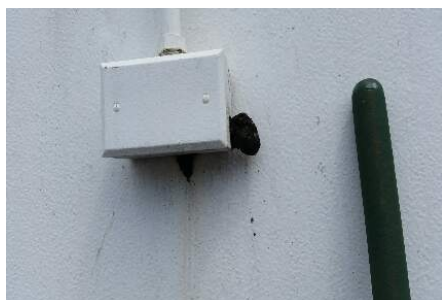
44.

Location: Exterior Rear **System:** Electrical **Condition:** Open Knock Outs Of Junction Box

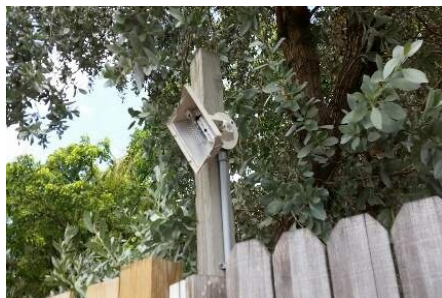
45.

Location: Exterior Rear **System:** Electrical **Condition:** Electrical Fixture has a missing or damaged globe or glass
