## STAFF REPORT

RE: 531 Elizabeth Street (permit application # T2020-0147)

FROM: Karen DeMaria, City of Key West Urban Forestry Manager

## Tree Species: Mahogany (Swietenia mahagoni)

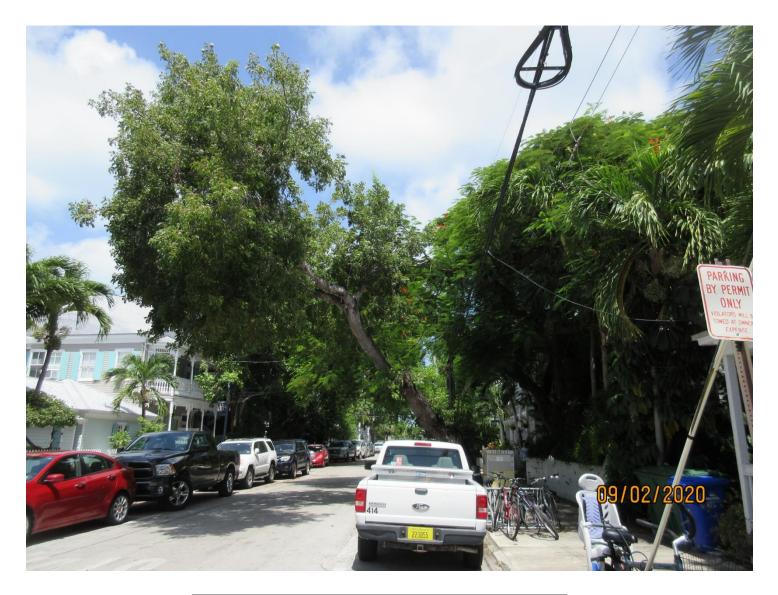
Photo showing location of tree along street, view 1.

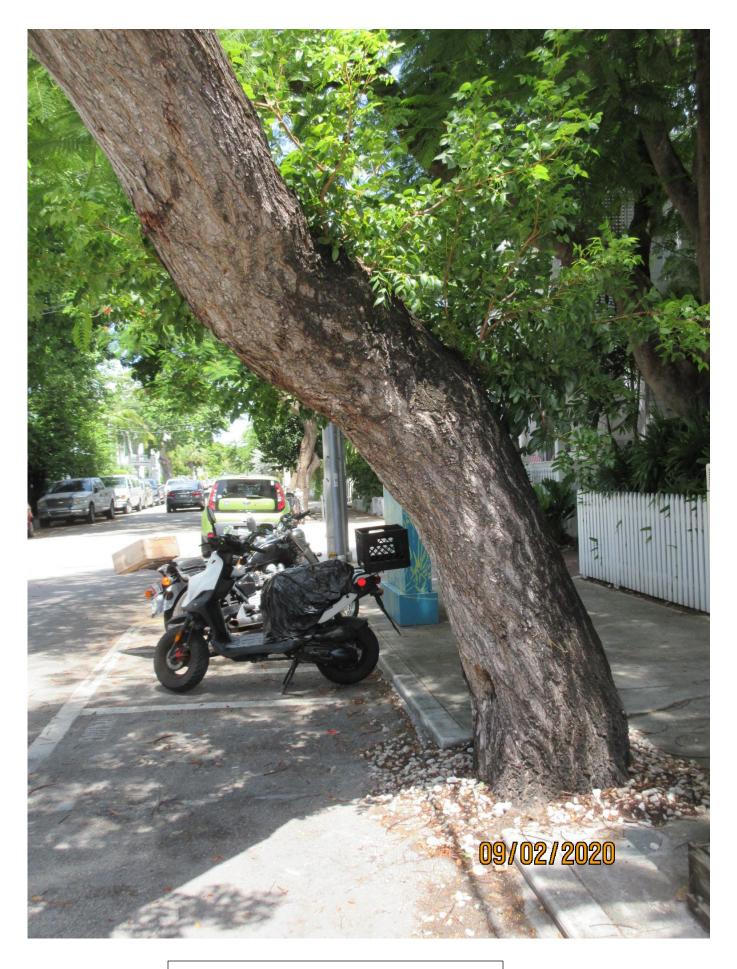
Photo showing base of tree and trunk, view 1.

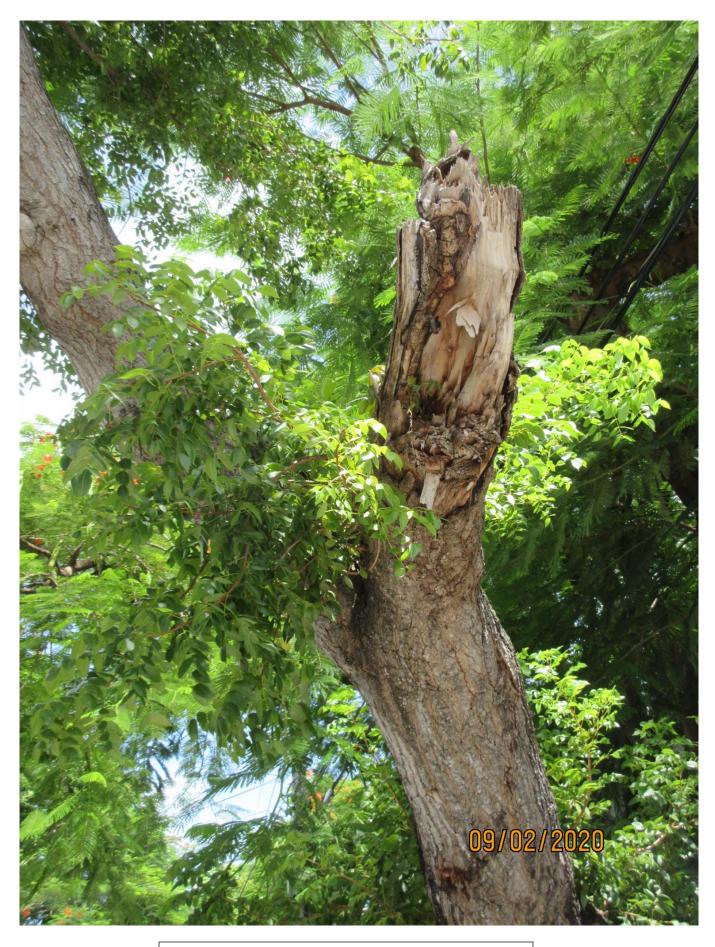
Photo showing trunk damage from Hurricane Irma.

Condition: 40% (poor, tree unbalanced-portion of tree torn off in Hurricane

Irma, all the growth and weight of tree is over parking area and road. Damage to main tree trunk in several area-potential fail lcoations.)

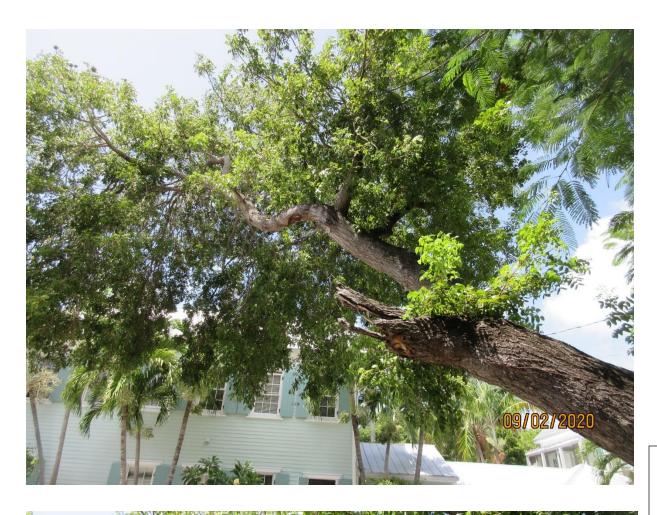
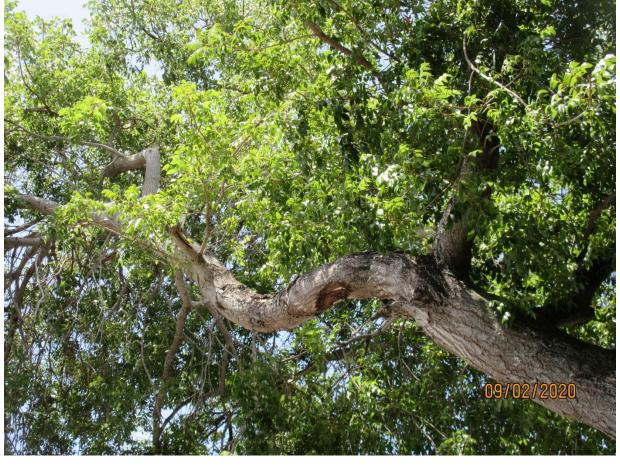
Two photos showing tree trunk and canopy.

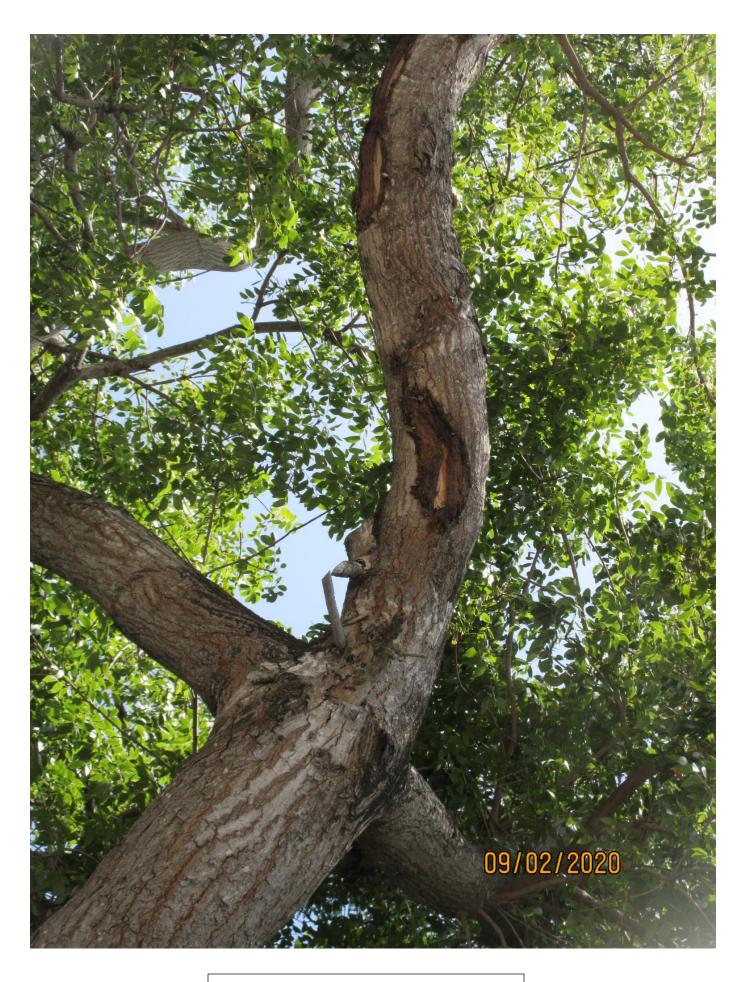
Close up photo of damage on main trunk.

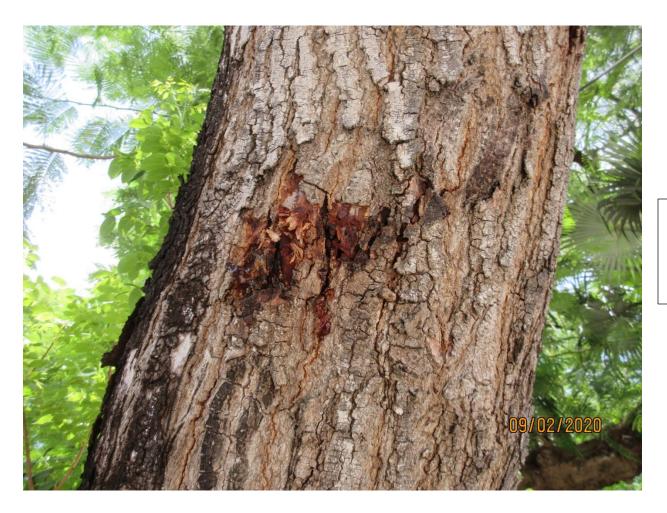
Close up photo of injurydamage area on trunk.

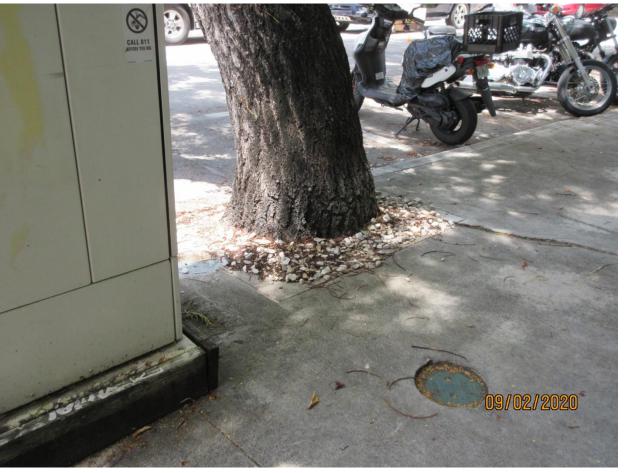
Photo showing base of tree in street planter.

Location: 60% (growing in street planter with ATT utility box within 5 ft of

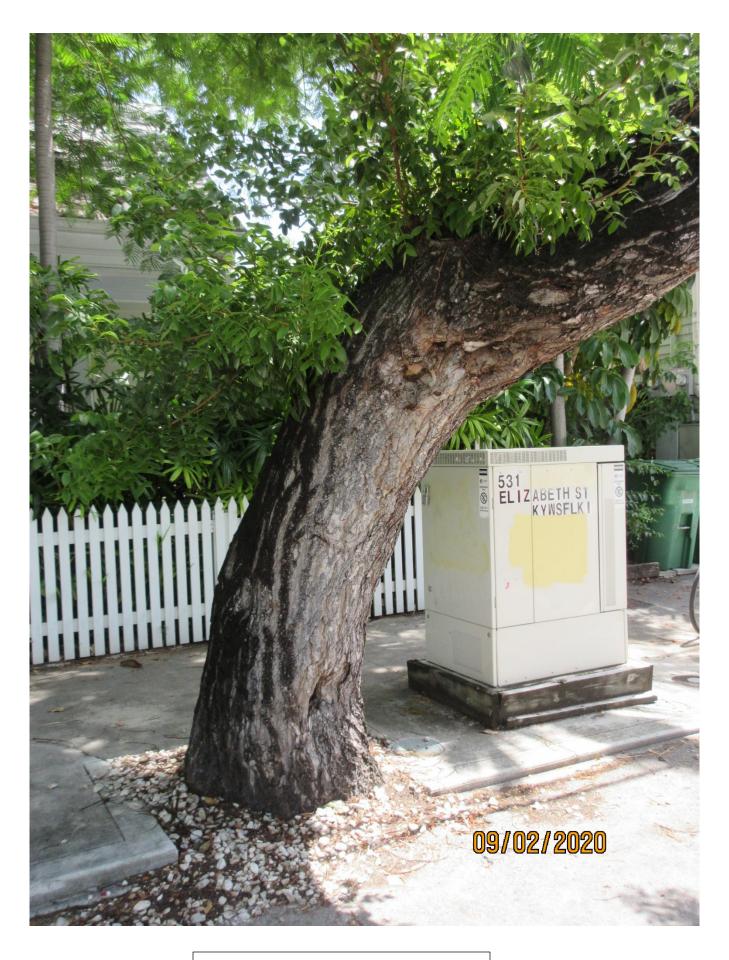
Photo of base of tree and trunk, view 2.

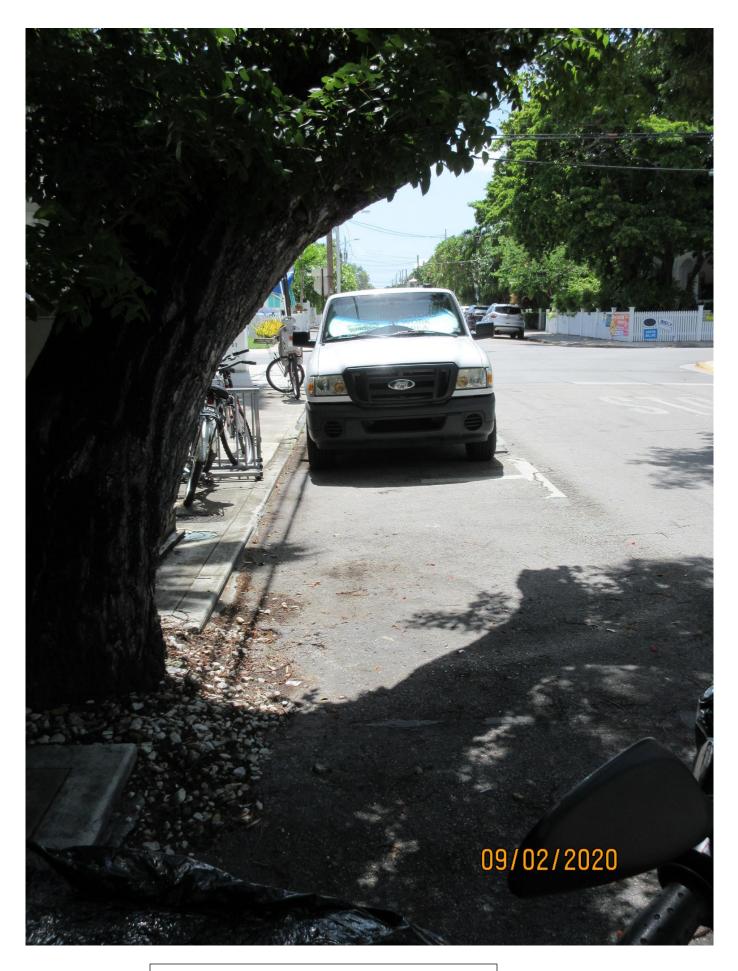
View of tree trunk over parking and road area.

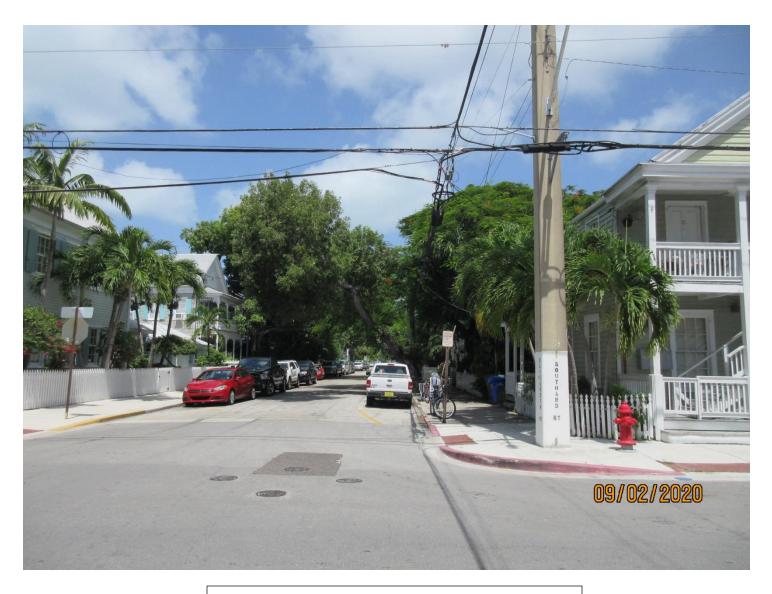
Photo showing location of tree along street, view 2.
