STAFF REPORT

RE: 2214 Seidenberg Avenue (permit application # T2020-0280)

FROM: Karen DeMaria, City of Key West Urban Forestry Manager

An application was received requesting the removal of (5) Sea Grape tree clumps. A site inspection was done and documented the following:

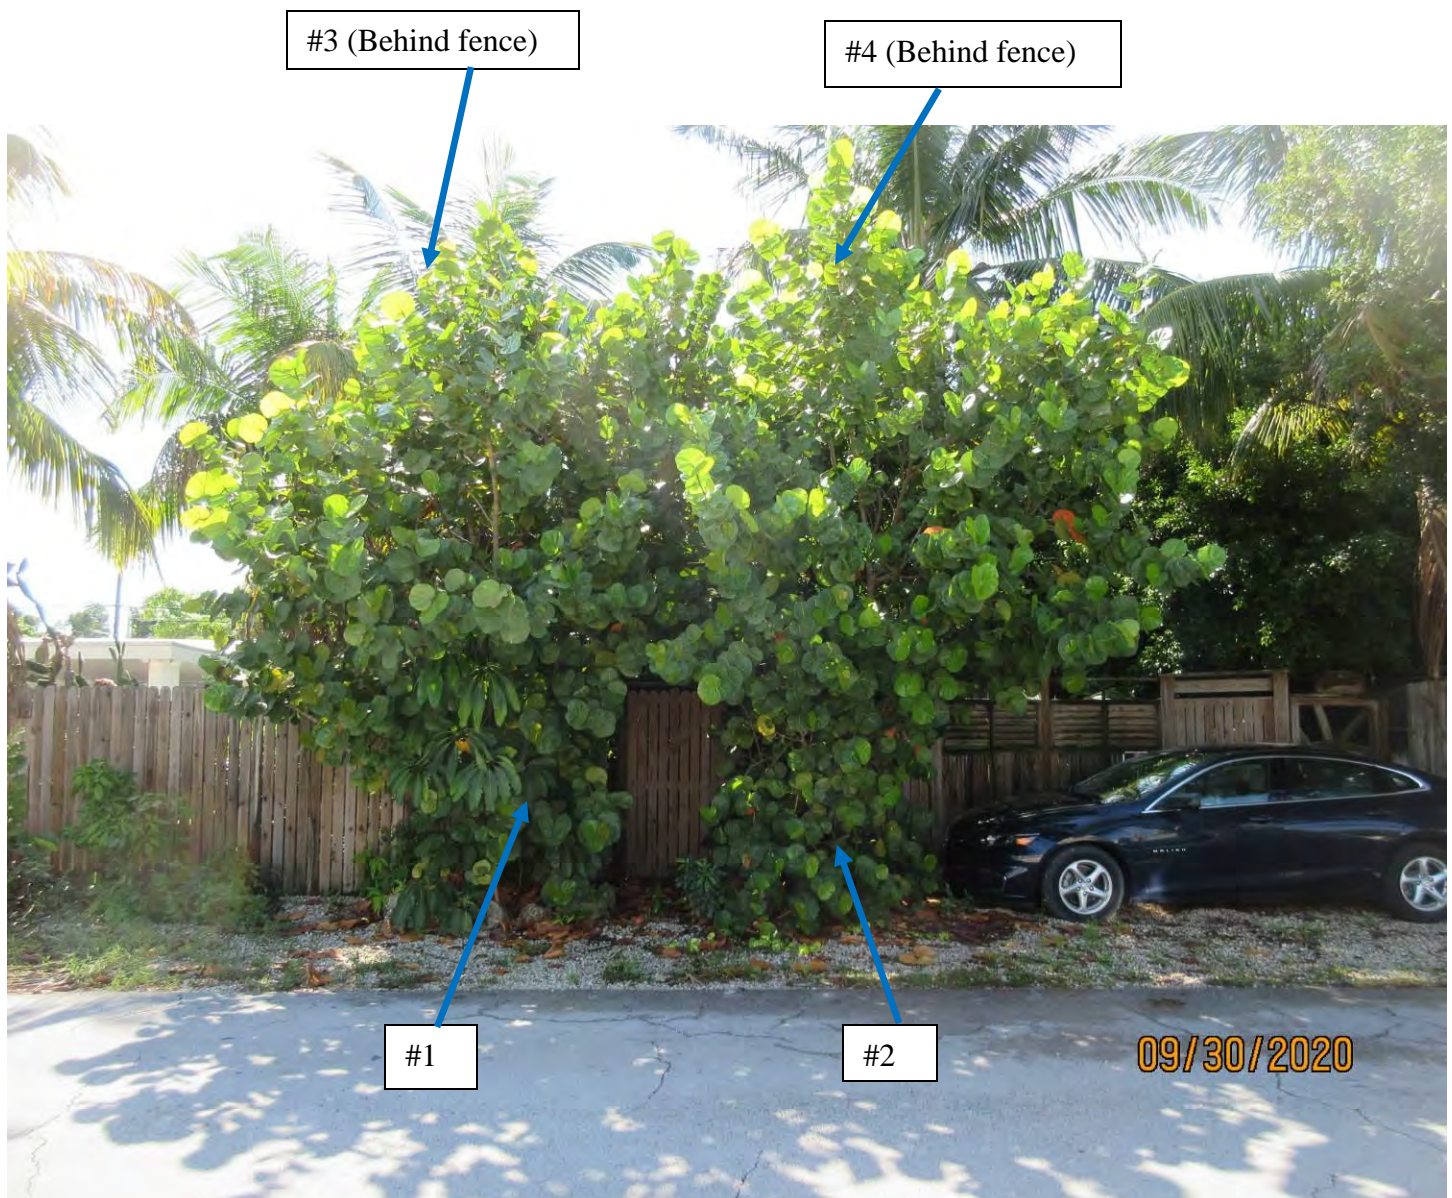
Photo showing location of trees 1, 2, 3, and 4.

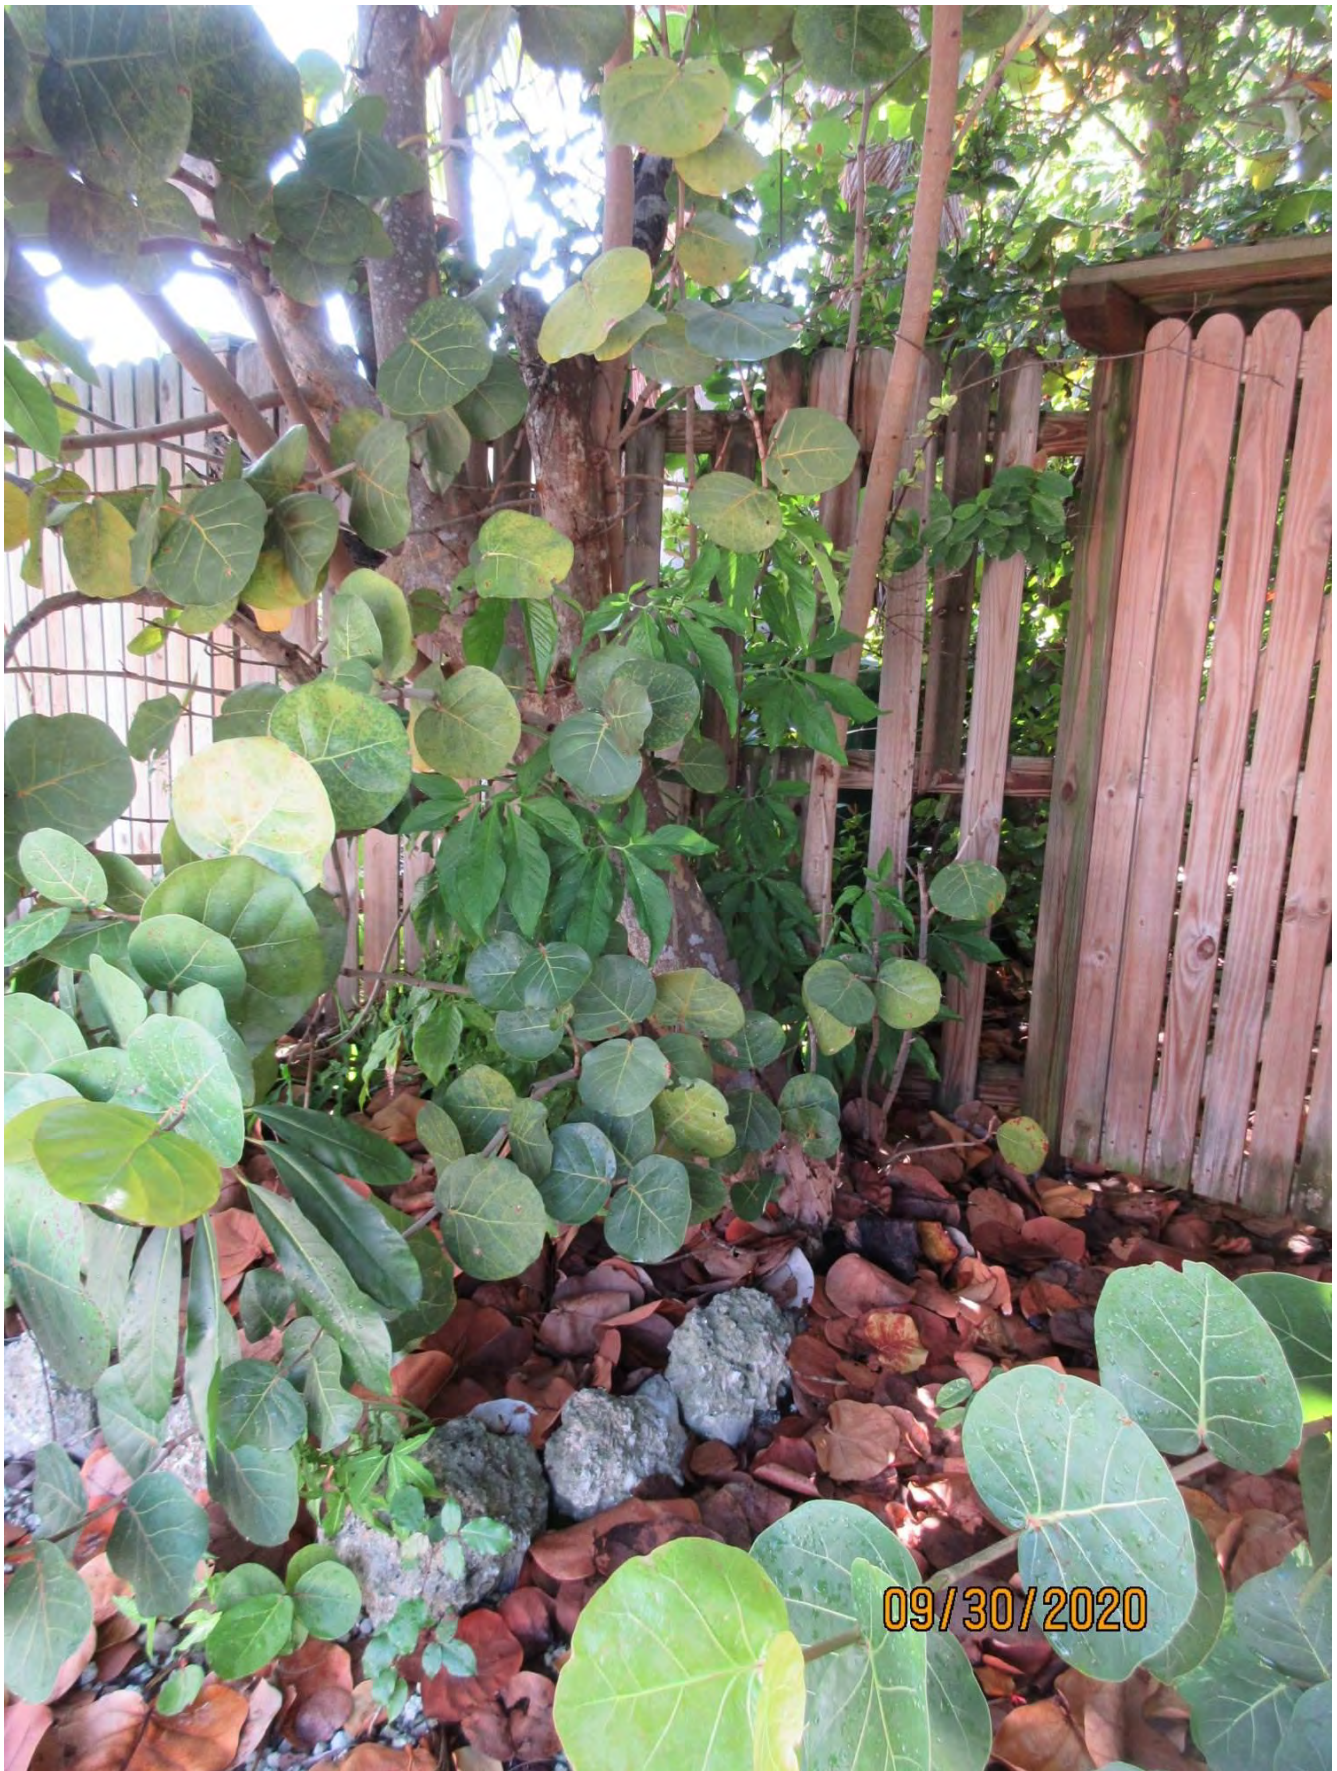
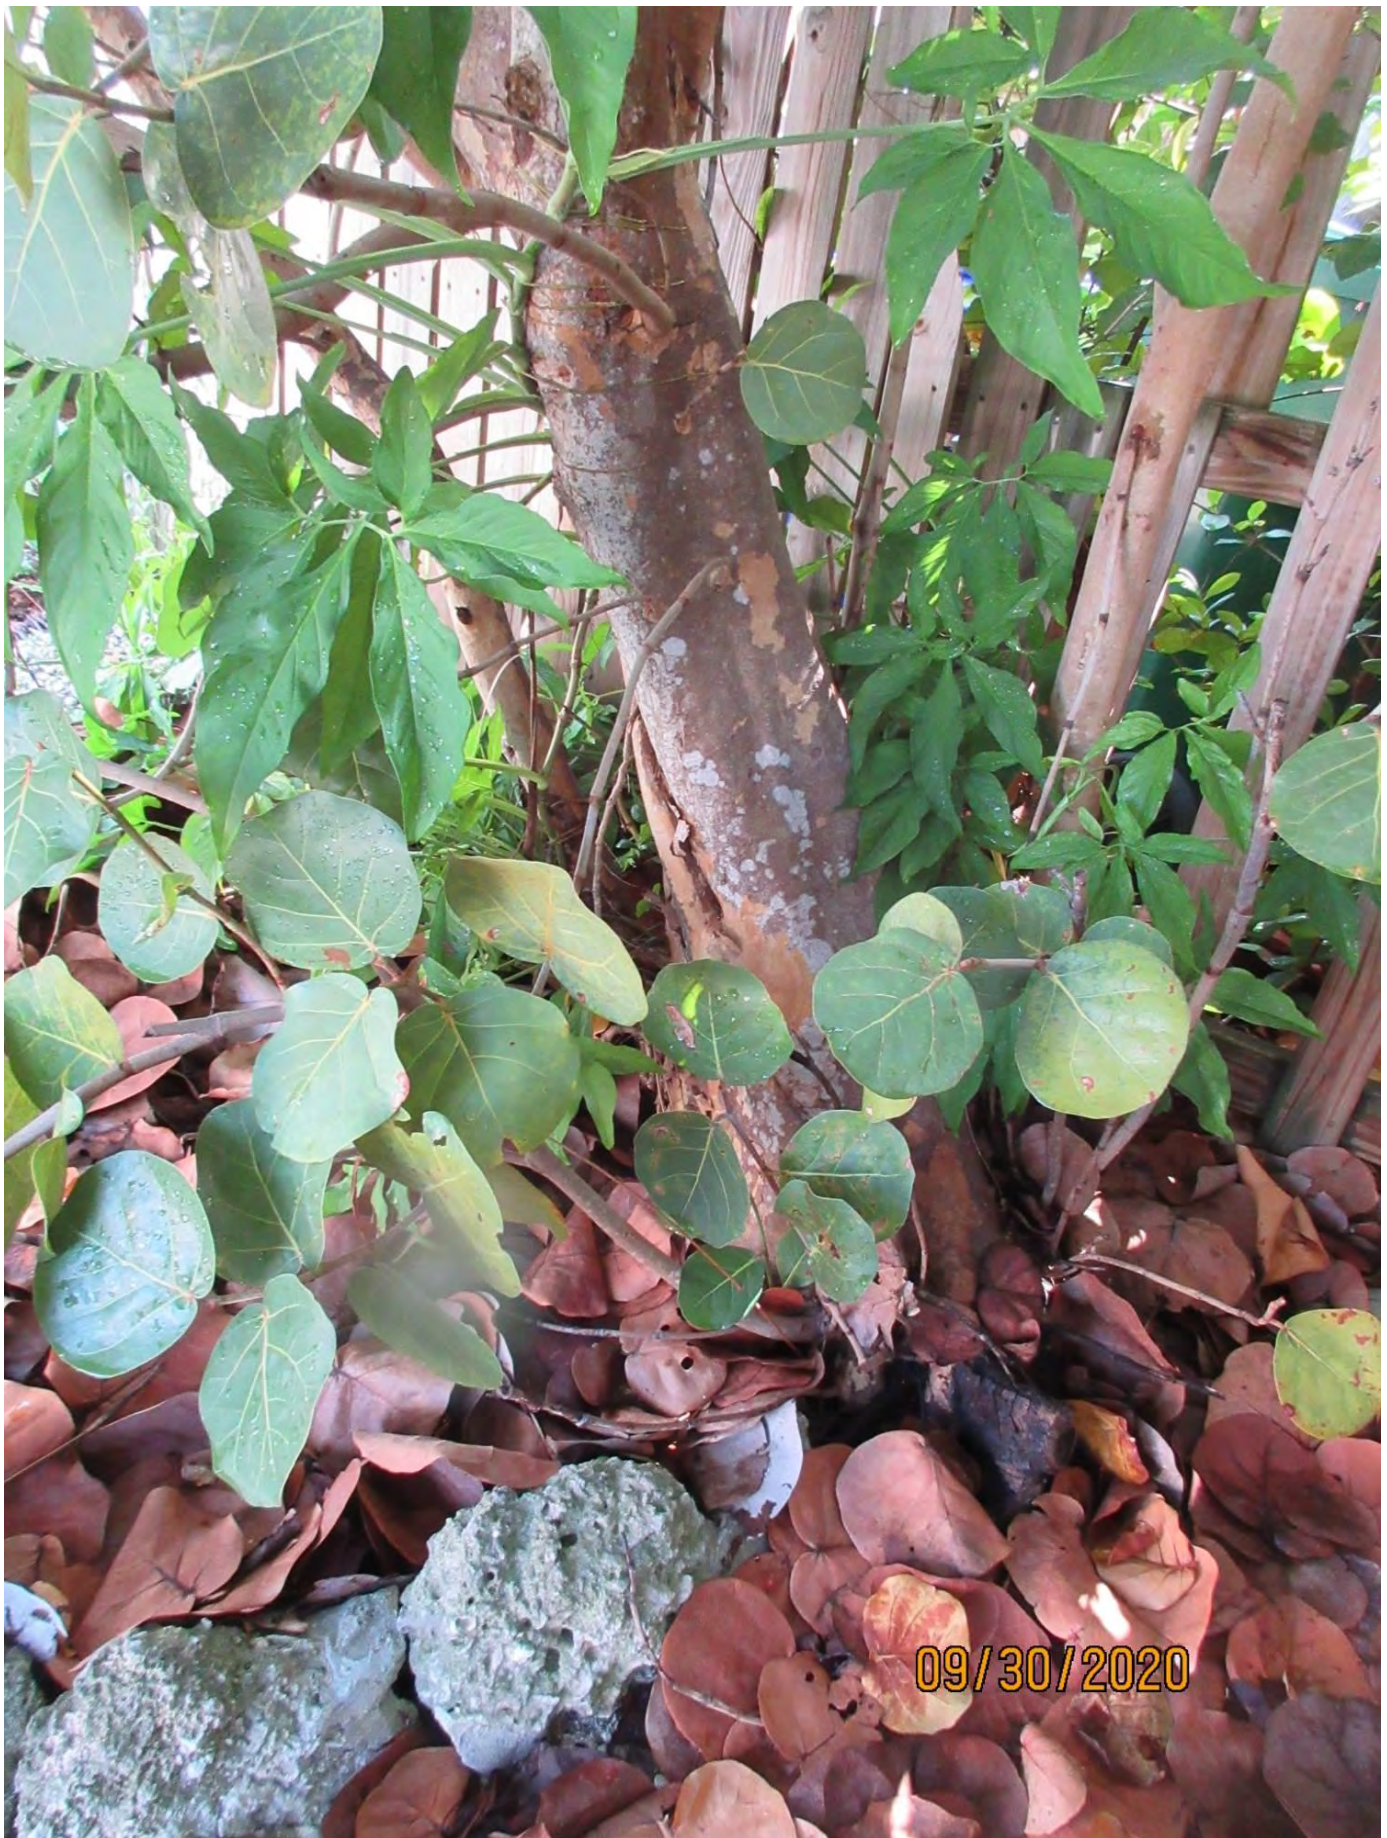
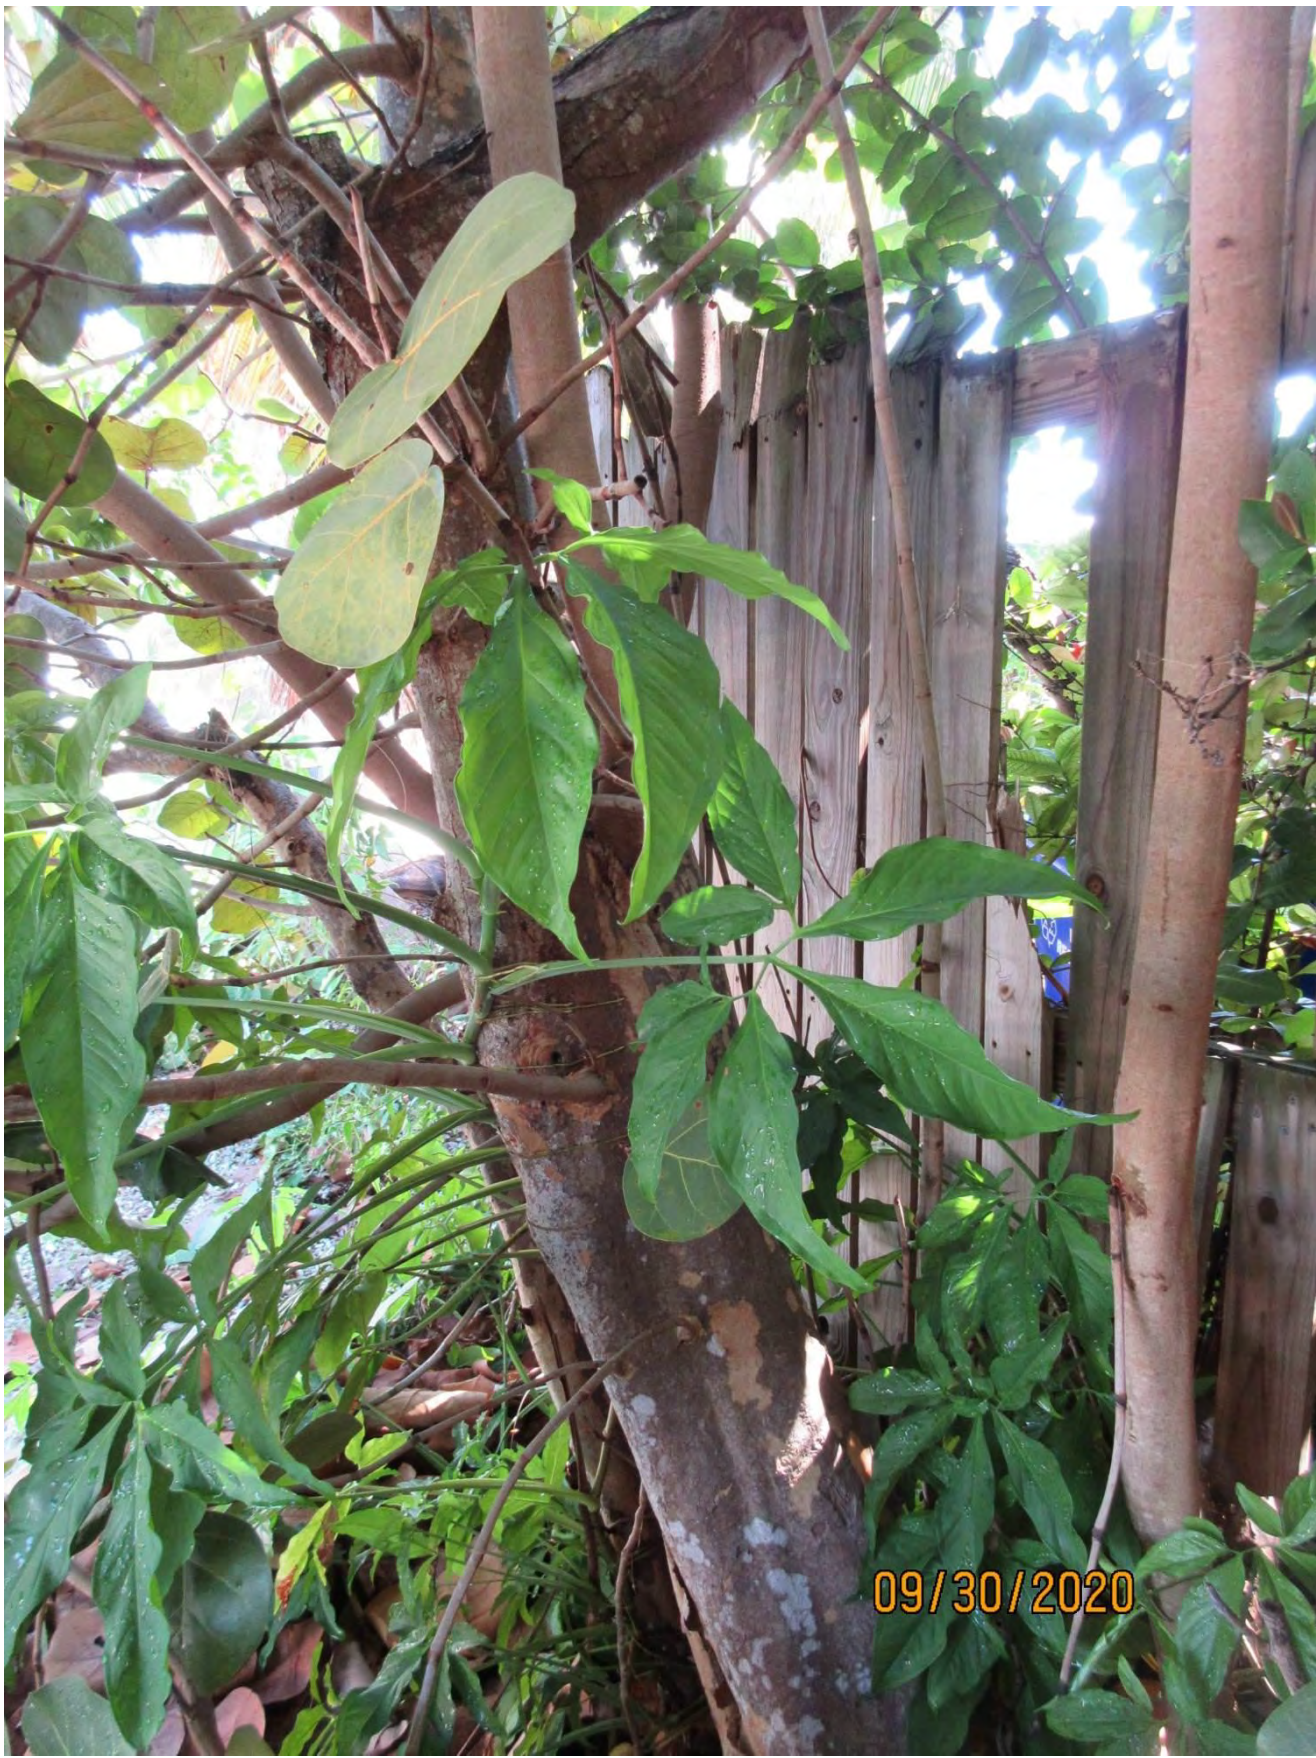
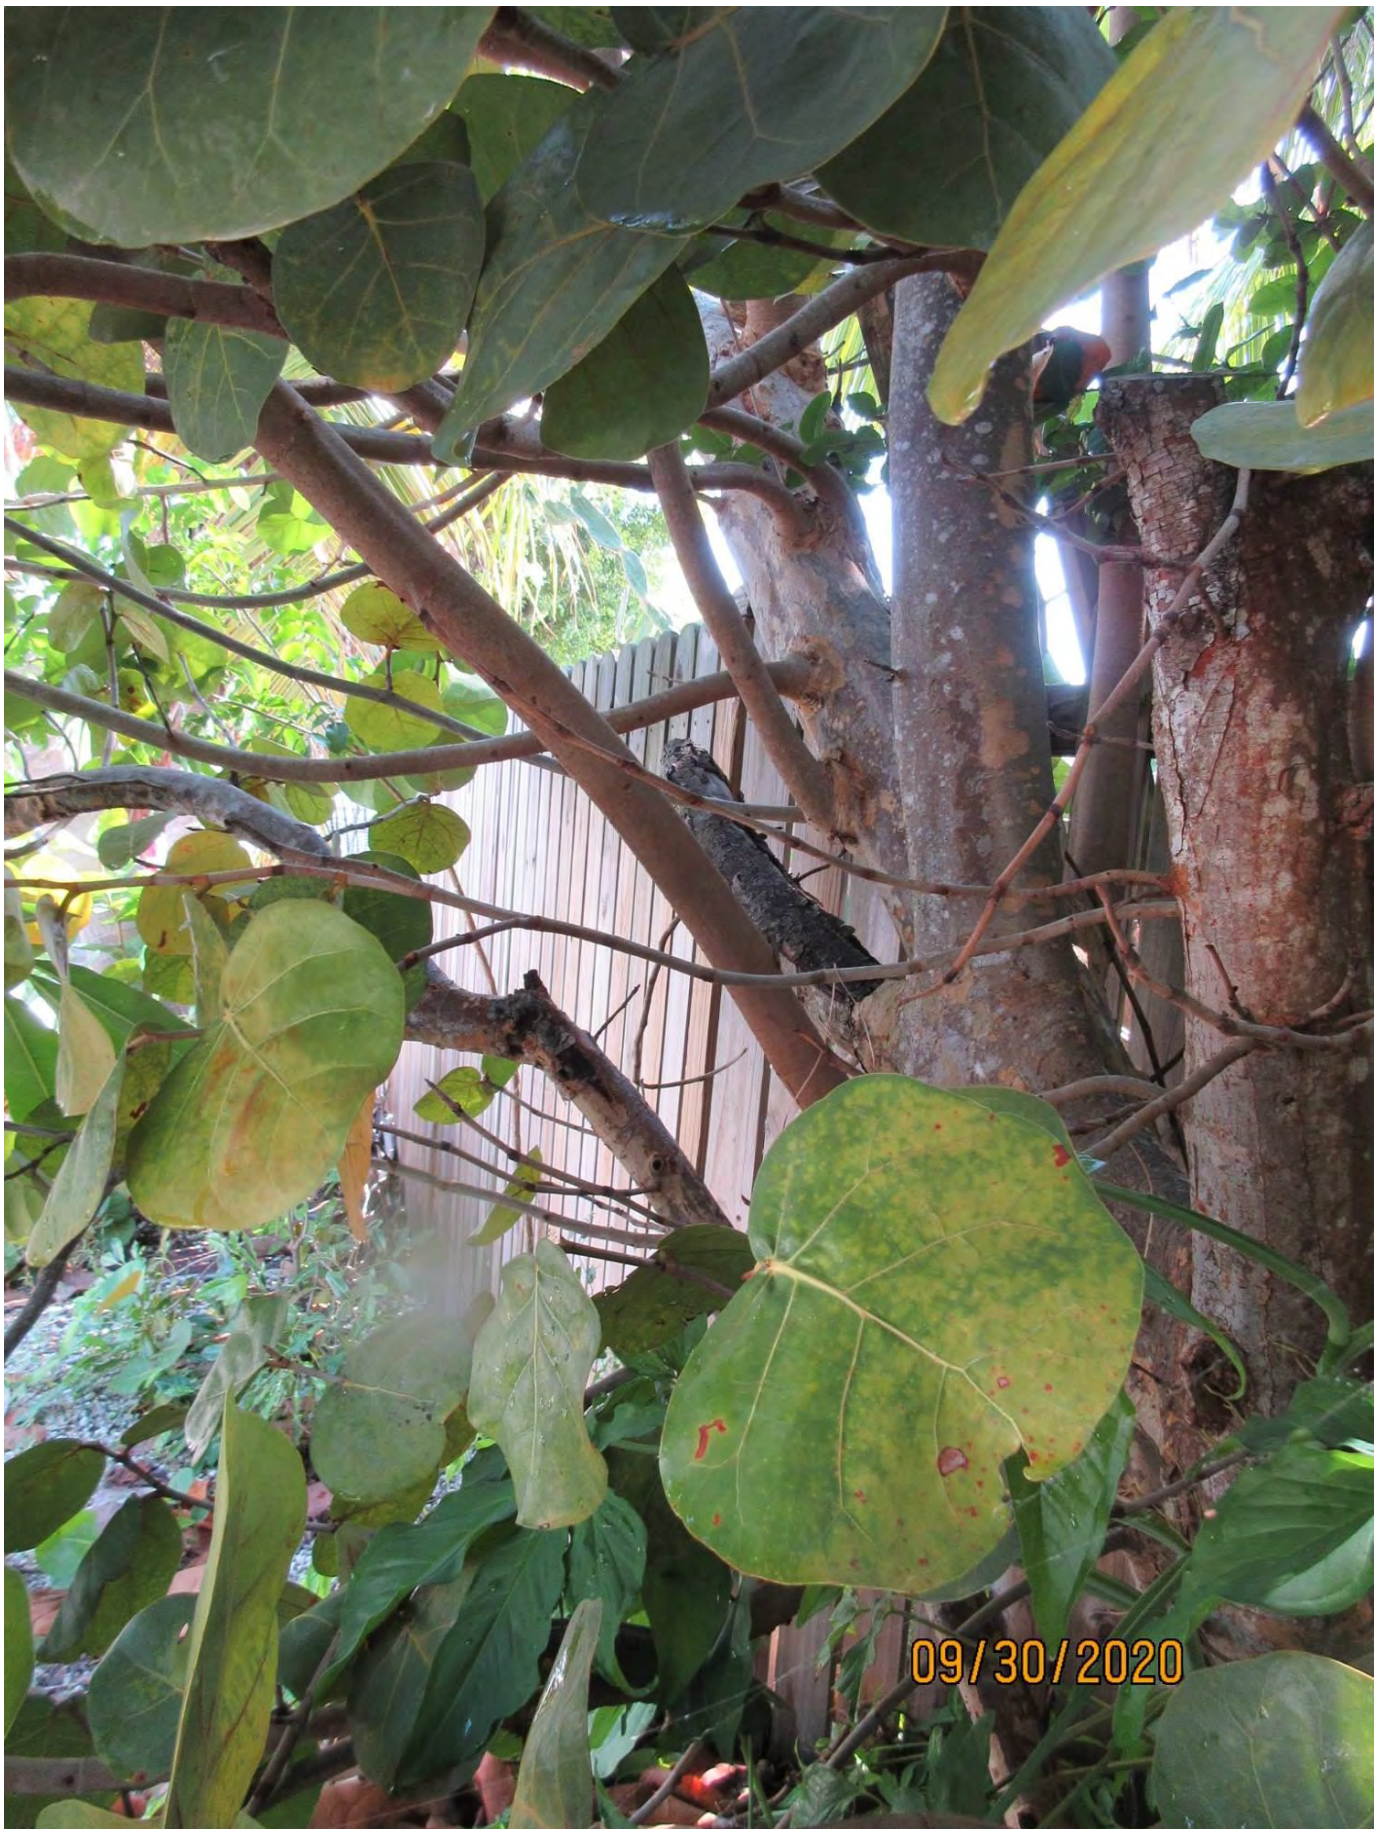
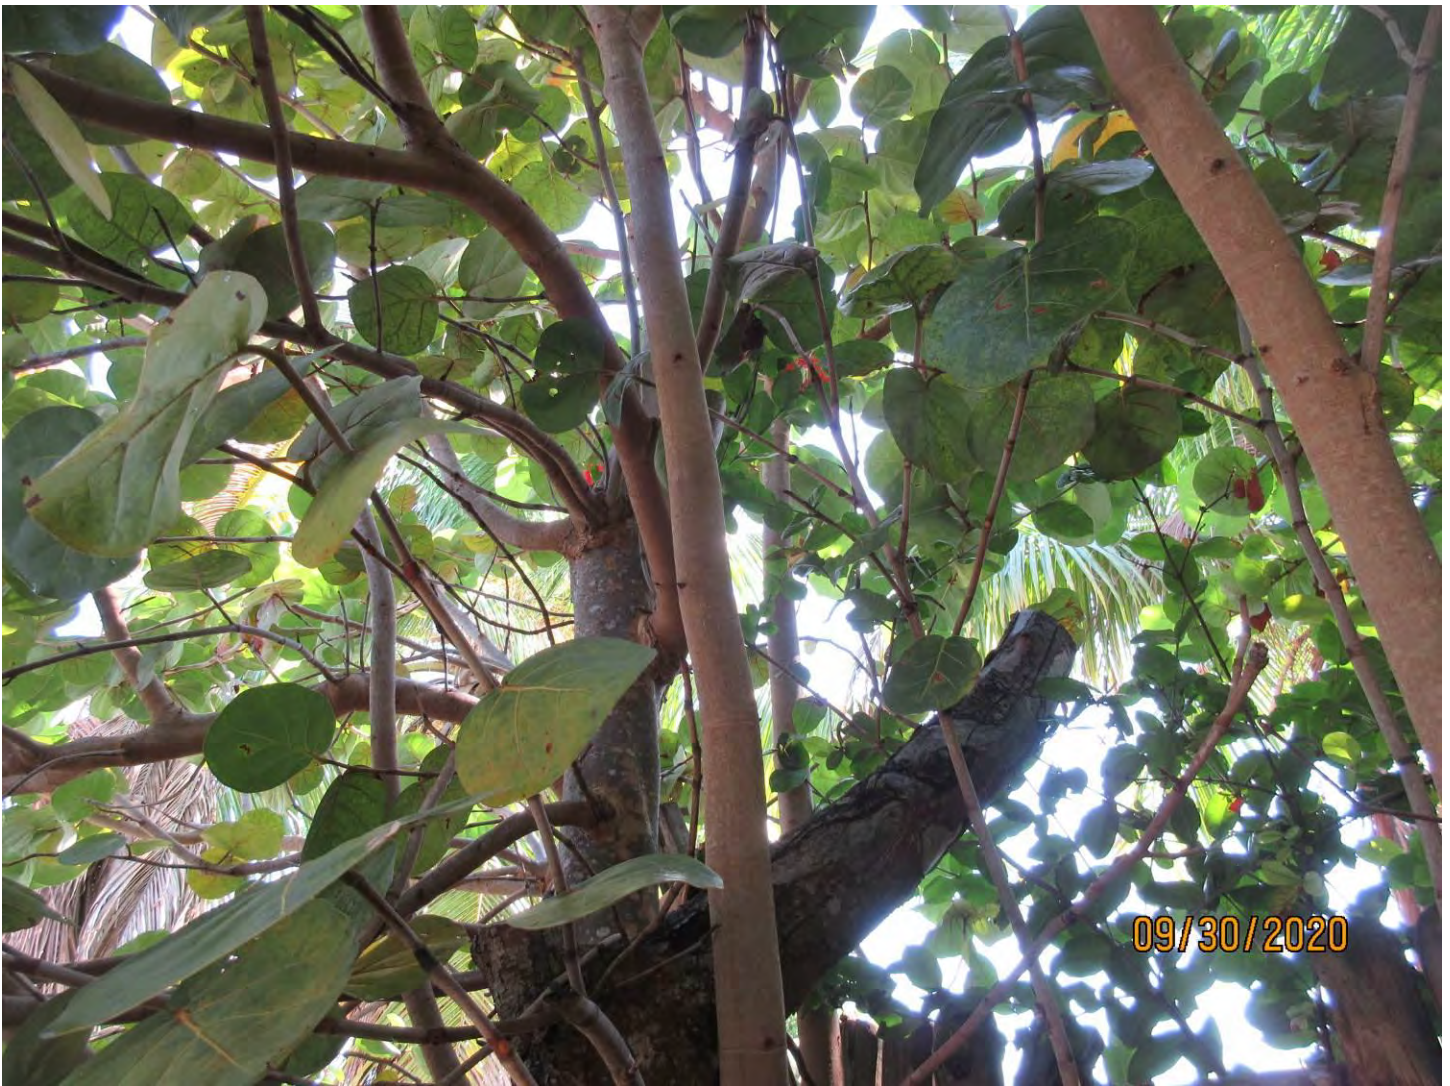
Tree #1

Photo showing location of tree #1.

Photo showing base of tree #1.

Photo showing tree trunks, canopy and fence, view 1.

Photo showing tree canopy.

Diameter: 16.8"

Location: 60% (growing against fence along right of way on private property)

Condition: 40% (overall poor tree structure-more of an overgrown shrub, old storm damage to canopy-old stub cuts, constant maintenance due to location and structure with right of way)

Value x Diameter = 11 replacement caliper inches
