STAFF REPORT

RE: 2214 Seidenberg Avenue (permit application # T2020-0280)

FROM: Karen DeMaria, City of Key West Urban Forestry Manager

An application was received requesting the removal of (5) Sea Grape tree clumps. A site inspection was done and documented the following:

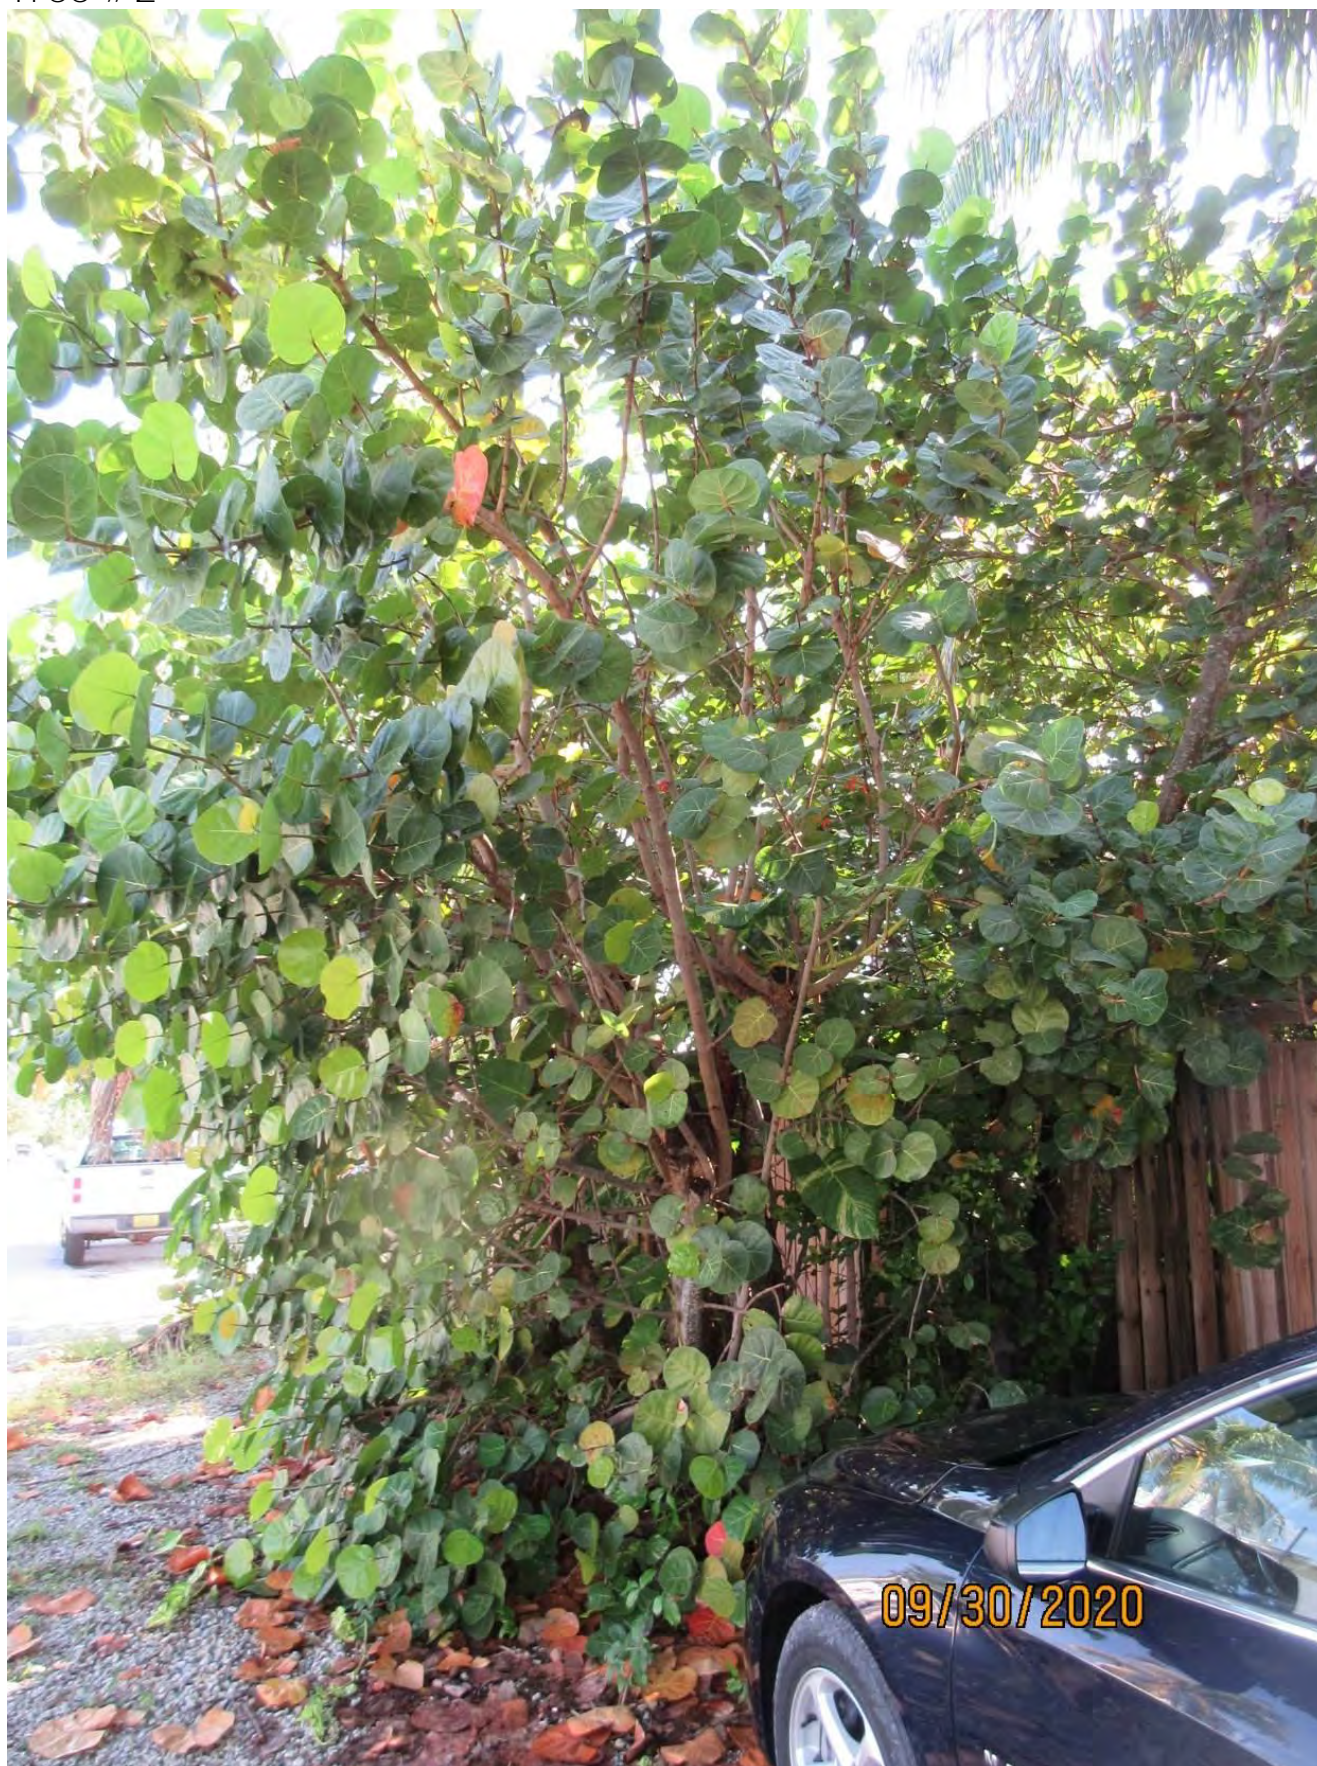
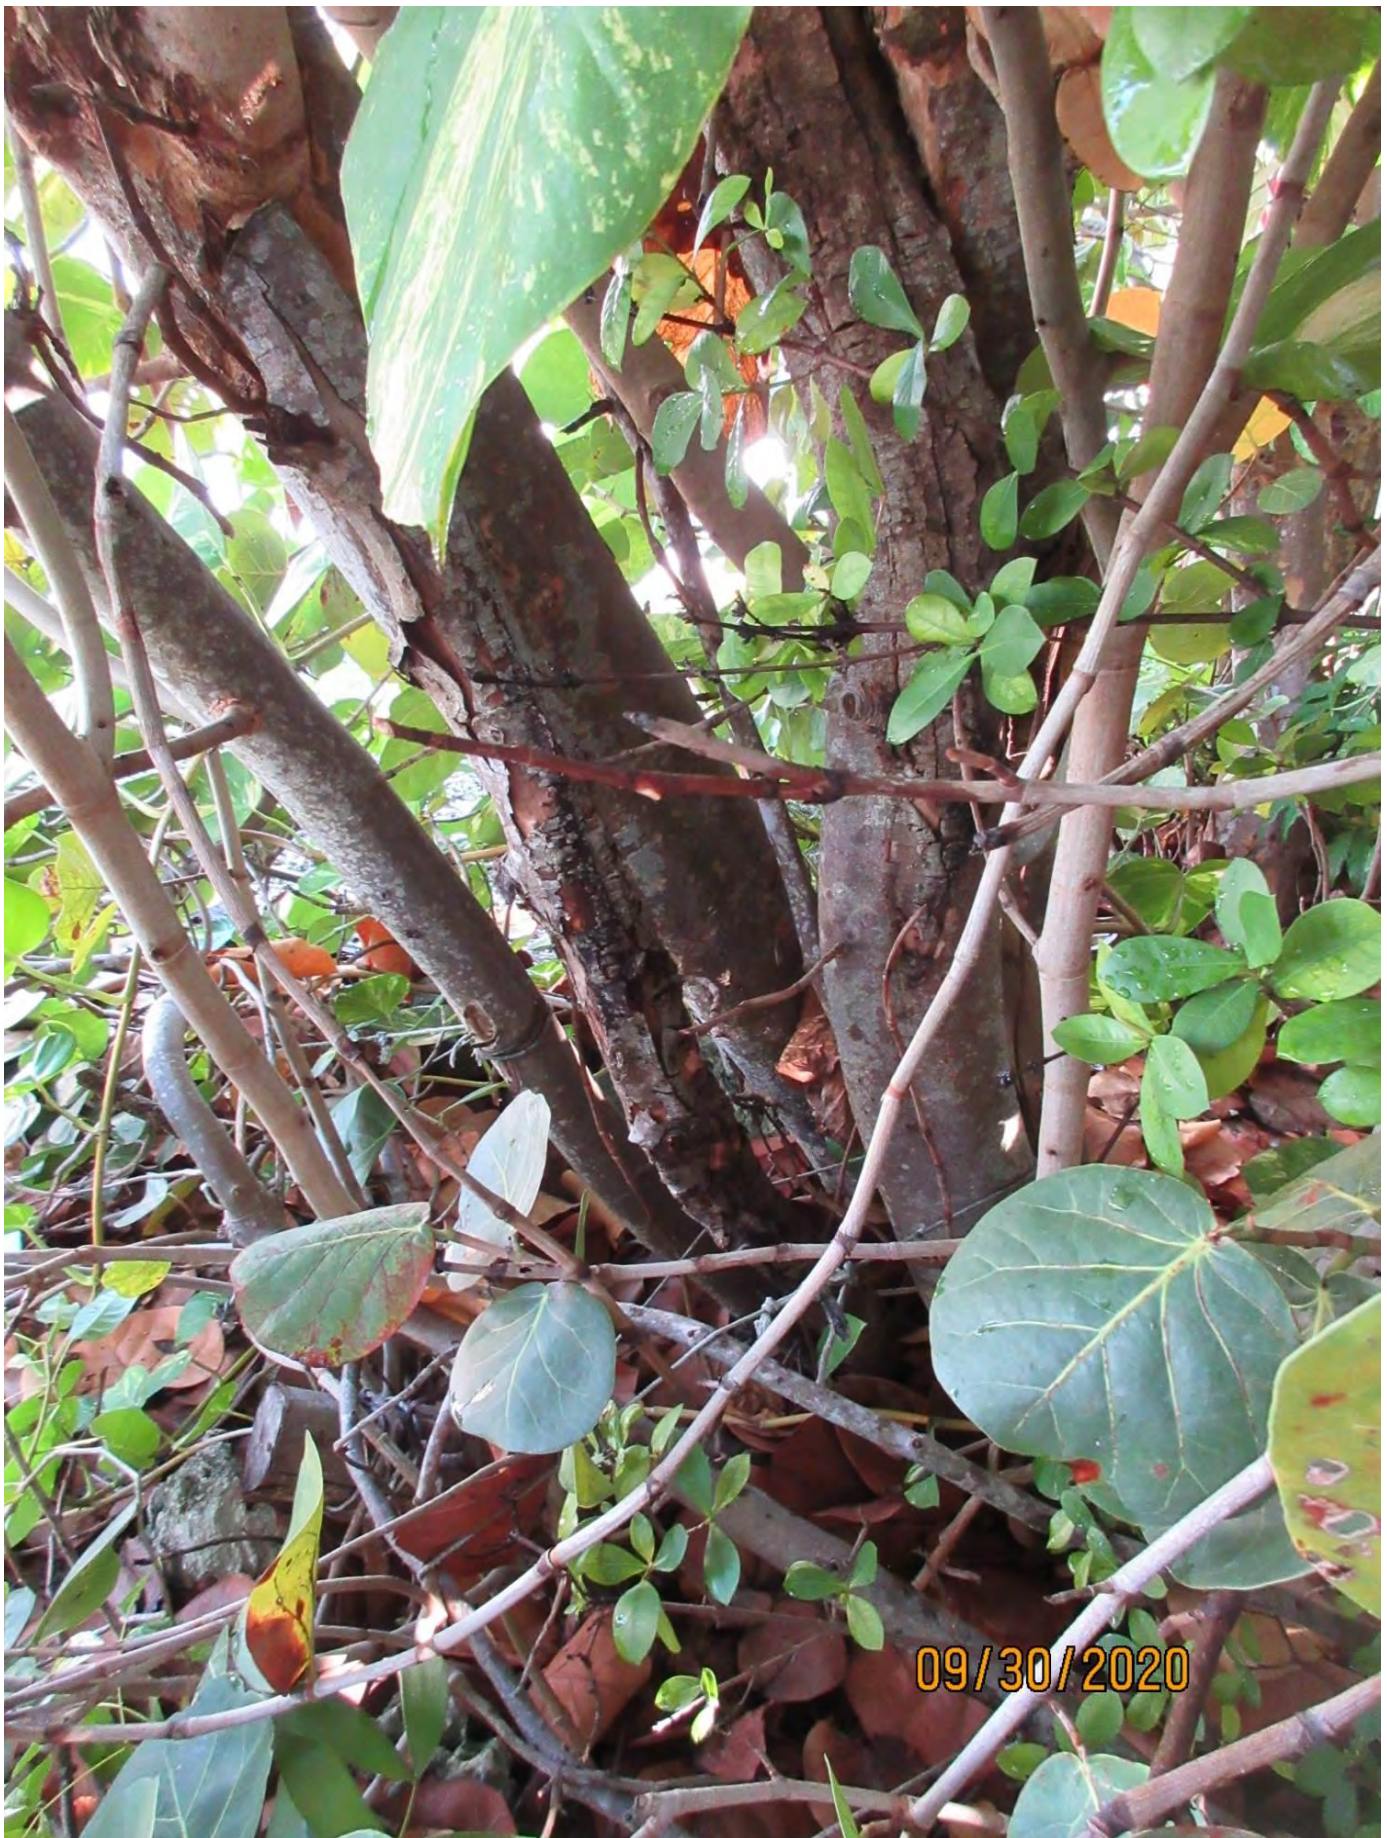
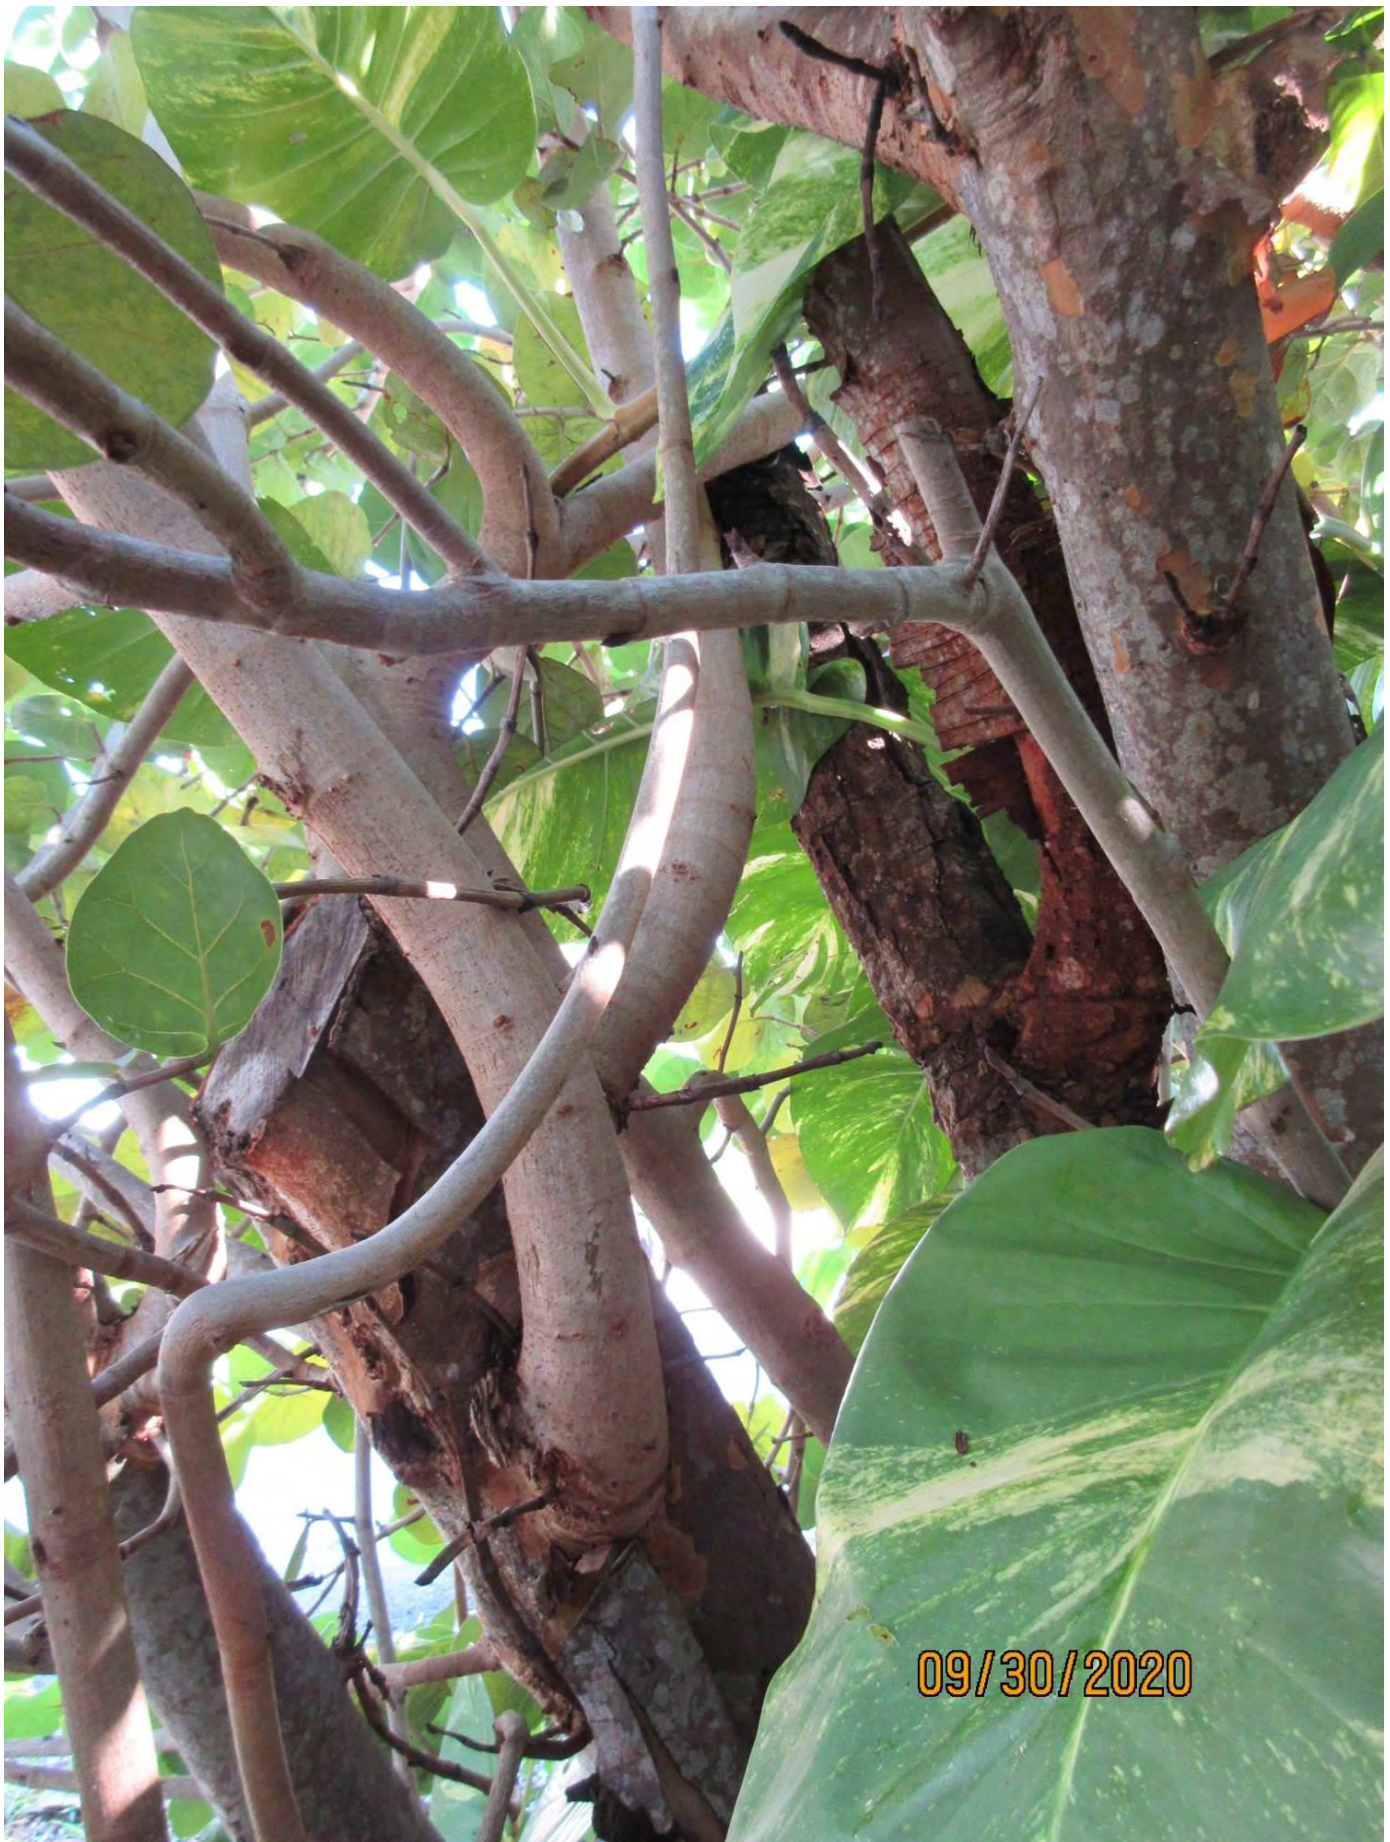
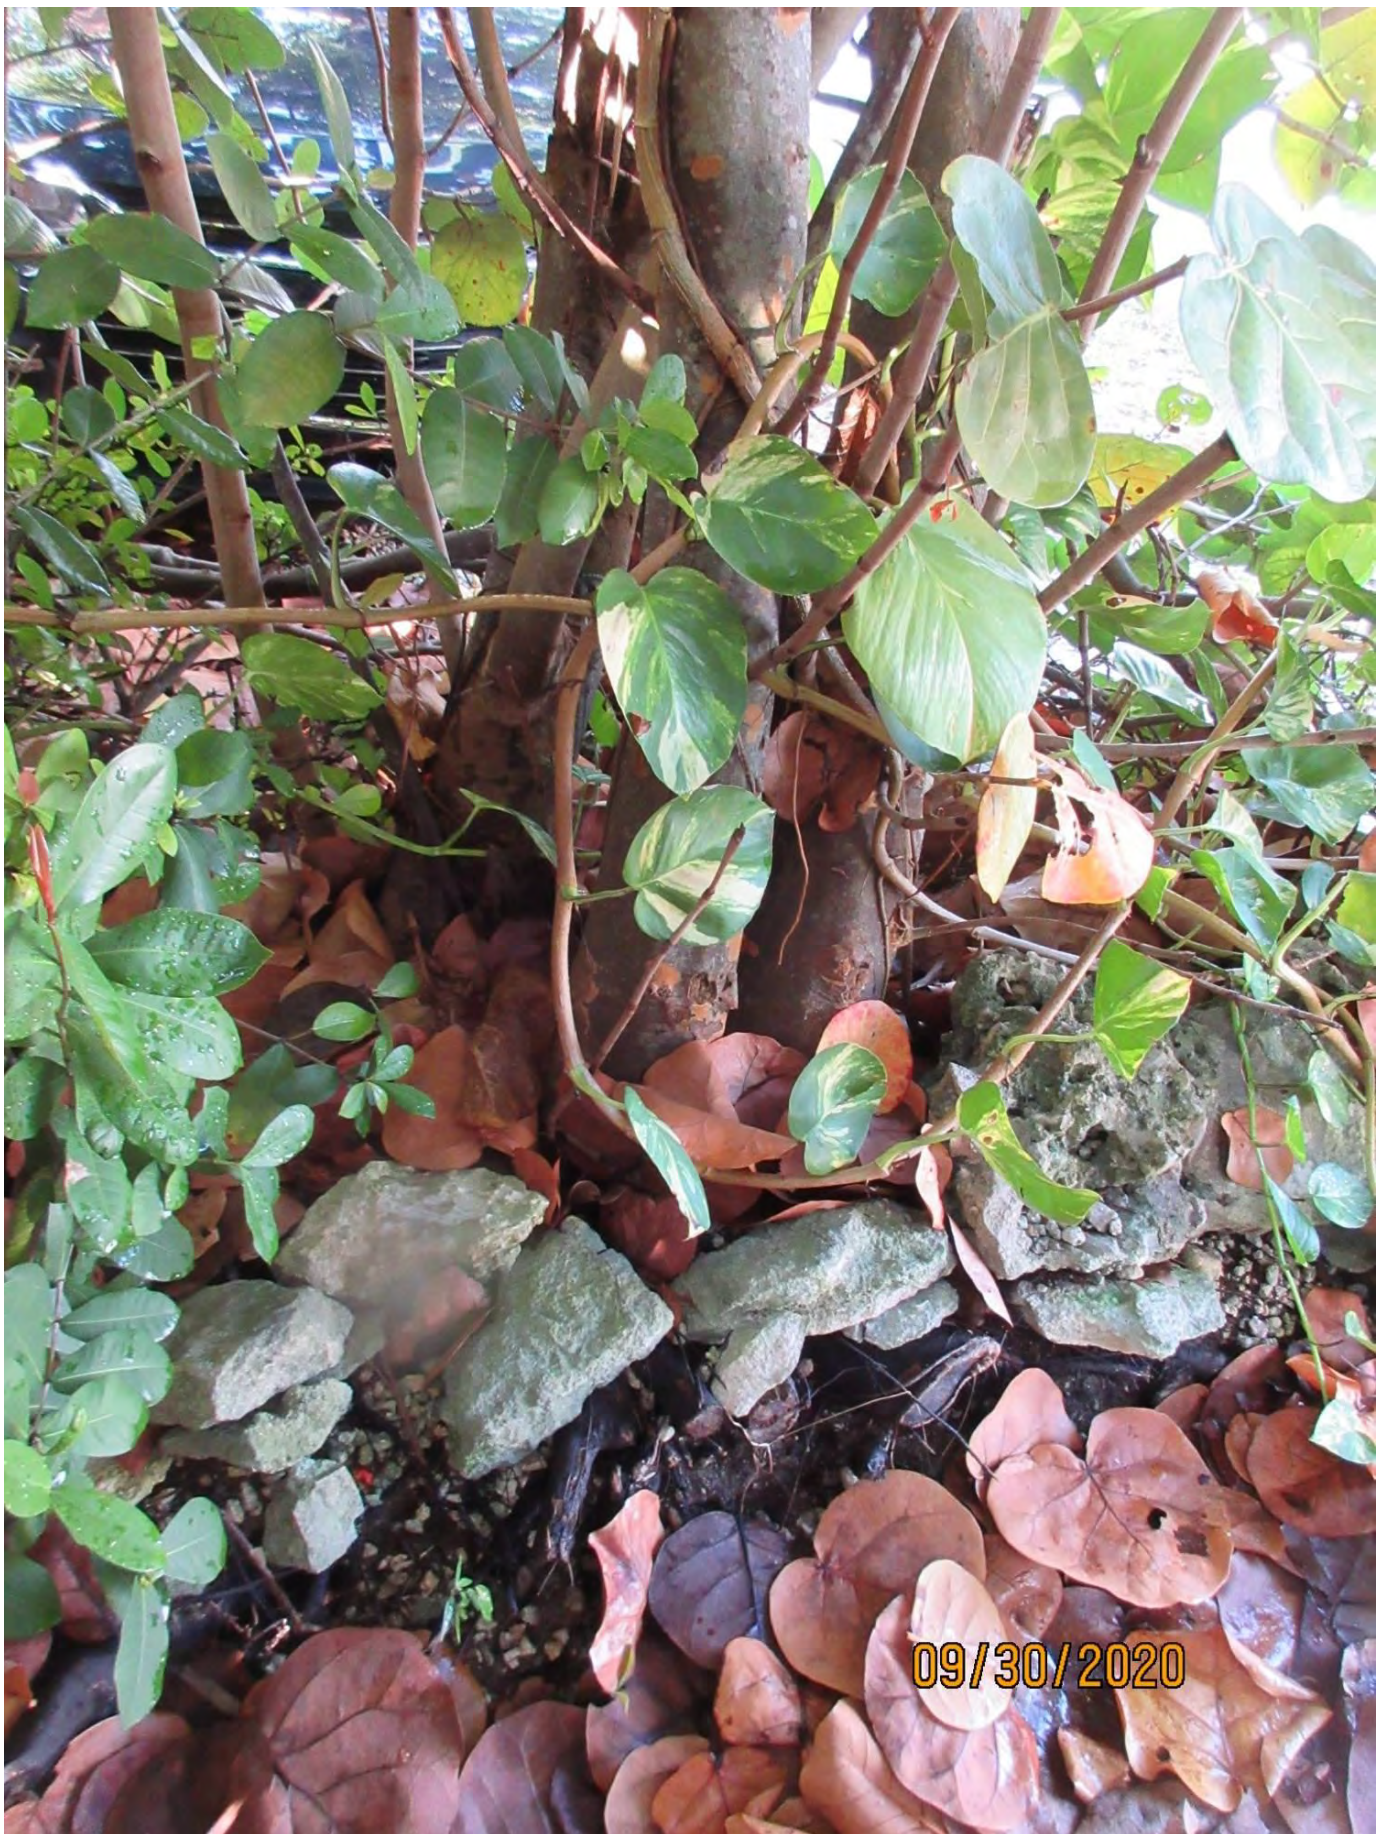
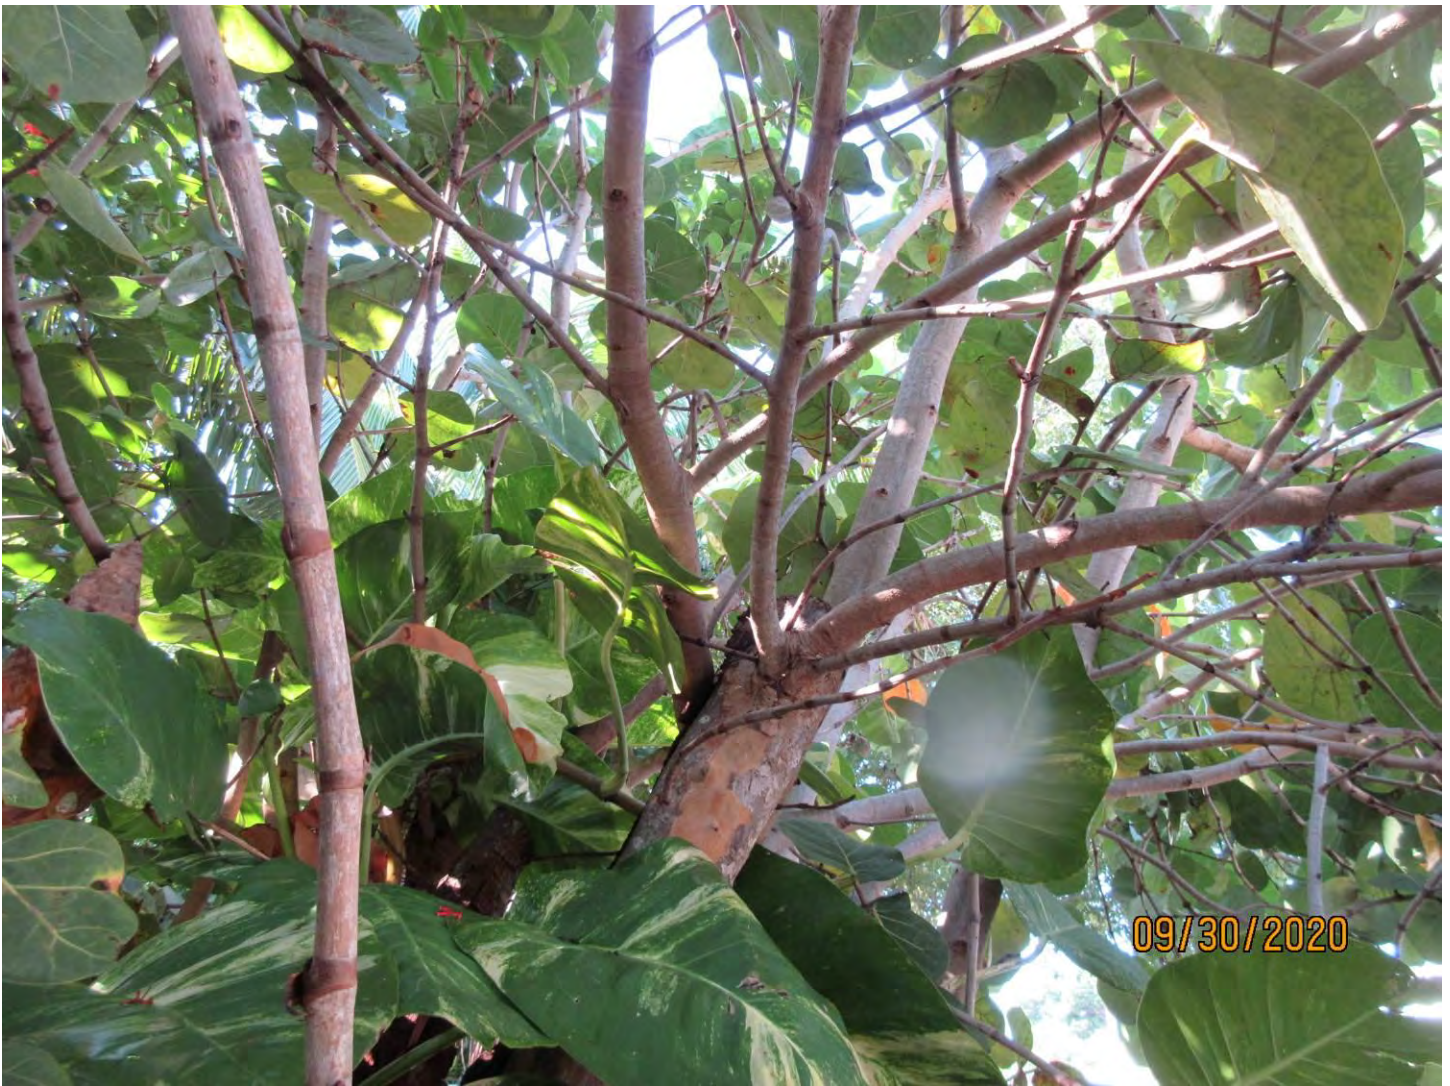
Tree #2

Photo showing location of tree #2.

Photo showing base of tree #2, view 1.

Photo showing tree trunks and canopy.

Photo showing base of tree, view 2.

Photo of tree canopy.

Diameter: 17.5"

Location: 60% (growing against fence along right of way on private property)

Condition: 40% (overall poor tree structure-more of an overgrown shrub, old storm damage to canopy-old stub cuts, constant maintenance due to location and structure with right of way)

Value x Diameter = 11.5 replacement caliper inches

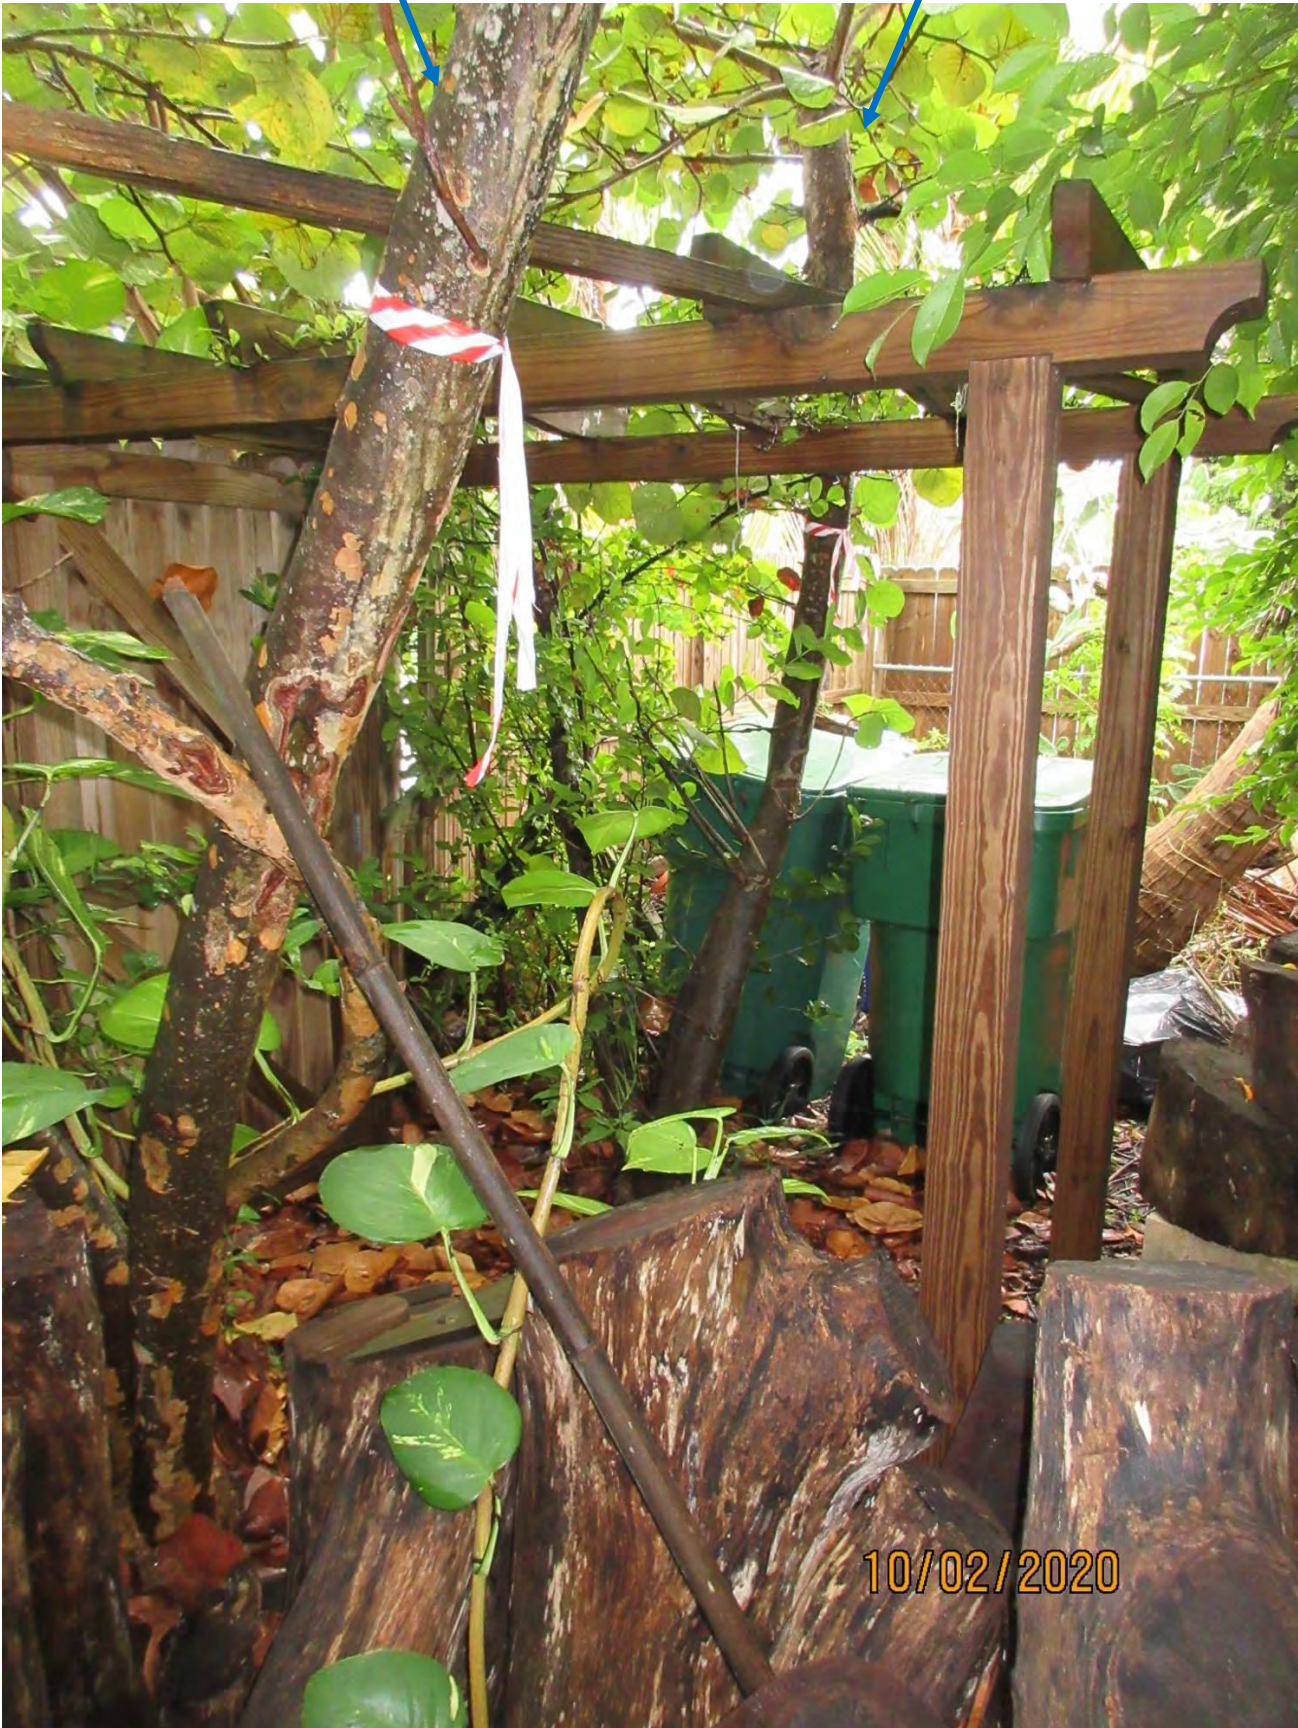
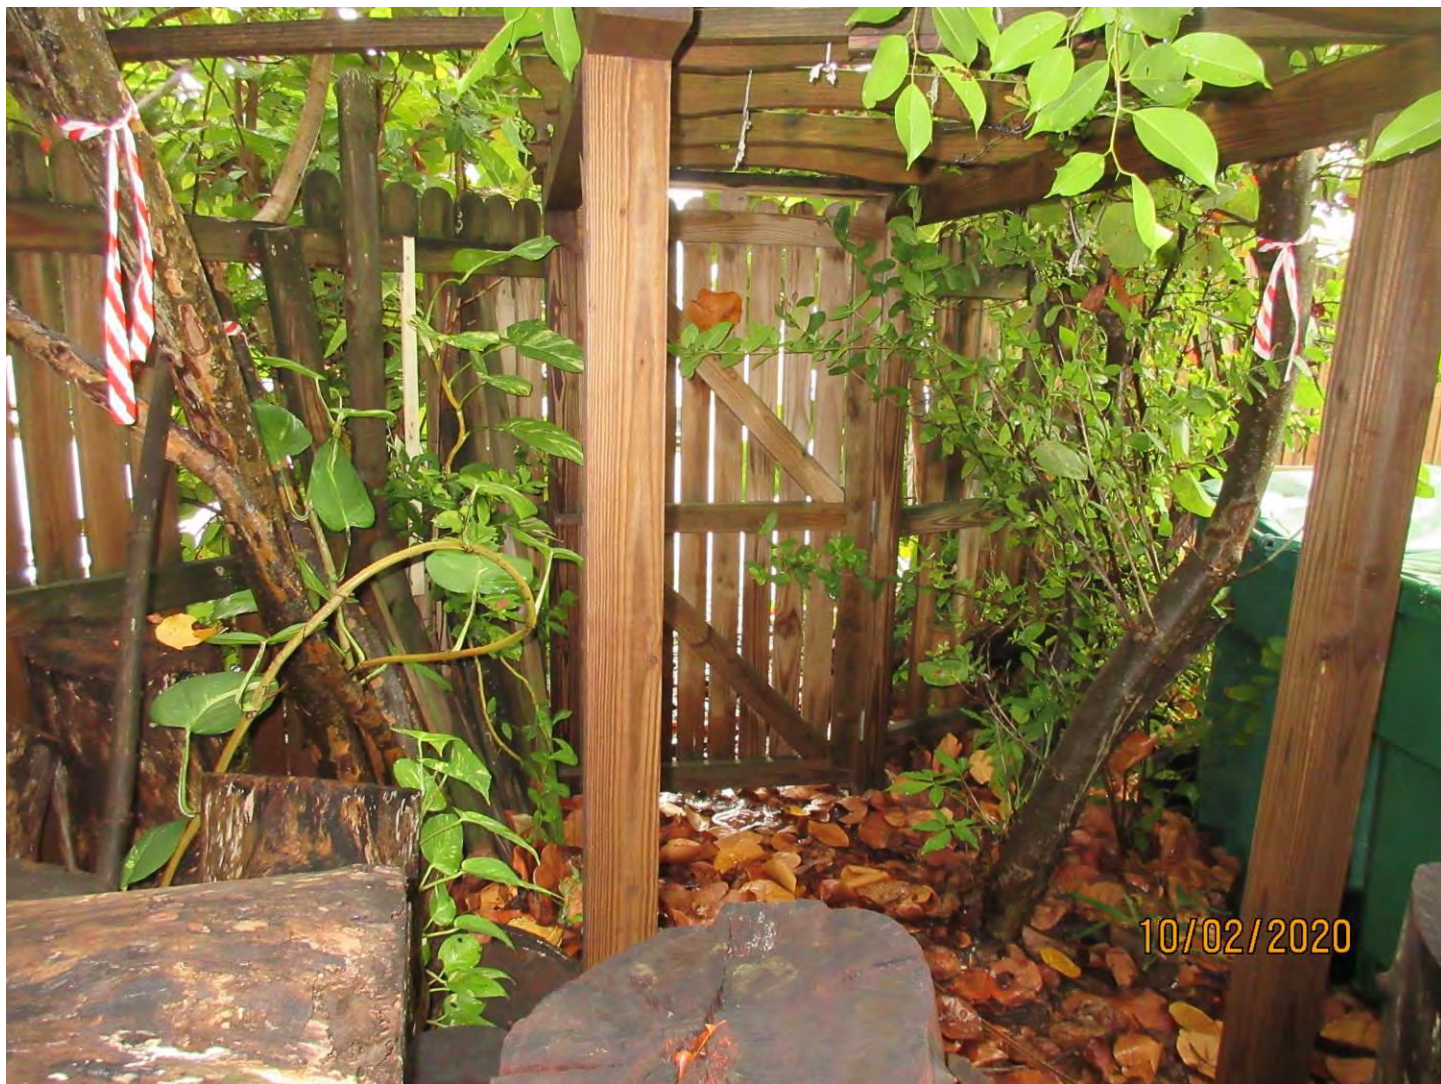
Photo showing location of tree #4 and tree #3, view 1.

Photo showing location of tree #4 and tree #3, view 2.

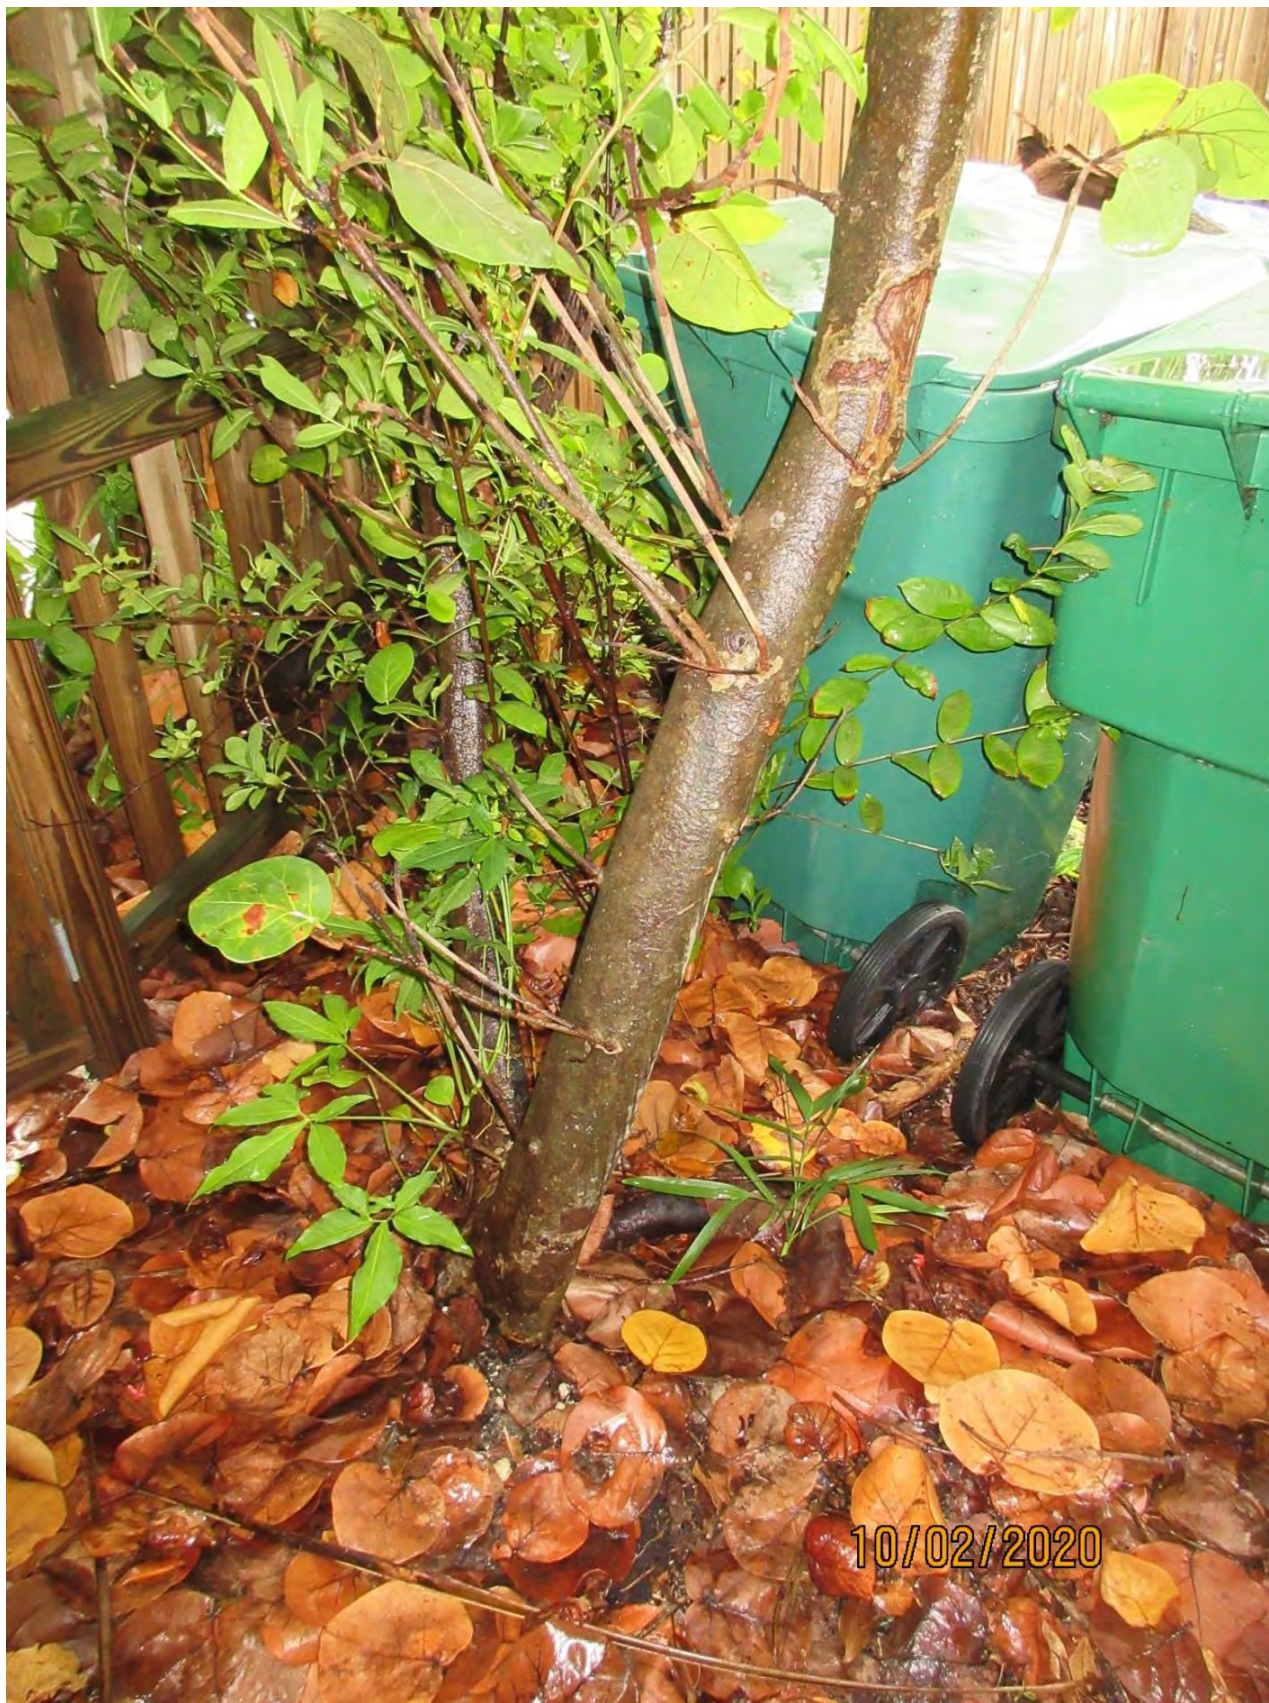
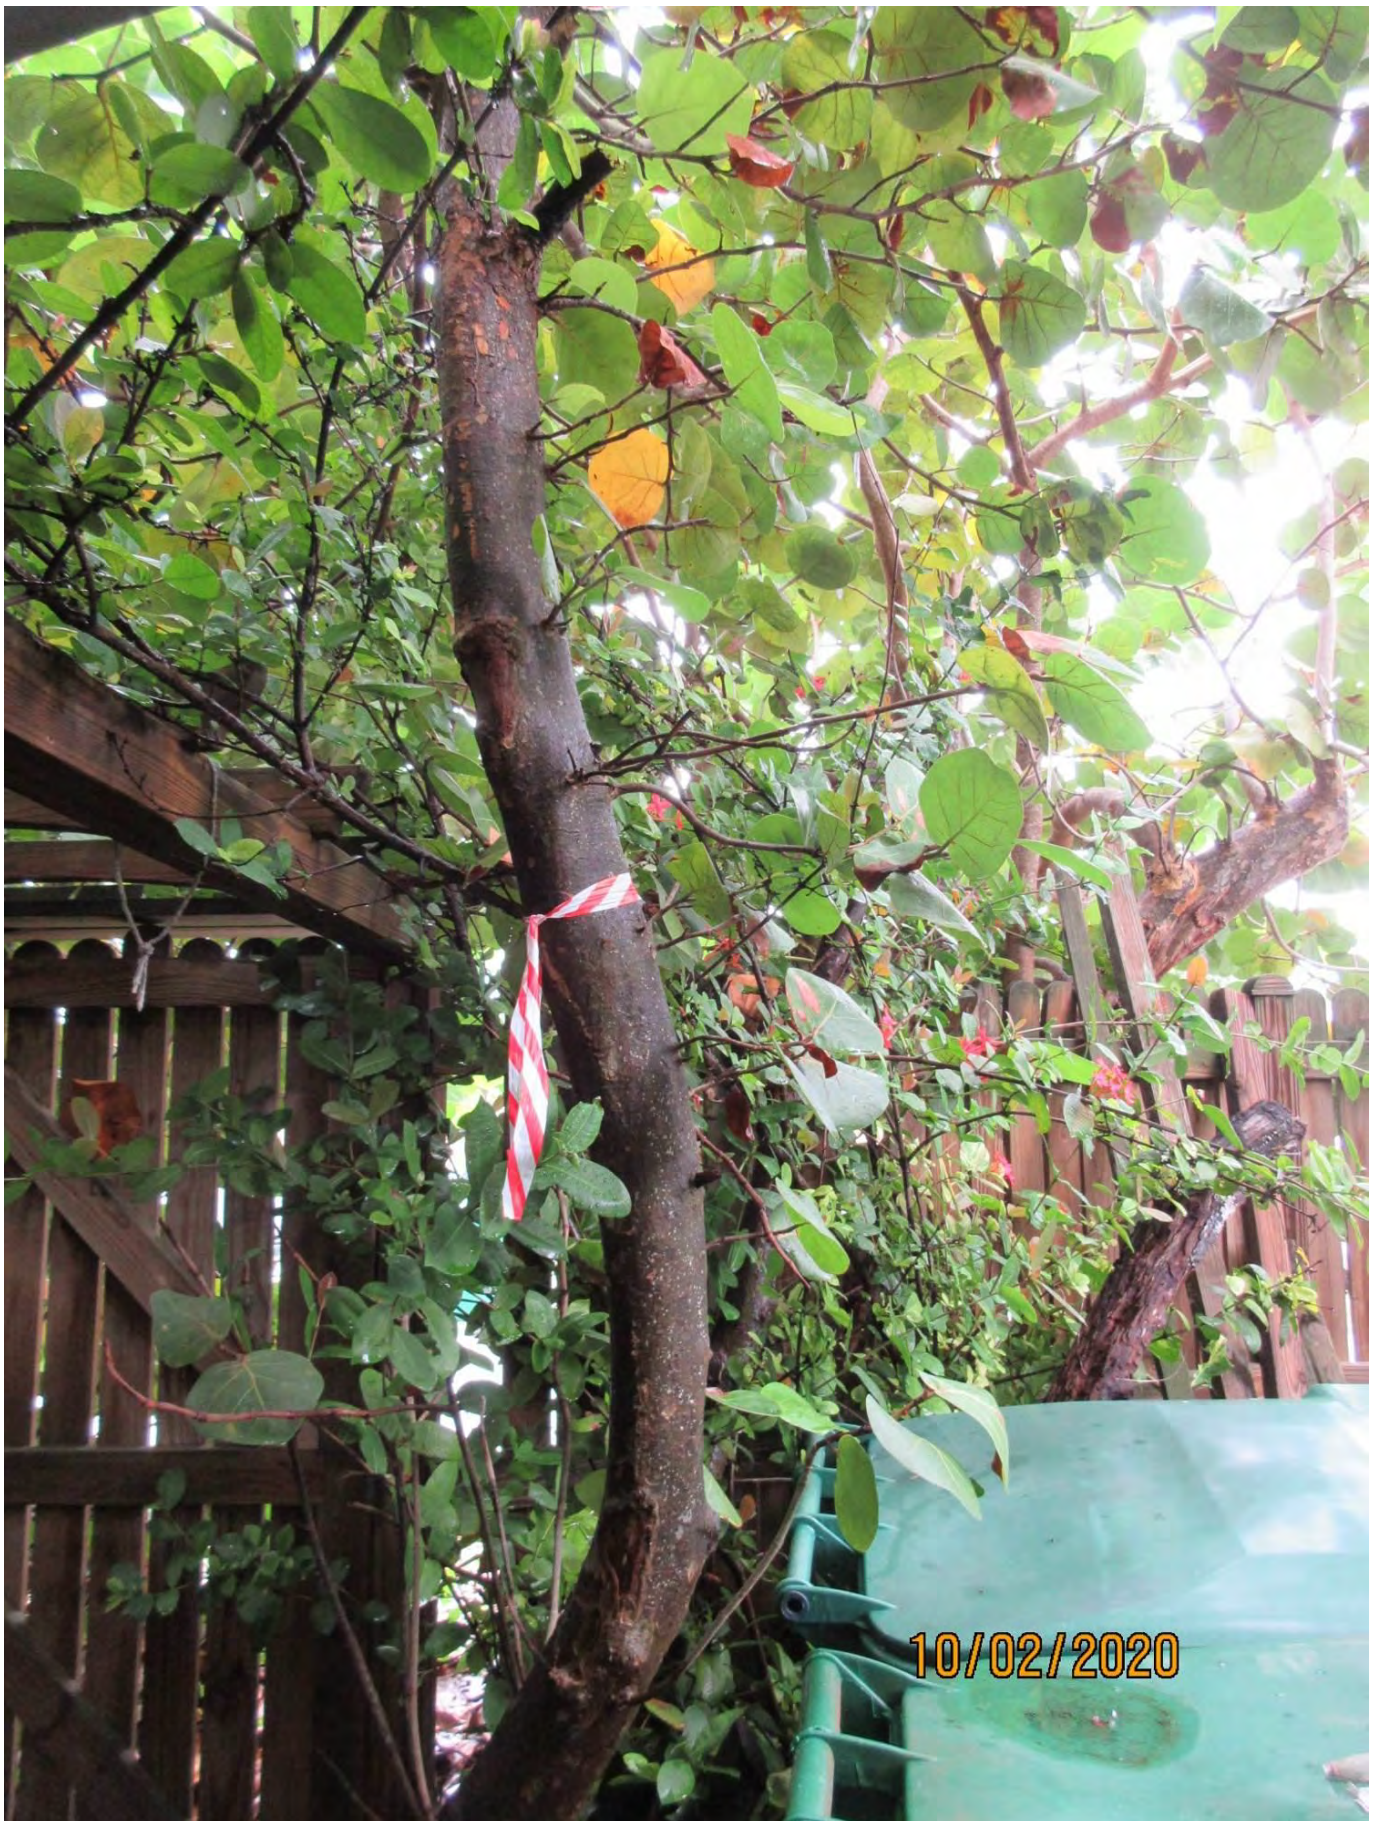
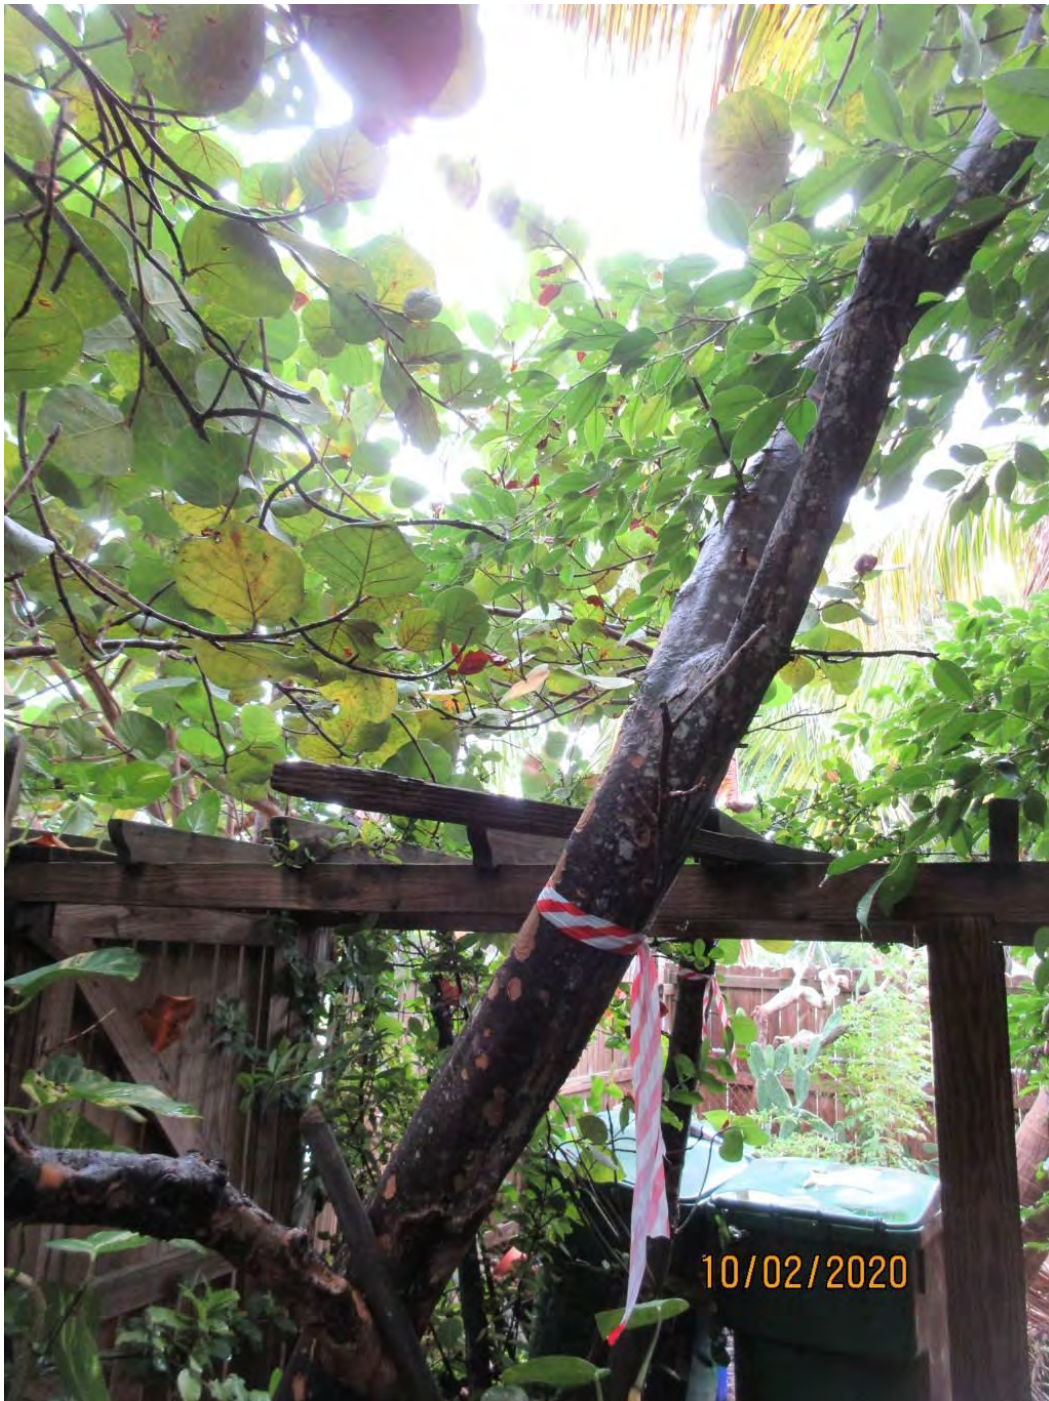
Tree #3

Photo showing trunk and Base of tree #3.

Photo showing trunk and canopy of tree, view 1.

Diameter: 9.5"

Location: 60% (canopy growing into sea grape #1 and #2, located in front of property behind fence)

Condition: 40% (overall condition is fair to poor structure, storm damage)

Value x Diameter = 6.2 replacement caliper inches
