STAFF REPORT

RE: 2214 Seidenberg Avenue (permit application # T2020-0280)

FROM: Karen DeMaria, City of Key West Urban Forestry Manager

An application was received requesting the removal of (5) Sea Grape tree clumps. A site inspection was done and documented the following:

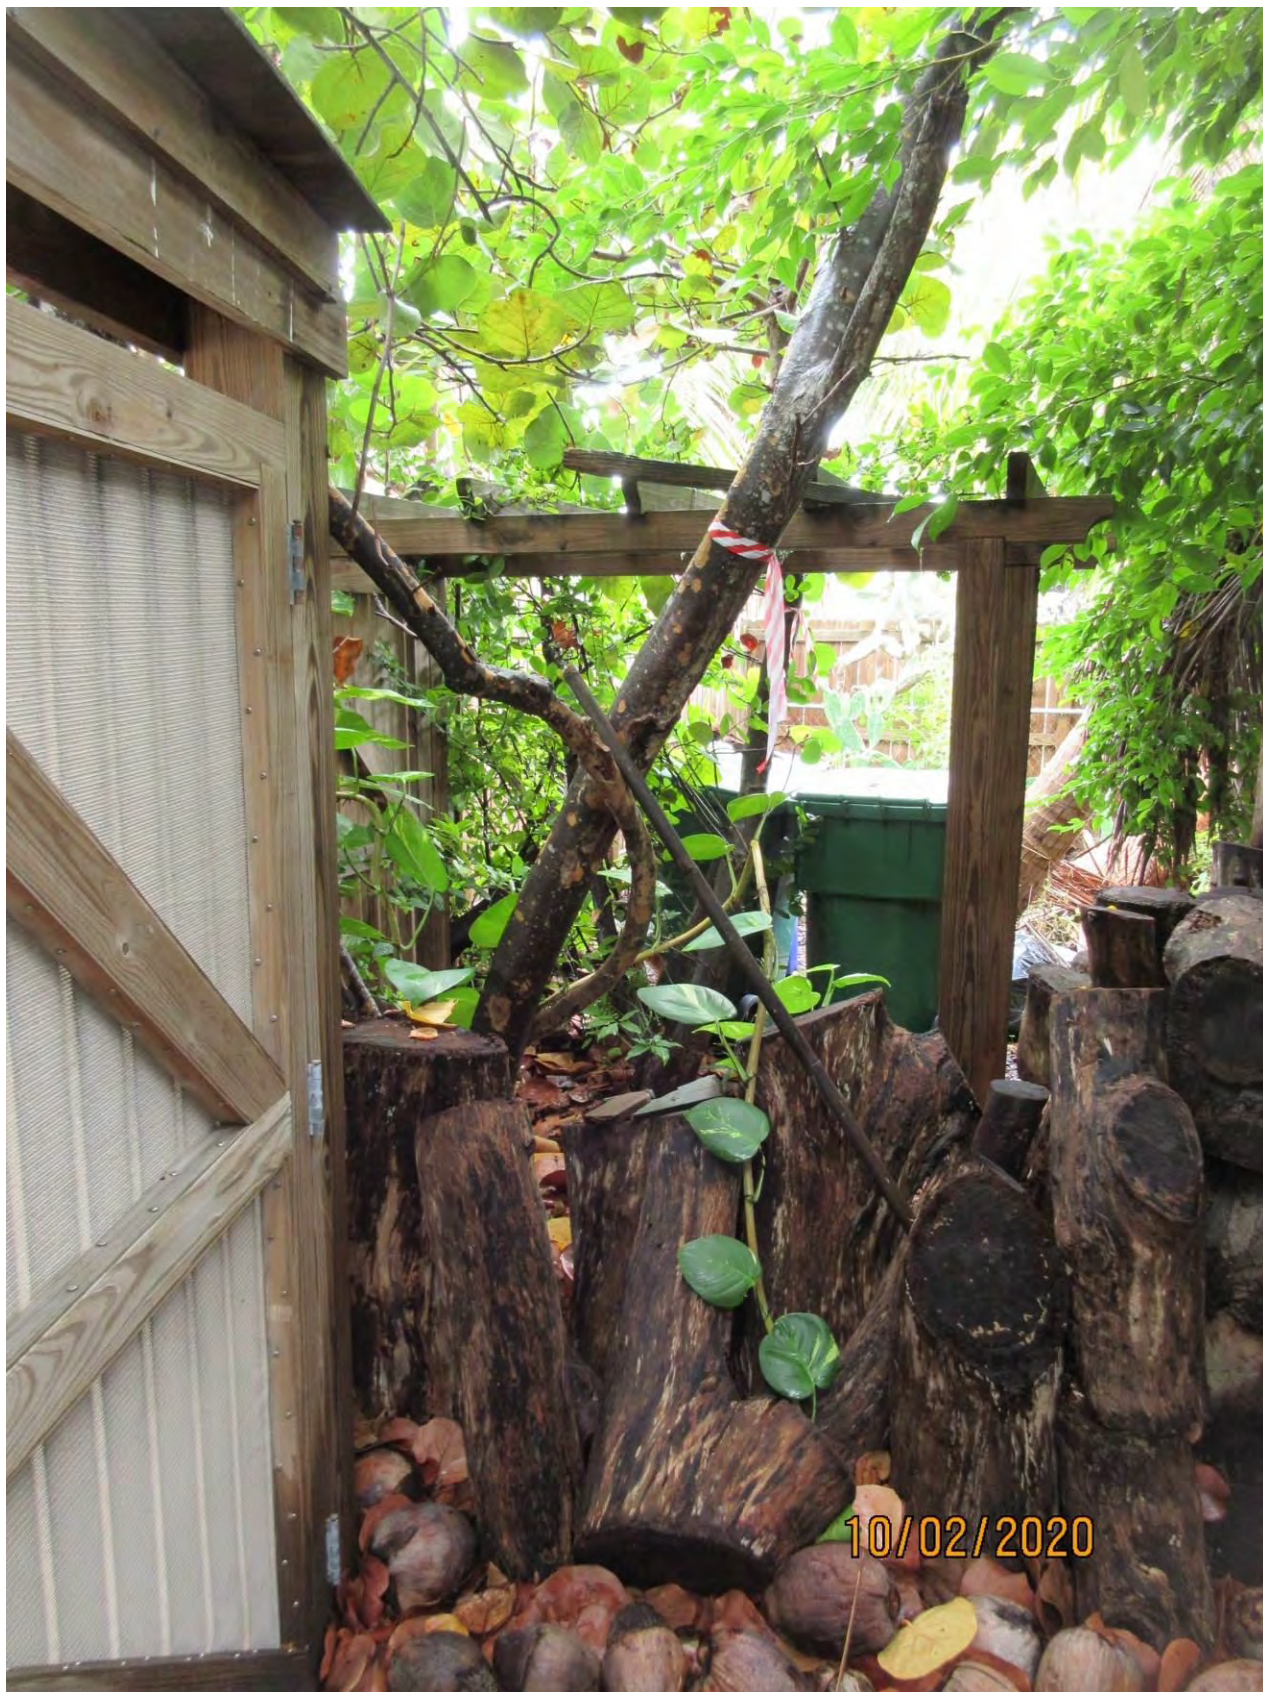
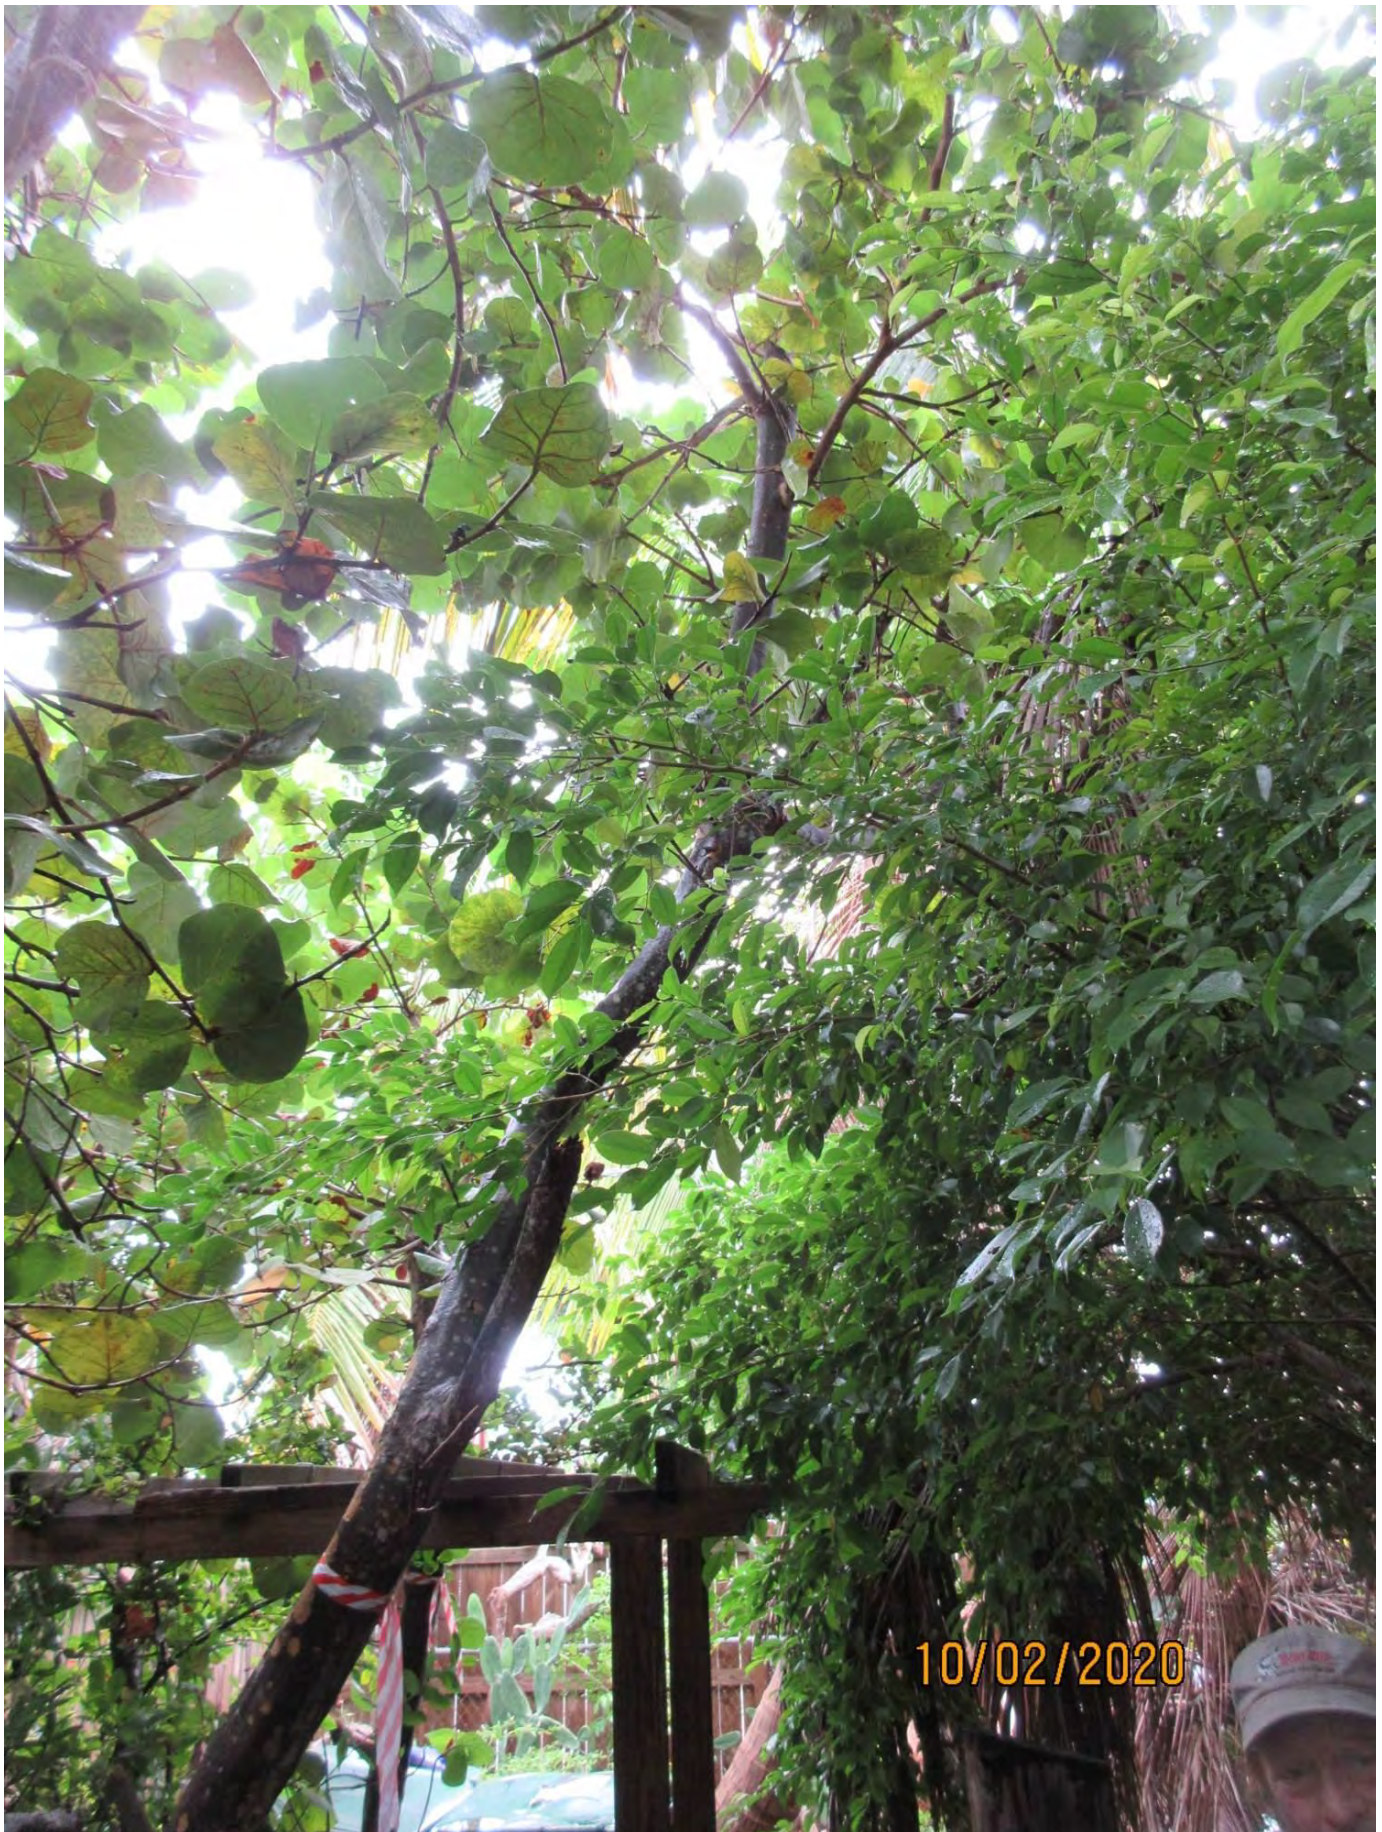
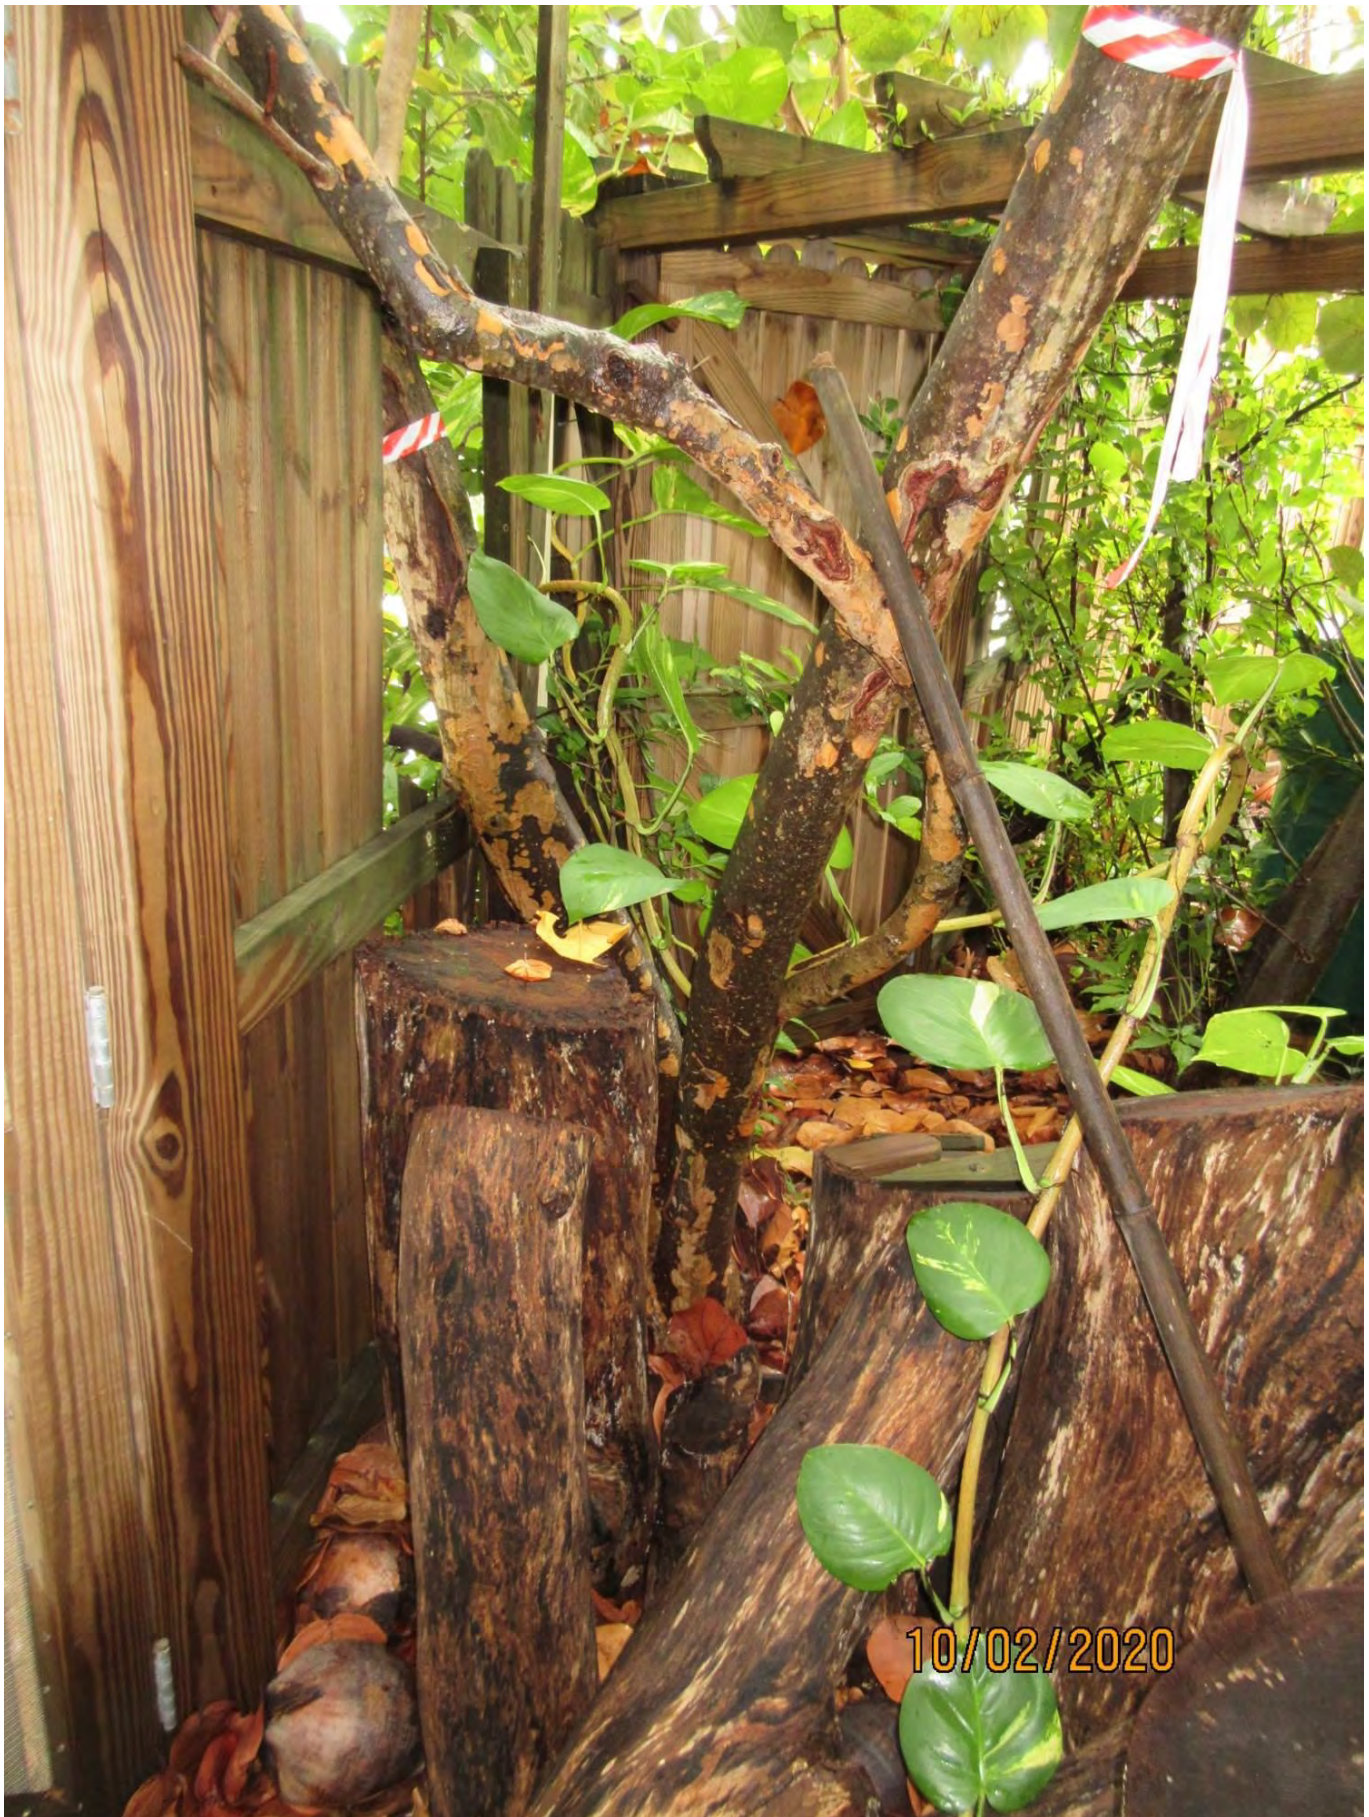
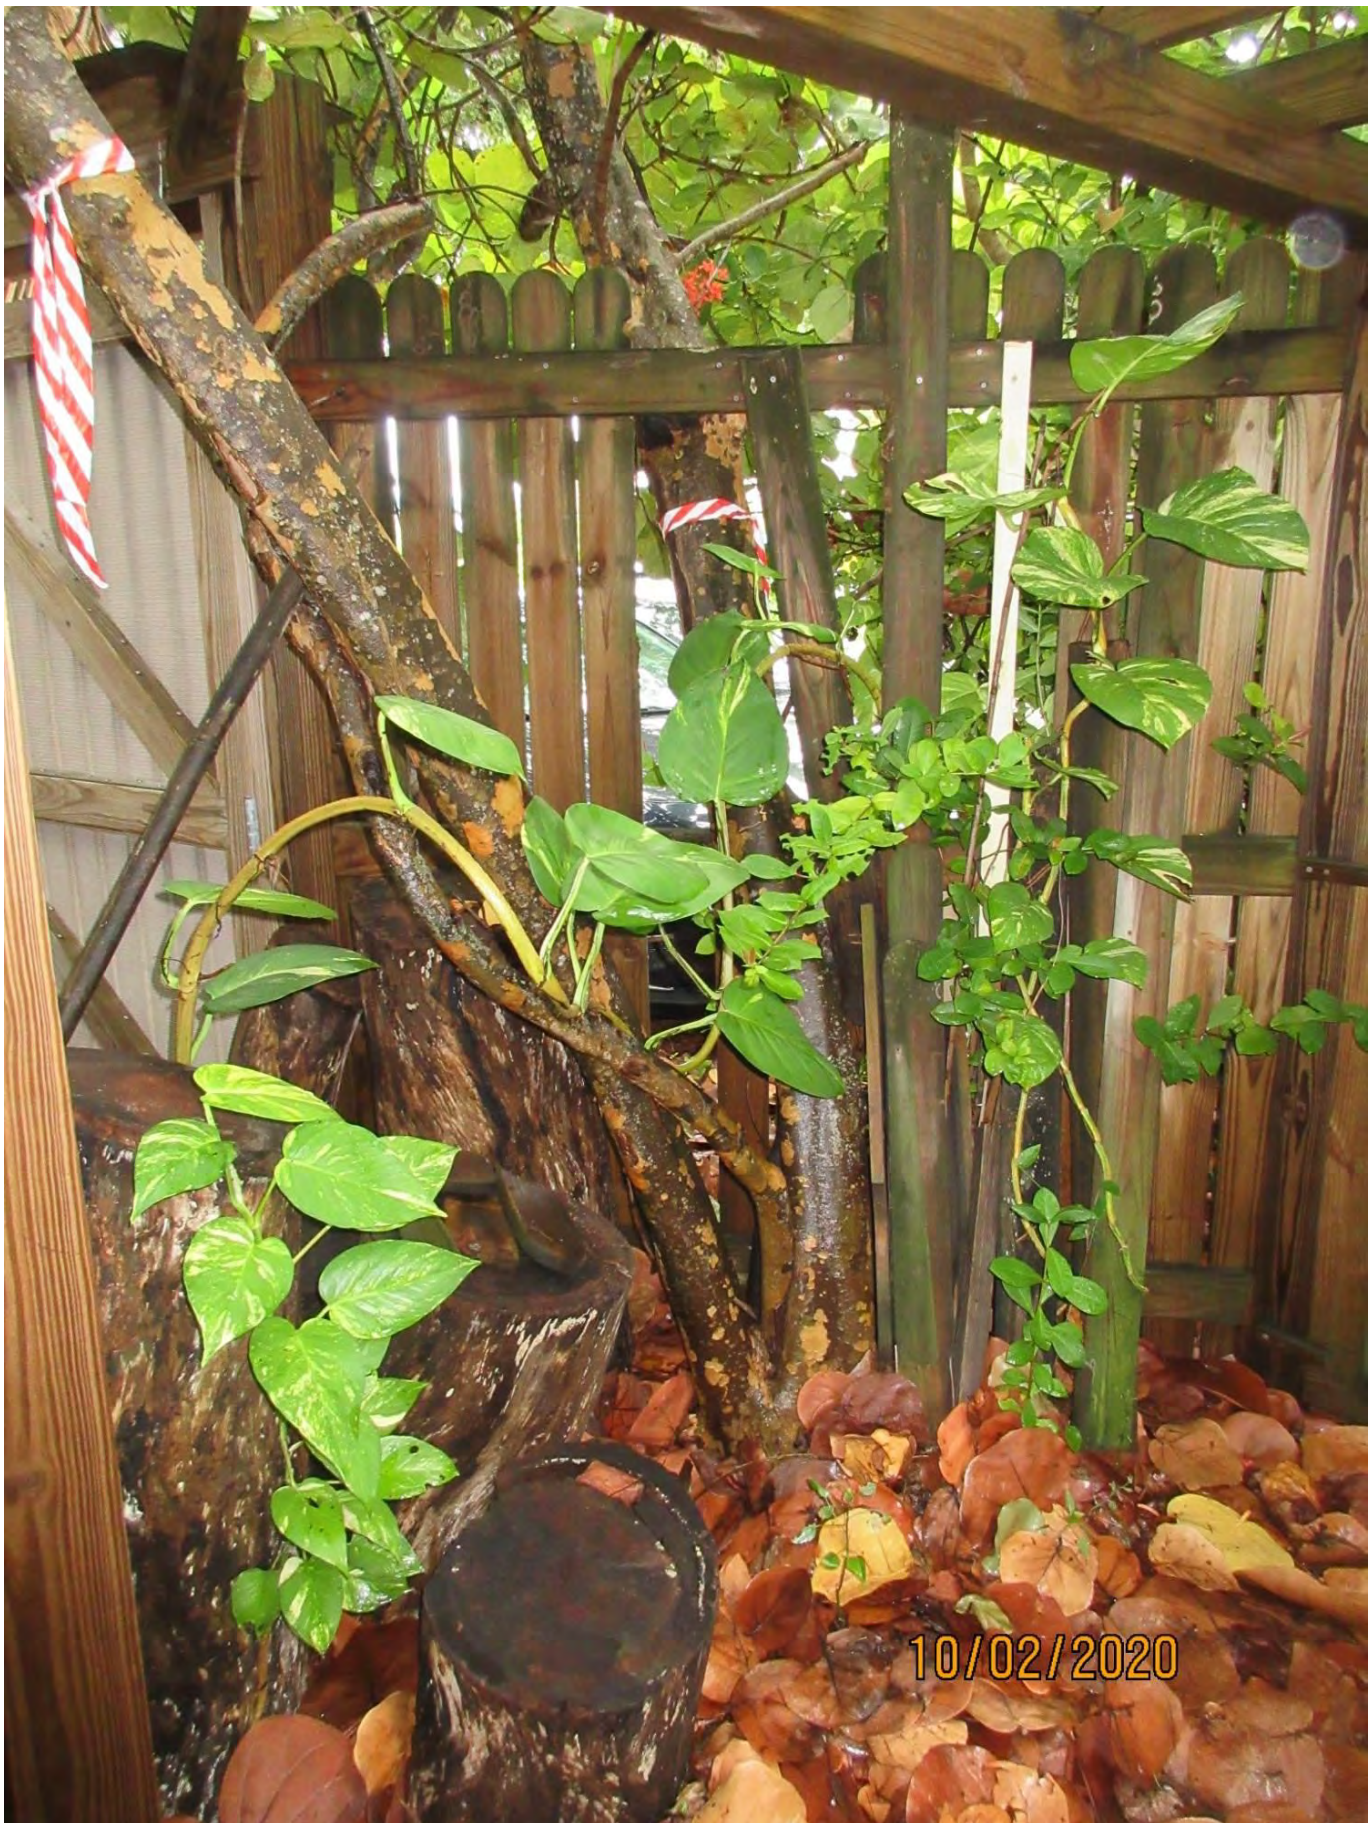
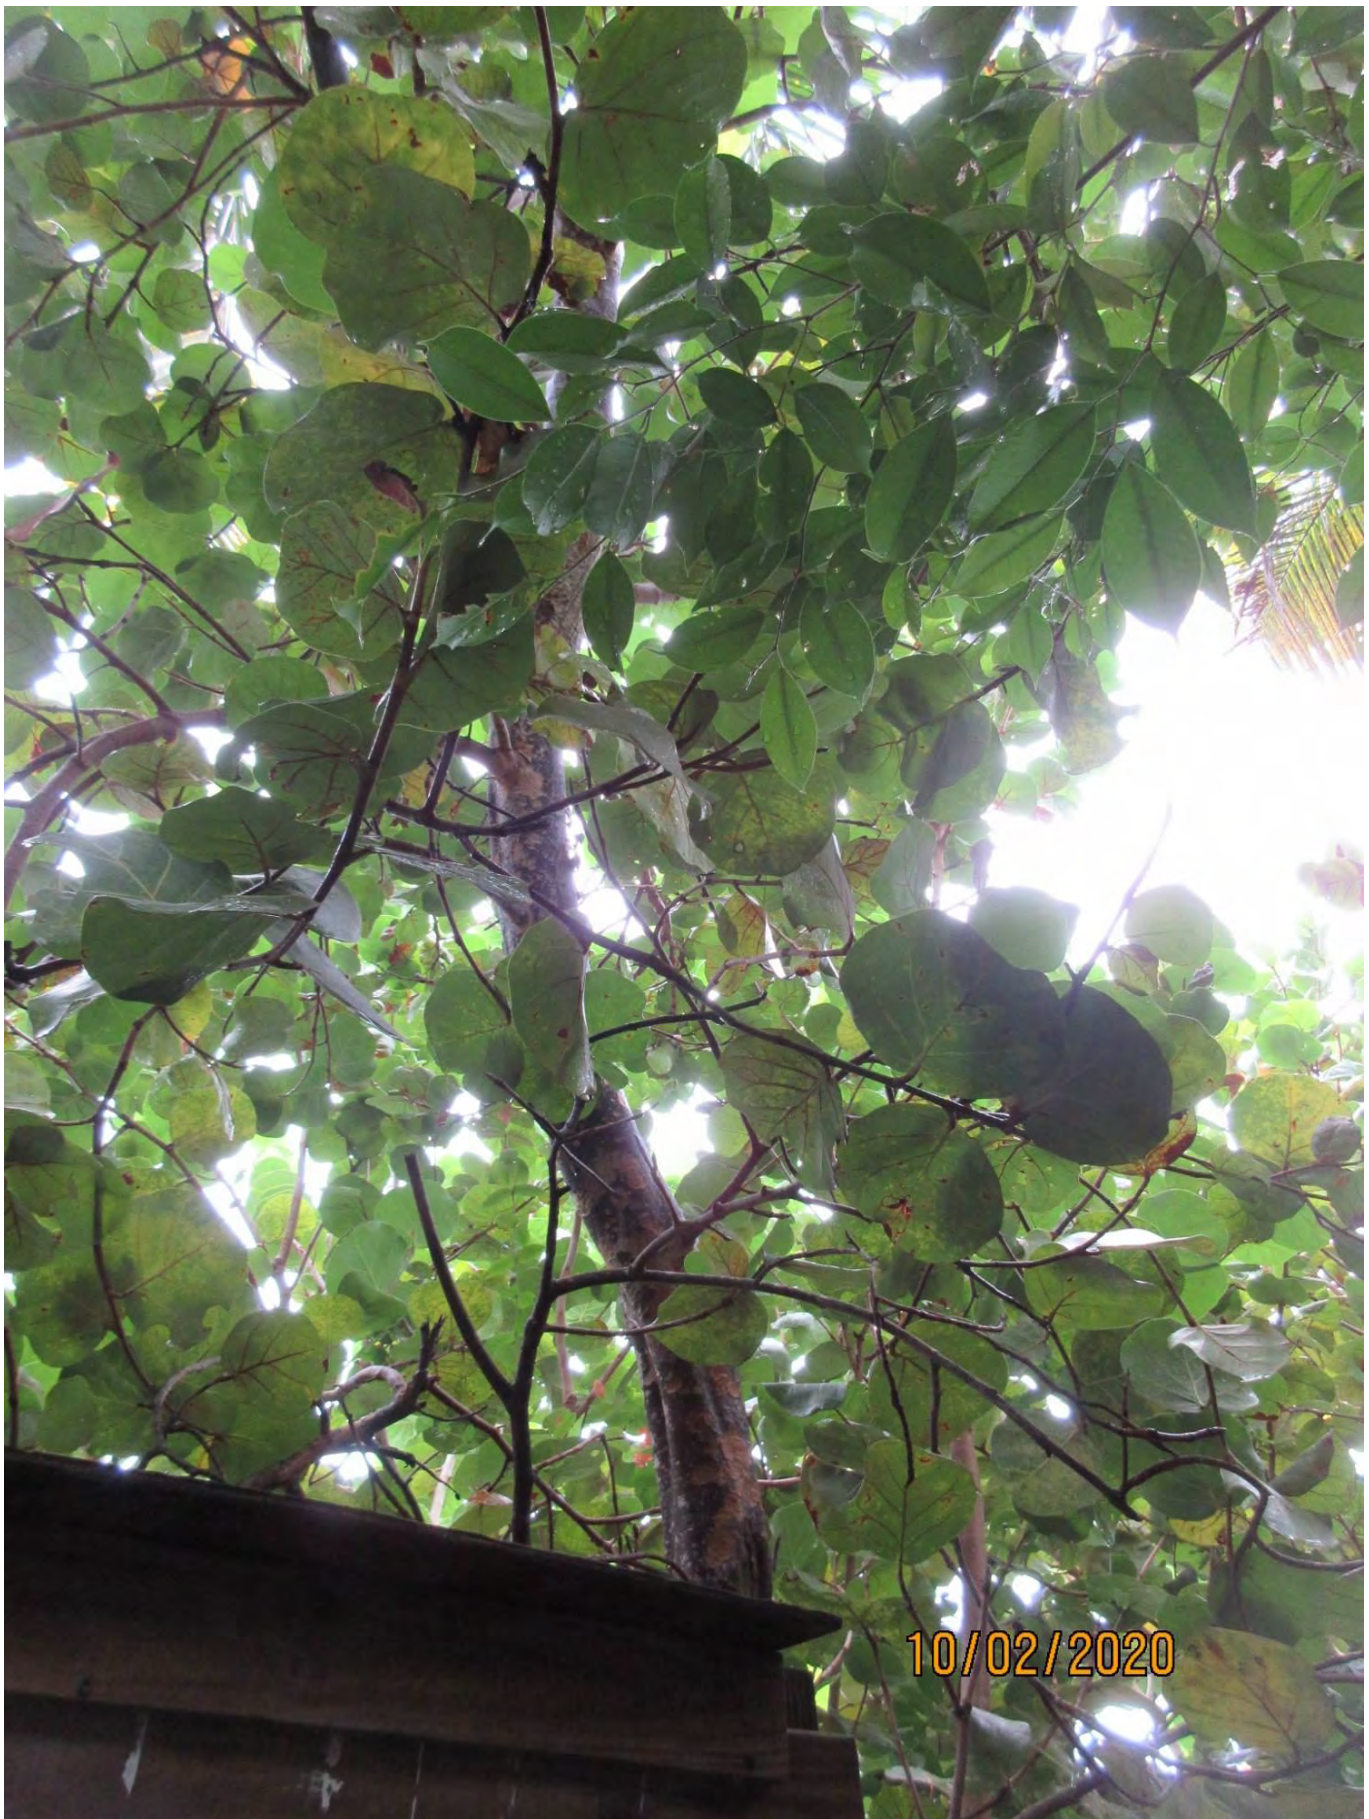
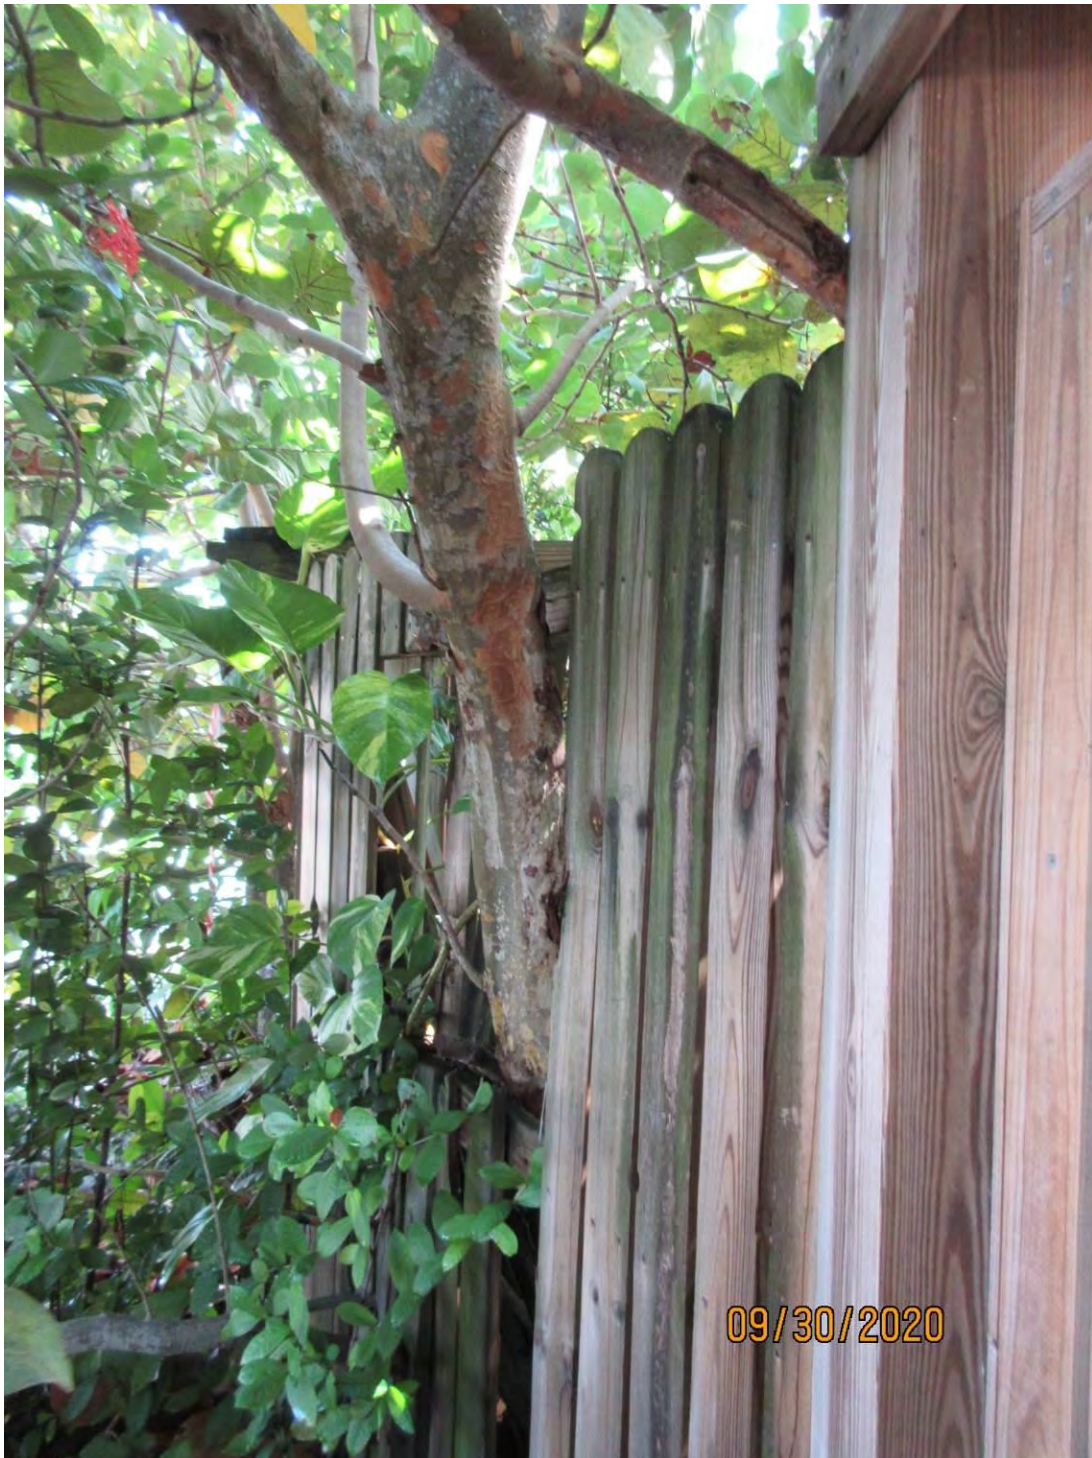
Tree# 4

Photo showing trunk of tree #4, view 1.

Photo showing trunk and canopy of tree #4.

Photo showing trunks of tree #4, view 2.

Photo showing trunks of tree #4, view 3.

View of tree canopy.

Photo of tree trunk through fence.

Diameter: 7"

Location: 60% (canopy growing intertwined with other sea grape canopies)

Condition: 50% (overall condition is fair to poor, codominant trunks starting low at base.)

Value x Diameter = 4.9 replacement caliper inches

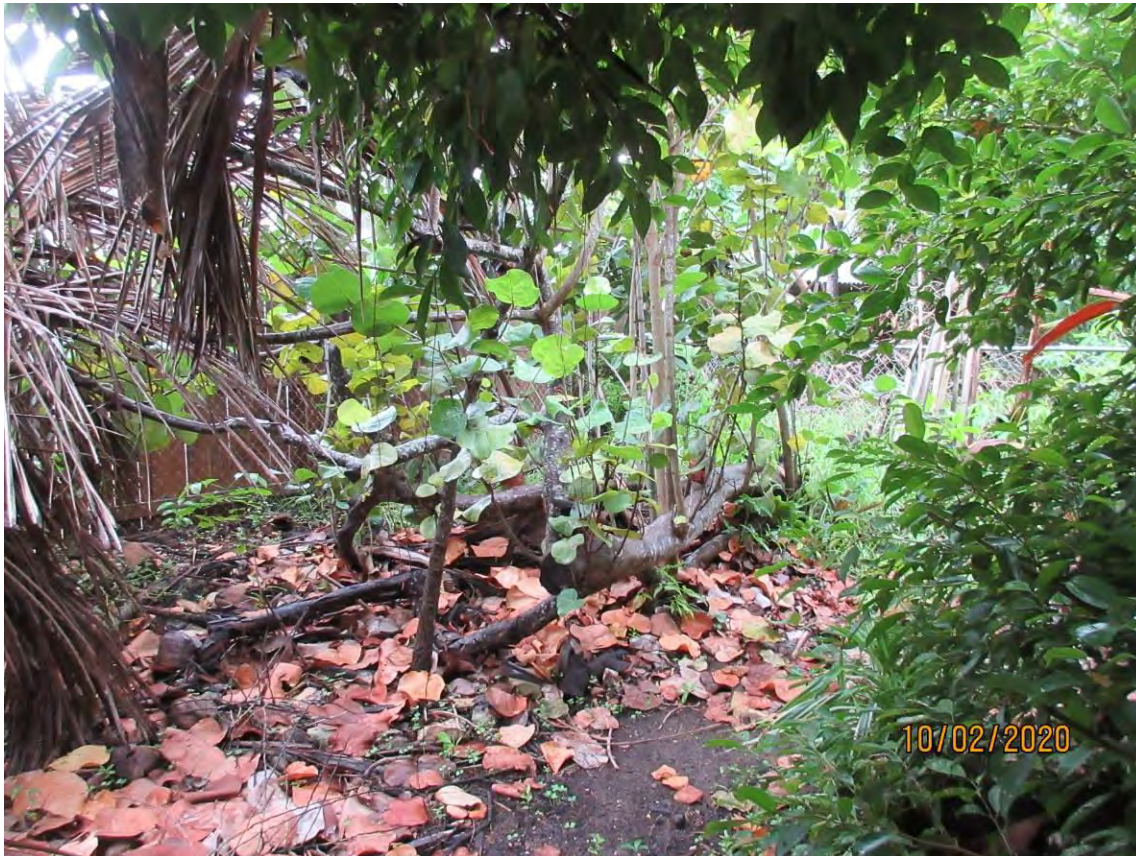
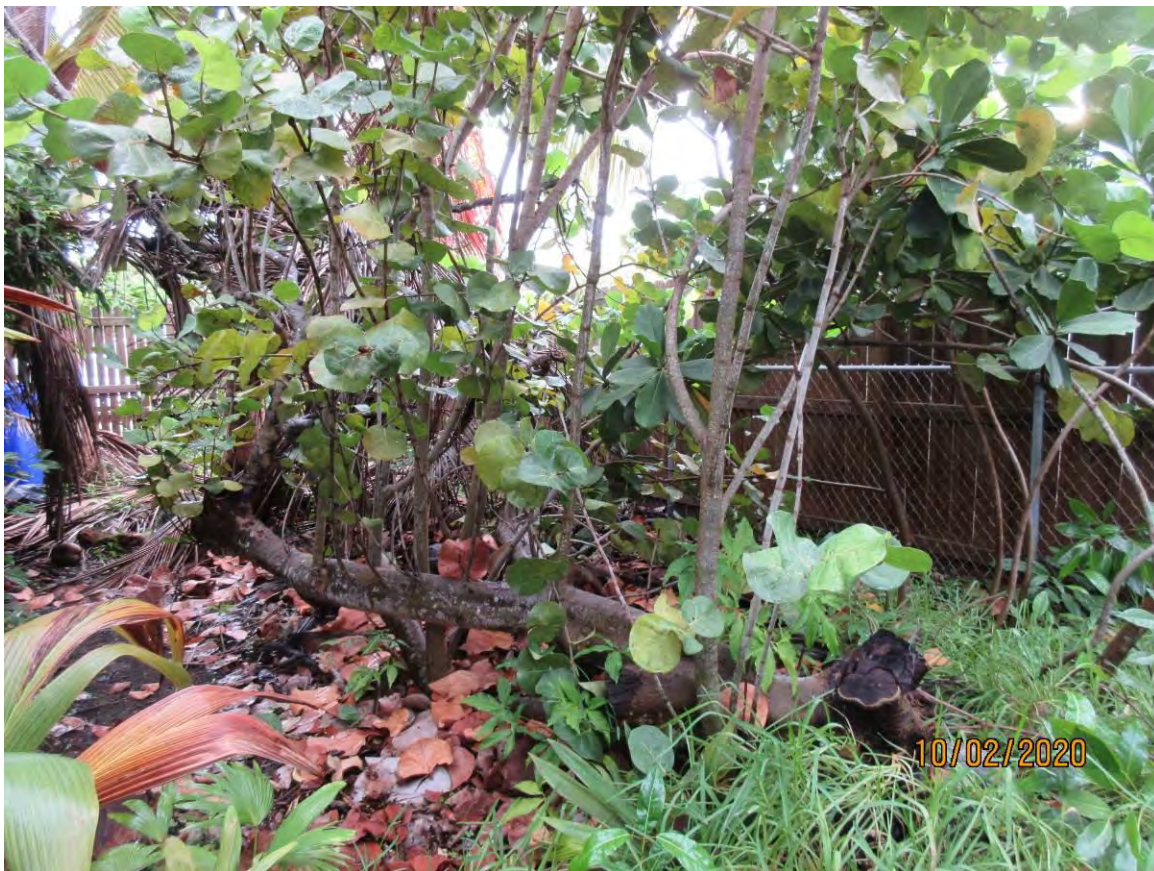
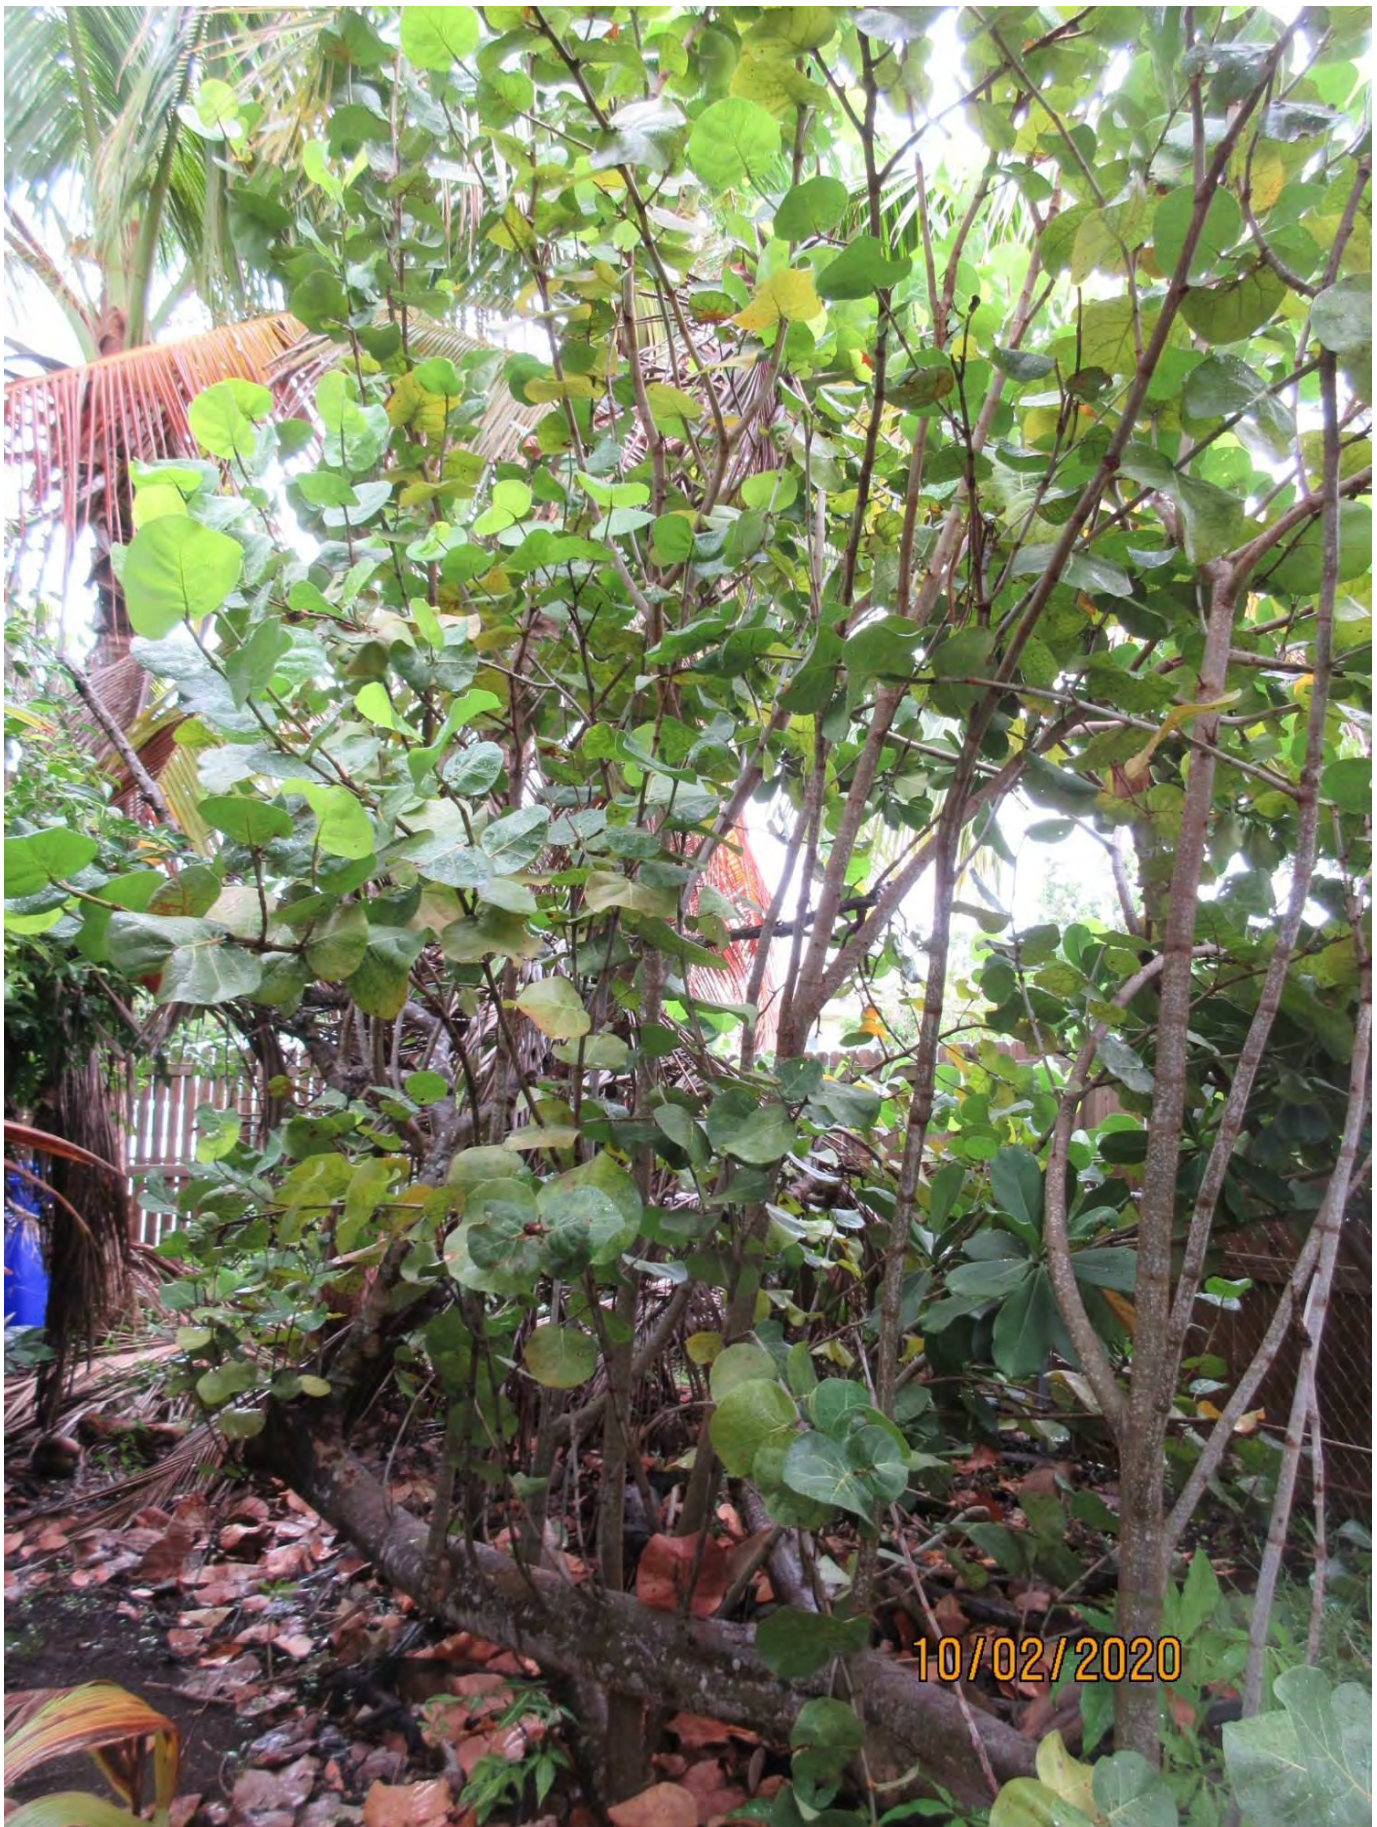
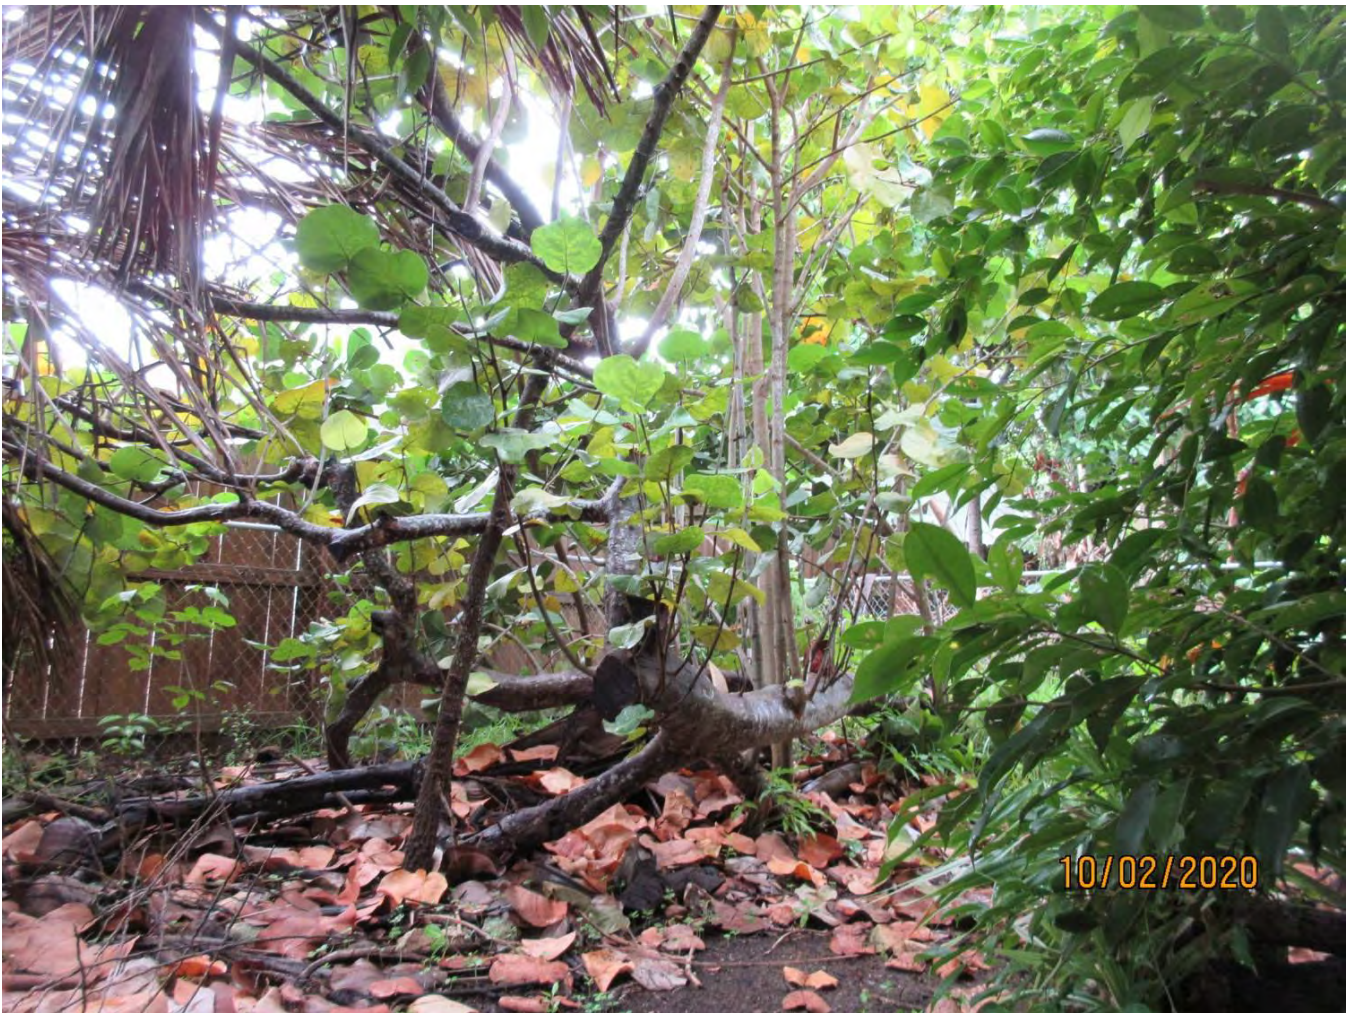
Tree #5

Two photos showing whole tree and location.

Close up photo of tree, view 1.

Close up photo of tree, view 2.

Diameter: 13"

Condition: 40% (for a single family residence tree, condition is poor-tree fell over in storm years ago and started regrowing which is a normal growth pattern for this species in the woods)

Value x Diameter = 9.4 replacement caliper inches
