# STAFF REPORT

RE: 714 Passover Lane (permit application # T2020-0287)

FROM: Karen DeMaria, City of Key West Urban Forestry Manager

An application was received requesting the removal of (1) Silver Buttonwood, (1) Mahogany, (1) Mango, (1) Frangipani, and (1) Sapodilla tree. A site inspection was done and documented the following:

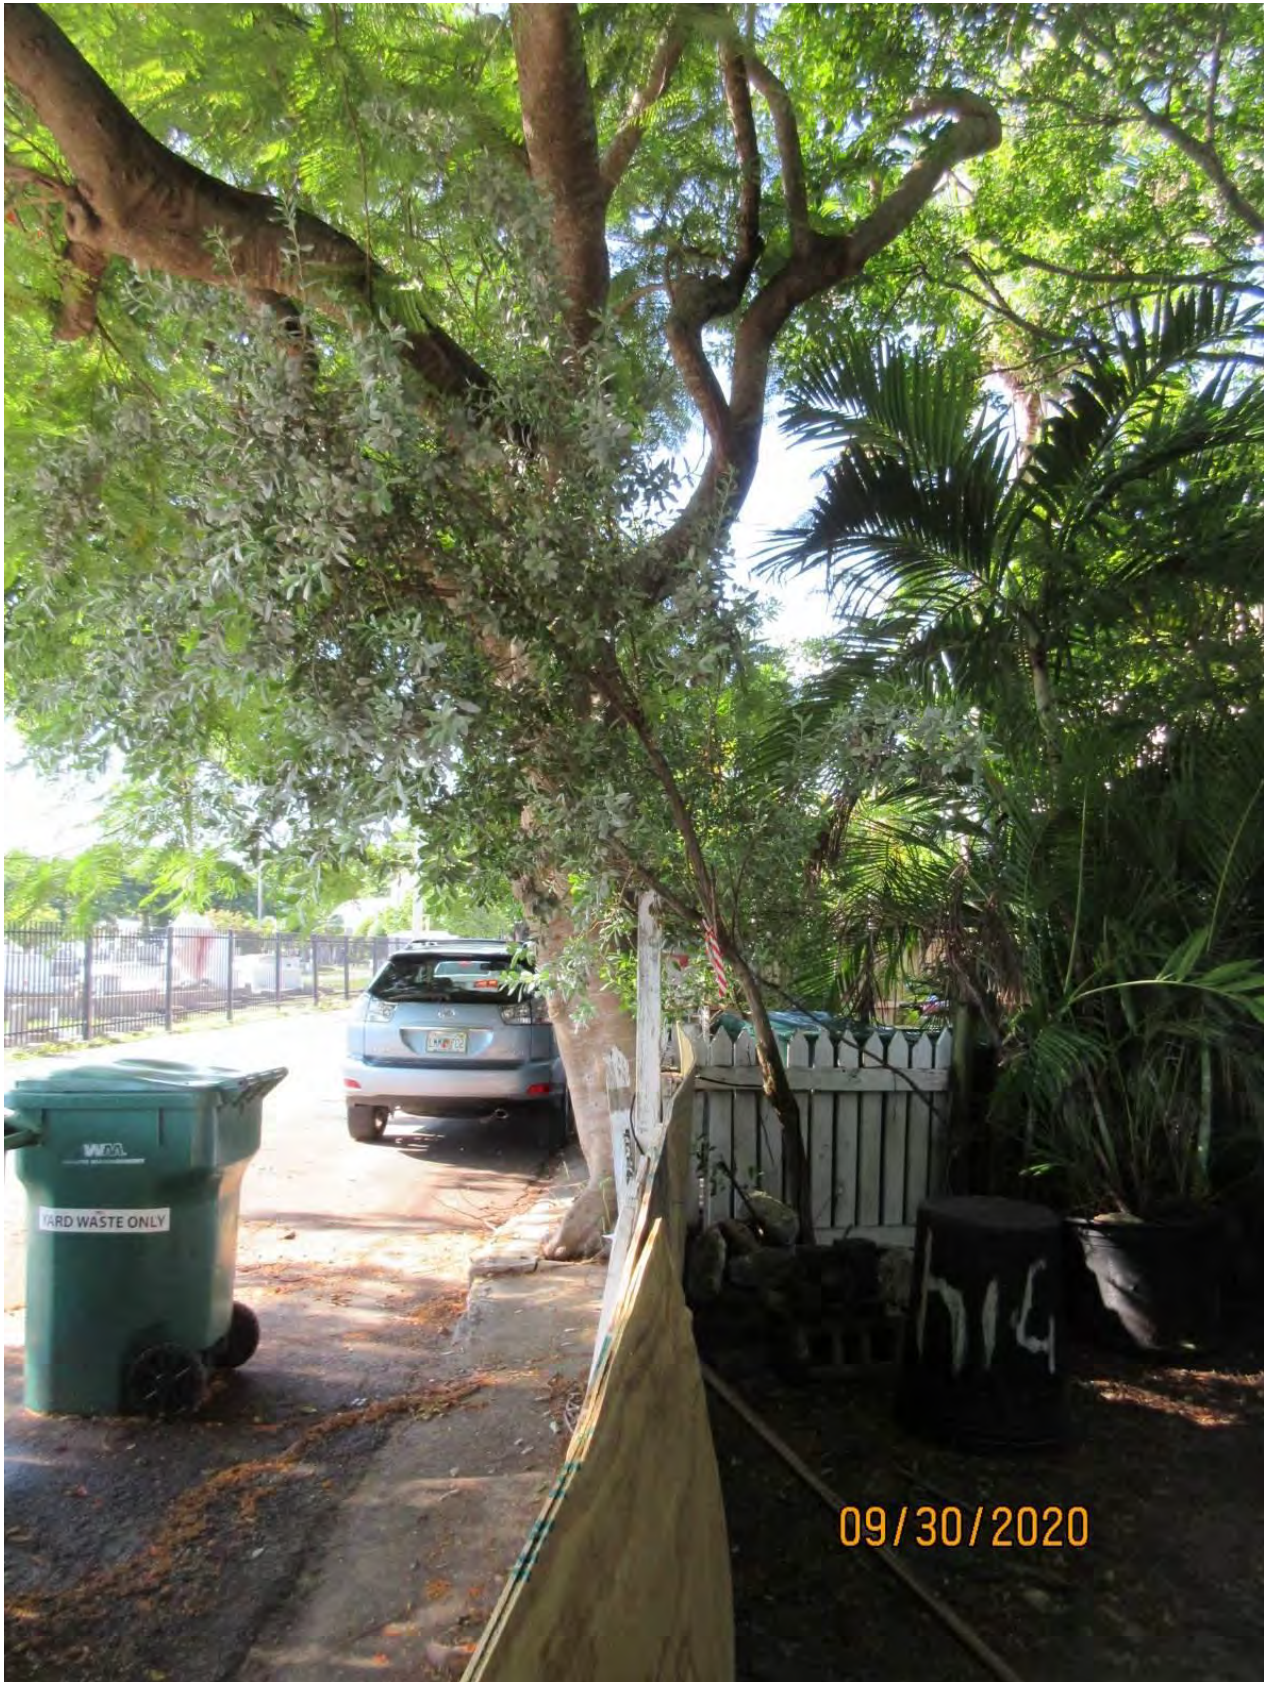
Photo showing location of tree.

Condition: 60% (overall condition is fair, trunk has growth lean toward sidewalk/road, could not see base of tree or root system due to rocks/bricks piled in the area)

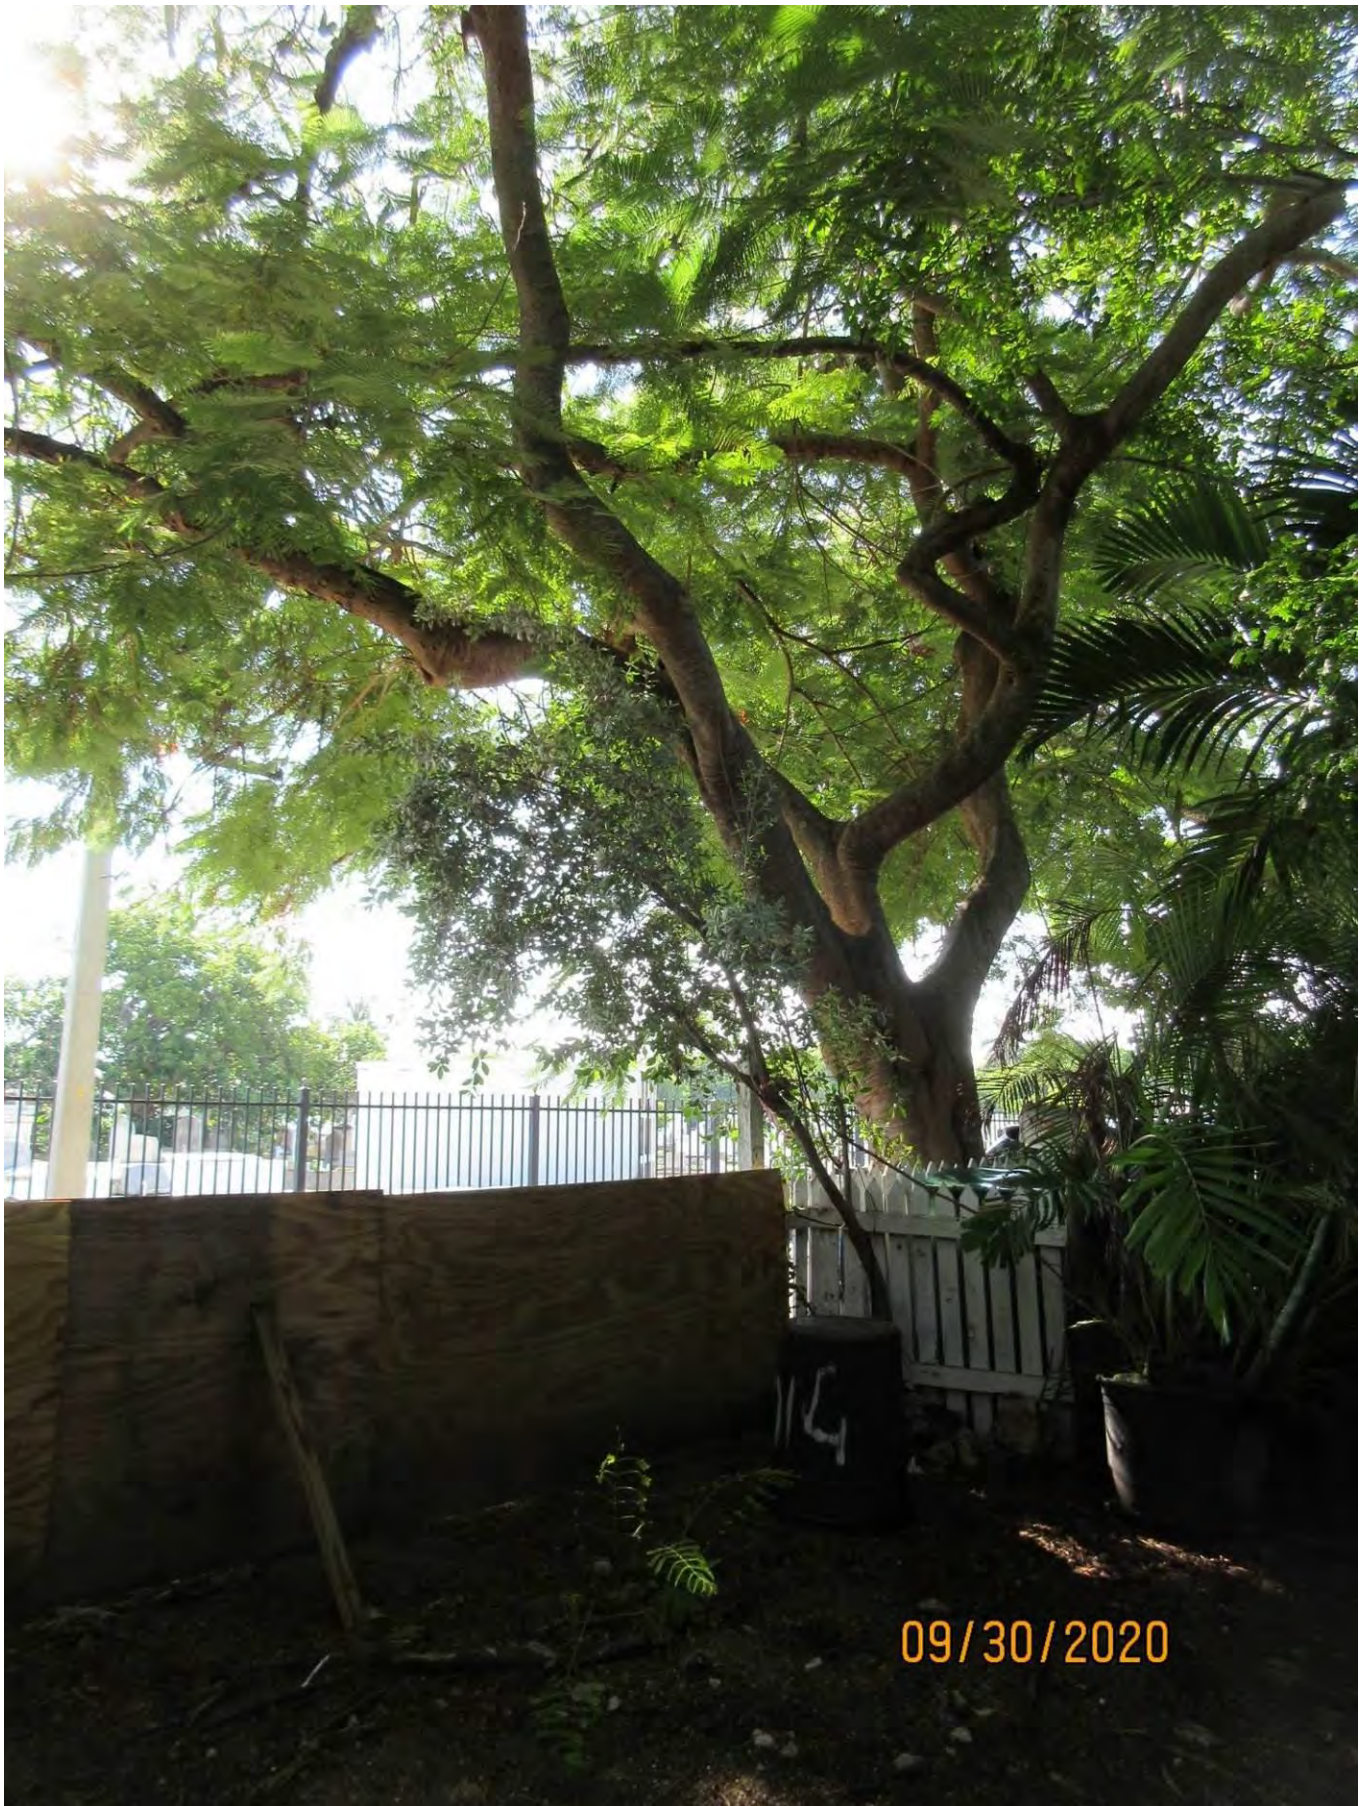
Photo showing whole tree.

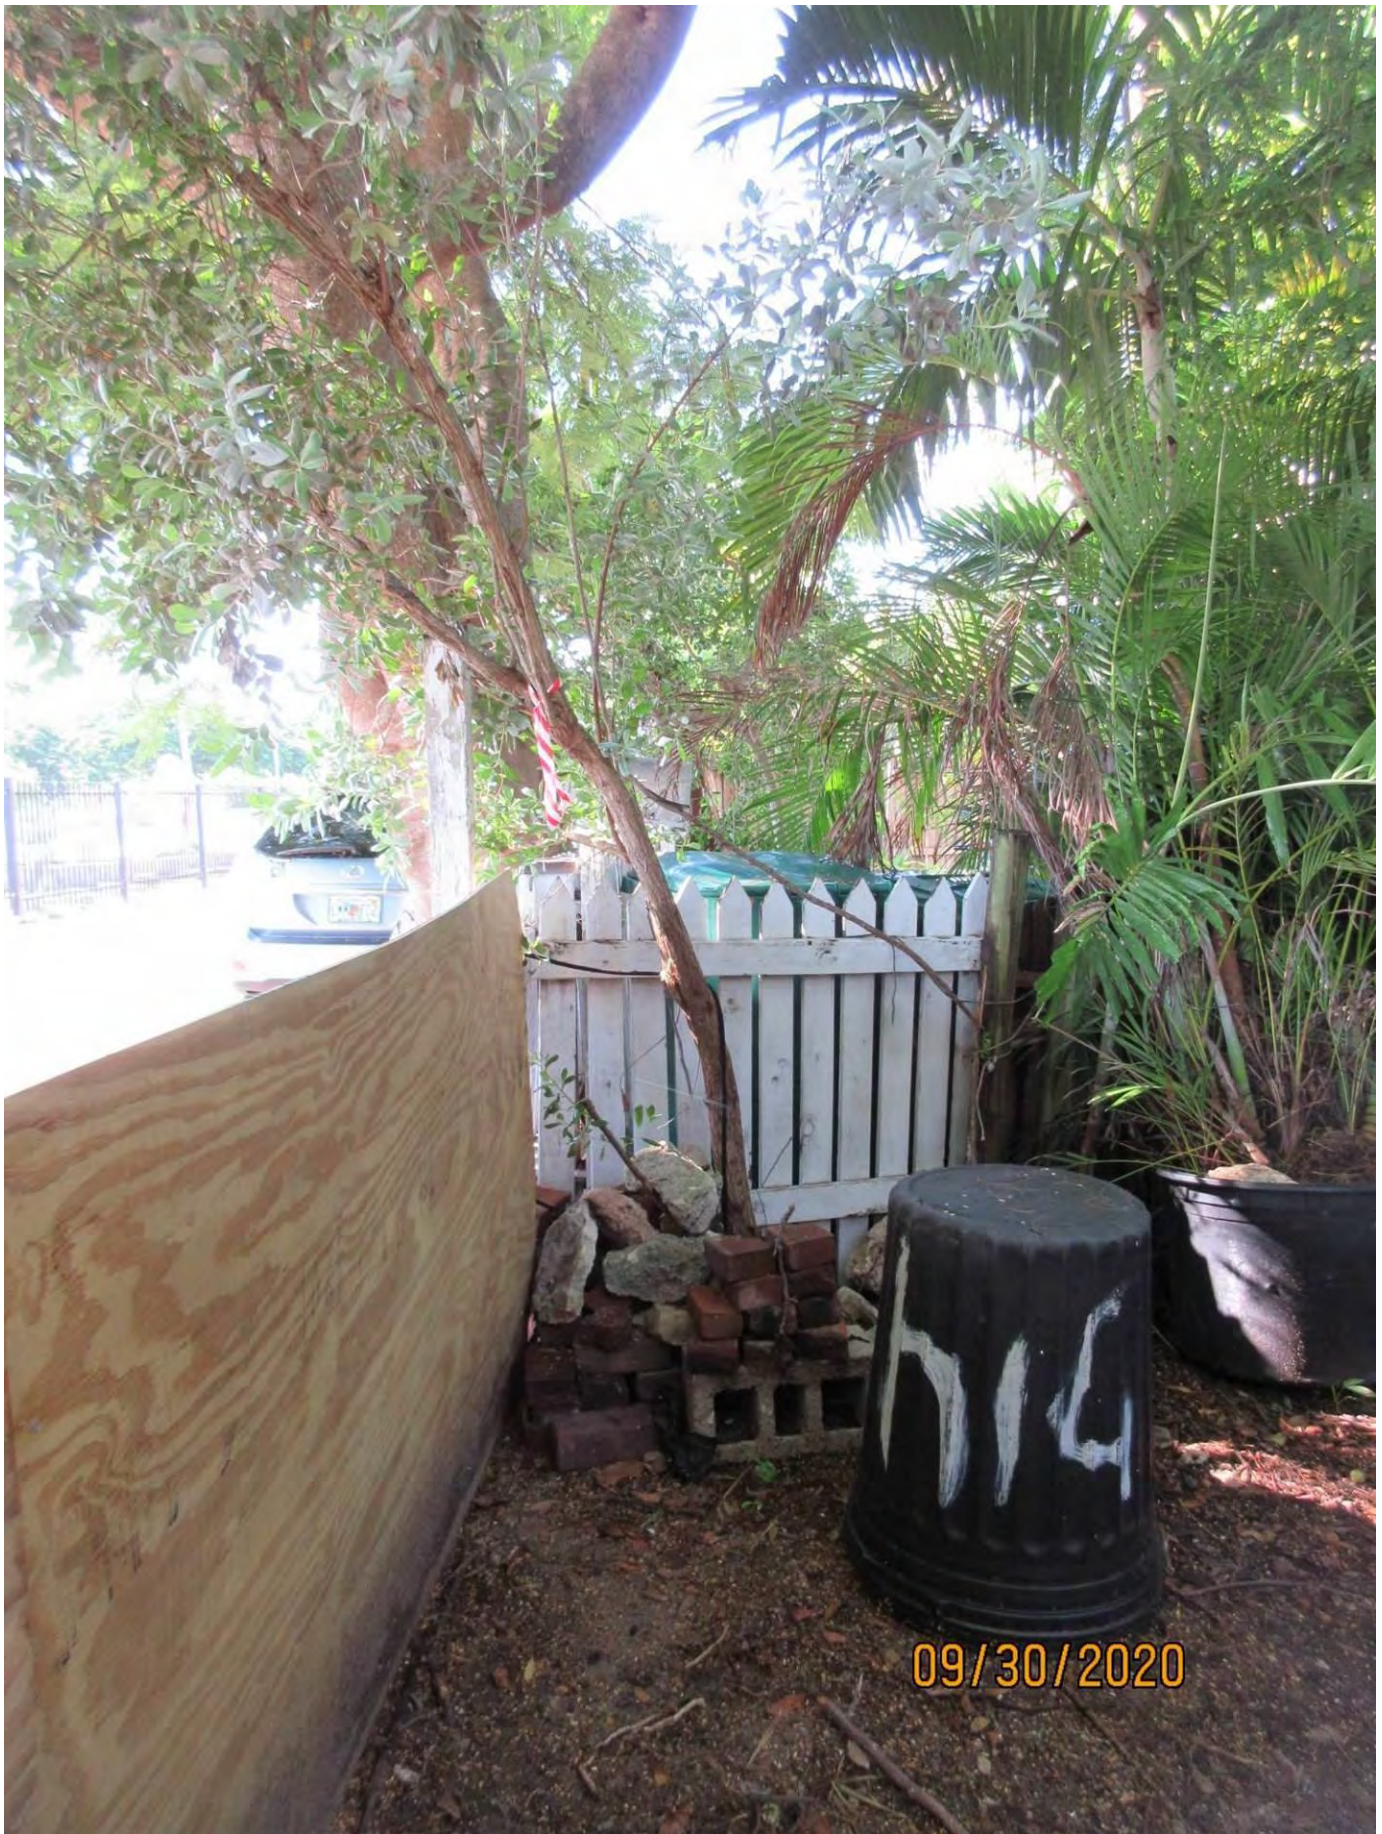
Photo showing base of tree and trunk.

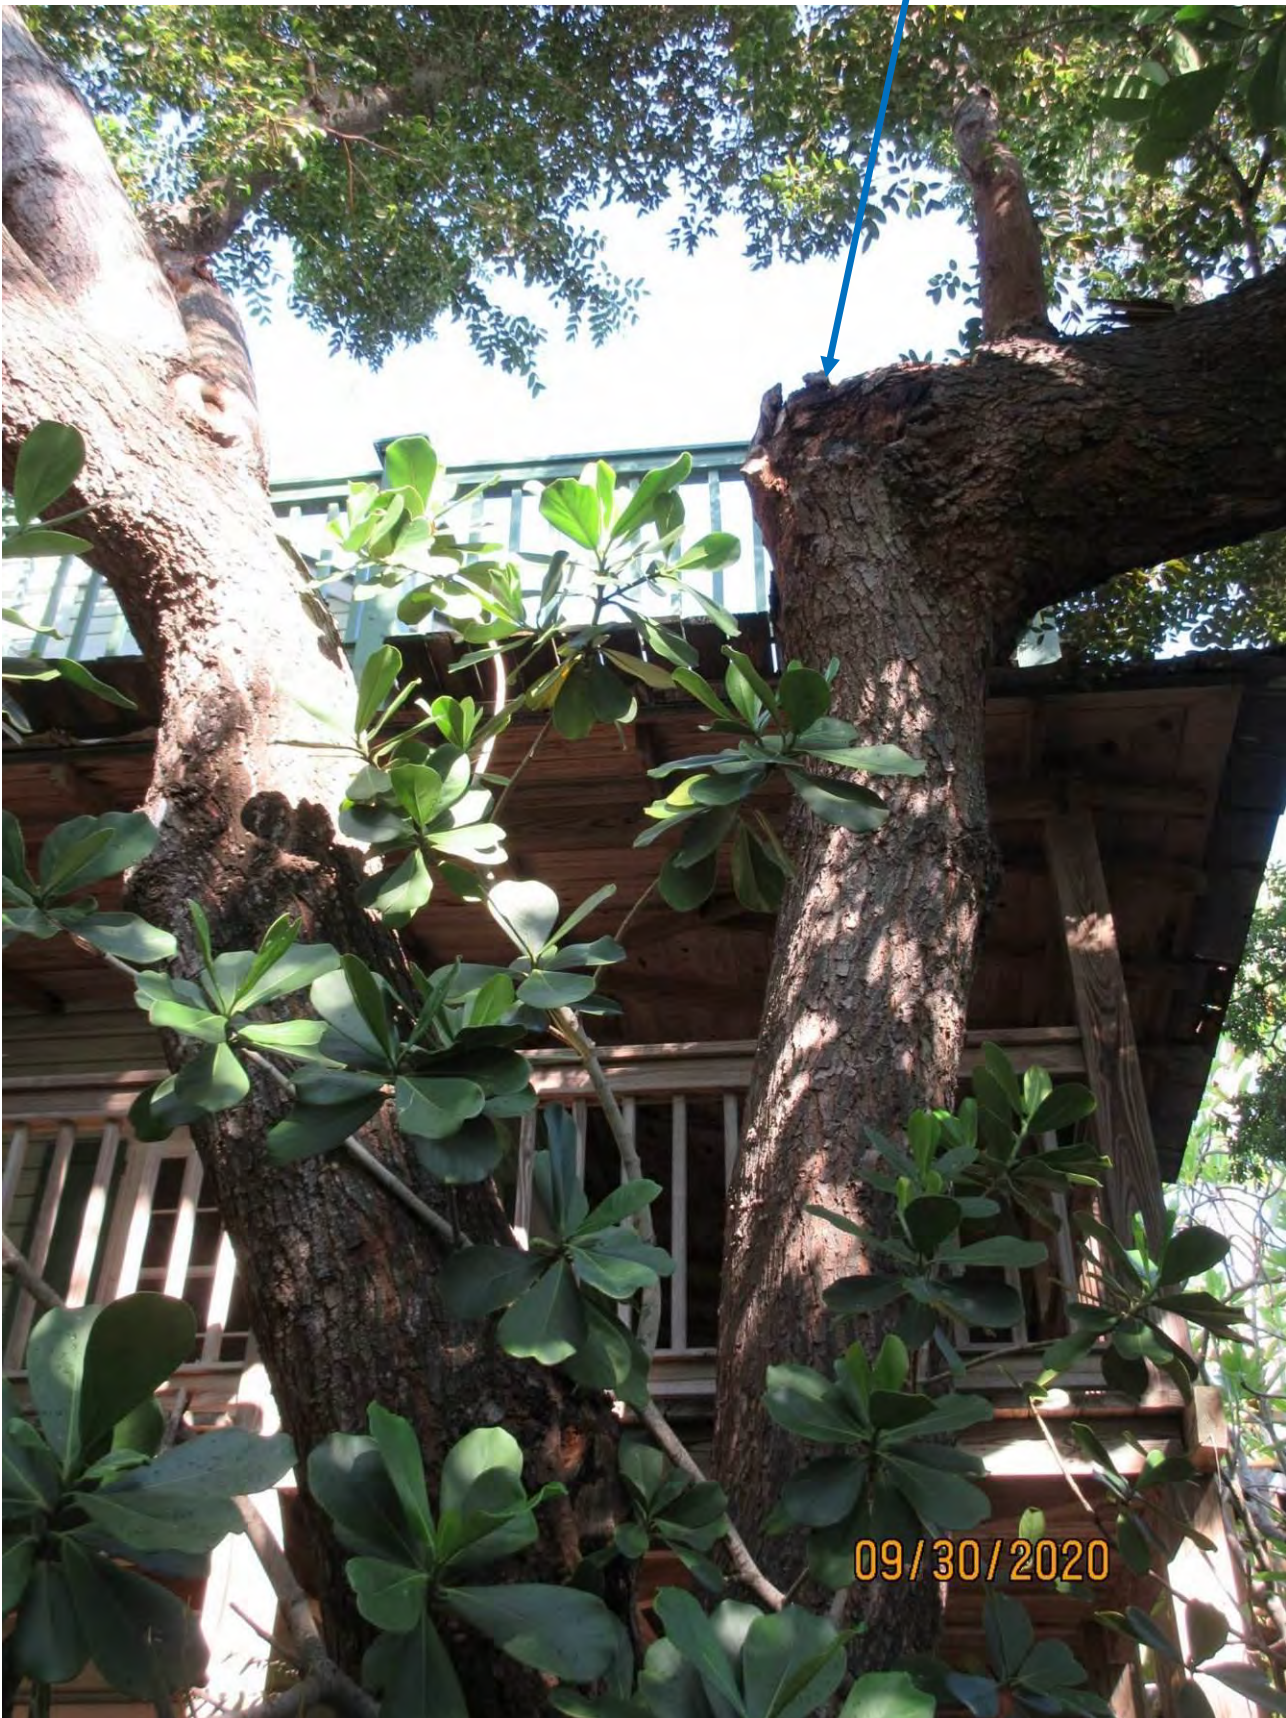
Close up photo of the main two trunks.

Condition: 50% (overall condition is fair to poor, codominant trunk system- one trunk has what appears to be an old tear-major decay prior to area where branches are located, second trunk branches out to three main branches all with included bark and mushrooms growing in at least one area and a decay hole close to juncture )

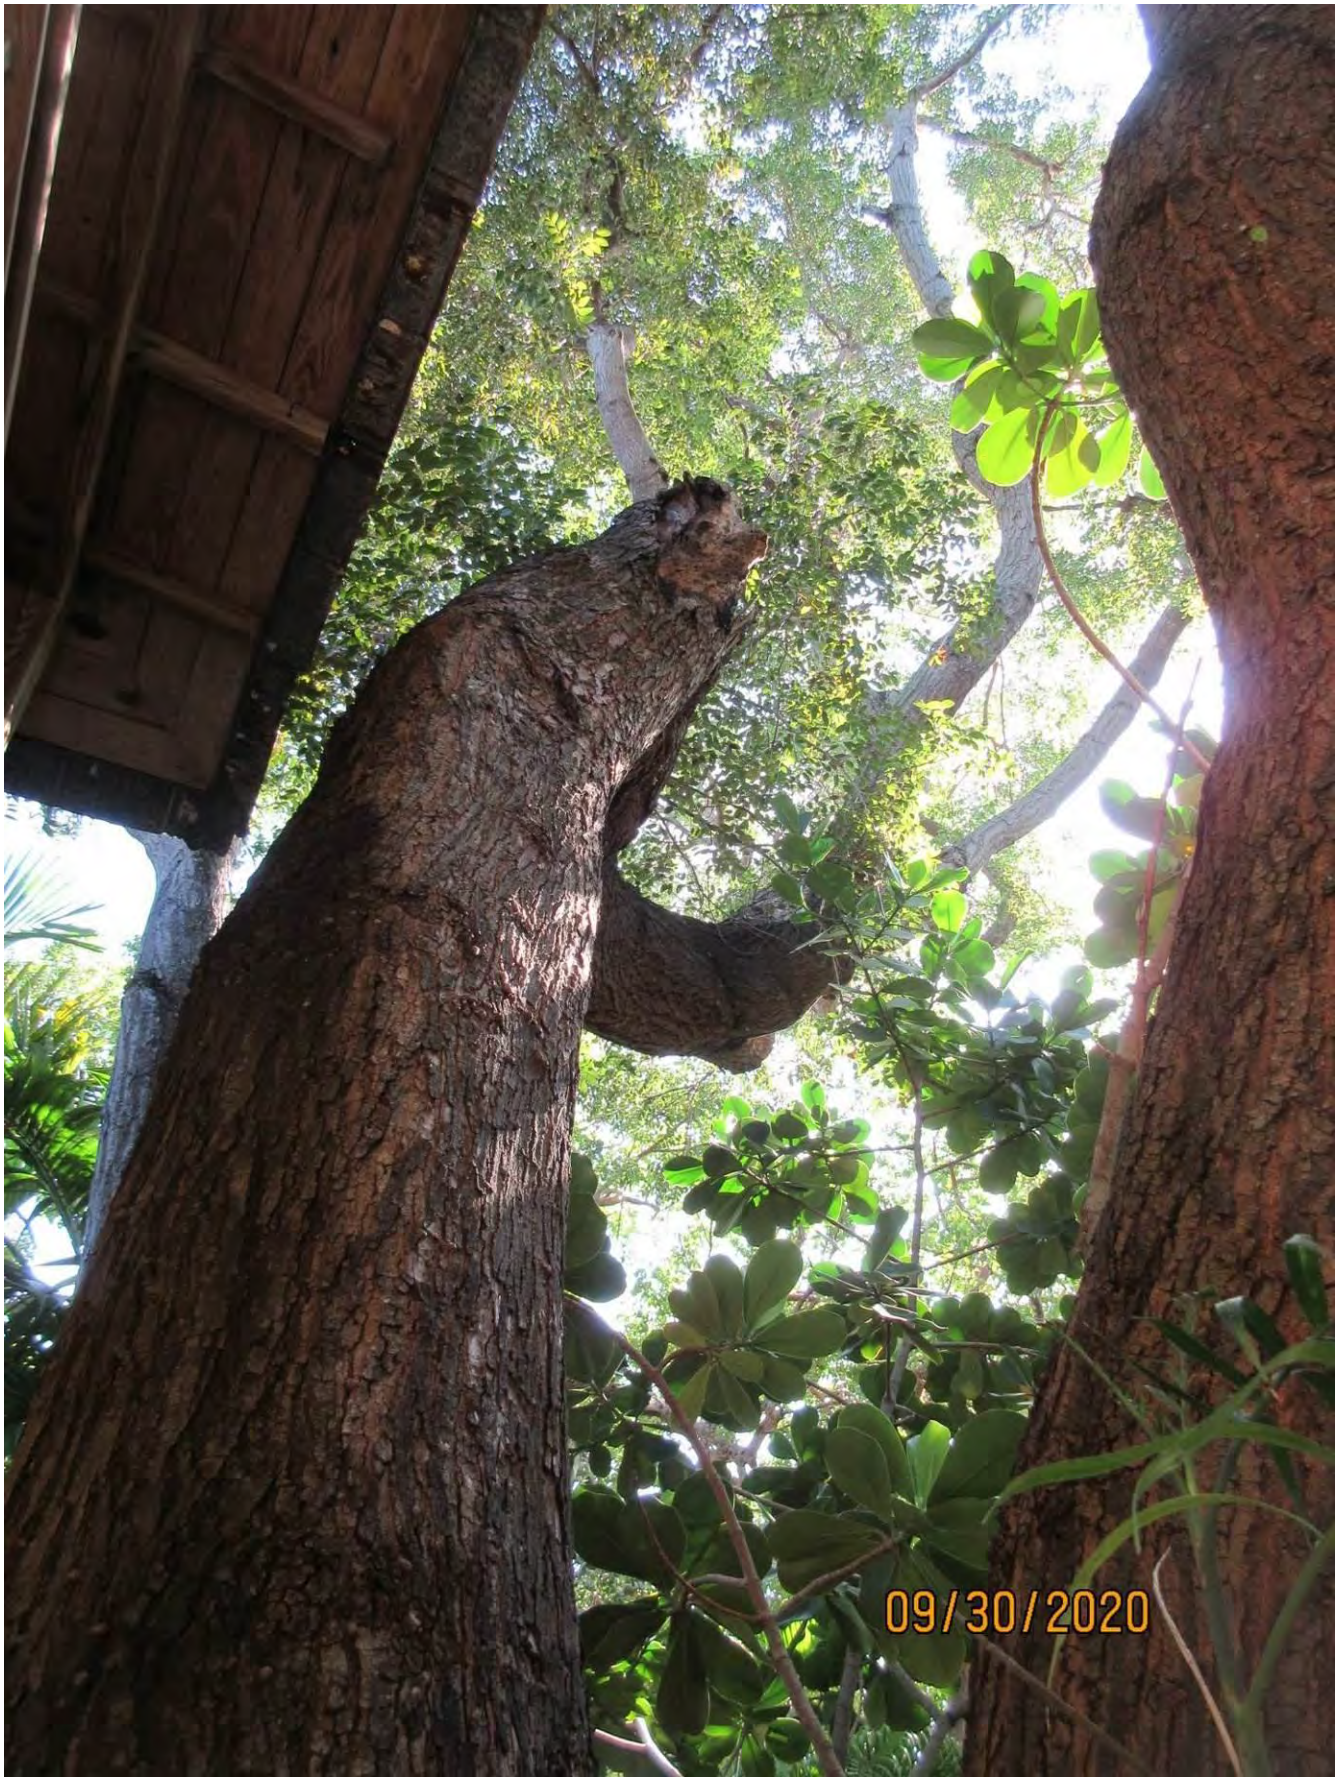
Photo looking up main tree trunk 1 toward canopy and decay area.

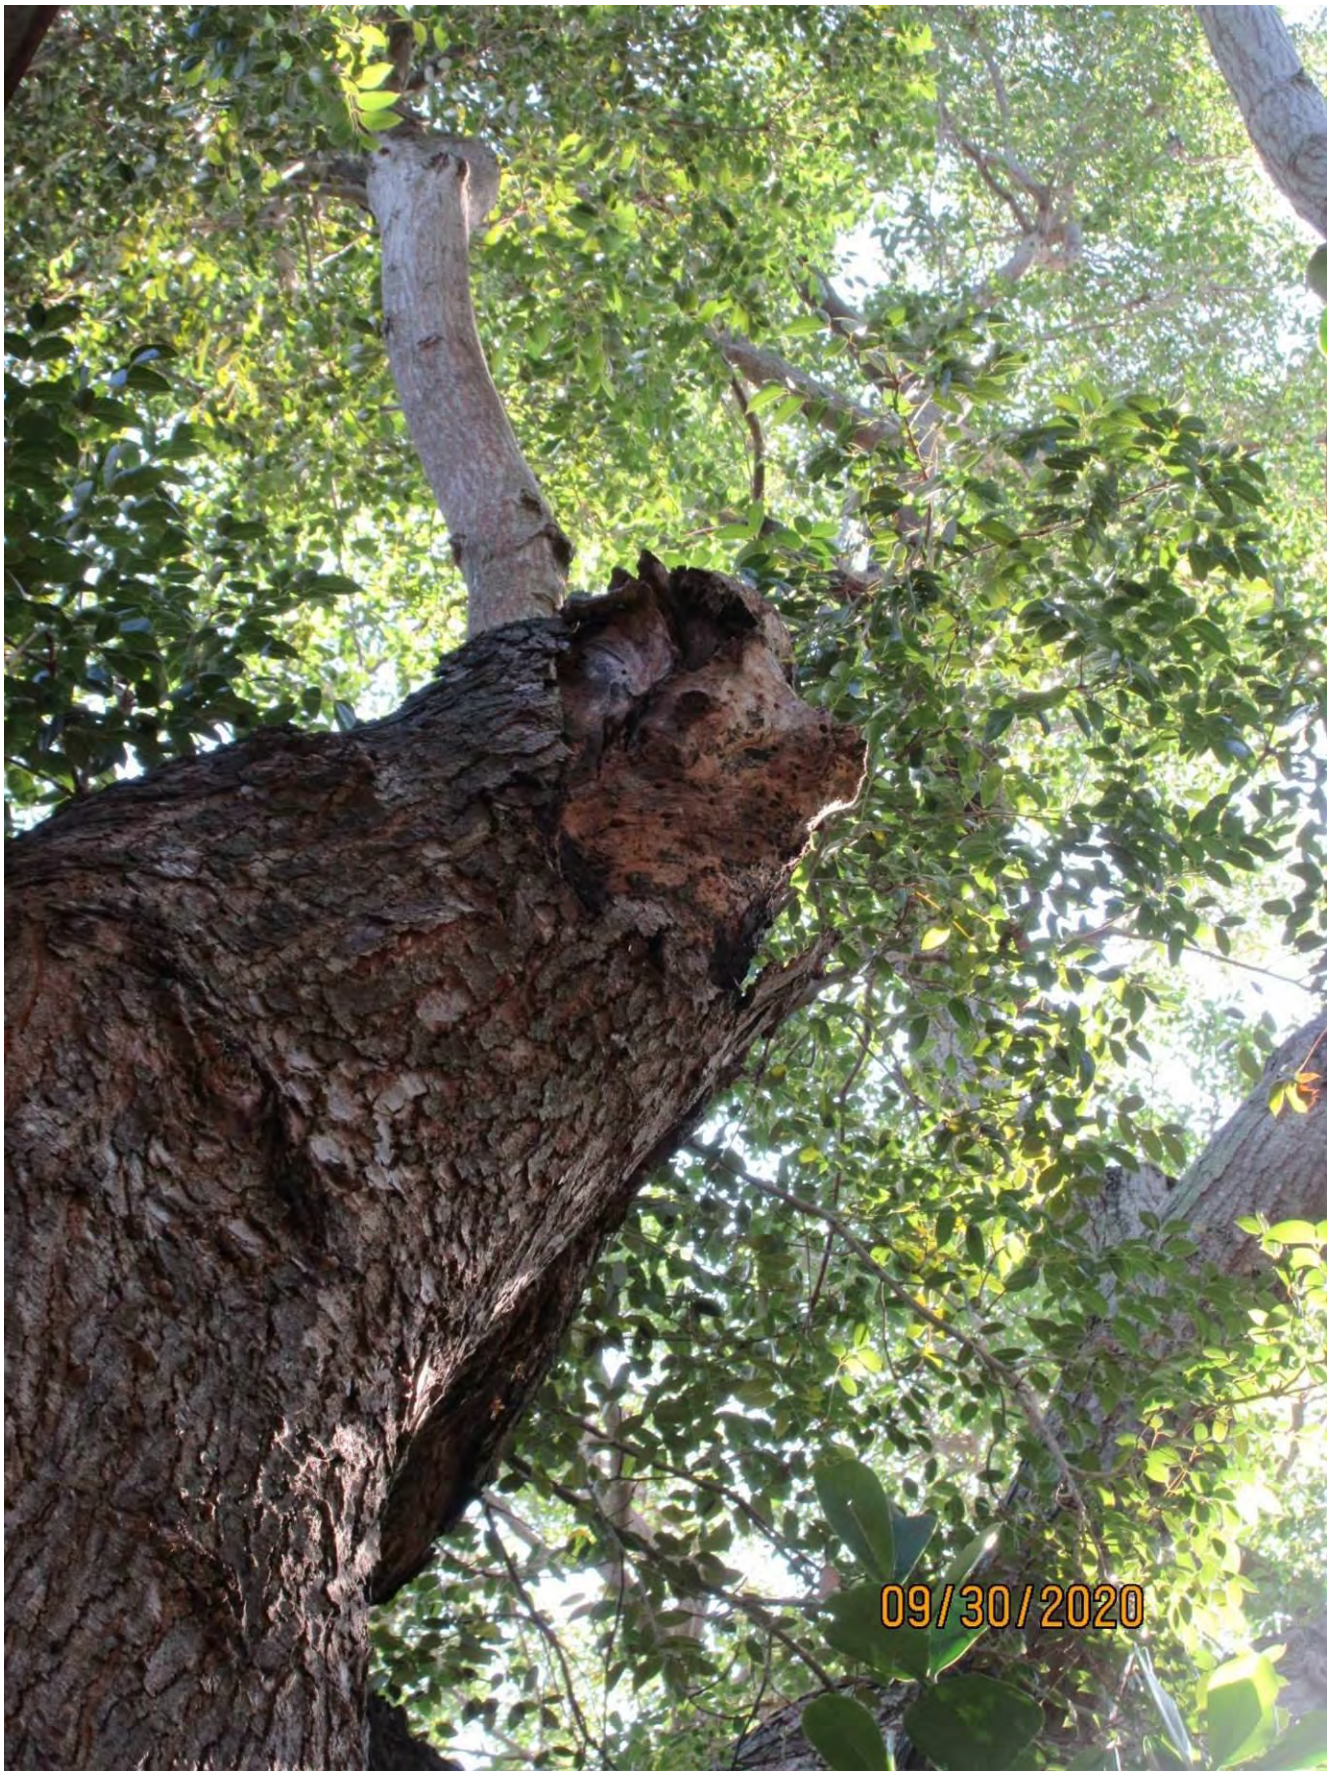
Close up photo of tear/decay area in trunk 1, view 1.

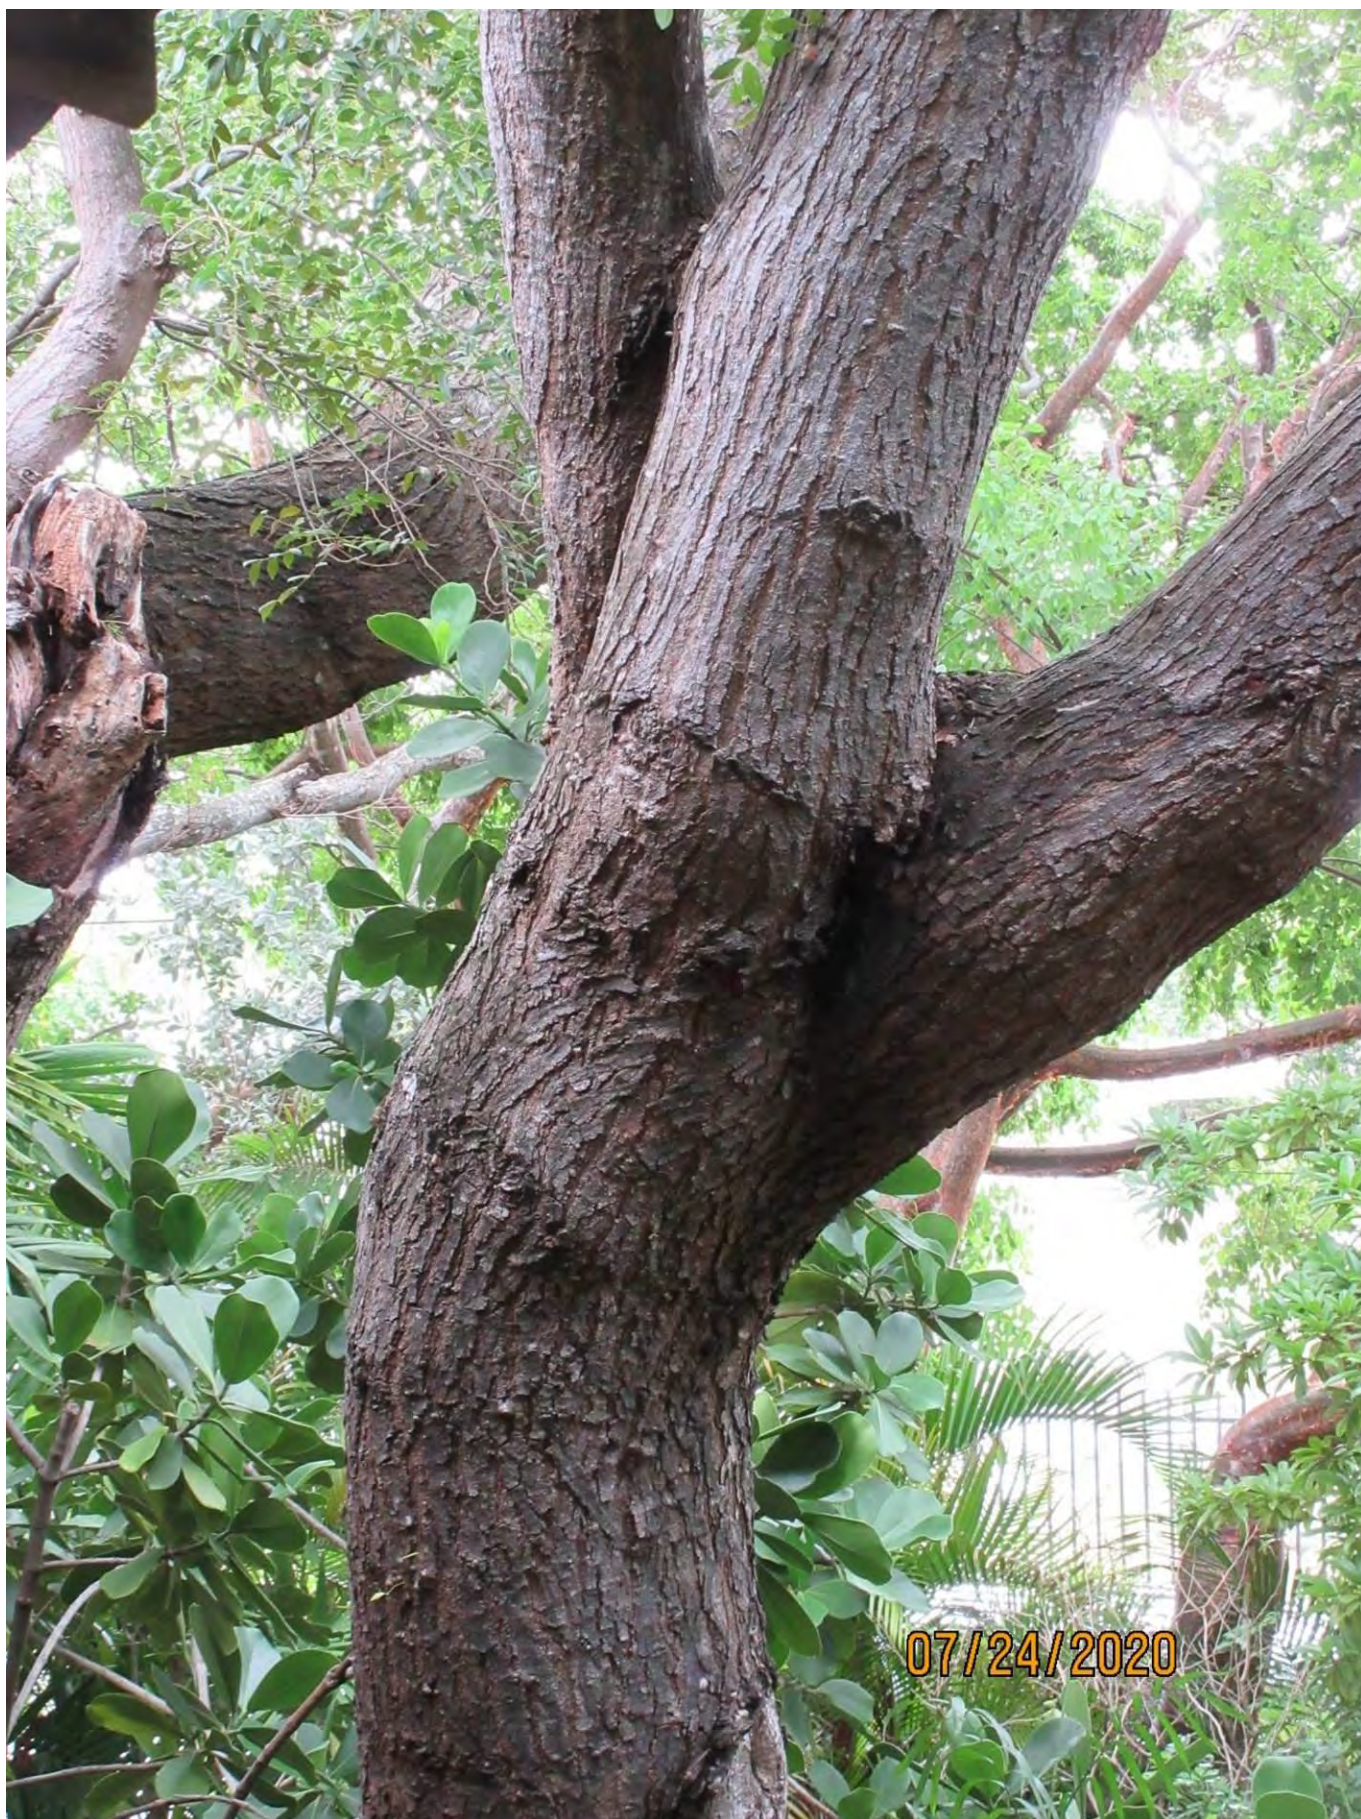
Close up photo of trunk 2 and branches, view 1.

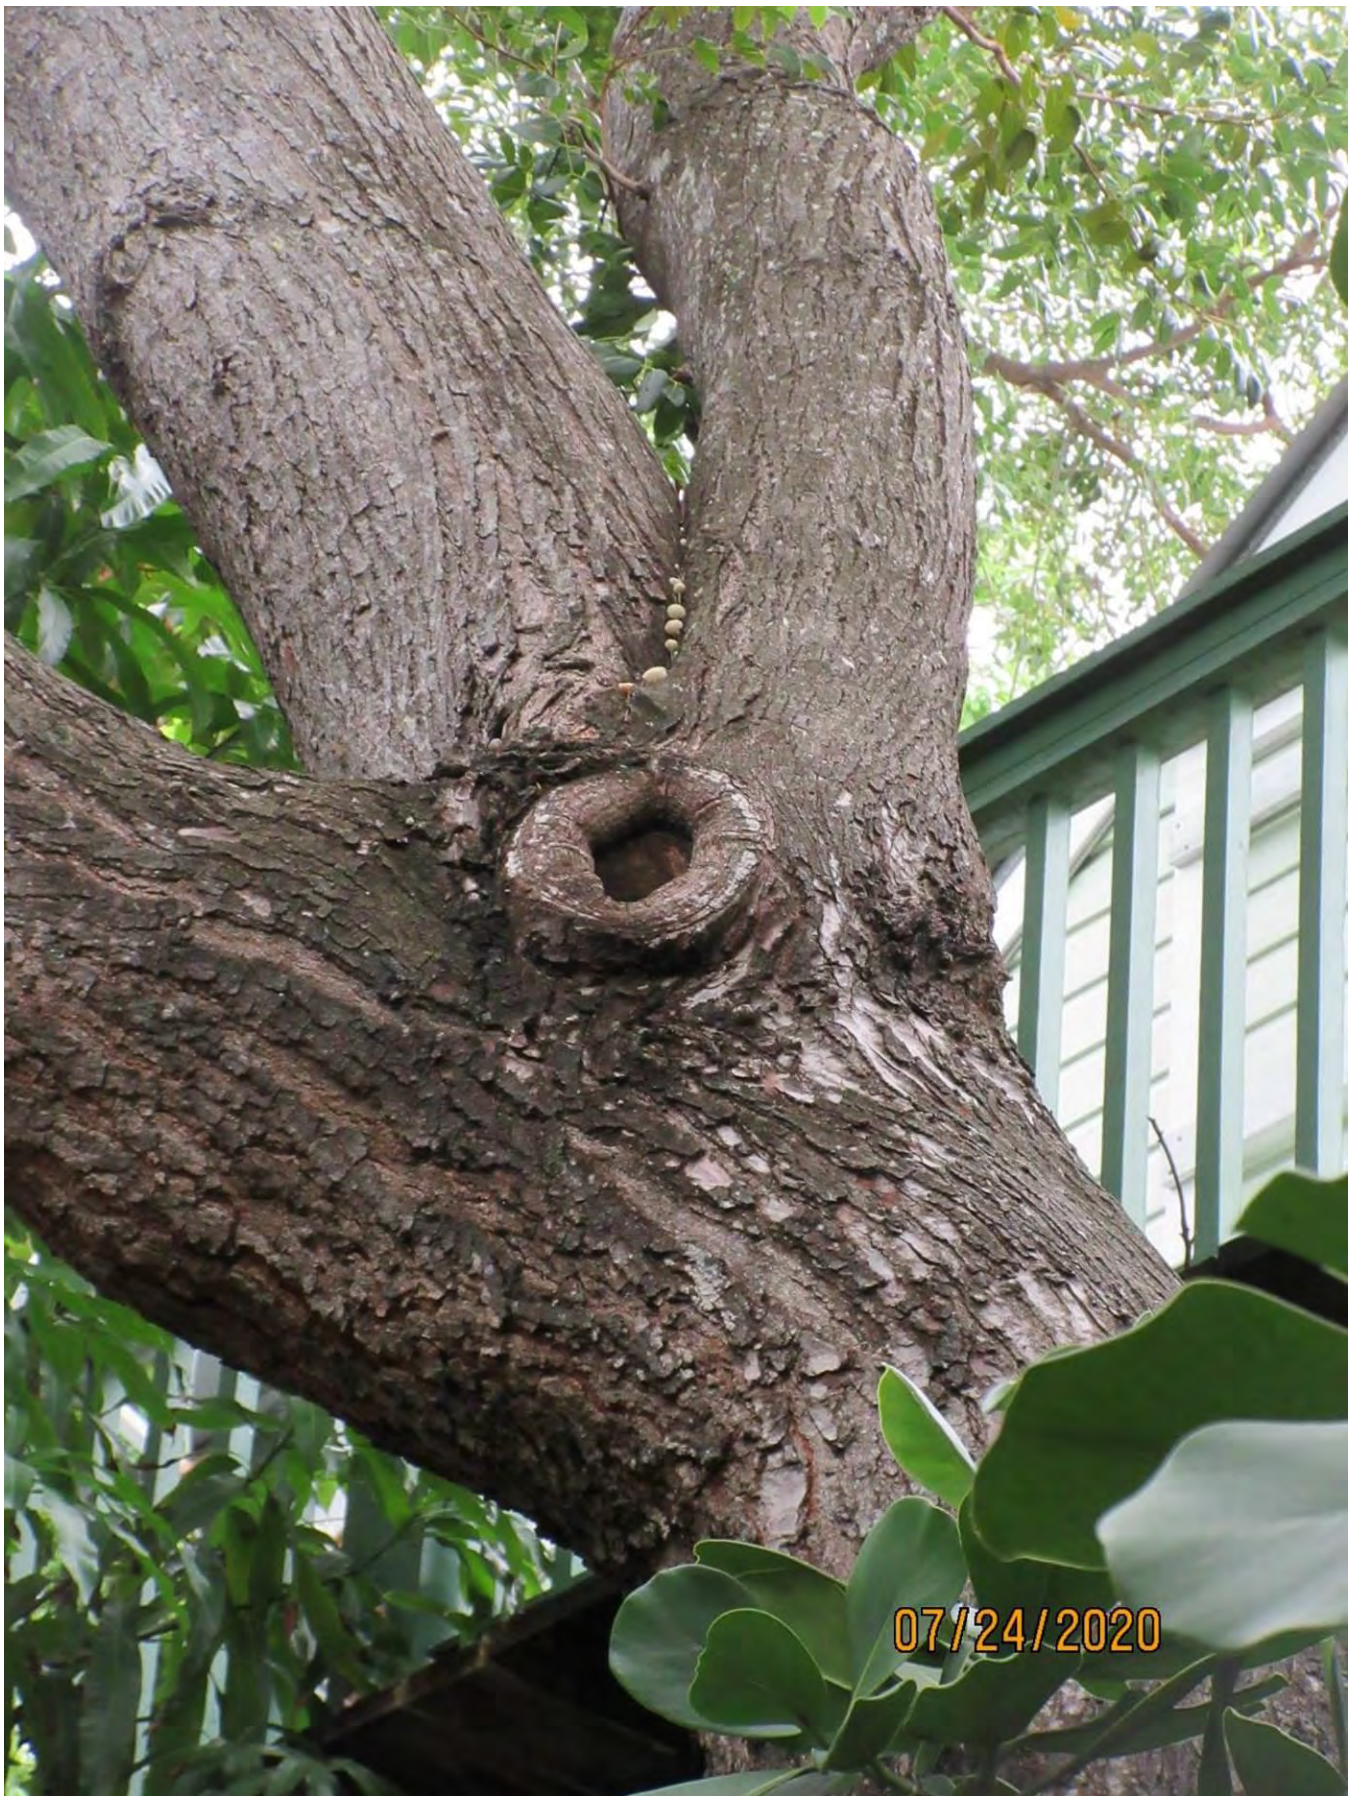
Close up photo of trunk 2 and branches, view 2.

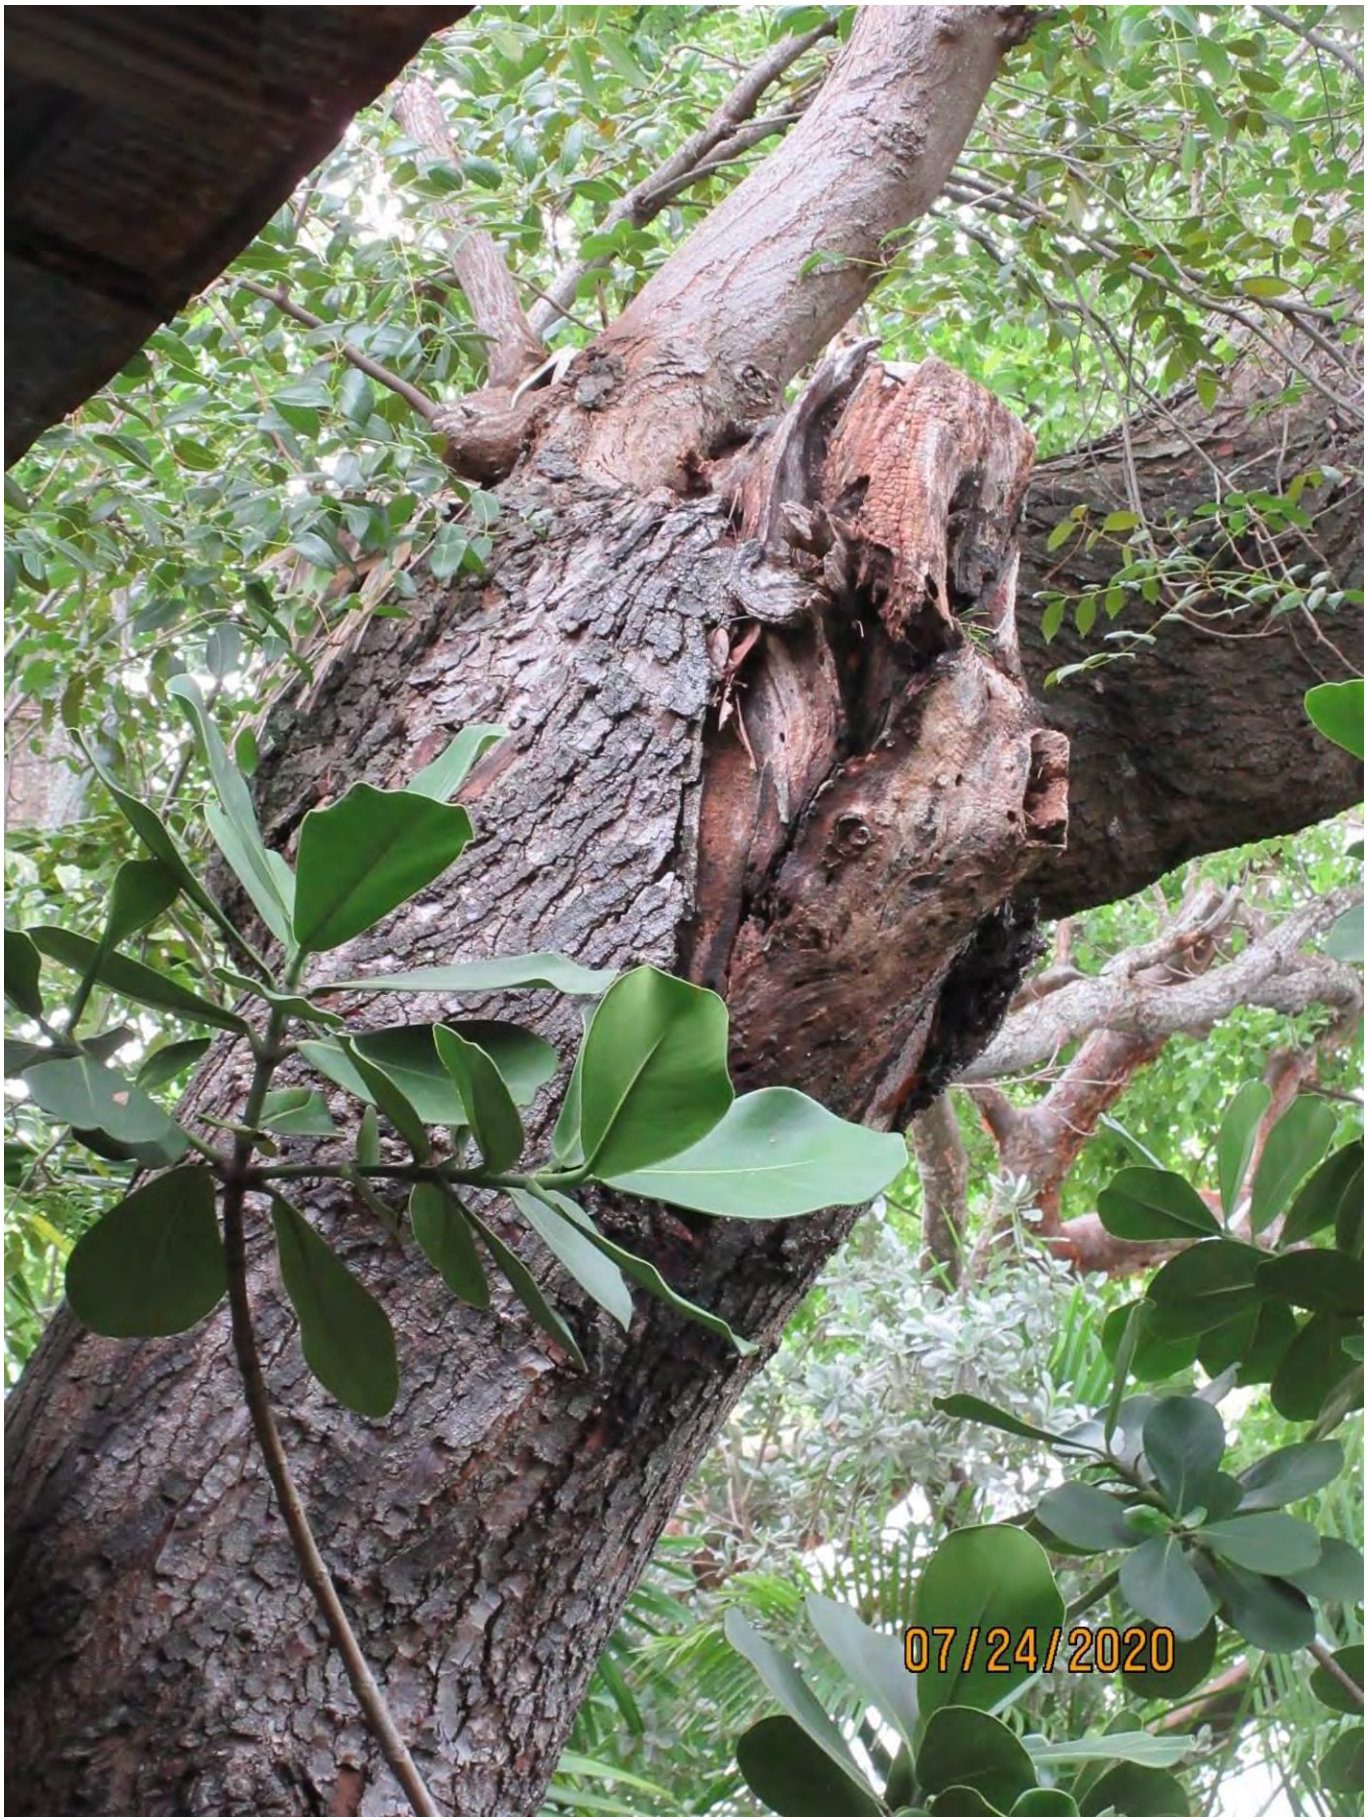
Close up photo of tear/decay area in trunk 1, view 2.
