# STAFF REPORT

RE: 714 Passover Lane (permit application # T2020-0287)

FROM: Karen DeMaria, City of Key West Urban Forestry Manager

An application was received requesting the removal of (1) Silver Buttonwood, (1) Mahogany, (1) Mango, (1) Frangipani, and (1) Sapodilla tree. A site inspection was done and documented the following:

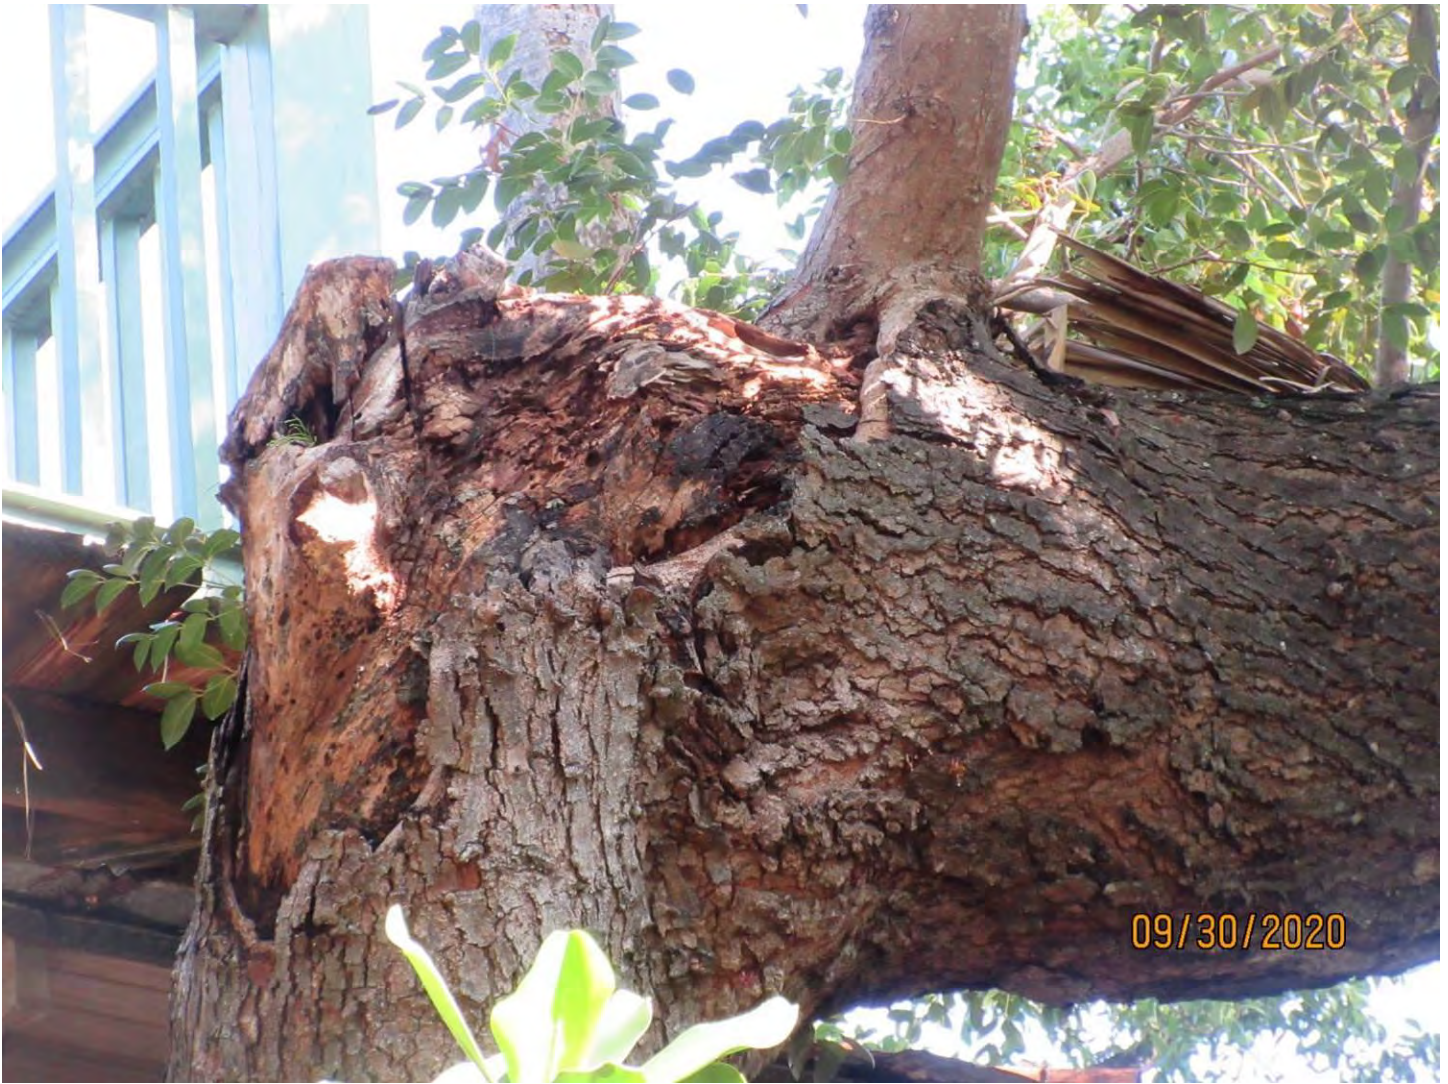
Close up photo of tear/decay area in trunk 1, view 3.

Condition: 50% (overall condition is fair to poor, codominant trunk system- one trunk has what appears to be an old tear-major decay prior to area where branches are located, second trunk branches out to three main branches all with included bark and mushrooms growing in at least one area and a decay hole close to juncture )

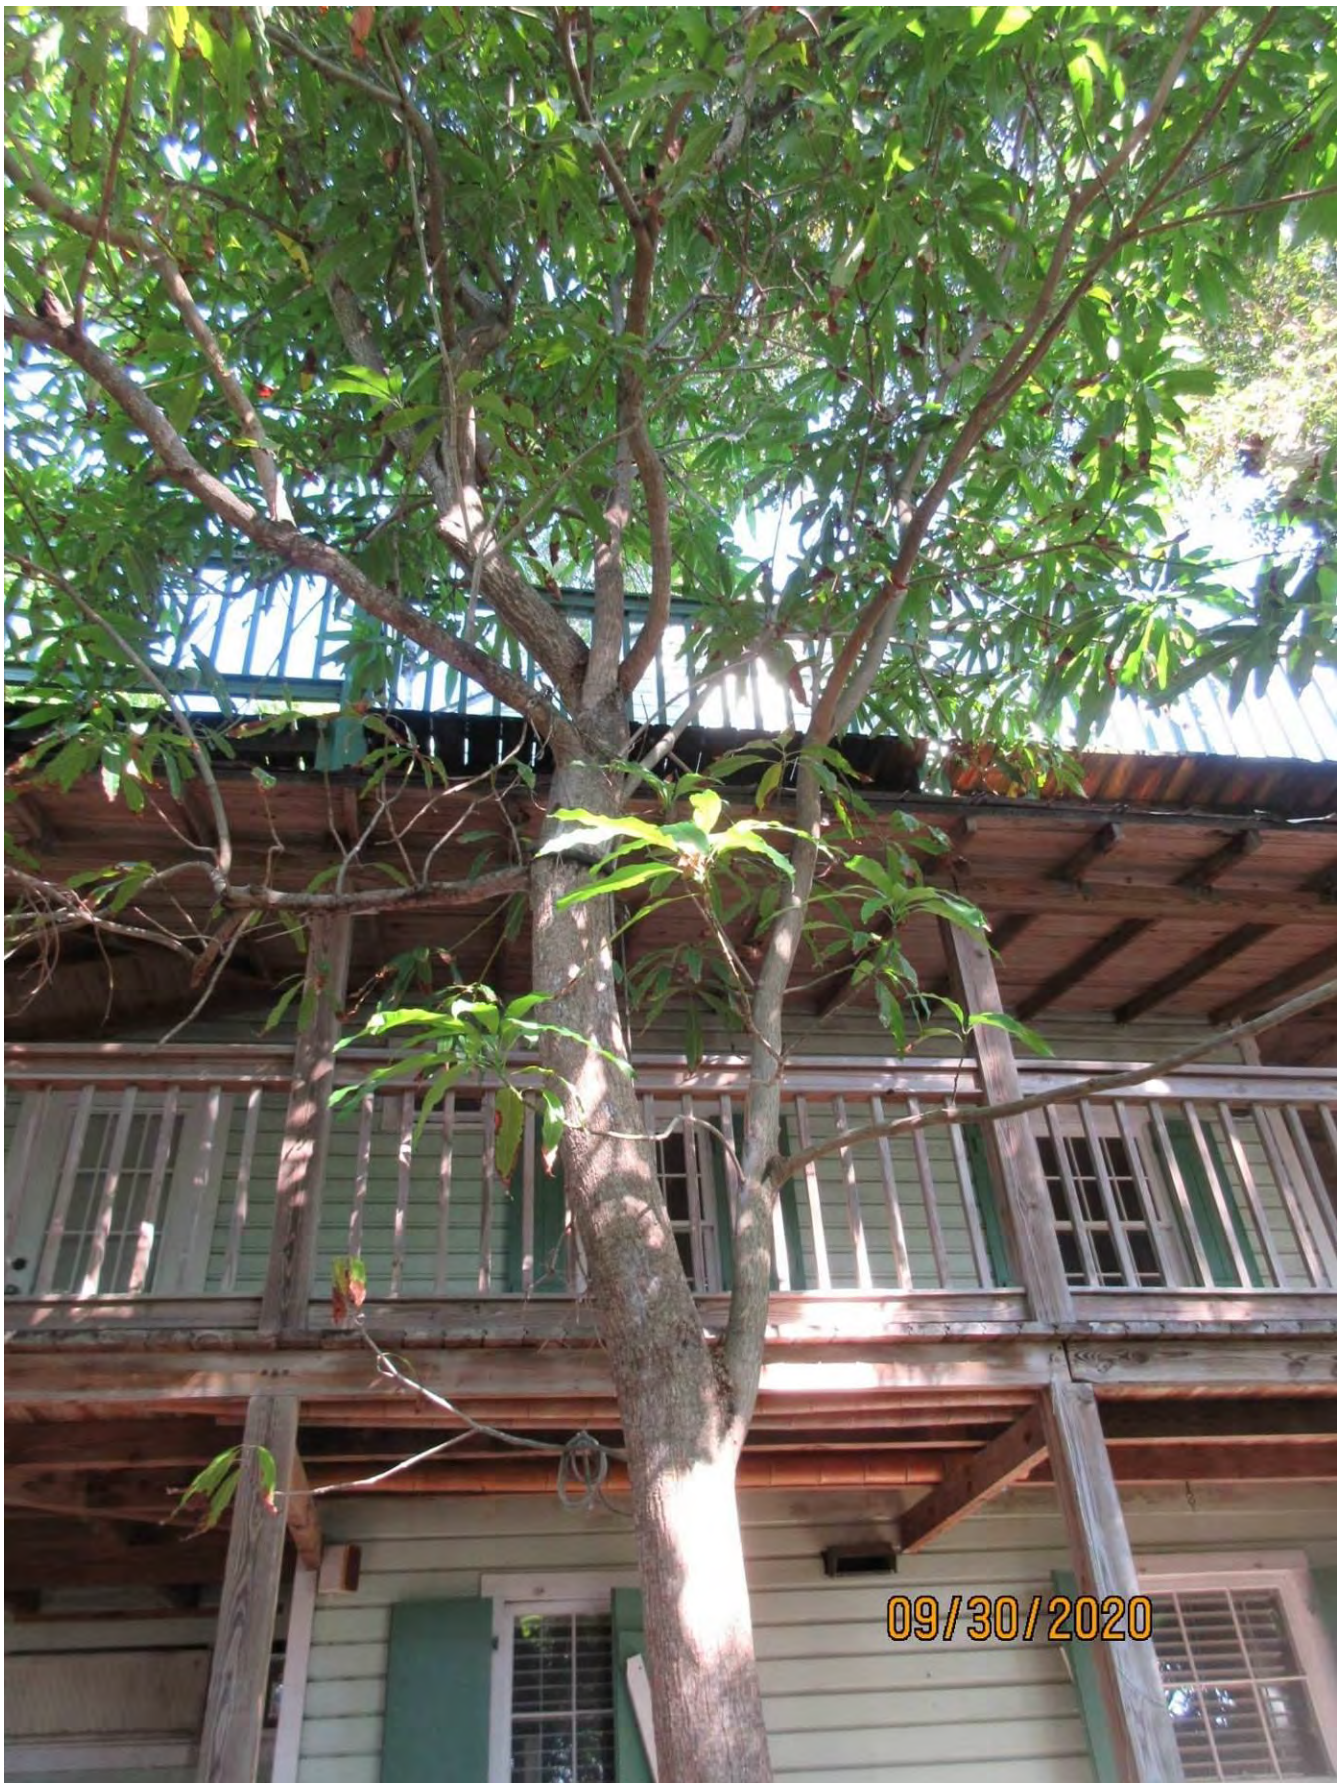
Photo showing tree trunk and canopy, view 1.

Condition: 70% (overall condition is fair to good, canopy shape impacted by house on one side-statement submitted with application says tree has never fruited)

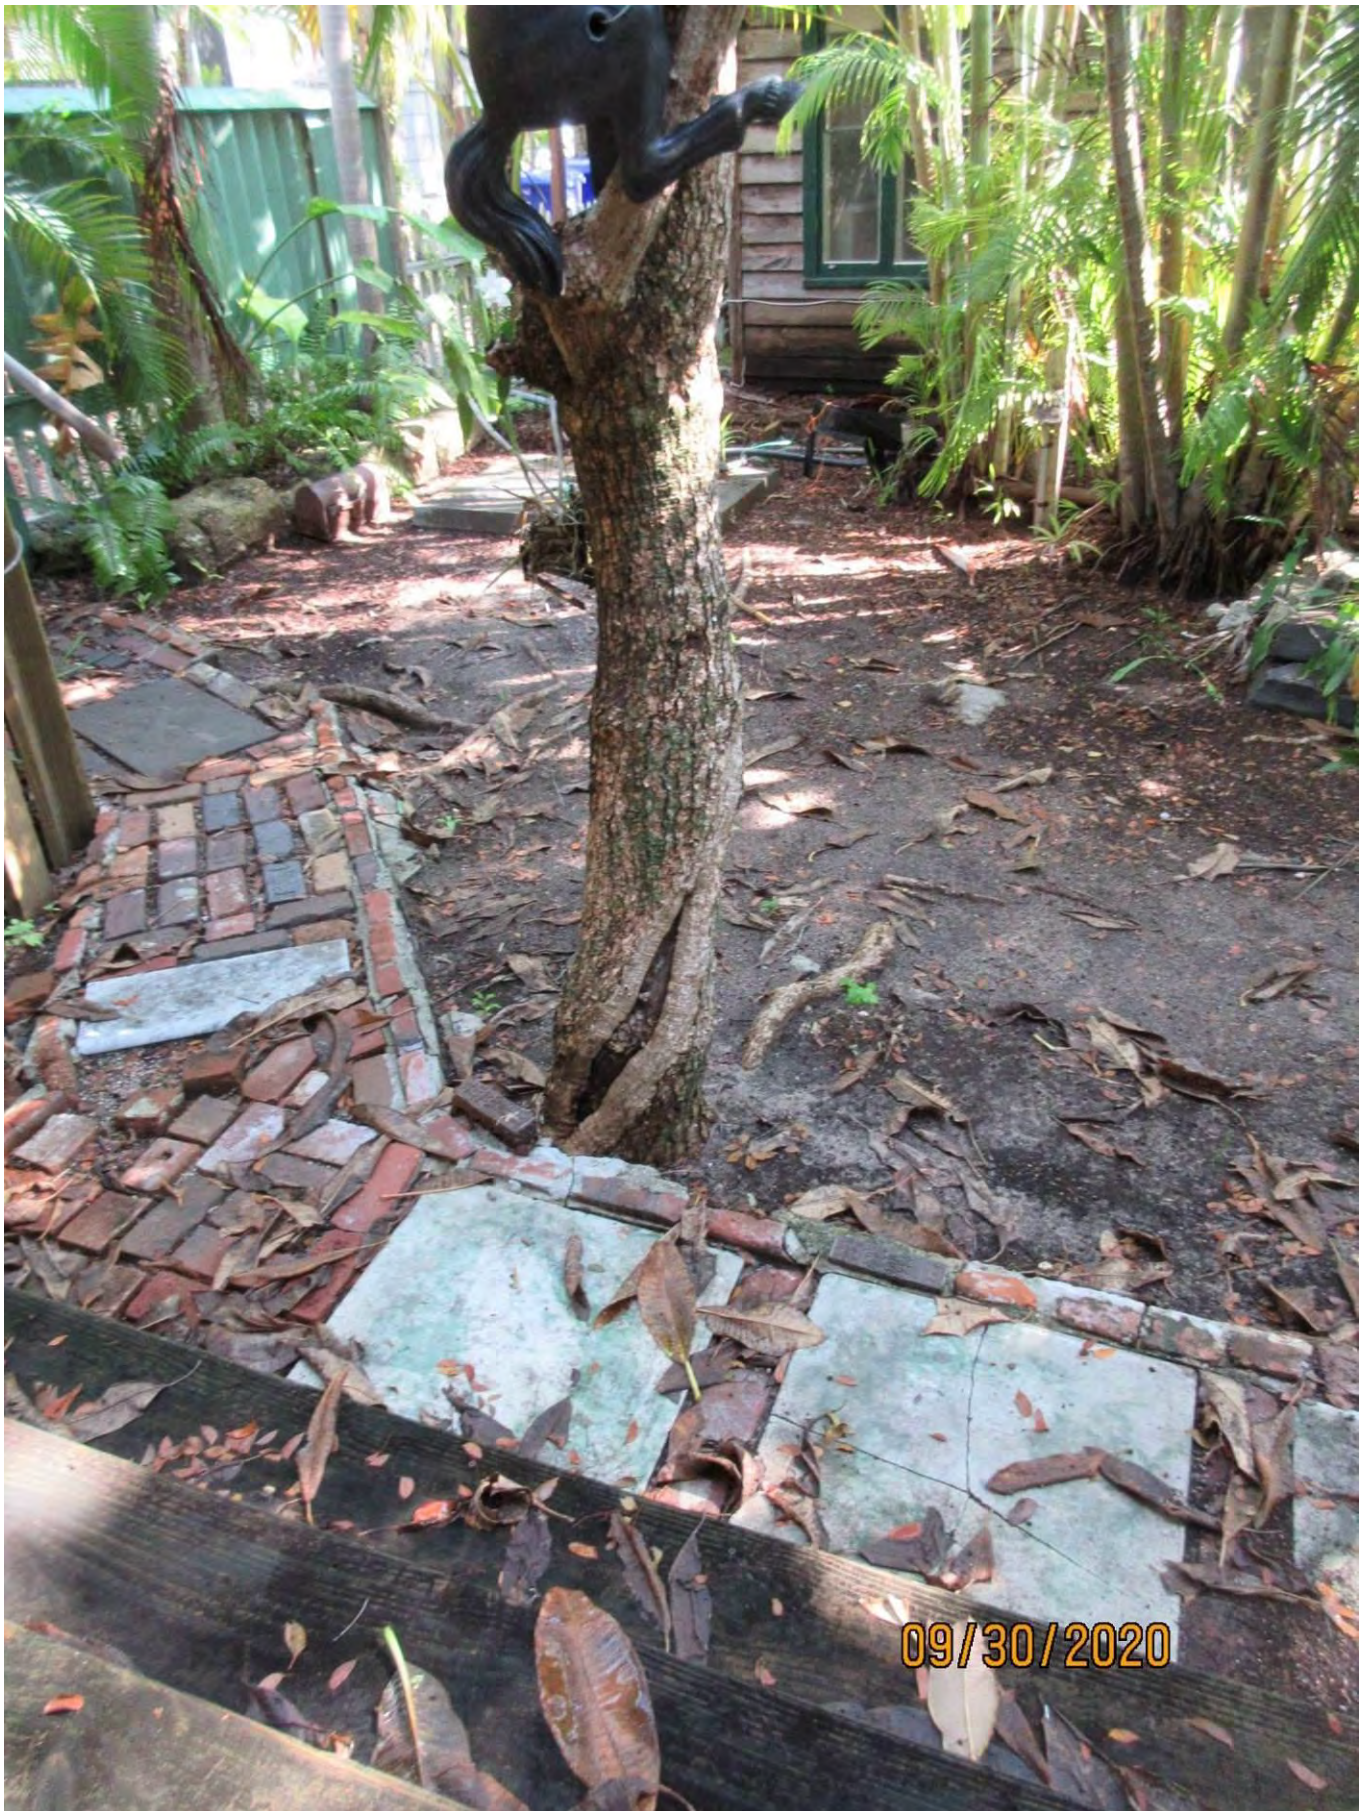
Photo showing base of tree and trunk.

Condition: 50% (overall condition is fair to poor, trunk has decay-old injury near base, canopy has small decay areas at old breaks and cuts.)

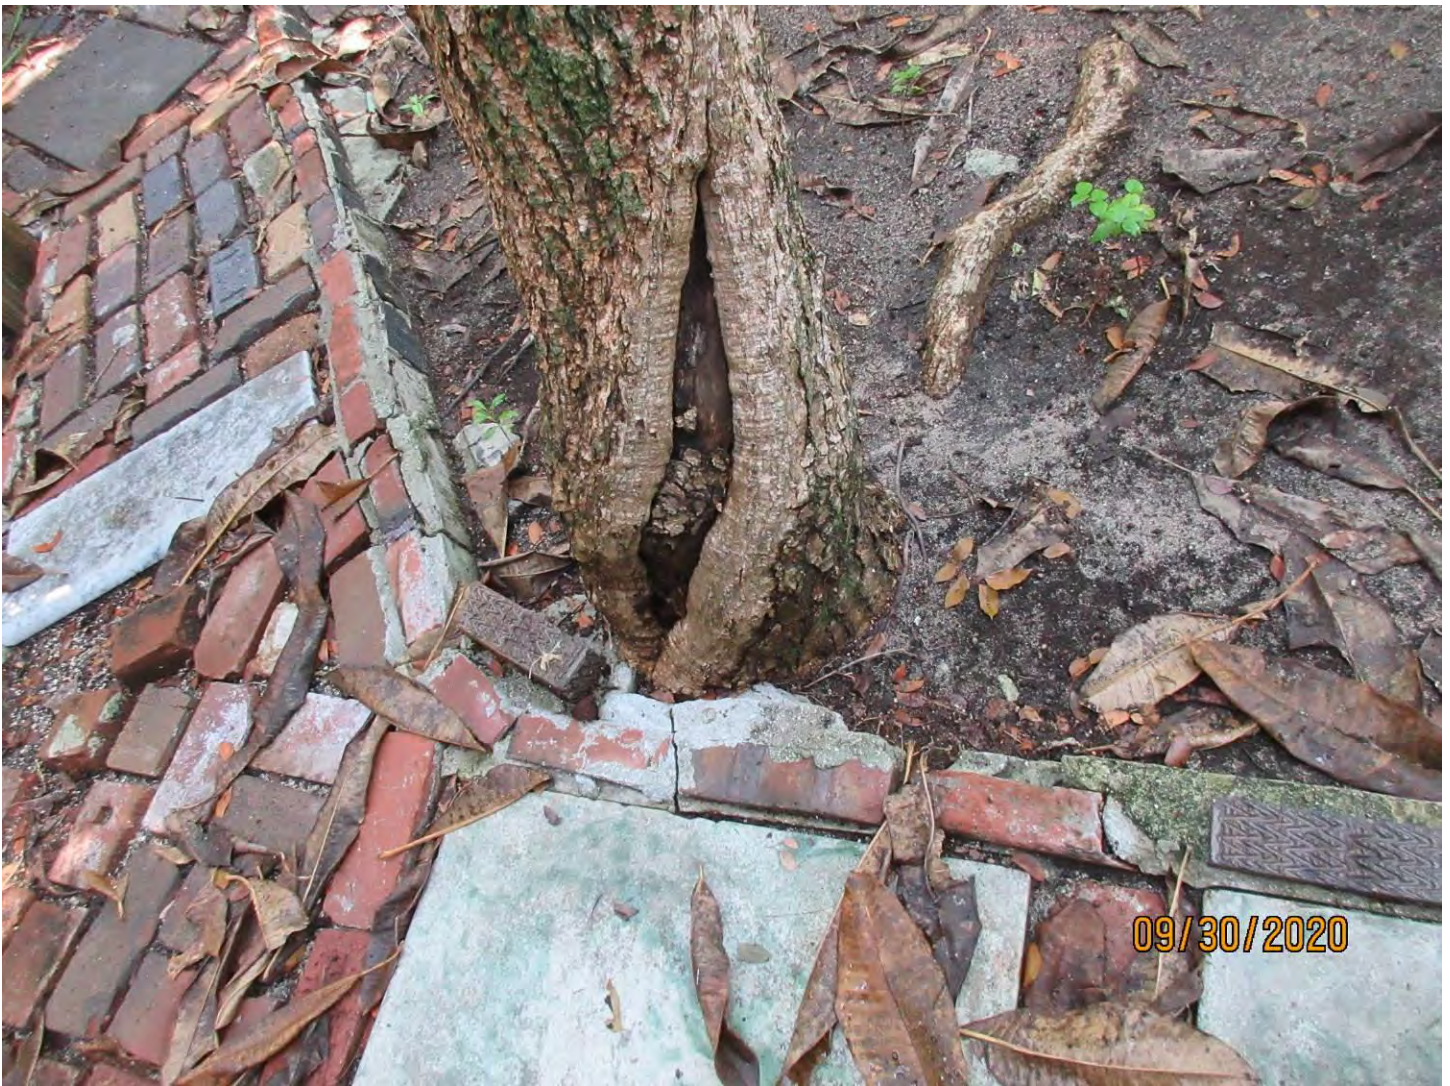
Photos of base of tree.

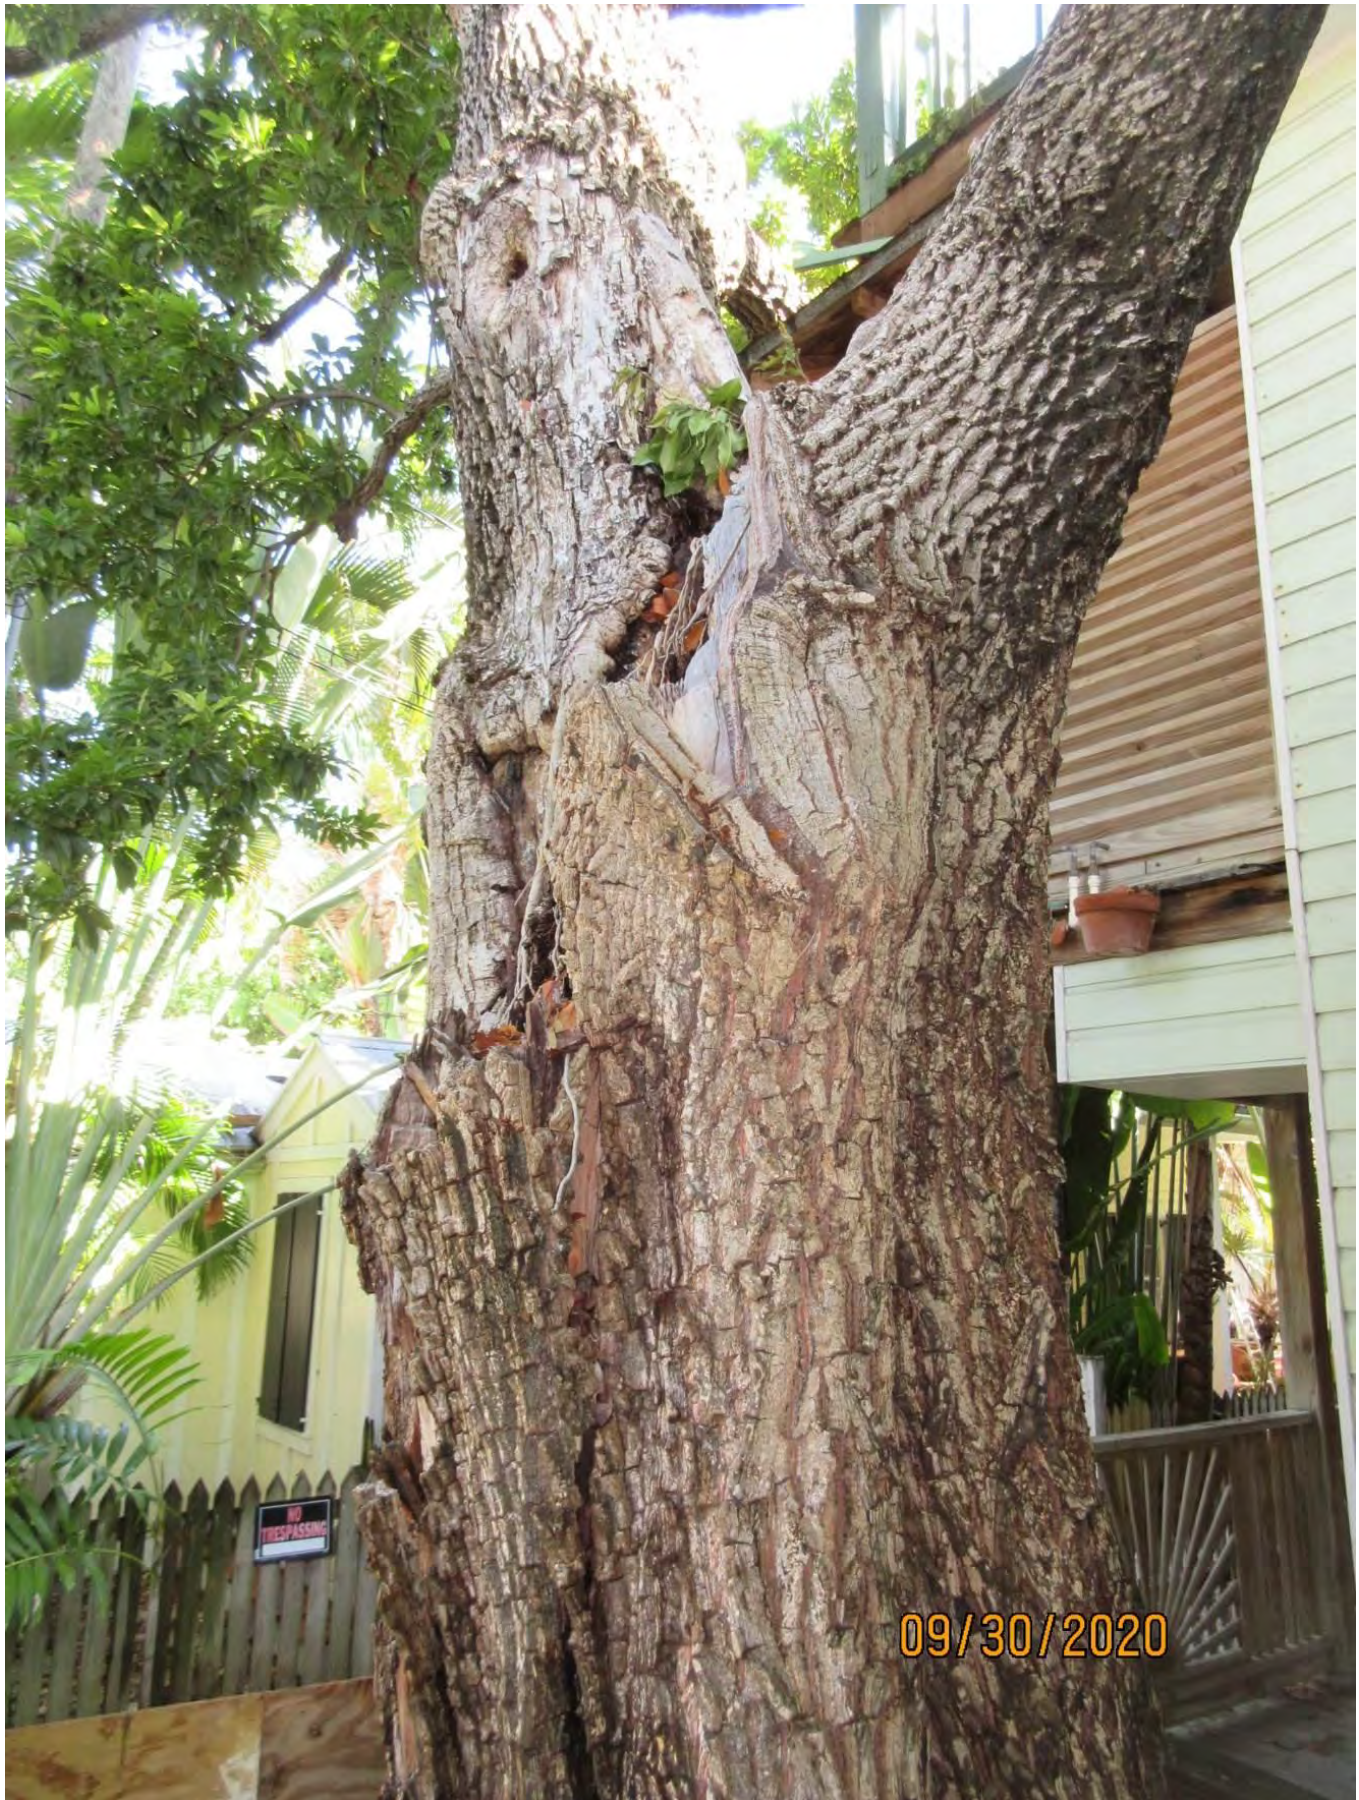
Photo of tree trunk and tear/decay area, view 1.

Condition: 40% (overall condition is fair to poor, large tear/decay area at main branch/trunk juncture, canopy lopsided with most of weight over house, lane, and utilities)

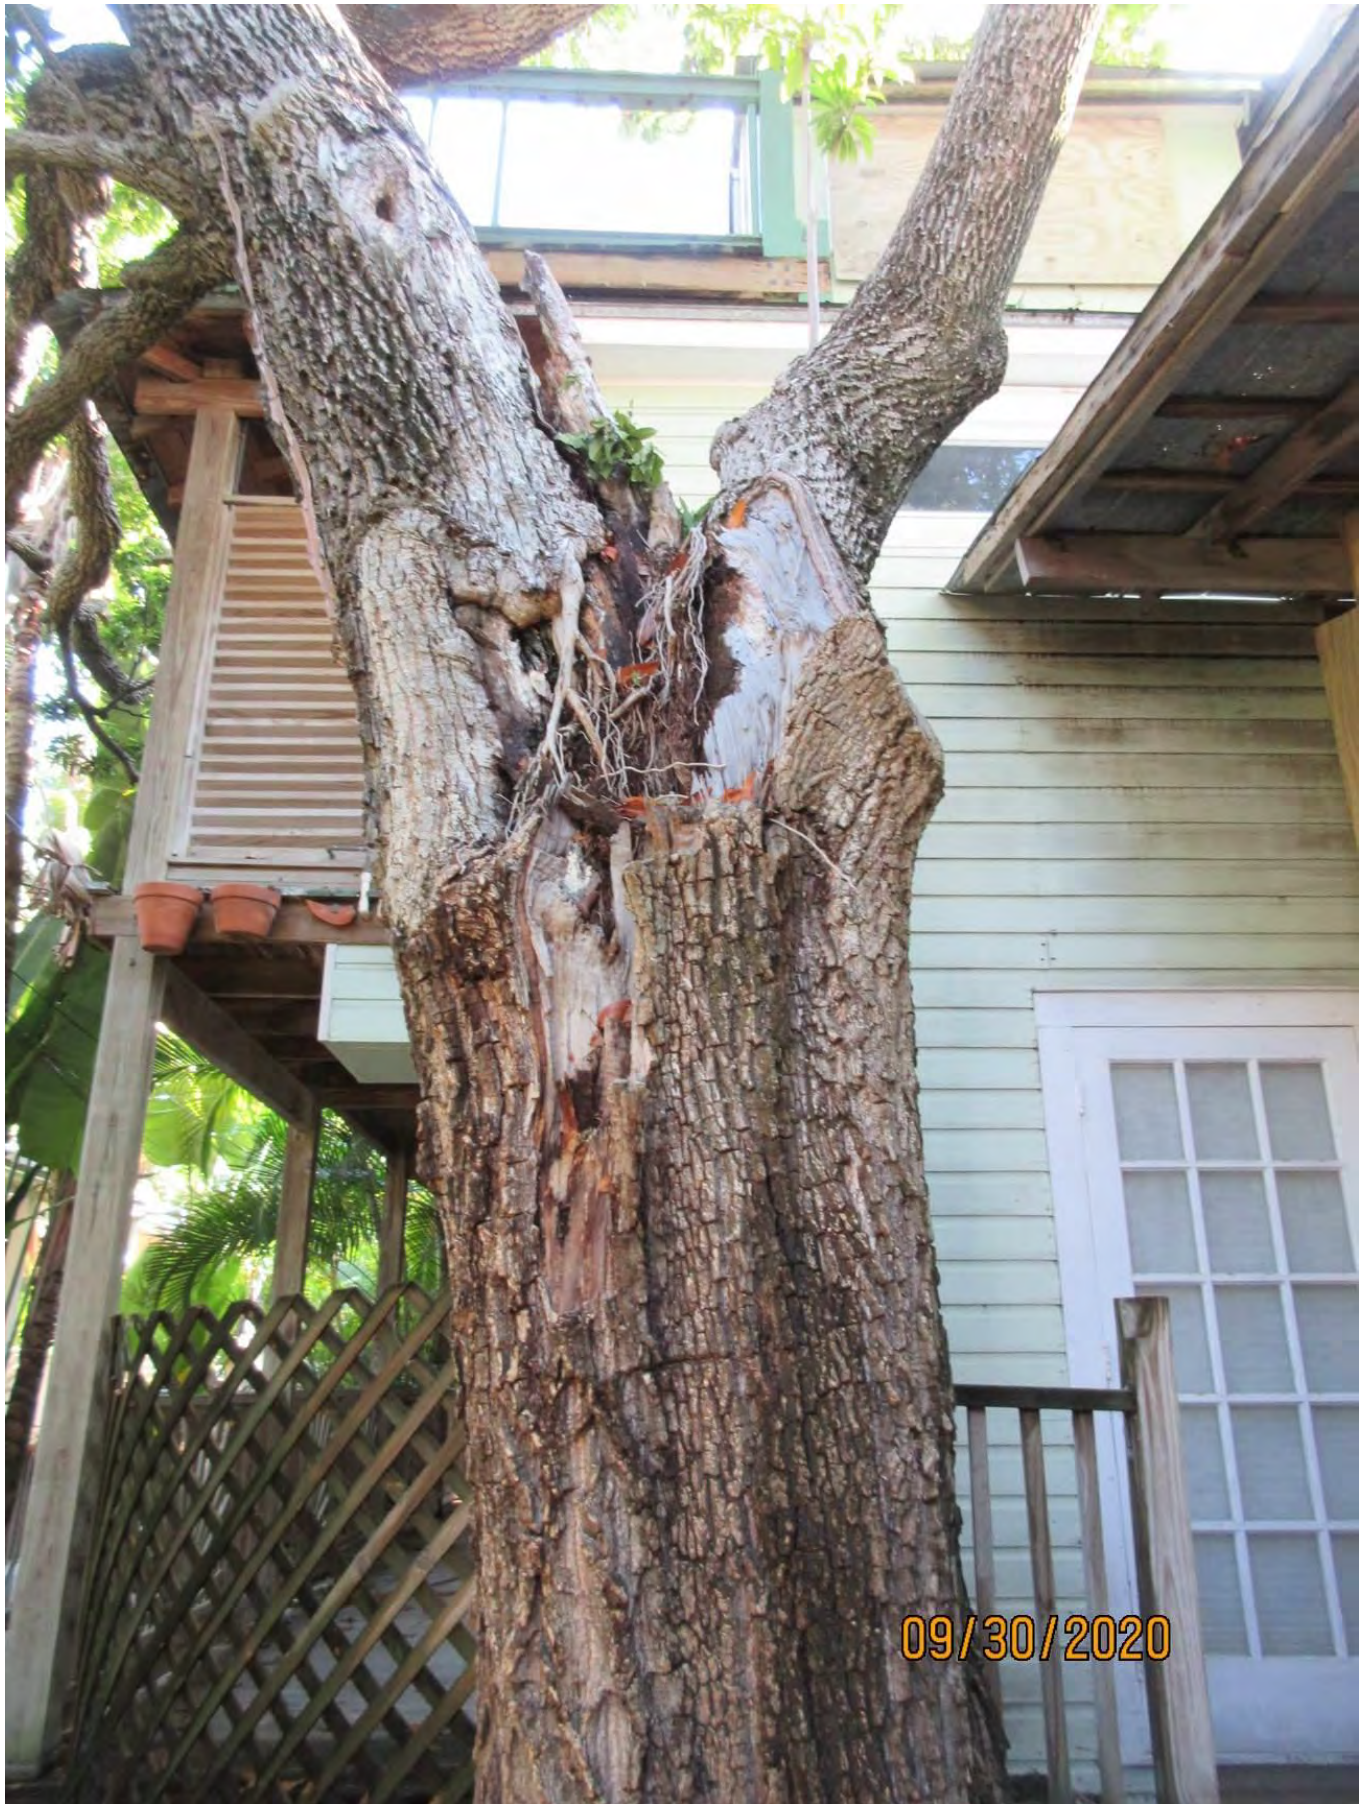
Photo of tree trunk and tear/decay area, view 2.

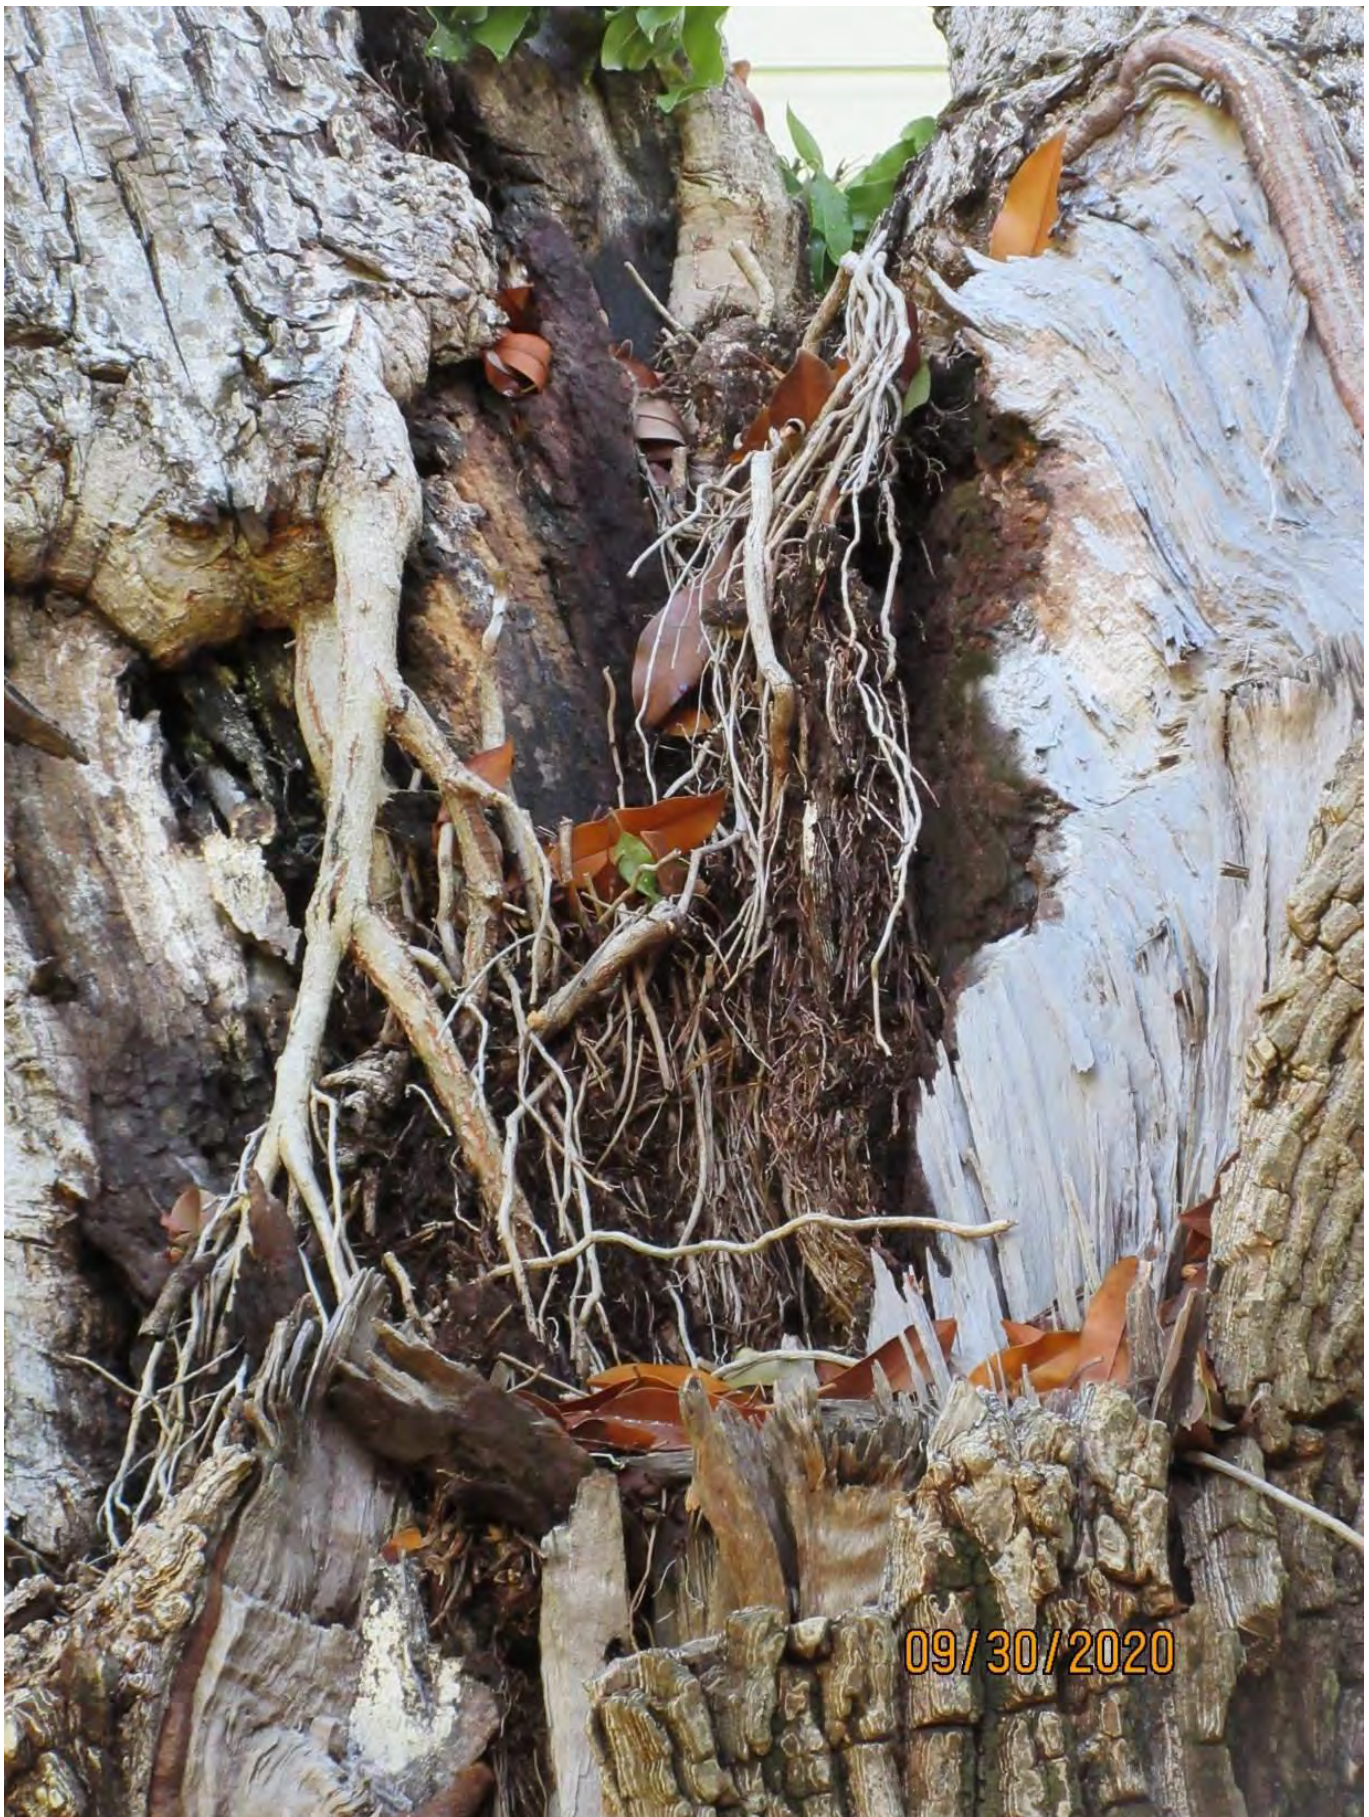
Close up photo of tear/decay area.

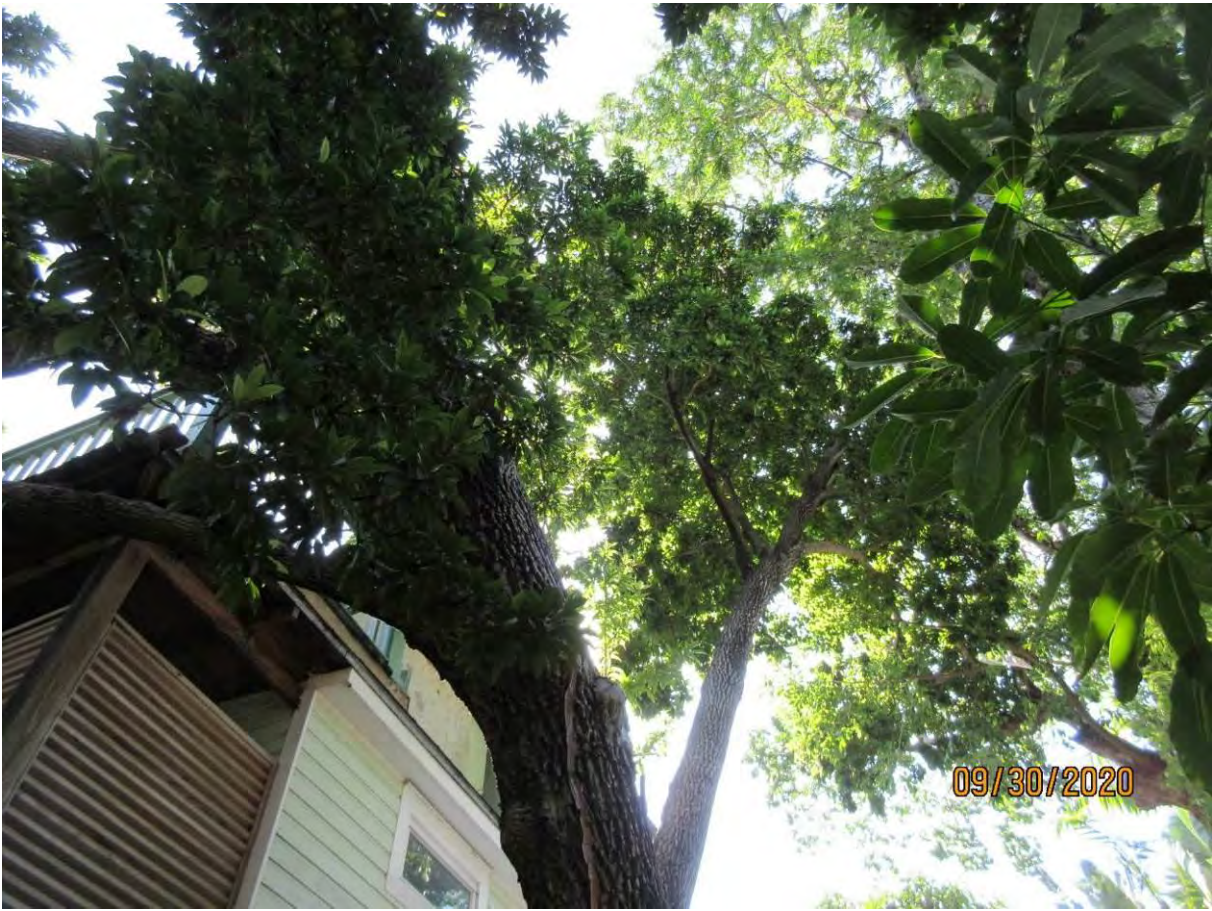
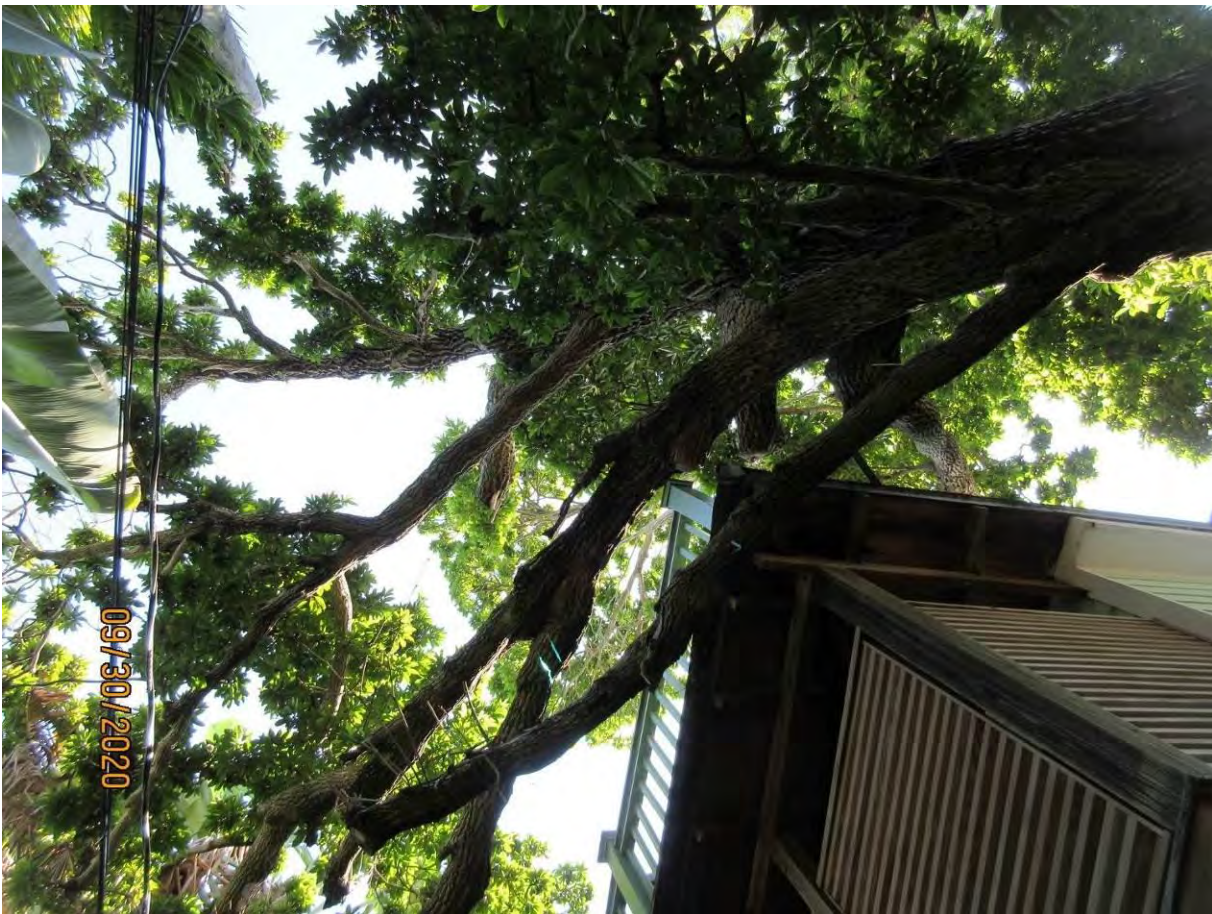
Two photos  
of tree  
canopy.

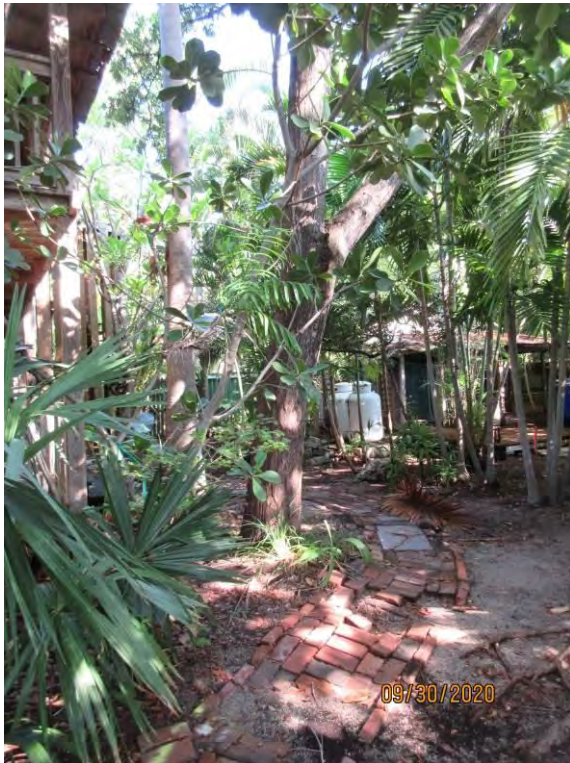
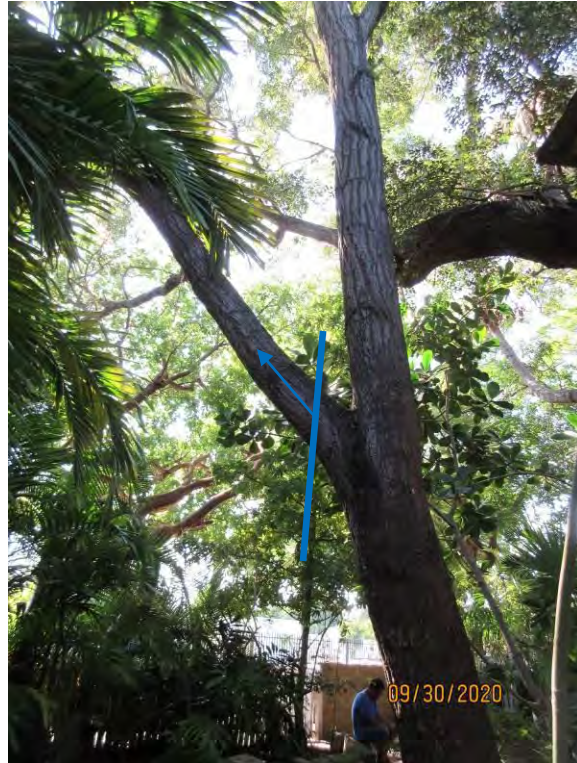
Mahogany tree to remain and trimmed (tree #4):

Two photos  
of tree to be  
trimmed.

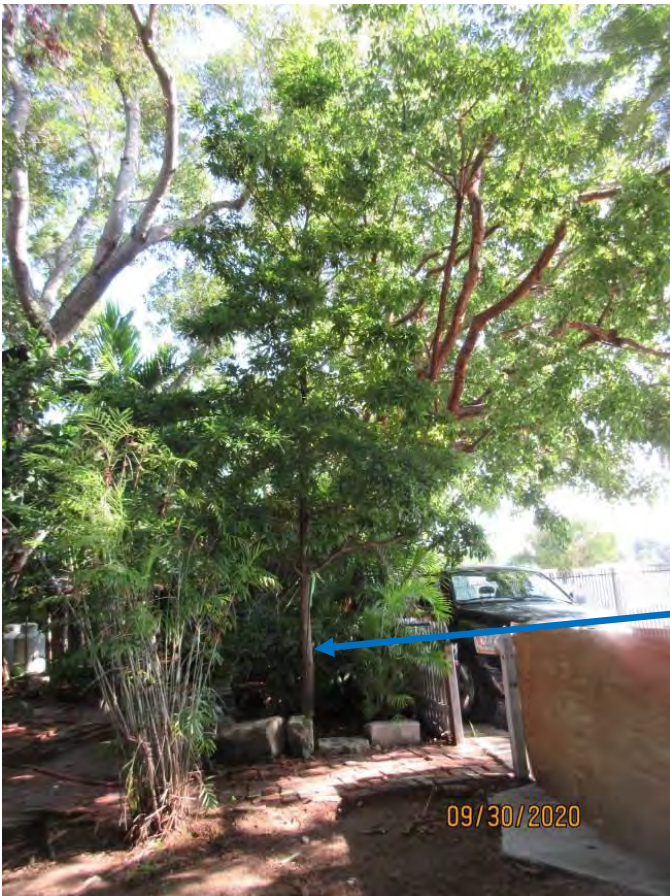
Sapodilla to be transplanted:

Photo of tree to be  
transplanted.
