Structural evaluation report

of exposed walls, columns, beams, and slabs affected by concrete spalling.

**Structural Complex housing Port Operations,
Waterfront Brewery, Retail, and other uses.
201 William St, Key West, FL 33040**

July 19, 2019

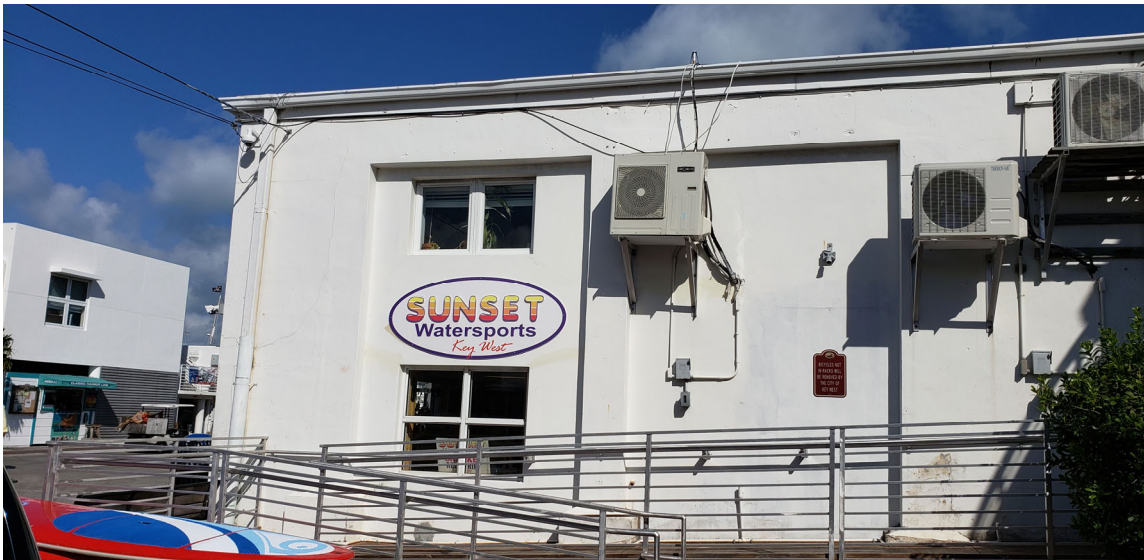
Figure 2. Front Elevation near roundabout. Location 1: Diagonal crack in the corner of CMU Wall and the corner column.

The columns at locations **1,2,3,16,17,19,20,21,24,26,27,29,31,32,33,35,36** and **38** show lesser cracking and damage than the rest of the columns. Thus, the columns only require smaller and less invasive repairs of concrete in the region of cracking. In parts where concrete is removed all corroded reinforcement must be cleaned by mechanical means (recommended use of needle scalers), sistered with new

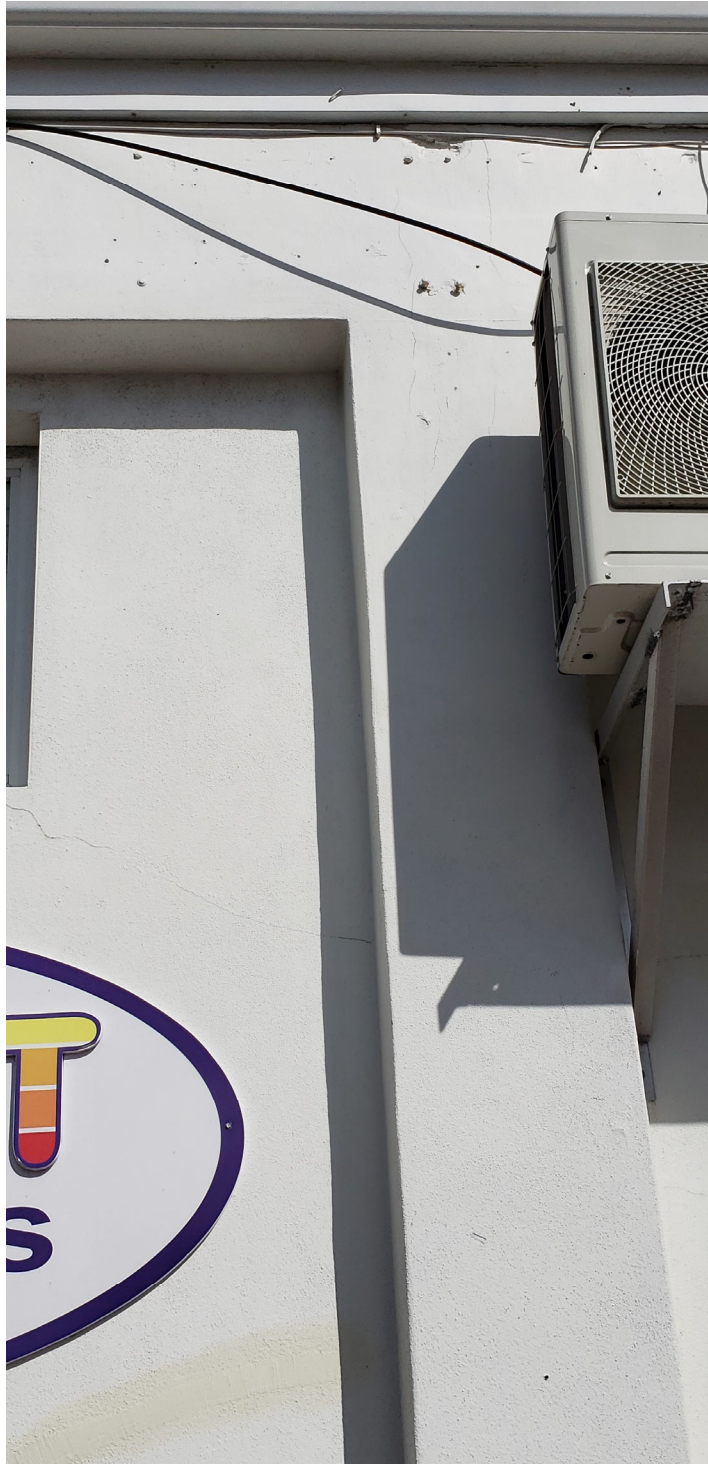
Figure 3. Front Elevation near roundabout. Location 2: Diagonal crack in the CMU Wall and vertical cracks in column developing at its top. Some spalling of concrete in column visible as well.

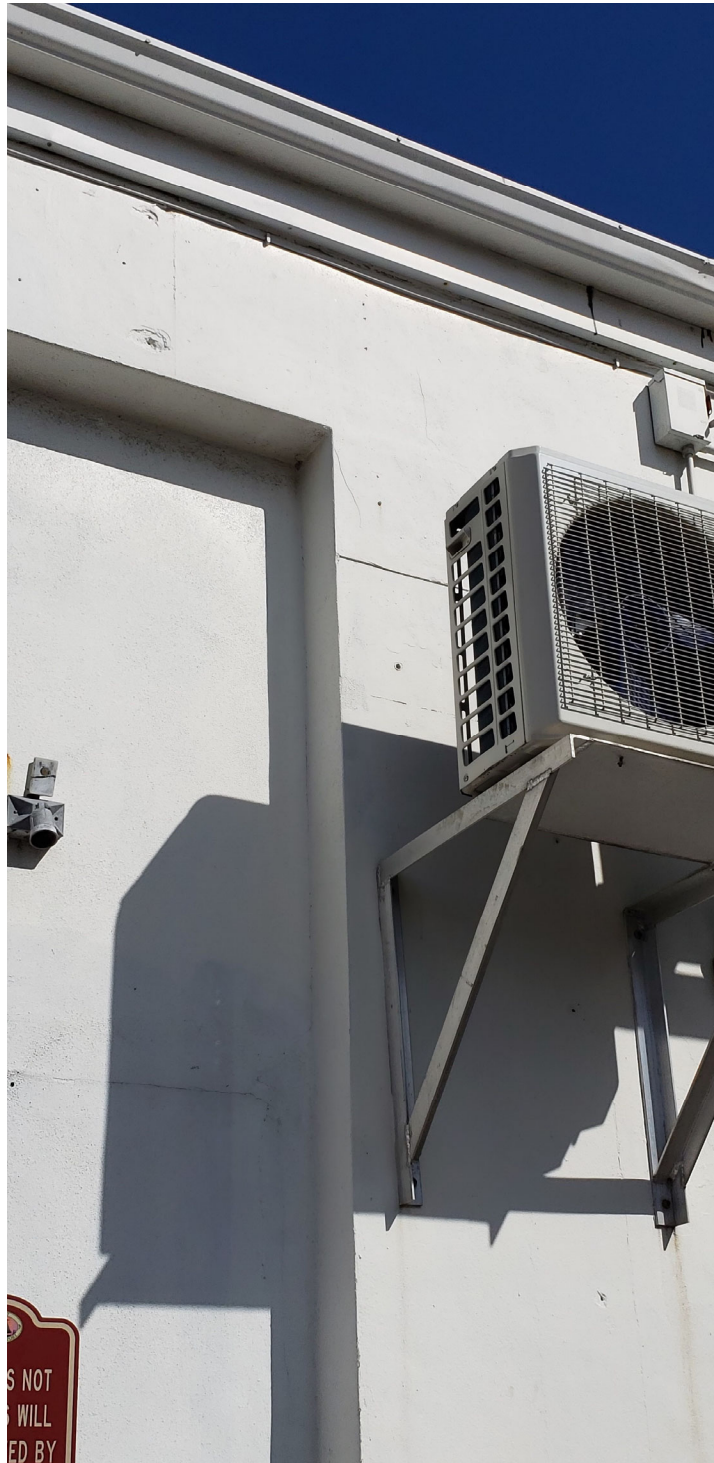
Figure 4. Front Elevation near roundabout. Location 3: Cracking developed in the CMU wall. Light Cracks and spalling observed in the column.

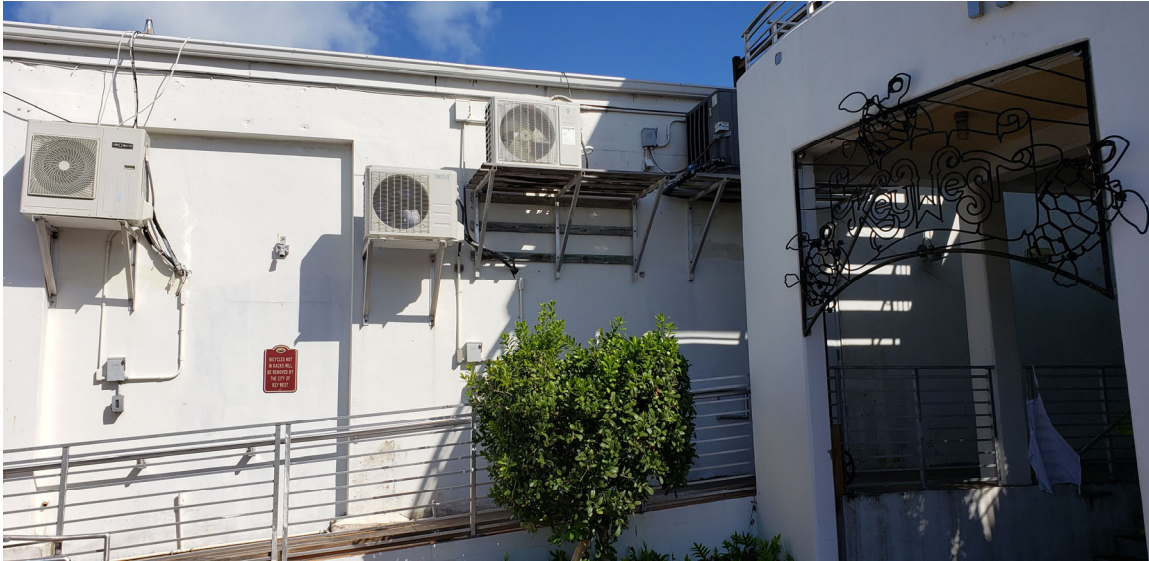
Figure 5. Front Elevation near roundabout. Location 4: Horizontal tie-beam cracks seen near the AC units. Vertical cracks at the top of the CMU wall also develop above the horizontal cracks in the tie-beam.

The beams at location **4**, between location **25 and 26** shall be repaired in a similar way to the less-invasive method recommended for the column at location **34**. The repair of these beams would require the galvanized anodes between the old concrete and new concrete unless whole sections of the beam are replaced entirely without any existing reinforcement embedded into new cast.

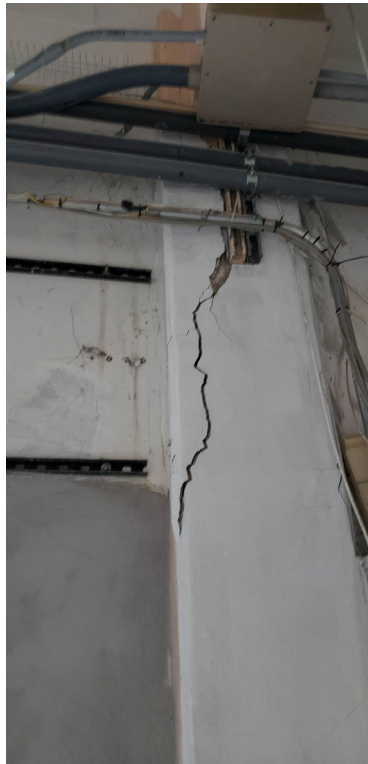
Figure 6. Interior of the Building. Location 4: The interior portion of the column is heavily cracked. Large diagonal cracks along with concrete spalling is observed. Existing electrical conduit is supported to a pipe sitting in the damaged portion.

The columns that require total replacement are located at Locations **4,9,10,11,12,18,22 and 40**. Temporary shoring and bracing for beams and walls at respective column locations must be provided to provide structural safety to the occupants and the public. The columns, after the supported structure is supported temporarily, shall be demolished till the top of the existing foundation they rest on. The reinforcement cages of the new column would be doweled into the existing foundation. Subsequently, fresh concrete can be then cast once the reinforcement is in place.

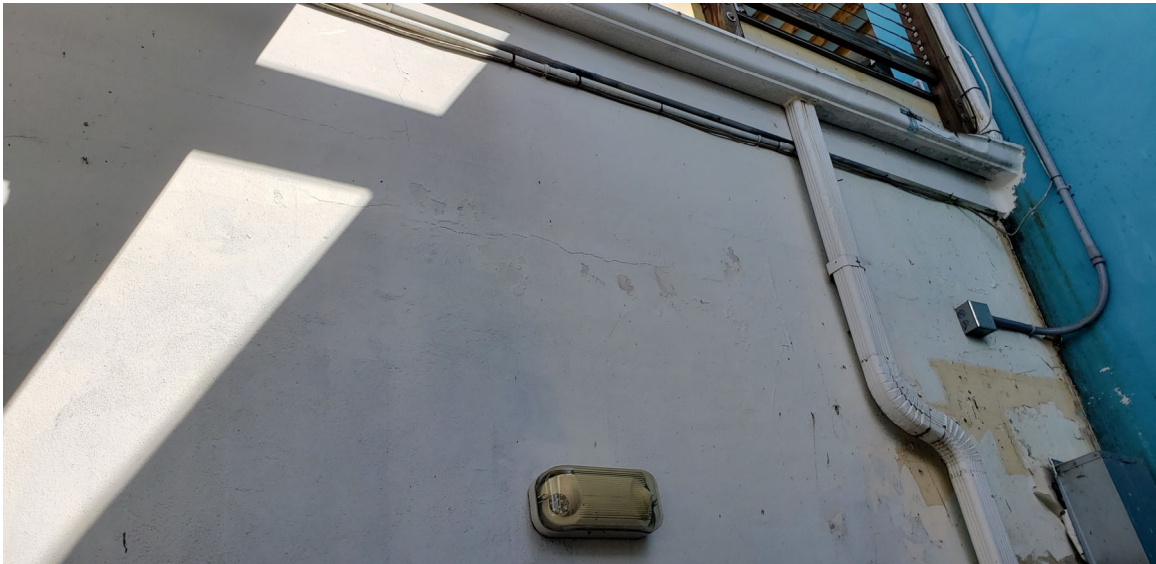
Figure 7. Location 5: Horizontal CMU wall cracks have formed.

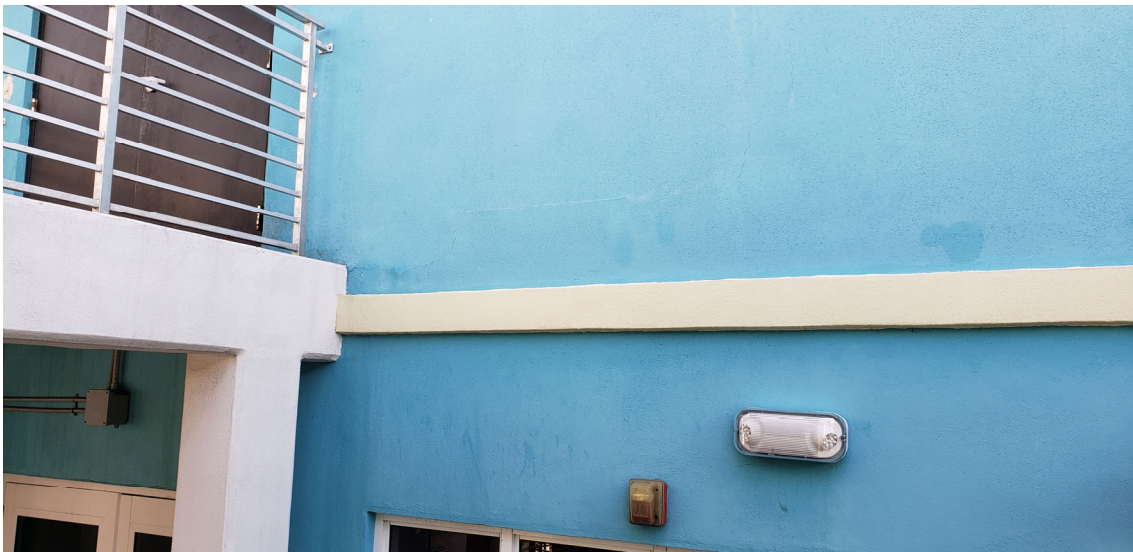
Figure 8. Location 6: Diagonal step ladder cracking on the CMU wall formed as seen next to the concrete frame perpendicular to the wall.

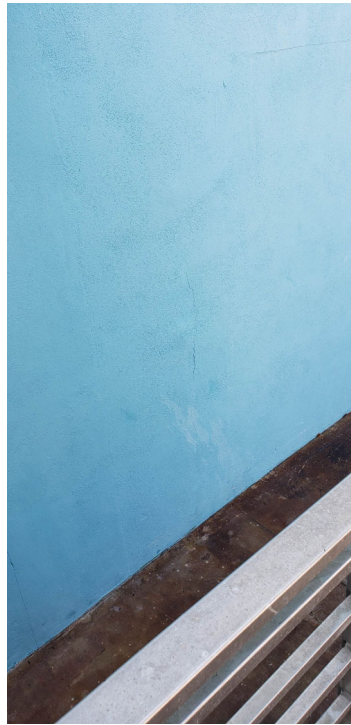
Figure 9. Location 7: Diagonal cracks in the wall developing

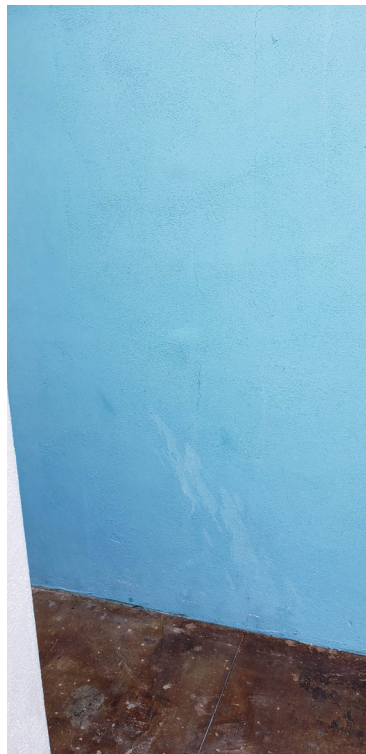
Figure 10. Location 8: Diagonal cracks in the wall developing here as well.

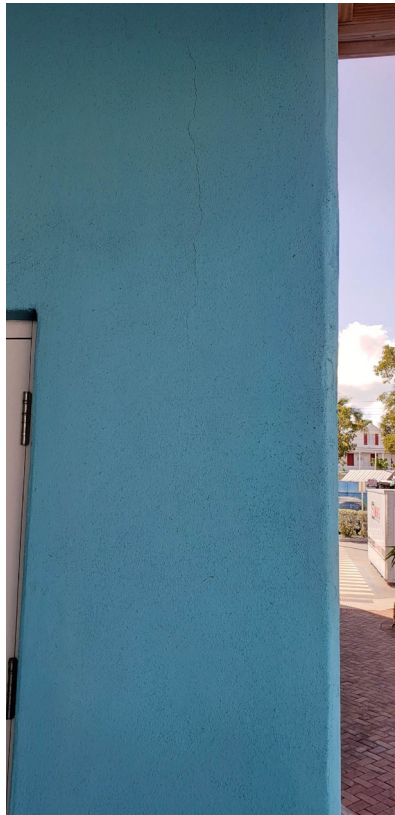
Figure 11. Location 9: Spalling cracks in the wall (corner tie-column).

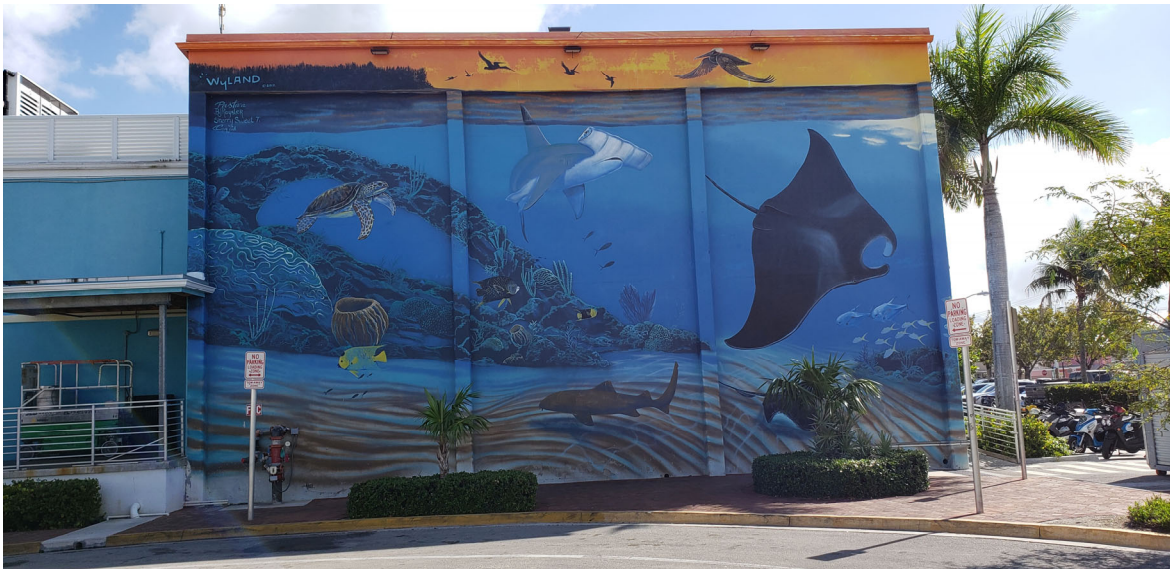
Figure 12. Location 9-12. Wall shown between location 9 and location 12. The wall panels have extensive cracking in the tie-beam at the mid-height of the wall. The 4 columns at location 9, 10, 11 and 12 have heavy spalling and cracking of concrete.

Cracks in the walls have been repaired with sealant in the past repair works. All this can be observed in figures 12-16.

The cast-in-place concrete tie-beam between locations **9 and 12, 18 and 19** and **43 and 44** needs to be removed completely and be replaced with new tie-beams that shall be cast with new concrete and new rebar. The tie-beams between location **9 and 12, and 43 and 44** are approximately located at the mid-height of their walls. The one between location **18 and 19** is located at the top of the wall. Once the temporary supports are provided to the structure supported by the tie-beams, the beams can be demolished in a set of segments. Each set would be demolished, new rebar will be placed, and casting of fresh concrete shall follow. Remaining sets of segments of the beams would be cast one at a time to ensure structural integrity of the building. Proper lapping of reinforcement between segments would need to be provided by the means of doweling into existing segments.

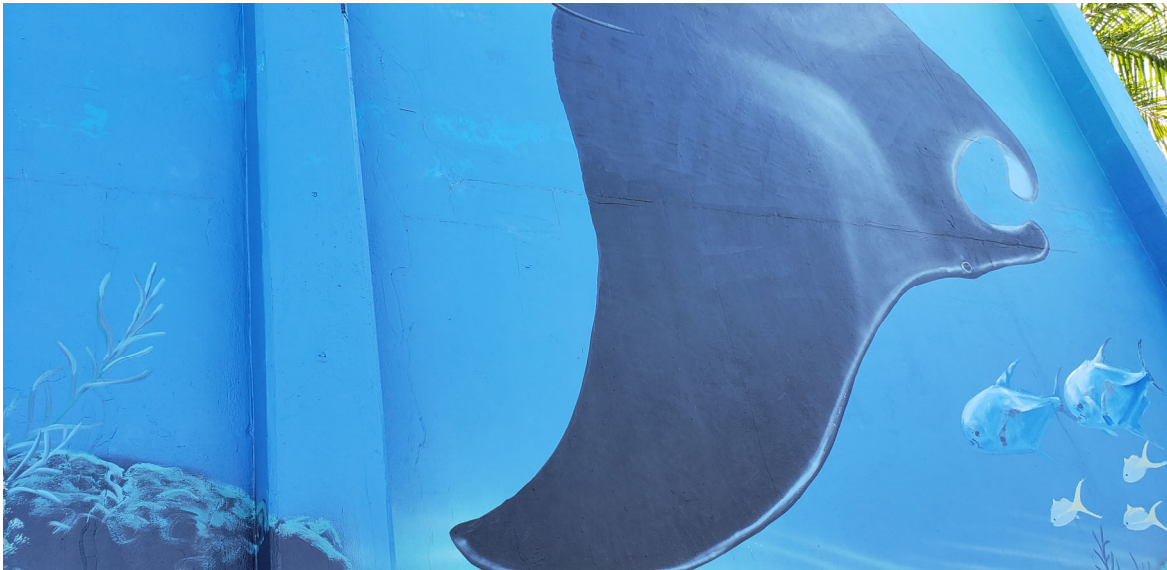
Figure 13. Tie-beam cracks in wall panels (mid-height of the wall).

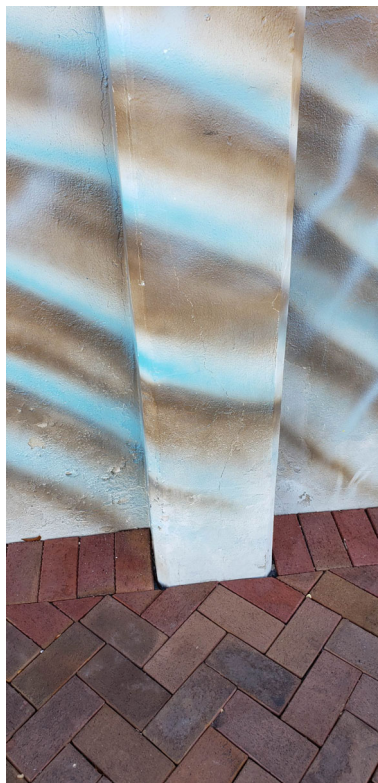
Figure 14. Location 10: Cracking in the column consistent with progressive spalling.

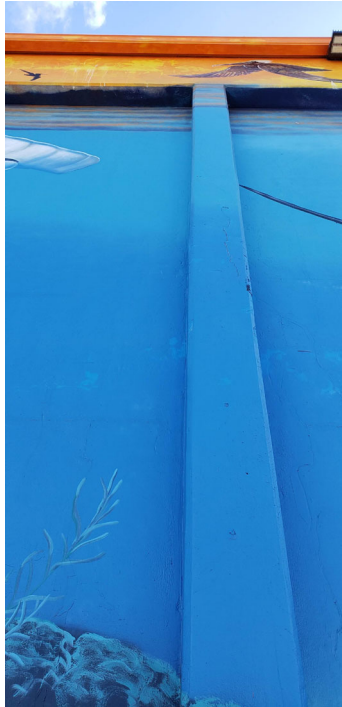
Figure 15. Location 11: Heavy cracking and spalling in the column. Please note that some of the cracks are not as obvious since they are covered by elastomeric paint and sometimes sealant.

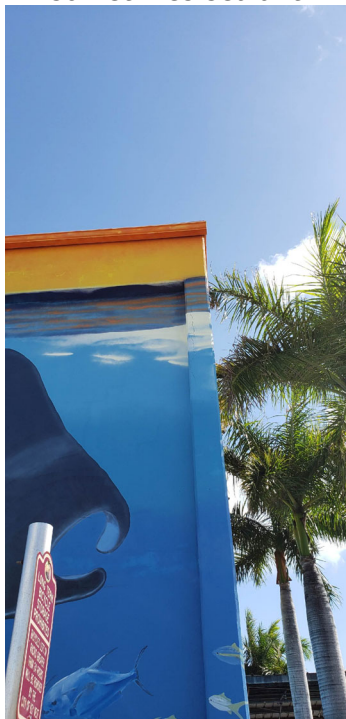
Figure 16. Location 12: Heavy cracking and spalling in the corner column

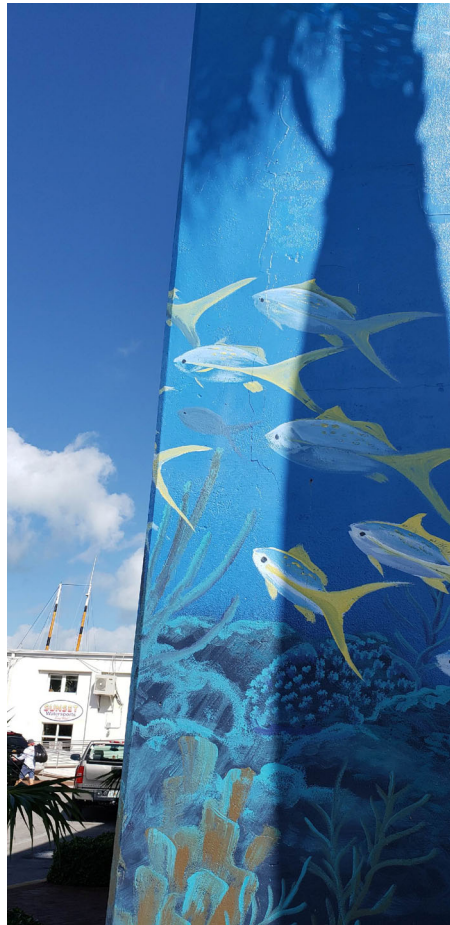
Figure 17. Location 12: Corner column heavy cracking

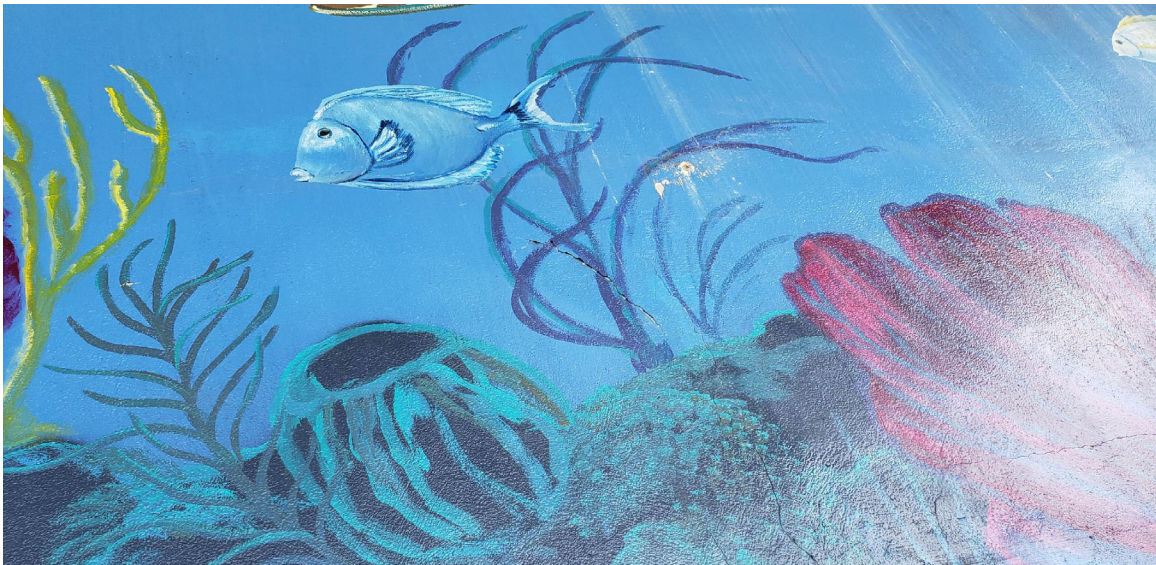
Figure 20. Location 13: Cracking in the wall and some spalling of concrete observed.

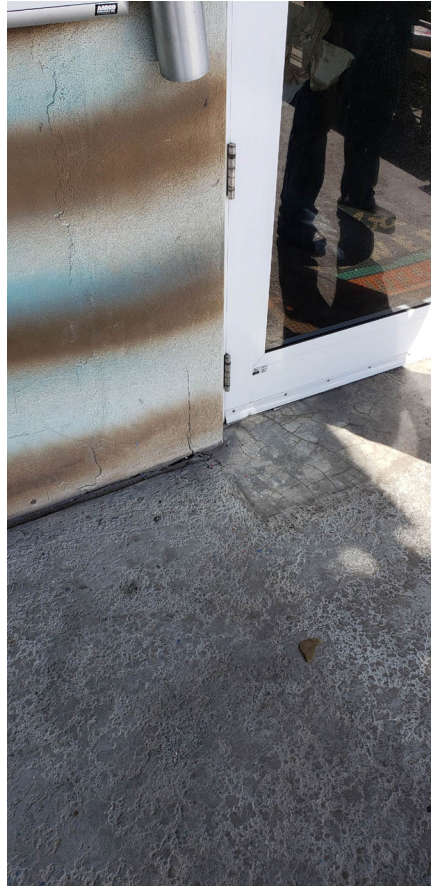
Figure 21. Front Entrance. Location14: Crack formation in the side of the opening.

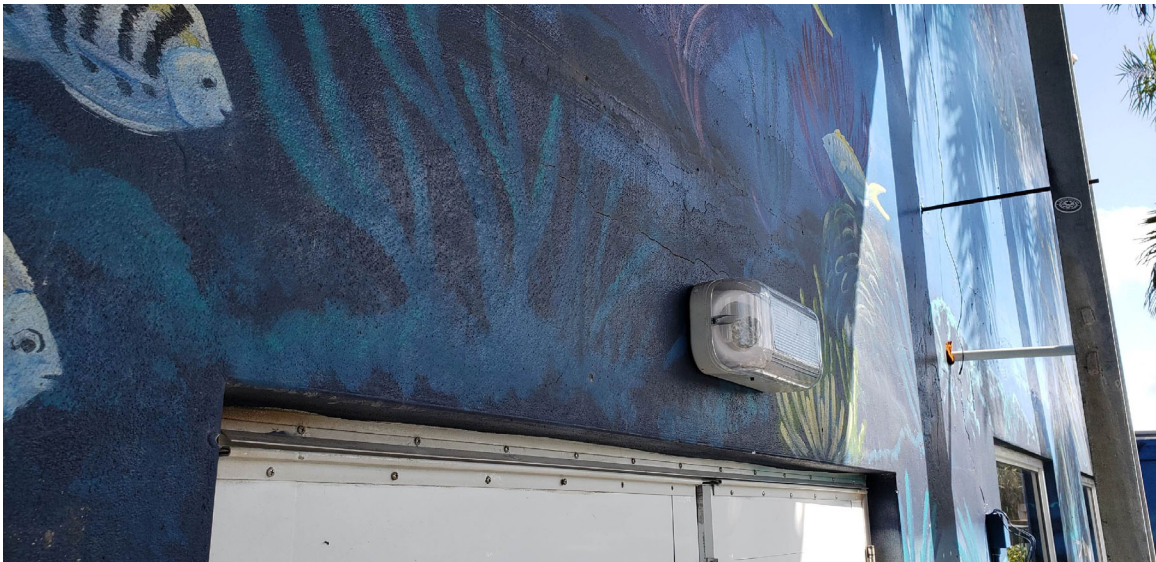
Figure 22. Front Entrance. Location 15: Cracks in the wall forming above the entrance door. (likely spalling of the tie-beam or header).

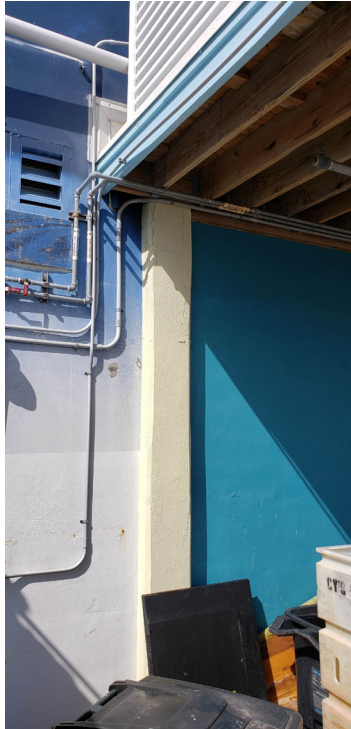
Figure 23. Location 16: Cracking in concrete column at close to mid-height seen. Please note that bottom of these columns were likely to be repaired previously and re-occurring spalling is consistent with the limited area repair approach.

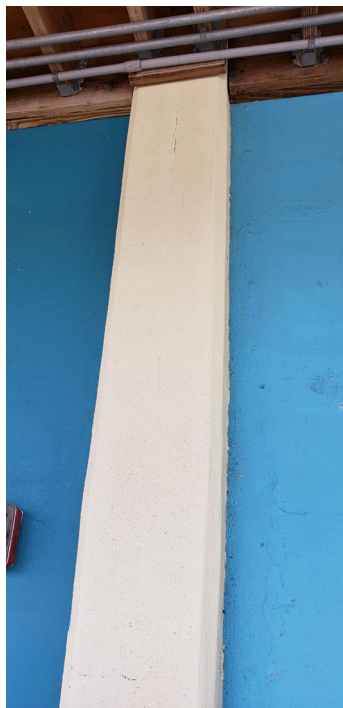
Figure 24. Location 17: Well developed cracks in the column center.

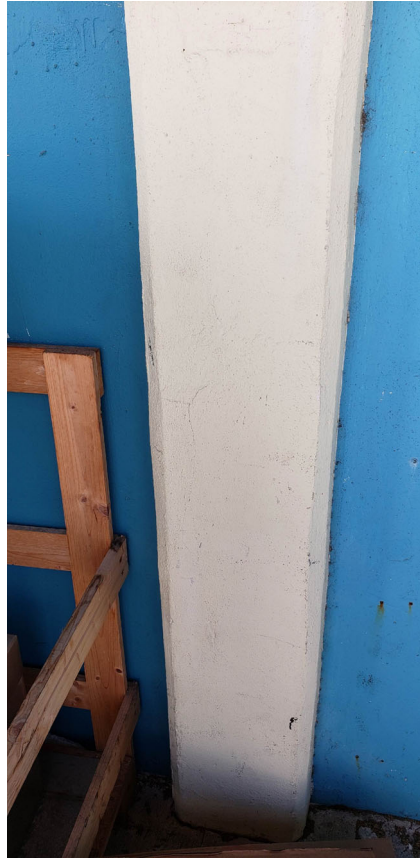
Figure 25. Location 18: Developed spalling cracks in the bottom of column.

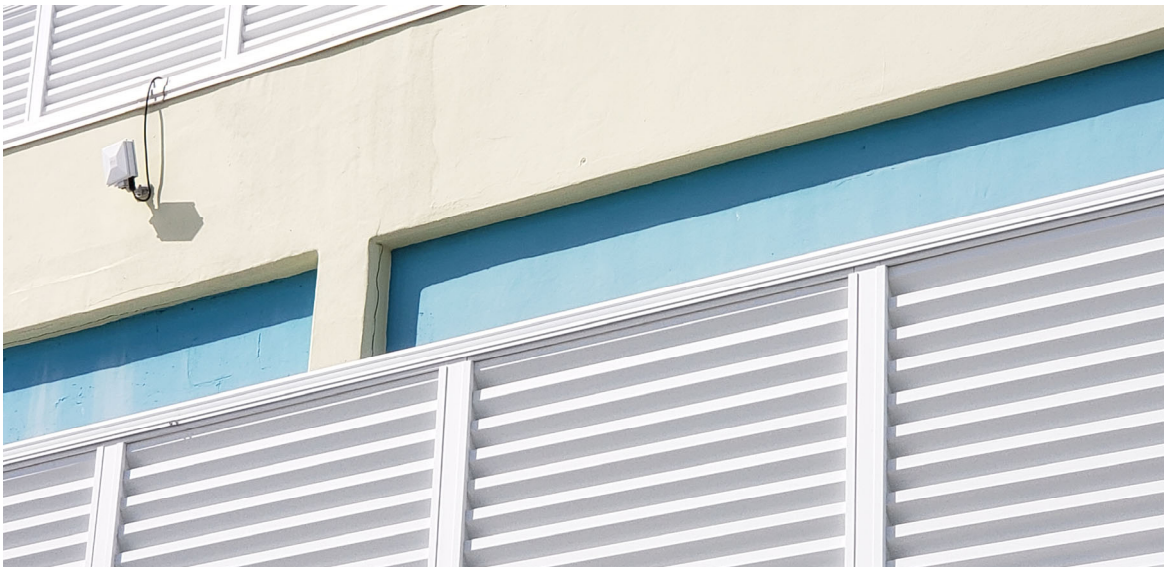
Figure 26: Location 18: Heavy cracking in the column closer to its top observed.

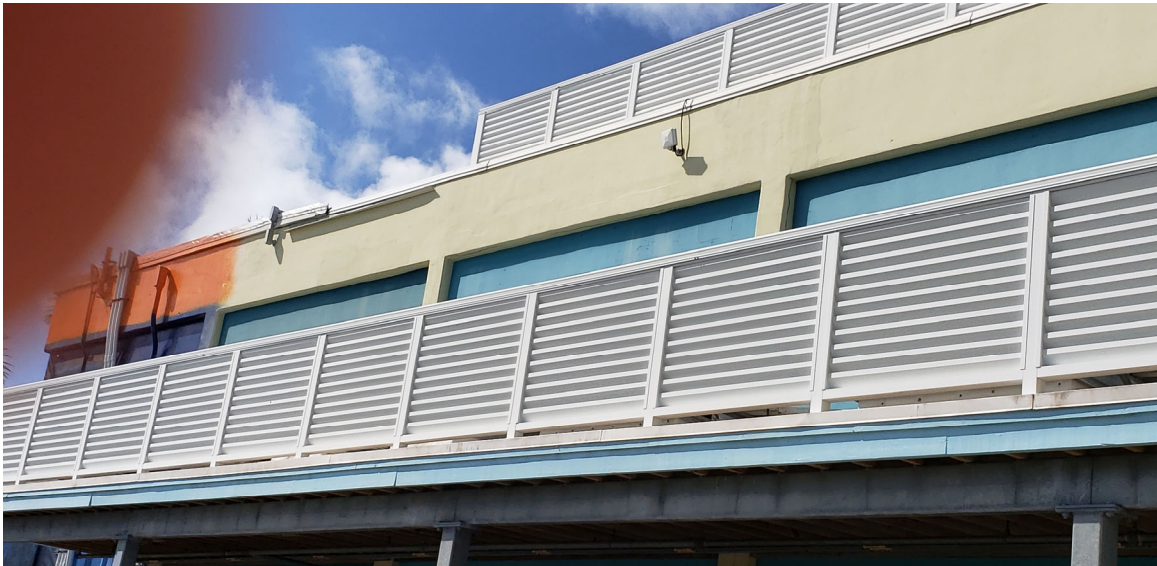
Figure 27. Between Location 18 and 19: Heavy cracking at the bottom the tie-beam.

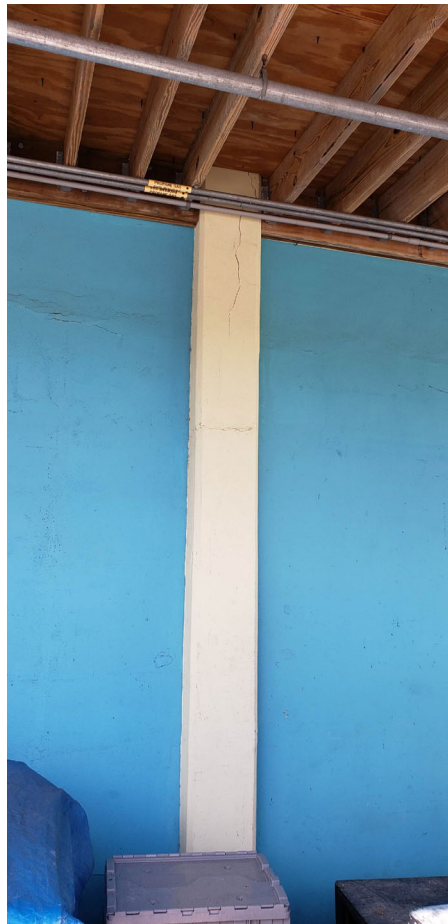
Figure 28. Location 19: Heavy cracking in the column at its mid-height approximately.

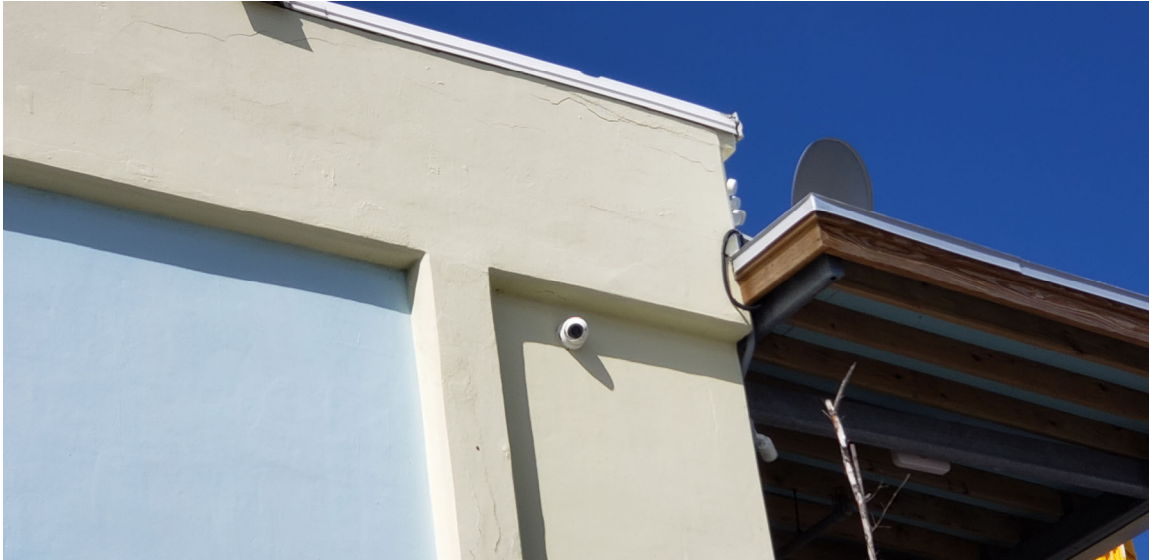
Figure 29. Between Location 20 and 22: The tie-beam has extensive cracking the top.

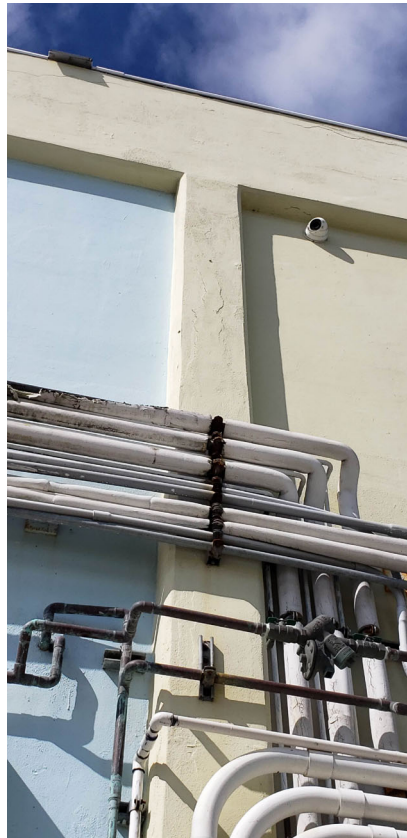
Figure 30. Location 21: Heavy spalling of column around electrical service and conduits. Typical condition due to multiple penetrations, electromagnetic currents and difficulty of proper paint and maintenance of the area.

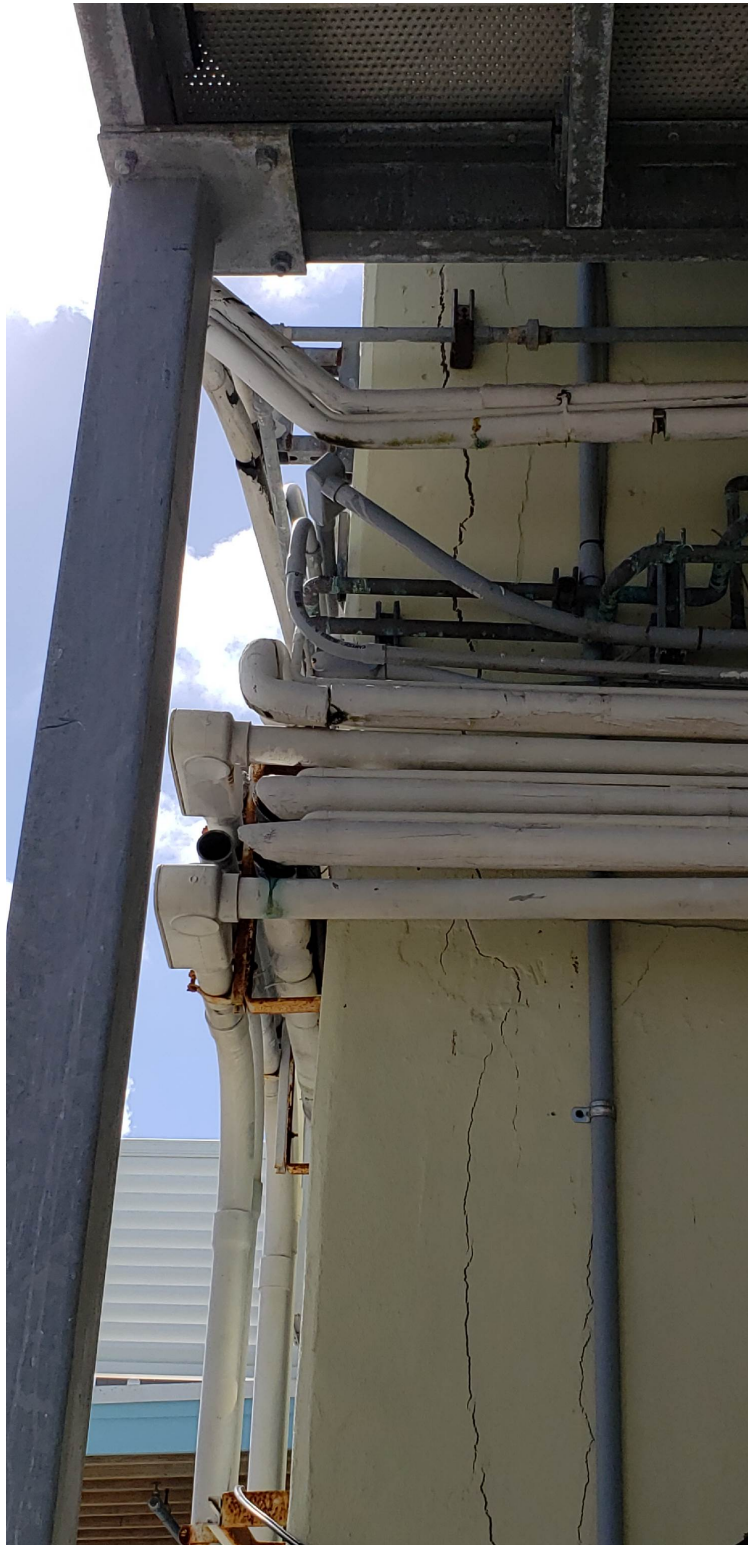
Figure 31. Location 22&23: Same as location 21. Heavy damage of the concrete corner and wall.

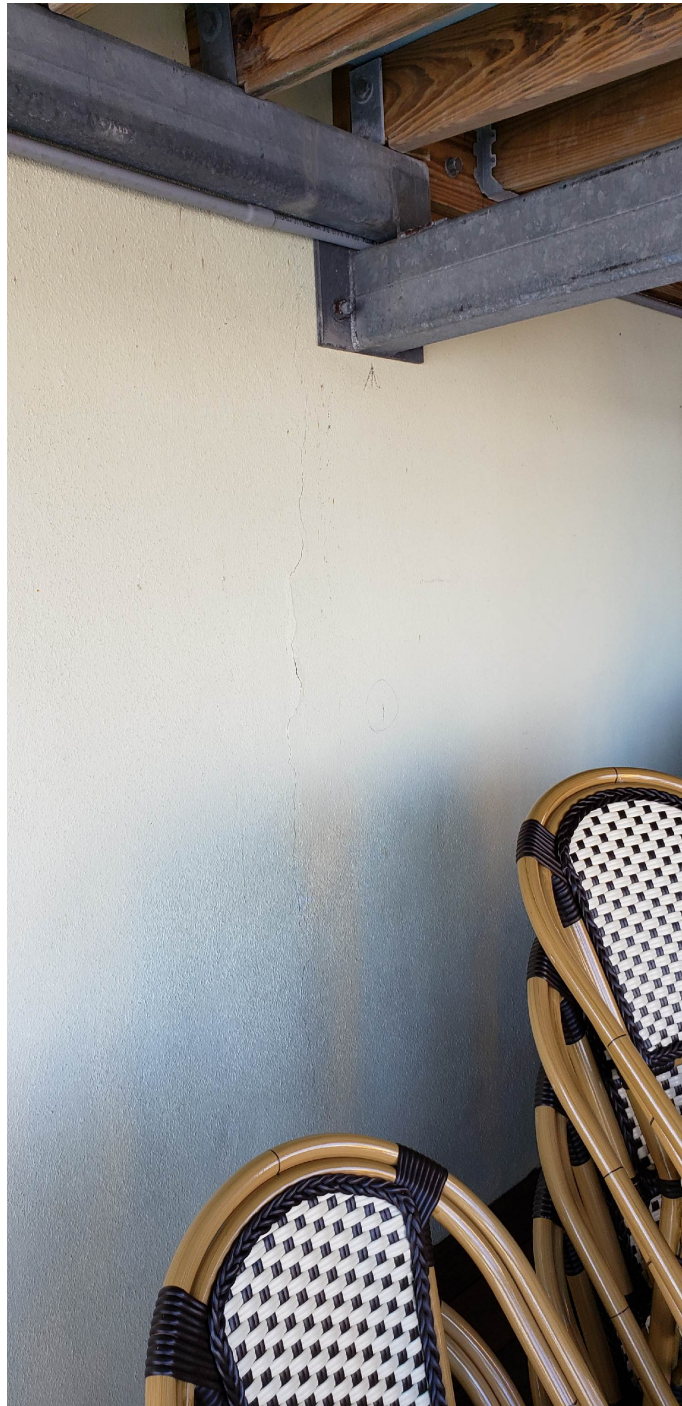
Figure 32. Location 24. Column is witnessing light cracking and spalling of concrete at second floor.

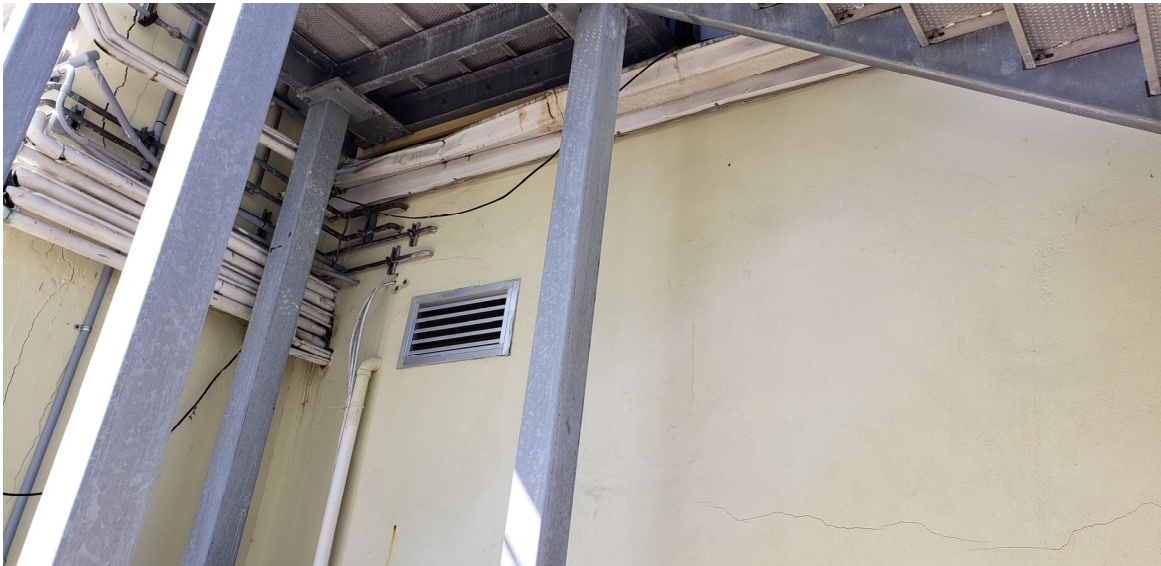
Figure 33. Location 25: Cracks in the wall (likely horizontal tie-beam spalling).

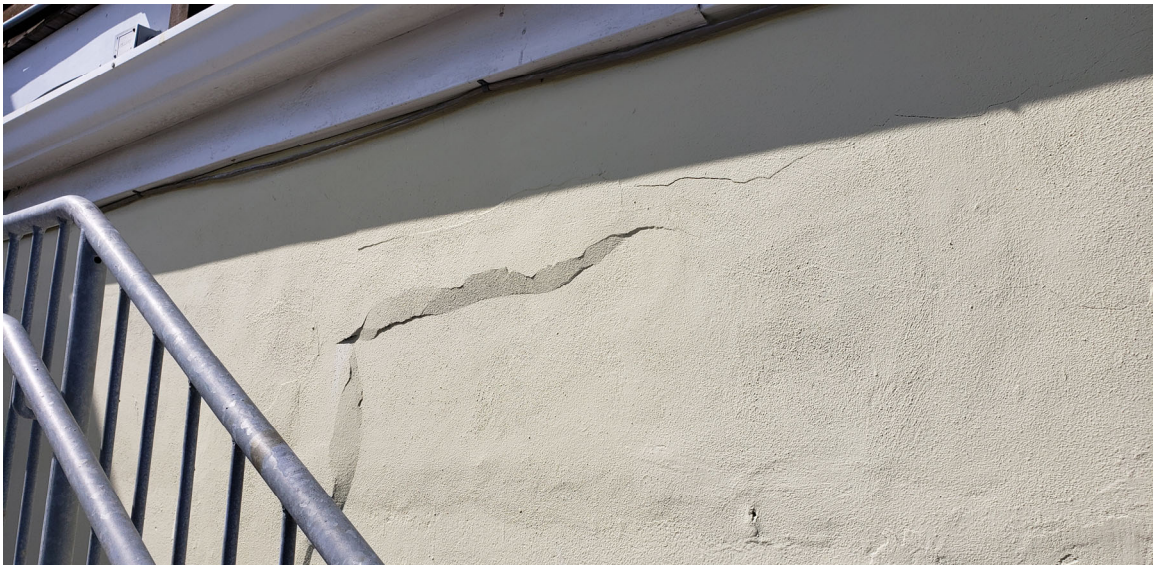
Figure 34. Between location 25 and 26. Above the staircase, the concrete tie-beam at the top has significant cracking in it. Heavy spalling and delamination of the concrete

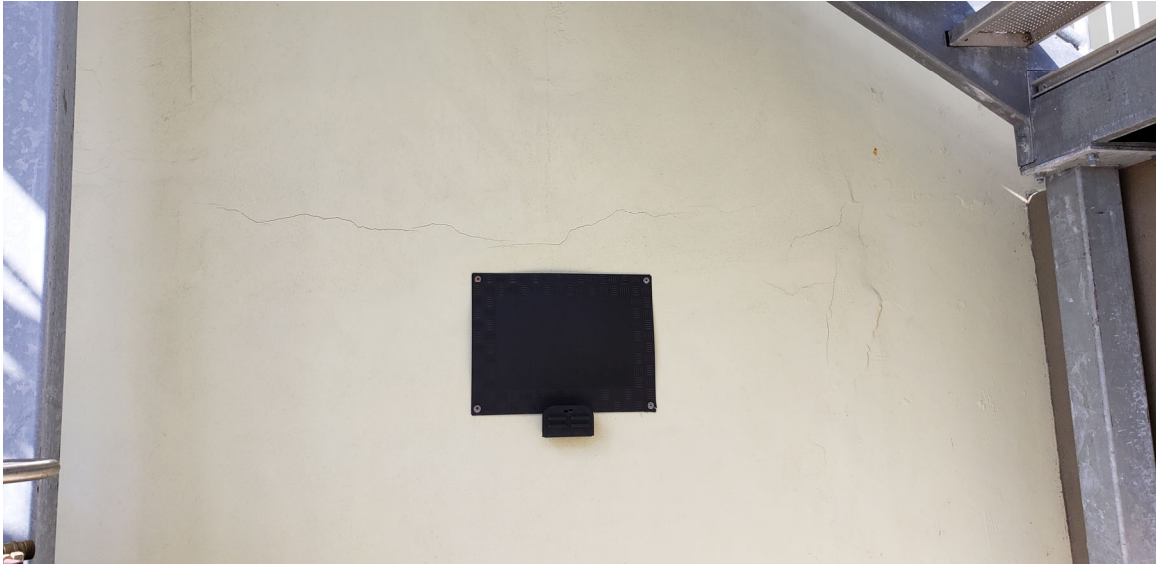
Figure 35. Location 28: Cracks formed in the wall in this area underneath the staircase as well.

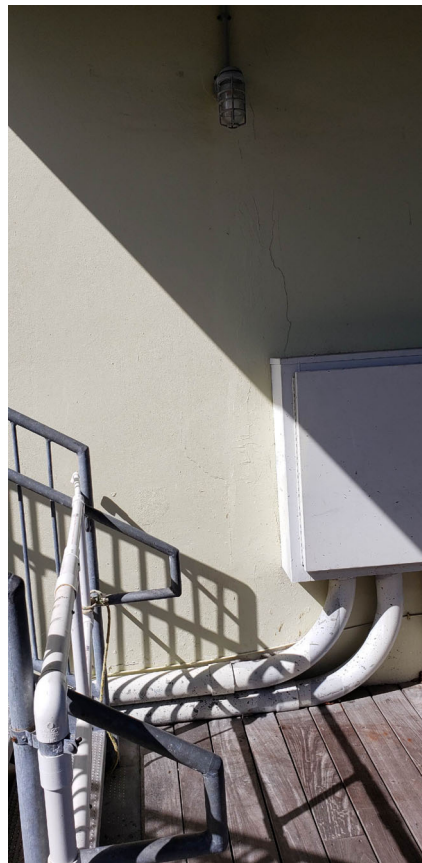
Figure 36. Location 29: Concrete spalling in the column and cracks developing.

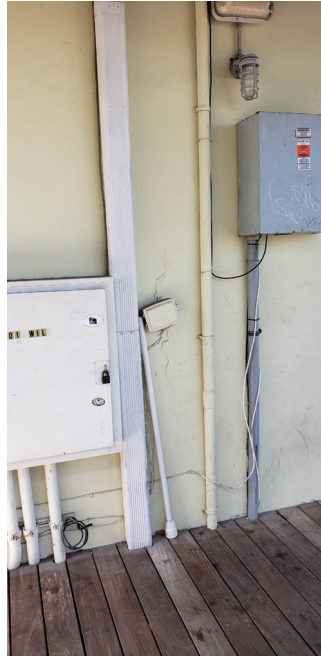
Figure 37. Location 30: Concrete spalling in the wall coupled with several cracks.

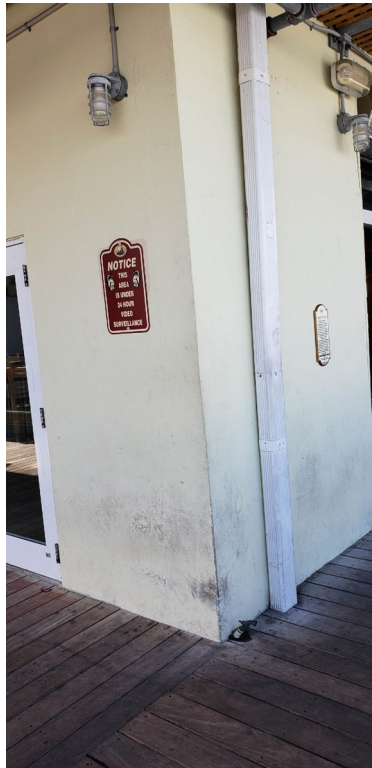
Figure 38. Location 31: Corner of the column showing concrete spalling covered with paint and sealant.

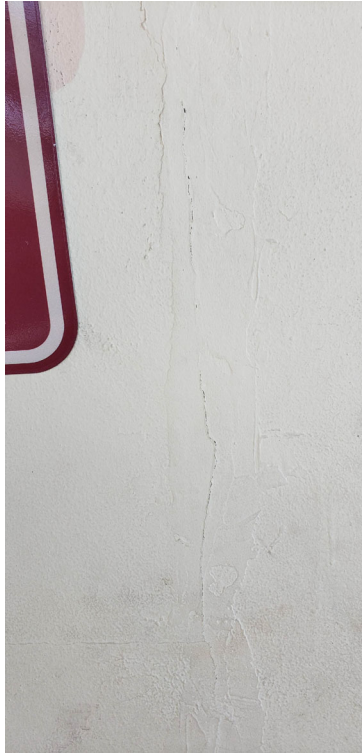
Figure 39. Location 31: Cracks developing at the corner in the wall.

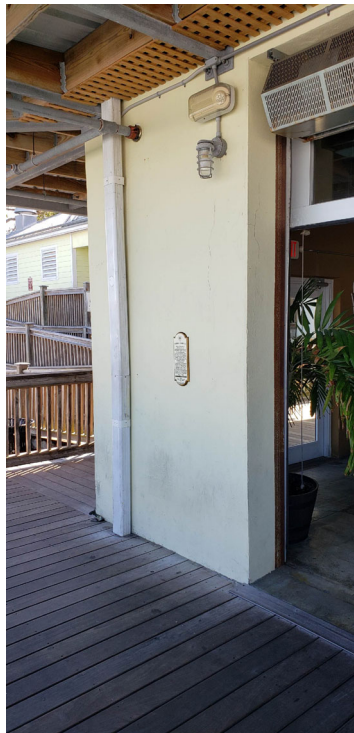
Figure 40. Location 32: Vertical cracks has formed in the column by the door.

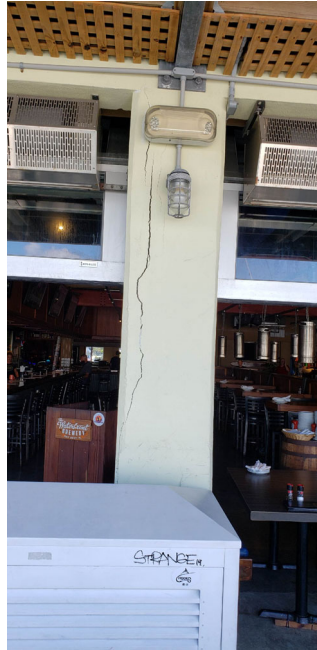
Figure 41. Location 34. Heavy damage in the column nearly next to entry to waterfront brewery from board walk side.

The column at location **34** requires new installation of a concrete column as well. Because the location of this column is situated in an area with large public presence throughout the day, we recommend a less-invasive approach. New casting of column would interfere with the businesses and flow of pedestrian traffic along main boardwalk of the port. The replacement of the column would provide much more efficient and lasting. An approved galvanic anode must be attached inside the column opening before new concrete is cast in the required patch region. Use of the anode would increase the durability of the repairs done. This approach will not resolve the issue permanently though. It is up to the discretion of the City of Key West whether to repair the column without complete removal or to demolish the column and cast a fully new one at its place.

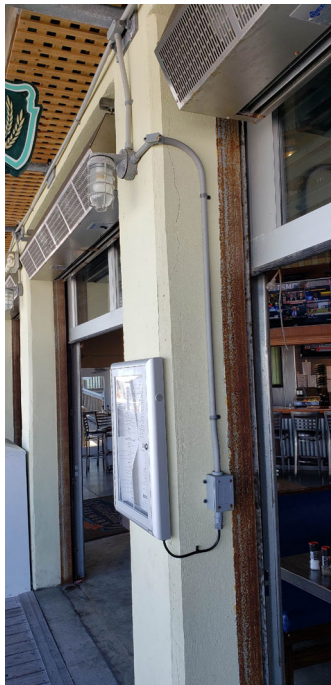
Figure 42. Location 35. Small vertical cracks in the column have formed at its mid-height and at the bottom.

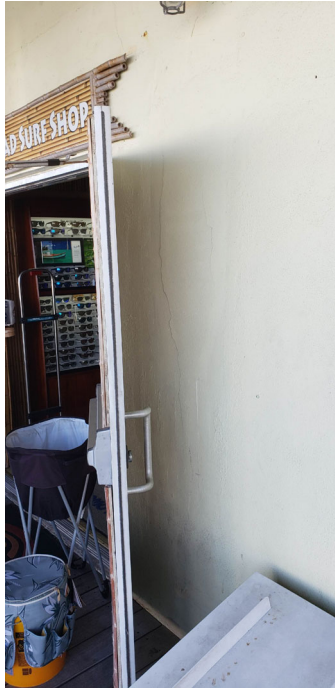
Figure 43. Location 36. Vertical cracks in the column starting from the bottom to its mid-height.

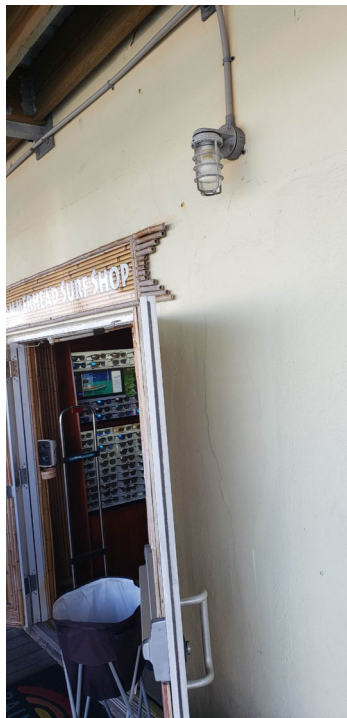
Figure 44. Location 36. Horizontal cracks in the wall can be seen developed above the door.

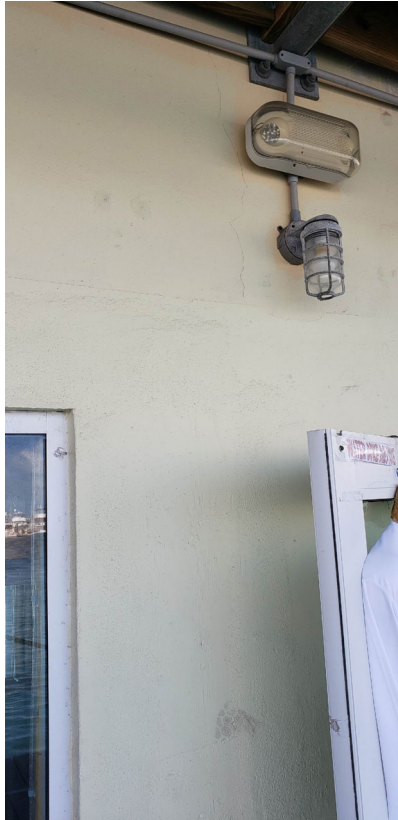
Figure 45. Location 37&38. Horizontal and vertical cracks in the wall propagating spalling of tie beams.
