Structural evaluation report

of exposed walls, columns, beams, and slabs affected by concrete spalling.

**Structural Complex housing Port Operations,
Waterfront Brewery, Retail, and other uses.
201 William St, Key West, FL 33040**

July 19, 2019

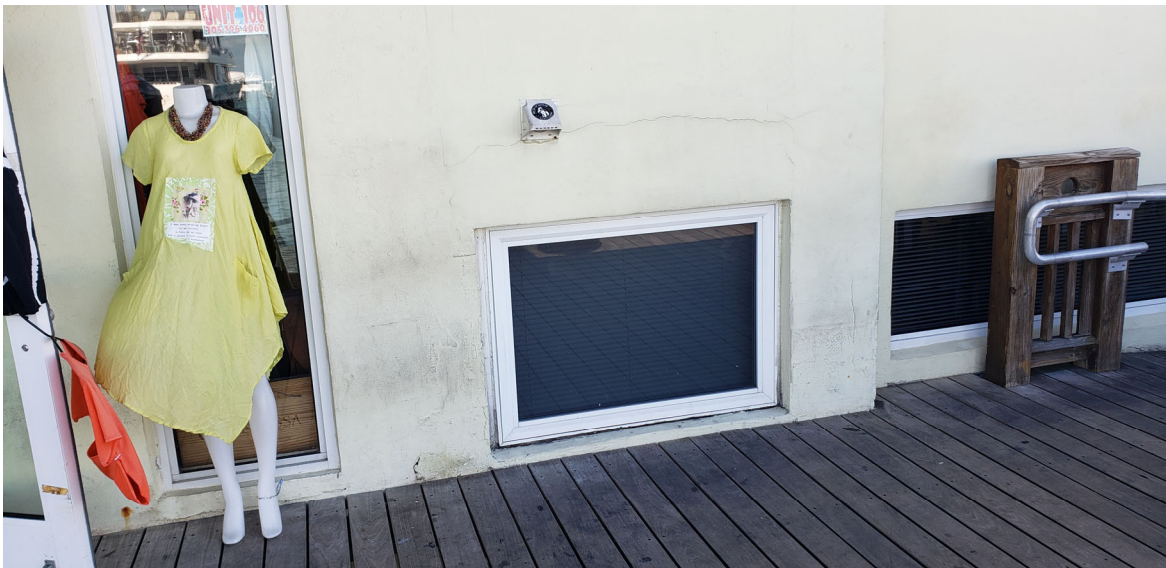
Figure 46. Location 39: Light cracking and spalling of concrete beam above low windows.

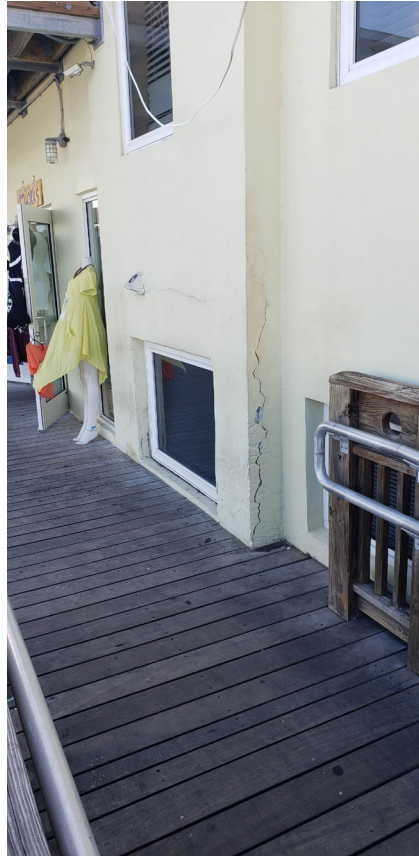
Figure 47. Location 40: Large cracks and heavy spalling of concrete in corner column.

The columns that require total replacement are located at Locations **4,9,10,11,12,18,22 and 40**. Temporary shoring and bracing for beams and walls at respective column locations must be provided to provide structural safety to the occupants and the public. The columns, after the supported structure is supported temporarily, shall be demolished till the top of the existing foundation they rest on. The reinforcement cages of the new column would be doweled into the existing foundation. Subsequently, fresh concrete can be then cast once the reinforcement is in place.

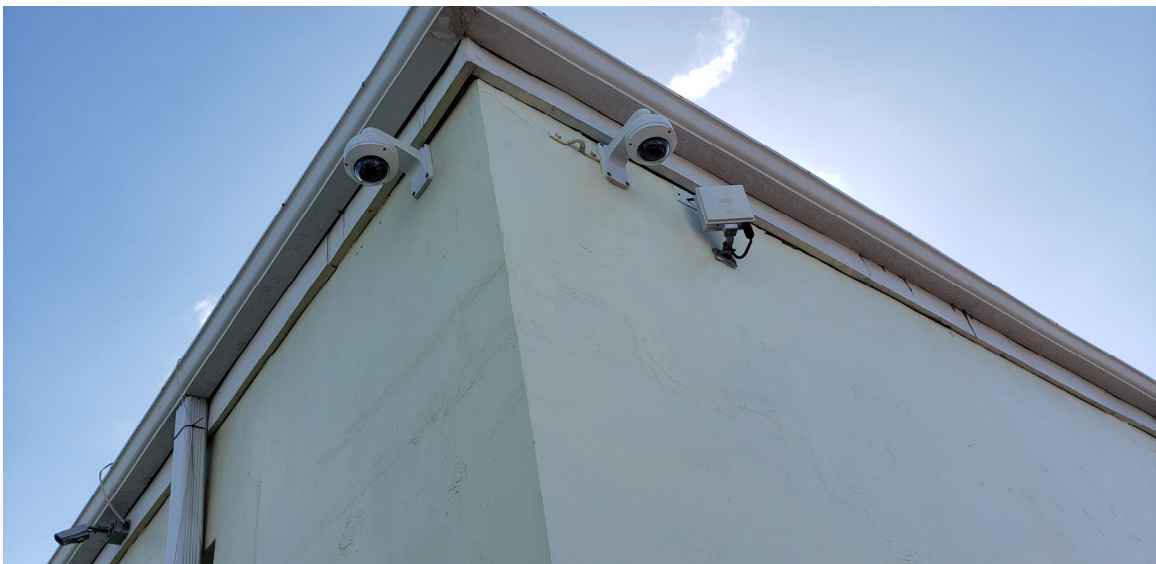
Figure 48. Location 41: Step ladder cracks in the wall starting from roof level propagating downwards. Likely related to incidental settlements of foundations.

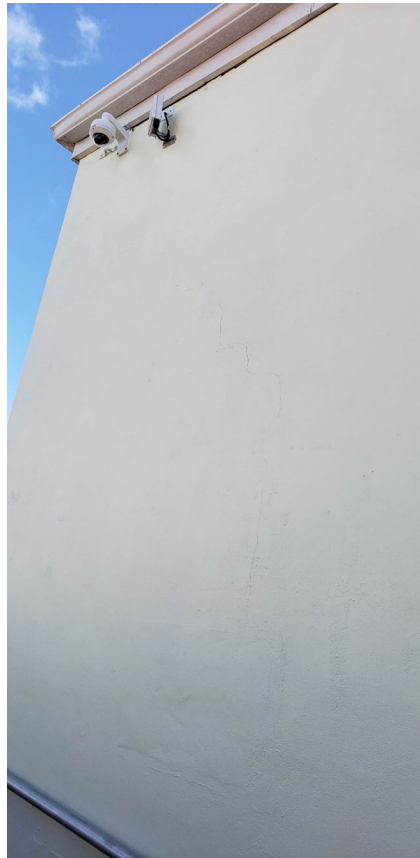
Figure 49. Location 42. Step ladder cracks visible propagating further down

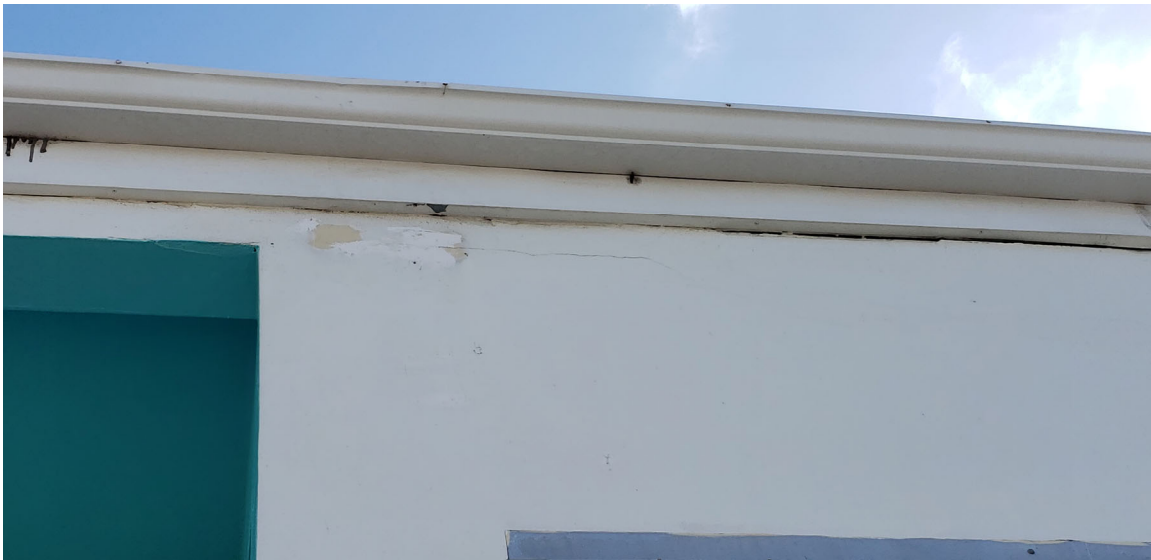
Figure 50. Location 43: Cracks forming in the wall at roof level. Please note that top of roof level tie-beam is concealed with fascia board and gutters. Likely more similar spalling will be observed.

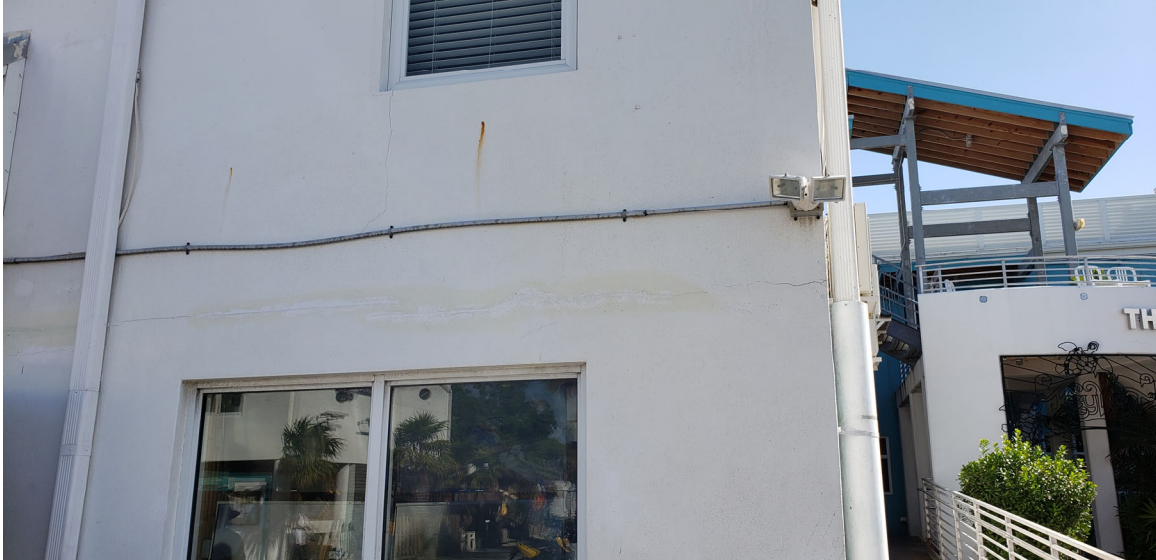
Figure 52. Location 44: Cracking in the tie-beam is continued here from Figure 50 as well. The portion of the wall above the tie-beam is also experiencing vertical cracking (bottom left corner of the top window).

The cast-in-place concrete tie-beam between locations **9 and 12, 18 and 19** and **43 and 44** needs to be removed completely and be replaced with new tie-beams that shall be cast with new concrete and new rebar. The tie-beams between location **9 and 12, and 43 and 44** are approximately located at the mid-height of their walls. The one between location **18 and 19** is located at the top of the wall. Once the temporary supports are provided to the structure supported by the tie-beams, the beams can be demolished in a set of segments. Each set would be demolished, new rebar will be placed, and casting of fresh concrete shall follow. Remaining sets of segments of the beams would be cast one at a time to ensure structural integrity of the building. Proper lapping of reinforcement between segments would need to be provided by the means of doweling into existing segments.

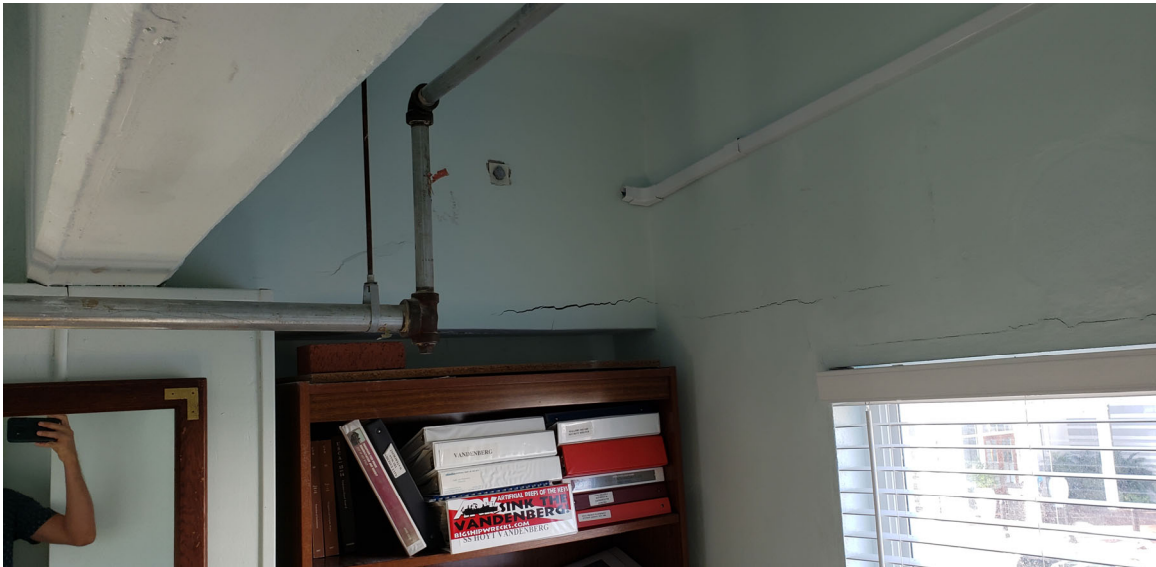
Figure 53. Location 44: The tie-beam above the window on the second floor at location 44 is getting large horizontal cracks.
