STAFF REPORT

RE: 100 Grinnell Street

(permit application # T2021-0156 and T2021-0157)

FROM: Karen DeMaria, City of Key West Urban Forestry Manager

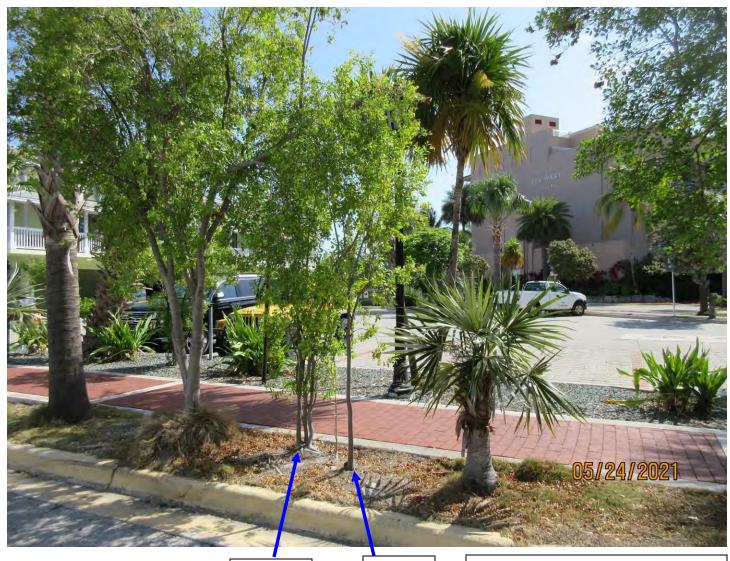
Photo showing location of trees along Grinnell Street.

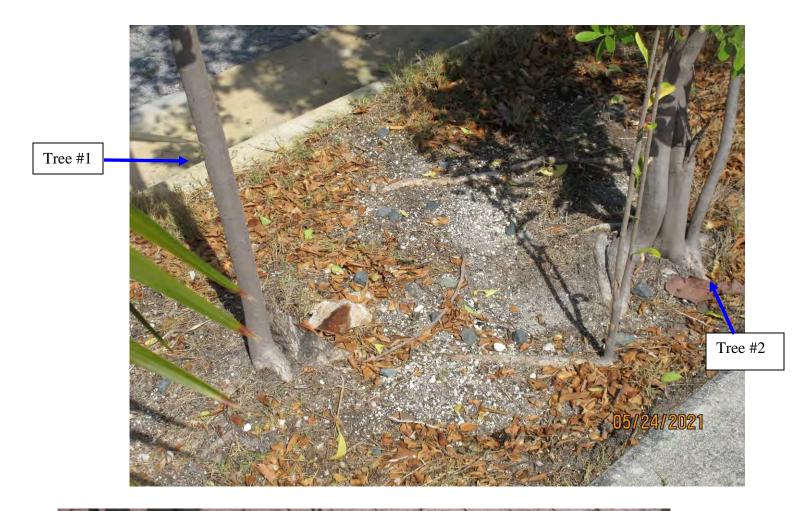
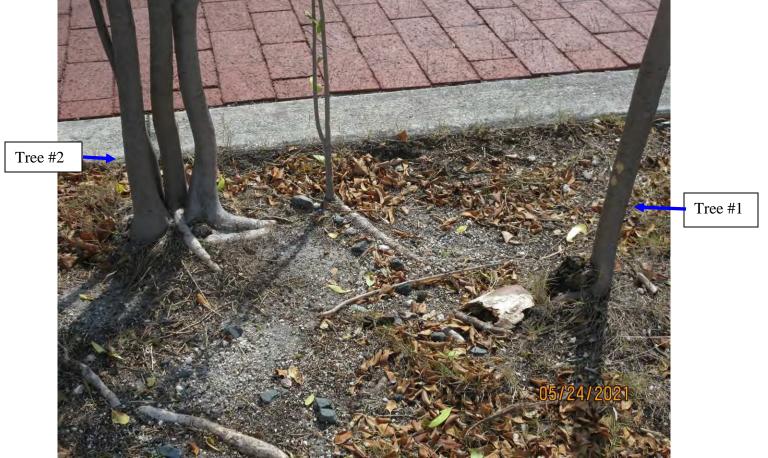
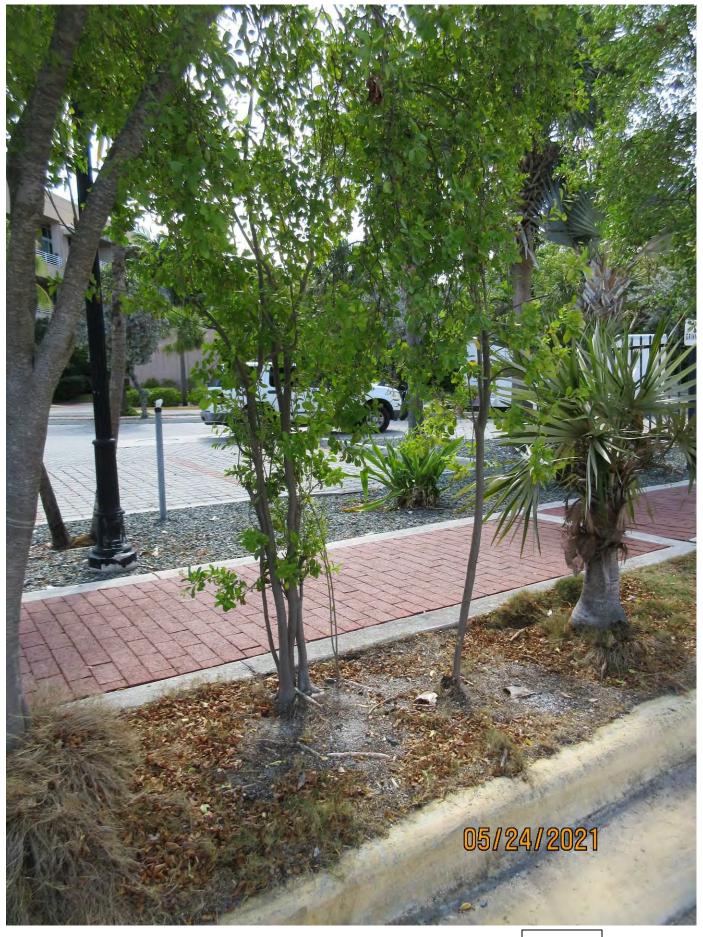
Tree #1-Diameter: 1.5"

Location: 80% (growing in center of sidewalk planter from root system of

mother tree, very visible)

Condition: 70% (overall condition is good to fair. Young, single trunked

tree.)

Tree #2-Diameter: 2.5" (multi trunked)

Location: 70% (growing in sidewalk planter closer to edge, under canopy of

mother tree, growing from root system of mother tree, very visible.)

Condition: 60% (overall condition is fair, multi trunked young tree, as tree grows there will be competition with trunks creating included bark. Visible girdled root across surface)

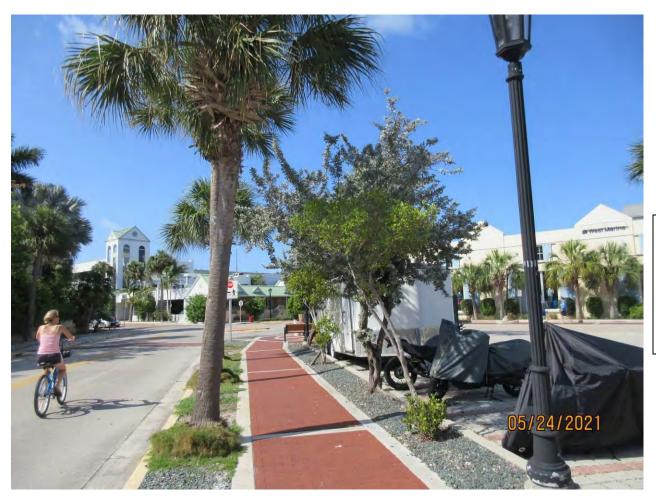
Photo showing location of trees along Trumbo Road sidewalk area.

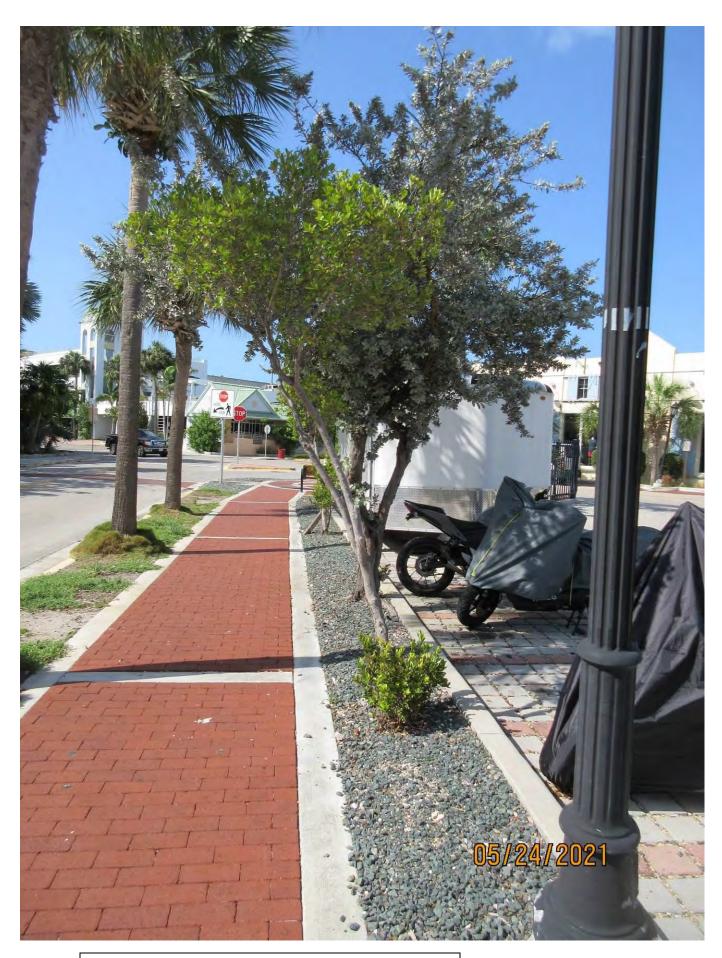
Standing on sidewalk, photo showing tree #7, view 1.

Condition: 50% (overall condition is fair to poor. Tree heavily damaged during Hurricane Irma but is recovering, growth lean toward sidewalk)

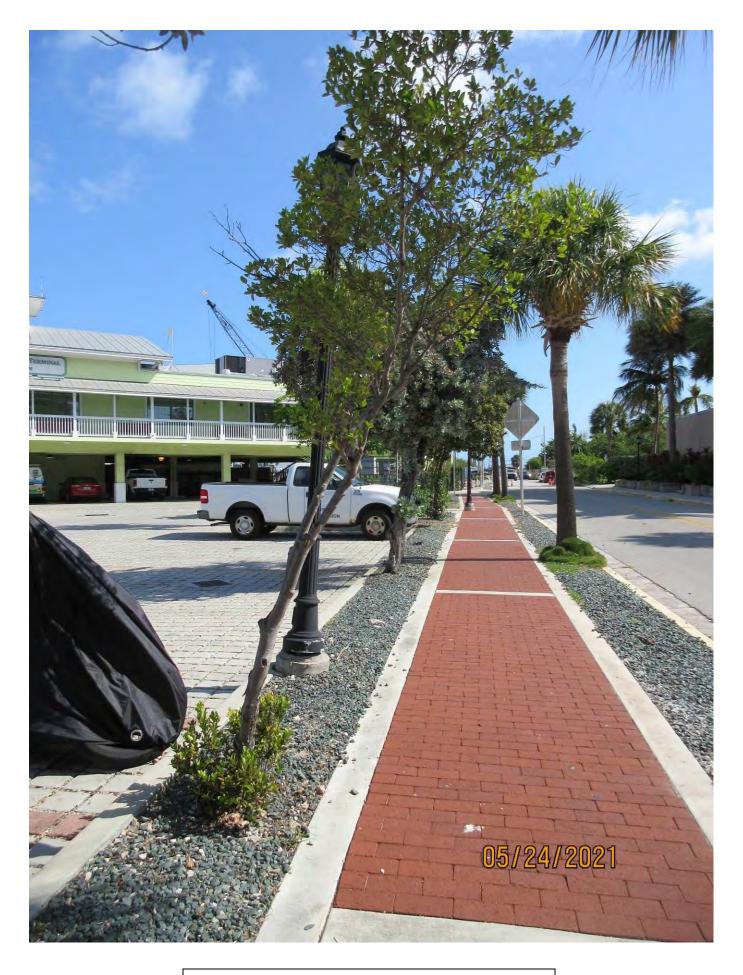
Standing on sidewalk, photo showing tree #7, view 2.

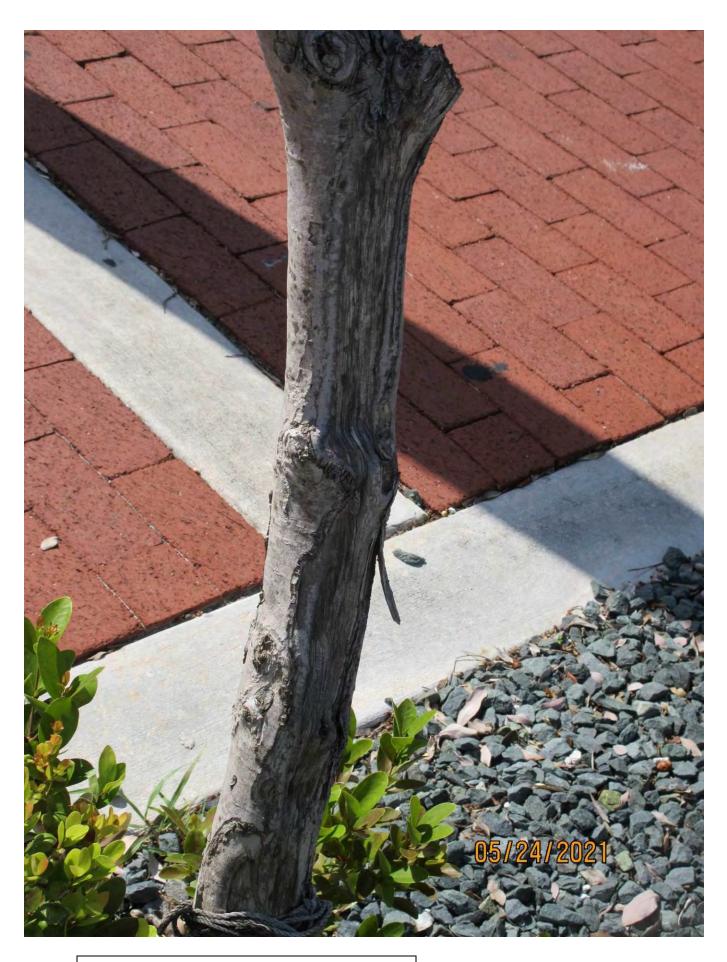
Close up photo of tree #7 showing trunk damage.

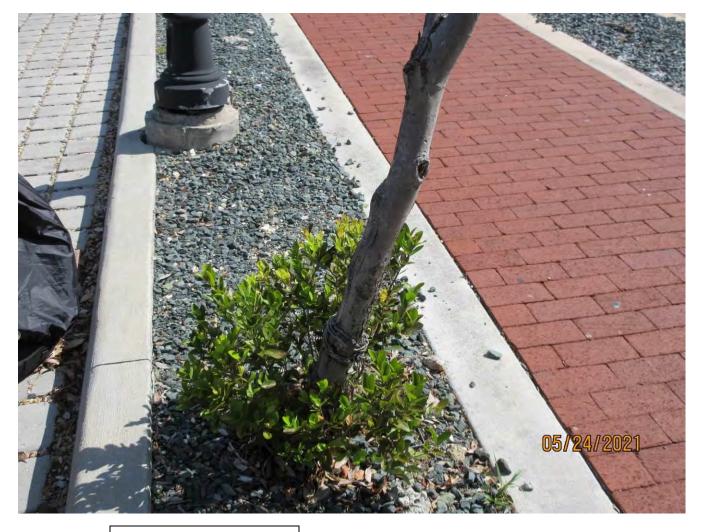
Photo of base of tree #7.

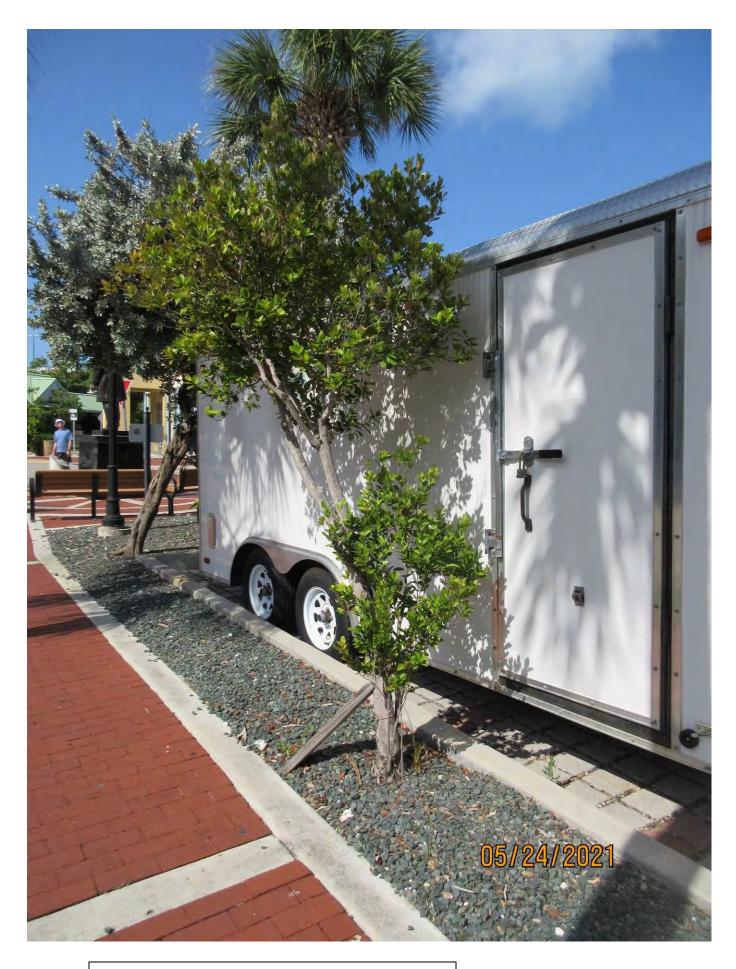
Standing on sidewalk, photo showing tree #8, view 1.

Condition: 50% (overall condition is fair to poor, tree heavily damaged by

Hurricane Irma but us trying to recover.)

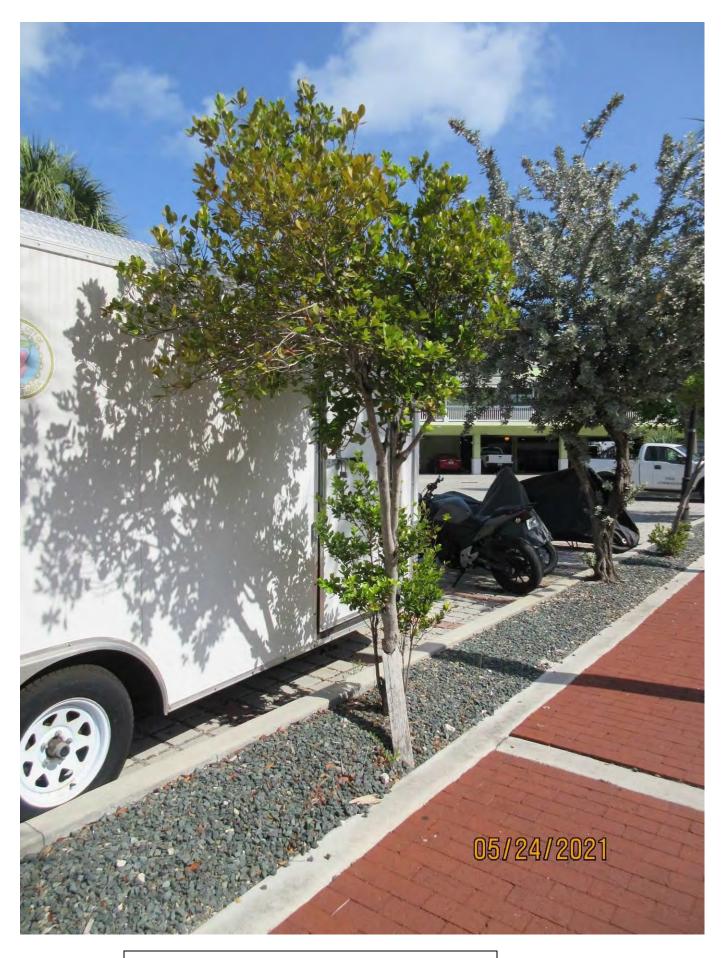
Standing on sidewalk, photo showing tree #8, view 2.

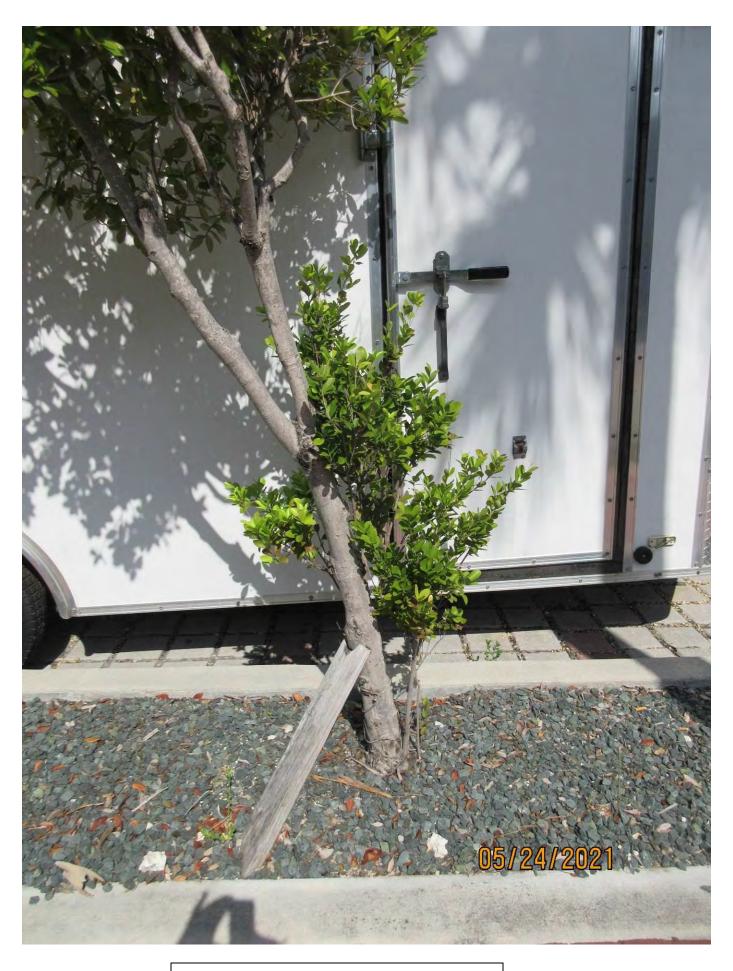
Photo showing base of tree and trunk structure.

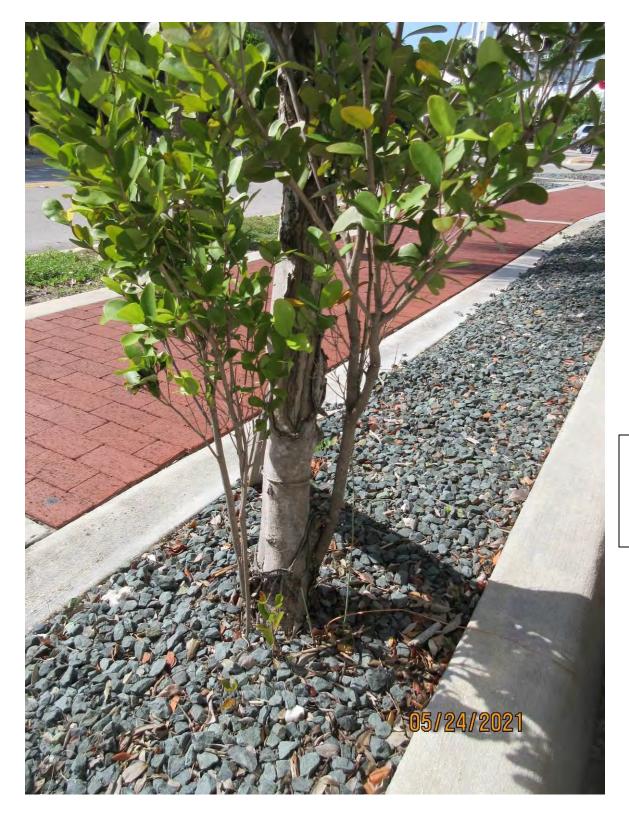
Photo showing base of tree and trunk damage.

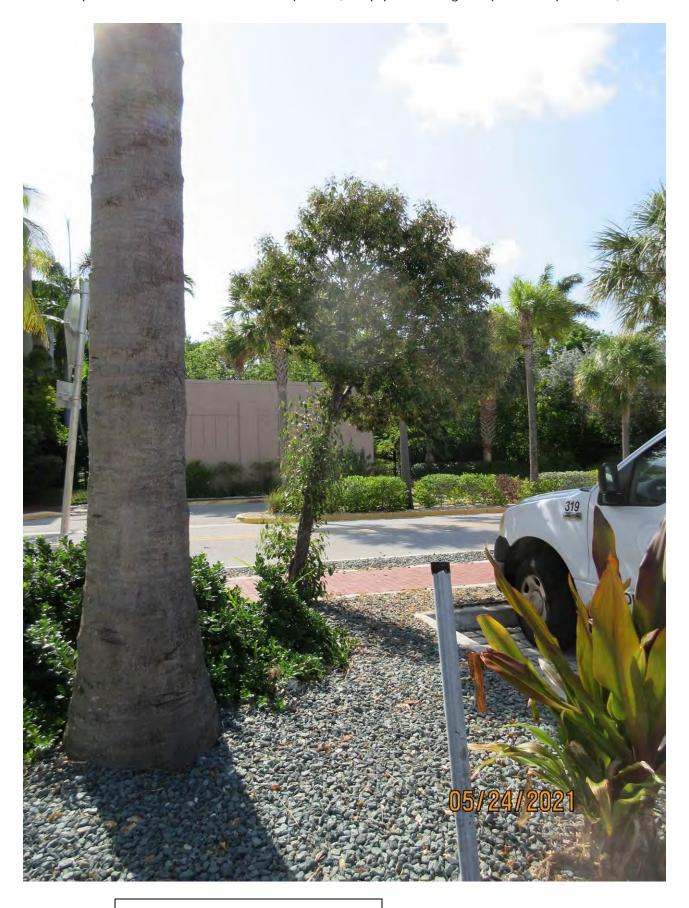
View of tree #5 from parking lot.

Condition: 50% (overall condition is fair to poor, tree has growth lean

toward sidewalk, trunk damage from Hurricane Irma)

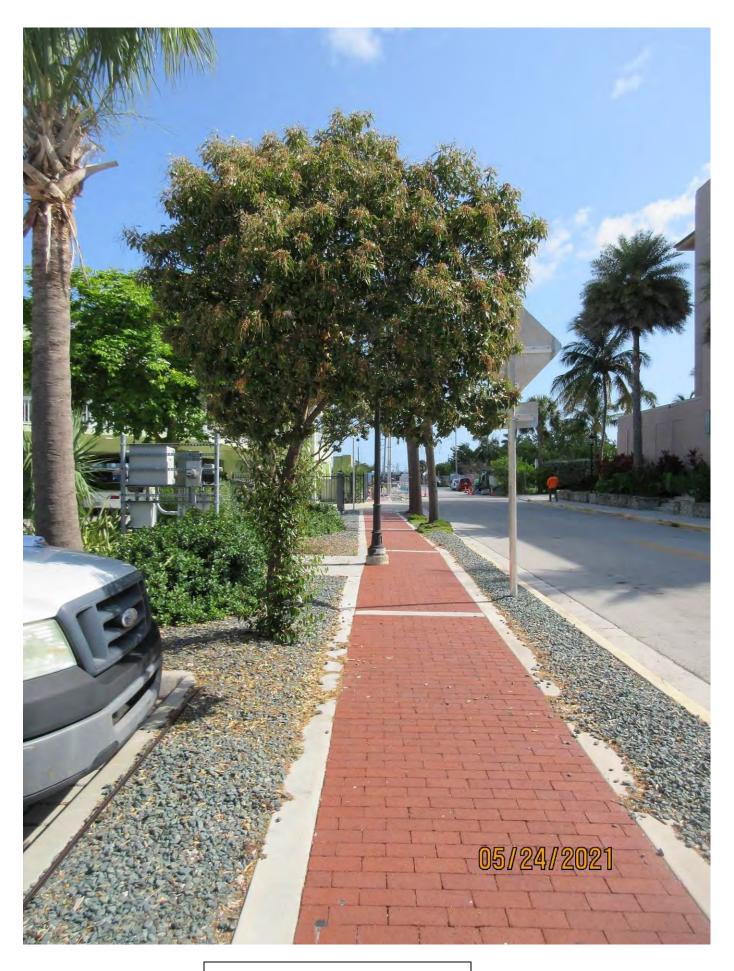
Photo of whole tree showing location.

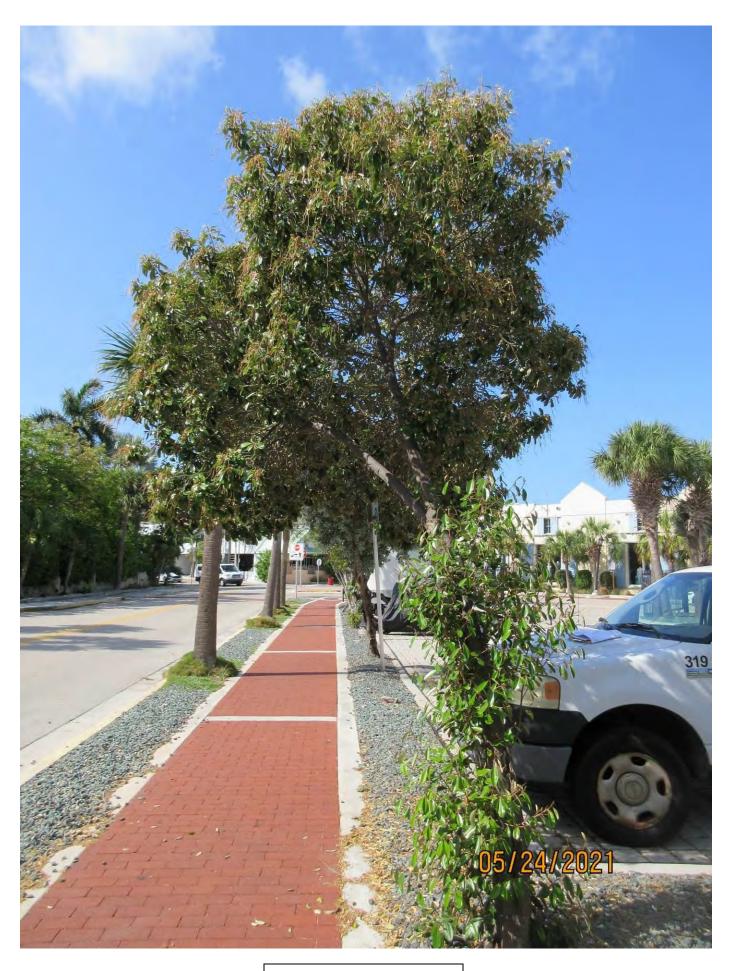
Closer view of whole tree.

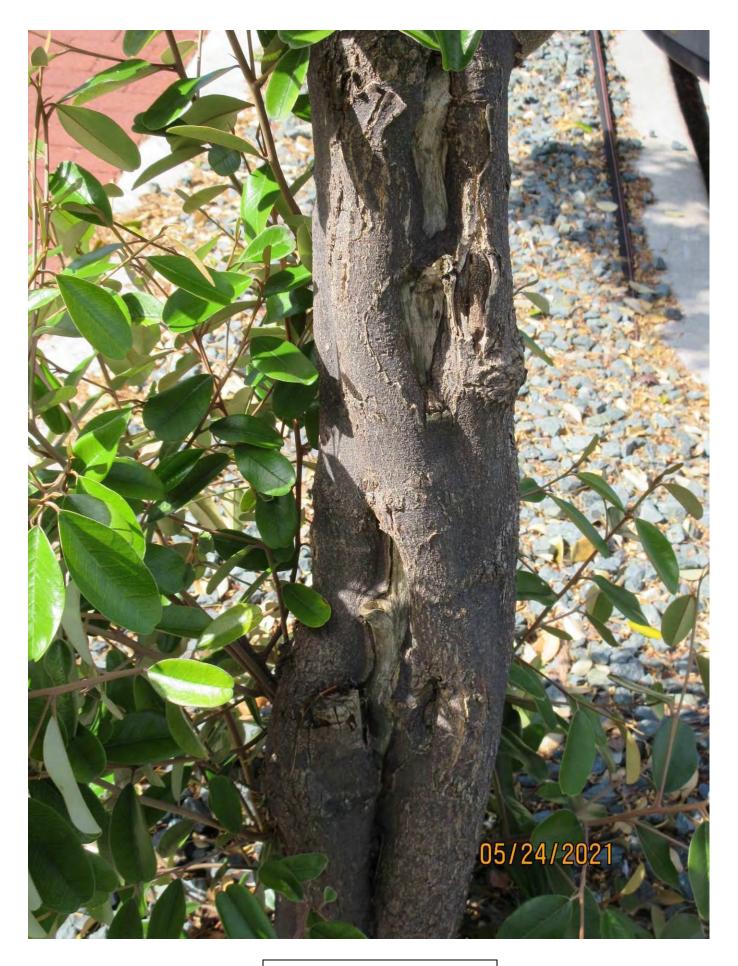
Close up view of trunk damage.

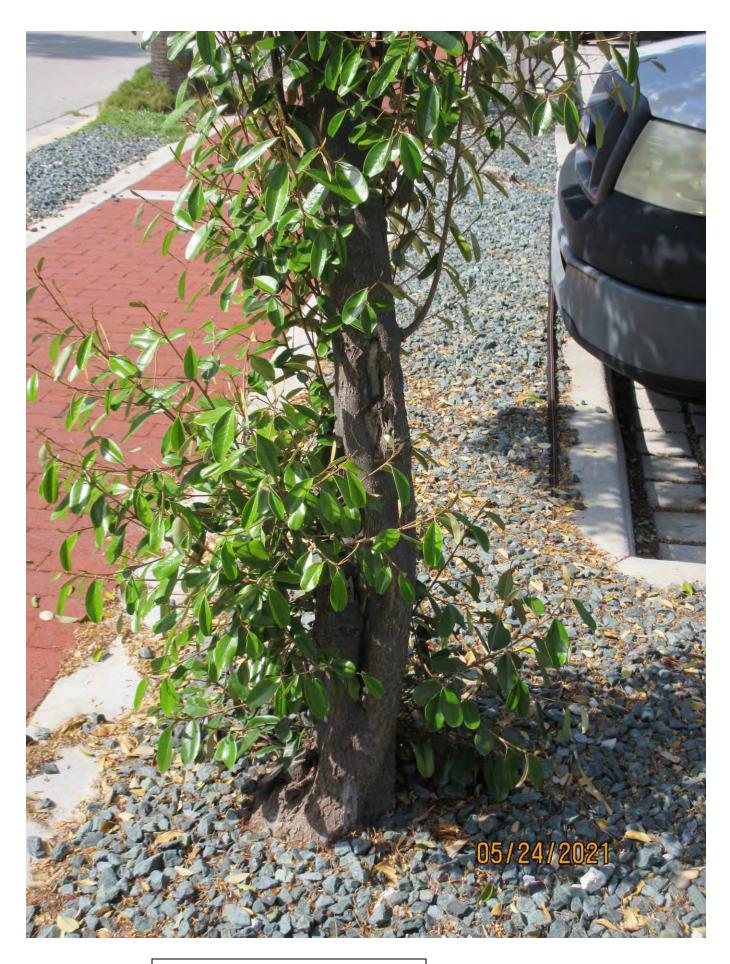
Photo showing base of tree and trunk.

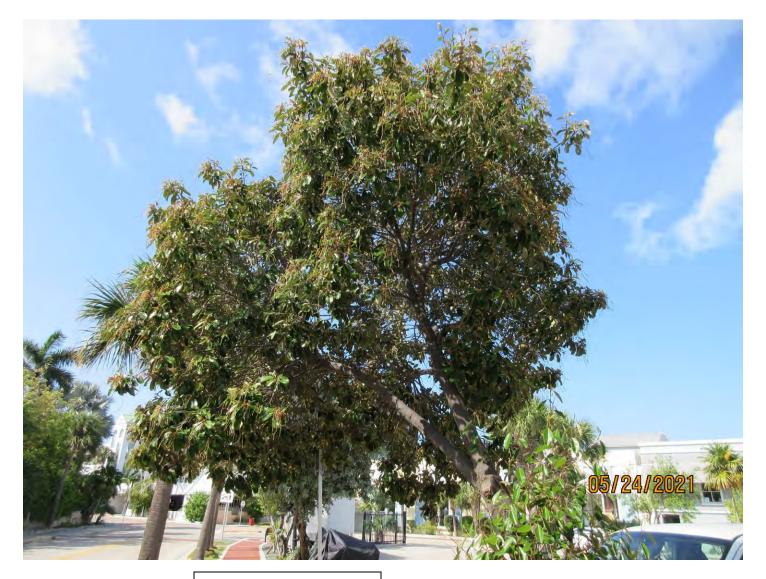
Photo of tree canopy.
