STAFF REPORT

RE: 613-631 Greene Street (permit application # T2021-0202)
(Tree located at 613 Greene)

FROM: Karen DeMaria, City of Key West Urban Forestry Manager

An application was received requesting the removal of (1) Strangler Fig tree. A site inspection was done and documented the following:

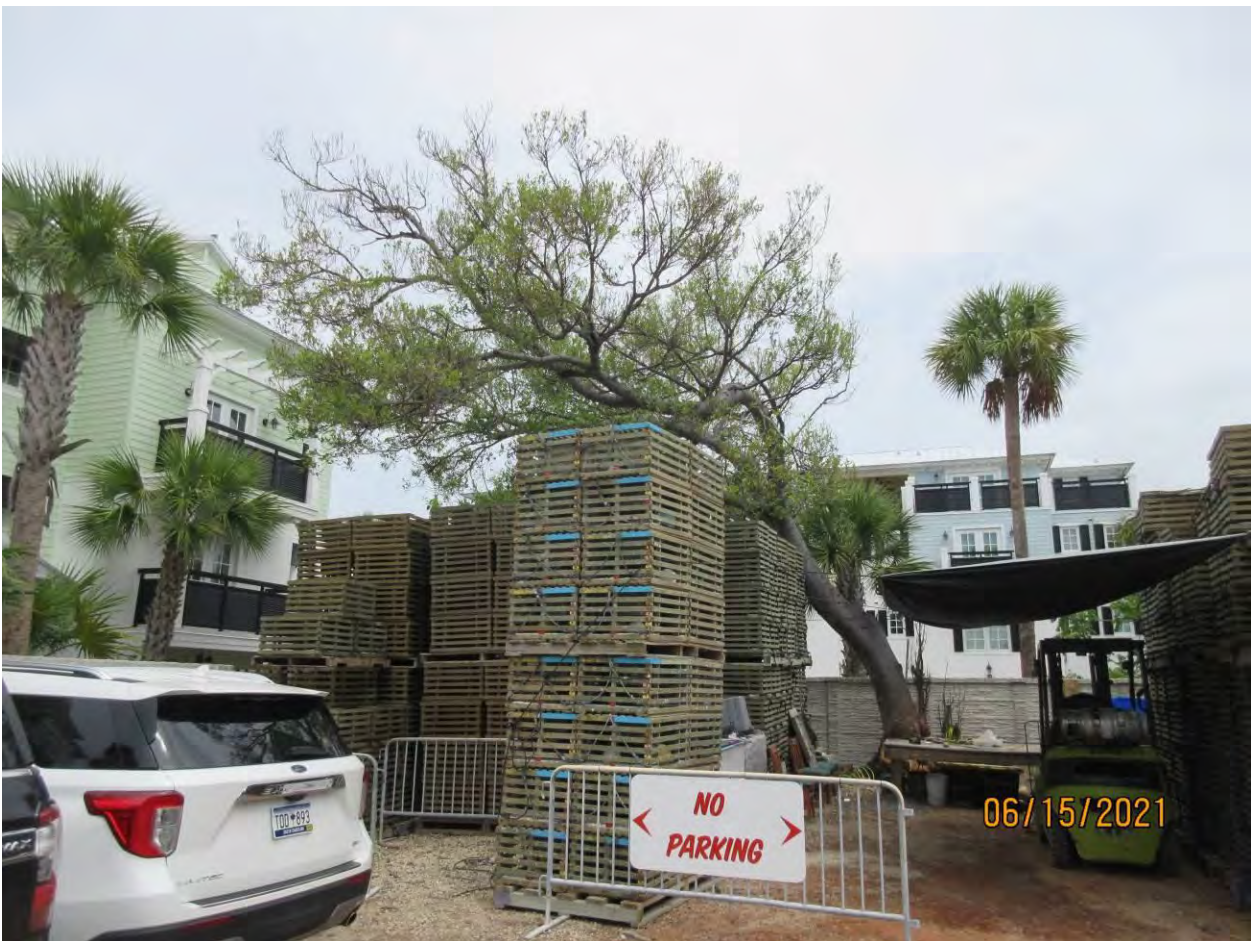
Photo of remaining tree on June 15, 2021. A large section of the tree broke off and fell into parking area a week prior to this photo.

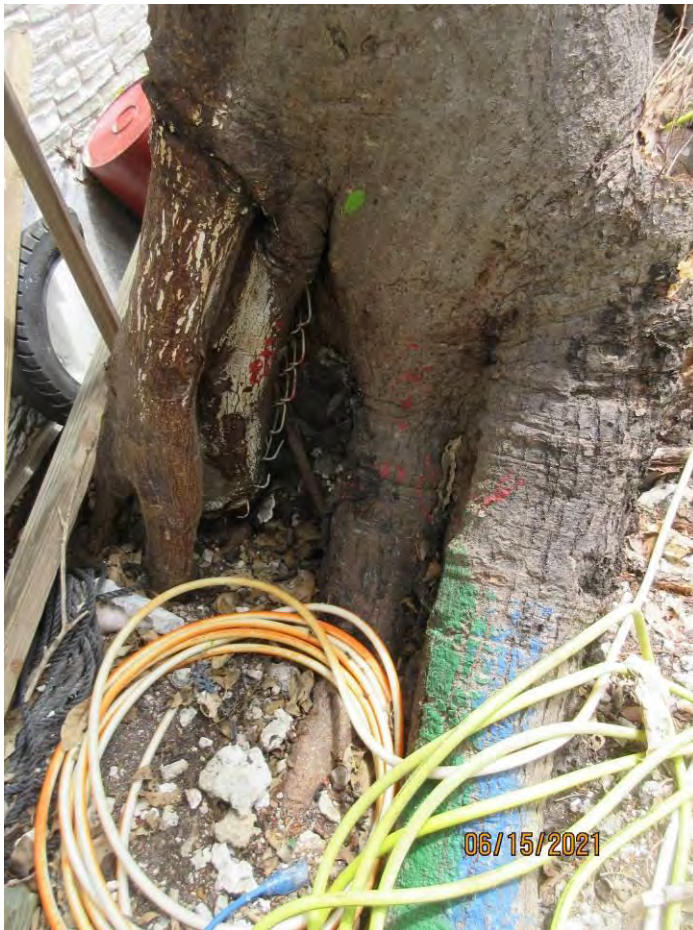
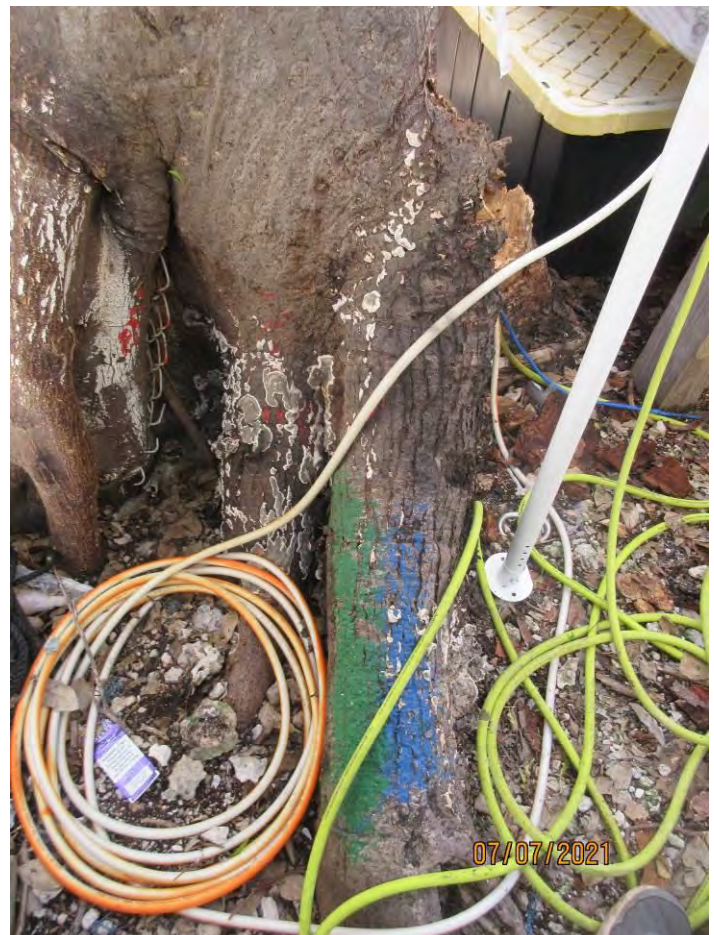
Two photos showing base of tree a few weeks apart-note wood rotting fungus growth.

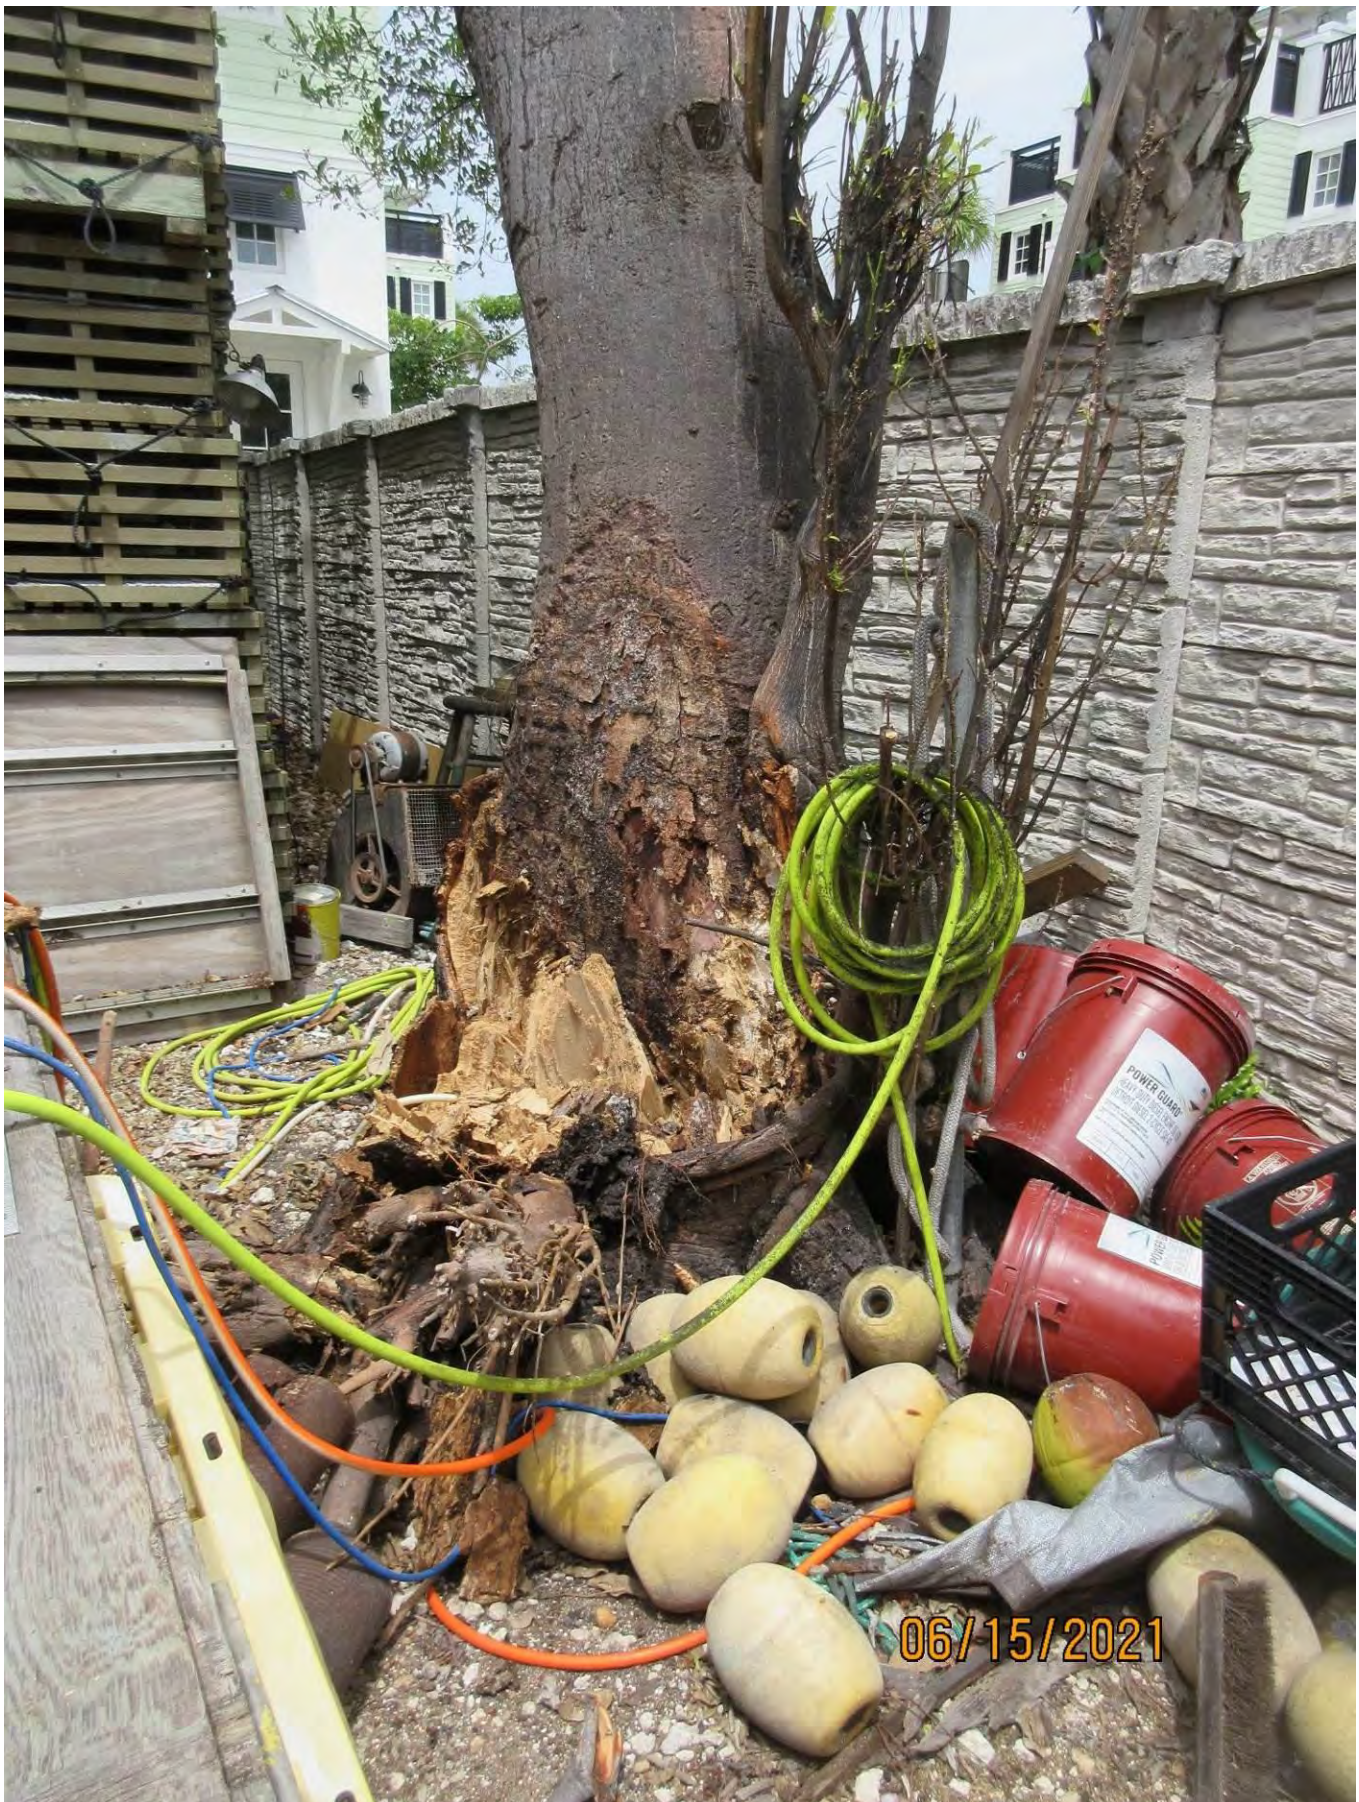
Photo of base of tree showing area where trunk tore/broke off main tree (was a codominant tree trunk system with included bark).

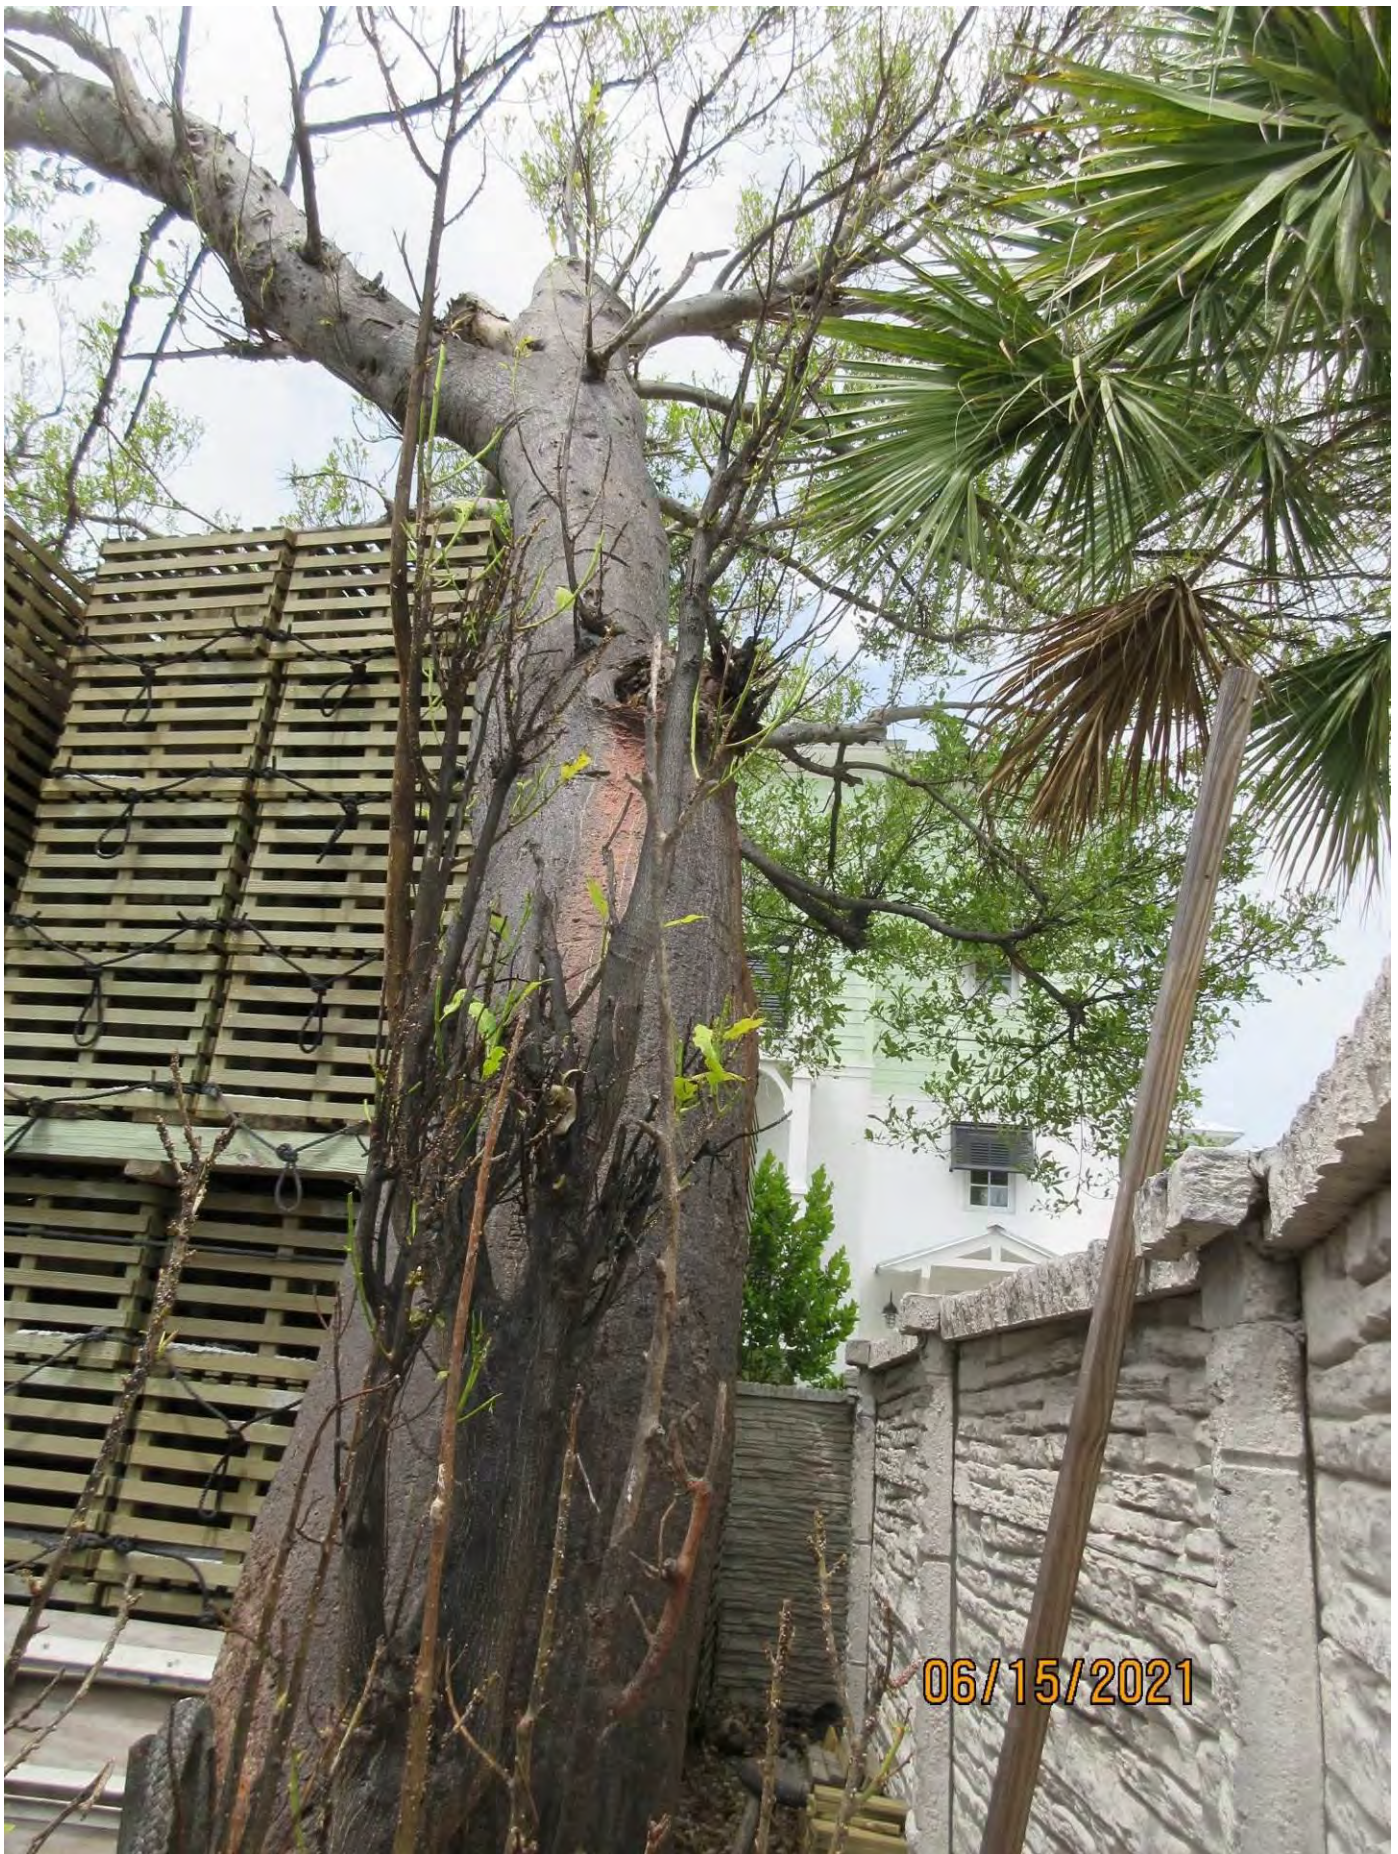
Photo of remain tree trunk, view 1.

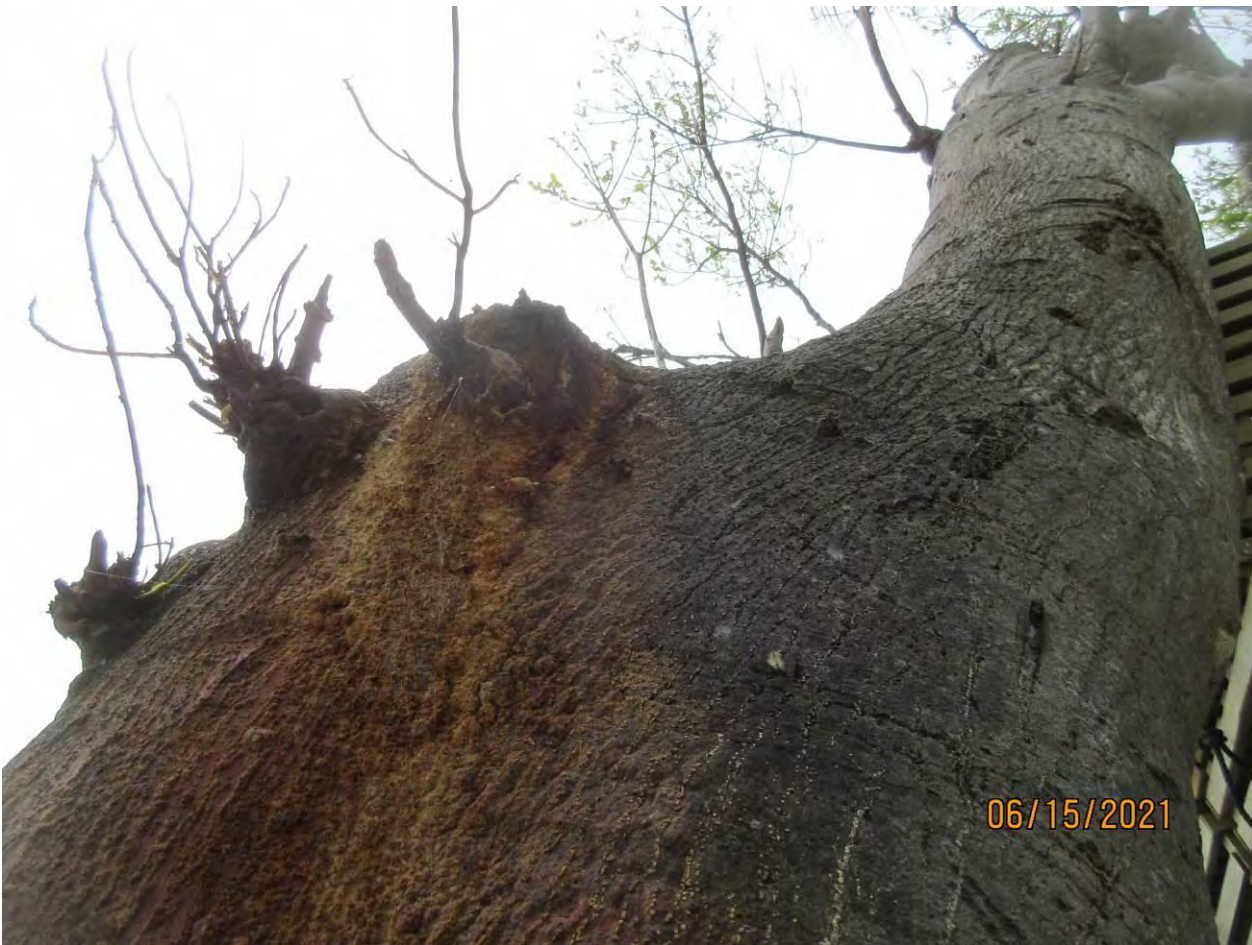
Photo of tree trunk, view 2.

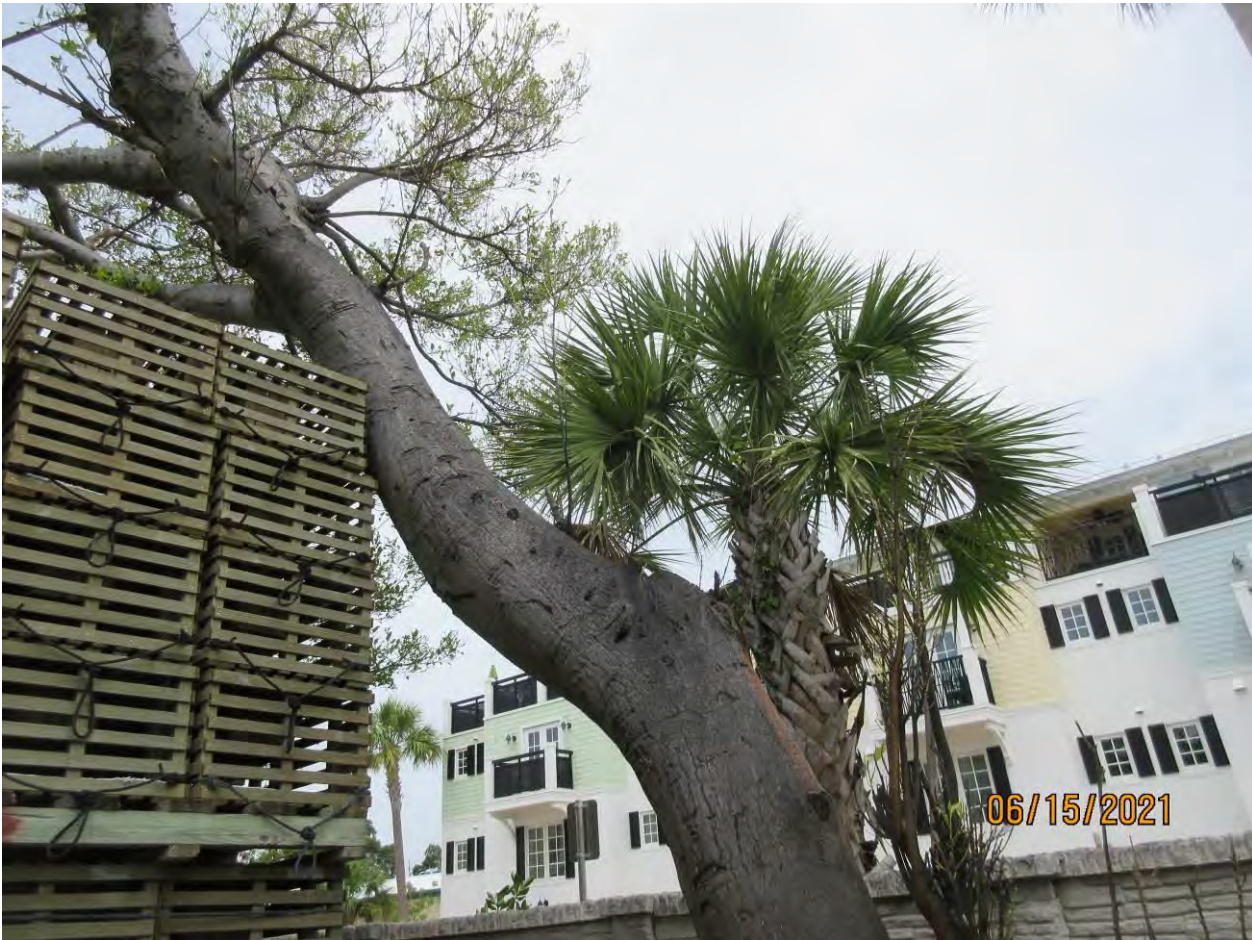
Photo of tree trunk, view 3.

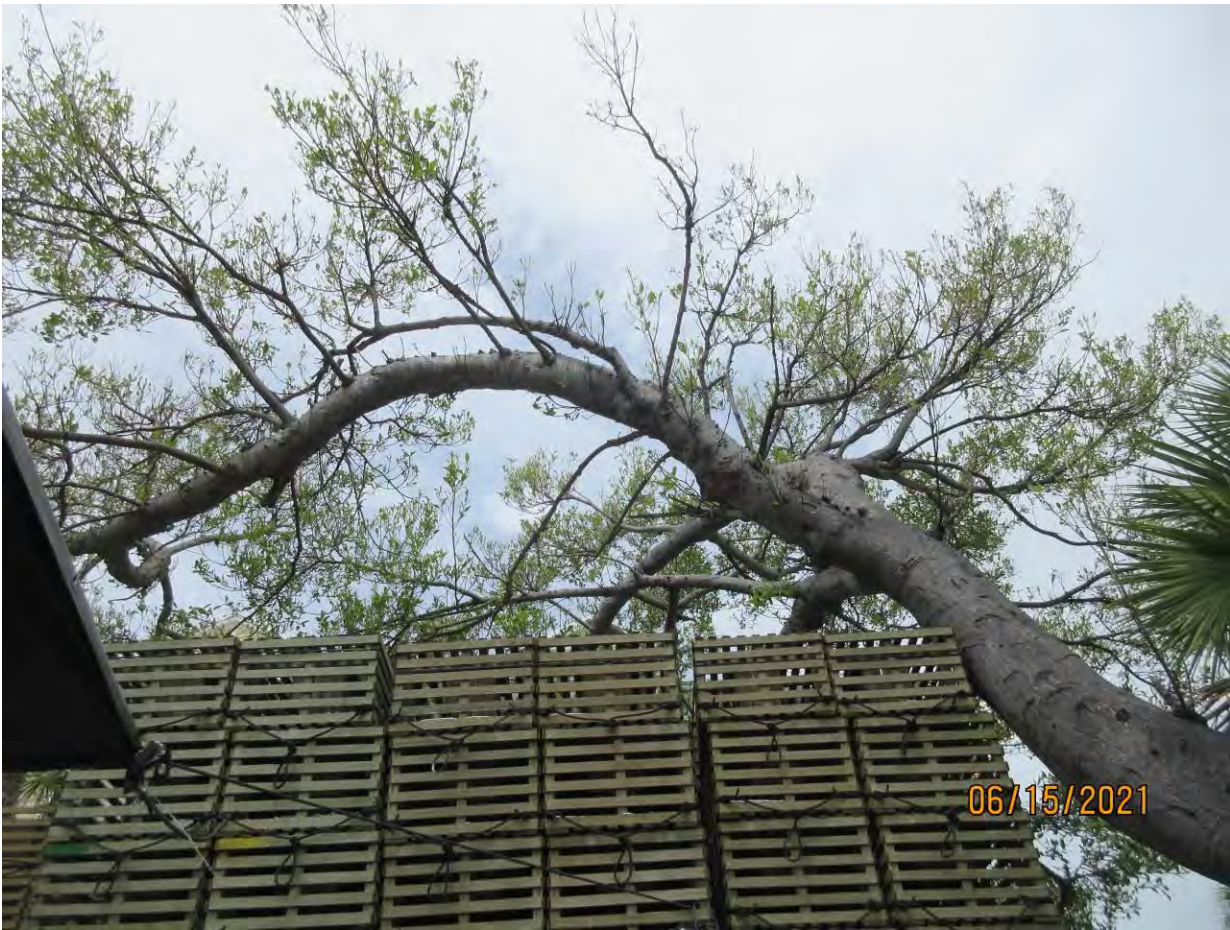
Photo of
tree
canopy.

Condition: 40% (poor, part of canopy broke off tree-codominant trunks with included bark, canopy very lopsided)

Currently, the remaining trunk is severely one sided and a potential threat of failure during a storm. If tree is to remain, a heavy crown reduction would be needed. Due to the lopsided structure of the remaining trunk and canopy branches, a severe crown reduction would eliminate a significant portion of the tree canopy and tree might go into decline.

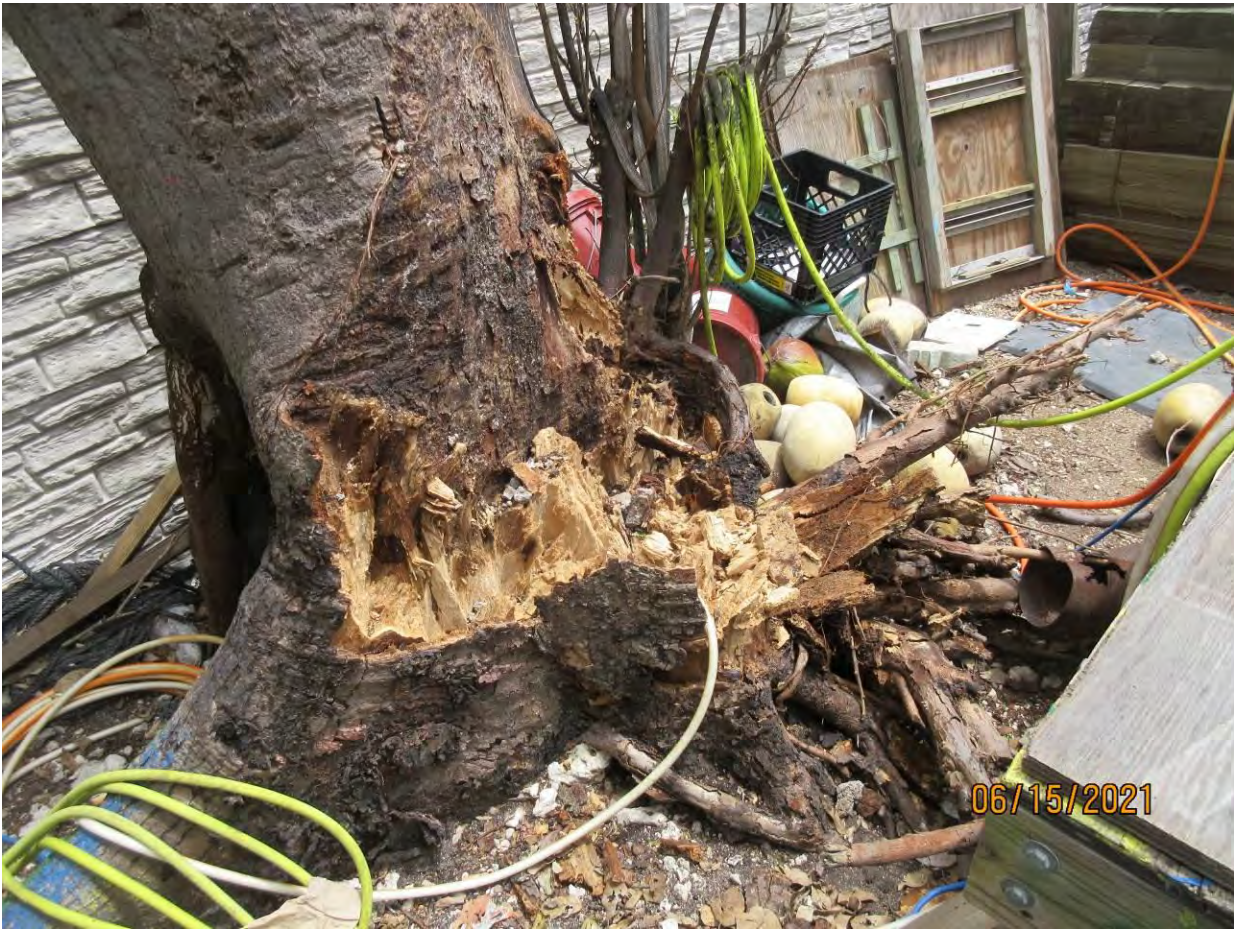
Photo of
base of tree.

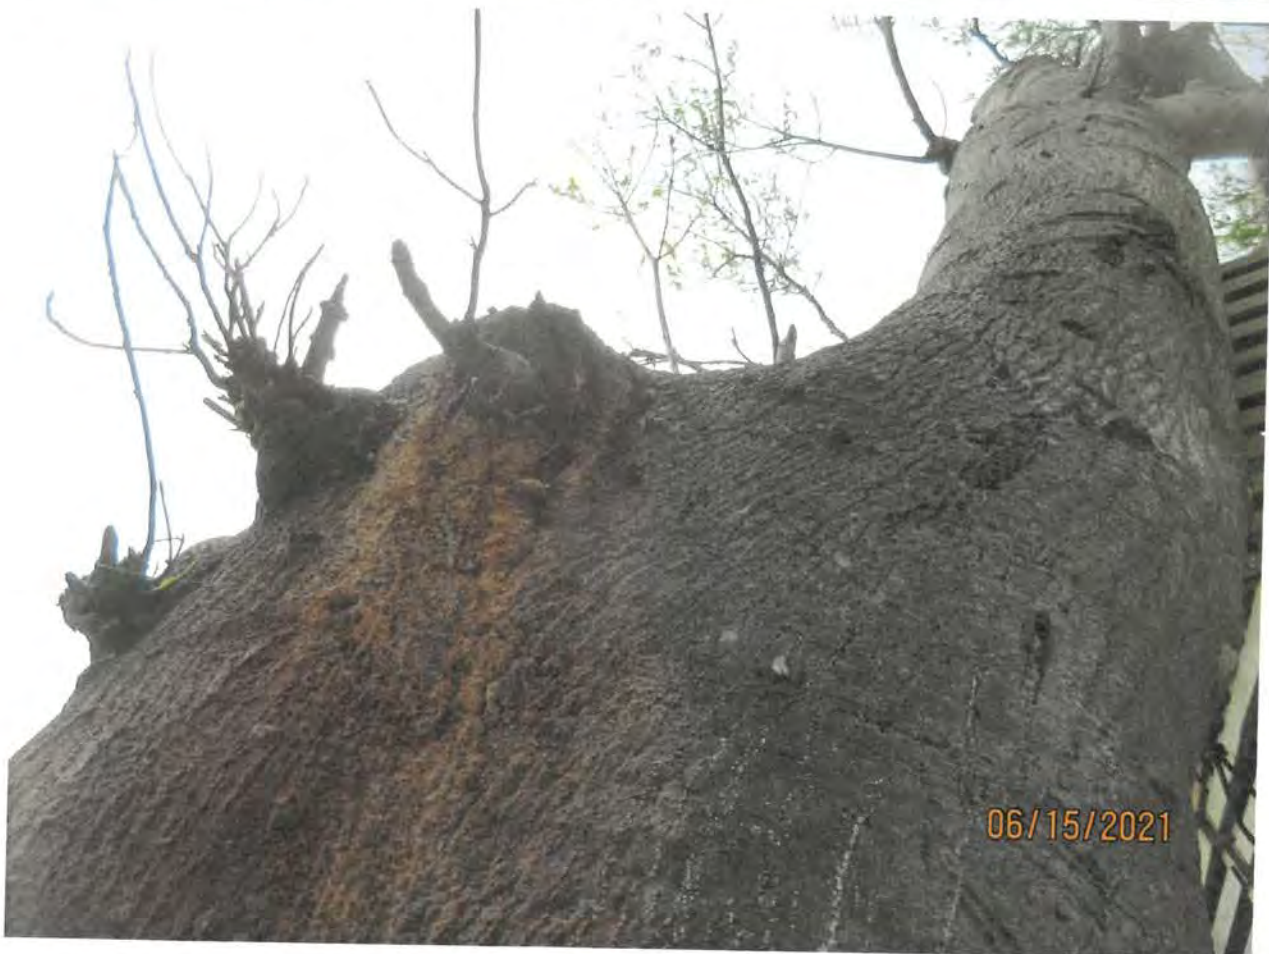
close up of
old damage
area on tree
trunk

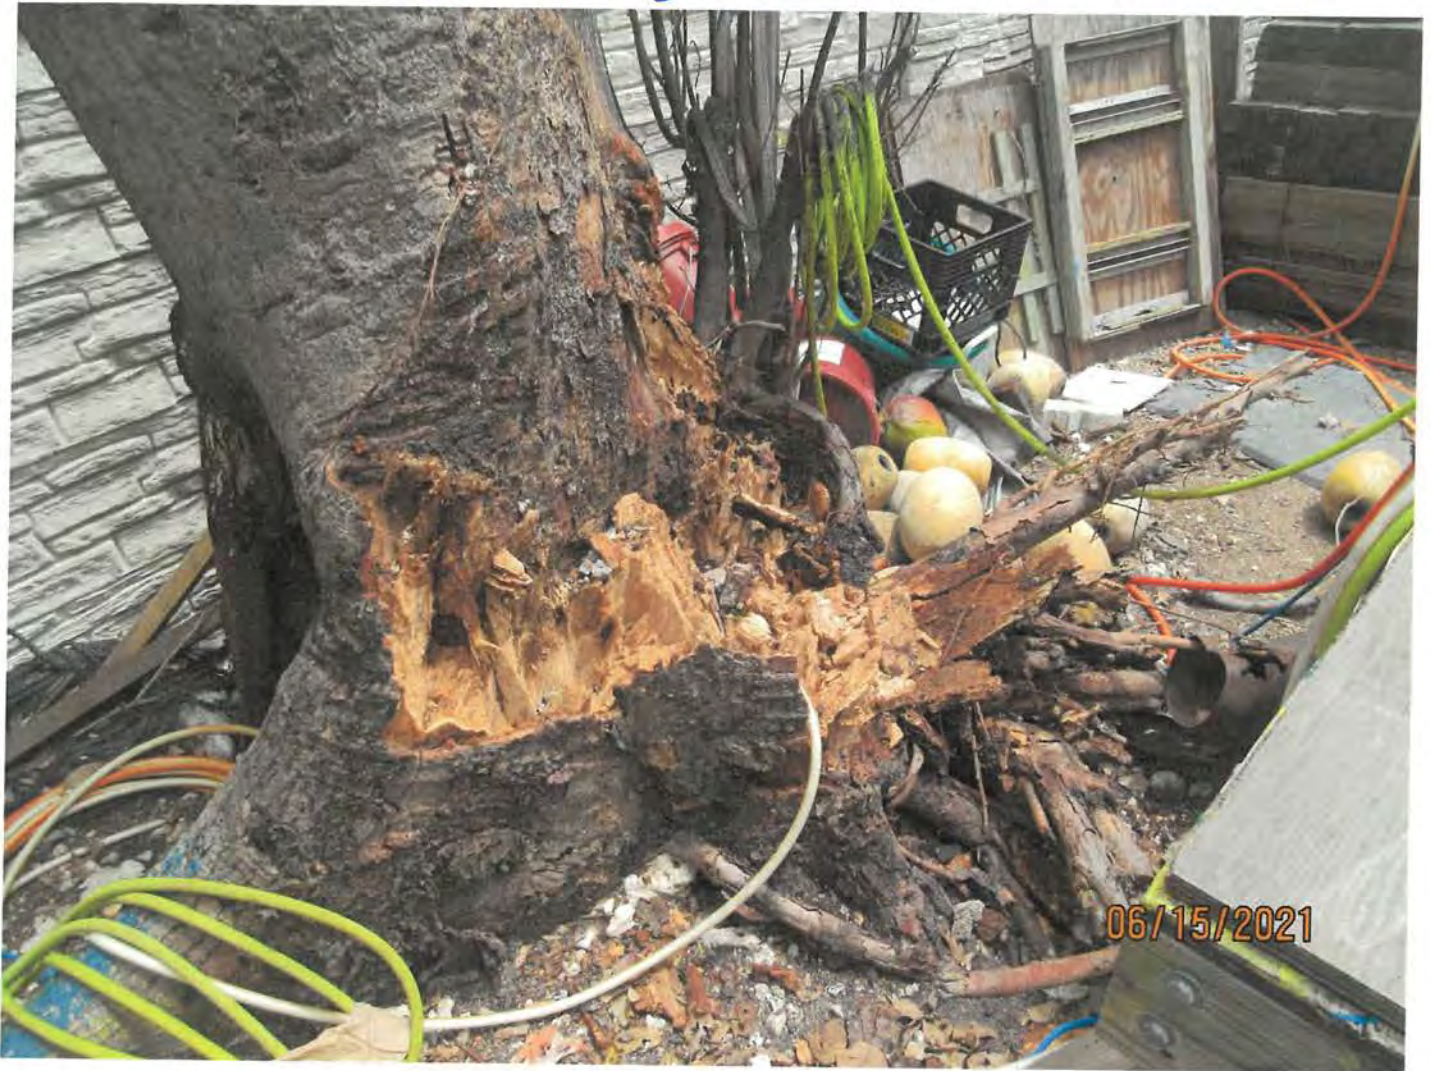
Photo showing base of area the broke off

This tree used to be a codominant trunked tree with included bark. City Seaport staff stated that a large amount of termites were observed in the base area of the tree in the section that broke off. Termites not observed in the remaining base pictured above during the inspection.

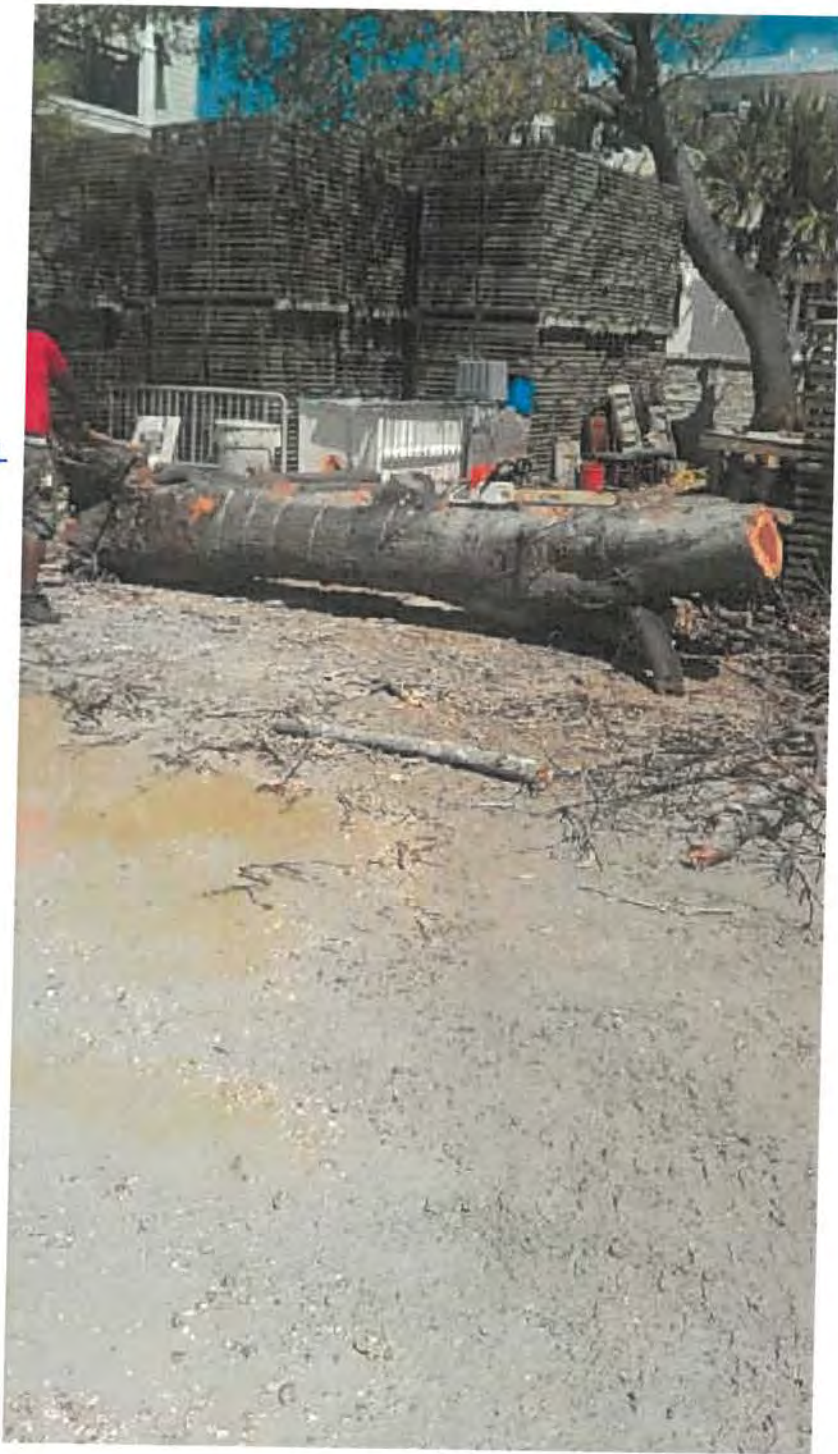
Section of tree that
broke off

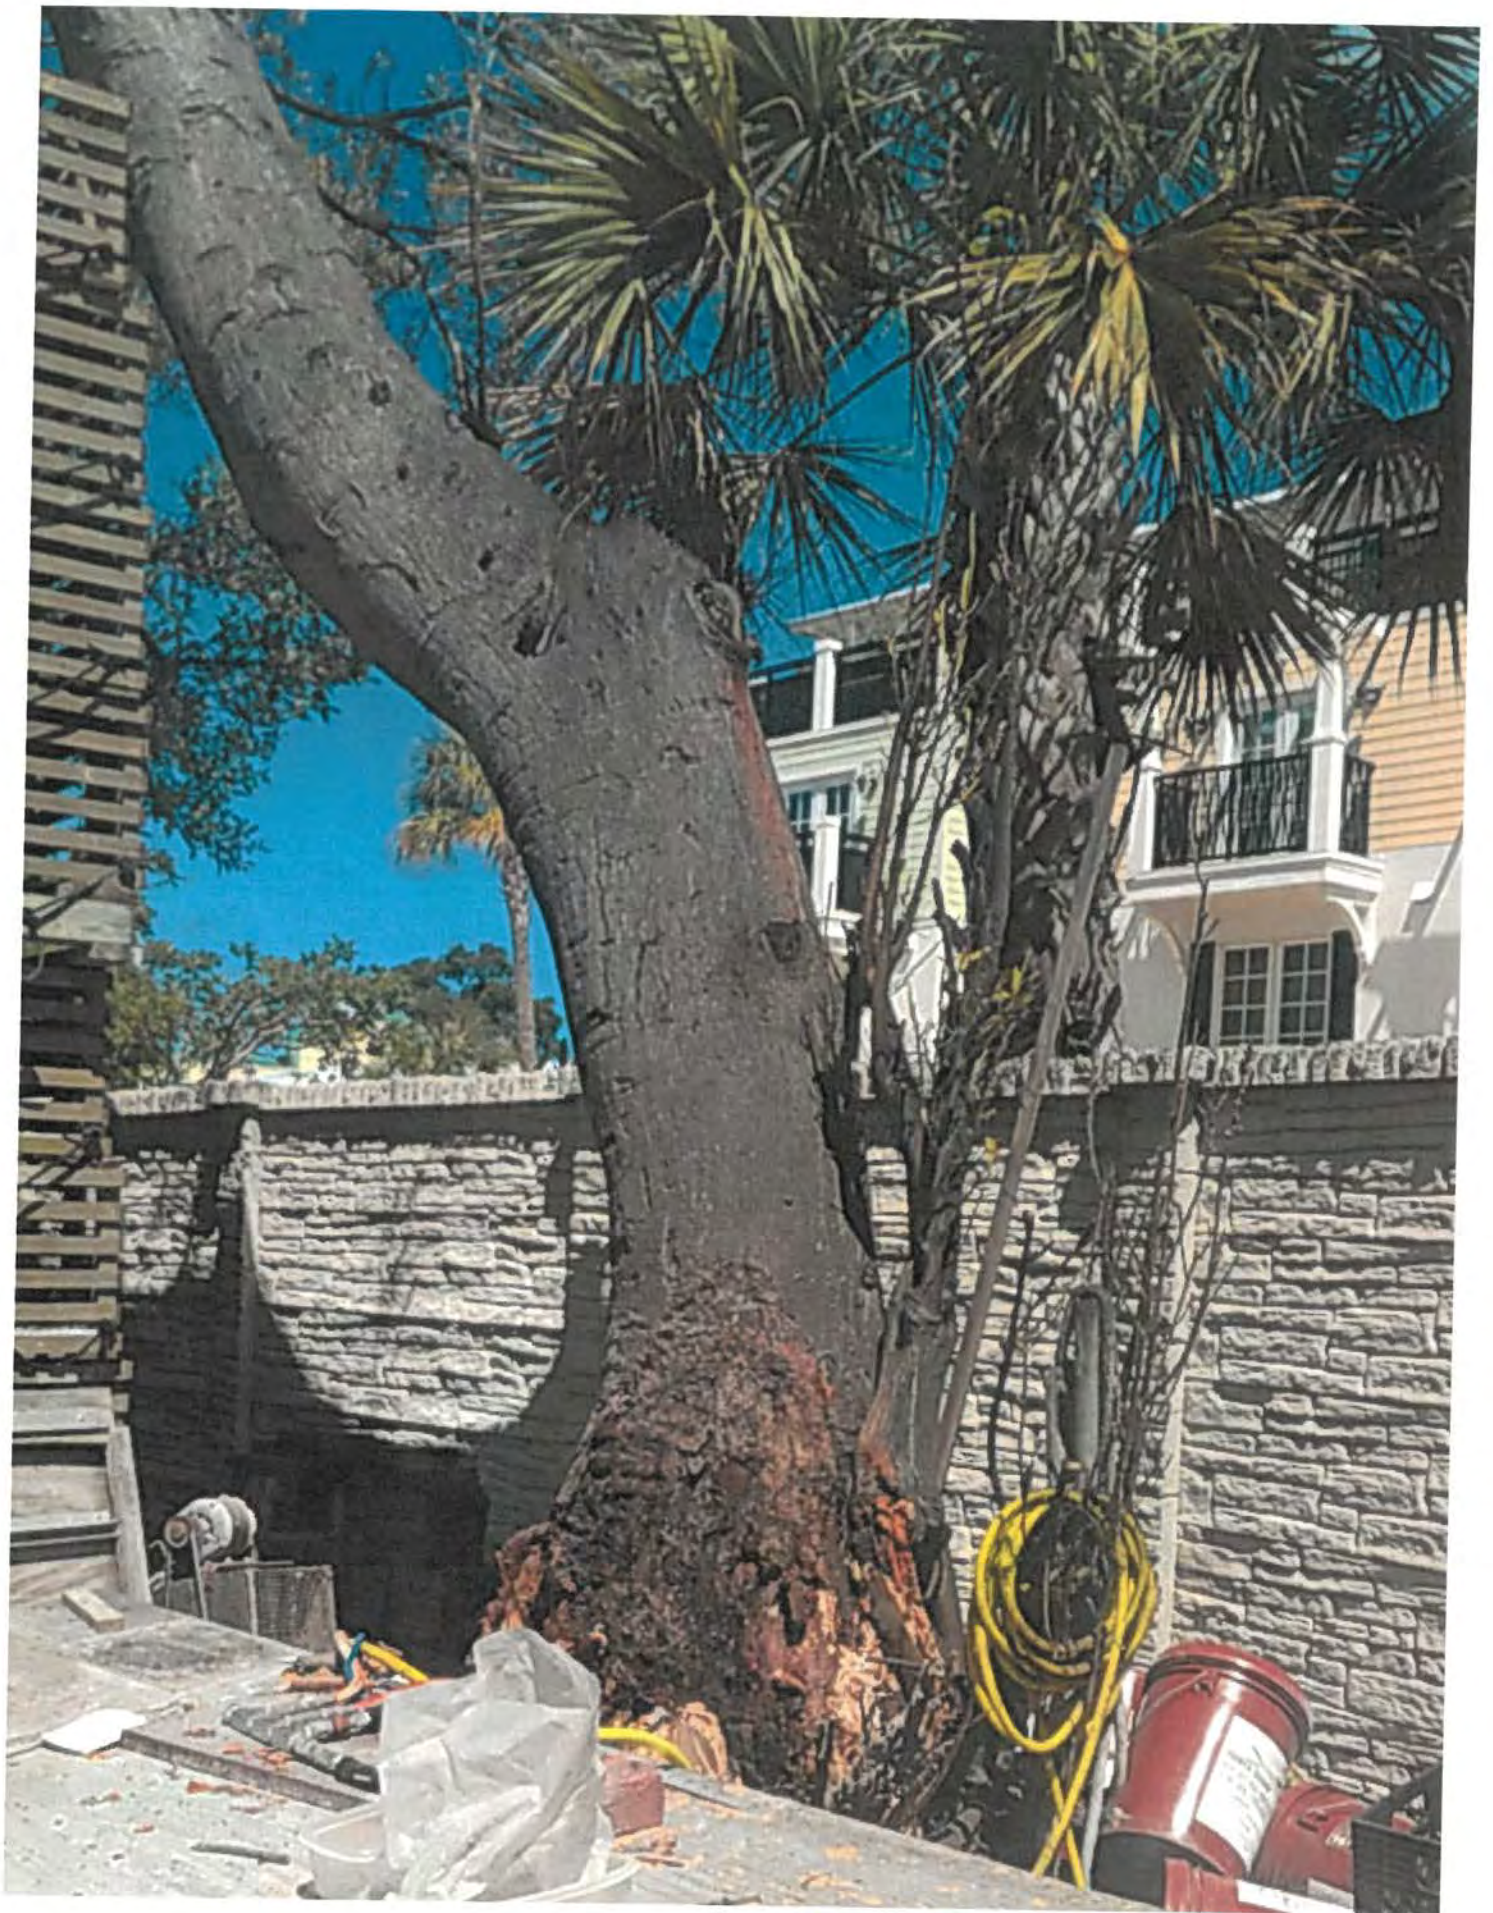
photo Fran crew showing
where tree broke.

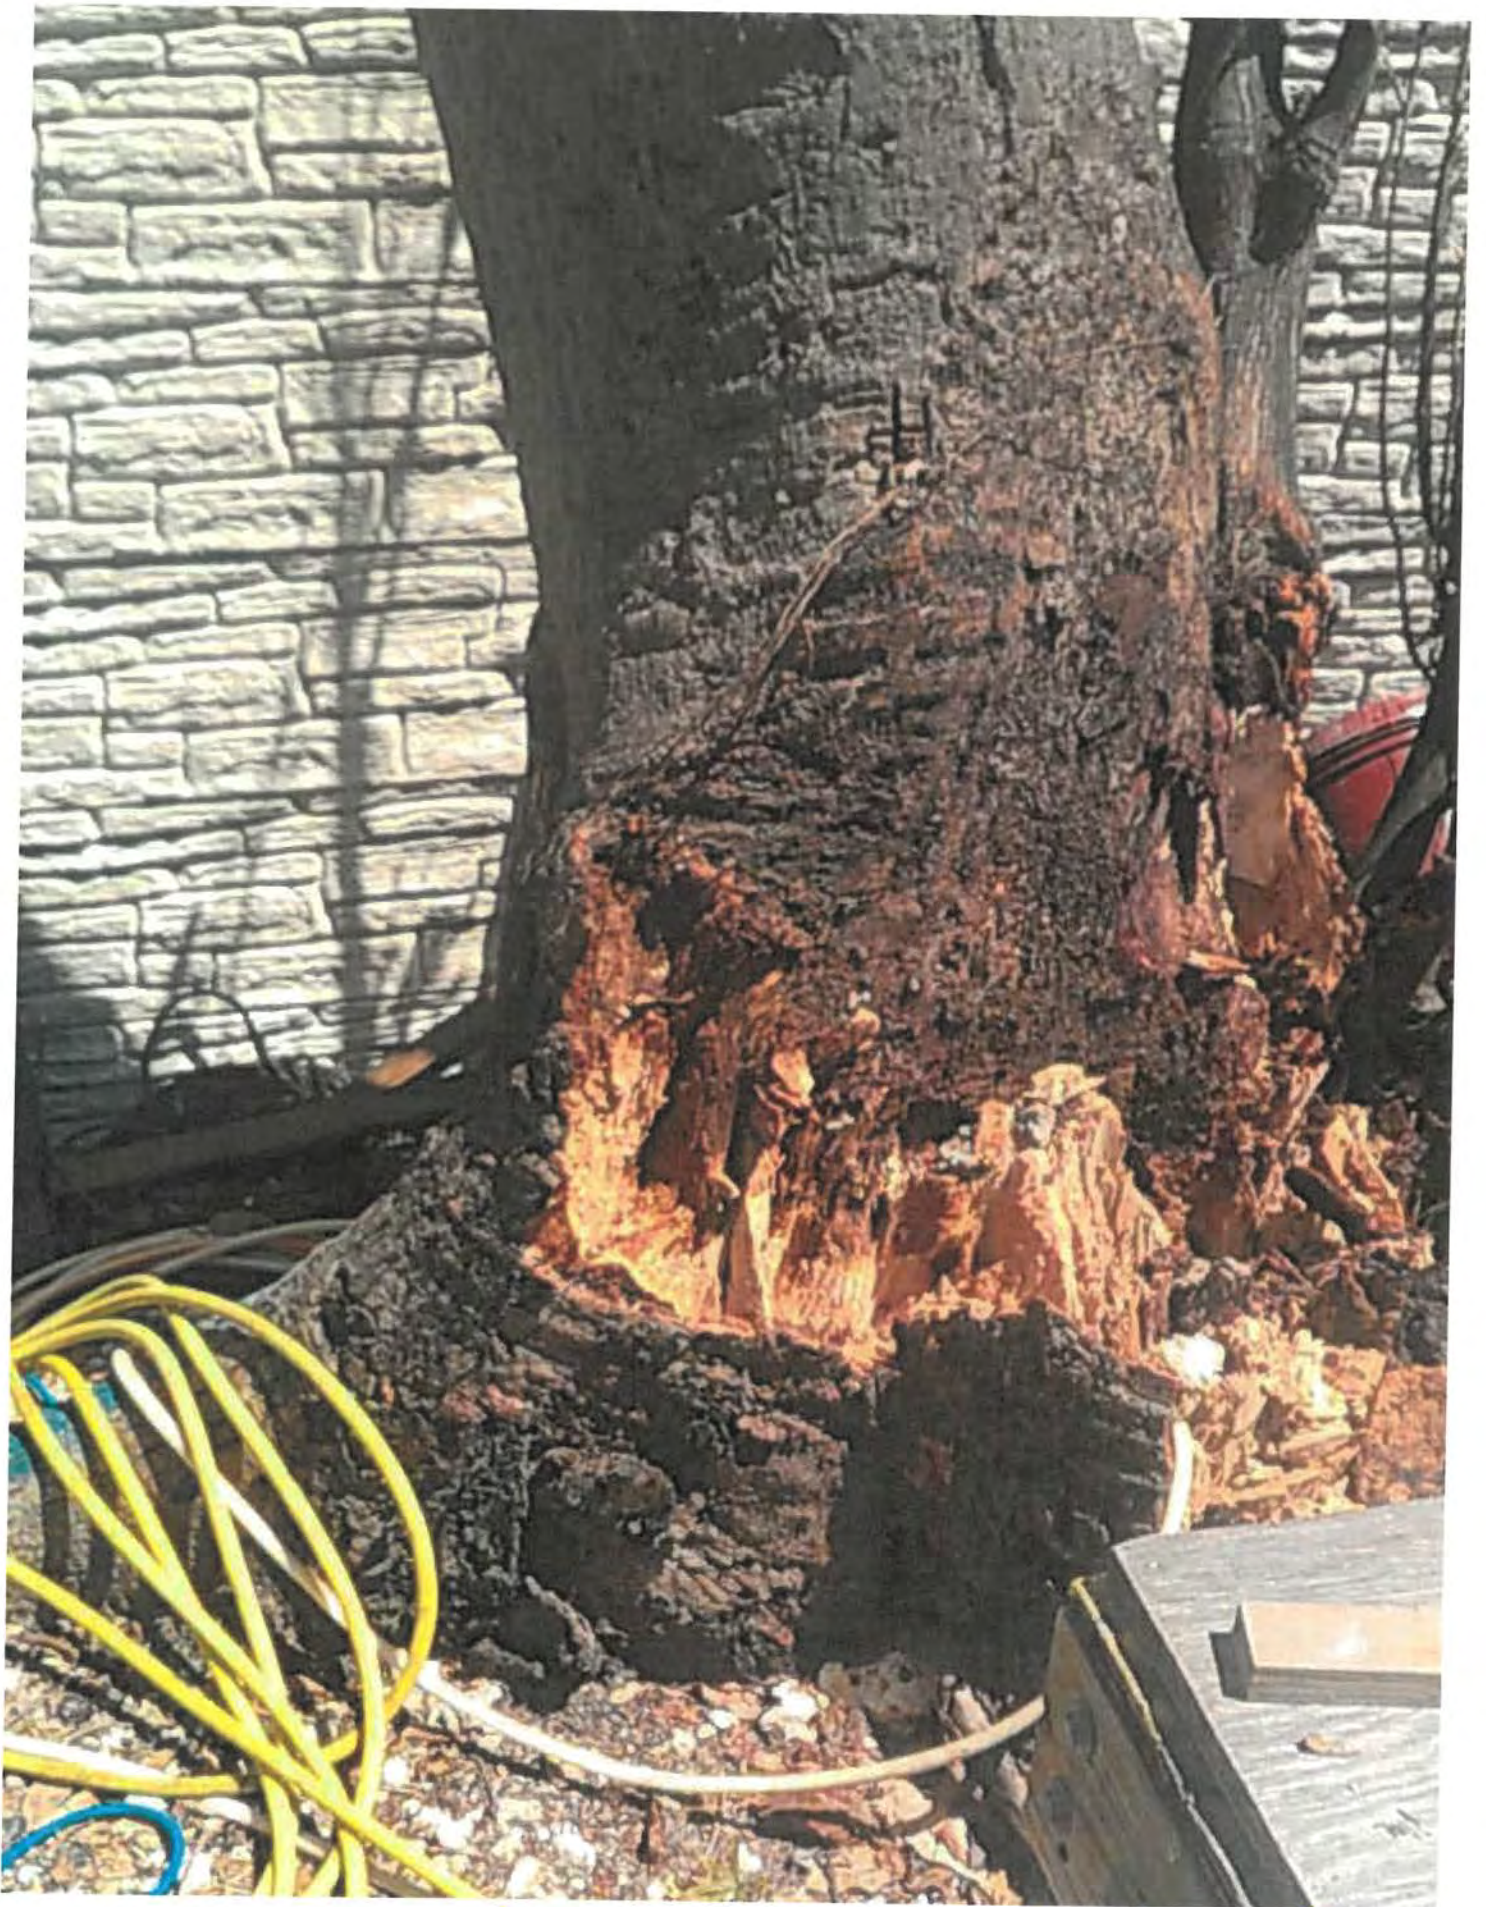
photo from crew⁴ - area where tree broke off.
