STAFF REPORT

RE: 613-631 Greene Street (permit application # T2021-0202)
(Tree located at 613 Greene)

FROM: Karen DeMaria, City of Key West Urban Forestry Manager

An application was received requesting the removal of (1) Strangler Fig tree. A site inspection was done and documented the following:

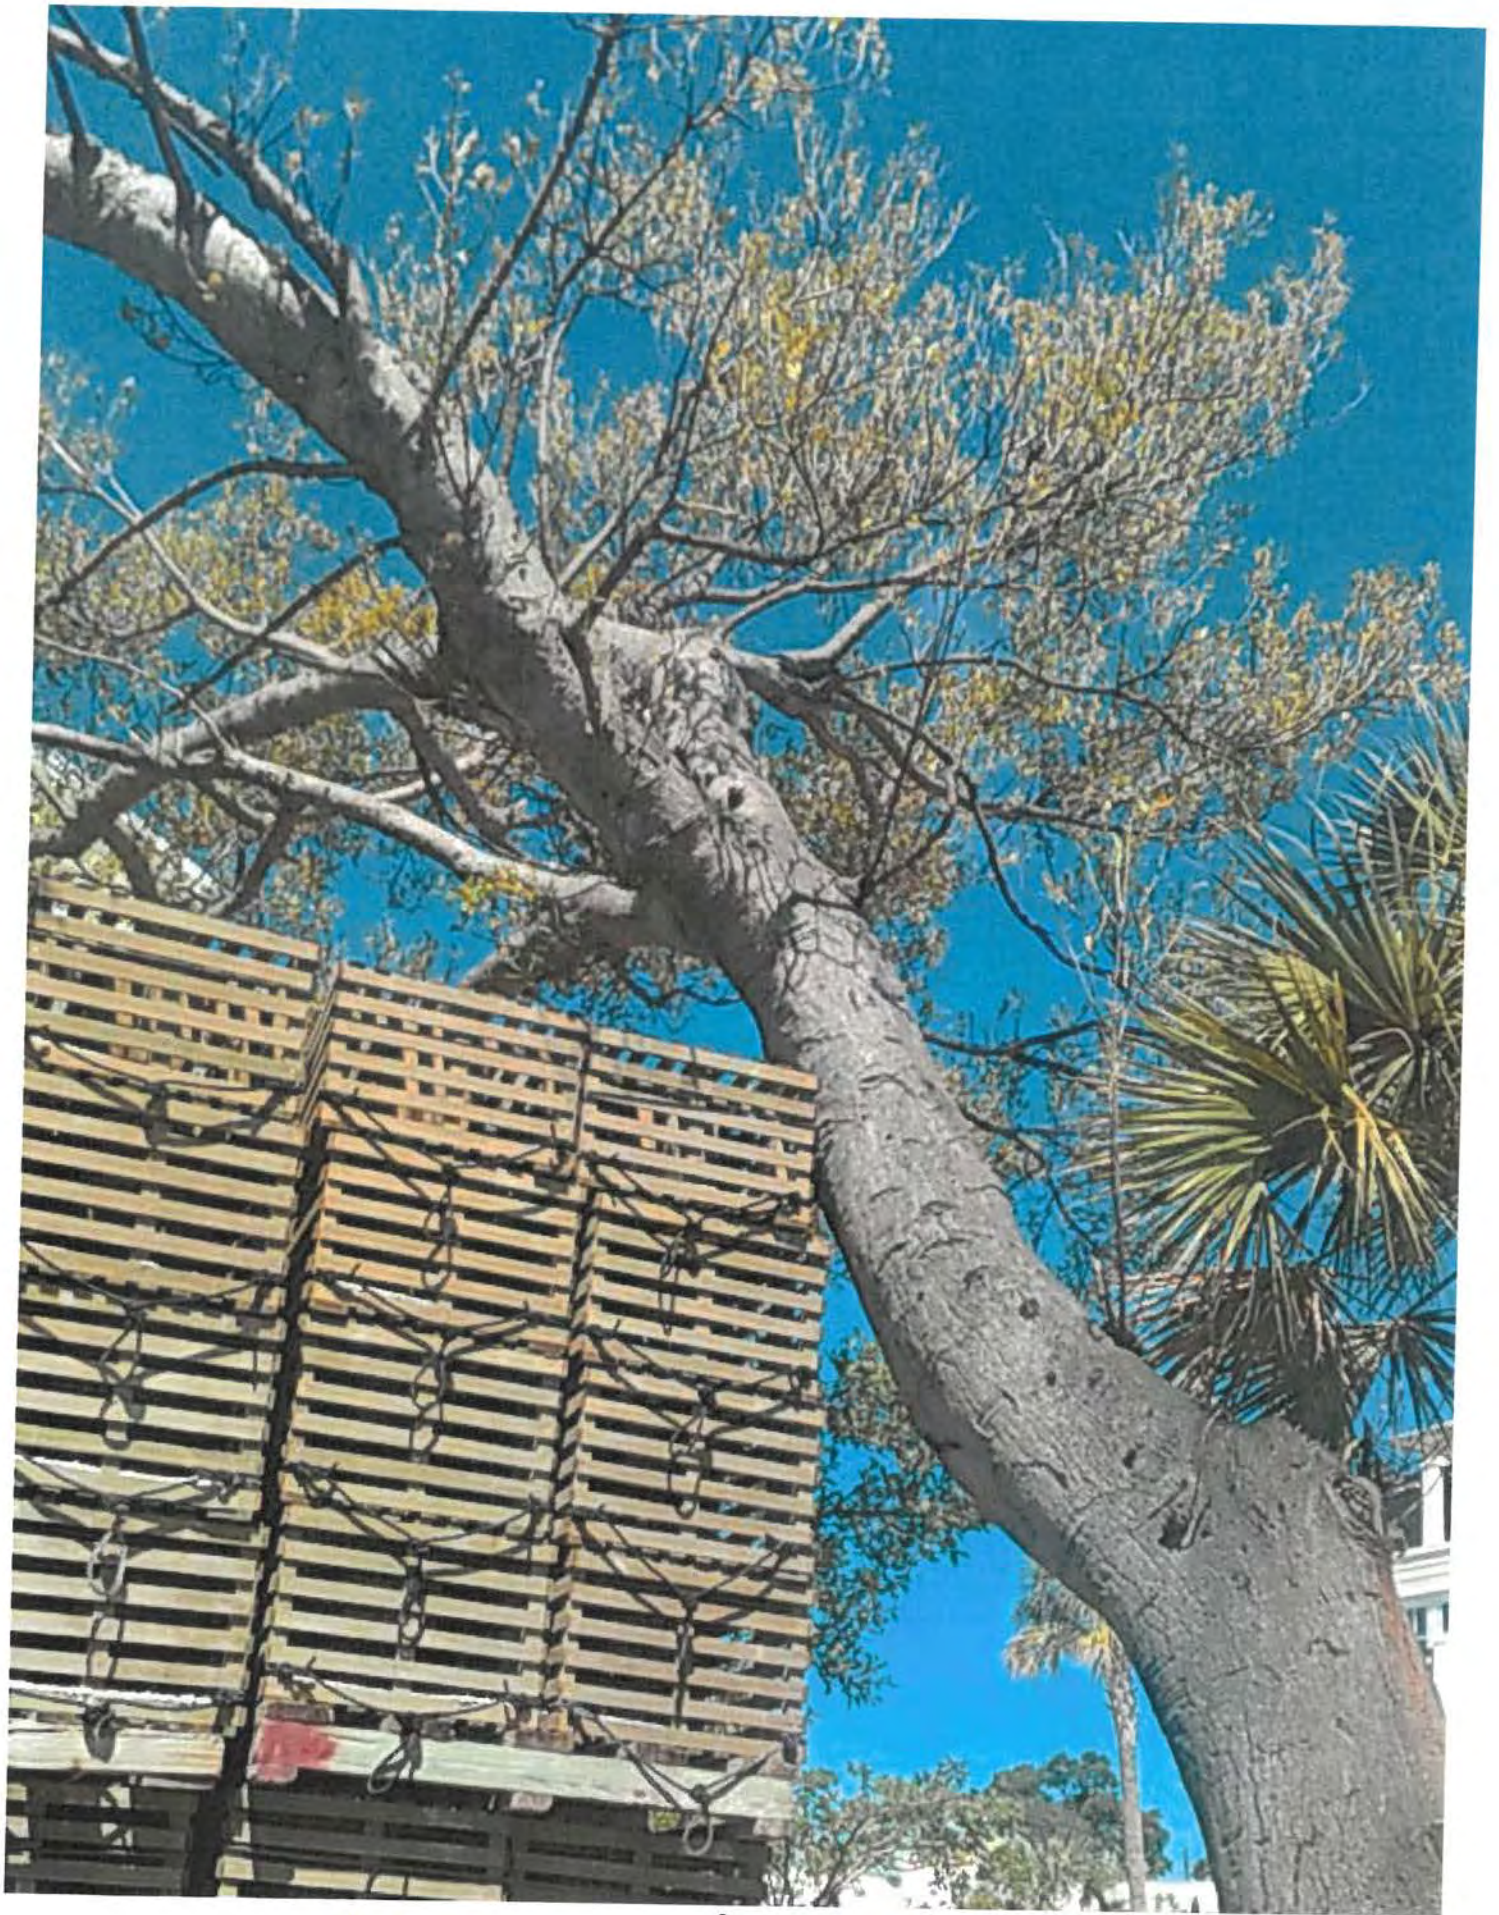
photo from crew - ³ shows remaining trunk.
